**North Carolina Department of Natural and Cultural Resources
State Historic Preservation Office**

SUBJECT: Historic Structures Survey Report, Widening of NC 210 from US 17 to South of SR 1518 (Old Folkstone Road), PA 17-10-0027, U-5949, Onslow County, ER 18-2088

HISTORIC ARCHITECTURE ELIGIBILITY EVALUATION REPORT

**TIP# U-5949: WIDEN NC 201 FROM US 17 TO SOUTH OF SR 1518
(OLD FOLKSTONE RD), ONSLOW COUNTY**

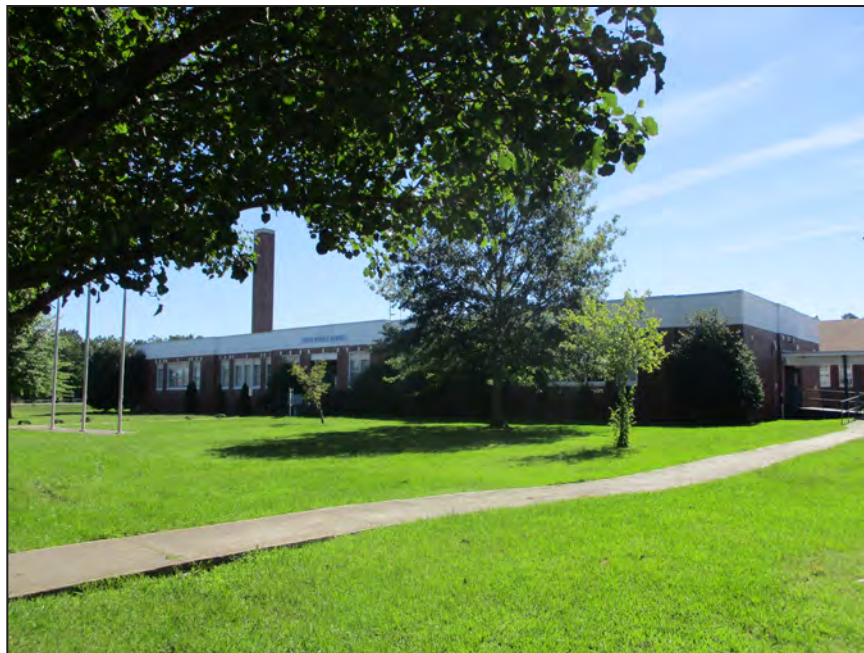
Photograph 1: Façade Dixon School; looking northeast. (2018)

The Front Hall's south elevation features a centered set of double metal doors (Photograph 1). The doors are flanked on either side by four, square concrete accent blocks; the top and bottom blocks are vertically aligned, and the east and west blocks are horizontally aligned. The top two blocks and bottom two blocks are connected by soldier courses of bricks, while the two blocks on the right and two blocks on the left are connected by a stack of bond course bricks. These blocks mimic the size and shape of the window openings seen on the façade.

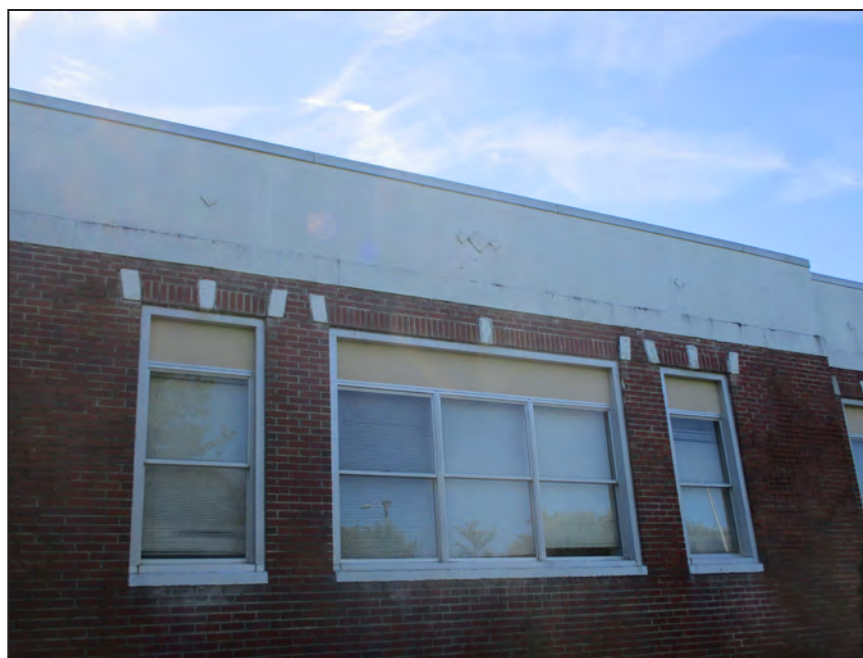
Photograph 2: Detail of window and cornice on Dixon School's Front Hall ; looking east. (2018)

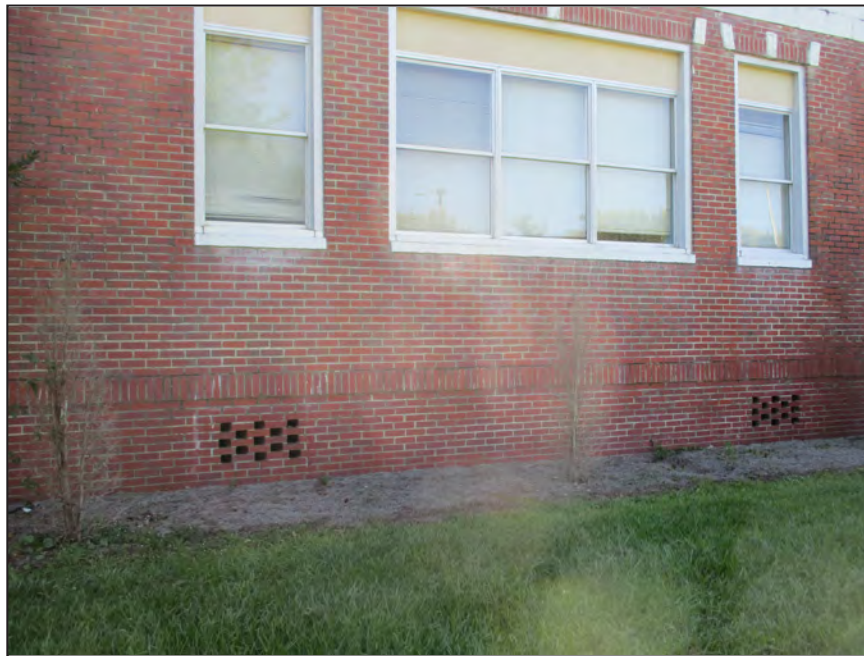
Photograph 3: Detail of water table on Dixon School's Front Hall; looking east. (2018)

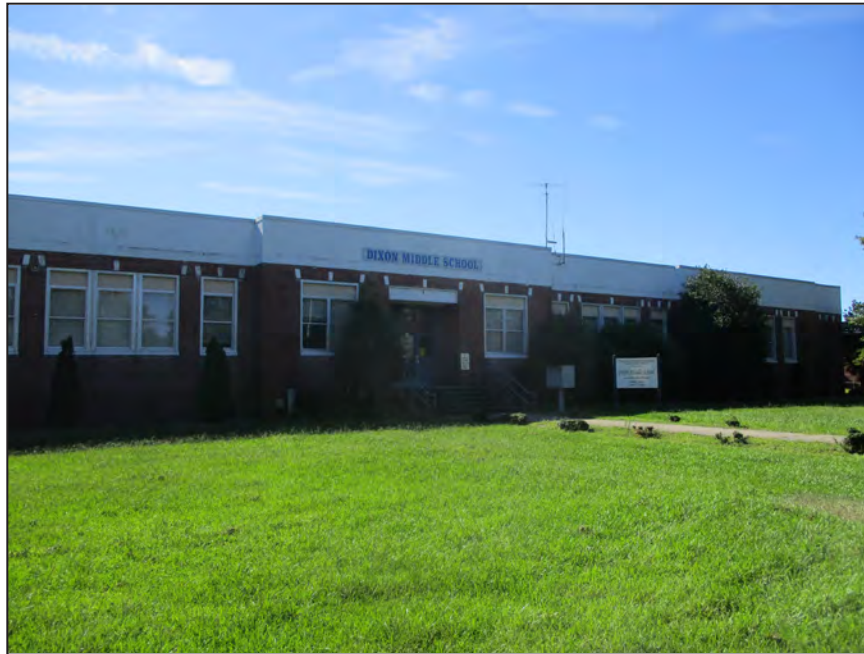
The Front Hall’s west-facing façade features stepped bays with the centered entrance bay projecting further than the other four bays. The entrance bay is comprised of a central recessed doorway flanked on either side by a pair of windows. Descriptions of the similar Tabernacle School detail a “stoop with fluted Doric columns, dentil moldings, and decorative balustrade above the cornice shelters the principal entry with sidelights and transom” (NCHPO 1996: 5). Although no longer extant, photographs from the late 1930s show similar details on the Dixon School entrance (Photograph 4). Today, the stoop has been replaced by a set of concrete steps leading to the recessed front entrance. The original wooden front door, sidelights, and transom have been replaced by a set of metal doors with single light separated by a metal and glass sidelight and topped by a metal and glass transom. The central entrance bay is flanked on either side by two bays. Each bay features a band of three windows flanked on both sides by a single window (Photograph 5).

Photograph 5: View of Front Hall façade; looking east. (2018)

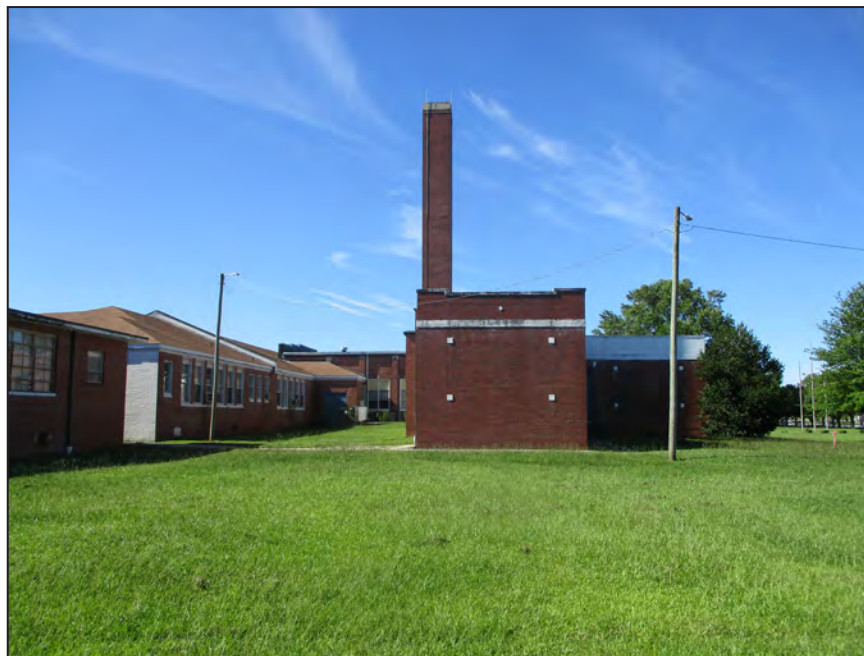
The north elevation features a set of double metal doors and one set of concrete accent blocks, apiece with those seen on the south elevation. The eastern half of the elevation consists of a rectangular brick boiler room. The north elevation of the boiler room features a concrete belt course and four, square concrete accent blocks apiece with those seen on the south elevation (Photograph 6).

Photograph 6: View of Front Hall and boiler room's north elevation; looking south. (2018)

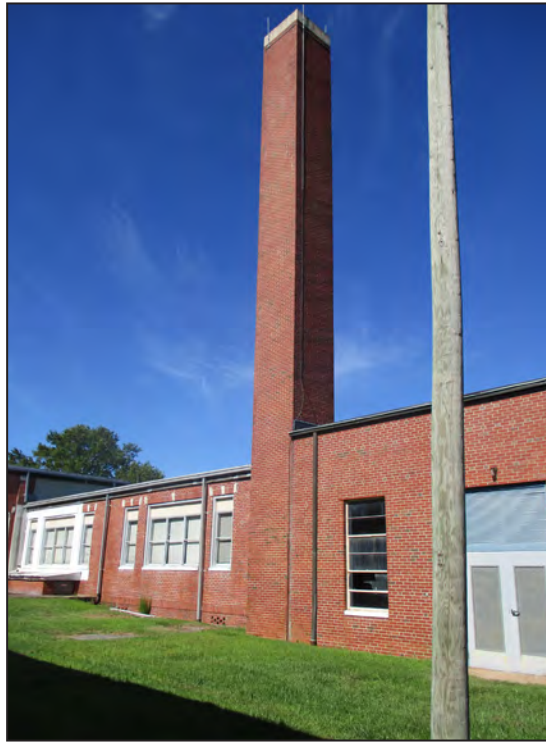
Photograph 7: View of east elevation of Front Hall and boiler room; looking southwest. (2018)

smoke stack is located at the northeast corner of the building and divides the main portion of the building from the boiler room (Photograph 7). The east elevation of the boiler room features a large, metal garage door and metal utility cabinet built into the wall north of center. A set of vented metal doors topped by a vented transom and a large rectangular six-light wood sash window are located south of center. The brick on this portion of the boiler room is laid in five-course Flemish bond (Photograph 8).

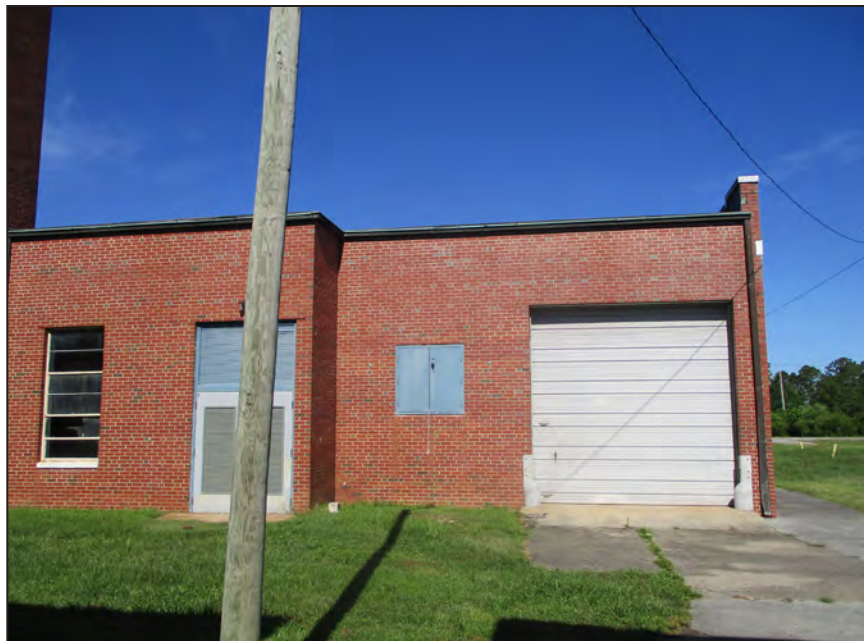
Photograph 8: View of boiler room's east elevation; looking west. (2018)

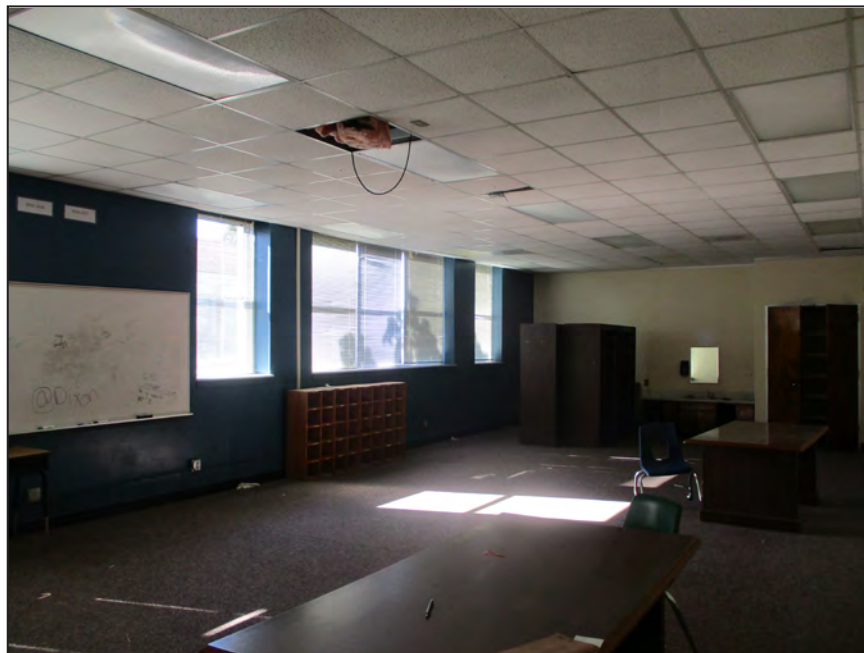
Photograph 9: View of interior of Dixon School's Front Hall; looking northwest. (2018)

The interior of the front hall has undergone some material alterations, but the floorplan remains largely unchanged. Drop ceilings, carpeting, and linoleum tile have been added in the hallways and classrooms. Some doors have been replaced by wood or metal doors, and the front office features built-in desks that appear to be later additions (Photograph 9).

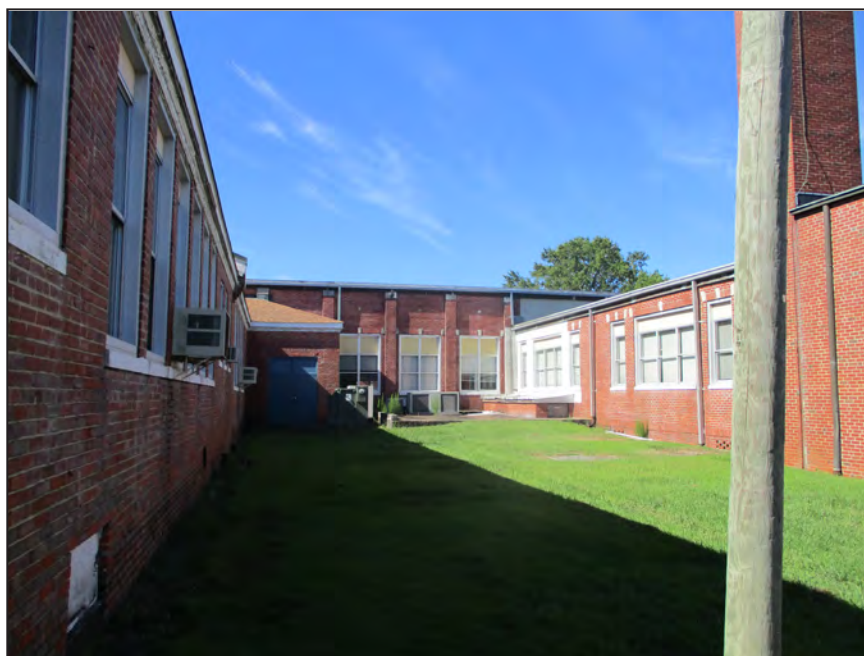
Photograph 10: View of the 1933 library addition; looking south. (2018)

to the 1945 addition (Spring 1996: 83-84). This one-story brick library is capped by a low-pitched gable roof. The north and south elevations of the library are identical and each feature four large six-light wood windows separated by brick and concrete pilasters. The windows are capped by soldier-brick jack arches with concrete keystones. Diamond-shaped concrete accent blocks adorn the walls between the windows and the roof (Photograph 10). The north and south elevations are not visible as they connect the original school to the 1945 addition.

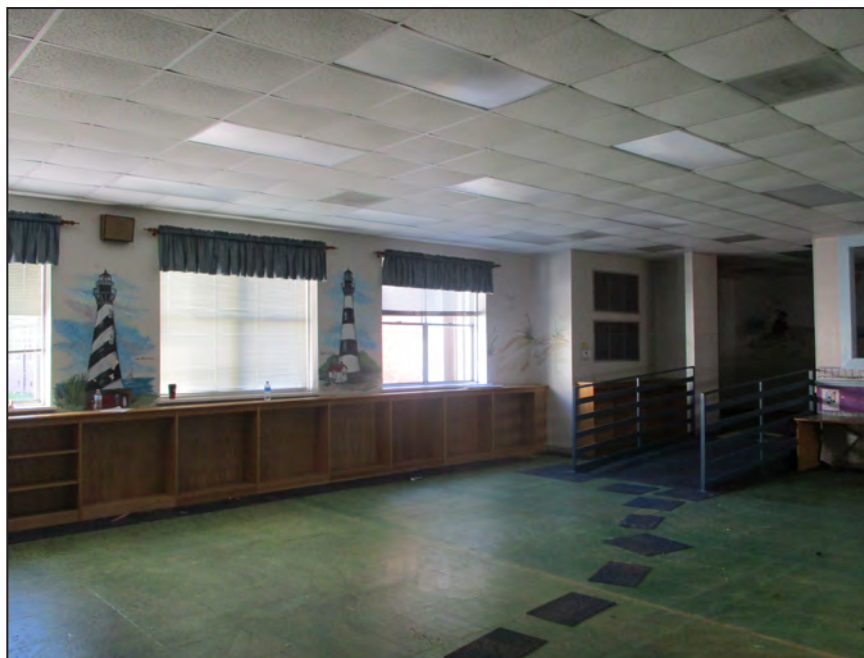
Photograph 11: Interior view of library addition; looking northeast. (2018)

The interior of the library addition has undergone some material alterations but retains its original floorplan. The library features drop ceilings and a linoleum floor that was later covered with carpet tiles. Many of the tiles have been removed for reuse in areas of the modern school. Door openings feature double metal replacement doors with a single light. Replacement built-in bookshelves line the walls beneath the windows, and a ramp was added in the northeast corner of the room to provide an ADA accessible entrance to the back hall (Photograph 11).

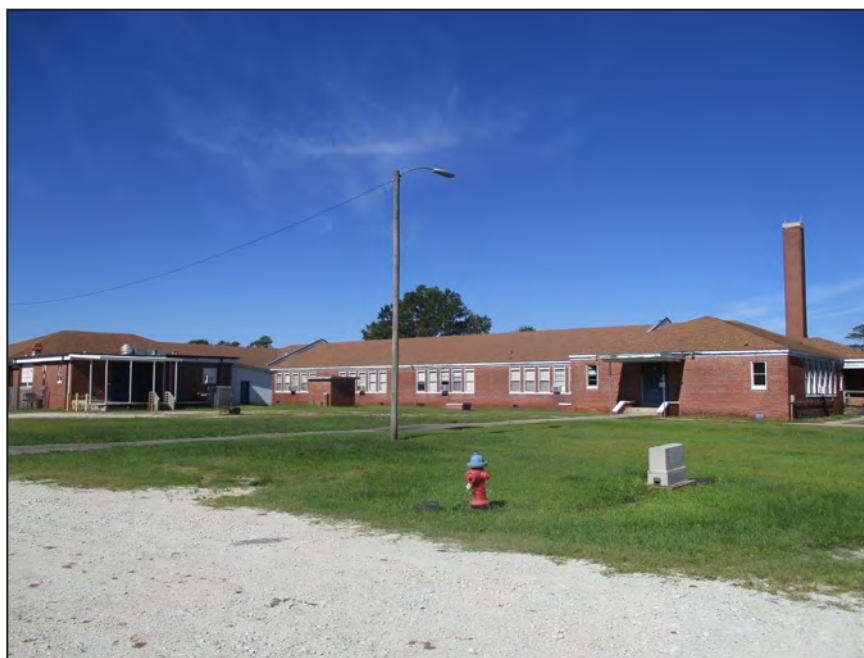
Photograph 12: View of the Back Hall's east elevation; looking west-southwest. (2018)

The window fenestration on the Back Hall's east elevation consists of four bands of evenly spaced sets of five replacement, one-over-one, metal, double-hung sash windows. Similar to the fenestration on the façade of the Front Hall, these replacement windows are smaller than the originals resulting in some infill at the top of the opening. The Back Hall's west elevation is partially covered by the library addition. The west elevation to the north and south of the library addition are identical. Each feature a set of five windows identical to those on the east elevation and a small projecting bay with a set of double doors.

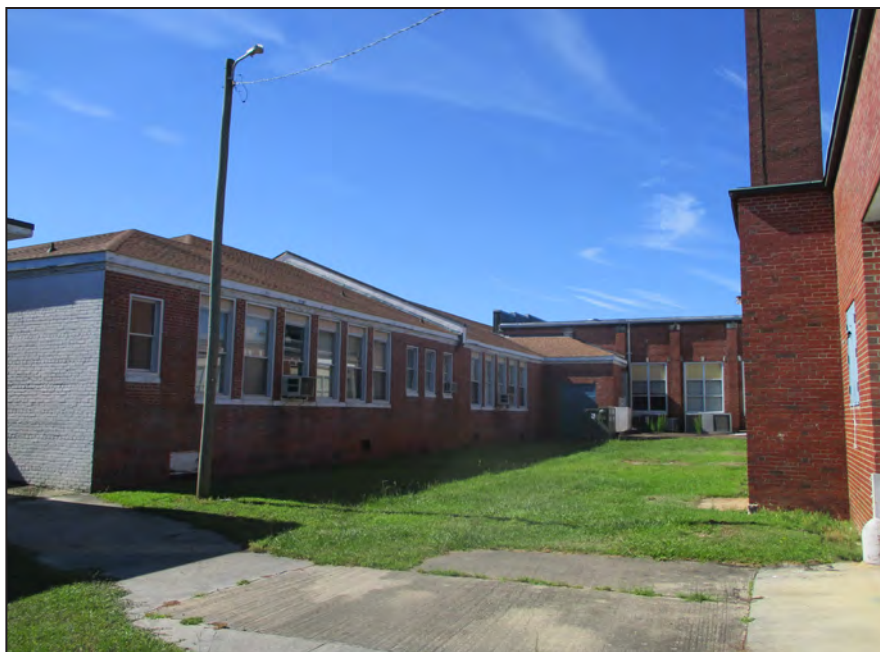
The north wing of the Back Hall is irregular in plan and capped by a hipped roof with a wide, wood cornice. The east elevation features a set of doors located south of center and flanked on either side by a single replacement, one-over-one, double-hung metal sash window. The double doors can be reached by a set of two concrete steps and are sheltered by a flat roof overhang. The wing's north elevation features a band of six replacement, one-over-one, metal, double-hung

Photograph 13: View of Back Hall and the Back Hall's north wing; looking southeast. (2018)

windows apiece with those located on the Back Hall's east elevation. A single original, six-over-six double-hung wood sash window is located west of the band of windows. A set of metal doors are topped by an original wood and glass transom. The doors are located west of the six-over-six window and are sheltered by a brick portico capped by a hipped roof and supported by square, brick columns. The west elevation features three groupings of windows. At the north end, is a single replacement, one-over-one double-hung metal window followed by a band of six replacement, one-over-one, double-hung, metal sash windows identical to those on the Back Hall's east elevation then a band of three replacement, one-over-one double-hung metal windows. The band of three windows are shorter than the individual window and band of six windows (Photograph 13).

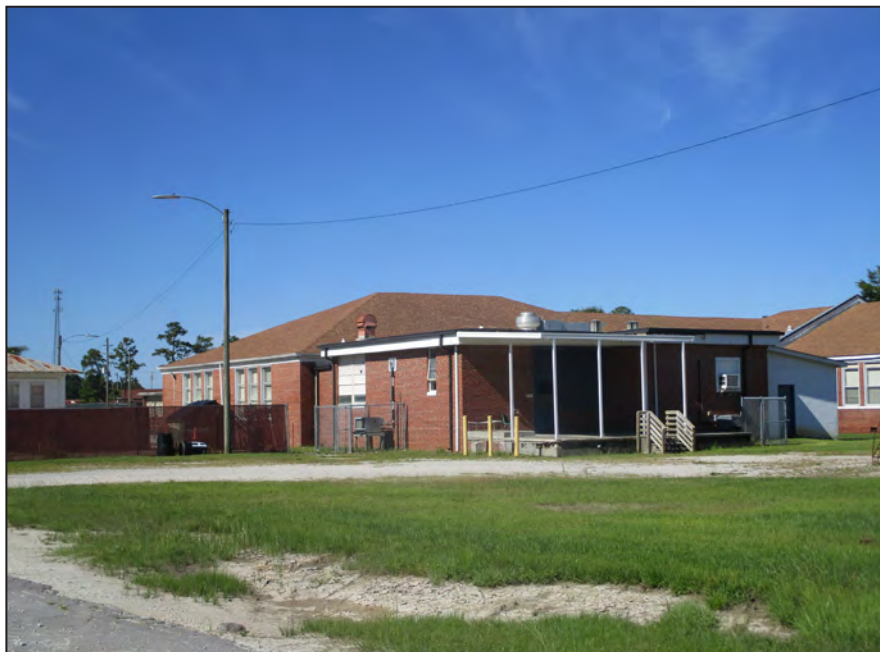
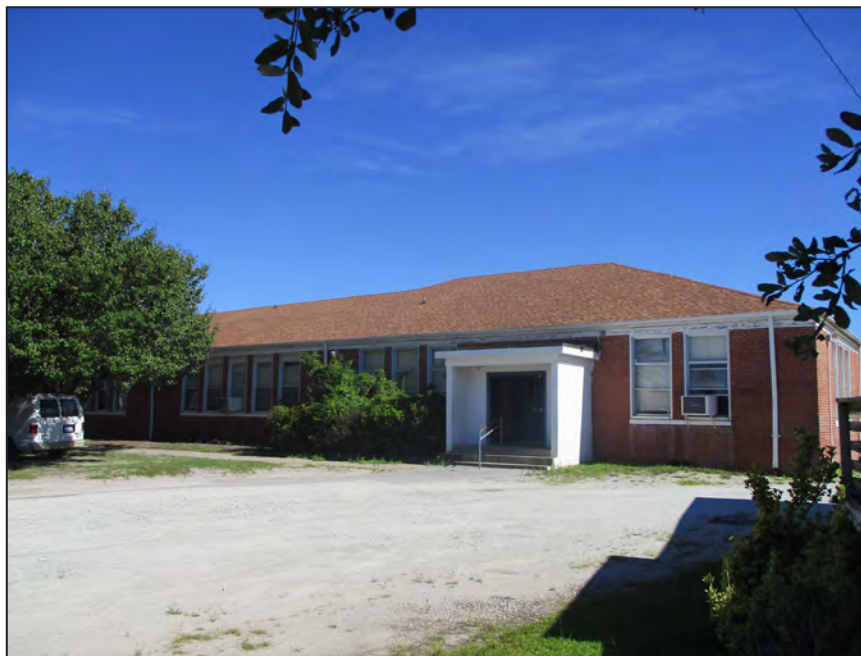
Photograph 14: View of Back Hall's south wing; looking southwest. (2018)

The south wing of the Back Hall is irregular in plan and capped by a hipped roof with overhanging eaves and a wide, wood cornice. The western section of the wing houses the cafeteria, also constructed in 1945. The south wing's east elevation features two bands of three replacement, triple-hung metal windows. The south wing's south elevation features a set of five replacement, one-over-one, double-hung metal sash windows located west of center and a band of three replacement, triple-hung metal windows east of center. Further east is a door opening sheltered by a shallow, concrete block entry porch capped by a flat roof. This entry porch is a later addition. East of the porch is a pair of triple-hung vinyl replacement windows. The south wing's west elevation features three groupings of windows. At the north end, is a band of three replacement, one-over-one double-hung metal windows followed by a band of six replacement, one-over-one double hung metal sash windows identical to those on the Back Hall's east elevation then a single replacement, one-over-one, double-hung, metal window. The single window and band of three windows are smaller than the band of six windows (Photographs 14 & 15).

Photograph 15: View of Back Hall's south wing; looking north-northwest. (2018)

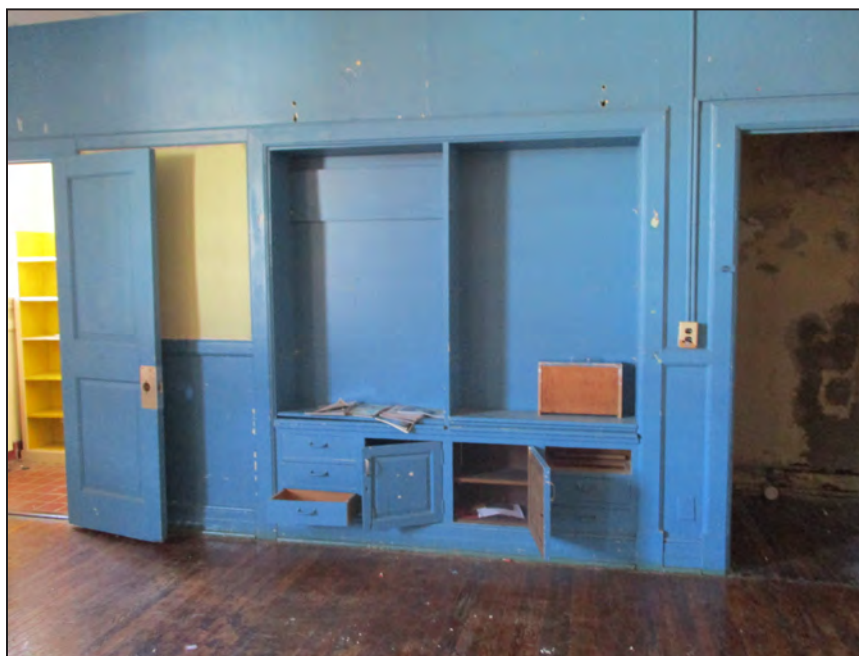
The interior of the back hall has undergone some material alterations, but the floorplan remains largely unchanged. Drop ceilings have been added throughout and metal lockers have been added in the hallways. Some doors have been replaced by wood or metal doors, and the front office features built-in desks that appear to be later additions. The back hall retains its original wood floors, which are in good condition. Classrooms still feature original baseboards, moldings and built-in

closest, cabinets, and chalkboards (Photograph 16). Original six-light wood windows located on the wall between the hallway and classrooms remain but are partially obscured by the drop ceilings (Photograph 17). Although the doorways leading outside have been replaced with double metal doors, they retain their original wood transoms (Photograph 18).

Photograph 16: Interior view of Back Hall. (2018)

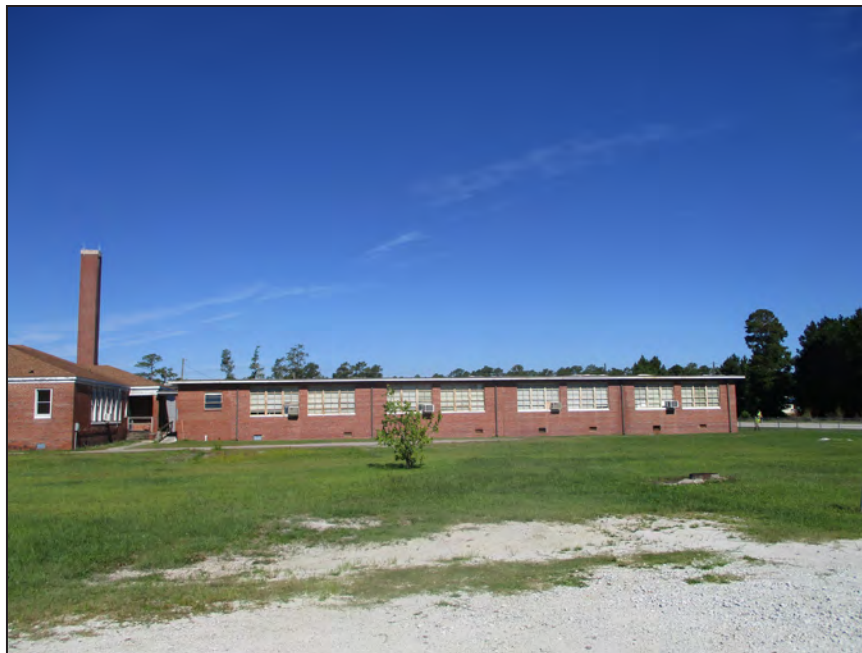
breezeway. Due to the location of the addition, it was likely constructed after the 1945 back hall was constructed, but before 1956 according to historic aerials. The addition is rectangular in plan and features five-course English bond brick. It is capped by a flat roof with wide overhanging eaves. Fenestration on the east and west elevations is identical. Each include eight bands of three original, four-over-four, metal, double-hung windows. Each window is topped by a two-light transom. The north and south elevations lack window openings, but each feature a set of double metal replacement doors topped by original wood transoms. The addition houses additional classrooms (Photograph 19).

Photograph 19: View of wing addition (ca. 1945-1956); looking west. (2018)

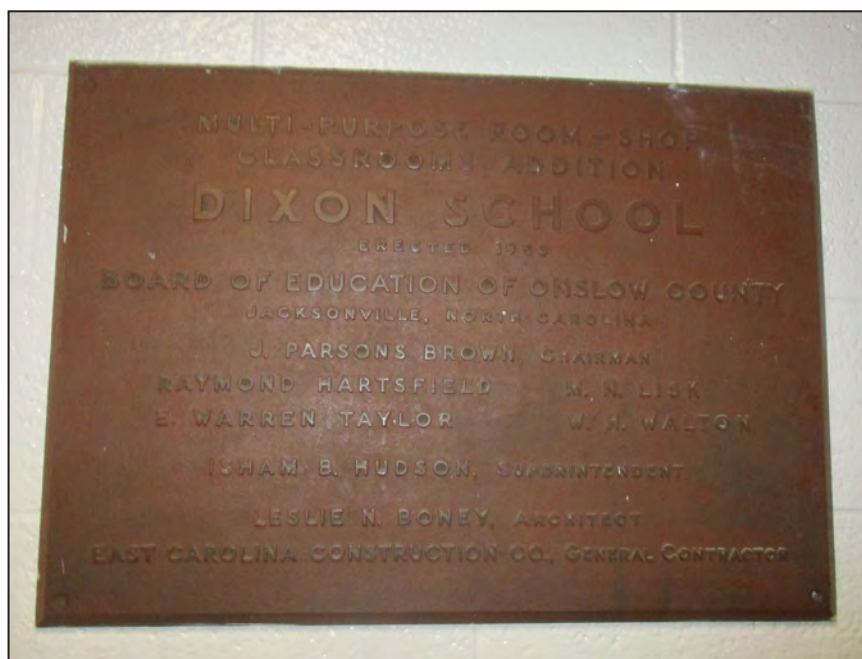
Photograph 20: View of plaque in 1953 classroom and gymnasium addition. (2018)

In 1953 a one-story addition was constructed south of the front hall and connected by an open breezeway. According to a dedication plaque, this concrete block addition originally featured a multi-purpose room (gymnasium) and shop classrooms (Photograph 20). The addition was designed by Leslie N. Boney and constructed by East Carolina Construction Company. The building is capped by a flat roof with wide, overhanging eaves, has prominent metal drain spouts and is clad in brick. The east and west elevations are identical. The brick on the bottom third of the building is laid in five-course Flemish bond,

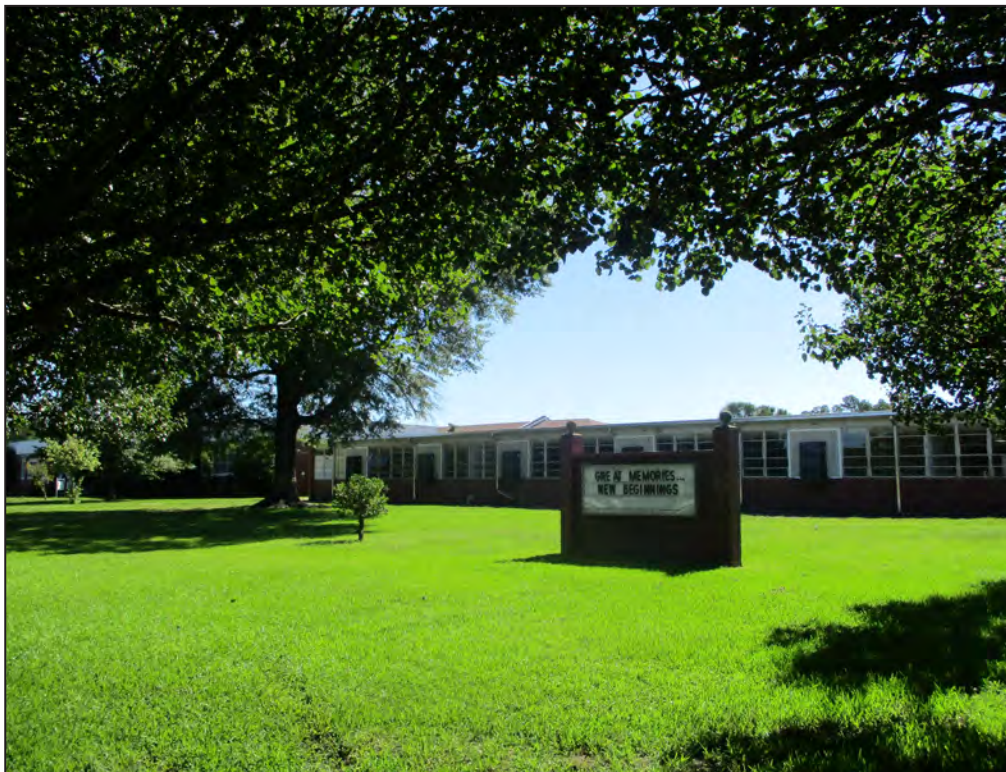
and the top two-thirds of the building is comprised of an almost uninterrupted wall of original, five-light horizontal pane, metal, awning windows. Originally uninterrupted, the window walls on the east and west elevations now feature concrete wall panels to accommodate large air-conditioning units. According to Google Earth, this alteration occurred sometime between December 2016 and July 2018 (Photograph 21).

Photograph 21: View of west elevation of 1953 classroom addition; looking east-northeast. (2018)

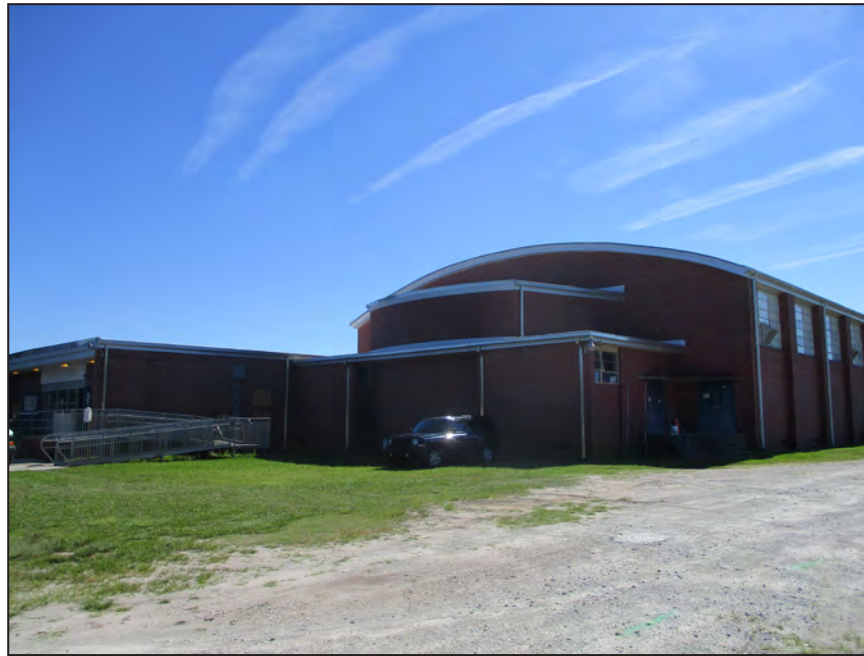
A one-story gymnasium lobby and a two-story stepped wing all capped with flat roofs are located off the west side of the gymnasium. The gymnasium lobby is comprised of a one-story square block with a large entrance. The entrance features two single metal doors separated by a large, original six-light, metal fixed window. The entrance be reached by a set of six concrete steps with a brick planter located off the north side and a concrete and brick ramp located off the south side. The two-story stepped wing contains the dressing rooms and backstage areas located behind the gymnasium stage. The west elevation of the wing features one small, original, six-light, metal awning window and two sets of original double, metal doors (Photograph 22).

Photograph 22: View of gymnasium lobby and west wing; looking northeast. (2018)

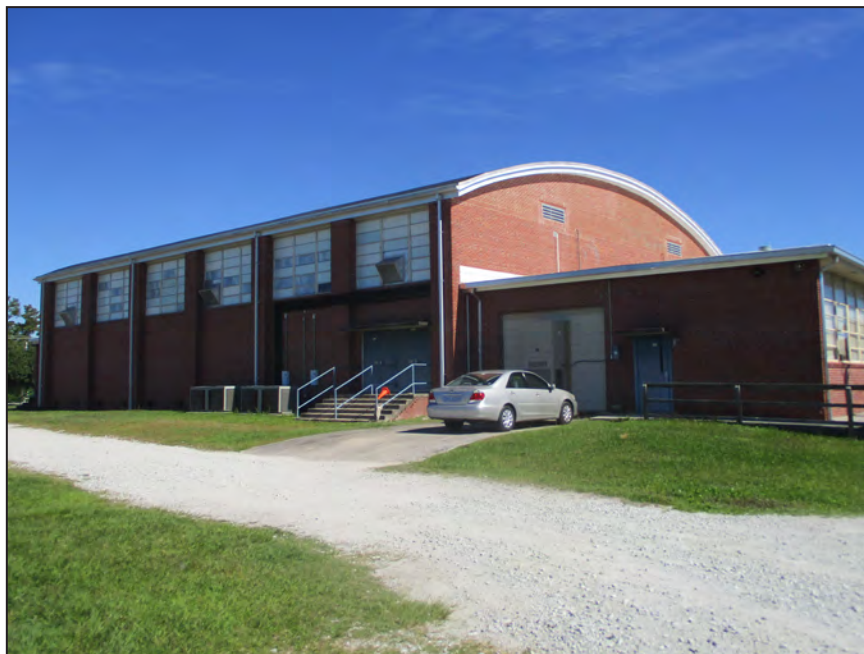
The south elevation of the gymnasium features six evenly-spaced bands of three original, six-light horizontal pane, metal, awning windows. The bands are separated by brick pilasters. Two sets of double, metal doors are located at the east end of the elevation. The doors can be reached by a set of concrete steps and are sheltered by a shallow, metal overhang (Photograph 23).

Photograph 23: View of gymnasium and band room's south elevation; looking northwest. (2018)

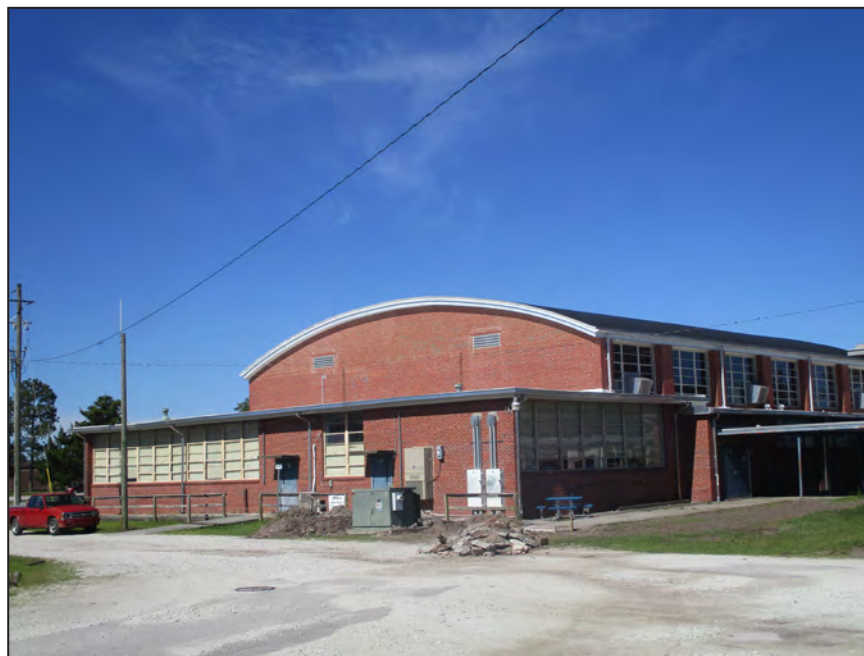
Photograph 24: Oblique view of gymnasium and band room; looking southwest. (2018)

Flemish bond brick and is capped by a flat roof with widely overhanging eaves. The south elevation of the band room features a large garage opening that has been infilled and now holds a large air conditioning unit. An original, metal door is located east of the garage opening and sheltered by a shallow, metal overhang. A band of ten original, six-light horizontal pane, metal, awning windows are located along the southern half of the elevation. Two original, metal doors are located on the northern half of the elevation and are sheltered by shallow, metal overhangs. Between the doors are a band of two original, six-light horizontal pane, metal, awning windows. The second floor of the gymnasium is visible above the roof of the band room and features two metal vents that were previously window openings (Photograph 24).

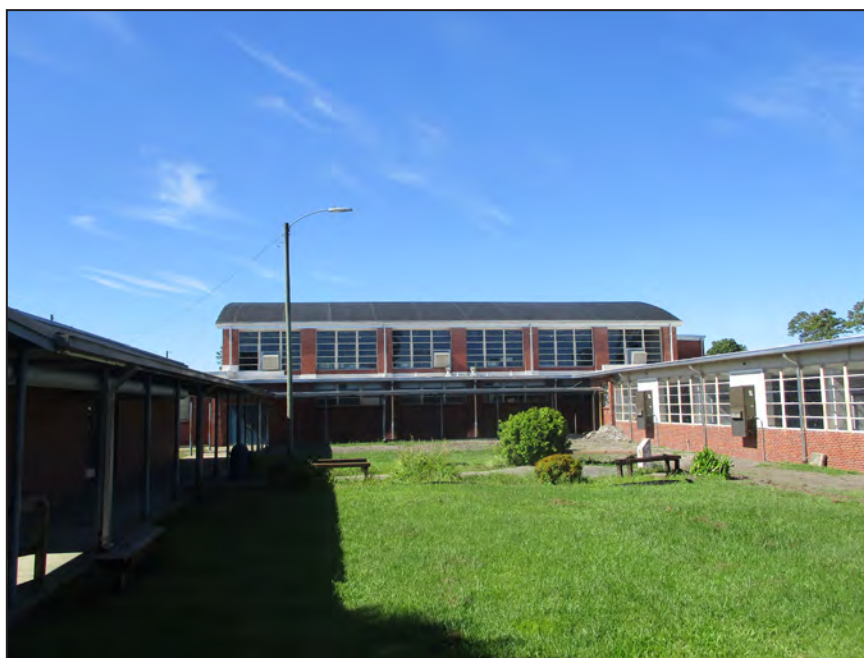
Photograph 25: View of gymnasium and north wing; looking south. (2018)

The first floor of the gymnasium's north elevation is completely obscured by the one-story wing containing additional classrooms. The wing features three bands of three original, three-light horizontal pane, metal, awning windows. A set of original double metal doors are located on the east end of the elevation. The north elevation of the band room features a band of seven original, six-light horizontal pane, metal, awning windows. The second floor of the gymnasium is visible above the roof of the wing addition and features six bands of three original, six-light horizontal pane, metal, awning windows. Each band of windows is separated by a brick pilaster (Photograph 25).

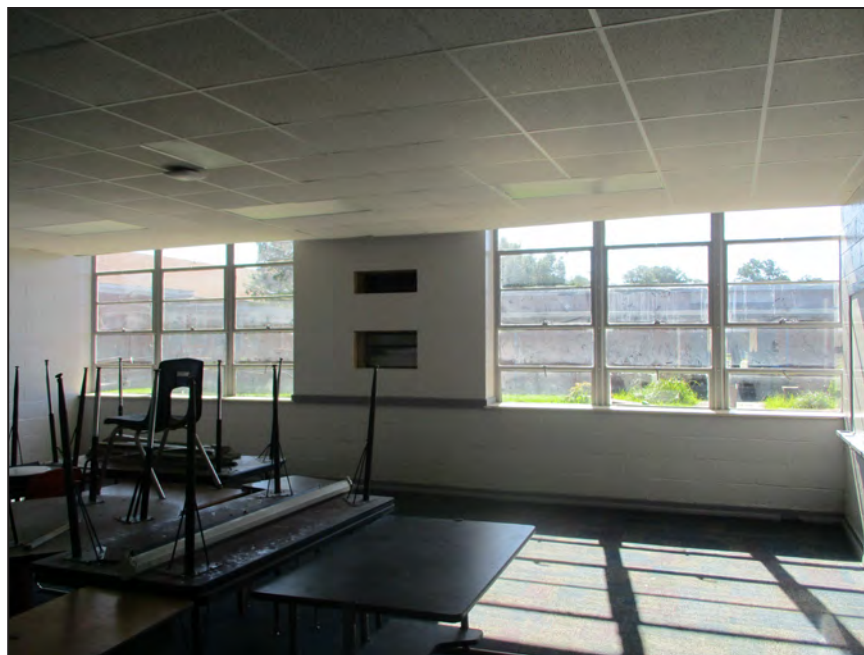
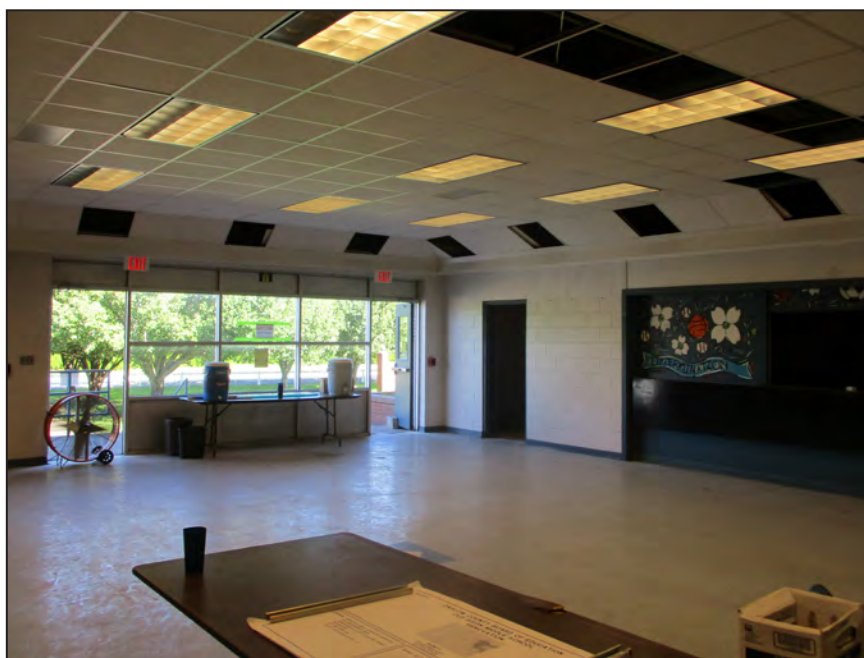
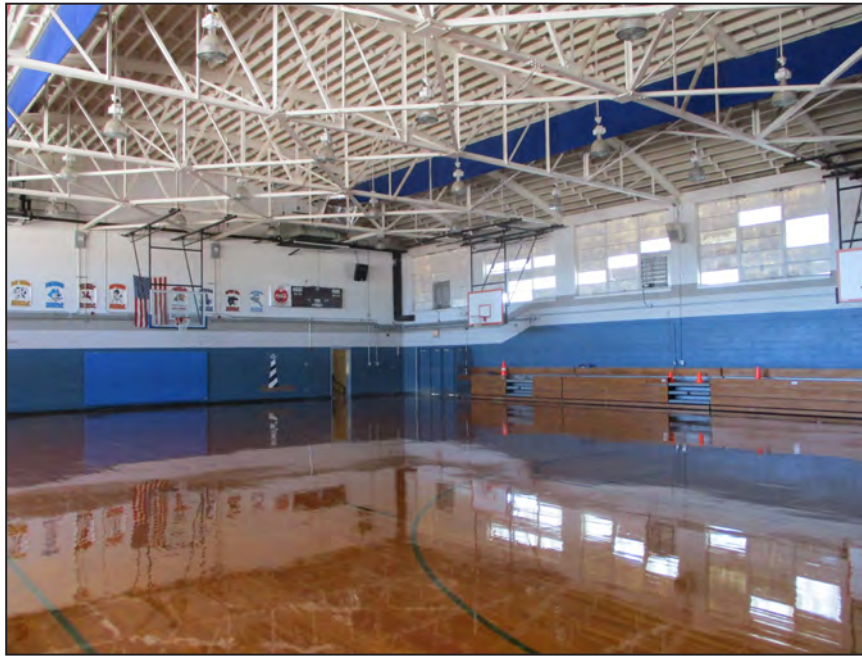
Photograph 26: Interior of 1953 classroom addition; looking east. (2018)

Photograph 27: Interior view of gymnasium lobby; looking northwest. (2018)

Photograph 28: Interior of 1953 gymnasium addition; looking southeast. (2018)

The interior of the 1953 addition has undergone some material alterations, but the floorplan remains largely unchanged. Drop ceilings have been added throughout the space and some windows have been removed and replaced with dry wall and air conditioning units. The original windows and concrete block walls remain. The interior of the gymnasium features original floors and concrete block walls. Wood and metal bleachers line the north and south walls. The gym and lobby retain the original floorplan (Photographs 26-28).

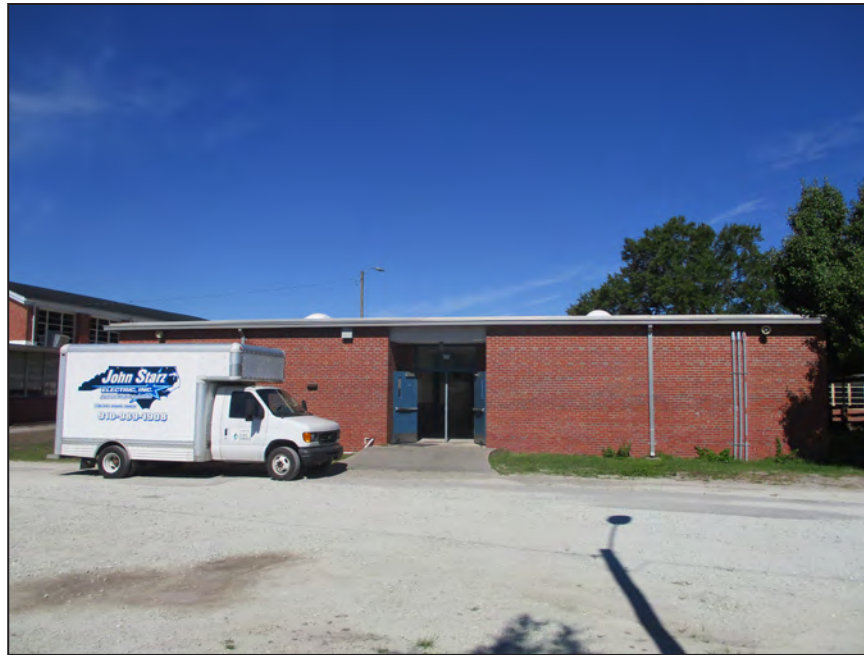
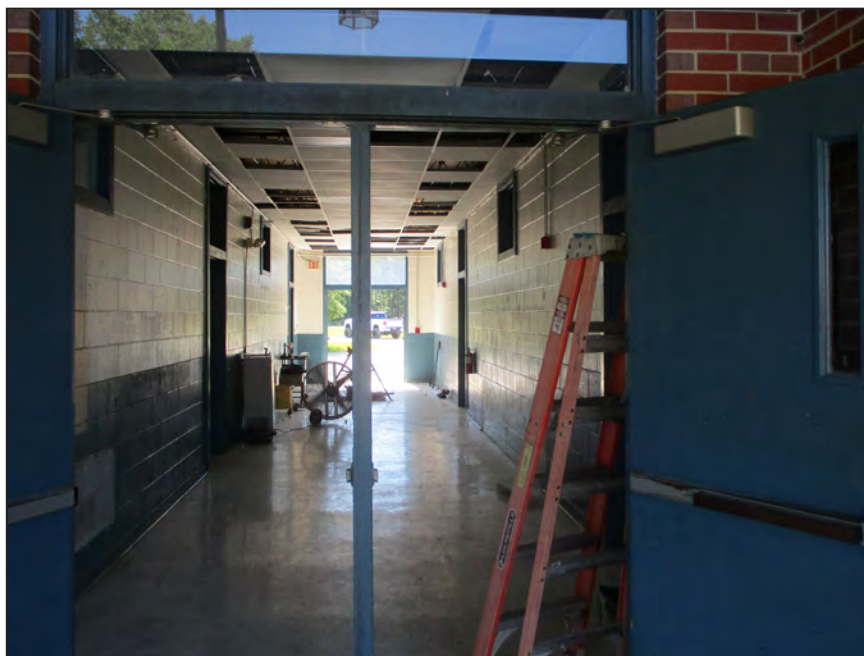
Photograph 29: View of Annex's east elevation; looking west. (2018)

An annex was constructed circa 1958 in the space south of the back hall, west of the 1953 addition, and north of the gymnasium. The one-story brick building is connected to the gymnasium and Back Hall via a covered walkway. It features original, six-light horizontal pane, metal, awning windows on all elevations (Photographs 29 & 30).

Photograph 30: Interior view of Annex; looking east. (2018)

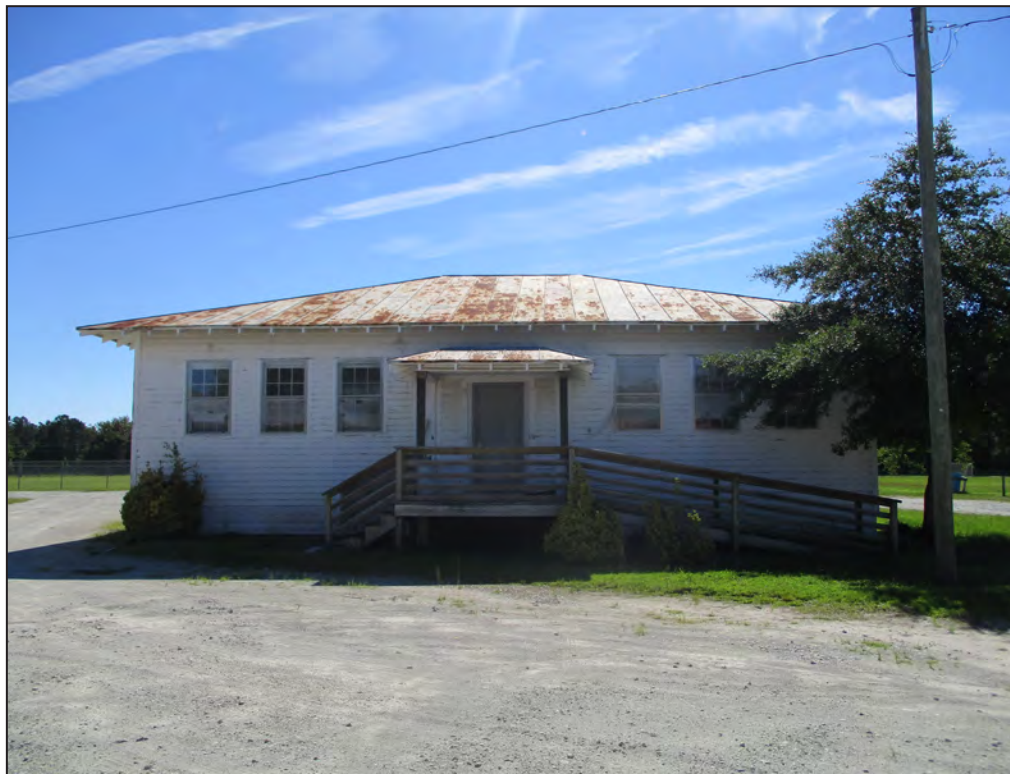
Approximately 35 feet southeast of the back hall is a ca. 1927 frame building. The one-story frame building is capped by a hipped roof with exposed rafter ends and covered in standing seam metal. The building is situated on a brick pier foundation that has been covered by metal molded to look like stone. The west façade features a centered entrance sheltered by a porch capped by a half-hipped roof that is supported by square, wood posts. The porch is accessed by a set of wooden steps or a wooden ramp. The front entrance is flanked on either side by three original, six-over-six, wood, double-hung sash windows. The original windows are protected by storm windows. Secondary elevations also feature original, six-over-six, wood, double-hung sash windows. According to a previous survey of the site, the building was originally used as a gymnasium. The current use is unknown, and surveyors were not permitted to enter (Photograph 31).

Photograph 31: View of original gymnasium (ca. 1927 frame building); looking east. (2018)

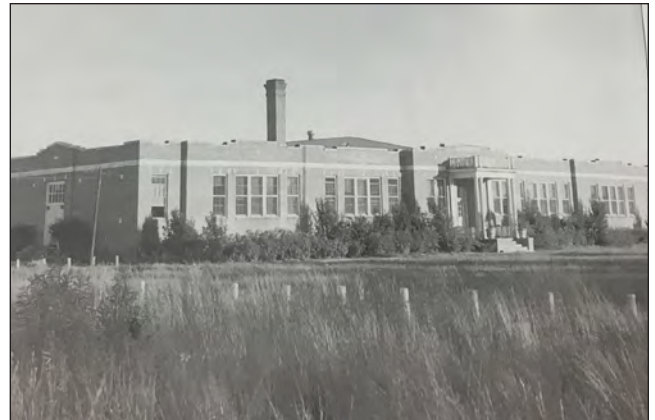
Photograph 32: Tabernacle Elementary School (Source: Onslow County Museum printed in Images of America, 2016)

Tabernacle Elementary School (no longer extant) was determined eligible for the listing in the National Register of Historic Places in 1996 under Criterion A and C (Photograph 32). Located along SR 1434 in the Morton Fork vicinity, Onslow County, North Carolina, approximately 30 miles northwest of the Dixon School, photos and descriptions of the building show that it was almost identical in design and plan to the Dixon School. Like the Dixon School, it was also constructed in 1927 by Simon and Sons Construction Company as part of the consolidation process. According to the eligibility evaluation,

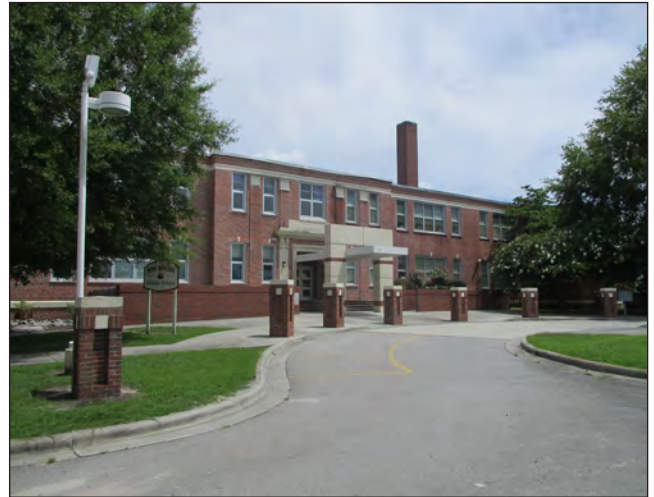
Photograph 33 : Former Jacksonville Senior High School. (2018)

The former Jacksonville Senior High School (now New Bridge Middle School), constructed ca. 1935, is another example of an early to mid-twentieth century brick school building (Photograph 33). The school is located at 401 New Bridge Street, Jacksonville, Onslow County, North Carolina, approximately 14 miles north of the Dixon School. This building replaced an earlier Jacksonville High School that existed prior to consolidation. The earlier Jacksonville High School was used as a consolidated school during the beginning of the movement. The large two-story school is capped by a flat

roof and features a central entrance on the west-facing façade. The school was designed with Beaux Arts style elements and a single-loaded corridor plan (Pezzoni 1987: 2). A large brick chimney and boiler room are located on the southeast corner of the school. A gymnasium addition is located south of the building's main block. The school features multiple additions, changes to fenestration pattern, and some material alterations including replacement windows and doors and an altered front entrance. Comparatively, the Dixon School has not seen changes to its original fenestration pattern and it retains more original material.

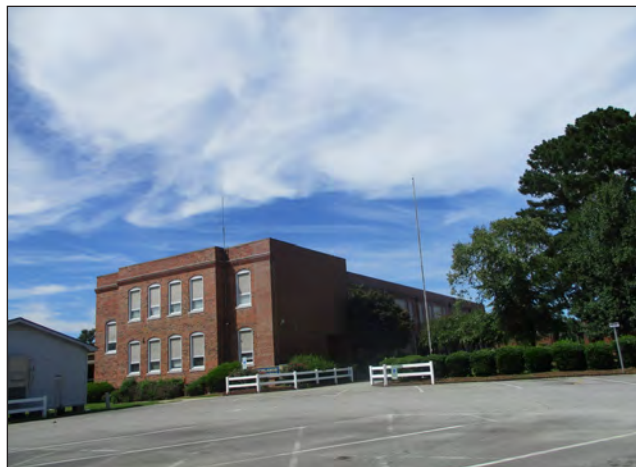
Photograph 34: Richlands Elementary School. (2018)

According to the Onslow County School District Website, Richlands Elementary School was constructed around 1926 (Photograph 34). However, the original use of the building is unknown and historic research did not uncover any mention

of the construction of Richlands Elementary school. Historic resources about the consolidation movement mention that Richlands had an adequate school building prior to consolidation. The students of Richlands Elementary School will move into a newly constructed building in Fall 2018. The historic school is located at 110 East Foy Street, Richlands, Onslow County, North Carolina, approximately 25 miles northwest of the Dixon School. The two-story brick building is irregular in plan and capped by a flat roof with stepped parapets. The building features a large brick cornice and arched window openings on the south elevation. The building appears to have undergone multiple additions that partially obscure the original school building. Additionally, the fenestration pattern has been altered on multiple elevations and the school has undergone material alterations including replacement windows and doors. Comparatively, the Dixon School has not seen changes to its original fenestration pattern and it retains more original material.
