MEMORANDUM

SUBJECT: Historic Structures Survey Report, Widen NC 150 from US 64 to Forsyth County Line,
PA 17-12-0078, U-5902, Davidson County, ER 18-3639

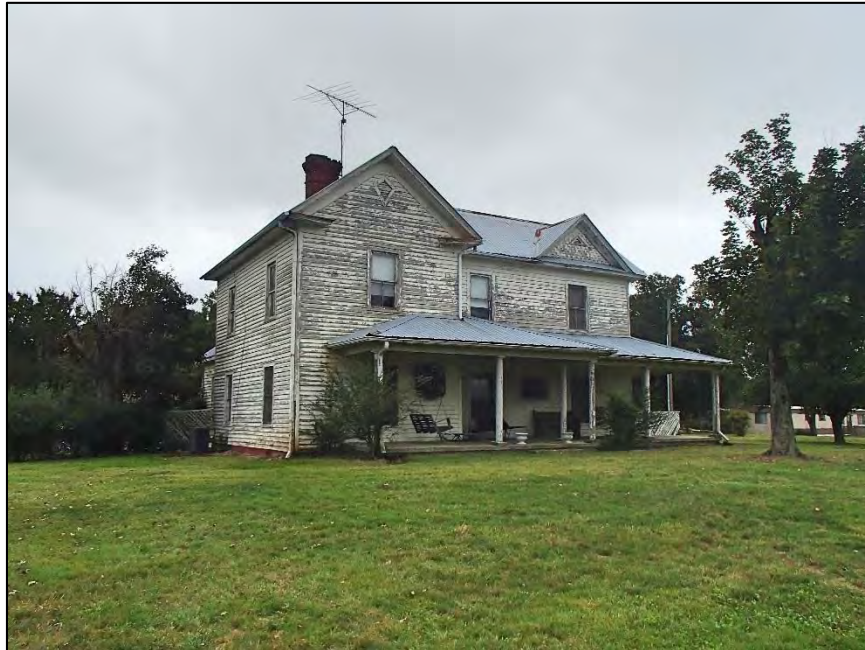
5: Lafayette and Fallie Scott House, north elevation

The façade (north elevation) features a single window in the front-facing gable end at both the first and second floors. The front-facing gable has gable returns and an elongated diamond-shaped attic vent. On the first floor of the side-gable wing, the front door is located in the interior bay. The front door is original and is composed of a glazed panel above raised panels. Upstairs, above the front door is a single window. The outer bay of the façade contains windows at both levels. A one-story porch with Colonial Revival Tuscan columns extends across the front and around the south gable end.

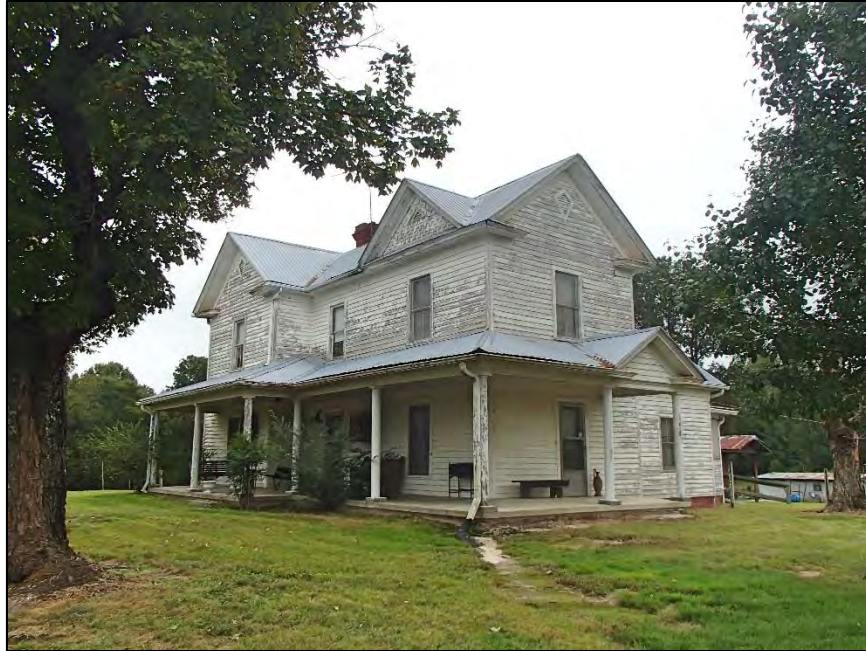
6: Lafayette and Fallie Scott House, west elevation

On the west gable end, a west-facing gable in the porch roof highlights a single-leaf door located in the first floor of the west gable. The west gable has gable returns and an elongated diamond-shaped attic vent.

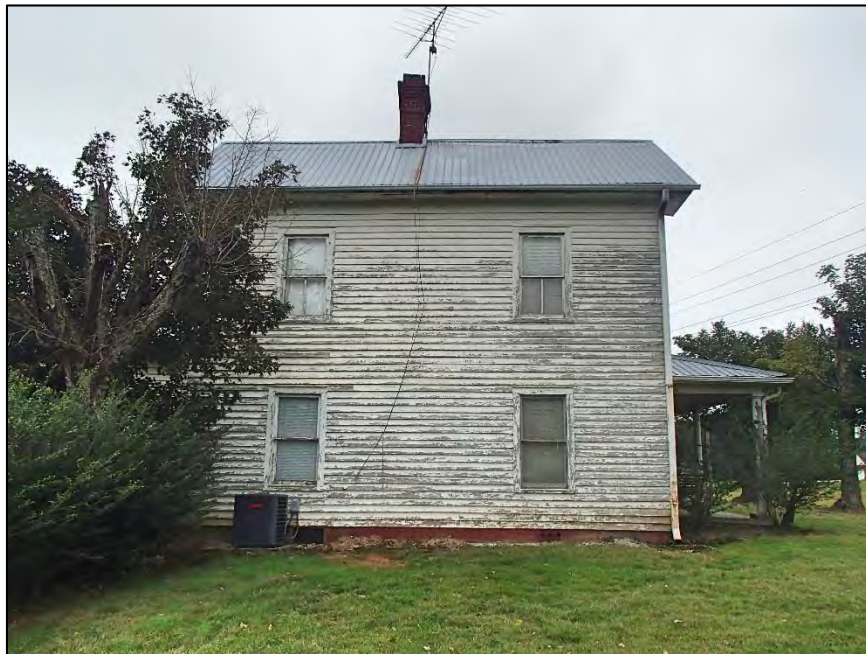
7: Lafayette and Fallie Scott House, east elevation

Four windows (two upstairs and two downstairs) punctuate the east elevation.

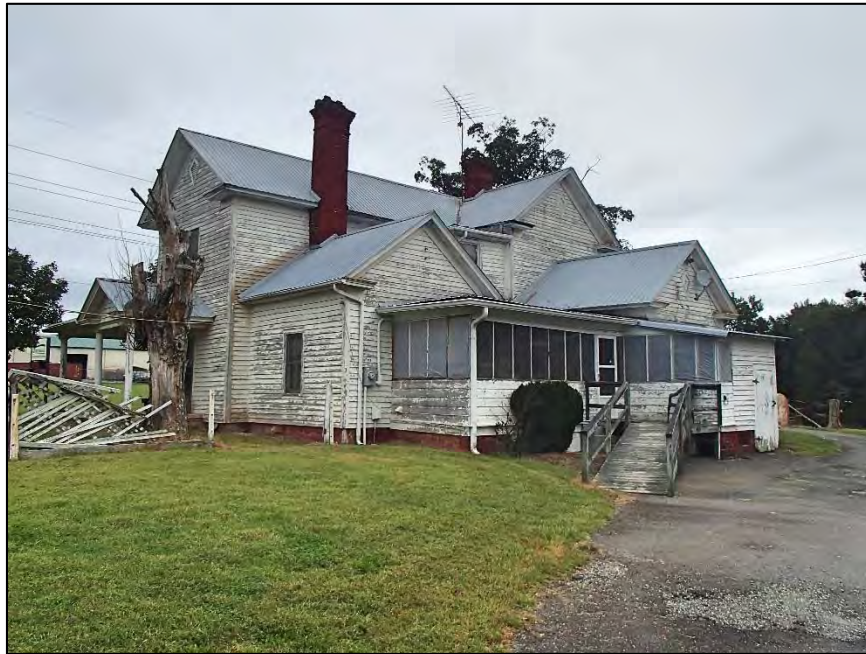
8: Lafayette and Fallie Scott House, southwest corner

Two one-story gabled ells are attached to the rear or south elevation. One ell is situated toward the west end of the side-gable wing. The other is attached to the rear-facing gable end of the main block's cross gable. Both ells have gable returns, but only the northernmost also contains an elongated diamond-shaped attic vent. A hip-roof addition stands between the main block's cross gable and the westernmost one-story ell. An enclosed back porch extends across the entire rear elevation.

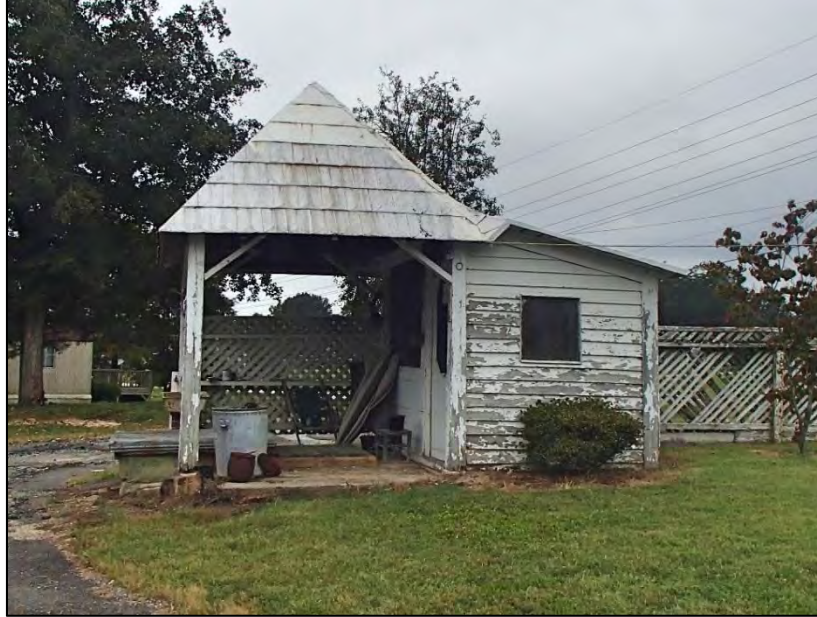
9: Lafayette and Fallie Scott House, well house

High-hip roof clad in pressed metal shingles on rectangular-in-plan wooden posts. Diagonal brackets extend from the posts to the eaves. The floor is paved in concrete and the pavilion shelters a concrete block well. A weatherboarded shed is attached to the pavilion's north side.

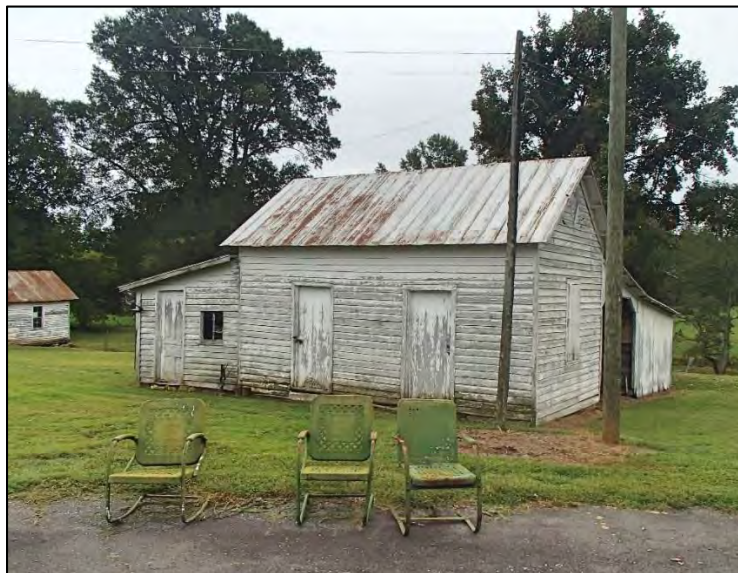
10: Lafayette and Fallie Scott House, kitchen

This building's size and proximity to the house suggests this was a kitchen. This is a one-story, side-gable building with two front doors. The board-and-batten doors are the only articulation on the west or front elevation. A shuttered window and elongated diamond-shaped attic vent are located in the west gable end. A shed addition stands on the east gable end, which also features an attic vent to match the main house. Shed additions are located on the south elevation. The building stands on a brick and stone foundation and weatherboards cover the exterior.

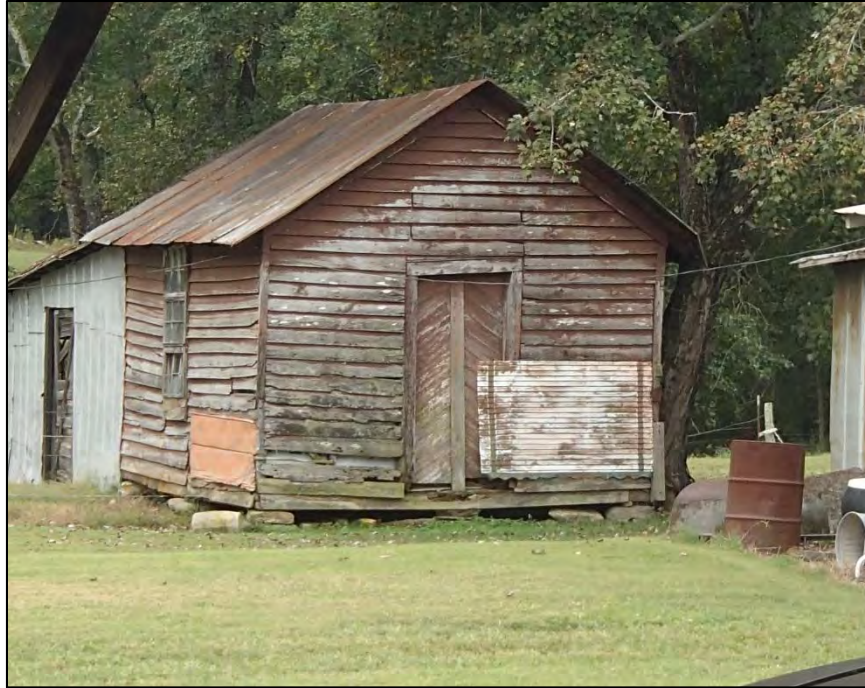
11: Lafayette and Fallie Scott House, outbuilding

One-story, gable-front, frame outbuilding with weatherboard siding. This building has a batten door with diagonally-laid boards. Windows are located on both side elevations. A metal-clad shed addition stands on the south gable end.

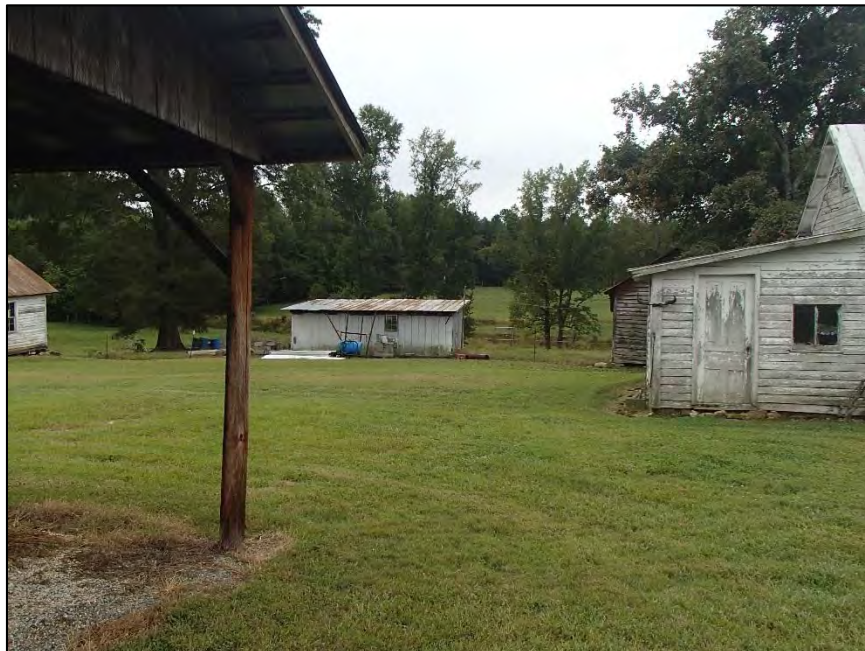
12: Lafayette and Fallie Scott House, equipment shed

One-story, shed-roofed building with metal siding.

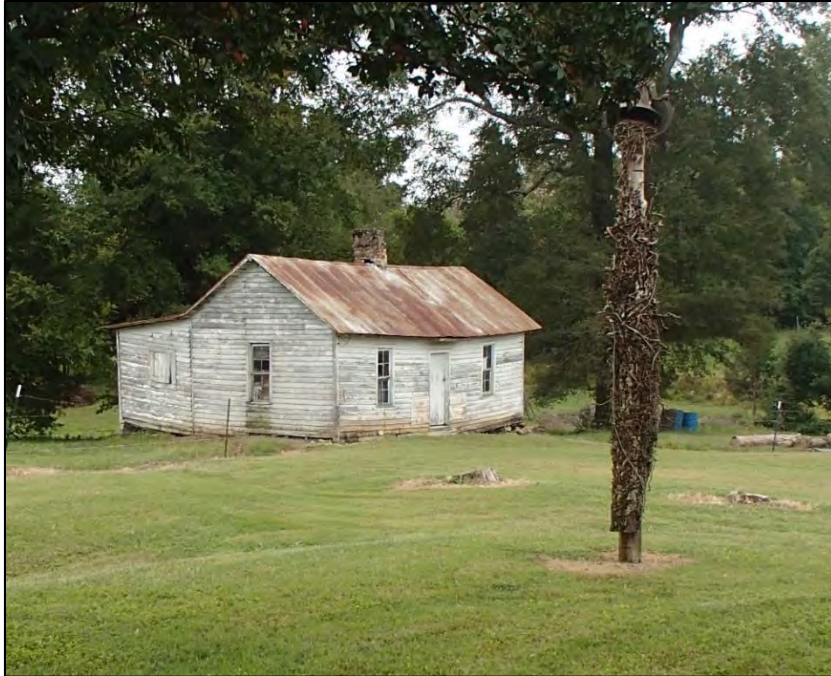
13: Lafayette and Fallie Scott House, tenant house

One-story, side-gable, saddlebag house with central, board-and-batten front door, four-over-four sash windows, and a central brick chimney. A shed roof addition extends across the east elevation. The house stands on a stone foundation.

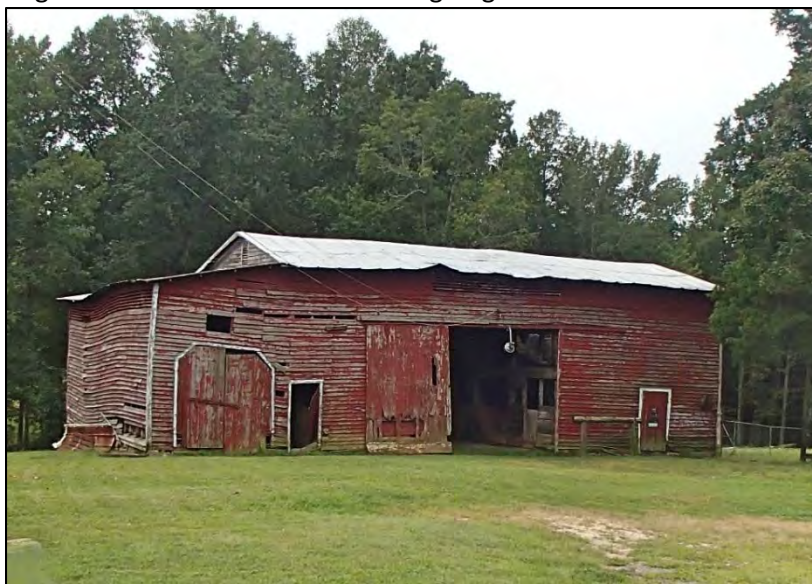
14: Lafayette and Fallie Scott House, barn

Large frame barn with central drive-through. The front elevation features pedestrian doors on either side of this central drive, which could be closed with an extant sliding wooden door. A shed roof addition on the east gable end contains a double-leaf garage door.

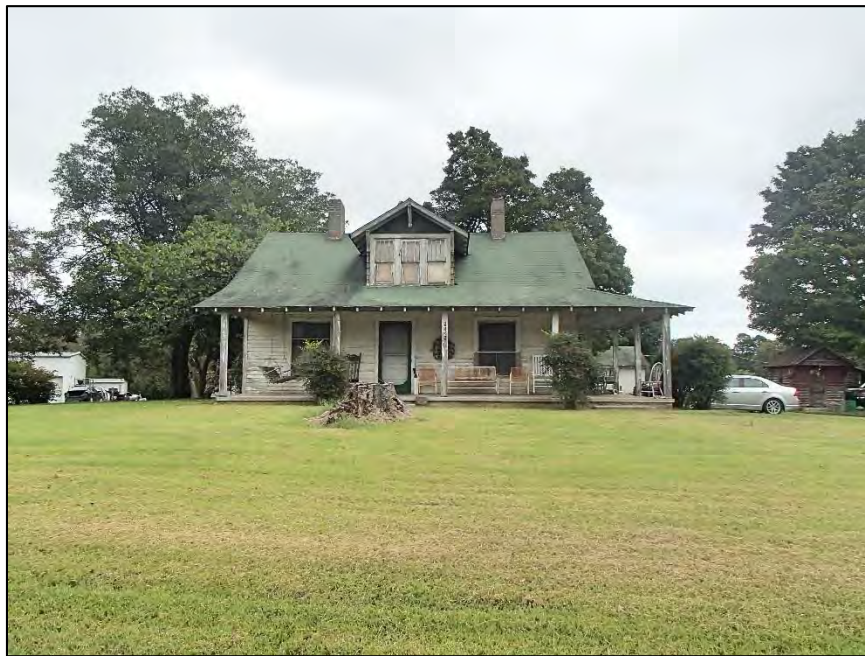
26: Frank and Maude Sowers House, west elevation

The front (west) elevation is symmetrical with a front door centered between two windows. Those windows are large and composed of ten-light sashes over large single-light sashes. The front roof slope breaks at the wall plane to engage the front porch. The porch columns are square and the porch wraps around the south gable end. The porch floor has been replaced with concrete, which was a common alteration seen at most older houses in the study area. A gabled dormer clad in wooden shingles punctuates the front roof slope. The dormer contains a bank of three four-over-one sash windows and is finished with kneebraces and exposed raftertails.

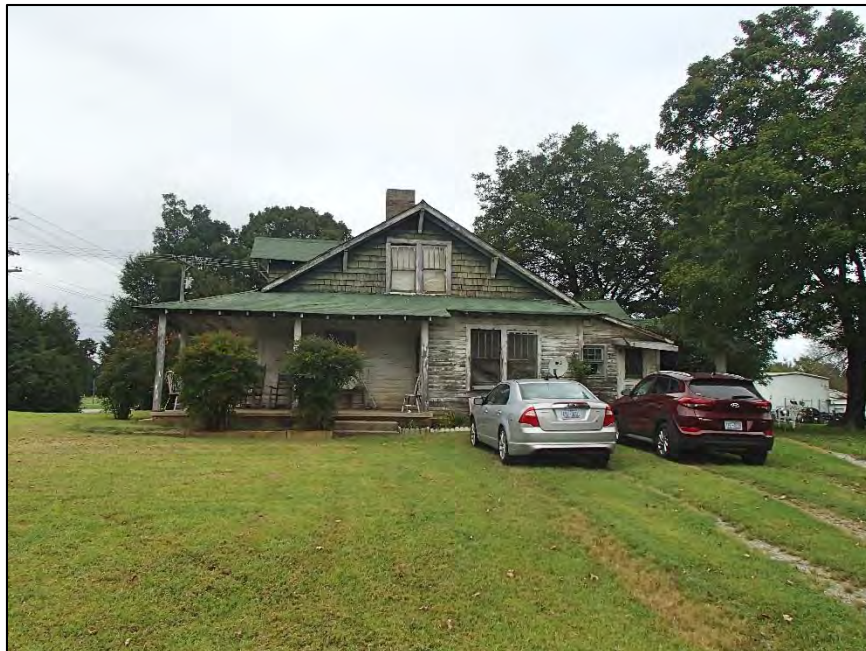
28: Frank and Maude Sowers House, south elevation

On the south gable end, the gable is sheathed in wooden shingles and trimmed with kneebraces. A pair of four-over-one sash windows illuminates the attic. The wrap-around porch terminates at a shallow shed-roof projection which appears to be original to the house. Windows on the first floor are, like the attic windows, configured with four-over-one sashes.

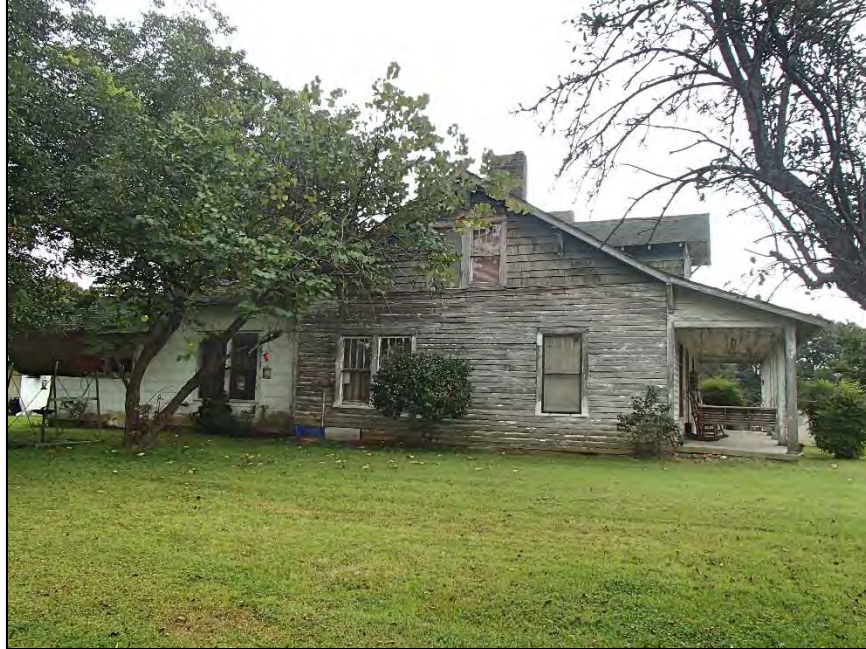
29: Frank and Maude Sowers House, north elevation

The north gable end is clad in weatherboards with shingles and kneebraces in the gable end. Windows are arranged singly and in pairs and are four-over-one.

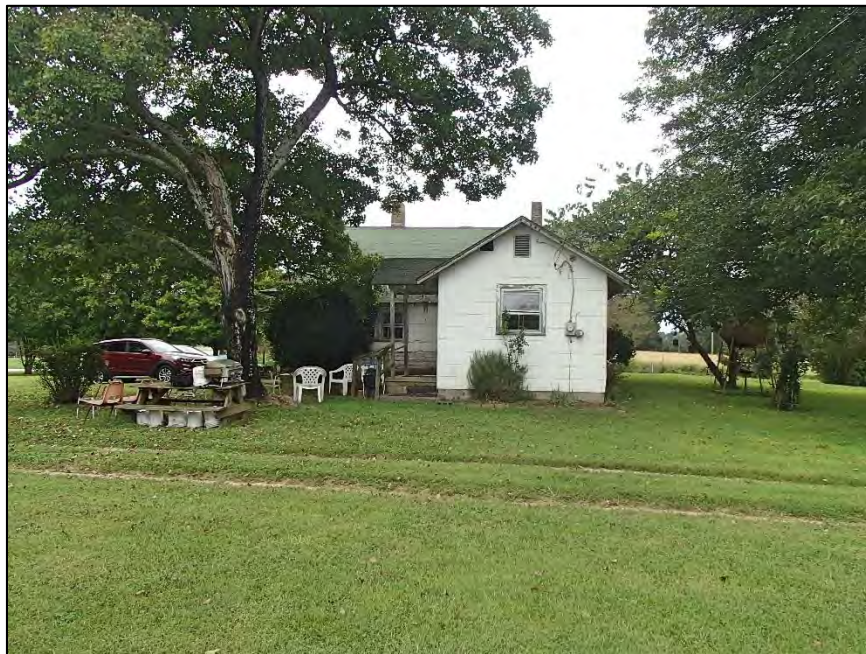
30: Frank and Maude Sowers House, east elevation

The east elevation is composed of a gabled ell projecting from the rear of the main block and an enclosed porch running along the back of the main block from the ell to the southeast corner. The porch enclosure contains six-over-one windows and its south end is covered in weatherboards. The enclosure's east elevation and the entirety of the gabled ell is covered in asbestos siding. The ell contains a mix of horizontal-light windows and six-over-one sash windows.

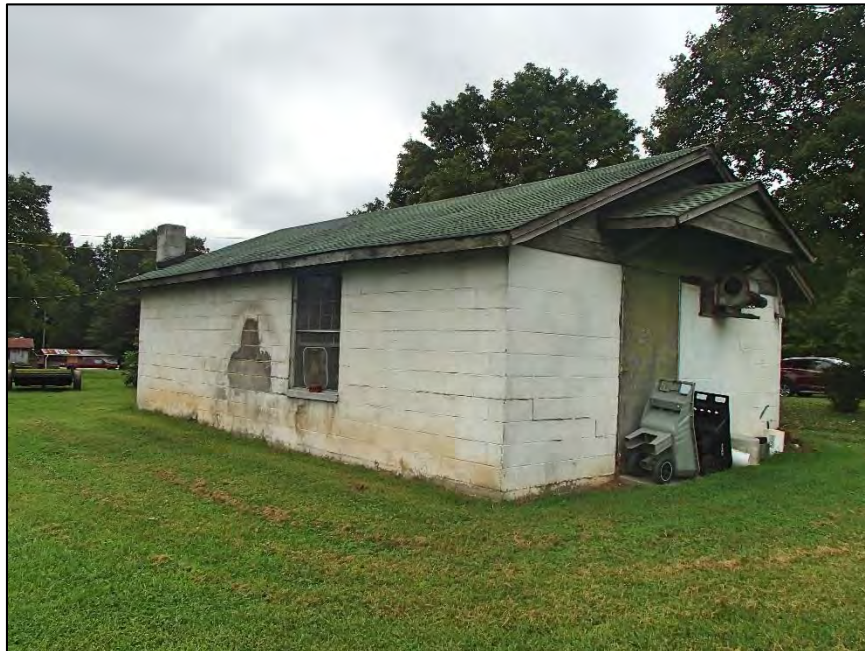
31: Frank and Maude Sowers House, sausage kitchen

This one-story, side-gable, concrete block building is used for processing sausage for sale. Doors are located on both gable ends and the west elevation. Metal-frame six-over-six sash windows are located on the east and west elevations. A concrete block chimney flu stands on a corner of the south gable end. Weatherboards finish the gable ends.

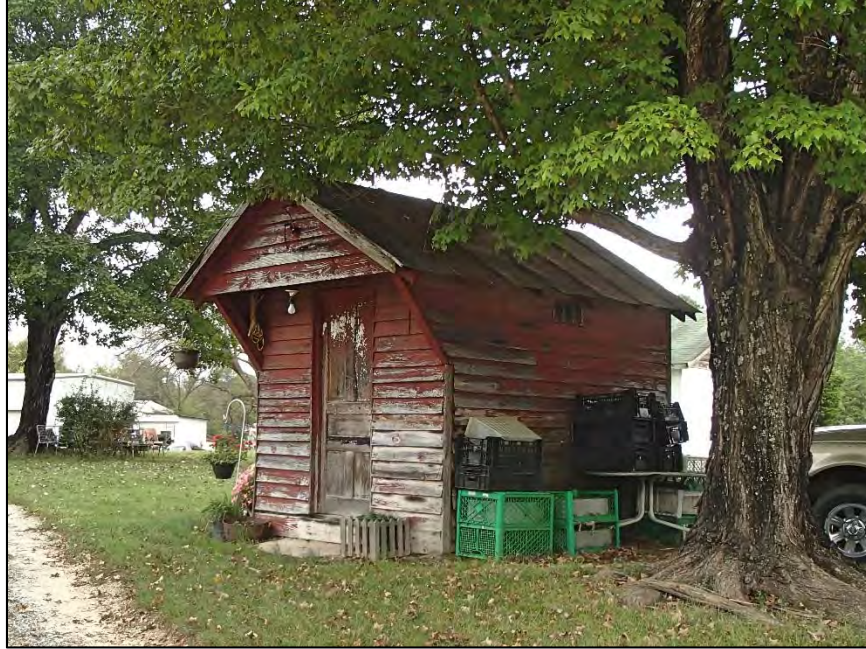
32: Frank and Maude Sowers House, smokehouse

This small, gable-front building features an overhanging gable on the west (front) elevation. The door is board-and-batten and the building is covered in weatherboards and stands on a stone foundation. This building form is seen at many historic properties on the Highway 150 corridor.

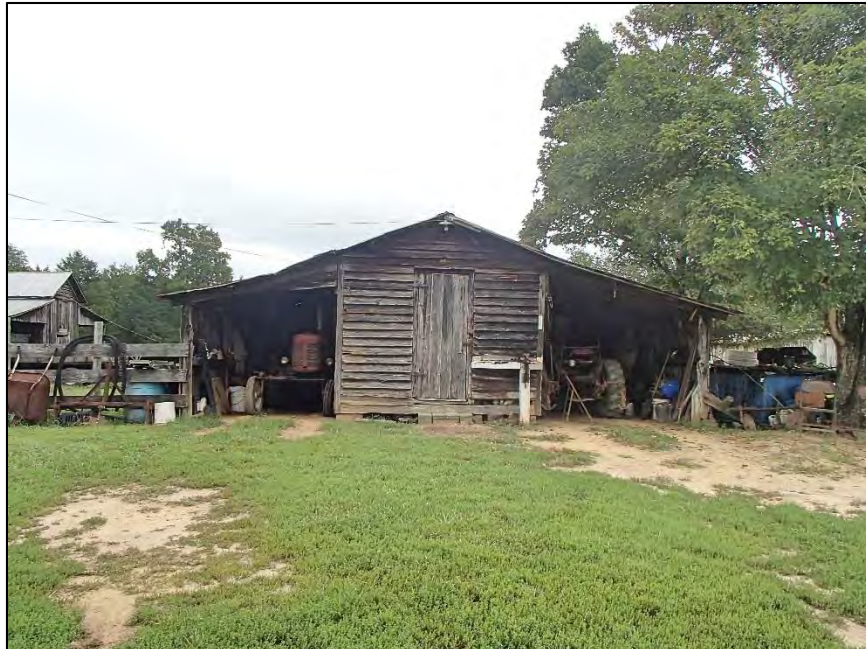
33: Frank and Maude Sowers House, granary

One-story, frame, gable-front building with a board-and-batten door and weatherboard siding. Shed additions, enclosed on three sides, stand on either side elevation.

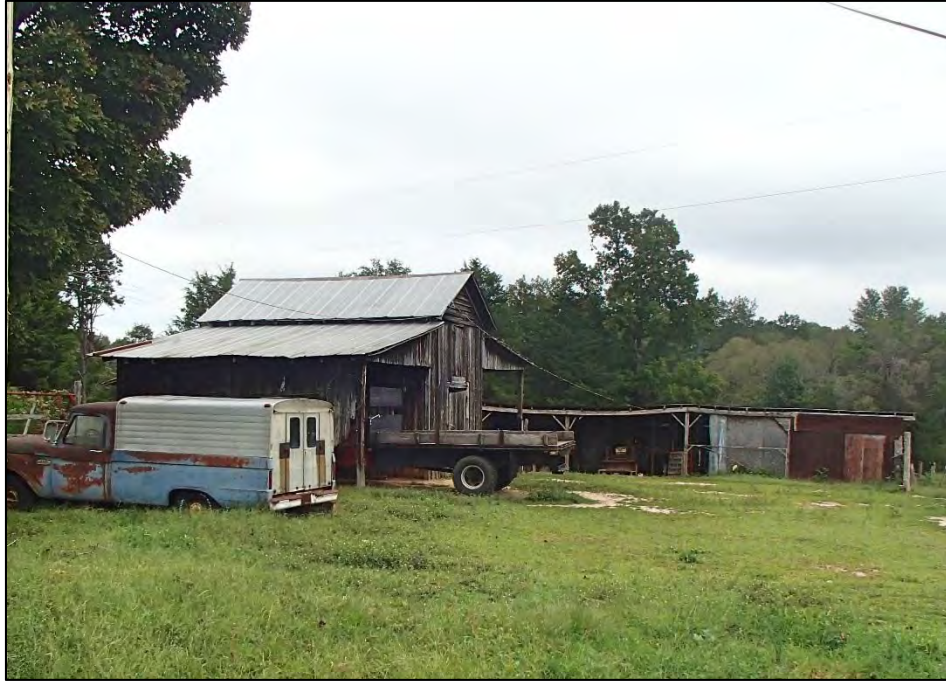
34: Frank and Maude Sowers House, tobacco pack house with equipment shed behind

Gable-front frame building with open sheds on the side elevations. Vertical wood siding covers the exterior. The pack house was used for re-moisturizing cured tobacco (the process is called “ordering” or “bringing to order”) and then sorting or grading the leaves before taking them to market.

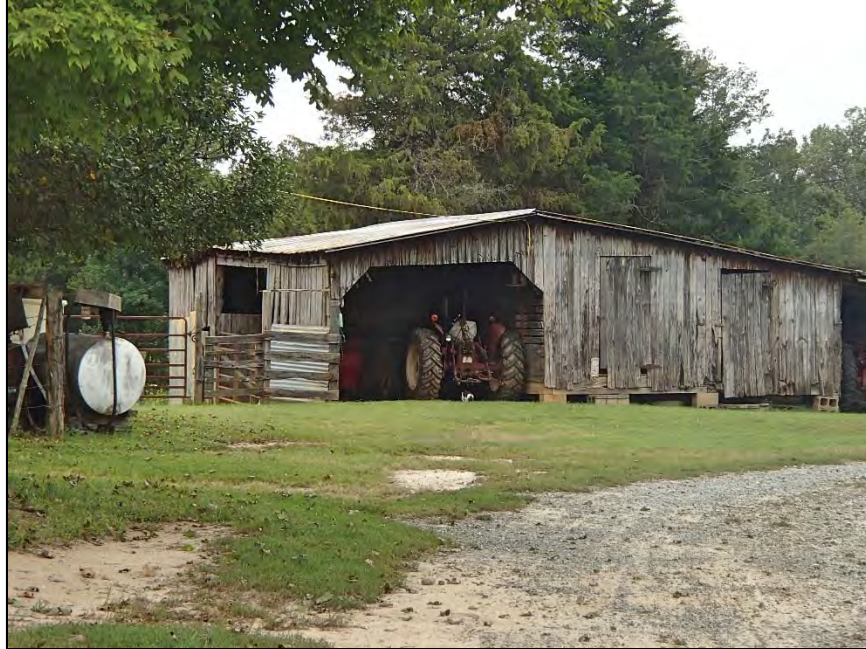
35: Frank and Maude Sowers House, barn

One-story, gable front, frame barn with one garage bay opening and board-and-batten pedestrian doors. Vertical wood siding covers the building.

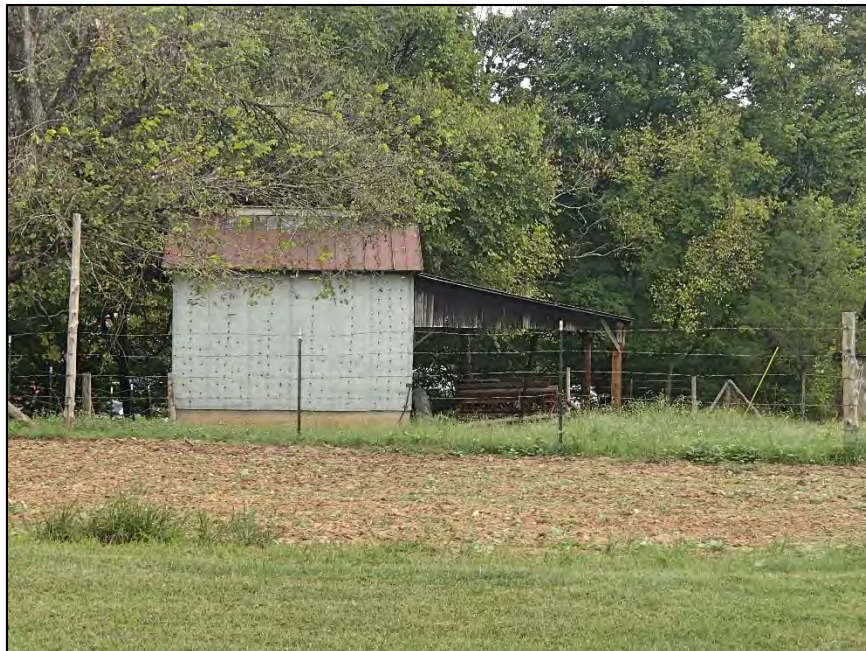
36: Frank and Maude Sowers House, tobacco barn

Traditional tobacco barn of frame construction on a concrete foundation, clad in metal sheathing.

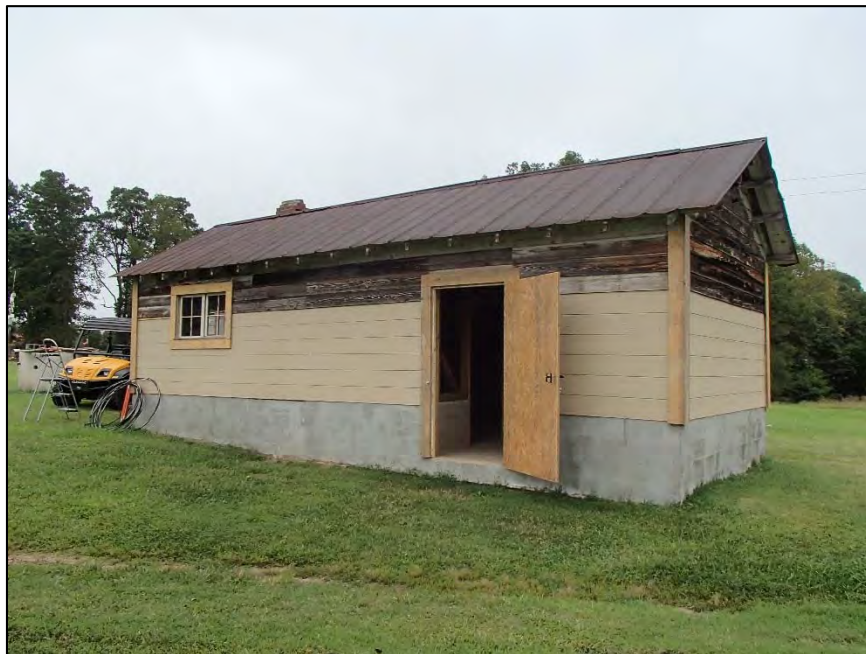
50: Felix DeLapp House, DV 237, milk house

Specifically related to the processing of farm products, the Sowers' sausage kitchen can be compared to the milk house at the nearby Felix DeLapp House.

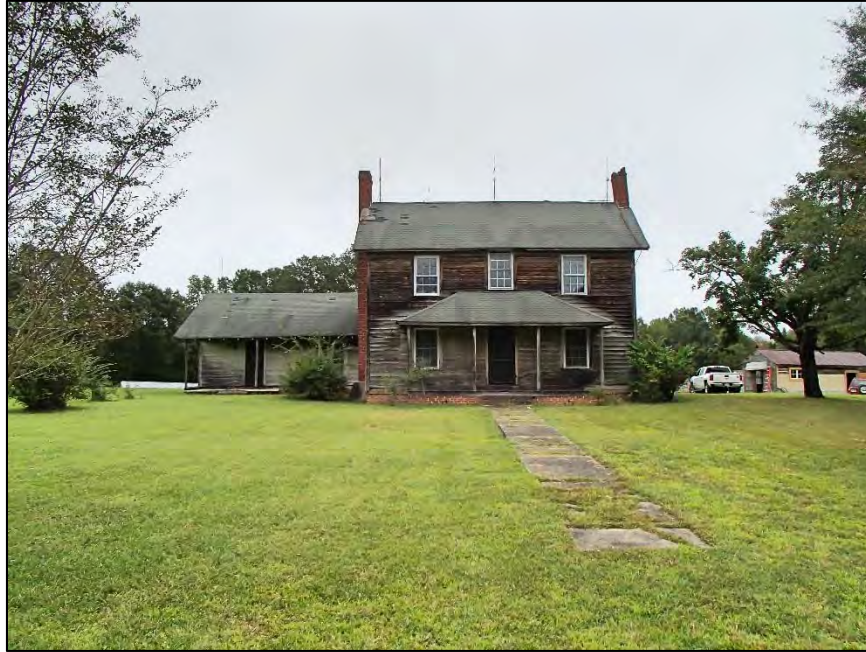
53: Felix DeLapp House, west elevation

The house is a two-story I-house with gable-end chimneys and a two-story rear ell. Weatherboards cover the exterior and all windows have been replaced with modern, vinyl windows. The symmetrical façade has a central, single-leaf front door flanked by windows and sheltered by a partial-width, hip-roof porch. Three windows are located at the second floor level with the center window raised slightly to accommodate the porch roof. Four chamfered posts support the porch roof. Four chamfered posts support the porch roof.

The Felix DeLapp House is not eligible for the National Register of Historic Places under Criterion C. The house's historic windows have been replaced with non-historic, vinyl-clad units. This is a significant loss in light of the house's simplicity and absence of decorative elements. When a building is finished with so few architectural features, the loss and incompatible replacement of a visually prominent feature, such as fenestration, is striking. Davidson County retains a large number of I-houses, and, while many have

been covered with vinyl siding, several examples were noted that appear to be unaltered. Because of the loss of historic windows, the house's integrity of design and materials have been diminished, and it no longer adequately conveys the distinctive characteristics of an I-house; nor does the house possess high artistic value or represent the work of a master.

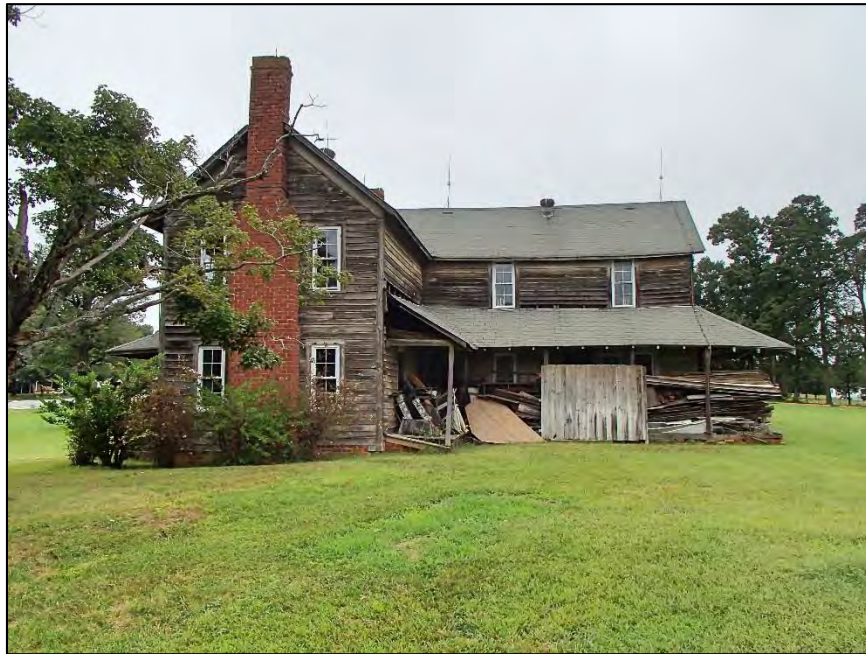
55: Felix DeLapp House, south elevation

The north and south gable ends are identical: single-shoulder, brick chimneys are flanked by windows at each level. The corners are finished with cornerboards with narrow caps. The gable eaves are finished with exposed purlins.

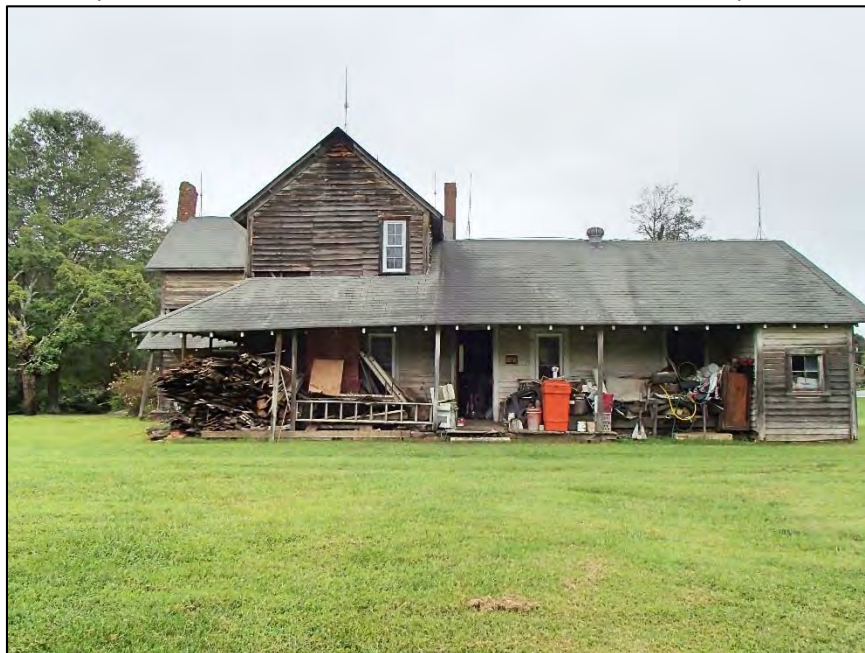
58: Felix DeLapp House, east elevation

On the east elevation, a two-story ell extends from the north bay of the main block. This ell matches the main block, although the cornerboards are not capped and the gable-end chimney has been demolished. A one-story ell is attached to the north elevation of the two-story ell.

A one-story, hip-roof porch with chamfered posts follows the east elevation from the southeast corner of the main block, along the ell's south elevation, around the ell's east-facing gable end, and then along the east elevation of the one-story ell that extends to the north from the two-story ell's north elevation.

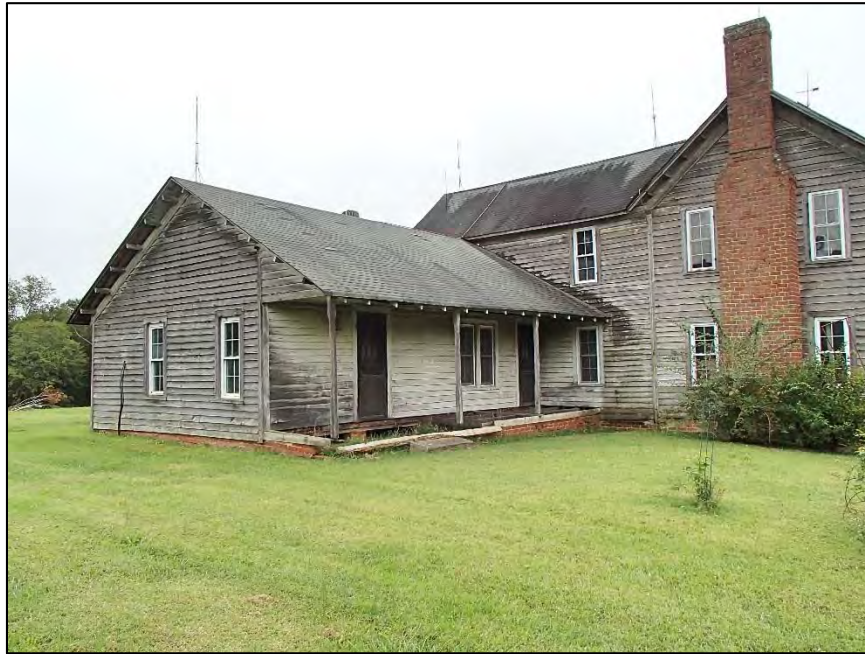
59: Felix DeLapp House, north ell

The one-story ell housed a kitchen and dining room and had a center chimney. Like the main house, the one-story ell has exposed purlins and weatherboards. The ell is configured with a gabled roof that engages a porch on the west elevation. The porch shelters two doors and a pair of modern replacement windows.

The entire house stands on a continuous brick foundation and asphalt shingles cover all the roofs.

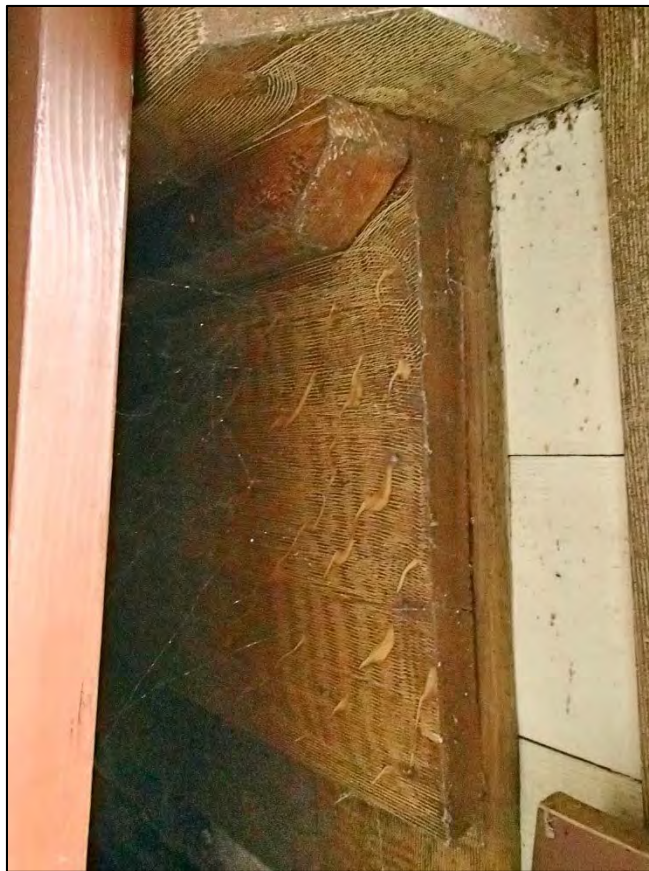
61: Felix DeLapp House, north downstairs room mantel graining

First floor mantels in the main block are simple post-and-lintel compositions. In the north room of the main block, original or early graining is present. The doors, window surrounds, and mantelpiece were painted brown and combed into a grain. The mantel's decorative finish also features periodic squiggles in the finish.

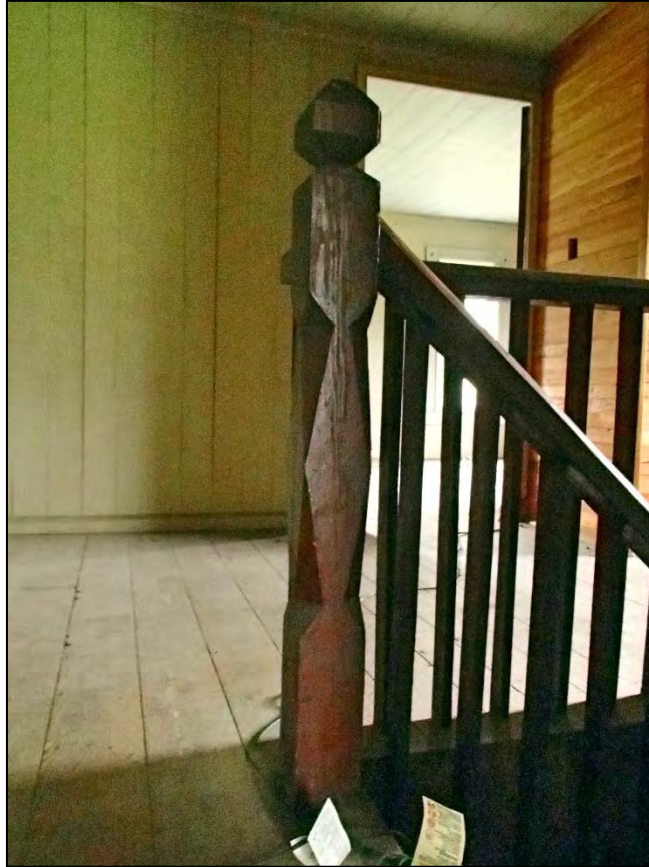
62: Felix DeLapp House, newel post

The upstairs rooms in the main block do not appear to have had fireplaces, and the owner stated wood stoves were used in these rooms, though no evidence (such as flue holes in the walls) was seen. Leaving rooms unheated appears to have been a common, but as yet unexplained, practice in Davidson County. In the main block's center hall, a narrow stair features square newel posts with the corners cut away to create diamonds on each side of the posts.

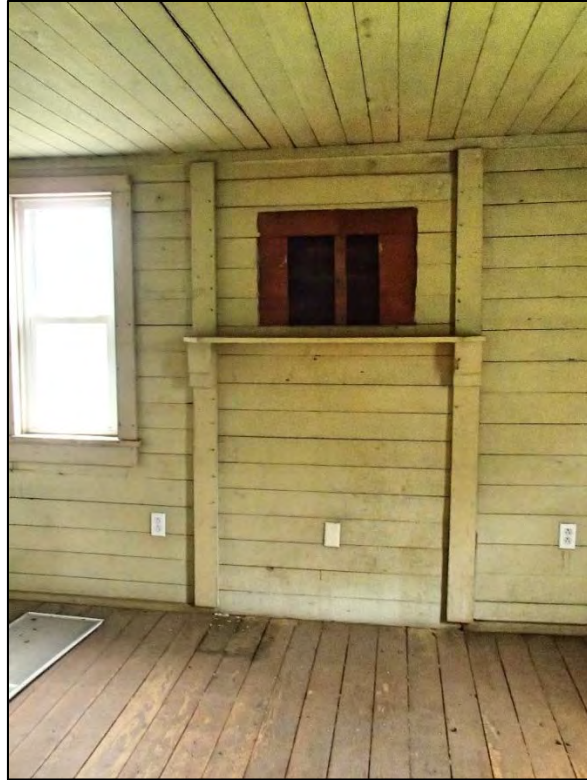
63: Felix DeLapp House, rear ell mantel

The rear ell contains a very narrow stair along the original exterior wall of the main house. The ell's upstairs room was heated and the ell's mantels are simple shelves with stepped blocks underneath the shelves. One original, four-over-four sash window is located in the two-story ell's north wall where it opens into the one-story ell's attic space.

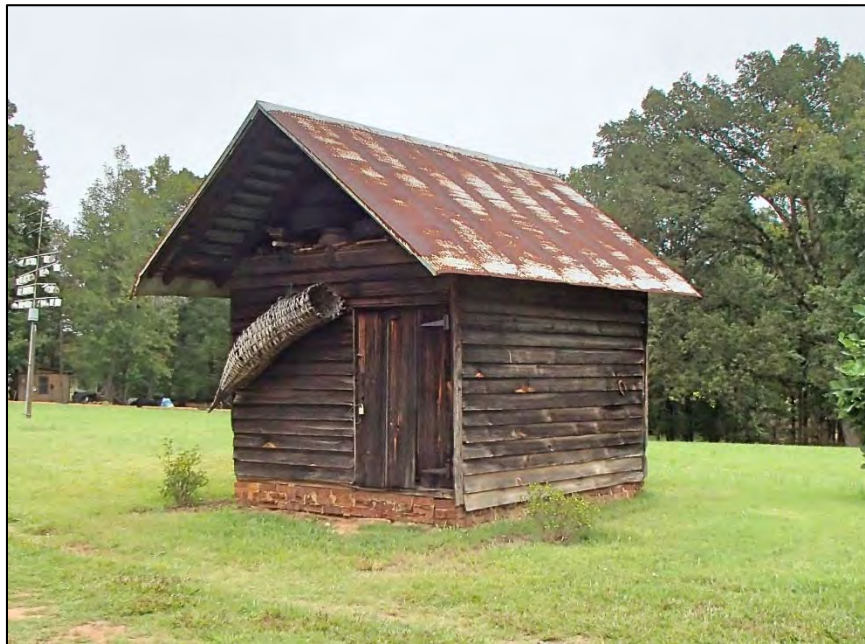
65: Felix DeLapp House, smokehouse

This is a gable-front, frame building with an overhanging front gable eave and an off-center board-and-batten door. Weatherboards cover the building and it stands on a brick foundation. This form is a very common outbuilding at farms in northern Davidson County.

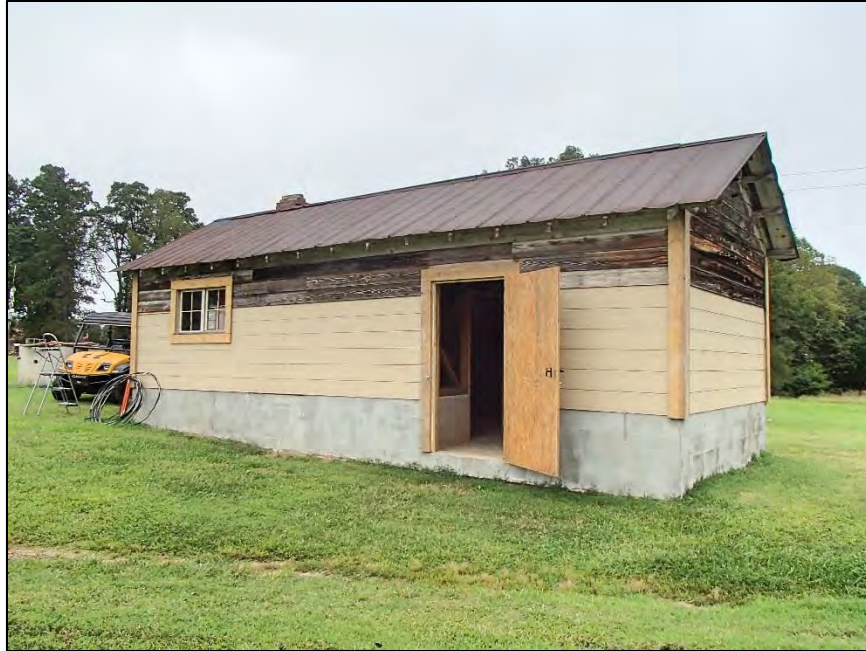
66: : Felix DeLapp House, milk house

This gable-roof building housed a cooler for milk and a steamer to clean bottles. The frame building rises from a concrete block foundation that extends above the concrete floor to create a kneewall. Some exterior weatherboards have been replaced with modern cementitious siding. On the rear elevation, a pair of original six-over-six sash windows and a single four-over-four sash window remain. Other doors and windows have been replaced. A brick chimney flue pierces the east roof slope. The date was written in the concrete floor.

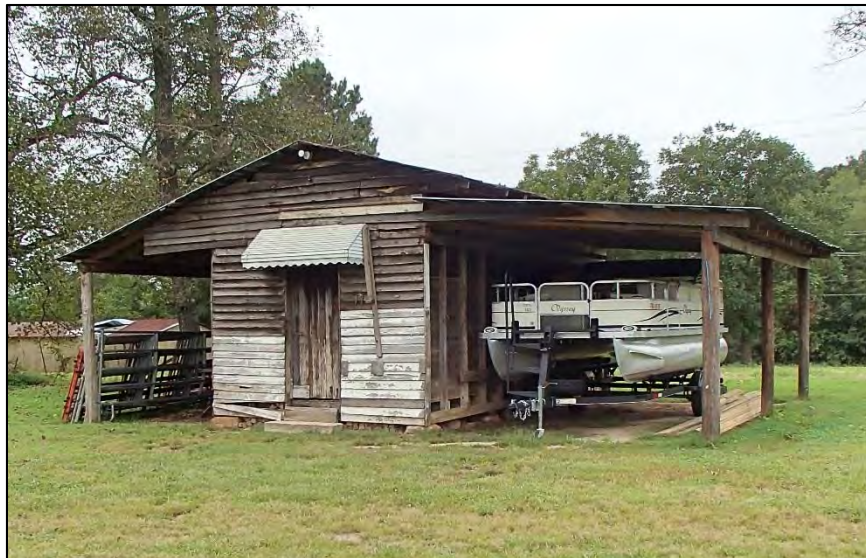
67: Felix DeLapp House, granary

One-story, gable-front outbuilding with weatherboard siding. An open shed on the south elevation appears to be original while a larger open shed has been added to the north elevation.

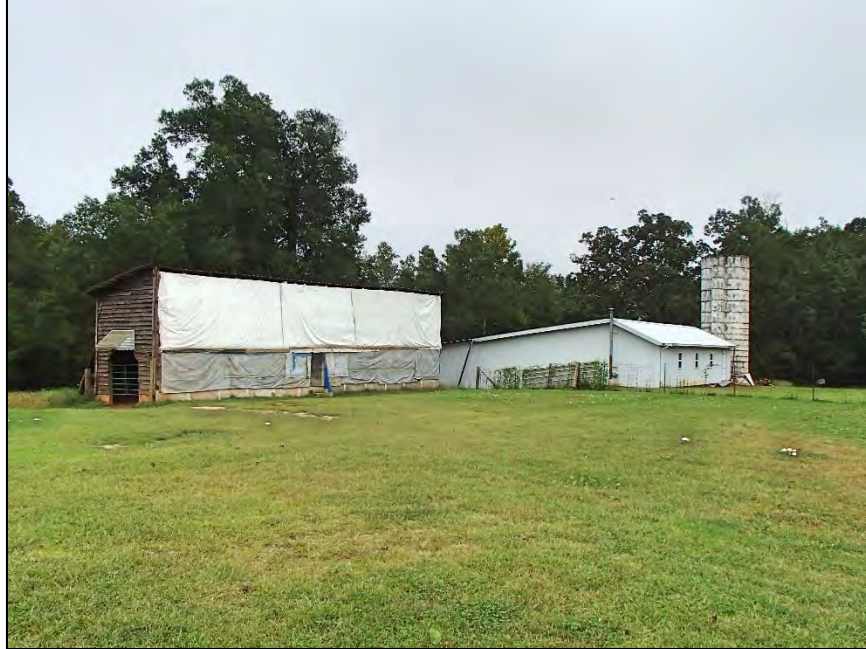
68: Felix DeLapp House, partially demolished barn, remodeled milk barn, and silo

This tall barn has been partially-demolished. Photos made during the 1981 countywide survey show this as a double-crib log barn that had been altered with the addition of a frame, shed roof section. The west walls of the log section appear to have been removed.

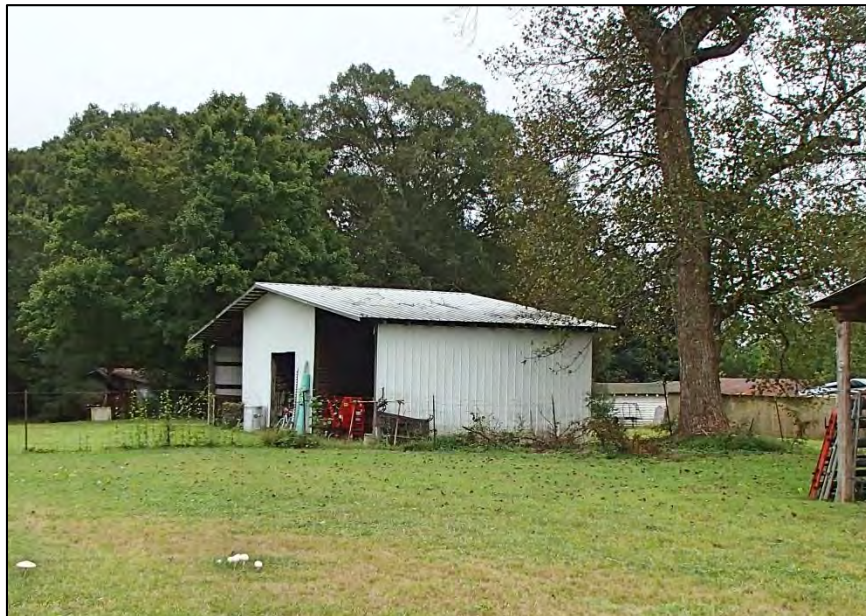
69: Felix DeLapp House, barn

Gable-front, frame barn with sheds on either side. Covered in metal sheathing.

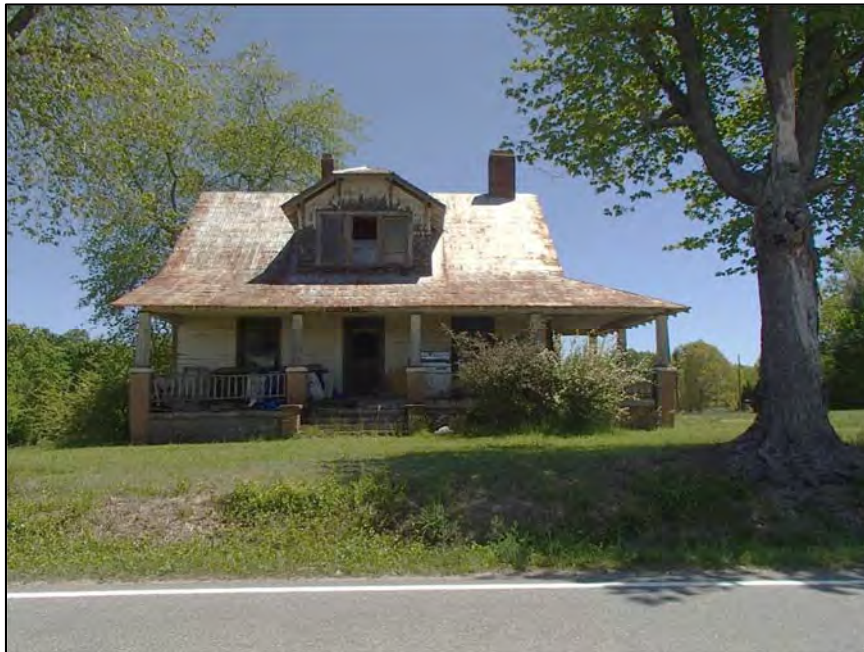
82: Charles and Jennie Miller House, west elevation

The Charles and Jennie Miller House is a one-story, side-gable bungalow similar to the Frank and Maude Sowers House. The house is covered in weatherboard siding and retains original eight-over-one sash windows. Pressed metal shingles cover the roof. Interior brick chimneys rise through the roof. The house stands on a continuous brick foundation.

The façade is three bays wide with a central front door flanked by single windows. The front roof slope breaks to engage a front porch with battered posts on brick piers. The porch extends across the façade and wraps around the south gable end, terminating in a shed-roof projection on the south elevation. The porch has exposed raftertails and a wooden floor. A jerkinhead dormer with a bank of three windows is centered on the front roof slope. Wooden shingles cover the dormer, and the dormer retains exposed raftertails and kneebraces.

The Charles and Jennie Miller House is not eligible for the National Register of Historic Places under Criterion C. The house has been minimally altered, but it has suffered from neglect and deterioration which has diminished its integrity of design, materials, and workmanship. Upstairs windows are lost and other windows and exterior woodwork is deteriorated to the point that the house is no longer a good example of a Davidson County bungalow. The semi-bungalow house form is common in Davidson County, and many better and more intact examples are extant, including the Frank and Maude Sowers House, which is recommended eligible in this report.
