MEMORANDUM

SUBJECT: Historic Structures Survey Report, Widen NC 150 from US 64 to Forsyth County Line,
PA 17-12-0078, U-5902, Davidson County, ER 18-3639

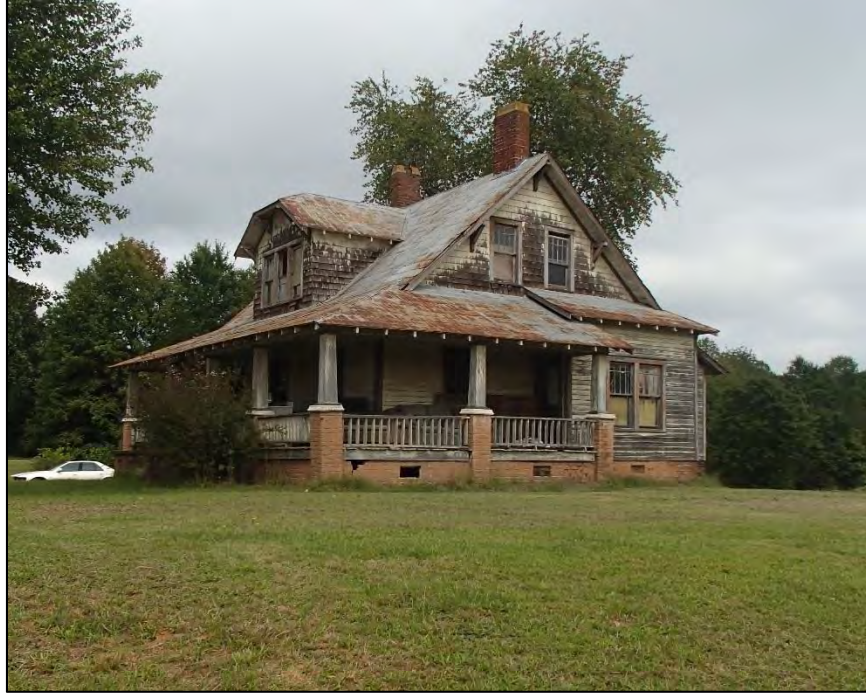
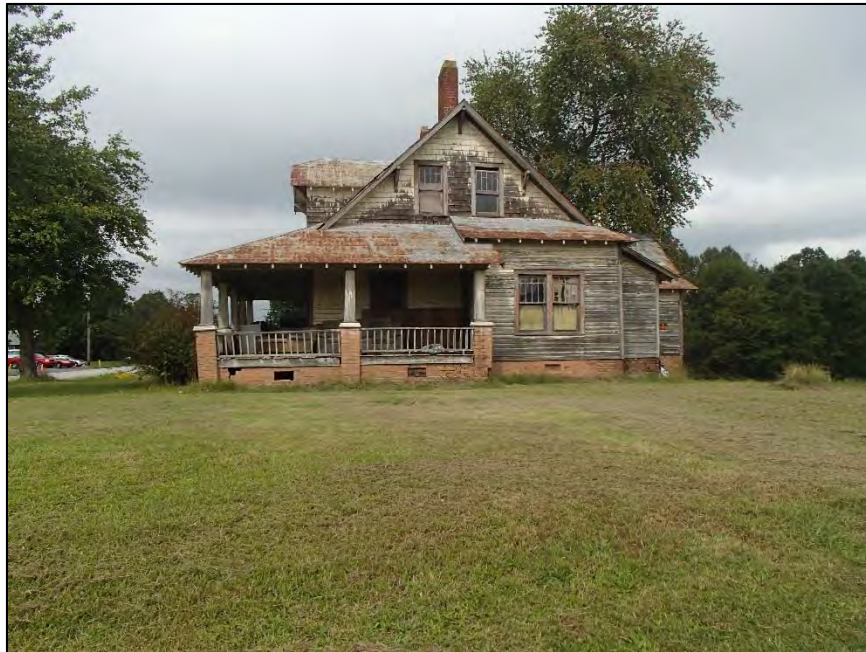
83: Charles and Jennie Miller House, south elevation

On the south elevation, two windows occupy the shingled gable end. A shed-roof projection is located at the end of the wrap-around porch. Kneebraces are located in the gable end.

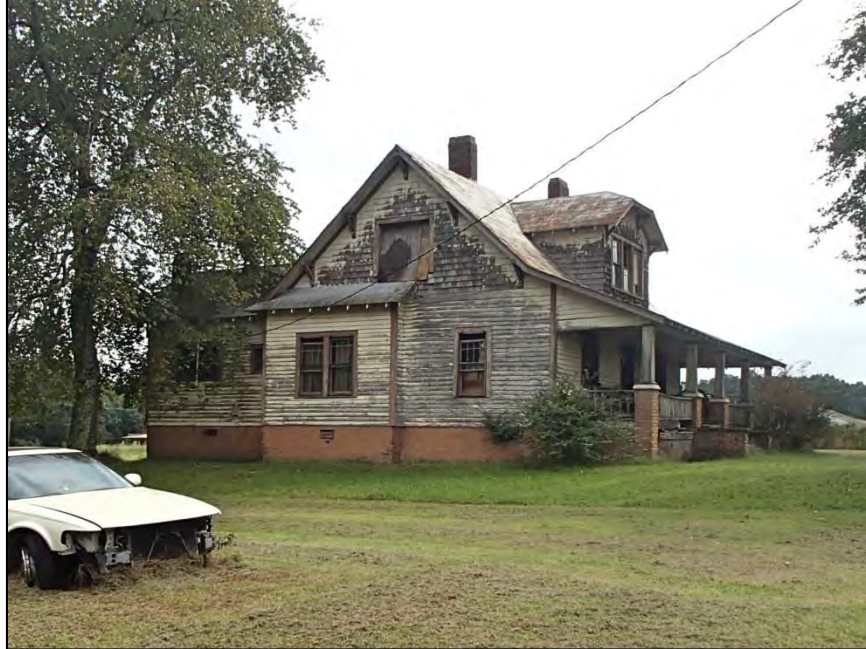
85: Charles and Jennie Miller House, north elevation

On the north elevation, the attic windows have been removed and the window opening has been covered with plywood. A shed-roof projection is also located on this gable end.

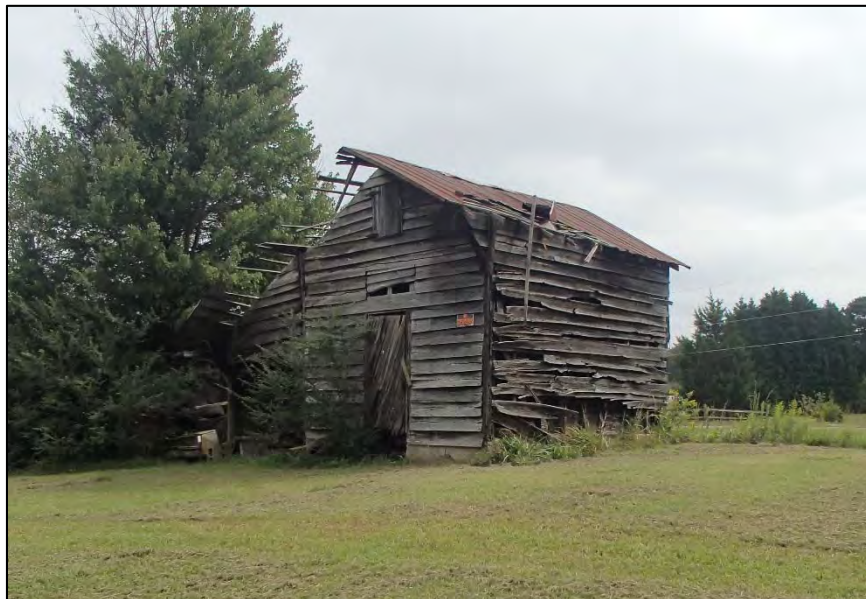
86: Charles and Jennie Miller House, tobacco pack house

A frame, gable-front tobacco pack house stands to the south of the dwelling. Aerial photography indicates that a second outbuilding was adjacent to the pack house, but this building has been demolished.

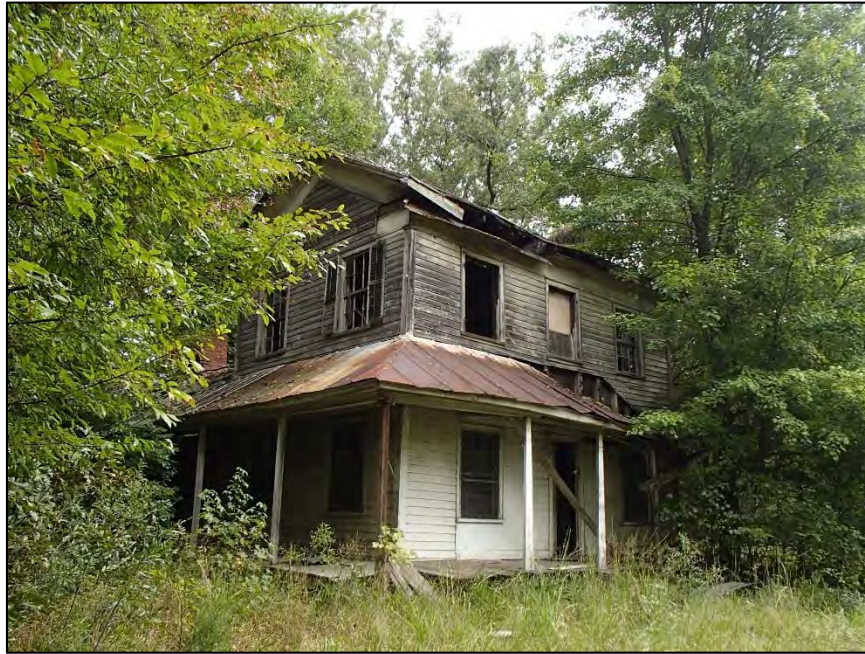
101: Ollie Low Craver House, northwest corner

The Ollie Low Craver House is a two-story hall-parlor house with a side-gable roof. The 1981 architectural survey file for the house describes the house as being of log construction, but the investigator does not think the window and door openings are deep enough to enclose log construction and the house does not exhibit any tell-tale leaning in the walls.

The Ollie Low Craver House is not eligible for the National Register of Historic Places under Criterion C. The house has not been significantly altered, but it is deteriorated to the point that it has lost architectural integrity. The porch is partially collapsed and many window sash are missing or significantly deteriorated. The main roof is failing leading to significant destruction of materials and structural unsoundness. Other more intact hall-parlor houses from the second half of the 1800s can be found in Davidson County, and this house's condition is such that it no longer embodies the characteristics of the county's late hall-parlor plans.

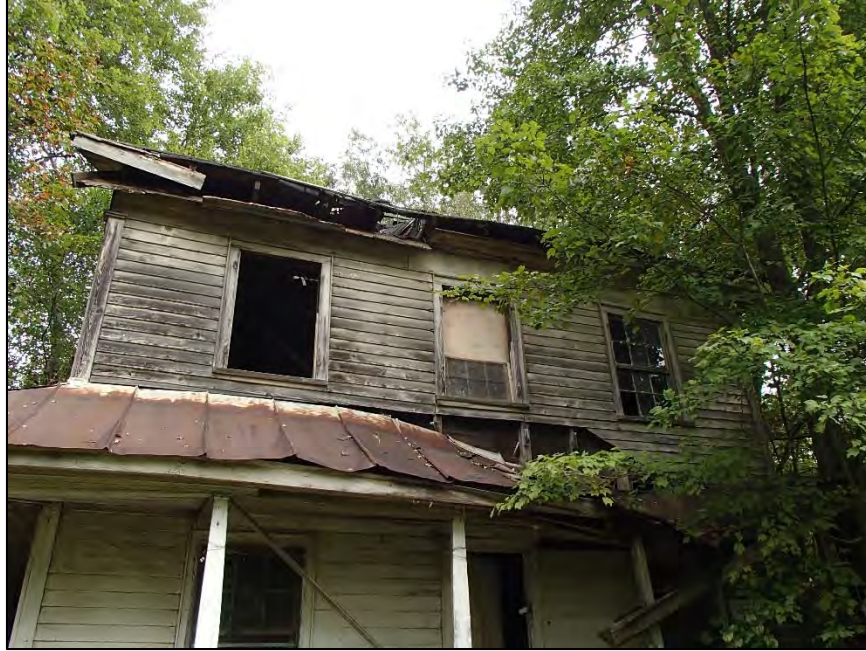
102: Ollie Low Craver House, west elevation

The symmetrical façade is three bays wide with a central front door flanked by windows. The front door is a nineteenth-century, single-leaf door with two vertical panels above a horizontal panel, and two shorter vertical panels below the horizontal panel. Many windows are missing or deteriorated, but extant windows have original six-over-six sashes. Weatherboards cover the exterior with flush sheathing covering the wall between the first floor windows and the front door. Corner boards are finished with a simple molded cap and a wide cornice board runs between the eave and top of the windows. A hip-roof porch extended across the façade and wrapped around the north gable end, but the south end of the porch roof and sections of the porch floor have collapsed. The porch retains most of its delicate, tapered, rectangular-in-plan posts.

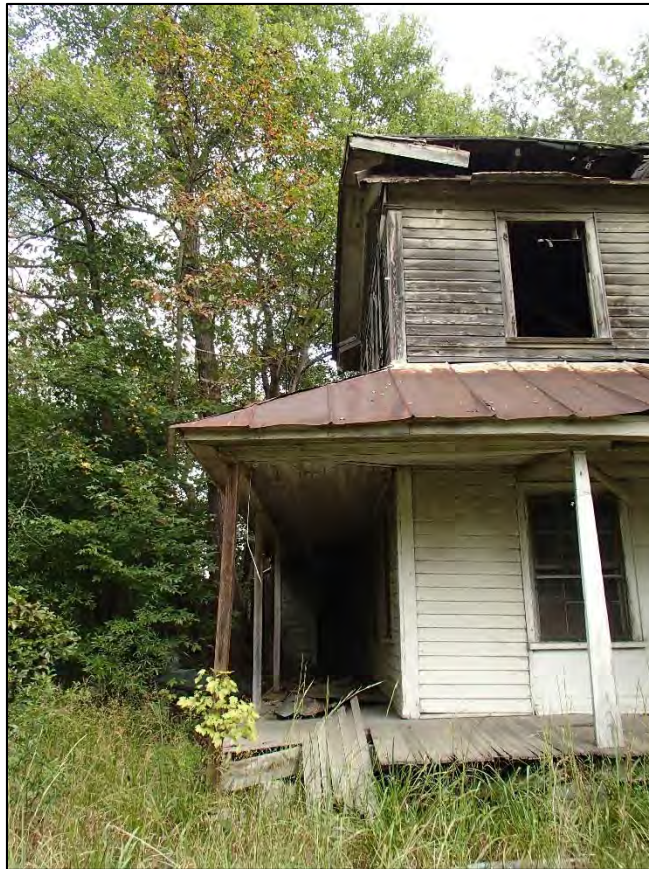
103: Ollie Low Craver House, west elevation

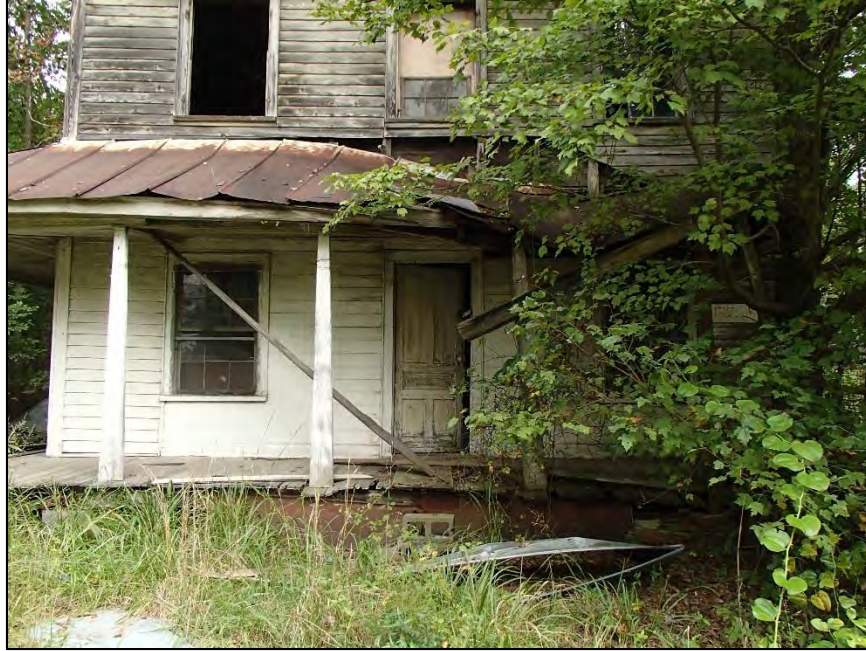
104: Ollie Low Craver House, west elevation

The south gable end is overgrown, but a vine-covered brick chimney remains on the south gable end. The north gable end has two windows at each floor and gable returns. Like other three-room or hall-parlor houses in the study area, only one side of the house was heated.

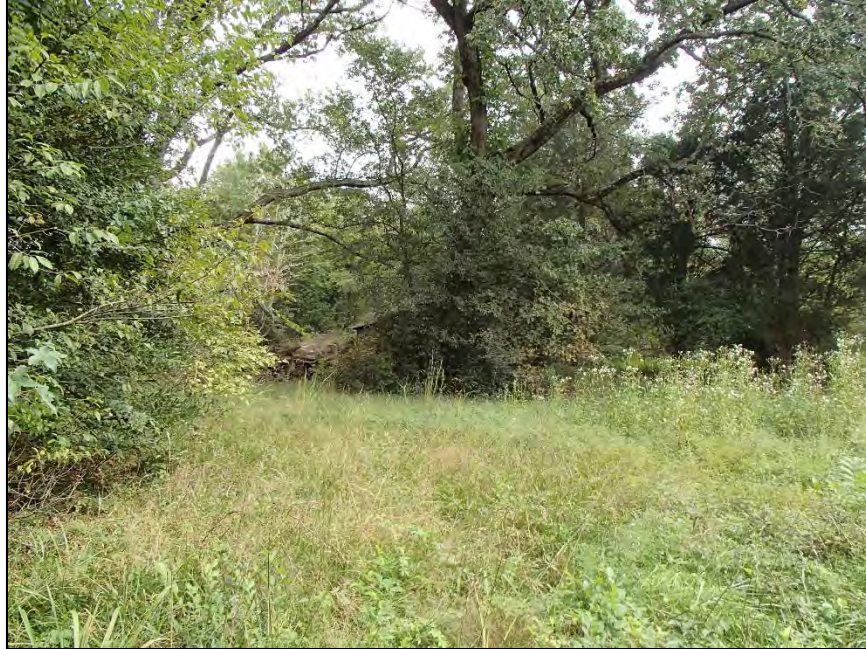
To the south of the house is a small frame outbuilding that may have been a small barn or granary. To the east is another small frame building that may have been a smokehouse, which is a very common outbuilding in the study area. To the southeast is a larger outbuilding that was probably a tobacco pack house, and to the southeast of the pack house is what appears to be a tenant house with a saddlebag plan.

105: Ollie Low Craver House, possible granary

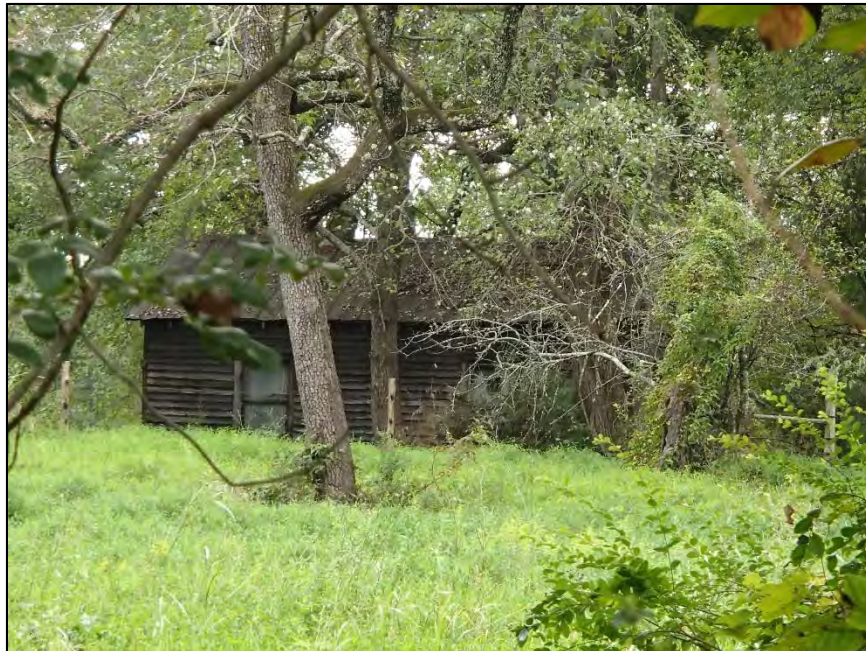
106: Ollie Low Craver House, tenant house

When the investigator visited the property, extensive roof damage could be seen when looking up through open second floor windows. This damage is also visible in aerial photography. The roof failure suggests that the interior has suffered water damage and is likely unstable, so the investigator did not go inside. Furthermore, the investigator was not able to contact the owner, and because the property was extremely overgrown, the investigator did not fully traverse it.

The Ollie Low Craver House is not eligible for the National Register of Historic Places under Criterion A for a significant historic association. The house retains outbuildings, including a tenant house, but the outbuildings are in very poor condition, and many other Davidson County farms retain good collections of intact outbuildings. Furthermore, no cultivated fields remain to communicate the house's association with agriculture, and the farm's known products (dairy products and eggs) are not represented by the extant outbuildings. The lot is entirely overgrown with tress, bushes, and mature vegetation. The property no longer conveys and is not otherwise known to possess a historically significant association with agricultural development in Davidson County.

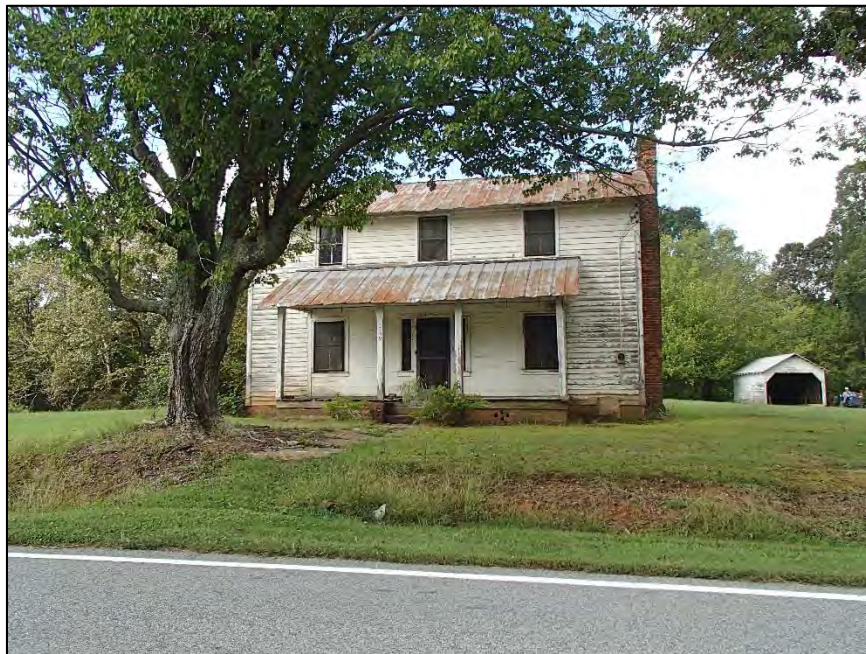
110: Old Herbert Wasler House, DV 265, Yadkin College Road; this is an I-house with chimneys on both gable ends, but the use of flushboard sheathing under the porch is similar to that at the Ollie Low Craver House

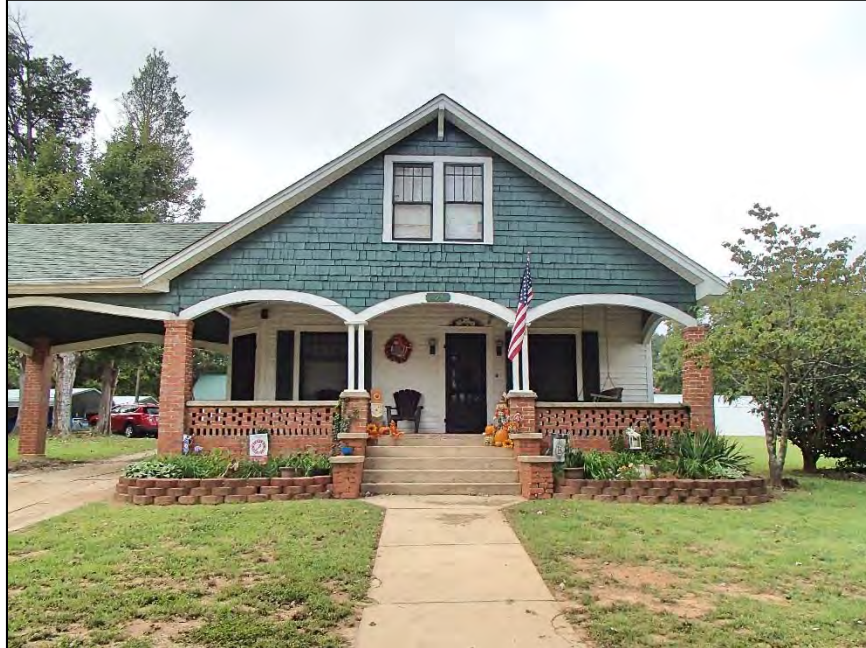
The Royal and Floy Leonard House is a side-gable bungalow with a prominent, full-width, gable-front porch. The house is covered in original weatherboards except for the soffits, which are clad in vinyl siding. Wooden shingles cover the side gable ends and porch gable.

112: Royal and Floy Leonard House, east elevation

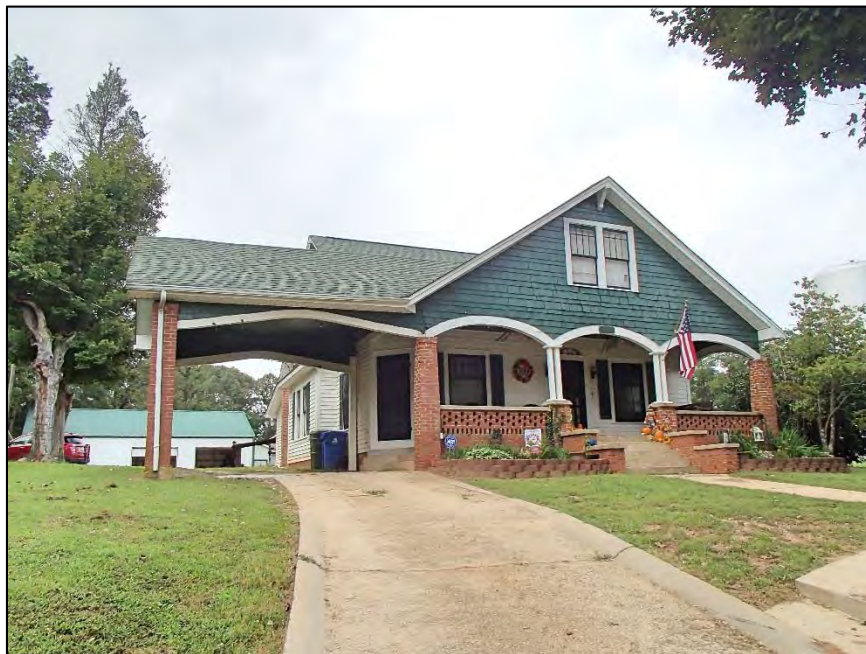
113: Royal and Floy Leonard House, east elevation with large, modern garage in background

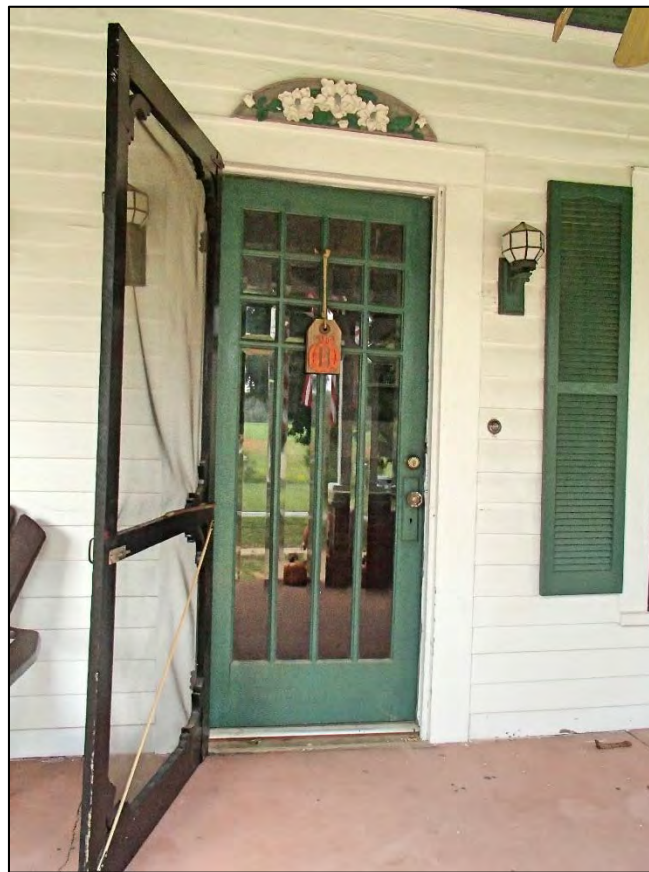
The façade under the porch features the original, single-leaf front door. The Craftsman door contains twelve square glazed panels over four long glazed panels. All the panes are beveled. Craftsman style sconces flanking the front door appear to be original. On the outer bays on either side of the front door are large, twelve-over-one sash windows. On the main block's southeast corner, under the porch, the corner is clipped and a second door occupies the resulting angled wall. Concrete steps are angled to join the concrete steps to the main porch and these steps lead to the porte cochere.

114: Royal and Floy Leonard House, front door

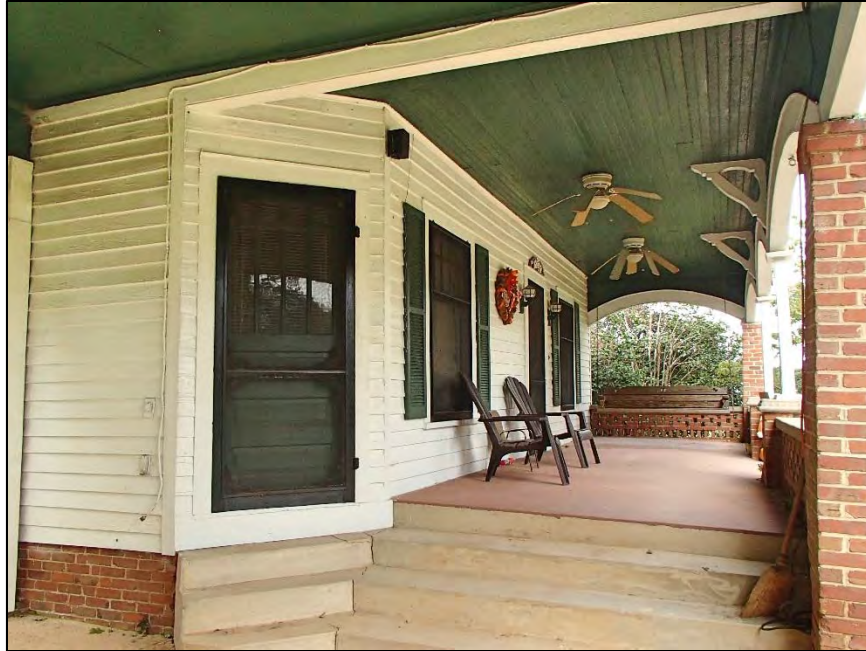
The porch is composed of battered brick posts at each end and a brick lattice balustrade with a concrete railing. Flanking the porch entrance are brick piers with paired, square posts. The porch openings are highlighted with segmental arches that spring from the porch posts. The porch floor is concrete and the date of 1932 is etched in the concrete in the driveway under the porte cochere. The concrete porch floor and possibly the porch's brickwork may date to 1932. A pair of original eight-over-one sash windows occupy the porch's front gable end and a kneebrace is located at the apex. The porch has been extended to the south to incorporate a porte cochere. The porte cochere posts are smooth brick that appears to be newer than the other brick on the porch, but other finishes on the porte cochere, including wooden shingles, match the main house.

115: Royal and Floy Leonard House, front porch

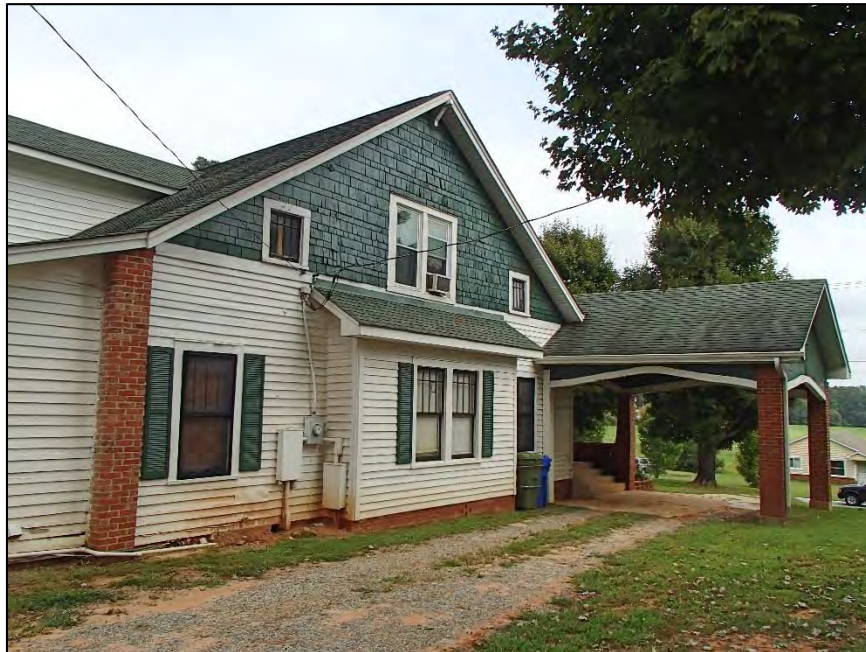
The south gable end retains original eight-over-one windows, a shed-roof projection and original attic windows. A brick chimney flue on this elevation has been truncated.

116: Royal and Floy Leonard House, south elevation

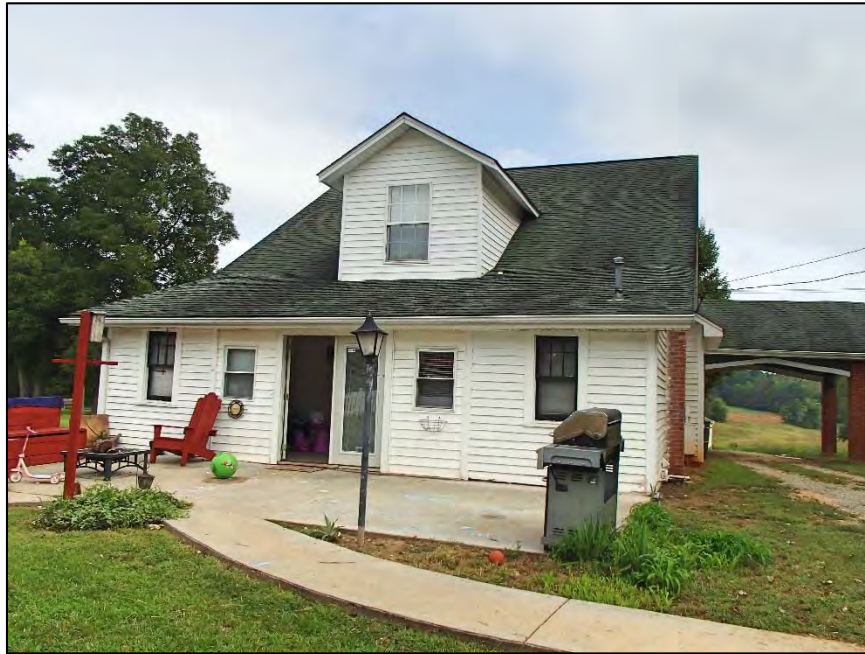
A rear shed extends across the entire west elevation. This shed originally contained rooms on either end with an open porch between the two rooms, but the porch has been enclosed. A gabled dormer is

centered on the rear roof slope and is probably an addition to the house. It is covered in vinyl siding and has a vinyl window.

117: Royal and Floy Leonard House, west elevation

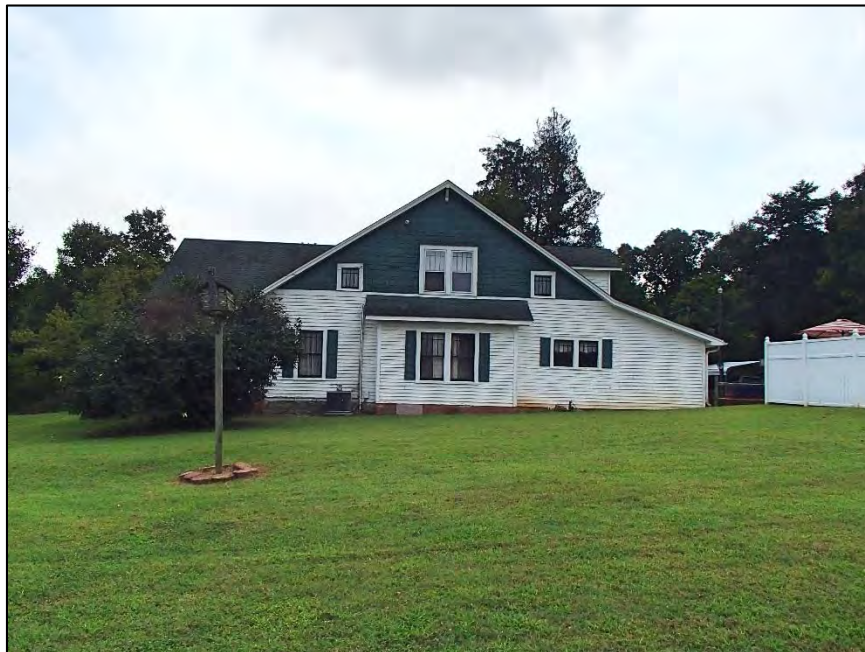
118: Royal and Floy Leonard House, north elevation with tall vinyl fence around pool

The north elevation mirrors the south with a shed roof projection, original windows, and a shingled gable end.

The roof is covered with asphalt shingles and the interior chimneys have been removed. The house stands on a continuous brick foundation.

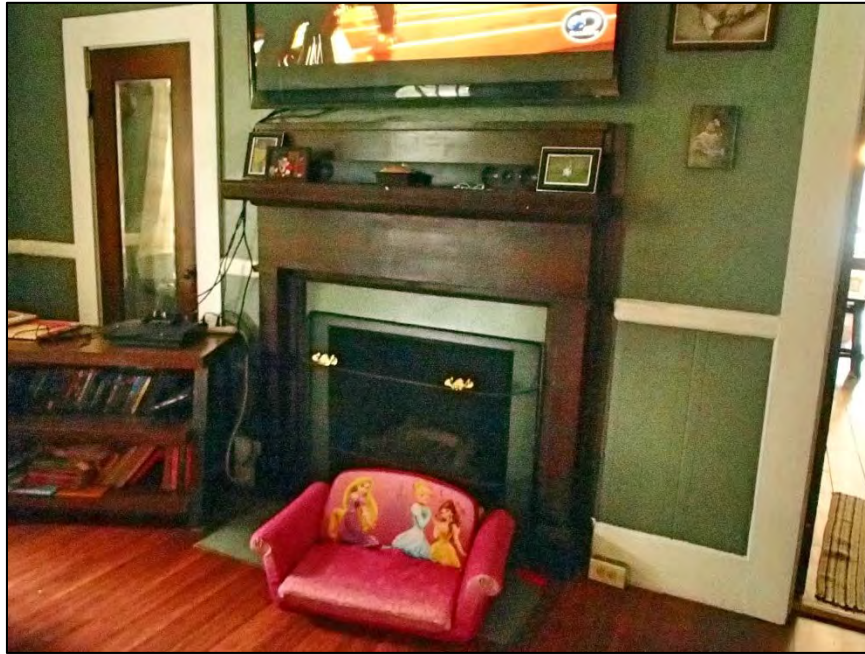
119: Royal and Floy Leonard House, front south room

The interior retains remarkable integrity. The front south room retains an original closet with a built-in beveled mirror, a wooden, Craftsman style, post-and-lintel mantel and an original chair rail. (The paneling below the chair rail is a later alteration.)

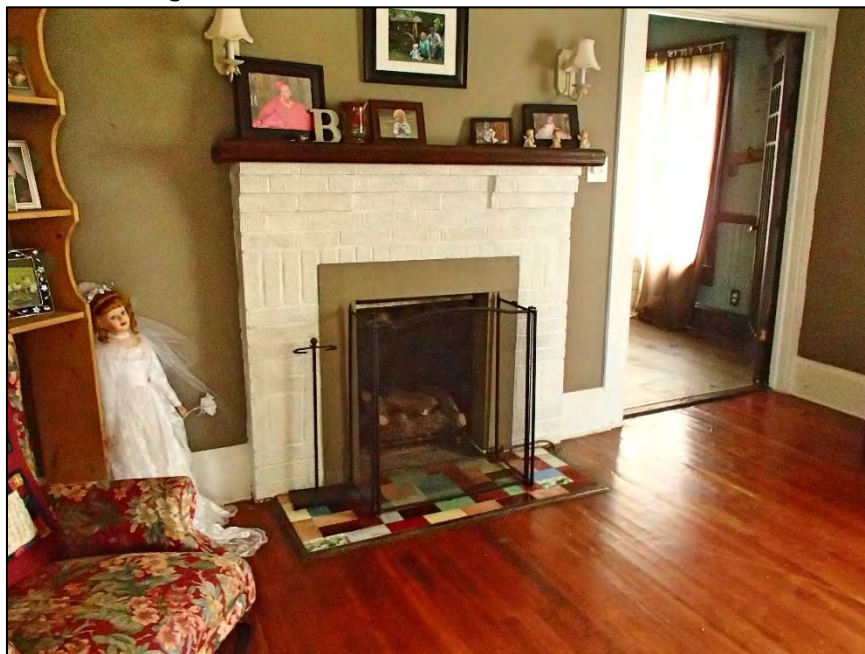
The north front room has a brick Craftsman style mantel, as does the north back room. The two north rooms are connected with original French doors.

120: Royal and Floy Leonard House, front north room

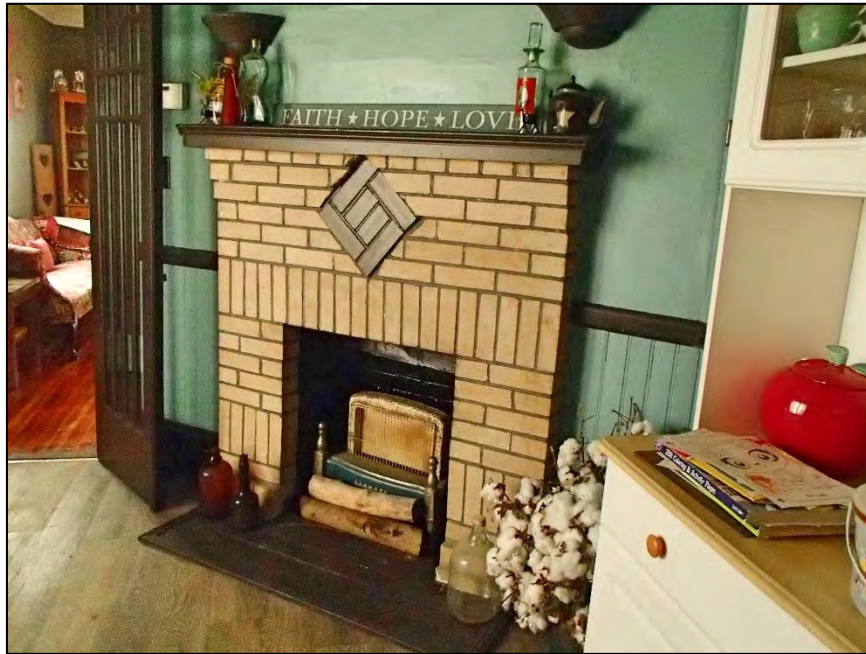
121: Royal and Floy Leonard House, north back room

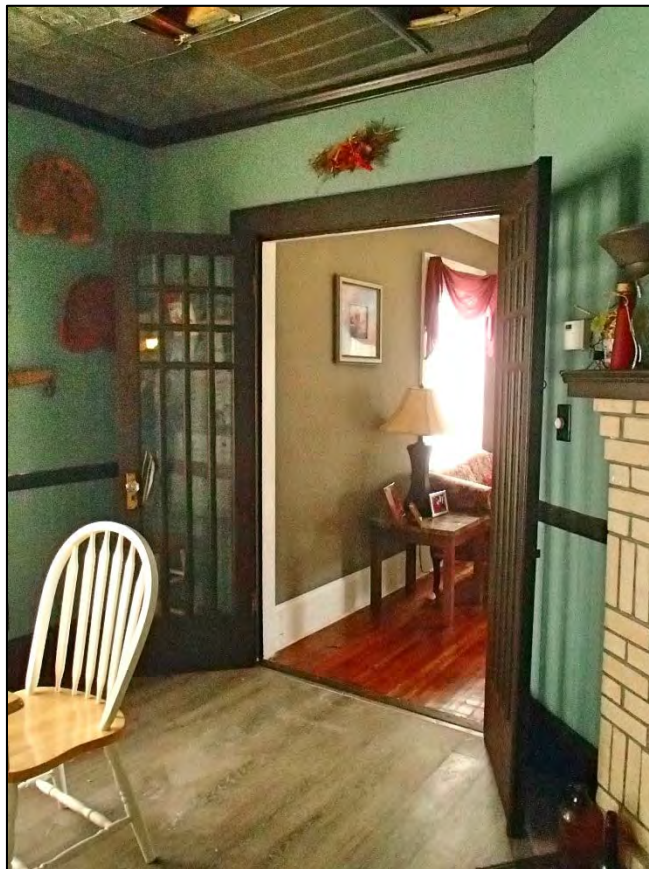
122: Royal and Floy Leonard House, doors between north front room and north back room

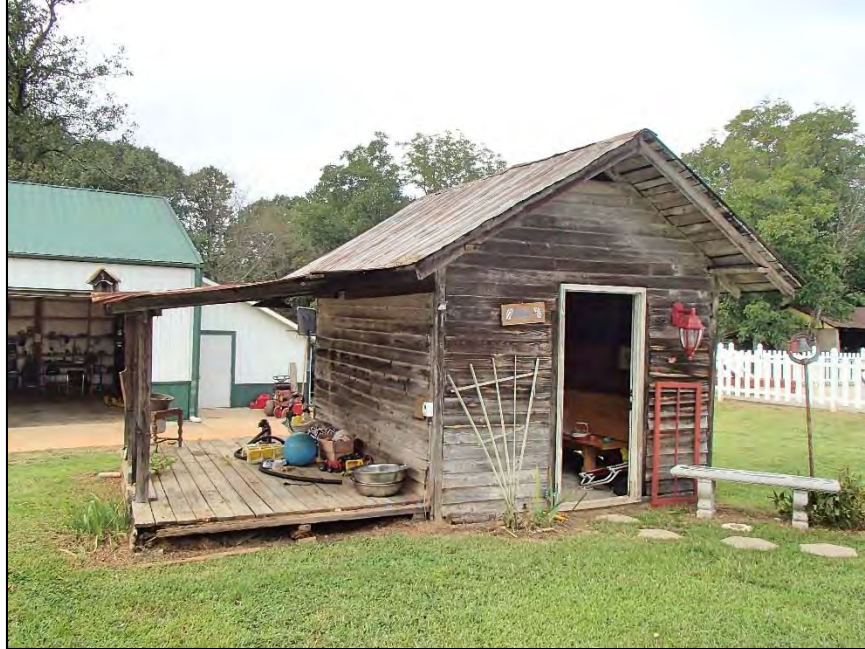
A frame, gable-front smokehouse is the only historic outbuilding on the property. A large garage, open-sided carport, and swimming pool with a tall vinyl fence are modern additions to the site.

124: Royal and Floy Leonard House, smokehouse with large garage and vinyl pool fencing in background

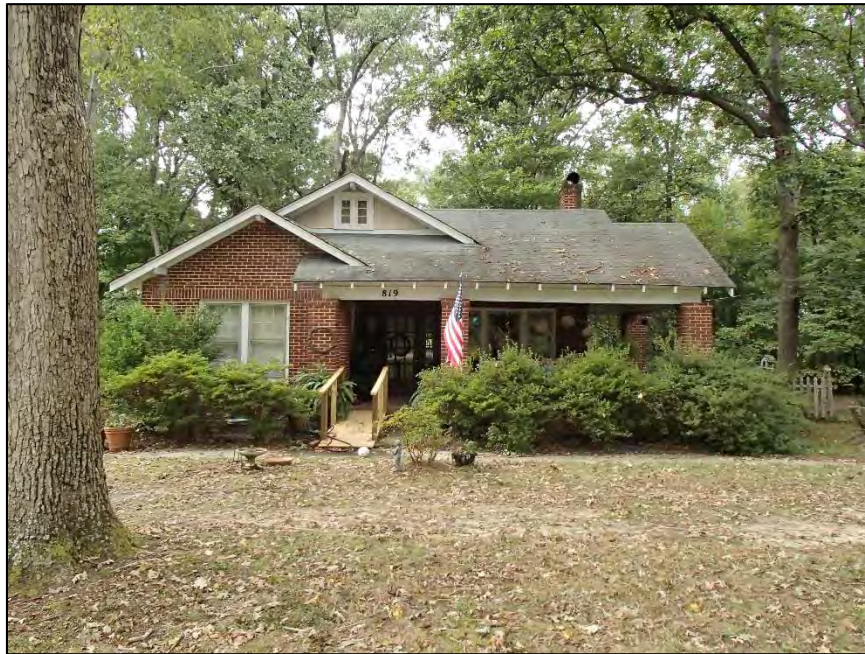
The Shiloh Methodist Church Parsonage is a diminutive brick bungalow. Brick soldier courses trim the windows and create a water-table. The house has a gable-front roof form with a side-gable wing projecting to the north. On the façade, the gable-front block has a lower gable-front projection with a pair of original six-over-one sash windows, while the taller portion of the gable-front block has a gable-end finished with pebbledash and a pair of three-light attic windows. The side-gable wing engages a full-

width porch with brick posts, a brick balustrade, and a concrete floor. The porch projects beyond the north wall plane and the resulting gable end is finished with pebbledash. The front door is a single-leaf French door with sidelights. A pair of windows is located on the façade, to the north of the front door.

139: Shiloh Methodist Church Parsonage, east elevation

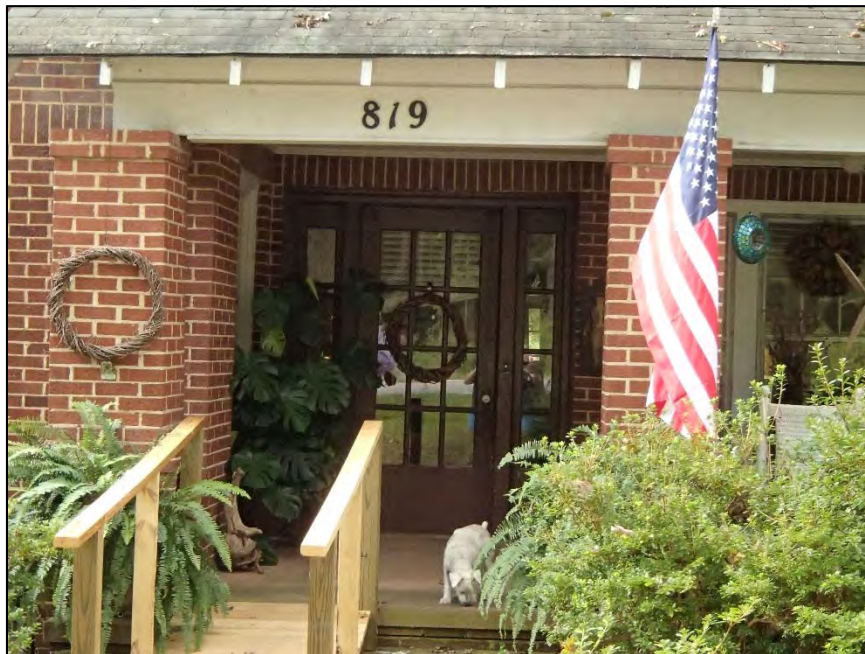
140: Shiloh Methodist Church Parsonage, front door

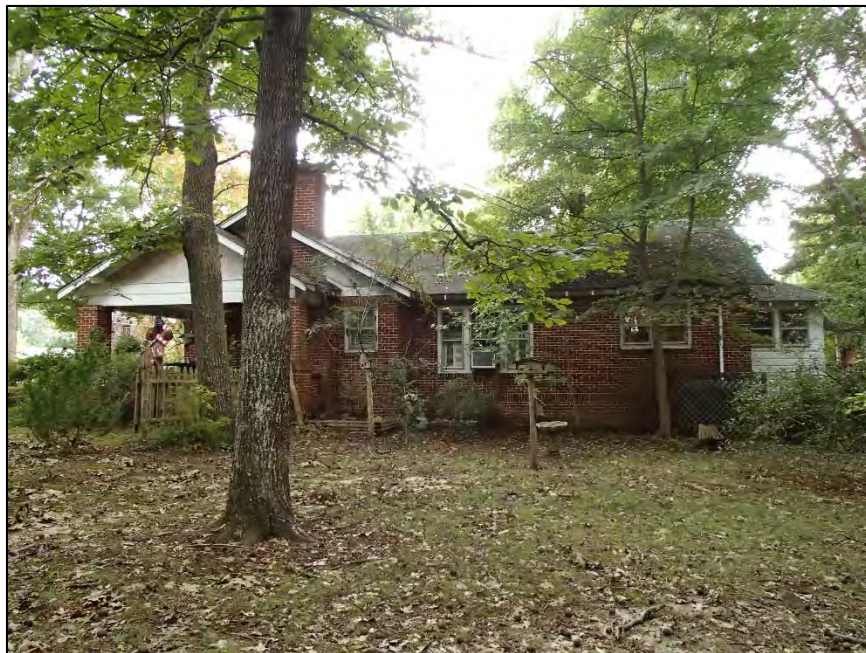
The north elevation retains original windows, and exposed raftertails.

142: Shiloh Methodist Church Parsonage, north elevation

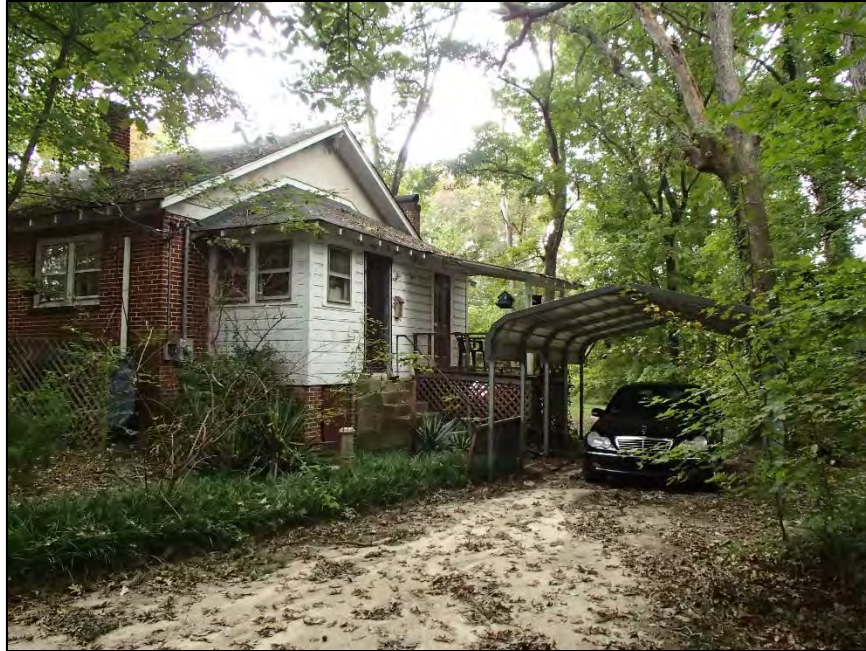
The west or rear elevation features a gable end finished with pebbledash and a hip-roof back porch enclosed with German siding. A shed roof projects over a small second porch added to the original back porch.

143: Shiloh Methodist Church Parsonage, northwest corner

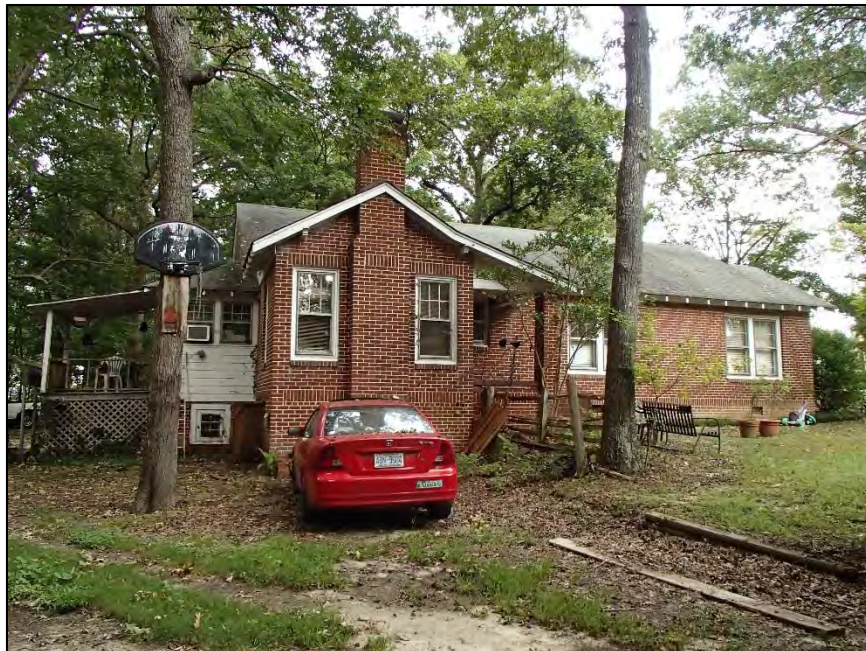
144: Shiloh Methodist Church Parsonage, south elevation

The south elevation retains original windows and exposed raftertails. Toward the back of the house, a small gabled ell extends to the south. This gable end is finished with a single-shoulder chimney flanked by original six-over-one windows. The ell's east elevation has a small brick stoop.

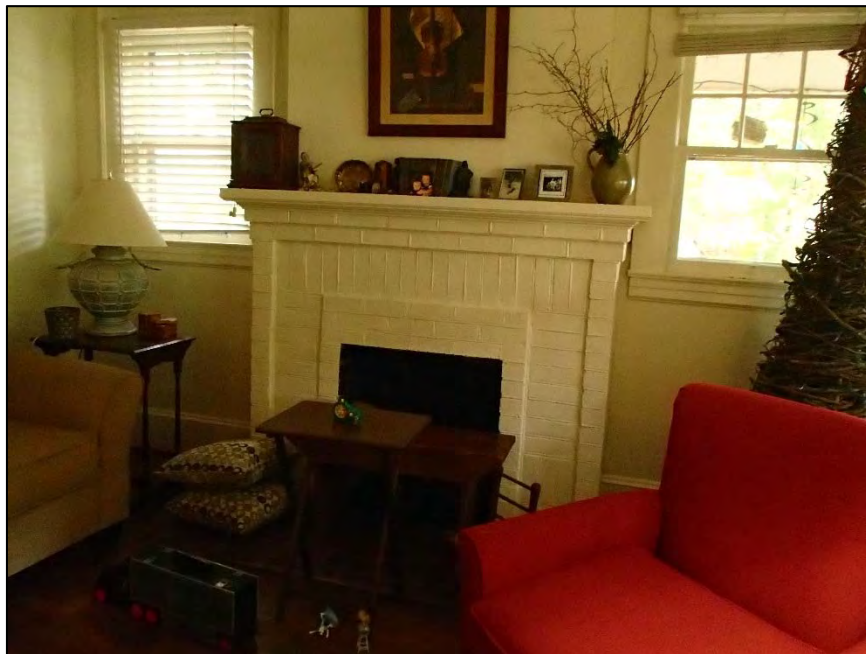
146: Shiloh Methodist Church Parsonage, living room fireplace

The interior is plainly finished with a brick Craftsman style mantel in the north front room and five-panel doors with glass knobs. The kitchen retains original glass-front doors.

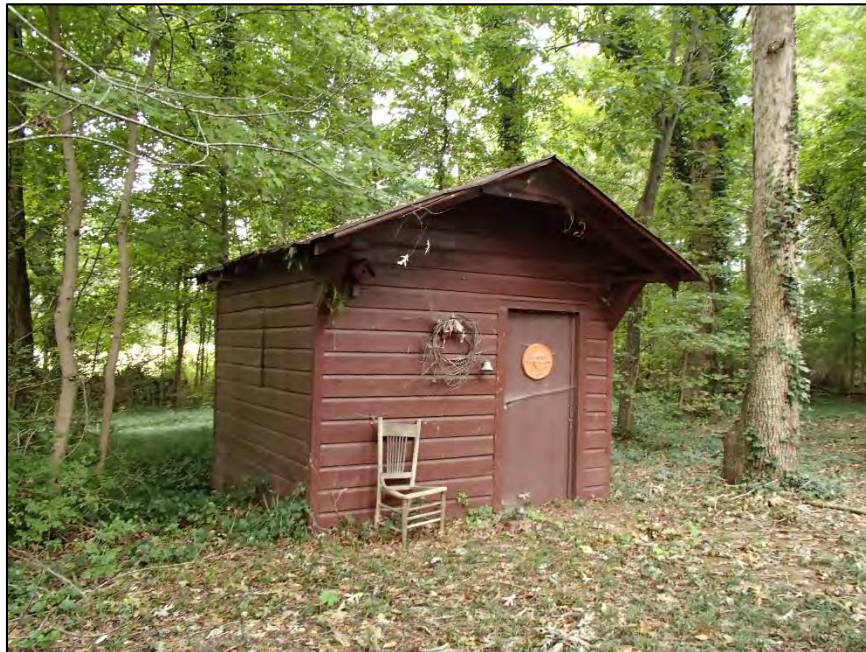
148: Shiloh Methodist Church Parsonage, smokehouse

A modern metal carport is situated immediately to the west of the house. A gable-front smokehouse with German siding and a gable-front garage, also with German siding, stand behind the dwelling.

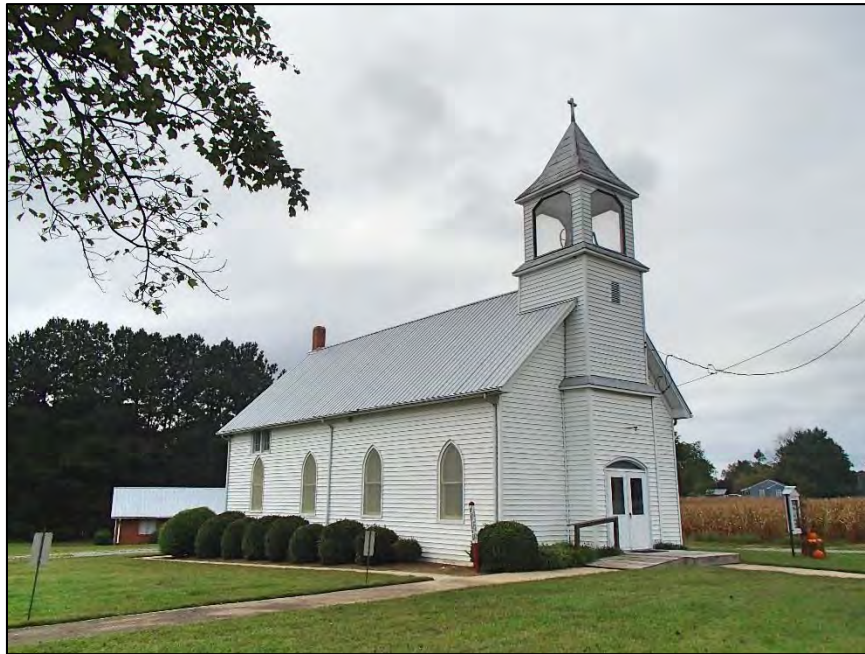
156: Maple Grove Church of the Brethren, southeast corner

The Maple Grove Church of the Brethren is a gable-front, frame church with Gothic arch windows and a projecting bell tower. The building is covered in vinyl siding and windows and doors have been replaced. Based on historic photographs and the photos taken in the 1982 countywide architectural survey, the building had weatherboard siding, multi-light wood frame windows, and wood shingles on the top stage of the bell tower. Today, the only original materials visible on the exterior are the molded concrete block in the foundation and the metal shingles on the steeple's roof.

Maple Grove Church of the Brethren is not eligible for the National Register of Historic Places under Criterion C. The church originally had weatherboards, multi-light windows, an oval vent in the bell tower, and wood shakes on the steeple. The windows have been replaced, and the other exterior features have been covered with vinyl siding. The interior retains some original doors and beaded board wainscoting, but modern materials cover the walls above the wainscoting, the ceiling, and the floors. The alterations have significantly diminished the building's architectural integrity.

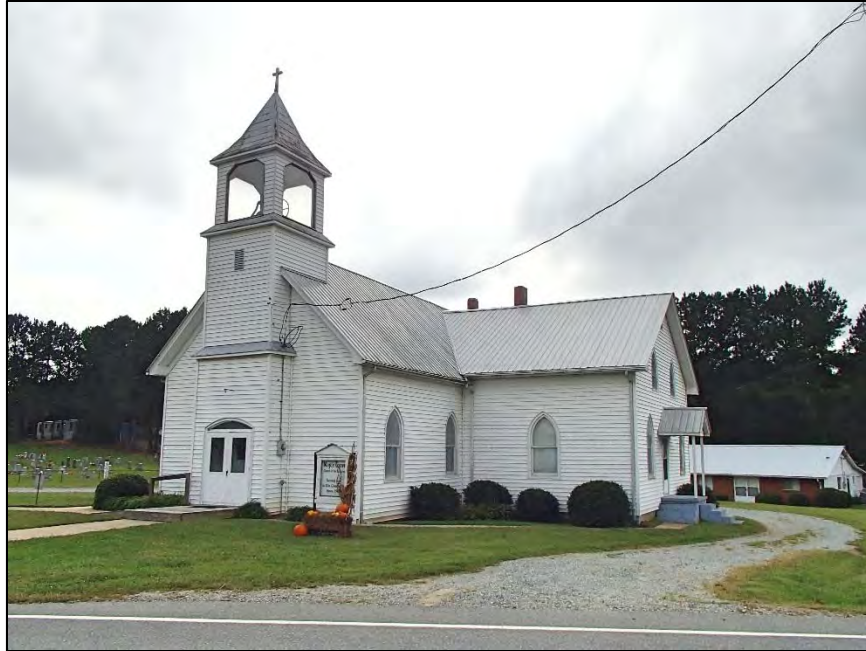
157: Maple Grove Church of the Brethren, northeast corner

The façade is dominated by the tower, which contains a double-leaf front door. The tower was added sometime after 1917 and before 1933. Above the door, about mid-way up the tower, is a shallow pent roof. The tower rises above the gable's apex and terminates at another shallow pent roof. Above this pent is an open bell tower with four clipped-corner openings. The original bell is visible inside. The bell housing is crowned with a pyramidal-roof steeple topped by a wooden cross. Pressed metal shingles cover the steeple roof. The rectangular vent in the tower was originally an oval vent.

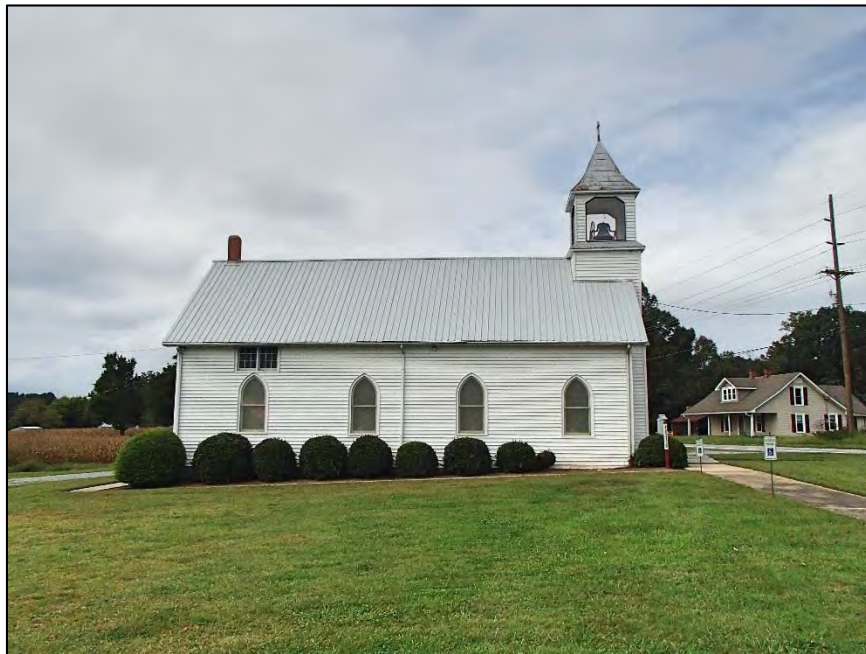
158: Maple Grove Church of the Brethren, south elevation

The south elevation features four Gothic arch windows.

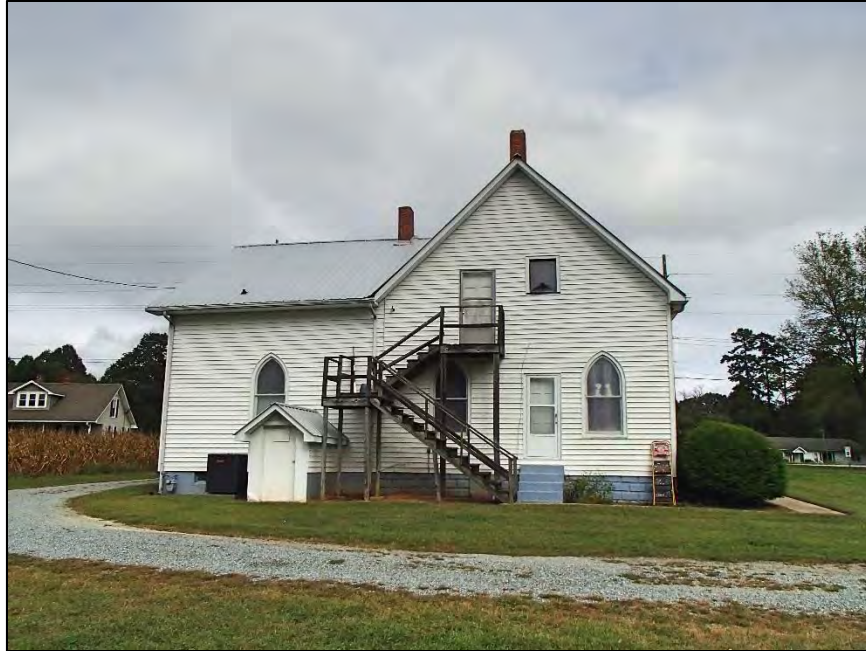
159: Maple Grove Church of the Brethren, west elevation

The west or rear elevation contains two Gothic arch windows at the first floor level and a modern paneled door. A wooden exterior stair leads to a door to a half-story space. Adjacent to this door is a square window. The west elevation also includes the west side of a north-facing gable addition. This wing's west elevation contains a Gothic arch window.
