MEMORANDUM

SUBJECT: Historic Structures Survey Report, Widen NC 150 from US 64 to Forsyth County Line,
PA 17-12-0078, U-5902, Davidson County, ER 18-3639

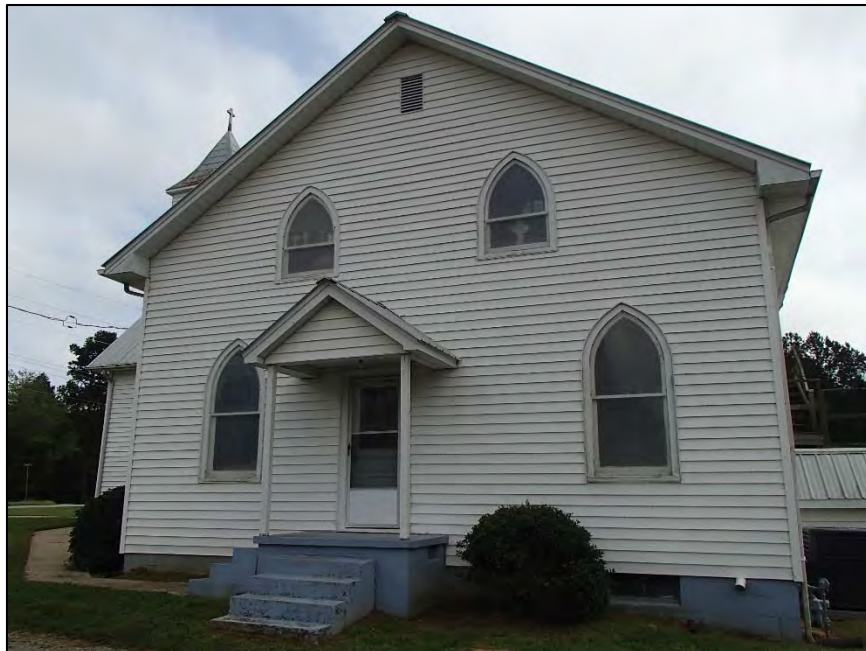
160: Maple Grove Church of the Brethren, north elevation

The north elevation is mostly devoted to a gabled addition. This wing has a central door flanked by Gothic arch windows. Small Gothic arch windows are located in the attic's half-story. The main block's north elevation contains two Gothic arch windows.

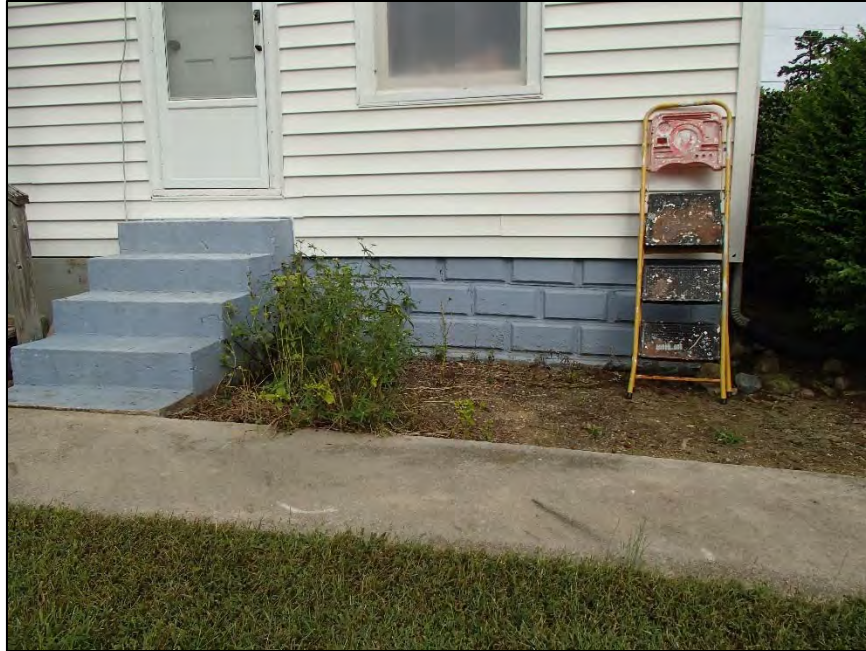
161: Maple Grove Church of the Brethren, original foundation detail

The original main block stands on a continuous foundation of concrete block molded so that the blocks have beveled edges. The north-facing ell rests on plain concrete blocks.

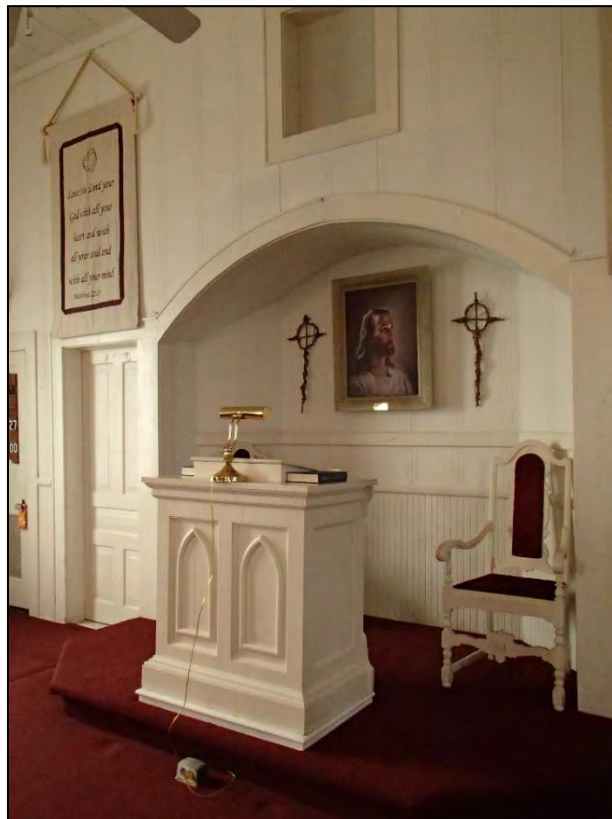
162: Maple Grove Church of the Brethren, pulpit

Inside, the sanctuary is a rectangular room with the front doors opening to a center aisle arrangement facing, on the opposite wall, a dais that projects from a segmentally arched apse recess. Original, five-panel doors flank the pulpit. To the south of the pulpit, the baptismal pool is set into the floor and remains covered when not in use.

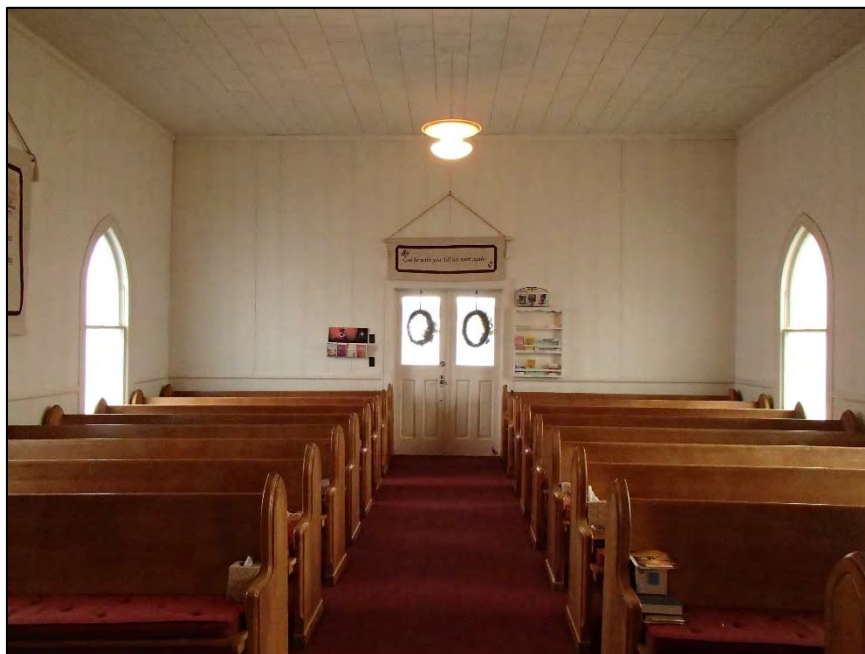
164: Maple Grove Church of the Brethren, interior from pulpit toward front door

The existing pews were in place at least as early as the 1960s, but they do not appear to be original. Original beaded board wainscoting and a chair rail remain, but above the chair rail, the walls are sheathed in a vertically grooved, synthetic wall board. Modern ceiling tiles cover the ceiling and the floor is carpeted. The north wall of the sanctuary opens into the side-gabled addition. Trim in the side-gable wing suggests it was added sometime in the mid-twentieth century.

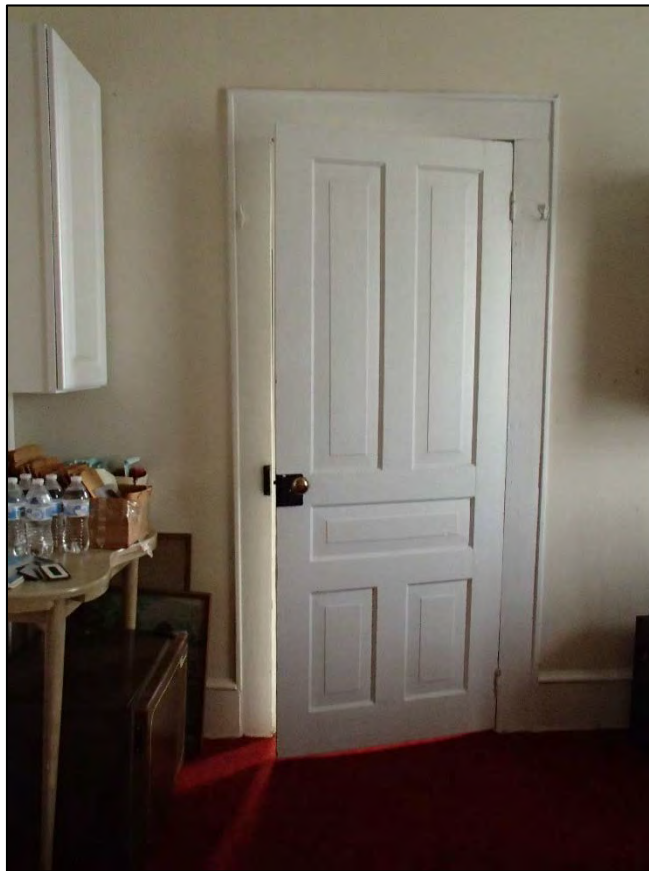
166: Maple Grove Church of the Brethren, original interior door

Behind the sanctuary, the space is carved into a storage area, nursery, and office.

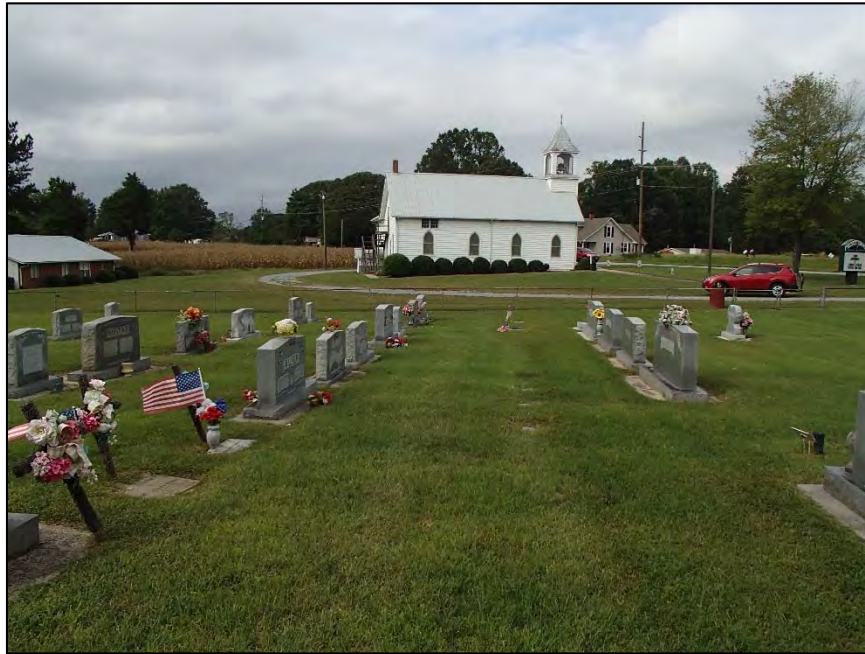
167: Maple Grove Church of the Brethren, cemetery, facing north toward church

To the south of the church is a cemetery. The earliest marked graves date from 1923. Markers from the 1920s and 1930s were executed in concrete or stone. Most markers are mass-produced granite markers typical of the twentieth century. One notable marker is Sallie Louisa Curry's 1933 memorial, created from white quartz rocks set in concrete.

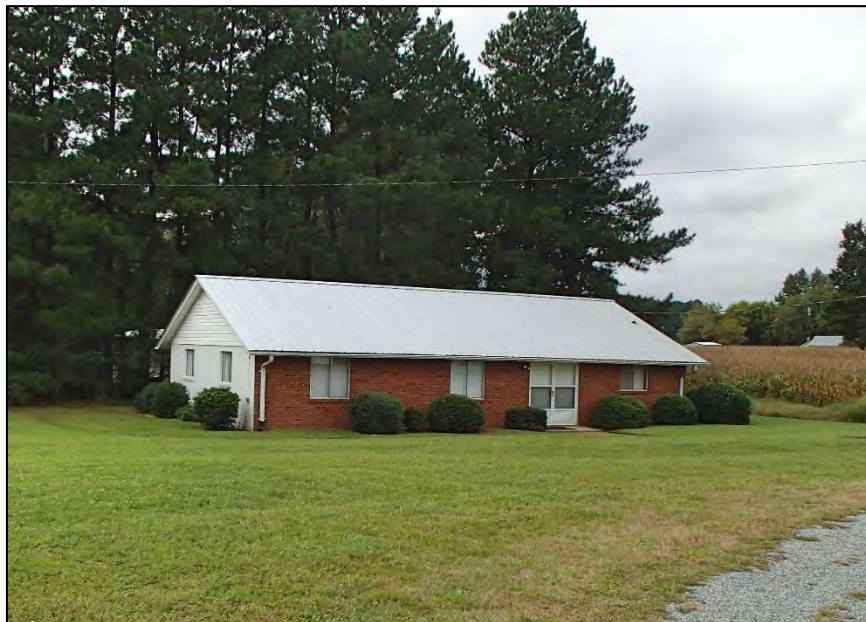
170: Maple Grove Church of the Brethren, fellowship hall

To the west is a one-story, fellowship hall with a brick façade and concrete block side and rear walls. The hall features metal-framed windows.

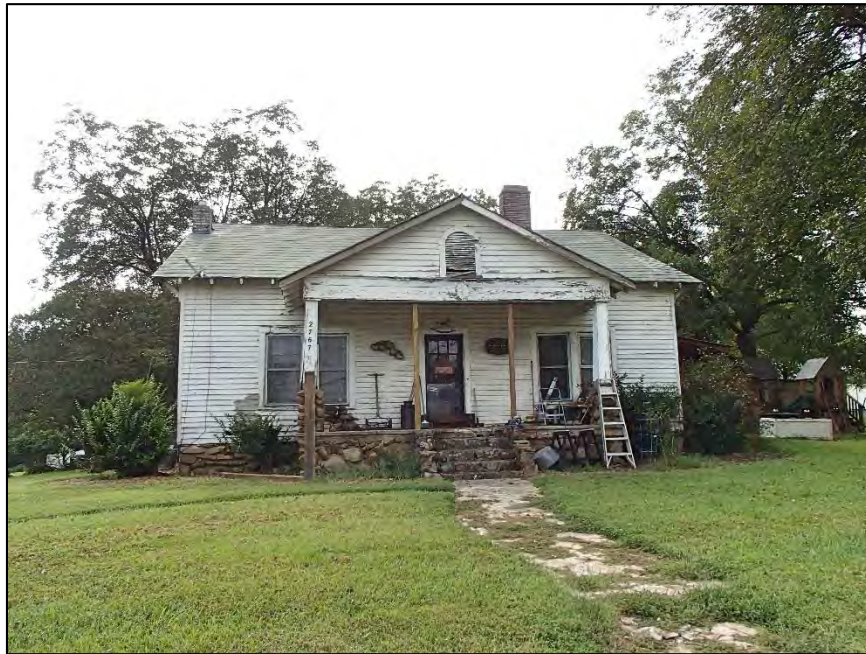
178: D.K. and Blanche Miller House, east elevation

The D.K. and Blanche Miller House is a one-story, side-gable house. The house retains original weatherboard siding, but all windows have been replaced. The house stands on a continuous stone foundation. Mr. Miller quarried the rock from a nearby creek. The eaves are finished with exposed raftertails.

On the east elevation, the single-leaf front door is centered between two paired windows. A partial-width, gable-front porch with battered posts on stone piers projects from the façade. An arched attic vent is centered in the porch's gable end.

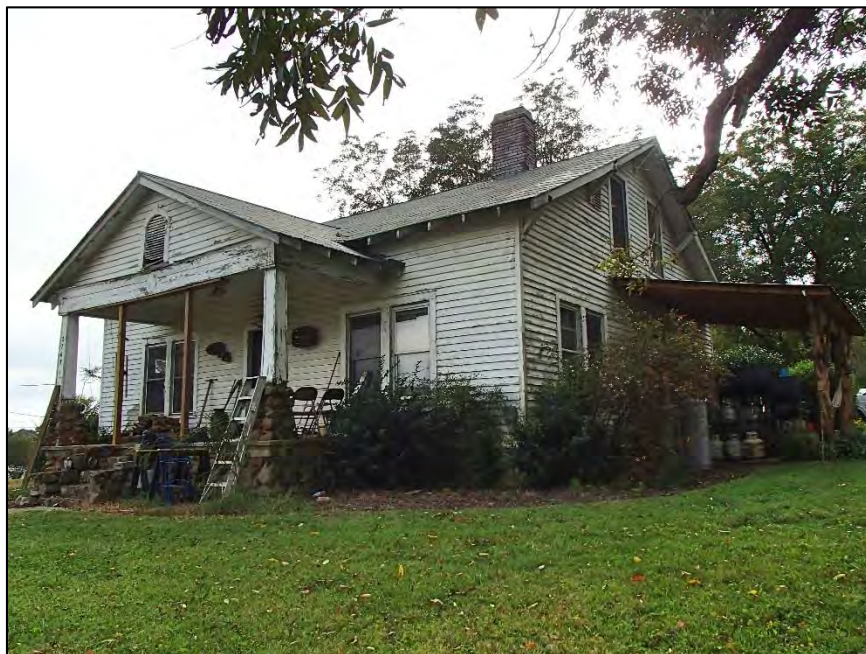
179: D.K. and Blanche Miller House, northeast corner

The north gable end has a pair of windows toward the front of the house. A second pair of windows, located toward the back of the house, has been converted to a doorway sheltered by a shed roof. Kneebraces highlight the gable end.

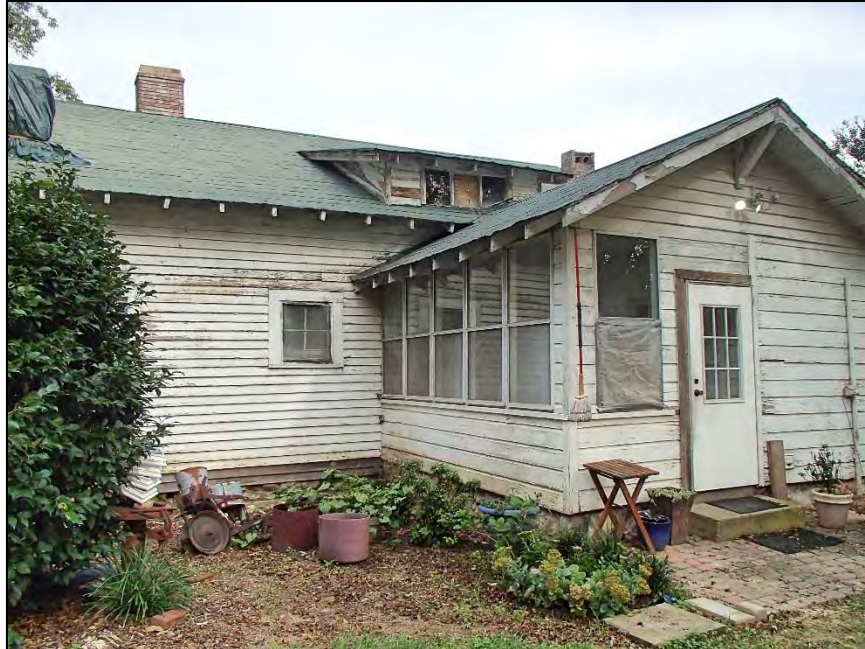
180: D.K. and Blanche Miller House, west elevation

The west elevation features two small square window openings, one of which retains the house's only original window, a small four-light sash. A gabled porch projects to the west. Part of the porch was enclosed to create a bathroom in the 1930s. Later, another enclosure completely enclosed the south half of this porch. The north side of the porch was enclosed with windows in the later twentieth century.

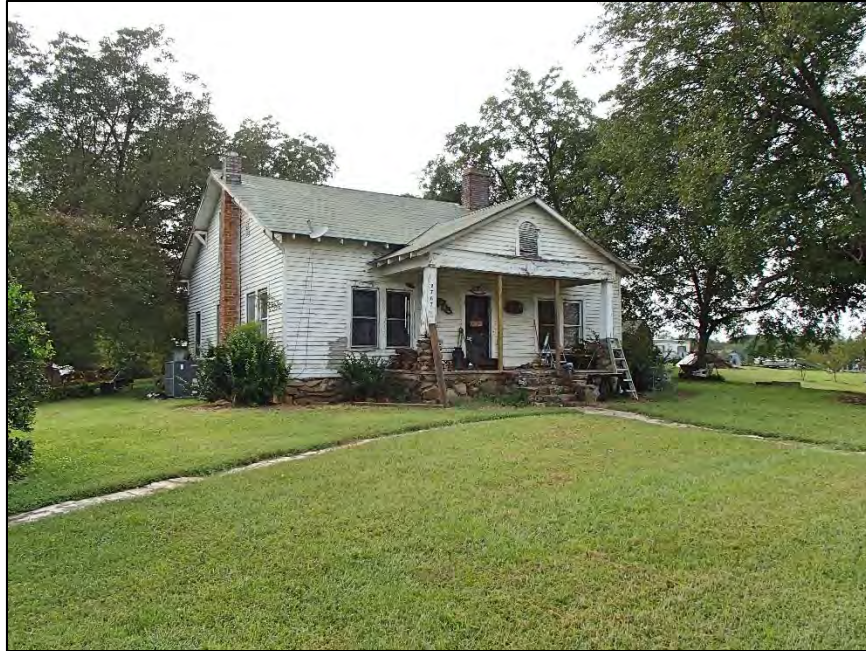
182: D.K. and Blanche Miller House, southeast corner

A brick chimney flu rises along the south gable end. The south gable end is finished with kneebraces and a pair of windows and single window.

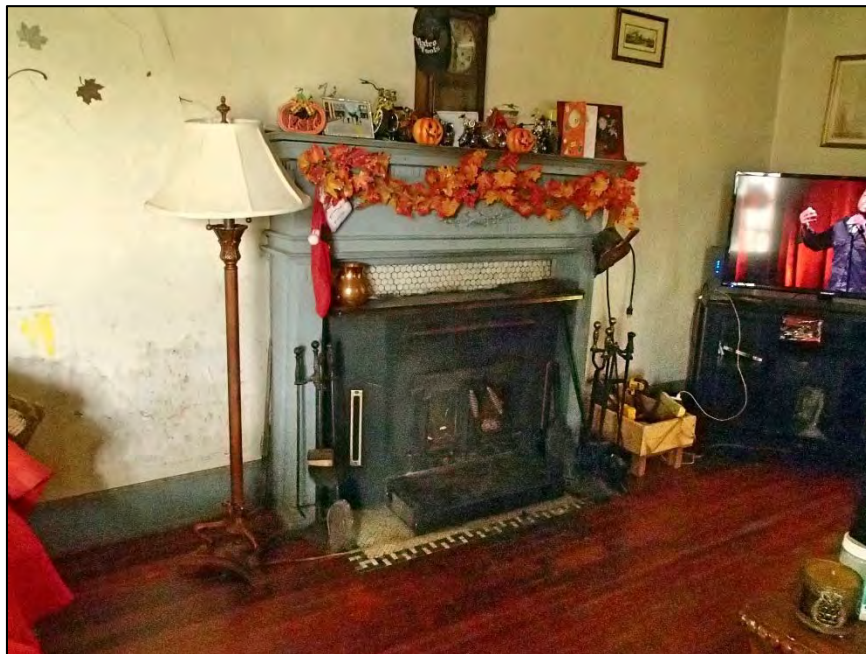
183: D.K. and Blanche Miller House, front north room mantelpiece

The front door opens into a large room that occupies the north end of the front half of the house. The south front room and north front room are connected by French doors. The north front room retains a fireplace with a Colonial Revival mantelpiece and hexagonal penny tile.

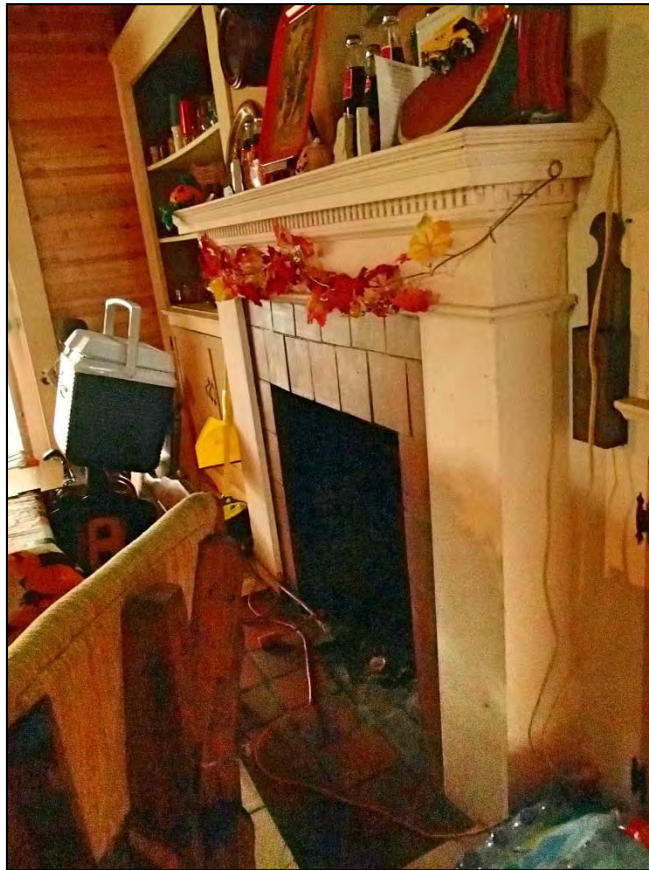
184: D.K. and Blanche Miller House, north back room mantelpiece

The two back rooms are separated by a hallway. The back rooms and the hallway are finished with flush wood sheathing. Both five-panel doors and older, nineteenth-century paneled doors are found in the back of the house. The north back room includes another Colonial Revival mantelpiece flanked by original built-in cupboards. The south back room is not heated and is simply finished with flush sheathed

wood. A stair in the hallway rises toward the back of the house to a landing where it turns toward the front of the house. Headspace for the landing area is created from a low shed dormer on the rear roof slope.

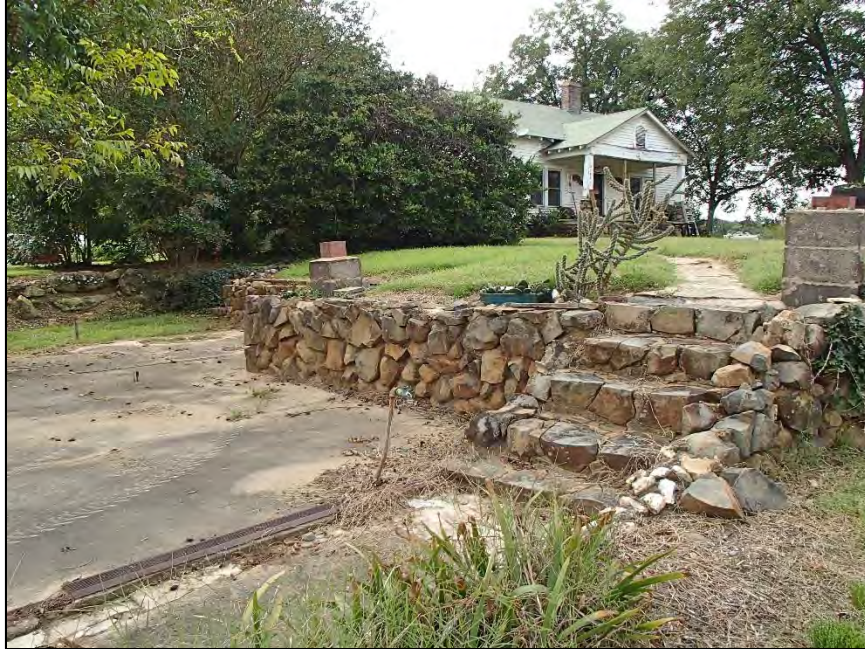
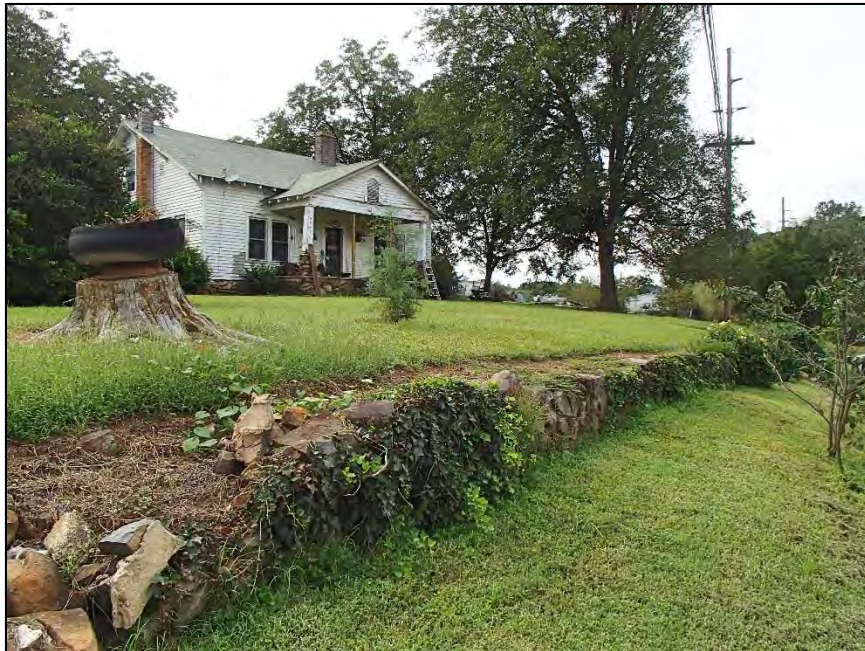
The house does not retain historic outbuildings, but a stone retaining wall along the front of the property matches the house's foundation. At the southeast corner of the property, the retaining wall joins a stone foundation that surrounds a concrete floor. This is the foundation for a store that the Millers ran.

185: D.K. and Blanche Miller House, store foundation

186: D.K. and Blanche Miller House, front retaining wall

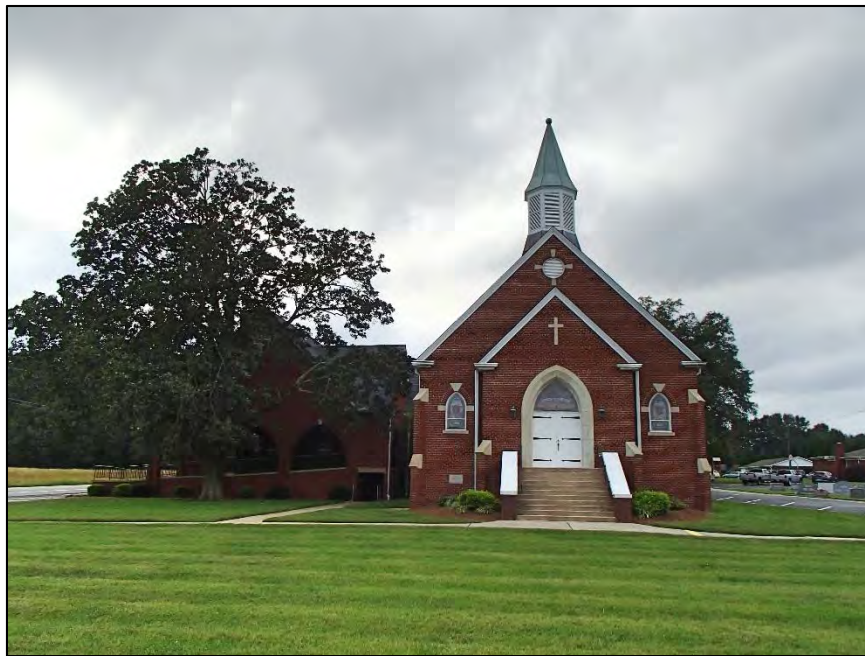
198: Good Hope Methodist Church, east elevation

Good Hope Methodist Church is a gable-front, brick, Gothic Revival church building. Stained glass windows throughout are original. The façade is symmetrical with a gable-front vestibule projecting forward. The projecting vestibule features a central, double-leaf wooden door with iron strap hinges below a stained glass, Gothic-arch transom. The doorway is surrounded by a wide cast stone, Gothic-arch opening. Above the entrance, a cast stone cross is set in the brick. On either side of the vestibule projection are small Gothic-arch windows highlighted with cast stone sills and keystones. Centered in the main block's front gable is a round attic vent also highlighted with cast stone keystones. Both the main block's gable and the vestibule gable are finished with gable returns. Truncated buttresses with angled cast stone caps are situated on the vestibule's front corners while two-stage buttresses with cast stone caps at each stage occupy the main block's corner. Concrete steps lead to the front door and are flanked by wide brick cheek walls capped with cast stone. At the main block's apex is an octagonal steeple with louvered panels and a metal roof topped with a round finial.

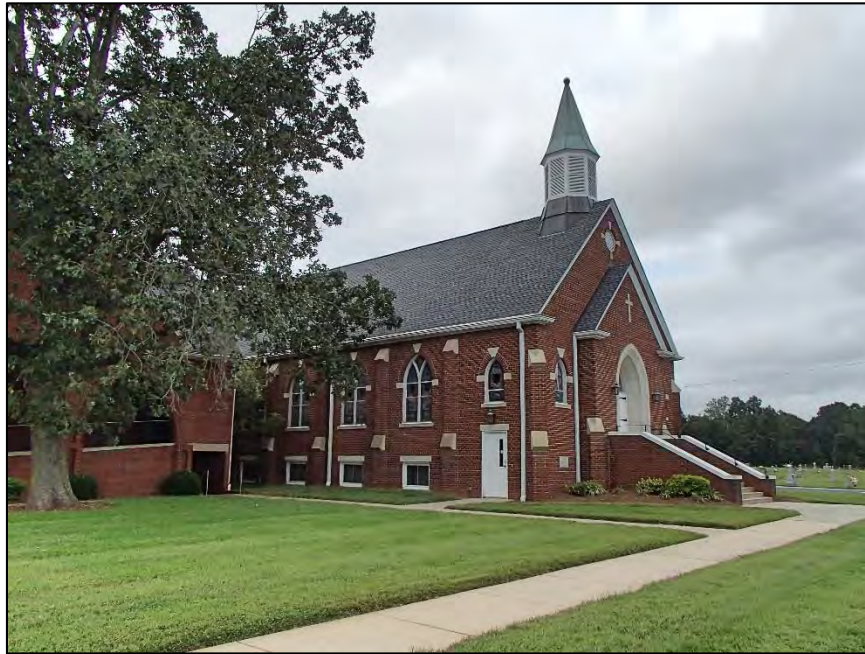
201: Good Hope Methodist Church, southeast corner

The north and south elevations are nearly identical. The north elevation is five bays deep while the south elevation is only four bays deep because the rear-most bay is obscured by an addition. On both sides, the forward-most bay contains a small, single Gothic arch window. The other bays contain large, stained glass, Gothic arch windows. Cast stone keystones and sills trim the windows. Below each window is a small basement-level window. These window openings contain modern vinyl windows but are trimmed with a cast stone cap. Two-stage buttresses extending from the grade to the eave separate each bay.

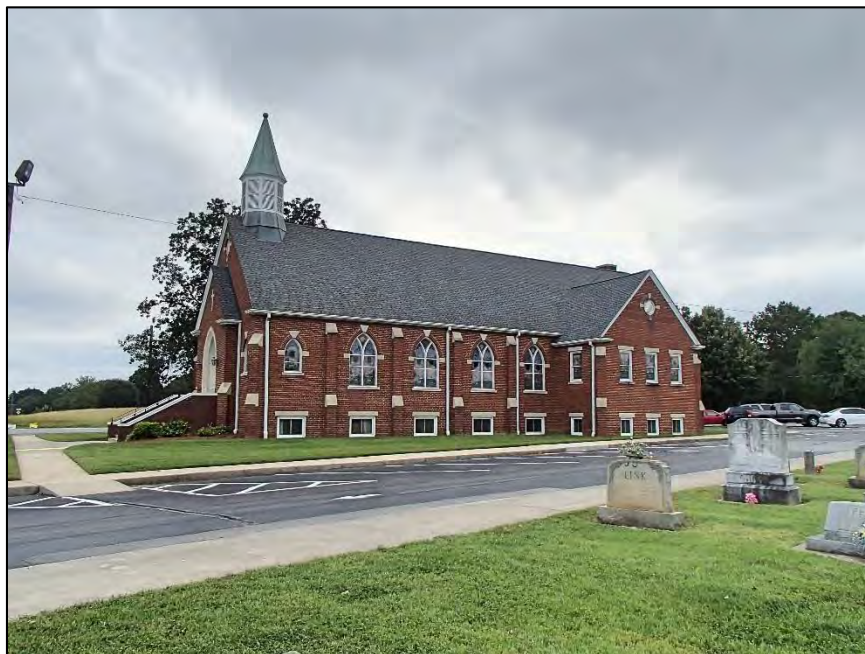
202: Good Hope Methodist Church, north elevation

Toward the rear of the north elevation, a gabled wing projects to the north. This wing appears to be original. The wing's windows are not arched, but contain stained glass windows. The finishes of cast stone sills and headers on the windows and buttresses at the corners match the building's main block.

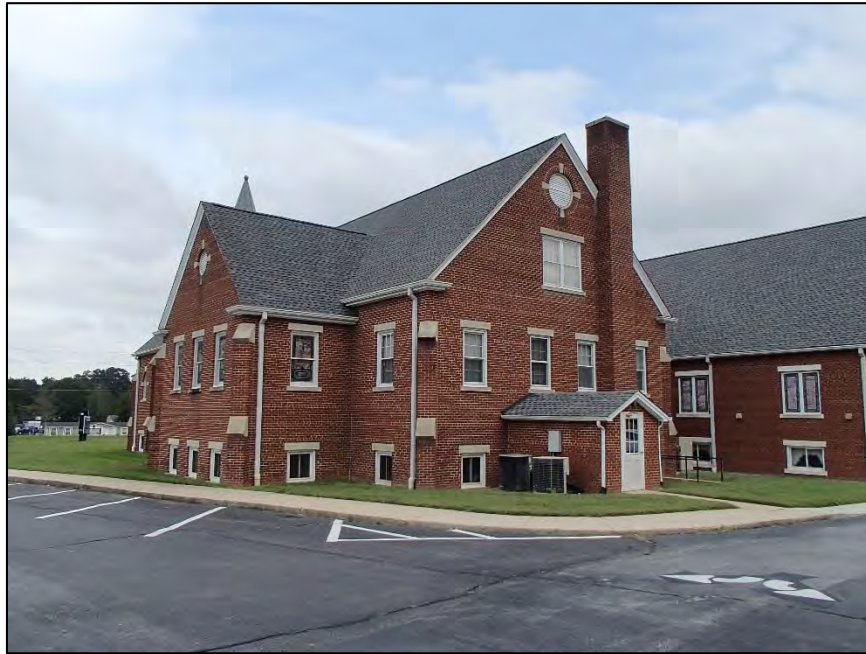
203: Good Hope Methodist Church, northwest corner

The rear or west elevation of the main block includes six-over-six sash windows with cast stone sills and headers at the main level and in the gable end, and two-stage buttresses at the corners. A gabled projection houses a single door that leads to the basement. A brick chimney flue rises along this elevation.

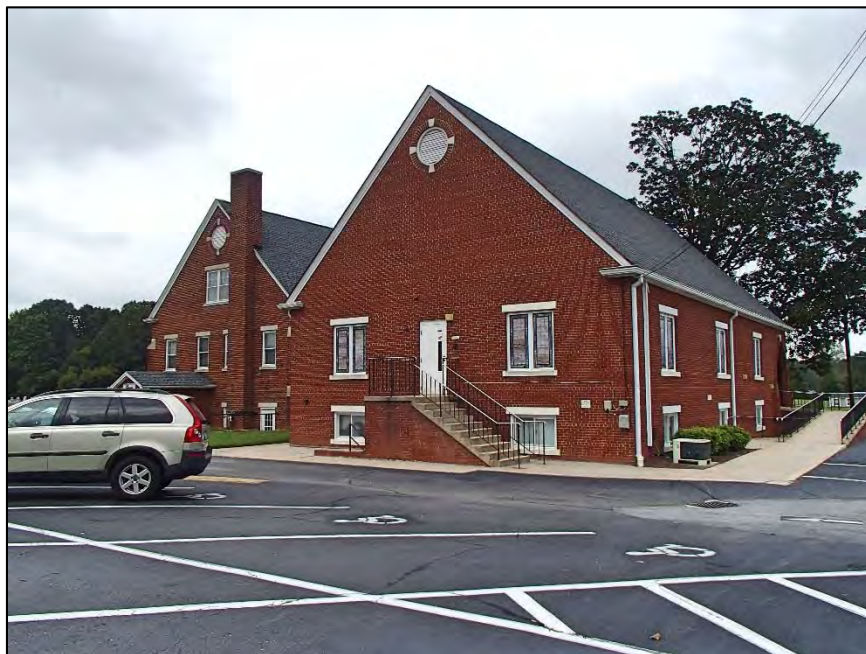
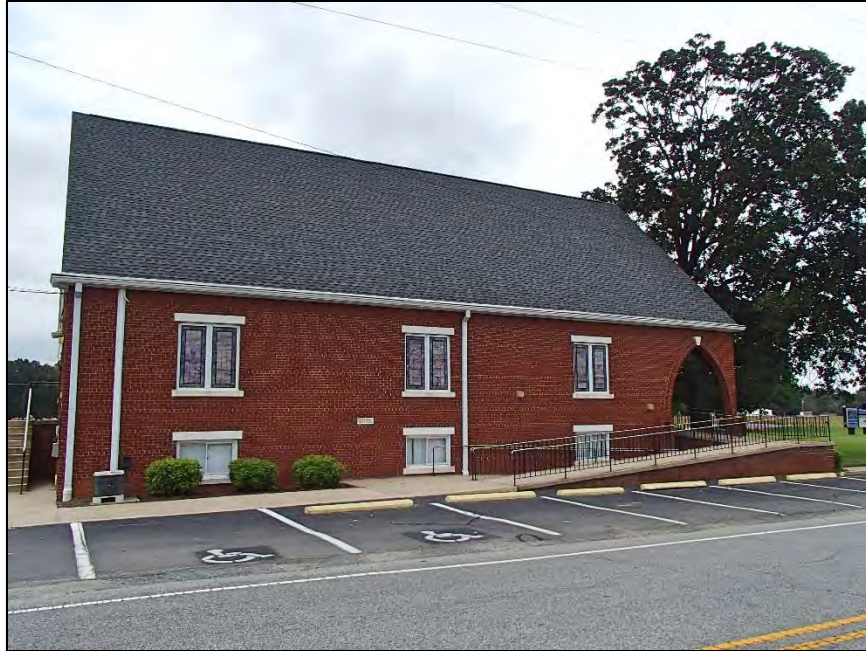
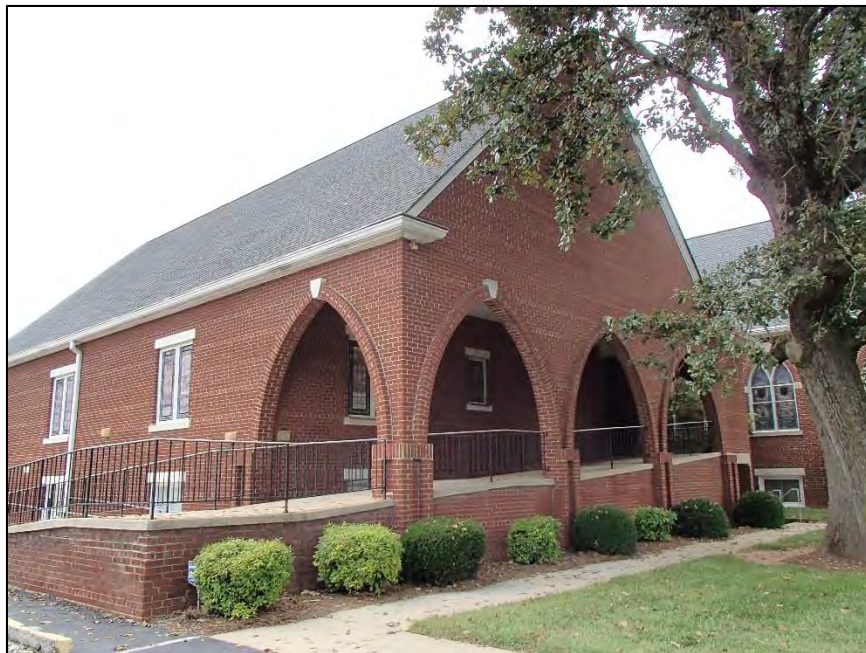
To the south, a substantial addition is connected to the original main block by a brick hyphen. The addition references the main block's cast stone window sills and headers, as well as keystones and round attic vents. The addition's windows are paired stained glass windows. The bulk of the addition is a gable-front structure with an engaged, full-width portico with Gothic arch openings and cast stone keystones. A long concrete ramp runs under the portico and turns to extend along the addition's south elevation. The façade of the addition is set well back from the original main block and leaves the main block as the complex's primary elevation.

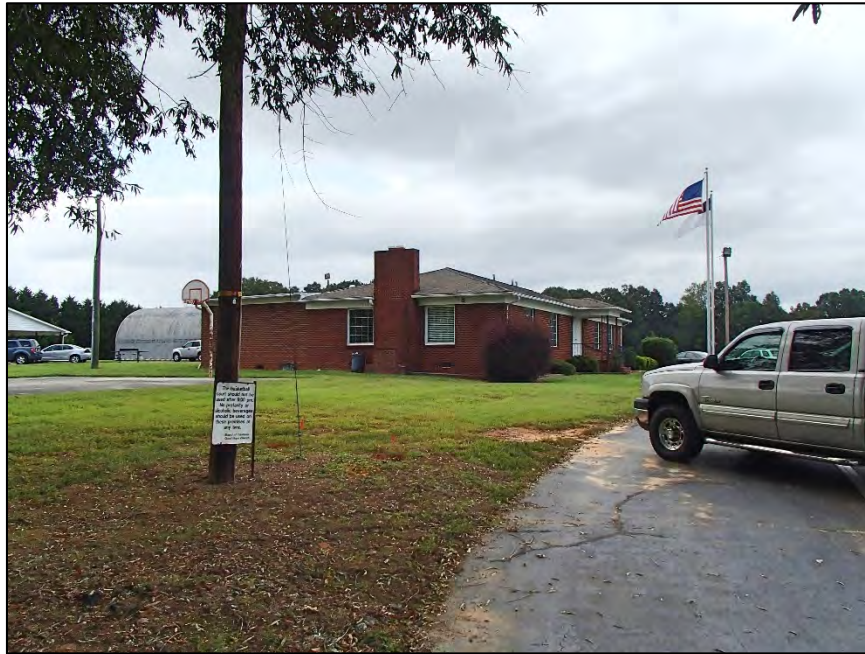
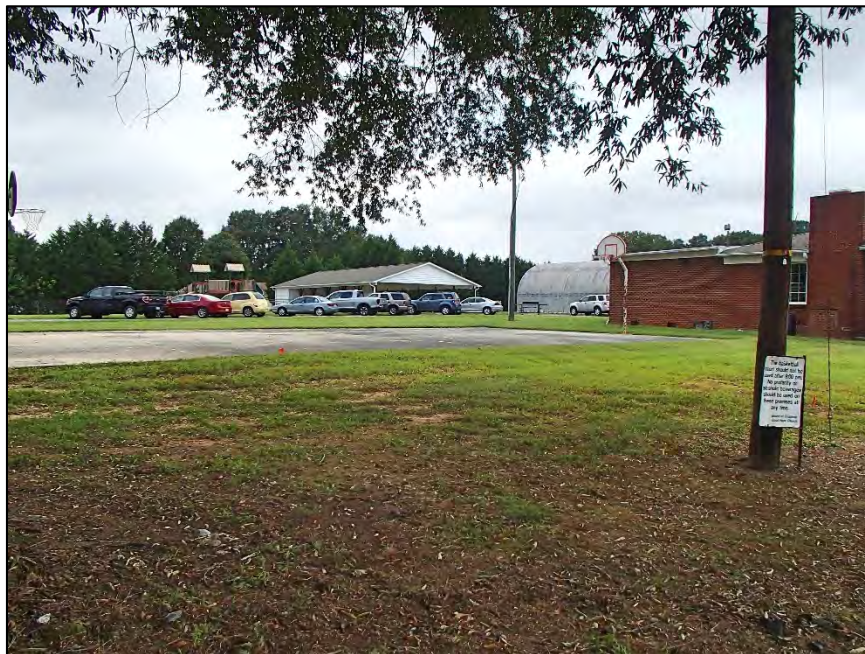
Behind the church, to the northwest, is a long, low, one-story, hip-roof building that, presumably, serves as a fellowship hall. This building has a hip-roof stoop with metal posts, modern vinyl replacement windows, and a wide chimney on the south elevation.

Behind this building, to the west, is a large, gable-roof open pavilion or picnic shelter and a large metal, prefabricated, storage building similar to a Quonset hut, but of recent vintage. To the south of the fellowship hall is a paved basketball court and immediately south of the basketball court is a single-car, brick garage. This garage was part of the parsonage, which was a hip-roof, brick Ranch house that faced

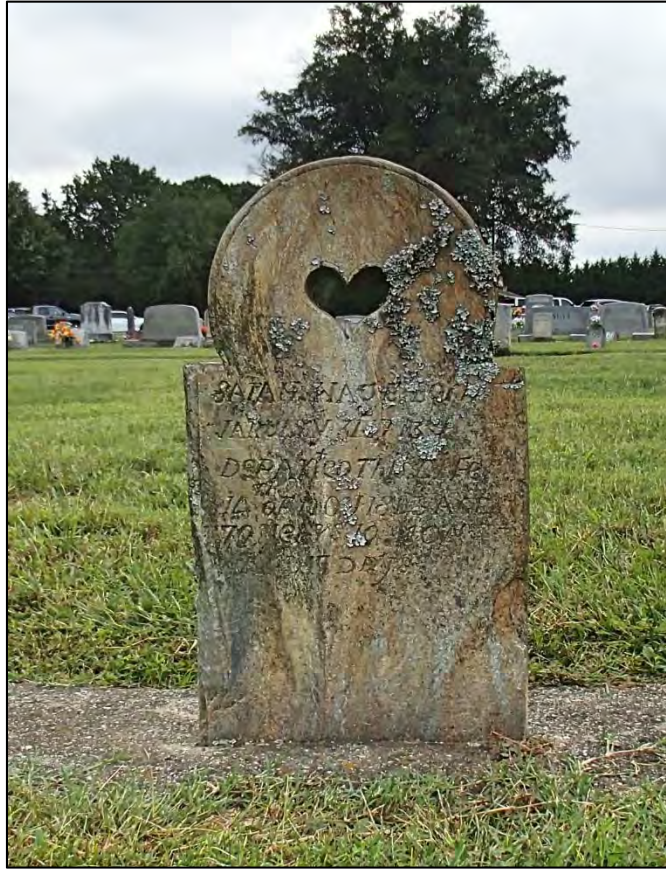
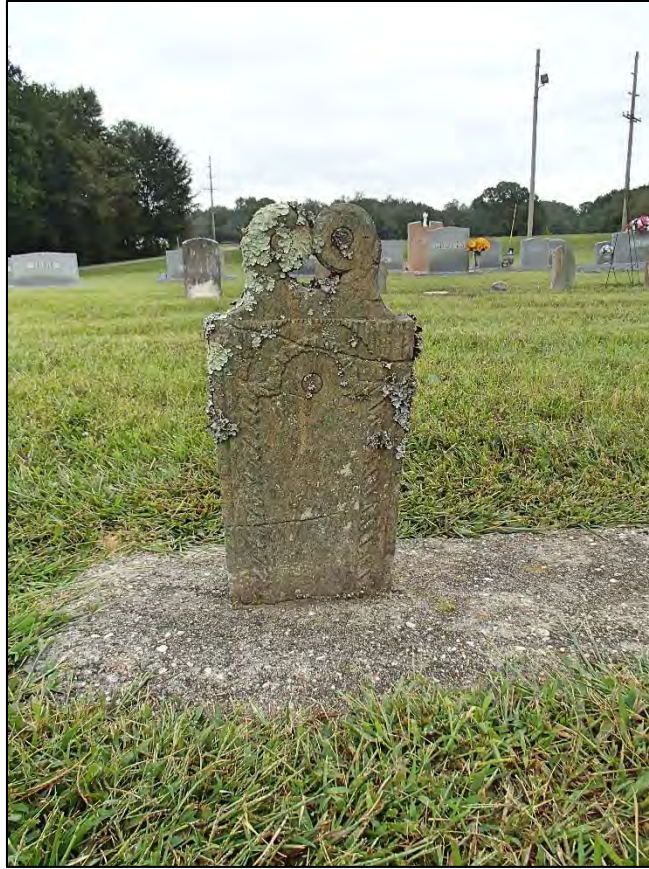
North of the church building and east of the fellowship hall is Good Hope’s cemetery. This cemetery predates the church’s organization (1851). According to the National Register nomination, the cemetery contains over 350 grave markers. The cemetery is significant for a group of twenty-six markers dating primarily from the 1830s and 1840s, including eight by a stonecutter who styled himself as “Master of

the Upper and Lower Case.” The remaining markers are typical memorials from the nineteenth, twentieth, and early-twenty-first centuries.

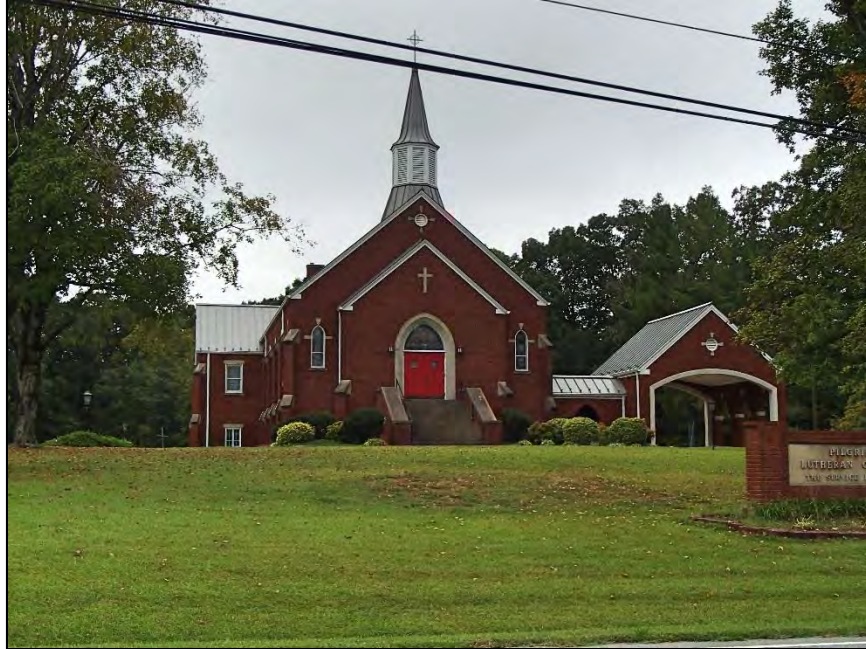
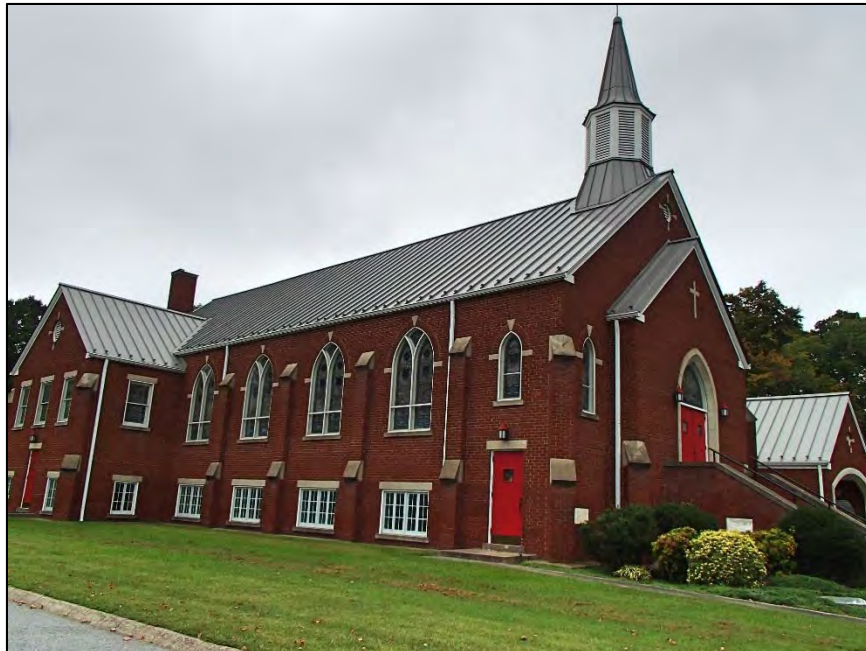
217: Pilgrim Lutheran Church, DV 355, 823 Ridge Road; Pilgrim Lutheran was built in 1944 and it identical to Good Hope

Brick, mid-twentieth-century, Gothic Revival churches are extremely common in Davidson County. Comparable examples demonstrate that Good Hope is a typical example and one of many.

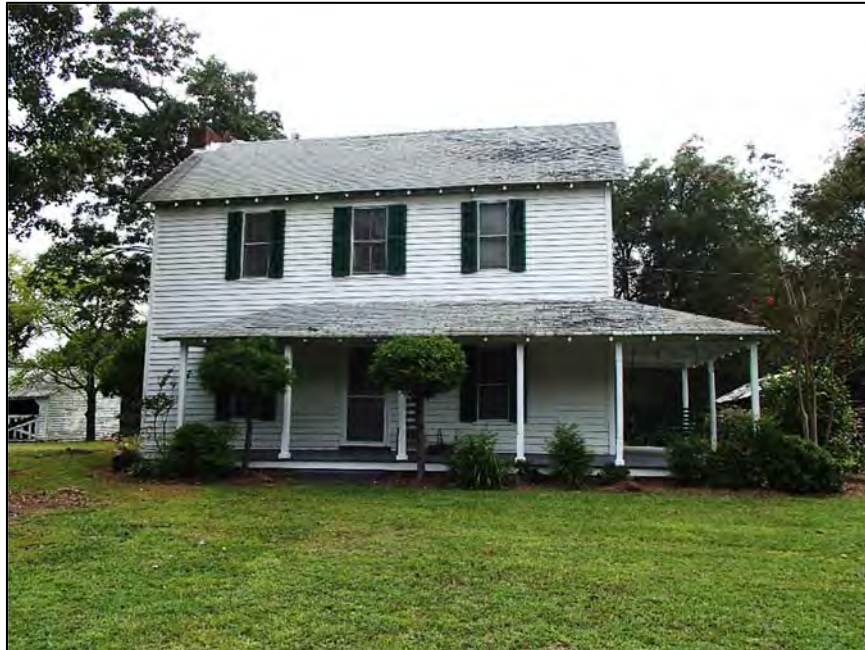
224: John D. and Addie Hill House, east elevation

The John D. and Addie Hill House has a three-bay façade with a central front door flanked by windows. Windows throughout the house are a combination of original two-over-two sash and what appear to be original or early replacement one-over-one sash windows. The hip-roof porch extends from the south bay across the center and north bay and then wraps around the north gable end. The porch posts are finished with a chamfer that terminates at the bottom and top of the post with a rounded edge rather than an angled edge to create a modified lambs tongue finish. The porch roof and main block roof feature exposed raftertails.

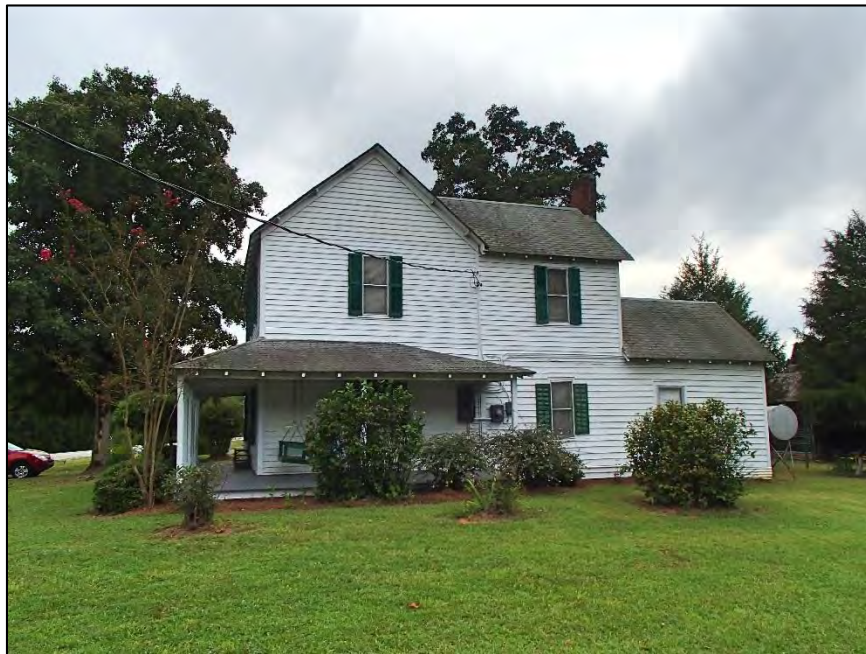
226: John D. and Addie Hill House, north elevation

Single windows are centered on the north gable end both upstairs and downstairs.

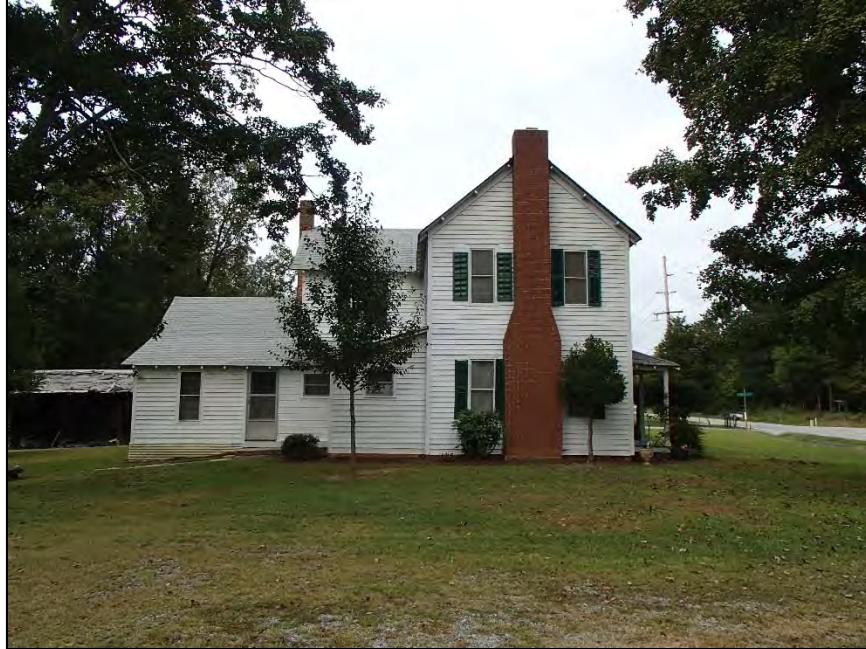
227: John D. and Addie Hill House, south elevation

The south gable end has a single-shouldered chimney with the shoulders located between the first and second story. This chimney was constructed in the mid-twentieth century to replace the original chimney. Windows flank the chimney at both levels of the house. Exposed purlins are found on both gable ends.

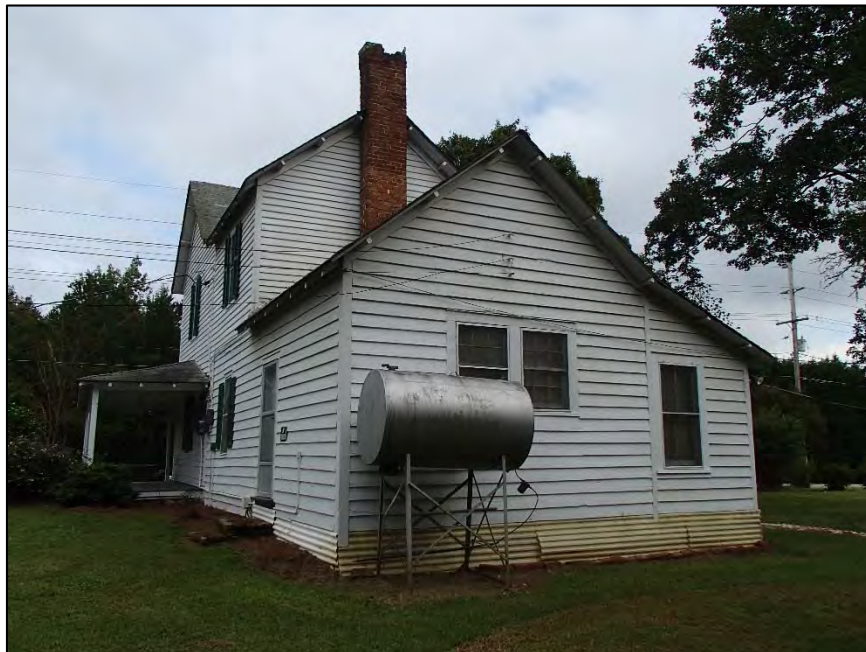
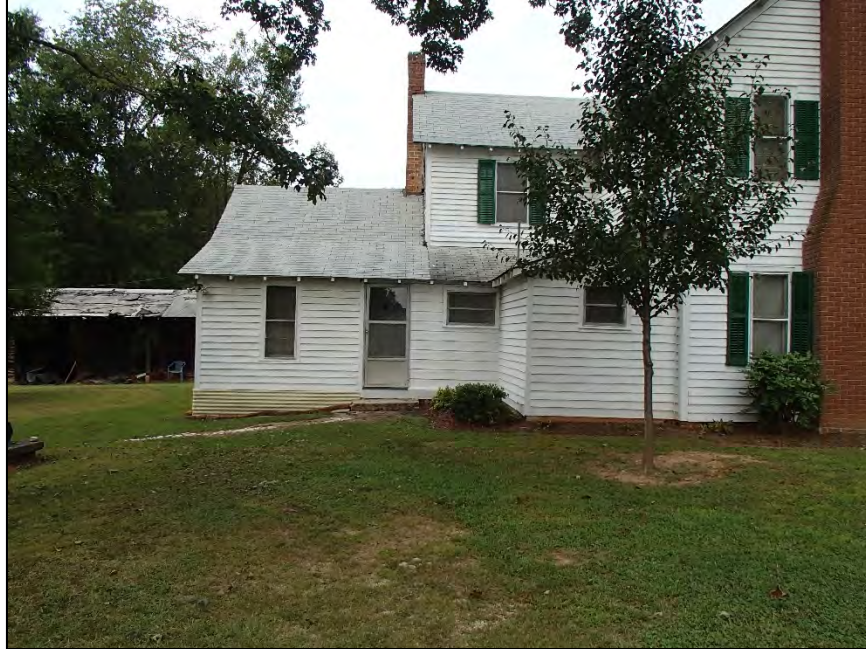
A two-story, one-room-deep, gabled ell projects to the west. A one-story ell projects from the two-story ell's gable end. A brick chimney rises between the two-story ell and the one-story ell. Both the one and two-story ells match the main block with exposed raftertails, exposed purlins, and one-over-one sash windows. An enclosed shed roof porch extends along the ell's south elevation and turns the interior corner to run along the main block's west elevation. Two-over-two and four-over-four windows are in the enclosed porch.
