MEMORANDUM

SUBJECT: Historic Structures Survey Report, Widen NC 150 from US 64 to Forsyth County Line,
PA 17-12-0078, U-5902, Davidson County, ER 18-3639

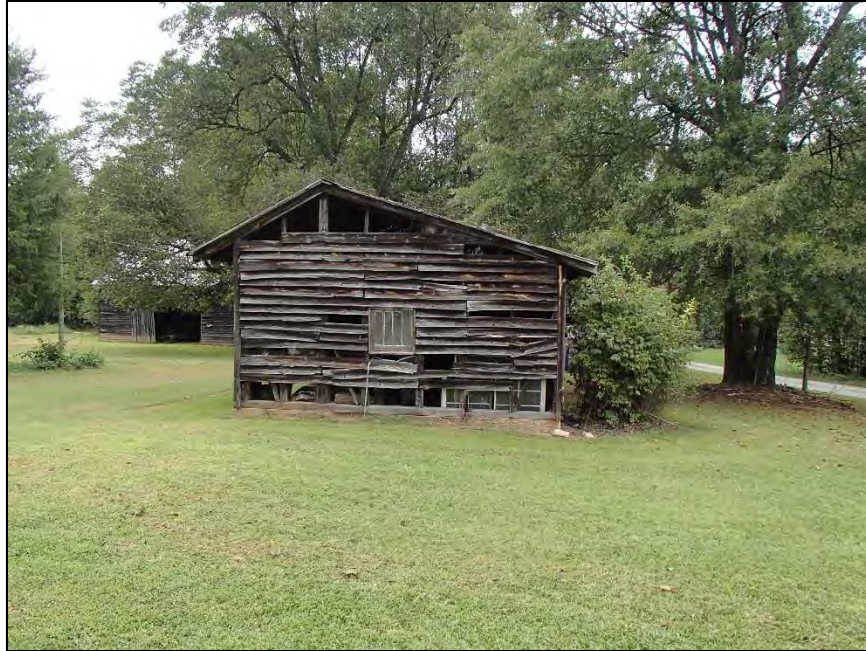
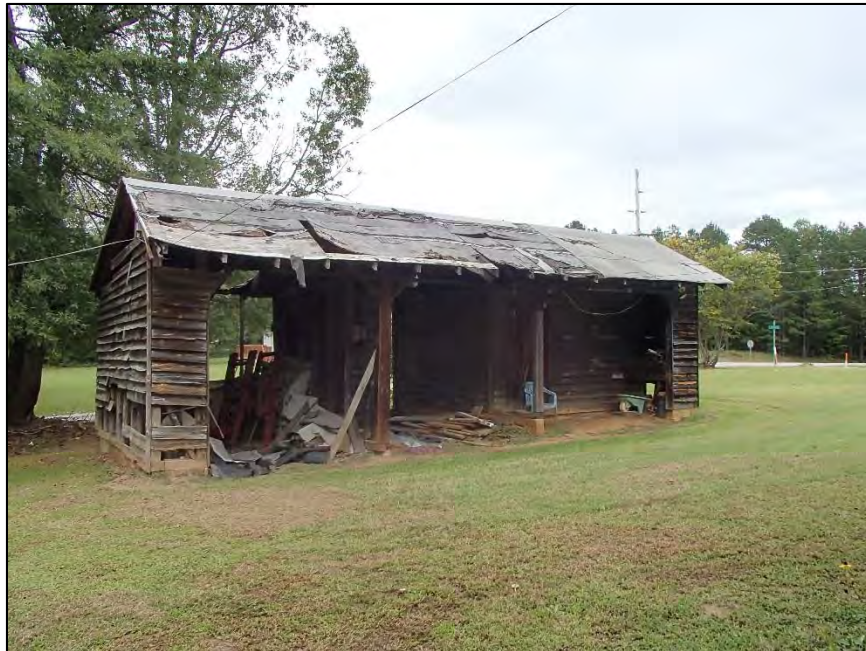
This one-story side-gable, frame shed incorporates two open bays and a third bay that has been partially enclosed with a frame room. The enclosure was used as a “meat house” where meat was salt-cured. Wood was stored in the center bay, and the westernmost bay housed a Delco generator. This building is significantly deteriorated; part of the north wall is missing and the roof is failing.

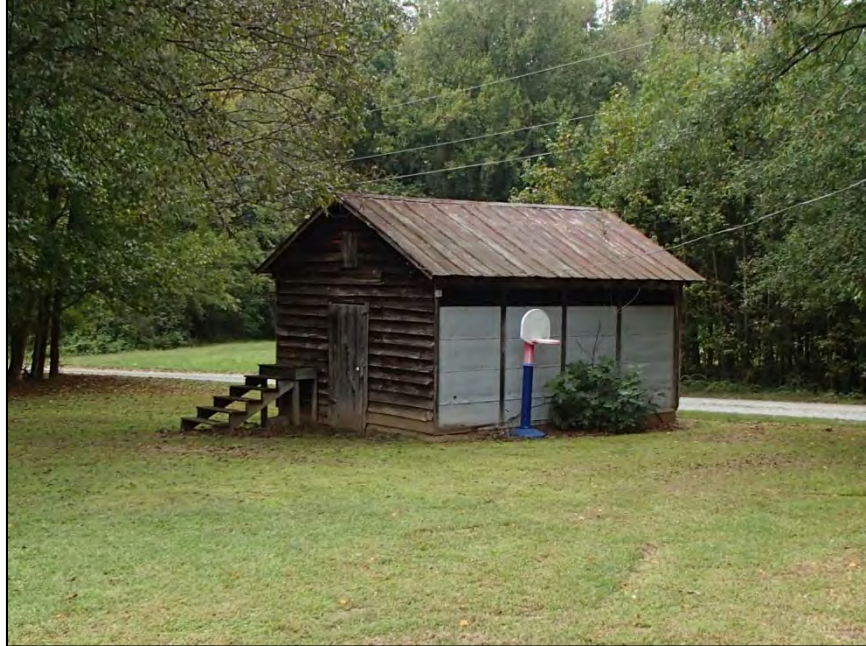
232: John D. and Addie Hill House, potato house

One-story, gable-front, frame outbuilding with weatherboard siding. Potato houses were used to “cure” sweet potatoes and were a common fixture on Davidson County farms.

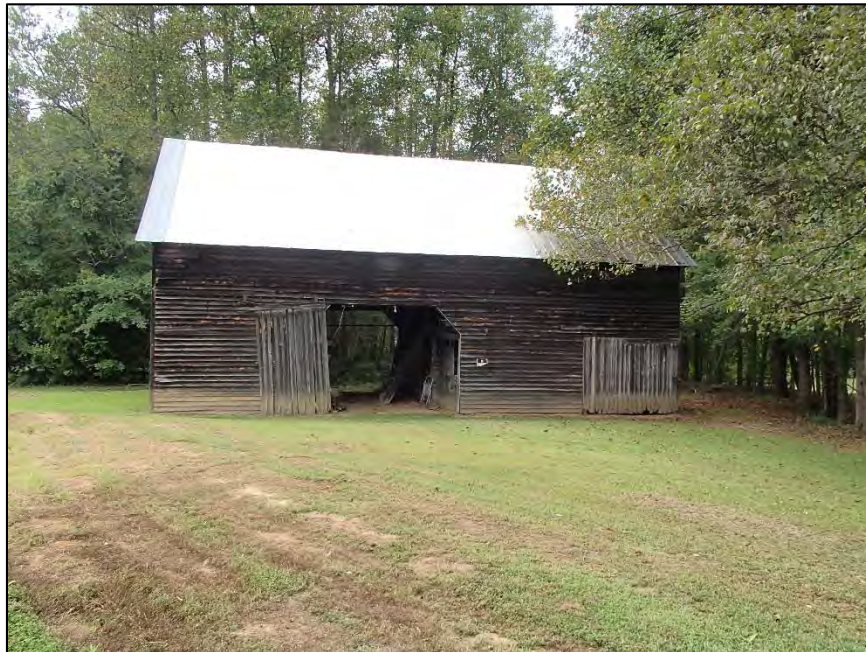
233: John D. and Addie Hill House, barn

This large, frame, side-gable barn features weatherboard siding and a wide, off-center drive-through.

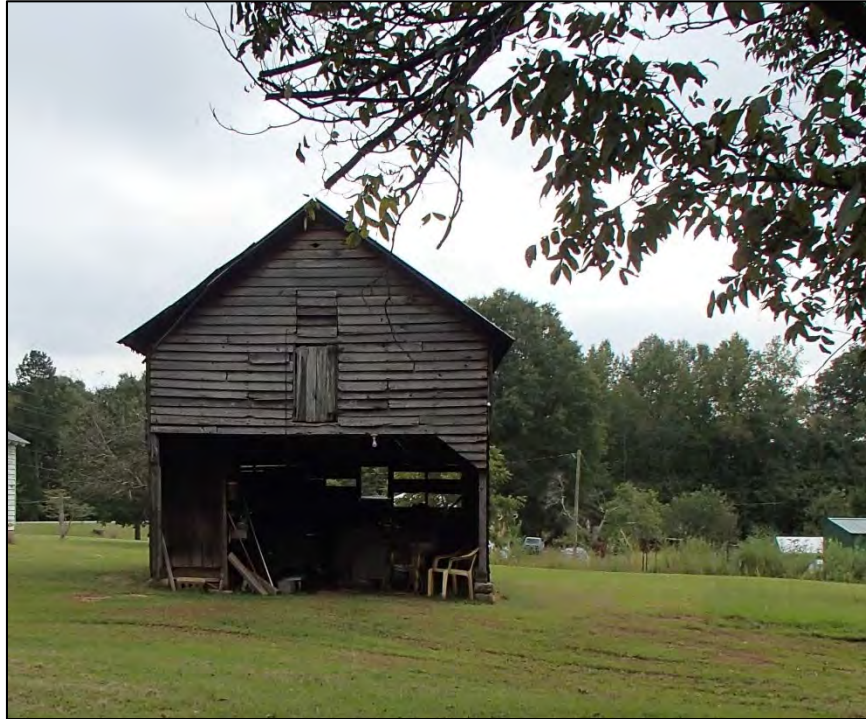
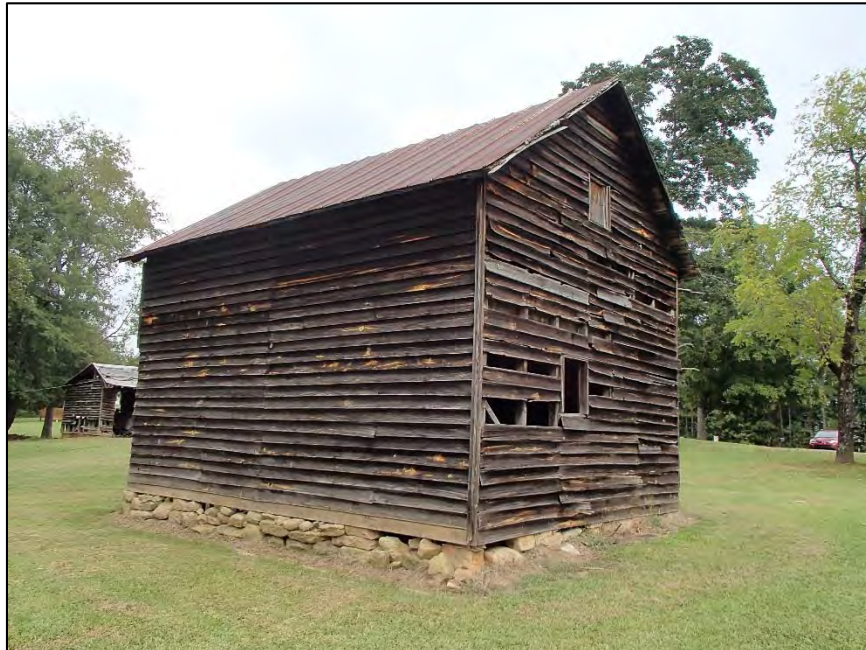
The north gable end (front) is an open bay, but this opening may be a later modification. A small door is centered in the north gable end and an enclosed staircase rises from the front floor to the upstairs room. The building stands on a stone foundation. Small square windows are located on the rear (south)

gable end. Weatherboards cover the exterior. The extant bay housed a tractor-powered corn mill. Sheds once stood on either side of this building and were used to shelter a tractor and thresher.

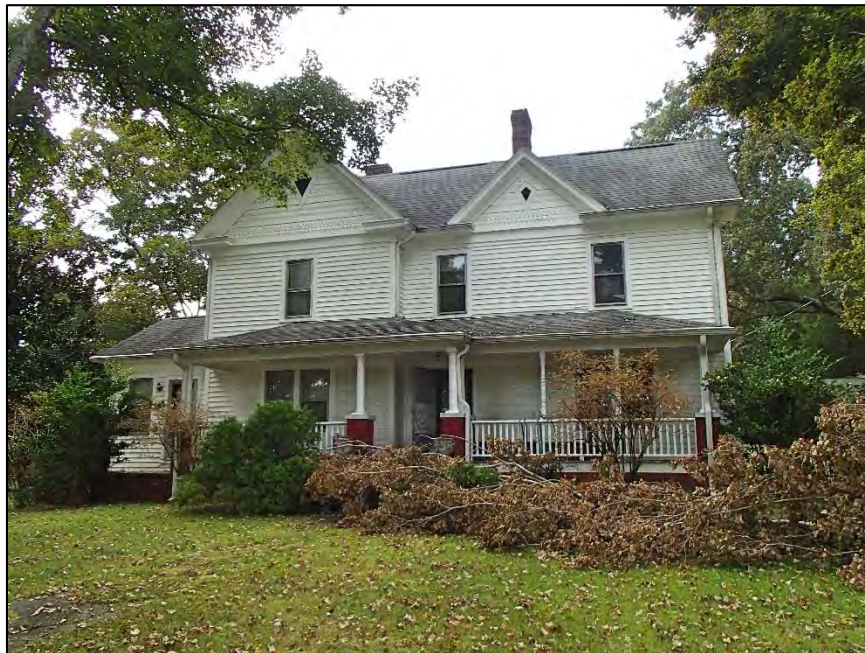
241: Manie and Letha Hege House, southeast elevation

The façade features a pair of windows centered in the first floor of the gable-front wing, a centrally-located, single-leaf door, and a pair of windows in the outer bay, to the north of the front door. The original door contains a single pane of glass above paneling and an original door bell. A one-story, full-width porch extends across the façade and has paired Tuscan columns on brick piers flanking the entrance and at the corners. Two other turned posts appear to be later additions to the house. Above the front porch, a single window is centered in the front-facing gable, a single window is centered over the front door, and a single window is centered over the pair of windows in the façade's north bay. The front-facing gable is finished with decorative shingles that have a variety of edges: sawtooth, straight, and a small sawtooth that creates a fringe. An elongated diamond-shaped attic vent and gable returns complete the front gable. A secondary roof gable is centered on the front roof slope of the side-gable section. This small gable is finished to match the larger gable end with decorative shingles and a diamond-shaped attic vent.

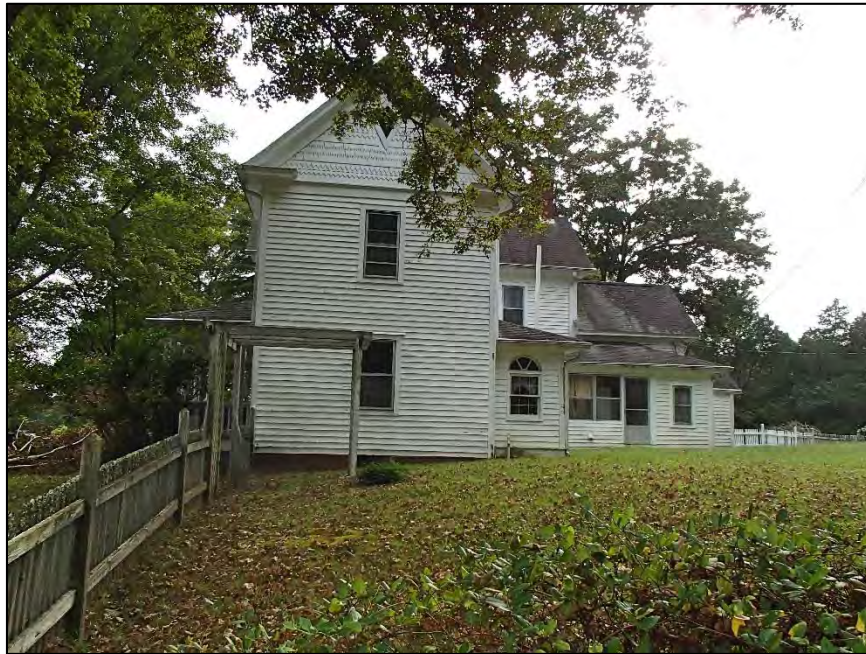
244: Manie and Letha Hege House, northeast elevation

The northeast gable end matches the front-facing gable with decorative shingles, an attic vent, and gable returns. Single windows are centered on this end at both the first and second story.

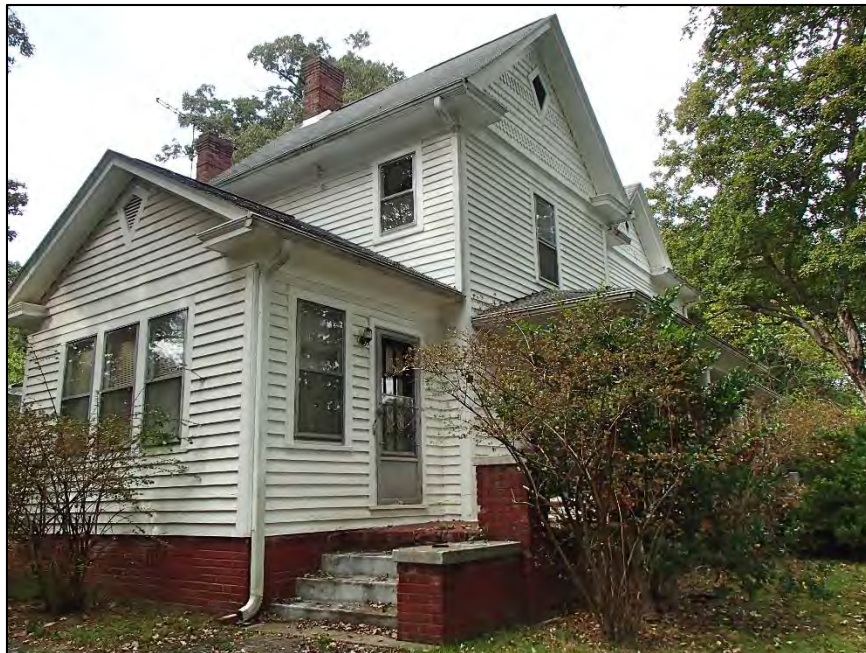
245: Manie and Letha Hege House, southwest addition

A one-story, gabled ell is attached to the southwest elevation. This ell contains one-over-one sash windows and a diamond-shaped attic vent to match the other gable ends, but it appears to be an addition based on its location, banked windows, and French door.

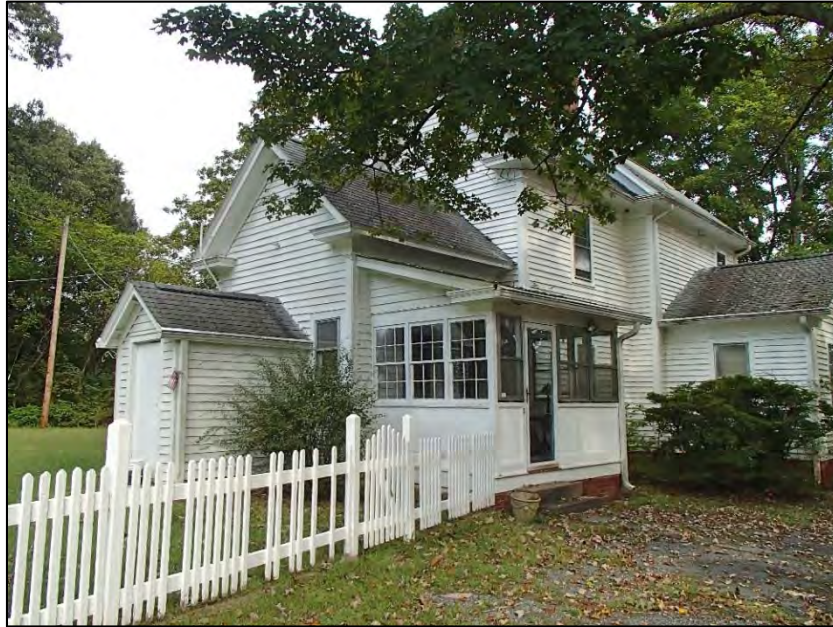
246: Manie and Letha Hege House, northwest elevation

A two-story gabled ell is attached to the main block's northwest gable end and a one-story ell is attached to this ell's gable end. Both of these ells are original or early additions and retain corner boards

and gable returns. An enclosed, shed-roof porch is attached to the one-story ell's south elevation. On the one-story ell's gable end, a final small gable projects to house steps to the basement level.

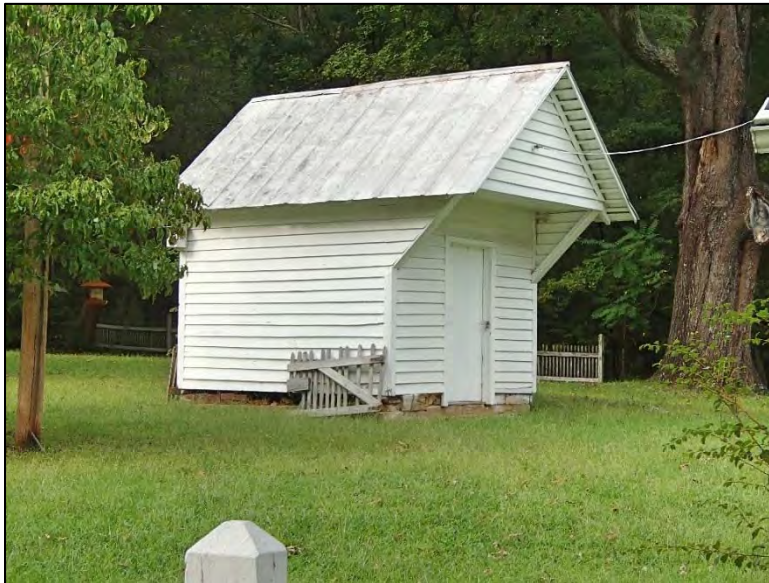
247: Manie and Letha Hege House, smokehouse

This one-story, gable-front, frame outbuilding has a bracketed, overhanging gable over a board-and-batten door. The building stands on a stone foundation. Smokehouses were noted at many older homes in the study area.

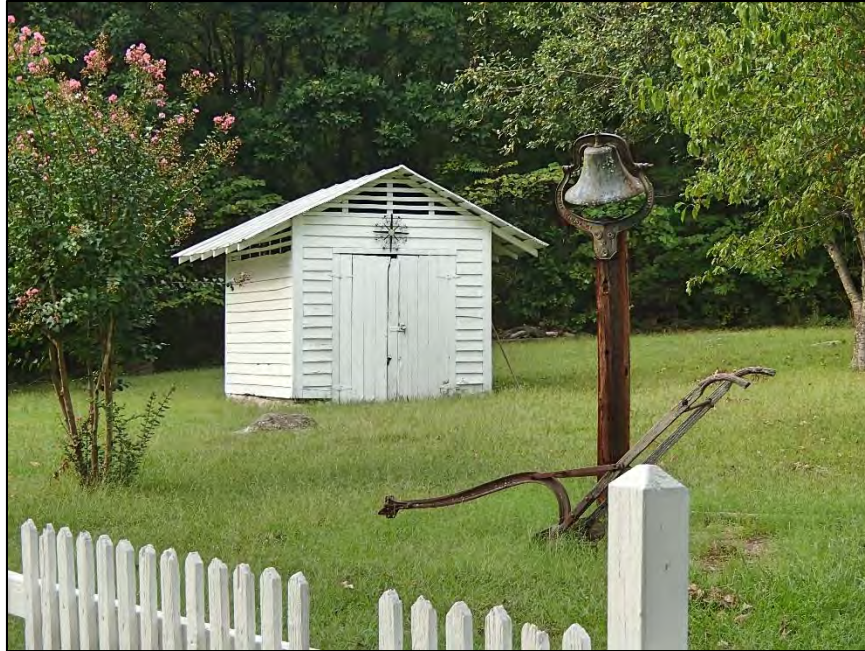
248: Manie and Letha Hege House, granary

This small, frame, gable-front outbuilding has weatherboard siding and slatted vents around the eaves and in the gable end. The eaves overhang deeply on the side elevations.

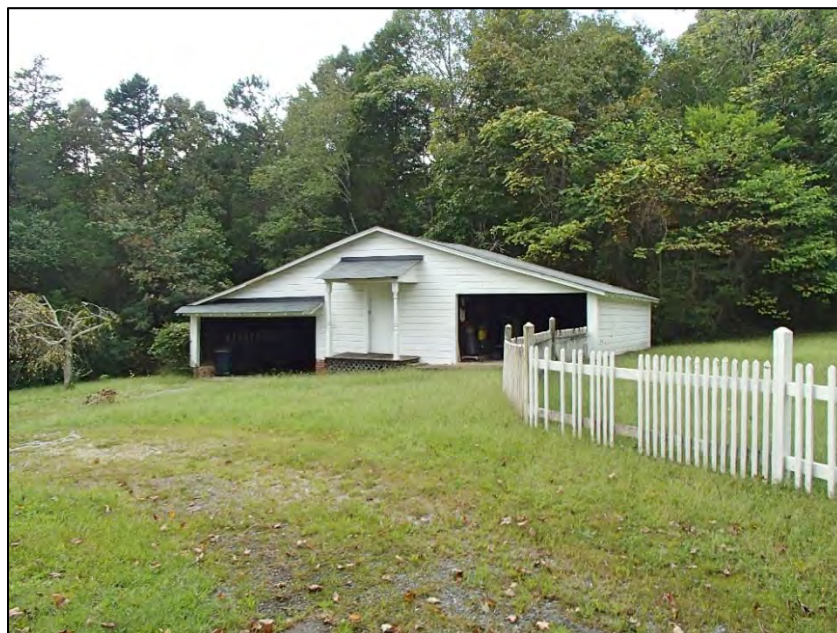
249: Manie and Letha Hege House, garage

The garage is a gable-front building with drop siding. Wide, open garage bays flank a central pedestrian door.

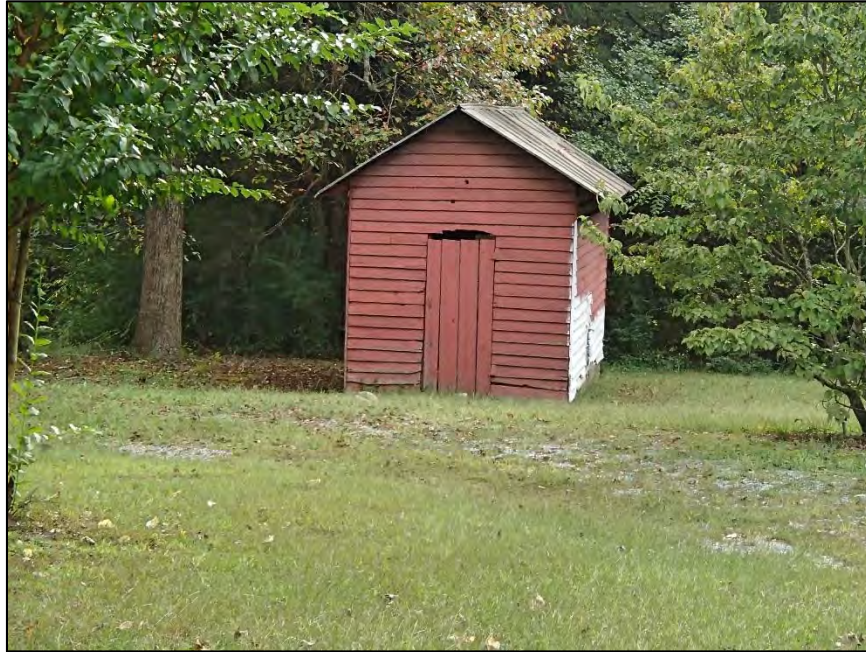
250: Manie and Letha Hege House, outbuilding

Gable-front, frame, weatherboarded outbuilding with a board-and-batten door.

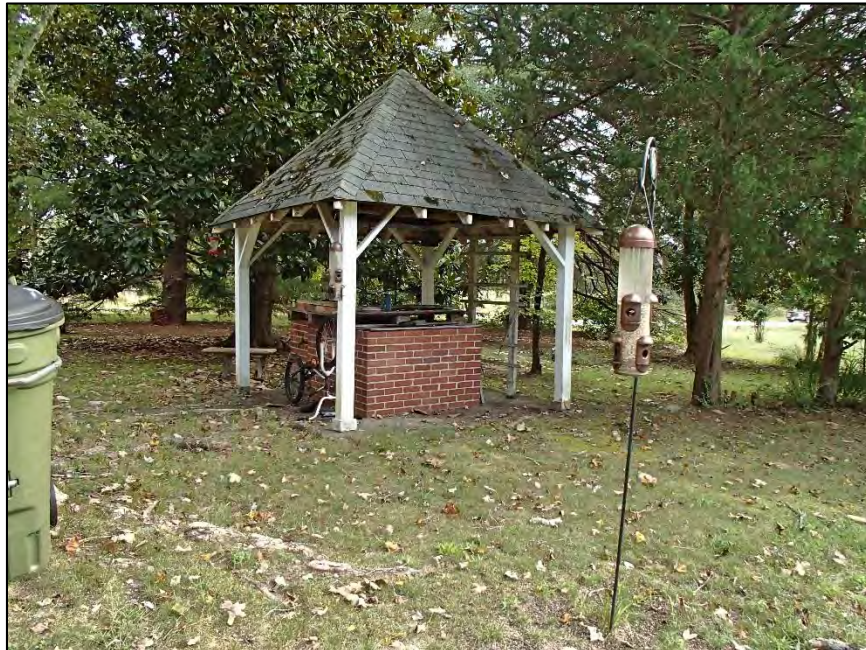
251: Manie and Letha Hege House, well house

Open-sided pavilion with square, bracketed posts supporting a pyramidal roof. The well itself is walled with mid-twentieth-century brick.

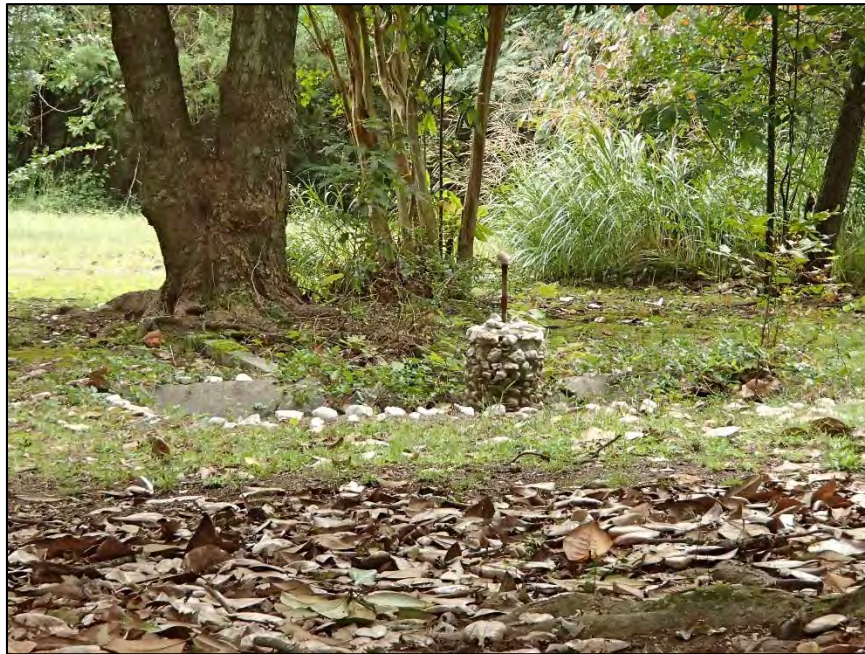
252: Manie and Letha Hege House, fish pond

Rock-lined pool with small foundation used as a gold fish pond and, later, as a home for a small pet alligator.

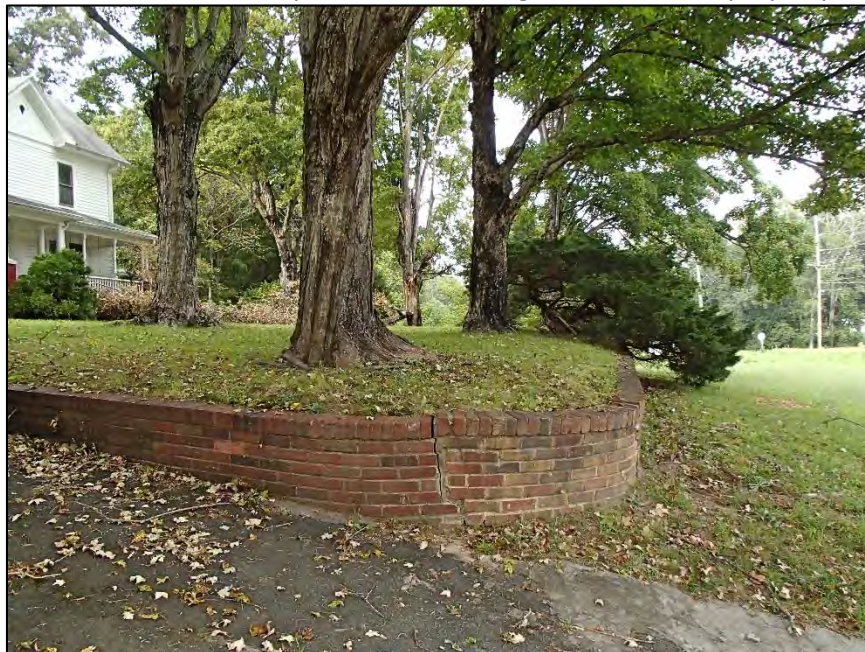
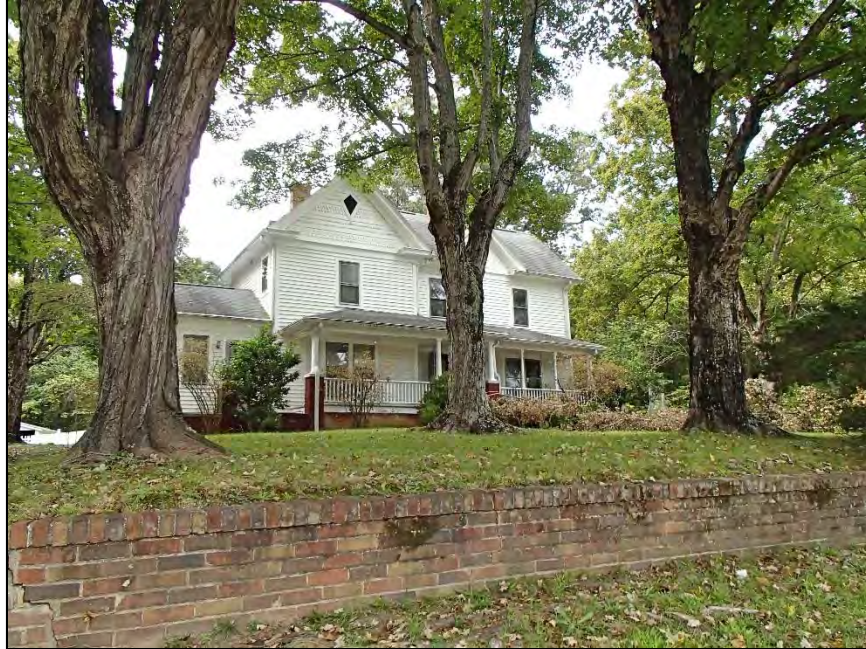
253: Manie and Letha Hege House, retaining wall

Retaining walls of mid-twentieth-century brick extend along the front of the property.

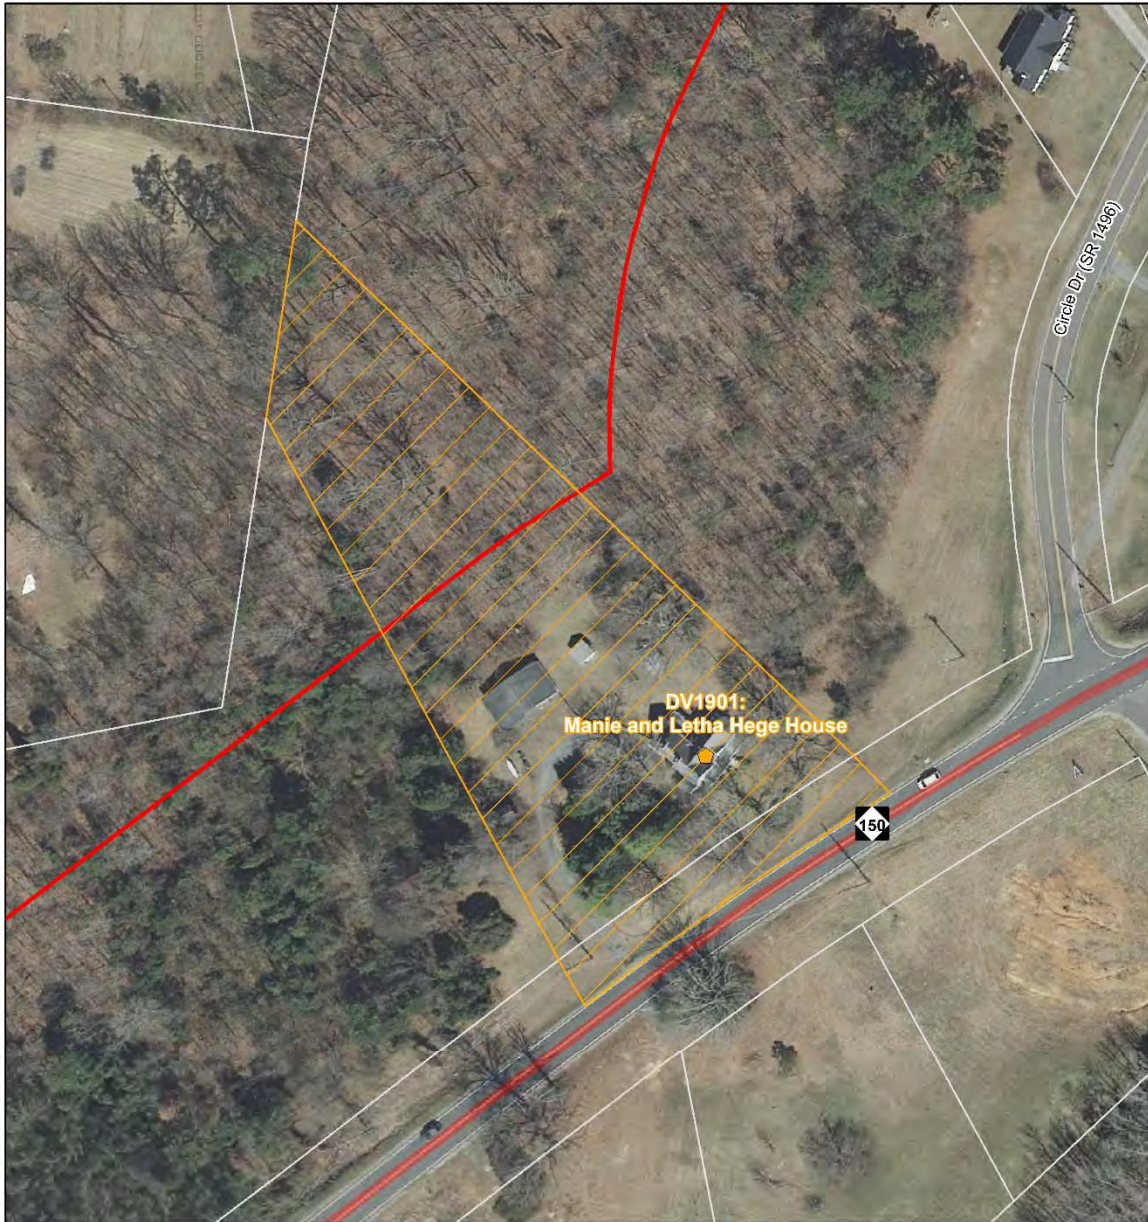
264: Manie and Letha Hege House, National Register Boundary

The Manie and Letha Hege House boundary follows the parcel lot lines of the tract (Davidson County PIN 6800-04-70-8333) associated with the house except along the front of the property where it conforms to the existing edge of pavement. Right-of-way in this area contains portions of the house's lawn, which is a contributing feature of the resource. The proposed boundary encompasses the house, its outbuildings, and its landscape features which include mature trees and retaining walls along the front of the property.

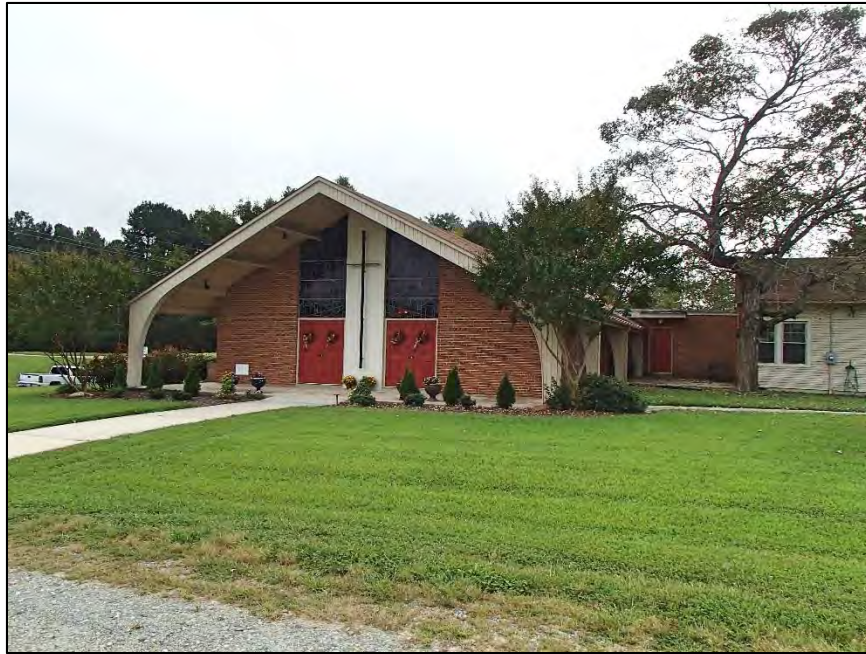
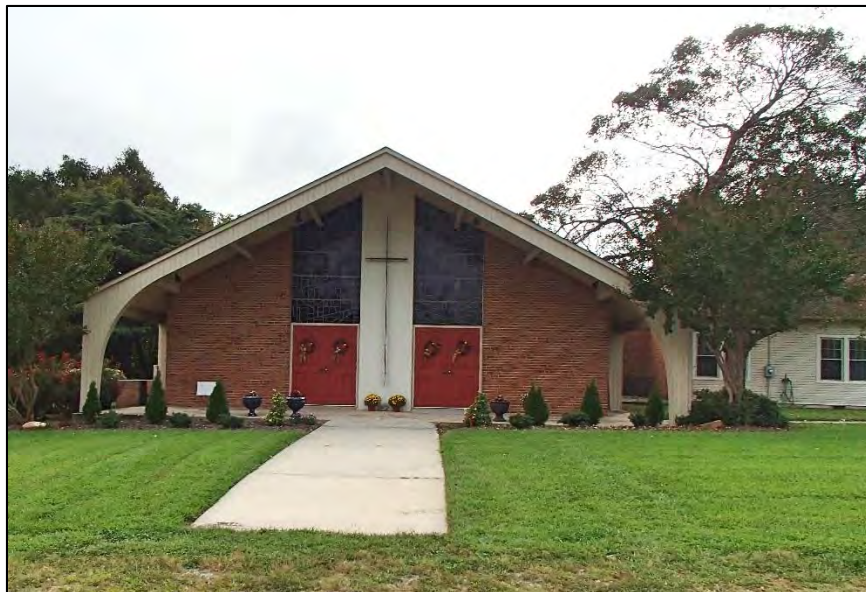
266: Arcadia Methodist Church, north elevation

Arcadia United Methodist Church is a one-story, gable-front, Modernist church building. The façade incorporates a portico created by a deep gable overhang supported by columns at each corner that rise with an interior curve into rafter beams that meet at the roof's apex. Exposed purlins extend across the portico's ceiling. The wall under the overhang features a central concrete panel that extends from the apex to the grade. A thin metal cross is mounted on this concrete panel. The panel is flanked by double-leaf, Colonial Revival-style six-panel doors that are likely replacements given their traditional appearance. Above the door, stained glass panels extend up to the roof. The outer bays of the façade are brick.

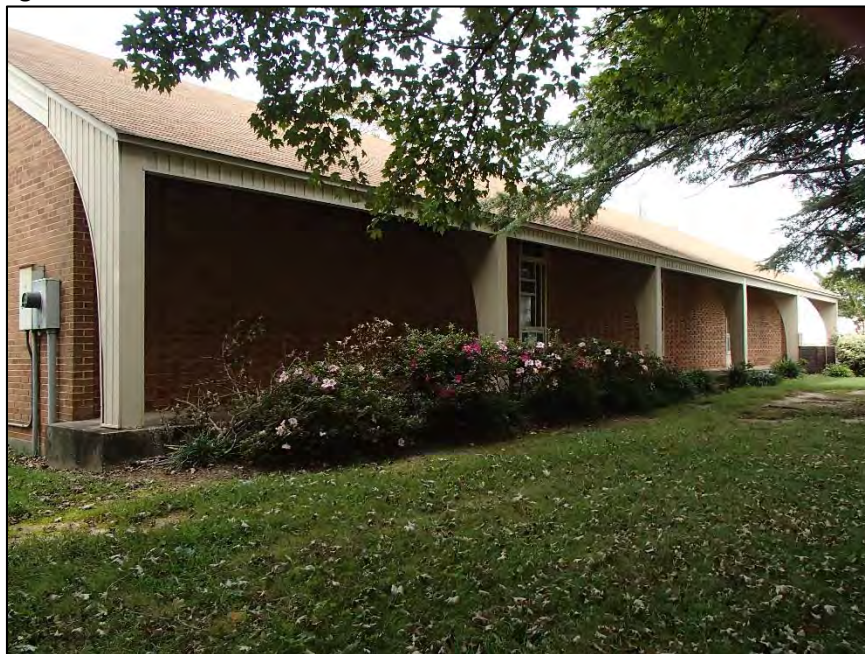
269: Arcadia Methodist Church, east elevation

The side walls are inset inside the structural beams, so that a colonnade runs along each side elevation. Bricks on the side elevations are slightly staggered to create a textured pattern. Windows are centered in the bays between the columns. The windows feature a fix-panel divided into three horizontal lights of varying sizes and two vertical lights. Each pane of glass is a different color. Below this fix-panel is a hinged window with three vertical glazed panels, each with a different color stained glass. Above the fixed panel is another hinged window with three panels: one square, and two rectangles, again in varying colors of glass.

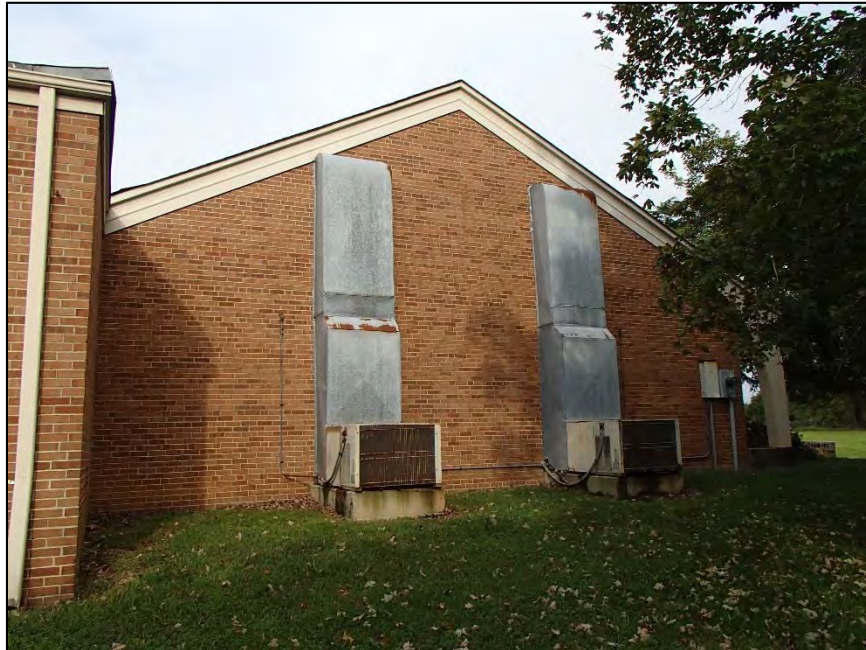
273: Arcadia Methodist Church, south elevation

The rear, or south elevation, is blank.

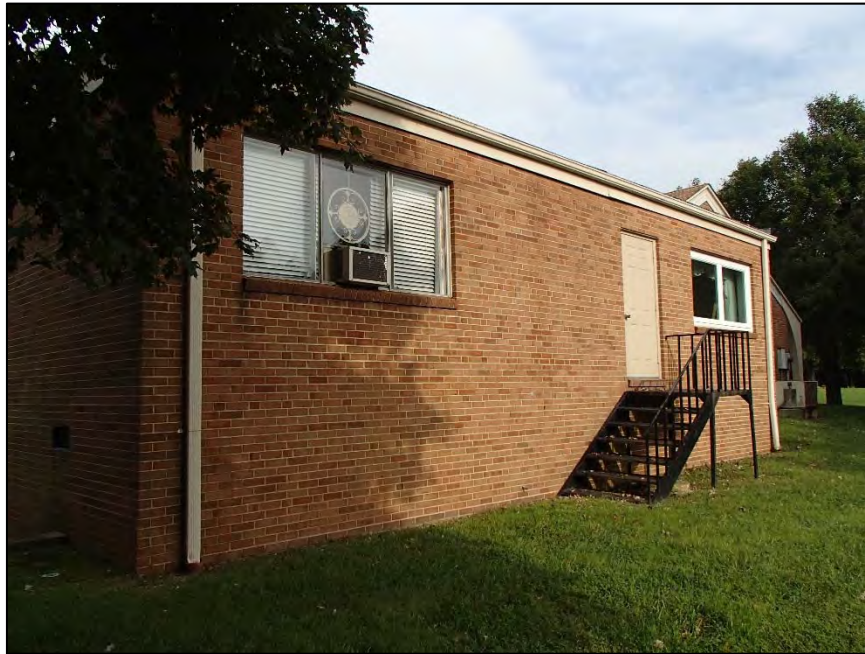
274: Arcadia Methodist Church, flat-roof addition

A flat-roof addition stands on the main block's southwest corner. This section is brick and contains sliding metal-frame windows.

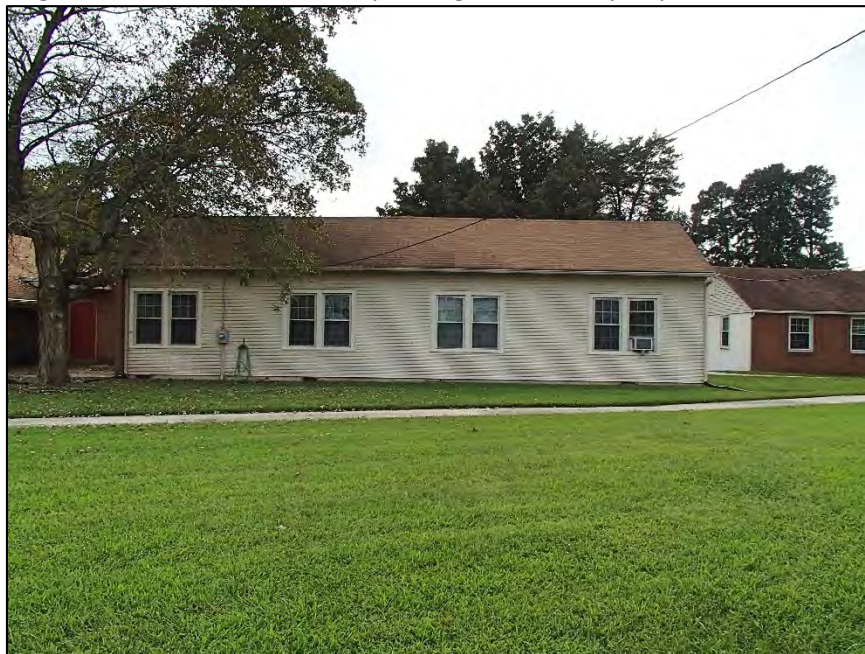
275: Arcadia Methodist Church, gabled addition

This flat roof section of the complex also serves as a hyphen to join the sanctuary to a side-gable building. This side-gable block is covered in vinyl siding and has vinyl replacement windows.

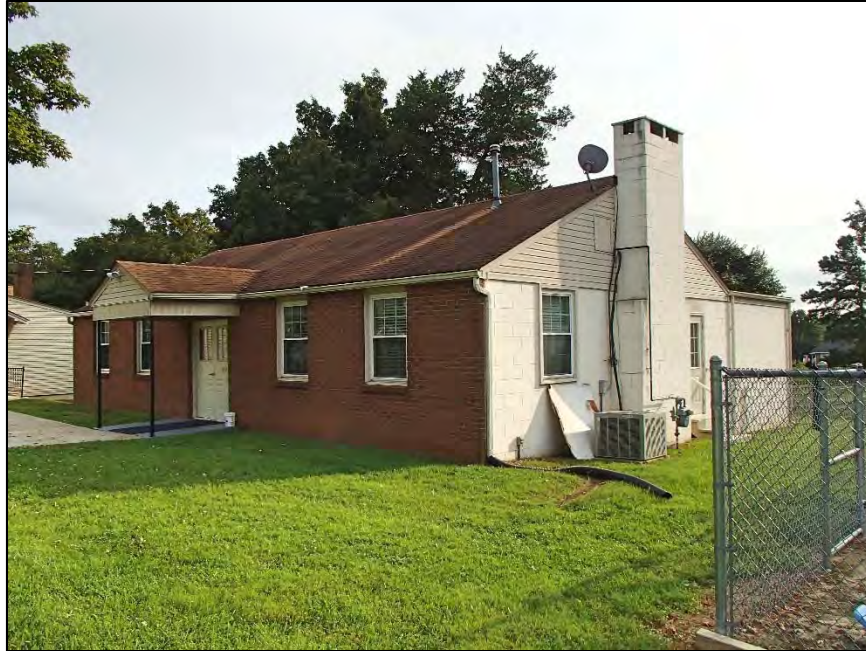
276: Arcadia Methodist Church, side-gable building

To the west of this side-gable wing is a side-gable building with a brick façade and concrete block gable ends and rear elevation. This building has vinyl replacement windows and a small gabled stoop with metal posts. The stoop's gable end and the side gable ends are clad in vinyl siding.

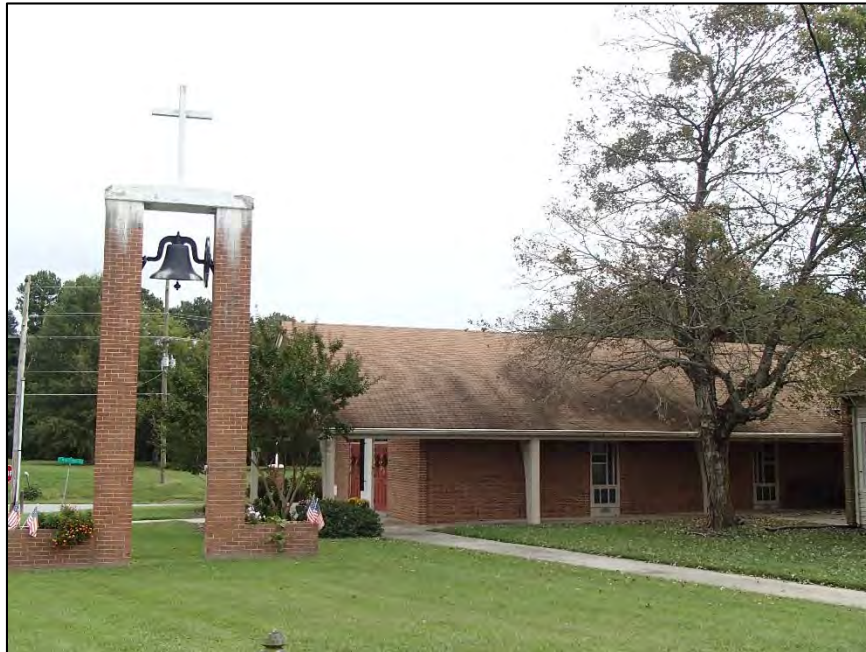
277: Arcadia Methodist Church, bell tower

A pair of brick pylons stand in front of the sanctuary and support a bell that was probably in the church's earlier building. Above the bell, a wooden beam spans the pylons and is topped with a wooden cross.

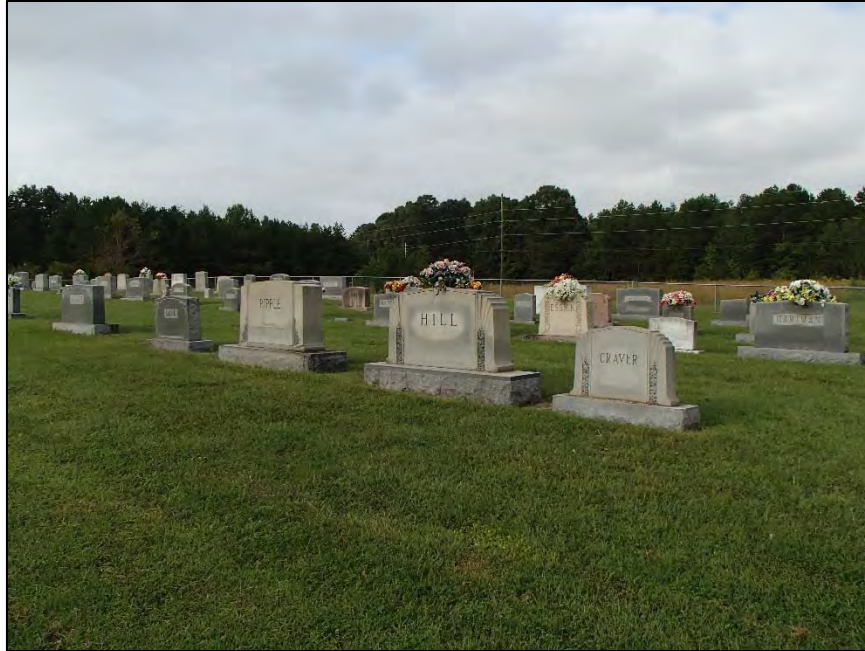
278: Arcadia Methodist Church, cemetery

To the east of the complex is the church's cemetery. The 1919 marker of an infant son of the Hartman family appears to be the earliest marker. The vast majority of the markers date to the mid-twentieth century and are typical, mass-produced, mid-twentieth century granite markers.
