SUBJECT: Historic Structures Survey Report, Convert US 17 Intersection to an Interchange at NC 311,  
PA 18-01-0010, U-5932, Brunswick County, ER 18-4166

## **HISTORIC STRUCTURES SURVEY REPORT**

# **TIP# U-5932: CONVERT US 17 AT NC 211 INTERSECTION TO AN INTERCHANGE BRUNSWICK COUNTY, NORTH CAROLINA**

### Concord United Methodist Church and Cemetery

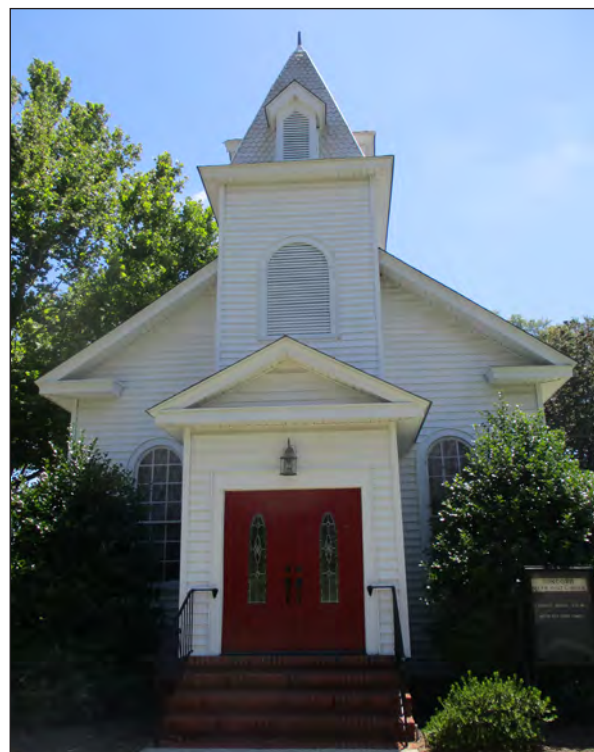
The Concord United Methodist Church and Cemetery is located along NC 211 (Southport-Supply Road SE), Brunswick County, North Carolina (Photograph 1). Supply is an unincorporated community at the intersection of US 17 and NC 211 connecting Bolivia and Shallotte. The community's name was derived from its former role as the location where boats coming from Lockwood Folly River stopped to pick up tar and other naval stores in exchange for groceries and other supplies. The area is low lying and generally level. Today, Supply is still relatively rural and features some residential and commercial development.

Photograph 1: Concord United Methodist Church façade; looking southwest. (2018)

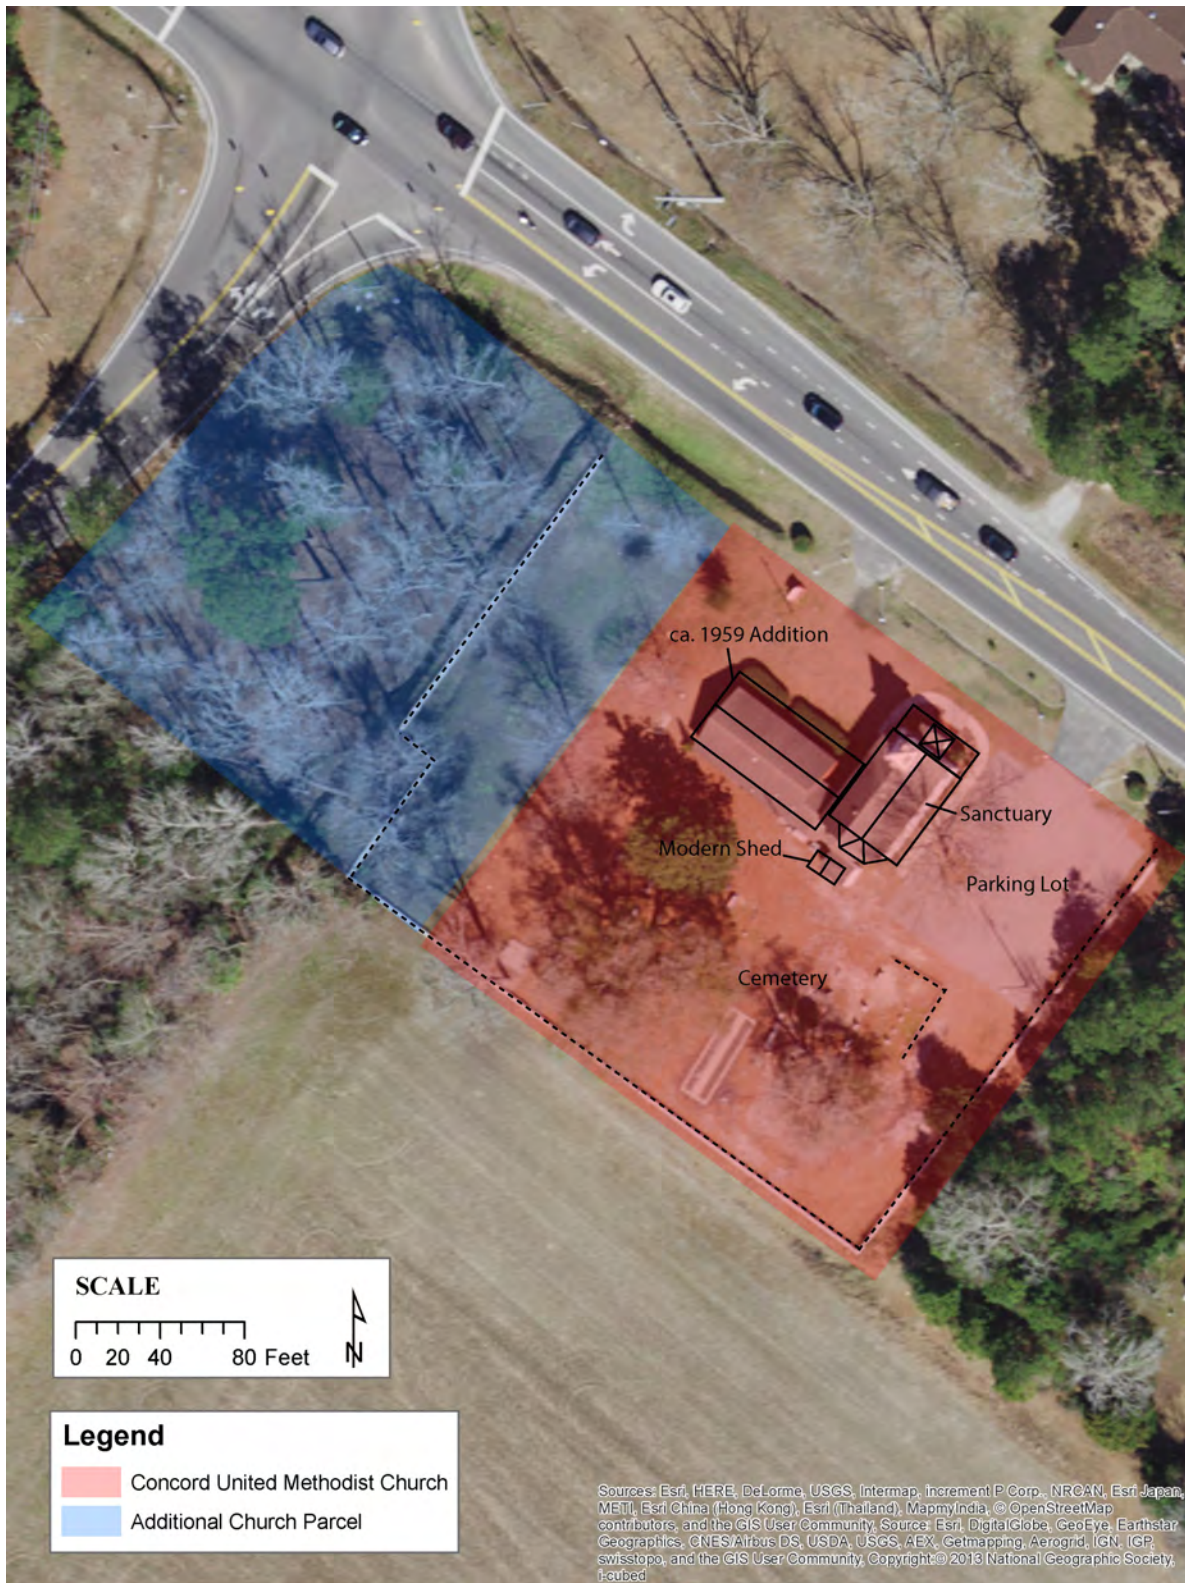
Figure 4: Concord United Methodist Church parcel boundary and site plan (Source: ESRI)

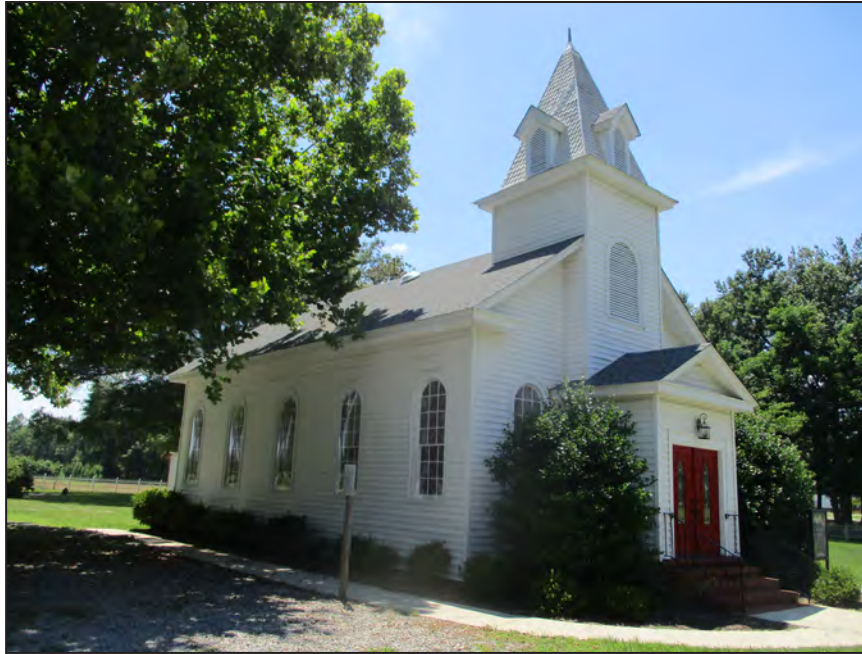
This one-story, rectangular building of framed construction is capped by a front-gable roof with cornice returns covered in asphalt shingles (Photograph 2). The building sits on a brick pier foundation. The main block (sanctuary) is three bays wide by five bays deep, with a partial-width, pedimented vestibule attached to the façade (northeast elevation). The church's original weatherboard siding has been replaced with vinyl. A central tower pierces the front gable roof and features a large arched vent on the northeast elevation. The tower is topped by a pyramidal roof covered in pressed sawtooth metal with wide overhanging flared eaves and features gabled dormer vents on each elevation (Photograph 3). All windows in the sanctuary are original, arched, twelve-over-nine, wood, double-hung sashes with opalescent glass (Photograph 4). A one-story, ca. 1959 brick veneer addition is located off of the sanctuary's northwest elevation. The building is referred to as the "annex" or "educational building" and is used for religious education classes and other gatherings.

Photograph 2: Concord United Methodist Church looking west. (2018)

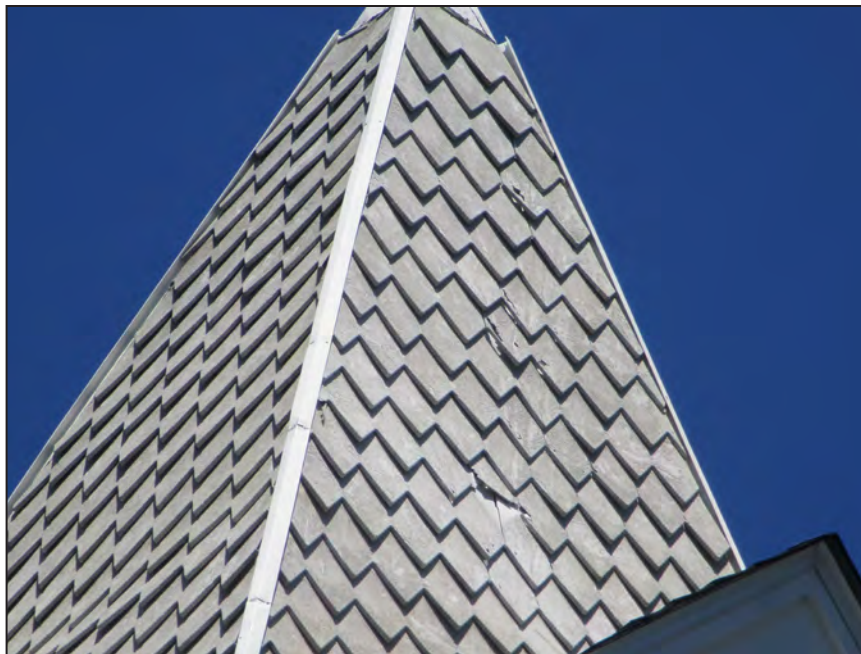
Photograph 3: Detail of pressed sawtooth metal on Concord United Methodist Church's tower. (2018)

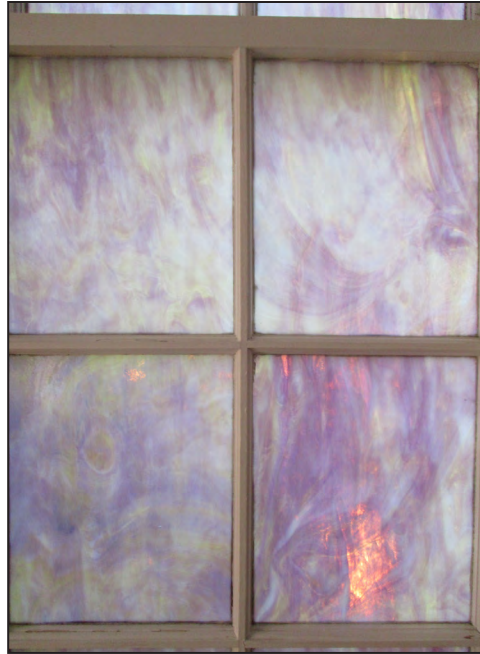
The church's main entrance is centered on the façade within the pedimented vestibule and is reached by a set of brick steps with iron balustrade. The original double door opening features replacement fiberglass doors each with a single decorative light. The center vestibule is flanked on both sides by a single original window.

Photograph 4: Detail of original windows on Concord United Methodist Church. (2018)

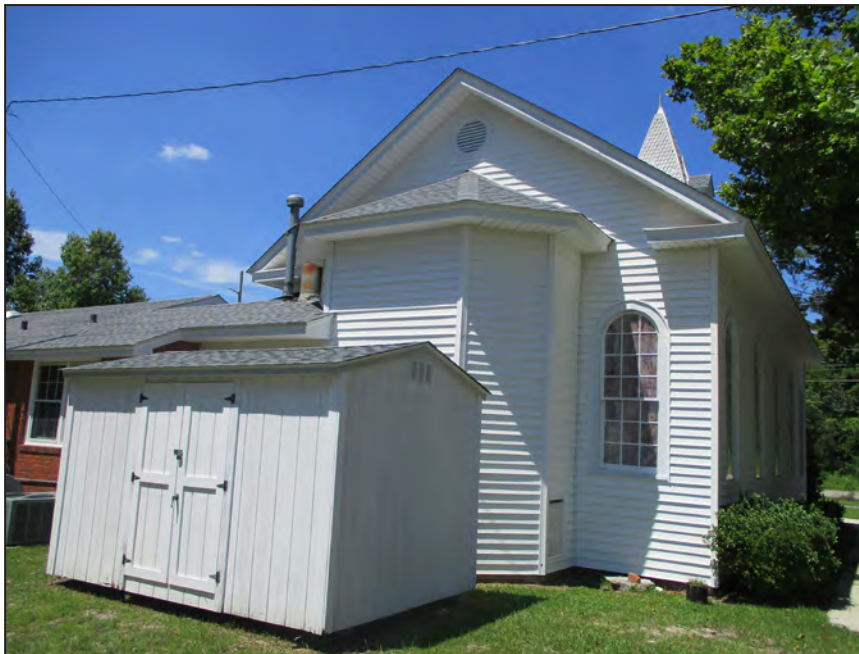
The rear (southwest) elevation features a circular louvered vent centered in the gable (Photograph 5). A one-story apse is located off the rear elevation. It is topped by a half-hipped roof covered in asphalt shingles. The apse does not feature any fenestration. Two original windows are evenly spaced, one on either side of the apse.

Photograph 5: Rear (southwest) elevation of Concord United Methodist Church looking north. (2018)

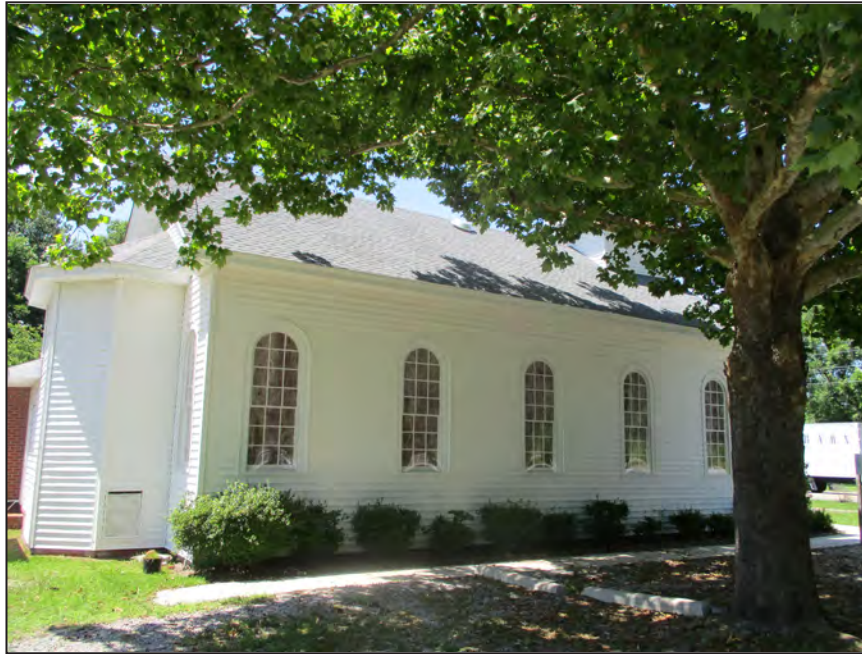
The southeast elevation features five evenly spaced windows (Photograph 6). Prior to the ca. 1959 addition, the northwest elevation was identical to the southeast elevation, featuring five evenly spaced windows. Today, the northwest elevation features only four evenly spaced windows (Photograph 7). When the educational building was constructed ca. 1959, the fifth and southernmost window opening was made smaller and replaced with a doorway that allows access between the sanctuary and the addition.

Photograph 6: Southeast elevation of Concord United Methodist Church looking northwest. (2018)

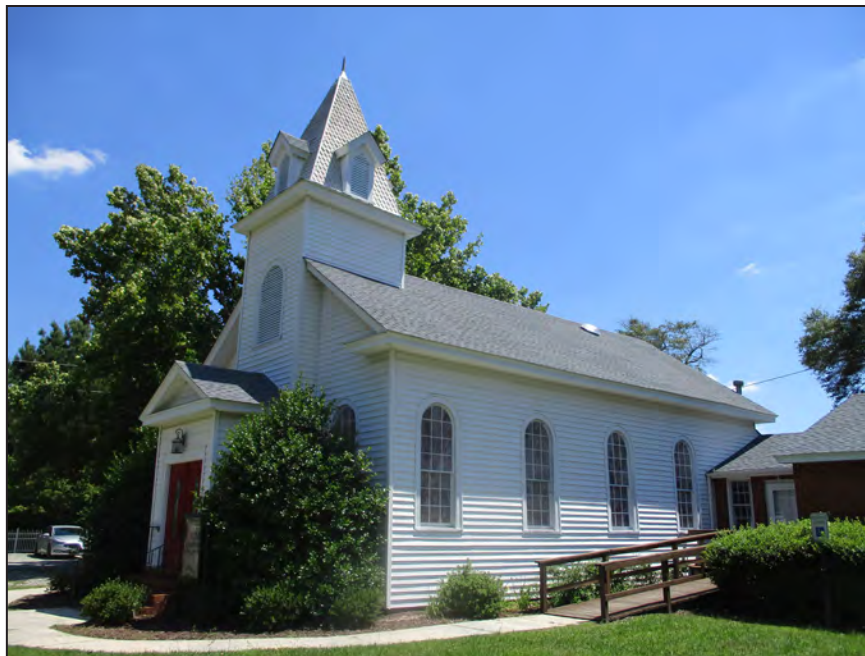
Photograph 7: Northwest elevation of Concord United Methodist Church looking south. (2018)

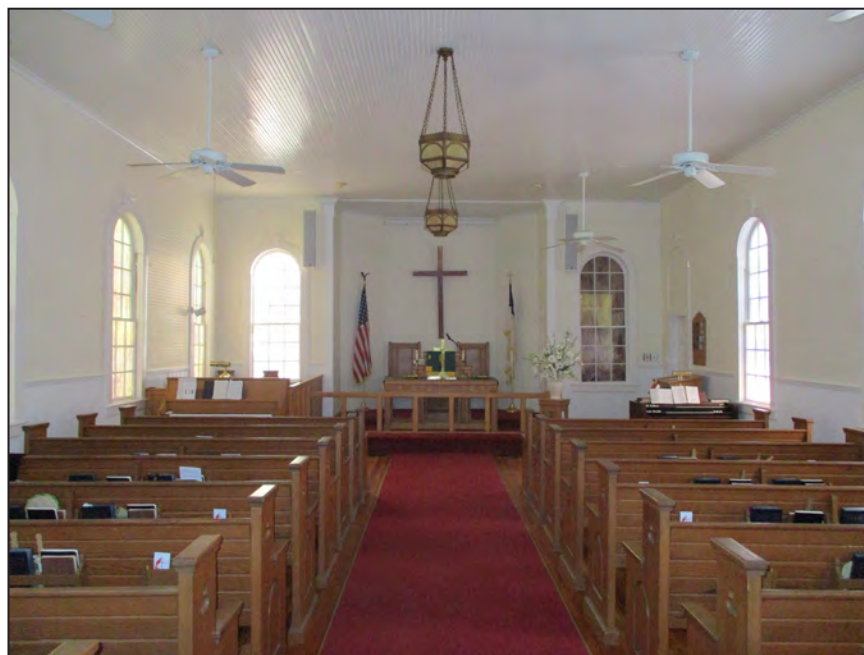
The interior of the sanctuary is one, single space. A center aisle spans the northern two-thirds of the room flanked on both sides by original wood pews. The southern one-third of the sanctuary features the altar, which is set into an alcove (the rear apse). A small choir section is located southeast of the altar. The sanctuary retains its original hardwood floors, shiplap ceiling and walls, and wood window surrounds which include a wood keystone. Some material alterations/additions have been made including the addition of modern ceiling fans and the partial enclosure of one window on the northwestern

Photograph 8: Interior view of Concord United Methodist Church looking southwest. (2018)

wall to accommodate the connecting door to the addition as noted above (Photographs 8 & 9).

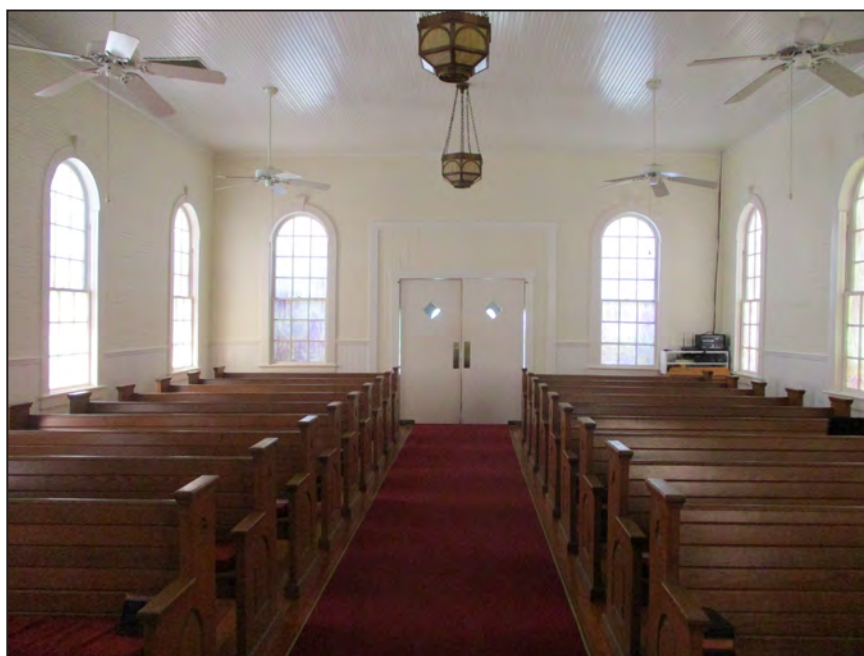
Photograph 9: Interior view of Concord United Methodist Church looking northeast. (2018)

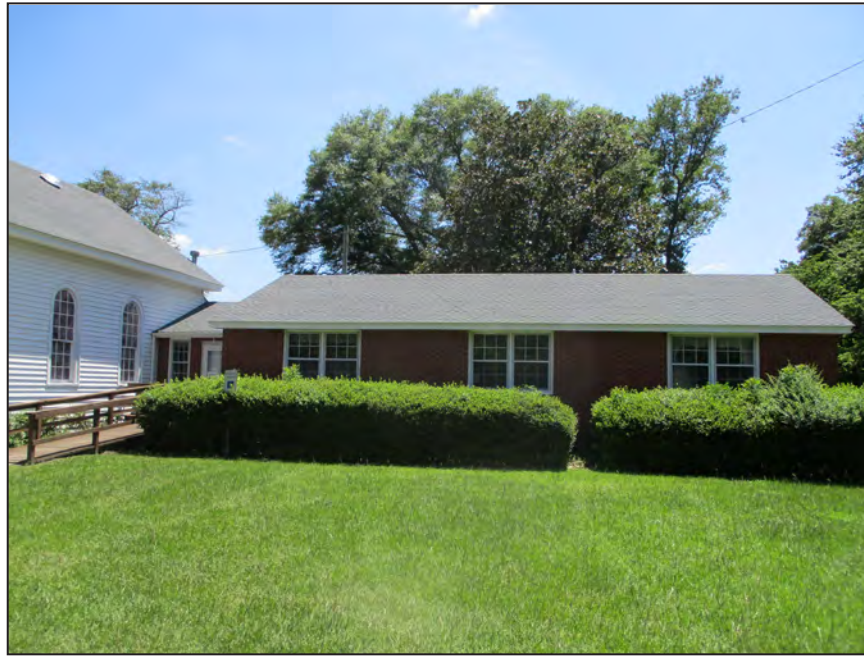
The ca. 1959 educational building was constructed off the sanctuary's northeast elevation (Photograph 10). The one-story brick veneer addition is rectangular in plan, is capped by a side-gable asphalt shingle roof with wide overhanging eaves and is connected to the sanctuary by a small gabled hyphen. The hyphen features a centered door flanked on both sides by original, six-over-six, metal, double-hung windows. It is reached by a wood, ADA accessible ramp. The addition's

Photograph 10: Ca. 1959 addition northeast elevation. (2018)

northeast elevation features three pairs of evenly spaced original, six-over-six, metal, double-hung sash windows. The addition's northwest elevation features two pairs of evenly spaced original, six-over-six, metal, double-hung sash windows (Photograph 11). A rectangular vent is centered in the gable. Two rectangular vents are located at the foundation and are vertically aligned with the windows. The southeast (rear) elevation backs up to the cemetery. Starting at the northern end and moving south, the elevation's fenestration pattern is as follows: a pair of original, six-over-six, metal, double-hung windows a multi-paneled door protected by a metal and glass storm door; a pair of original six-over-six, metal, double-hung

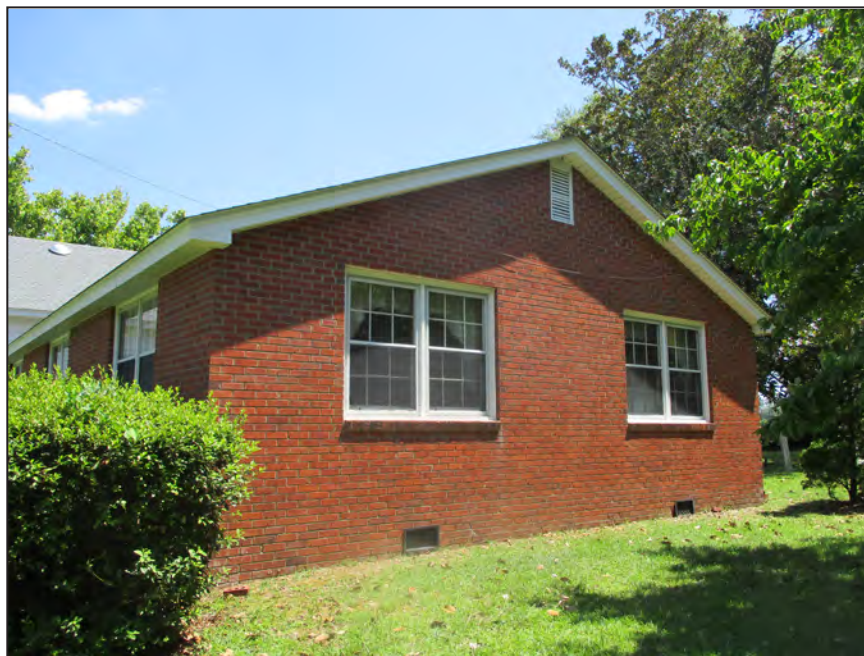
Photograph 11: Ca. 1959 addition northwest elevation. (2018)

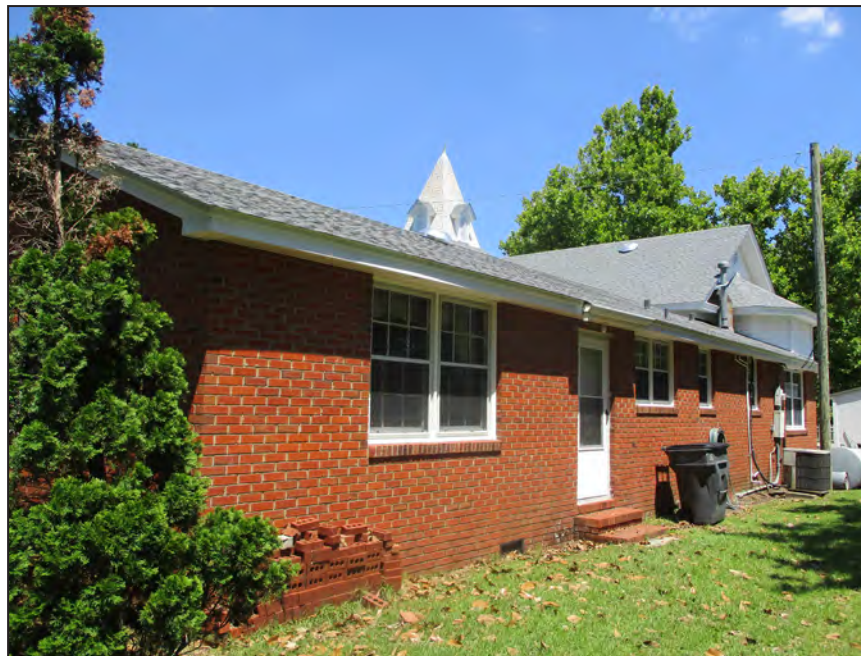
Photograph 12: View of ca. 1959 addition's southeast (rear) elevation; looking east. (2018)

windows that are shorter than the other windows on the addition; two evenly-spaced, original six-over-six, metal, double-hung windows; and a pair of original, six-over-six, metal, double-hung windows (Photograph 12). The interior of the educational building was not accessible and was therefore not surveyed.

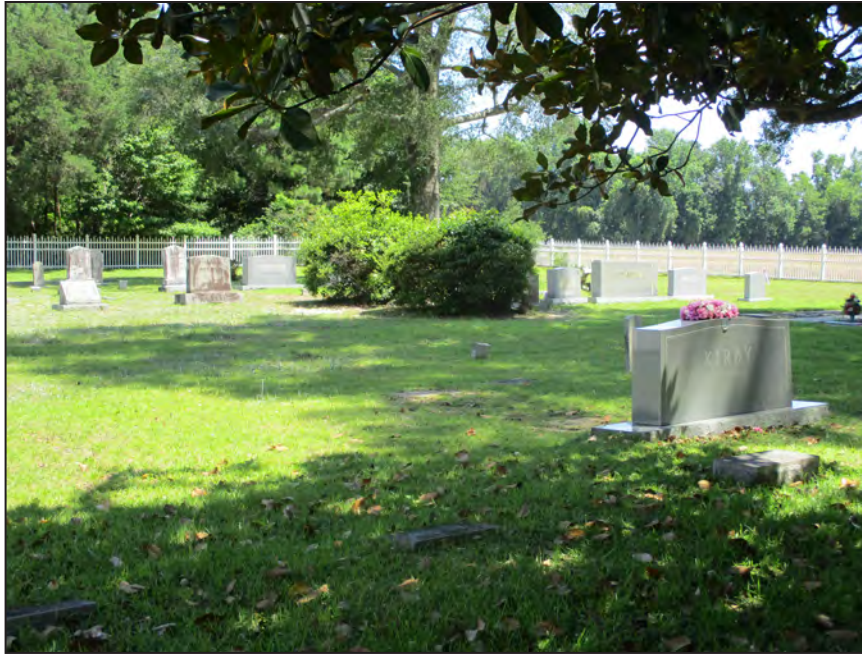
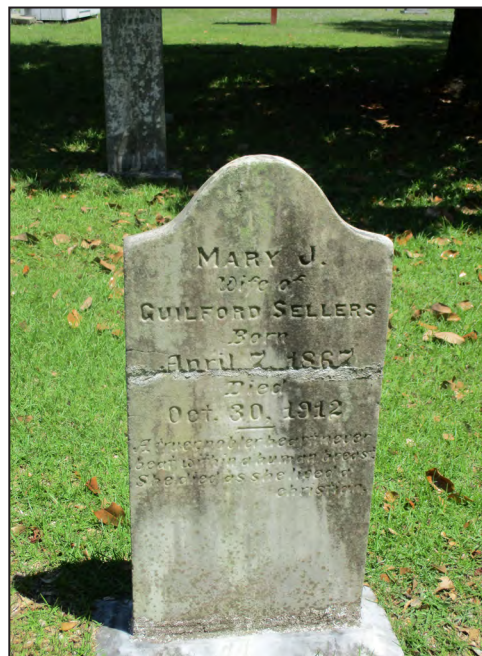
Photograph 13: Concord United Methodist Cemetery Map. (2018)

Photograph 14: Concord United Methodist Church Cemetery looking south. (2018)

Approximately 25 feet south of the church is an associated cemetery (Photographs 13-15). The oldest burials at the cemetery are Daniel Fulton Mercer (1852-1878) and M.R. McKeithen (1876-1882). The cemetery can be accessed via the church's parking lot.

Photograph 15: Headstone at Concord United Methodist Church Cemetery; looking east. (2018)

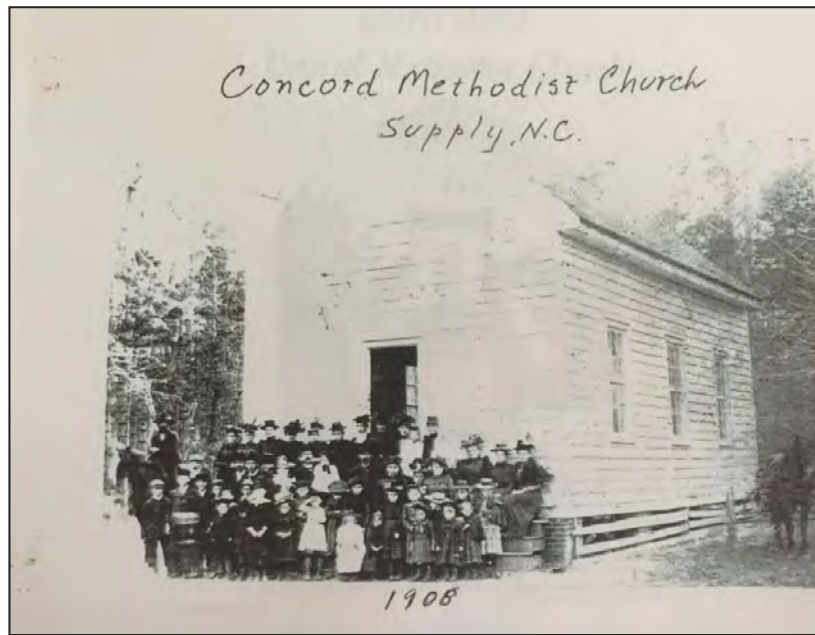
“Concord” which means “Peace and Harmony.” A photo from 1908 shows the original sanctuary, which means that the present sanctuary was constructed sometime after 1908 (Photograph 16; Koletar 2017). The church's pyramidal tower is similar to that on Bolivia's Bethel United Methodist Church, which was constructed in 1920, so the present Concord United Methodist Church sanctuary was likely built around the same time (ca. 1920) (Pezzoni 2010: 1).

Photograph 16: View of the former Concord United Methodist Church; ca.1908. (Source: Koletar 2017)

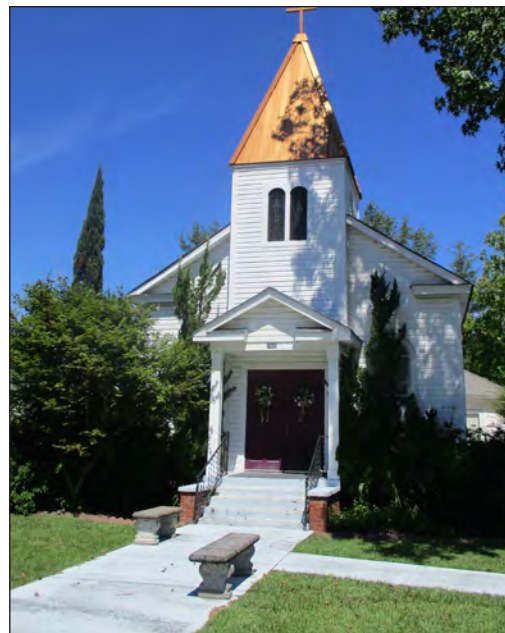
The previously surveyed Bethel United Methodist Church (BW0223), constructed in 1920, reflects the regional form for churches, adopting the classic gable-front nave form with a central tower (Photograph 17). The church is located in Bolivia, Brunswick County, North Carolina, approximately 9 miles northeast of the Concord United Methodist Church. It was surveyed in 2009, but no determination of eligibility was made. The congregation was founded in 1857 and has always been located in the Bolivia area. According to the 2009 survey by architectural historian Dan Pezzoni,

The one-story frame building features a large front entry tower capped by a pyramidal roof with flared eaves, gabled ventilation dormers of attenuated Gothic character, and a modern cross finial made of copper. A gabled porch shelters the double-leaf front doors, with above it a pair of round-arch stained glass windows. Round arches are also used over the nave's front and side windows, which have textured amber glass panes. Exterior modernization is restricted mainly to vinyl siding. A lower hip-roofed rear section extends on the south side to form a long gabled wing with its own double-leaf entry and gabled porch. In 2008 a gable-front addition was made to the south end of the side wing. The addition respects the character of the earlier sections with its matching gabled entry porch and 6/6 windows (Pezzoni 2009).

Photograph 17: Bethel United Methodist Church. (2018)

Bethel United Methodist Church retains its original tower, windows, and entry porch, and material alterations are largely confined to the addition of vinyl siding. Although the church features two additions, the style and details respect those of the original sanctuary. Comparatively, the Concord United Methodist Church also reflects the simple frame form commonly used in the region at the turn of the century. However, unlike Bethel's cohesive addition, Concord's addition stands in stark contrast with the original sanctuary creating a lack in integrity of material and design.

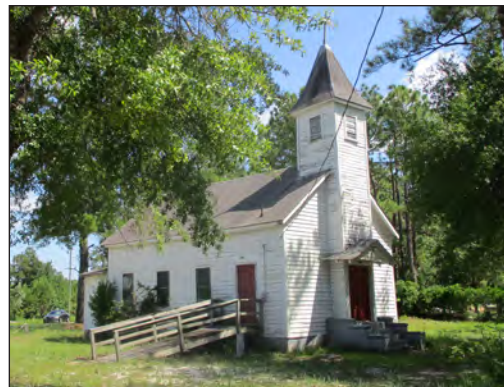
The study listed St. Mark A.M.E. Zion Church (BW0414), constructed ca. 1900-1920, is another example of the regional form popular for rural churches in area (Photograph 18). Located in Shallotte, Brunswick County, North Carolina, approximately 11 miles southwest of the Concord United Methodist Church, this gable-front frame building was one of the county's least altered historic churches as of 2009. According to the 2009 survey by architectural historian Dan Pezzoni,

Photograph 18: St. Mark A.M.E. Zion Church. (2018)

The gable-front frame building has weatherboard siding and features a center entry tower capped by a pyramidal roof with flared eaves and a recent cross finial. At the base of the tower, under a gabled stoop, are double-leaf stack-panel entry doors. Some of the 6/6 windows have textured glass. To the rear is a gabled apse probably an original feature, flanked by shed-roofed additions, and adjoined by a brick flue (Pezzoni 2009).

The church sanctuary retains a high degree of architectural integrity, but as of 2018 appears to be vacant and in fair condition. Comparatively, the Concord United Methodist Church also reflects the simple frame form commonly used in the region at the turn of the century, but it lacks the material integrity that makes St. Mark significant. Furthermore, the Concord United Methodist Church features a ca. 1959 addition, while St. Mark features no additions. Unlike the small changes made to St. Mark A.M.E. Zion Church, those made on the Concord United Methodist Church impact its architectural integrity.
