SUBJECT: Historic Structures Survey Report, Widening SR 1109 (Williamson Road) from I-77 to SR 1100 (Brawley School Road), R-5100A, PA 18-08-0002, Iredell County, ER 18-4172

**HISTORIC STRUCTURES SURVEY REPORT
WIDEN SR 1109 (WILLIAMSON ROAD)
FROM I-77 TO SR 1100 (BRAWLEY SCHOOL ROAD)
MOORESVILLE, IREDELL COUNTY, NORTH CAROLINA**

**TIP PROJECT R-5100A
WBS NO. 41890.1.D1
PA TRACKING NO. 18-08-0002**

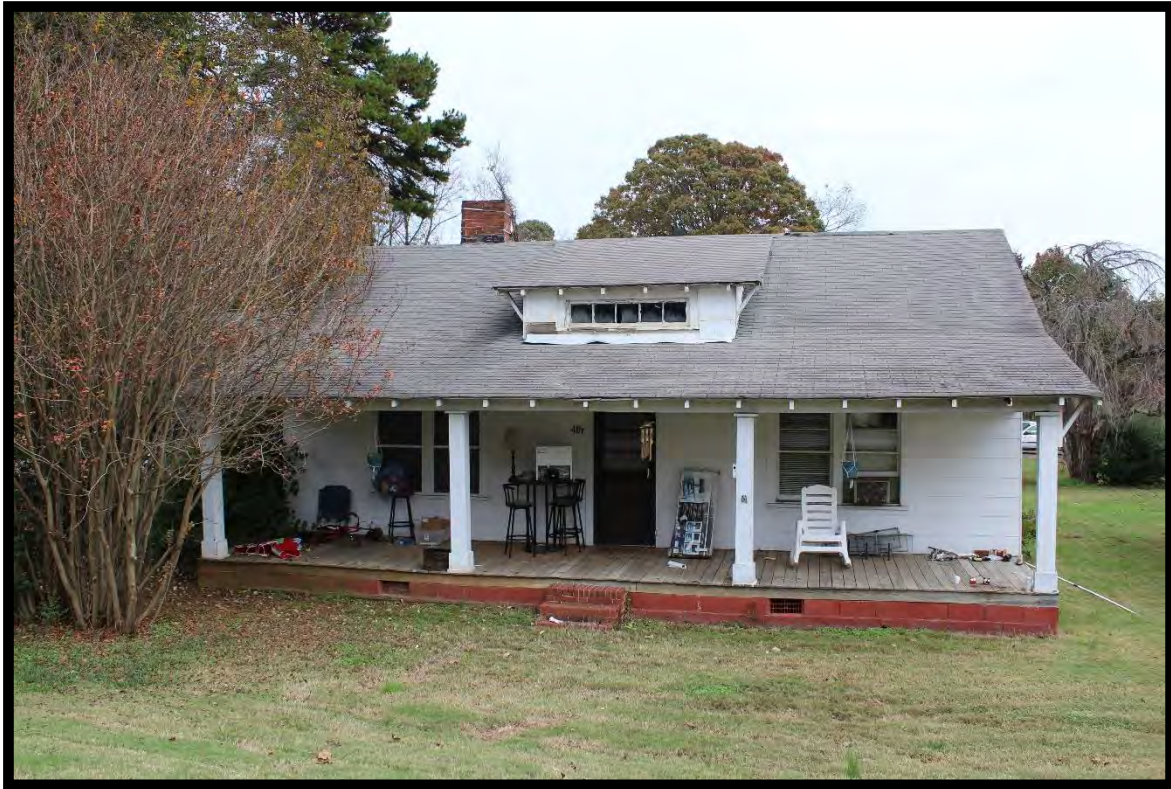
Figure 3: Chester Farmstead, Original Dwelling, Looking Northeast.

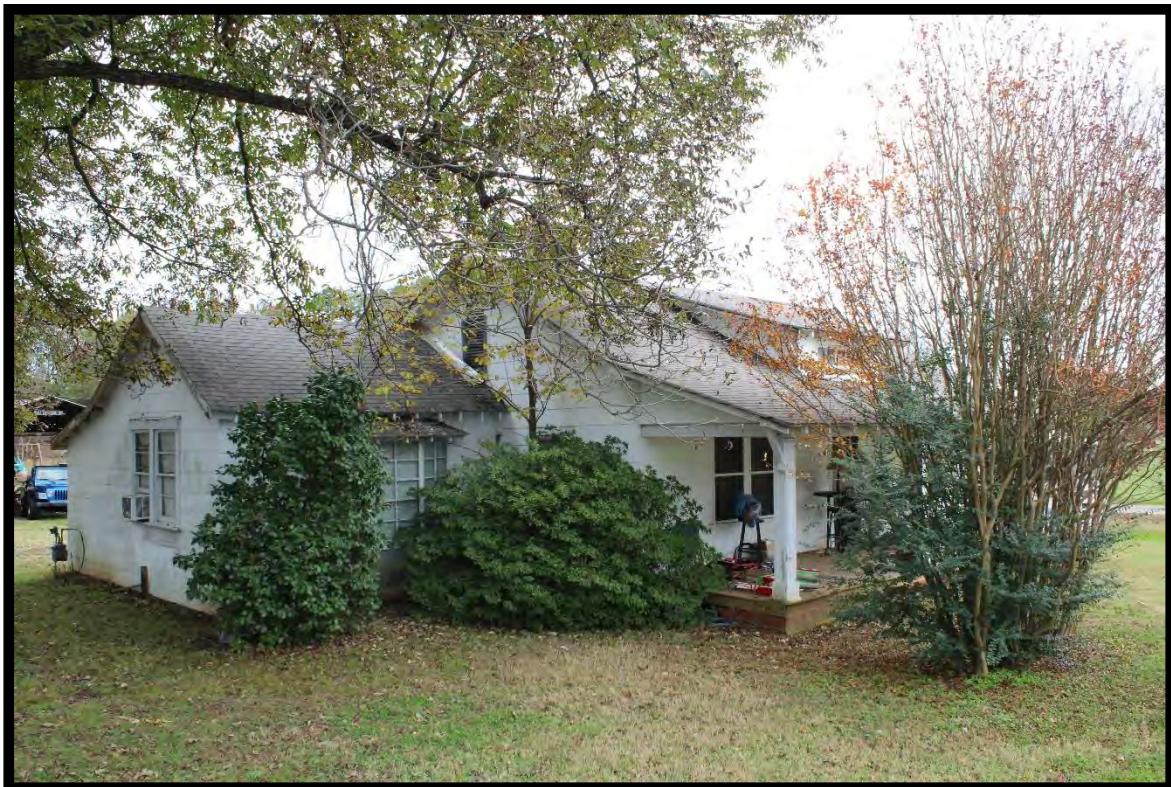
The original house is a one-story vernacular dwelling with a concrete block foundation, asbestos over wooden siding, and a side-gabled asphalt shingle roof. Though it does not fully embody the style, it displays modest Craftsman-style features such as exposed rafter tails and gallows brackets. It has an integral full-width front porch supported by square wooden posts and a small pop-up dormer that is centered on the front slope of the roof and lit by a linear five-pane window. The porch shelters a symmetrical façade with a wooden entry door flanked by paired two-over-two horizontal pane wooden sash windows. The entry door has three horizontal lights over three equal-sized horizontal panels. The porch is approached by a small set of brick steps (see Figure 3). A small wing extends from the north (side) elevation of the dwelling. It has a bay window with three ten-pane windows on its west (front) elevation and a paired window on its north (side) elevation (Figure 6).

Figure 6: Chester Farmstead, Original Dwelling, Looking Southeast.

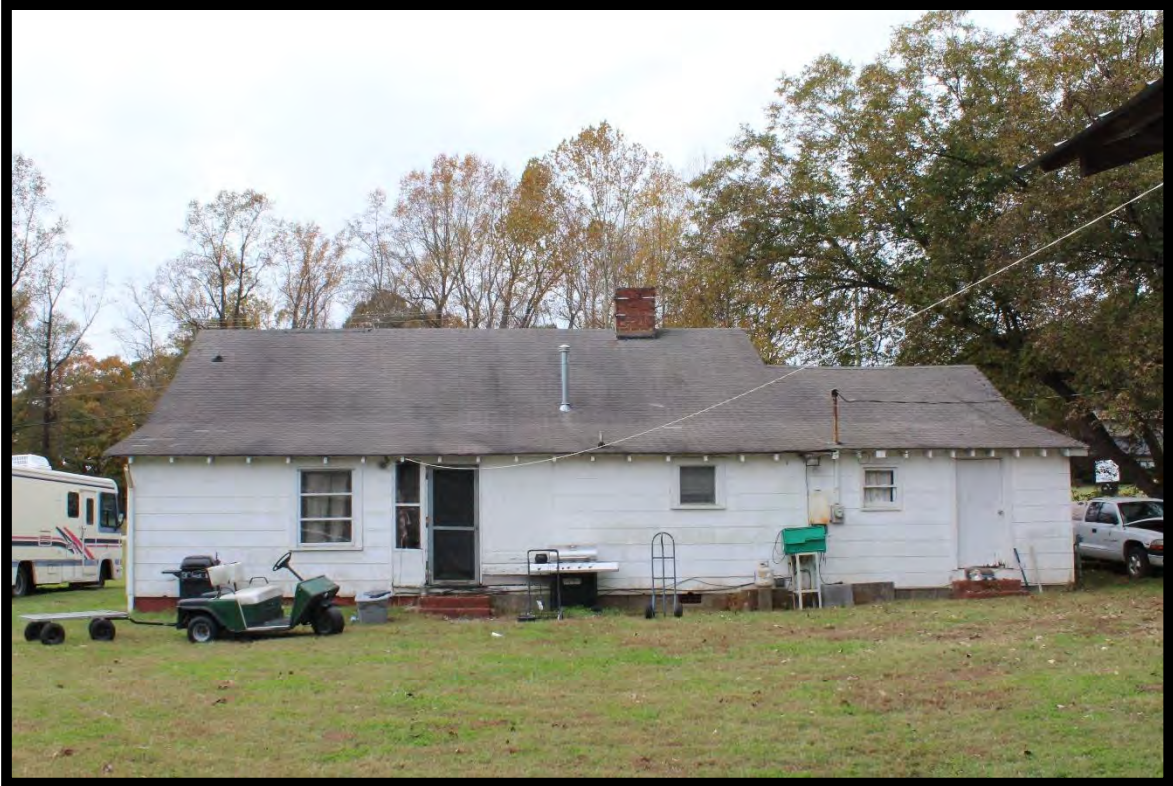
The east (rear) elevation contains from south to north a window with three horizontal panes, a screened entry door flanked on the south by a two-over-two window, and a jalousie window. A small one-over-one window and an entry door pierce the rear elevation of the wing. The rear portion of the dwelling is sheltered by a roof with a slightly lower pitch than the center portion of the house, suggesting that it may have begun as a porch. This idea is further substantiated by a boarded over section on the north side of the door and window (Figure 7).

Figure 7: Chester Farmstead, Original Dwelling, Looking West.

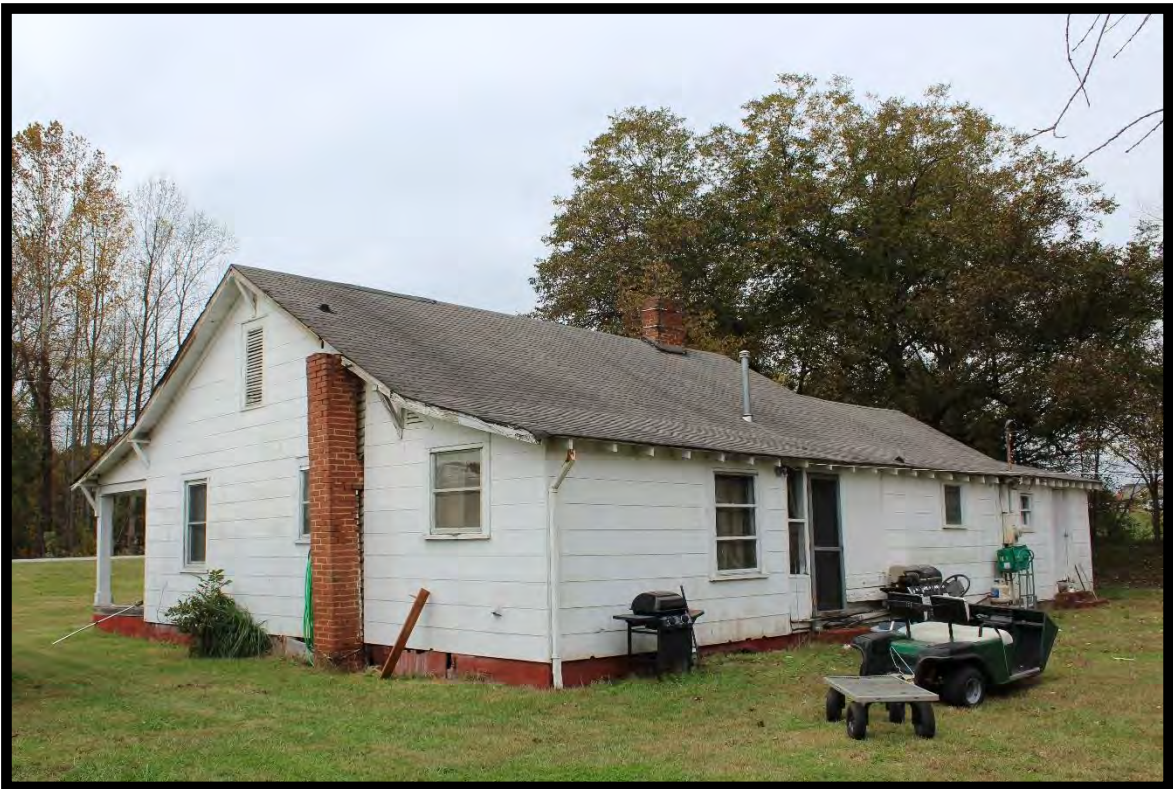
Figure 8: Chester Farmstead, Original Dwelling, Looking Northwest.

The south (side) elevation contains three one-over-one wooden sash windows. A brick chimney rises between the easternmost windows, though it is truncated at the roofline and is pulling away slightly from the dwelling, and the original wooden siding is visible behind the chimney. A large vent is placed below the peak of the gable (Figure 8). A similar vent is present on the north (side) elevation above the wing and a second chimney rises from the peak of the roof near the north gable end.

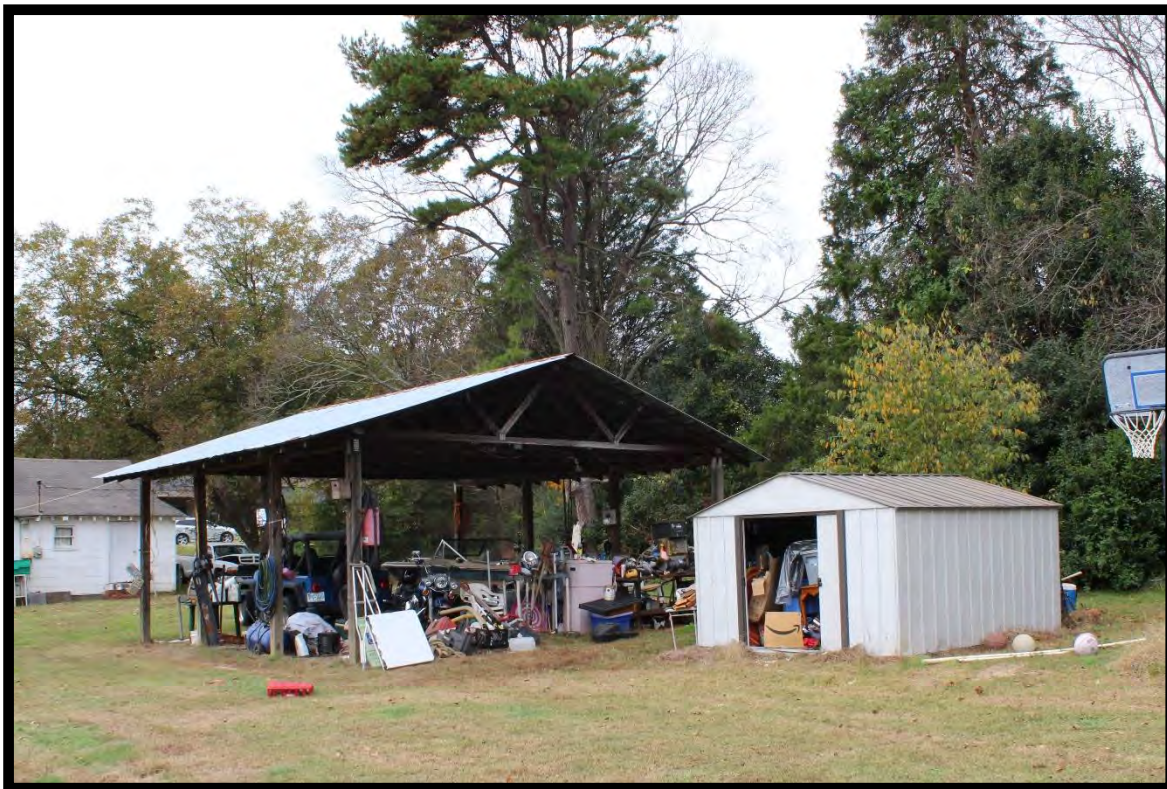
Ancillary structures associated with the dwelling include a front-gabled shelter that faces west and is open on each side. It is supported by square wooden posts and sheltered by a standing seam metal roof. The second structure is a front-gabled shed that faces south. It is clad with metal sheets that display a profile similar to boards and battens and has a standing seam metal roof. It has double leaf sliding doors on the front elevation (Figure 9).

Figure 9: Chester Farmstead, Shelter and Shed, Looking Northwest.

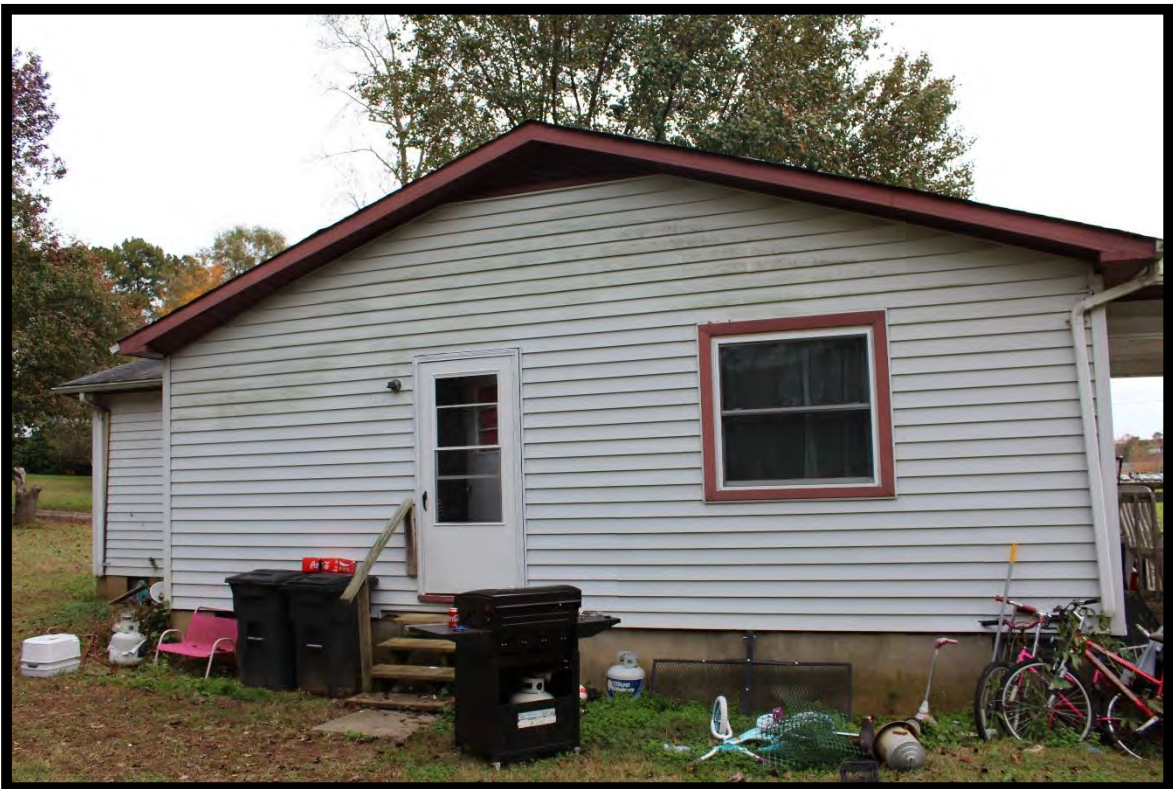
The north (side) elevation contains an entry door flanked on the west by a one-over-one vinyl sash window. The door is approached by wooden steps. The side elevation of the rear wing is blind (Figure 11).

Figure 11: Chester Farmstead, Second Dwelling, Looking Southeast.

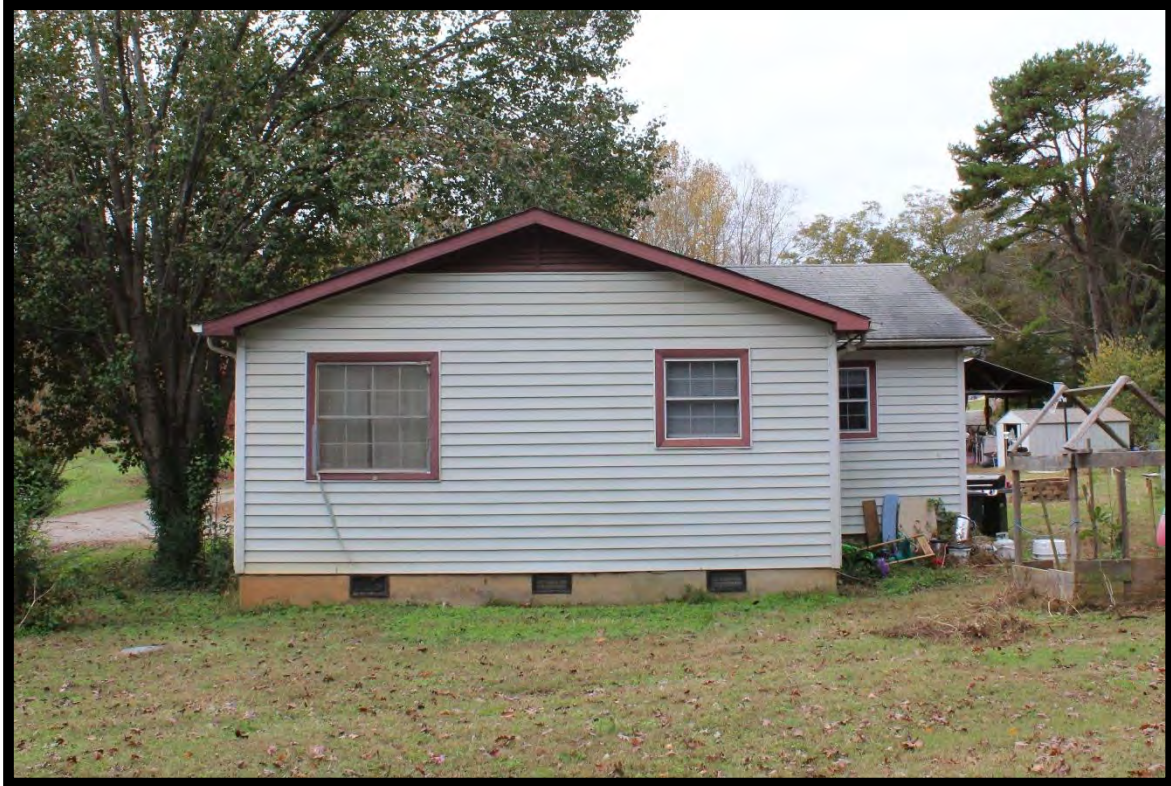
The rear wing extends from the south side of the east (rear) elevation and contains one eight-over-eight and one six-over-six vinyl sash window. A six-over-six vinyl sash lights the rear elevation of the main body of the dwelling, north of the wing (Figure 12).

Figure 12: Chester Farmstead, Second Dwelling, Looking West.

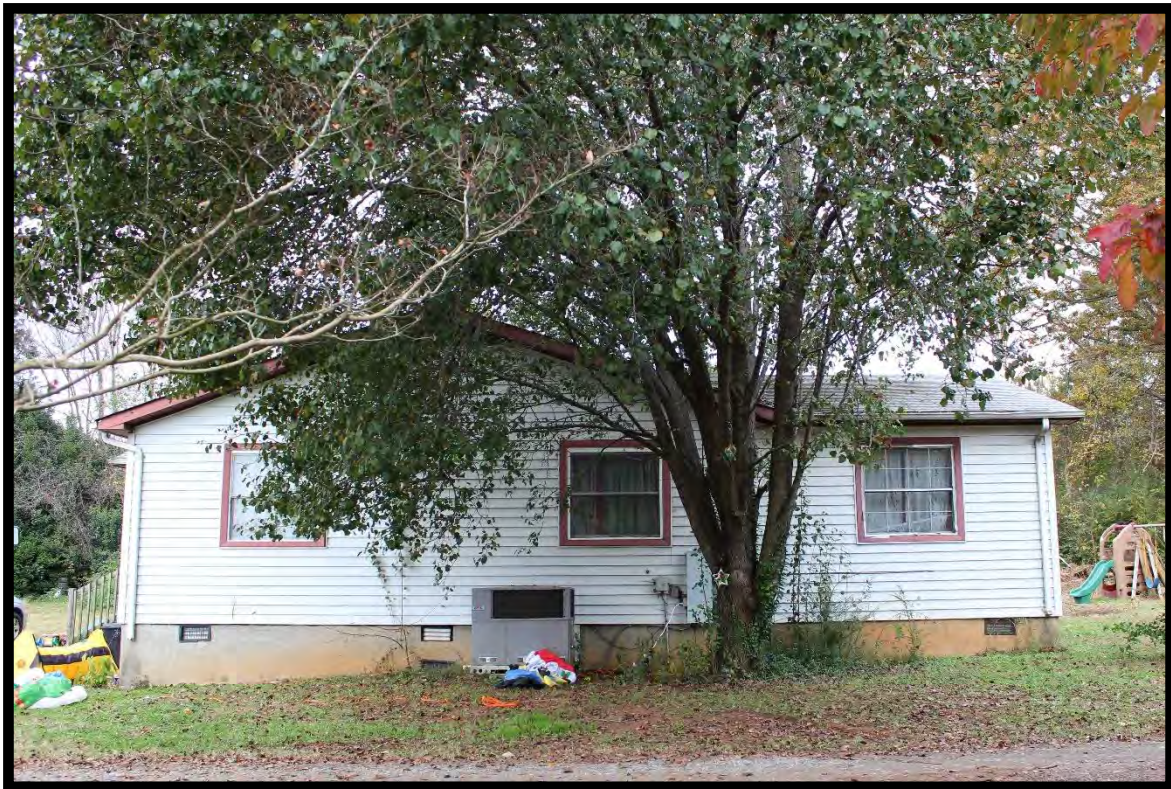
The south (side) elevation contains three windows. Two eight-over-eight vinyl sash windows that flank a one-over-one vinyl sash window (Figure 13).

Figure 13: Chester Farmstead, Second Dwelling, Looking North.

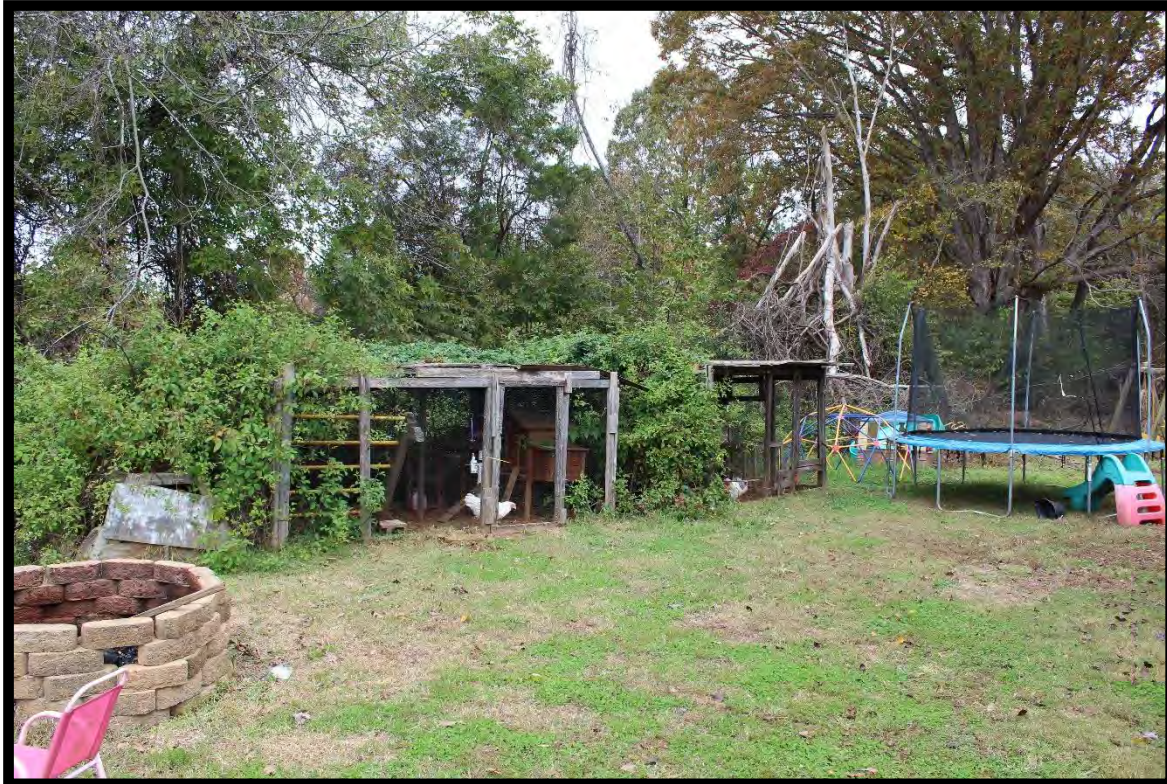
Ancillary structures associated with the dwelling include two frame and wire chicken coops to its north and the frame of what may have been a greenhouse to the east. Many children's items such as a trampoline, swing set, and basketball goal fill the yard as well (Figure 14).

Figure 14: Chester Farmstead, Chicken Coops, Looking Northeast.

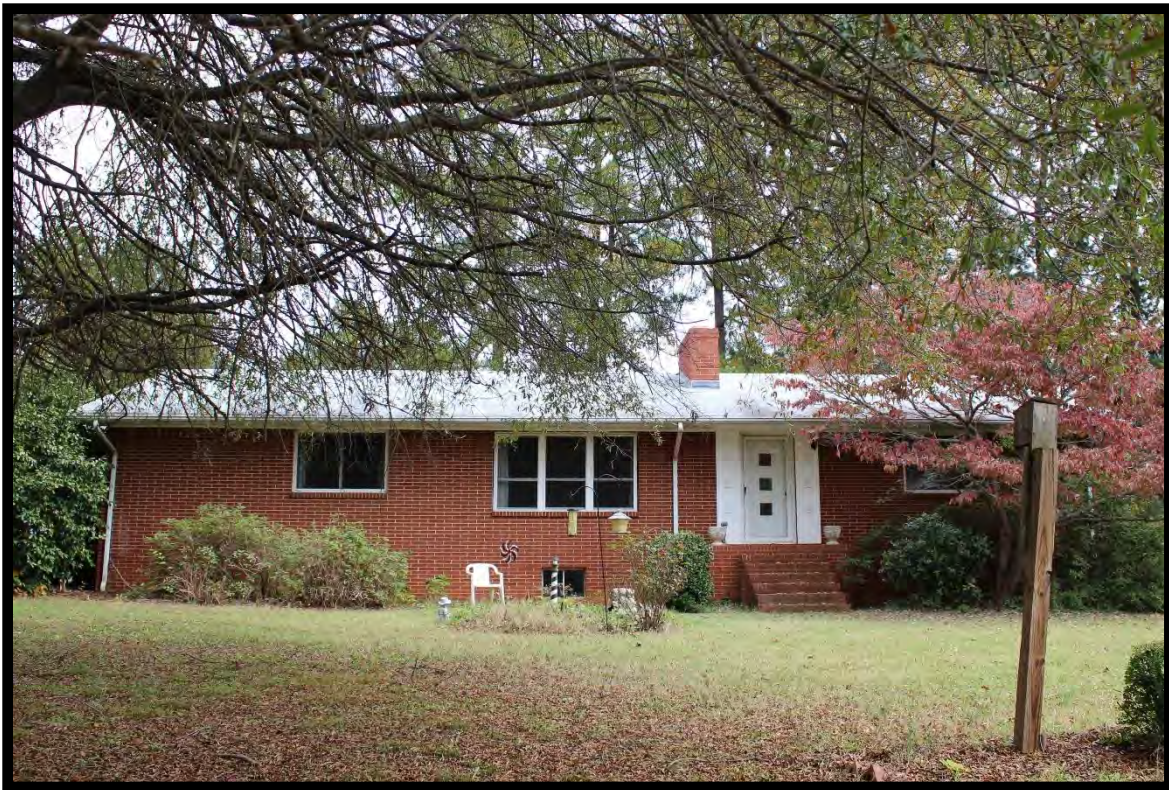
The ca. 1964 Ranch-style dwelling stands east of the other houses on a slight rise. It is one story with a basement and has a side-gabled asphalt shingle roof, is clad with brick veneer, and rests on a brick foundation. The west (front) elevation contains four unequally-sized bays that are filled, from north to south, with a paired single-pane window, a tripled one-over-one window, an entry door with three square lights arranged vertically, and a second paired single-pane window. The entry door is flanked by wooden panels with insets that mirror the arrangement of the door's windows and approached by brick steps that lead to a brick stoop. A chimney rises from the forward slope of the roof, just below the roof's crest. It is particularly wide and is oriented perpendicular to the roof's crest. Small two pane windows pierce the lower portion of the elevation (Figure 15).

Figure 15: Chester Farmstead, Ranch Dwelling, Looking East.

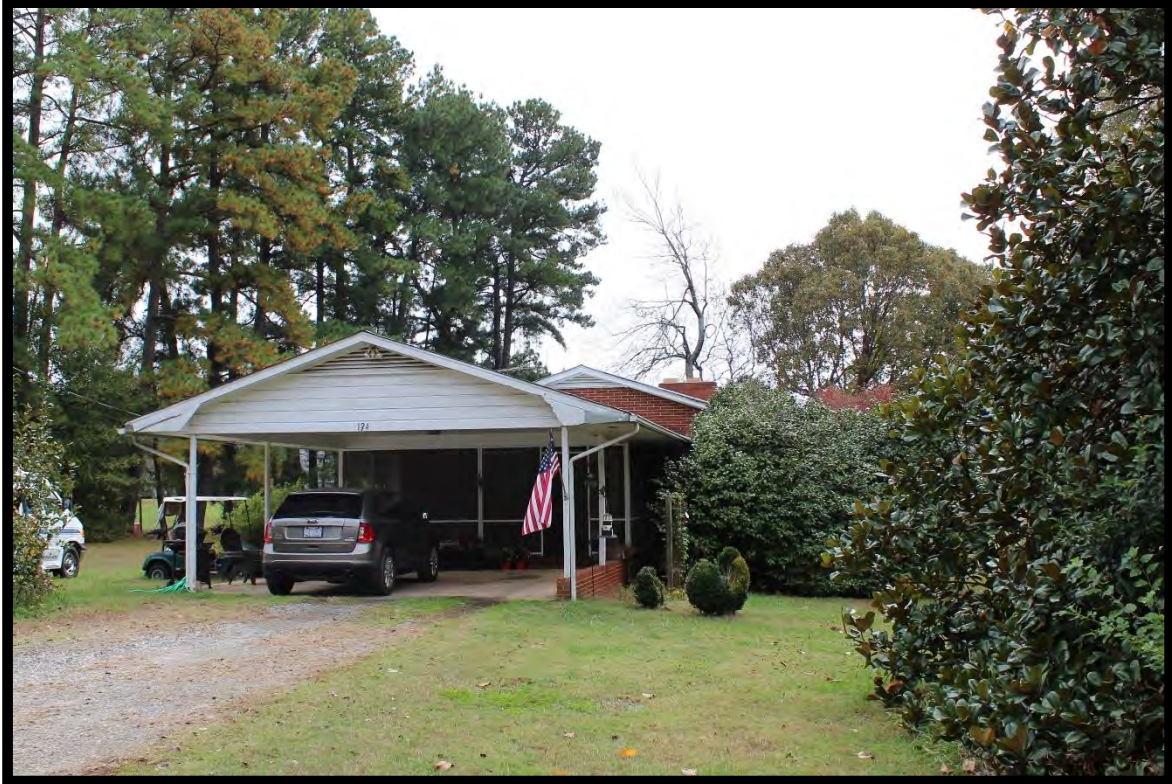
A gabled carport telescopes from the north (side) elevation and shelters a concrete pad as well as a screened porch. It is supported by thin metal poles which are set in a low brick wall on the west side (Figure 16).

Figure 16: Chester Farmstead, Ranch Dwelling, Looking Southeast.

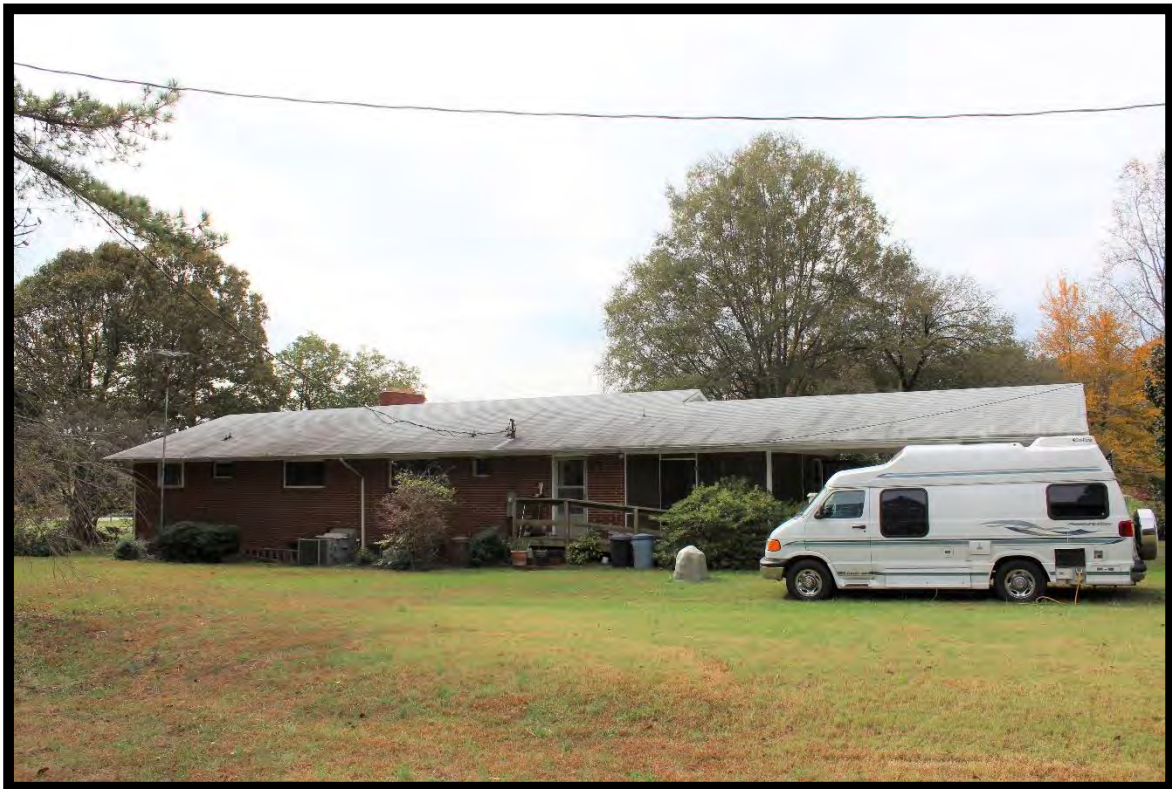
The windows on the east (rear) elevation are all set high on the elevation, close to the dwelling's eave. They include, south to north, a paired single-pane window, a small one-over-one window, and three paired single-pane windows, the last of which is particularly small. North of the windows is an entry door with two horizontal lights (Figure 17).

Figure 17: Chester Farmstead, Ranch Dwelling, Looking Southwest.

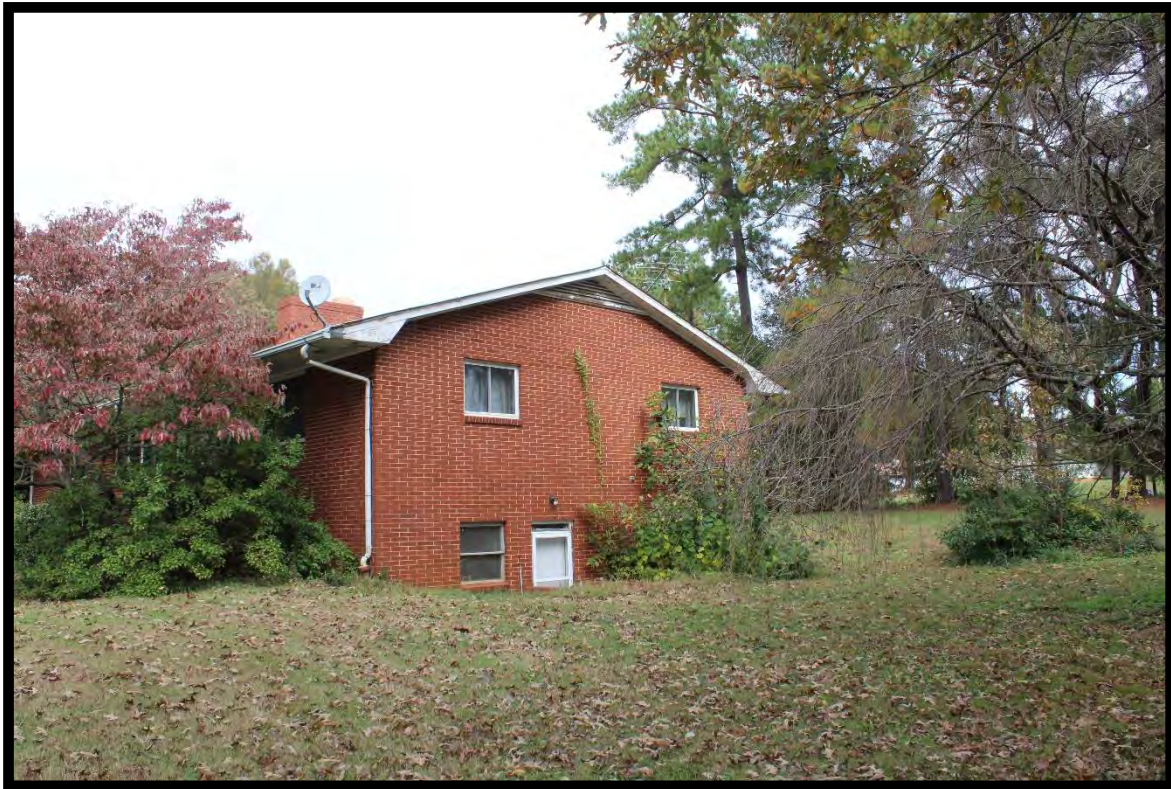
The south (side) elevation contains two paired single-pane windows on the first story and two one-over-one horizontal paned windows and an entry door on the basement story. The entry door is accessed by steps that are recessed into the ground (Figure 18).

Figure 18: Chester Farmstead, Ranch Dwelling, Looking Northeast.

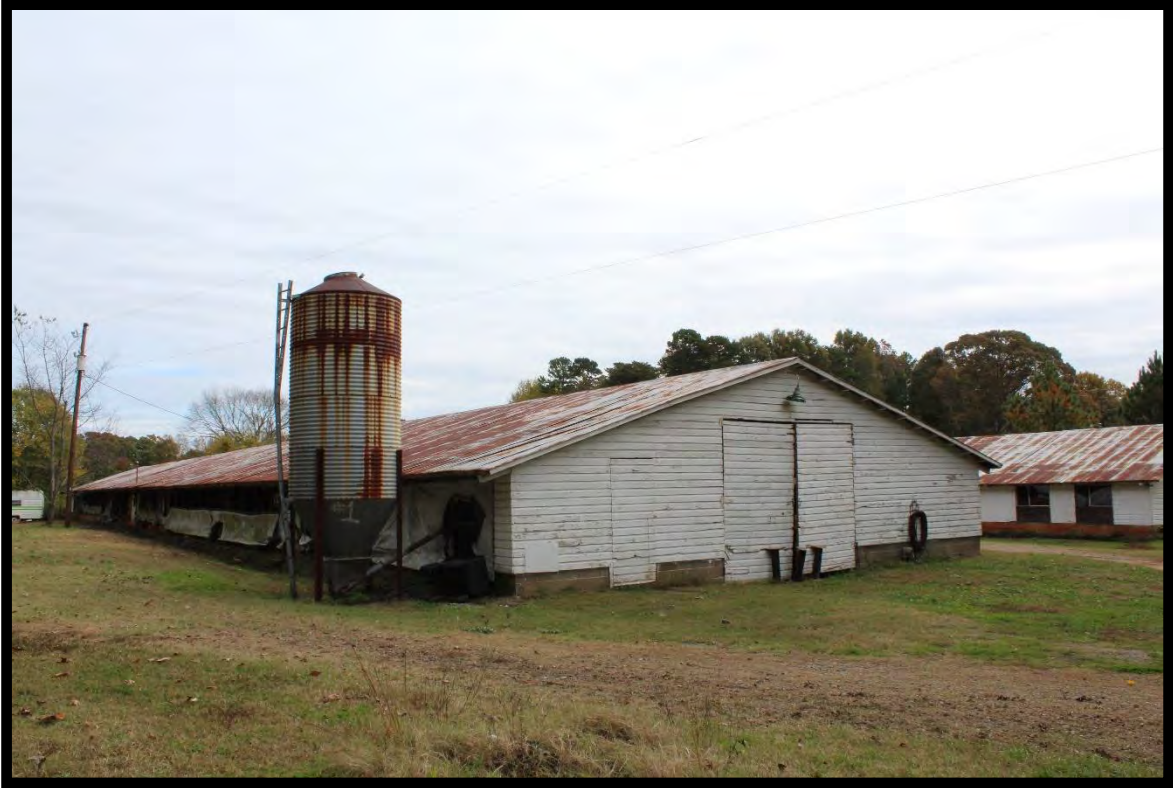
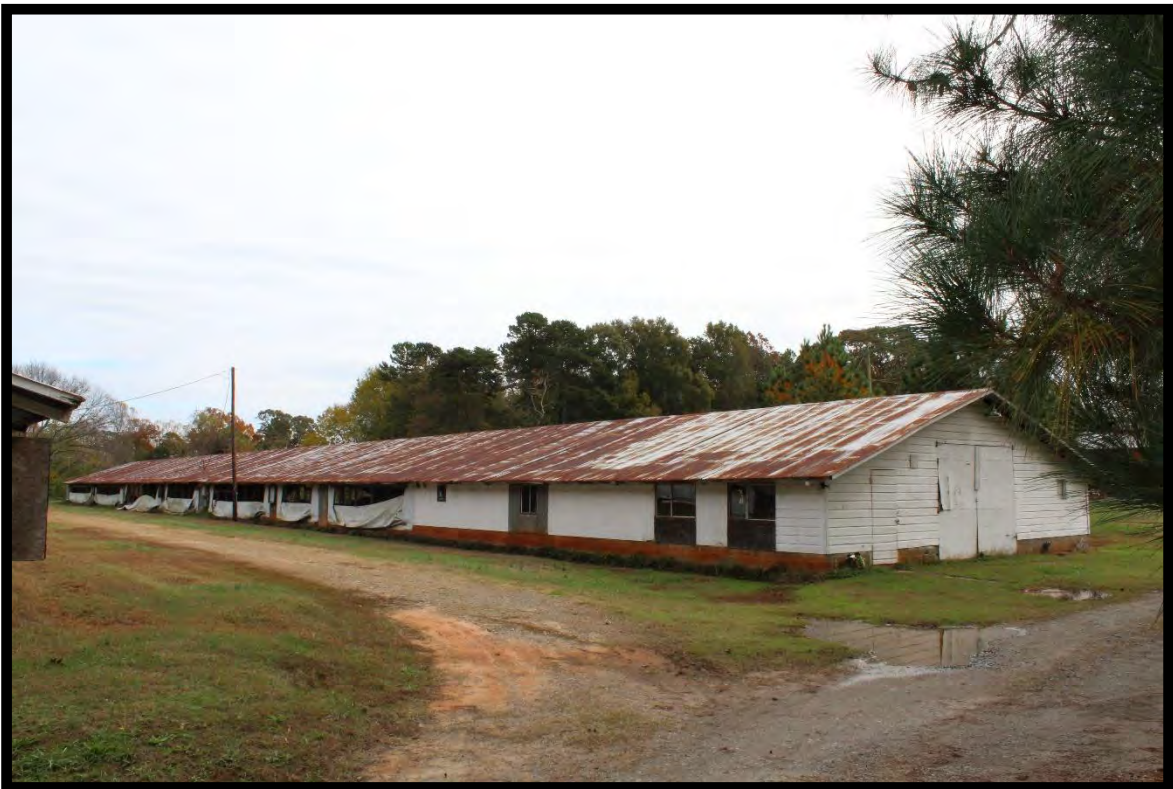
East of the dwelling are two poultry sheds and a general shed. According to the property's appraisal card, all three structures were constructed in 1968. The poultry sheds are linear buildings with gabled ends, concrete block foundations, German siding and plywood sheet cladding, and standing seam metal roofs. Both have large double-leaf doors on the west gable end and banks of windows that light the north and south (side) elevations. Tarps partially cover some of the window, many of which have no panes or screens. A grain bin stands at the northwestern corner of the northern poultry shed. It has an auger at its base that once fed grain into the shed (Figures 19 and 20).

Figure 19: Chester Farmstead, Poultry Shed, Looking Southeast.

Figure 20: Chester Farmstead, Poultry Shed, Looking Southeast.

As for the outbuildings, the poultry sheds appear to be in a state of disrepair with portions covered by tarps, while the other buildings appear to be in decent condition but are no longer utilized for agricultural purposes. Furthermore, the buildings appear to relate more to the later part of the nineteenth century (1960s) versus the period in which the original dwelling was constructed.

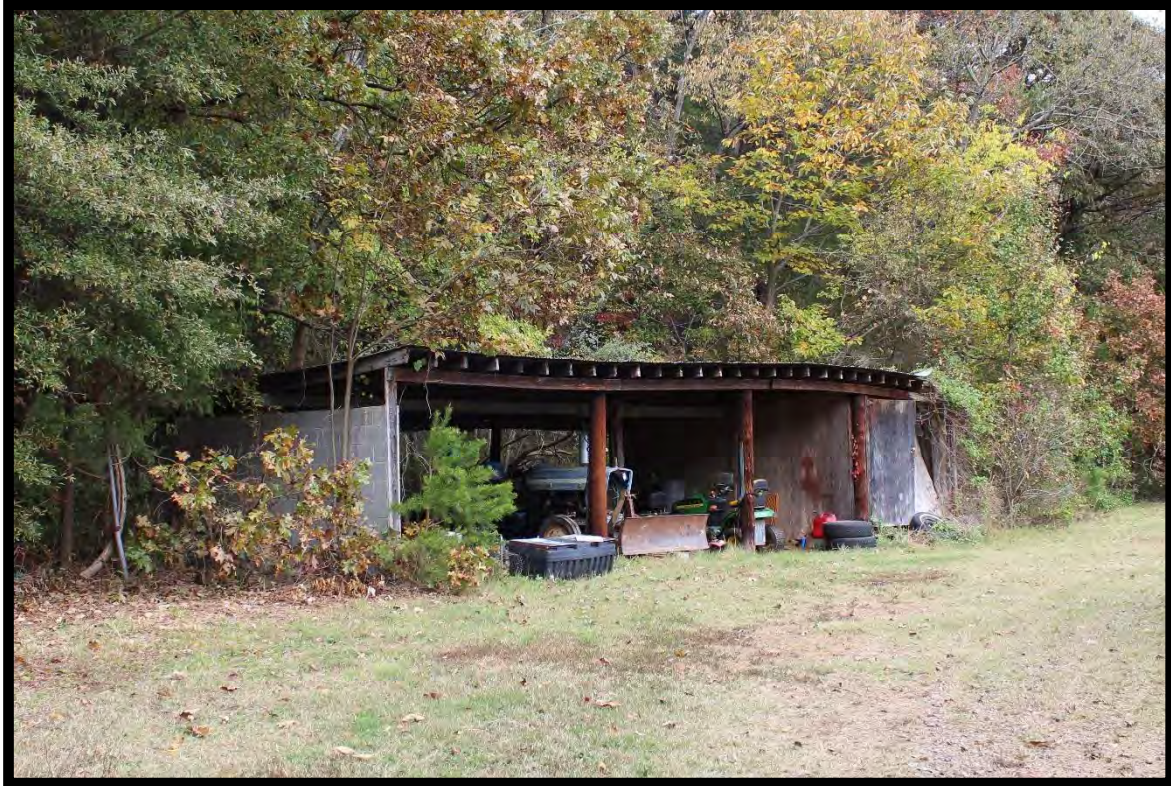
The shed-roofed shed stands north of the poultry sheds and faces south. It is four bays wide with tree-trunk like posts for supports and is open on the south (front) and north (rear) elevations. The west (side) elevation is constructed of concrete block and the east end is enclosed with plywood sheets. It has a standing seam metal roof (Figure 21).

Figure 21: Chester Farmstead, General Shed, Looking Northeast.

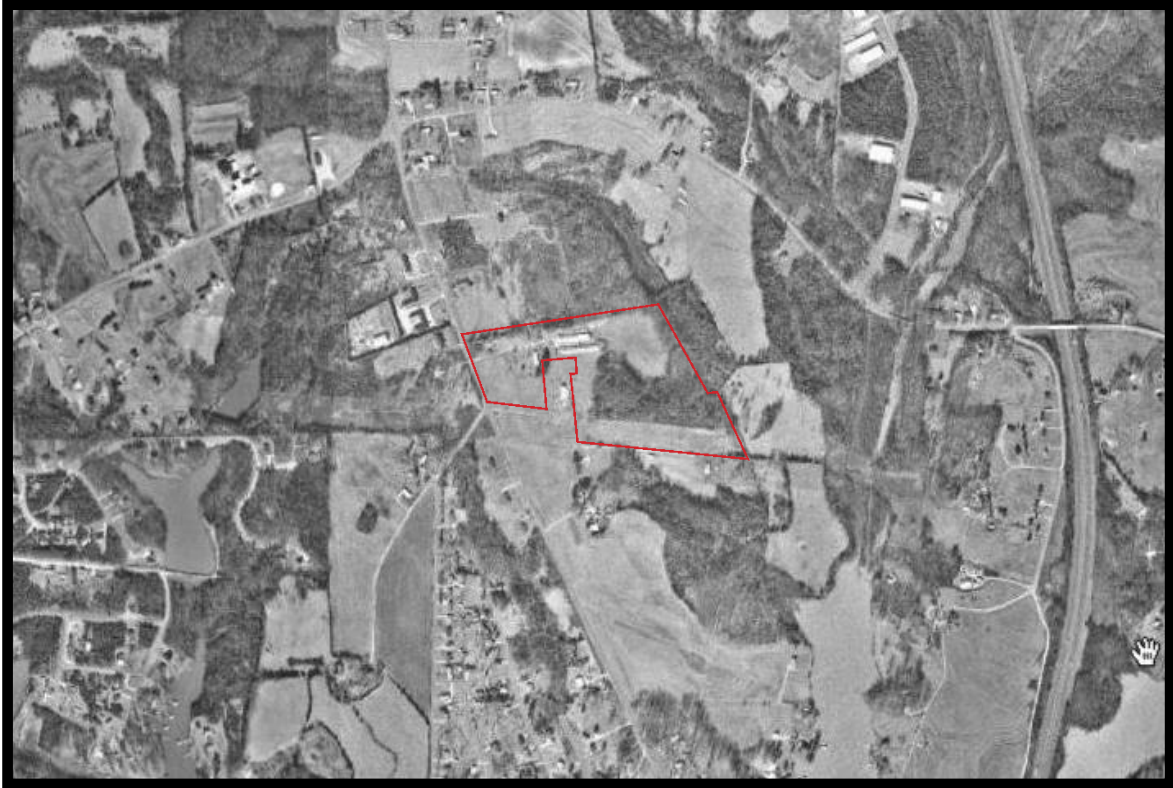
Figure 24: 1993 Aerial Image (HPOWeb).

Between 1993 and 2002, the pace of commercial and residential development began to increase to the north and south of the parcel (Figures 24 and 25). Today, the parcel measures just over 30 acres and contains three residences – the small dwelling near Williamson Road, the Ranch-style dwelling, and the ca. 1940 dwelling that was moved to the property before 2002. Though a number of ancillary structures remain on the property and a small number of chickens are still raised by its owners, the property no longer operates as a farm.

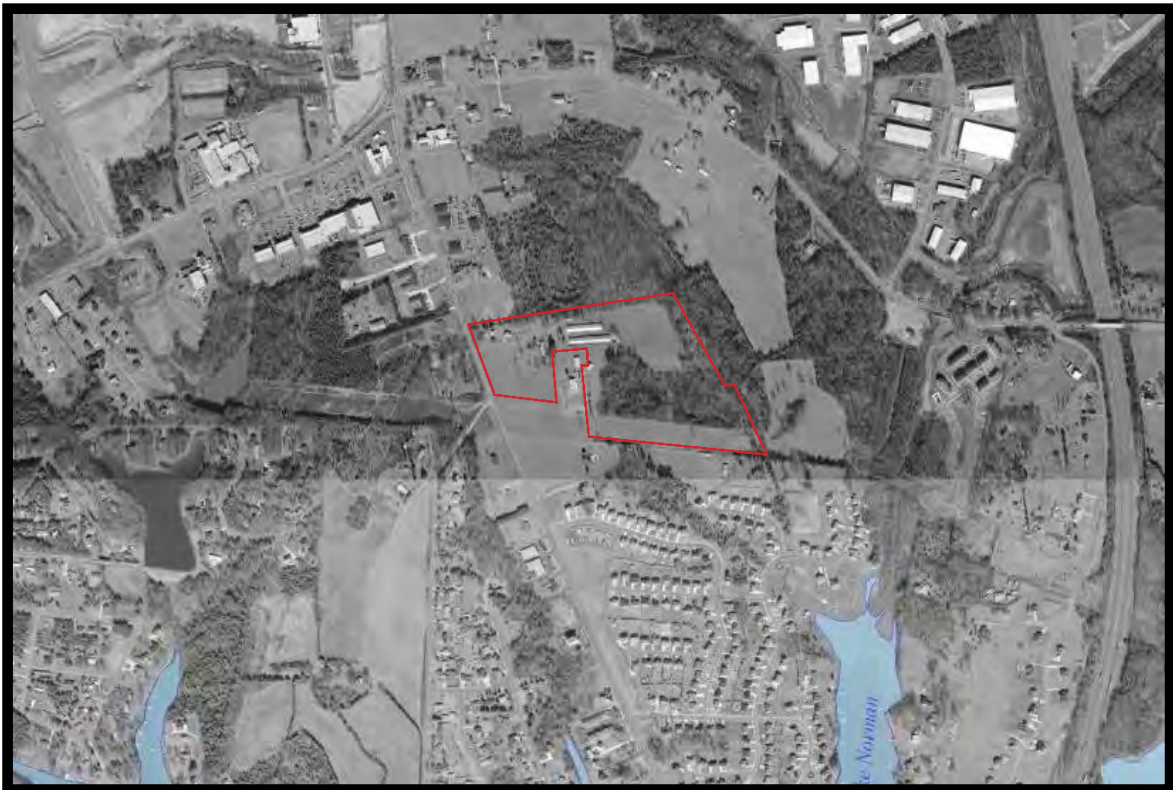
Figure 25: 2002 Aerial Image (Iredell County GIS).

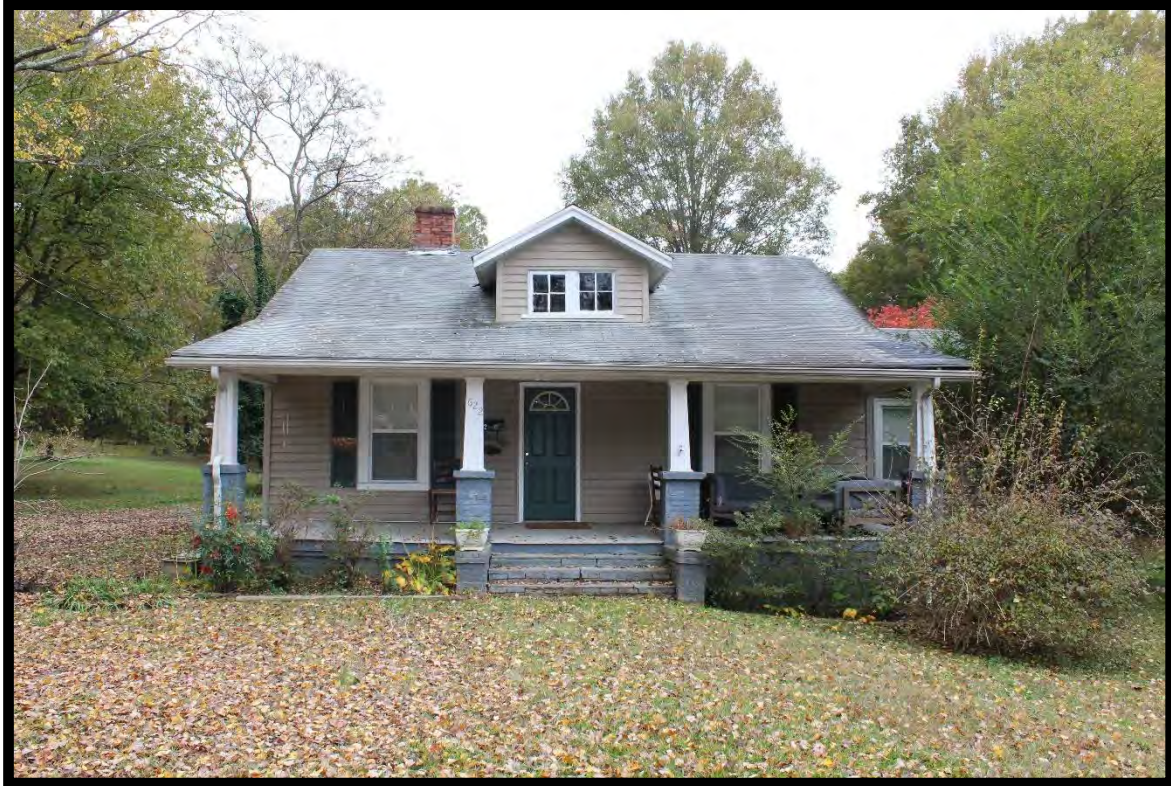
Figure 26: 622 W. Wilson Avenue, Looking South.

HPOWeb lists 86 Craftsman-style resources in Iredell County, all of which are located in or on the outskirts of Mooresville and Statesville, and none of which are listed on the NRHP. Many of these serve as larger, more articulated versions of the style and most, even the smaller examples, have gabled versus shed-roofed dormers. One similarly scaled example is a house at 622 W. Wilson Avenue (Figure 26). Constructed ca. 1925, the dwelling has an integral porch supported by battered box columns on brick pedestals and a central entry door flanked by one-over-one windows. Like the house, its original siding has been replaced with a modern material, in this case, vinyl, and unlike the house its windows have also been traded for vinyl replacements. Nonetheless, the dwelling retains many Craftsman-style features and serves as a better example of the style.

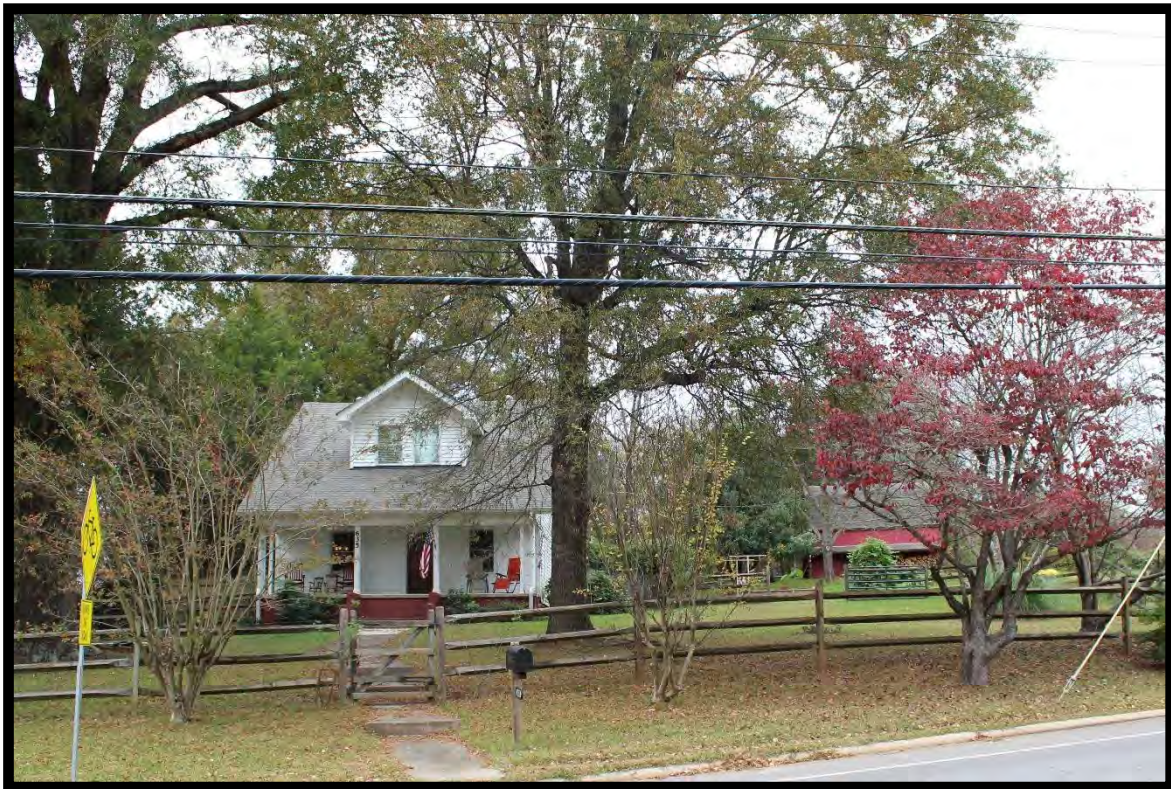
Figure 27: John Bradford House (ID1719), Looking North.

(Figure 27). The house, which is located in an area of Mooresville that has experienced widespread residential development, differs from the Chester House in that it is larger and has lost much of its associated land, but is more well-preserved. Its barn is also more well-preserved than the outbuildings associated with the Chester Farmstead and though it is not likely used for agricultural purposes it provides a strong sense of how the property was originally arranged and functioned.
