SUBJECT: Historic Structures Survey Report, Upgrade NC 11 to Interstate Standards from Proposed Greenville SW Bypass to Proposed Harvey Parkway Extension, R-5815, Lenoir and Pitt Counties, ER 19-0079

The report considers six resources – the Jesse Franklin Hart House (PT2737), the Claudius Jackson House (PT0136), the Rountree-Smith House (LR0717), the Robert Francis Hart House (PT2738), the Marion Edward Hart House (PT2739), and the Martha Deal House (PT0135). All six resources are recommended as not eligible for listing in the National Register of Historic Places. Initial screening of the project area by NCDOT Historic Architecture identified which resources warranted additional study. Lenoir County Bridge Numbers 76 and 77 are not eligible for the National Register.

AECOM prepared this report in September and October 2018. As a result of its analyses, AECOM recommends none of the evaluated resources merit NRHP eligibility. The following table identifies the resources requiring evaluation and summarizes the recommendations regarding their eligibility.

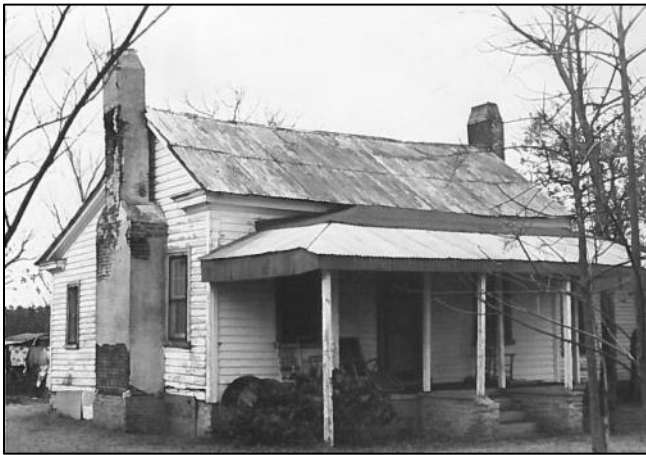
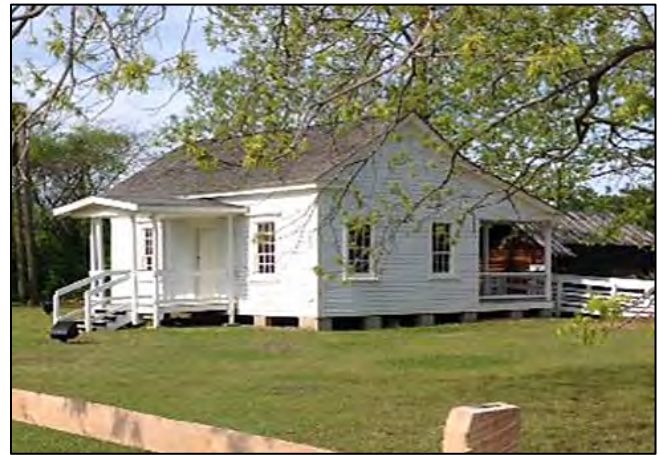
Figure 6: Thomas Adrian Savage House in late 1980s (Power 1991:56), at left, and ca.2016 (<http://www.eastcarolinavillage.org/buildings>), at right

In his late 1980s Pitt County inventory, Power recorded a small number of one-story, end-gabled, frame houses from the late-eighteenth and early/mid-nineteenth centuries that had hall-parlor plans like that of the Deal House. Some, such as the late-eighteenth-century Edwards-Elks-Adams House (PT0214) near Schelmerdine and the 1832 Guilford Murphy House (PT0034) near St. Johns, no longer stand (Power 1991:23-24, 41-42, 237-238, 277) (Figure 5). Others—including the Jesse Shivers House (PT0042), built between 1781 and 1803, and the ca.1857 Thomas Adrian Savage House (PT0316), built near Bell's Fork but now standing in Greenville (Power 1991:23-25, 54-56, 359, 475; East Carolina Village and Farm Museum website)—survive, apparently little altered since their recordation (Figure 6).

The Shivers and Savage houses retain far more integrity than the Deal House, which has lost its doors, windows, partition wall, chimney, and even much of its cladding. Its most notable surviving components are its wood roof shingles, visible in part beneath a taller and wider, later-added roof.

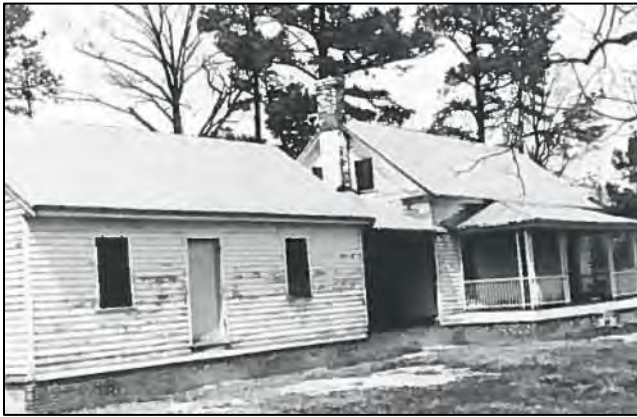
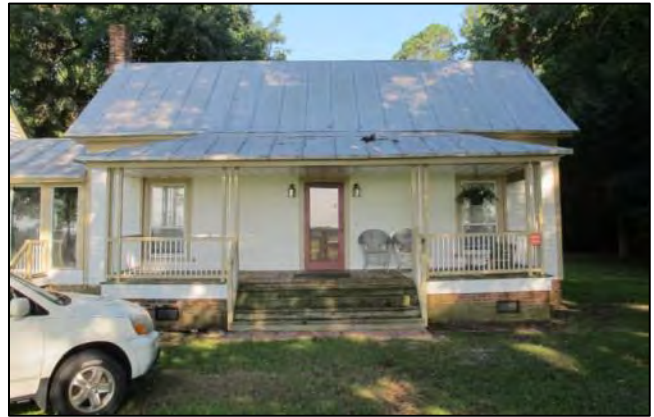
Figure 7: Noah Forbes, Sr. House in late 1980s (Power 1991:370), at left, and in 2016 (photographer: Jeroen van de Hurk), at right

Of the more numerous one-story, gable-end, frame houses built from the mid-nineteenth into the twentieth century, the smallest cohort date from the latter part of the nineteenth century. Two largely intact examples are the three-bay-wide Noah Forbes, Sr. House (PT0047) in the Greenville area and the Robert J. Lang, Jr. House (PT0457) near Fountain. The ca.1850 Forbes House, which retains modest Greek Revival-style details, was determined eligible for NRHP listing in 2016. The more vigorously Greek Revival-style Lang House, built ca.1870, was listed in the NRHP in 1990 (van den Hurk 2016; Black 1990) (Figure 7 and Figure 8).

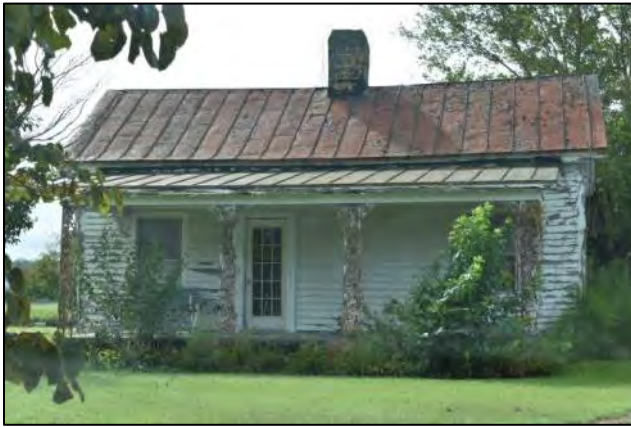
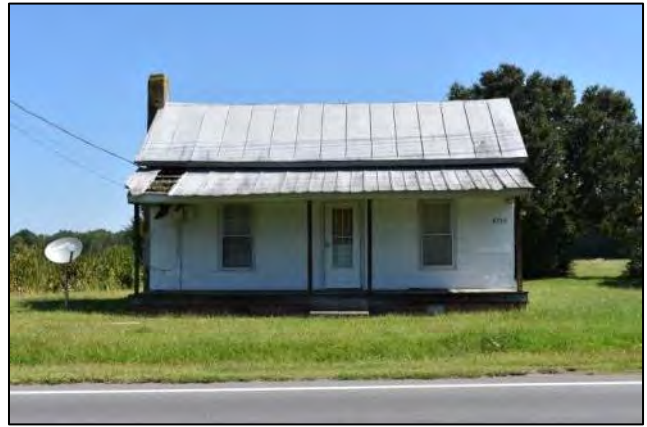
Figure 9: Left, Claudius Jackson House; right, house at 4715 NC 43 near Ayden

The ca. 1889 Claudius Jackson House (PT0136) within the APE near Littlefield, for example, is a straightforward representative of the form. Although its front bays have been altered, their asymmetric placement conforms with a late nineteenth-century date of construction. The symmetrically placed bays of the similarly fashioned house at 4715 NC 43 near Ayden suggest a slightly later construction date (Figure 9). These two houses are akin to four, no-longer-extant, late-nineteenth- or early-twentieth-century tenant houses erected on the edge of the Ichabod H. Little Farmstead (PT0018) near Bethel (Figure 10). While the NC 43 house may well have been a tenant house, the Claudius Jackson House was erected and lived in by its owners

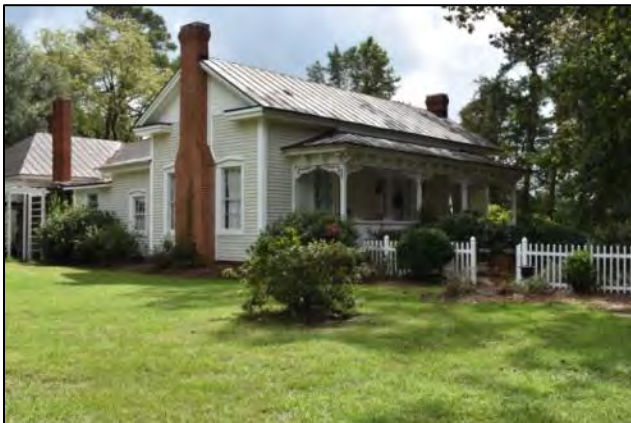
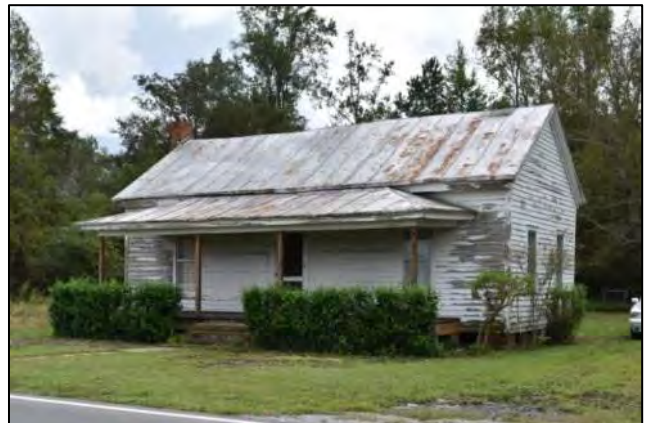
Figure 11: Left, Mumford-Jolly House; right, house at 1037 Forlines Road

The builders of the ca.1870 Mumford-Jolly House (PT0161) near Ayden added to the basic form of their home such Italianate-style ornament as pointed-arch surrounds, deep cornice returns, brackets, and floriated sawnwork. The turn-of-the-century house at 1037 Forlines Road (PT2763) near Winterville is unadorned (though what its original porch looked like is not known). The well-detailed and intact Mumford-Jolly House was placed on the North Carolina Study List in 1989. The plain Forlines Road house, which retains early weatherboards and sash, was determined not NRHP-eligible in 2014 (van den Hurk) (Figure 11).

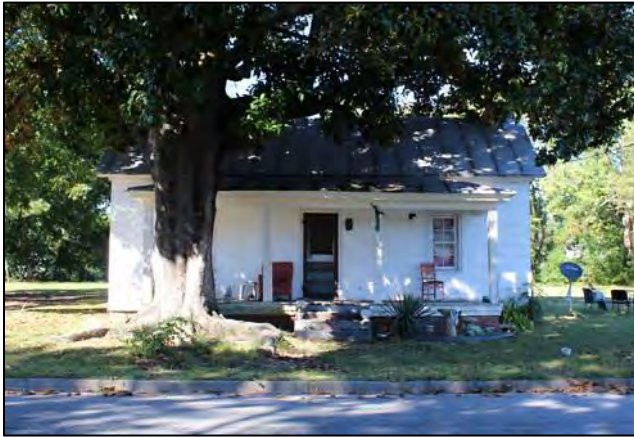
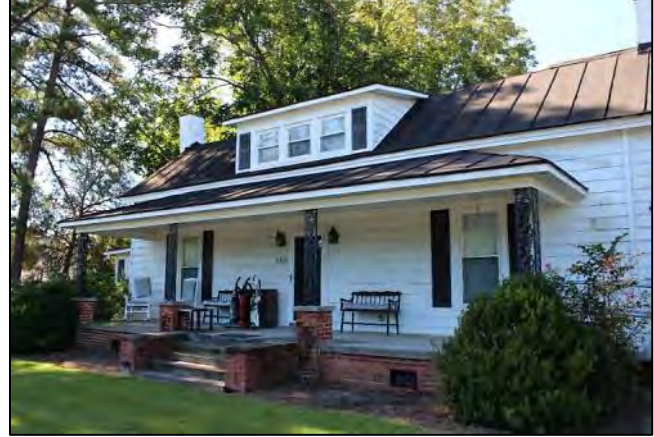
Figure 12: Left, House at 173 Main Street and, right, Edwards House (PT3321), Greenville (photographer of both: Megan Funk 2017)

The basic three-bay, frame, gable-end form continued into the twentieth century at such houses as 173 Main Street in Winterville, erected ca.1923, and the Edwards House (PT3321) on East 14th Street in Greenville, which dates from 1930. Both are commonplace examples of the form. The Edwards House, which includes a shallow front dormer, an altered front porch and siding, and extensions to either side, was determined not eligible for NRHP listing in 2017 (Funk) (Figure 12).

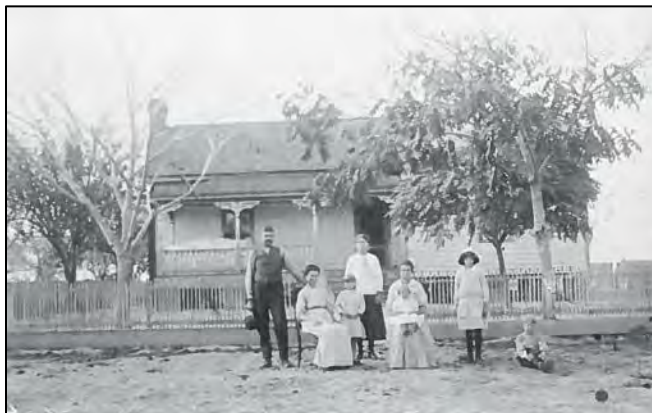
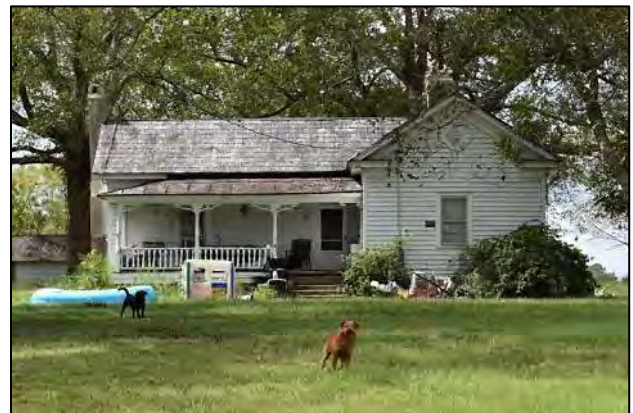
Figure 13: William Amos Shivers House in the early twentieth century (Power 1991:124), at left, and currently, at right

By the turn of the twentieth century, the form at many houses had been extended to the front, giving it an L-shaped footprint, and sometimes to the rear as well, creating a T- or stepped-back-shape. (These houses, as did the more straightforward ones discussed above, are generally extended to the rear by one-story, gable-end ells as well.) Power (1991:122-123) says of the form (Figure 13):

In contrast to the [ornately finished, two-story, no-longer-extant] Sumrell House is the William Amos Shivers House (c. 1900) [PT0377] located near the town of Winterville and built as a one-story, center-hall plan dwelling with a front ell. This example, more modest in its expression of ornament, is also more representative of the type. Plain turned balusters and delicate brackets distinguish the three-quarter front porch. An early-twentieth-century photograph shows the house much as it is today [ca.1991]; the exception is a replacement pressed-tin shingle roof. The original roof was wood shingle.

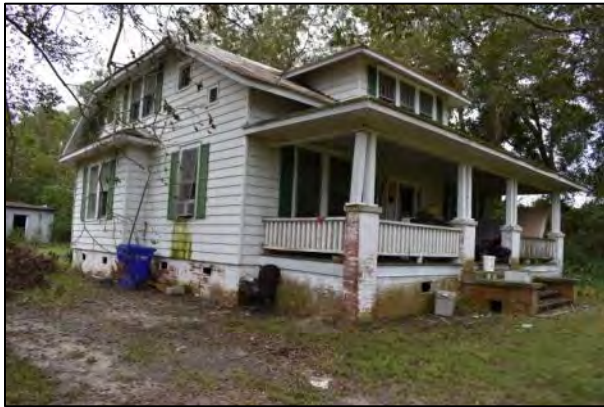
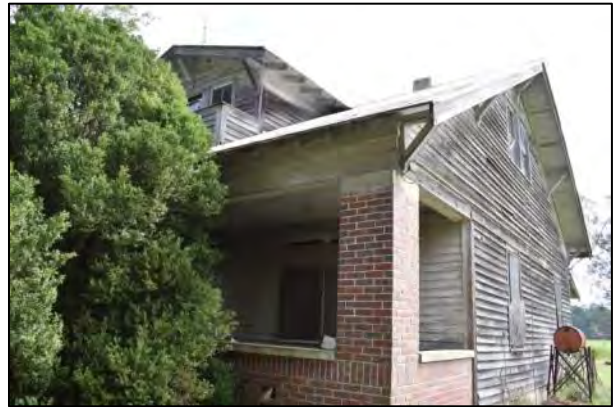
Figure 19: Left, Henry Garris Farm (PT0123); right, Marion Edward Hart House

While the one-story, gable-end form appears to be the most common at late-nineteenth- and early-twentieth-century houses within the APE and throughout rural Pitt and Lenoir counties, many houses stand one-and-a-half or two stories tall. Most of these are effectively taller versions of their one-story companions. The ca. 1923 house at the Henry Garris Farm (PT0127) at 242 East Littlefield Road (just to the east of the APE) is three bays wide and has gable ends, albeit clipped ones. A hipped-roof front dormer gives it an additional half story. Its multi-light-over-one sash windows and paired porch posts on tall brick piers are suggestive of the Craftsman style. The Marion Edward Hart House (PT2739) nearby within the APE (assessed below) makes use of the same form. It retains Craftsman-style triangular kneebraces, tall brick porch piers, and exposed rafter ends that were likely added within a few decades of its initial construction (Figure 19).

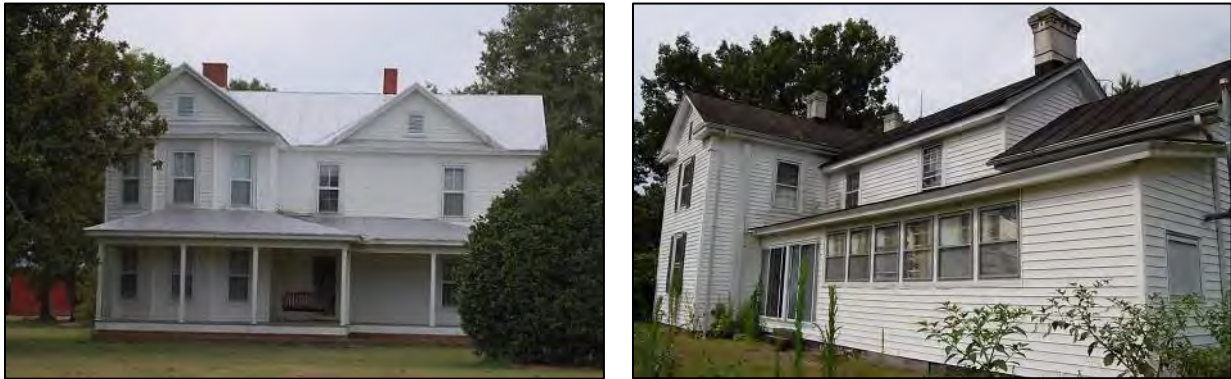
Figure 24: Left, William Parker Gilbert House (LR-0725); right, Tom Worthington House (LR-0721) (photographer: Marvin Brown 2017)

Many large, two-story, frame houses from the late-nineteenth and early-twentieth centuries still stand in rural Lenoir County (Brown and Potere 2017). Around 1910 William Parker Gilbert erected a farmhouse (LR0725) in the Hugo community that is similar to the Rountree-Smith House (Little et al. 1998:350). (The two houses stand about three miles apart.) Two stories tall with a T-shaped footprint and one-story rear ell, the Gilbert House features a two-story front bay, pedimented gables, and a long porch supported by delicate columns. A number of outbuildings continue to stand to its rear. The turn-of-the-century Tom Worthington House (LR0721) near Grifton is two stories tall with a two-story ell that gives it a T-plan footprint (Little et al. 1998:351). It retains cornice returns at its end gables, sidelights and a transom at its centered entry, six-over-six sash, and three heavily corbeled interior chimney stacks similar to those found at the Rountree-Smith House (Figure 24).

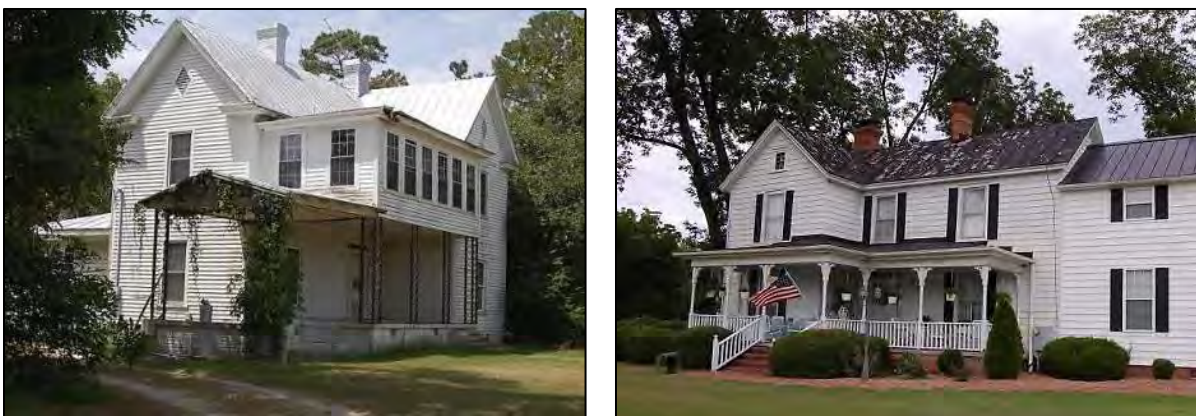
Figure 25: Left, H. William Davis House (LR1018); right, Joseph Williams House (LR1204) (photographer: Marvin Brown 2017)

Other similar large, two-story farmhouses in Lenoir County include the late-nineteenth-century H. William Davis House (LR1018) in the Strabane community and the mid-1910s Joseph Williams House (LR1204) in the Southwood community (Figure 25). Original features retained at the Davis House include a tripartite entry and door with round-headed panels, weatherboard siding, cornice returns, diamond-shaped ventilators, and corbeled brick chimney stacks. A second-story sunroom, placed atop the front porch, is original or an early addition. The Williams House (Little et al. 1998:418) retains a Victorian porch with turned posts and jigsaw brackets, along with heavily corbeled chimney stacks similar in form and placement to those at the Rountree-Smith House.

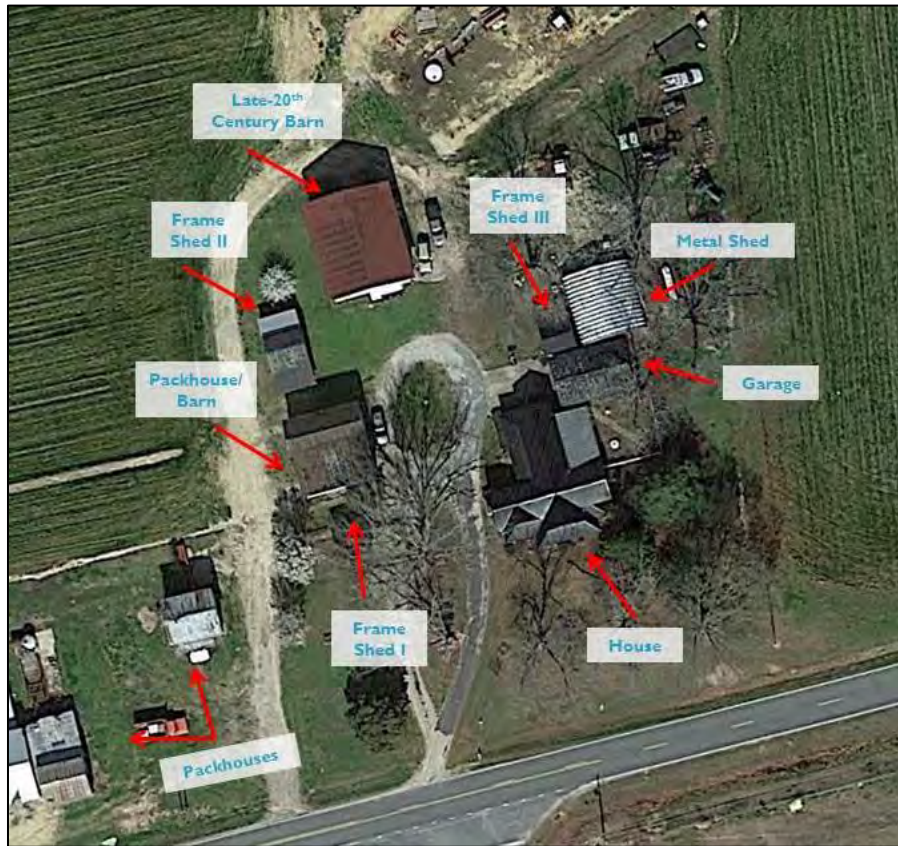
Figure 26: Site plan

The Jesse Franklin Hart House sits on the southern edge of a 34.59-acre agricultural parcel, approximately two miles south of the town of Ayden. At the north and east, the parcel is bounded by farmland. It is bounded to the west by NC 11 and to the south by Littlefield Road. Save for the resources along Littlefield Road, and a small wooded patch found in the northeast corner of the lot, the parcel largely comprises active agricultural fields.

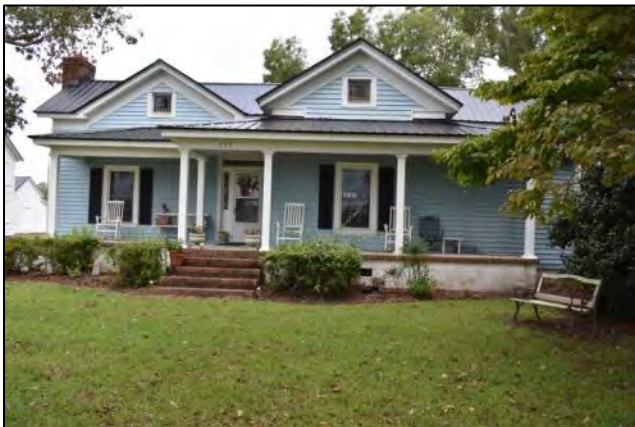
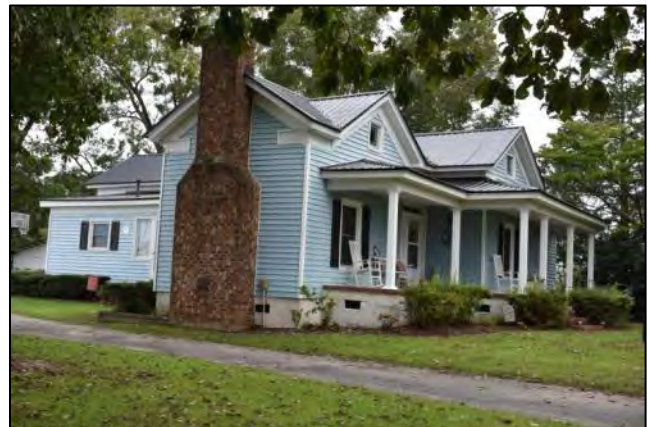
The one-story, frame, J.F. Hart House is comprised of a single-pile, four-bay, front block with a long, centrally placed, enclosed rear-ell. Although simple in finish, the residence presents a multi-gable, stepped-back façade, with two façade gables (Figure 27). The house rests on a continuous brick foundation that has been covered with modern stucco. Replacement seam-metal roofing covers the building's multiple gabled roofs, which retain their wide cornice returns. Vinyl siding covers the entire house, replacing original weatherboards.

Figure 27: Left, front (southern) elevation; right, view of southwestern corner

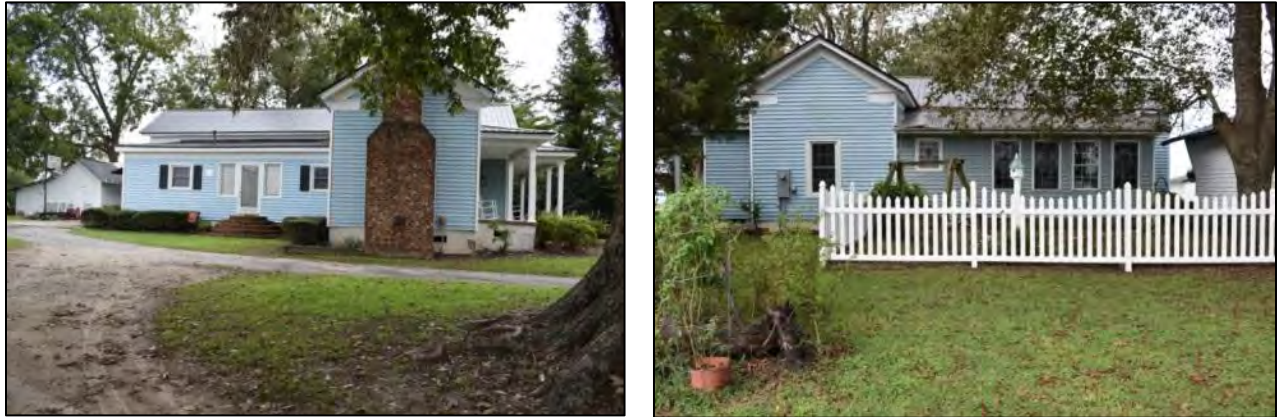
A modern, exterior-end, shouldered chimney rises on the building's western gable end. A four-bay porch, which embraces the house's front elevation and mirrors its stepped-back design, appears to have replaced the original porch. Six square, vinyl columns support a replacement cornice and hipped-roof with deep eaves, at the porch, that is capped with the same replacement seamed metal as the rest of the house's roofs. New brick stairs lead up to the porch. Porches that once flanked the long elevations of the rear ell are now fully enclosed (Figure 28)

Figure 28: Left, western elevation; right; eastern elevation

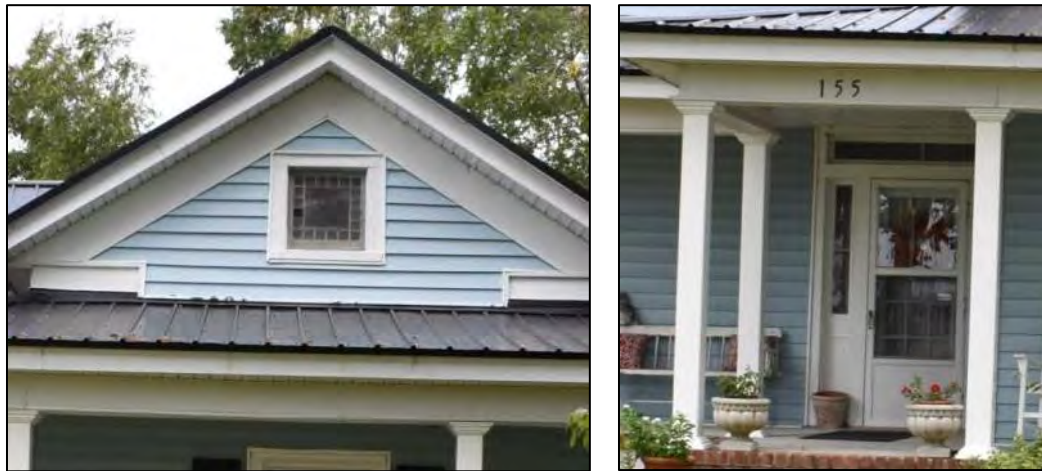
Replacement windows and surrounds are found on all elevations of the house. Two early windows mark both of the building's front gable peaks and are comprised of a large, colored, square light surrounded by a border of smaller, colored, square lights. The building's primary entrance, placed off-center on the front elevation, holds a replacement, multi-light door. The door is flanked on either side by what appear to be original sidelights, composed of rectangular wooden panels topped by rectangular one-over-one lights. A simple two-light transom tops the door (Figure 29).

Figure 29: Left, detail of gable window; right, detail of front door

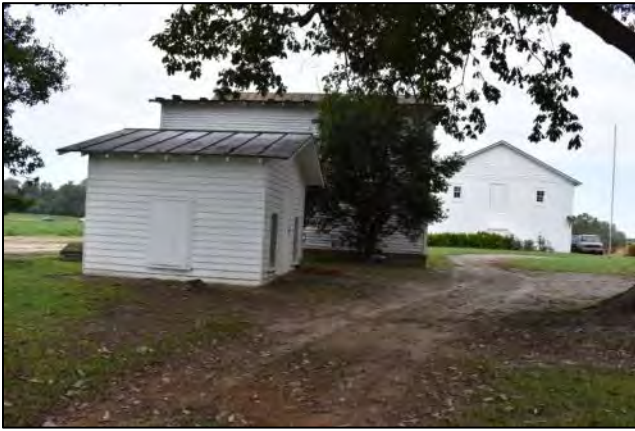
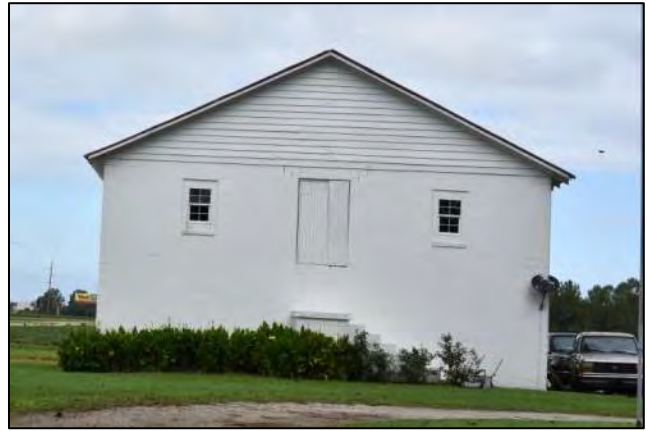
Figure 30: Left, shed I in foreground; right, late-twentieth-century barn/packhouse

Frame Shed I (Figure 30, left, and Figure 31)

This small frame shed stands to the west of the house, just south of the packhouse/barn, and likely dates from the early twentieth century. The side-gabled building is clad in weatherboards and topped

with a standing-seam-metal roof and exposed rafter tails. A boarded-over opening marks the building's southern elevation. A door and two windows open at its eastern gable end, facing the house.

Late-20th-Century Barn/Packhouse (Figure 30, right)

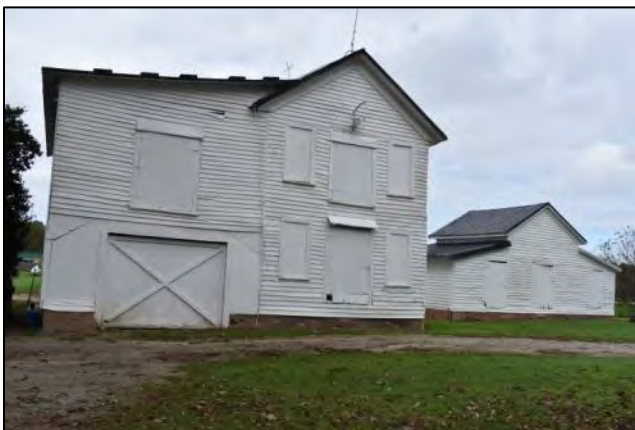
Figure 31: Left, east elevations of packhouse/barn and shed II; right, west elevations of (left to right) shed II, packhouse/barn, and shed I

The early-twentieth-century packhouse/barn is located to the west of the house and is oriented to the east. The main body of the frame, gabled building has a traditional packhouse form with large doors for loading cured tobacco set above each other at its front gable. A two-story, shed-roofed, frame addition extends off its southern side. Its large openings, front and rear, suggest it too held tobacco or, perhaps, hay. The addition appears to be early and, like the packhouse block, is clad in weatherboards. A large, single-bay doorway at the first floor of the addition would have opened for equipment storage.

Frame Shed II (Figure 31)

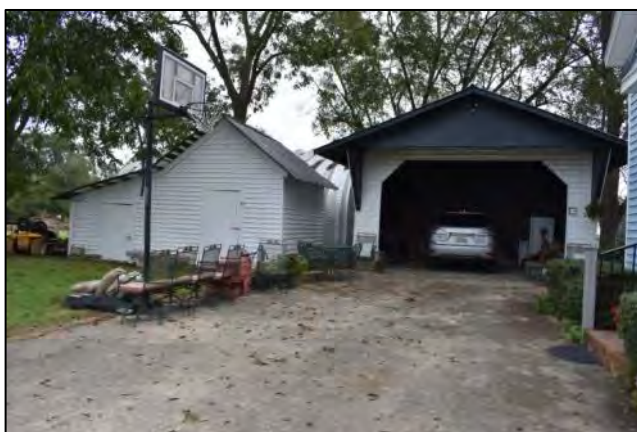
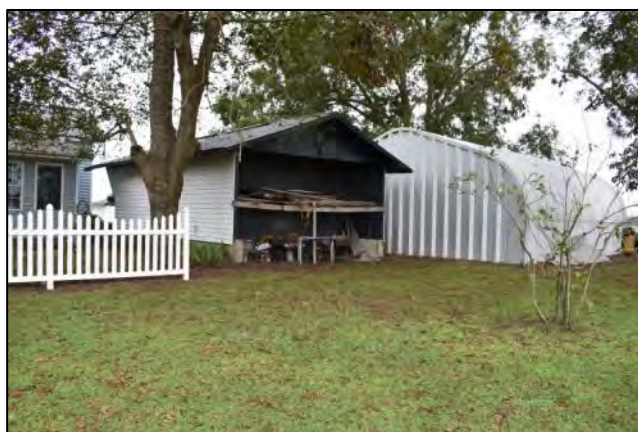
Figure 32: Left, frame shed III and single-bay garage; right, view of garage rear (eastern) elevation and modern metal shed

Another early-twentieth century frame shed stands to the northeast of the house. The front-gabled building is oriented to the west and stands on brick piers. An enclosed frame, shed-roof addition extends off the shed's northern elevation. Both the original shed and its addition are clad in weatherboards and topped with metal sheathing.

The frame garage stands near the northeast corner of the house. The front-gabled building has a double-wide bay to accommodate two vehicles. The late-twentieth century garage is clad in vinyl siding and rests on a continuous concrete foundation.

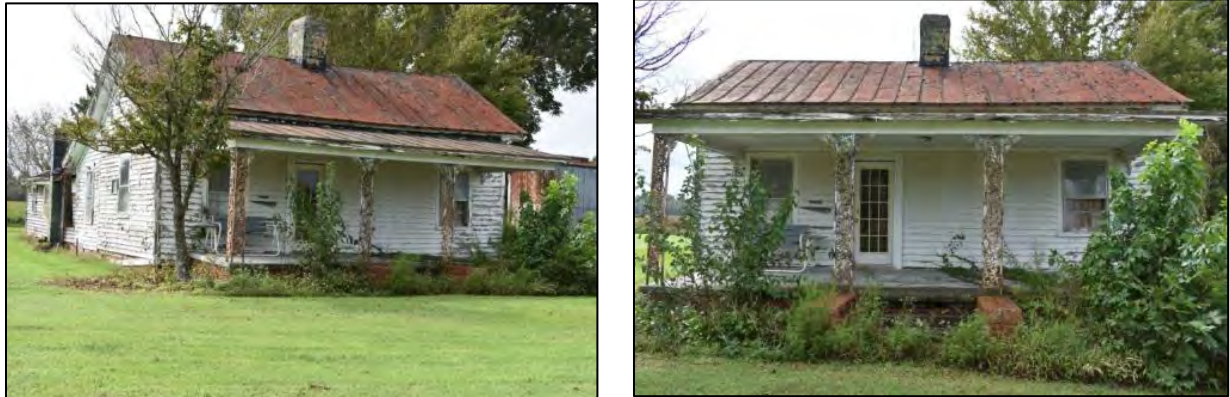
A centrally placed, interior, brick chimney rises from ridgeline of the house's side-gabled roof, which is topped with seamed metal. The chimney placement suggests a two-room interior plan. The roof has wide overhanging eaves and a flush returning friezeboard. Six-over-six double-hung windows remain at the building's original sections. The front door is modern. The rear-ell shed additions retain original two-over-two sash windows. An exterior concrete-block flue stack edges the east side of the rear ell.

Figure 33: Left, north front and east side elevations; right, front elevation

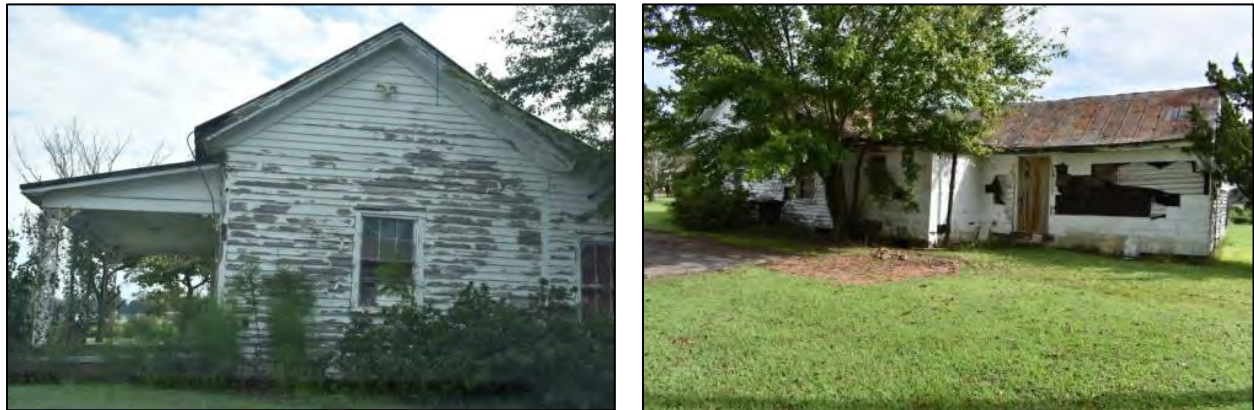
Figure 34: Left, west side elevation; right, east side and south rear elevations

The one-story, single-pile, gable-end, frame Claudius Jackson House is clad in weatherboard siding and edged with simple wooden cornerboards (Figure 33 through Figure 35). Three bays wide, the north-facing front elevation holds an off-centered door and two windows. A 1987 survey by Scott Power notes that a second door once existed on the front elevation but was later filled in. A semi-detached rear kitchen ell was attached to the house by the enclosure of its breezeway, according to Power (1987a). Early-twentieth-century, single-pile, shed-roofed additions extend from both the eastern and western sides of the rear ell. The ell is partly covered in asphalt shingles that are peeling away from its original weatherboards. The building stands on a brick pier foundation, which was later filled in with brick. A three-bay, shed-roofed porch supported by four later-added, metal posts embraces the building's front elevation.

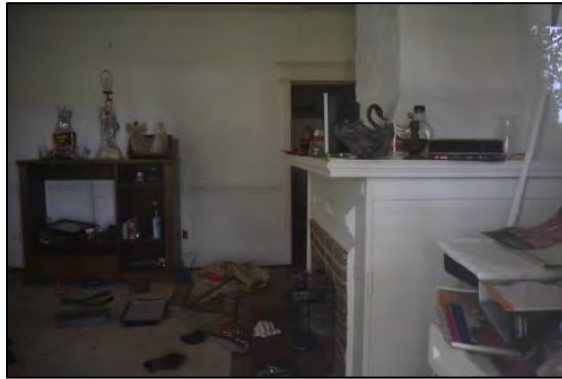
Figure 36: View through front door of house into front room (looking to south)

Views to the building's interior, as seen through the front door, reveal slightly more decorative finishes than suggested by the building's exterior. The large central firebox is enclosed with flushboard and fronted by a carved wooden mantle. A molded chair rail runs the perimeter of the front room, and simple beaded baseboards edge both the wall's tops and bottoms. A classically styled entablature complete with a molded cornice and frieze with raised panel tops a doorway on the far wall, which leads to the enclosed breezeway (Figure 36). With the exception of deferred maintenance, the house appears little changed since it was surveyed in 1987.

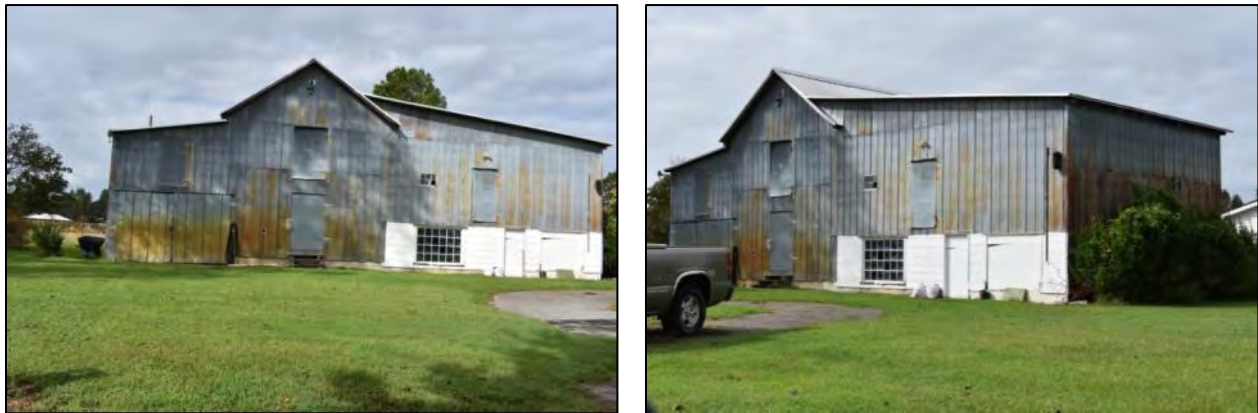
The early/mid-twentieth-century packhouse/barn stands to the west of the Claudius Jackson House and is oriented to the east. The central block of the building displays the typical packhouse design, with two doors centered on its primary elevation. A large, double-pile, shed-roof addition extends from the building's northern elevation. A smaller two-story shed-roof addition extends to the south. Both the main block and the two additions rest on continuous concrete-block foundations and are clad in metal sheathing (the bottom portion of the northern addition is faced in asbestos siding). The size of the building, and barn doors at the left, suggest it was used not only as a packhouse, but also for equipment storage and, perhaps, other agricultural activities. The large size of the fixed-window on the right (framed by the asbestos shingles) suggests that this lower portion of the building may have been utilized as a strip-house.

Figure 37: Packhouse/barn east elevation, at left, and east and north elevations, at right

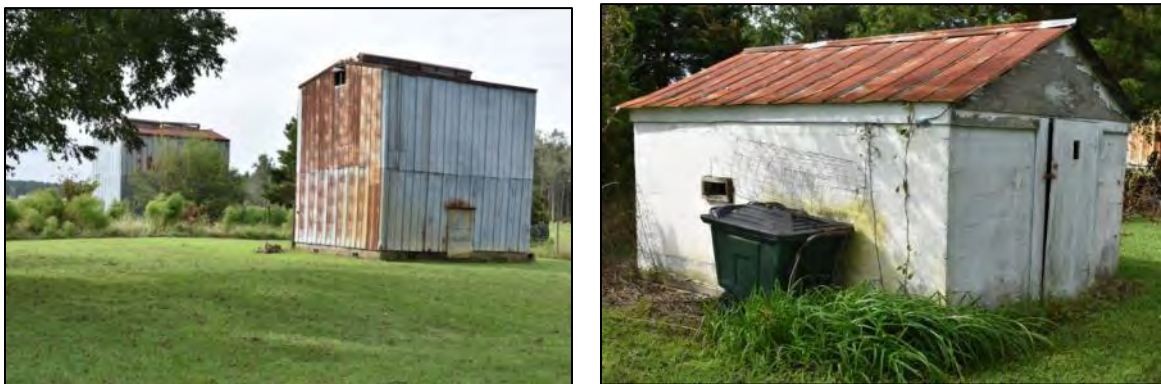
Located to the south of the packhouse are two tobacco barns. Both are clad in metal sheathing and retain their original form with first floor openings on their eastern elevations. File photos from 1987 depict a long, open, equipment shed connecting them. It is no longer extant.

Figure 38: Looking southwest at tobacco barns, at left, and outbuilding, at right

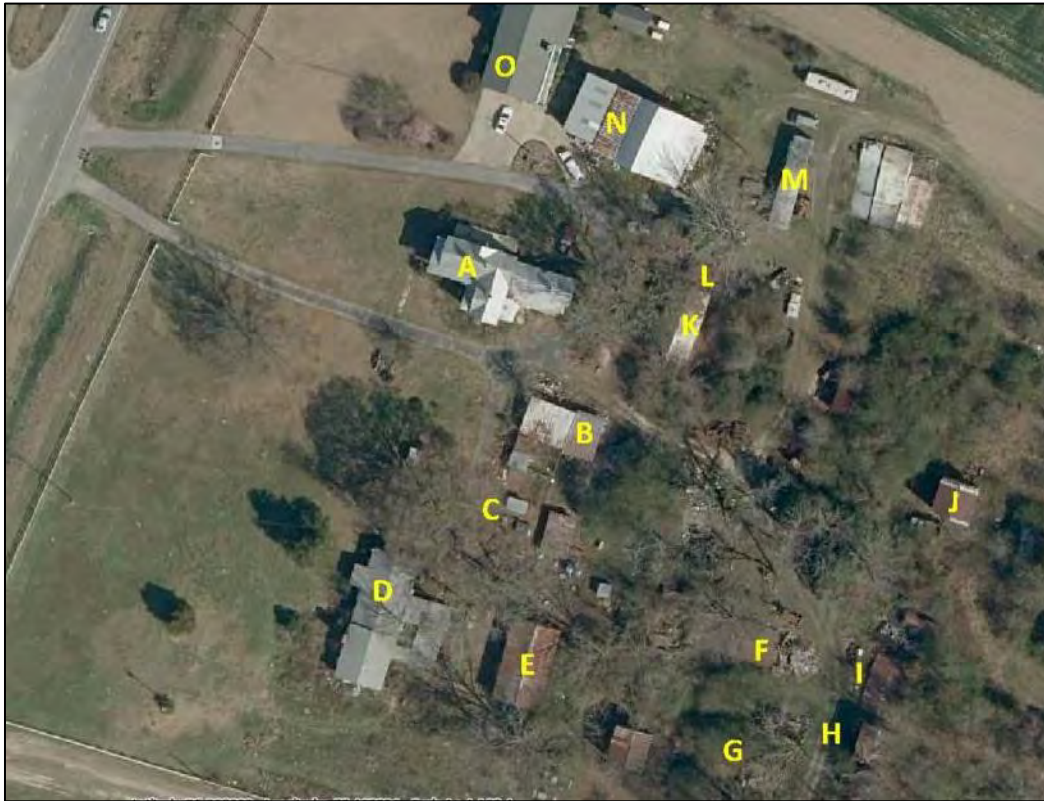
Figure 40: Site plan of Rountree-Smith House with north at top and NC 11 visible to west, at upper left

Numerous outbuildings, remnants of a thriving late-nineteenth and twentieth-century tobacco operation, are scattered about the Rountree-Smith parcel. While aerial imagery of the property reveals the farm once contained over two dozen outbuildings, only a small percentage remain extant and were accessible for evaluation at the time of the survey. (Some of the buildings are heavily overgrown.) These secondary structures include an early/mid-twentieth-century equipment shed, a chicken house, a tobacco barn, a brick smokehouse, and a barn; an early-twenty-first-century mausoleum; a 1950s house and garage; and a modern mobile home (Figure 40).

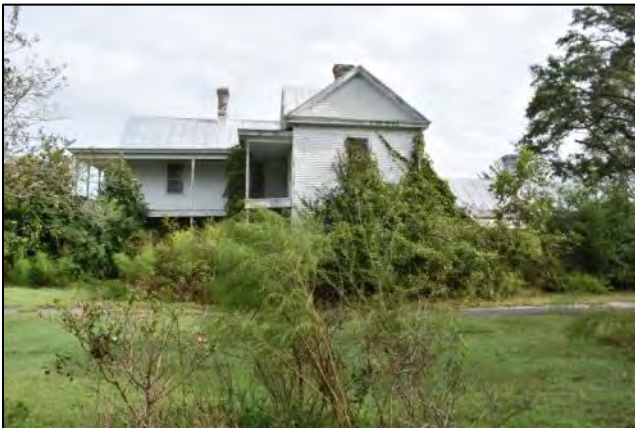
Figure 41: Left, south elevation; right, south and west elevations

The frame Rountree-Smith House is a two-story, L-plan residence (Figure 41). It was originally oriented to the north, but its west façade fronts on NC 11, the path of which postdates the farmstead. An original, single-story, formerly detached kitchen is attached to the building’s eastern gable end by an enclosed breezeway (Figure 42). Vinyl siding covers all sections of the house, although original weatherboards are visible underneath where the synthetic material has fallen away. Pedimented gables sit atop the house’s cross-gable roof, which is topped with standing-seam metal.

Since 1993, the house has deteriorated significantly as a result of deferred maintenance and accompanying decay. Jones noted that the interior of the building had undergone numerous remodels and that by 1993 retained only two original mantels and its original main stair with newel post and rail. Interior access at the time of the current survey was not possible due to the building’s heavy deterioration.

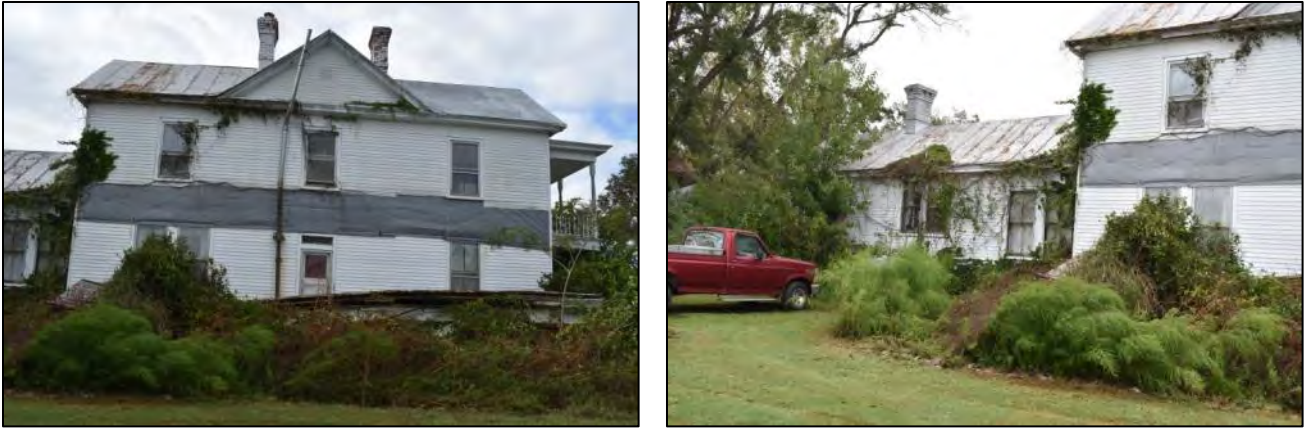
Two interior brick chimneys centrally placed on the north-facing block’s ridgeline are topped with corbelled caps. Two more chimneys of the same style rise from the building’s roof, one from the center ridgeline of the south block and one from the center ridgeline of the kitchen ell (Figure 42).

Figure 42: Left, north elevation with porch fallen away; right, north elevation detail with kitchen ell to rear— windows at center of image mark location of once-open breezeway

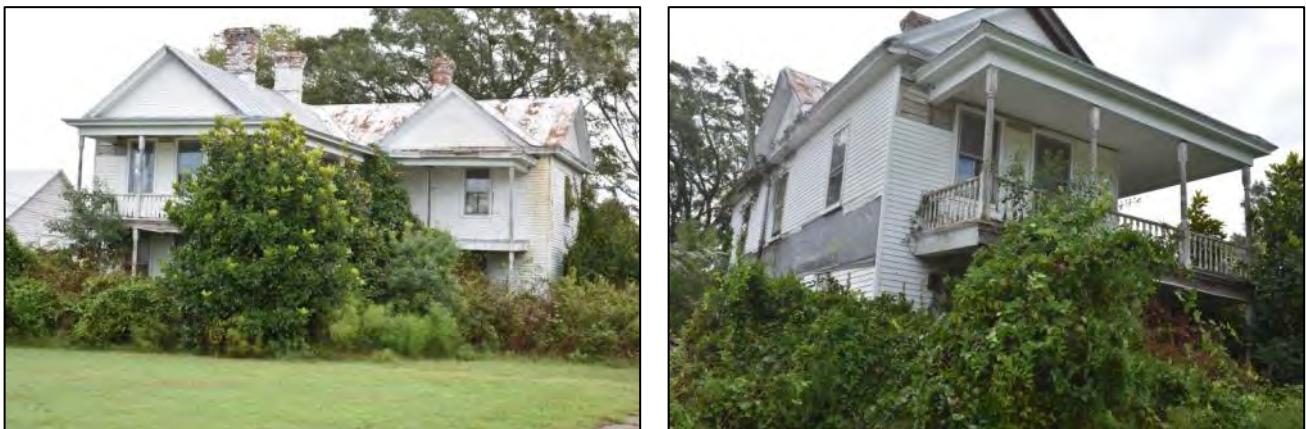
A two-story porch wraps around the house’s west and south elevations, facing NC 11. A pedimented gable tops the porch where it meets the rear ell, as seen at Figure 43, left. The porch’s low sloped roof is supported by original turned wooden posts, which are connected by original turned balustrades (Figure 43). Vinyl replaces both the porch’s original unadorned cornice and flushboard ceiling. At the time of Robbie Jones’ 1993 survey of the house, a second porch, one-story tall, crossed the house’s north elevation. It fell sometime after 2016, according to aerial photographs (Figure 42, left). Many original two-over-two, double-hung, sash windows fill the house’s bays, enframed by replacement vinyl surrounds. A mid-twentieth-century paneled door centrally placed on the north elevation retains a single-light transom.

Figure 43: Left, west and south elevations; right, west and north elevations

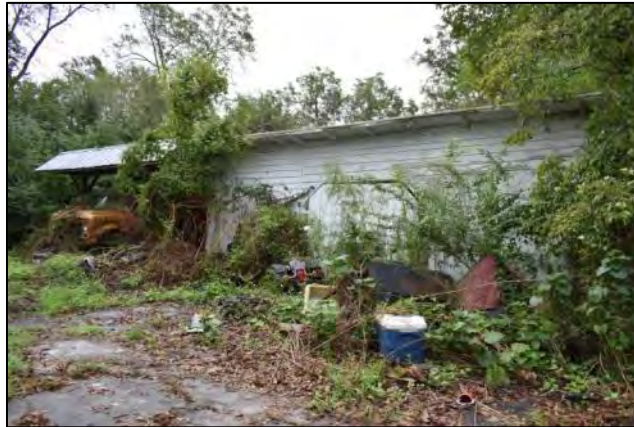
Figure 44: Equipment shed/garage

According to Jones (1993), this linear, frame, shed-roofed building was built in the 1930s as a garage. Standing southeast of the house, it is clad in weatherboards and features multiple large bays on its northern elevation to allow for the storage of cars or farm equipment. An open, pole-supported structure, also used for equipment storage, was later appended to its southeast side.

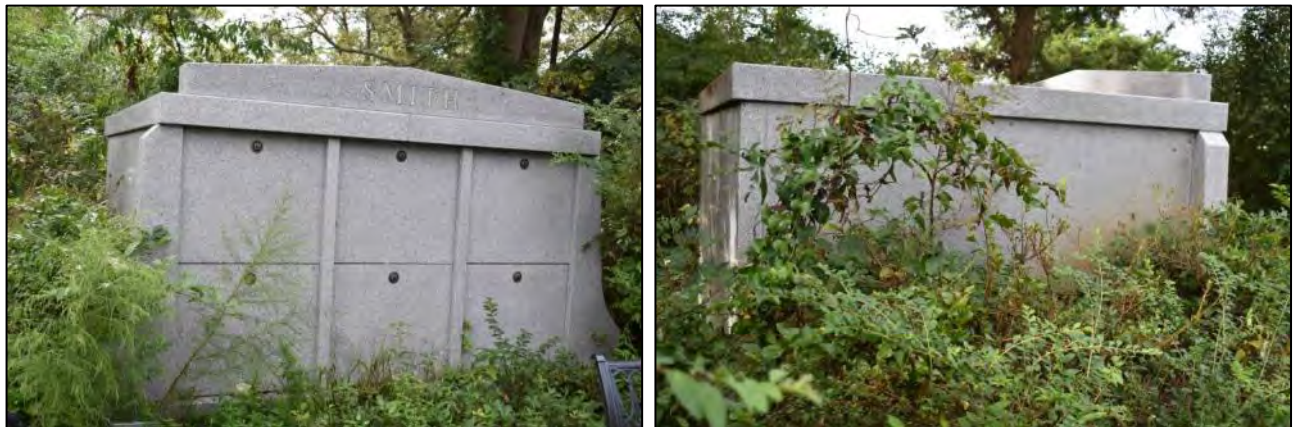
Figure 45: Left, Smith Mausoleum west front elevation of Smith Mausoleum; right, south side elevation

The Smith Mausoleum, which stands to the south of the equipment shed/garage, is a six-drawer crypt built solidly of granite. It is unadorned save for the surname “Smith” engraved on a stone pediment crossing its front, which faces west toward NC 11. No inscriptions have been carved into, nor plaques placed upon, any of its drawers. A small, temporary, metal marker placed in the ground at its base by Farmer Funeral Service of Ayden identifies “Wilson H. Smith 1918-2000” as resting within. The date of Smith’s death and the singular marker suggests that he is the only individual interred in the mausoleum and that it was built at his behest. It was not in place in 1993.

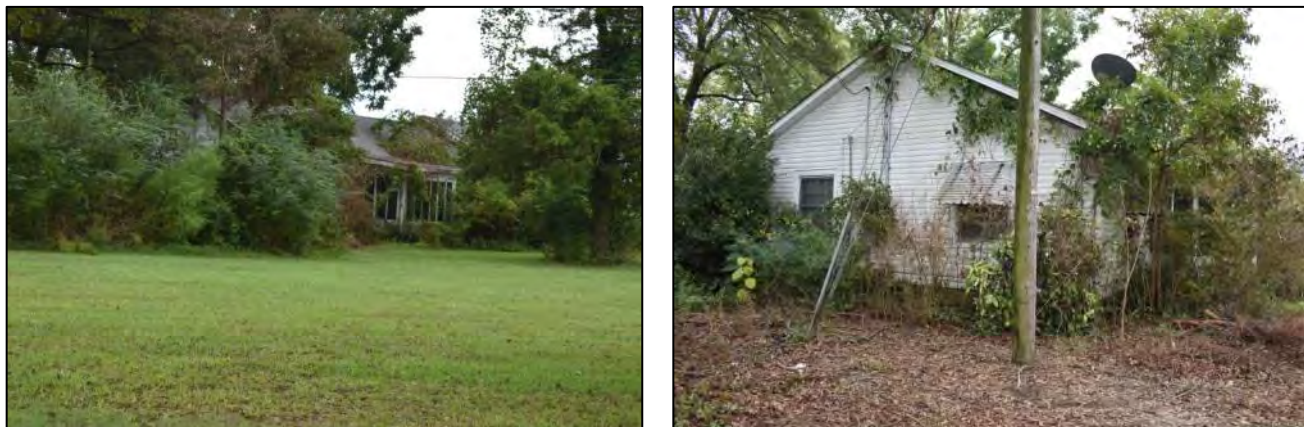
Figure 46: Left, view of house looking to southeast; right, northern elevation

Jones identified this vacant, one-story, side-gabled, frame house as dating to the 1950s. The building is clad in vinyl and the two windows on its northern gable end are snap-in sash. The house is located to the south of the Rountree-Smith House and is heavily covered by vegetative matter making it difficult to discern any other architectural features.

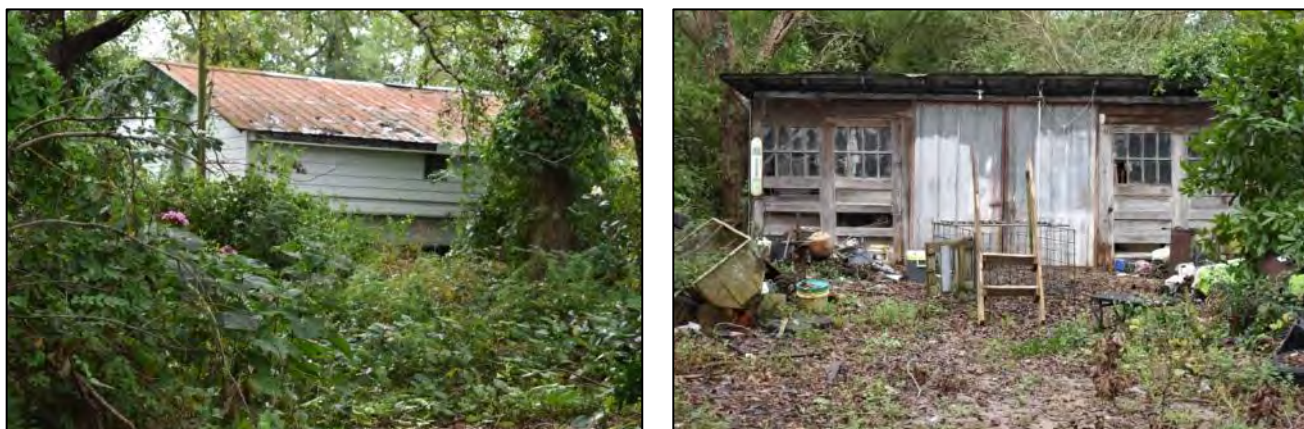
Figure 47: Left, garage; right, chicken coop

The frame, side-gabled garage sits to the east of the 1950s house and is likely its contemporary. The building is oriented to the east, clad in vinyl siding, and topped with metal sheathing.

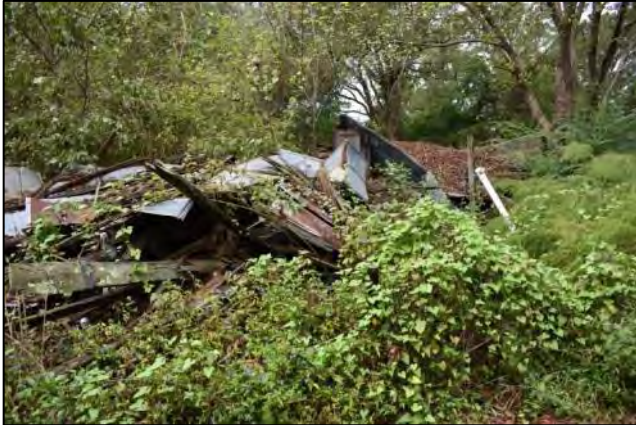
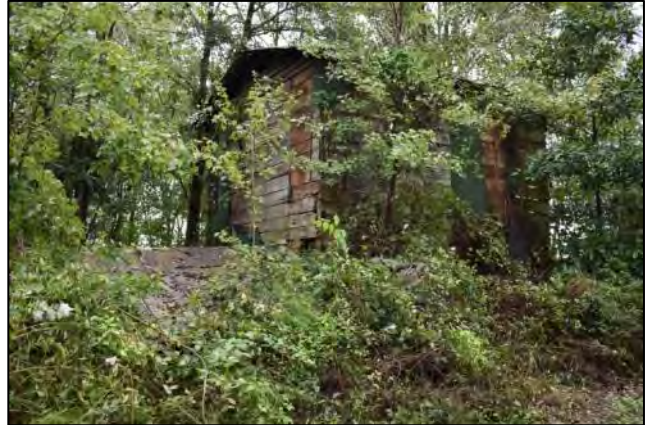
Figure 48: Left, collapsed outbuilding; right, tobacco barn

At its height of agricultural success in the mid-twentieth century, the Rountree-Smith House was supported by well over two dozen secondary structures. In recent years many of these buildings have suffered from neglect and have collapsed as result. Figure 48 depicts one of the many collapsed buildings near the eastern bounds of the farm complex. Its original use could not be determined

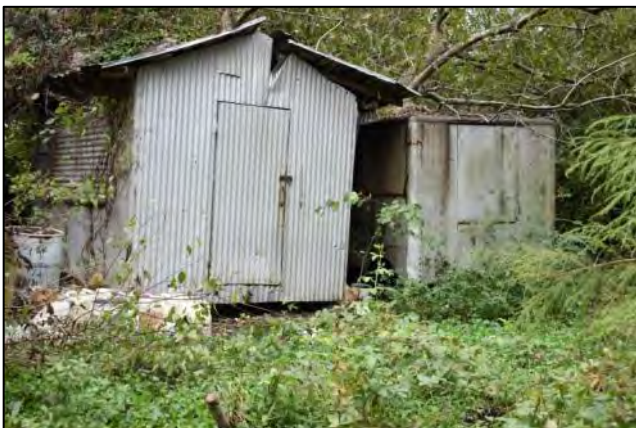
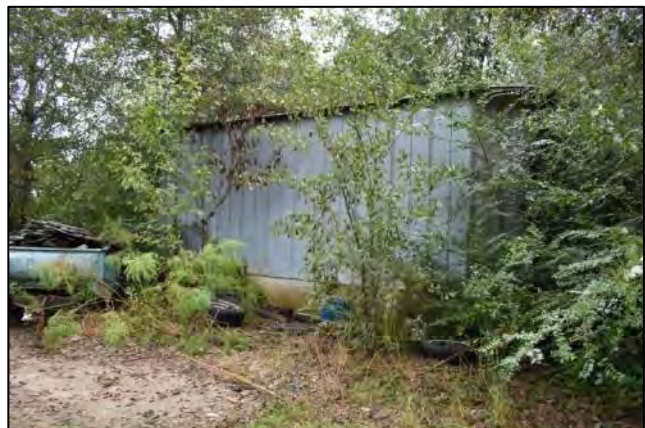
A grouping of mid-twentieth-century sheds (in various states of decay) stand in a line to the north of the tobacco barn. The front-gabled buildings are clad in metal sheathing and capped with metal roofs.

Figure 49: Left, sheds; right, shed
