SUBJECT: Historic Structures Survey Report, Upgrade NC 11 to Interstate Standards from Proposed Greenville SW Bypass to Proposed Harvey Parkway Extension, R-5815, Lenoir and Pitt Counties, ER 19-0079

The report considers six resources – the Jesse Franklin Hart House (PT2737), the Claudius Jackson House (PT0136), the Rountree-Smith House (LR0717), the Robert Francis Hart House (PT2738), the Marion Edward Hart House (PT2739), and the Martha Deal House (PT0135). All six resources are recommended as not eligible for listing in the National Register of Historic Places. Initial screening of the project area by NCDOT Historic Architecture identified which resources warranted additional study. Lenoir County Bridge Numbers 76 and 77 are not eligible for the National Register.

AECOM prepared this report in September and October 2018. As a result of its analyses, AECOM recommends none of the evaluated resources merit NRHP eligibility. The following table identifies the resources requiring evaluation and summarizes the recommendations regarding their eligibility.

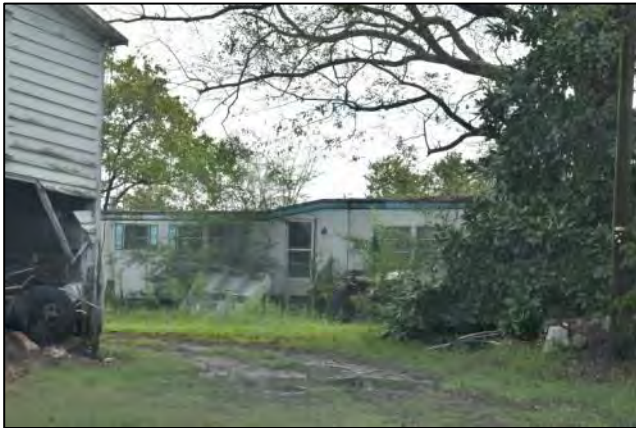
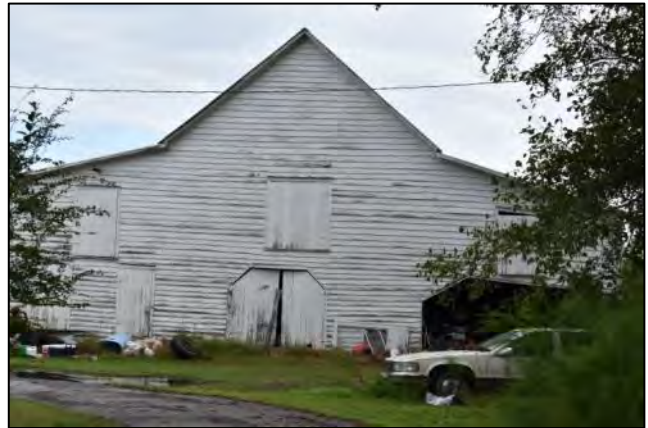
This late-twentieth-century mobile home sits to the northeast of the Rountree-Smith House and is oriented to west. A broken low-sloped roof tops the building, which appears to be clad in vinyl. A door is off-centered on the building's primary elevation and is flanked on either side by a set of fixed, three-light, paired windows. The building is uninhabited and heavily overgrown.

This early/mid-twentieth-century, frame barn stands west of the modern mobile home and north of the Rountree-Smith House. The front-gabled building is composed of a central two-story block flanked on either side by one-story, shed-roofed blocks. A large centrally placed bay is found on both the first

floor of the central block and the eastern shed roof block. Smaller doors are found on the second floor of each of the three blocks and two on the first floor of the western block, suggesting the barn's original use for hay and other crop storage. The building is clad in weatherboards and topped with metal sheathing. A late-twentieth-century, shed-roof addition clad in vinyl extends off the building's western end.

Figure 51: Left, modern trailer; right, barn

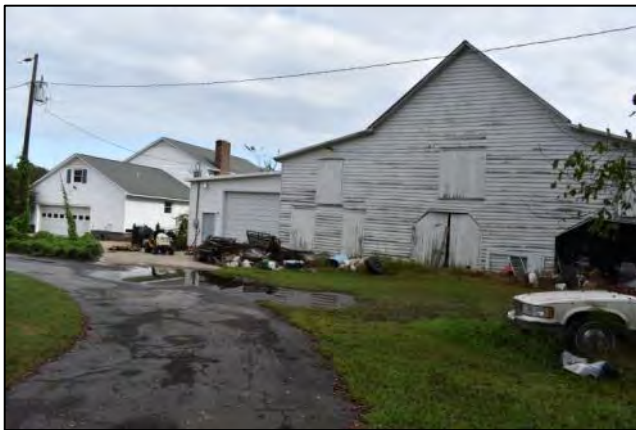
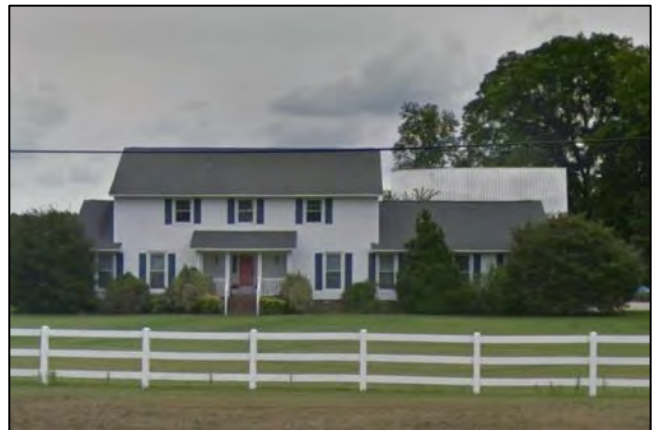
Figure 52: Left, barn with modern house in background; right, view of modern house from NC 11

This late-twentieth-century house, referred to as the “modern” house by Jones (1993), stands to the direct north of the Rountree-Smith House on a separate parcel, which historically belonged to the Rountree-Smith property. According to Lenoir County tax records, the frame, two-story, three-bay house was built in 1981.

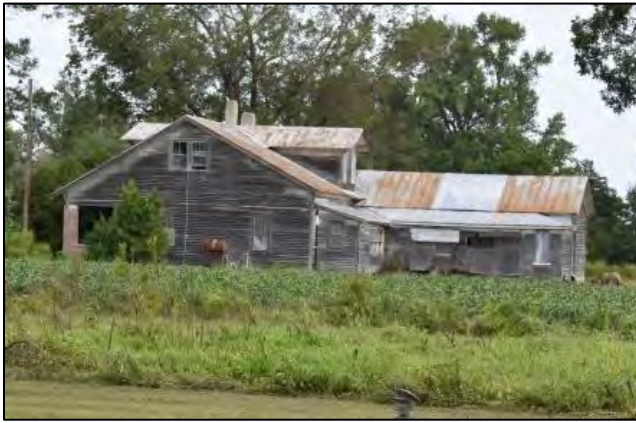
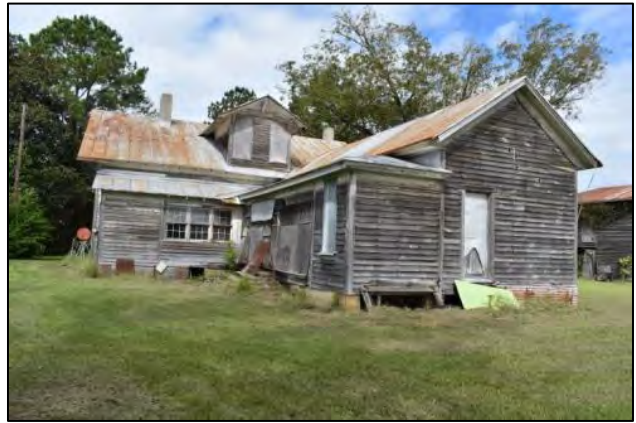
The Robert Francis Hart House is a one-and-a-half story, frame, Craftsman-style house likely built ca. 1908. It has a three-bay-wide, two-pile-deep, front block with an early long, one-story, rear-ell extending from its northeastern corner. The ell’s original shed-roof porch has been enclosed, and a small, one-pile, shed-roof addition extends from the ell’s south elevation. The latter addition appears to be early and may have originally been an open porch (Figure 54). The house is clad in weatherboards and edged with wooden cornerboards. It rests on a brick-piered foundation that was later filled in with concrete block.

Figure 54: Left, view of south side elevation; right, view of east rear elevation

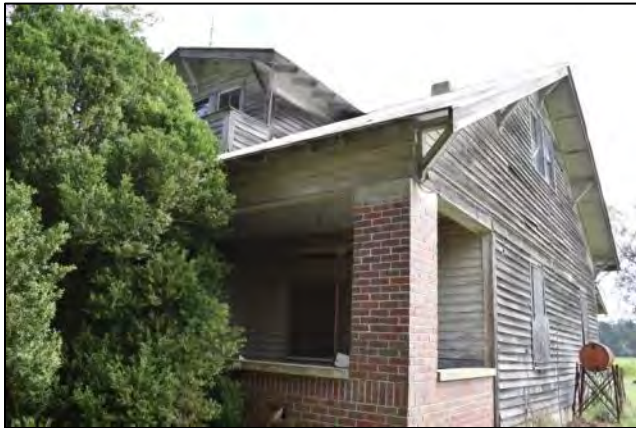
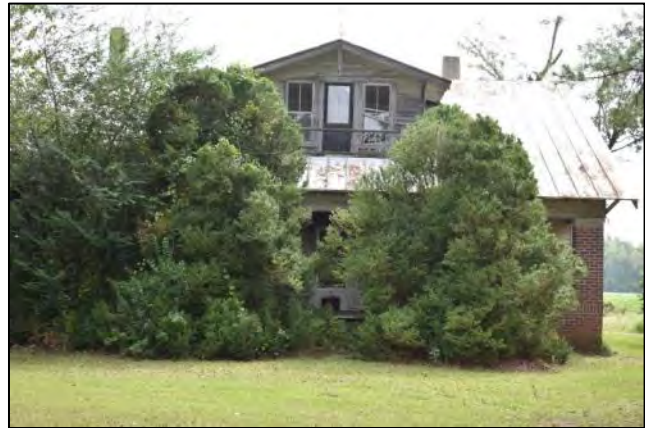
A low-pitched, side-gabled roof capped with standing-seam-metal tops the house. Craftsman-style triangular knee braces and exposed rafter ends adorn the roof's overhanging eaves (Figure 55). Front-gabled dormers are centered on the building's front and rear elevations and are also ornamented with triangular knee braces. The front dormer additionally features a small balcony surrounded by a rail with turned balusters. A centrally placed replacement door provides access to the balcony and is flanked on either side by original two-over-one sash in disrepair. The rear dormer, as seen in Figure 54, is smaller in size and originally featured two window openings which have since been covered. Two stuccoed interior chimneys project from main block of the house—one on the western slope and one on the eastern slope. Both are centrally placed between the dormers and the roof's end on their respective sides. No evidence exists of a chimney on the building's rear-ell.

Figure 55: Left, west front and south side elevations; right, west front elevation

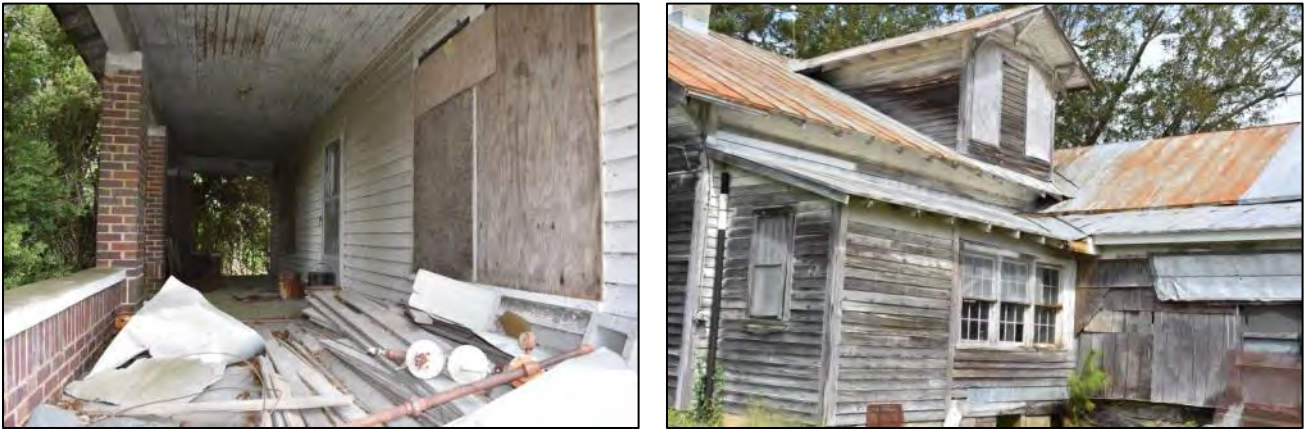
An engaged, recessed, front porch crosses the house's front (western) elevation. It is supported by four brick columns which are connected by a low brick balustrade (Figure 56, left). The ceiling of the porch is covered by flushboards. The building's primary entrance is centrally placed and flanked on either side by original three-over-one sash. This window type is found in all first floor bays of the house that have not been boarded up, with the exception of three six-over-six double-hung sash found on the eastern elevation of the house's rear shed-roof addition (Figure 56, right). Interior access was not available. The house has been sealed and vacant for a number of years.

Figure 56: Interior view of porch, looking north; right, view of southern elevation

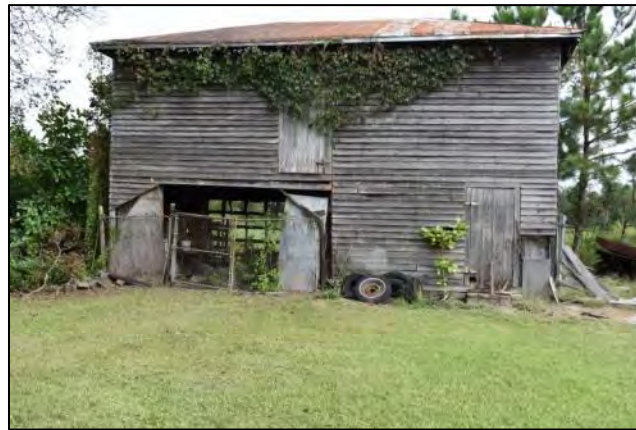
Located to the northeast of the house is a two-story, frame building clad in weatherboards and topped with a pyramidal roof. It is the house’s only surviving outbuilding. The building is oriented south toward the house and features a large, two-bay opening on the left side of its front elevation that once held farm equipment. Doorways filled with simple wood-batten doors are found on the southern and eastern elevations, and a door of the same style is centered on the second floor of the building’s primary elevation. This suggests an original use as a packhouse or for other crop storage, although this could not be confirmed as the building was not safe to access for further investigation.

Figure 57: Frame garage

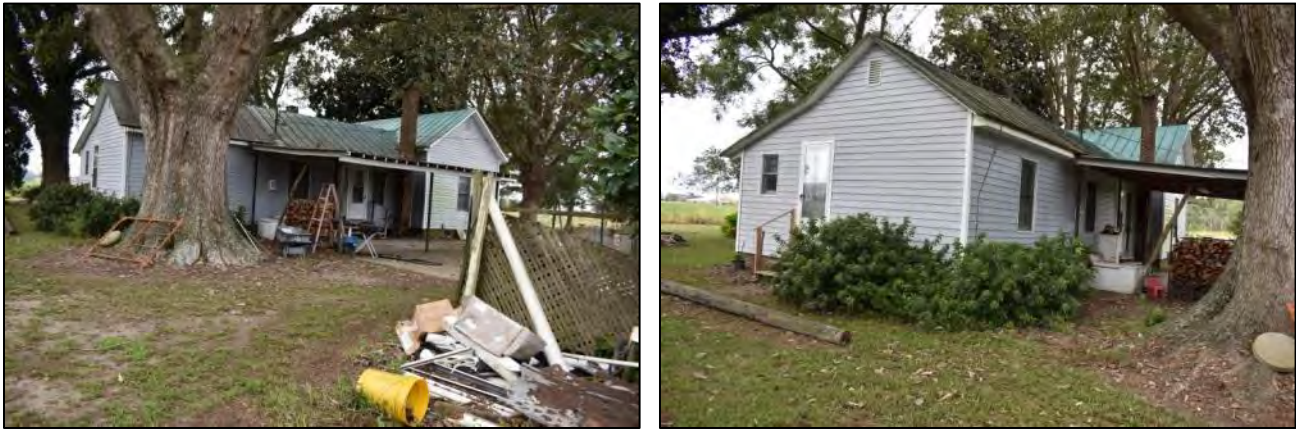
Figure 59: Left, north side elevation; right, east rear and north side elevations

The central block of the Hart House stands one story tall, three bays wide, and one pile deep. The frame residence rests on a continuous brick foundation and features an original, rear, single-story kitchen ell, which has been attached to the building's northeastern corner through the enclosure of an original breezeway. The east rear and south elevations of the house are wrapped by a later-added shed-roofed porch. A façade gable rises at the rear elevation behind the porch, where the front block extends a room to the rear. A shed-roofed addition on the ell's south elevation was likely originally an open porch (Figure 59 and Figure 60).

Modern vinyl siding covers all of the building's elevations and its corners are edged with replacement vinyl cornerboards. The building's gabled roof is capped with metal sheathing. A simple, single-stack, brick chimney rises from the ridgeline of the rear ell where the appendage meets the center block. A second brick chimney of a similar simple design rises on the exterior of the enclosed breezeway's eastern side (Figure 59). All of the building's windows, doors, and surrounds are replacements.

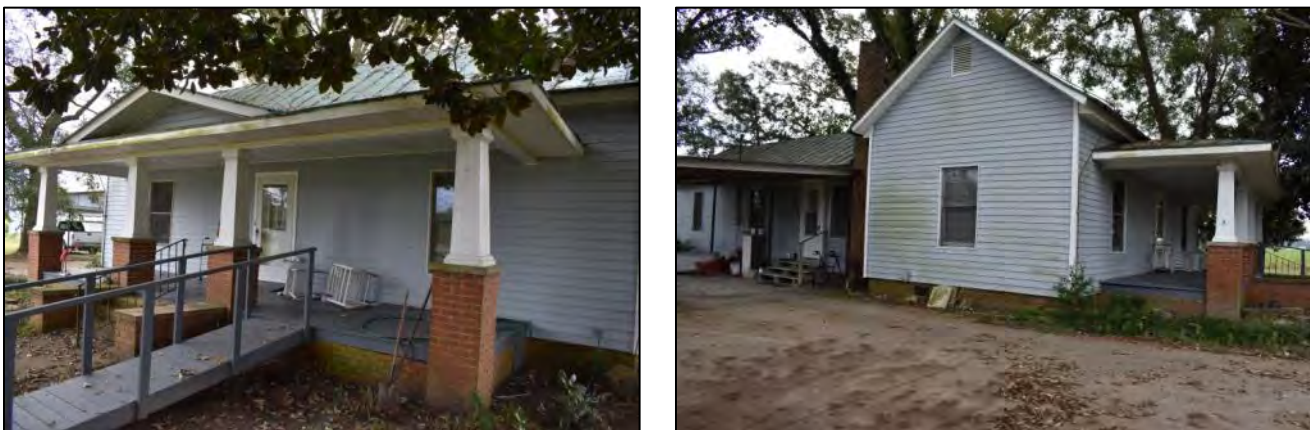
Figure 61: Left, west front elevation; right, north side and west front elevations

A three-bay front porch supported by battered wood columns resting on brick piers crosses the house's west-facing front elevation. A pedimented gable sits atop the porch's low-sloped hipped-roof, which is clad in metal sheathing. The porch's original flushboard ceiling has been replaced with vinyl. It rests on a continuous brick foundation and is accessed by centrally placed cement stairs. A modern carport supported by metal poles, extends off the northern elevation of the kitchen ell. Interior access to the building was not granted by the homeowner.

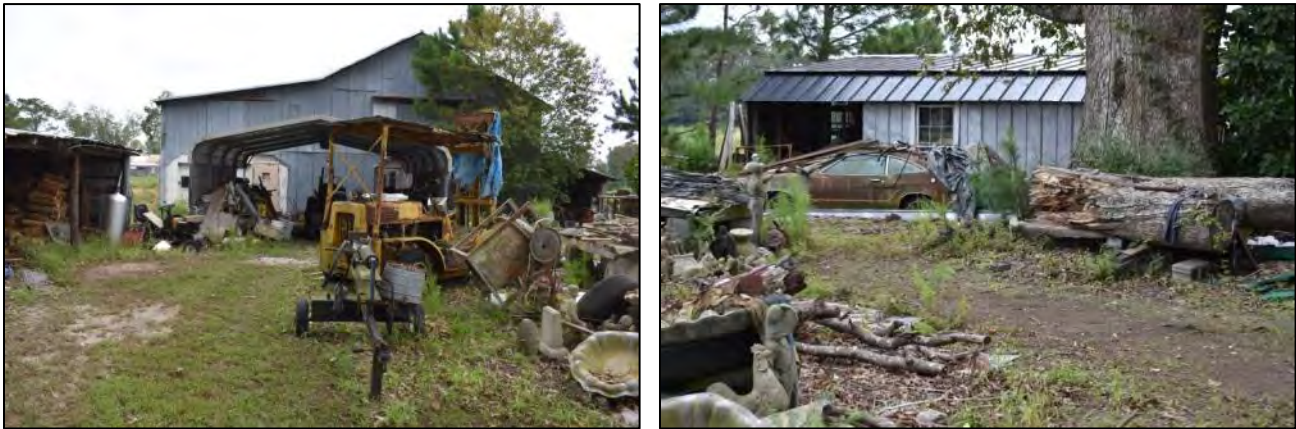
Figure 62: Left, barn; right, shed

This side-gabled, frame shed is located to the house's northeast. The building is clad on all sides by standing-seam metal and displays numerous window and door openings, which are haphazard in their placement. The building likely dates from the mid/late-twentieth century. It may have been used by its current owners, the Stricklands (Little 2018), for the manufacture of the concrete lawn ornaments that and are still displayed on the property).

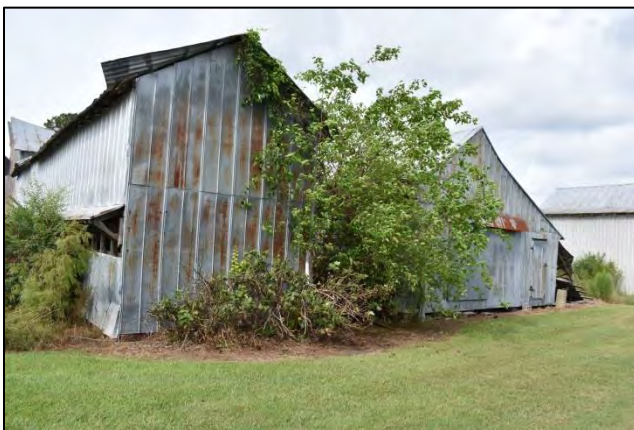
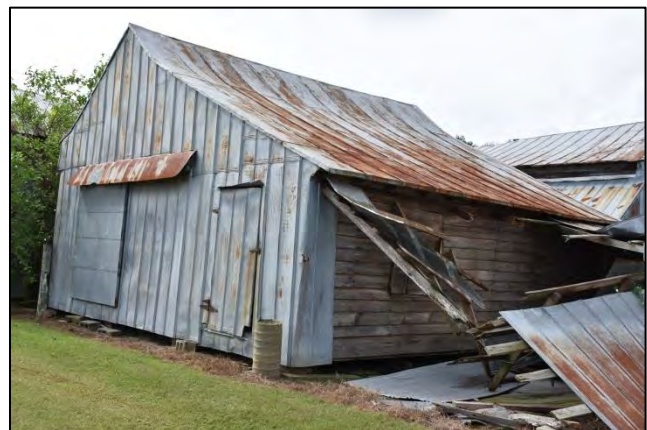
Figure 67: Left, east elevation of house with outbuilding to which it was attached by shed roof at left; right, view of east and north elevations of house with outbuilding wrapping around two sides to rear

The metal-clad, east-facing, gable end features a large metal sliding track door and a second door that enters the north shed addition. The long north side of the addition was not metal-clad, as it was shaded and protected by an open shed. This shed extension has fallen, revealing weatherboards (Figure 67, right, and Figure 68).

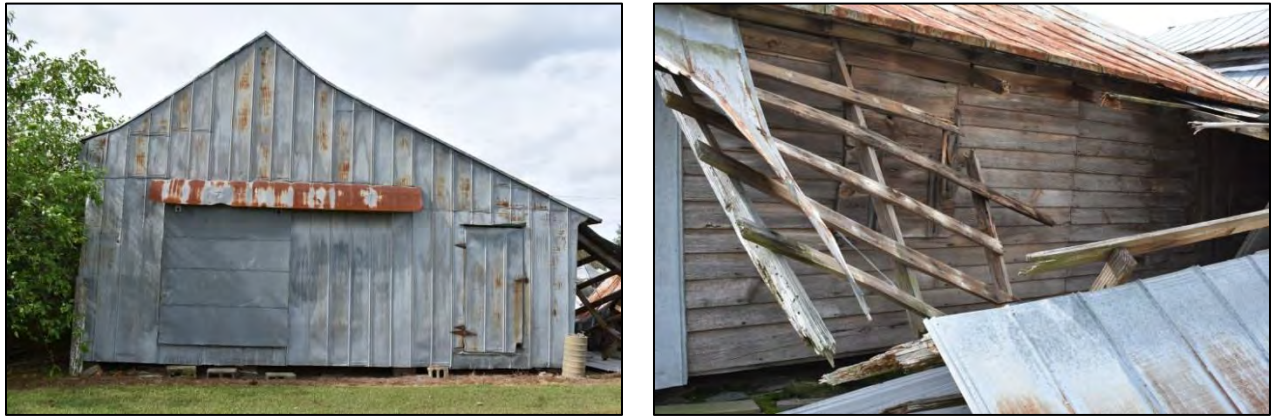
Figure 68: Left, east elevation with later sliding door and door to shed room; right, north elevation of shed

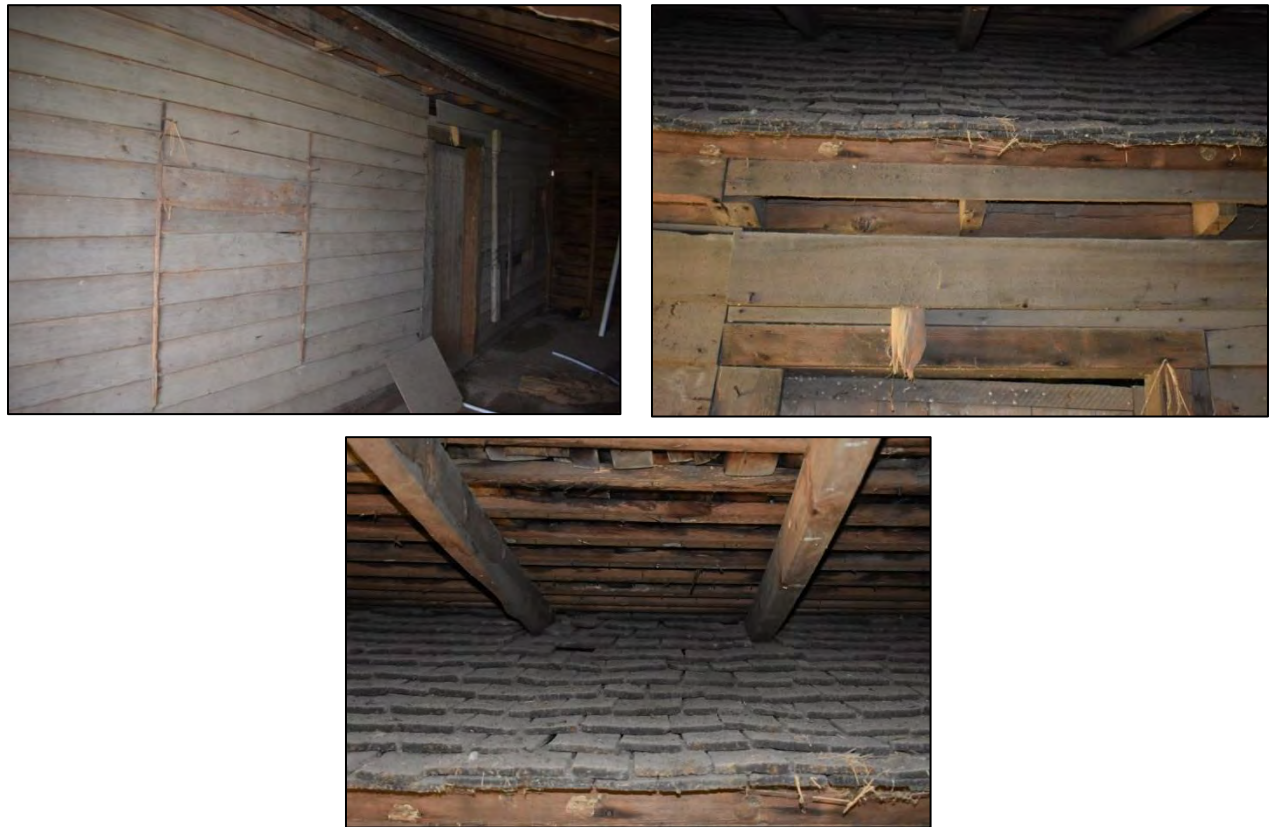
Figure 69: Left, view of house's original eastern exterior wall (now enclosed by shed roof addition); right and bottom, view of original wood shingle roof (now covered by roof of addition)

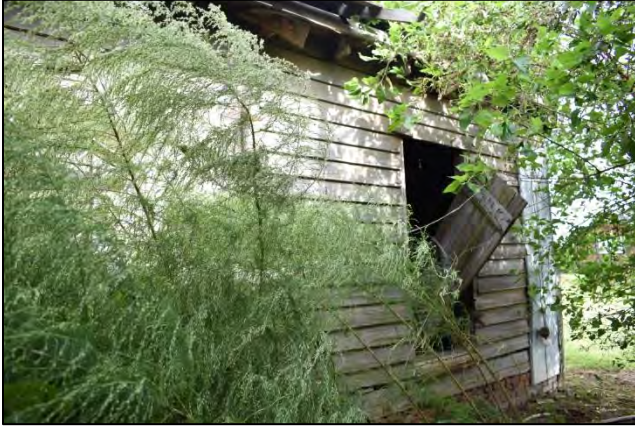
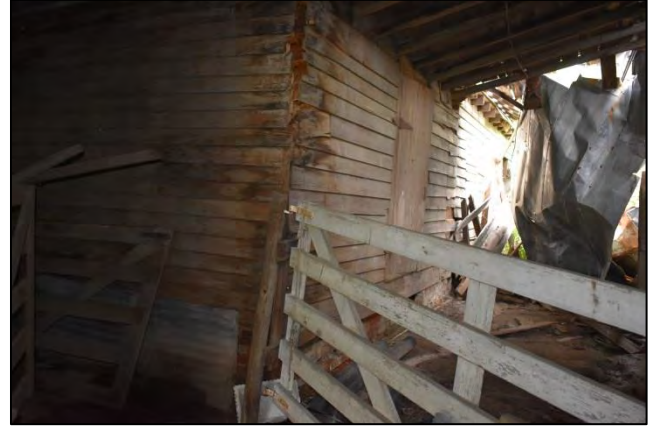
Figure 70: Views of south elevation

The house's gabled south elevation has two bays. The eastern one holds a vertical-board, battened door that is not original. The window or door of the western bay is no longer extant; in its place is a foreshortened door. The west gable-end of the house is now supported by exterior rather than interior framing and was likely entirely rebuilt when the house was moved (Figure 70 and Figure 71).

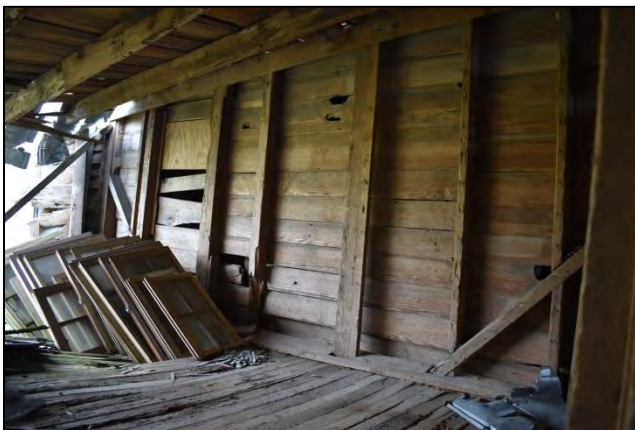
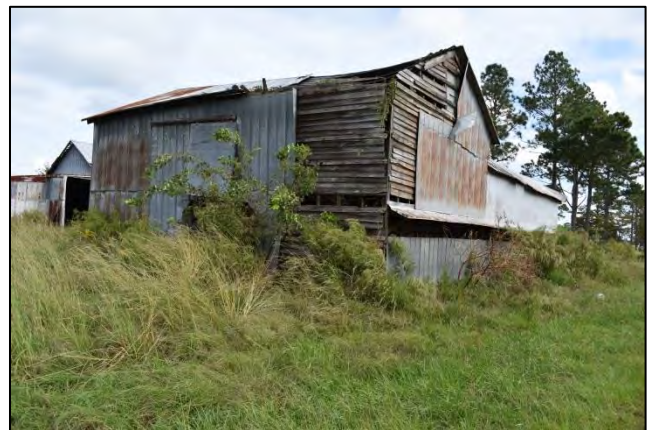
Figure 71: Left, west exterior gable end, now enclosed by later barn addition; right, view of west side and south gable-end of barn that wraps around house, which is hidden from this vantage point

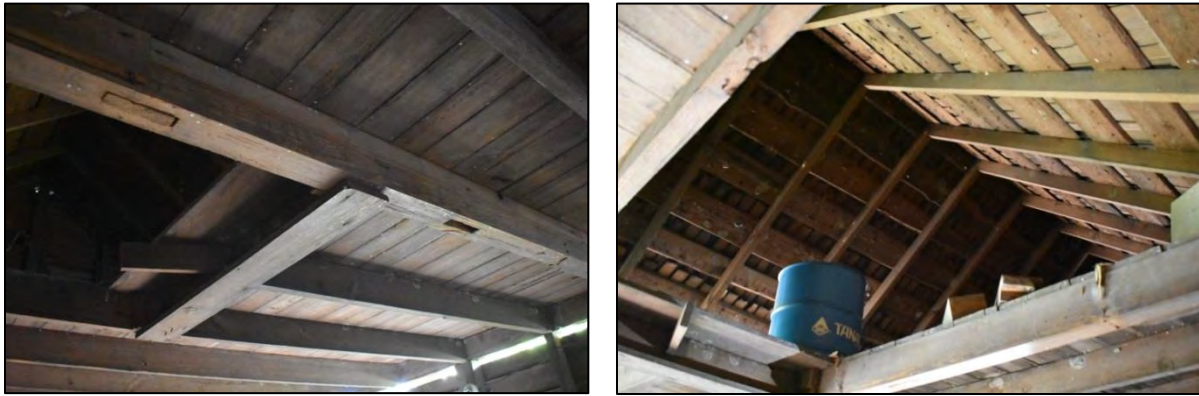
Figure 72: Left, view of building’s interior framing with ghost mortises of original partition wall; right, view looking up into loft, with common rafters and undersides of shingles visible

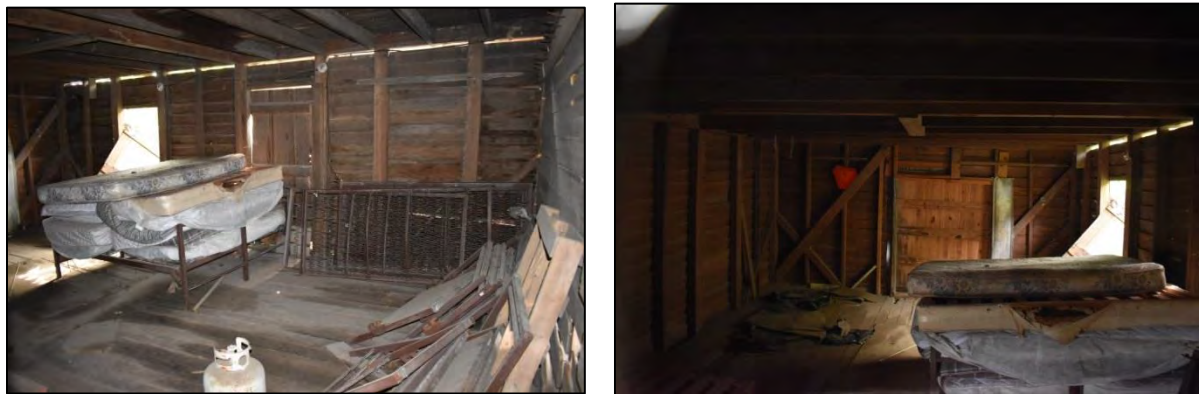
Figure 73: Left, interior looking toward northern wall; right, interior looking toward eastern wall

Given the low amount of interior finish remaining in the house, a clear view of the building's framing system is visible (Figure 72 and Figure 73). In his 1987 survey of the building Power described the house's exposed framing system:
