**SUBJECT:** Historic Structures Survey Report, BR-0036, Replace Bridge 41 on NC 33 over I-95,  
PA 17-12-0062, Nash County, ER 19-0081

**Historic Structures Survey Report  
Replace Bridge No. 41 on NC 33 Over I-95  
Nash County, North Carolina**

T.I.P No. BR-0036  
WBS# 67036.1.1  
PA No. 17-12-0062

December 3, 2018 – Final Report

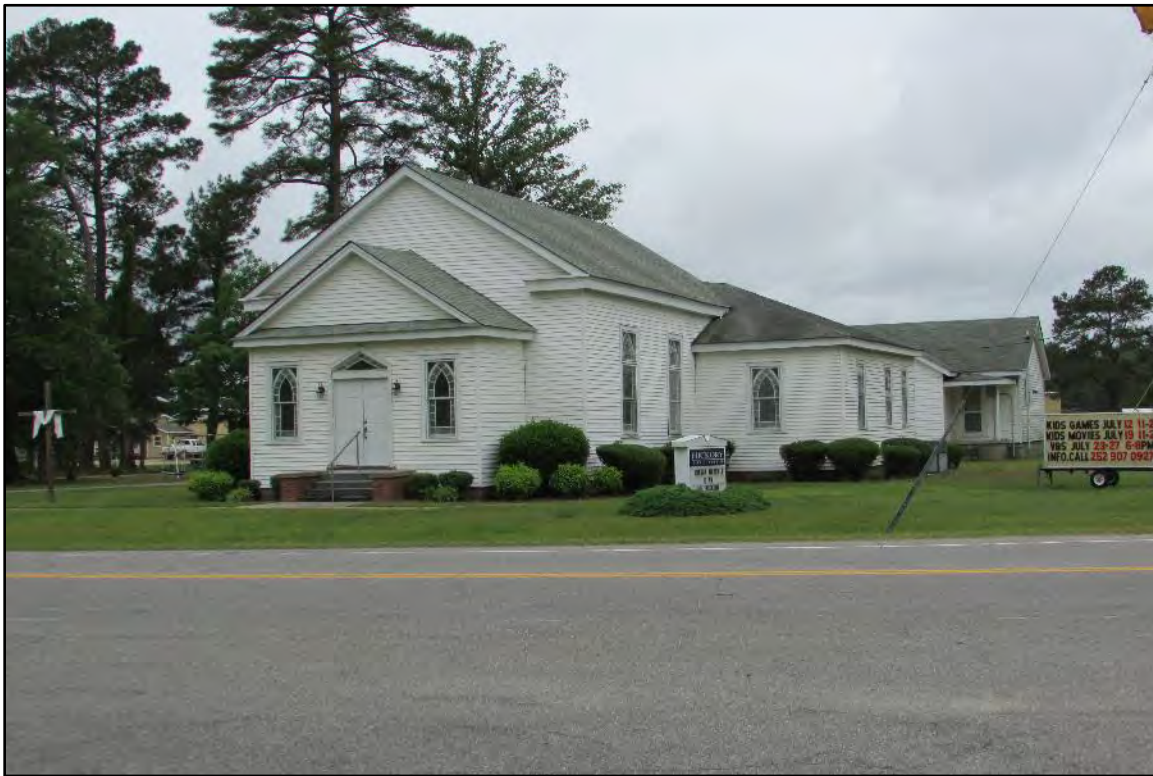
**Figure 4. Hickory Baptist Church, front (east) elevation.**

The original form of this one-story church was a two-bay wide by three-bay long rectangle, but subsequent additions have created an irregular shape (Figure 11). In 1947, a vestibule was added to the front elevation and an addition with Sunday School rooms was attached to the rear (Figure 12). In 1981, the Gold Rock Community Club building was relocated to the property and attached by a connector to the west end of the Sunday School addition to serve as a Fellowship Hall (Figure 13). The original mass of the building has a gable roof with cornice returns. The vestibule has a closed gable roof with a pent roof along the east elevation. The Sunday School addition has a hip roof, while both the connector and the Fellowship Hall have gable roofs. All of the roofs are surfaced with composition shingles. The entire building is clad with vinyl siding. The original building and the Sunday School addition rest on a continuous brick foundation pierced by vents, while the connector and Fellowship Hall have a continuous concrete block foundation.

The Hickory Baptist Church does not retain sufficient integrity to be considered eligible for the NRHP. The structure appears to be in its original location, and the overall rural setting remains intact. The church continues to be associated with the same congregation and retains the feeling of a rural church. However, extensive alterations to the form, design, and materials have severely impacted its architectural integrity. Alterations include the redesign of the front entrance with the construction of the vestibule, the possible replacement of windows, and the application of vinyl

The original design and architecture of Hickory Baptist Church is no longer apparent due to extensive alterations and additions. It does not possess high artistic merit and is no longer a good example of vernacular architecture. Other, more intact, examples of rural churches exist throughout the county. Therefore, it is not recommended as eligible for listing in the NRHP under Criterion C for its physical design and construction.

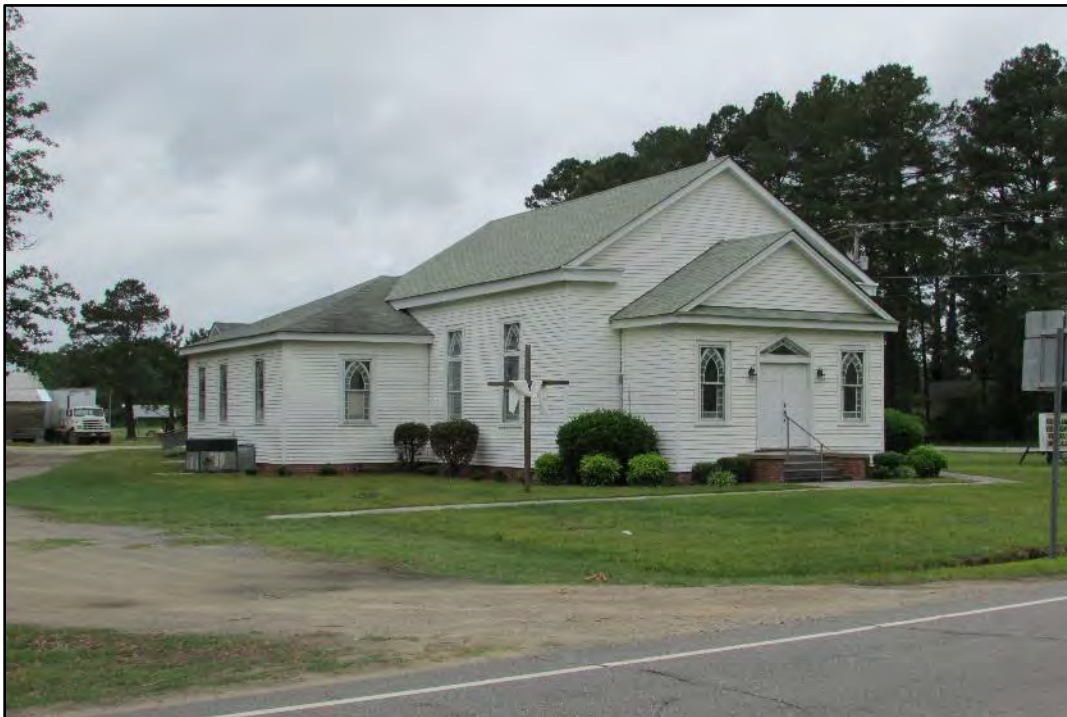
**Figure 11. Hickory Baptist Church, front (east) and south elevations, looking northwest.**

foundation. It is accessed by concrete steps flanked by pipe railings. The door at this entrance is a six-light, three-panel door. A concrete and brick handicap ramp is attached to the south elevation of the connector and provides access to the building through a shed roofed portico supported by a wrought iron post. The door at this elevation has a nine-light, two-panel door. Another entrance is through a hipped roof porch supported by a square wood post on the northeast corner of the Fellowship Hall addition.

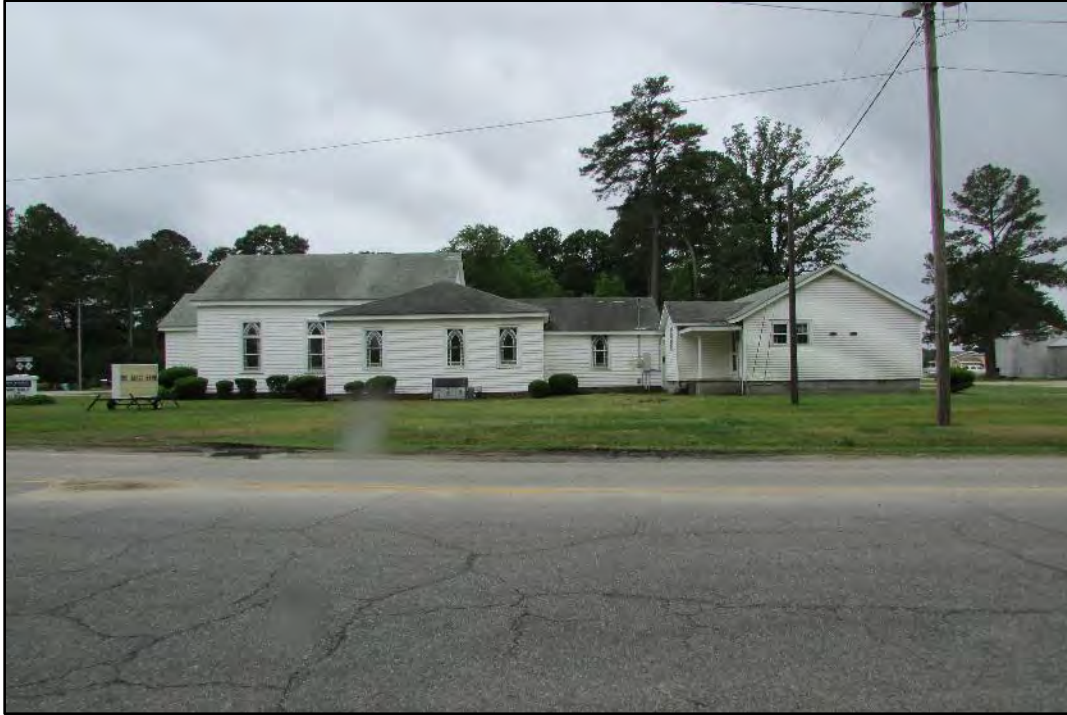
**Figure 12. Hickory Baptist Church, north elevation, looking south.**

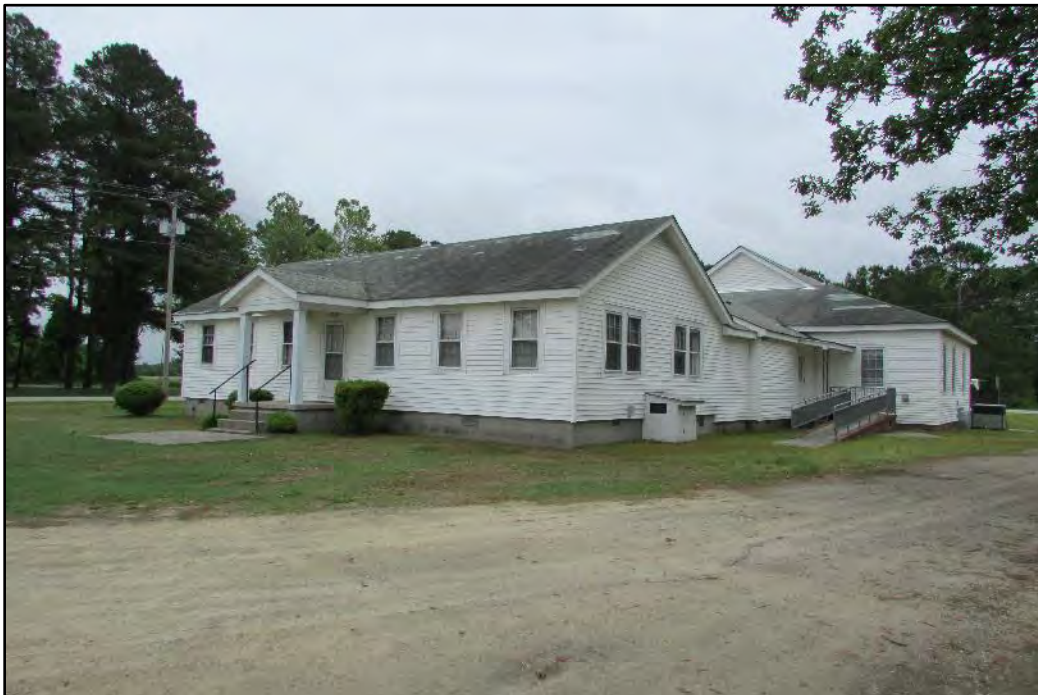
**Figure 13. Hickory Baptist Church, rear (west) and south elevations, looking northeast.**

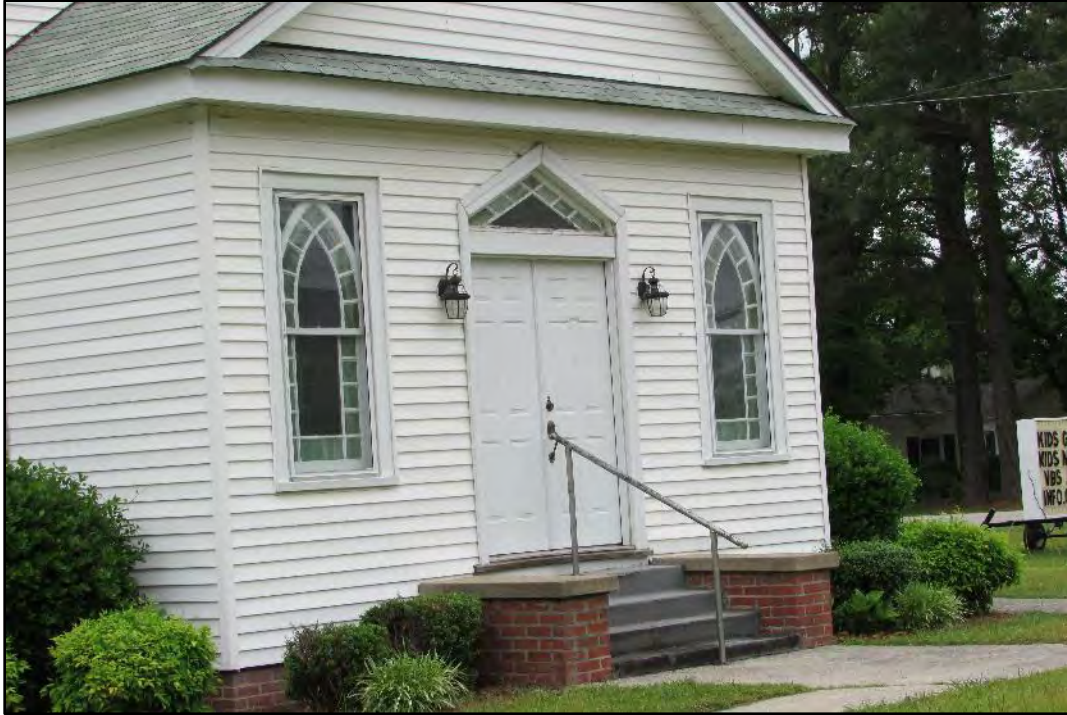
**Figure 14.** Hickory Baptist Church, detail of east entrance, looking northwest.

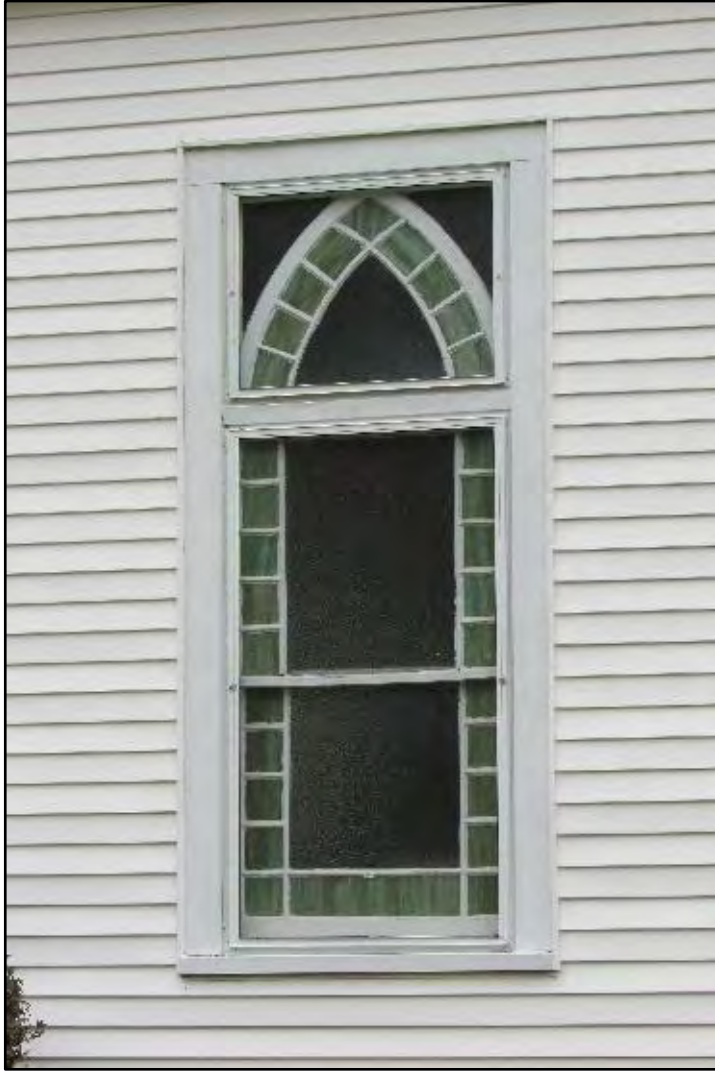
**Figure 15. Hickory Baptist Church, detail of window on south elevation, looking north.**

The windows in the vestibule and the Sunday school addition are independently placed rectangular, wood, double-hung sash with an inset decorative design of a pointed arch using smaller stained glass lights. Windows on the sanctuary have the same design spread over a transom window and the double-hung sash (Figure 15). Windows on the Fellowship Hall are independently placed and paired wood six-over-six double-hung sash. All windows have exterior storms. An attached pump house is on the south elevation of the Fellowship Hall. Access to the interior was not provided at the time of the site visit.

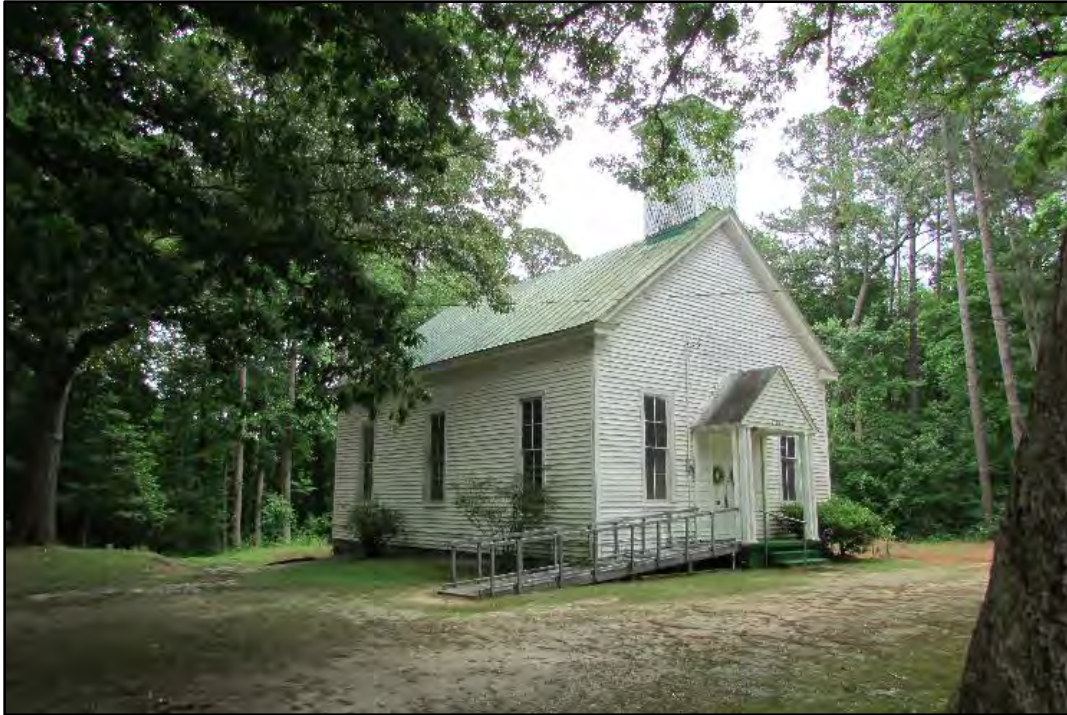
The North Carolina state survey inventory maintained by the HPO includes 56 recorded churches in Nash County. Of these, the York Chapel (NS441), Shiloh Church (NS1025), and the Whitakers Baptist Church (NS546) were analyzed for comparison. York Chapel is a one-story, wood frame church built between 1882 and 1885 along a stage route near Hilliardston (Figure 17). The form exhibits a Gable-End Church design with a short steeple. The rectangular building has cornice returns, classical corner boards, and four-over-four double-hung sash windows. The front entrance has paired four-panel doors set within a gabled portico supported by grouped square wood posts. The church remains an excellent example of a rural church with a high degree of architectural integrity.

**Figure 17. York Chapel (NS441), 9779 York Chapel Road, looking southeast.**

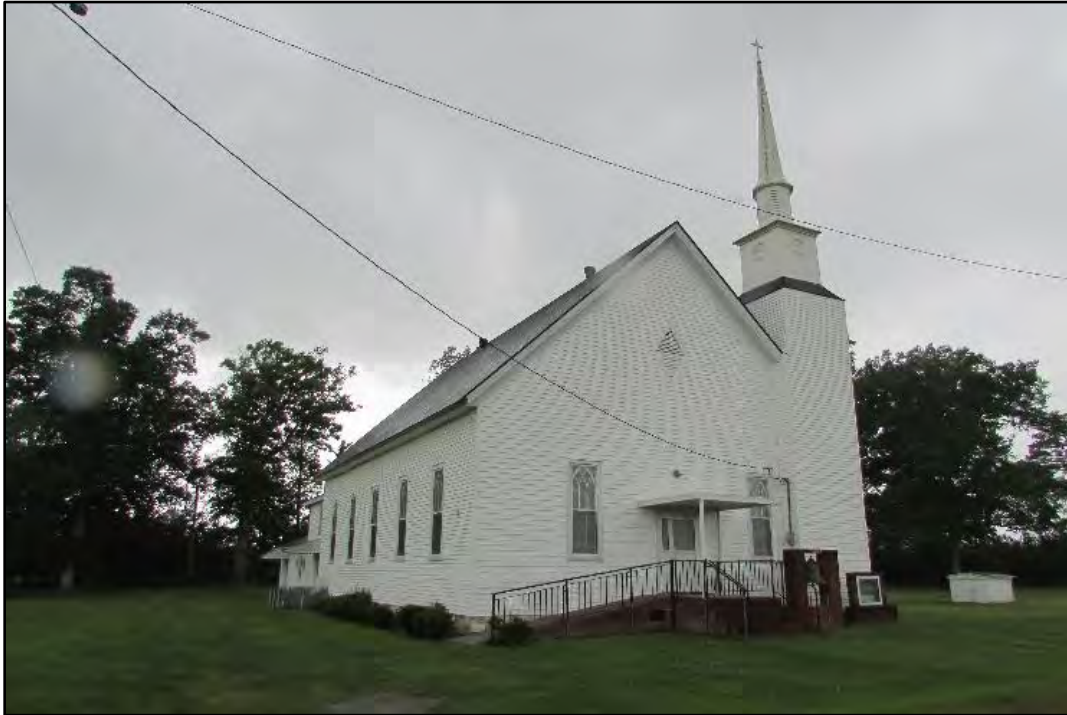
**Figure 18. Shiloh Missionary Baptist Church (NS1025), 9191 NC 33, looking southwest.**

Shiloh Missionary Baptist Church was constructed ca. 1900 by the African Americans who were formerly members of Hickory Baptist Church (Figure 18). The wood frame building exhibits the Side-Steeple Church form with the primary entrance centrally located in the gable end instead of the steeple. Like Hickory Baptist Church, Shiloh Church has rectangular, double-hung sash windows with a pointed arch design in stained glass. The building is clad with vinyl siding and the main entrance has a modern replacement stoop with a flat roof and a new door. Additions have

been attached to the rear. Overall, the structure retains its original form and overall design, in spite of some replacement materials and additions.

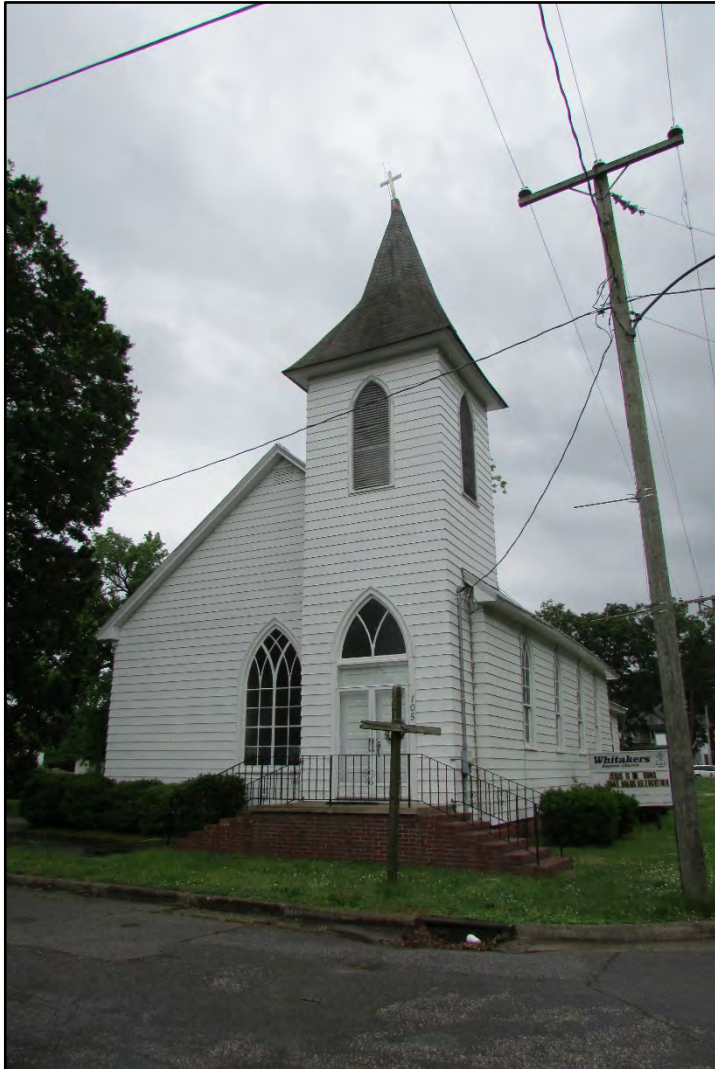
**Figure 19. Whitakers Baptist Church (NS546), 105 West Pittman Street, looking southeast.**

Whitakers Baptist Church was completed in 1910 demonstrating a vernacular interpretation of the Gothic Revival style typical of churches in small towns (Figure 19). The wood frame building has a Side-Steeple Church form with the entrance in the steeple. The original paired seven-panel doors, the conical roofed tower, and pointed arched windows with tracery remain. The edifice has been altered with the application of aluminum siding and a replacement entrance stoop. This small

church retains the majority of its original design in spite of the application of aluminum siding and the replacement stoop.

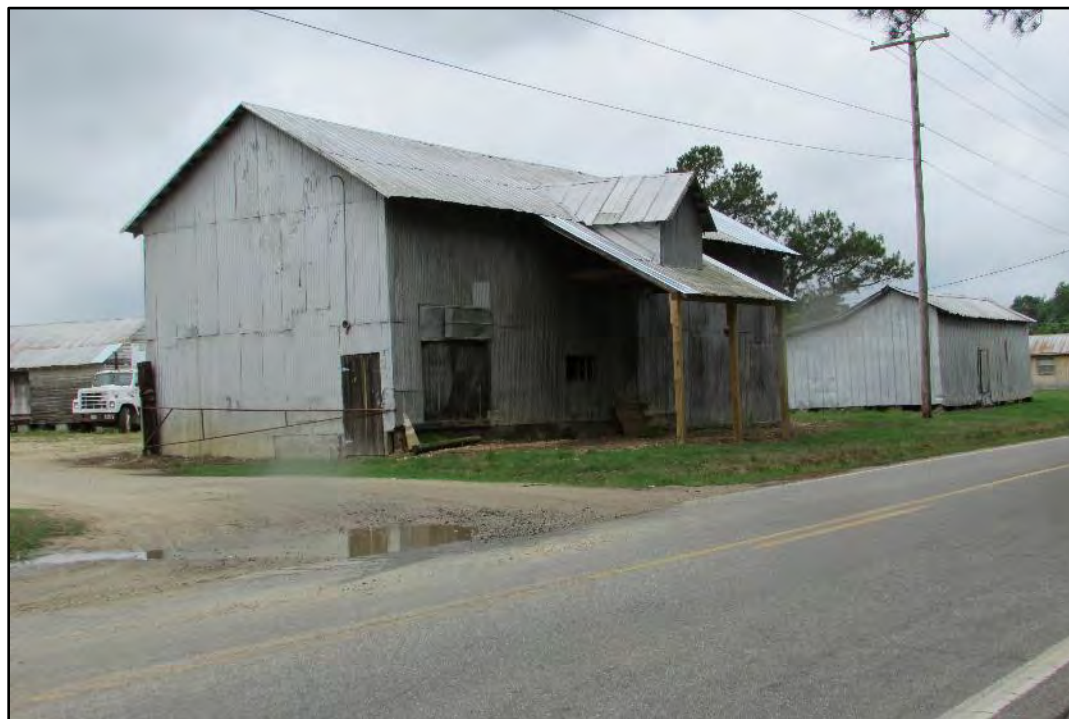
**Figure 20. O.J. Smith Cotton Gin, front (north) and east elevations, looking southwest**

The wood frame O.J. Smith Cotton Gin is surfaced with corrugated metal and 5V crimp sheet metal and set on a poured concrete foundation (#1 on the site plan). It appears to have been built ca. 1935 (Mattson and Poff 1987:243). The side gable roof is clad with 5V crimp and has exposed rafter ends in the eaves. The drive-through pneumatic feeder overhang is on the north elevation (Figure 27). The awning protected trucks and wagons from rain and contained the telescoping pipe that sucked raw cotton into the gin so it could be processed. A truck scale on the ground under the shelter likely weighed the cotton. The shed roof of the overhang is supported by square wood replacement posts and has a gabled dormer which housed the feeder. A six-light wood frame window is set within the wall under the overhang. A shed overhang that likely functioned as the bale dock is on the south elevation at the west end (Figure 28). The shed roof has exposed rafter ends and is supported by round wood poles. A large sliding door composed of sheet metal is centrally located on the south elevation (Figure 29). A wood pedestrian door is on the east elevation at the north corner, and a wood loading dock door is on the north elevation at the east end. The machinery has been removed, but the original concrete floor is evident (Figure 30).

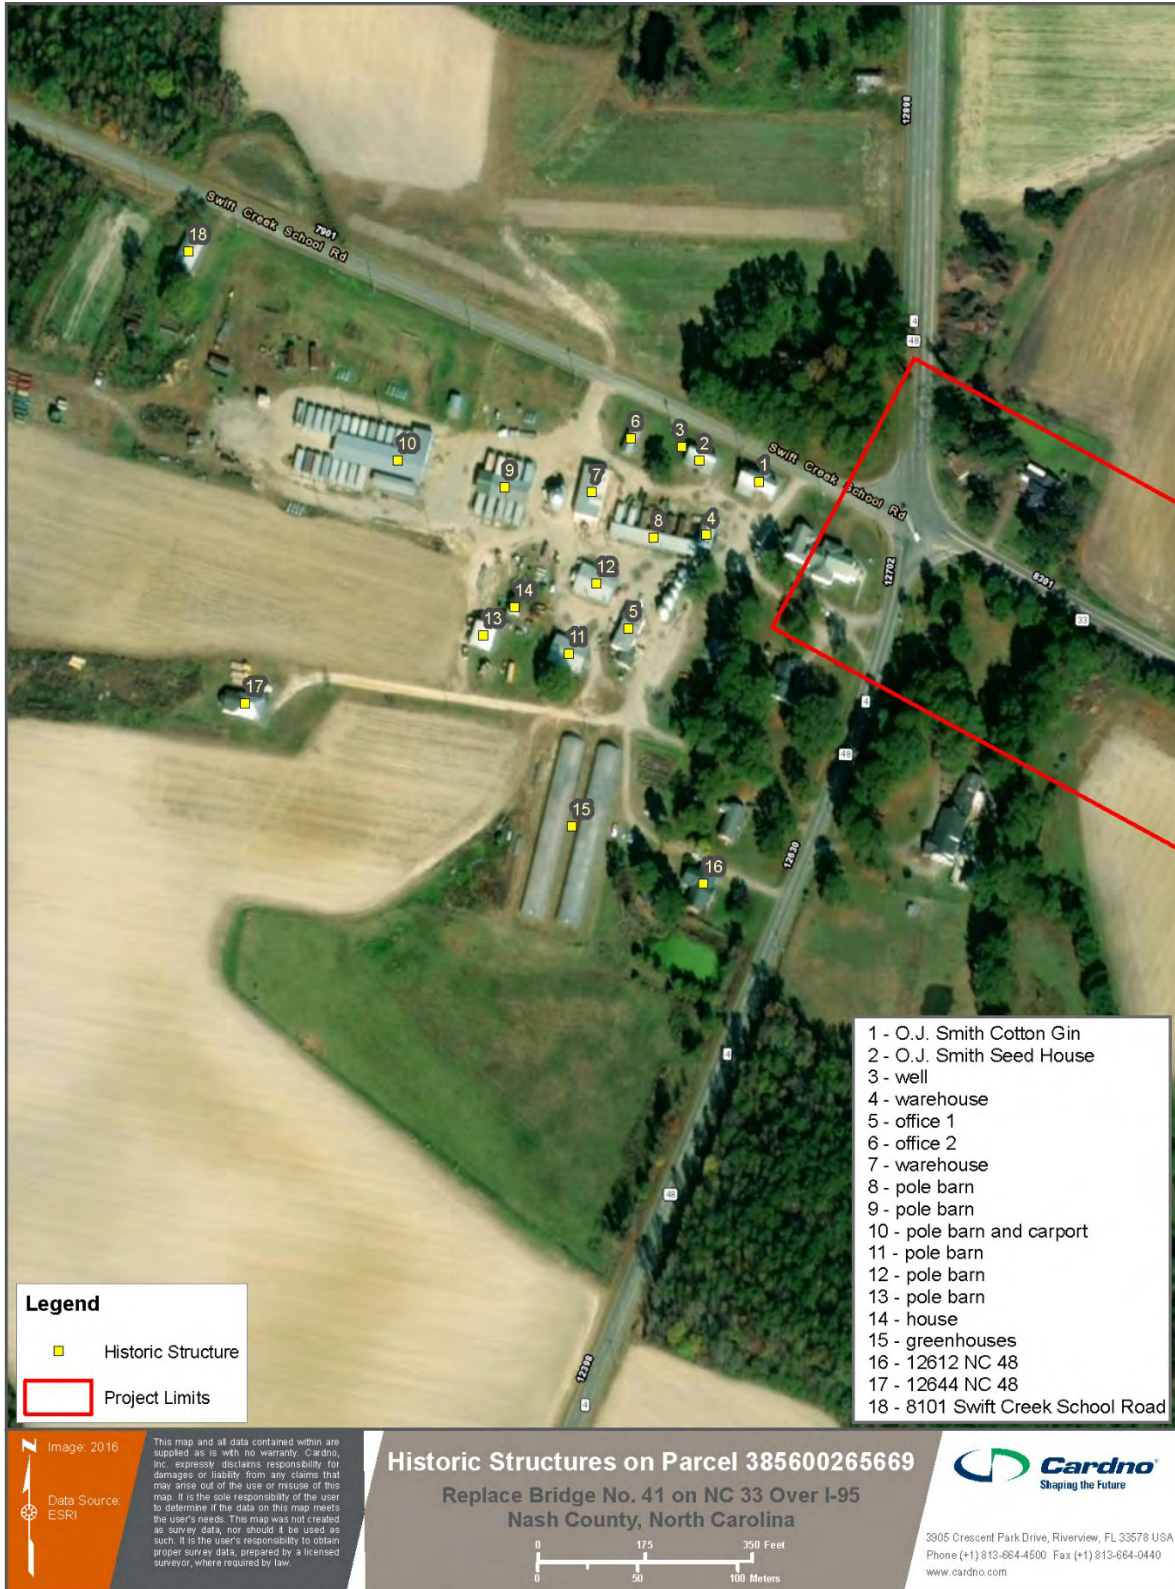
**Figure 21. Structures on the O.J. Smith Cotton Gin property.**

The seed house is situated approximately 50 feet west of the cotton gin (Figure 31; #2 on the site plan). Likely constructed at the same time as the cotton gin, this wood frame building is clad with 5V crimp and set on a brick pier foundation supplemented by some replacement concrete blocks. The structure has a side gable roof with a shed addition to the south (Figure 32). Exposed rafter ends are in the eaves. Two pedestrian sized vertical wood doors are on the south elevation, while one is on the north elevation. A structure that appears to be part of a poured concrete well is adjacent to the west (#3 on the site plan).

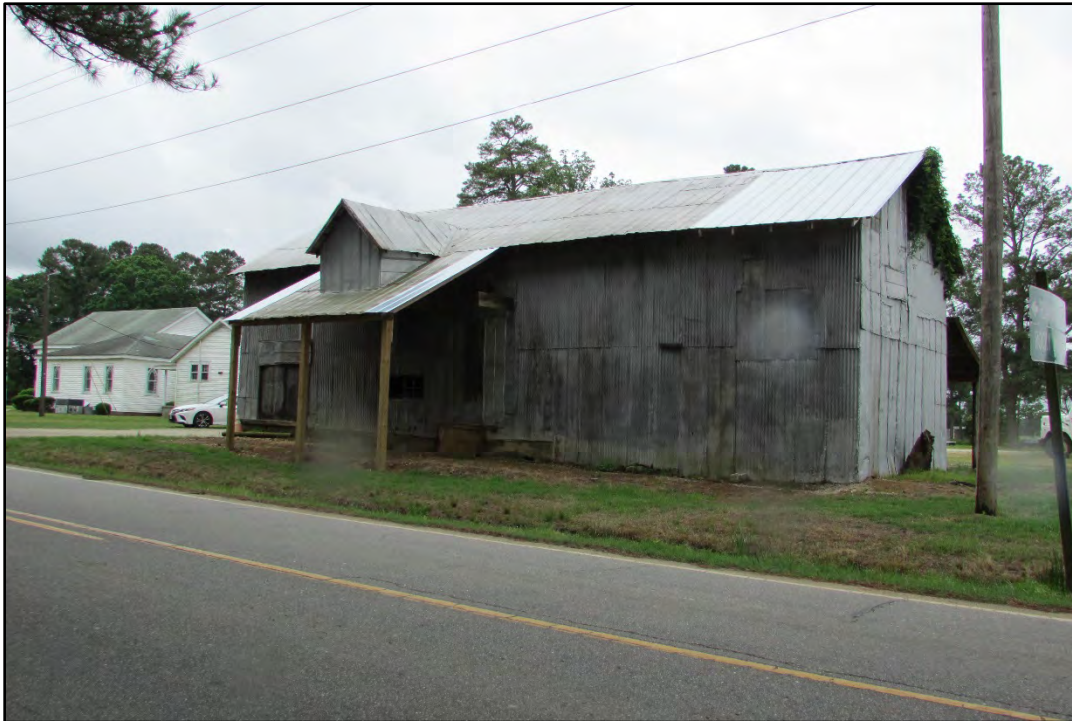
**Figure 27. O.J. Smith Cotton Gin, front (north) and west elevations, looking southeast.**

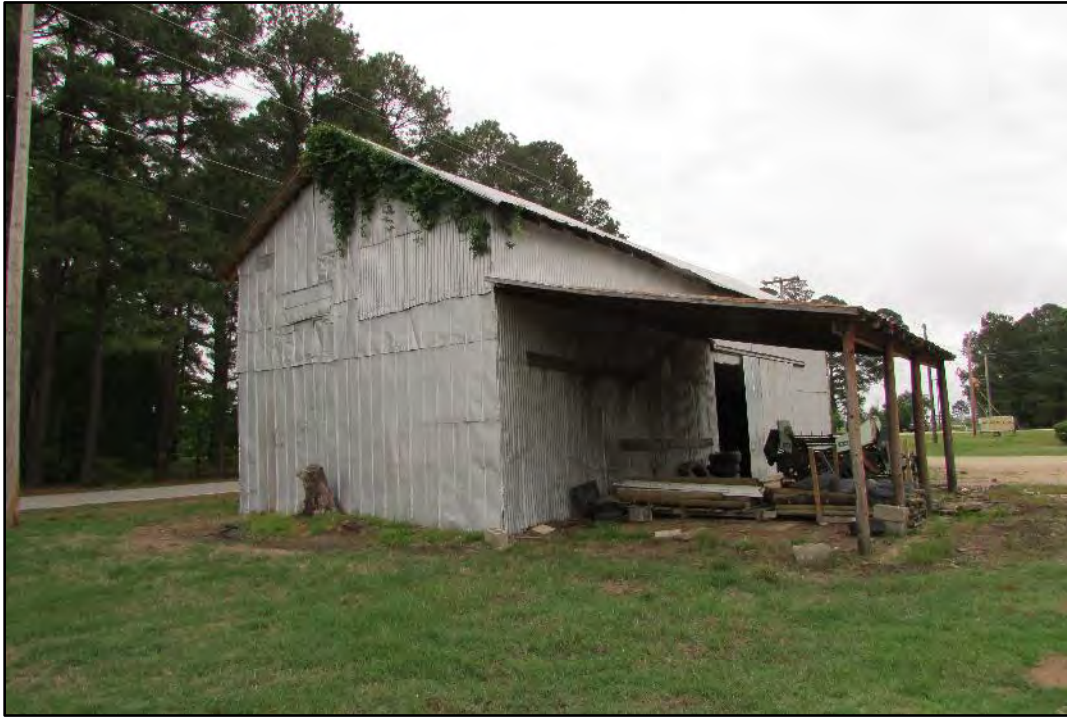
**Figure 28. O.J. Smith Cotton Gin, west and south elevations, looking northeast.**

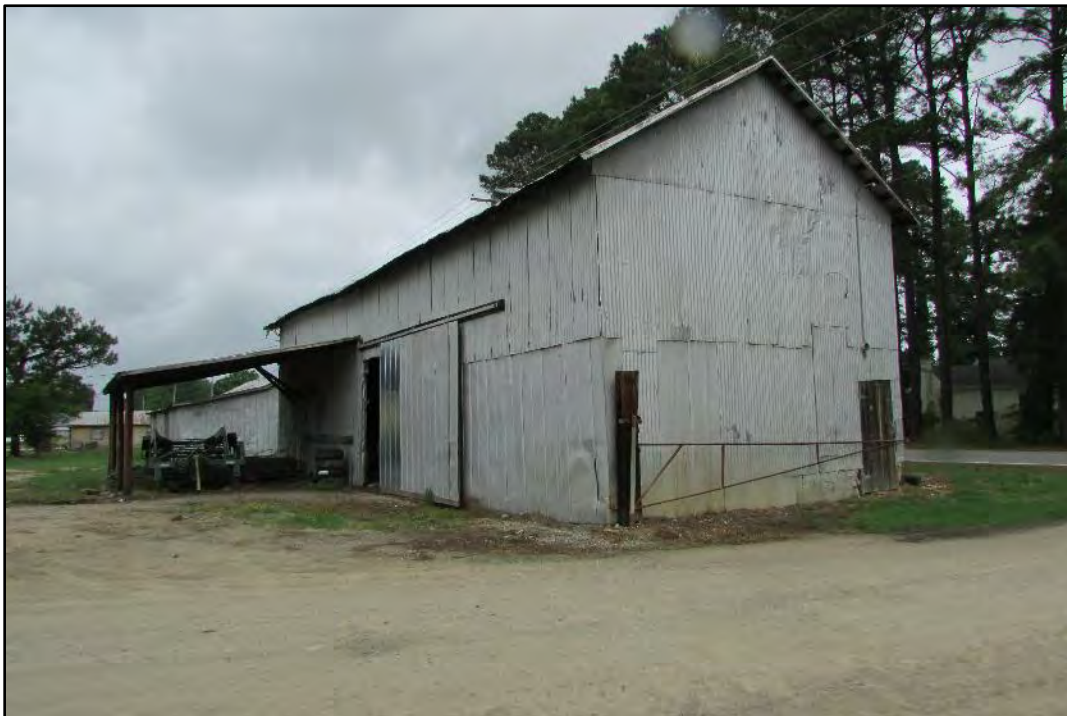
**Figure 29. O.J. Smith Cotton Gin, south and east elevations, looking northwest.**

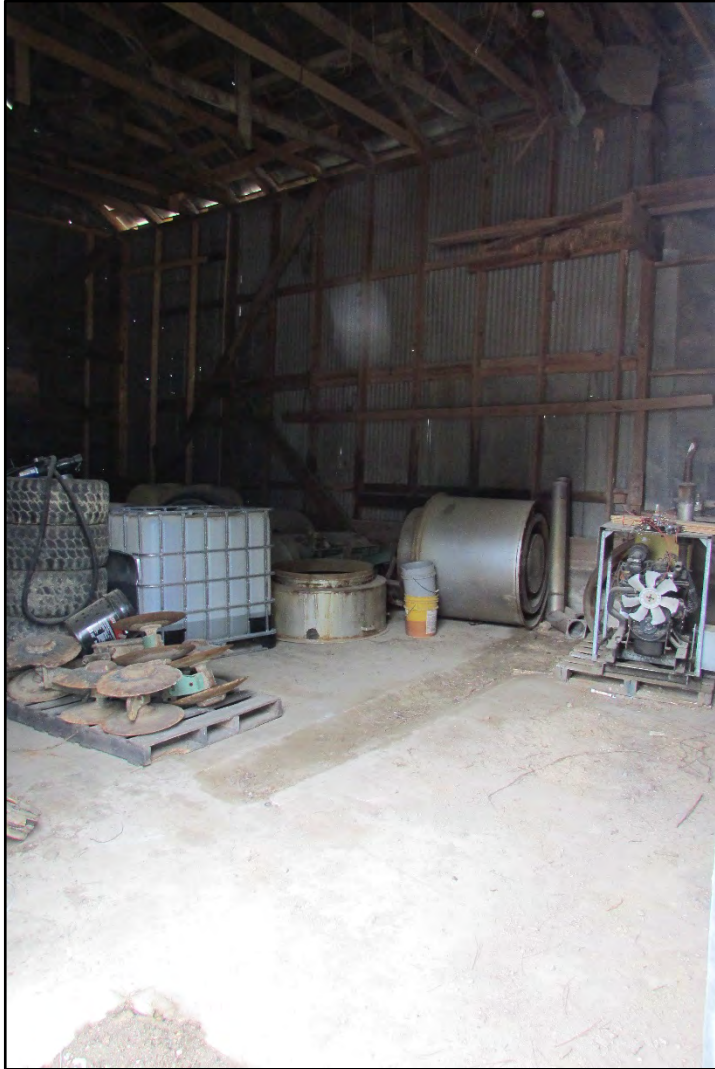
**Figure 30. O.J. Smith Cotton Gin, interior view from south entrance, looking northwest.**

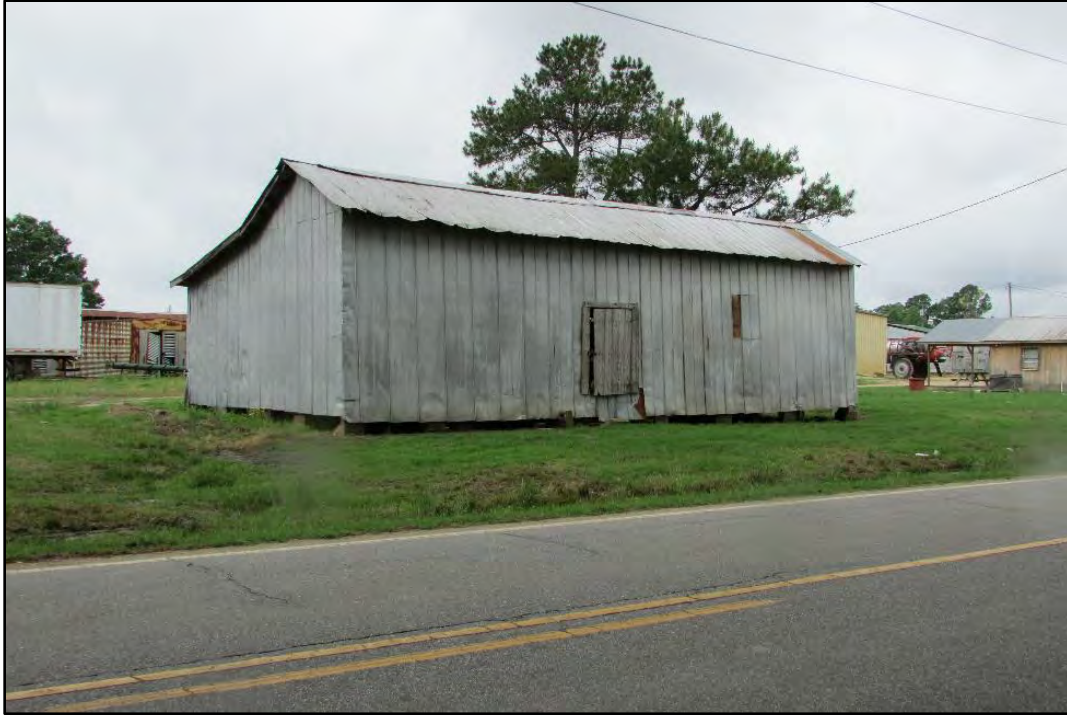
**Figure 31. O.J. Smith Cotton Seed House (#2 on site plan), front (north) and east elevations, looking southwest.**

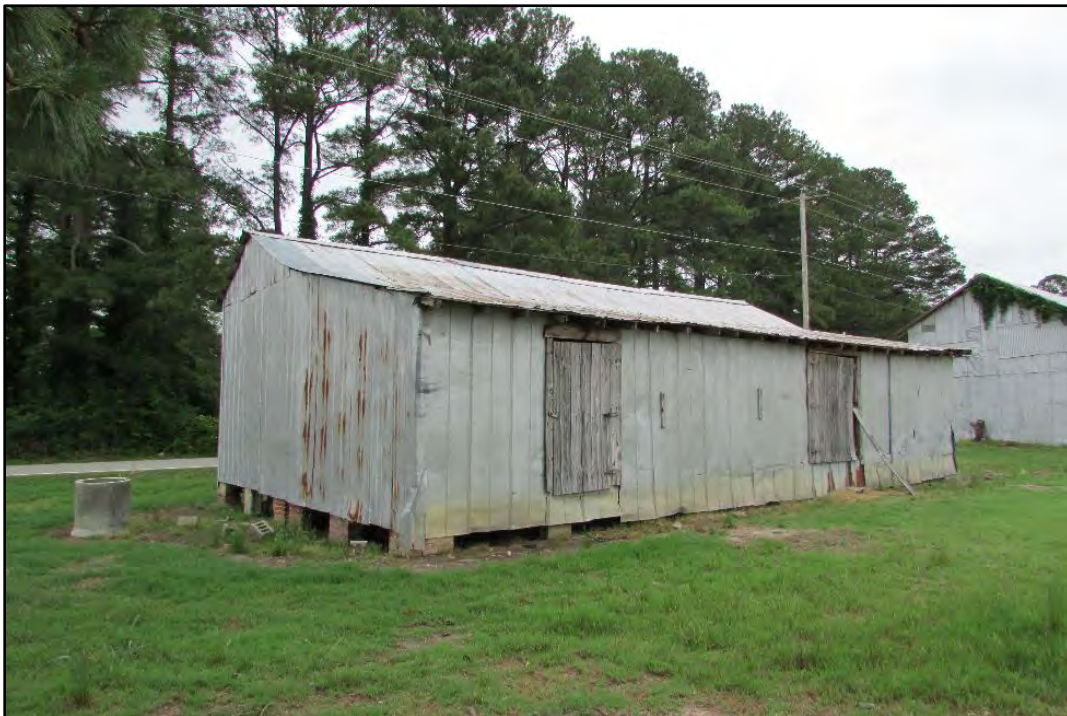
**Figure 32. O.J. Smith Cotton Seed House and well (#2 and #3 on site plan), west and south elevations, looking northeast.**

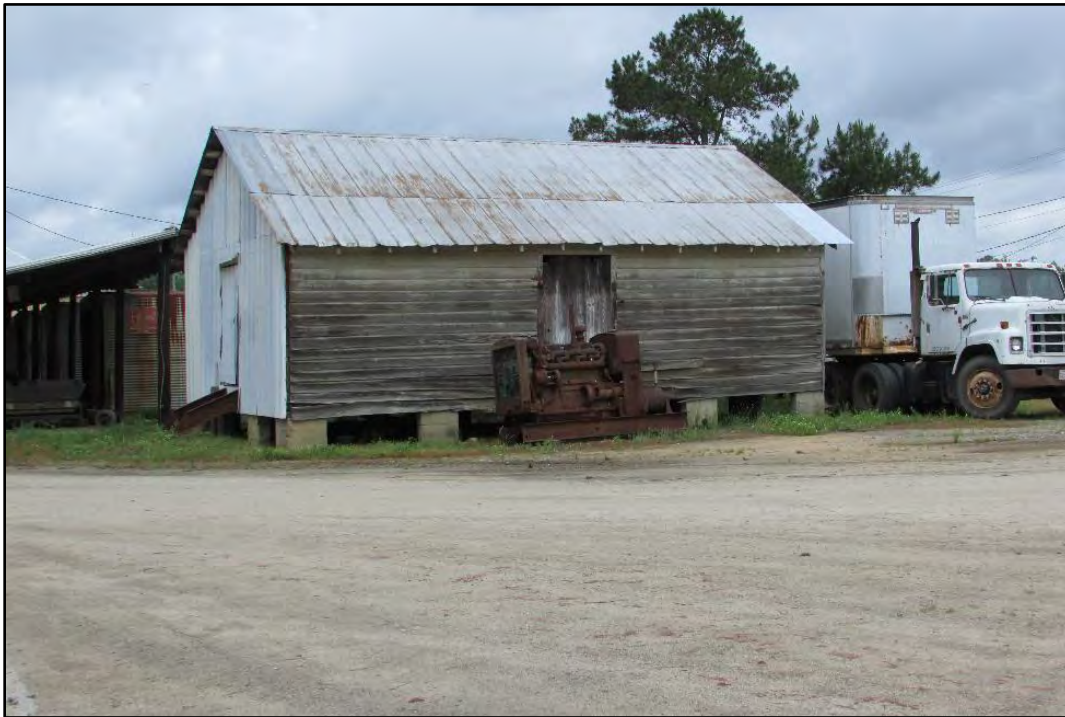
**Figure 33. Warehouse (#4 on site plan), east and south elevations, looking west.**

South of the cotton gin, a wood frame warehouse is situated to face east (Figure 33; #4 on the site plan). The building has a side gable roof surfaced with 5V crimp and a concrete block pier foundation. The east, west, and north elevations have weatherboard siding, while the south elevation is clad with corrugated metal. Exposed rafter ends are in the eaves. An entrance with a vertical board door is centrally located on the east elevation. The exact date of construction for this building remains unknown. Aerials indicate that it was on site in 1957, but was a longer structure extending further north; the northern end was partially demolished between 2014 and 2016, and the structure was set on a new foundation (NCDOT Photogrammetry Unit 1957; NETR 1958, 2014, 2016).

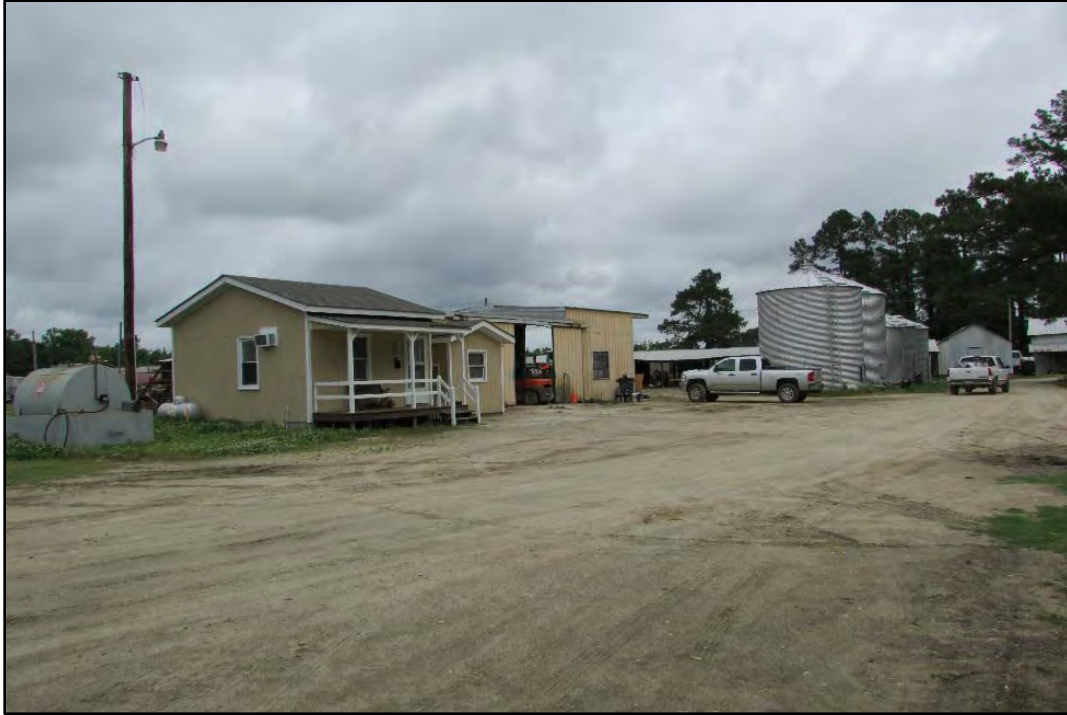
**Figure 34. Office 1 and equipment shed (#5 on site plan), east and south elevations, looking northwest.**

The office and attached equipment shed first appears on the 1975 aerials (Figure 34; #5 on site plan; NCDOT Photogrammetry Unit 1975). Featuring a side gable roof clad with composition shingles, the wood frame rectangular-shaped office has T1-11 siding on the exterior and one-over-one double-hung sash windows placed independently. The building rests on a poured concrete foundation and has a shed roofed porch supported by square posts along the front façade. The equipment shed is attached to the north end of the office and has a concrete slab foundation, a steel structure surfaced with sheet metal, and a gable roof covered with corrugated metal. A nine-light pivot window is on the front façade. Several large bays accessed by sliding doors provide entrance for vehicles. A small wood frame room addition whose design mirrors the office projects from the front façade of the equipment shed.

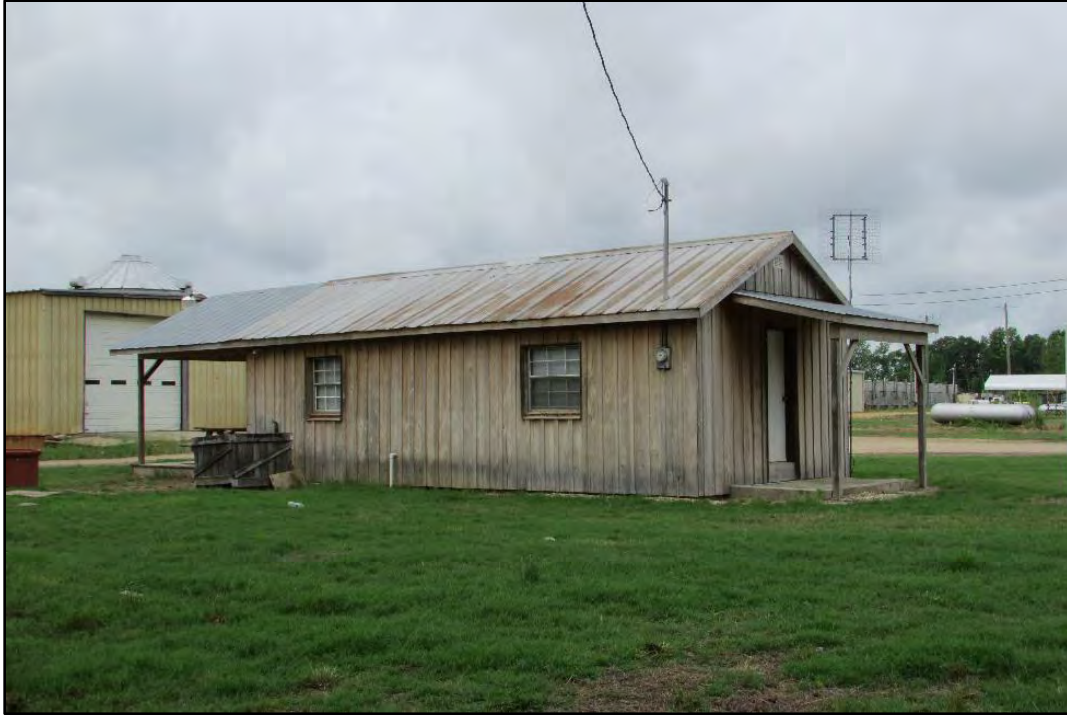
**Figure 35. Office 2 (#6 on site plan), east and north elevations, looking southwest.**

A second office building has the Bungalow form which makes it appear to be an older structure, but aeriels first show it on the property in 1983 (# 6 on site plan; NCDOT Photogrammetry Unit 1983). This small, rectangular building has a front-facing gable roof surfaced with 5V crimp and board and batten siding (Figure 35). Windows are six-over-six, vinyl, single-hung sash placed independently. Set on a continuous poured concrete foundation, the edifice has a shed roofed front porch supported by square wood posts. A rear porch was created by extending the main gable roof and using square wood posts for supports. This section appears to be an addition, and both the siding and windows are replacements.

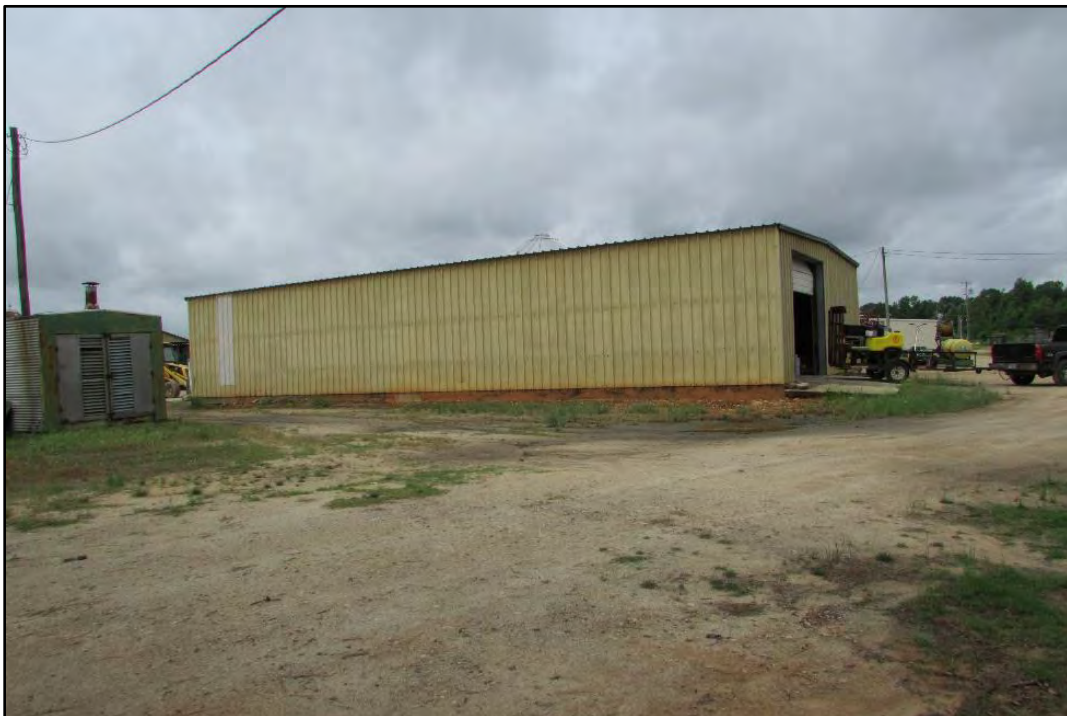
**Figure 36. Warehouse (#7 on site plan), looking southwest.**

This corrugated metal clad warehouse has a steel structure, a low-pitched gable roof, and large roll-up doors on the north and south elevations (#7 on site plan; Figure 36). It rests on a continuous concrete foundation and first appeared on the 1983 aerials (NCDOT Photogrammetry Unit 1983).
