**SUBJECT:** Historic Structures Survey Report, BR-0036, Replace Bridge 41 on NC 33 over I-95,  
PA 17-12-0062, Nash County, ER 19-0081

**Historic Structures Survey Report  
Replace Bridge No. 41 on NC 33 Over I-95  
Nash County, North Carolina**

T.I.P No. BR-0036  
WBS# 67036.1.1  
PA No. 17-12-0062

December 3, 2018 – Final Report

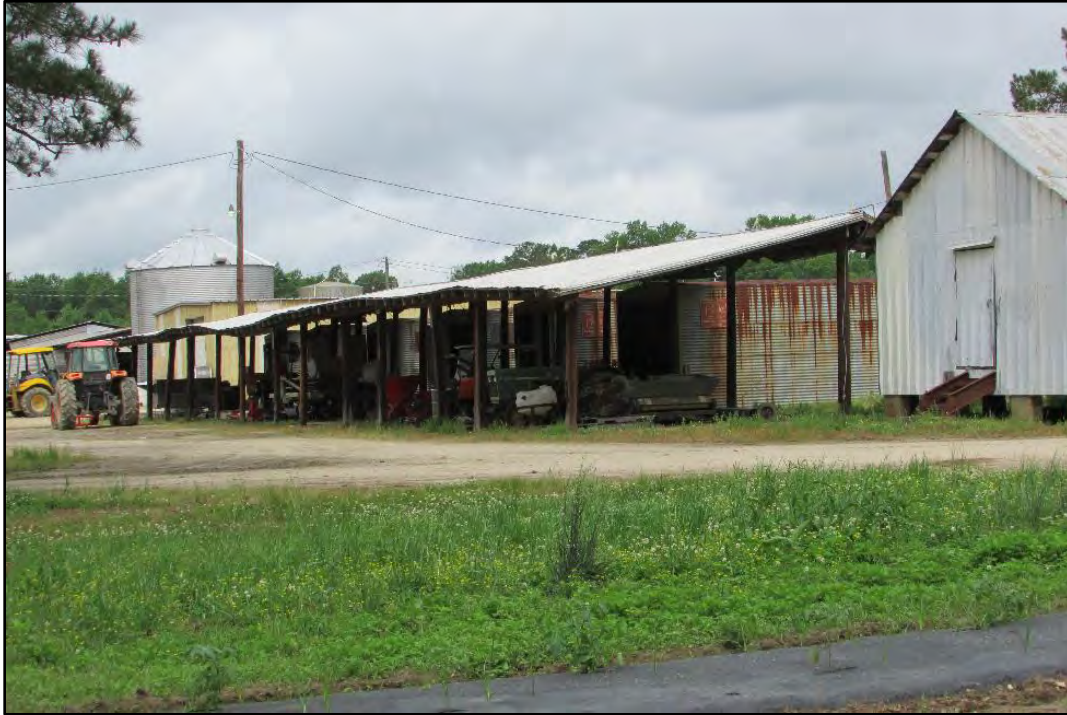
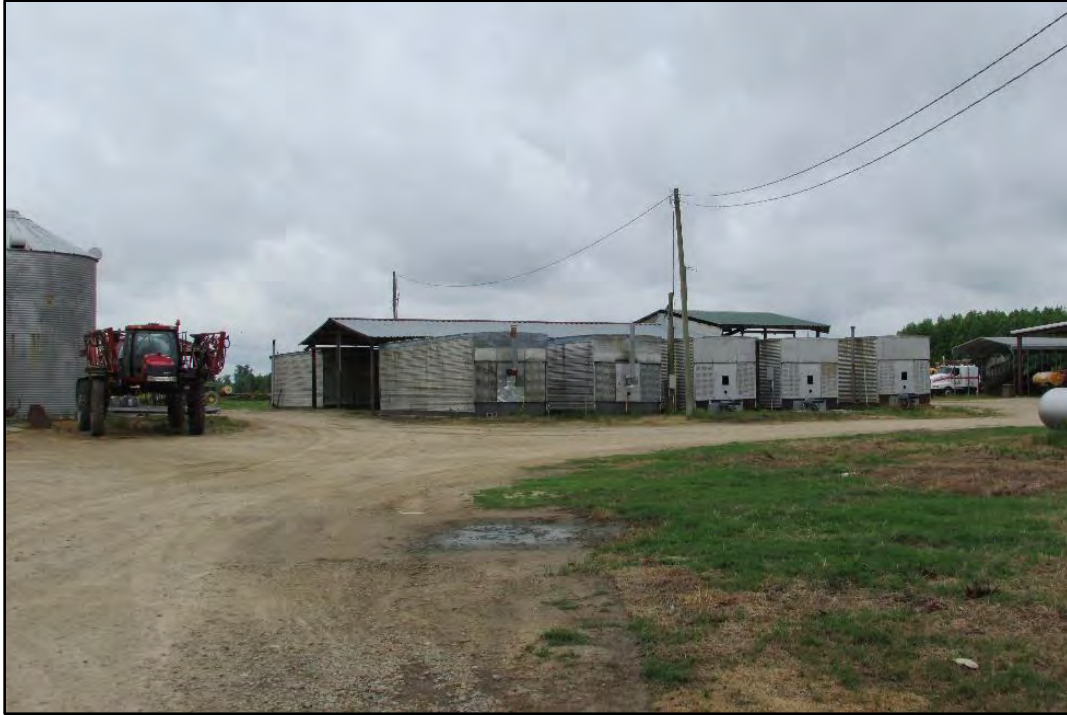
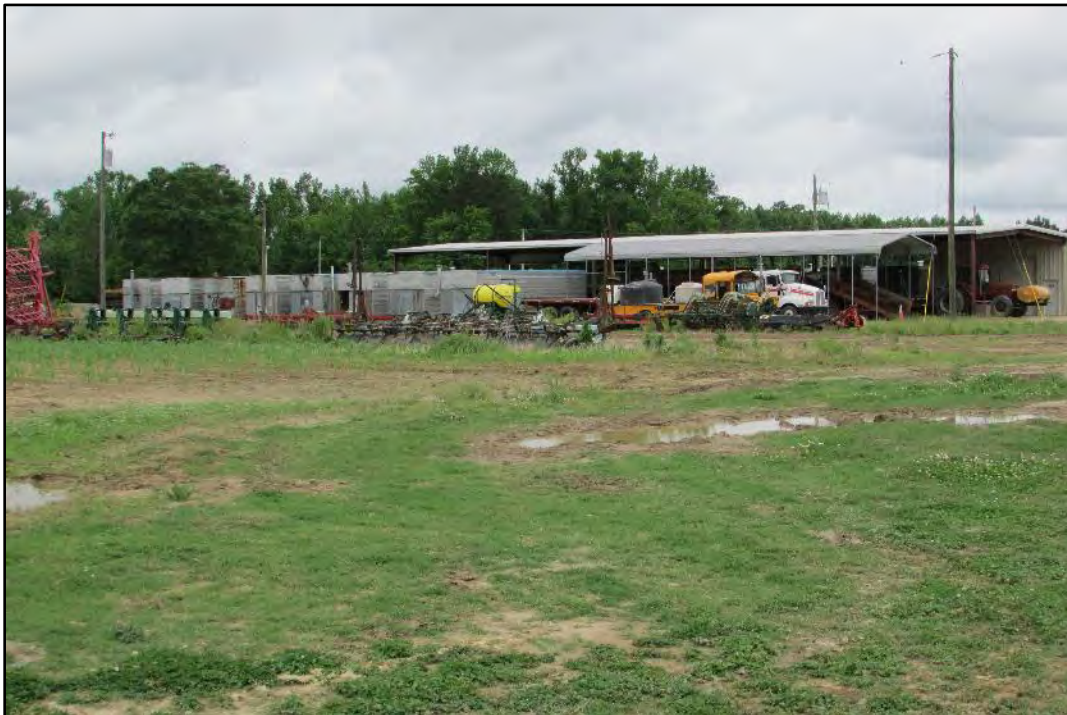
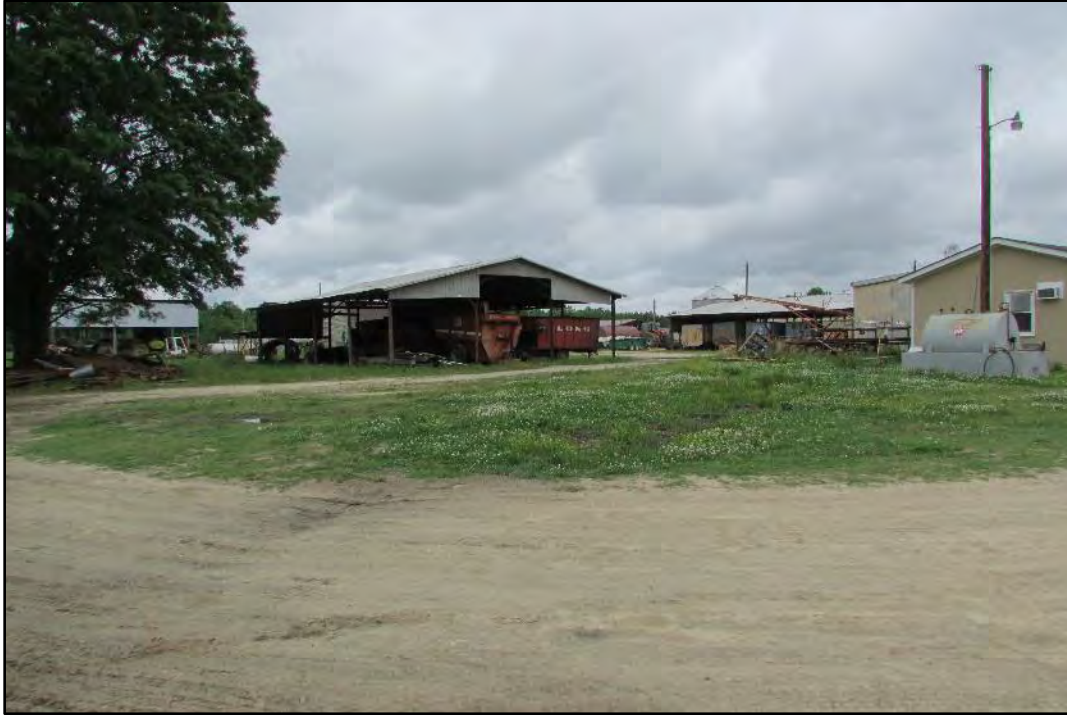
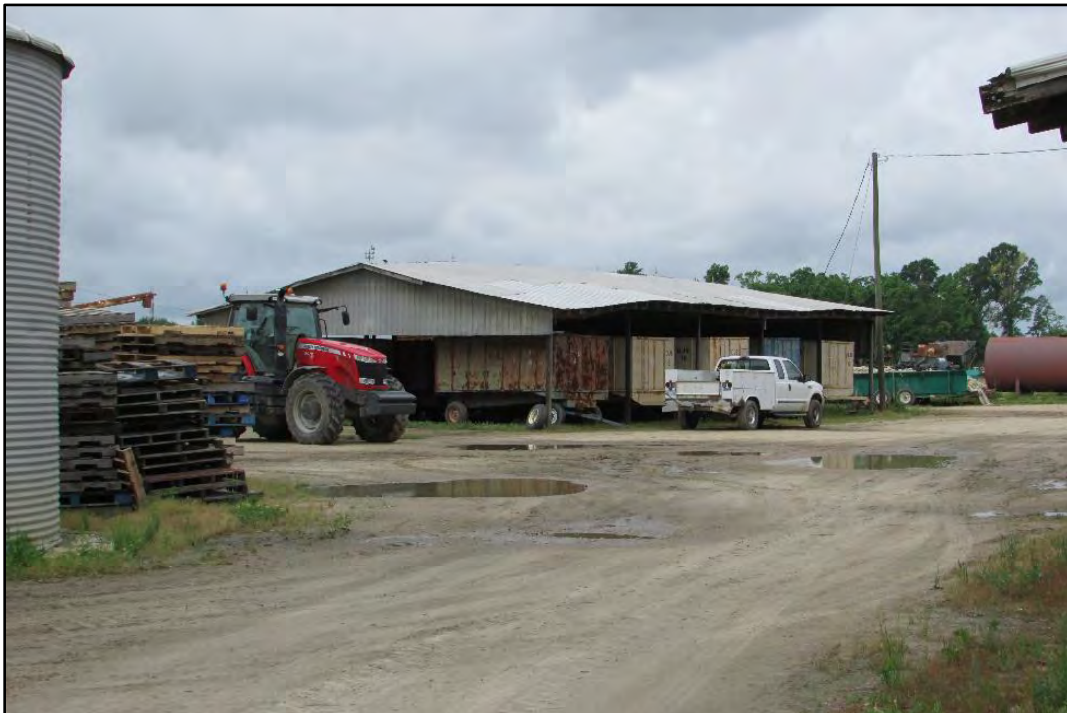
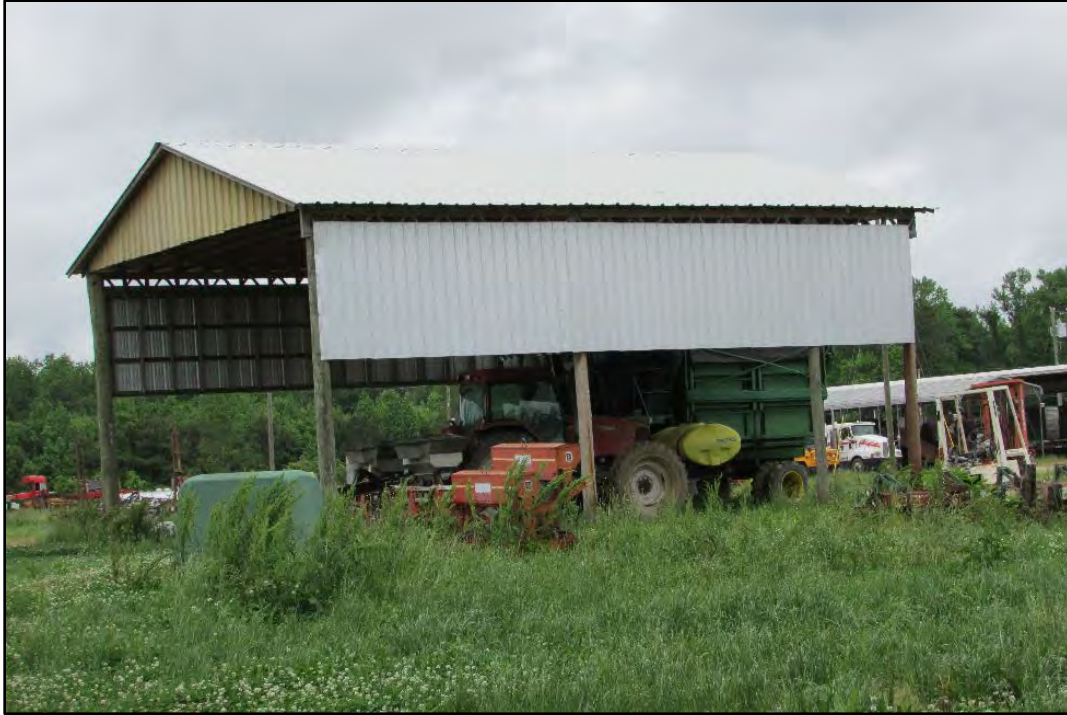
**Figure 37. Pole Barn (#8 on site plan), looking west.**

**Figure 38. Pole Barn (#9 on site plan), looking southwest.**

**Figure 39. Pole barn and carport (#10 on site plan), looking northwest.**

**Figure 40. Pole barn (#11 on site plan), looking northwest.**

**Figure 41. Pole Barn (#12 on site plan), looking southwest.**

**Figure 42. Pole barn (#13 on site plan), looking northwest.**

Six pole barns with gable roofs surfaced with sheet metal and supported by square wood posts are on the property (#8 [Figure 37], #9 [Figure 38], #10 [Figure 39], #11 [Figure 40], #12 [Figure 41], and #13 [Figure 42] on the site plan). These structures first appear on aerials starting in 1983 with the latest built ca. 2016 (NETR 1993, 1994, 1998, 2006, 2008, 2009, 2010, 2012, 2014, 2016, 2018).

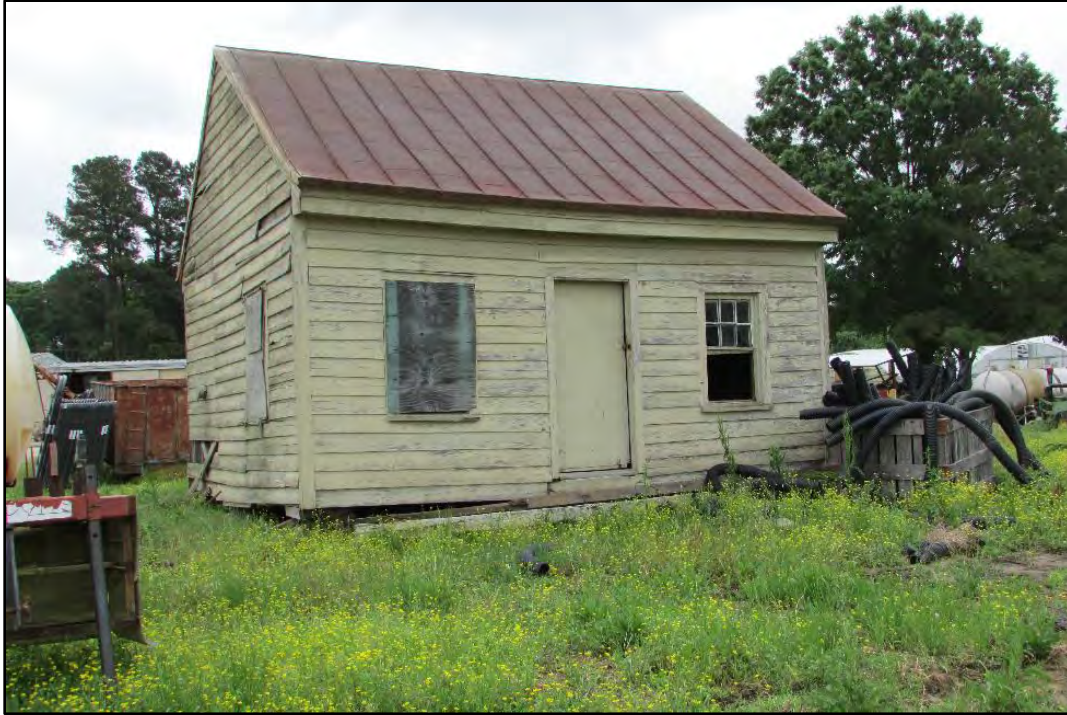
**Figure 43. House (#14 on site plan), looking southeast.**

This small, wood frame structure appears to date from the 1940s, but was moved to the site between 1998 and 2006 (#14 on site plan; Figure 43; NETR 1998, 2006; Google Earth 1998, 2006). The owner's grandson and manager of the property, Phillip Watson, indicated that this was the former post office in Gold Rock, but no independent verification of that was found (Watson 2018). In poor condition, its original location and use remain unknown, but it may have served as a house or small office. The rectangular building is sheathed with weatherboard siding and rests on a wood and concrete block pier foundation. The side gable roof has minimal overhanging eaves and is surfaced with standing seam metal. Most of the windows are covered with plywood, but a six-over-six wood, double-hung sash is independently placed on the front (west) façade. Centrally-located entrances on the east and west elevations have simple plywood doors.

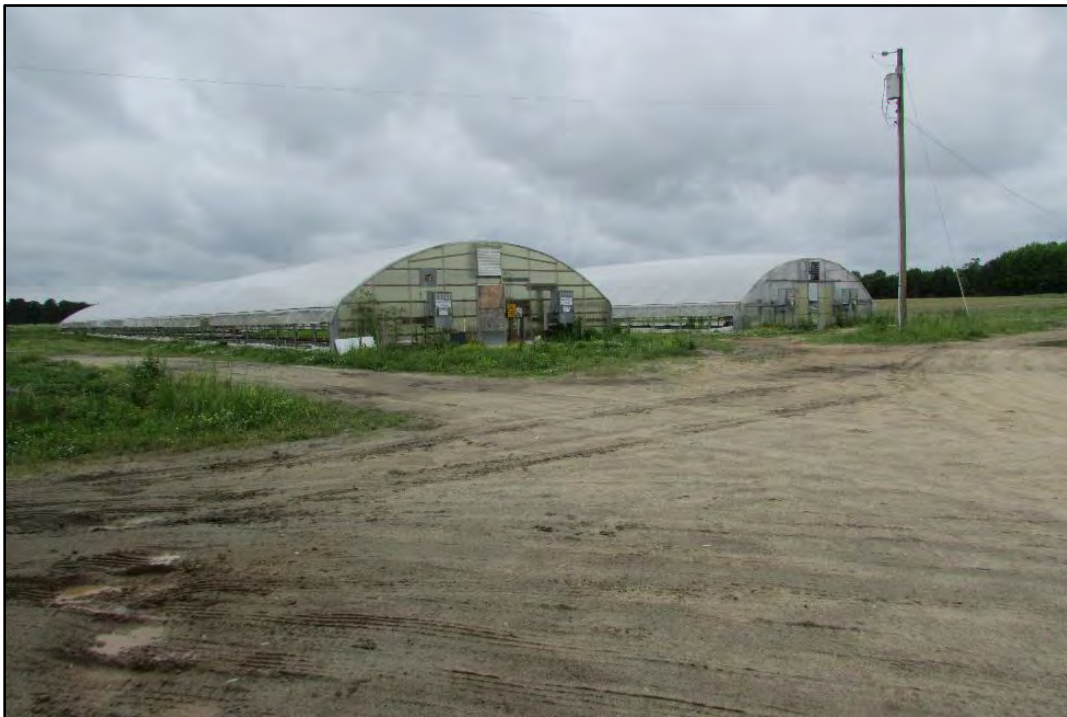
**Figure 44. Greenhouses (#15 on site plan), looking southwest.**

Two greenhouses, with steel structures and plastic panels, were installed onsite between 2012 and 2016 (#15 on site plan; Figure 44; Google Earth 2012, 2014, 2016).

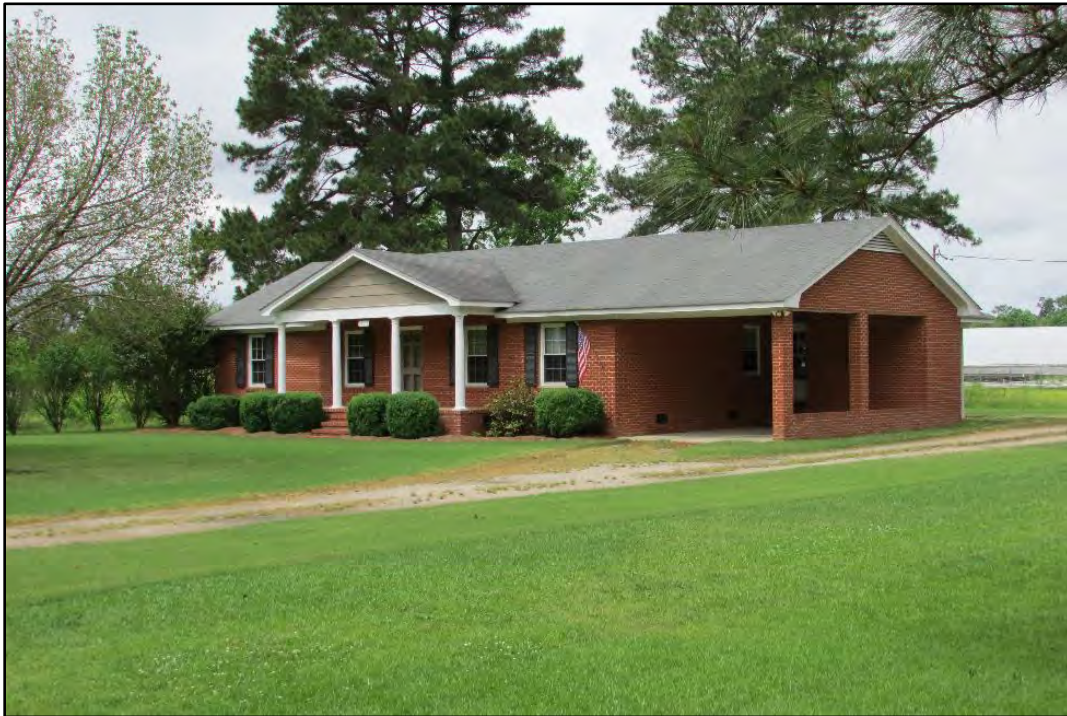
**Figure 45. 12612 NC 48 (#16 on site plan), looking southwest.**

The Ranch style house situated at 12612 NC 48 was built on the parcel in 1971 according to the property records (#16 on site plan; Figure 45). The main mass of the structure is rectangular and incorporates a carport at the north end. The masonry structure is clad with brick veneer set in a common bond pattern and topped by a side gable roof surfaced with composition shingles. A gable roofed entrance portico is supported by Tuscan columns and shelters a six-panel front door. Windows are six-over-six, single-hung sash vinyl placed independently and flanked by fixed louvered shutters. A gable roofed porch extends off of the rear elevation and is supported by metal pipe posts. Aluminum siding and louvered vents are in the gable ends.

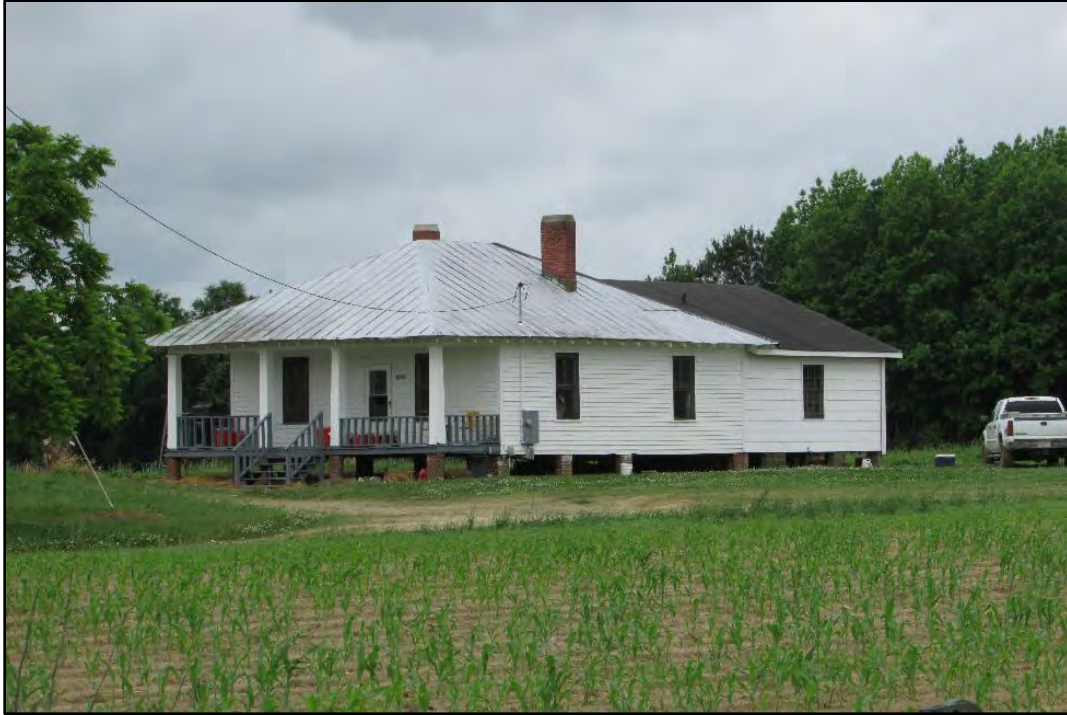
The residences at 12644 NC 48 (NS1498; Figure 46; #17 on site plan) and 8101 Swift Creek School Road (NS1499; Figure 47; #18 on site plan) are on the same parcel, but were assigned site numbers as part of the *Architectural Reconnaissance Survey of the Atlantic Coast Pipeline Project Corridor, Northampton, Halifax, Nash, Wilson, Johnston, Sampson, Cumberland, and Robeson Counties, North Carolina* (Dovetail Cultural Resource Group 2016:69-70). These two historic buildings will be addressed independently in the following two sections.

**Figure 46. 12644 NC 48 (#17 on site plan), looking southwest.**

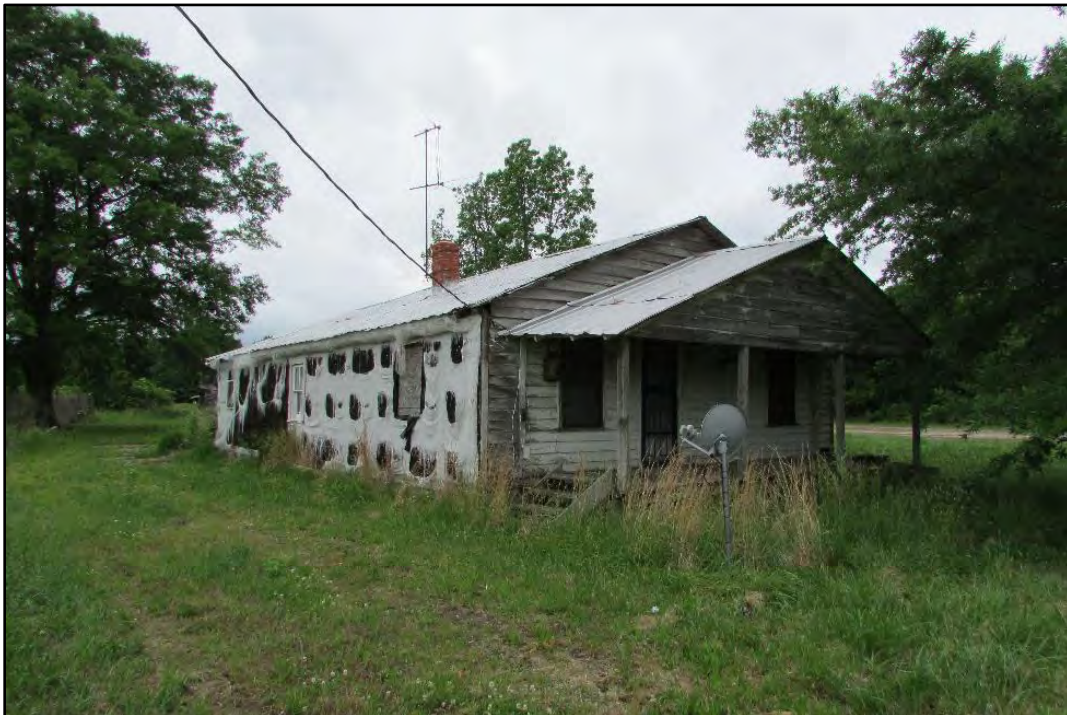
**Figure 47. 8101 Swift Creek School Road (#18 on site plan), looking southwest.**

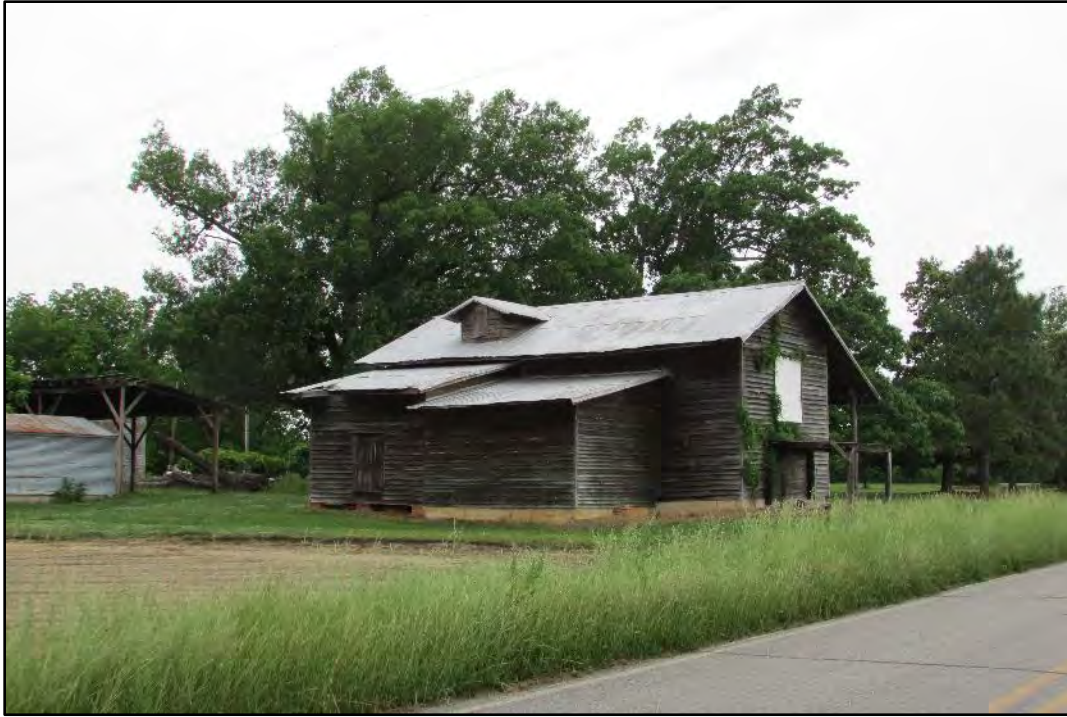
The Davenport Cotton Gin was constructed in the 1930s as a family farm gin likely built by Offie Davenport (ED646). The two-story sawn frame structure is clad with weatherboard and topped

by a gable roof (Figure 49). The drive-through overhang remains on the north elevation, and the seed room is attached on the south elevation. A newer addition is adjacent to the seed room. At the time of the 1984 survey, part of the seed auger remained in the building, but the remaining machinery was removed.

**Figure 49. Davenport Cotton Gin, dating from the 1930s, south and east elevations.**

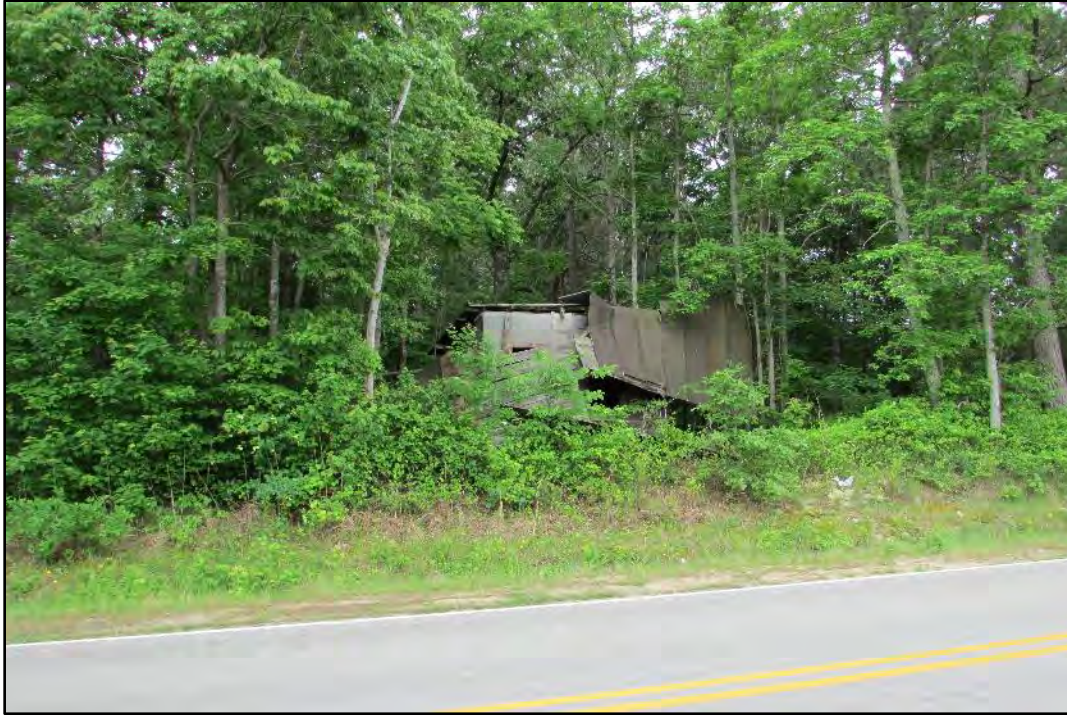
**Figure 50. Cousins Cotton Gin, constructed in 1919, north elevation.**

When recorded in 1986, the Cousins Cotton Gin was noted as one of Halifax County's few surviving cotton gins (HX144). Built in 1919 by the M.E. Cousins family, the gin remained in operation until after World War II. The building was a two-story edifice clad with sheet metal and topped by a gable roof. Now in ruins, only a one-story crumbling structure was evident during the field visit (Figure 50). It had an attached seed house and power shed. Due to its condition, it has lost integrity and does not appear NRHP eligible.

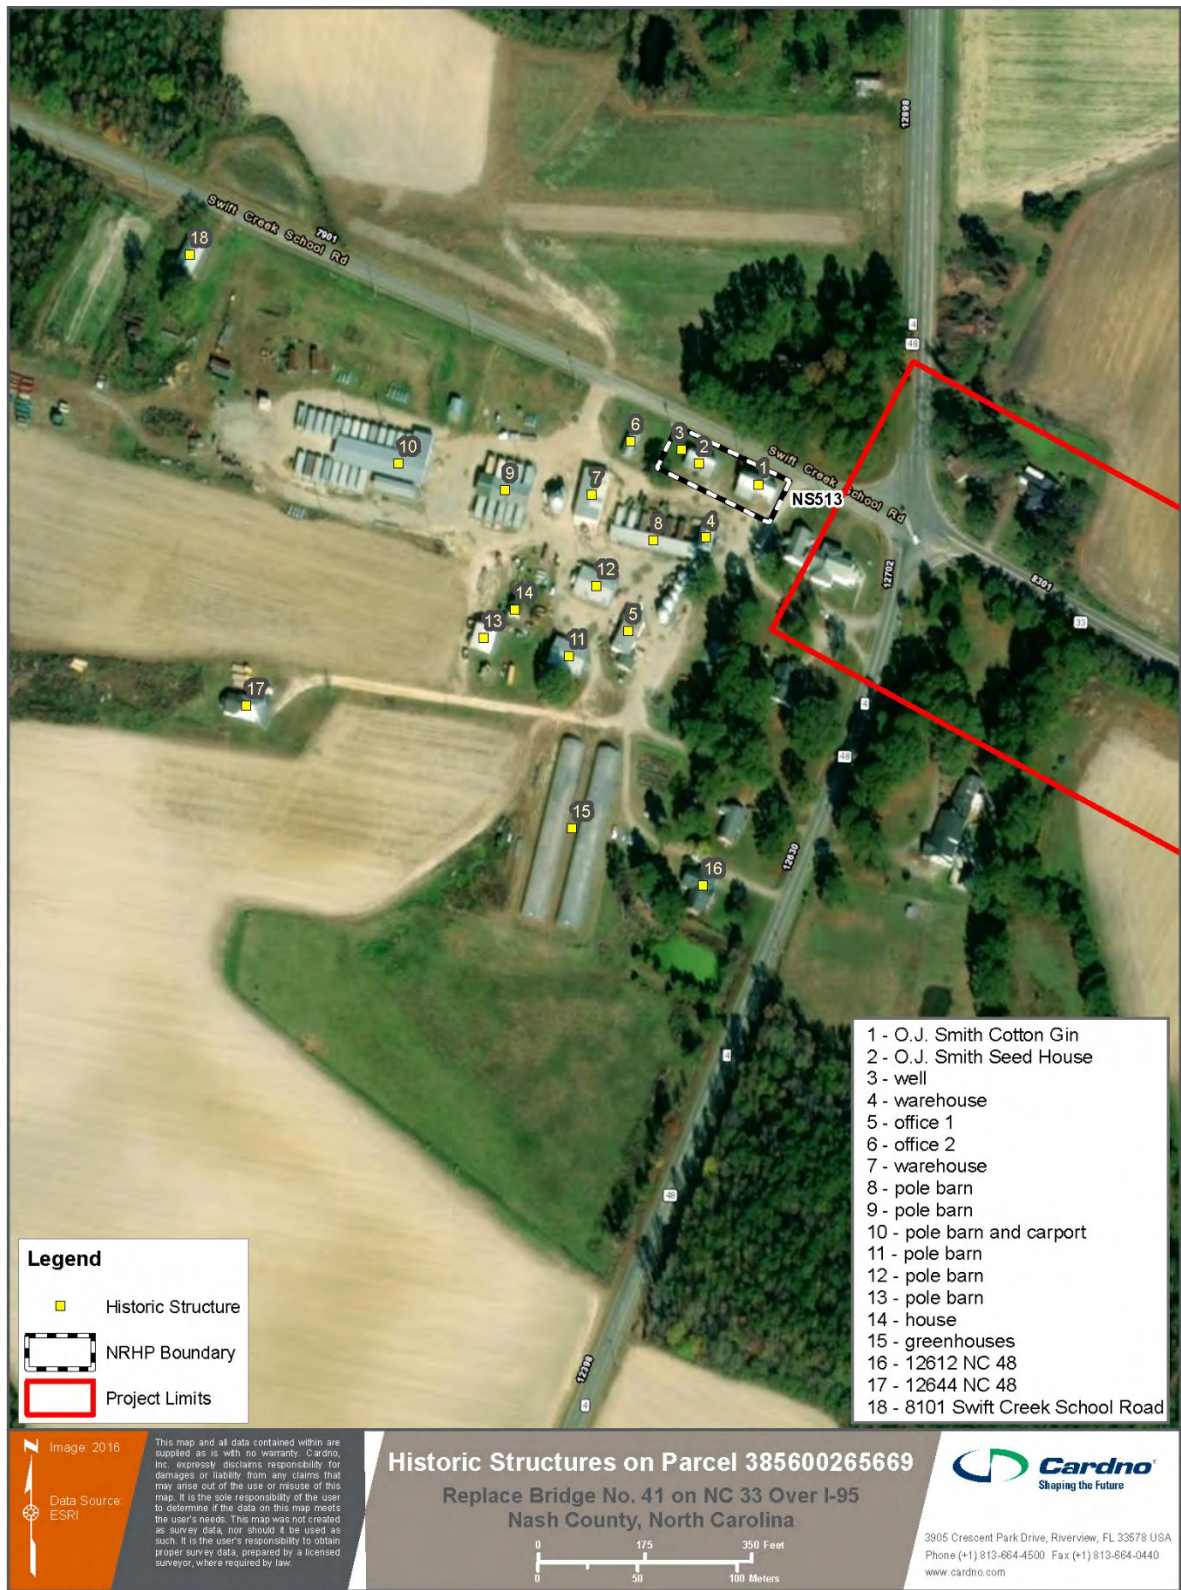
**Figure 51. O.J. Smith Cotton Gin, proposed NRHP boundaries.**

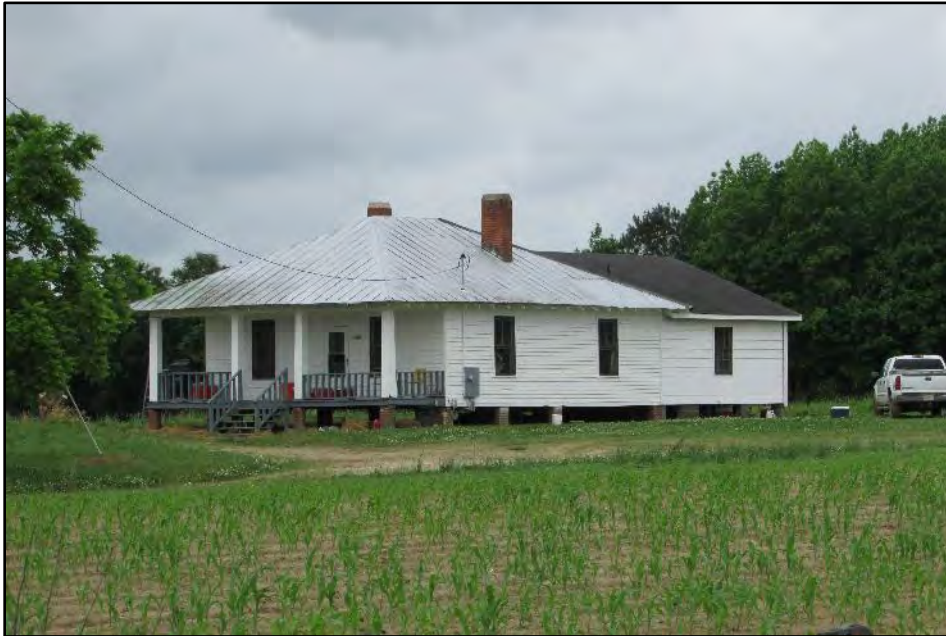
**Figure 52. Faucett House, 12644 NC 48, looking southwest.**

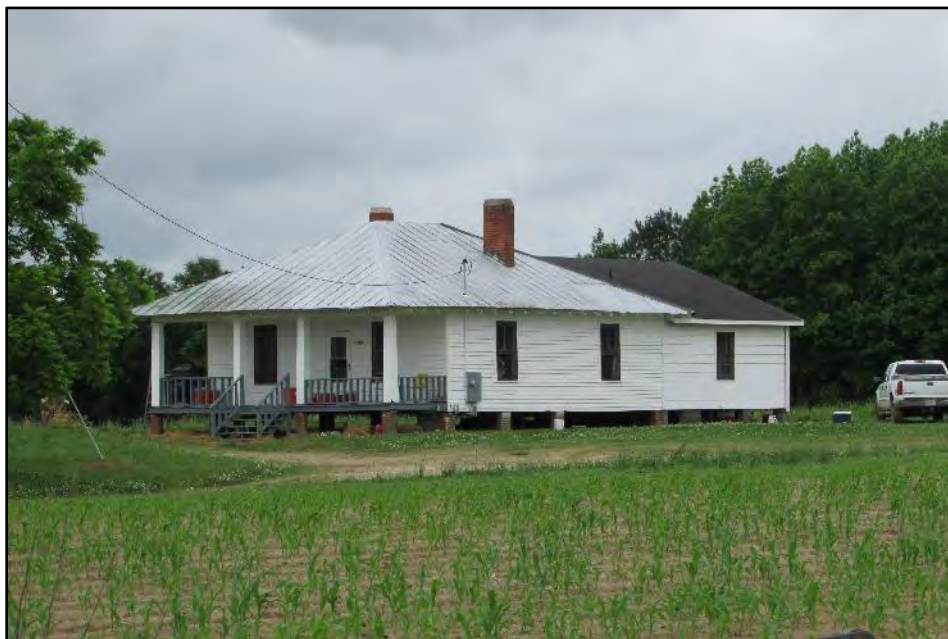
Access to this house was limited as requested by the occupant. The house at 12644 NC 48 is a one-story, center hall, double-pile house (Figure 57). The original mass of the structure was two rooms wide by two rooms deep separated by a central hall extending from the front entrance to the rear. Interior brick chimneys mark the separation of rooms on each side of the hall. The central portion of the house has the character-defining large pyramidal hip roof surfaced with standing seam metal decorated with exposed rafter ends in the eaves. A full-width front porch on the east façade is set under the main roof and supported by battered wood posts. The wood frame structure is dressed in weatherboard siding and rests on a brick pier foundation. Windows are wood, two-over-two double-hung sash set independently. The main entrance has a metal storm door set in front of the three-light, three-panel wood door. Wood steps bordered by a simple wood railing which extends around the edge of the porch provides access to the house. Around 1982, an addition was attached across the rear (west) elevation changing the formerly square shaped residence into a rectangular form. The addition has a composition shingle clad gable roof, aluminum siding, and a concrete block pier foundation. Windows in the addition are six-over-six double-hung sash placed independently and paired. A shed roofed porch denotes the rear entrance.

**Figure 57. Faucett House, 12644 NC 48, looking southwest.**

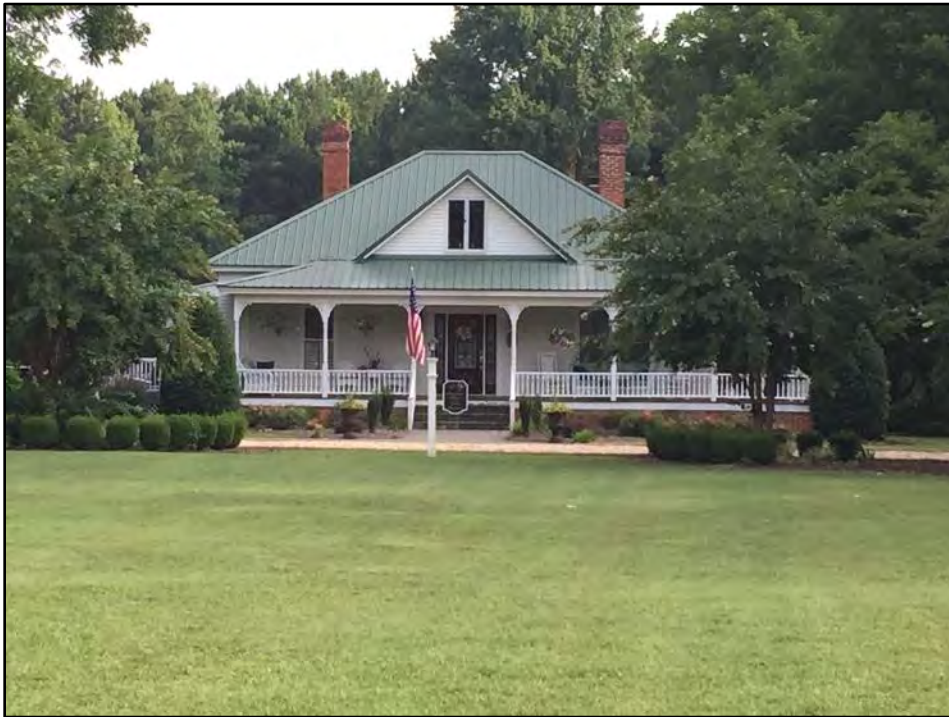
**Figure 60. John Jordan House (NS604), 7290 Jordan Road, Sharpsburg vicinity, looking north.**

Located near Sharpsburg, the John Jordan House (NS604) was built in 1920 (Figure 60). It has the characteristic large hipped roof and double-pile form with chimneys marking the division of rooms on the east and west. Both the double-pile form and the Queen Anne inspired wrap-around porch are unusual for 1920s era construction. Although it retains good integrity overall, it appears to have been modernized with replacement windows. The structure was built by contractor Bob Viverette for farmer John Jordan (Mattson and Poff 1987:268).

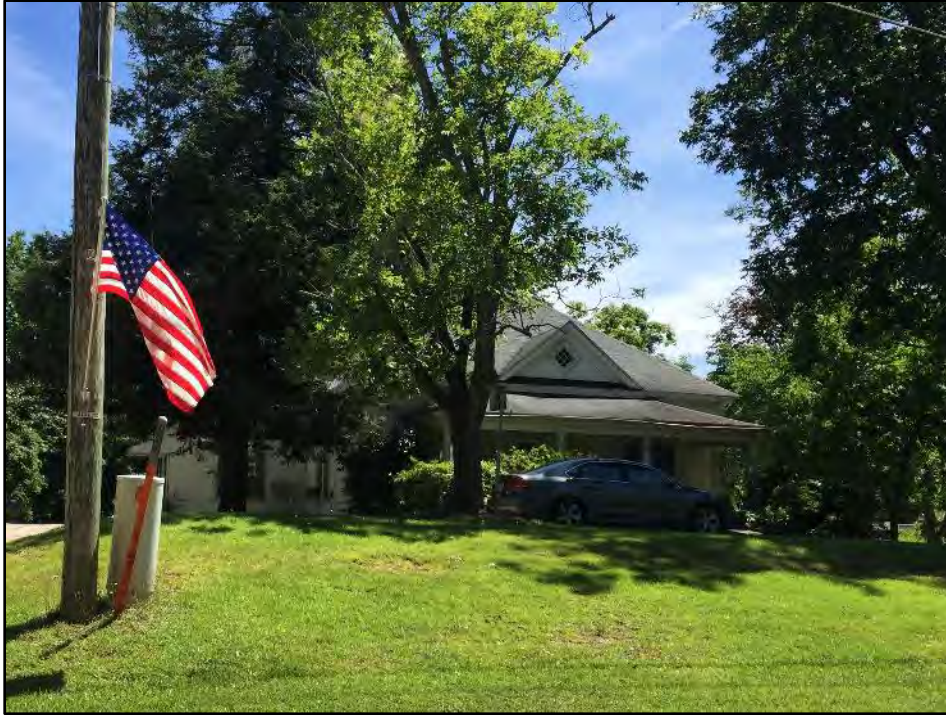
The cottage with a double-pile plan and large hipped roof located 8523 Red Oak Boulevard was built during the early twentieth century for Red Oak physician Dr. Joseph E. Ellen (NS434; Figure 61). The building exhibits the characteristic form with chimneys marking the division between rooms on the north and south. A hipped roof porch with square supports extends across most of the front elevation. Decorative features include a nine-light diamond shaped window set within a gable on the front façade. In the early 1920s, Dr. Joseph Henry Martin occupied the residence and maintained an office in a separate building on the parcel (Mattson and Poff 1987:216).

**Figure 61. Drs. Ellen-Martin House (NS434), 8523 Red Oak Boulevard, Red Oak, looking northeast.**

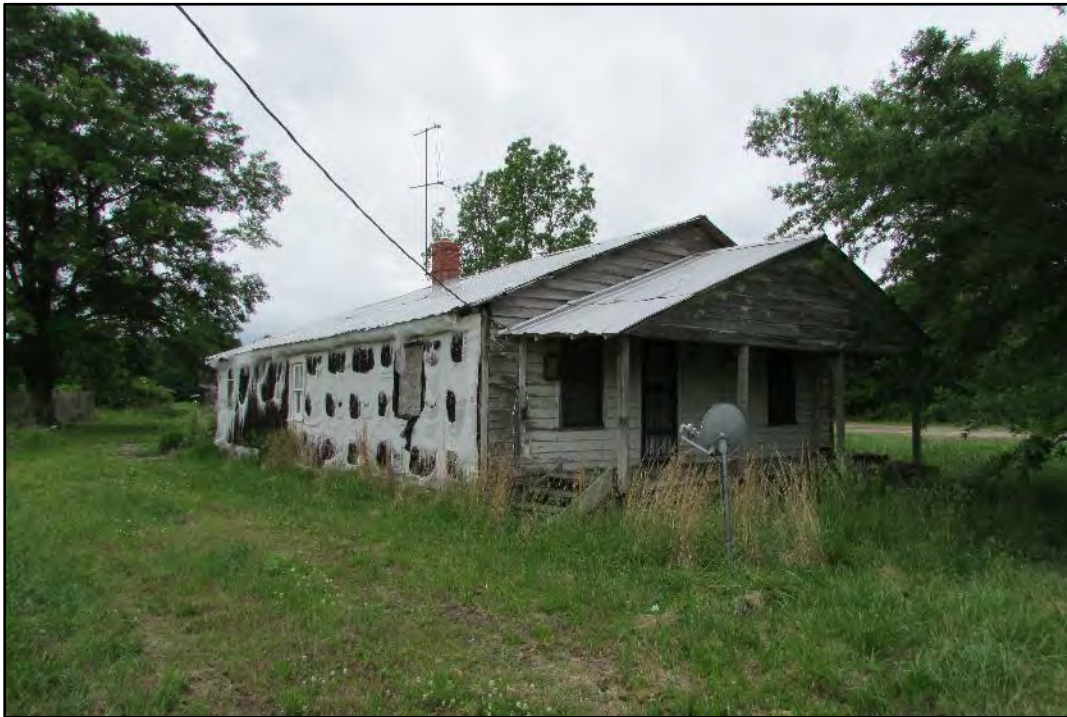
**Figure 62. Smith Tenant House, 8101 Swift Creek School Road, looking southwest.**

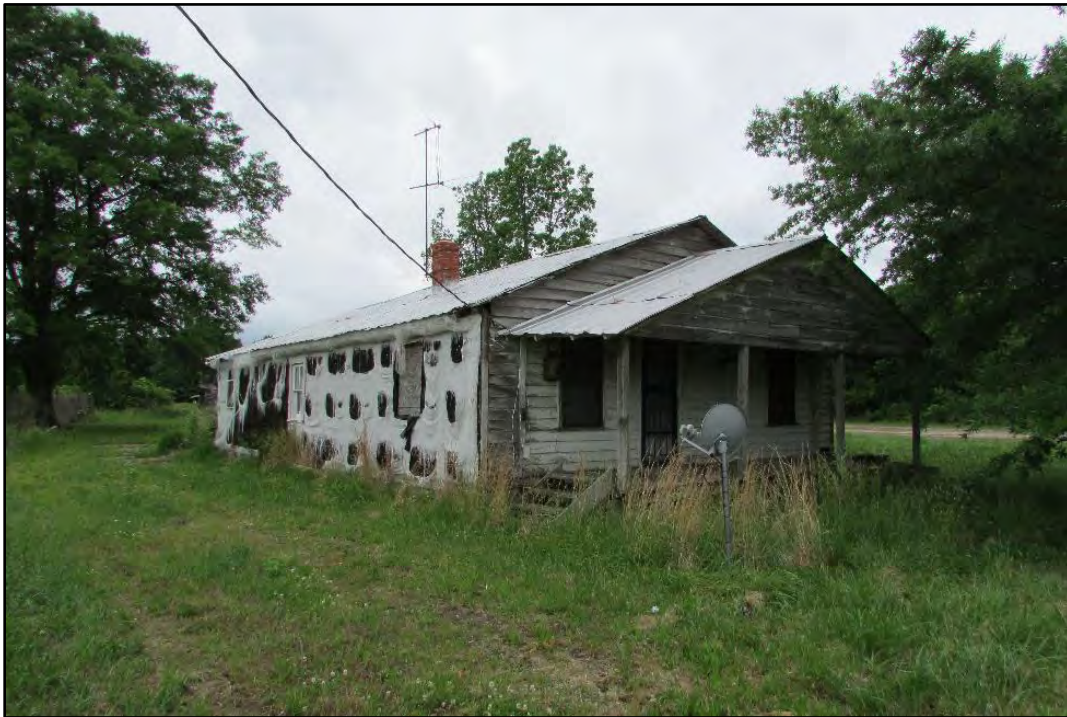
**Figure 65. Smith Tenant House, 8101 Swift Creek School Road, looking southwest.**

The Smith Tenant House at 8101 Swift Creek School Road is a rectangular building with a gable roof surfaced with 5V crimp pierced by two interior brick chimneys on the east and west slopes

(Figure 65). The front of the building retains its original weatherboard siding, but it has been removed from the remaining elevations leaving the underlayment and plywood open to the elements (Figure 66). Overall, the building is in a deteriorated condition. Resting on a concrete block pier foundation, the wood frame building has a mixture of six-over-six and two-over-two, wood double-hung sash windows, as well as a few one-over-one vinyl replacement double-hung sash windows. The windows are placed independently. The main entrance has a five-panel wood door behind a metal storm door that is set off-center within the front porch which is supported by square wood posts. The rear has a small shed roofed addition constructed of plywood. Decorative elements include exposed rafter ends and vents in the gable ends. A wood frame outbuilding in ruinous condition (Figure 67) and a privy (Figure 68) constructed of plywood are in the rear yard.

Although the Smith Tenant House remains indicative of its original design as a traditional Bungalow tenant house in Nash County, it does not possess high artistic merit. The removal and partial replacement of original materials has impacted the architectural integrity of the building. The house was once part of a tenant farm, but the majority of the outbuildings have been lost indicating that it is not an intact agricultural landscape. Other, more intact, examples of this form exist throughout the county. Therefore, it is not recommended as eligible for listing in the NRHP under Criterion C for its physical design and construction.

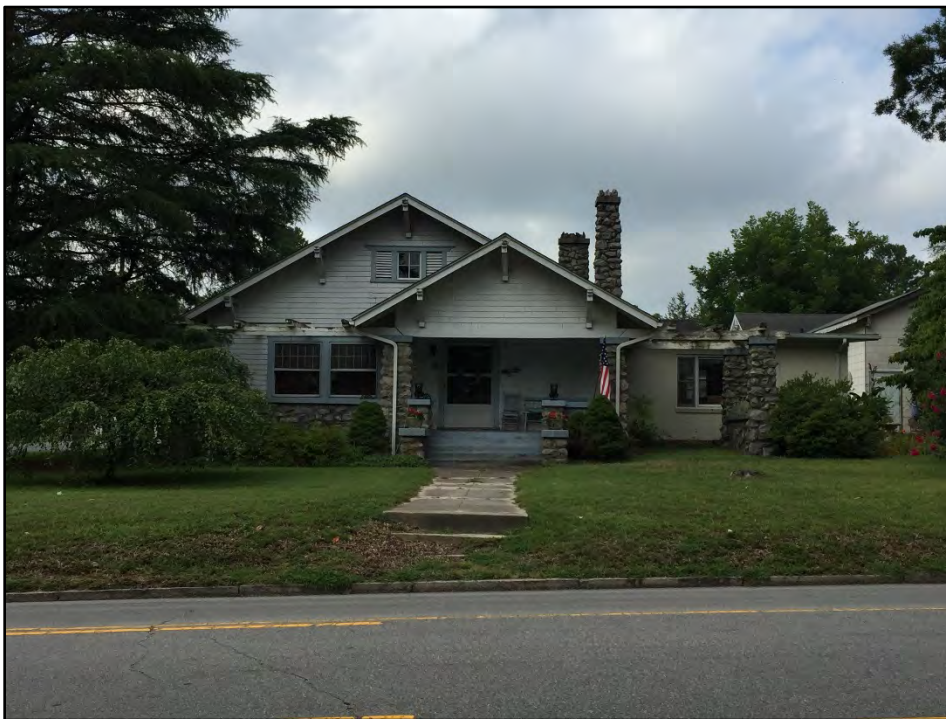
**Figure 70. Guy Bissett House (NS178), 413 E. Washington Street, Nashville, looking south.**

Of the multitude of Nash County residences recorded in the North Carolina state survey inventory maintained by the HPO, three examples of Bungalows profiled in *The History and Architecture of Nash County, North Carolina* were selected for comparison. These include, the Guy Bissette House (NS178), the Ira Winfield Rose House (NS713), and the Nick Ross House (NS113). All three of the examples are maintained and have good integrity. Constructed ca. 1915, Guy Bissette House (NS178) exhibits the gable front Bungalow form with an inset gabled porch (Figure 70).

Although the original rectangular form is identifiable, the integrity of the design has been compromised by an incompatible addition on the west elevation. However, many of its decorative elements remain intact. The exterior is surfaced with wood shingles, and the roofline is accented by knee braces. The most notable feature is the cobblestone porch, porte cochère supports, and chimneys. Windows are twelve-over-one double-hung sash with a horizontal emphasis typical of the Craftsman style. The structure was built by George N. Bissette for his son, Guy (Mattson and Poff 1987:179).

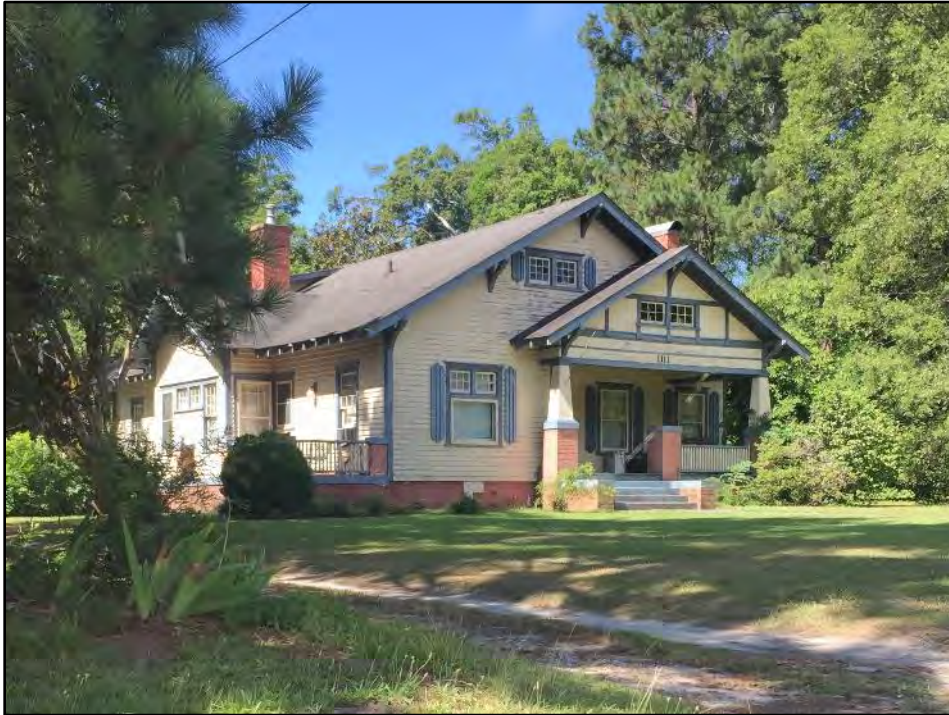
**Figure 71. Ira Winfield Rose House (NS713), 1111 Sunset Avenue, Rocky Mount, looking southwest.**

Of the three examples, the Ira Winfield Rose House (NS713) is the most ornate example of a Bungalow (Figure 71). Built by contractor D.J. Rose around 1917, this residence was constructed for druggist Ira Winfield Rose. It has the rectangular, gable front form with an offset gable front porch supported by battered posts set on brick piers. Knee braces and exposed rafter ends accent the eaves. The wood frame building is clad with clapboard and stucco with half-timbering in the gable end. Windows are a combination of double-hung sash, casement, and cottage with multiple

light configurations. Although in need of some maintenance, it appears to retain excellent integrity (Mattson and Poff 1987:281)

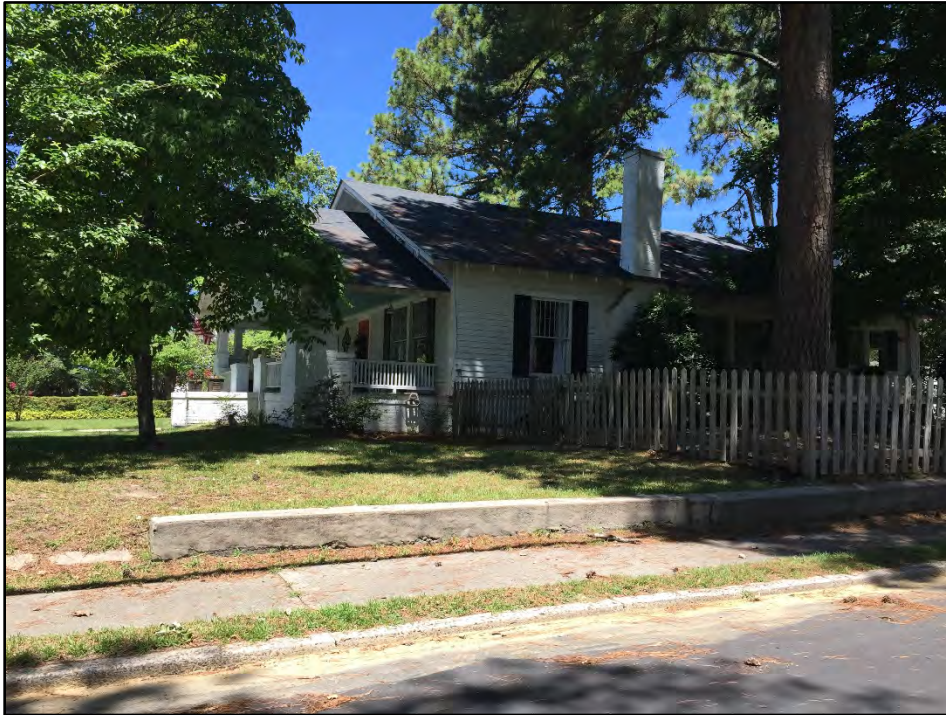
**Figure 72. Nick Ross House (NS113), 112 E. Washington Street, Nashville, looking northwest.**

Nick Ross, who operated a dairy farm and served as mayor of Nashville, built this Bungalow at 112 E. Washington Street (NS113) in 1918 (Figure 72). It has the character defining rectangular form with a front gable roof and an almost full width front porch. The porch has grouped tapered wood posts set on brick piers. Windows are decorative sixteen-over-one-light double-hung sash paired and set independently. Decorative elements include exposed rafter ends and knee braces (Mattson and Poff 1987:173). This house retains excellent integrity with its original form and design intact.
