April 1996

**Historic Structures Survey at Seymour Johnson Air Force
Base, Goldsboro, Wayne County, North Carolina**

**United States Air Force
Air Combat Command**

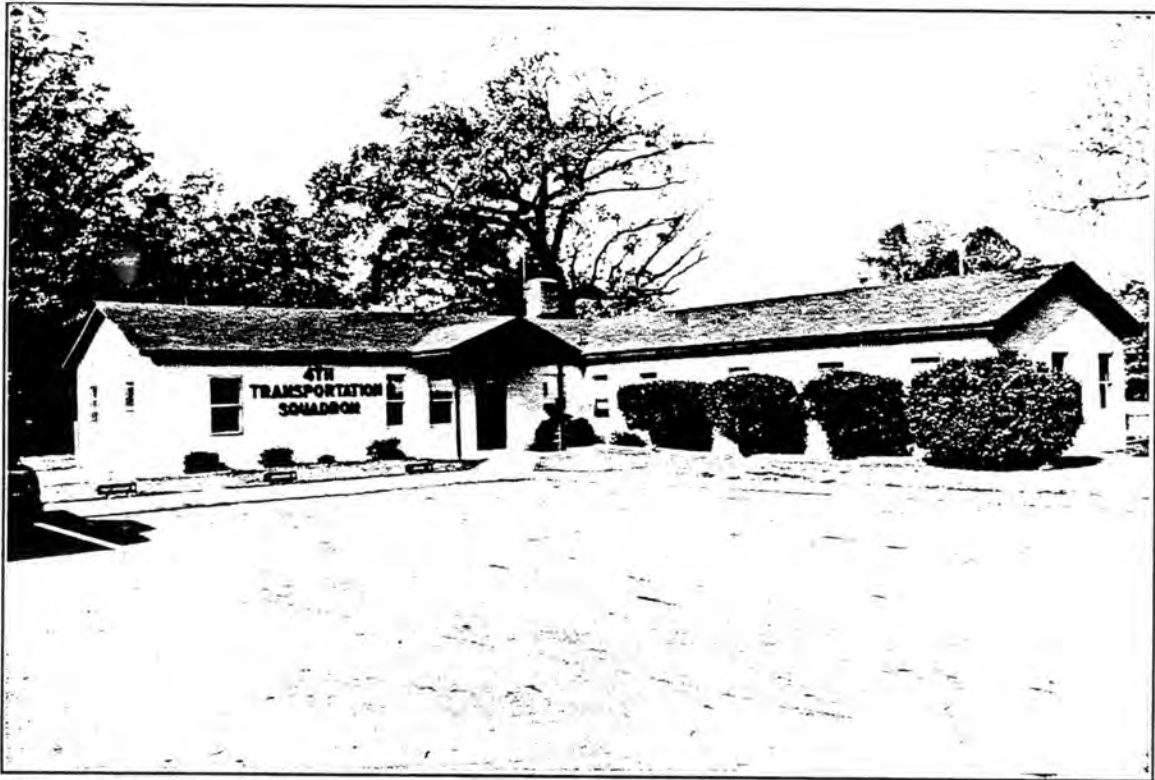
Plate 4. Building 3681 - 4th Transportation Squadron Building.

BUILDING 3681. 4TH TRANSPORTATION SQUADRON BUILDING. Building 3681 is located at 1215 Cannon Street near Pope (Plate 4). This concrete block structure has four principal wings which date to the Second World War. A fifth wing on the northeast side of the building was added at a later date. The structure is one story high with a gabled roof, whose line is broken by an interior brick chimney located near the center of the building. Fenestration is symmetrical and the replacement double-hung windows have 1/1 lights .

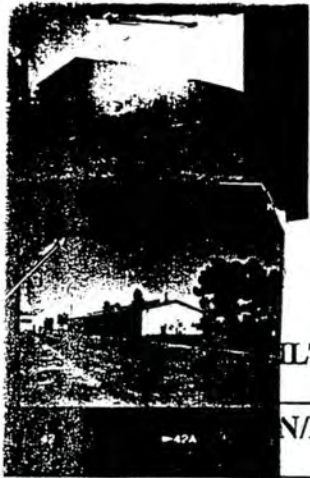
COMMENTS: Located on RR tracks; covered plywood loading dock area near upright posts. One of the few wood structures remaining on base. Features some original floors with metal strap hinges. Original Card indicates this was built in 1942 then shown as retired. Had various storage uses. May have been moved.

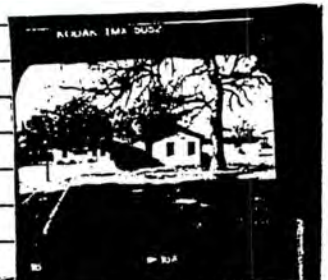
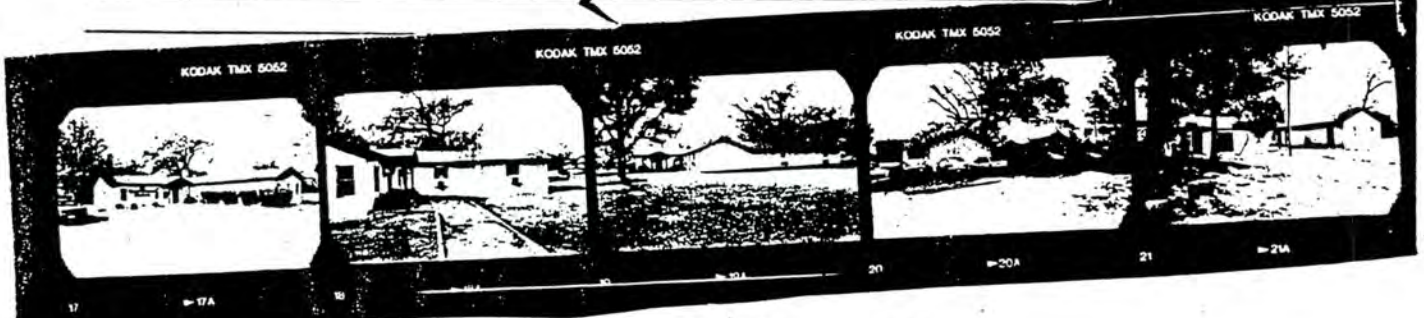
COMMENTS: Overhanging eaves; Inside completely remodelled and repanelled.
Gable roof, has four principal wings. Interior brick chimney at rear center
of structure. All windows have storm windows; windows sash-type. Building
has look of later mid-20th century. Slated for demolition. On real estate
card, originally listed as Red Cross Office. Later changed to Nursery School,
Child Care Center. Originally shown as semi-permanent, later shown as sub-
standard. Patio and sidewalk added in 1986; "redesigned" in 1971; ceiling
tile added in 1967; additions built in 1966. Now has courtyard area in back.
Boiler now inside old chimney.

Slated for demolition

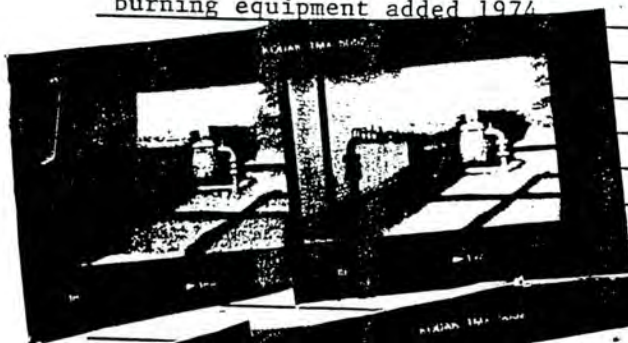
COMMENTS: Main boiler plant for hangars; outside are elevated steam pipes running from boiler to hangars. Twin of 4502. Combines fixed and hinged windows, multi-pane, allows ample light to enter building. Six main bays on one side, three on other side near section used to contain fuel. Can see exposed steel beams. On real estate card: concrete foundation and floor; building listed as "donated". Electrical system modified 1967, elevator installed 1971, damper installed 1978, monitoring system installed 1979. Coal handling facility removed 1973. Facility remodelled 1957, changing square feet from 5246 sq. ft. to 4539 sq. ft. Listed in 1957 as Low Pressure Heating Plant (with 116 horsepower), later changed to 90 hp each with 450 hp total. Other modifications include steam plant modification in 1964; coal and ash handling equipment modified 1965; ash and coal conveyors removed 1972; oil burning equipment added 1974.

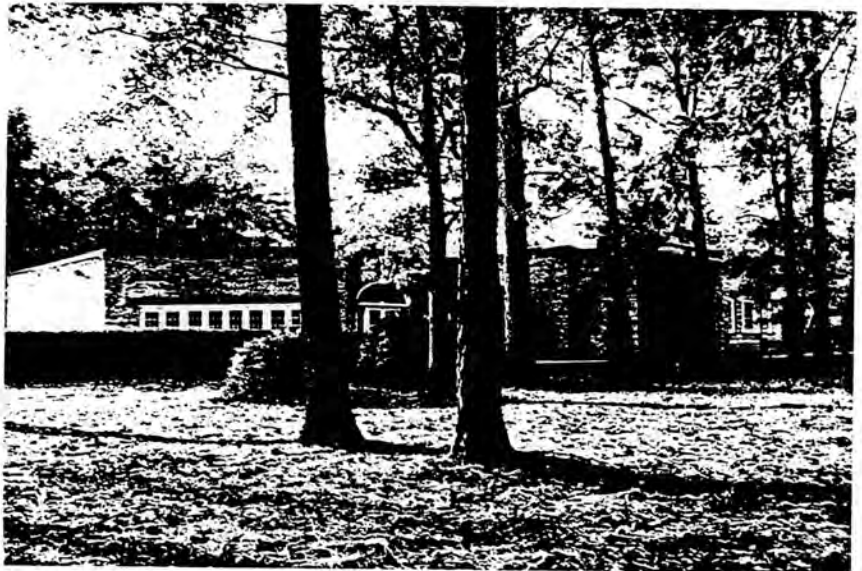
Building No. 1600

Date of Construction 1957
Original Use Officers' Mess
Current Use Officers' Club

Structural System Masonry.
Wall Covering Brick veneer.
Foundation Brick on concrete footings.

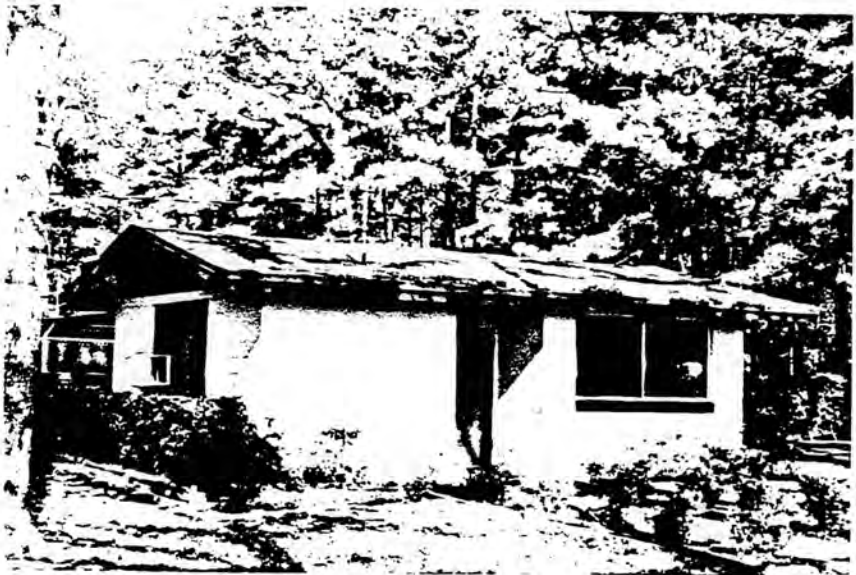
Date of Construction 1959
Original Use Kennel Support Facility
Current Use Kennel Support Facility

Structural System Concrete block.
Wall Covering Painted.
Foundation Block on concrete slab.

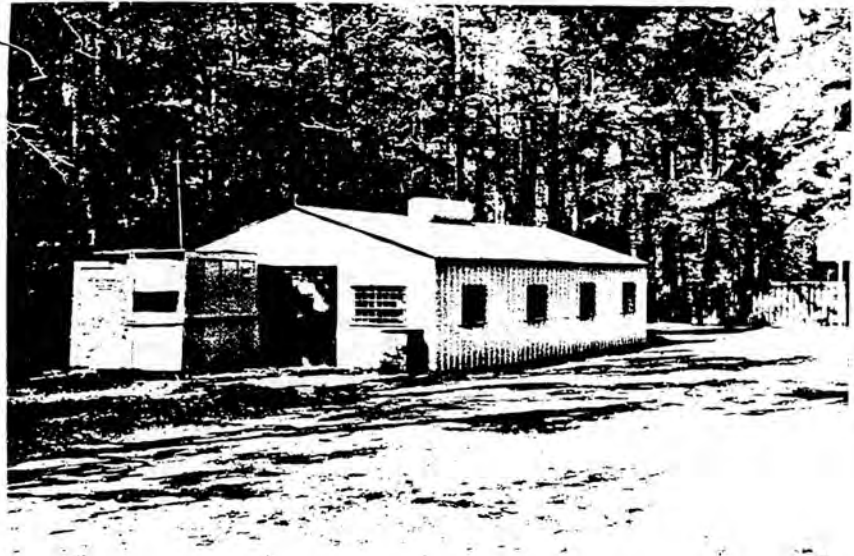
Building No. 1911

Date of Construction 1983
Original Use K-9 Training Facility
Current Use Security Police Fac.

Structural System Metal frame.
Wall Covering Metal siding.
Foundation Concrete slab.

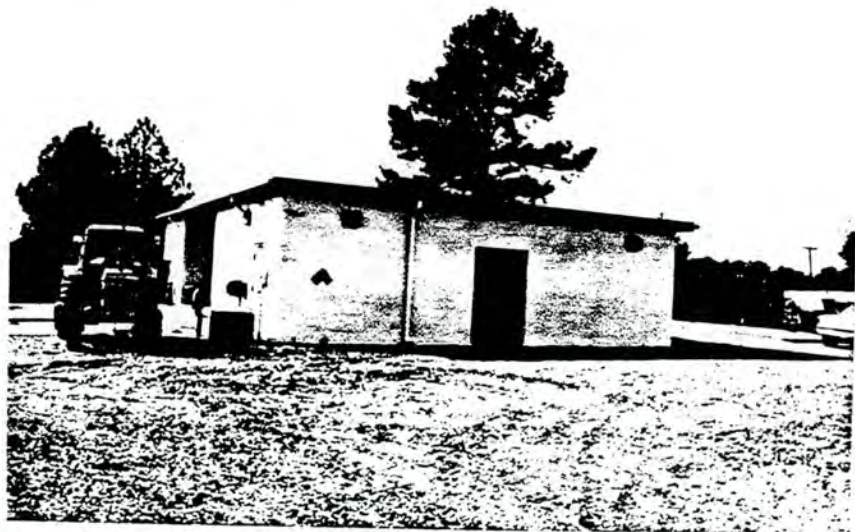
Building No. 2020

Date of Construction 1986
Original Use Cold Storage Building
Current Use Cold Storage Building

Structural System Masonry.
Wall Covering Brick veneer.
Foundation Block on concrete footings.

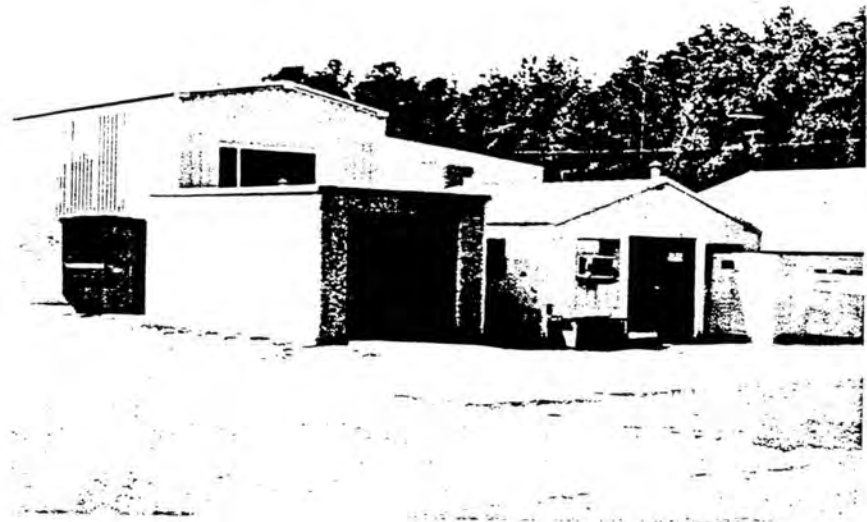
Building No. 2503

Date of Construction 1973
Original Use Special Services
Current Use Warehouse

Structural System Masonry bearing walls.
Wall Covering Metal panels..
Foundation Block on concrete slab.

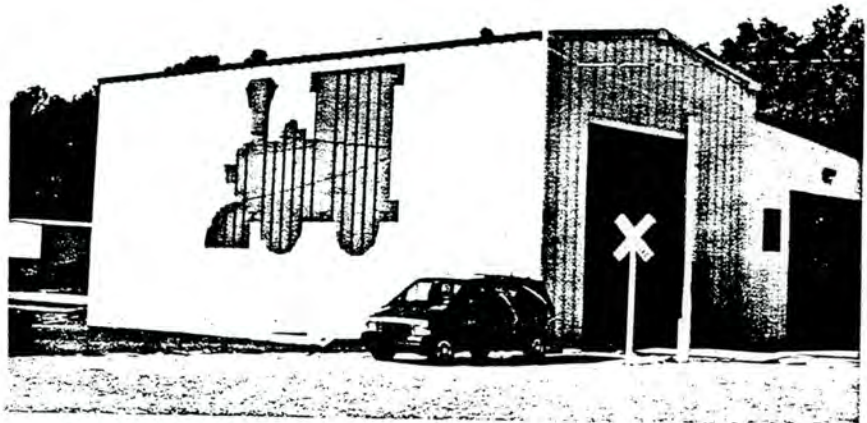
Building No. 2505

Date of Construction 1961
Original Use General Shop.
Current Use Locomotive Storage.

Structural System Steel frame.
Wall Covering Corrugate.
Foundation Concrete slab.

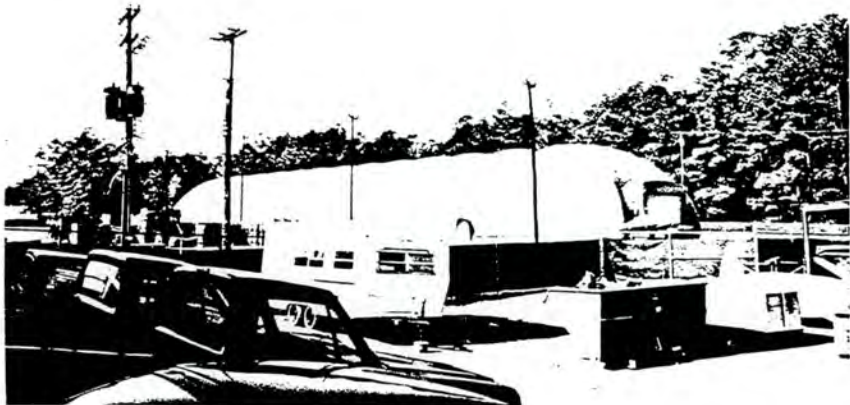
Building No. 2507

Date of Construction 1985
Original Use Warehouse
Current Use Warehouse

Structural System Canvas over frame modular.
Wall Covering Canvas.
Foundation Concrete pad.

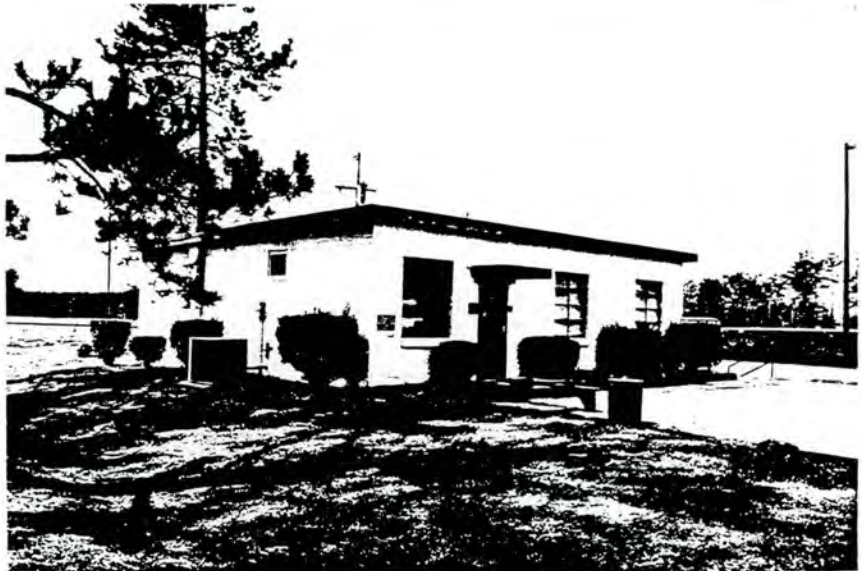
Date of Construction 1962
Original Use Med/Food Inspection
Current Use Animal Clinic

Structural System Masonry.
Wall Covering Painted.
Foundation Block on concrete footings.

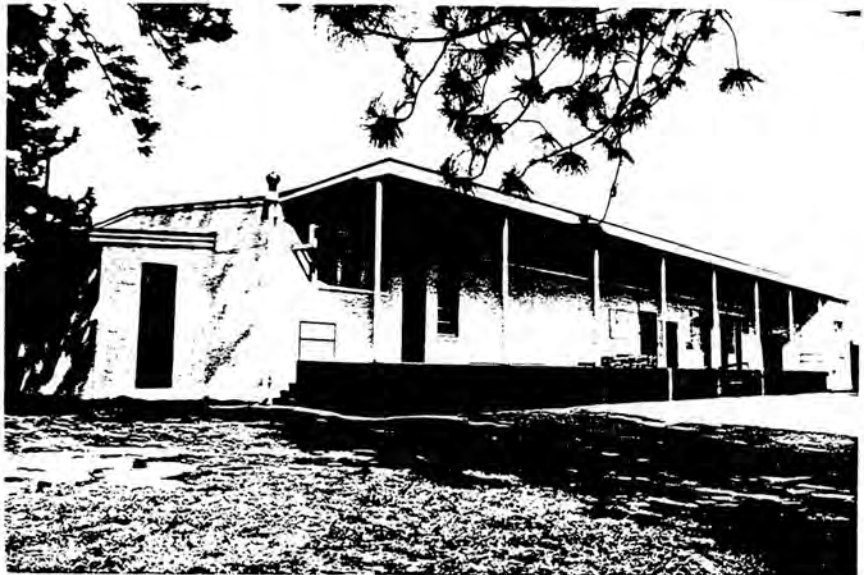
Date of Construction 1957
Original Use Cold Storage
Current Use Cold Storage

Structural System Masonry.
Wall Covering Painted.
Foundation Block on concrete slab.

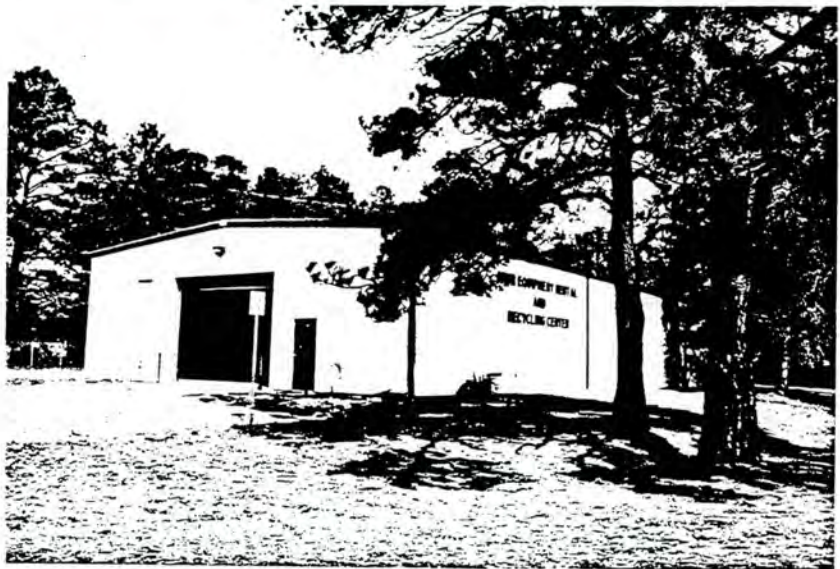
Date of Construction 1987
Original Use General Storage
Current Use MWR Facility

Structural System Metal frame.
Wall Covering Metal siding.
Foundation Concrete slab.

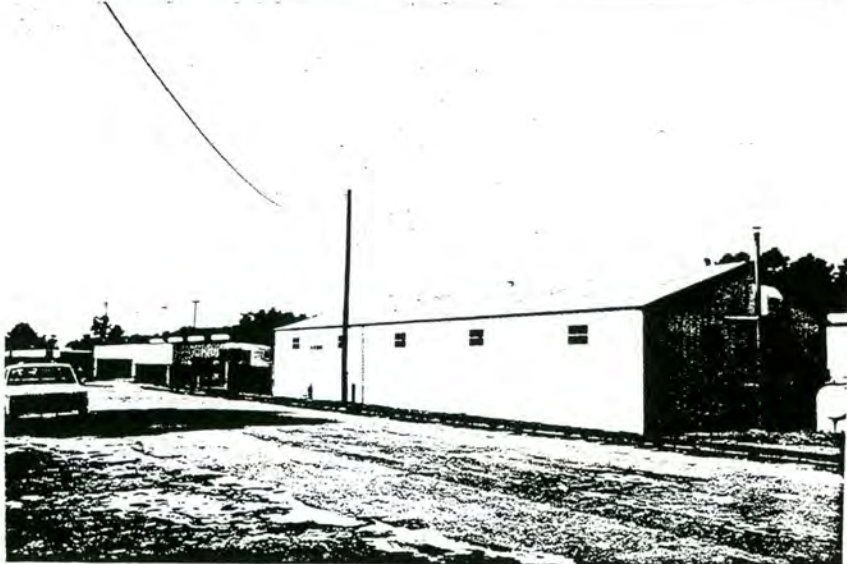
Date of Construction 1976
Original Use Warehouse
Current Use Warehouse

Structural System Masonry and beam bearing walls.
Wall Covering Sheet metal panels.
Foundation Block on concrete spread footers.

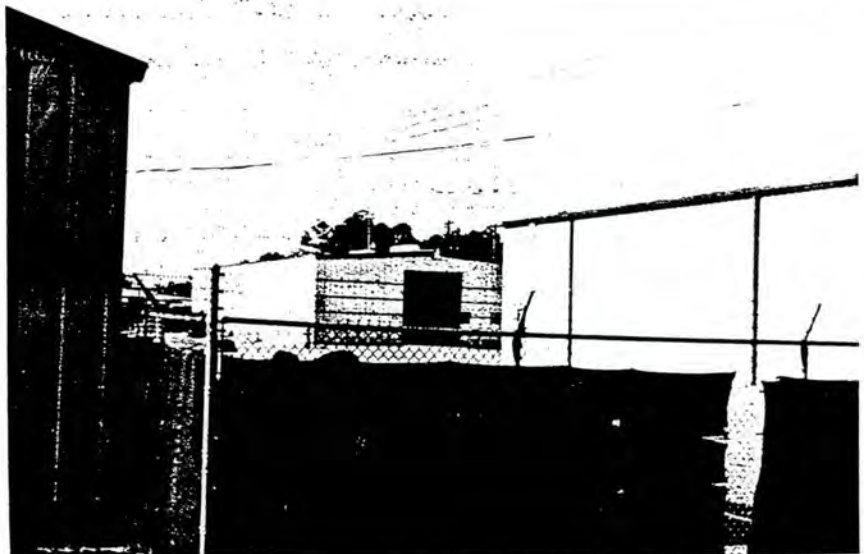
Date of Construction 1957
Original Use Warehouse
Current Use Warehouse

Structural System Masonry and beam bearing walls.
Wall Covering Sheet metal panels.
Foundation Block on concrete spread footers.

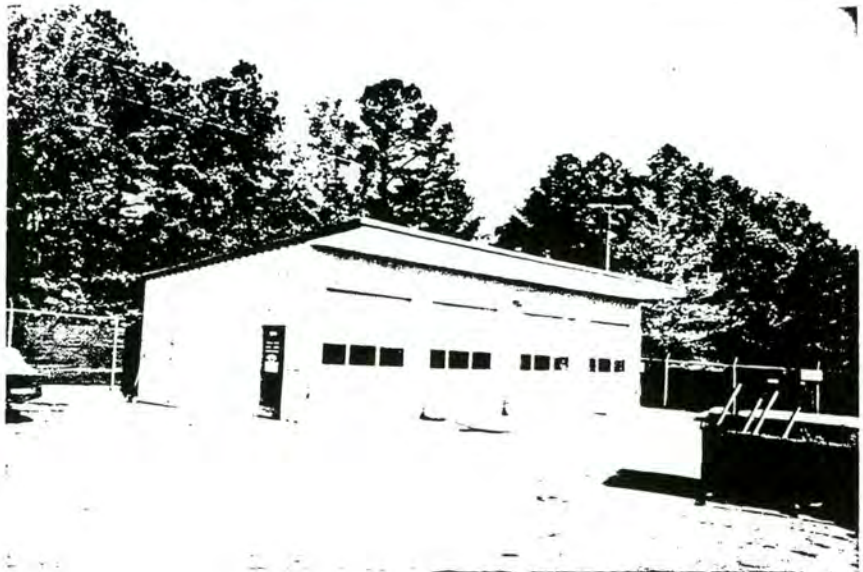
Date of Construction 1984
Original Use Warehouse
Current Use Hazardous Storage

Structural System Masonry.
Wall Covering Painted.
Foundation Masonry on concrete footings.

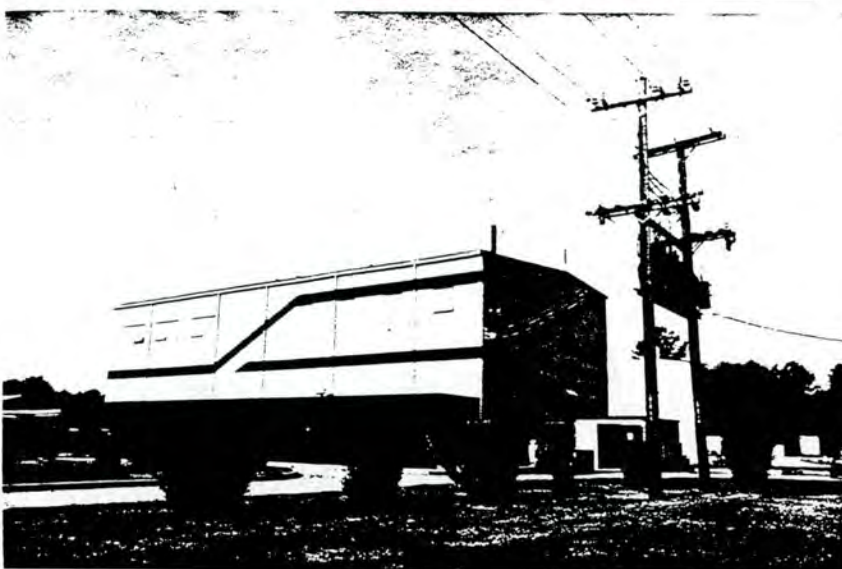
Date of Construction 1957
Original Use Steam Boiler Plant
Current Use Steam Boiler Plant

Structural System Metal I-Beam load bearing members.
Wall Covering Asbestos sheeting.
Foundation Block on concrete slab.

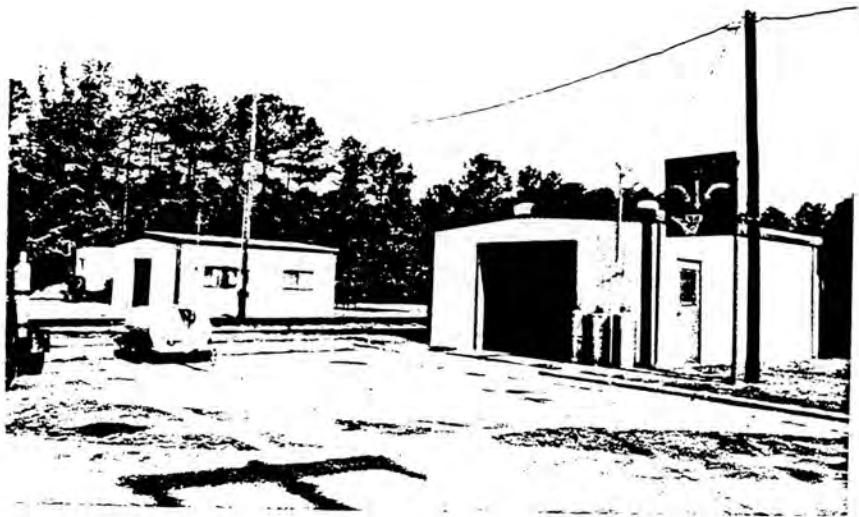
Building No. 2701

Date of Construction 1983
Original Use Boiler Plant Storage
Current Use Boiler Plant Storage

Structural System Metal frame.
Wall Covering Metal siding.
Foundation Concrete slab.

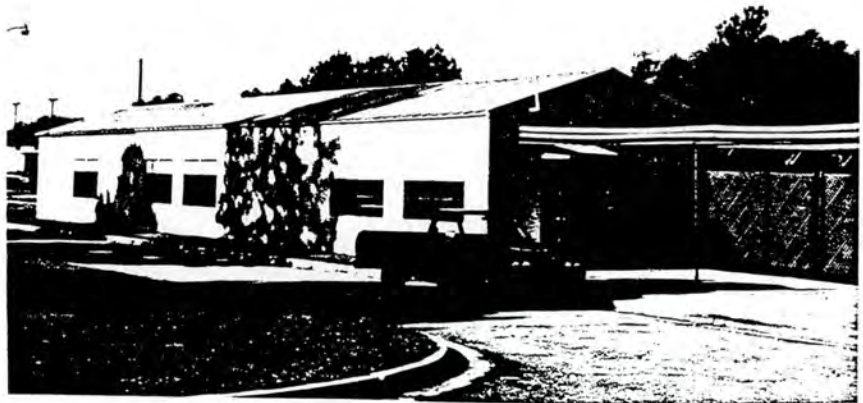
Building No. 2702

Date of Construction 1961
Original Use Maintenance Shop
Current Use Maintenance Shop

Structural System Masonry & I-Beam load bearing walls
Wall Covering Sheet metal panels.
Foundation Block on concrete slab.

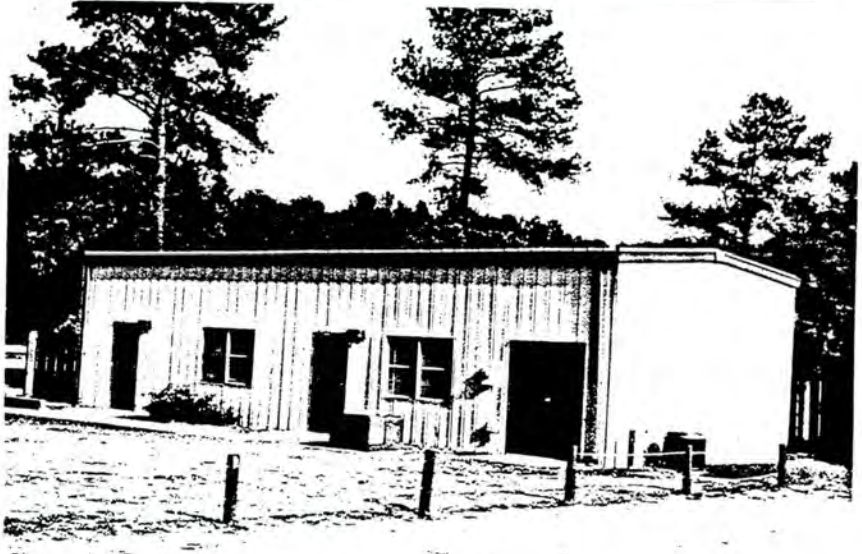
Date of Construction 1975
Original Use General Purpose Shop
Current Use General Purpose Shop

Structural System Metal frame.
Wall Covering Metal siding.
Foundation Concrete slab.

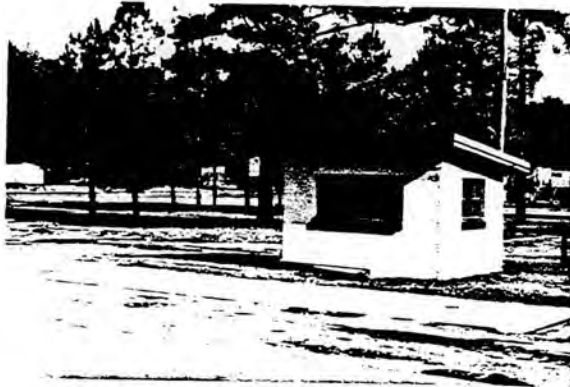
Original Use Scale house.

Current Use Transportation Building

Structural System Concrete block.

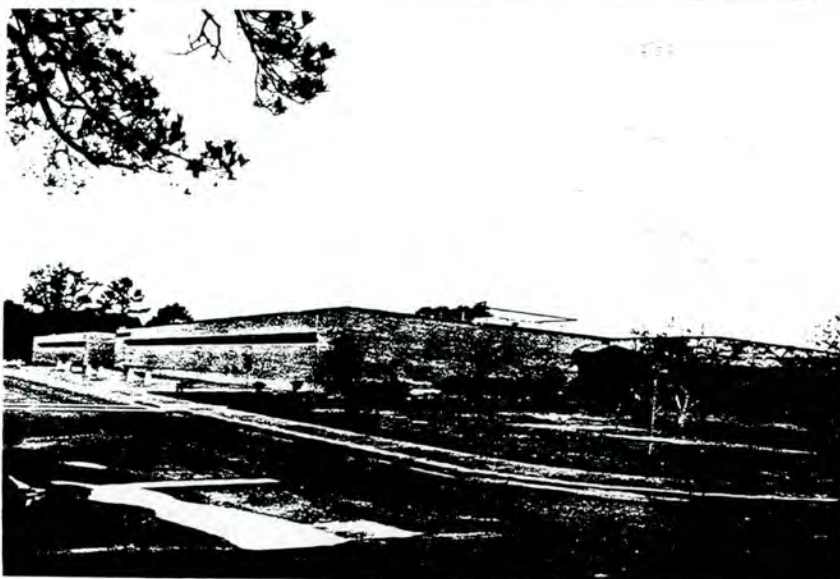
Date of Construction 1960
Original Use Hospital Complex
Current Use Hospital

Structural System Masonry.
Wall Covering Brick veneer.
Foundation Block on concrete slab.

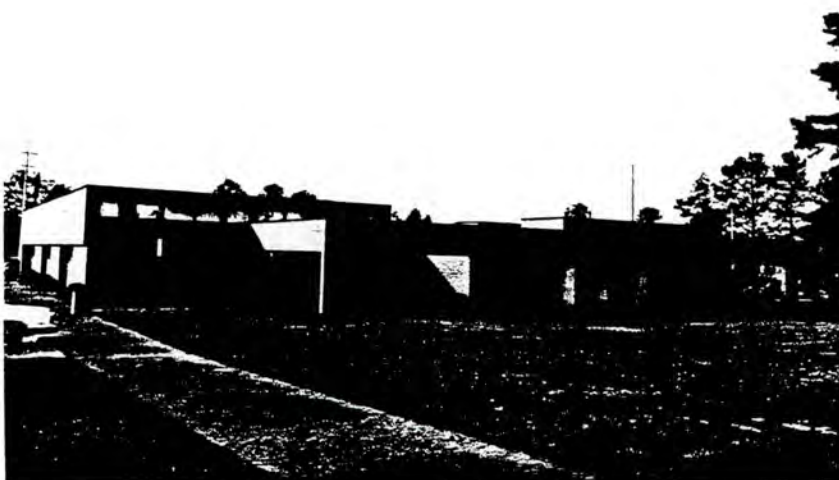
Building No. 2805

Date of Construction 1977
Original Use Dental Clinic
Current Use Kiecker Dental Clinic

Structural System Masonry.
Wall Covering Brick veneer.
Foundation Block on concrete slab.

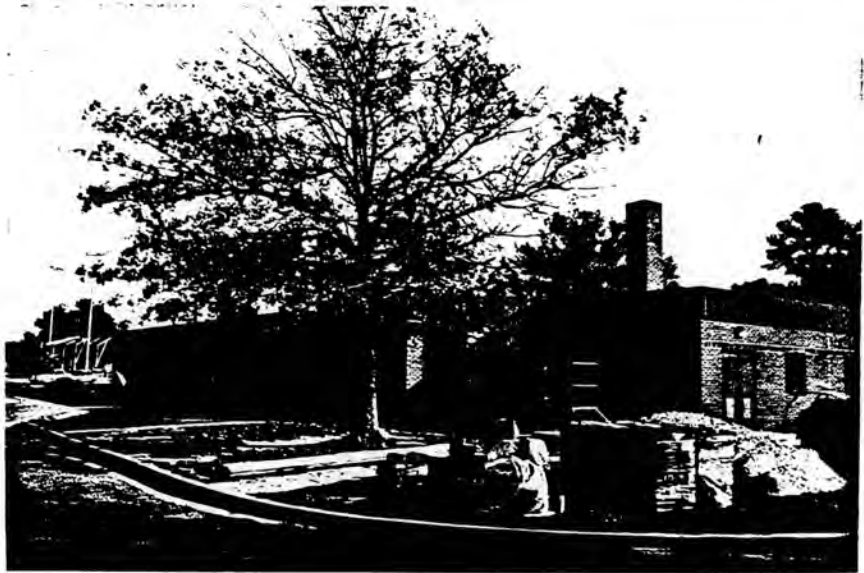
Date of Construction 1961
Original Use General Storage
Current Use Med. Storage/Supply

Structural System Masonry.
Wall Covering Brick veneer.
Foundation Block on concrete slab.

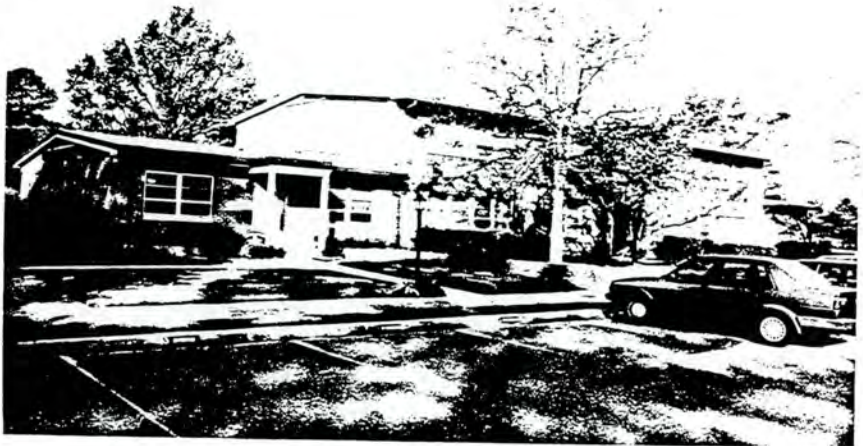
Building No. 2820

Date of Construction 1961
Original Use Medical Facility
Current Use Goldsboro Suite

Structural System Masonry.
Wall Covering Brick veneer.
Foundation Block on concrete spread footers.

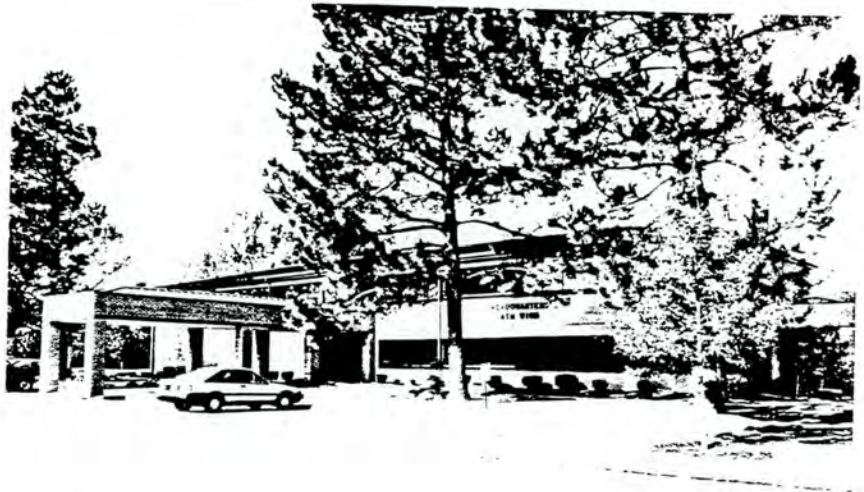
Building No. 2902

Date of Construction 1957
Original Use Division Headquarters
Current Use 4th Wing, Headquarters

Structural System Reinforced masonry.
Wall Covering Stucco.
Foundation Masonry on concrete slab.

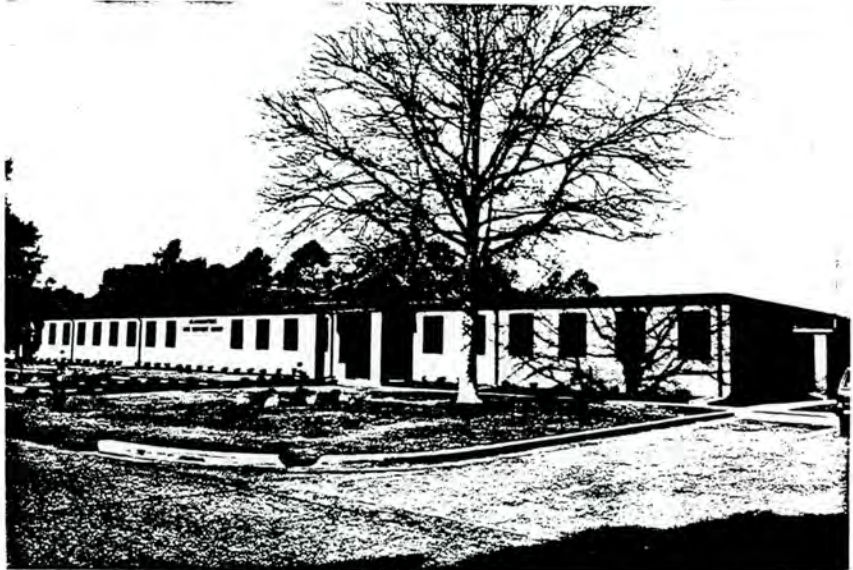
Date of Construction 1957
Original Use Wing Headquarters
Current Use Headquarters

Structural System Masonry.
Wall Covering Brick veneer.
Foundation Block on concrete slab.

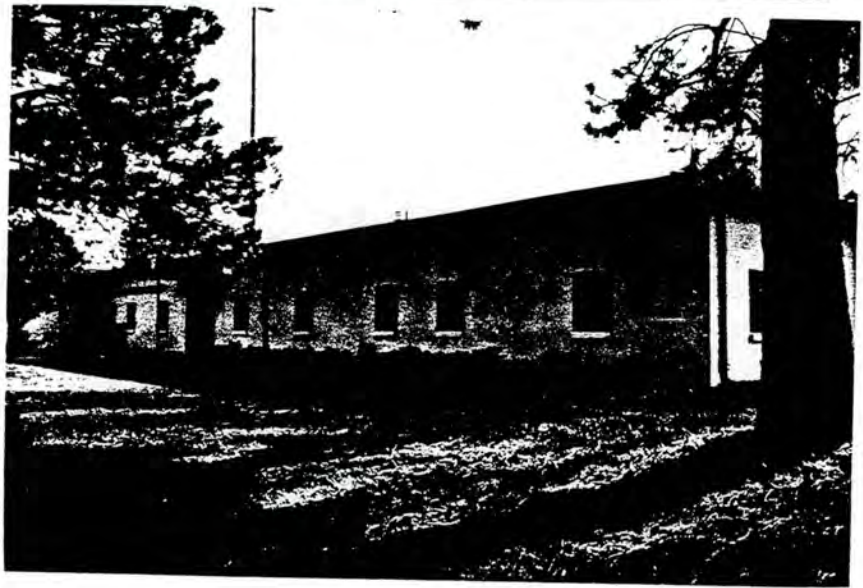
Date of Construction 1956
Original Use Administration Building
Current Use Headquarters Building

Structural System Masonry.
Wall Covering Stucco.
Foundation Block on concrete

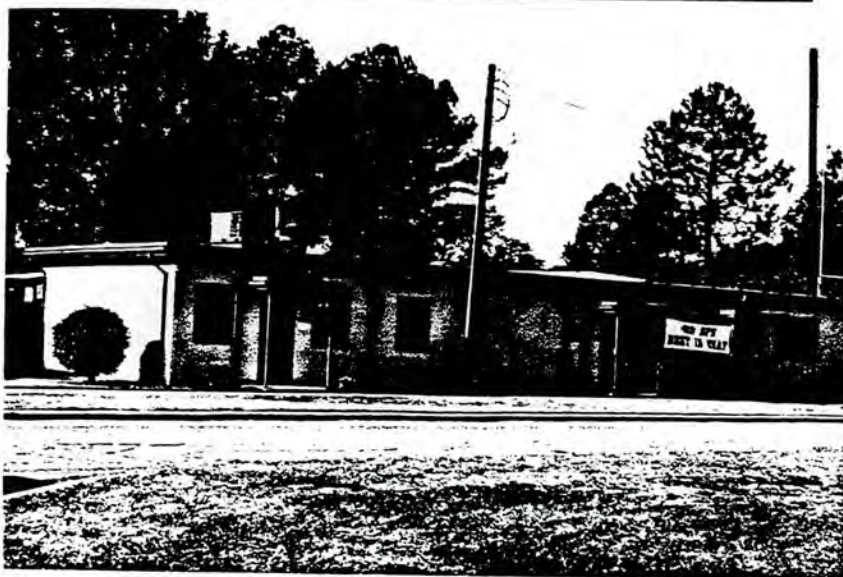
Date of Construction 1957
Original Use Administrative Office
Current Use Security Police Ops

Structural System Masonry.
Wall Covering Paint.
Foundation Block on concrete slab.

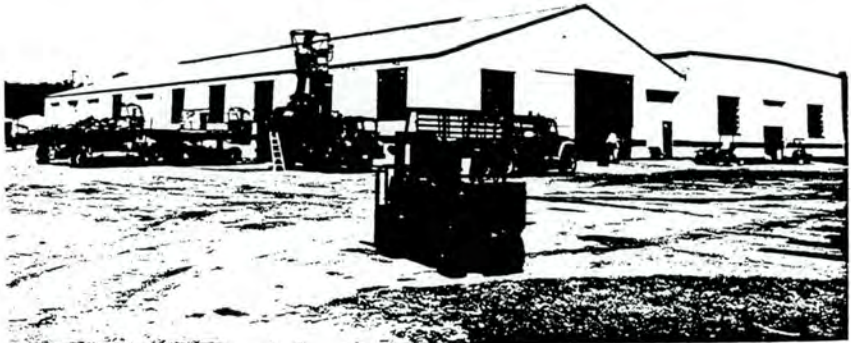
Building No. 3100

Date of Construction 1957
Original Use General Shop
Current Use Vehicle Maintenance Shop

Structural System Masonry.
Wall Covering Metal siding..
Foundation Concrete slab.

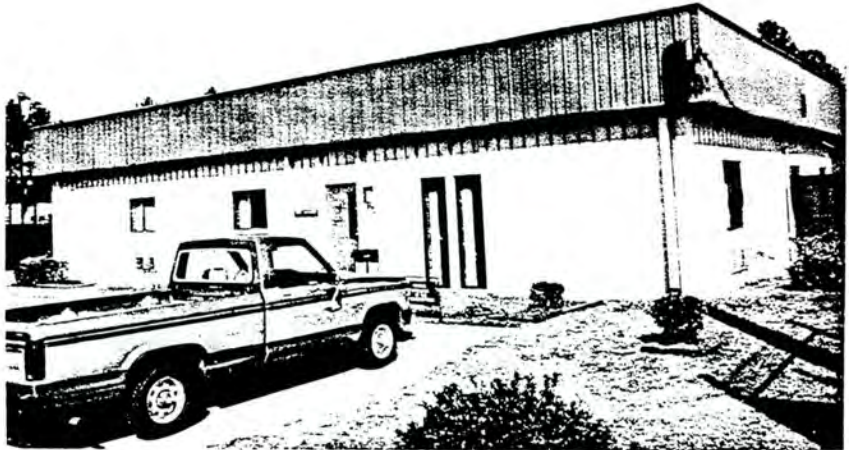
Building No. 3101

Date of Construction 1982
Original Use General Shop
Current Use Fleet Management

Structural System Masonry & brick bearing pillars.
Wall Covering Metal sheeting panels.
Foundation Block on concrete slab.

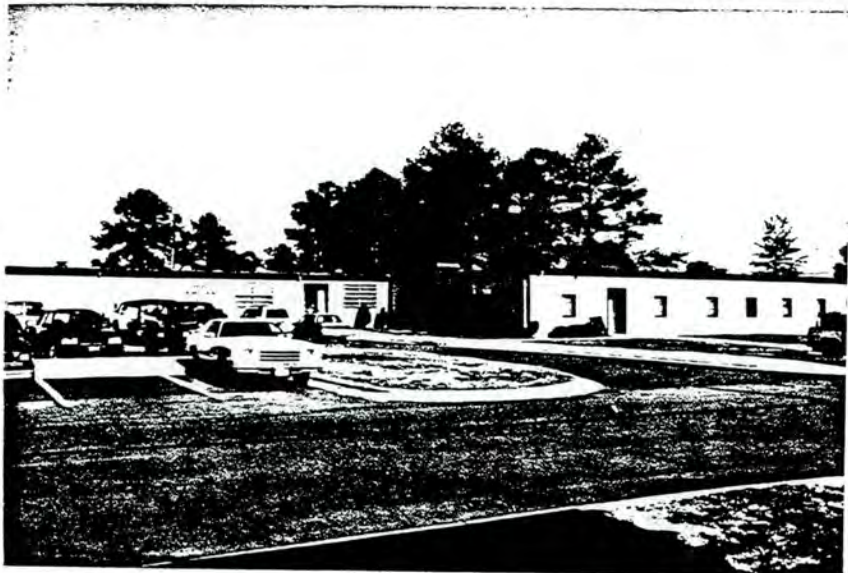
Date of Construction 1956
Original Use Communications Center
Current Use Base Computer Center

Structural System Masonry.
Wall Covering Painted.
Foundation Block on concrete slab.

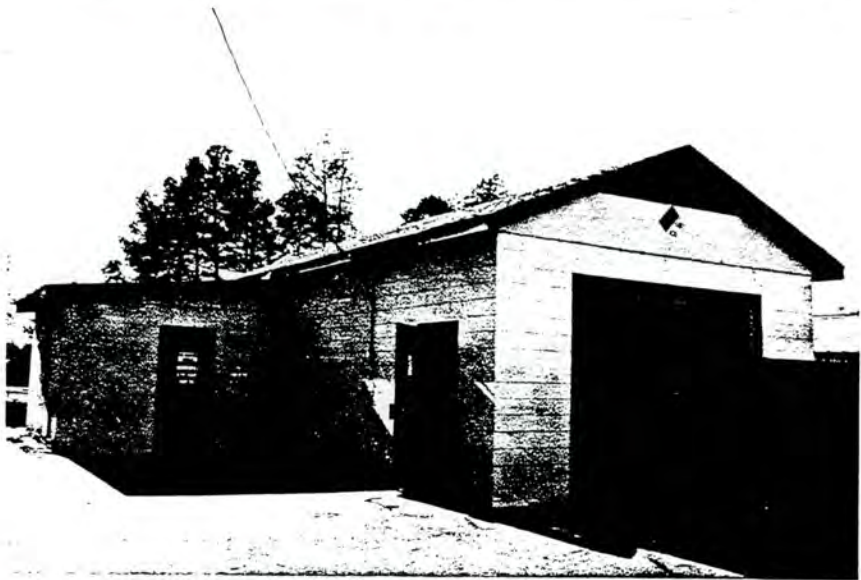
Date of Construction 1978
Original Use General Maintenance Shop
Current Use Vehicle Maintenance Shop

Structural System Masonry & I-beam bearing pillars.
Wall Covering Painted.
Foundation Masonry on concrete slab.

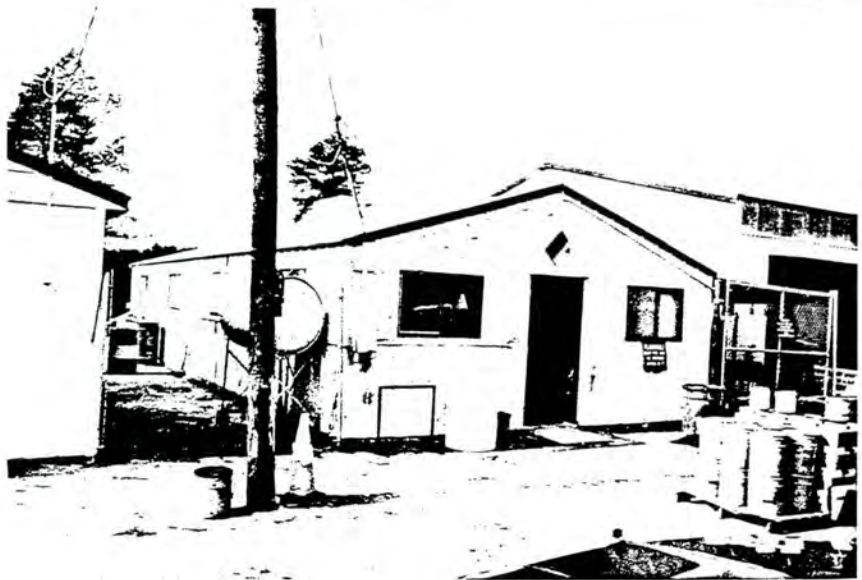
Building No. 3303

Date of Construction 1973
Original Use Storage Shed
Current Use Storage Shed

Structural System Frame, metal.
Wall Covering Metal sheet panels.
Foundation Block on concrete slab.

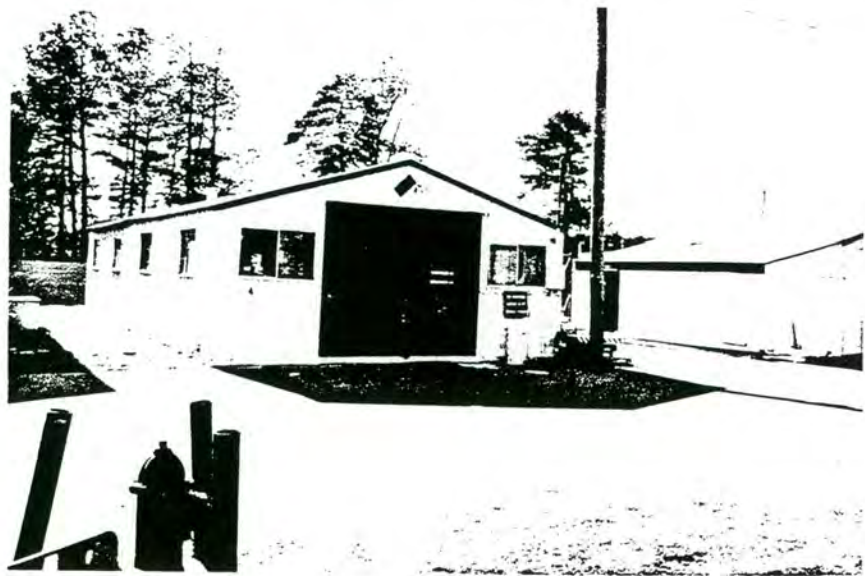
Building No. 3305

Date of Construction 1980
Original Use Storage Shed
Current Use Storage Shed

Structural System Frame, metal.
Wall Covering Metal, prefabricated.
Foundation Block on concrete slab.

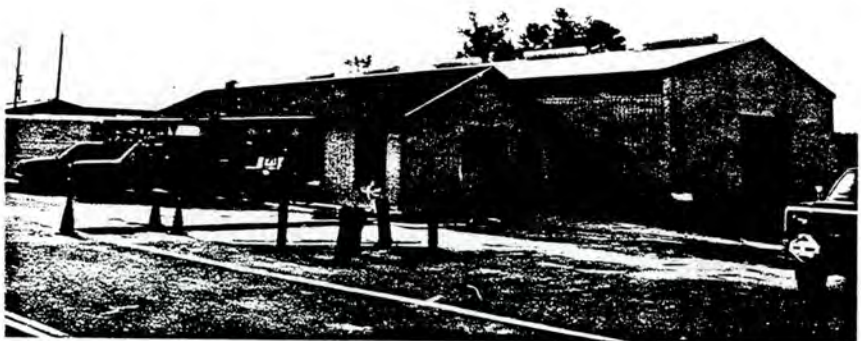
Building No. 3308

Date of Construction 1986
Original Use Storage Facility
Current Use Storage Facility

Structural System Frame, metal.
Wall Covering Metal panel sheets.
Foundation Block on concrete slab.

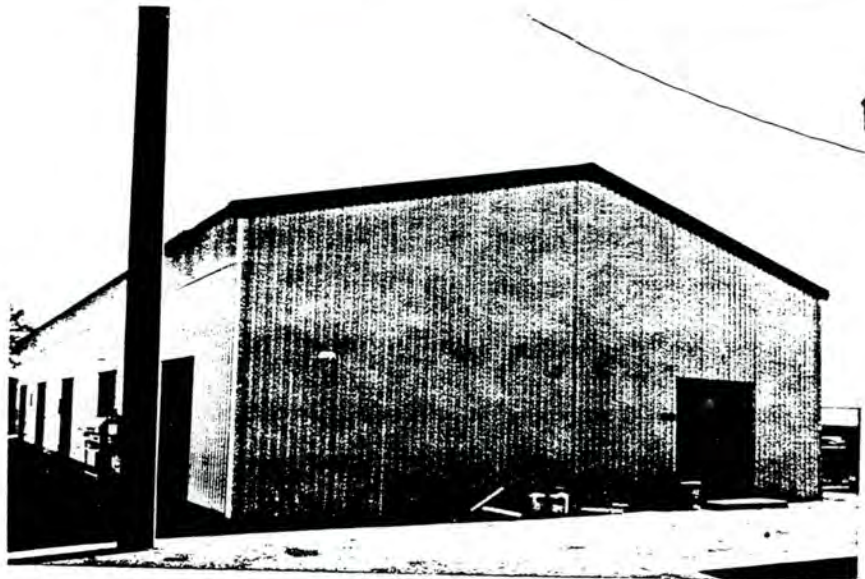
Building No. 3315

Date of Construction 1989
Original Use Storage Facility
Current Use Storage Facility

Structural System Frame, metal.
Wall Covering Metal siding.
Foundation Block concrete slab.

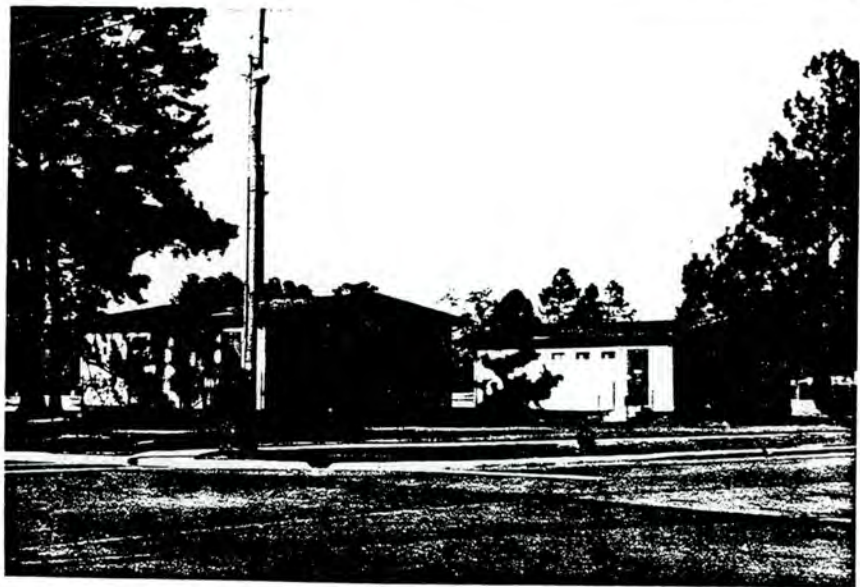
Building No. 3509

Date of Construction 1979
Original Use Educational Center
Current Use Educational Center

Structural System Masonry.
Wall Covering Painted with added siding.
Foundation Block on concrete slab.

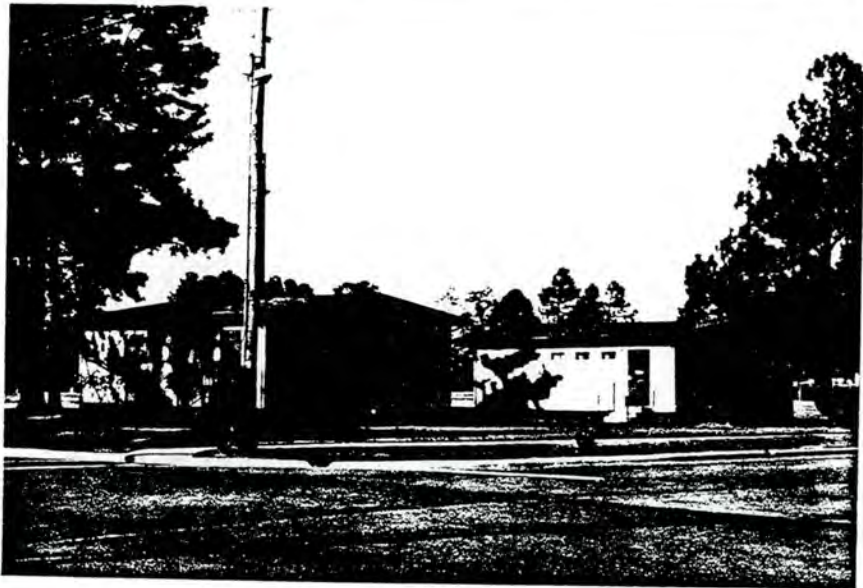
Building No. 3510

Date of Construction 1979
Original Use Educational Center
Current Use Educational Center

Structural System Masonry.
Wall Covering Painted with some siding added.
Foundation Block on concrete slab.

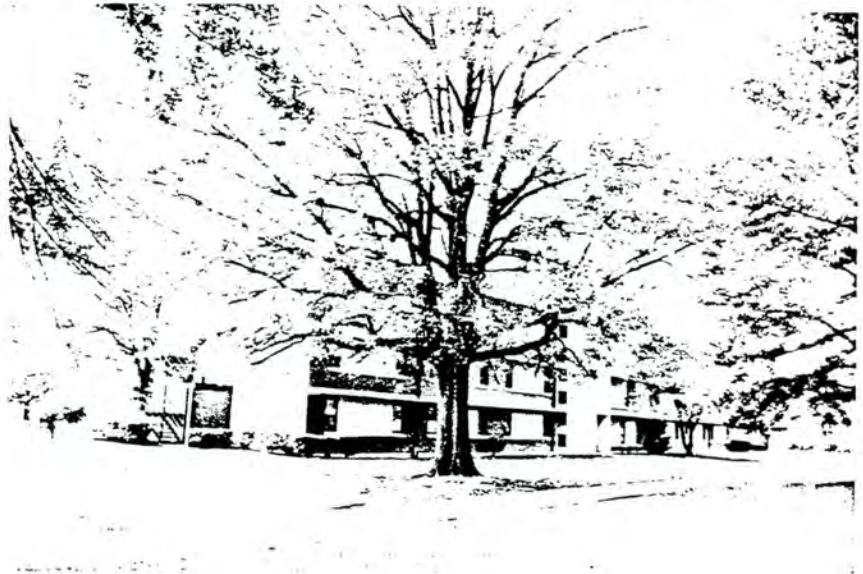
Building No. 3601

Date of Construction 1958
Original Use Enlisted Mens Barracks
Current Use Law Center

Structural System Reinforced masonry.
Wall Covering Brick veneer.
Foundation Masonry on concrete spread footers.

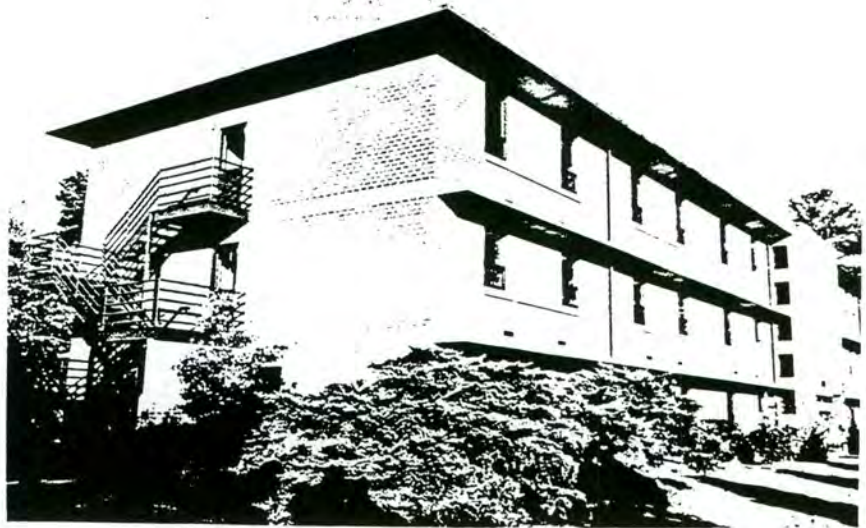
Building No. 3612

Date of Construction 1960
Original Use Enlisted Mens Barracks
Current Use Headquarters

Structural System Reinforced masonry.
Wall Covering Brick veneer.
Foundation Masonry on concrete spread footers.

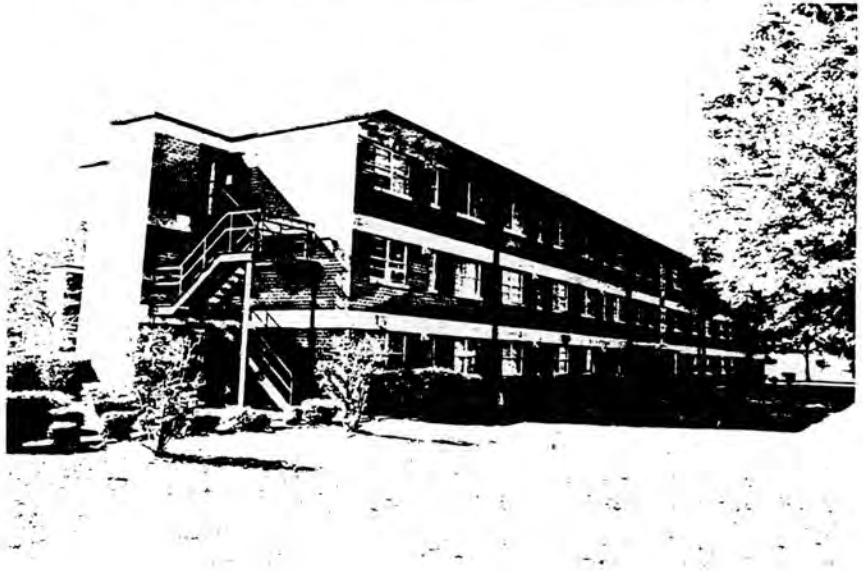
Building No. 3615

Date of Construction 1956
Original Use Enlisted Mens Barracks
Current Use Enlisted Mens Barracks

Structural System Reinforced masonry.
Wall Covering Brick veneer.
Foundation Masonry on concrete spread footers.

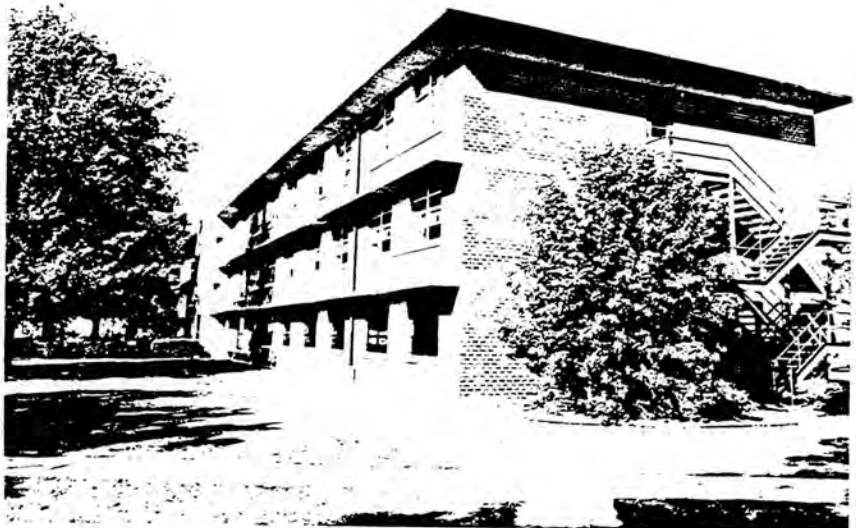
Building No. 3616

Date of Construction 1956
Original Use Enlisted Mens Barracks
Current Use Enlisted Mens Barracks

Structural System Reinforced masonry.
Wall Covering Brick veneer.
Foundation Masonry on concrete spread footers.
