April 1996

**Historic Structures Survey at Seymour Johnson Air Force
Base, Goldsboro, Wayne County, North Carolina**

**United States Air Force
Air Combat Command**

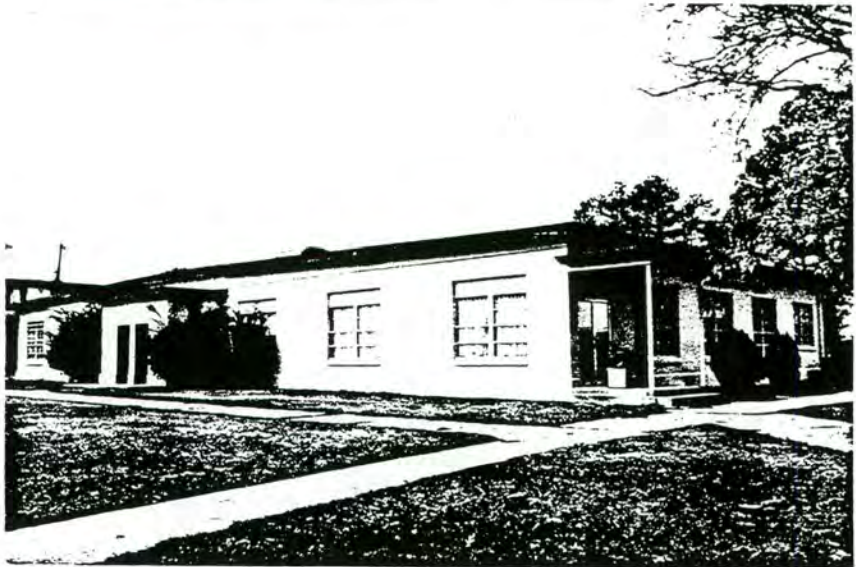
Building No. 3621

Date of Construction 1956
Original Use EM Dining Hall
Current Use Audio/Visual Facility

Structural System Reinforced masonry.
Wall Covering Painted.
Foundation Masonry on concrete footings.

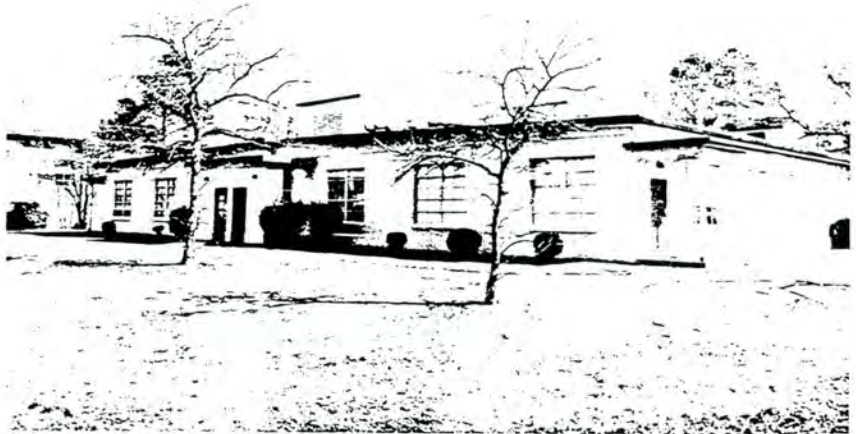
Building No. 3624

Date of Construction 1956
Original Use EM, Dining Hall
Current Use Education Center

Structural System Reinforced masonry.
Wall Covering Painted.
Foundation Masonry on concrete slab.

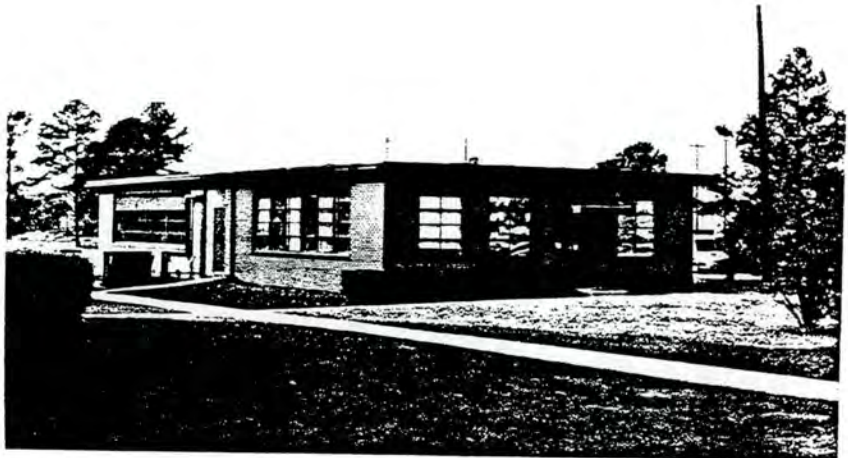
Building No. 3631

Date of Construction 1959
Original Use Squadron Headquarters
Current Use Communication Facility

Structural System Reinforced masonry.
Wall Covering Brick veneer.
Foundation Masonry on concrete slab.

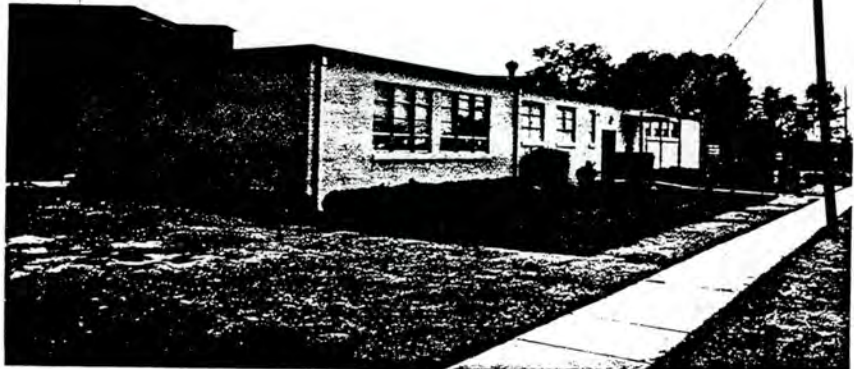
Building No. 3632

Date of Construction 1957
Original Use Squadron Headquarters
Current Use Education Center

Structural System Reinforced masonry.
Wall Covering Stucco.
Foundation Masonry on concrete slab.

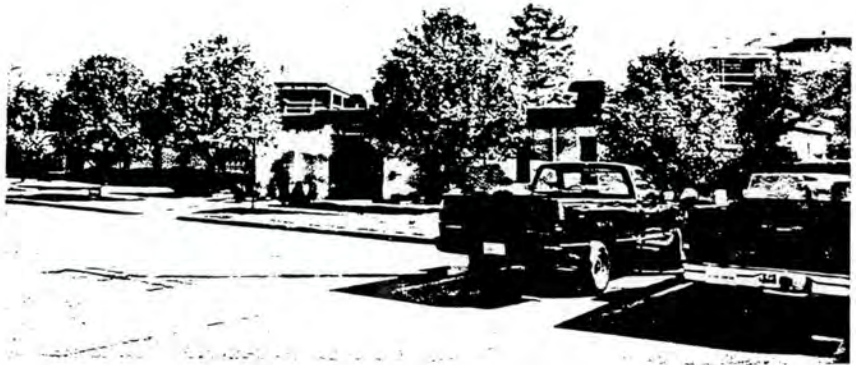
Building No. 3634

Date of Construction 1957
Original Use Group Headquarters
Current Use Contracting Office

Structural System Reinforced masonry.
Wall Covering Stucco.
Foundation Masonry on concrete slab.

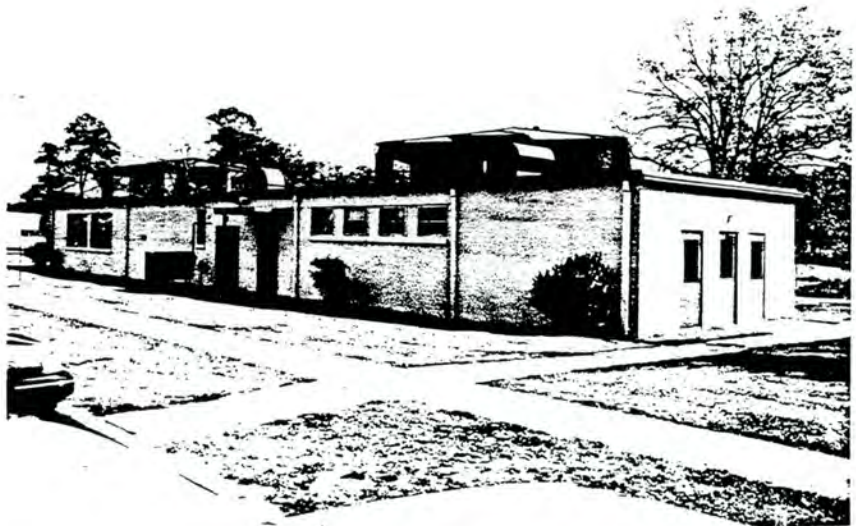
Building No. 3635

Date of Construction 1957
Original Use Group Headquarters
Current Use AF-OSI Clinic

Structural System Reinforced masonry.
Wall Covering Painted.
Foundation Masonry on concrete slab.

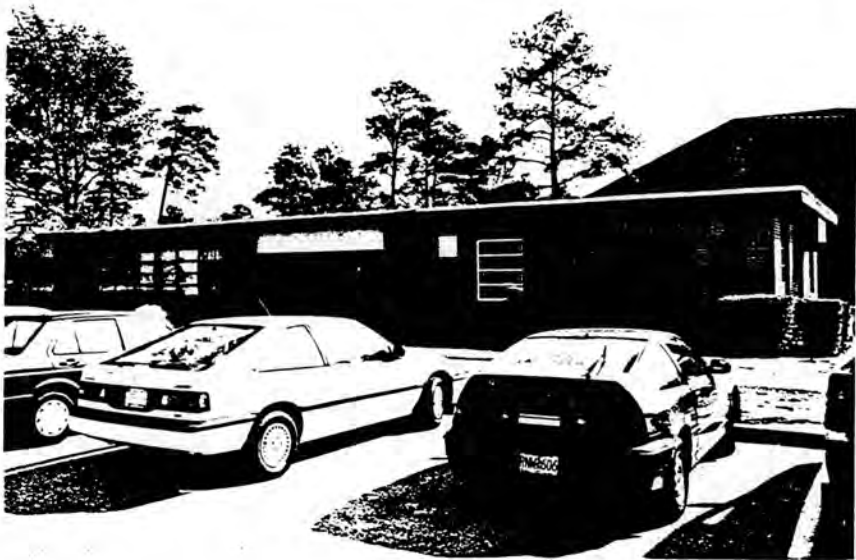
Building No. 3636

Date of Construction 1959
Original Use Squadron Headquarters
Current Use Group Headquarters

Structural System Reinforced masonry.
Wall Covering Stucco.
Foundation Masonry on concrete slab.

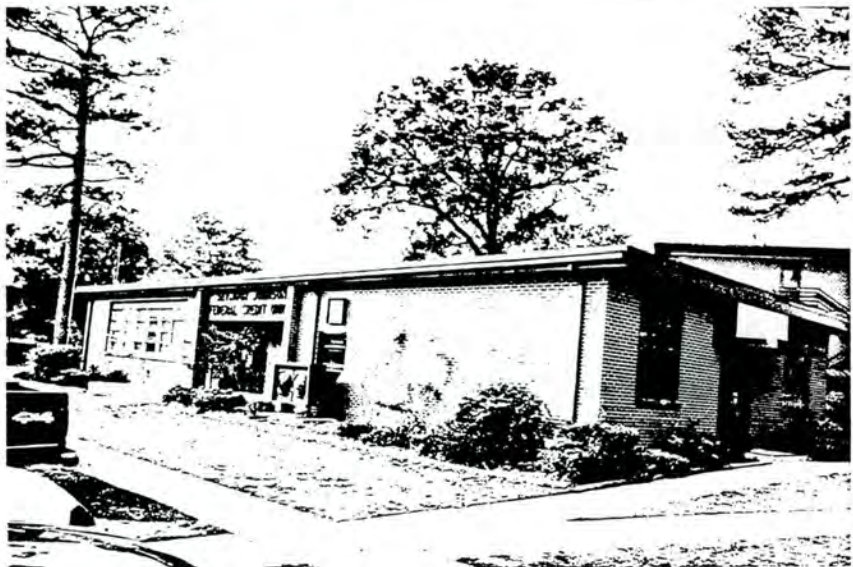
Original Use No Listing.

Current Use Federal Credit Unit

Structural System Reinforced masonry.

Foundation Masonry on concrete slab.

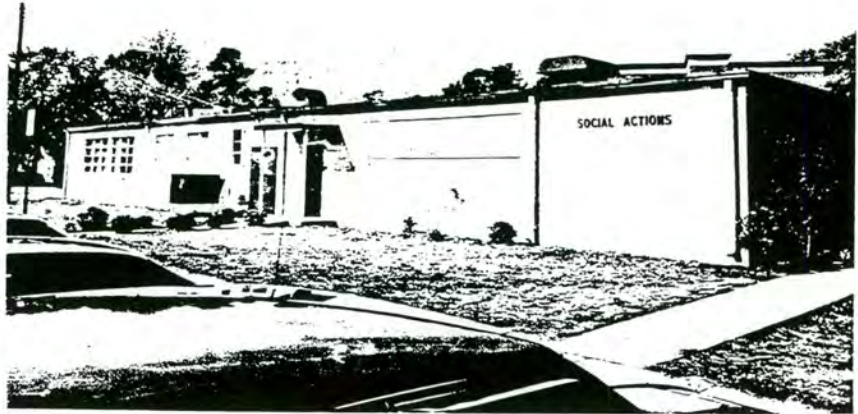
Building No. 3641

Date of Construction 1957
Original Use Squadron Headquarters
Current Use Social Actions Building

Structural System Reinforced concrete.
Wall Covering Brick veneer.
Foundation Masonry on concrete slab.

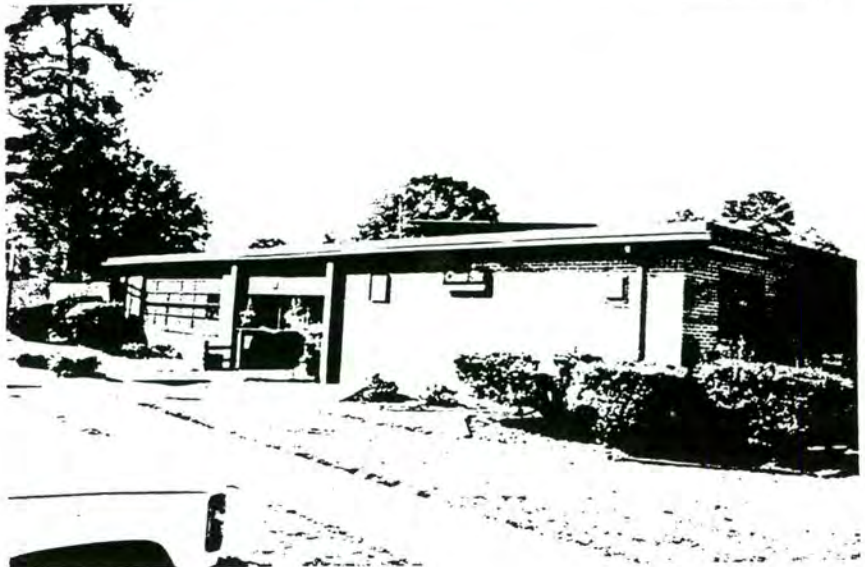
Building No. 3642

Date of Construction 1959
Original Use Squadron Headquarters
Current Use Base Package Store

Structural System Reinforced masonry.
Wall Covering Brick veneer.
Foundation Masonry on concrete slab.

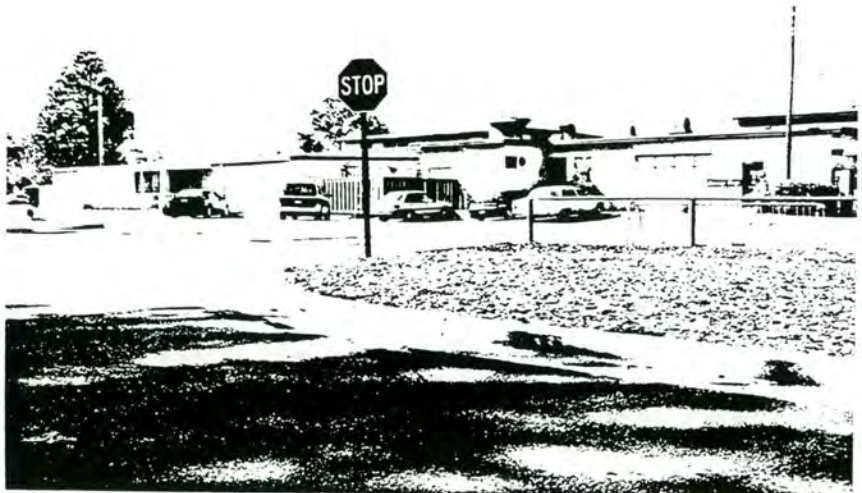
Building No. 3702

Date of Construction 1956
Original Use Exchange Sales Store
Current Use Base Exchange

Structural System Reinforced masonry.
Wall Covering Paint, some metal siding.
Foundation Masonry on concrete slab.

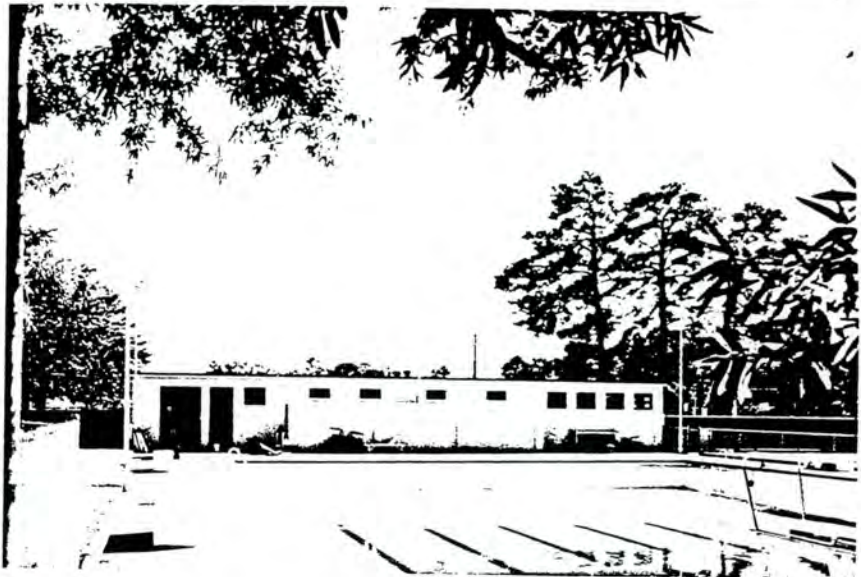
Building No. 3704

Date of Construction 1957
Original Use Swimmers' Bath House
Current Use Swimmers' Bath House

Structural System Reinforced masonry.
Wall Covering Painted.
Foundation Masonry on concrete slab.

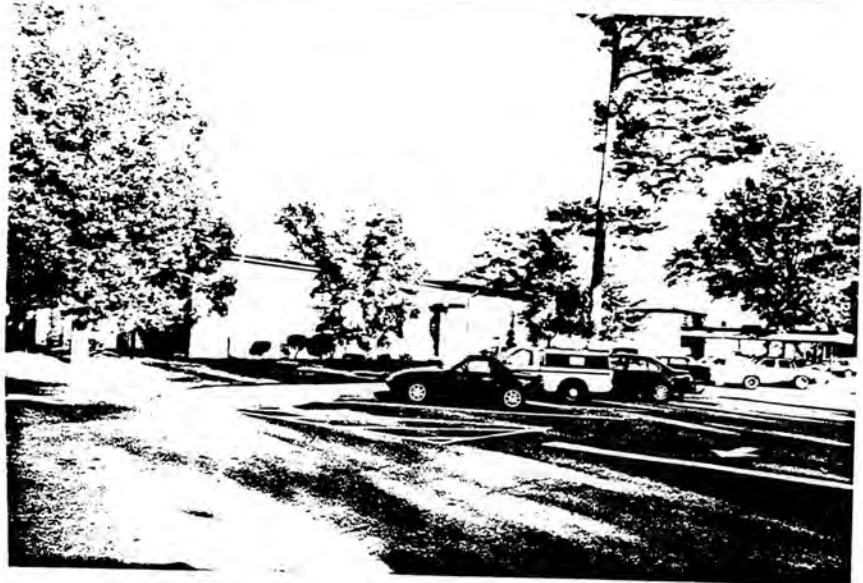
Original Use NCO Club

Current Use NCO Club

Structural System Reinforced masonry.

Foundation Masonry on concrete slab.

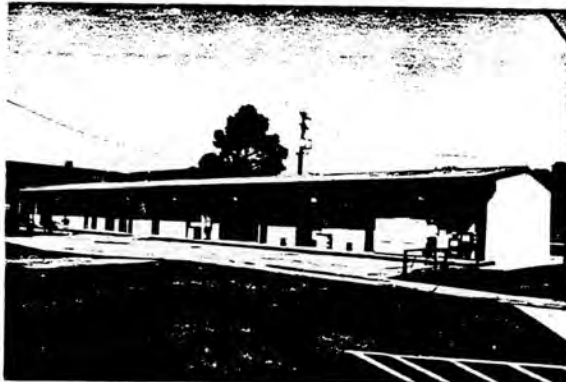
Current Use Base Exchange, Service Outlet

Structural System Concrete Block

Foundation Concrete

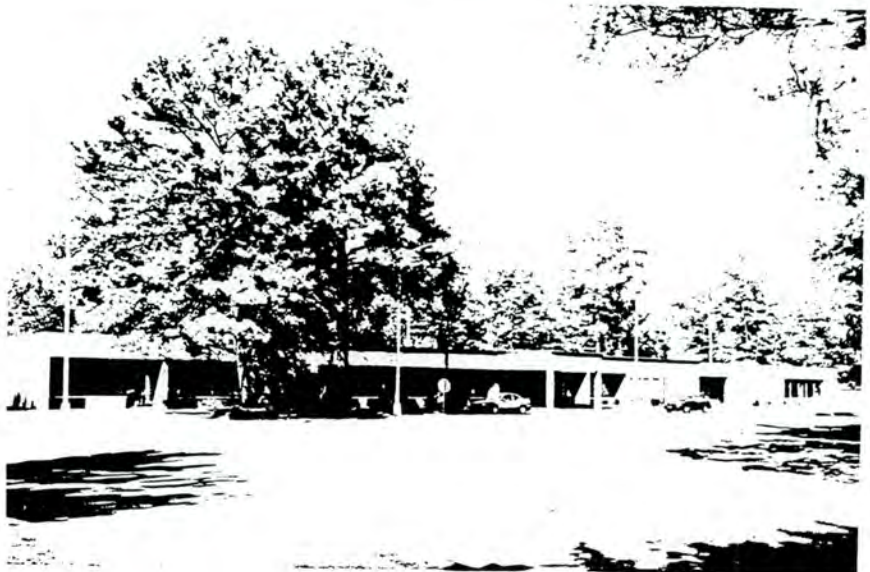
Building No. 3710

Date of Construction 1975
Original Use Child Care Center
Current Use Child Care Center

Structural System Reinforced masonry.
Wall Covering Brick veneer.
Foundation Masonry on concrete slab.

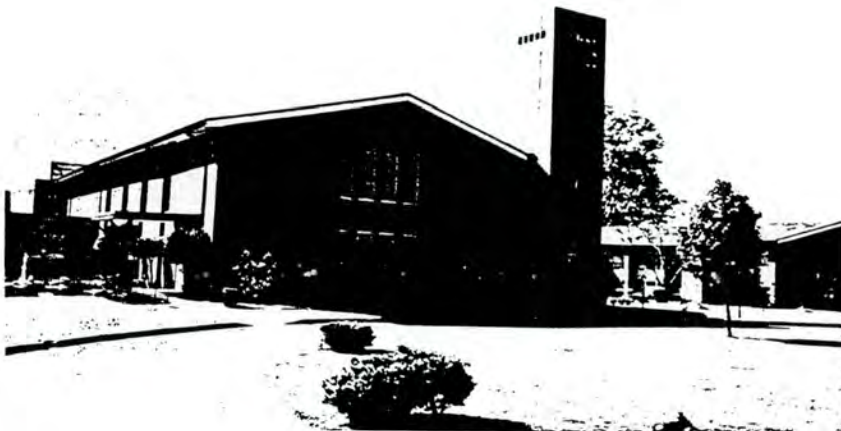
Building No. 3720

Date of Construction 1959
Original Use Base Chapel
Current Use Base Chapel

Structural System Reinforced masonry.
Wall Covering Brick veneer.
Foundation Masonry on concrete slab, footings.

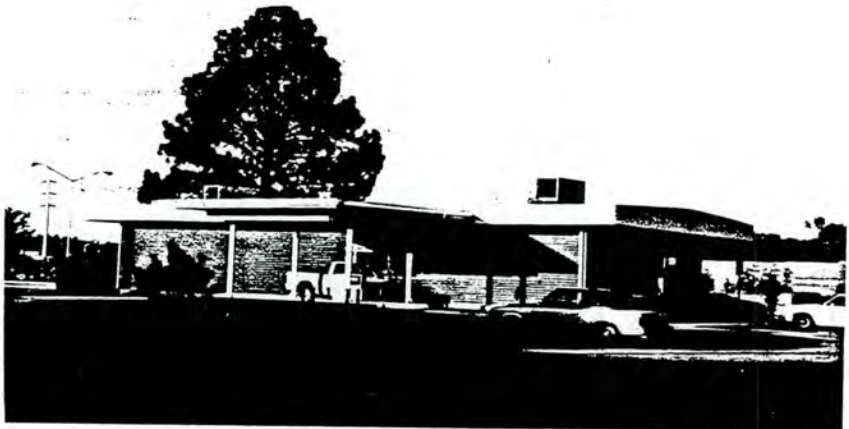
Building No. 3725

Date of Construction 1963
Original Use Commercial Building
Current Use Wachovia Bank

Structural System Reinforced masonry.
Wall Covering Brick veneer.
Foundation Masonry on concrete slab.

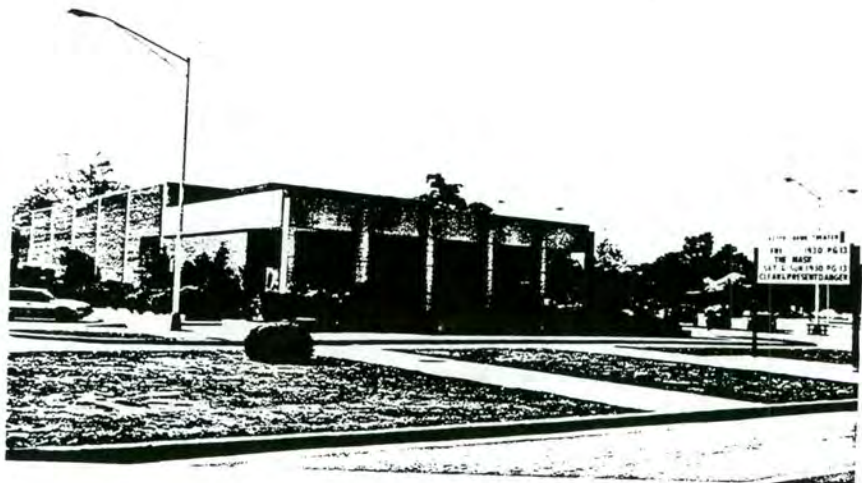
Current Use Kitty Hawk Theatre

Structural System Reinforced masonry.

Foundation Masonry on concrete slab.

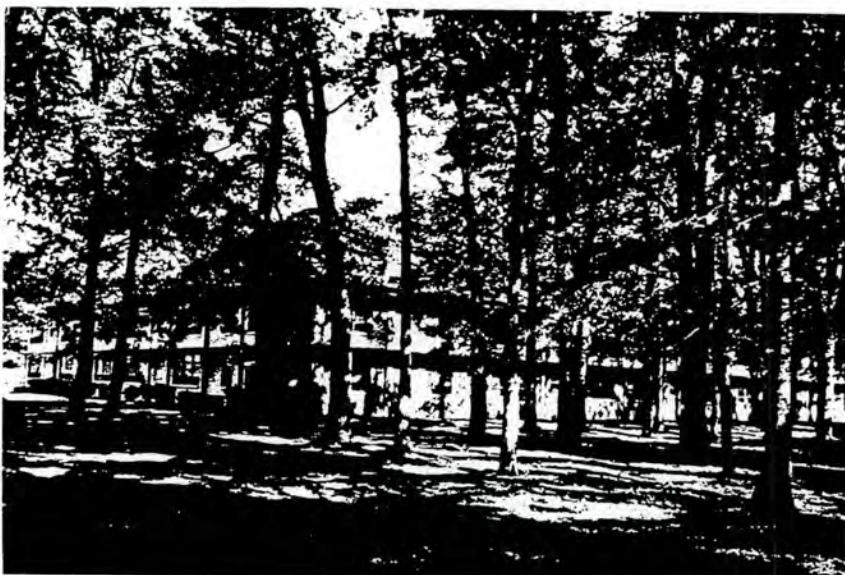
Building No. 3802

Date of Construction 1958
Original Use Transit Housing
Current Use Transit Housing

Structural System Reinforced masonry.
Wall Covering Stucco.
Foundation Masonry on concrete slab.

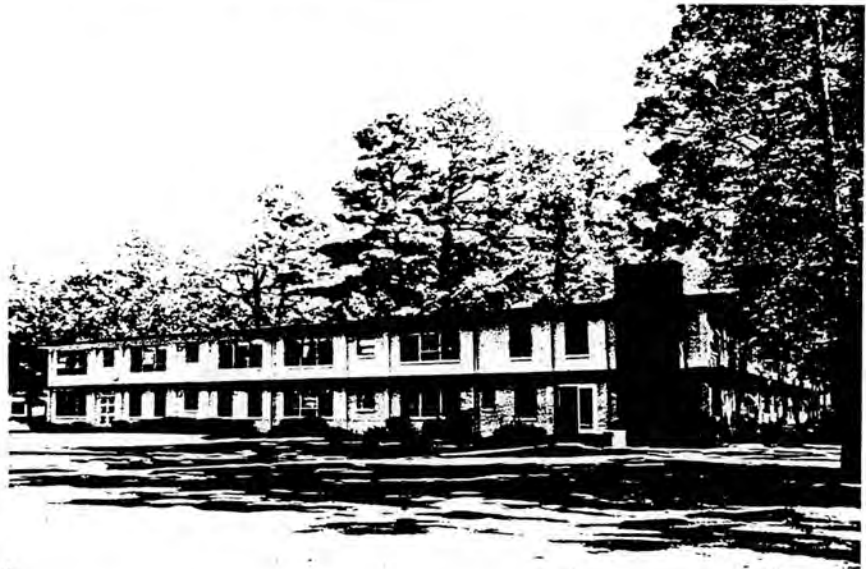
Building No. 3803

Date of Construction 1957
Original Use BOQ
Current Use Billeting Office

Structural System Reinforced concrete.
Wall Covering Stucco.
Foundation Masonry on concrete slab.

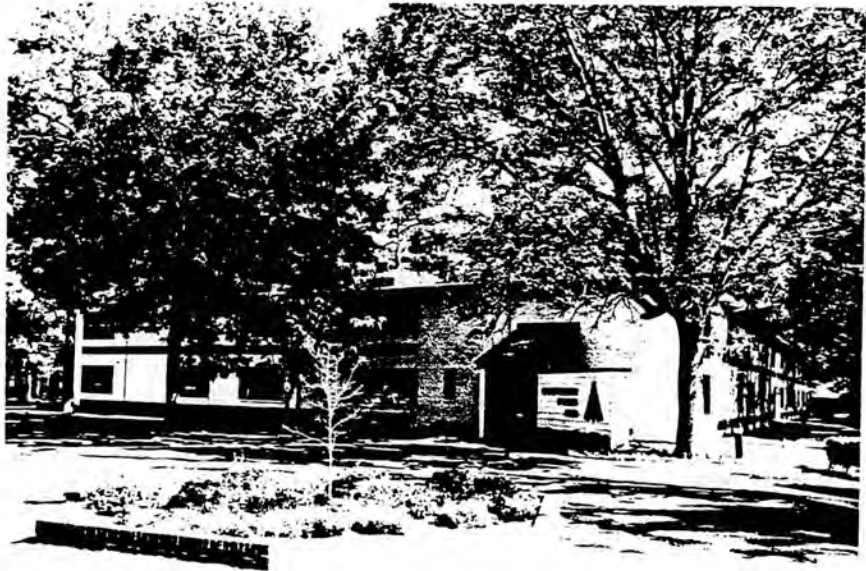
Building No. 3804

Date of Construction 1957
Original Use BOQ
Current Use Billeting Office

Structural System Reinforced concrete.
Wall Covering Stucco.
Foundation Masonry on concrete slab.

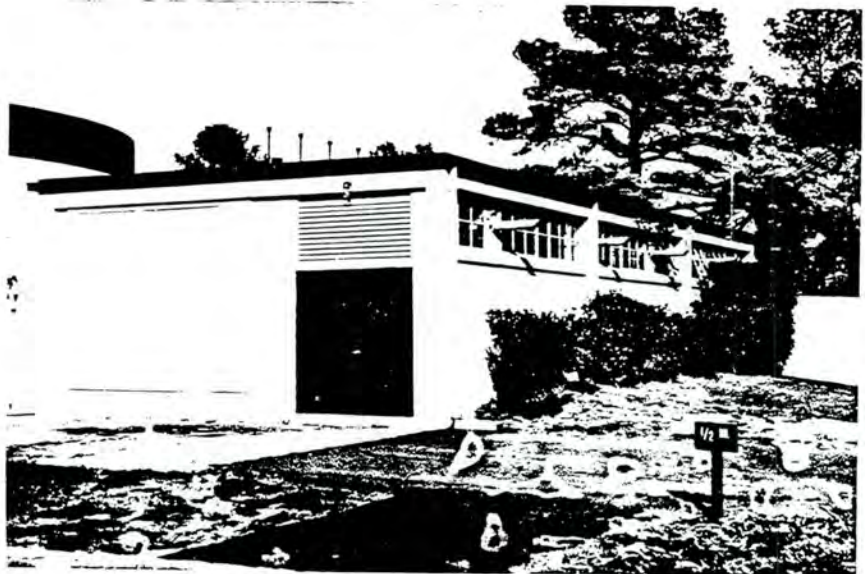
Building No. 4002

Date of Construction 1957
Original Use Water Pump Station
Current Use Water Pump Station

Structural System Reinforced masonry.
Wall Covering Painted.
Foundation Masonry on concrete slab.

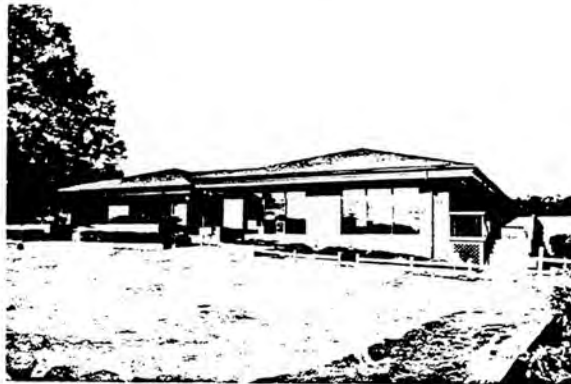
Current Use Golf Clubhouse

Structural System Masonry and steel frame

Foundation Brick sills and concrete slab

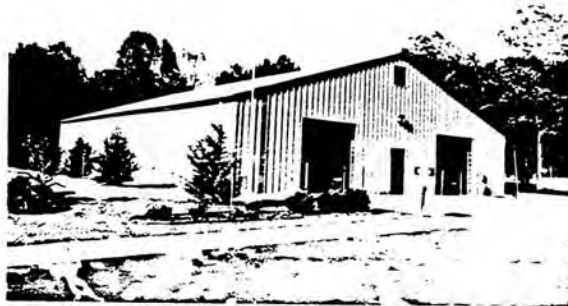
Building No. 4084

Date of Construction 1988
Original Use Golf Clubhouse, Equipment Storage
Current Use Golf Clubhouse, Equipment Storage

Structural System Strip steel frame
Wall Covering Metal Siding.
Foundation Concrete

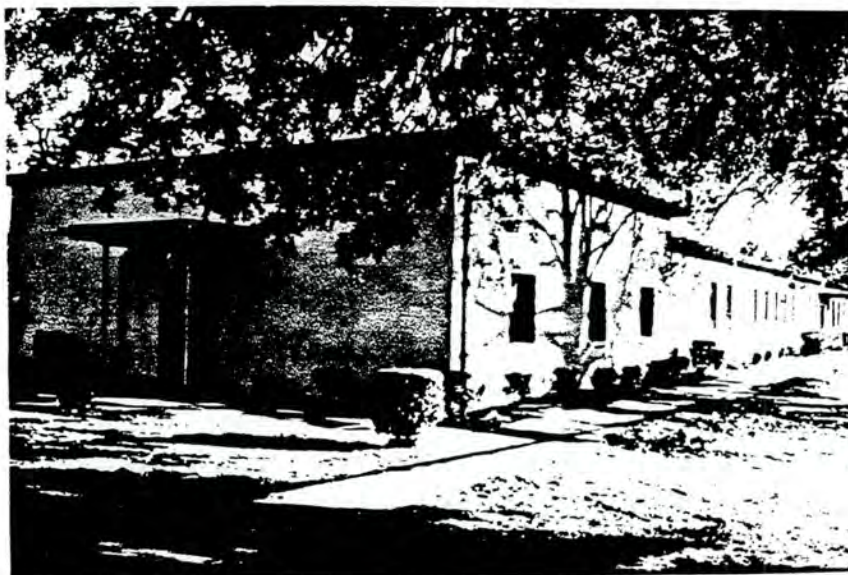
Building No. 4200

Date of Construction 1957
Original Use Group Headquarters
Current Use Base Personnel Office

Structural System Reinforced masonry.
Wall Covering Stucco.
Foundation Masonry on concrete slab.

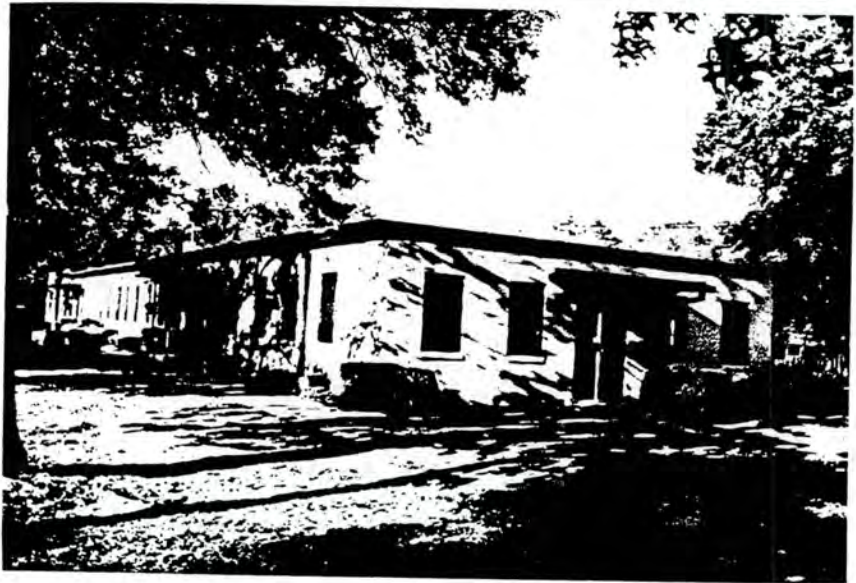
Current Use Base Personnel/ID Center

Structural System Reinforced masonry.

Foundation Masonry on concrete slab.

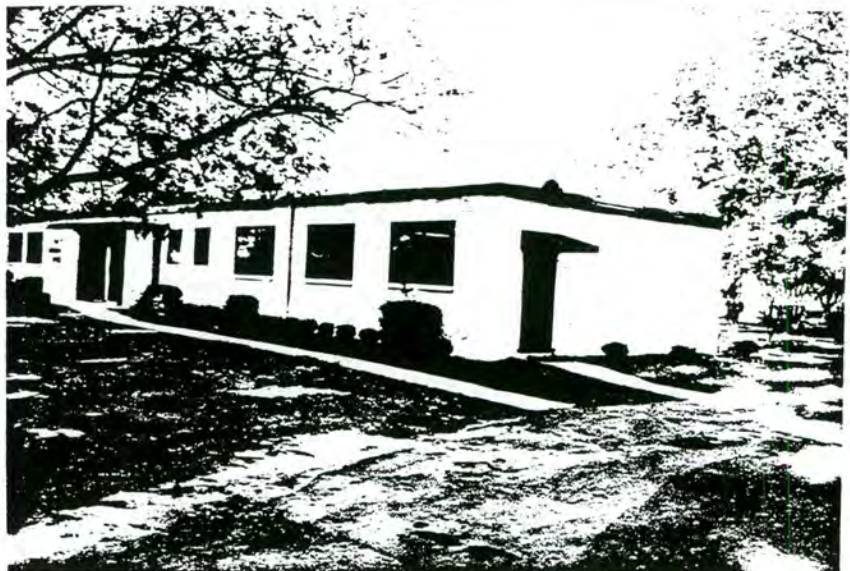
Building No. 4203

Date of Construction 1957
Original Use Dental Clinic
Current Use Traffic Management

Structural System Reinforced masonry.
Wall Covering Stucco.
Foundation Masonry on concrete slab.

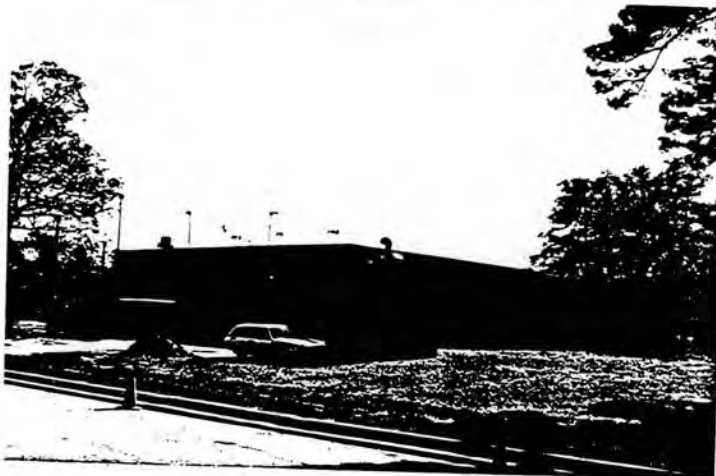
Current Use Arts and Crafts

Structural System Reinforced masonry

Foundation Masonry on concrete slab

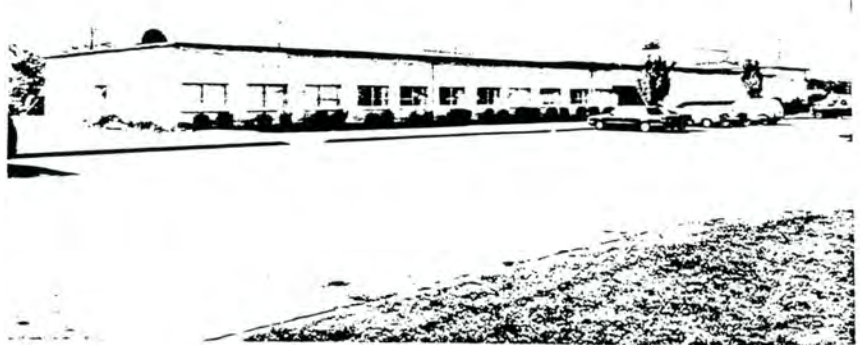
Building No. 4403

Date of Construction 1957
Original Use Proficiency Training Bldg
Current Use Field Training Facility

Structural System Reinforced masonry.
Wall Covering Stucco.
Foundation Masonry on concrete slab.

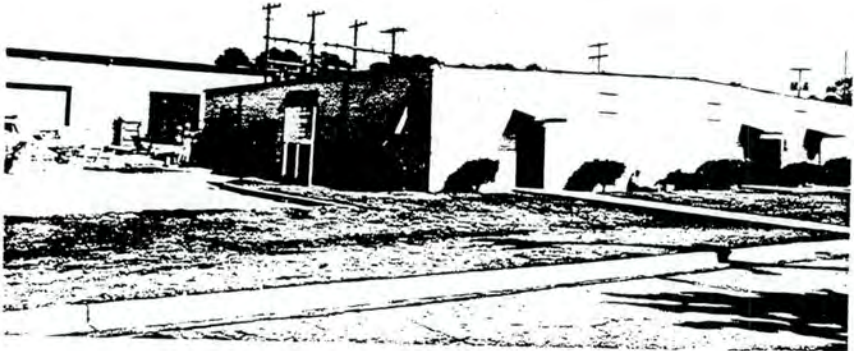
Building No. 4402

Date of Construction 1957
Original Use Warehouse
Current Use Wing Headquarters

Structural System Reinforced masonry.
Wall Covering Painted.
Foundation Masonry on concrete slab.

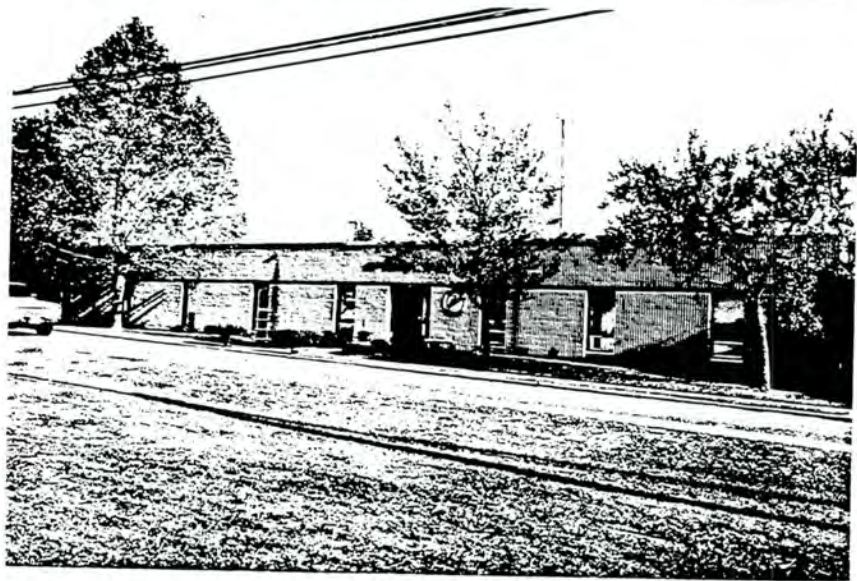
Building No. 4421

Date of Construction 1979
Original Use Squadron Headquarters
Current Use Squadron Operations

Structural System Reinforced masonry.
Wall Covering Stucco or textured paint.
Foundation Masonry on concrete slab.

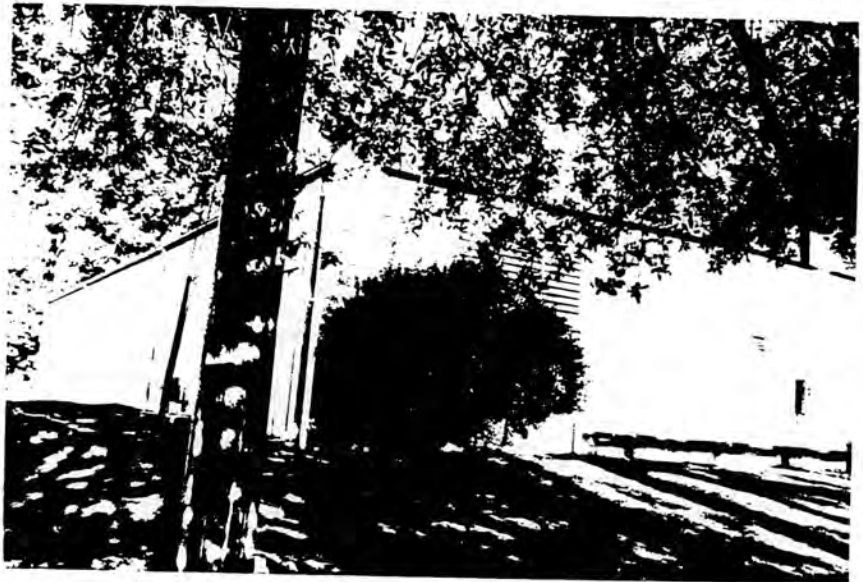
Building No. 4430

Date of Construction 1969
Original Use Target Intelligence Training Building
Current Use Maintenance Building

Structural System Reinforced masonry.
Wall Covering Metal siding.
Foundation Masonry on concrete slab.

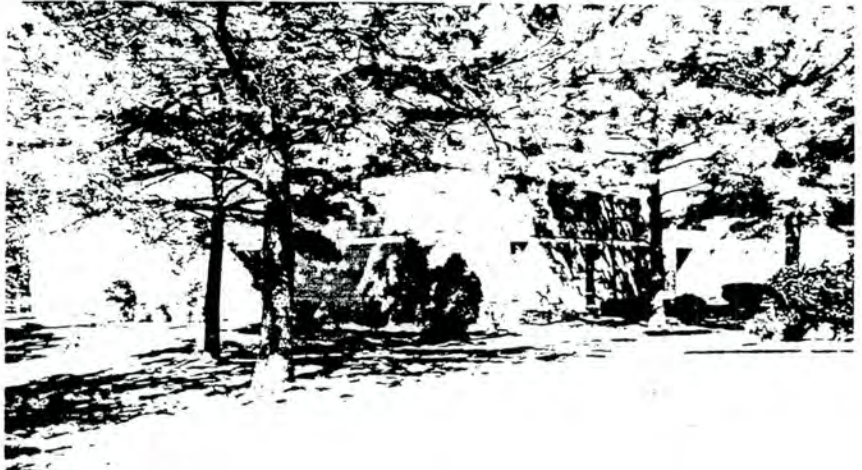
Building No. 4423

Date of Construction 1979
Original Use Squadron Operations
Current Use Squadron Operations

Structural System Reinforced masonry.
Wall Covering Molded block veneer.
Foundation Masonry on concrete slab.

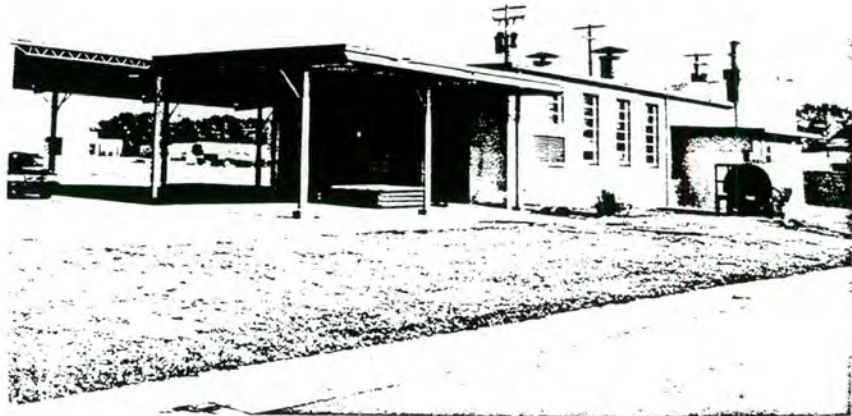
Building No. 4500

Date of Construction 1960
Original Use Base Paint Shop
Current Use Emerg. Ordnance Disposal

Structural System Reinforced masonry.
Wall Covering Painted.
Foundation Masonry on concrete slab.

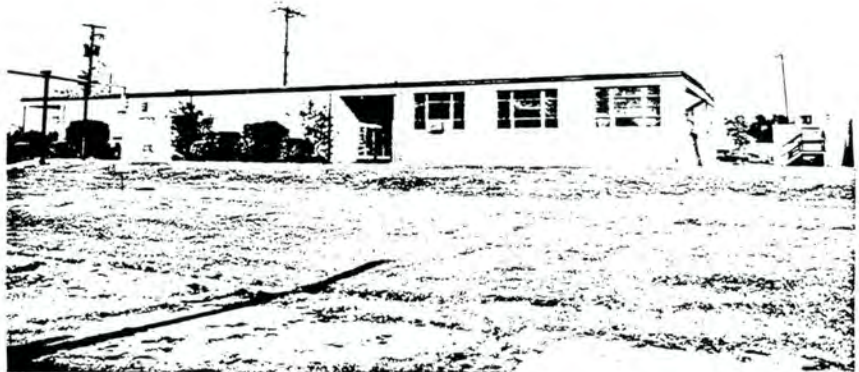
Building No. 4501

Date of Construction 1960
Original Use A/C Maintenance Shop
Current Use General Purpose Shop

Structural System Reinforced masonry.
Wall Covering Painted.
Foundation Masonry on concrete slabs.

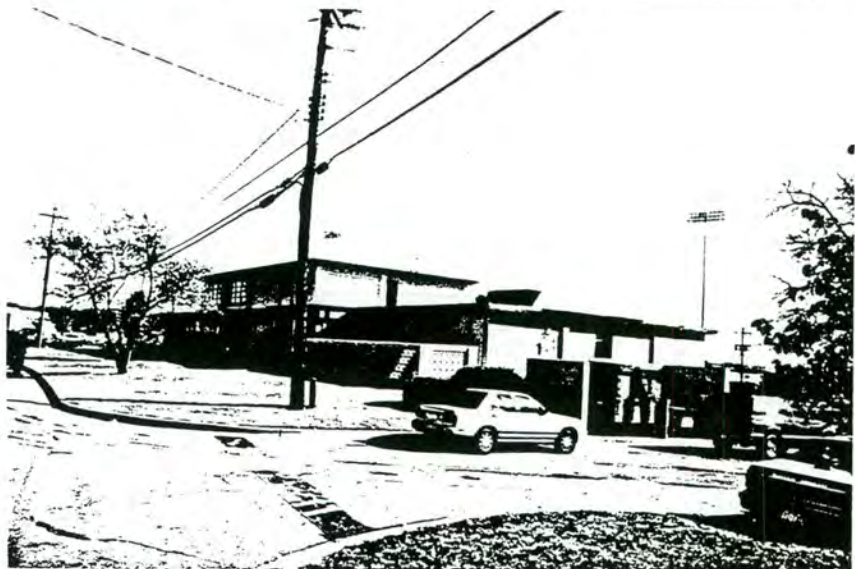
Current Use Base Operations

Structural System Reinforced masonry.

Foundation Masonry on concrete slab.

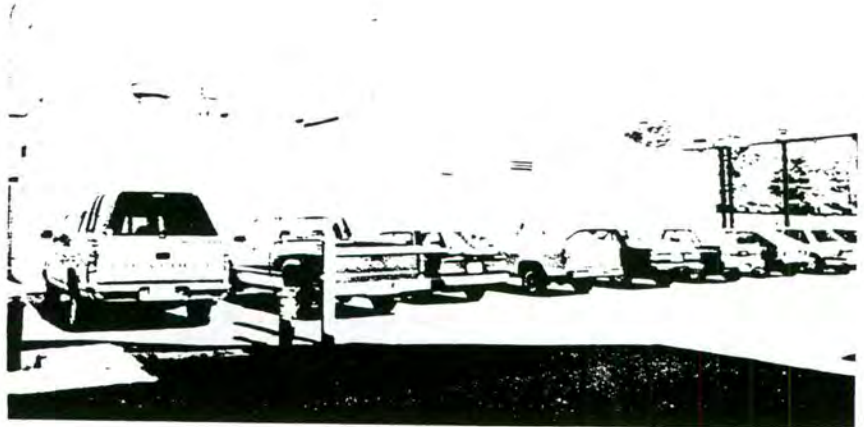
Building No. 4508

Date of Construction 1983
Original Use Storage Facility
Current Use Storage Facility

Structural System Reinforced masonry.
Wall Covering Painted
Foundation Masonry on concrete slab.

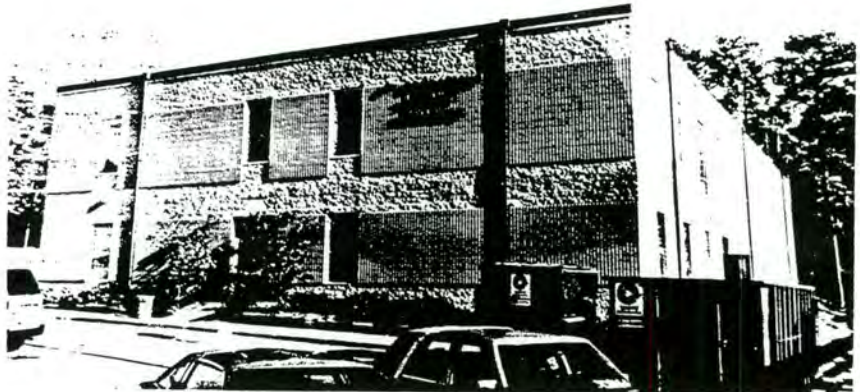
Building No. 4517

Date of Construction 1979
Original Use Maintenance Office
Current Use HQ Wing Operations

Structural System Reinforced masonry.
Wall Covering Molded masonry blocks.
Foundation Masonry on concrete slabs.

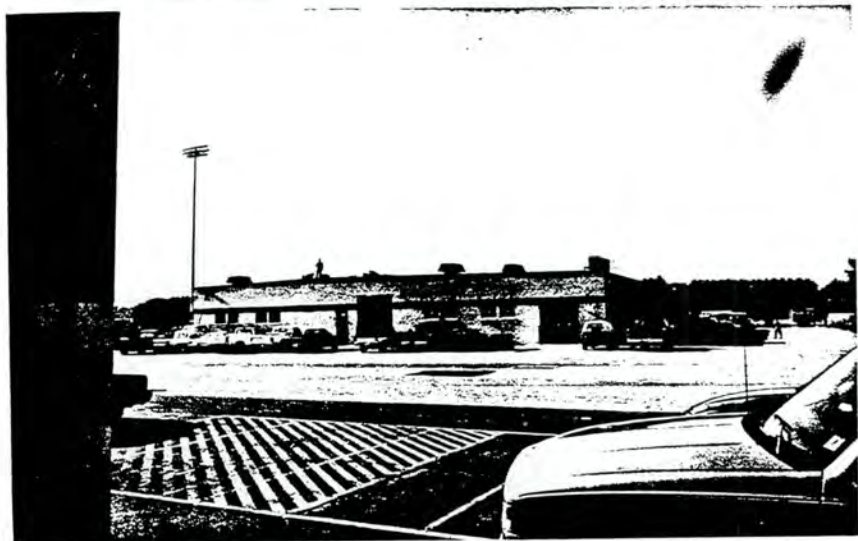
Building No. 4534

Date of Construction 1979
Original Use General Equipment Shop
Current Use General Equipment Shop

Structural System Reinforced masonry.
Wall Covering Molded masonry block veneer.
Foundation Masonry on concrete slab.

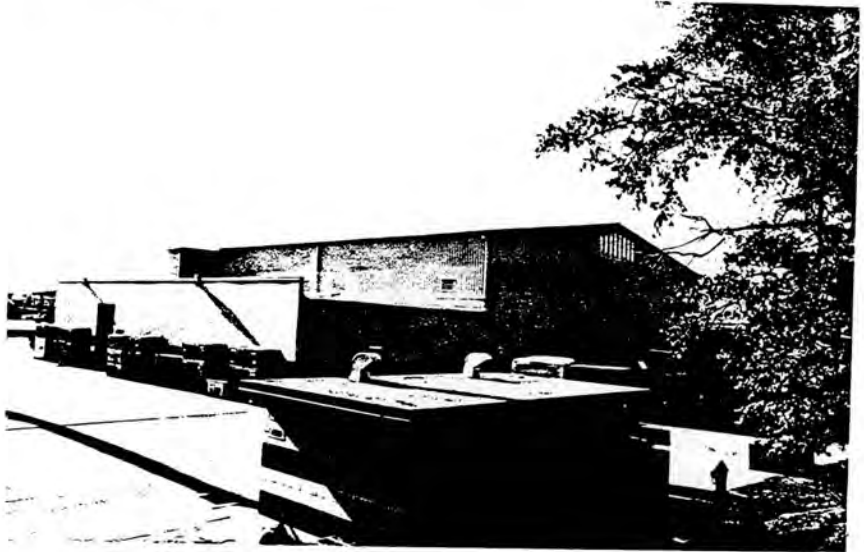
Building No. 4537

Date of Construction 1985
Original Use Aircraft Hangar
Current Use Aircraft Hangar

Structural System Steel frame.
Wall Covering Metal siding.
Foundation Masonry sills, concrete slab.

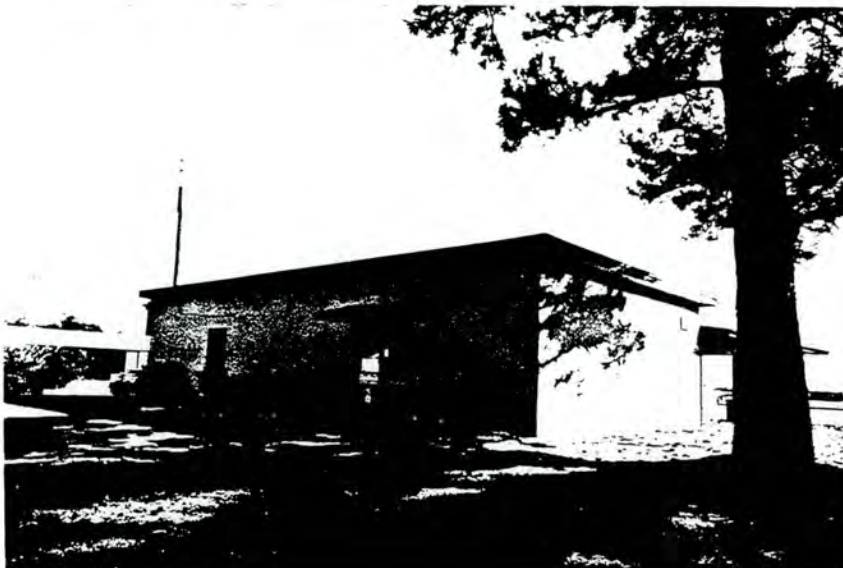
Building No. 4620

Date of Construction 1963
Original Use Security
Current Use Security Police

Structural System Reinforced masonry.
Wall Covering Painted.
Foundation Masonry on concrete slab.

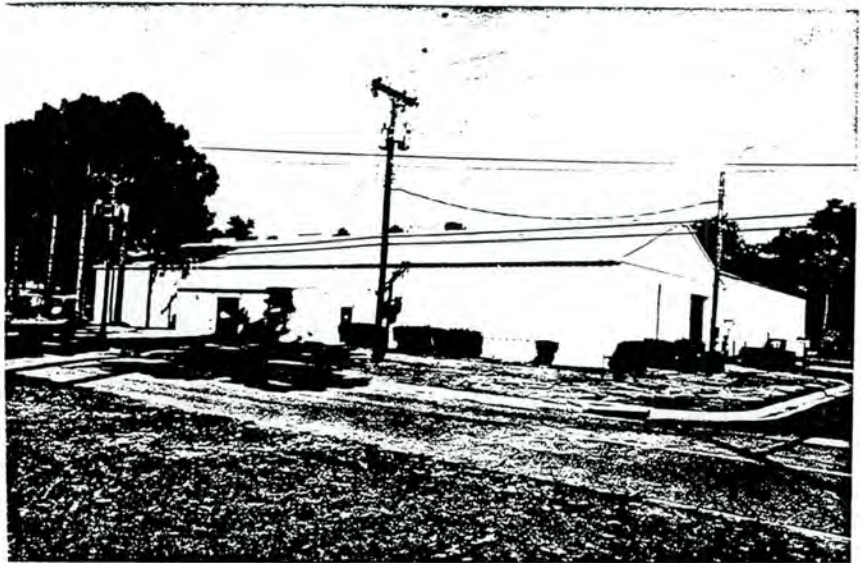
Building No. 4720

Date of Construction 1962
Original Use Ground Supply
Current Use Storage Facility

Structural System Steel frame.
Wall Covering Metal siding.
Foundation Masonry sills & concrete slab.

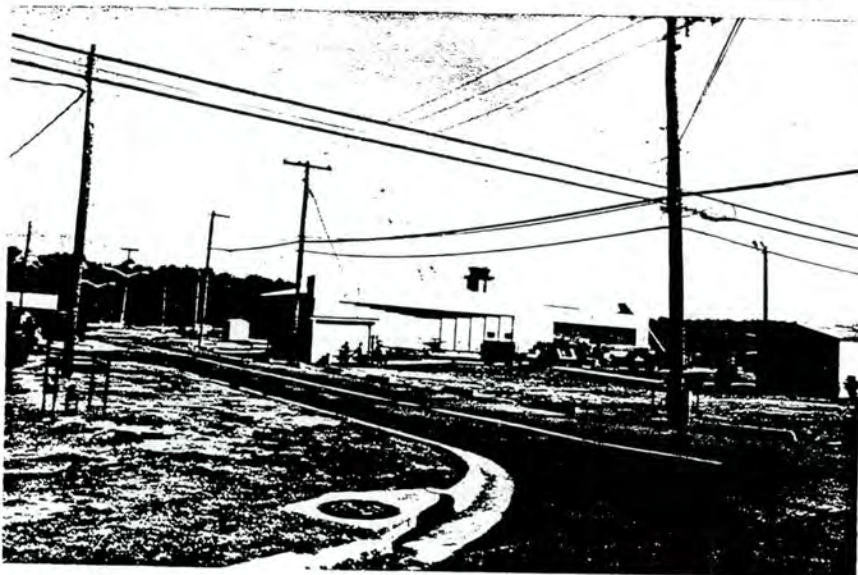
Building No. 4735

Date of Construction 1969
Original Use Aircraft Hangar
Current Use Maintenance Dock

Structural System Steel frame.
Wall Covering Metal siding.
Foundation Masonry sills & concrete slabs.

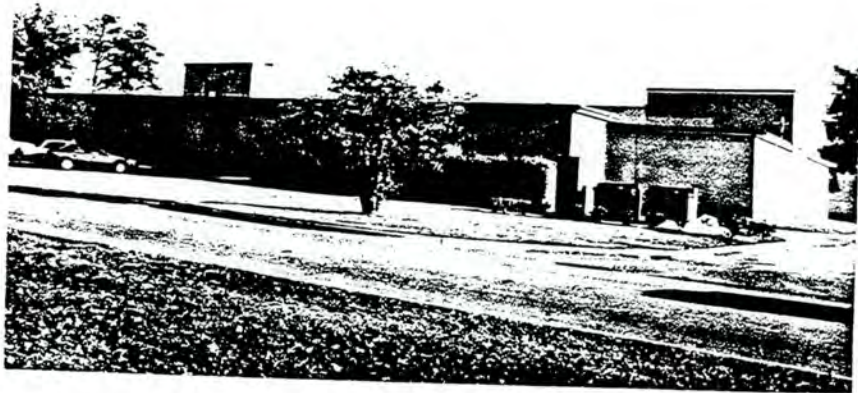
Building No. 4900

Date of Construction 1957
Original Use No Listing
Current Use Reserve Forces Training

Structural System Reinforced masonry.
Wall Covering Stucco.
Foundation Masonry on concrete slab.

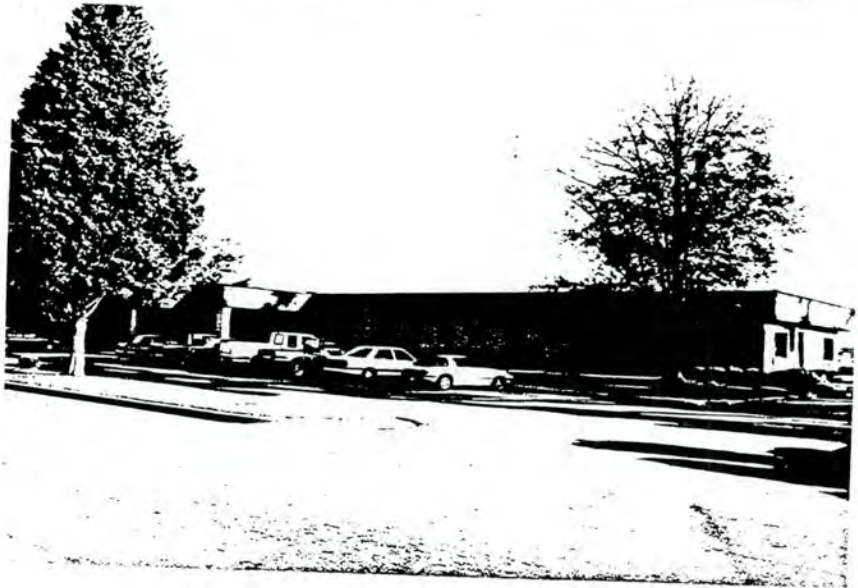
Original Use Wing Headquarters

Current Use Wing Headquarters

Structural System Reinforced masonry.

Foundation Masonry on concrete slab.

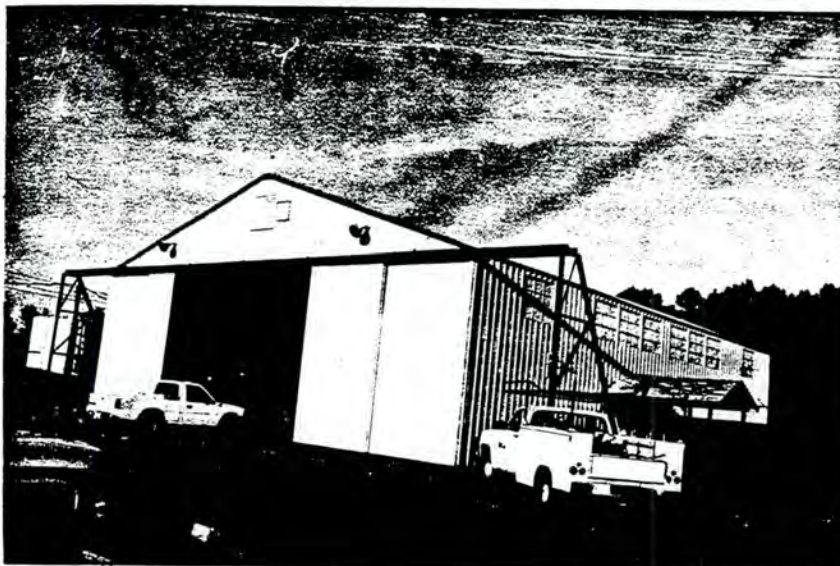
Original Use Maintenance Shop

Current Use Maintenance Shop

Structural System Steel frame.

Foundation Masonry sills & concrete slab.

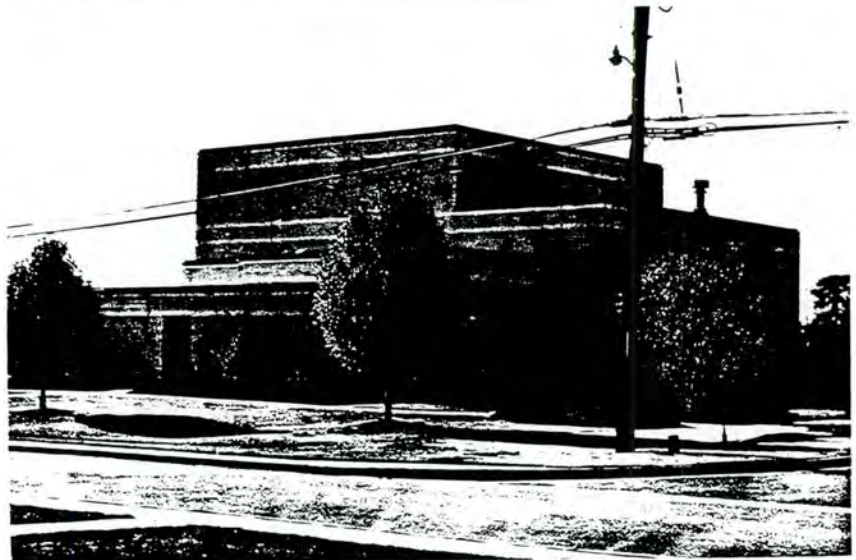
Building No. 5006

Date of Construction 1957
Original Use Flight Simulator Training
Current Use Flight Simulator Training

Structural System Reinforced masonry.
Wall Covering Textured masonry block.
Foundation Masonry on concrete slab.
