SUBJECT: Historic Architectural Resources Survey Report, Replace Bridge No. 117 on
SR 118 over North Fork New River, B-4012, Ashe County, ER02-8492

HISTORIC ARCHITECTURAL RESOURCES SURVEY REPORT

REPLACEMENT OF BRIDGE NO. 117 ON S.R. 1118
OVER NORTH FORK NEW RIVER
ASHE COUNTY

NORTH CAROLINA DEPARTMENT OF TRANSPORTATION
T.I.P. NO. B-4012
STATE PROJECT NO. 8.2712201
FEDERAL-AID PROJECT NO. BRZ-1118 (3)

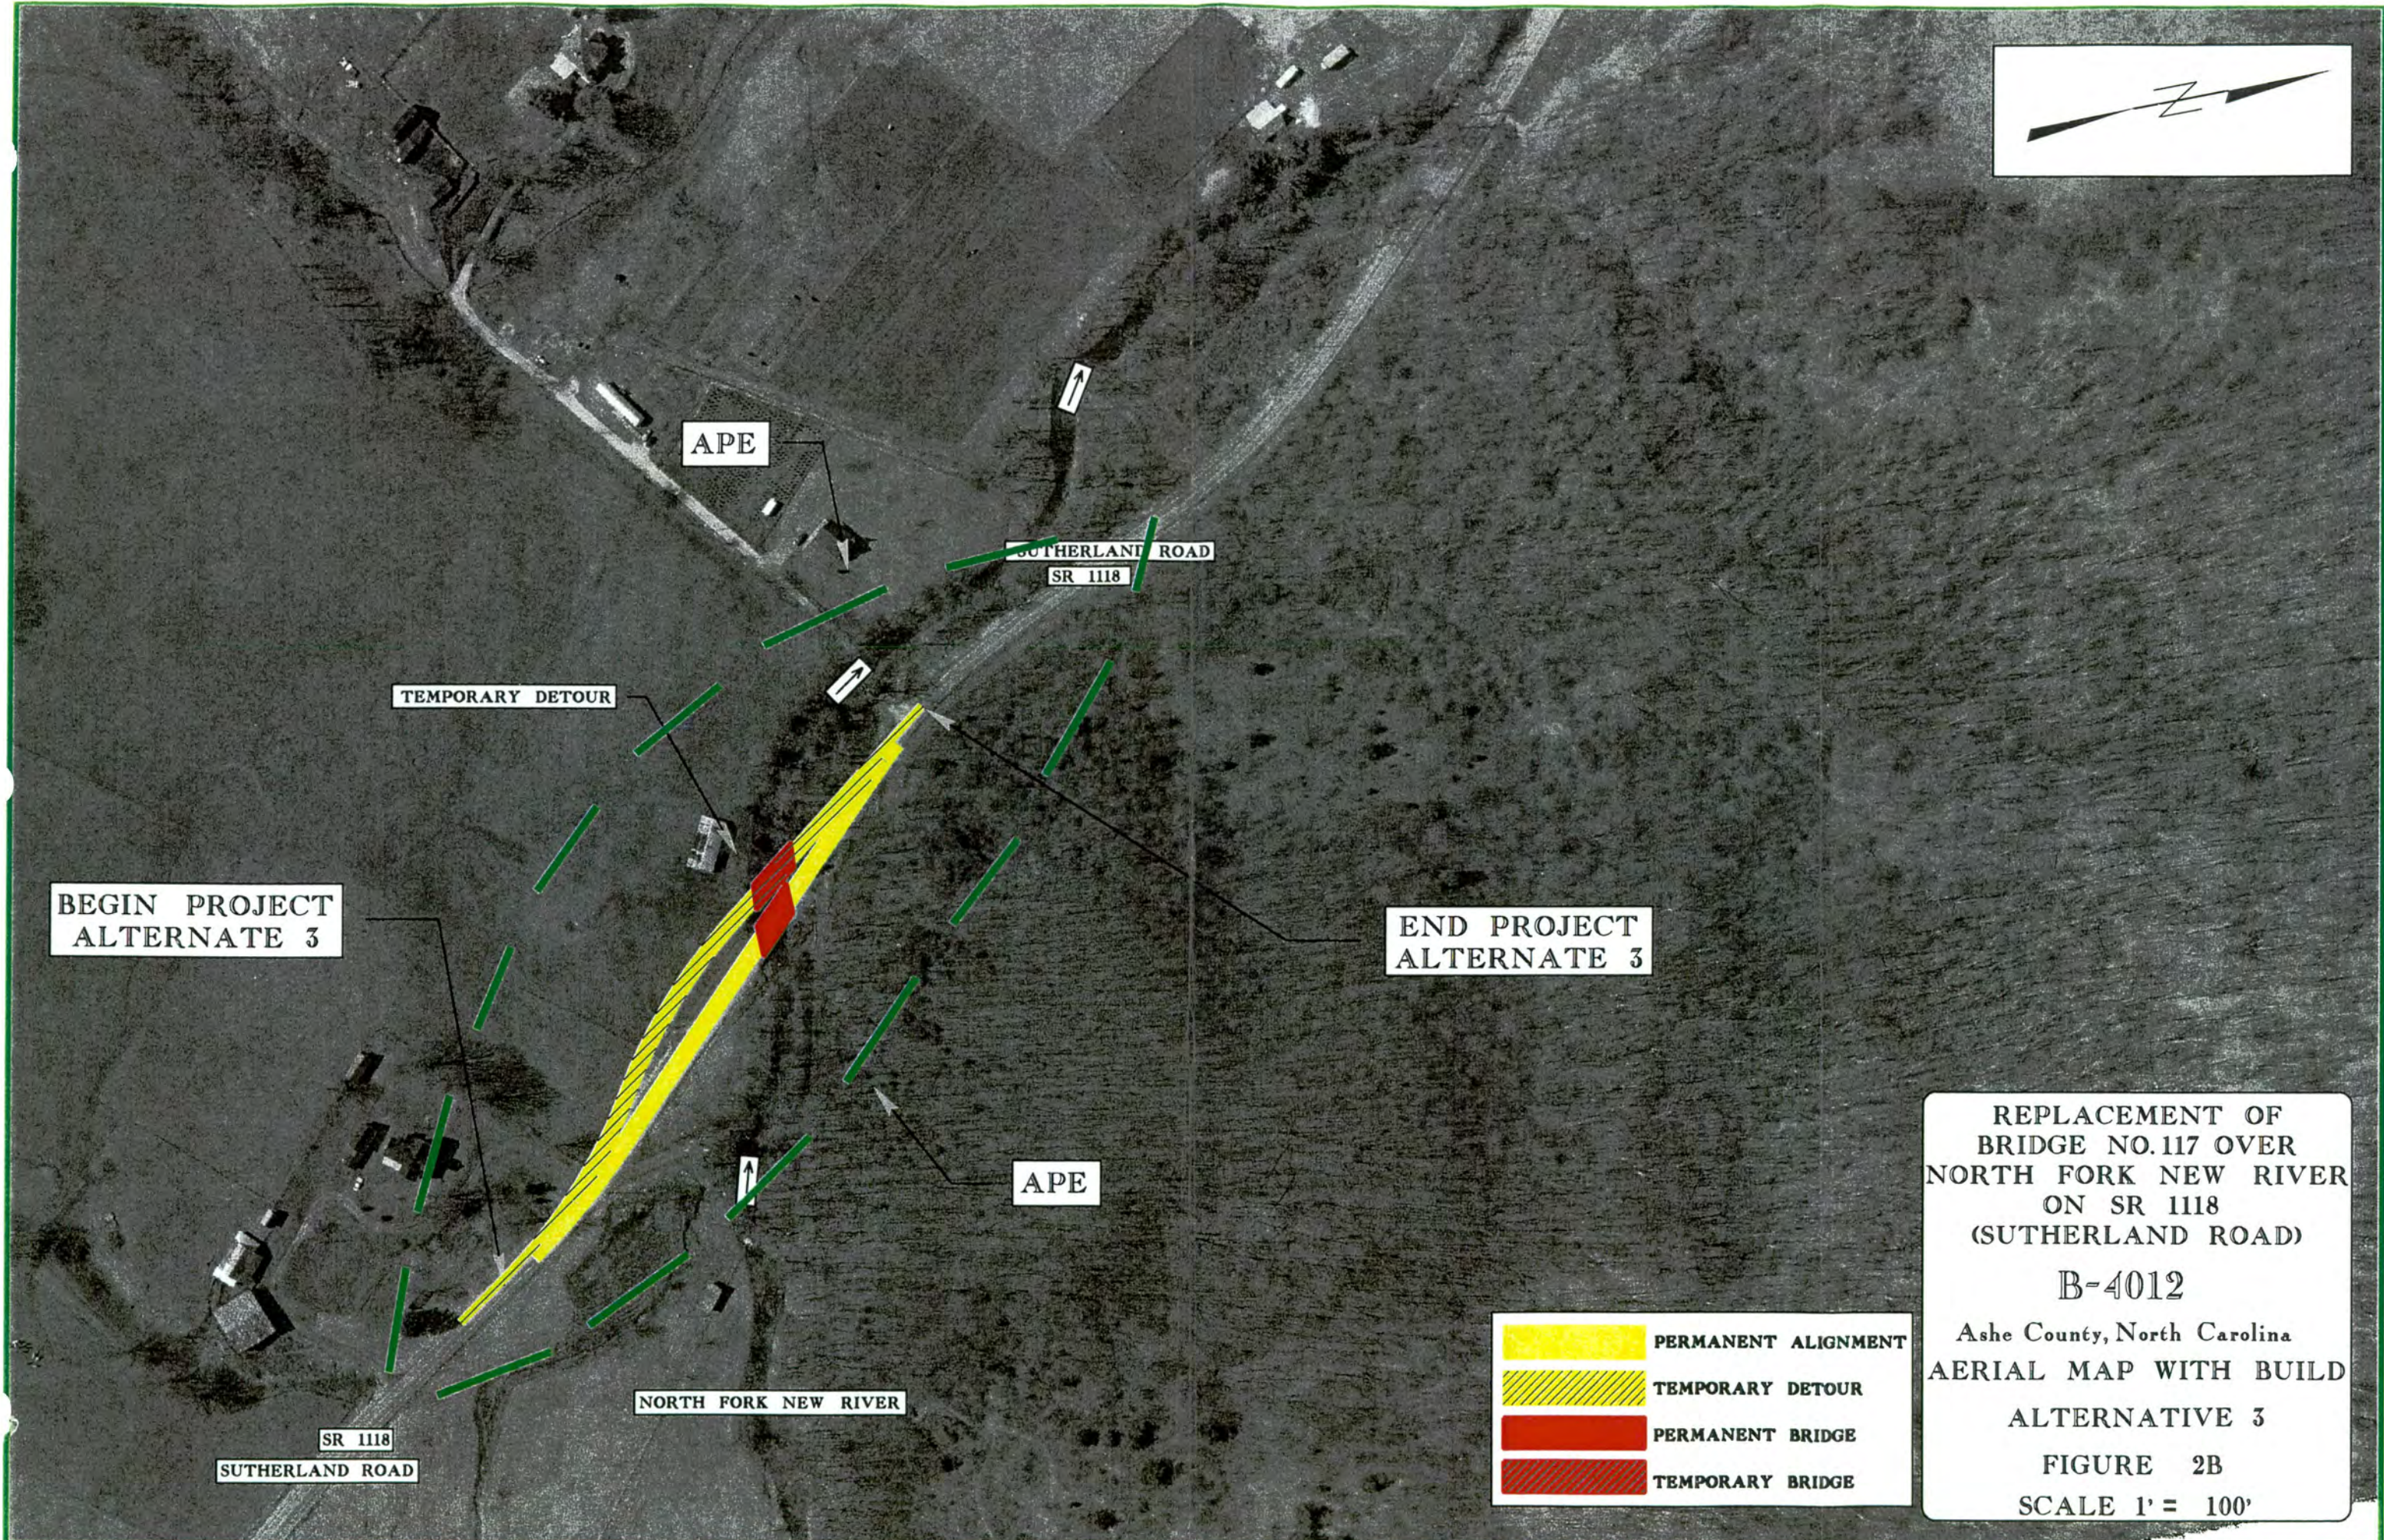
PERMANENT ALIGNMENT
	TEMPORARY DETOUR
	PERMANENT BRIDGE
	TEMPORARY BRIDGE

REPLACEMENT OF
BRIDGE NO.117 OVER
NORTH FORK NEW RIVER
ON SR 1118
(SUTHERLAND ROAD)
B-4012
Ashe County, North Carolina
AERIAL MAP WITH BUILD
ALTERNATIVE 3
FIGURE 2B
SCALE 1' = 100'

The project involves the replacement of the existing one-lane bridge with a two-lane structure. There are three alternatives for the new bridge. Alternative 1 proposes to realign SR 1118 and construct a new structure on the upstream (north) side of the existing bridge; alternative 2 proposes to realign SR 1118 and construct a new structure on the downstream (south) side of the existing bridge (Figure 2); alternative 3 proposes to replace the existing bridge with a new structure in the same location (Figure 3) with an onsite detour to the downstream (south) side of the existing bridge.

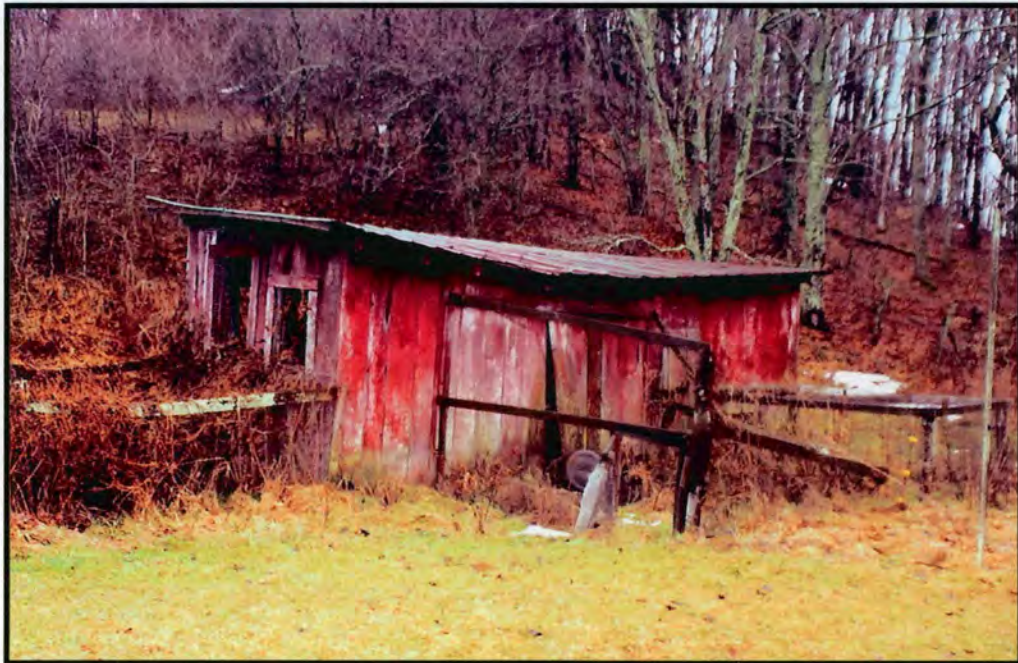
Plate 8. Chicken Coop

The dwelling and outbuildings of the Thomas H. Sutherland Farm possess excellent integrity. The house is one of only four dwellings in the district that retains original siding material. The additions to the house represent expansions to the dwelling within the district's period of significance. The arrangement of buildings on the site is typical of a twentieth-century Ashe County farmstead and conveys the property's historic agricultural uses. The outbuildings are in good condition with the exception of the chicken coop, which is deteriorated, although still recognizable.

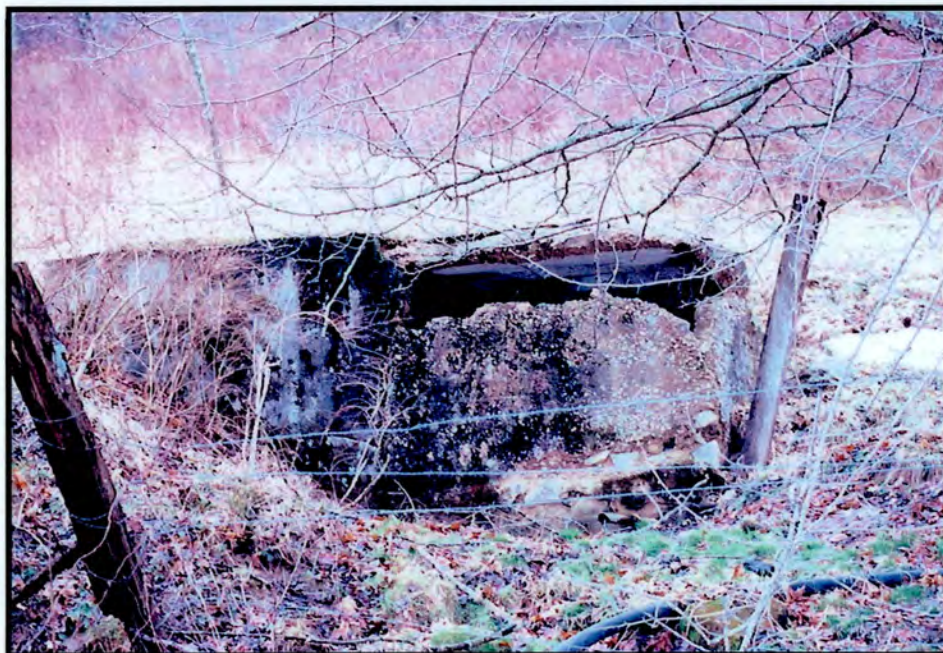
Plate 36. Springhouse foundation

A stone and concrete springhouse foundation for the creek that runs through the property.

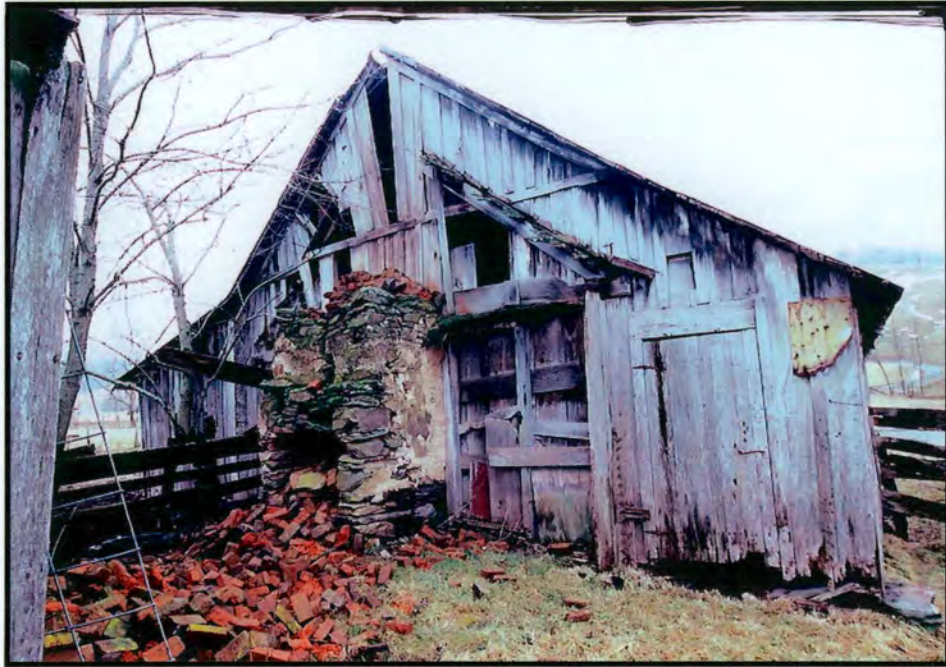
Plate 39. Tannery

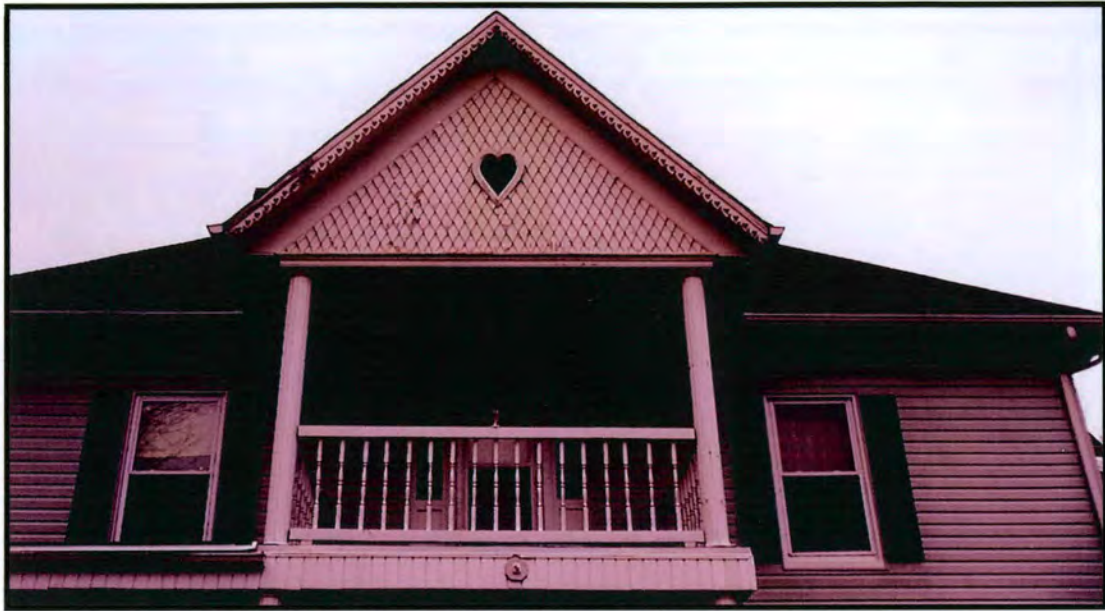
Plate 58. Wilson Farm house - front porch detail

A three-bay, square, hipped-roof house with wide overhanging eaves. The house's most distinctive feature—its two-story, one-bay central porch—has been altered by the loss of its original porch posts and balustrade. However, the porch's front gable is unchanged and retains its fanciful diamond-shaped shingles, lattice barge board, and a heart-shaped vent. Another two-story porch is found on the northwest elevation; it has also lost its original posts, balustrade and gable treatment. Another interesting feature of the house is the inset porch on the side (southeast) elevation. The roof is covered with asphalt shingles; two interior chimneys pierce the roof plane. Alterations to the house include: vinyl siding and shutters, one-over-one replacement windows, and a one-story, shed-roofed addition off the side (southeast) elevation.

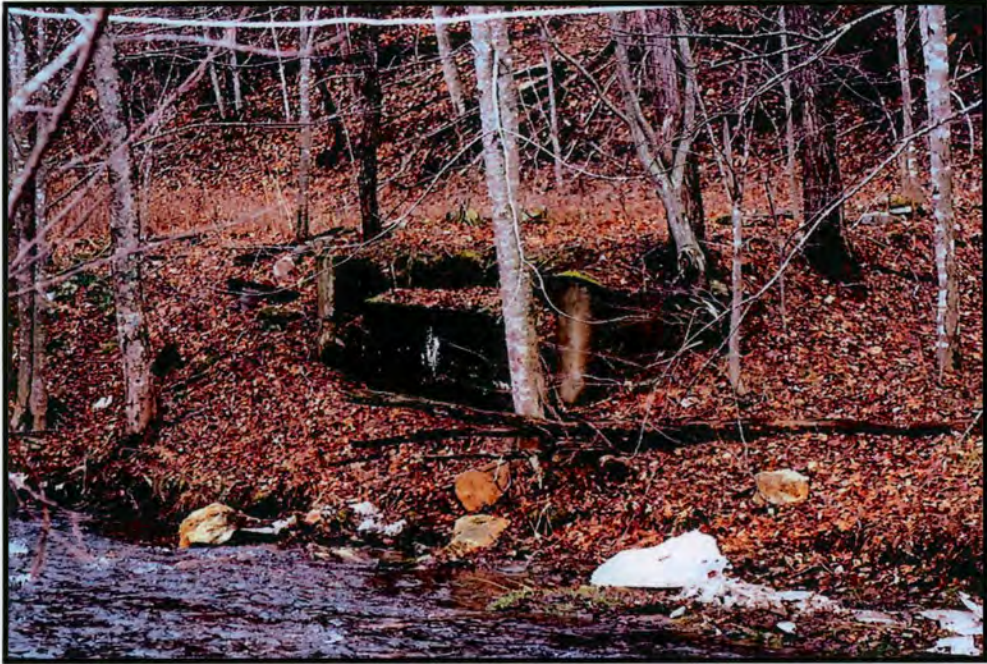
Plate 83. Old Mill site

Remnants of the mill site include a few log piers and decayed floor plank.

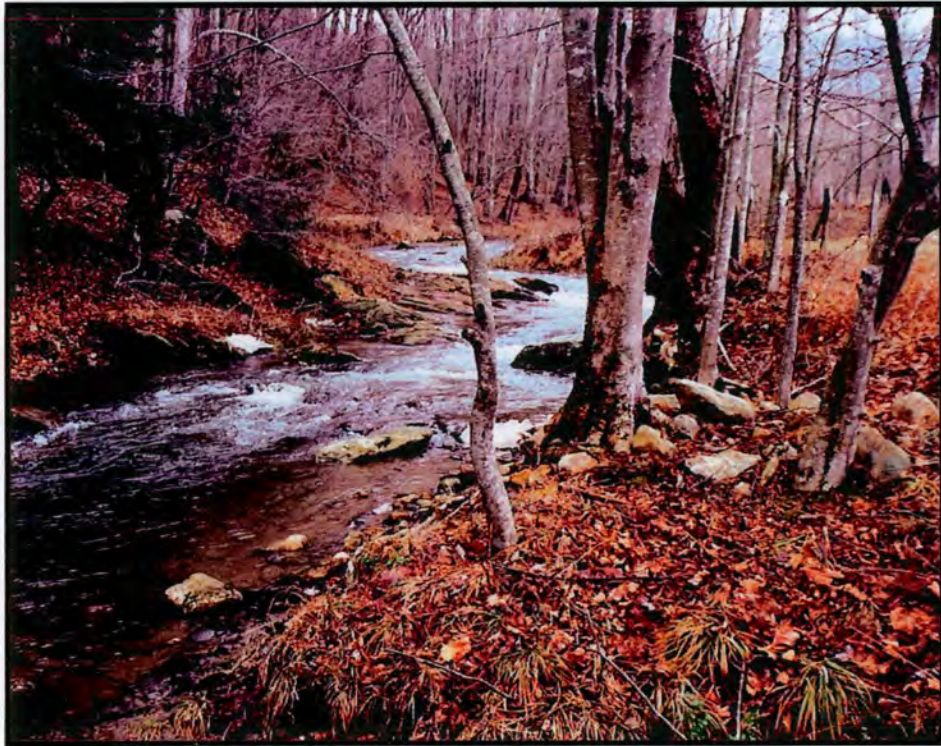
Plate 84. Old Mill site
