Re: Historic Structures Survey Report
for Mallard Creek Road Improvement,
Mecklenburg County, Federal-Aid M-5238(1),
State 9.8100316, U-2507, ER 92-7443

HISTORIC STRUCTURES SURVEY REPORT FOR
THE MALLARD CREEK ROAD
IMPROVEMENT PROJECT MECKLENBURG COUNTY,
NORTH CAROLINA

STATE PROJECT NO.: 9.8100316
TIP NO.: U-2507

October 1991

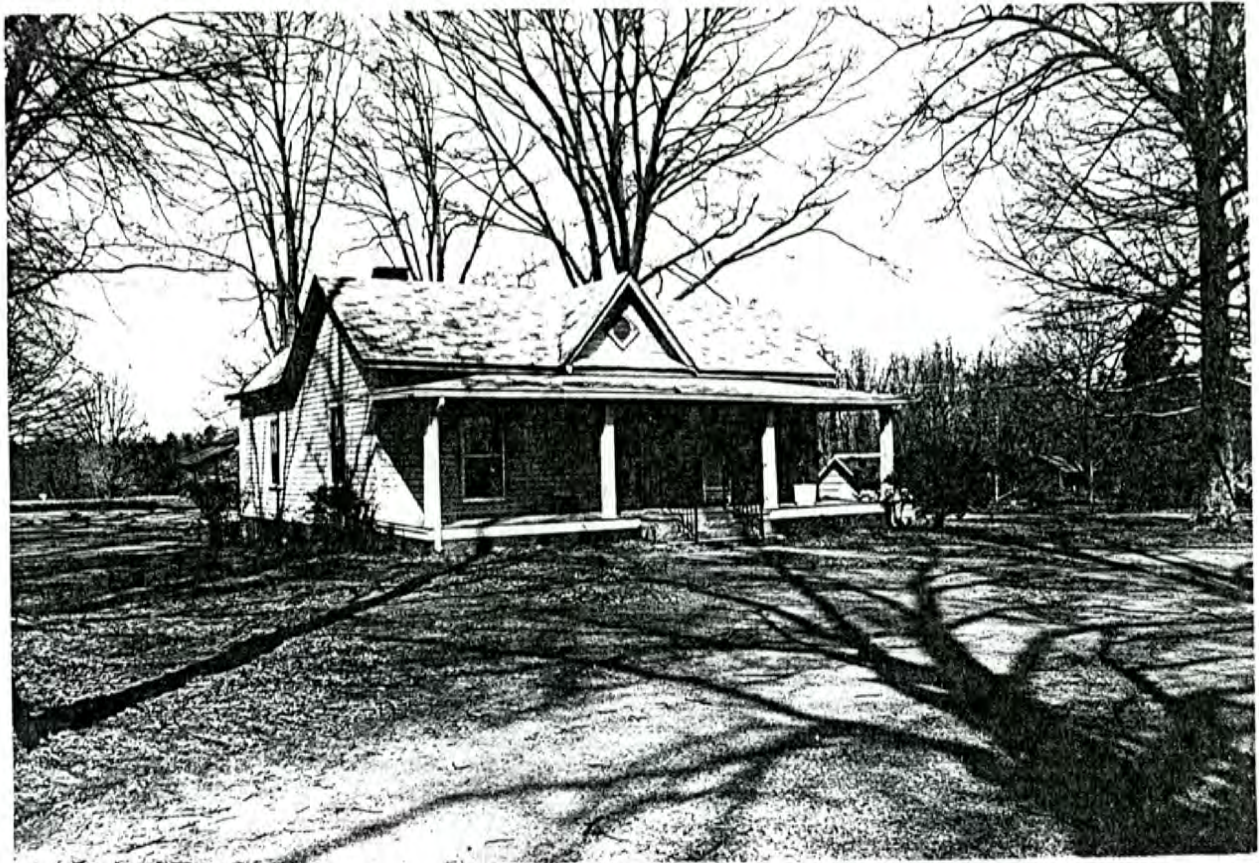
PLATE 5: Bisaner-Block House (MK-1530). View Looking Northwest

The Bisaner-Block House is a late-19th century, one story, side gabled dwelling with a cross gable centered over the symmetrical three-bay facade, a full width front porch, supported on square posts with recessed panels, and a shed roofed, enclosed porch across the rear (Plate 5). The frame house is sheathed with beveled weatherboard siding. The facade rests on a foundation of

cut ashlar-faced stone while the side and rear foundations are of concrete blocks and bricks. Asphalt shingles cover the roof, which has wide boxed eaves. The facade is divided into three bays with long 2/2 double-hung windows flanking a plywood door. The windows of the side walls are 6/6 sash while those of the rear addition are 4/4. An interior brick chimney is located on the ridge of the eastern cross gable.

Aside from the application of asphalt roofing, no changes are apparent on the exterior. Integrity of design, materials, and workmanship are apparent in the cross-gable plan, drop siding, full-width front porch, and stone, brick, and concrete block foundation. The sum of these features conveys the vernacular character of the house. In addition, the setting conveys an aura of settled permanence and rural isolation uncommon in the rapidly developing, exurban environment characteristic of this portion of Mecklenburg County. Large trees shield the house from view of Hubbard Street and line the driveway that circles the house. A drive-through barn, set slightly apart from the house, borders a meadow in the adjacent lot.

Evaluation: According to Dr. Dan Morrill of the Charlotte-Mecklenburg Historic Landmarks Committee, the Bisaner-Block House represents a type common in many areas of the county at the turn of the century, although their numbers have decreased as the county has undergone increasingly intensive suburban redevelopment. However, the house does not possess qualities of architectural importance that would significantly distinguish it from other triple-A houses of its type in Mecklenburg County or the lower North Carolina Piedmont region, and any significance that it may possess derives from the loss of many houses of similar design in recent years in Mecklenburg County (Morrill, personal communication 1991). This report therefore agrees with the SHPO's June 13, 1990 opinion that the Bisaner-Block House is not eligible for listing in the National Register.

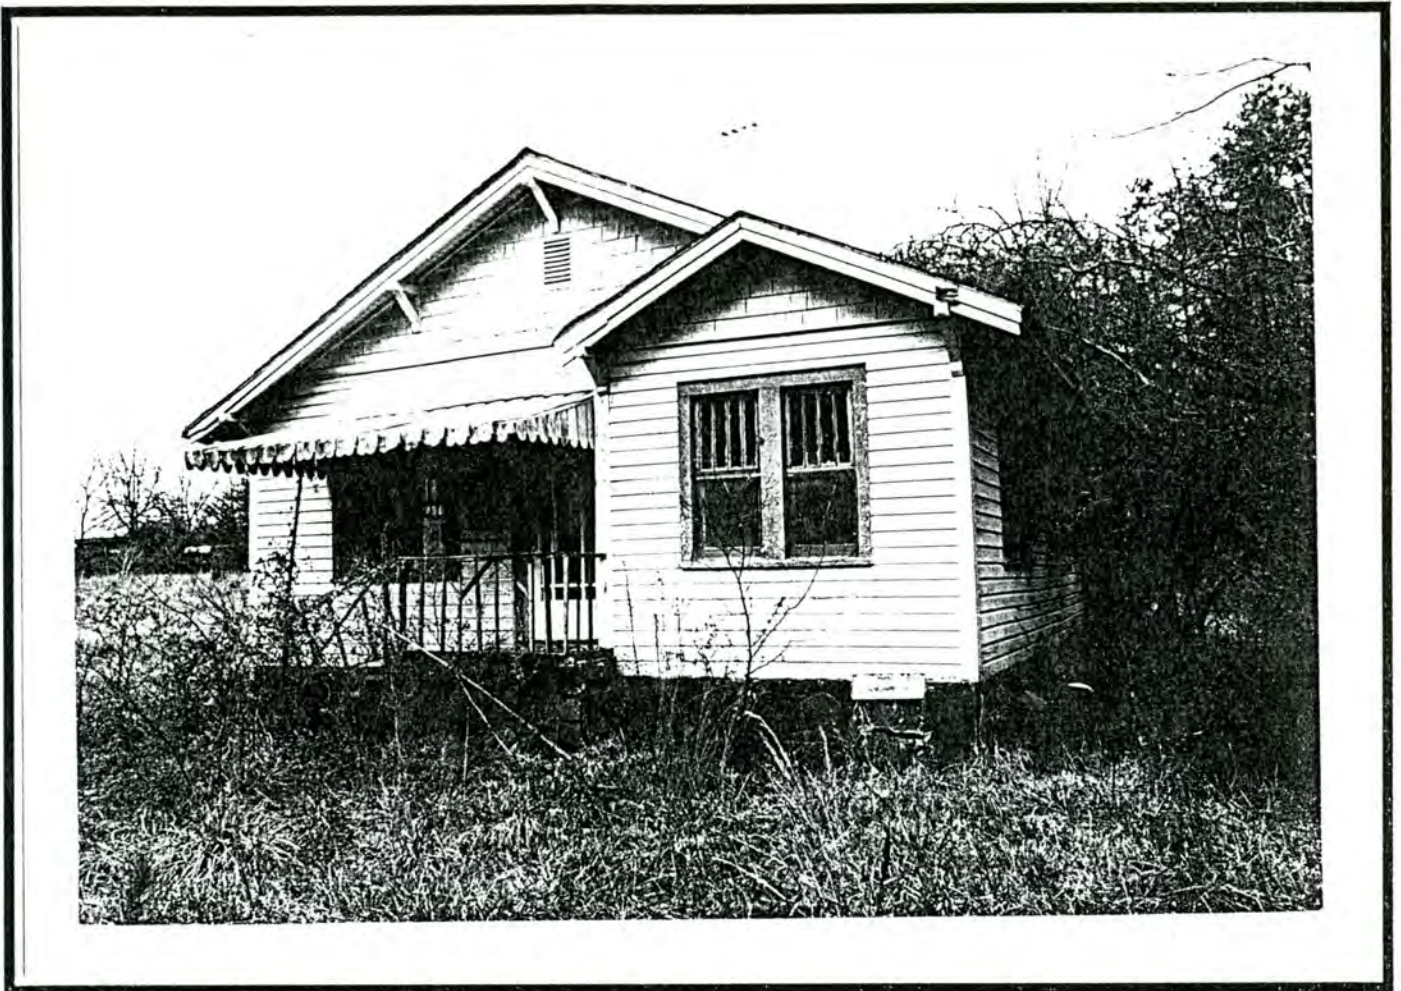
PLATE 7: Chen House. View Looking Northwest

The one-story Craftsman-type cottage is front-gabled with a lower projecting gable occupying the southern half of the main block (Plate 7). The exterior of the structure, resting on a partially stuccoed, brick foundation, is sheathed with wide, beveled weatherboards with shingles in the gable peaks. A brick chimney pierces the asphalt shingle roof on the ridge toward the rear of the building. Window openings are filled with paired 4/1 double-hung sash, and the front door features three long lights centered between three small lights, in a distinctive, almost Wrightian pattern also seen on the front door of the Garrison-McGee House (see below). The gables of the facade are bracketed as is the rear projection of the lower gable.

Evaluation: The Chen House is very much like "low-end" cottages promoted by mail-order concerns such as Aladdin and Sears, and possesses distinctive features of small-scale Craftsman-style buildings. However, although in good physical condition and well sited off the road, the house does not possess distinguishing qualities of importance in terms of architecture or association, and therefore is not eligible for the National Register.

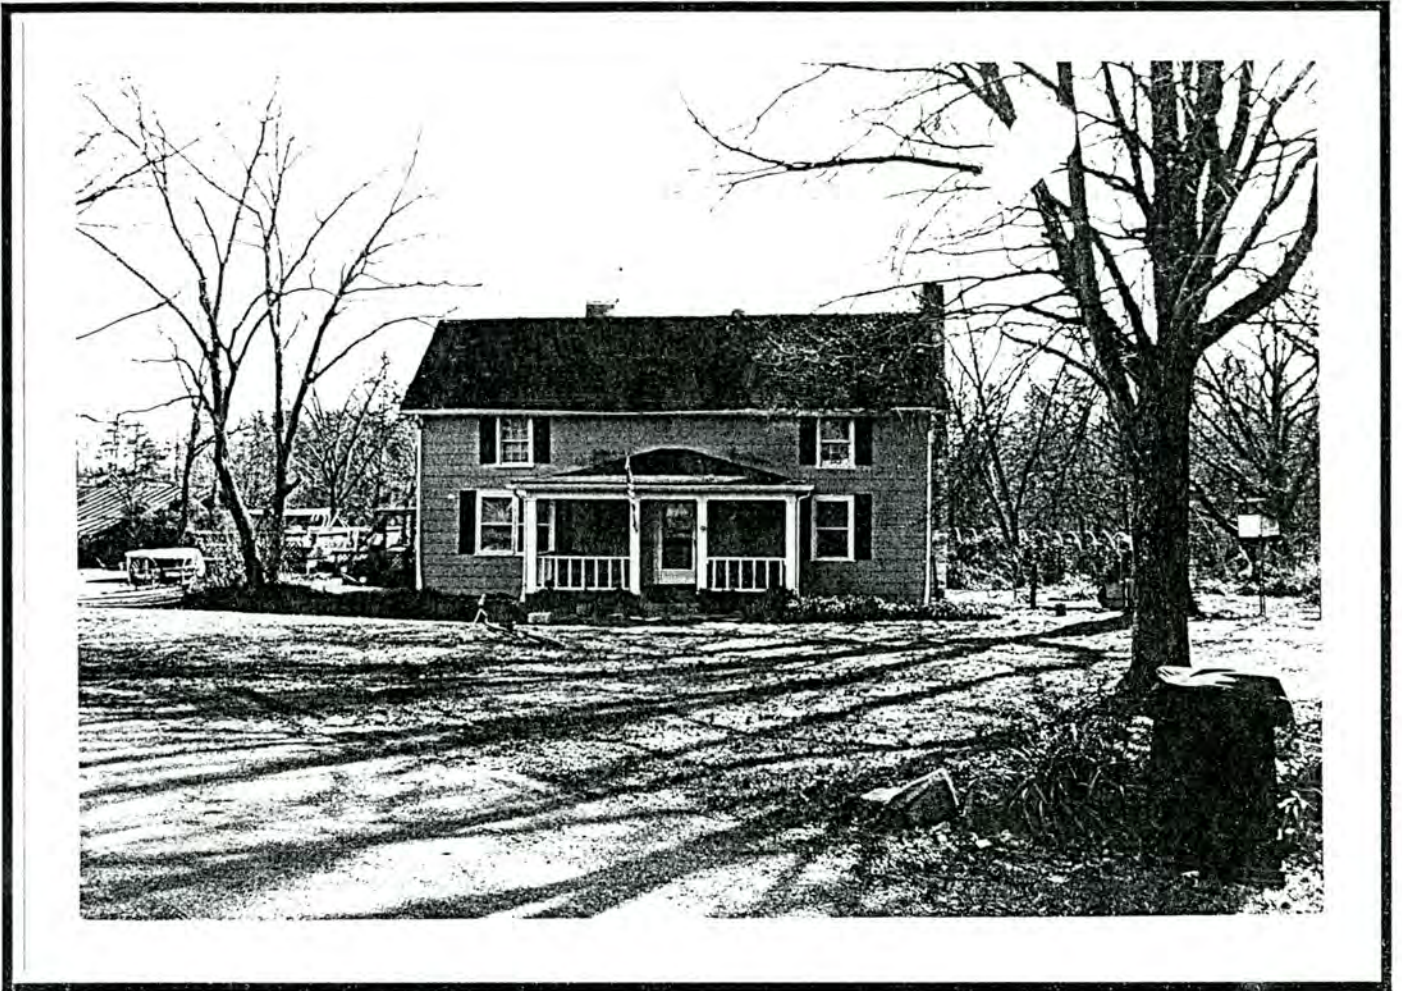
PLATE 8: Christensen House. View Looking South

The Christensen House built in the late-19th century is a two-story, L-shaped, asbestos-shingled house one-room wide, with an asphalt shingle roof and a shouldered, exterior brick chimney centered on the western gable end wall (Plate 8).

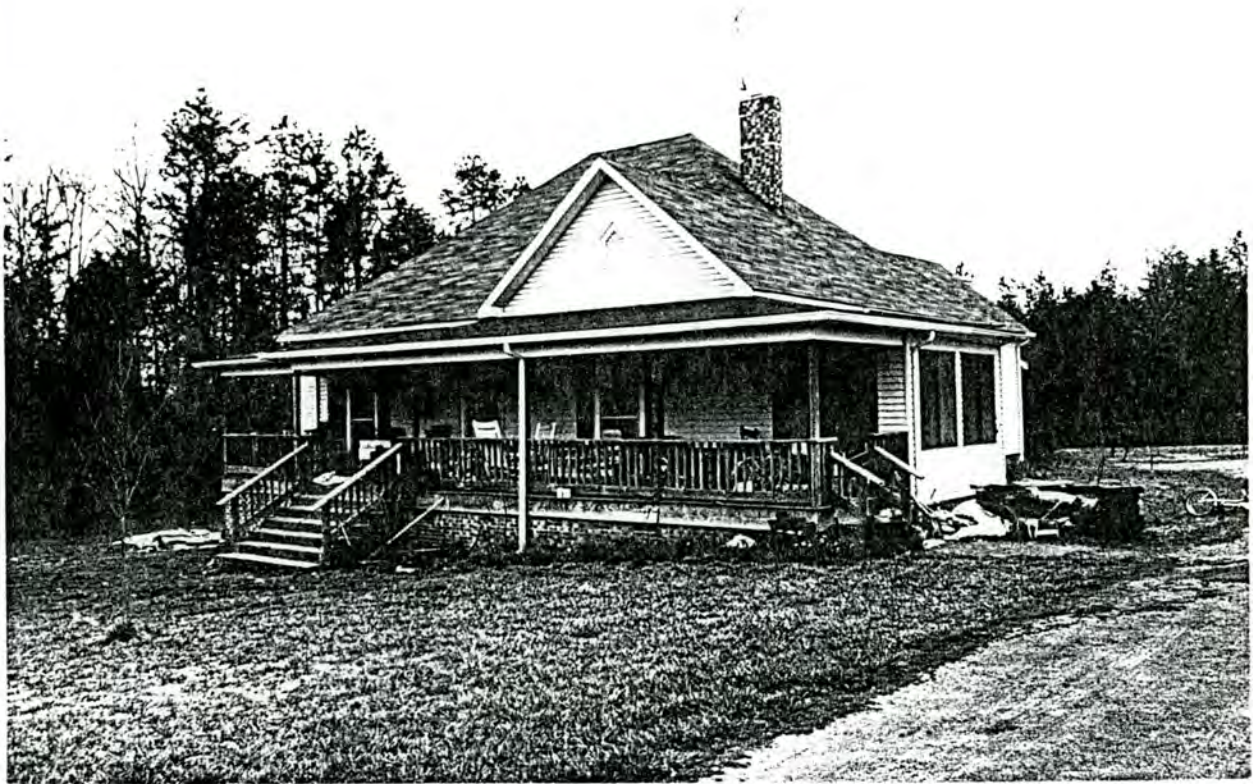
PLATE 9: Cochran-Hewitt-Fox-Hartiss-Terry House. View Looking Northeast

The aluminum sided, asphalt roofed, Cochran House is approximately 80 to 90 years old (Plate 9). It is a one-story structure with a steep hipped roof and a full width front porch. A cross gable emerges from the front and back of the southern half of the rectangular main block, and a second gable projects from the northern half of the rear elevation parallel to the first. On the rear, the first cross gable is shorter in length than the second and the difference in length is filled with an enclosed porch. A brick chimney rises from the southern slope of the steep pyramidal, hipped roof. The building is set on a modern stone foundation that recreates the original. The majority of window openings are filled with the original 2/2 double-hung sash, although some modern casement windows are found on the side and rear where open porches were enclosed.

The house was originally constructed by the Cochran family on their dairy farm around the turn of the century (possibly the abandoned outbuildings on the northeast corner of the intersection of Harris Boulevard and Mallard Creek Road, Plate 10). The Mecklenburg County dairy farming context mentions three members of the Cochran family (T.E., Fred, and Banks) who were dairy farmers in the county during the 1920s and 30s, one of whom was probably the owner of this property (North Carolina Department of Cultural Resources 1991:n.p.).

Evaluation: In spite of the application of synthetic siding, asphalt roofing, and a replacement, pressure-treated-lumber porch, the form of the Cochran House remains recognizable as an example of early-20th century vernacular design. Originally a farm house, it has been moved from its original location and is no longer sited in an agricultural setting. The alterations have sufficiently weakened the integrities of location, materials and workmanship so that the Cochran House no longer possesses qualities of architectural or historical significance to qualify for the National Register of Historic Places.

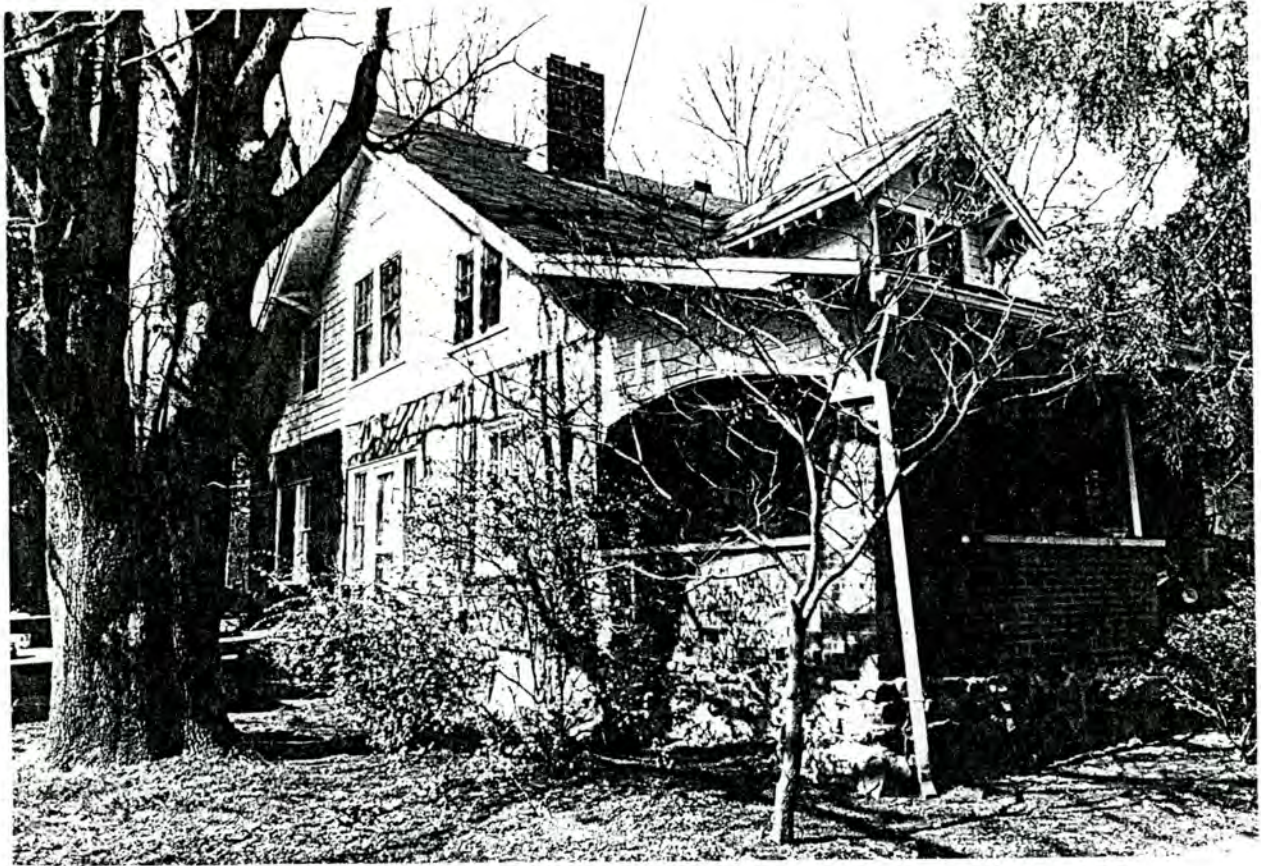
PLATE 11: Garrison-McGee House. View Looking North

The Garrison-McGee House is a 1-1/2 story brick bungalow covered with an asphalt shingled, side-gabled roof (Plate 11). The shed roof of the full-width-porch across the facade is supported by two metal poles framing the center and heavy brick piers with painted brick capitals resting on rusticated stone foundations at the outer corners. The brick facing of the side elevations is laid in running bond with a course of headers at the top of the foundation

and header window sills. The gable peaks are shingled and bracketed as is a gable dormer centered in the front roof slope. Two shed-roofed, clapboarded projecting bays are located at either end of the east side wall. A brick chimney with ceramic chimney pots rises in front of the ridge toward the western side of the front roof slope. A clapboarded shed-roofed dormer occupies the western half of the rear roof slope and a clapboarded, enclosed entrance which occupies the eastern (rear) half of the ground floor level (Plate 12). A pressure treated deck, centered in the western elevation, accesses an entrance to the upper story apartment. The front door, centered in the facade, is a vaguely Wrightian pattern, previously seen in the Chen House, with three long, rectangular lights capped on either end by three small, square lights. Typically, the window openings are filled with paired 6/1 double-hung sash or single 6/6 sash.

Evaluation: The Garrison-McGee House, built in the early 1920s, is an example of suburban Bungalow construction. Although in good, well-maintained condition, the house does not possess the architectural or associative qualities to qualify for the National Register of Historic Places.

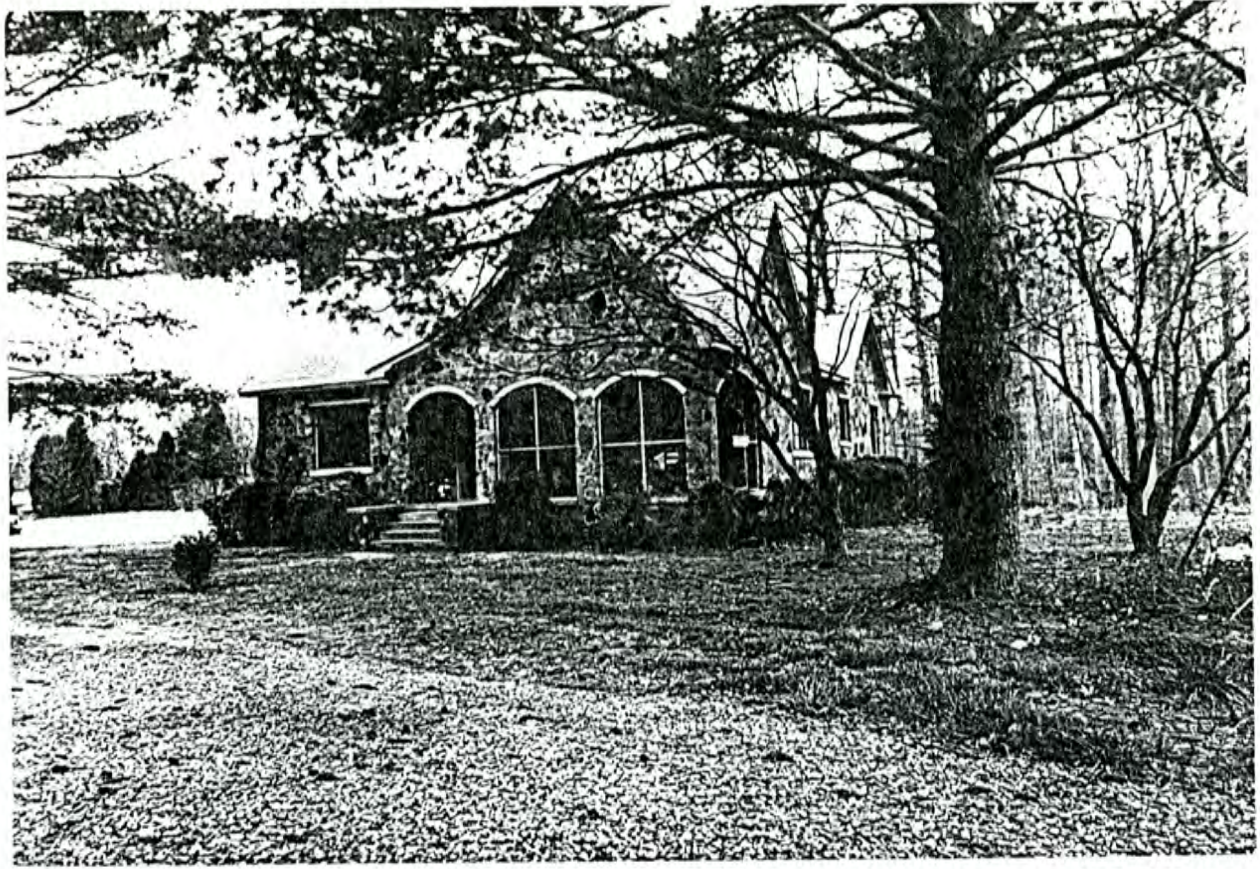
PLATE 13: James Property. View Looking Northwest

The James House is a 1-1/2-story, T-shaped building dating to 1941 (Plate 13). Ashlar faced stones, many of which were acquired by the builder during his travels around the southeast as a paint contractor, were applied over a stud-frame structure. An exterior,

Evaluation: Faced with rock collected by the builder during his travels around the southeast, the James House is an interesting vernacular interpretation of the Tudor style popular from the 1890s to the 1940s and most commonly found in urban and suburban environments. As such, it was, and still is, something of an architectural curiosity. However, it does not possess qualities of sufficient architectural importance to qualify for the National Register.

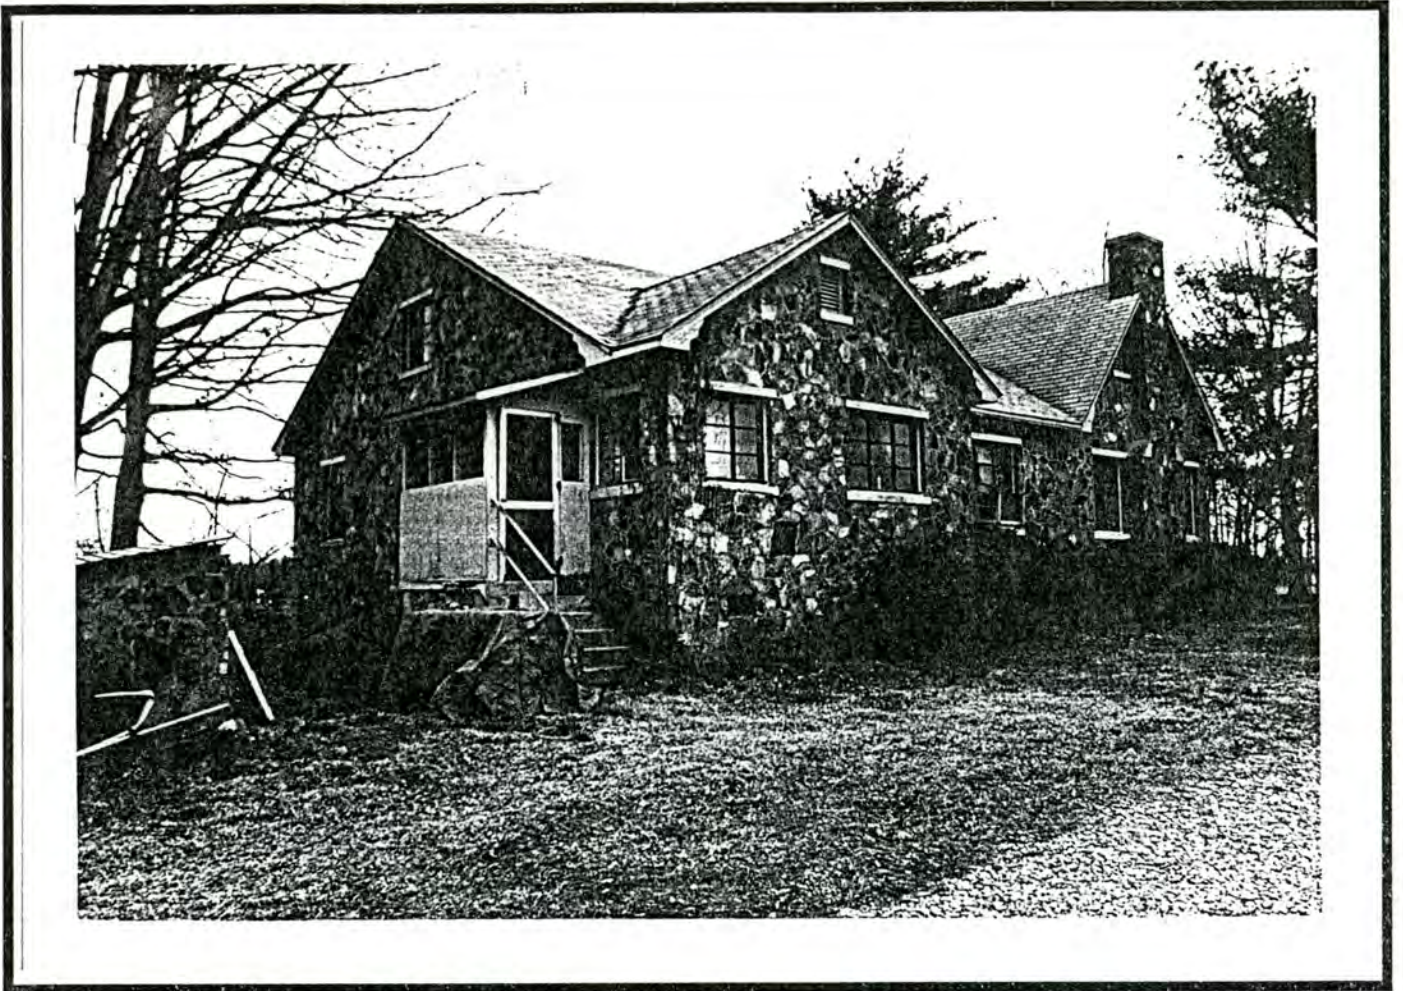
PLATE 14: James Property. View Looking Southeast

shouldered, stone chimney is located on the ridge of the asphalt shingle roof at the southern end wall (Plate 14). The Tudor Revival influence is acknowledged by the steep, sloping peaked roof of the projecting entrance porch, multi-paned casement windows and the heavy, vertical tongue-in-groove front door with "medieval" decorative door handle, knocker and strap hinges. The 14-inch thick walls of the building were built with 6 inches of dead air space between the exterior stone and interior walls creating a natural insulation barrier.

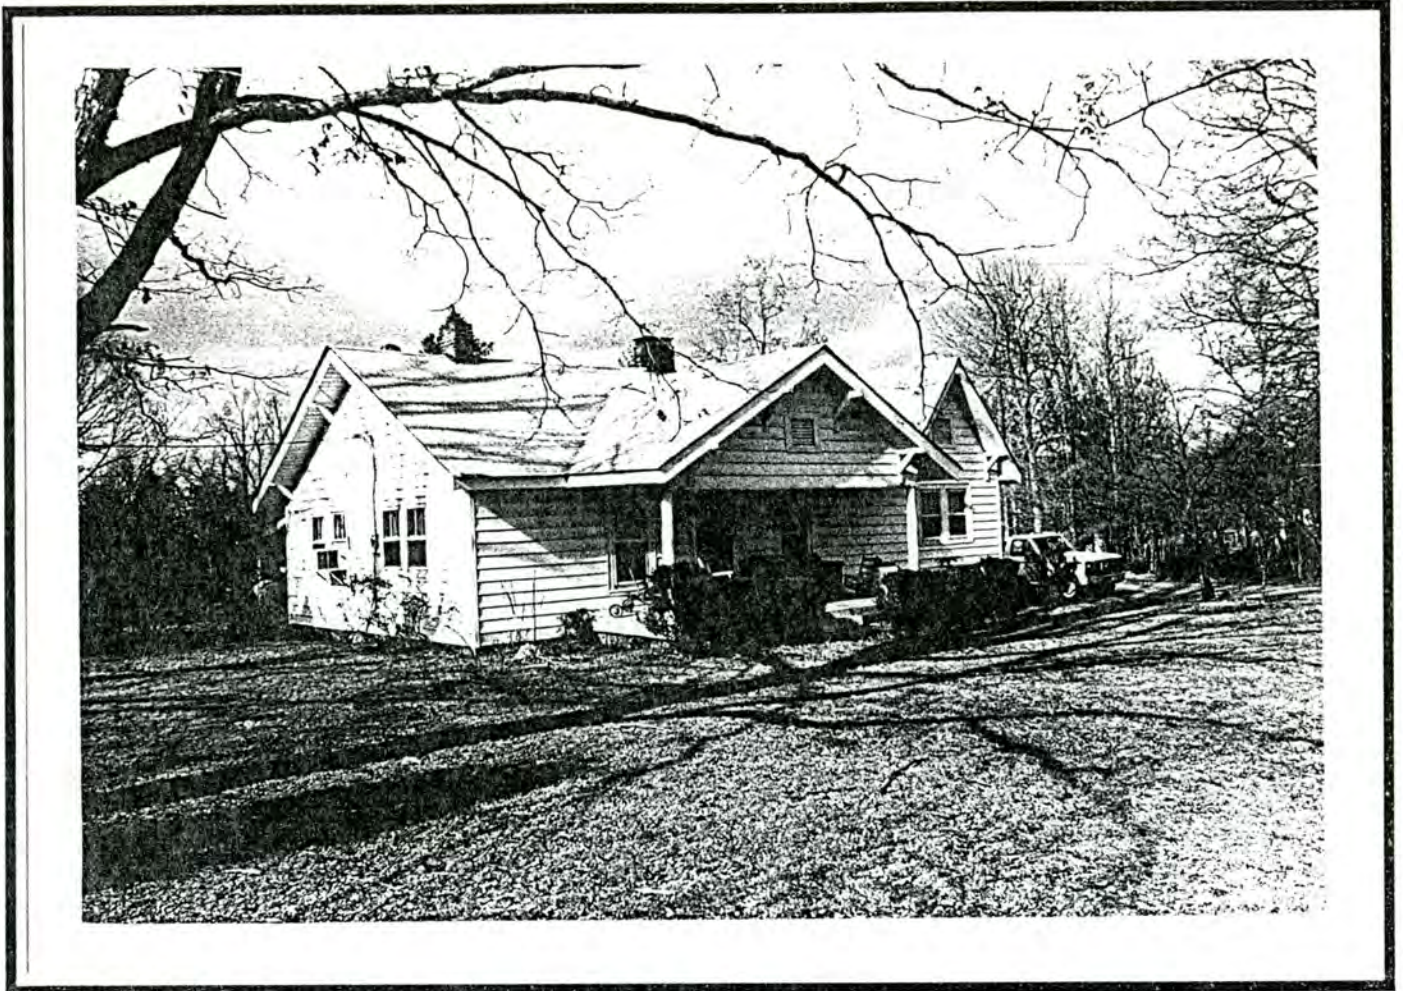
PLATE 16: B.Z. Pennenger House. View Looking Northwest

The Beatrice Z. Penninger House is composed of a main, side-gable block with a projecting cross gable occupying most of the front and rear elevations of this one-story, aluminum sided cottage (Plate 16). It rests on a stone and concrete block foundation and is roofed with asphalt shingles. A brick chimney is centered on the main ridge of the roof and another is located on the ridge just to the west. Two metal vents rise from the rear slope toward the east and west ends. Metal vents are located in the front and rear gables and the gable peaks are bracketed. The front gable projects

over a concrete entrance porch and is supported on Tuscan columns. A modern porch is located across the rear of the house.

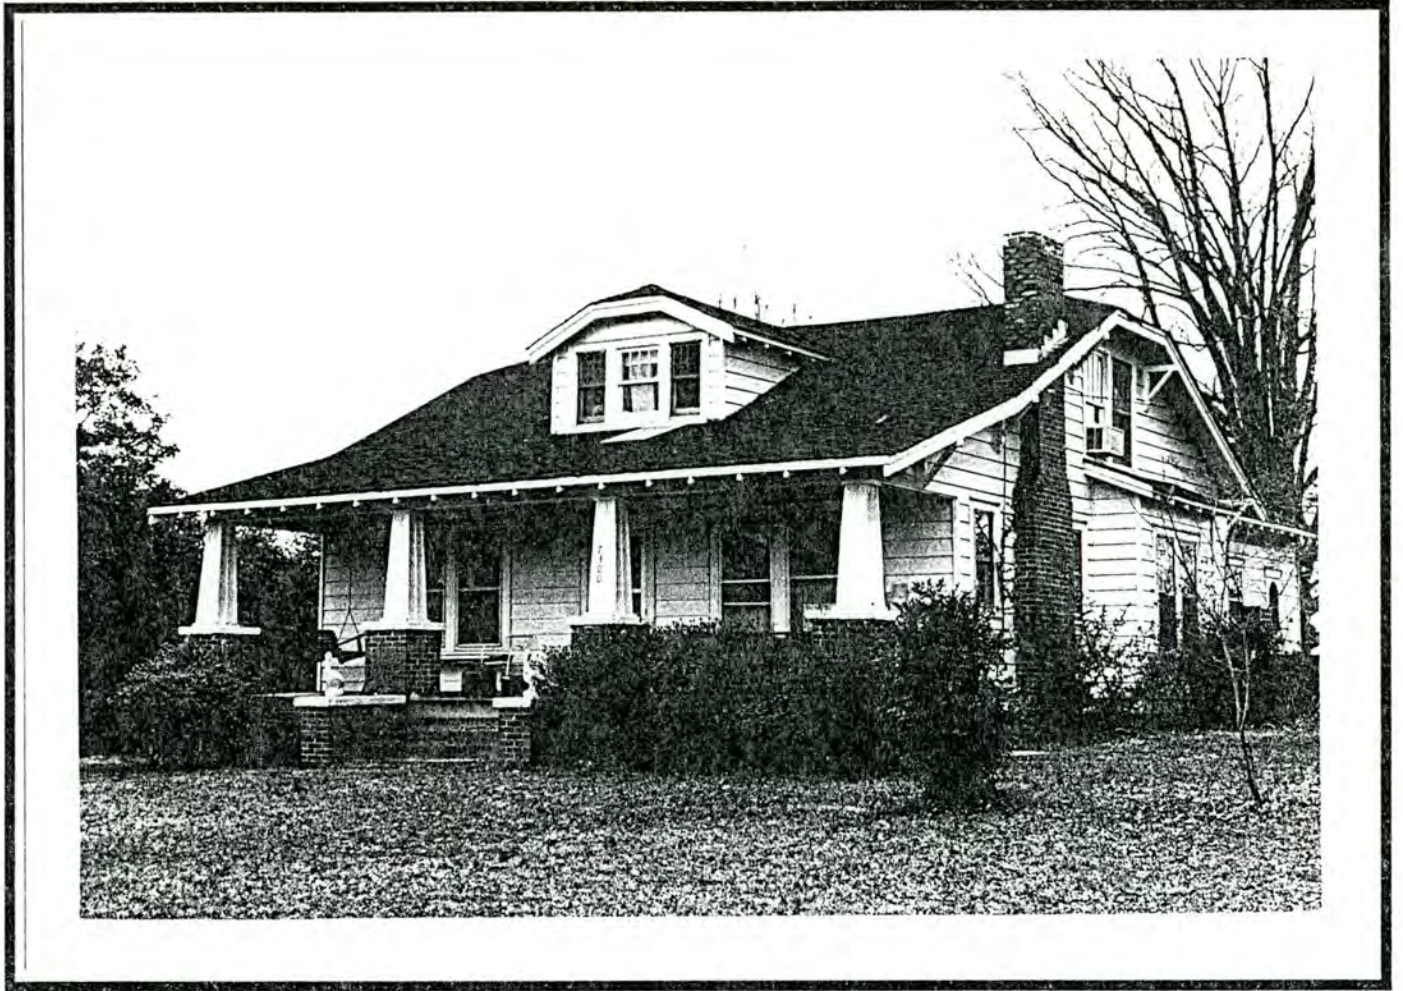
PLATE 17: Penninger-Warrick House. View Looking Southeast

The Penninger-Warrick House was the family home of the Penninger family, built circa 1911 (Plate 17). The 1-1/2-story bungalow has a side-gable main block and a cross-gable wing (an enclosed porch) centered on the rear elevation. A porch extends across the full width of the facade, its shed roof supported on tapered posts resting on brick piers. The gable ends of the asphalt shingled roof are clipped as is the roof of the dormer centered in the roof of the facade. According to the present owner, Vicki L. Warrick, the rear wing was a later addition constructed circa 1960. The building is aluminum sided over wide beveled weatherboards. It rests on a brick foundation with cross-shaped openings left in the brick for ventilation. A shouldered exterior brick chimney rises along the western side of the main block. Another brick chimney rises from the east side of the roof of the rear wing just in from the main block. Shed roofed, square oriels are centered in the gable ends of the main block, each with a pair of 4/1 double-hung windows. All of the windows of the house are 4/1 double-hung sash.

A modern deck of pressure treated lumber wraps around the rear wing to form a porch for the west side entrance to the rear wing. Large brackets are located in the gable ends of the main block and rear wing.

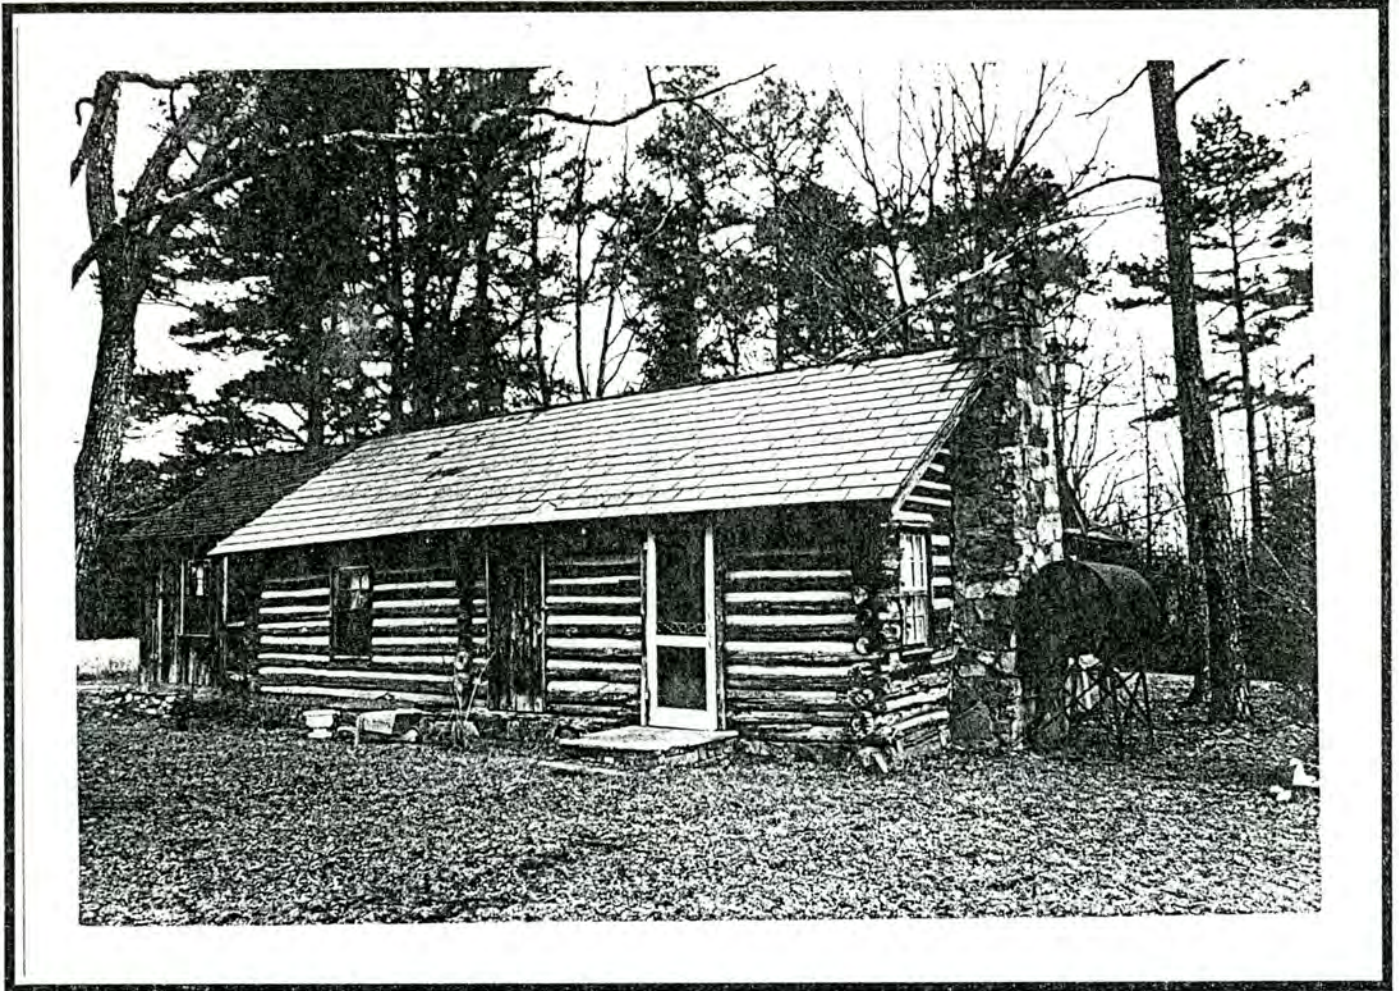
PLATE 19: Piercy House. View Looking North

The Piercy House is of pole-log construction with cement daubing and rests on a stone foundation (Plate 19). Rafter tails are visible below the eaves of the slate roof. The building is composed of two sections. The main block is an off-set T in shape. The main portion is three-bays wide and one-room deep with a large stone exterior chimney located at the southern end of this section. Projecting from the rear, just offset from the southern wall, is a one-room cross-gable (Plate 20). At the northern end of the main block is a one-room addition sheathed with vertical boards. According to Gladys Fundburk, daughter of the owner, this room contains the bathroom and was added to the house in 1945. All of

Evaluation: The Piercy House is visually distinctive due to its pole-log construction and slate roof shingling, the latter more commonly associated with dwellings of greater architectural pretention. However, the house does not clearly exhibit characteristics of type, period or method of construction sufficient to demonstrate architectural significance. Thus, it is concluded that the Piercy house is not eligible for listing in the National Register.

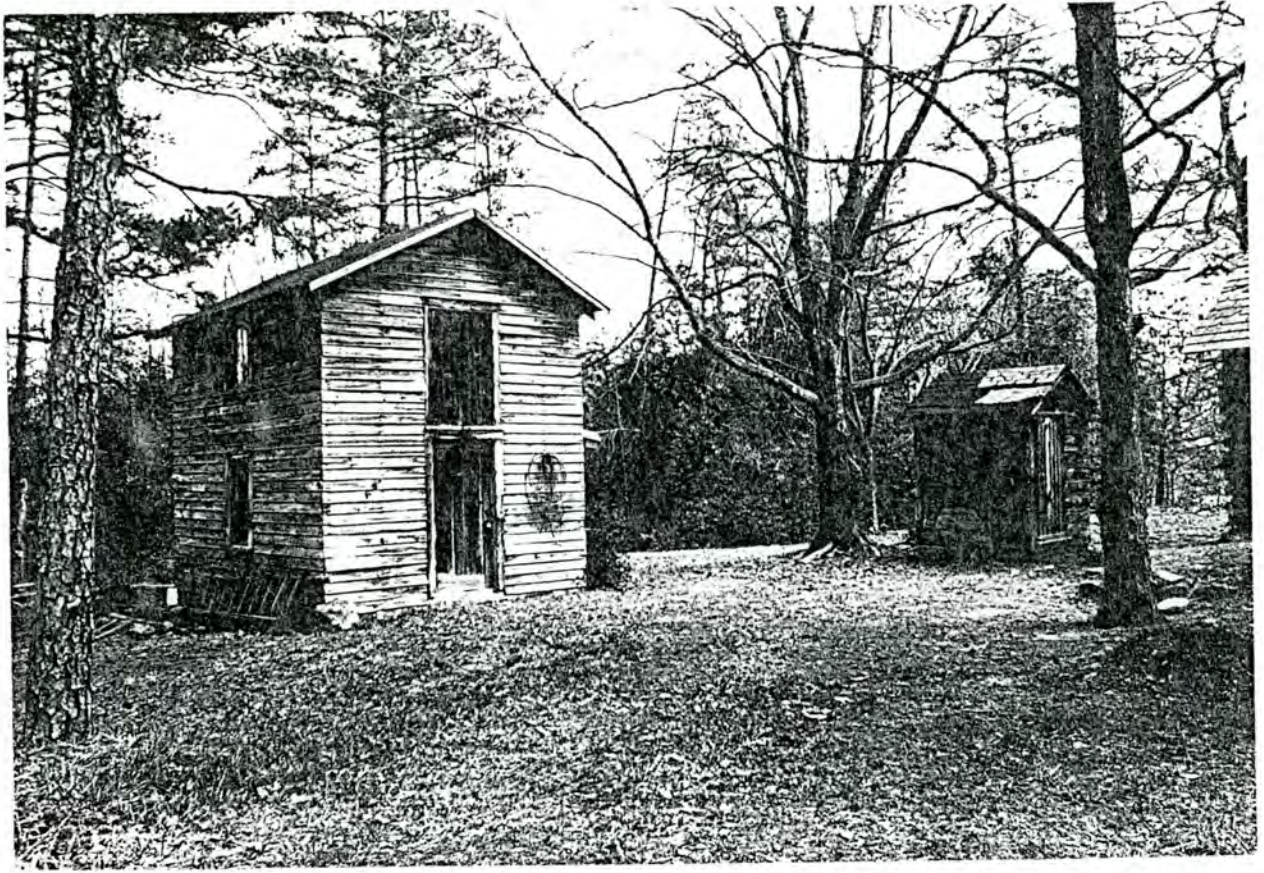
PLATE 21: Barn and Detached Kitchen Behind Piercy House. View Looking Southeast Addition

Directly behind the southern bay of the main block is a small one room structure with plank walls, resting on a brick foundation, that originally served as the kitchen for the house. A squarish hole in the asphalt roll roof indicates where the chimney was once located.

Behind the house and summer kitchen is a two-story storage barn of frame construction with weatherboard exterior, seamed metal roof and stone foundation (Plate 21). The lower story opening in the facade is filled with a plank door while the upper opening is filled with a four-light sash. This structure, also built in 1945, served as a storage facility.

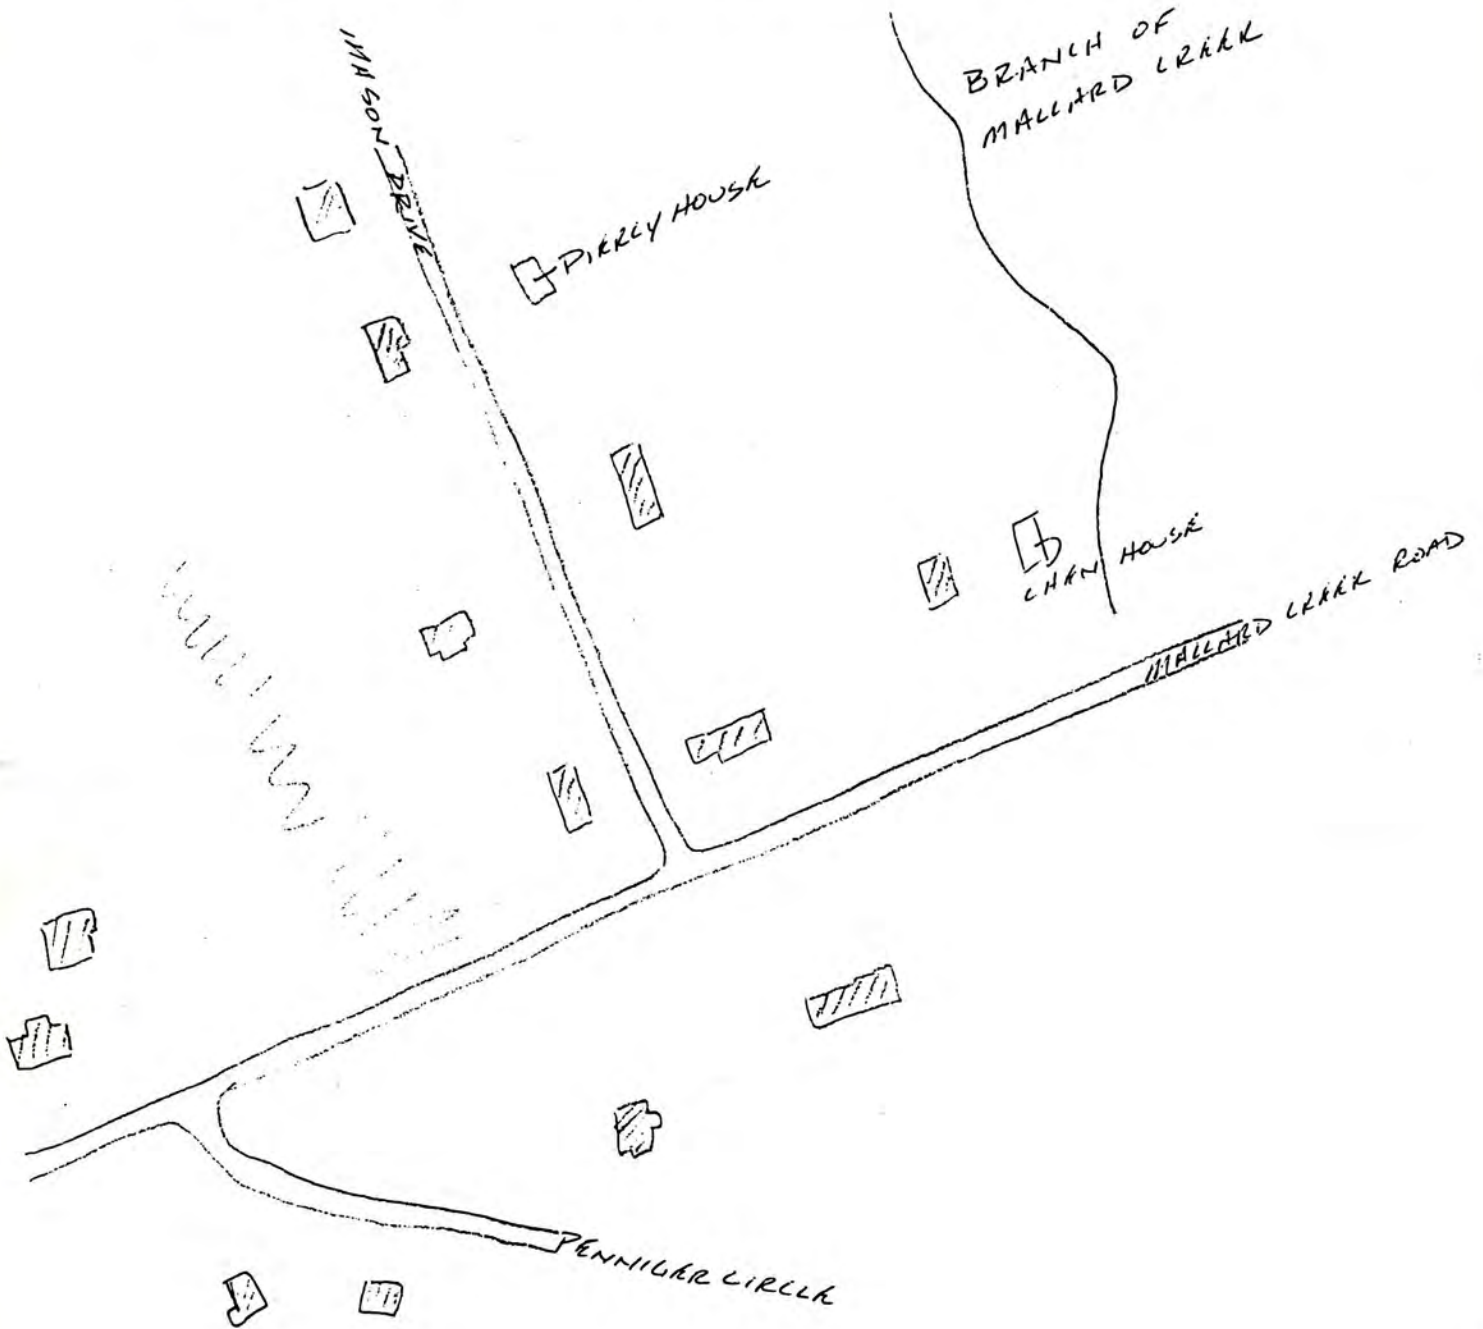
REQUIRED SKETCH MAP OF PROPERTY. Indicate any roadways by name and show other major topographic features.

Wavy line - TRAILER PARK
Hatched rectangle - MODERN HOUSES
