Re: Evaluation of Kitchen Groups A and B, Camp Butner National Guard Training Center,  
Granville County, ER 11-2343

**AN EVALUATION OF  
KITCHEN GROUP A AND  
KITCHEN GROUP B,  
CAMP BUTNER NATIONAL GUARD  
TRAINING CENTER, GRANVILLE COUNTY  
NORTH CAROLINA**

December 2011

By:  
Amanda G. Kincaid and Mathia N. Scherer

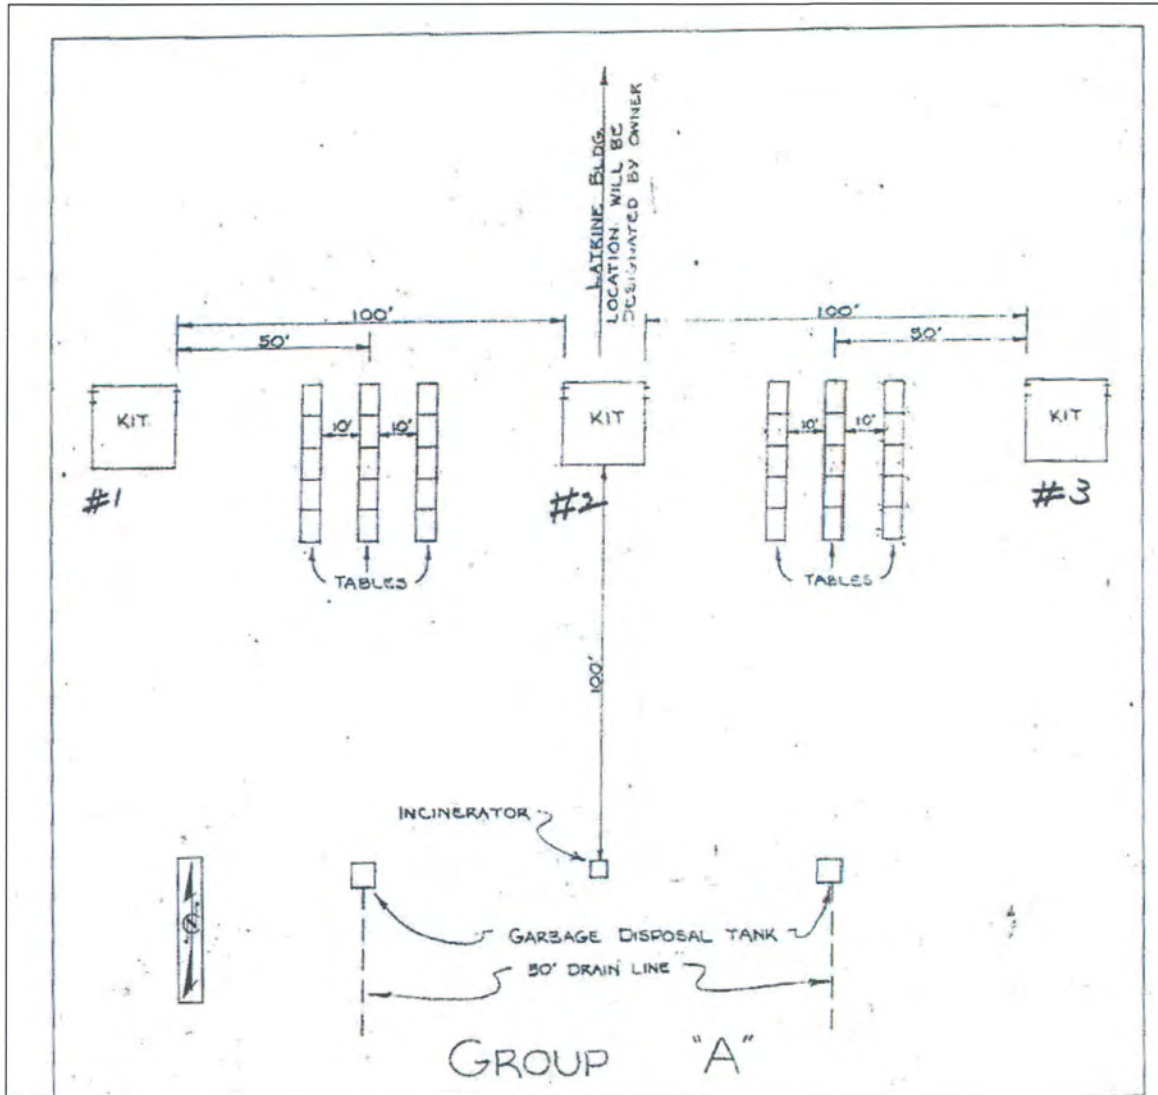
In 1957 the Adjutant General's Department drew up plans for support buildings at Camp Butner. These support buildings were at the rifle ranges and included kitchens, rows of concrete-block benches and tables, and latrines. In 1958, the Adjutant General's Department also created site plans for two groups of kitchens based on three kitchen buildings; six tables spaced evenly in groups of three between the kitchens, and a latrine building. The plans included elevation drawings and floor plans for kitchen buildings; a general site plan for both Kitchen Group A (**Figure 3.1**) and Kitchen Group B (**Figure 3.2**); specifications for the concrete table and benches (**Figure 3.3**); and elevations, floor plans, and plumbing specifications for the latrines (**Figure 3.4**). A basic elevation for the kitchen buildings in both Kitchen Group A and Kitchen Group B was also located (**Figure 3.5**) (Brown 2005). Despite having these specifications, it is still unclear the exact year the kitchen groups were constructed. Retired MSG David Rook and MSG Kenneth Beal both recall that the buildings were constructed in 1970 and 1971, but it is likely that the memory is from the building of a third kitchen in Kitchen Group B that was built around the same time (Personal Communication: 5 October 2011). Since the site plans, elevation, and floor plans were designed in 1957 and 1958, it is likely that most of the kitchen buildings and latrines were built circa 1958 with an additional kitchen being added to Kitchen Group B in 1970 or 1971.

Figure 3.1. Site plan for Kitchen Group A from February 1958 (North Carolina National Guard Headquarters; Brown 2005).

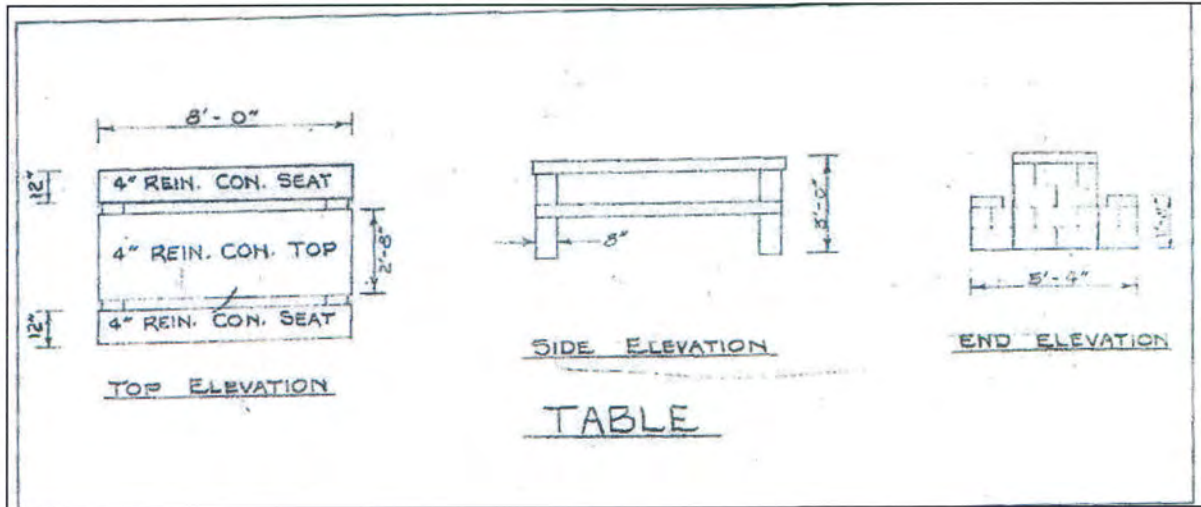
Figure 3.3 Table construction detail plan (North Carolina National Guard Headquarters; Brown 2005)

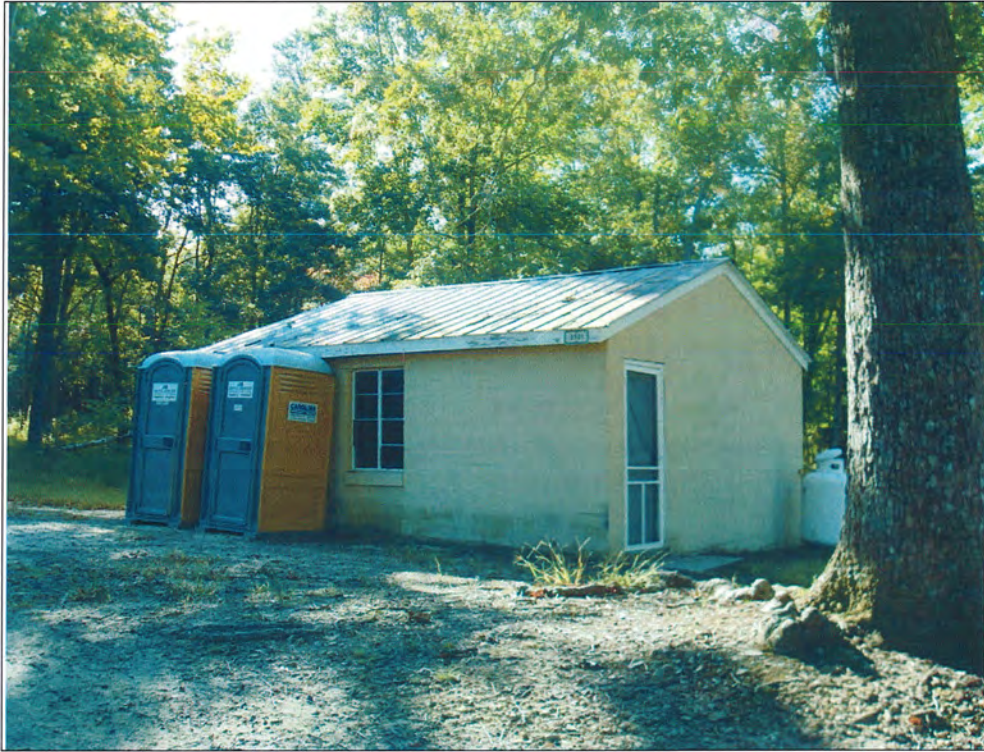
Building 3501 is a rectangular-shaped building made of concrete block with a corrugated metal, side gabled roof (**Figure 5.1**, **Figure 5.4**, and **Table 5.2**). There is no distinguishable foundation between the concrete block that was used to construct the walls and the concrete block foundation, although the floor is a concrete slab. The walls are painted cream whereas the trim is painted white. The north elevation of Building 3501 is partially obscured by two portable toilets, but there is one window that is centered in the middle of the north elevation wall. The windows have poured concrete lintels and consist of a casement window system with four panes on each side of the window that opens in the middle with a turn crank. Both the east and west elevations have one opening, which is a metal door covered by a screen door. The metal door is original to the structure but the screen doors have been recently replaced. The south elevation has two window openings with windows that are identical to the window on the north elevation. Building 3501 was built ca. 1958 and measures 21.4 X 21.4.”

**Figure 5.4. West and south elevations of Building 3501.**

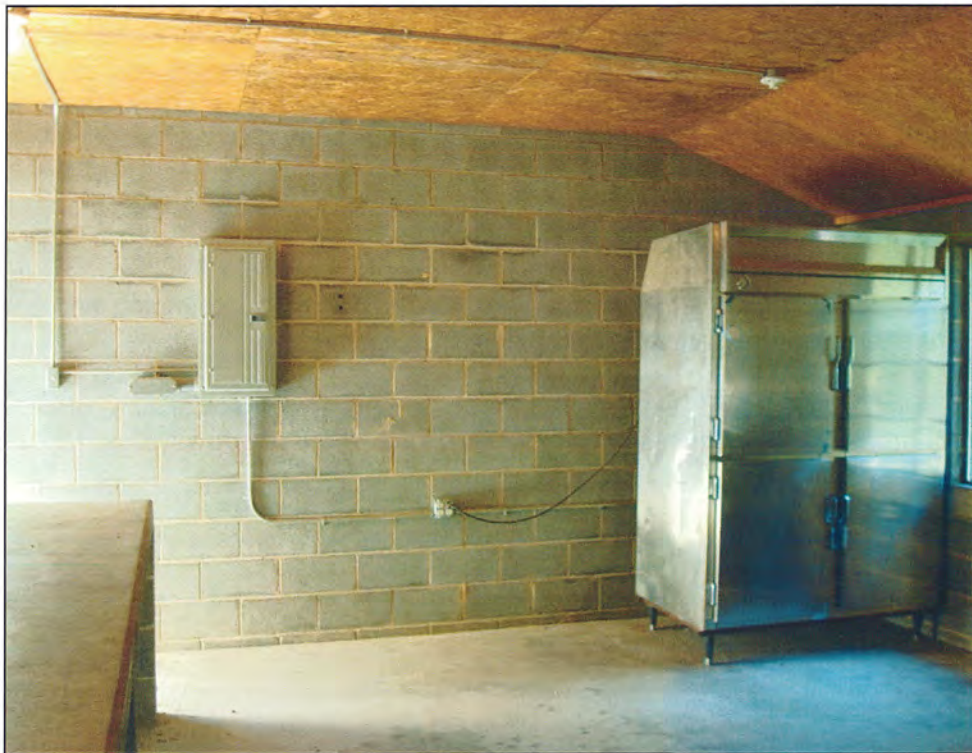
**Figure 5.5. The poured concrete counter in Building 3501, which is duplicated in the other kitchens documented in this survey.**

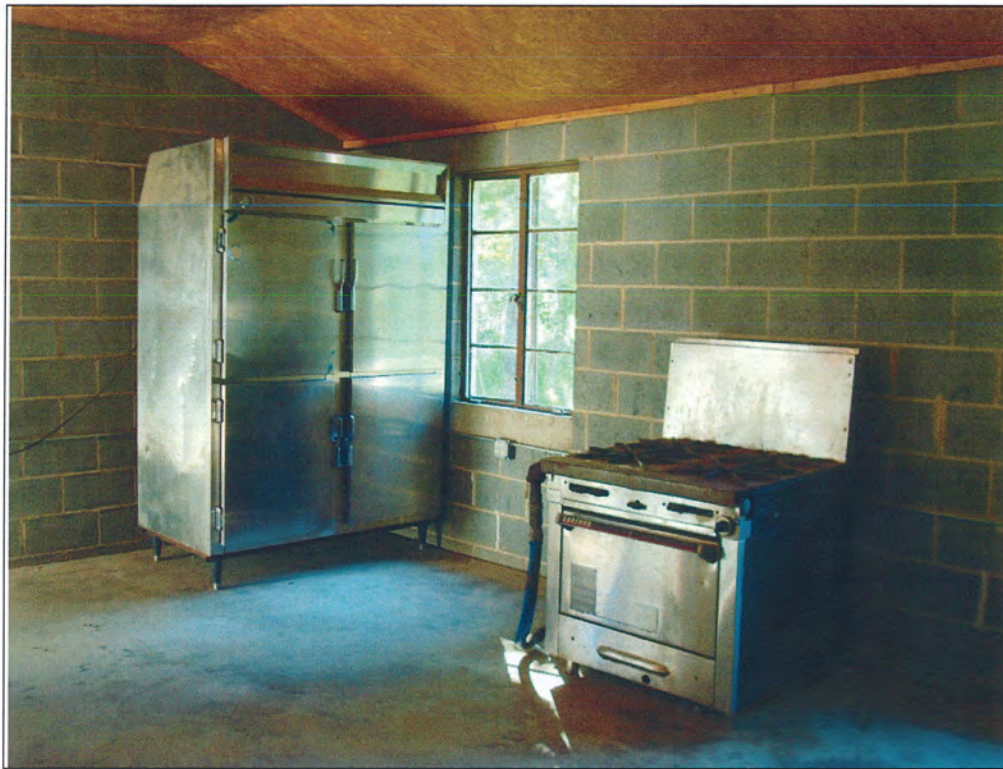
**Figure 5.6. Building 3501 interior with stove and refrigerator.**

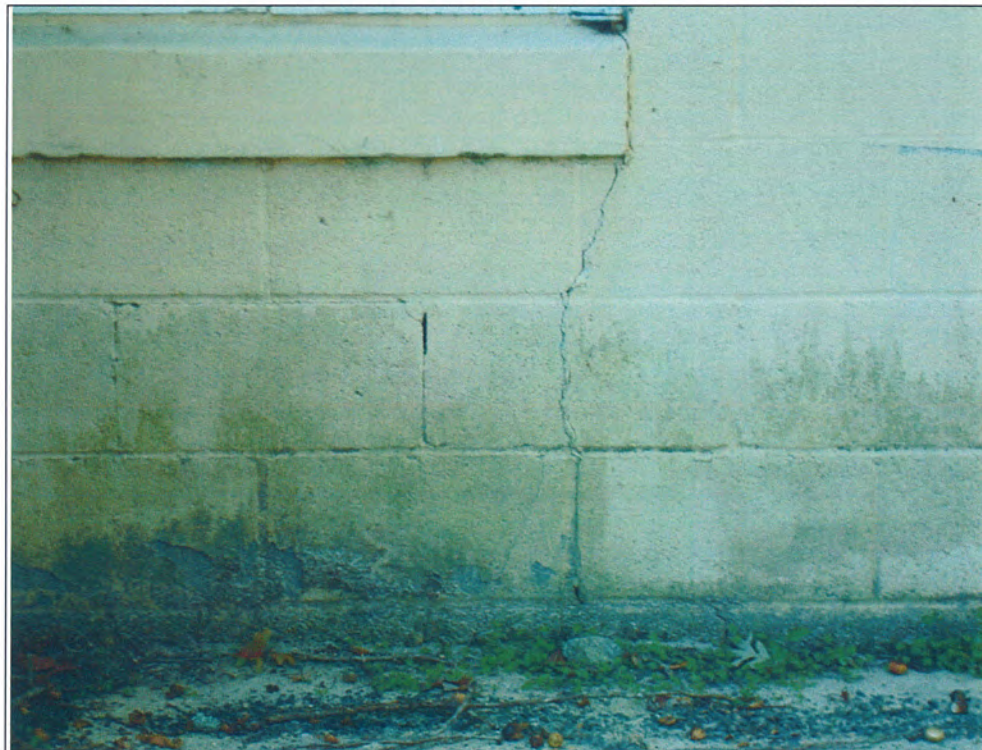
Alterations have made to building that has damaged its historic fabric. Holes were drilled into the wall to accommodate use of appliances. There are major cracks that run the entire width of the concrete walls under all window openings (**Figure 5.7**). Additional cracks in concrete blocks have been observed throughout the entire building, some of which run the length of a mortar joint and others that are in the actual concrete block. Since the buildings are not climate controlled, it is subject to the elements of winter and summer that have caused these large cracks (**Figure 5.8**). These large cracks, although not a major threat to the historic integrity of the building now, can cause further damage in the historic materials. The cracks allow moisture to gather in the concrete block and the block may fail due to the expanding and contracting of moisture as the temperature varies through different seasons.

**Figure 5.7. Detail of crack below window of Building 3501.**

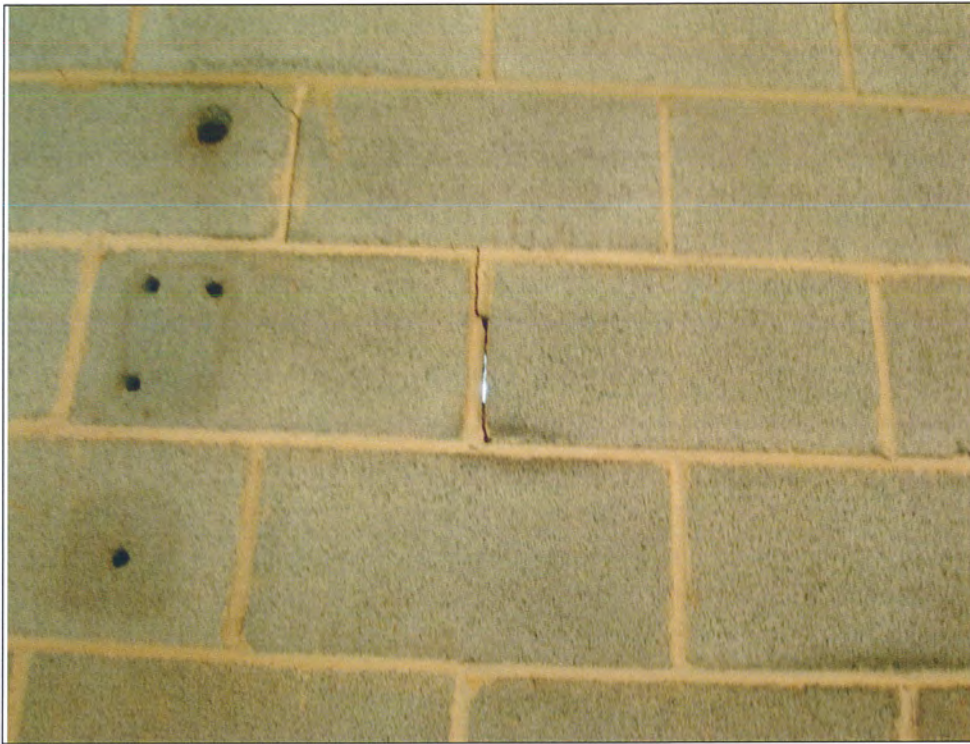
**Figure 5.8. Detail of interior damage in Building 3501.**

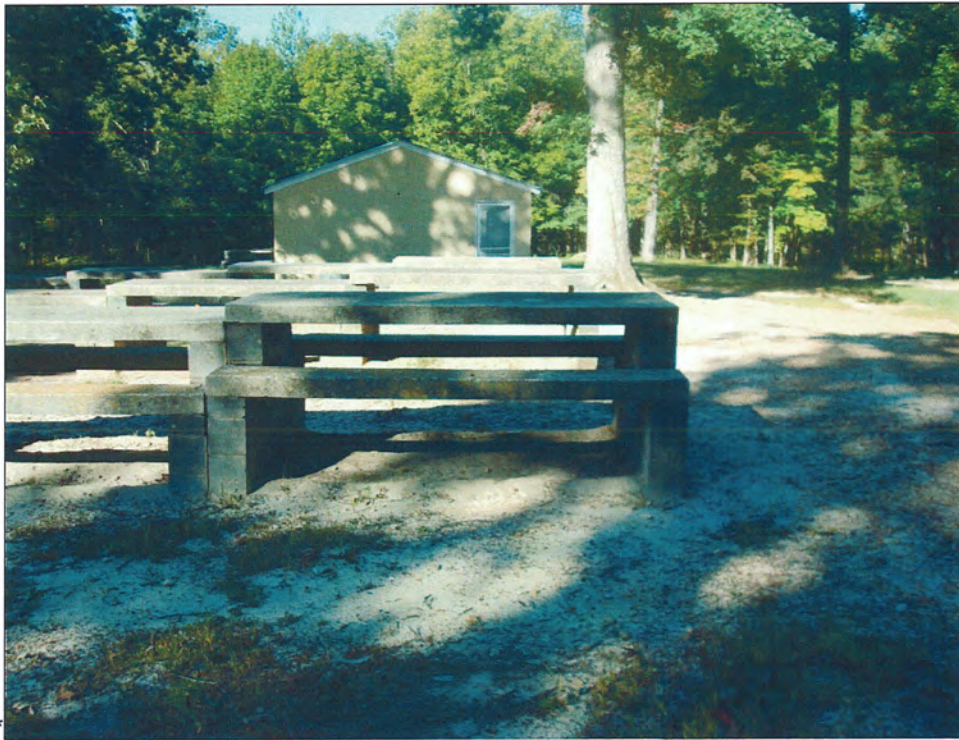
In between Building 3501 and Building 3502 is an eating area that consists of concrete block tables and concrete block benches (**Figure 5.9**). There are three rows of benches and tables with four tables and benches in each row.

**Figure 5.8. Detail of tables and benches located between Buildings 3501 and 3502.**

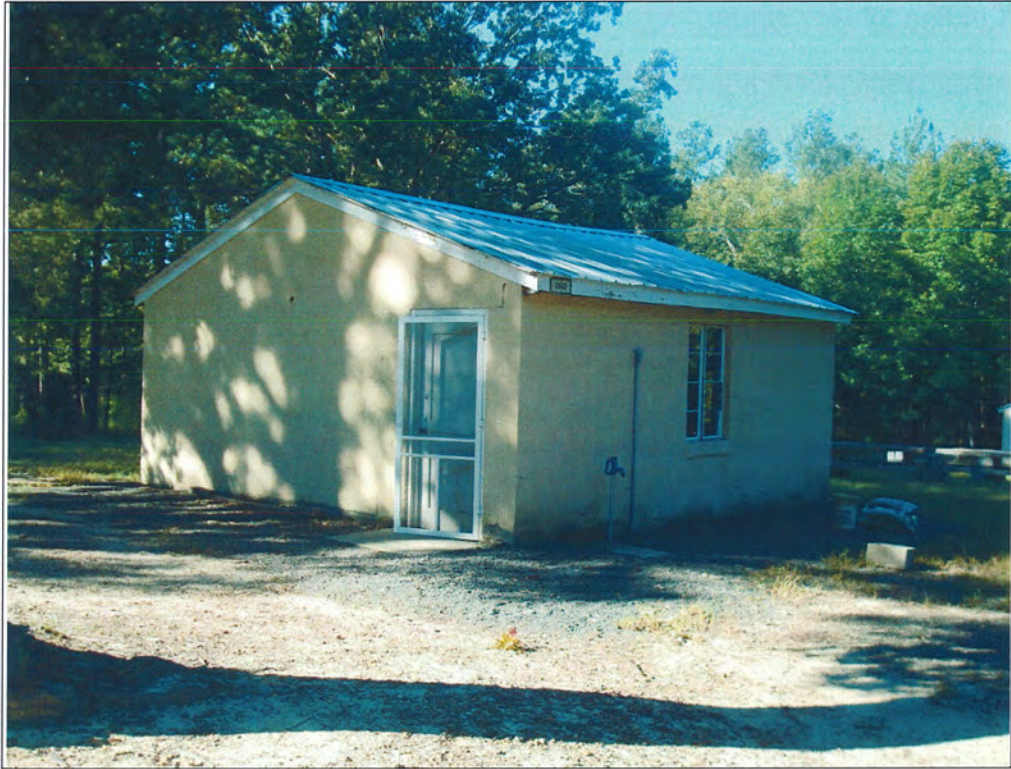
Building 3502 in Kitchen Group A is almost identical to building 3501. It is a rectangular shaped building made of concrete block (**Figure 5.1, Figure 5.10, and Table 5.3**). There is no visible differentiation from between the concrete blocks that construct the walls and a foundation. The roof covering is corrugated metal. The only openings on the east and west elevation are single doors that hold original metal doors. The screen doors are not original to the building. The north elevation has one window opening which has a poured concrete lintel and is filled with double casement windows that contain four fixed panes each. The casement windows open on a turn crank system. There are two of the same windows on the south elevation. Building 3502 was constructed in ca. 1958 and measures 21.4 X 21.4.”

**Figure 5.10. Oblique view of building 3502, north and east elevations.**

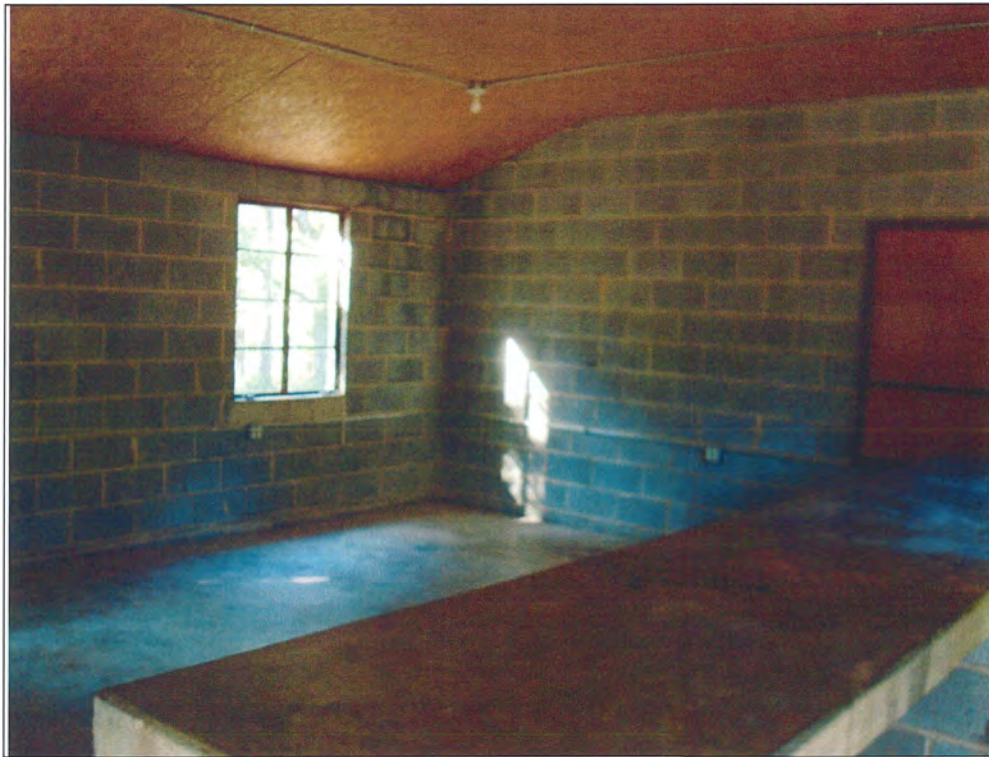
The interior of 3502 is almost identical to the interior of 3501 with the exception that there are no kitchen appliances in the building (**Figure 5.11**). There is a long concrete counter that has a poured concrete top and concrete block legs. The walls are unfinished concrete blocks and the ceiling is finished with particle board. The floor is poured concrete.

**Figure 5.11. Interior of Building 3502.**

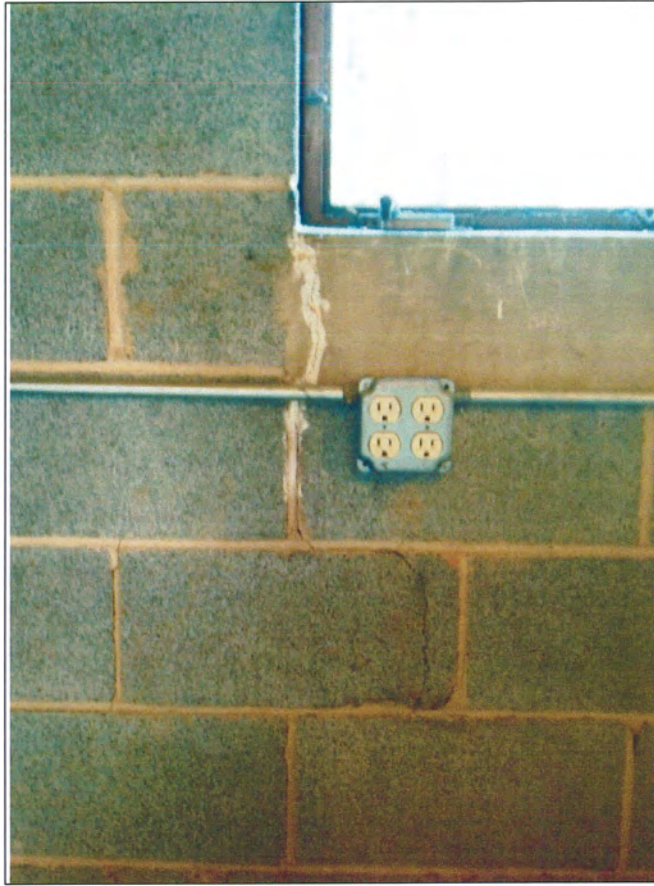
There are several condition issues on both the exterior and interior of building 3502 with cracks in several of the concrete blocks and under the interior of the windows (**Figure 5.12**).

**Figure 5.12. Detail of damage to interior of building 3502.**

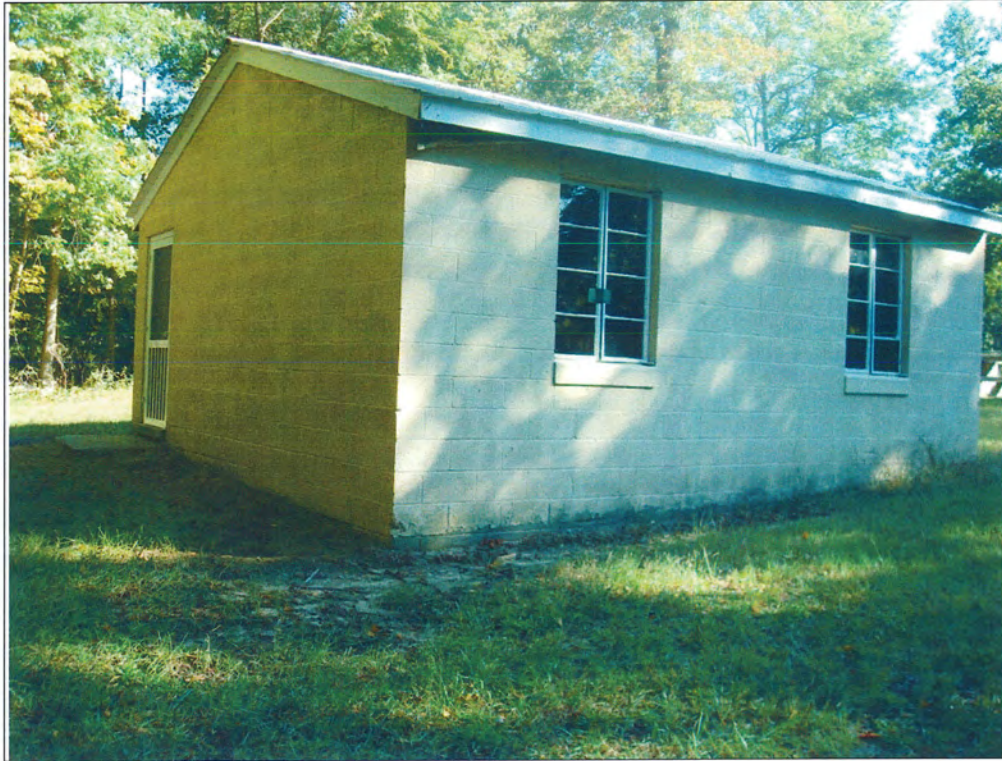
Building 3503 is almost identical to Building 3502 on both externally and internally (**Figure 5.1**, **Figure 5.13**, and **Table 5.4**). It is a rectangular cement block building with a corrugated metal roof. The east and west elevations have a single door opening with original metal doors and replacement screen doors. The north elevation has a single casement window that opens in the middle with a turn crank. Each side of the window has four fixed panes. The south elevation has a pair of windows that are identical to the window on the north elevation. Building 3503 was built around 1958 and measures 21.4 X 21.4.”

**Figure 5.13. Oblique exterior view of building 3503 showing the north and east elevations.**

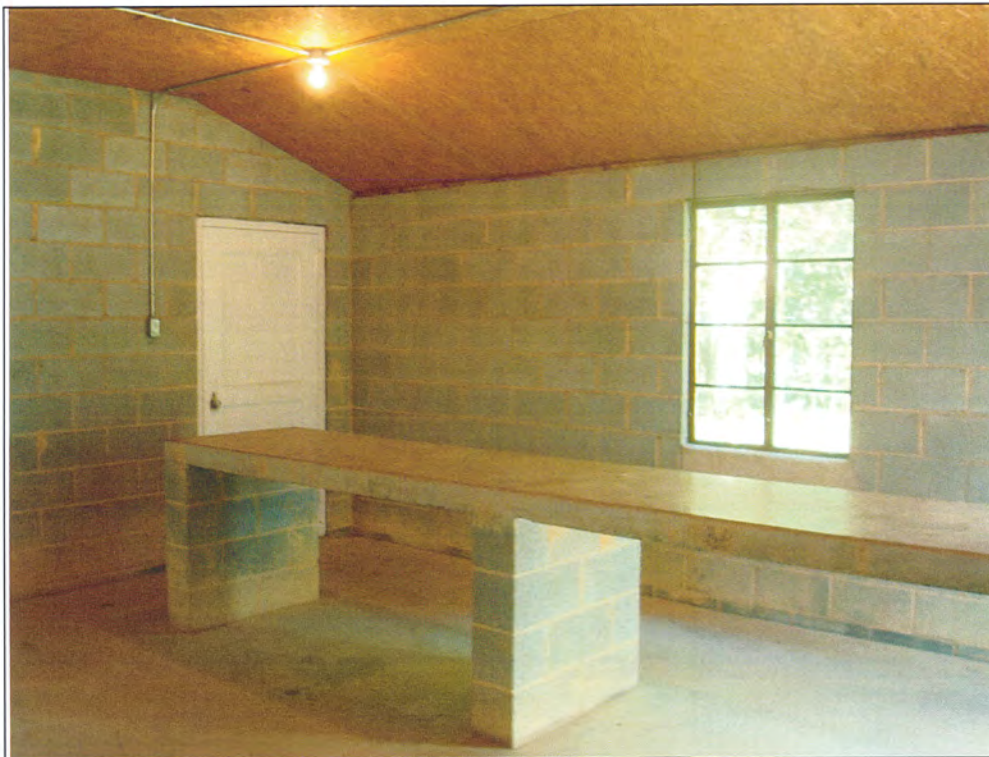
The interior of Building 3503 is identical to Building 3502. The interior walls consist of concrete block, poured concrete floor, and particle board ceiling (**Figure 5.14**). An interior detail photograph of a window shows the turn crank mechanism (**Figure 5.15**).

**Figure 5.14. Interior of building 3503.**

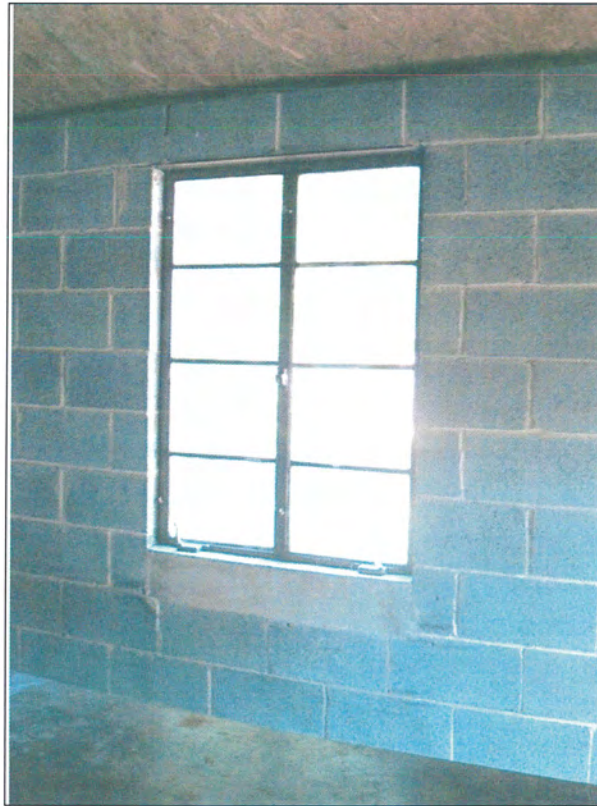
**Figure 5.15. Detail of interior window in building 3503.**

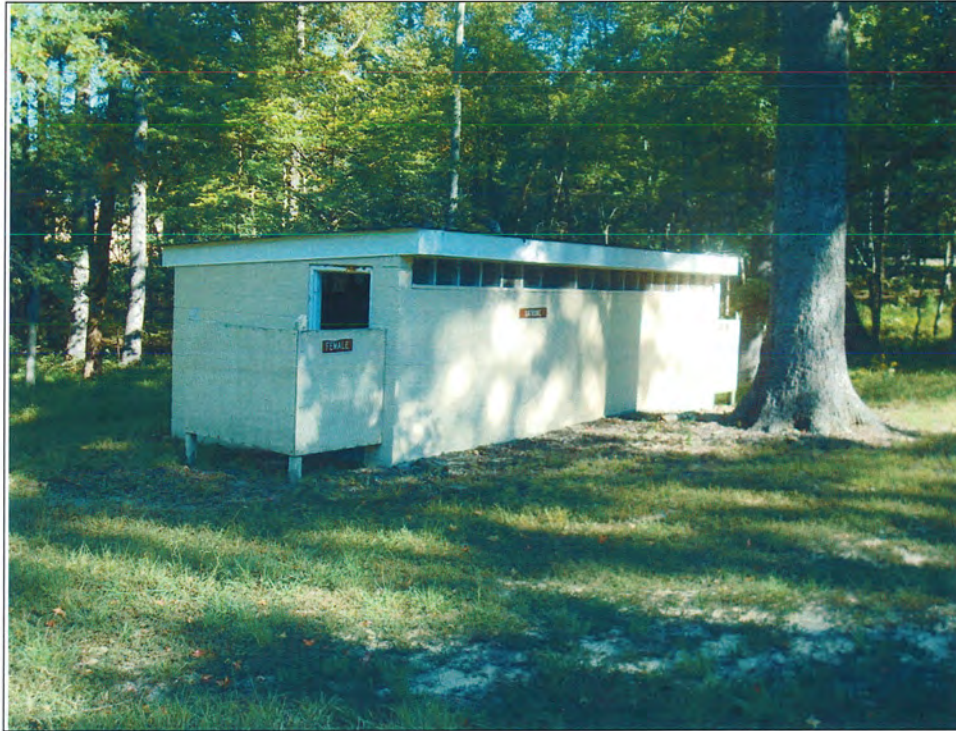
The latrine is similar in construction materials and technique as the kitchen buildings in Kitchen Group A (**Figure 5.1**, **Figure 5.16**, and **Table 5.5**). The building is a long, rectangular shaped building that has both walls and foundation constructed of concrete block. There is a shed roof that is covered in corrugated metal. On the north and south elevations, under the overhang of the roof, is a series of openings that are screened in. There are eighteen openings in total just under the roof that provide ventilation for the latrine. The west elevation has one door opening and a privacy screen in front of the entrance marked "Female." On the east elevation there is one door opening with a privacy screen blocking the entrance marked "Male." Building 3505 was constructed around 1958 and measures 25.4 X 13.4."

**Figure 5.16. Oblique view of the Building 3505 showing the west and south elevations.**

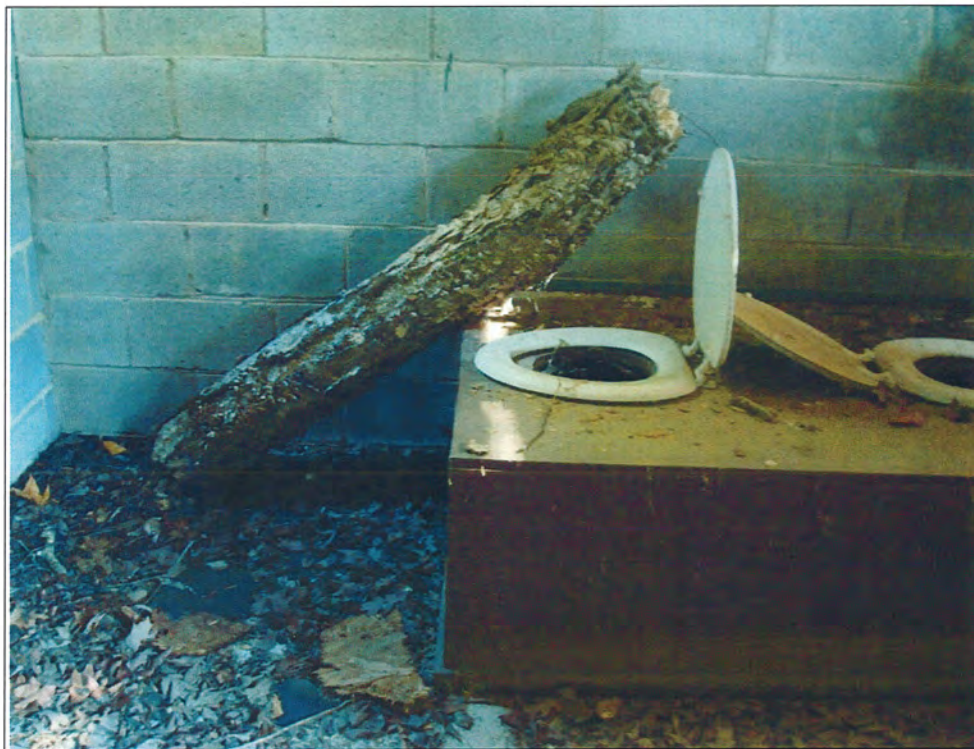
The interior is dedicated to the functions of a latrine and is broken into two rooms. The walls are concrete block with a poured concrete floor. The female side of the building has two toilets, whereas the male side of the latrine has six toilets (**Figure 5.17** and **Figure 5.18**). Originally the latrine was one room with toilets in the middle and a urinal on each end, but was later converted into separate female and male latrines as it appears today (Personal Communication; CAPT Andrew Lequick; 5 October 2011).

**Figure 5.17. Female latrine in Building 3505.**

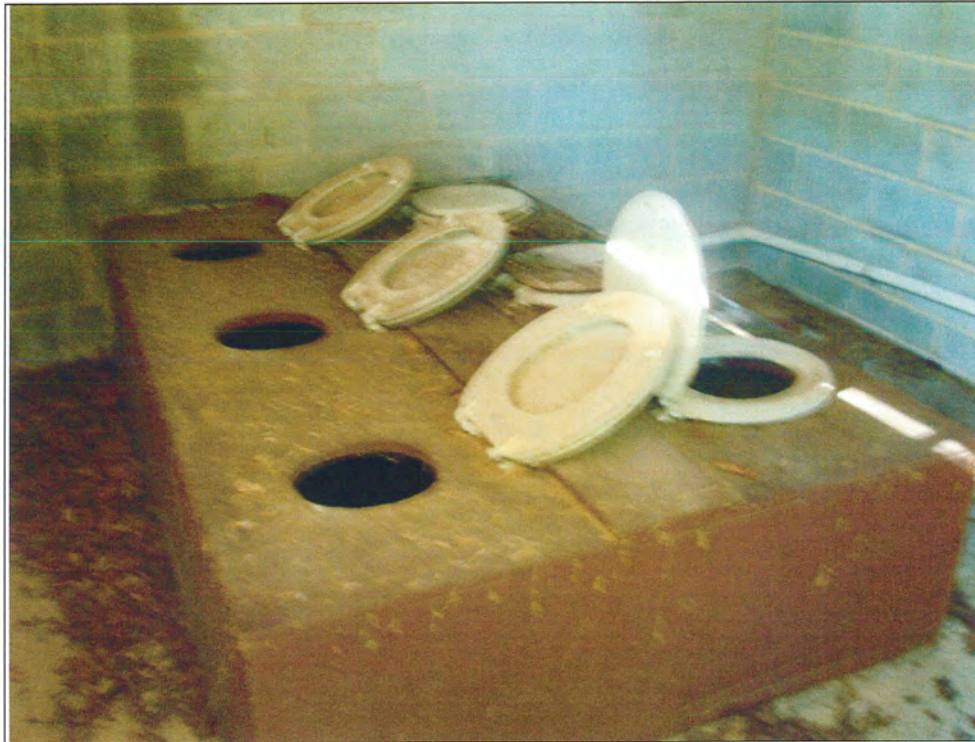
**Figure 5.18. Male Latrine in Building 3505.**

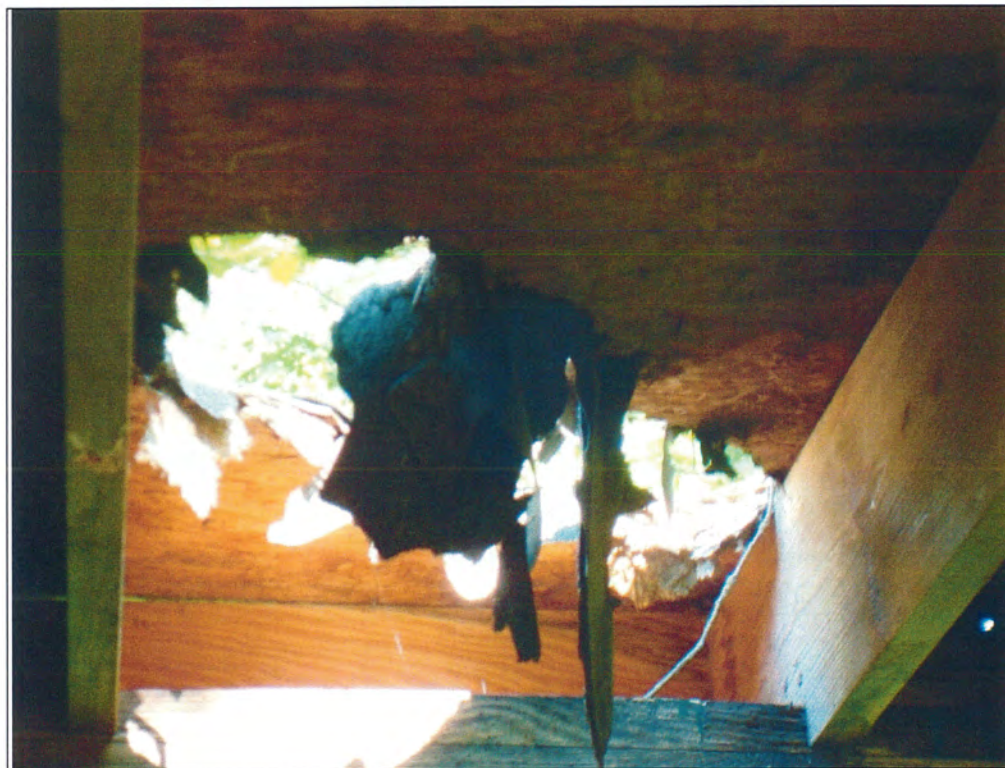
The historic integrity of the building's fabric has greatly deteriorated. The building has not been used for many years and there has recently been damaging storms that have compromised the building's roof (**Figure 5.19** and **Figure 5.20**). This deterioration has impacted the building's material integrity and has also caused severe safety issues.

**Figure 5.19. Hole in the roof of the female side of latrine in building 3505.**

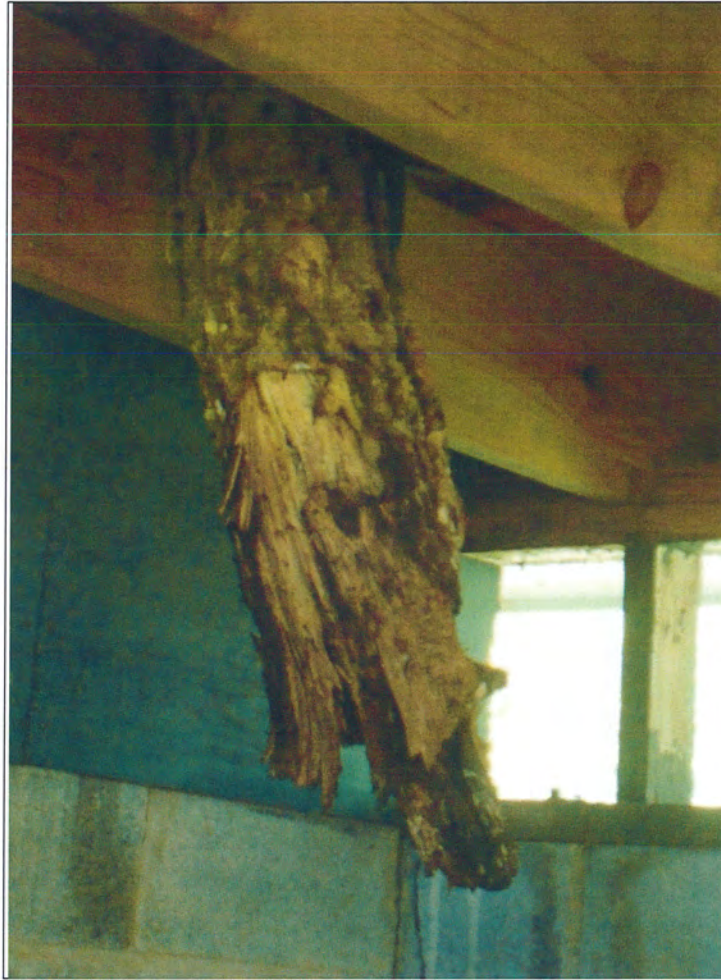
**Figure 5.20. Tree limb protruding through roof and ceiling of male latrine in Building 3505.**

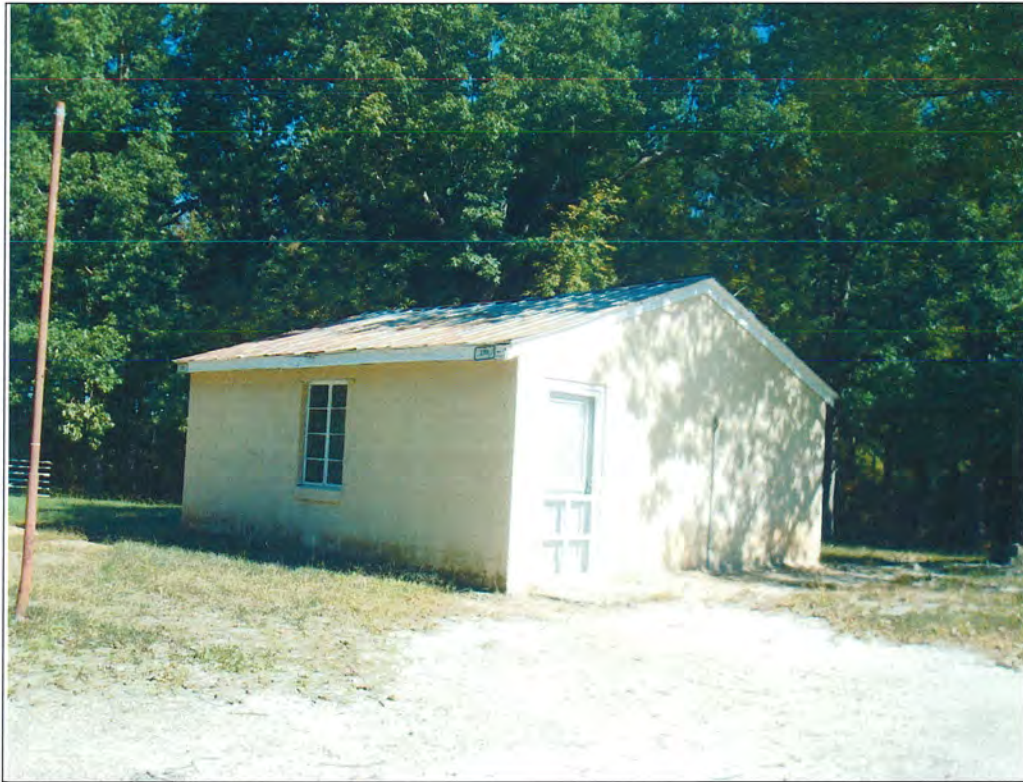
Building 3701 in Kitchen Group B is nearly identical on the exterior to Building 3501 in Kitchen Group A (**Figure 5.2**, **Figure 5.22**, and **Table 5.6**). It is a rectangular shaped building made of concrete block. There is no differentiation between the concrete walls used to construct the building and a foundation, although the concrete slab floor does indicate some poured foundation elements. The roof is side gabled and is covered in corrugated metal. There are two entrances into the building located on the east and west elevations. They are enclosed by original metal doors with a replacement screen door covering the metal door. The north elevation has one window opening, which is filled with double casement windows that contain four fixed panes each and has a poured concrete lintel under the frame. The casement windows open on a turn crank system. There are two of the same windows on the south elevation. Building 3701 was constructed in ca. 1958 and measures 21.4 X 21.4.”

Figure 5.22. Oblique view of west and north elevations of Building 3701.

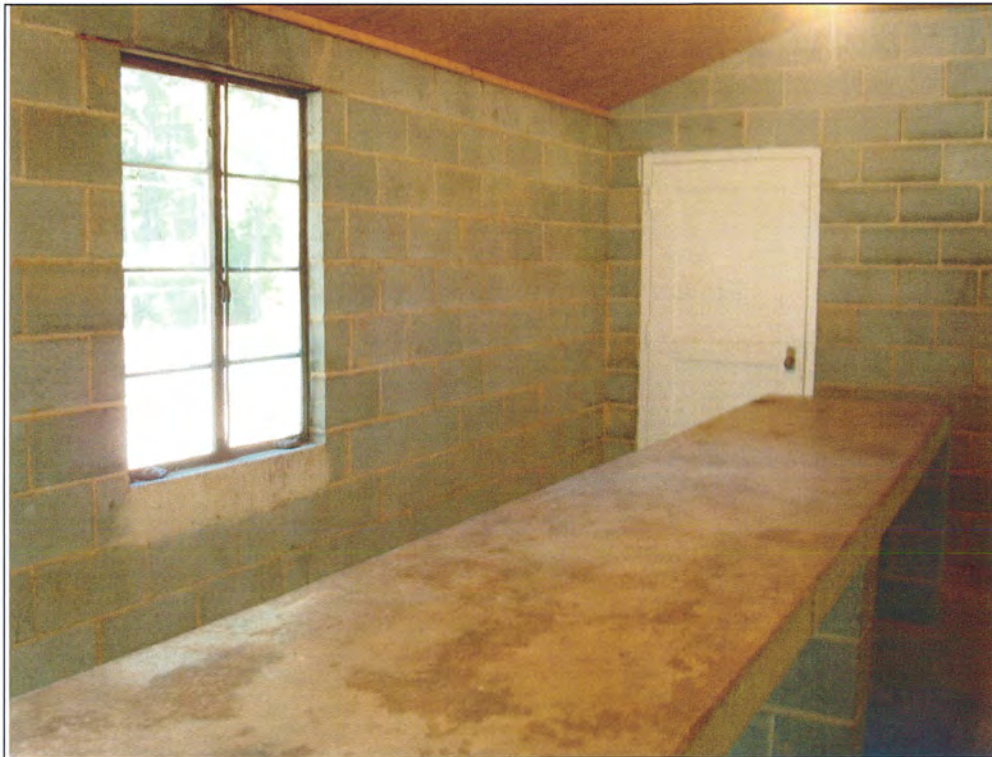
The interior walls of the building are unpainted, unfinished concrete block. There is a large poured concrete counter that runs almost the entire length of the building, situated between the two entrances to the building on the east and west elevations (Figure 5.23). On the interior east wall there is a large commercial stove and refrigerator. The ceiling is finished with particle board, which is unpainted. The floors consist of poured concrete. To equip the building with electricity and gas, holes were drilled into the concrete walls (Figure 5.24).

**Figure 23. Interior of Building 3701.**

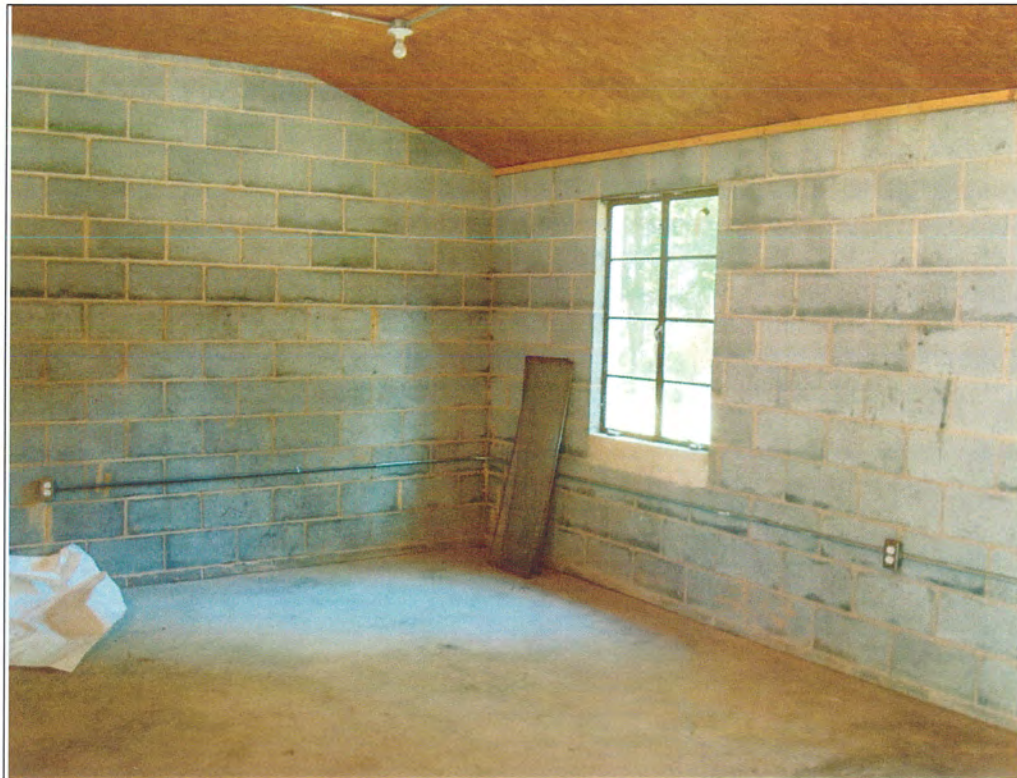
**Figure 5.24. Interior of Building 3701.**

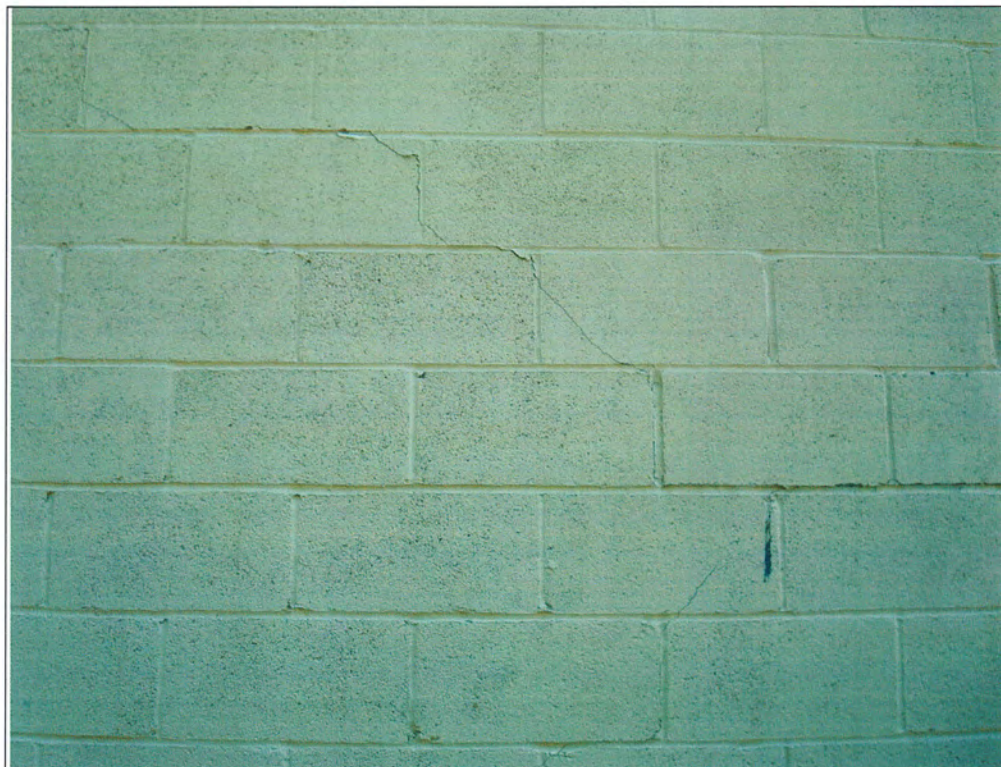
Alterations have made to building that has minimally damaged the historic fabric of the building. Holes were drilled into the wall to accommodate use of appliances and to add utilities to the building. These holes are not major alterations and do not significantly impact the evaluation of the building's NRHP eligibility. However, there are major cracks that run the entire width of the concrete walls. Additional cracks in concrete blocks have been observed throughout the entire building, some of which run the length of a mortar joint and others that are in the actual concrete block. Moisture is allowed to infiltrate the material of the concrete block and as the seasons change freezing and thawing of this moisture and the contracting and expanding of the moisture will eventually lead to failure of the building materials (**Figure 5.25**). This deterioration in the material integrity of the building is significant and would only continue to progress in the future and would more significantly impact the buildings acceptance on the NRHP.

**Figure 5.25. Detail of cracks in the concrete block in the exterior of 3701.**

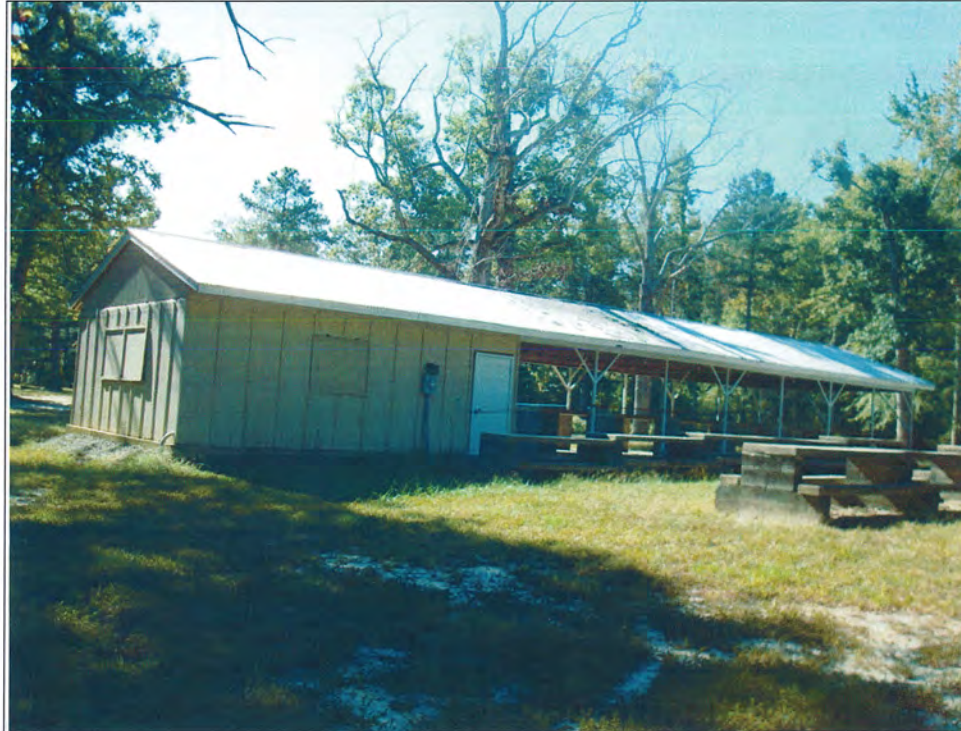
**Figure 5.26. South and east elevations of Building 3702.**

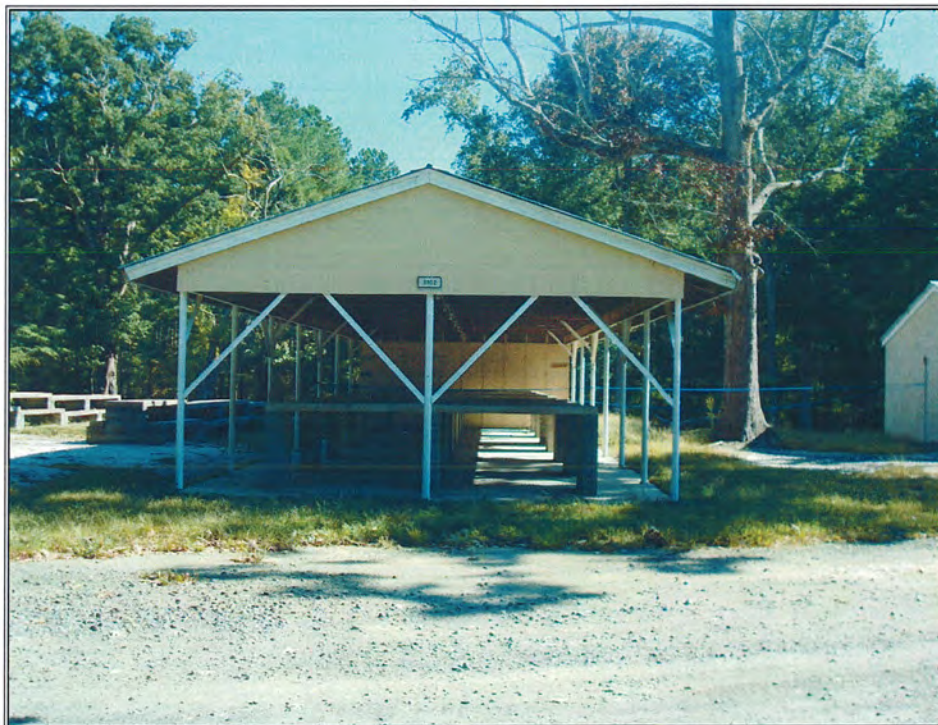
**Figure 5.27. Building 3702, showing tables under overhang.**

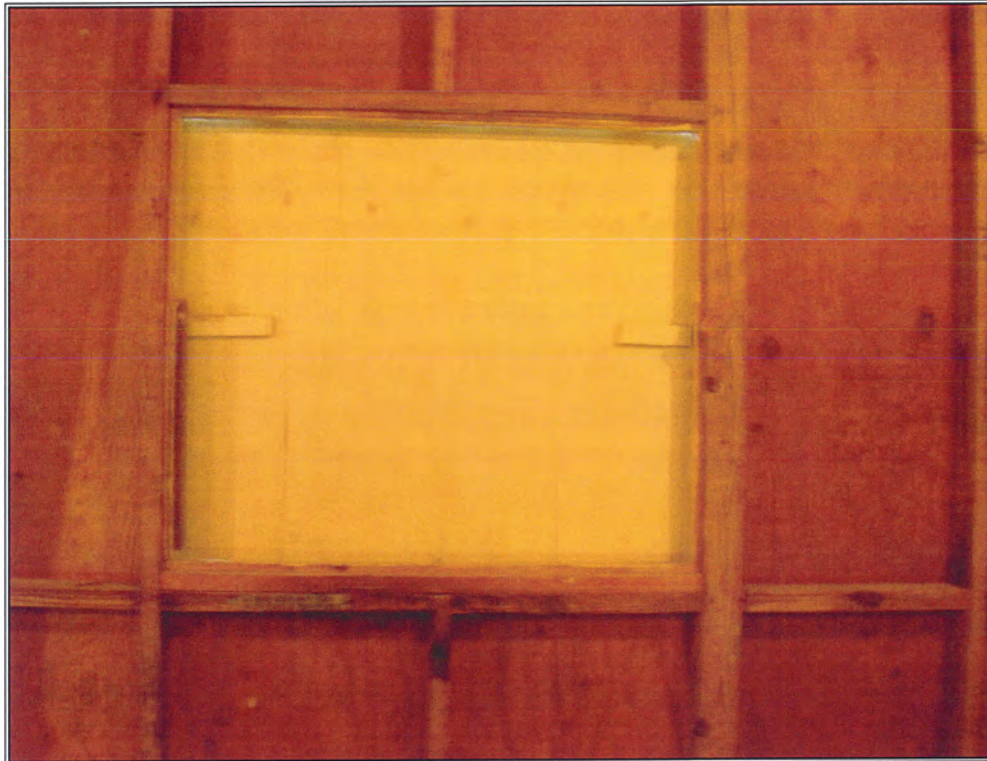
**Figure 5.28. Detail of a window with a frame flap.**
