Re: Evaluation of Kitchen Groups A and B, Camp Butner National Guard Training Center,  
Granville County, ER 11-2343

**AN EVALUATION OF  
KITCHEN GROUP A AND  
KITCHEN GROUP B,  
CAMP BUTNER NATIONAL GUARD  
TRAINING CENTER, GRANVILLE COUNTY  
NORTH CAROLINA**

December 2011

By:  
Amanda G. Kincaid and Mathia N. Scherer

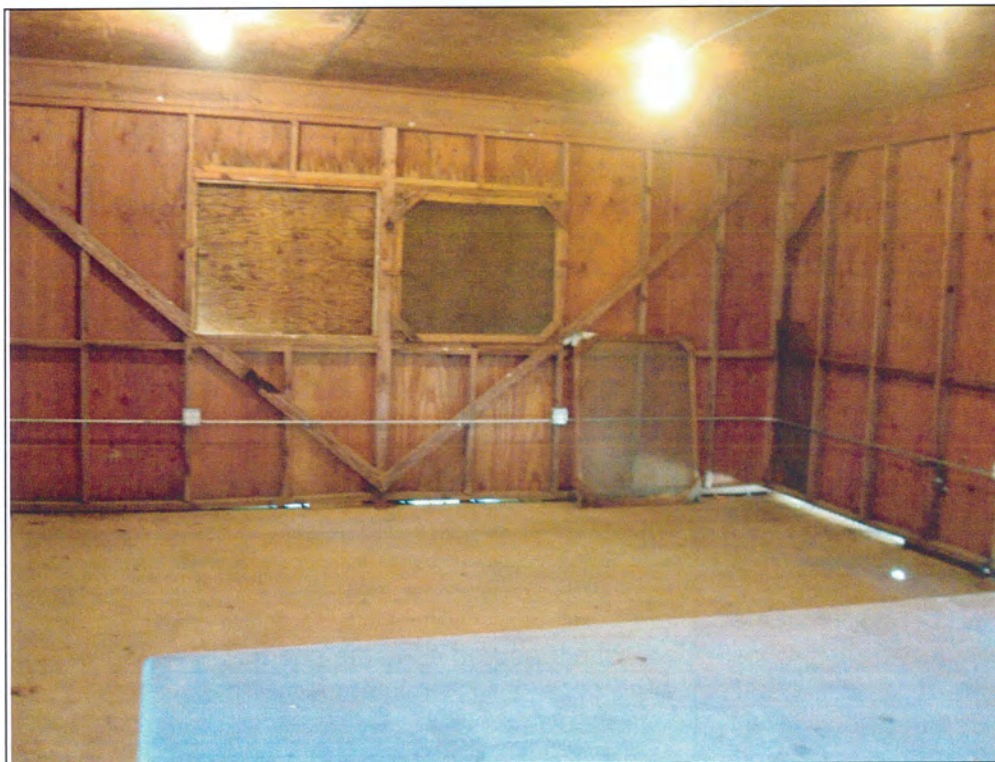
The interior of 3702 is an open room. The walls are unfinished and the floors are poured concrete (**Figure 5.29**). There is a long poured concrete counter on concrete block legs, which is the same as the ones that occur in all of the other kitchen buildings. There have been no visible alterations to the building.

**Figure 5.29. Interior of 3702.**

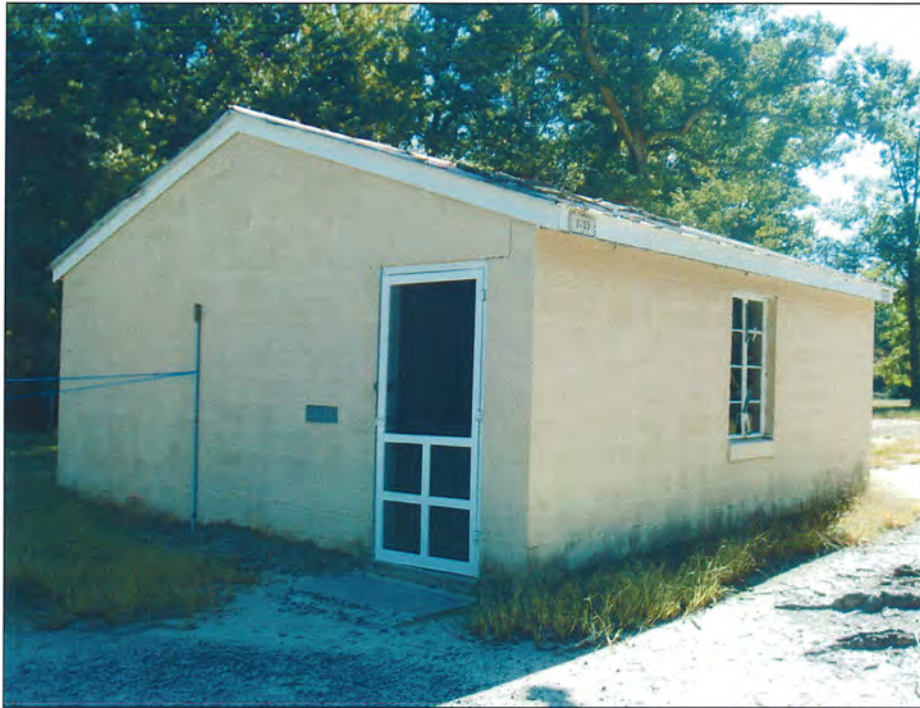
Building 3703 in Kitchen Group B is almost identical on the exterior to Building 3701 in Kitchen Group B and Buildings 3501, 3502, and 3503 in Kitchen Group A (**Figure 5.2**, **Figure 5.30**, and **Table 5.8**). Building 3703 is a rectangular shaped building constructed of concrete block with a side gabled frame roof covered in corrugated metal. Its fenestration and door openings are the same as in the other buildings listed above. Building 3703 was built around 1958 and measures 21.4 X 21.4.”

**Figure 5.30. Exterior of Building 3703 oblique view of north and east elevations.**

The north elevation has one window opening in the concrete block wall. It is a casement window that opens in the middle by a turn crank system. There are four fixed panes on each half of the window. There are poured concrete lintels under the window. On the south elevation there are two of these windows as the only openings on this elevation. On the east elevation the only opening is a door frame that is enclosed with a metal door, covered by a replacement screen door. The west elevation mirrors the east elevation.

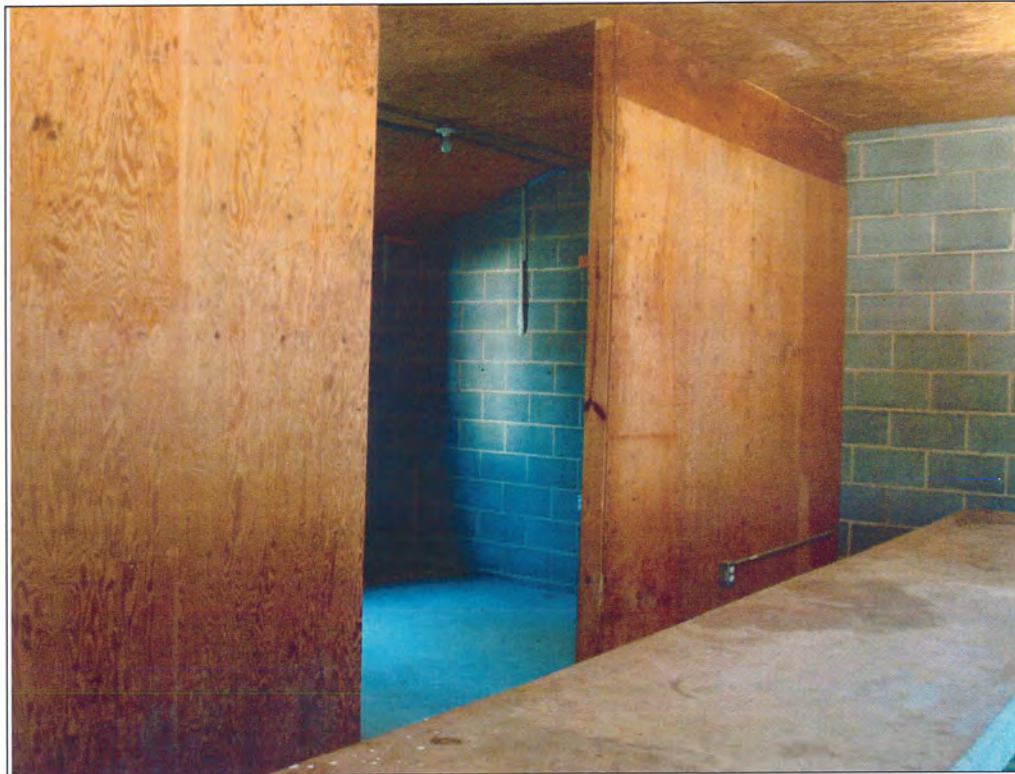
The interior of 3703 is different in that it has been altered. The same elements of the unfinished concrete block interior walls, and concrete counter are found in this building but a plywood divider has also been added (**Figure 5.31**).

**Figure 5.31. Interior of 3703, showing plywood divider.**

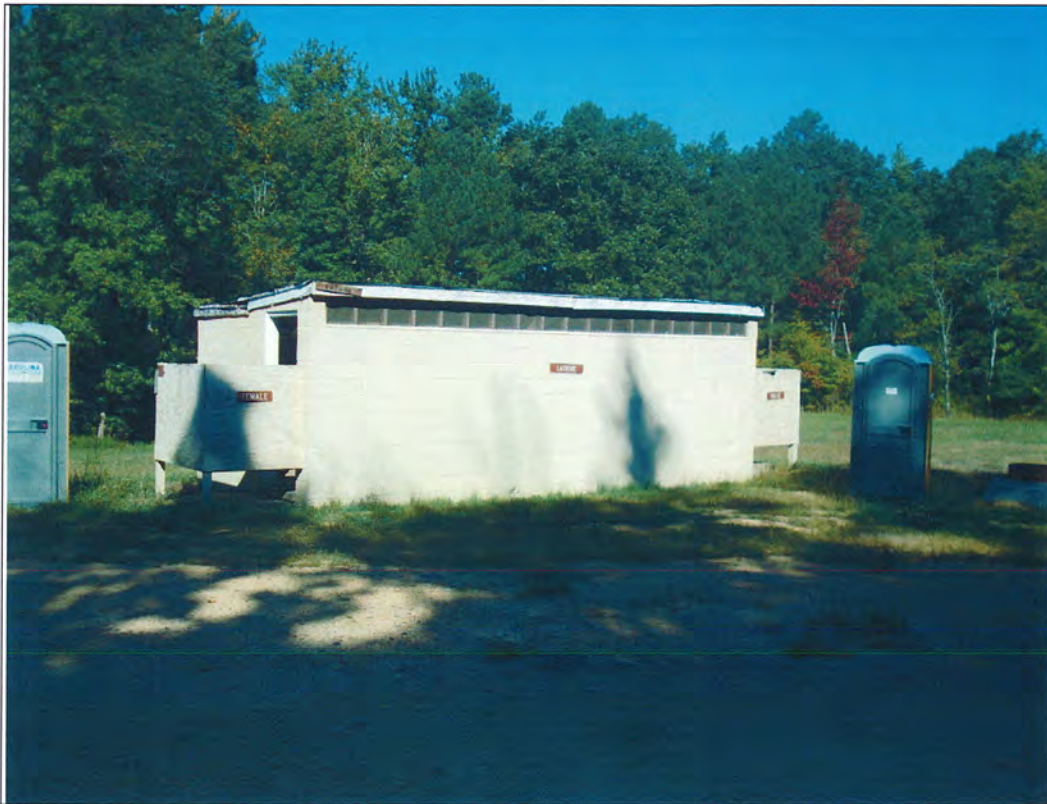
The latrine for Kitchen Group B is of identical construction to the latrine in Kitchen Group A, but much more deteriorated (**Figure 5.2**, **Figure 5.32**, and **Table 5.9**). It is a long, rectangular building that has one entrance on the east elevation and one entrance on the west elevation. Building 3704 was constructed in ca. 1958 and measures 25.4 X 13.4.”

Building 3704 has a shed roof that is covered in corrugated metal. The only openings on the north and south elevations are under the roof eaves and are a series of eighteen screened in openings that serve the purpose of ventilation. The west elevation has one door opening and a privacy screen in front of the entrance marked “Female.” On the east elevation there is one door opening with a privacy screen blocking the entrance marked “Male.”

**Figure 5.32. East elevation of Building 3704.**

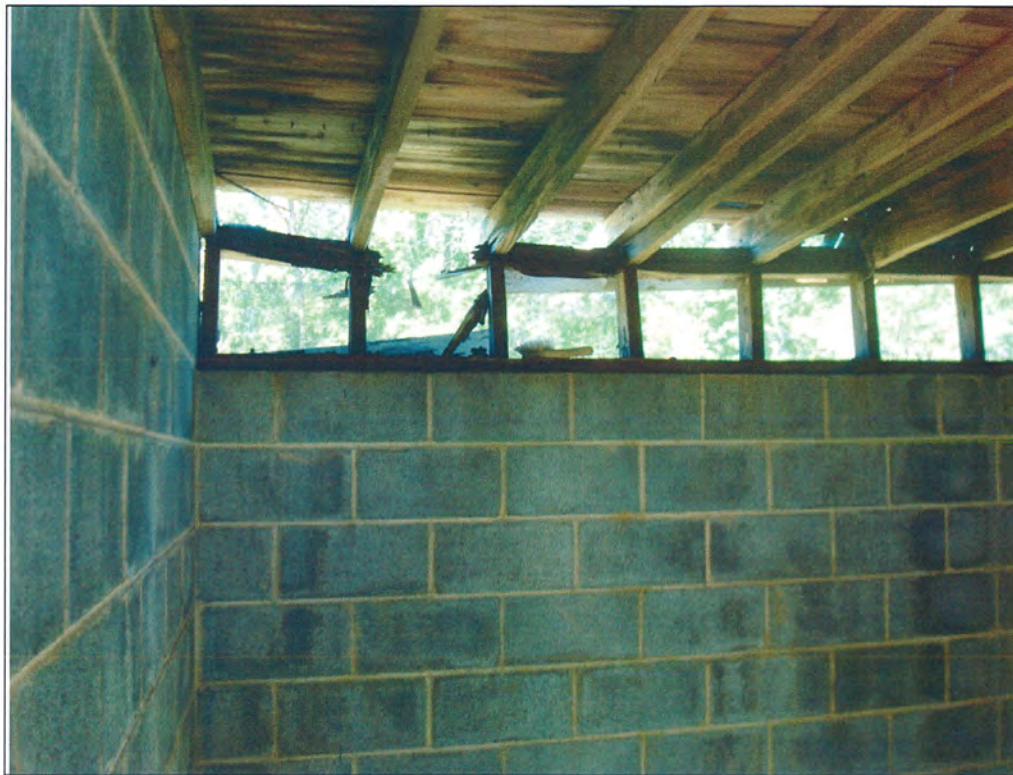
This building is much more deteriorated than any of the other buildings in Kitchen Group A or B. The wood that supports the roof is infested with termites and is very damaged, so much so that it can no longer support the roof in some places, on the north elevation of the latrine (**Figure 5.33** and **Figure 5.34**). This deterioration greatly affects the material integrity of the building because the north side of the roof will soon fail. Without the element of the screened-in windows the building would lose much of its historic integrity, which is that of a building built prior to the common use of air conditioning.

**Figure 5.33. Interior of latrine showing deteriorated wood.**

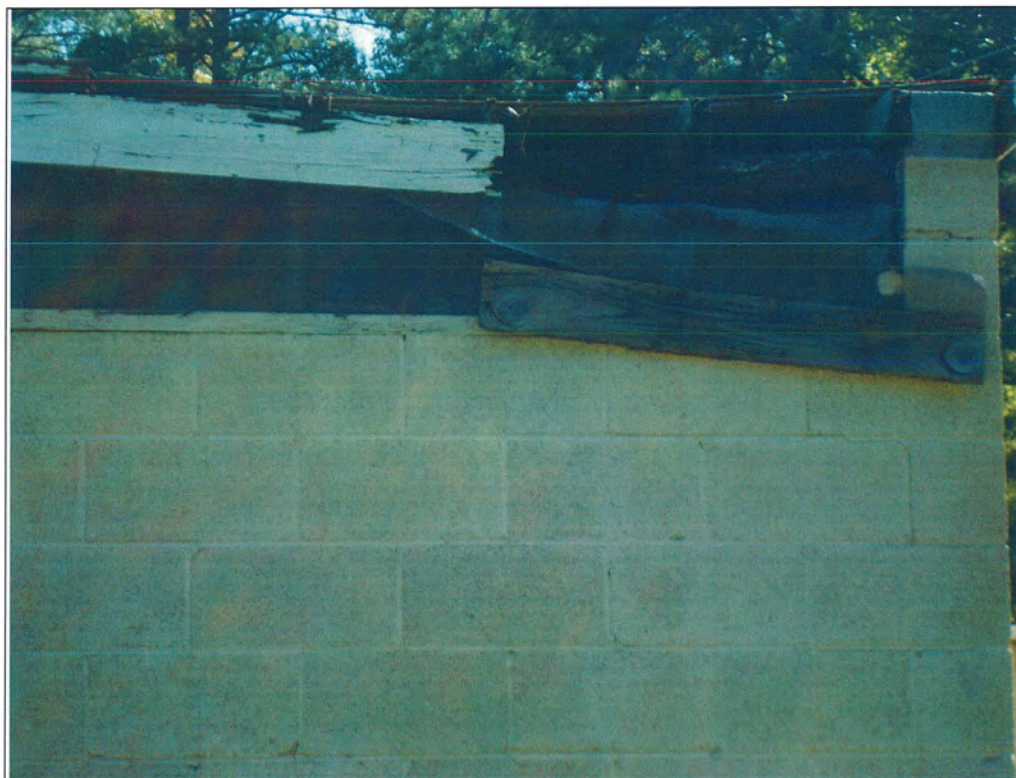
**Figure 5.34. Exterior deterioration on the north elevation.**
