Historic Architectural Survey Report, Replace Bridge 277 on Old Stage Road (SR 1006)over

Black Creek, B-4655, Wake County, ER 13-0276

Intensive-Level Historic Architectural Analysis of Myatt's Mill Complex for the Replacement of Bridge 277 on SR 1006 (Old Stage Road) over Black Creek

January 18, 2013 • Final Report New South Associates Technical Report 2229

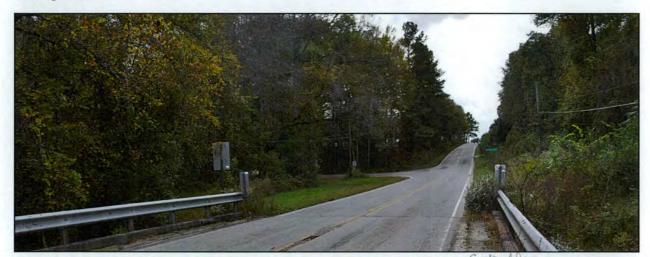
b. View from Bridge No. 277 Looking South on Old Stage Road to Intersection with Panther Lake Road

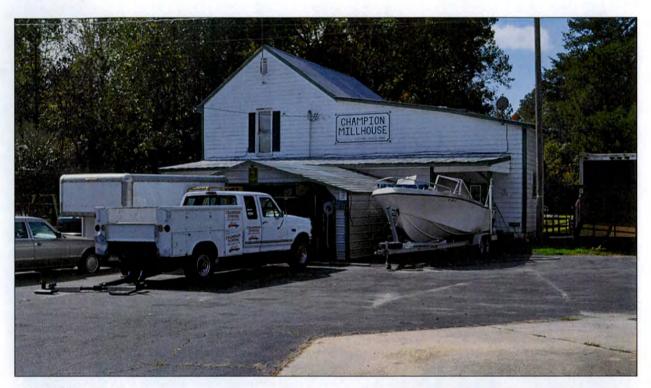
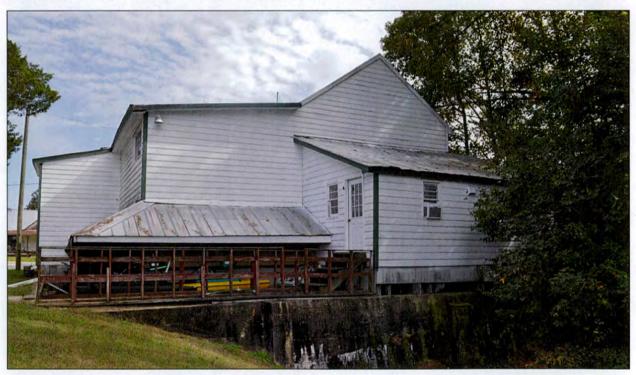
Figure 6. Exterior Views of Myatt's Mill

Myatt's Mill sits on the southeast shore of Panther Lake, a manmade impoundment created by the damming of Black Creek. The building shares a paved front parking lot on the east side with the (former) Adams-Monday Store. The basic form of this two-and-half story nineteenth-century gristmill with flush gable ends remains evident; however, the building has been expanded at least three times with shed additions on the north and west sides (Figures 6-7). A shed roof porch supported by unfinished four-by-four posts extends across the east elevation, which serves as the "front" of the owner Scott Champion's towing business today (Figure 8a). A gabled, metal-covered storage shed abuts the east side. The mill's doors and windows are modern vinyl replacements. An examination of materials on the interior suggests window openings are not original. Beaded Masonite siding covers the exterior; the owner stated that the original wood weatherboards remain underneath (Wake County Register of Deeds 1902). The roofs of the main block, shed additions and porch are covered with 5-V metal. The visible portions of the foundation are poured concrete (Figure 7b). The high pebble content of the foundation matches that of the concrete dam to the

Constructed in the mid-nineteenth century, Myatt's Mill was expanded with large shed additions in the twentieth century. Within the past 20 years, a front porch has been added or rebuilt, window openings have been cut into the walls of the main block and sheds, and vinyl window sashes and doors have been installed. Beaded Masonite siding covers the exterior obscuring the original weatherboards. A twentieth-century concrete perimeter foundation and millrace replaced or obscures the nineteenth-century stone foundation.

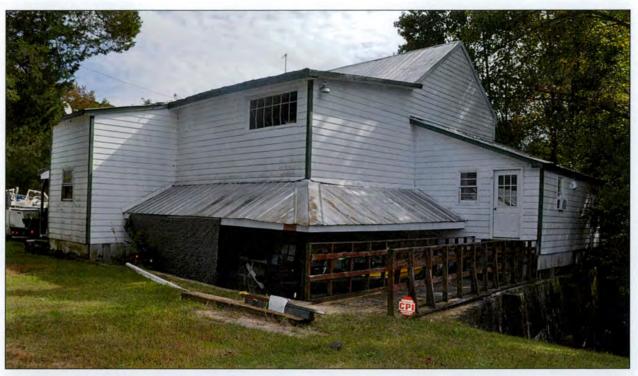
a. North and West Sides

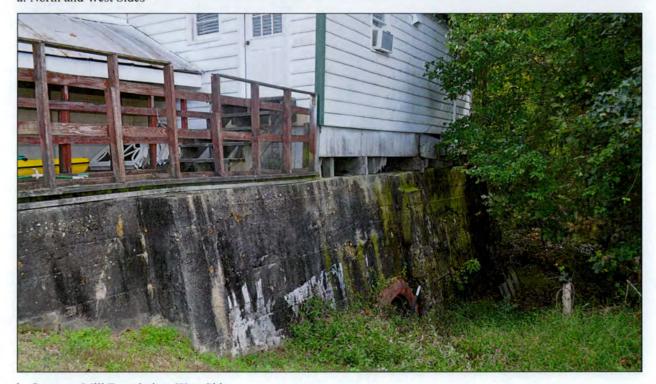
b. Concrete Mill Foundation, West Side

west, suggesting that that the foundation and dam were made at the same time. The underside of the building was not accessible for this study, but parts of metal milling equipment are visible underneath (Figure 8c). A concrete culvert passes through the earthen portion of the dam directing water to the head race (Figure 9). Several large millstones have been deposited in the marshy bottomland south of the mill (Figure 9c).

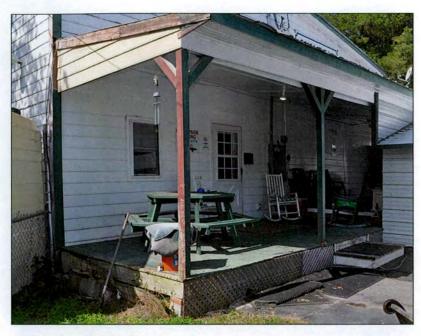
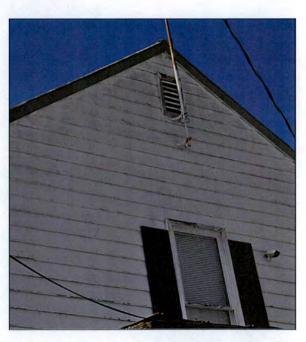
Figure 8. Exterior Details of Myatt's Mill

a. Porch Detail, East Side

b. Gable Detail, East Side

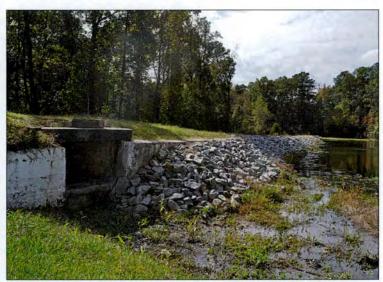
b. Mill Head Race Looking West to Dam of Black Creek

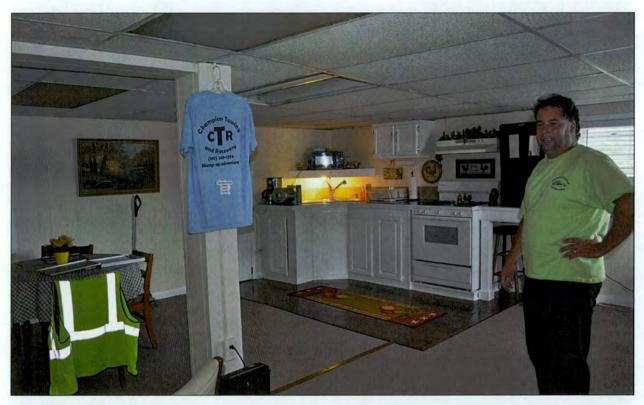
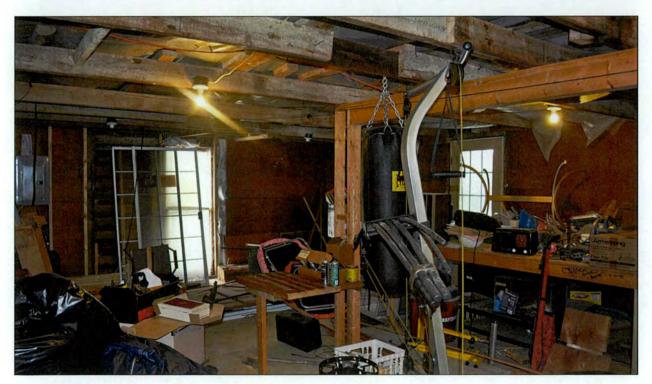
Figure 10. Interior Views of Myatt's Mill

The first level of the main block's interior has been remodeled from an agricultural/industrial space, to a modern office with a kitchen. Within this room, no vestiges of the building's historic use as a gristmill remain. On the second level, original historic material, such as the pegged framing and circular sawn siding, remains visible; however, the much of the frame has been reinforced or replaced, the walls are covered with plywood sheets, and window opening added. In general, the interior no longer conveys the feeling and design associations that would identify this building as a historic gristmill. In terms of integrity, Myatt's Mill does not compare well with circa 1820 Yates Mill (WA 50) located south of Raleigh. Yates Mill has been restored and is listed in the NRHP.

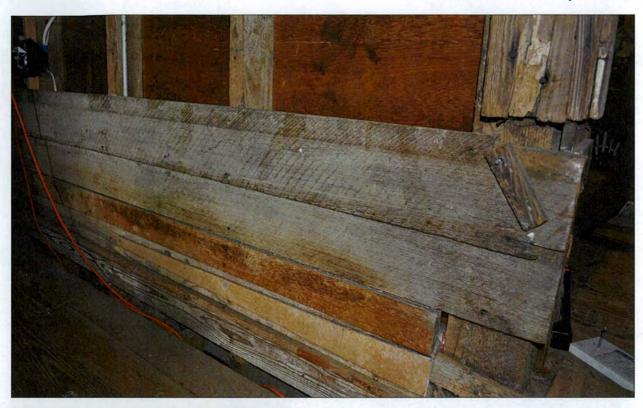
Figure 11. Interior Details of Myatt's Mill

a. Original Circular Sawn Weatherboards on North Side, Now Inside Shed Addition

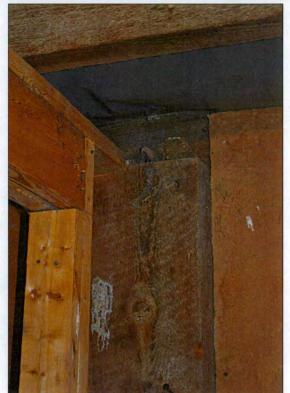
b. Pegged Joinery

The interior of the main block of Myatt's Mill has been remodeled for office use (Figure 10). The large open room features a kitchen along the west wall and drop ceilings, paneled walls, and carpeted floors (Figure 10a). The second floor is used for storage (Figure 10b). Plywood panels cover the walls and windows opening and vinyl sashes have been added (Figure 11a). Pegged structural joints remain visible, as does a small remnant circular sawn weatherboard siding on the north exterior wall (visible from the shed addition) (Figure 11b).

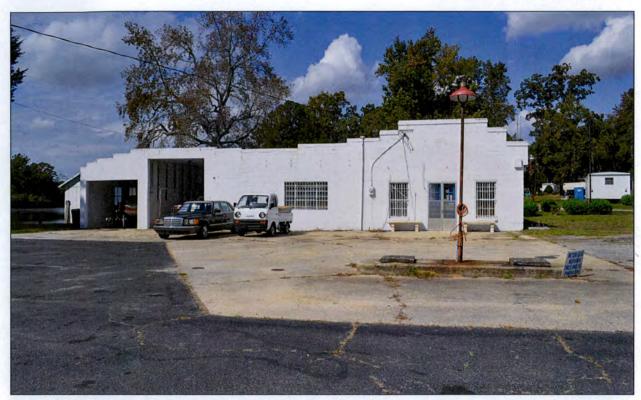
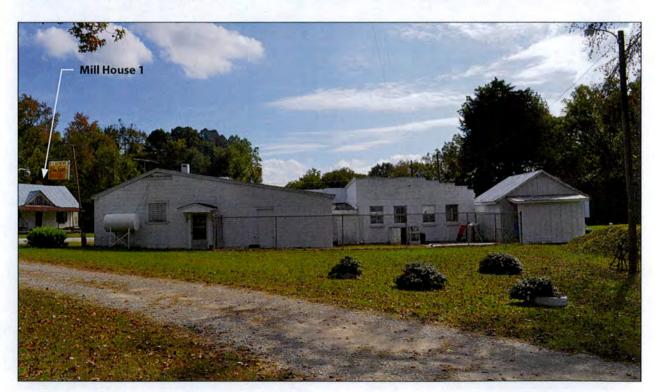
Figure 13. Views of Adams-Monday Store

wood window sash with a brick sill. A similar window is the sole opening on the store's east side. Above the entry is a ghost mark left by a gabled entry pavilion, which was visible on a 1996 tax photo. A 12-light metal sash display window is situated on the façade between the storefront and the garage bays of the west end. The west and north sides of the garage section have 4-light fixed windows. Metal security bars protect all of the windows of the front elevations.

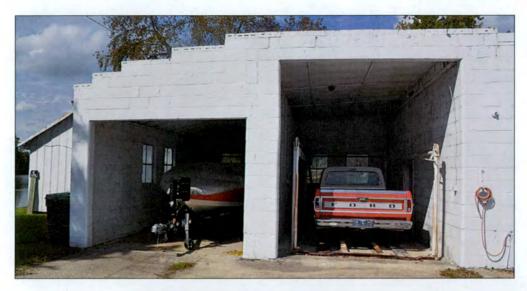
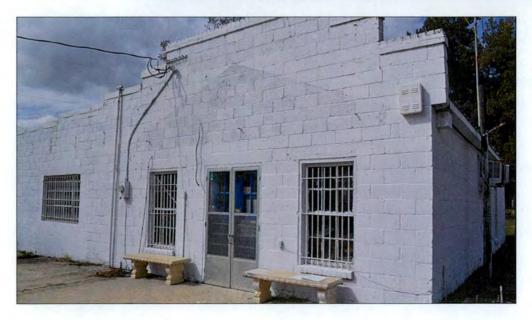
Figure 14. Details of Adams-Monday Store

a. Adams-Monday Store Garage Bays

c. Adams-Monday Store, Storefront

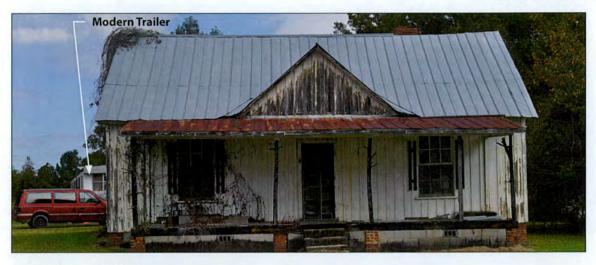
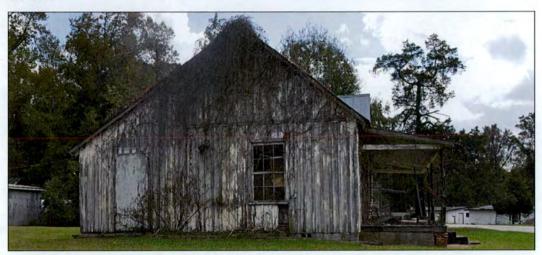
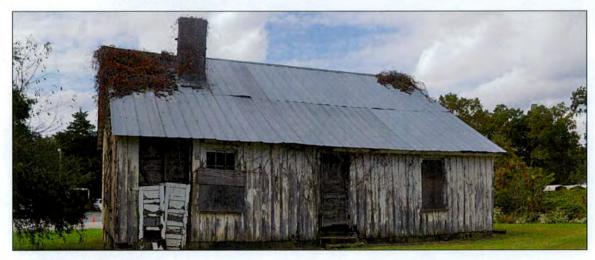
Figure 15. Views of Mill House 1

This dwelling may be the "miller's house" conveyed to Alfred R. Myatt by his mother in 1903. The ca. 1900 one-story, triple-A form dwelling is intact, though vacant and deteriorating (Figures 15 and 16). Board-and-batten siding covers the house, an exterior treatment that was not common, or has not often survived, in Wake County. A shed porch supported by unfinished cedar posts spans a symmetrical façade composed of a central entry flanked by original a wood 6/6 window sashes. An original shed runs across the rear (east) elevation (Figure 16b). The brick pier foundation has been infilled with concrete masonry units (CMUs). An interior chimney pierces the rear roof slope at the south end of the dwelling. Current Owner Rachel Monday recalls that the building was used as club lodging and a gathering place for visitors to the Panther Creek Club recreational site.

Although vacant and deteriorating, this dwelling has changed very little since its construction around the turn of the twentieth century. It retains its simple and vernacular triple-A form and original materials such as board-and batten siding, 6/6 sash, rustic porch posts, and a brick pier foundation.

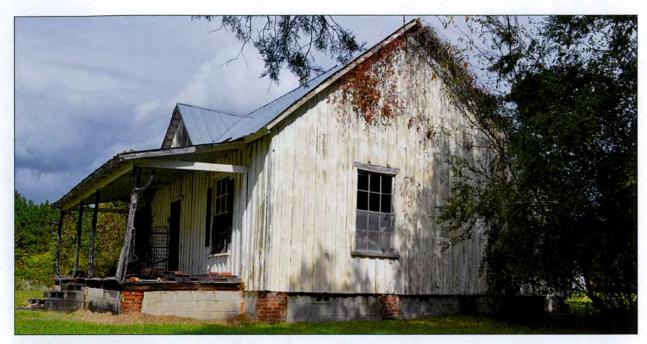
b. Mill House 1, South Side

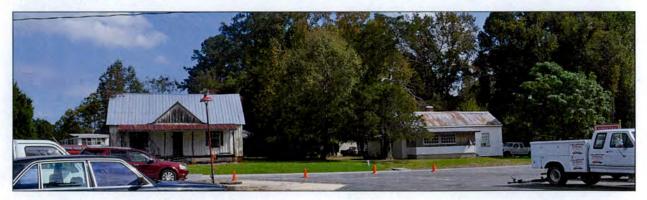
c. Mill House 1 (left) and Mill House 2 (right)

Thought to date from about 1900, Mill House 2 was badly damaged by fire in the early 1990s and extensively remodeled as a result (Figure 16c). Prior to the fire, the house consisted of a one-story, side-gable front block with a rear ell (Scott Champion Personal Communication 2012). Today, the front block is still evident, although its porch has been unsympathetically enclosed, and a shed-roofed addition has infilled the space south of the original rear ell (Figure 17). A second, partially enclosed storage shed has been built off the north side of the ell. A low shed dormer was added across the rear slope of the main block. The entire house is sheathed with Masonite siding and windows are a collection of mismatched wood and vinyl sashes. The roof is covered with 5-V metal sheets.

Repairs made after an extensive fire in the 1990s make it difficult to discern the original form and finishes of this dwelling. The treatment of the front porch obscures the façade and fenestration pattern. Masonite siding and a combination of replacement and reused windows have replaced original exterior materials.

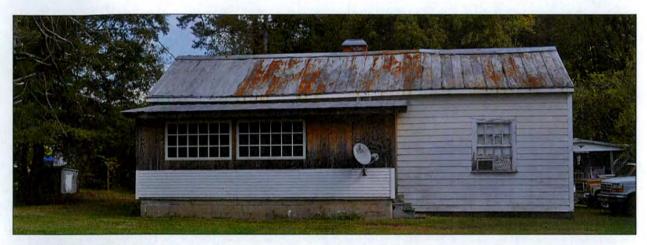
a. Mill House 2, West Side

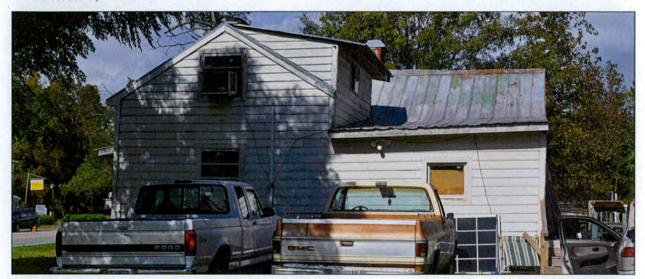
b. Mill House 2, South Side

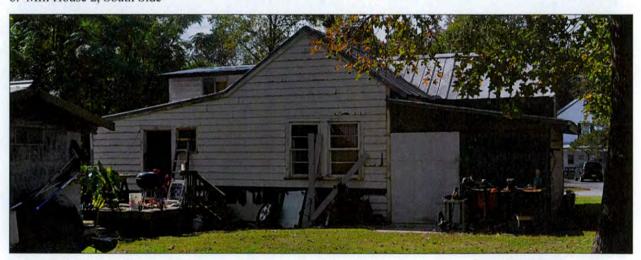
c. Mill House 2, East Side

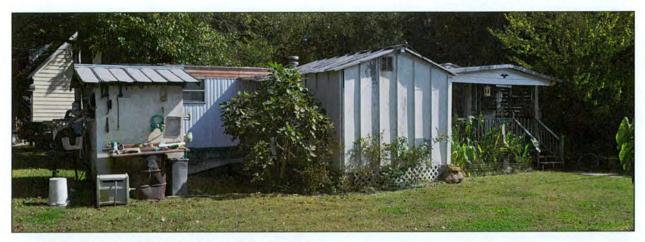
a. Trailer and Sheds in Rear (East) Yard of Mill House 2

In the dwelling's rear (northeast) yard is a low CMU well cover with a shed roof, an unpainted CMU shed topped by a shallow-pitched gable roof, a single-wide mobile home with a porch and metal storage shed attached to front (southwest) side, and a frame gabled outbuilding with a two-bay partially enclosed shed projecting from the northwest side (Figure 18).

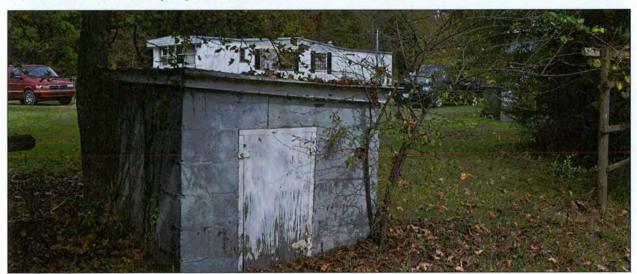
b. Mill House 2 Well House; Trailer in Rear (East) Yard of Mill House 2 in Background

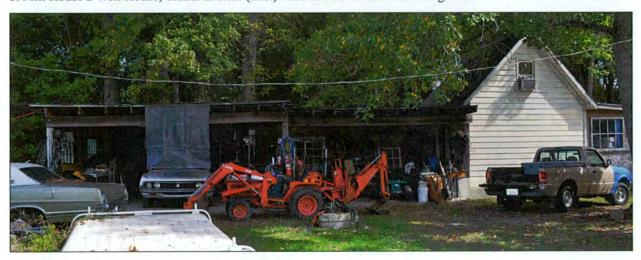
c. Shed and Additions in Rear (East) Yard of Mill House 2

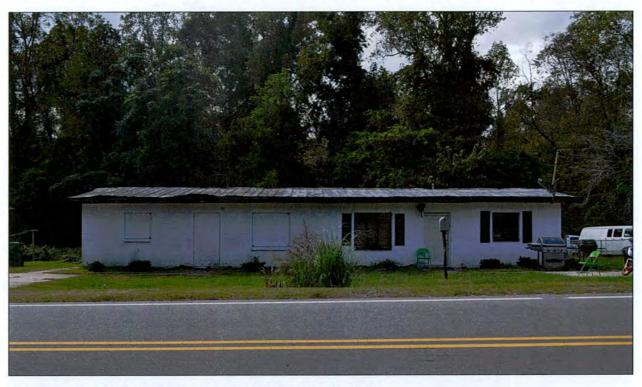
a. Panther Branch Club Housing, 8214 and 8216 Panther Lake Road

8214 and 8216 Panther Lake Road: This one-story CMU duplex has a shallow-pitched, sidegable roof covered with 5-V metal. The north unit retains its metal casement windows; the front door is a replacement. The door and window openings of the south unit are boarded up (Figure 19).

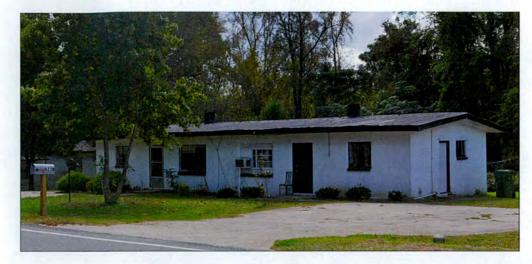
a. Panther BranchClub Housing, 8230Panther Lake Road

8230 Panther Lake Road: This one-story CMU duplex has a shallow-pitched, side-gable roof covered with 5-V metal (Figure 20a). The roof metal appears to be covering a previous tar and pebble roof. The north unit has a replacement window and a solid metal entry door; the south unit retains its metal casement windows and solid metal door.

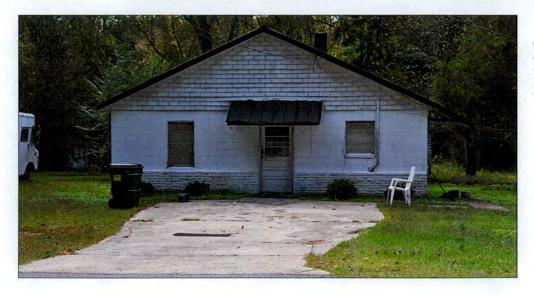
8250 Panther Lake Road: This front-gable, single-unit dwelling has metal 2/2 vertical window sashes flanking a glazed-and-paneled entry door sheltered by a pent (Figure 20c). There are shingles in the front gable end and a low "wainscot" of rough-faced Roman bricks on the façade. A small metal shed is in the rear (west) yard.

c. Panther Branch Club Housing, 8250 Panther Branch Road

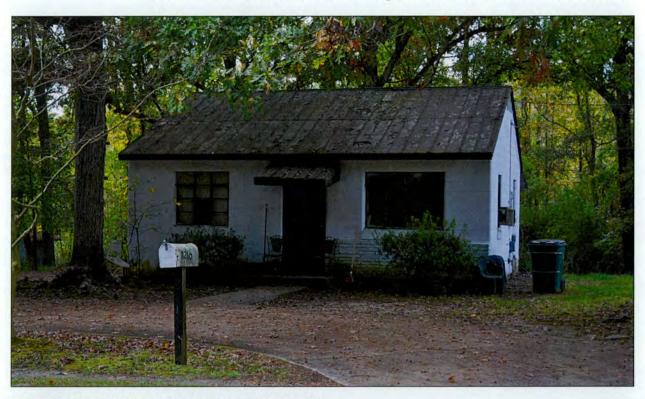
8260 Panther Lake Road: This side-gable, single-unit dwelling retains its original metal casement windows (Figure 21a). A pent shelters the central entry. North of the entry is a low "wainscot" of rough-faced Roman bricks.

a. Panther Branch Club Housing, 8260 Panther Lake Road

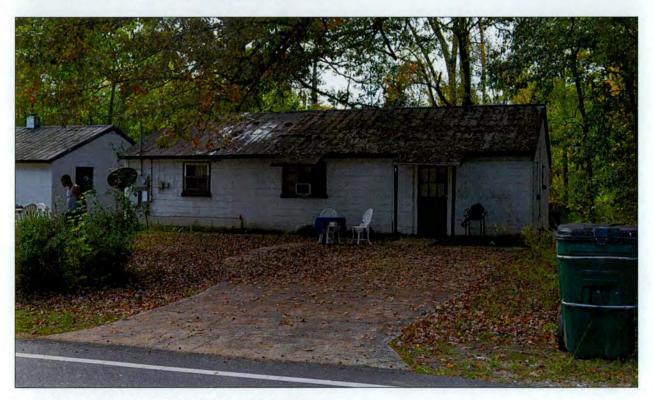
b. Panther Branch Club Housing, 8270 Panther Lake Road

8270 Panther Lake Road: The entry of this side-gable, single-unit dwelling is at the north end of the façade (Figure 21b). A one-bay shed roof on posts shelters the glazed-and-paneled entry door. Both original metal casement windows and replacement windows are present.

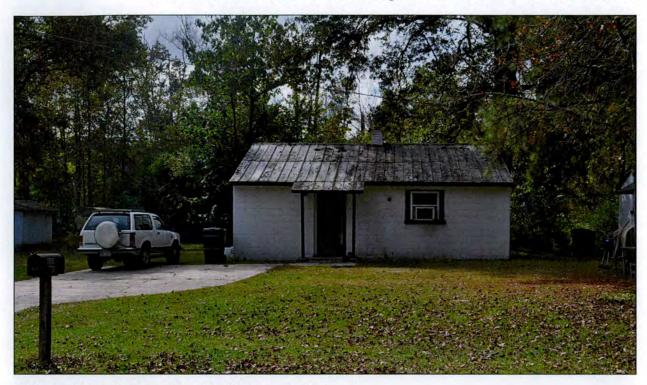
a. Panther Branch Club Housing, 8275 Panther Lake Road

8275 Panther Lake Road: The entry of this two-bay dwelling is sheltered by one-bay shed roof on posts at the south end, and a replacement window at the north end (Figure 22a).

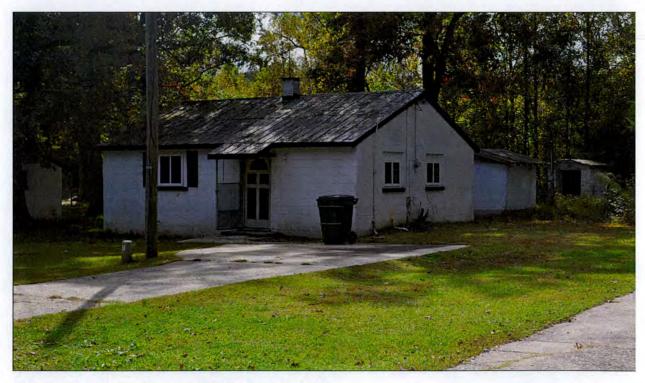
b. Panther Branch Club Housing, 8280 Panther Lake Road

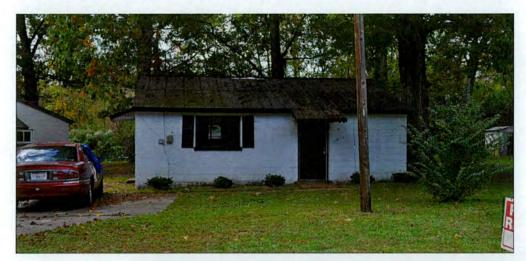
a. Panther Branch Club Housing, 8298 Panther Lake Road

8298 Panther Lake Road: This side-gable, single-unit dwelling has a pent over the entry and retains its original metal casement windows (Figure 23a).

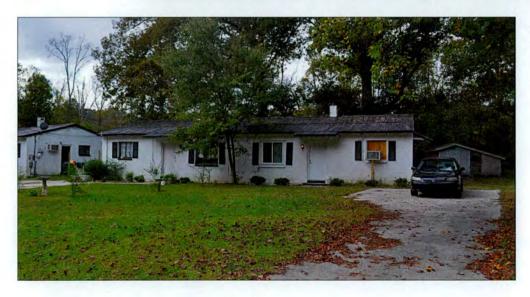
c. Panther Branch Club Housing, 12710 Old Stage Road

12710 Old Stage Road: This one-story duplex has a shallow-pitched, side-gable roof covered with 5-V sheet metal (Figure 23b). The sold metal entry doors to both units are sheltered by pents. The windows of the north unit have been replaced; the south unit retains its metal casement windows.

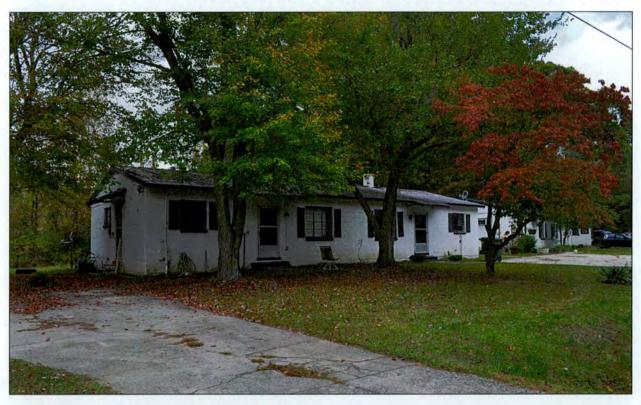
12718 Old Stage Road: This one-story duplex has a shallow-pitched, side-gable roof covered with 5-V sheet metal (Figure 24a). The entries to both units are sheltered by pents. Original metal casement windows remain in both units.

a. Panther Branch Club Housing, 12718 Old Stage Road

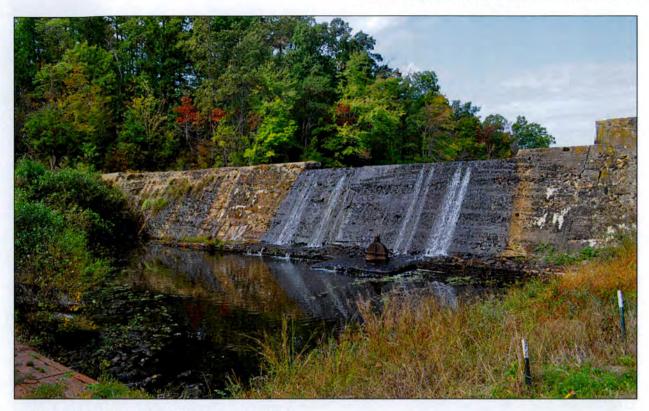
a. Panther Lake Dam at Black Creek Looking North

The dam retains a high degree of integrity from its nineteenth-century appearance. Recent alterations include the placement of riprap reinforcing stone at the east end, and the lowering of the top of the dam by approximately one-foot at the spillway. Panther Lake appears on the 1871

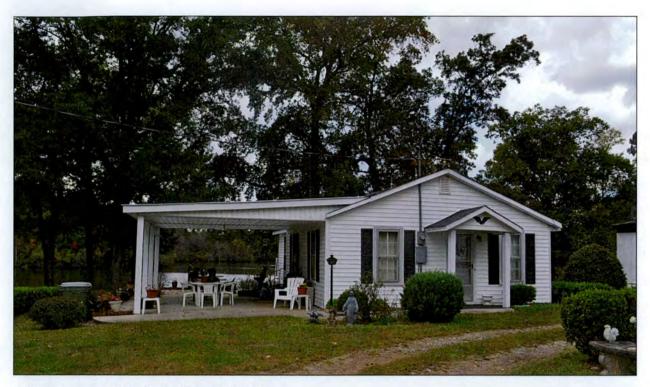
This small house sits on a knoll on the east side of Panther Lake, part of a 68-acre parcel that includes the lake, the Adams-Monday Store, and Mill House 1. According to the current owner this, one-story frame dwelling was built around 1950 as a vacation cottage for the Panther Branch Club (Figure 28). The simple dwelling has a one-bay, front-gable porch and massive carport on the south side. The 4/4 windows are original; vinyl shutters and siding have been added.

a. Panther Branch Club Rental Cottage, East Side

The modest front-gable form of this dwelling is severely impacted by the carport on the south side. The vinyl siding further obscures the house's historical appearance.

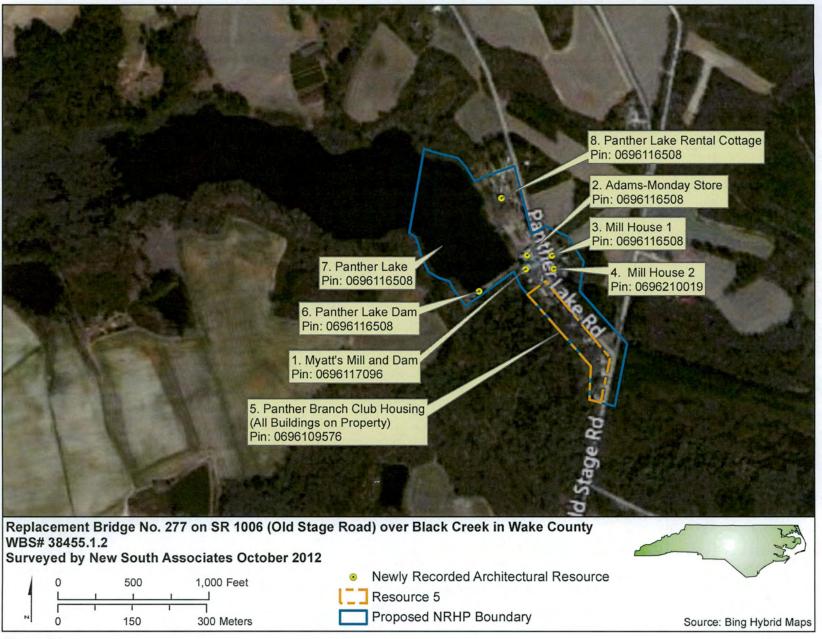
Figure 29. Map Showing NRHP Boundary

The recommend NRHP district boundary is shown on Figure 29. The boundary follows the rights-of-way of Old Stage and Panther Lake Roads and incudes the south end of Panther Lake. Buildings and structures within the district boundary are: Myatt's Mill, the Adams-Monday Store, Mill House 1, Mill House 2, the Panther Branch Club housing units, Panther Lake Dam, and the Panther Lake Rental Cottage. Important landscape features that contribute the historic district's setting are: the south end of Panther Lake, the abandoned roadbed linking SR 1006 (Old Stage Road) and Panther Lake Road (SR 2748), and SR 1006 and SR 2748. The southern portion of Panther Lake is included within the proposed boundary because the district's historic use as a recreational site was dependent upon the lake. A comparison of current and historic aerial photographs show the shoreline remains the same, and the lake continues to provide a vital element of the district's historic setting. The boundary is drawn at the lake's bend to the northwest. Due to the bend, the portion of the lake northwest of the boundary line is not visible from the mill, southern lakeshore, and dam. Therefore, the boundary as drawn provides an adequate and appropriate setting for the district.
