Re: Cultural Resource Survey for Charlotte Air National Guard Station, Mecklenburg County, ER 13-1453

**CULTURAL RESOURCES SURVEY OF THE
CHARLOTTE-DOUGLAS INTERNATIONAL AIRPORT
AIR NATIONAL GUARD BASE AND THE
STANLY COUNTY AIRPORT
AIR NATIONAL GUARD STATION
NORTH CAROLINA**

**Prepared For:
North Carolina Air National Guard
National Guard Bureau
Air National Guard Readiness Center**

October 2013

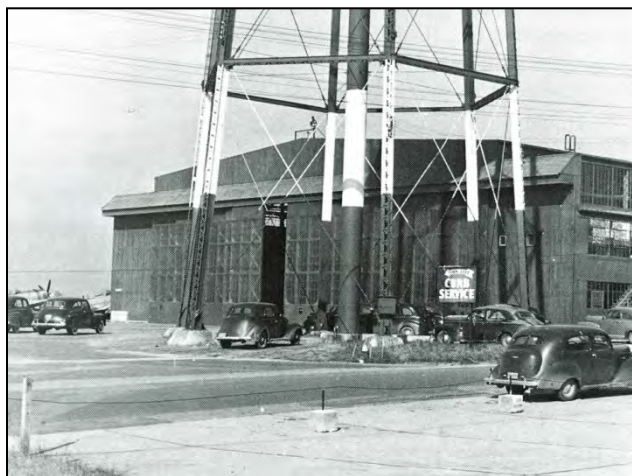
Figure 11. This 1948 Image Shows One of the Former Morris Field Hangars Located at the Charlotte Installation (Reid 1998:58).

The structure in the foreground is a water tower that has been demolished.

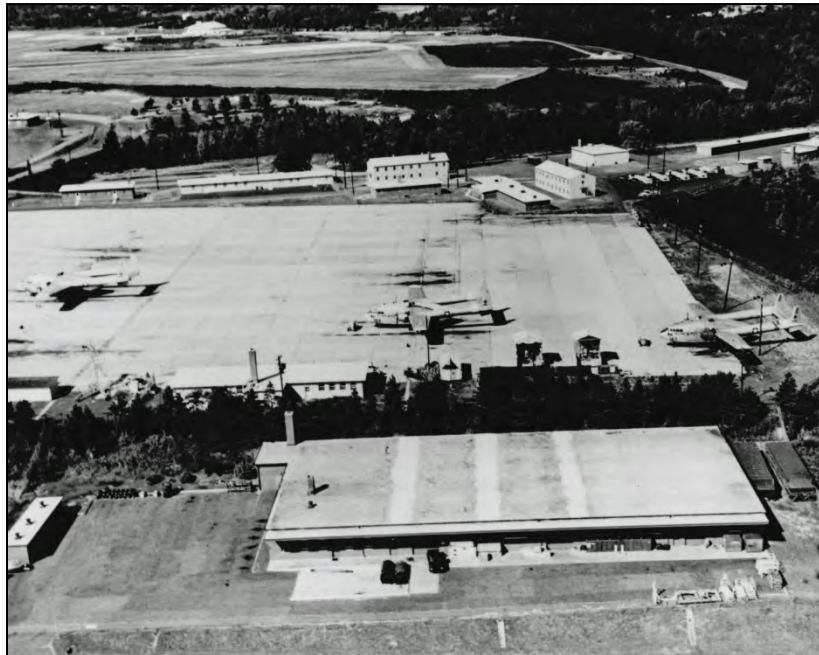
Figure 14. View to North, with Building 1 (1956) in the Foreground and Surplus Morris Field Army Buildings in the Background (NCANG Heritage Program 2012).

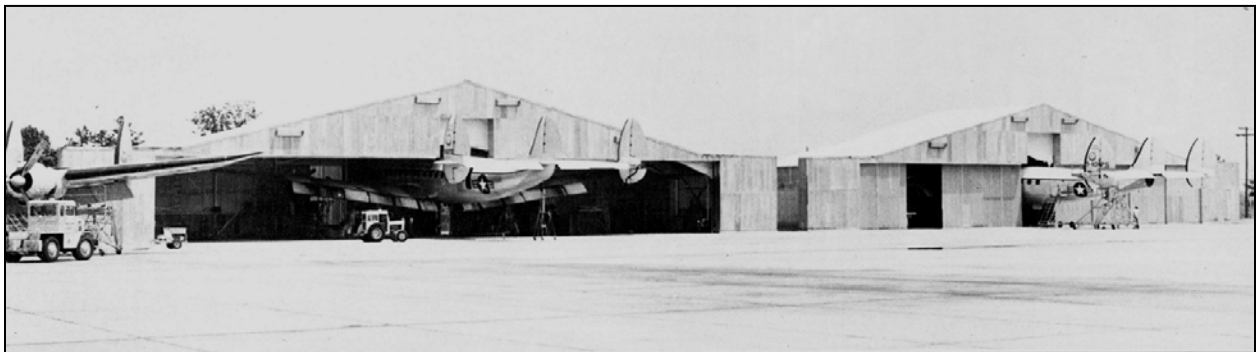
Figure 16. These NCANG C-121s Are Parked inside the Charlotte ANGB Hangars; One of the Hangars Was Building 22, Constructed in 1965 (Reid 1998:104).

One hangar reportedly came from the Charleston AFB in an NCANG plane and the Air Guard staff re-assembled it at Charlotte. Both of these hangars have been demolished.

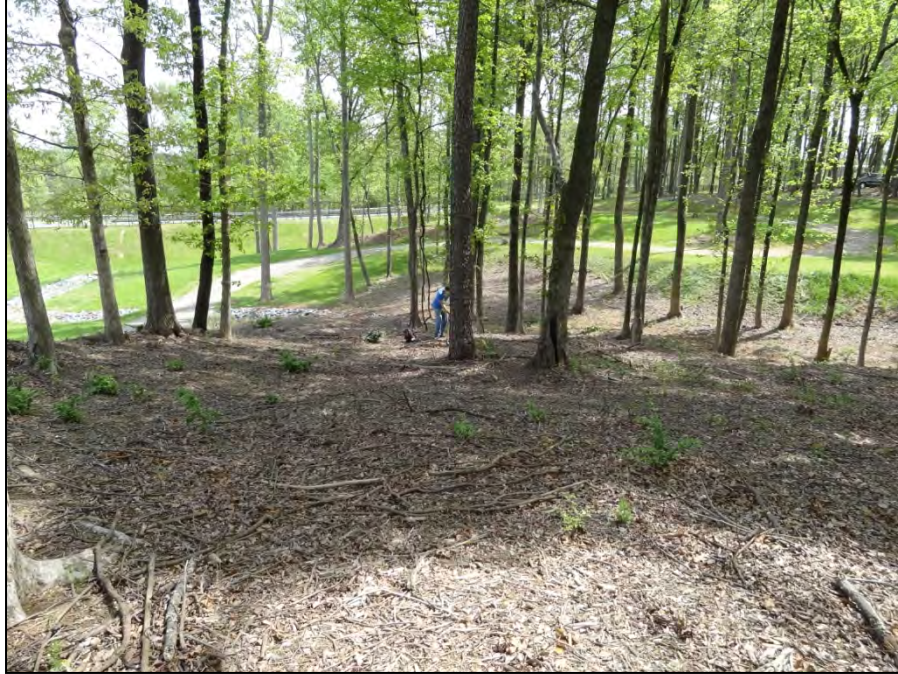
Figure 30. Charlotte Area 1 in the Vicinity of STP 1-a5, View to the East.

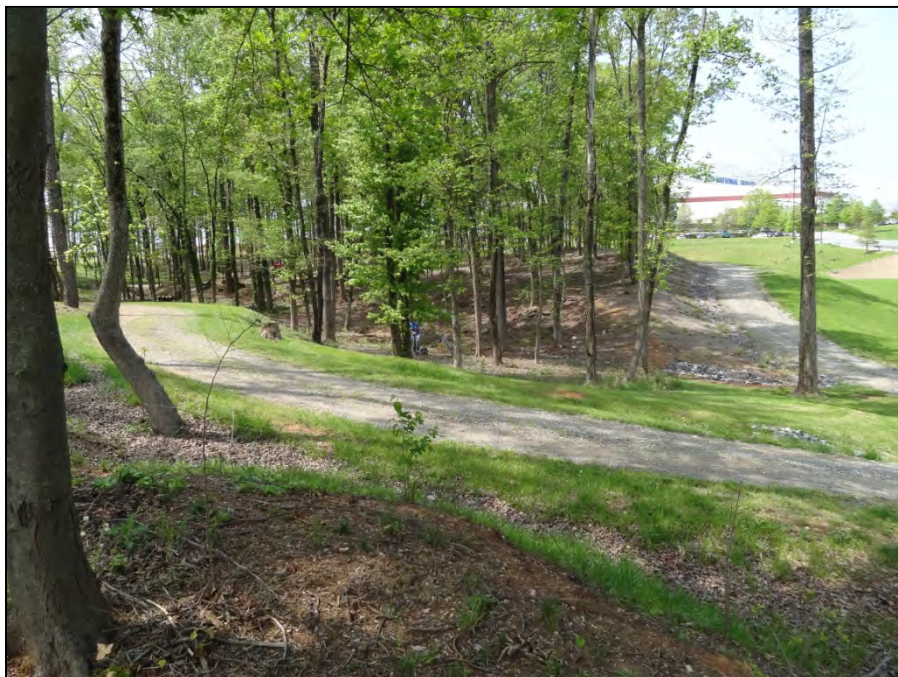
Figure 31. Charlotte Area 1 in the Vicinity of STP 1-e1, View to the West.

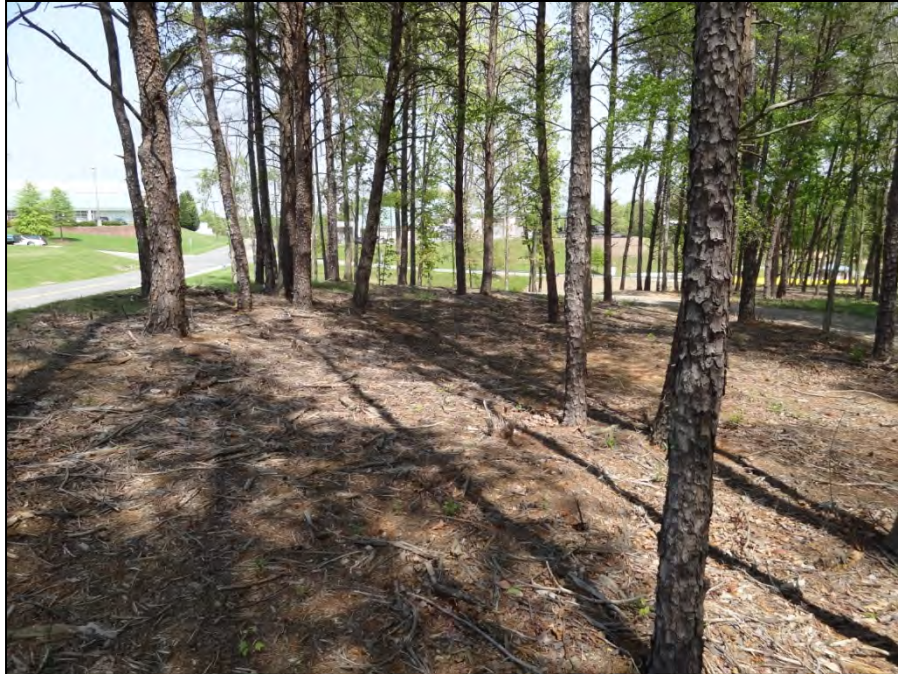
Figure 32. Charlotte Area 1 in the Vicinity of STP 1-d1, View to the North-Northeast.

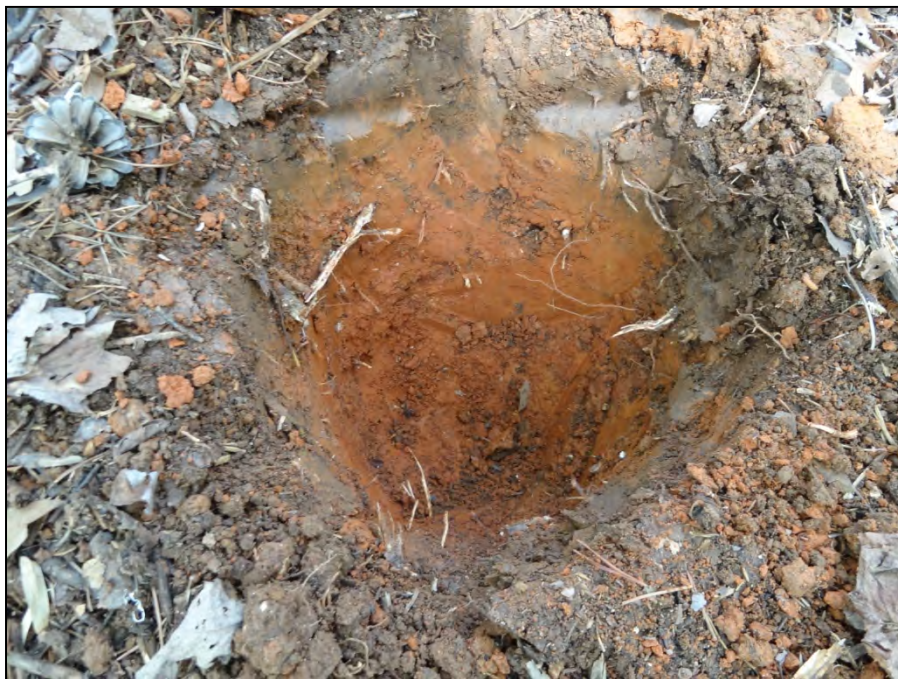
Figure 33. Soil Profile of STP 1-a2, Charlotte Area 1.

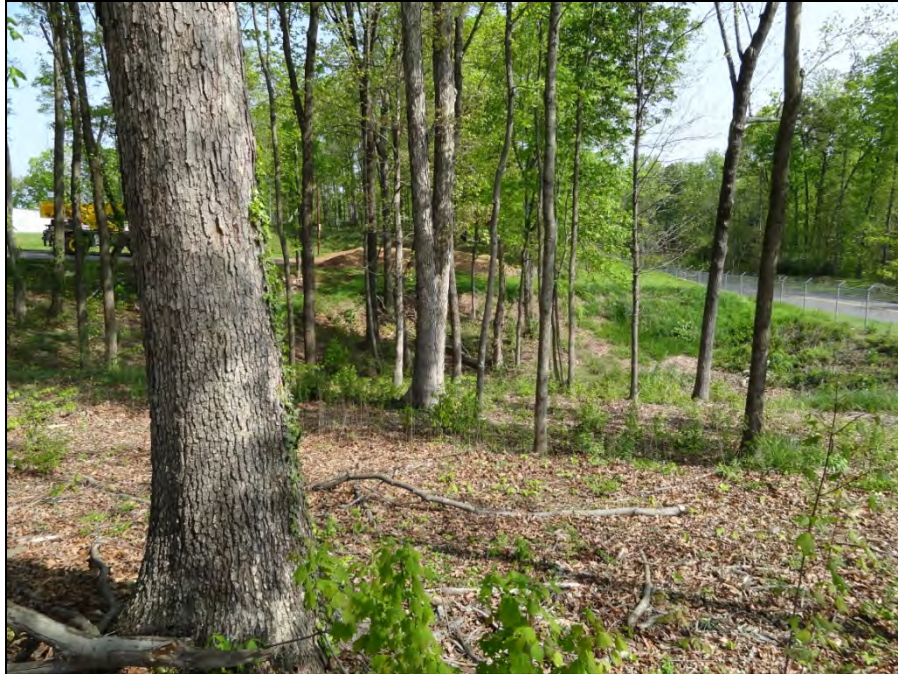
The crew divided Charlotte Area 2 into three unnamed subsections, as it was not possible to investigate continuous transects across the full area. The area is 3.2 acres, moderately sloped (5–15 percent), and like Area 1 wooded with little undergrowth (Figures 35 through 37). Much of this area also has been subject to construction in the immediate vicinity, as reflected by the soil profiles of several STPs that lacked Be horizons. Crew members excavated 12 STPs in Charlotte Area 2, ranging from 40–64 cm in depth (see Table 3). STP 2-2 represented the typical undisturbed soil profile (Figure 38): Stratum I (0–13 cm), a sandy loam of color 10YR3/2; Stratum II (13–19 cm), a sandy clay loam of color 10YR5/4; and Stratum III (19–46 cm), a sandy clay of color 5YR4/6 (see Figure 34). STPs with disturbed fill were represented by a coarse sand/sandy loam/sandy clay loam profile before terminating at the 7.5YR5/6 or 5YR5/6 sandy clay substratum. All STPs in Charlotte Area 2 were negative for cultural materials.

Figure 35. Charlotte Area 2, in the Vicinity of STP 2-11, View North.

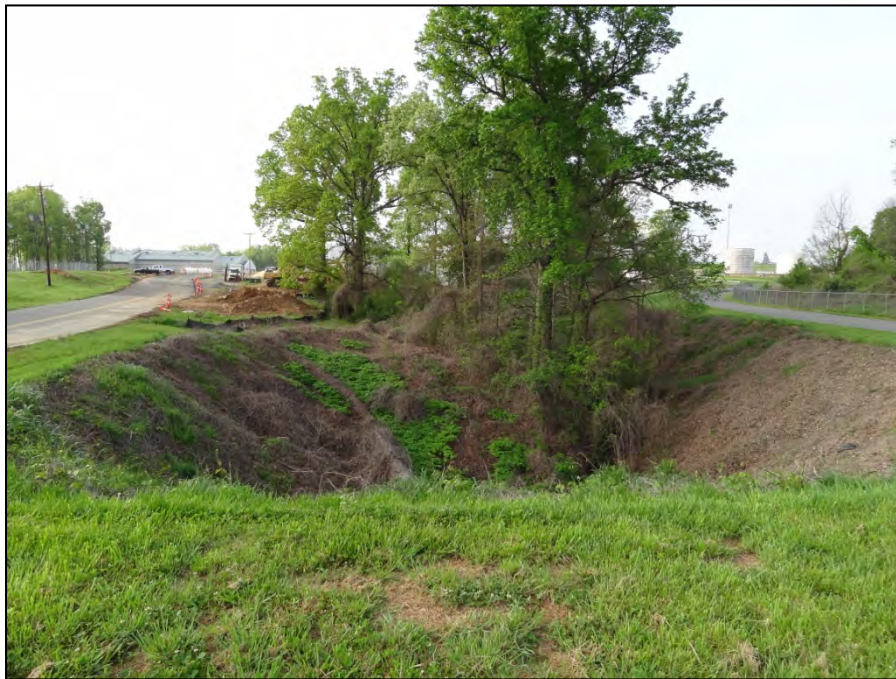
Figure 39. North End of Charlotte Area 3, View South.

Charlotte Area 3 consisted of a 1.2-acre section of steeply sloped woods with a creek/drainage at the bottom and moderate undergrowth (Figures 39 through 41). Two STPs were placed judgmentally on the only portions of this area flat enough to accommodate testing (see Table 3). One STP was placed on either side of the creek/drainage. Both shovel tests consisted of a single stratum, Stratum I, a sandy clay loam (subdivided into Strata Ia and Ib in STP 3-1; see Figure 34) ranging in depth from 45–60 cm. The color varied between STPs: for STP 3-1, Stratum Ia was 7.5YR4/4 and Stratum Ib was 5YR4/4, while for STP 3-2, Stratum I was 7.5YR3/3. Both STPs were negative for cultural material.

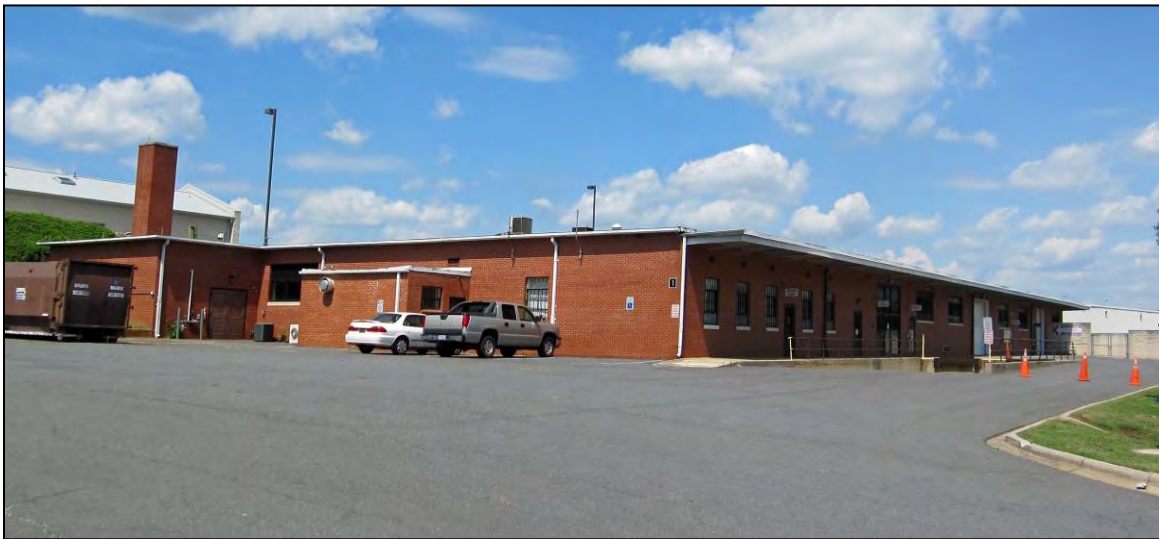
Building 1, constructed in 1956, is a one-story warehouse building with a rectangular footprint. The building has exterior brick wall cladding, and a flat roof clad with single-ply asphalt membrane. The building is bound on the south and west by a paved parking area. Payne Boulevard is to the south with landscaping consisting of a linear tree row and grass lawn. A sloping retaining wall covered with stone for an adjacent parking area is located to the north and east.

Figure 43. Building 1 West and South Façades, View to Northeast.

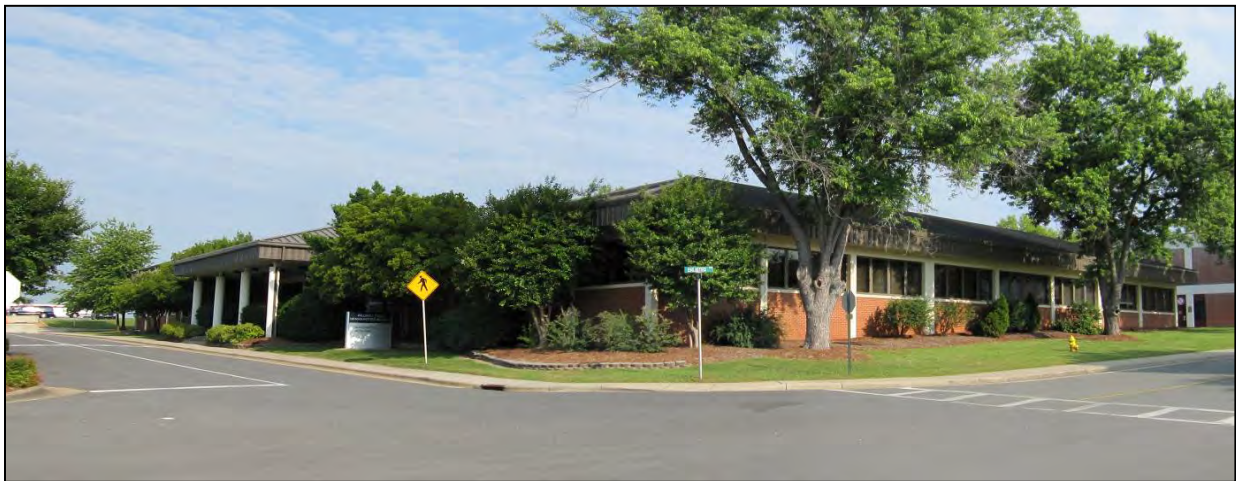
Figure 44. Building 2 South and East Façades, View to Northwest.

Building 2, constructed in 1960 as the NCANG headquarters, is a single-story building with an irregular U-shaped footprint. The building has brick exterior walls, a seamed metal fascia, and a low-pitched, complex hipped roof clad in metal. The southwest block of the building has a taller 1½ story segment. The building is bound on the south by Payne Boulevard, formal landscaping, and paved parking lots. A large paved parking lot is to the west; a series of joined brick buildings are on the north. First Union Road is located to the east.

Building 2's primary façade is its south elevation. It has five bays in the east portion with modern fixed metal-frame windows in the upper wall and brick below, each separated by a contrasting white concrete

Civil engineering records indicate that Building 2 has undergone extensive alterations. In 1997, contractors replaced all of the original windows and doors, extensively reconfigured the interior, added the south and north enclosed porch entrances, and replaced the original roof with the current metal one (Colonel Walters pers. comm. 2012).

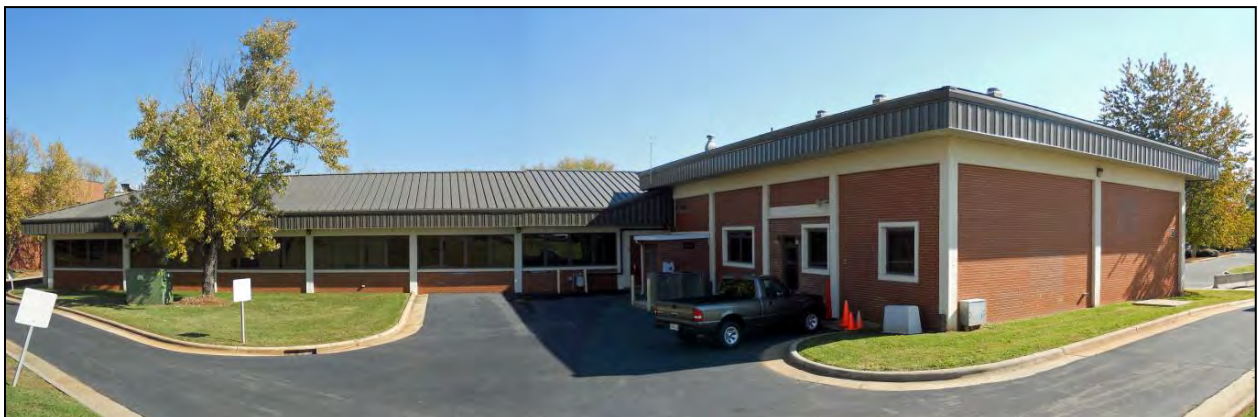
Figure 45. Building 2, West and North Façades, View to East.

The north façade contains the interior of the U-plan, forming a three-sided courtyard. The hipped roof extends and is supported by concrete columns to form a covered walkway along all three sides of the courtyard. The wall openings facing the courtyard are of the same configuration found on the south façade—bays with fixed metal-frame windows in the upper wall portion with brick below separated by concrete pilasters. Single metal and glass pedestrian doors are located at the wall junctions, and the central north façade has an enclosed entry porch with metal frame and glass walls. The east area of the courtyard has a heating, ventilating, and air-conditioning (HVAC) system that is enclosed with a concrete masonry lattice wall.

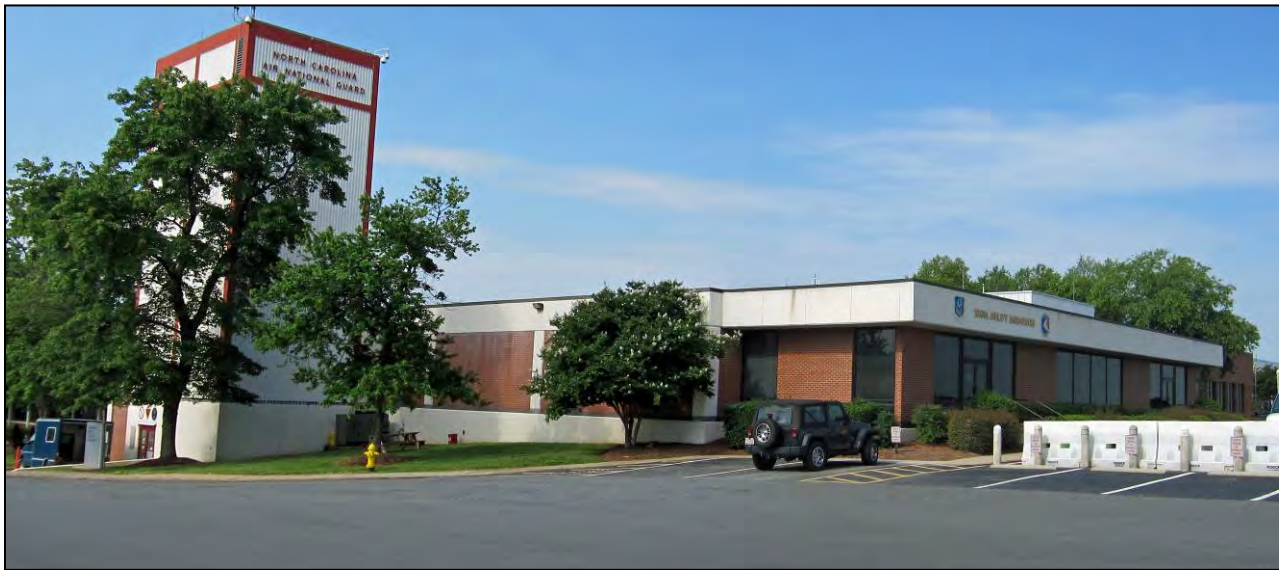
Building 3 is an operations building constructed in 1977. Building 3 is located in the southwest portion of the installation. It is bound on the north by the flight line; by 1st Union Road to the east; the hangar (Building 4) and the brick-clad Building 61 constructed in 1997 to the immediate west; and the brick-clad headquarters (Building 2) to the south. The landscaping consists of concrete sidewalks, and a landscaped area with plants is on the north and west façades.

Figure 46. Building 3 East and North Façades, View to Southwest.

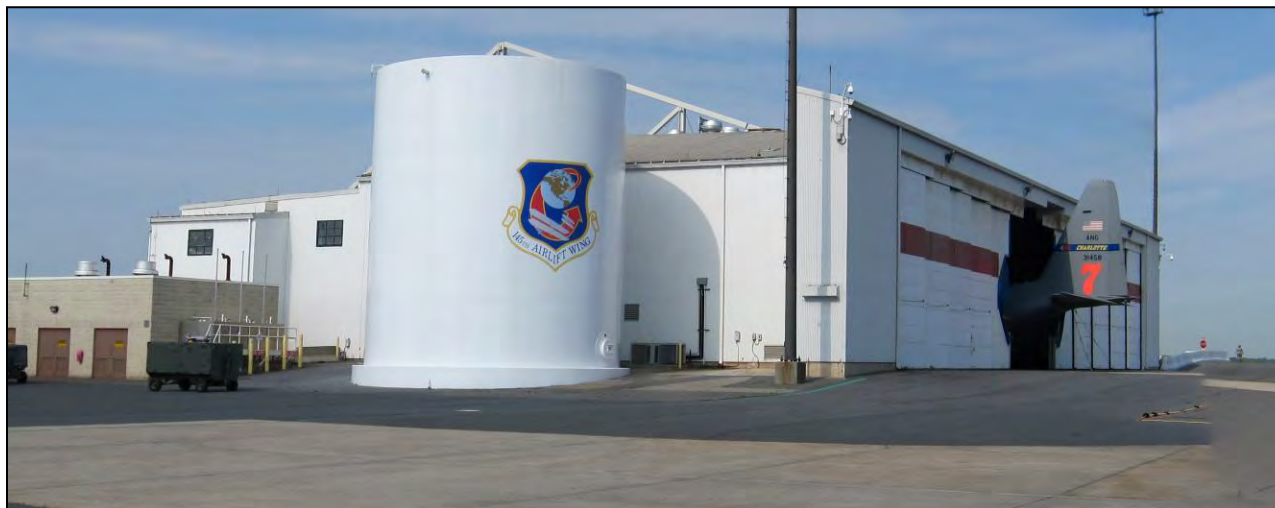
Building 4, constructed in 1968 as a nose dock maintenance dock hangar, is currently used as a fuel systems maintenance facility. The massive hangar faces north and has a rectangular footprint with a two-story office block with a low-pitch shed roof on the south façade.

Figure 47. Building 4 East and North (Primary) Façades, View to Southwest.
Building 137 is the tank containing fire suppression material.

Base civil engineering records indicate that Building 4 underwent a conversion from a nose dock hangar to a corrosion control hangar in 1998. Contractors also extensively renovated the administrative office area at that time.

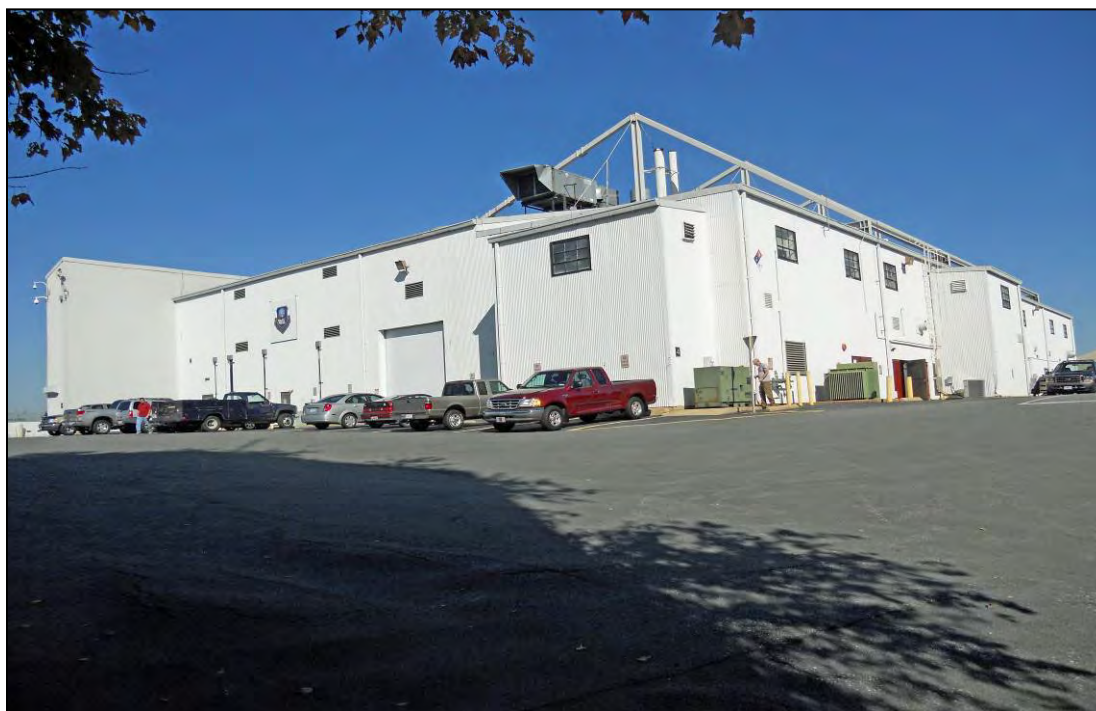
Figure 48. Building 4 West and South Façades, View to Northeast.

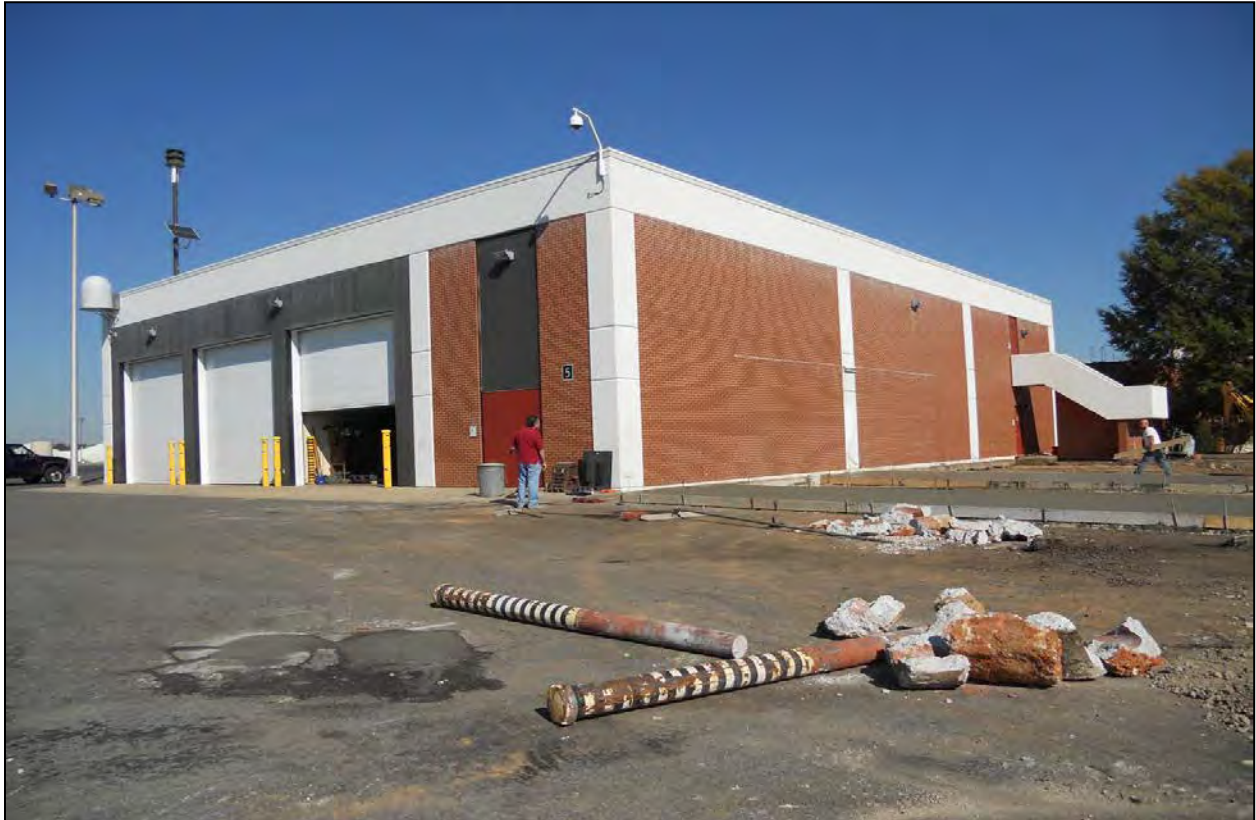
Building 5 is a training facility constructed in 1982. With an L-plan consisting of a two-story main block and a one-story block extending to the east, the brick-clad building is distinctive for its flush concrete pilasters and fascia and a flat roof.

Figure 49. Building 5, West (Primary) and South Façades of Two-Story Block, View to Northeast.

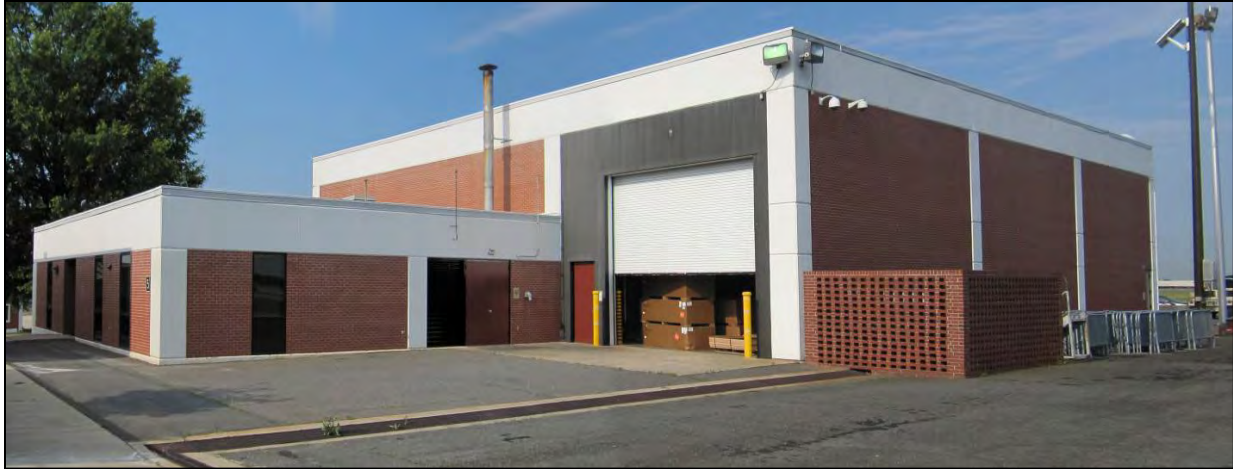
Figure 50. Building 5 East and North Facades, View to Southwest.

Building 5 is located on the southwest portion of the Air Guard base. It is bound on the north by the flight line, to the east by the brick-clad Building 61, and by paved parking lots to the south and west. There is no associated landscaping.

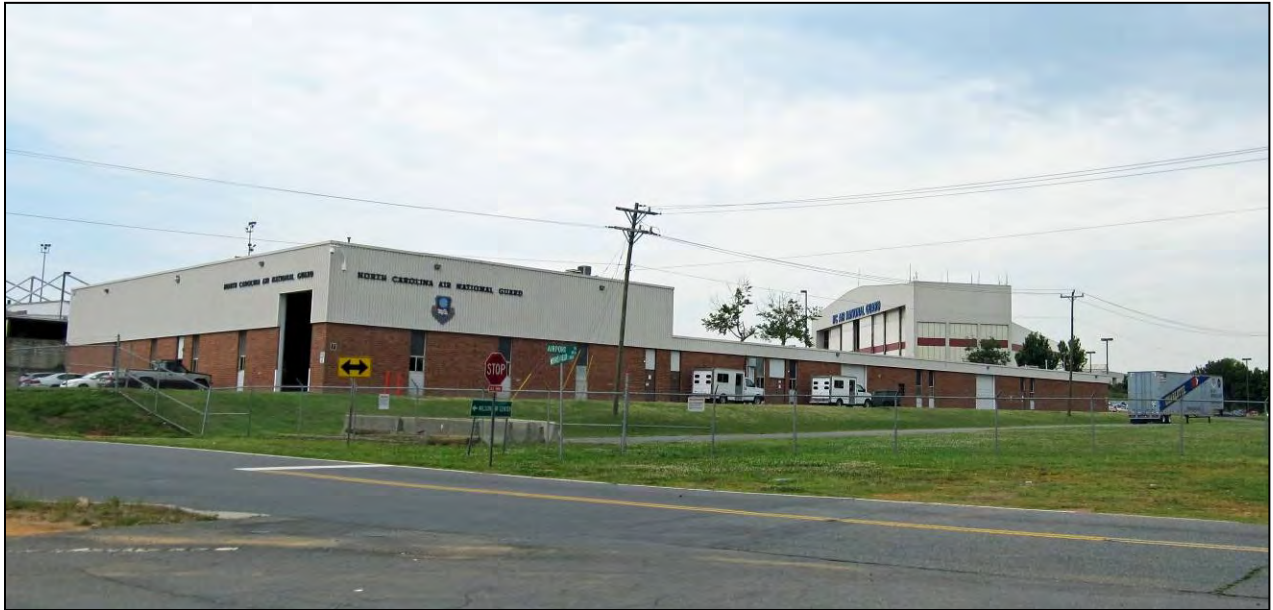
Building 7, constructed in 1974 as a maintenance facility, has an L-shaped footprint comprised of a two-story main block and a long one-story block extending to the north. The building has a flat roof and brick exterior walls with corrugated metal siding on the upper walls of the two-story block that transition to a fascia on the one-story block.

Figure 51. Building 7 South and East Façades, View to Northwest.

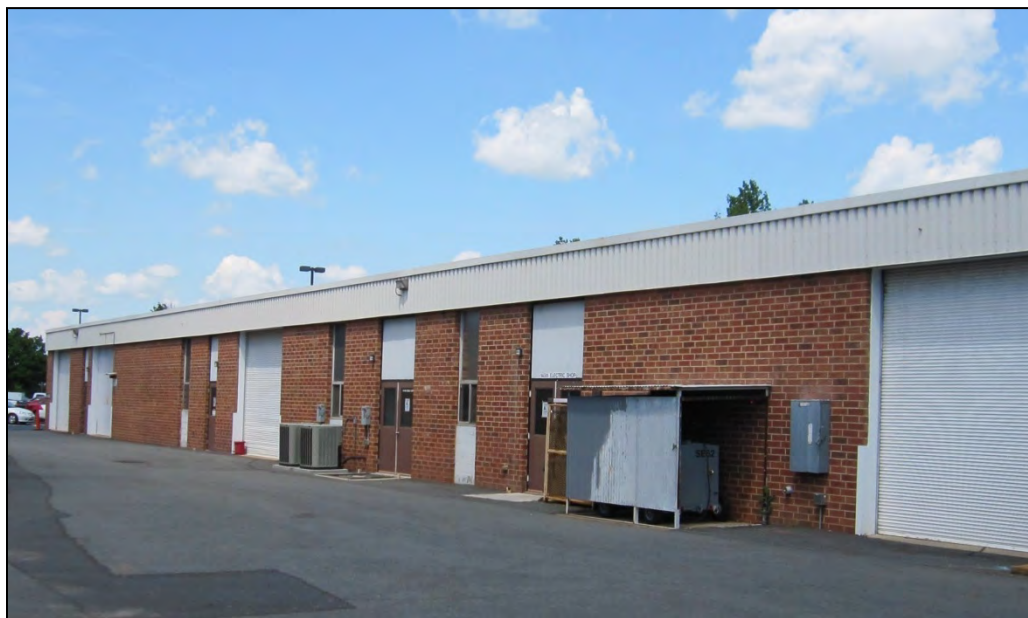
Figure 52. Building 7, West Façade of One-Story Block, View to Northeast.

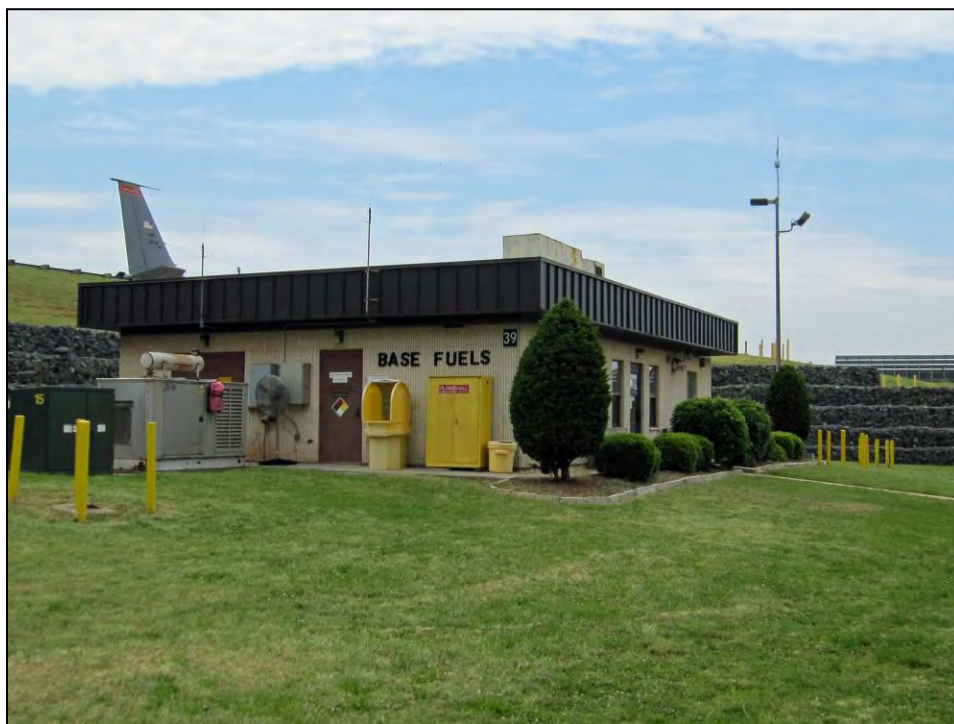
Building 39, constructed in 1984, is the base aviation fuels office. It is a single-story building with a rectangular footprint. The building has vertical grooved concrete panel exterior walls and a flat roof with a seamed metal projecting fascia. The north primary façade has a centrally-located single metal-glass pedestrian door that is flanked by metal-frame single-hung windows. Two additional metal-frame single-hung windows are located in the west and east corners of this wall. The west façade has a metal pedestrian door with an upper light, and is flanked to the north and south by metal-frame single-hung windows. The south façade has no wall openings. The east façade has a double metal pedestrian door and a single metal pedestrian door.

Figure 53. Building 39 East and North (Primary) Façades, View to Southwest.

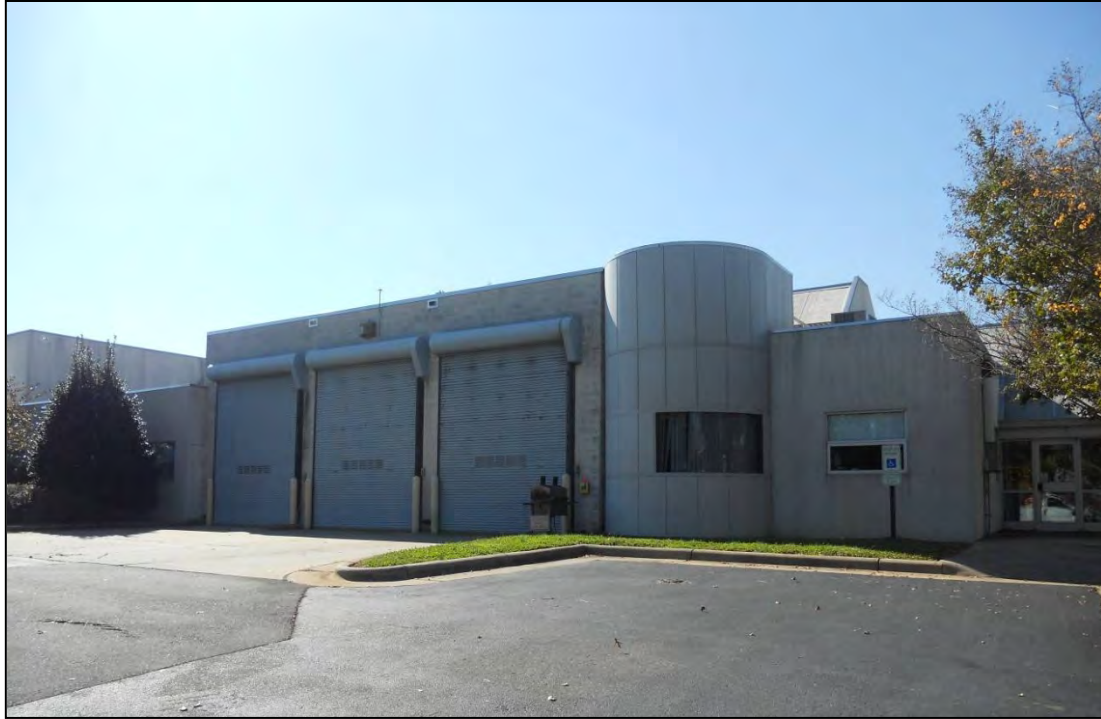
Base civil engineering records and information from base personnel indicate that Building 40 had an addition constructed in 1994 to the east side, and a west side addition built in 2005 (Colonel Walters pers. comm. 2012). Both of these took place to accommodate larger fire engines.

Figure 54. Building 40, East Primary Façade with Primary Entrance and Three Adjacent Fire Engine Bays That Are Oriented to the Street, View to Southwest.

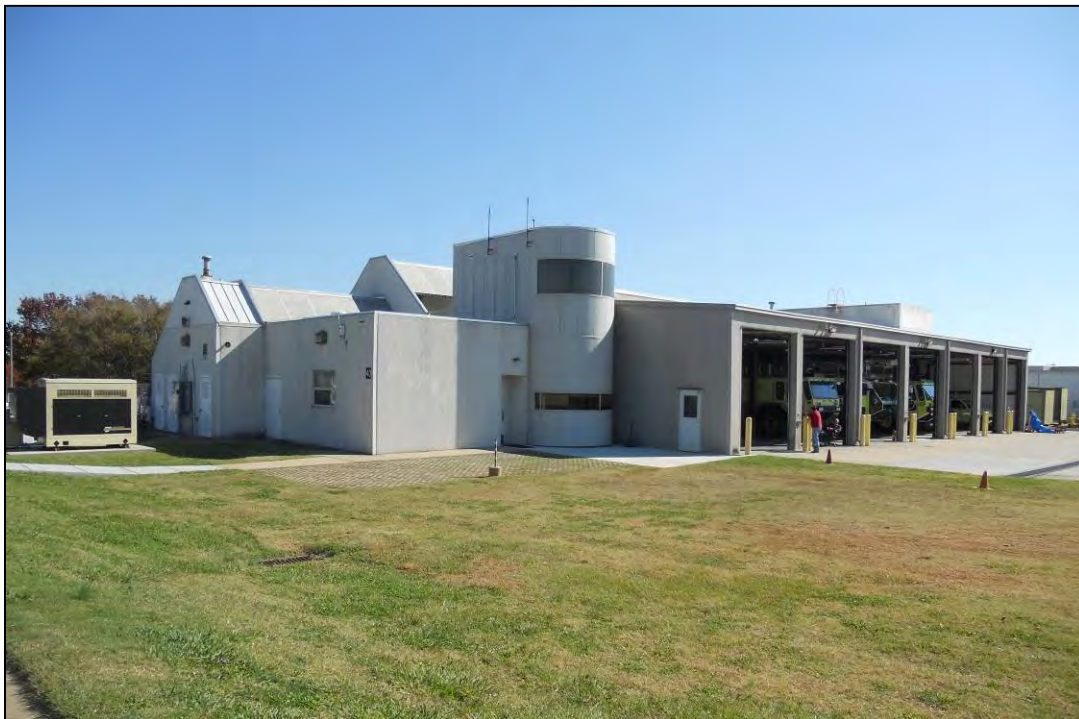
Figure 55. Building 40 North Façade and West Façade Oriented to the Airfield, View to Southeast.

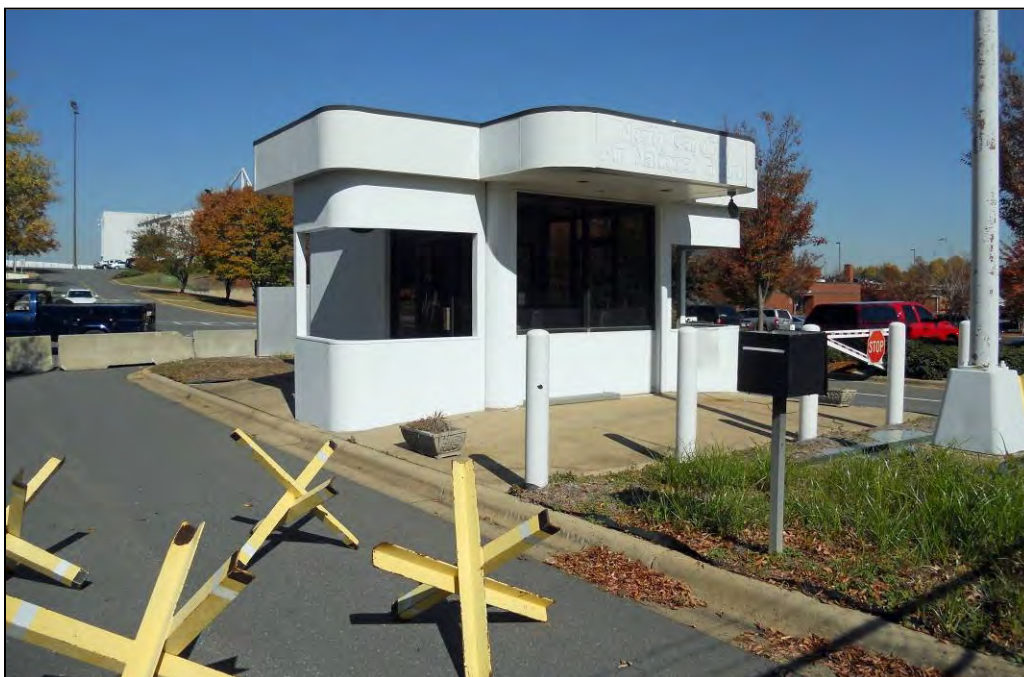
Building 41 is a metal panel-clad traffic checkpoint station constructed in 1985. Building 41 is located in the southwest portion of the ANGB in the administrative building cluster. The building is strategically positioned on 1st Union Road with a south orientation towards Morris Field Drive as a security point for the headquarters (Building 2) and the administration building (Building 45) to the north. Large paved parking lots are to the east and west, and the Charlotte-Douglas Airport boundary is to the south on Morris Field Drive. The area directly to the south of the building has a planted landscaped strip that serves as a traffic island.

Figure 56. Building 41 West and South Façades, View to Northeast.

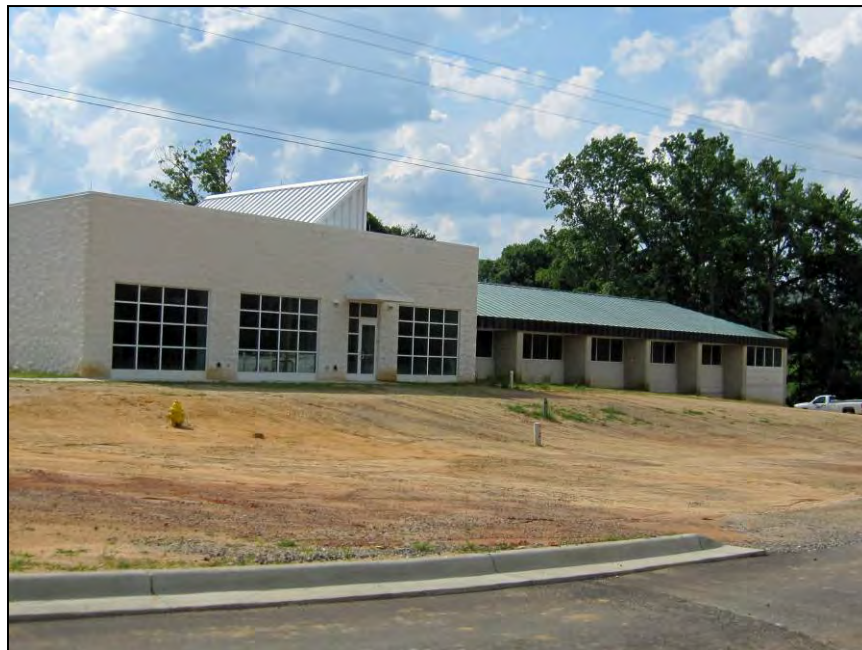
Figure 57. Building 43 East Façade, View to Northwest.

The block to the left is the 2012 training/briefing room addition, the green roof building to the right is the 1986 north-south wing.

The original north-south wing has textured concrete masonry unit walls and a seamed metal fascia below a hipped roof clad in metal. The east façade of this wing has six bays separated by concrete masonry unit buttress walls. Each bay has three fixed pane metal-frame windows with concrete masonry units below, except for the northernmost bay with four fixed pane windows. The north façade of this wing has a raised concrete stairwell. The first story of the west façade of this wing has a single pedestrian door and the second story has five fixed pane windows and a metal louvered vent.

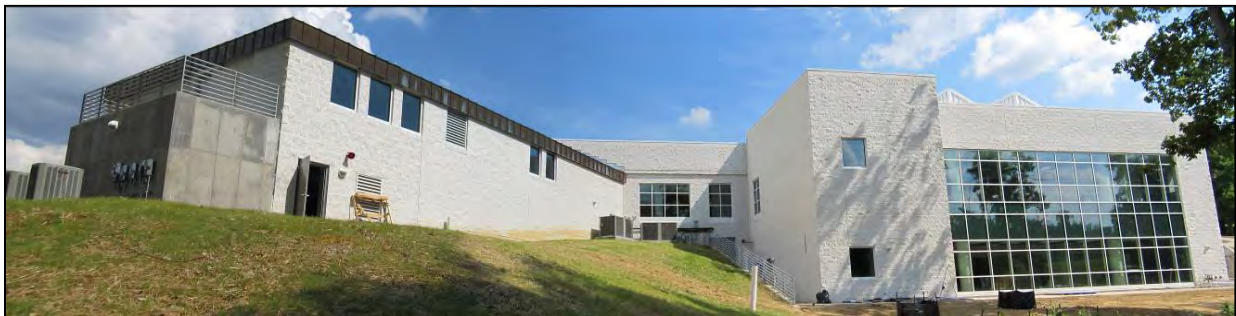
Figure 58. Building 43, View to South.

The 2011-12 addition along the west façade of the southwest-oriented wing begins at the juncture between the north-south wing and the southwest wing. The addition extends out from the previous façade with a two-story stairwell with a fixed metal-frame six-light window on the northeast facing wall and two fixed metal-frame windows on the northwest wall, one in each story. The northwest façade continues with a recessed wall composed of two stories of glass plate windows in metal frames.

Far left is the west façade of the 1986 north-south wing;
remainder is 2012 addition to northwest façade of 1986 southwest-oriented wing.

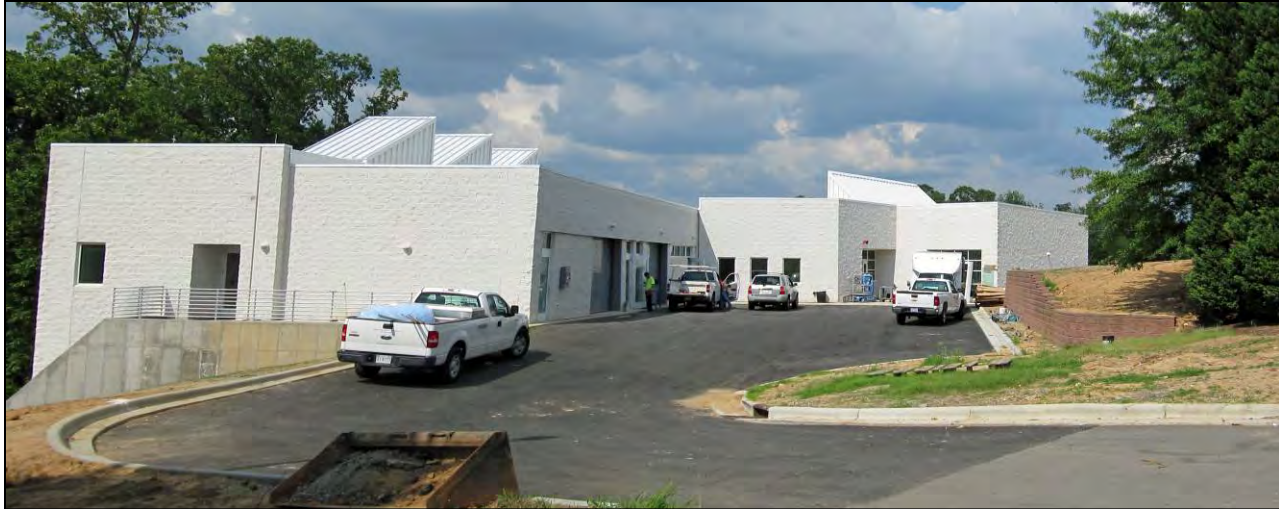
The 2012 lobby/office addition is an irregular shaped block that fills the former southeast corner of the southwest-oriented 1986 wing. Three fixed pane metal-frame windows are on the southwest façade of this block, and a recessed entry is on the south façade.

Figure 59. Building 43 Southwest and South Façades, View to East.

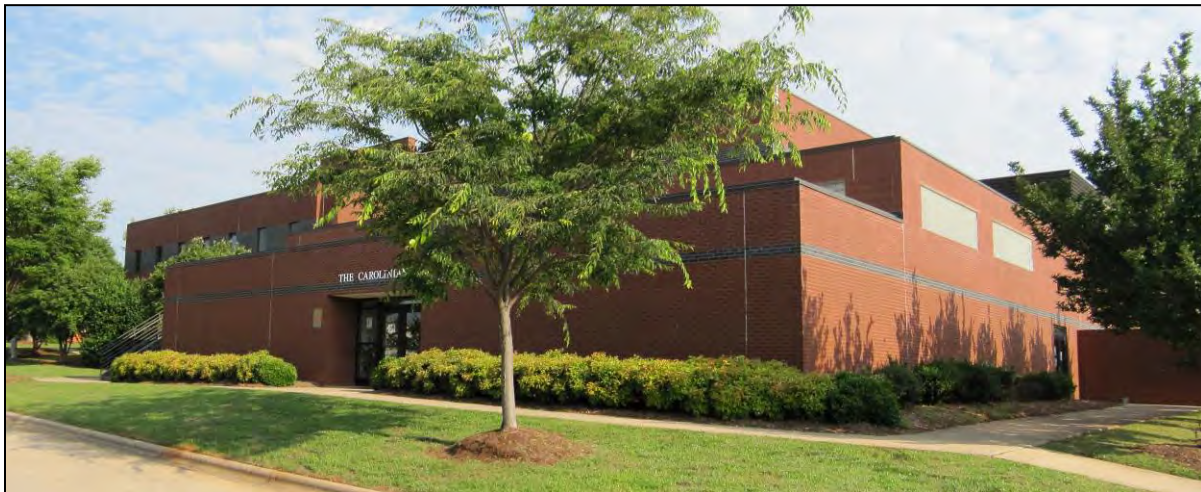
Figure 61. Building 45 South and East Façades, View to Northwest.

The south primary façade has a projecting one-story block with a lower height flat roof on the southeast corner and a recessed entryway with a double metal-glass door with fixed metal-frame window surrounds. The recessed second story of this block has a series of adjacent glass block windows. The west end of the south façade is recessed further and is separated from the east end by an exterior brick double-stairwell that ascends to a decorative brick arch leading to an interior courtyard. A set of glass-metal double doors are located under the stairwell. The west end is characterized by three bays with fixed metal-frame windows. The east bay has two upper and two lower windows, the central bay has three upper and three lower windows, and the west bay is identical to the east bay.

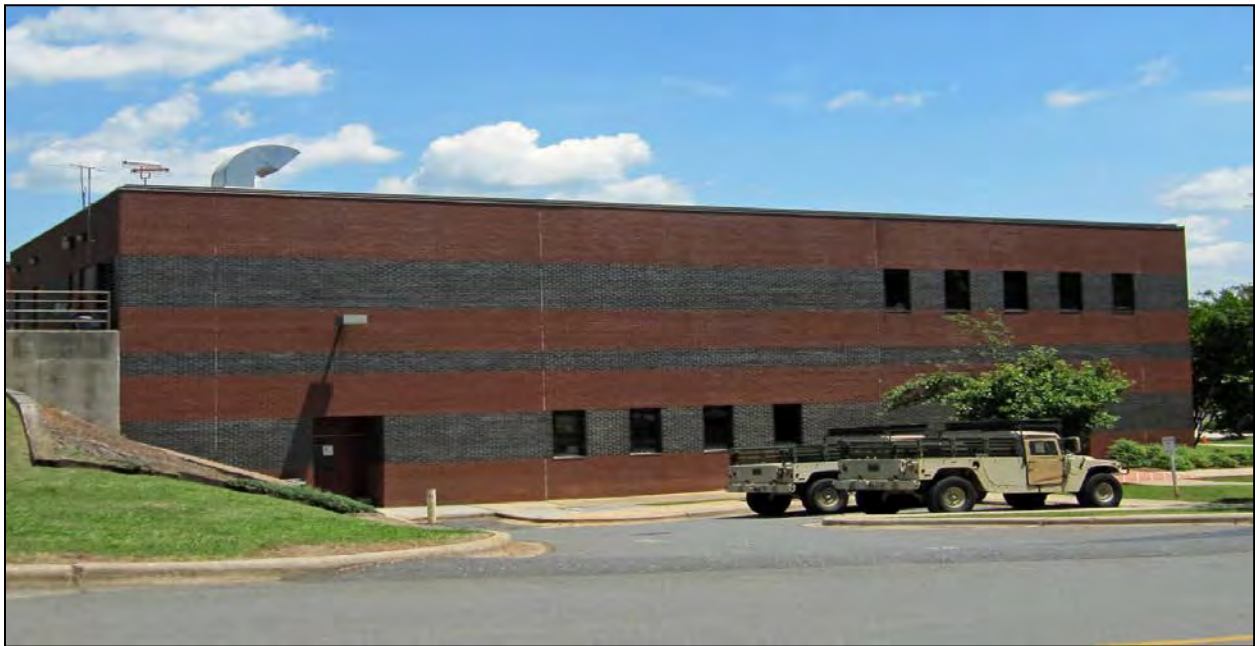
The west façade has three bays and two stories. The southernmost bay has double metal-glass doors in a recessed entryway on the first story and five adjacent fixed metal-frame windows in the second story. The central bay has four adjacent fixed metal-frame windows on the first story. The north bay has a single metal pedestrian door in a recessed entry. The grade slopes south to north and the north façade is one story on the same level as the second story of the west façade. The interior courtyard that runs north from the south façade separates the east and west portions of this façade. The west block has two metal pedestrian doors, and the east block has a single metal door.

Figure 62. View to East of Building 45 West Façade.

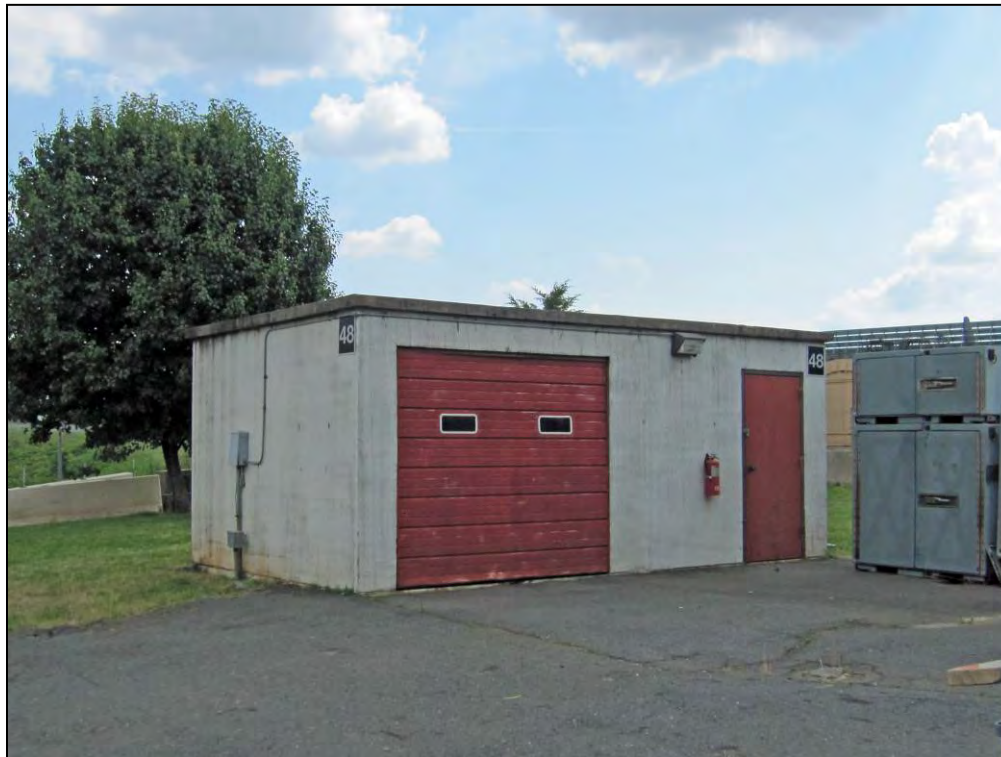
Building 48 is a single-story hazardous storage building constructed in 1991. The building is situated in the northwest portion of the installation inside a secured area surrounded by a metal chain link fence. To the east is Building 58, which is a series of storage lockers. A paved parking lot with an adjacent grass lawn and trees is to the south.

Figure 63. Building 48 North (Primary) and East Façades, View to Southwest.
