Re: Cultural Resource Survey for Charlotte Air National Guard Station, Mecklenburg County, ER 13-1453

**CULTURAL RESOURCES SURVEY OF THE
CHARLOTTE-DOUGLAS INTERNATIONAL AIRPORT
AIR NATIONAL GUARD BASE AND THE
STANLY COUNTY AIRPORT
AIR NATIONAL GUARD STATION
NORTH CAROLINA**

**Prepared For:
North Carolina Air National Guard
National Guard Bureau
Air National Guard Readiness Center**

October 2013

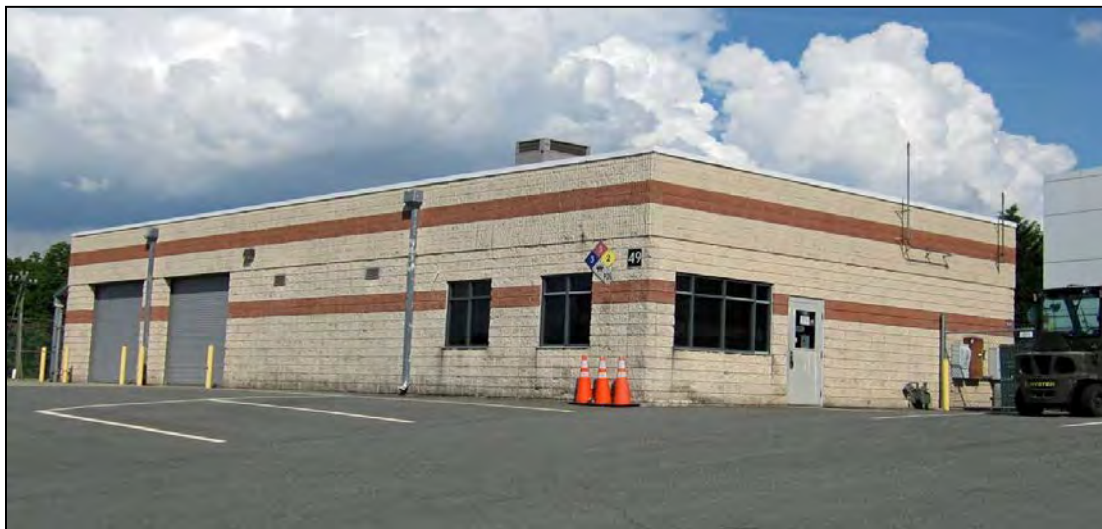
Figure 64. Building 49 North and West (Primary) Façades, View to the Southeast.

Building 49 is a one-and-a-half-story building with a rectangular floor plan. Its exterior walls are of coursed textured concrete masonry units below a decorative horizontal red block band also laid in a stack course. The upper wall area has a second red block band near the roofline. The roof is flat with a membrane surface.

The west primary façade has a single window opening with four fixed pane metal-frame windows with transom lights above and an adjacent metal pedestrian door with an upper light, both offset to the north end. The north façade has two window openings with paired fixed metal-frame windows with transom lights above. Offset to the east end of the north façade are two adjacent vehicle bays with metal roll-up vehicle doors. The east façade has two fixed metal-frame windows of the same type as found on the west façade, separated by a concrete masonry unit wall and sheltered by a metal shed roof. A single metal pedestrian door is located at the northeast corner of the east façade. The south façade exhibits a series of three vehicle bays with metal roll-up vehicle doors on the east end, and a single metal pedestrian door with an upper light is on the west end.

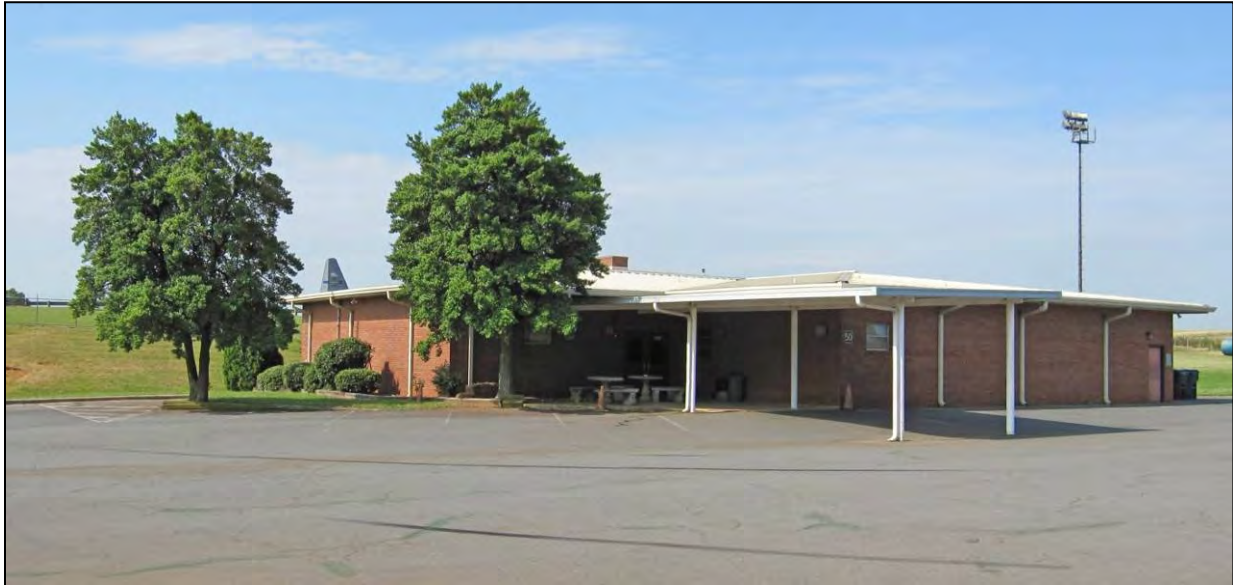
Figure 65. Building 50 North Primary Façade and East Façade.

Building 50, constructed in 1958 for use as a Reserve Forces Training center, is a single-story building with an irregular T-plan. The building has brick exterior walls and a low-pitched, complex hipped roof clad in metal.

An interior chimney is centrally located on the south pitch of the roof. The north primary façade has three bays and the outer two bays are recessed. The easternmost bay on the north façade has a recessed entry beneath a modern metal porte cochere or pavilion extension that was likely added in the 1980s. Under the

Building 50 has undergone some alterations. A metal flat roof pavilion extension was first added in 1993 on the north façade at the recessed entry. The westernmost bay on the south façade has a modern replacement window and glass-metal door installed in the westernmost bay of the south façade, but otherwise all other doors and windows appear original. Base civil engineering records indicate that Building 50 was re-roofed and had its brick chimney extended in 1993, in addition to the pavilion extension, all according to a design by Doar Associates of Charlotte, North Carolina.

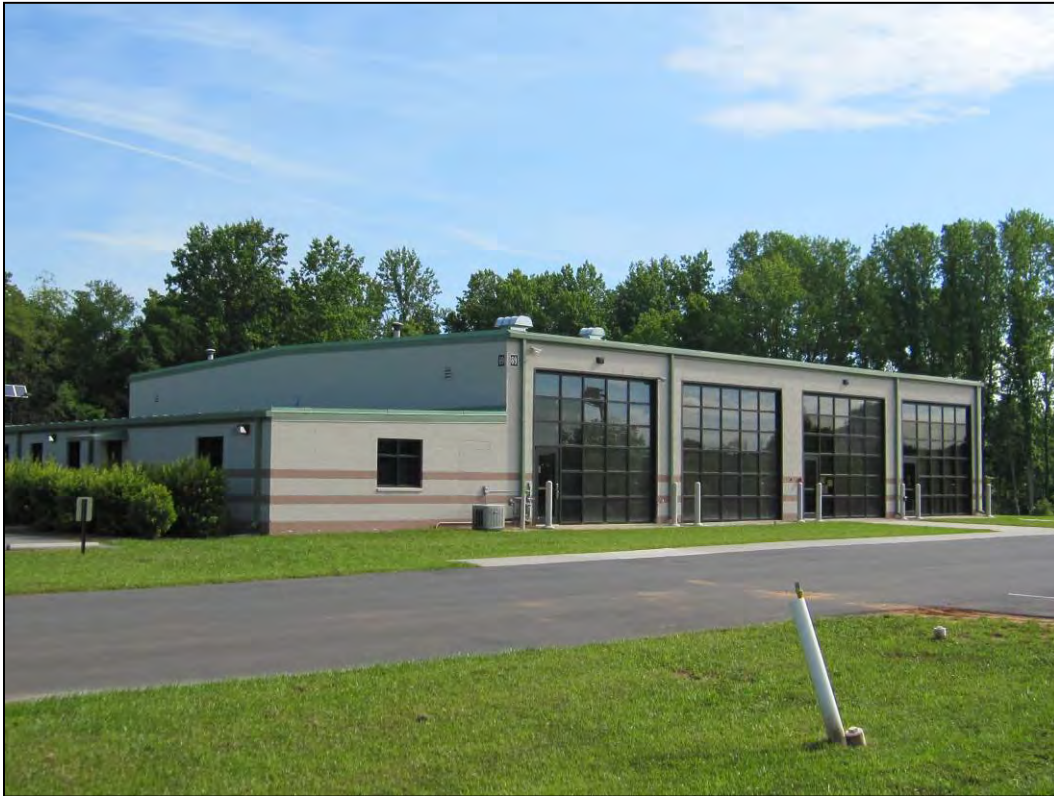
Figure 67. Building 69 West (Primary) and South Façades, View to Northeast.

Building 69 was constructed in 1975 by the ARNG as an armory, but was extensively remodeled in 2011 as a gymnasium. The building has a rectangular footprint with a one-story block on the primary west façade and an attached one-and-a-half story larger block to the east. The one-story block has a flat roof and the taller east block has a low-pitched, front gable, metal-clad roof.

The primary west façade has a modern metal-glass door on the north end, with a series of symmetrically spaced four-light fixed metal-frame windows to the south. On the other side of the series of windows is a single metal pedestrian door with an upper light that has a metal awning and is near a fixed metal-frame window. The south façade of the one-story block has a single four-light fixed metal-frame window. Along the taller section of the south façade are four bays of floor-to-ceiling, multiple-light, fixed metal-frame

windows. Three of the bays have 27 lights and glass-metal doors in the west corners. One bay has 30 lights. The east façade has no windows, and exhibits three decorative horizontal red brick bands on the lower wall. A single metal pedestrian door with an upper light is located in the southeast corner; three single-leaf metal pedestrian doors are located to the north. The north façade has the same four window banks located in the taller block, and the east and west units both have a set of double metal-glass doors. The one-story block of the north façade has two four-light fixed metal-frame windows.

Building 69 has undergone major changes from its conversion to a gymnasium in 2011 by the ANG. All of the windows have been replaced, and the bays on the north and south walls that formerly held metal vertical lift vehicle doors have been filled in with modern window banks. The roofs of the two blocks have been replaced with metal. The setting has been altered to accommodate an oval running track around the building.

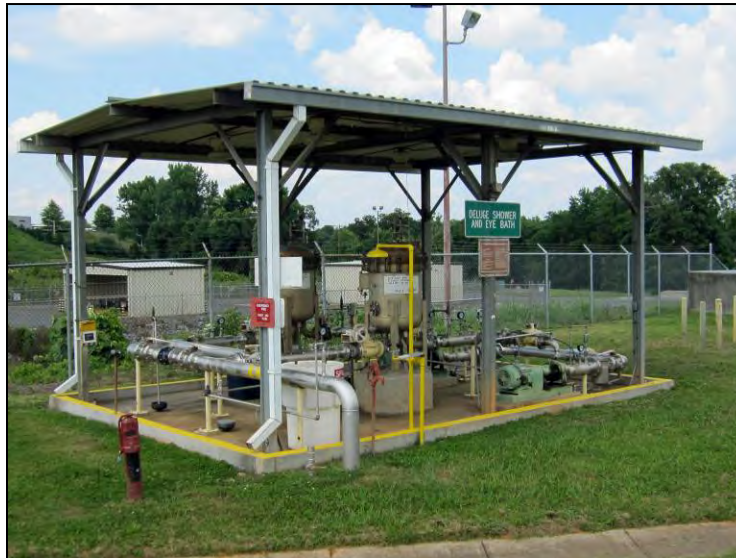
Figure 69. Building 131 West and South Façades, View to Northeast.

Building 131 is a concrete pad supporting a fuel pump sheltered by a low side-gabled metal roof. Constructed in 1984, the structure is in the fuel depot area of the installation. It consists of two aviation fuel pumps under the shelter roof in the fuel depot area. The roof is supported by four metal posts. The two pumps rest on the concrete slab pad. Building 131 is set in a paved area with fuel facilities. Two aviation fuel tanks are to the east. Building 51, a large hangar, is to the southwest on a hill above the fuel depot, and the installation tarmac is to the west.

A review of civil engineering records and examination of Building 131 suggests that the structure retains its integrity. It is possible that the pumps have been replaced; however, no records are available to confirm this.

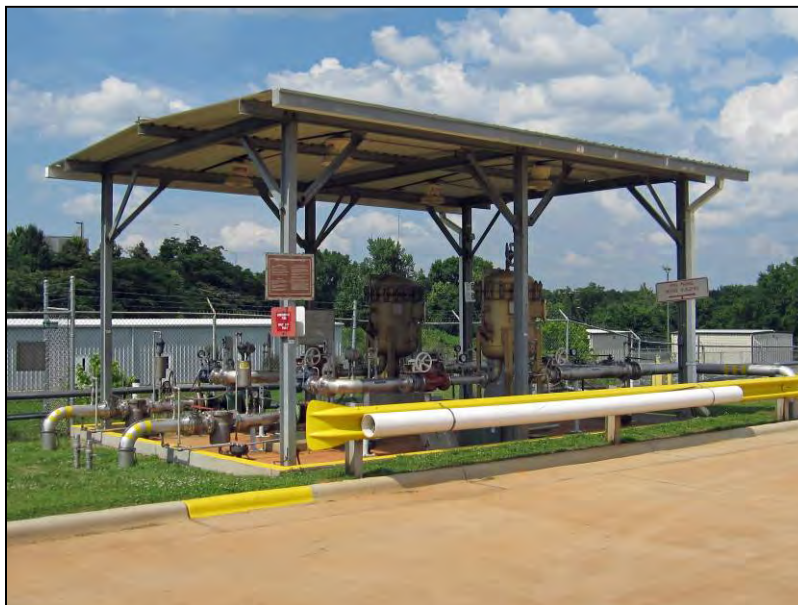
Figure 70. Building 132 West and South Façades, View to Northeast.

Constructed in 1984, Building 132 is nearly identical to Building 131. The structure also consists of a concrete pad that supports two aviation fuel pumps sheltered by a low-pitch, metal-clad gable roof. The roof is supported by four metal posts. The two aviation fuel pumps carry fuel from two aboveground fuel tanks to the east.

A review of civil engineering records suggests that the structure has had no substantial changes although the pumps may have been replaced; however, no records are available to confirm this. The setting is identical to Building 131 discussed above.

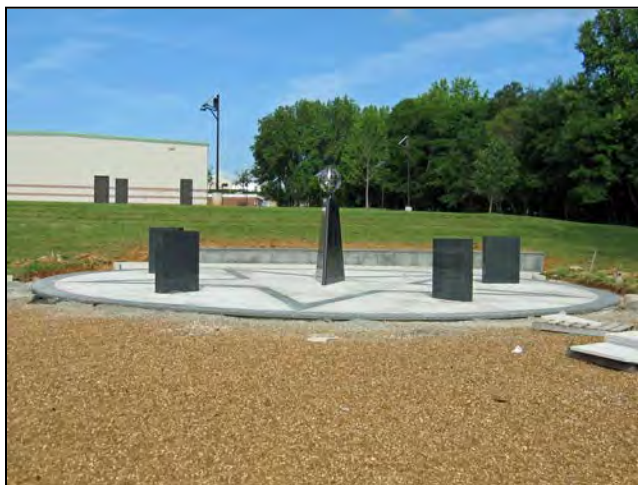
Figure 71. NCANG Memorial View to West.

This NCANG memorial was being constructed during the survey (2012). The concrete and marble circular base has a black outer ring, and a five point star with a black border. Four vertical black monoliths are positioned at the cardinal compass points. At the center of the star is a black marble memorial shaped like an airplane tail fin with a stainless steel world globe on its top. The globe has a model of the Wright Brothers' "Flyer" circling the globe. The east and west sides have names of ANG personnel who have lost their lives in service. The west side has the inscription "Dedicated to the memory of and with grateful appreciation of the North Carolina Air National Guard who have faithfully and proudly served their community, the state of North Carolina, and the United States of America."

The memorial is situated in a landscaped area on the southeast portion of the installation. The ground has pea gravel and is bordered by a grass lawn. Building 69 is located to the west and a C-130 static display aircraft is located immediately to the east.

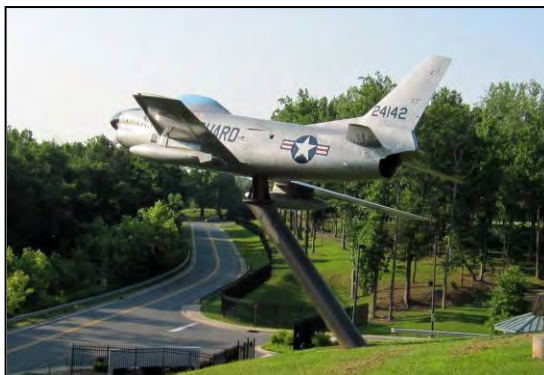
Figure 73. Building 144 F-86 Sabre Fighter Jet Static Display.

Building 144 is a static display F-86A *Sabre* fighter jet installed in 2011 on a metal pedestal above the installation east gate. The North American F-86A *Sabre* was the first swept-wing jet fighter aircraft that came into service in 1948. North American designed the aircraft initially for high-altitude day fighter service. It was utilized in Korea against the Russian MiG fighter (National Museum of the Air Force F-86A and F-86L Fact Sheets). The NCANG received the F-86A in 1954 for the continental defense Runway Alert program. They gained the F-86L interceptor that had all-weather capability in 1959 (Reid 1998:71, 73).

The aircraft has an east orientation within an earthen berm in the northwest corner of Minuteman Drive. It is bound by Minuteman Drive to the east, Building 67 to the west, the NCANG installation entrance to the south, and the earth berm is to the north. A floodlight is located to the west and east to illuminate the aircraft in the dark.

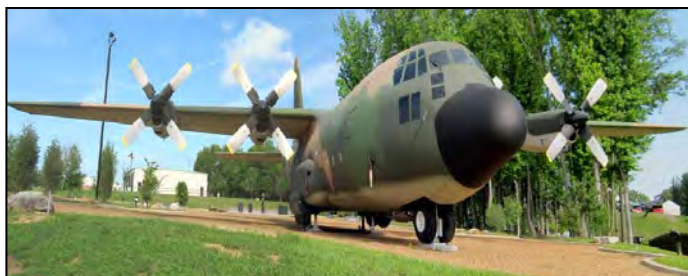
Figure 74. Building 151 C-130 Hercules Cargo Plane Static Display.

Building 151 is a C-130 *Hercules* static display aircraft located at the southeast area of the installation; Air Guard staff placed it there in 2010. It is positioned at the intersection of Morris Field Drive and Minuteman Drive. The aircraft is slightly elevated on metal posts located under the wheels. It has an east orientation. The aircraft is an E model painted as a Vietnam War-era B model, and has cockpit lighting from an H model (Colonel Walters pers. comm. 2012). The NCANG 145th Military Airlift Group began using C-130B *Hercules* aircraft in 1972 (Reid 1998:112). The new tactical mission involved airlifting and dropping personnel and equipment on a worldwide basis. The ANG installed a metal security fence to the east, and placed night-time accent lighting and tree and wood chip landscaping in 2012.

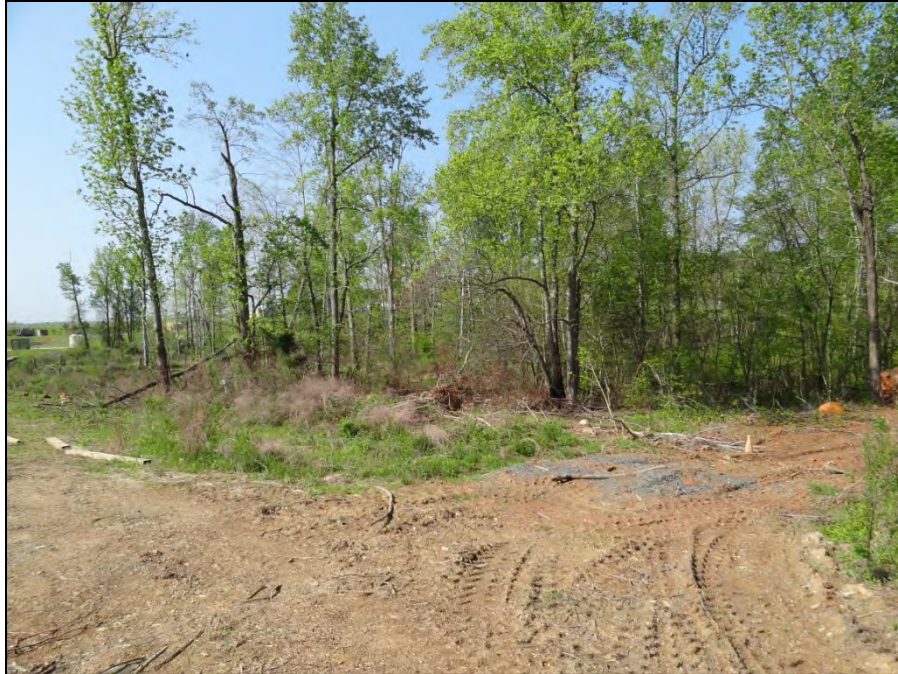
Figure 81. Northeast of Stanly Area 1 showing Heavy Machinery Disturbance, View Southwest.

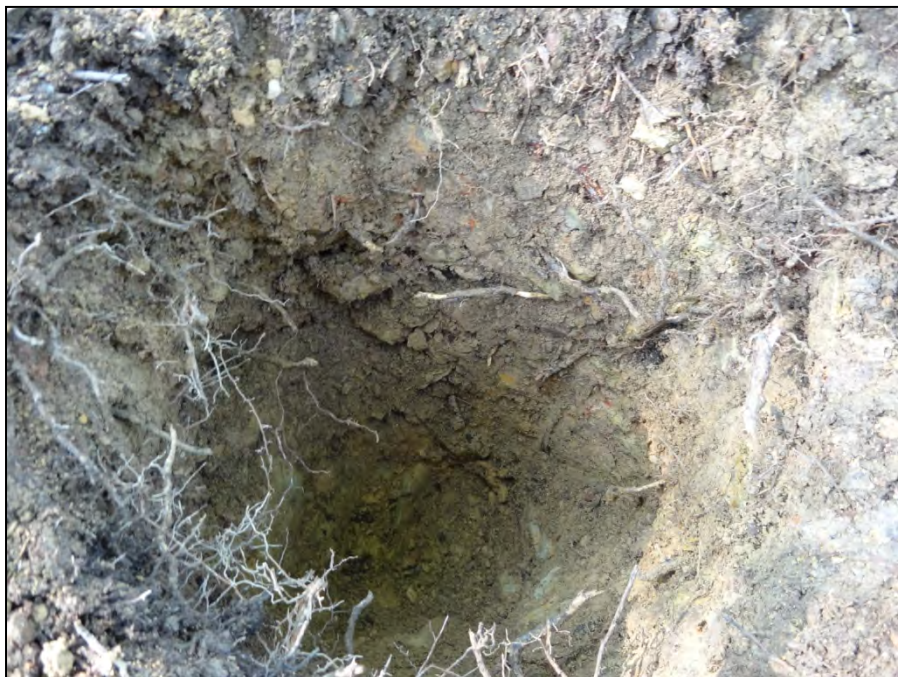
Figure 82. Soil Profile of STP 1-3, Stanly Area 1.

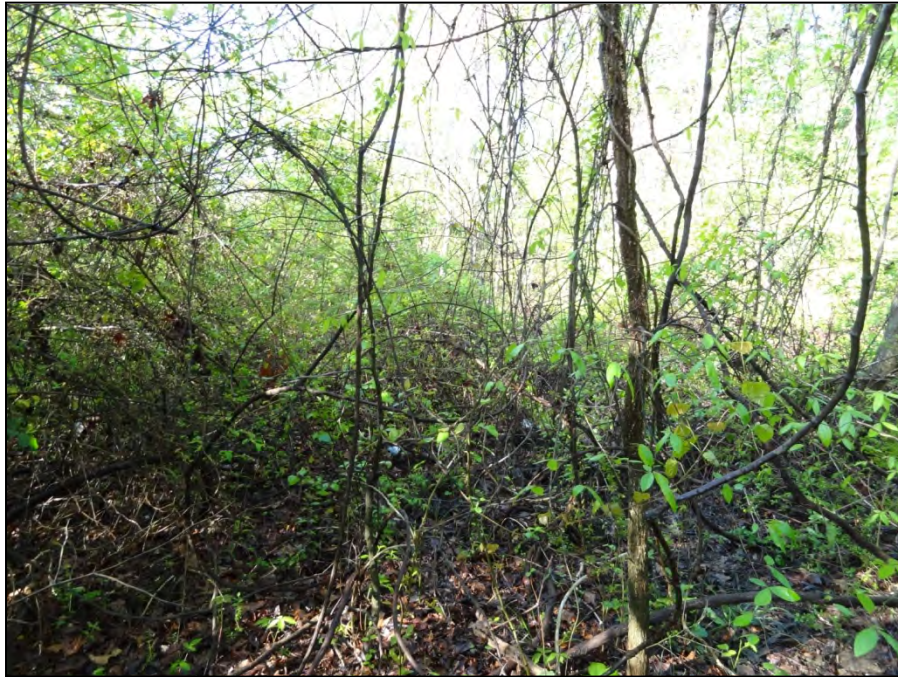
Figure 84. Wooded Section in Stanly Area 2, View South.

Stanly Area 2 consisted of a 4.2-acre area to the southwest of a large cluster of ANGS buildings. The majority of this area is open grassland. Shale bedrock is exposed across much of the surface, and a small wooded section occupies the land around a small stream and patch of wetland (Figures 84 and 85). Five STPs were excavated in this area: two within the wooded section at a 30-m interval and three to the southwest of the wooded section at 60-m intervals. No STPs were excavated northeast of the wooded section or at the southwest tip due to the exposure of shale bedrock at the surface (Figure 86). The test pits ranged in depth from 15–32 cm, terminating at bedrock (STPs 2-2 through 2-5) and the water table (STP 2-1). Other than STP 2-1, the STPs contained disturbed fill underlain by shale bedrock (see Figure 83). All STPs in Stanly Area 2 were negative for cultural material.

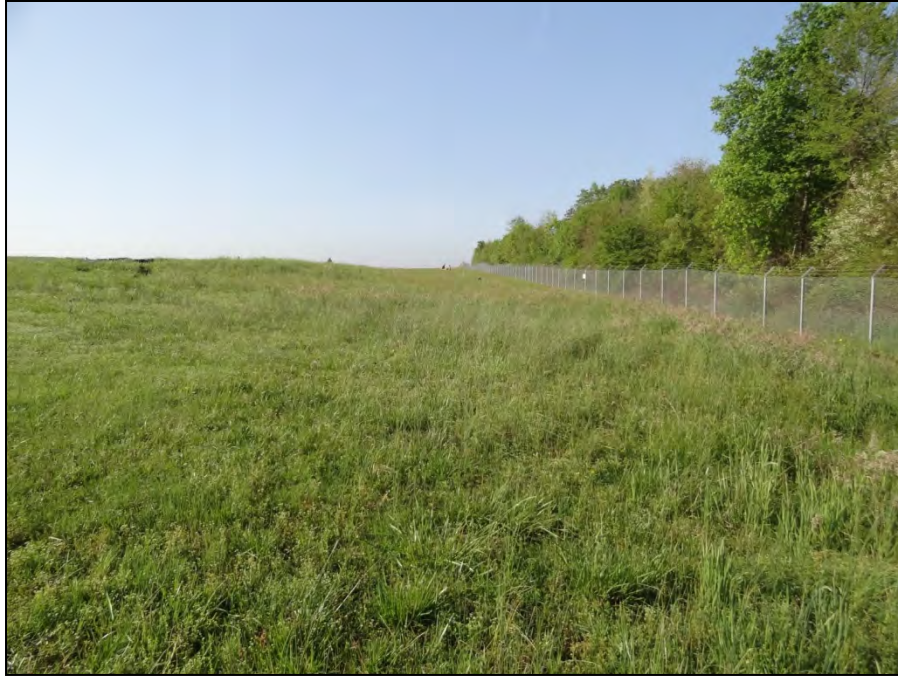
Figure 85. Southwest Portion of Stanly Area 2, View Southwest.

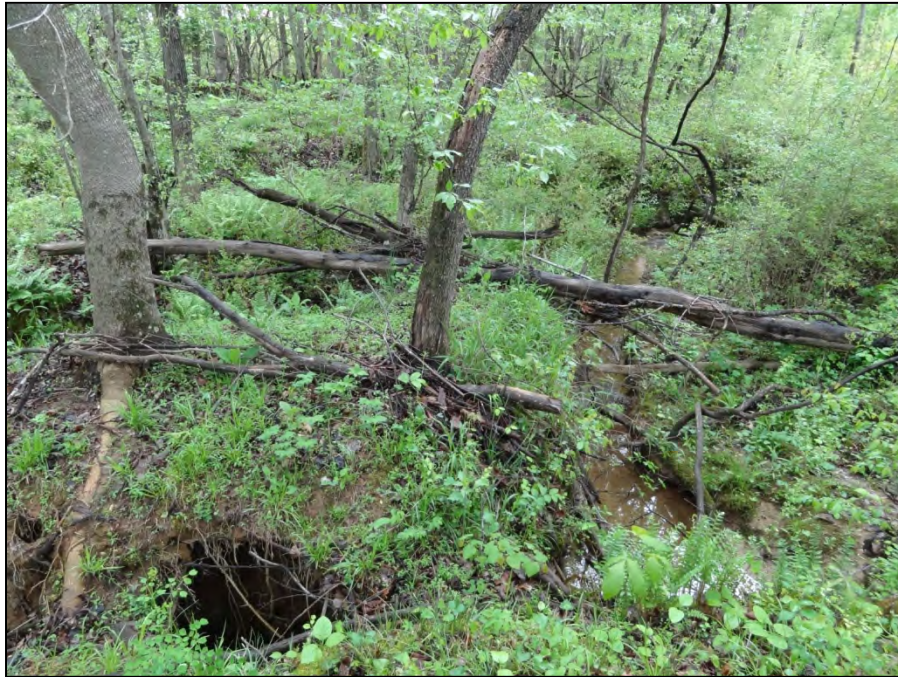
Figure 89. Wetland in Stanly Area 4A at Eastern End of Area, View East.

Stanly Area 4A is a 13.7-acre wooded parcel divided roughly in half by Little Mountain Creek. The northern half is predominantly wetland/marsh (Figures 89 and 91), while the southern half is mostly flat with some modern infrastructure (access roads/sewer lines) including sewer culverts. A ridge runs along the southern border of the area (extending 30–50 m into the area), with the entire area sloping from the southwest down to the creek, in some places as steeply as 15 percent. The crew delineated the marsh using the track logging feature of the Trimble GeoXT; although this is an approximation (due to dense undergrowth and difficulties crossing streams and marsh in certain areas), it provides a graphic representation of the extent of shallow surface streams and marsh north of Little Mountain Creek in a way not visible in aerial photography due to the forest canopy. The wetland continues to the northwest into Stanly Area 4C. Eight judgmental STPs were placed north of Little Mountain Creek, spaced across two transects of slightly elevated dry zones within the wetland. These STPs were placed in two transects with 30-m spacing (transects 4A-x and 4A-y; Figures 92 and 93) and a third cluster at the far southeastern end of Area 4A (4A-z; Figure 94). The five STPs in the 4A-x and 4A-y transects ranged from 30–65 cm in depth and all contained at least two strata, some with a third as described here representing STP 4A-y3: Stratum I (0–10 cm), a silt loam of color 10YR3/2; Stratum II (10–40 cm), a silt loam of color 7.5YR5/4; and Stratum III (40–50 cm), a silty clay of color 10YR5/4 (see Figure 83). All five STPs in these two transects were negative for cultural material.

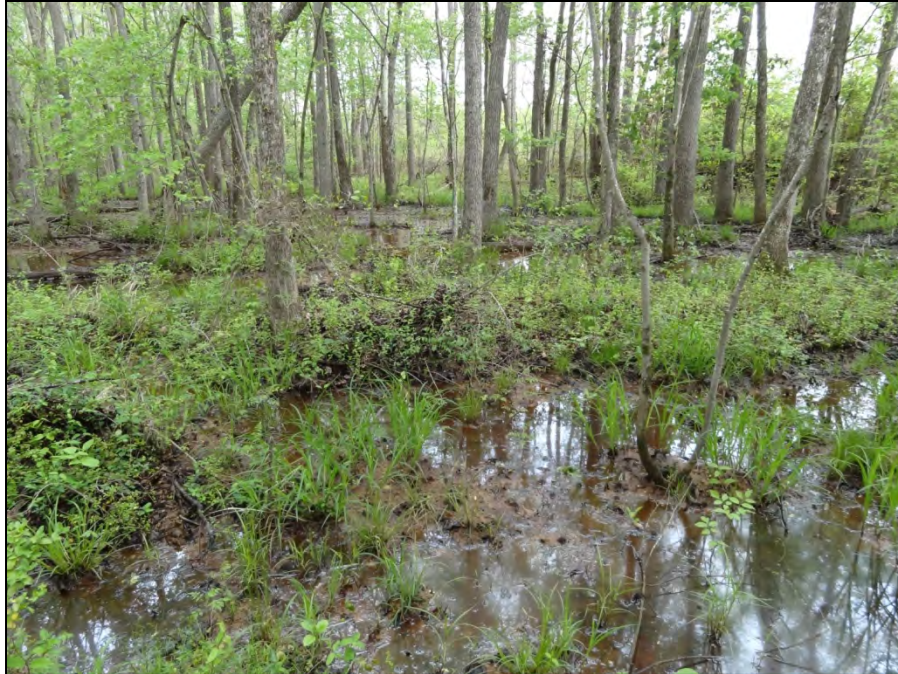
Figure 91. Wetland in Stanly Area 4A, Central Area, View North.

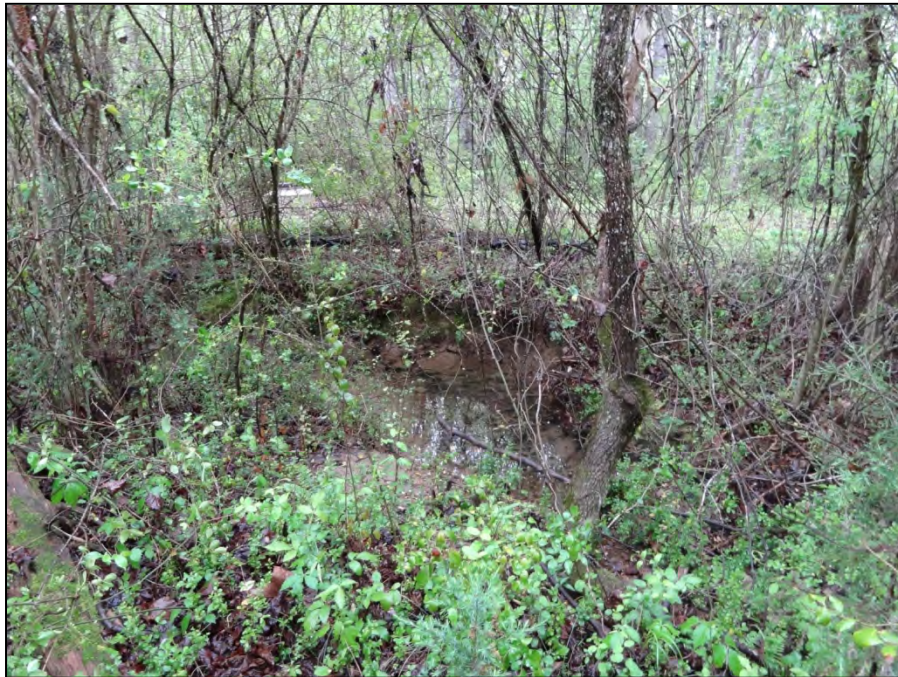
Figure 96. Cut Bank of Little Mountain Creek in Stanly Area 4A, View North.

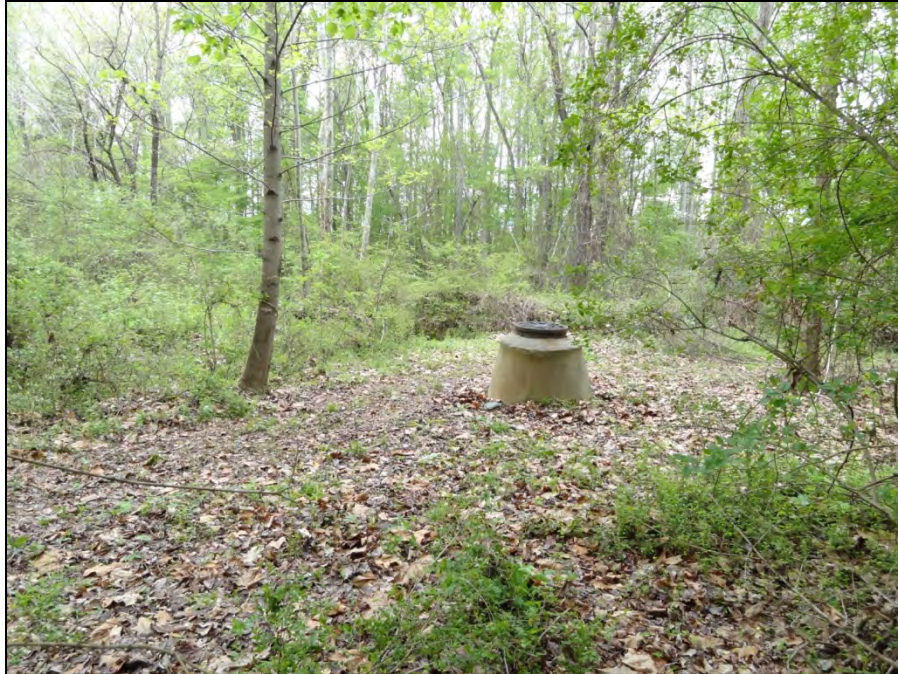
Figure 97. Access Road and Sewer Line/Culvert (foreground) and Stream (background) Northeast of STP 4A-a9, View Northeast.

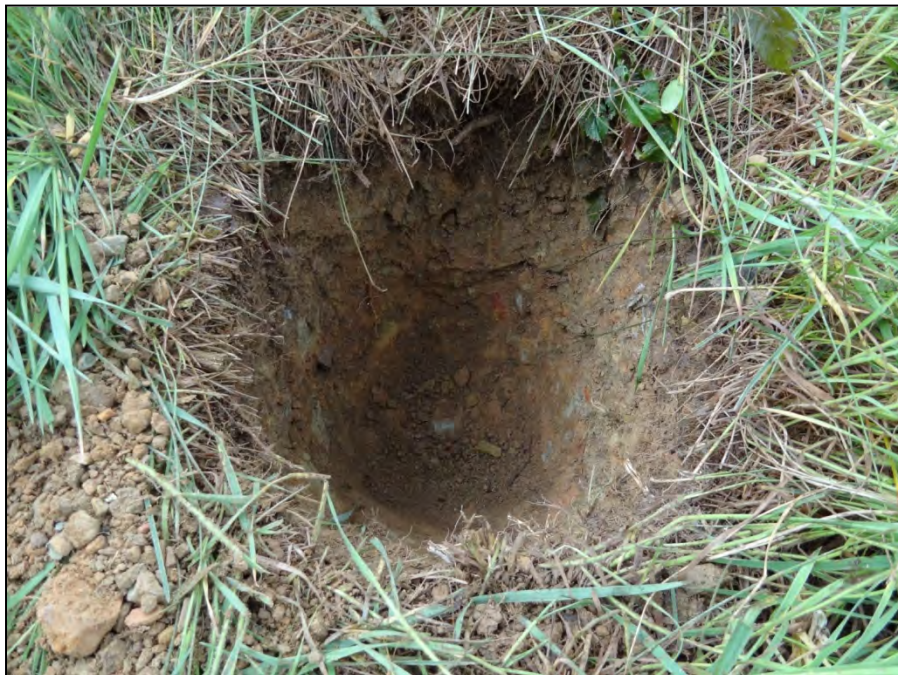
Figure 98. Soil Profile of STP 4A-a1, Stanly Area 4C.

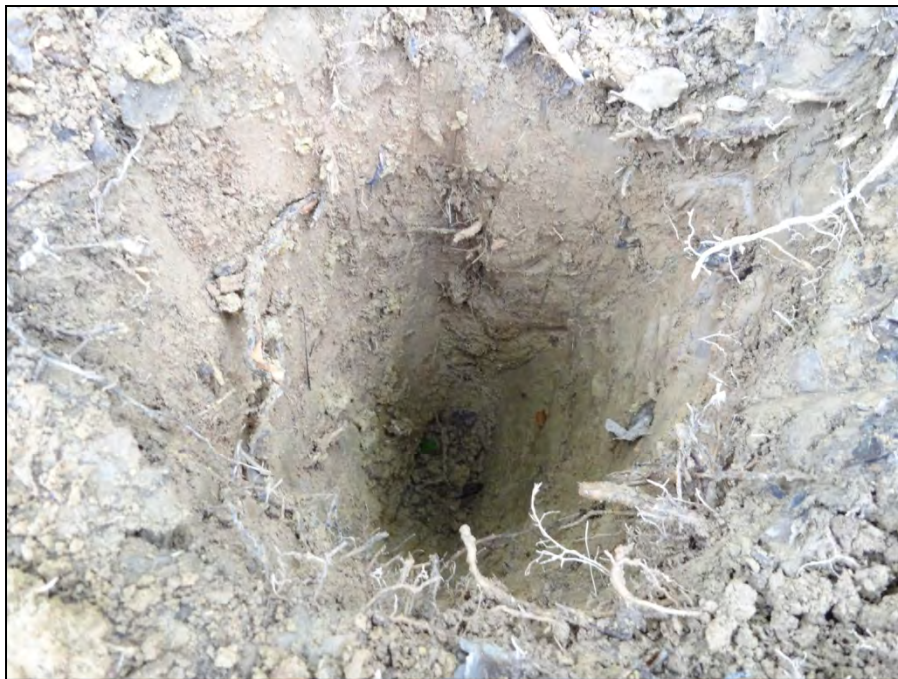
Figure 99. Soil Profile of STP 4A-a9, Stanly Area 4A.

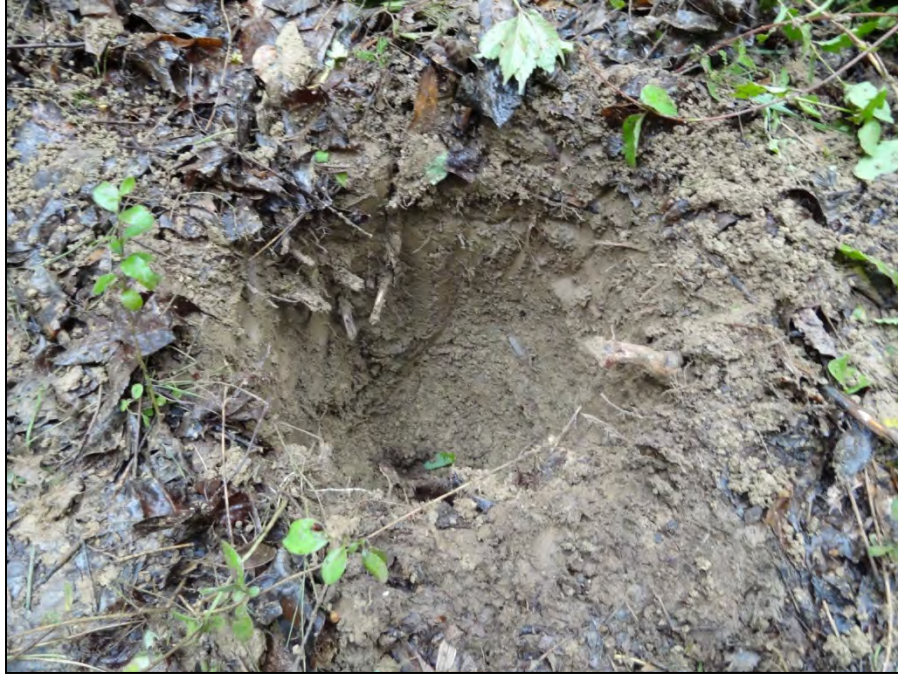
Figure 100. Soil Profile of STP 4A-d7, Stanly Area 4A.

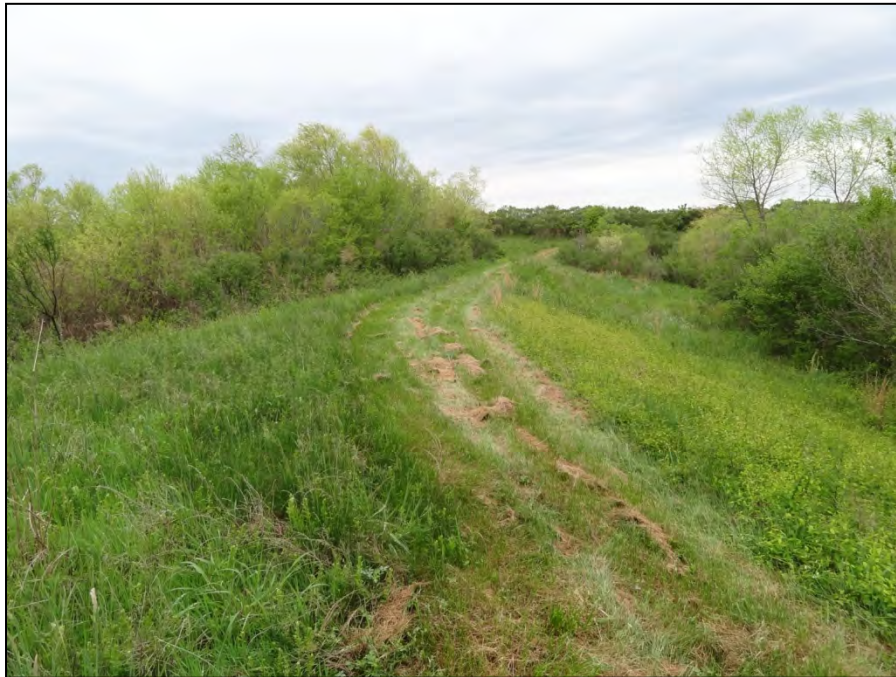
**Figure 106. Stanly Area 4C at Edge of Wooded Area,
View Northwest toward Airport Runways.**

Stanly Area 4C is a 5.2-acre section adjoining Area 4A immediately to the west. Its northwest edge runs along the Stanly County Airport southeastern runway. This area was considered separately due to the indication of modern grading in addition to the existence of a sediment pond along a large portion of its northwest boundary (Figures 106 and 107). Six STPs were excavated in the northern portion of Stanly Area 4C, four of which were placed at a 30-m interval in an opening along the forested area adjacent to Little Mountain Creek (STPs 4C-1 through 4C-4). The other two (STPs 4C-5 and 4C-6) were placed at 60-m intervals in the remaining open area of Area 4C. These six STPs ranged from 30–50 cm in depth and contained either two or three strata. Typically they were a thin silt loam over a silty or sandy loam, followed in some units by a sandy clay before terminating at bedrock or clay. STPs 4C-5 and 4C-6 clearly contained disturbed fill (see Figure 83). Because the southernmost portion of Area 4C was separated from the rest of 4C by Little Mountain Creek (Figure 108), the single STP transect going through this section was included with the same transect continuing through Stanly Area 4A (transect 4A-a), discussed above.

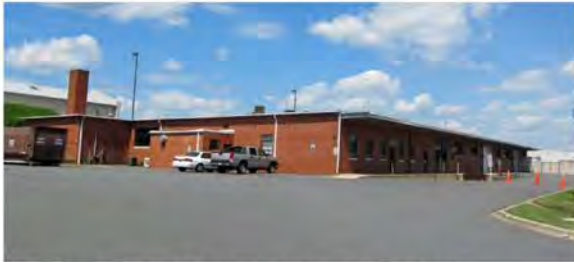
MK3152_CharlotteANGB_Bldg001_5-12_lp-01.jpg
West and South façades

As shown in the survey files, only Buildings 001 (MK 3152) and 002 (MK 3153) are more than fifty (50) years old. We concur that due to previous alterations, both of these buildings are not eligible for listing in the National Register of Historic Places at this time. We also concur that the following buildings that are less than fifty (50) years old do not meet Criteria Consideration G for exceptionally significant properties, and thus are also not eligible for listing in the National Register at this time.

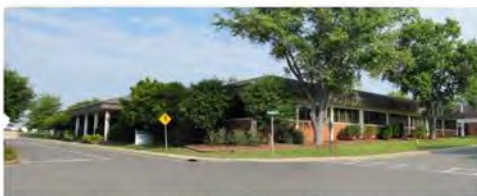
MK3153_CharlotteANGB_Bldg002_5-12_lp-01.jpg
West and North façades

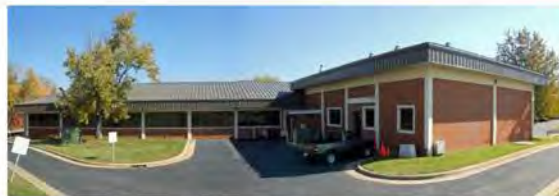
MK3153_CharlotteANGB_Bldg002_5-12_lp-02.jpg
South and East façades

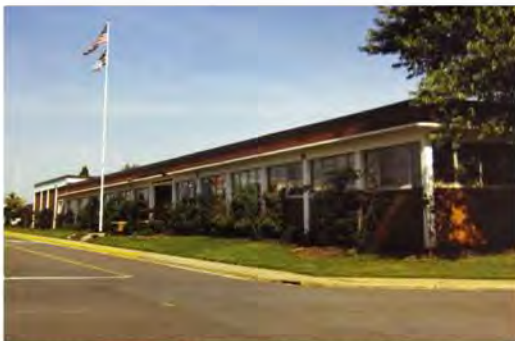
MK3153_CharlotteANGB_Bldg002_5-12_lp-03.jpg
South and East façades in 1960 photograph

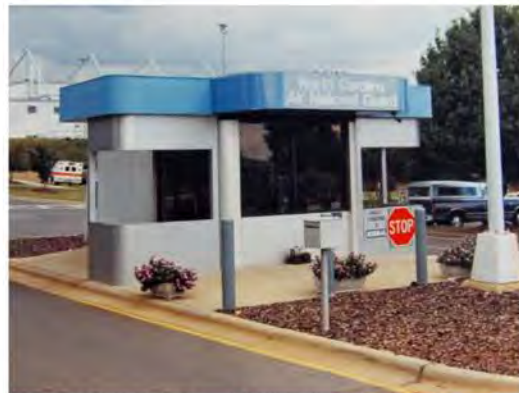
MK3160_CharlotteANGB_Bldg041_5-12_lp-03.jpg
West and South facades in 1985 photograph

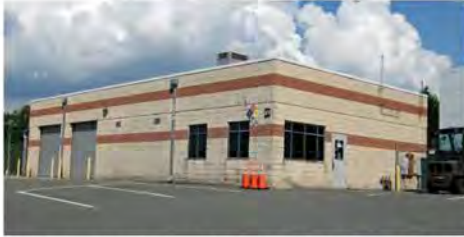
MK3164_CharlotteANGB_Bldg049_5-12_lp-01.jpg
North and West façades

Building 49 is the installation hazardous material pharmacy constructed in 1990. The building is surrounded by a paved parking lot on all elevations. Building 63, a concrete clad building constructed in 2003, is immediately to the south. An east-trending slope has a grass lawn and extends to Minuteman Boulevard.

The west primary façade has a single window opening with four fixed pane metal-frame windows with transom lights above and an adjacent metal pedestrian door with an upper light, both offset to the north end. The north façade has two window openings with paired fixed metal-frame windows with transom lights above. Offset to the east end of the north façade are two adjacent vehicle bays with metal roll-up vehicle doors. The east façade has two fixed metal-frame windows of the same type as found on the west façade, separated by a concrete masonry unit wall and sheltered by a metal shed roof. A single metal pedestrian door is located at the northeast corner of the east façade. The south façade exhibits a series of three vehicle bays with metal roll-up vehicle doors on the east end, and a single metal pedestrian door with an upper light is on the west end.

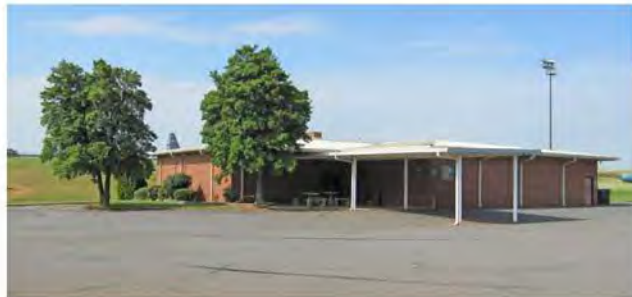
MK3165_CharlotteANGB_Bldg050_5-12_lp-01.jpg
North and West façades

Building 50 has undergone some alterations. A metal flat roof pavilion extension was first added in 1993 on the north façade at the recessed entry. The westernmost bay on the south façade has a modern replacement window and glass-metal door installed in the westernmost bay of the south façade, but otherwise all other doors and windows appear original. Base civil engineering records indicate that Building 50 was re-roofed and had its brick chimney extended in 1993, in addition to the pavilion extension, all according to a design by Doar Associates of Charlotte, North Carolina.

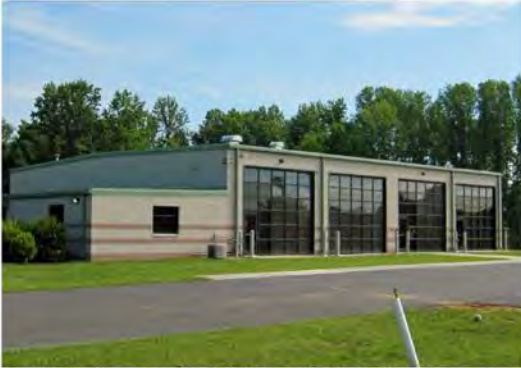
MK3166_CharlotteANGB_Bldg069_5-12_lp-01.jpg
West and South façades

Building 69 has undergone major changes from its conversion to a gymnasium in 2011 by the Air National Guard. All of the windows have been replaced, and the bays on the north and south walls that formerly held metal vertical lift vehicle doors have been filled in with modern window banks. The roofs of the two blocks have been replaced with metal. The setting has been altered to accommodate an oval running track around the building.

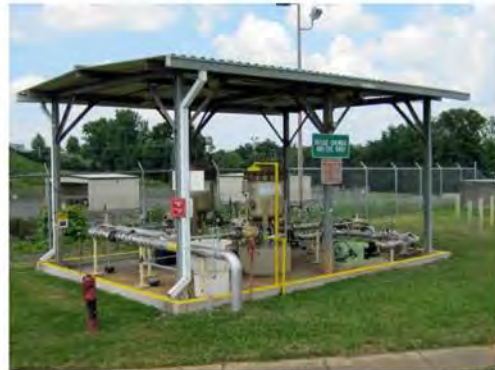
MK3167_CharlotteANGB_Bldg131_5-12_lp-01.jpg
South and West façades

A review of civil engineering records and examination of Building 131 suggests that the structure retains its integrity. It is possible that the pumps have been replaced; however, no records are available to confirm this.

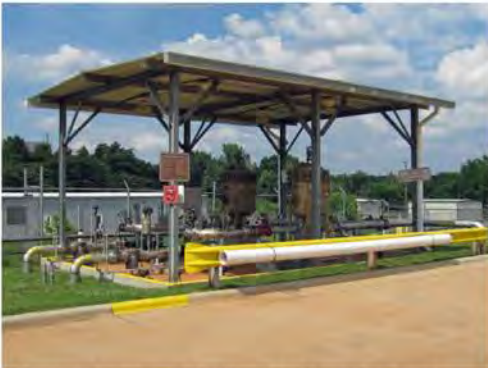
MK3168_CharlotteANGB_Bldg132_5-12_lp-01.jpg
West and South façades

A review of civil engineering records suggests that the structure has had no substantial changes although the pumps may have been replaced; however, no records are available to confirm this. The setting is identical to Building 131 discussed above.
