NATIONAL REGISTER ELIGIBILITY ASSESSMENT OF ISAAC TERRY FARM

REPLACEMENT OF BRIDGE NO. 118 ON US 501 (ROXBORO ROAD) OVER CLOVER HILL POND, DURHAM COUNTY, NORTH CAROLINA

WBS No. 17BP.5.R.4

TRC ENVIRONMENTAL CORPORATION 50101 Governors Drive, Suite 250 Chapel Hill, North Carolina 27517

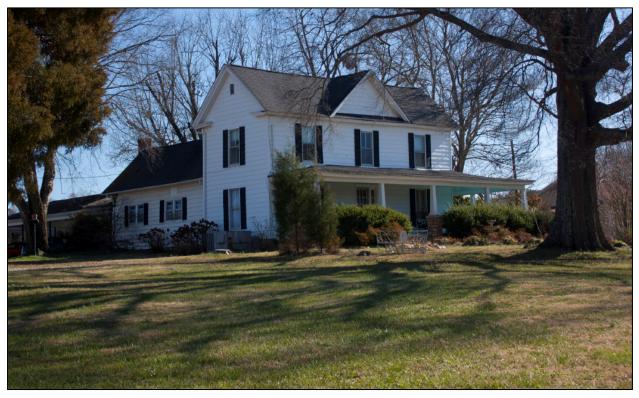
Figure 4. View of Isaac Terry House, façade with cross gable and wrap-around porch, north gable end, and 1-story rear ell on the left, looking southeast.

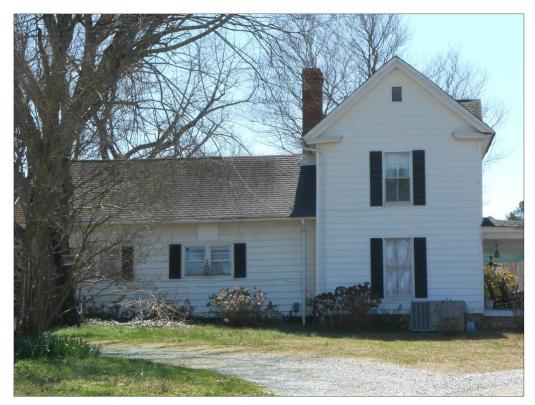
Figure 5. View of Isaac Terry House, north gable end of house with 1-story rear ell, looking south.

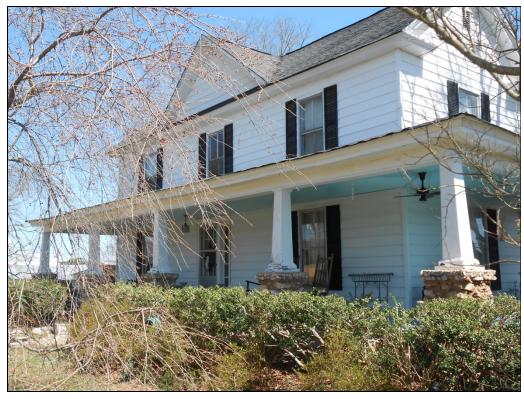
Figure 6. View of Isaac Terry House, west façade and wrap-around porch, looking northeast.

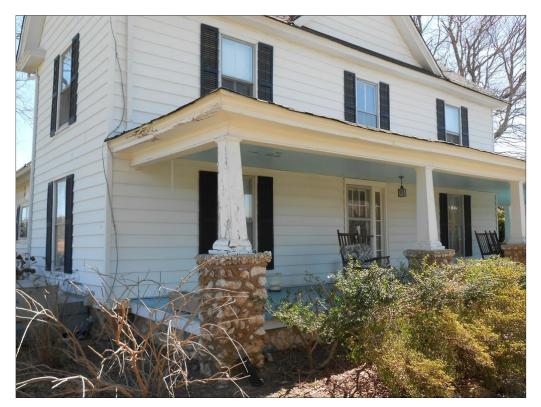
Figure 7. View of Isaac Terry House, detail of porch and porch posts, looking southeast.

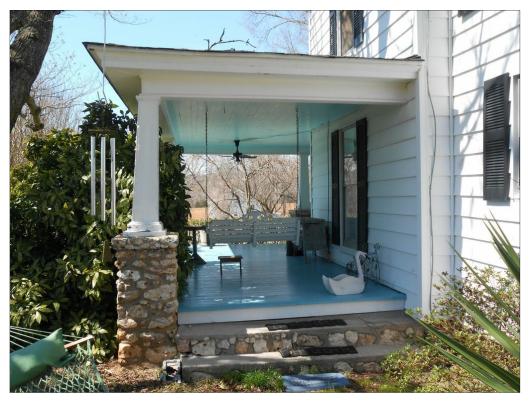
Figure 8. View of Isaac Terry House, detail of porch on the south gable end, porch steps with rock facing, and porch posts, looking west.

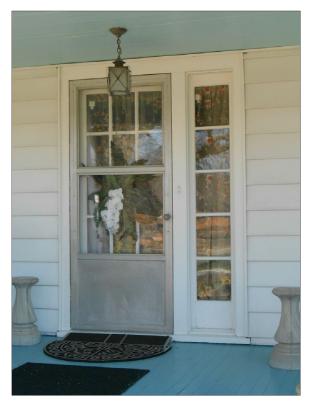
Figure 9. View of Isaac Terry House, detail of main entrance with door and single sidelight.

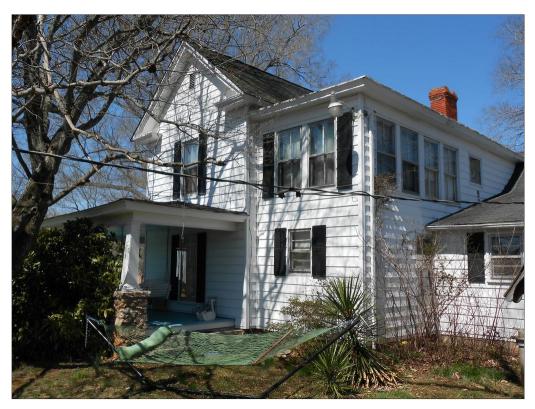
Figure 10. View of Isaac Terry House, rear elevation with 2-story rear section, looking northwest. The row of windows on the second story suggests a sleeping porch or sunroom. A portion of the gable-roofed rear ell with its later shed-roofed addition is visible on the right.

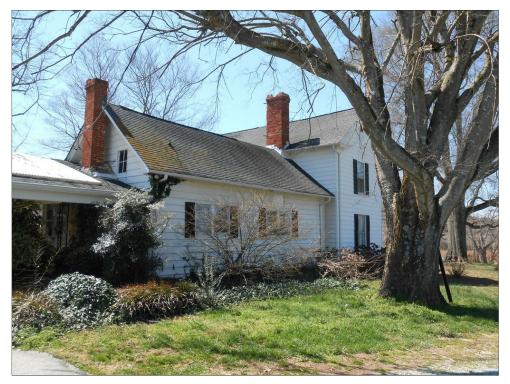
Figure 11. View of Isaac Terry House, rear wing with carport on left, looking southwest.

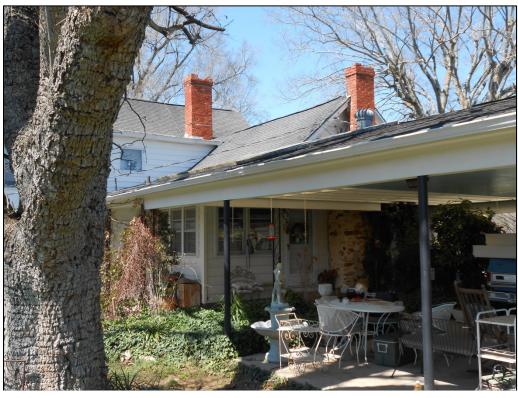
Figure 12. View of Isaac Terry House, rear ell with its addition, and part of the later carport, looking northwest.

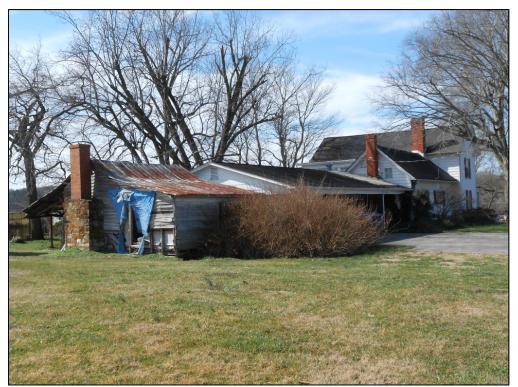
Figure 13. View of Isaac Terry House, looking southwest. One-story frame outbuilding is in foreground. Projecting off the rear of the main block is the 1-story ell and the carport.

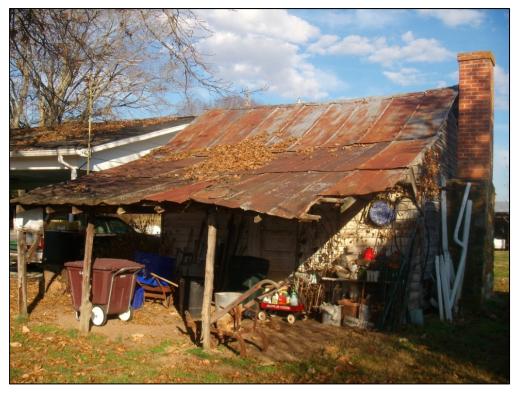
Outbuilding (Possible Kitchen or Quarters) (Figures 14–17): Constructed prior to 1940, a single-story, gable-roofed frame outbuilding is located immediately to the east of the non-historic carport. Based on its location directly behind and in close proximity to the main house, it is presumed to be a domestic outbuilding or service building, rather than an agricultural building. Unlike the main house, this building retains its original weatherboard siding and rests directly on the sill plate rather than a fieldstone foundation. The large exterior chimney on the east gable end has a shouldered lower half built of fieldstone laid in semi-regular courses topped by a later 20th-century brick stack. The size and placement of the chimney at the opposite end of the west gable-end entrance (facing the house's rear kitchen ell) suggests the building could have served as a summer (auxiliary) kitchen or a smoke house. At some unknown later date, the building was enlarged on the north by a shed-roofed addition, also with weatherboard siding and with a single window on the north and west obscuring the original north elevation. The south elevation has exposed rafter tails to which beams and down braces are adjoined to create an eave extension for the roof that was then extended to form a porch supported on rough-hewn poles. This enlargement, the shifting of the building's orientation from the west to the south, and the addition of the rough porch suggest that the building was re-purposed as a servant's living quarters. Although not accessible for interior inspection, the building currently serves as storage and has been allowed to deteriorate in comparison with the main house.

Figure 14. View of domestic outbuilding (possibly a kitchen/smokehouse converted to living quarters), south façade with later porch and east gable end chimney, looking northwest.

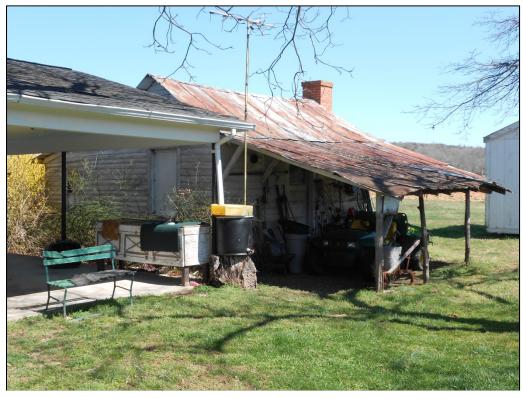
Figure 15. Outbuilding, view showing carport, west gable end entrance and porch on the south façade, looking northeast.

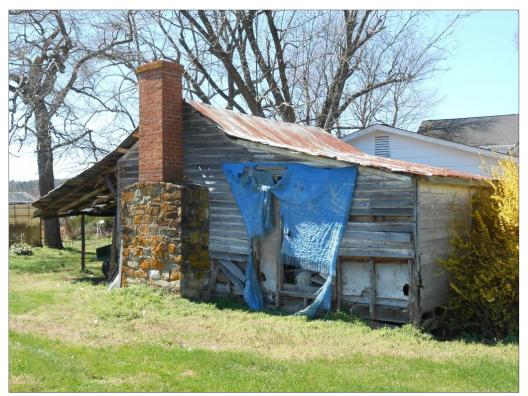
Figure 16. Outbuilding, view showing east gable end with stone chimney and replaced brick stack and north addition with shed roof, looking southwest.

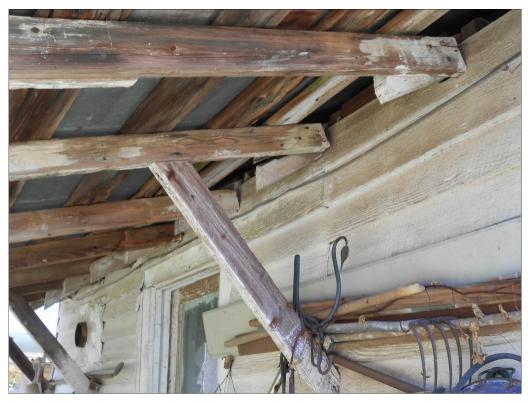
Figure 17. Outbuilding, view showing detail of braces attached to the south elevation and porch roof framing.

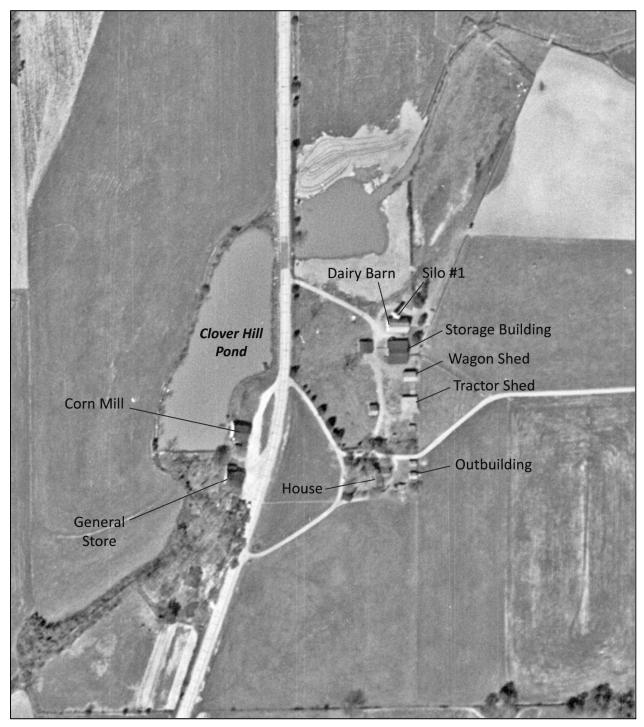
Figure 18. 1955 aerial view of Isaac Terry Farm property. Note the small building to the west of the storage building and the building immediately north of the quarters that appeared on a 1940 aerial view were still standing at this date. Some of the buildings in the small cluster between the house and storage building that appeared in 1940 have been replaced with the wagon shed and tractor shed.

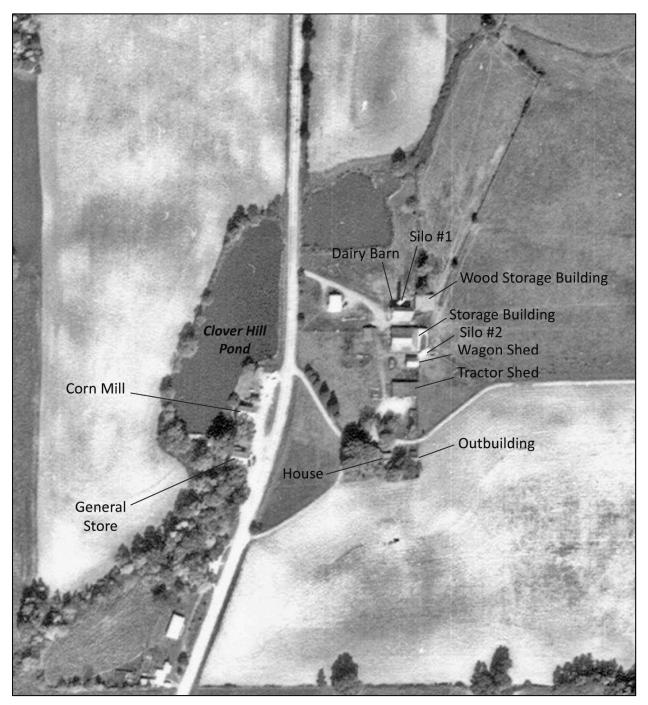
Figure 19. 1966 aerial view of Isaac Terry Farm property. Note the rear addition onto the storage building, the expansion of the tractor shed, and the construction of the wood storage building as well as the second silo. The small building to the west of the tractor shed has been demolished. The other buildings on the property appear unchanged since the 1955 aerial.

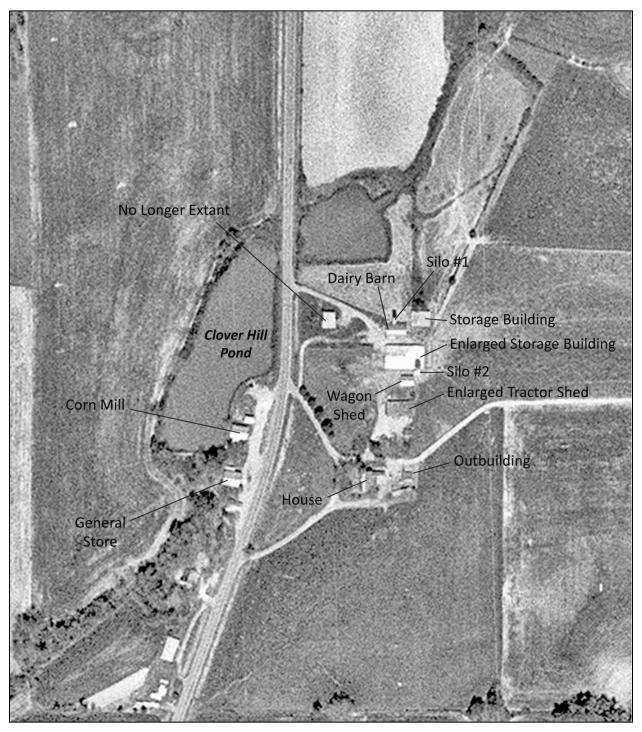
Figure 20. 1972 aerial view of Isaac Terry Farm property. Note the small building to the west of the storage building and the building immediately north of the quarters and the remaining cluster of buildings between the house and storage building have all been demolished. The carport has not yet been built; neither has the house currently used by the resident tenant on the property.

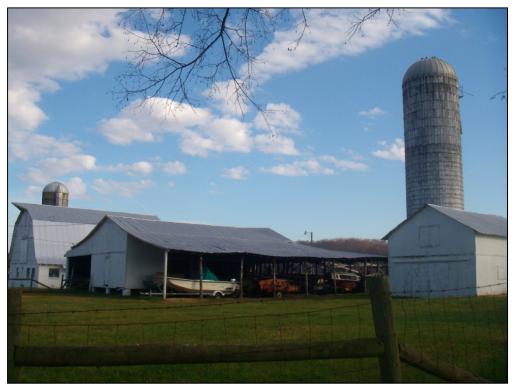
Figure 21. Isaac Terry Farm outbuildings from right to left (wagon shed, silo #2, storage building, dairy barn, and silo #1), looking northeast.

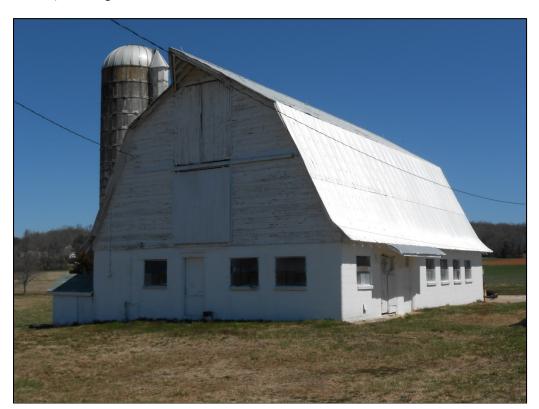
The small concrete-block milk house with single-leaf hinged door is located at the northwest corner of the barn's north side. A concrete-block hyphen with metal panels on the west elevation connects the dairy barn to a ca. 1947 pre-cast concrete stave silo. No longer used for dairy purposes, the dairy barn now serves as storage.

Figure 22. View of dairy barn, milk house on the left side, and silo #1, looking northeast.

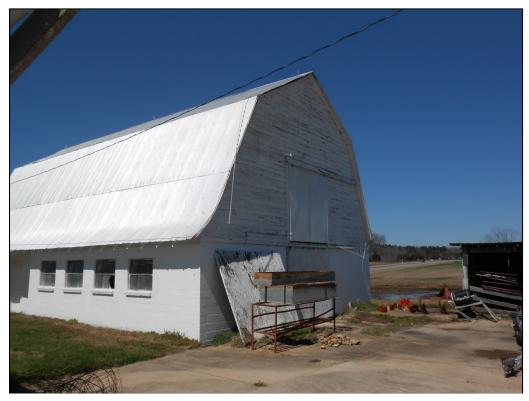
Figure 23. View of dairy barn south elevation and east gable end, looking northwest.

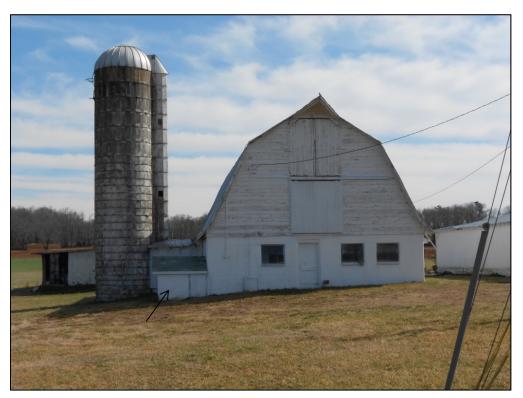
Figure 24. View of dairy barn, milk house, and silo #1, looking east. The small milk house at the left corner of the dairy barn is indicated by the arrow. The wood storage building is to the left of the silo.

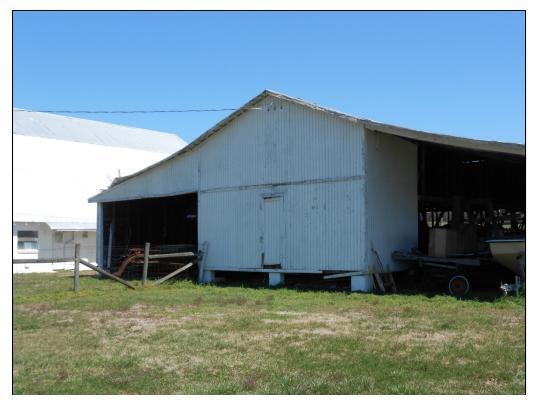
Storage Building (Figures 25 to 27): Just south of the dairy barn is the ca. 1910, single-story frame storage building. Set on brick piers, the building's original central frame section has flush-board sheathing and a vertical wood panel exterior. A single-leaf hinged entry door is centrally located in the west gable end. Around 1940, a pole barn consisting of a frame of lightweight posts and poles with a shallow-pitched, corrugated metal gable roof was built around the original frame section. Typical of this inexpensive pole barn construction, only the north elevation has vertical wood panel sheathing, forming the exterior wall, while the other elevations are left open. Based on aerial photographs, a ca. 1955–1960 rear addition formerly extended from the east elevation and at one point connected to concrete stave silo #2 (FSA 1955, 1972). The storage building is now used for hay and mechanical storage, and the rear addition is now in a ruinous state.

Figure 25. View of storage building west gable end, looking northeast.

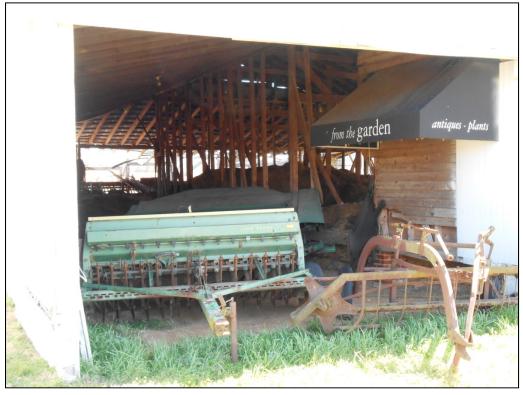
Figure 26. View of storage building showing original block (right) and pole barn framing, looking southeast.

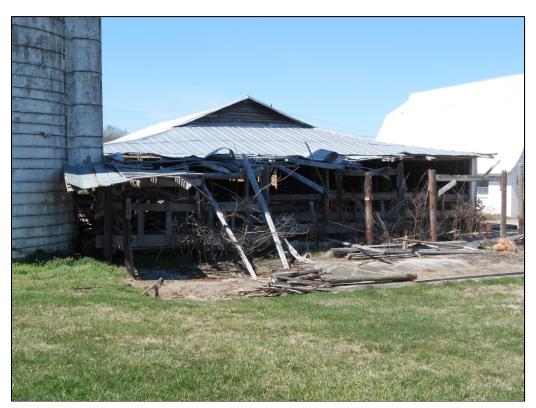
Figure 27. View of storage building showing east gable end, looking northwest. Concrete stave silo #2 is to its left.

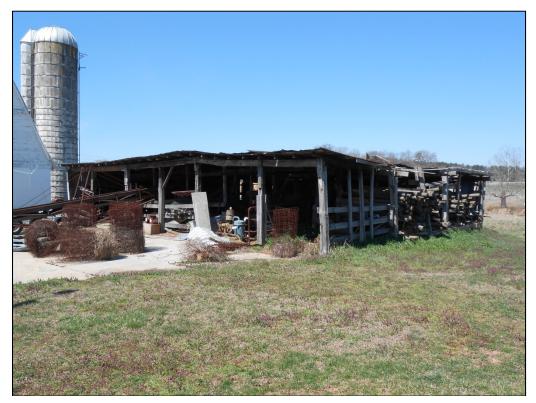
Wood Storage Building (Figure 28): Located off the northeast corner of the dairy barn is a single-story wood storage building. Based on historic aerial photos, the building was constructed sometime between 1960 and 1966. The north and west elevations have metal panel sheathing forming an exterior wall, while the remaining elevations are left open. The building currently provides storage for cut timbers, farm implements, and a vintage tractor and car.

Figure 28. View of wood storage building, looking northwest. Concrete stave silo #1 is to its left.

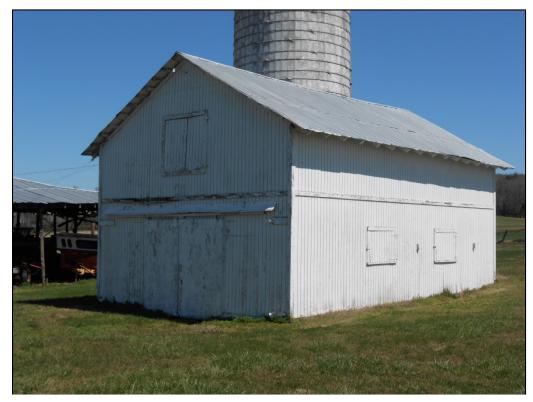
Wagon Shed (Figure 29): Located south of the wood storage building, the single-story-with-loft frame wagon shed has vertical wood panel sheathing and a wood band articulating the loft space. Constructed sometime between 1940 and 1955 based on aerial photographs, the shed has a front-gable roof covered with standing-seam metal and exposed rafter tails. The west gable end has a pair of sliding entry doors mounted on an exterior track with a small metal hood. Above the entry is a hinged double-leaf panel to access the loft. The two window openings on the south are presently sealed with hinged panel covers. There was no interior access and the building's current use is unknown.

Figure 29. View of wagon shed façade and north elevation, looking southeast.

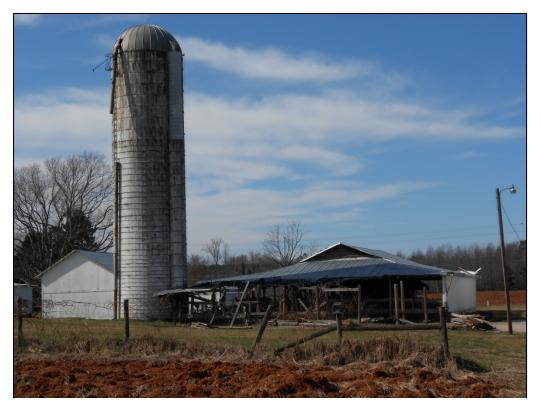
Concrete Stave Silo #2 (Figure 30): Constructed between 1960 and 1966, the pre-cast concrete stave silo stands immediately adjacent to the southeast corner of the wood storage building. The metal paneled domed roof is now partially deteriorated and the silo currently is not in use.

Figure 30. View of concrete stave silo #2, looking southwest. The storage building is to the right and the wagon shed is to the left.

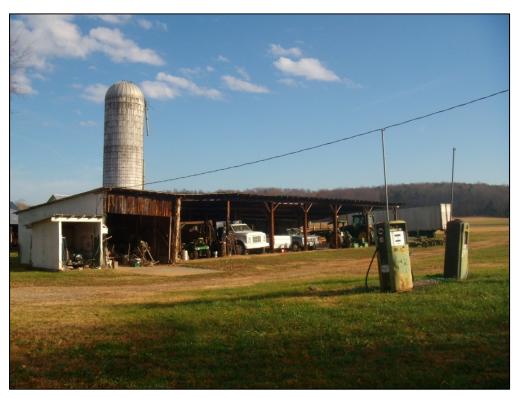
Gasoline Pumps (Figure 33; see Figure 31): There are two gasoline pumps located between the main house and the tractor shed. Based on historic aerial photos, these are located at what was once the former junction of a farm road (no longer there) and the current road to the agricultural buildings and were placed here sometime between 1940 and 1955 (FSA 1940, 1955, 1972). The manufacturing plate has been removed, thus the maker is not known. The pumps are no longer in use.

Figure 31. View of gasoline pumps (foreground), tractor shed, and silo #2 (background), looking northeast.

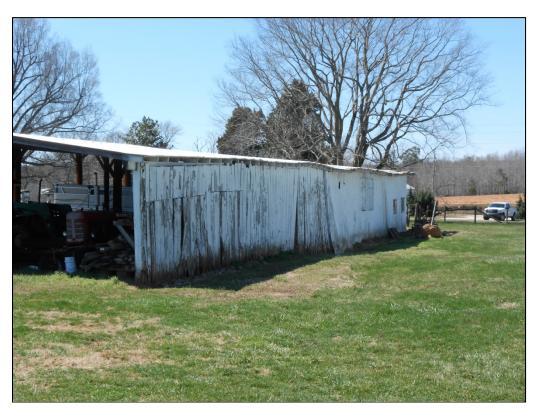
Tractor Shed (Figures 31 and 32): Located south of the wagon shed and north of the main house is a single-story, 7-bay tractor/machine pole barn. Constructed sometime between 1940 and 1955 based on aerial photographs, the gable roof with exposed rafter tails is supported by rough wood poles. The north elevation has vertical board sheathing forming the exterior wall, while the remaining elevations are left open. According to historic aerials photos, the building was originally the same size as the wagon shed and was enlarged to the west sometime between 1955 and 1960 (FSA 1955, 1960). This metal-clad addition features 6-light awning metal windows on the north and west elevations. A detached frame tool shed stands adjacent to the west elevation.

Figure 32. View of tractor shed, east and north (rear) elevations, looking southwest.

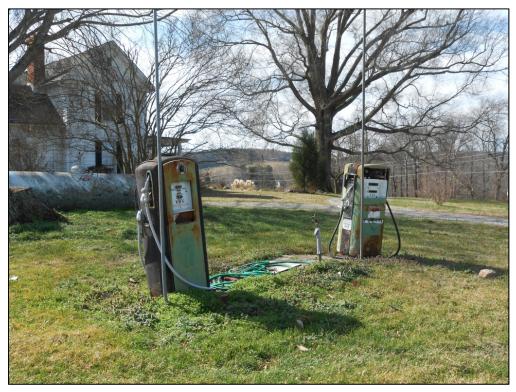
Figure 33. View of gasoline pumps, looking southwest.

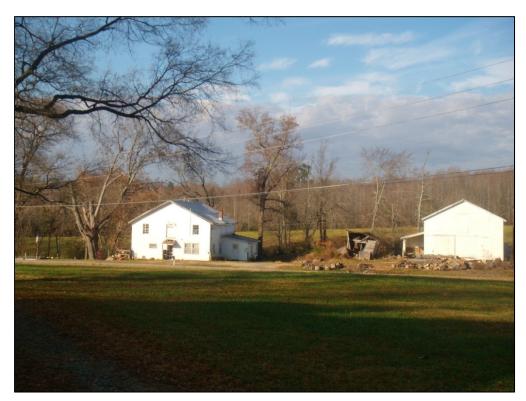
Figure 34. View of Clover Hill Corn Mill (right), outbuilding ruin, and Clover Hill General Store (left), looking southwest.

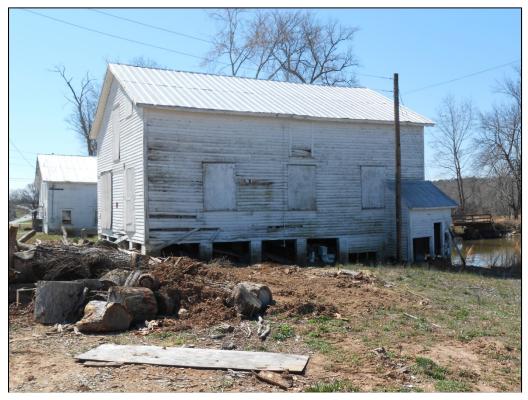
Set on brick piers, the single-story-with-loft frame mill building has weatherboard siding and a standingseam, and a front-gable roof with exposed rafter tails. There are two entrances on the first story of the façade: a sliding door mounted on an exterior track and a double-leaf door with strap hinges, both of which are raised slightly above ground level, indicating there may have been steps. A central single-leaf door with strap hinges provides access to the second-story loft. The north elevation has three window openings on the first story, currently boarded over. A small shed-roofed addition is on the building's northwest corner. There is a shed-roofed bay on the south elevation, partially enclosed with weatherboard siding and sheltering a sliding door mounted on an exterior track. A 6/6 double-hung wood sash window is located on this elevation. The west gable end has a single-leaf hinged door, a boarded-over window opening, and the remains of a 4/4 sash window in the gable end. The building rests on taller brick piers on this elevation, as the land slopes downward toward a pond located to the west.

Figure 35. View of Clover Hill Corn Mill, north elevation and east gable end, looking southwest.

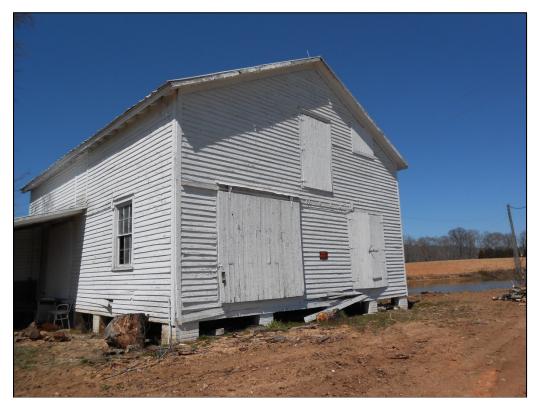
Figure 36. View of Clover Hill Corn Mill east gable end, looking northwest.

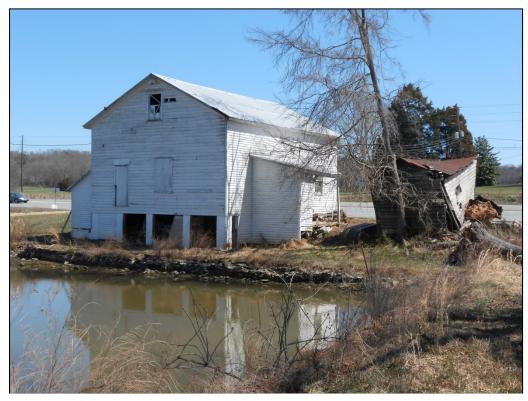
Figure 37. View of Clover Hill Corn Mill west gable end and outbuilding ruin, looking northeast. The small stone wall is at the edge of the pond.

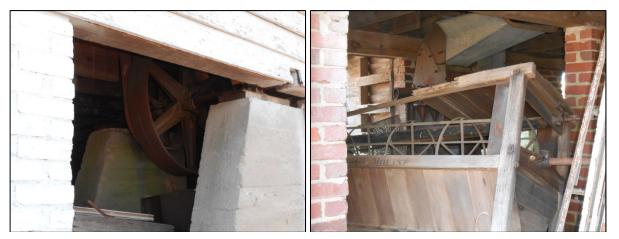
The interior was not accessible and it is not known how much original machinery remains inside, although some machinery, including the wheel mounted between two concrete supports and a metal chute are visible at the open foundation level. According to a 2004 interview with Isaac Terry Jr., the corn mill housed a semi-portable agricultural machine for producing corn for animal feed; apparently it never was water-powered. Instead, the corn mill was powered by a belt running from an International Harvester tractor. Grain was fed into a chute from the second-story loft to the hopper and milling machinery below, with the flow regulated by an adjustable plate (Terry Family File at Durham County Library). A small stone retaining wall lies west of the rear elevation, possibly to provide a flat surface for the parked tractor.

Figure 38. View of Clover Hill Corn Mill wheel (left) and chute (right), looking under building.

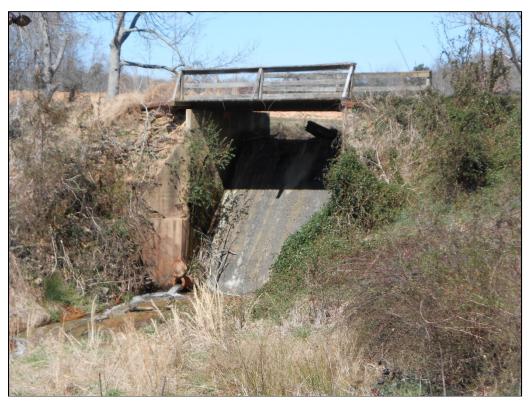
Clover Hill Dam/Bridge (Figure 39): A concrete dam located southwest of the corn mill creates a small pond. Built ca. 1922, it would logically appear to have been a pond excavated in connection with operation of the adjacent corn mill. However, Ike Terry Jr. claimed that the pond was created so that his "brothers and [he] could go swimming close by instead of in Little River" (Terry Family File at Durham County Library). In Isaac Terry Sr.'s will the pond is indeed referred to as a "millpond," however, based on the corn mill's motor-driven machinery and the construction date of the building, it is unlikely the mill ever required a corresponding millpond and the pond may have been created for use by humans and cattle. The dam consists of a single concrete spillway and concrete wingwalls encasing fieldstone. Atop the dam is a wooden footbridge with railings providing access to the fields to the west.

Figure 39. View of Clover Hill Dam and footbridge, looking northwest.

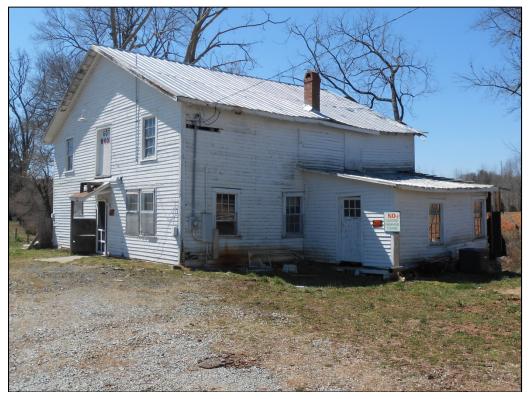
windows on the rear elevation are covered by wooden boards on the first story and a painted 6/6 doublehung sash window on the second story. The building could not be accessed for interior inspection or photography.

Figure 40. View of former Clover Hill General Store/"Clover Hill Dance Club," looking southwest.

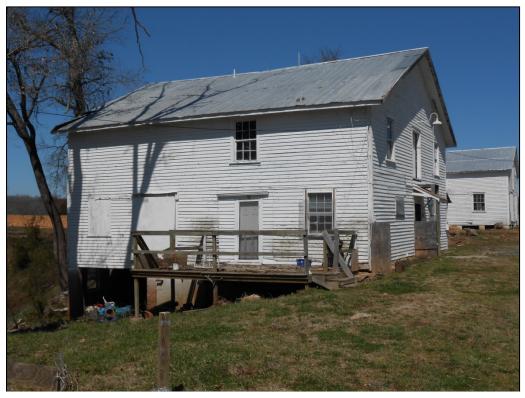
Figure 41. View of former Clover Hill General Store/"Clover Hill Dance Club," looking northwest.

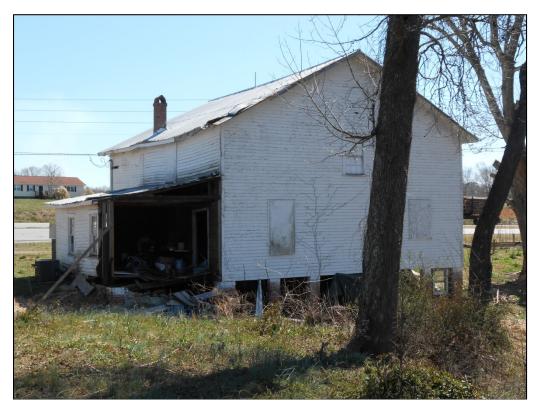
Figure 42. View of former Clover Hill General Store/"Clover Hill Dance Club," looking southeast.

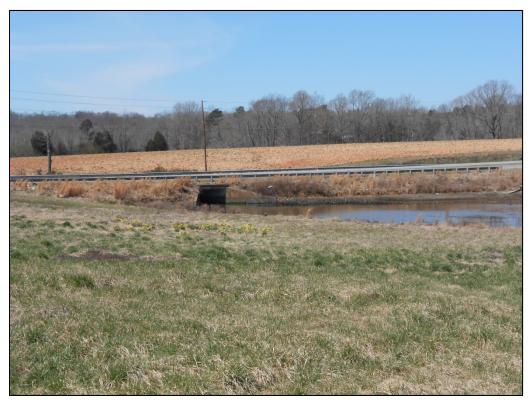
Non-Contributing Resources (Figure 43): Both the 1929 Bridge No. 118 and Roxboro Road (US 501) lie within the property boundaries, but do not contribute to the significance of the property as there is no association with the agricultural, commercial, and social history of Durham County.

Figure 43. View of Bridge No. 118, looking west.

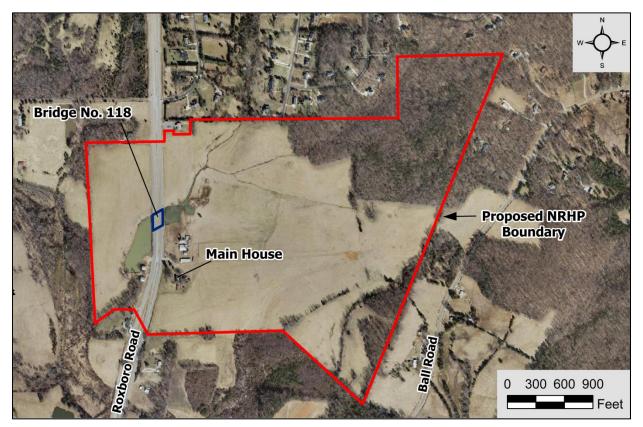
Figure 45. Isaac Terry Farm: aerial view with proposed NRHP boundary.

The NRHP boundary for the Isaac Terry Farm (Figure 45) has been drawn according to the guidelines of National Register Bulletin 21, *Defining Boundaries for National Register Properties* (NPS 1995). The boundary is drawn to correspond to the property passed to Isaac Terry Sr. by his father James F.M. Terry in a will executed June 30, 1910 (DCWB B:431). The property was passed from Isaac Terry Sr. to his sons Isaac Terry Jr. (171 acres) and Lewis Isaac Terry (24.3 acres) on November 9, 1955 and continues to reside in family trusts managed by the descendants (DCWB 20:2718).

Two parcels, one of 3.8 acres and one of two acres, have since been sub-divided from the western property in 1997 and 2005, respectively, and one parcel of 0.8 acres was subdivided from the eastern property in 2003. Modern buildings have been constructed on these parcels, thus they do not contribute to the significance of the property.
