SUBJECT: Historic Structures Survey Report for the US 70 Improvements from West of SR 2566
To West of SR 1915, W-5600, Johnston County, ER 14-2332

**HISTORIC ARCHITECTURAL ANALYSIS OF
FIVE PROPERTIES IN THE W-5600 PROJECT AREA
IMPROVEMENTS TO US 70 FROM WEST OF SR 2566
(SADISCO ROAD) TO WEST OF SR 1915 (TURNAGE ROAD)
JOHNSTON COUNTY, NORTH CAROLINA**

FINAL REPORT
TIP No. W-5600; WBS No. 50056.1.1
Federal Aid No. HSIP-0070(163); Tracking No. 12-08-0007

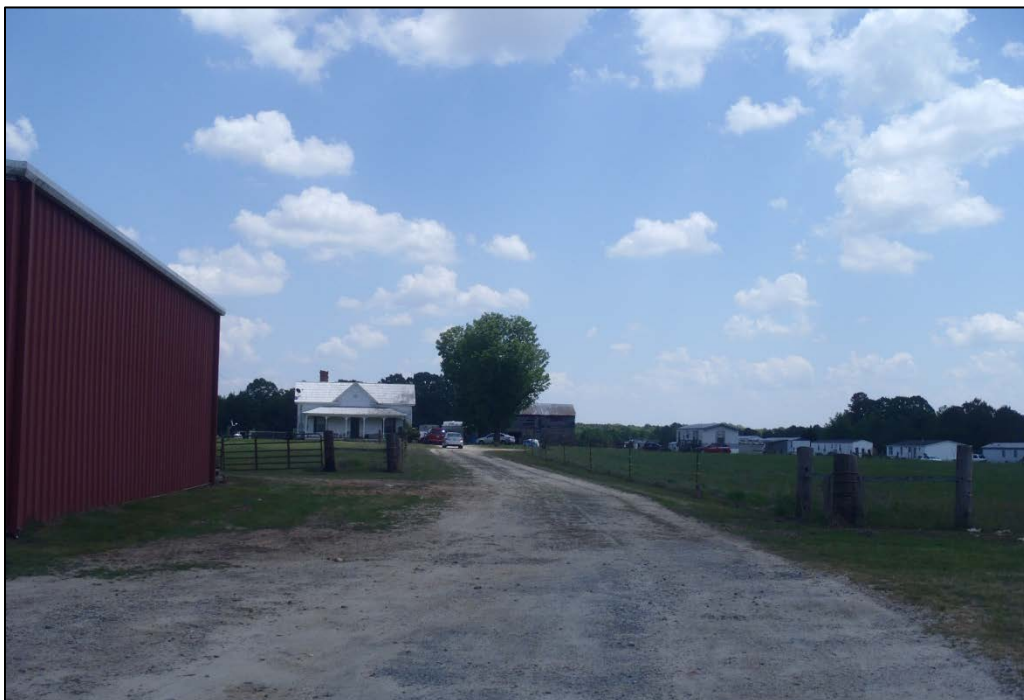
Figure 13. View of Jones Farm property (PIN 168600-94-1187) from Swift Creek Road, facing east.

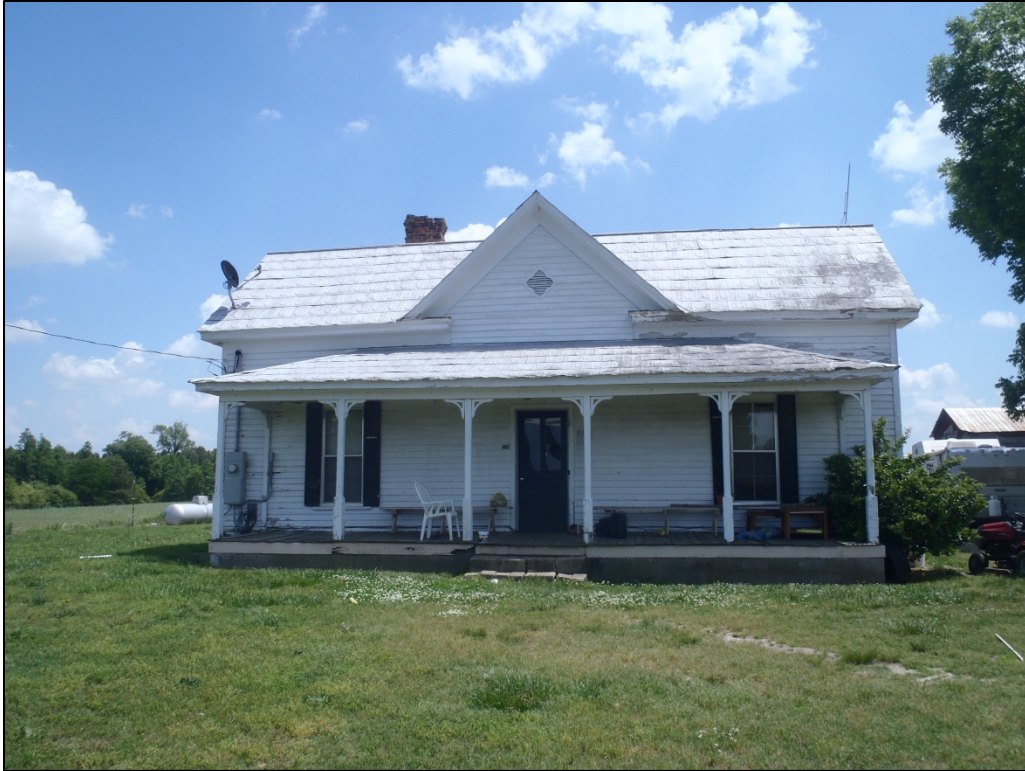
The Jones Farm (PIN 168600-94-1187) is located at 801 Swift Creek Road (Figures 2 and 3) and consists of a late-nineteenth-century residence, set back from the road and surrounded by various outbuildings, including a barn, a tobacco barn that has been converted into a residence, sheds, a trailer, and a modern metal building used for an office (Figures 13 and 14). The primary residence on the property is a one-and-one-half-story, Triple-A-style frame house with an L-shaped plan (Figures 15 and 16). The house sits on a stone pier foundation, which has been infilled with concrete block sometime during the mid-twentieth century. The main portion of the house is laterally gabled and features the central gable and full-width, hipped roof porch that were common in rural North Carolina during the late-nineteenth and early-twentieth centuries. The front porch, which is supported by partially chamfered posts, rests on a mid-twentieth-century concrete-block foundation. To either side of the central entry door is a single, four-over-four light, wooden sash window on either side.

Figure 15. View of Jones Farm house, front elevation, facing east.

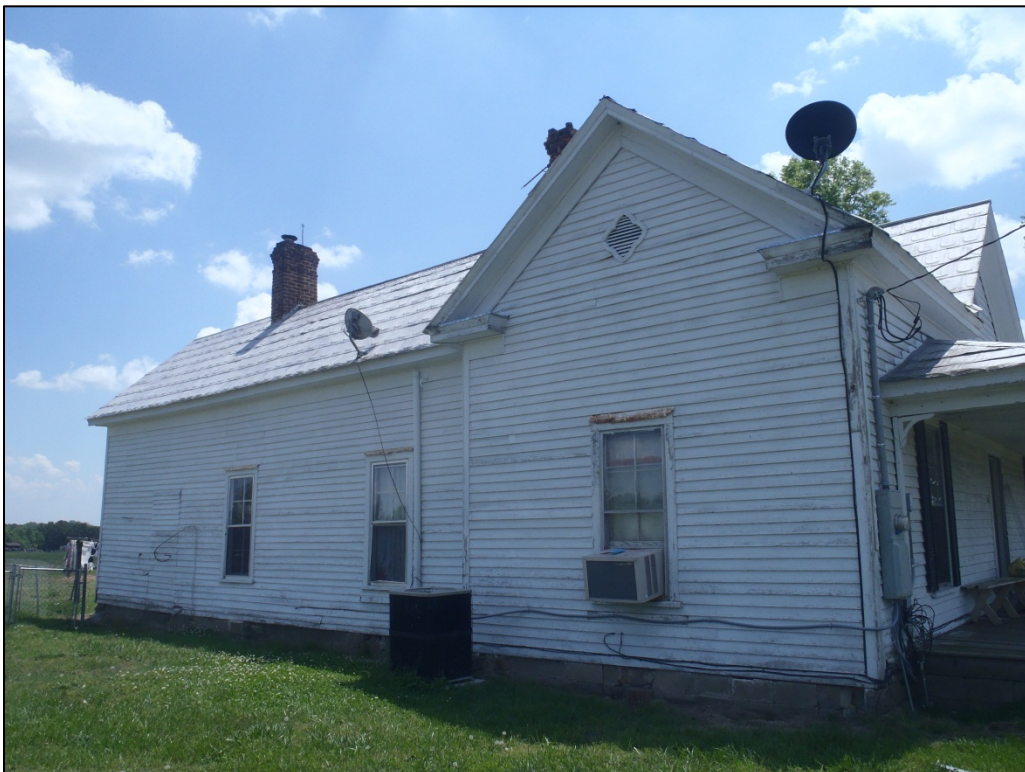
Figure 16. View of Jones Farm house, north elevation, facing southeast.

A single-story, gabled rear ell extends from the northeast corner of the house. The roof of the house is sheathed in decorative pressed metal, which mimic round-butt wooden shingles, and two interior, brick chimneys are visible along the roof ridge of the rear ell (Figures 17). A shed roofed porch, inset in the L formed by the front and rear sections of the house, has been enclosed and has standing-seam metal roofing (Figures 18 and 19). A third, truncated brick chimney rises slightly above the roof on the southern portion of the east elevation, near the intersection of the main house block with the rear porch. The exterior of the house is sheathed in wooden weatherboard siding, and fenestration on the house consists primarily of four-over-four wooden sash windows.

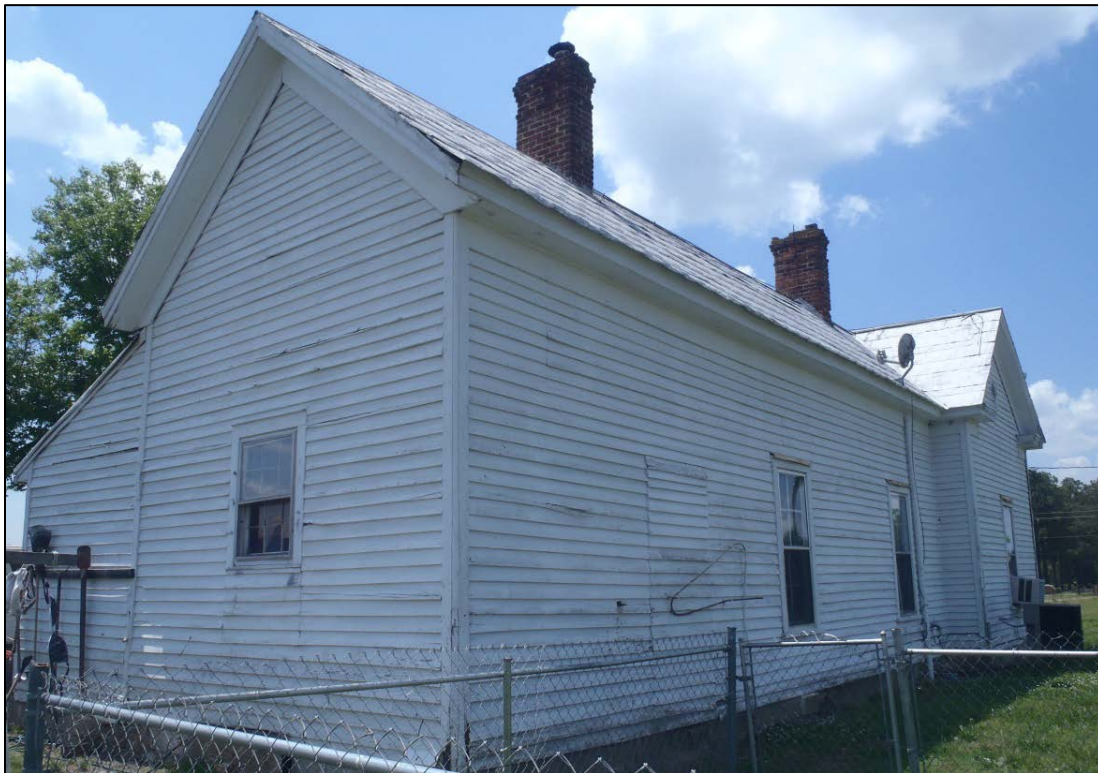
Figure 17. View of Jones Farm house, rear oblique view, facing southwest.

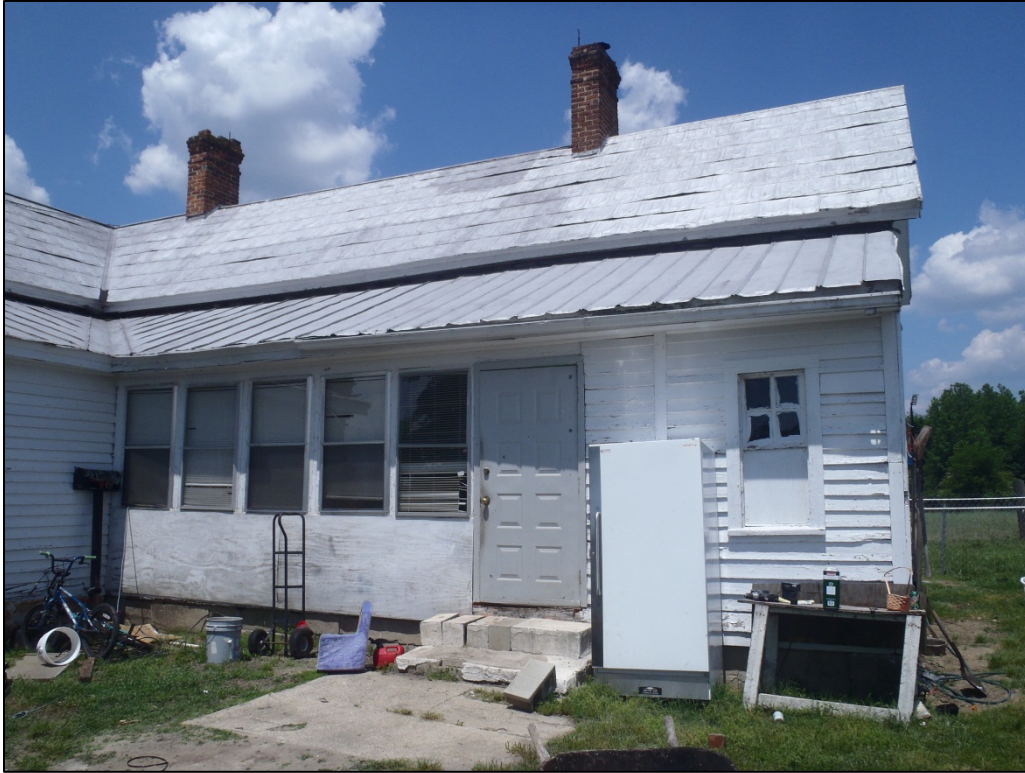
Figure 18. View of Jones Farm house, enclosed rear porch, facing northwest.

The house retains its original L-shaped form and single-story, Triple-A-style. There have been some alterations, including enclosure of the rear porch, removal of a window and door on the rear ell, and infill of the foundation. However, the original plan of the house is still evident, and the changes do not impact the overall visual effect of the house. The outbuildings and landscape have undergone significant changes, notably the demolition of some of the original agricultural buildings and the conversion of others to alternate uses.

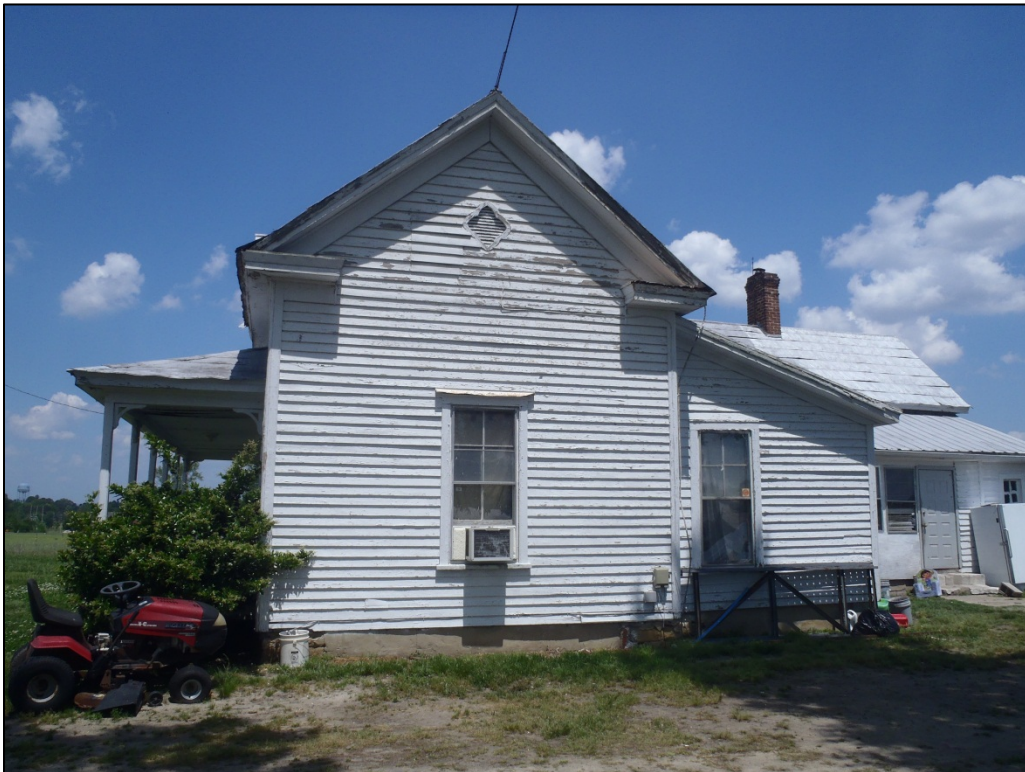
Figure 19. View of Jones Farm house, south elevation, facing north.

The windows are cased with simple surrounds and most have metal flashing visible above the surround, indicating the former presence of some type of awning or hood. The southern elevation of the enclosed rear porch features one-over-one aluminum sash windows and a plywood enclosure. Alterations to the house include the enclosure of a doorway along the north elevation of the rear ell and the replacement of the rear window on the ell with a smaller, wooden six-over-six sash window and the enclosure of the remaining portion of the opening. The owner did not discuss the interior condition of the house (personal interview with Kenneth Jones, 2014).

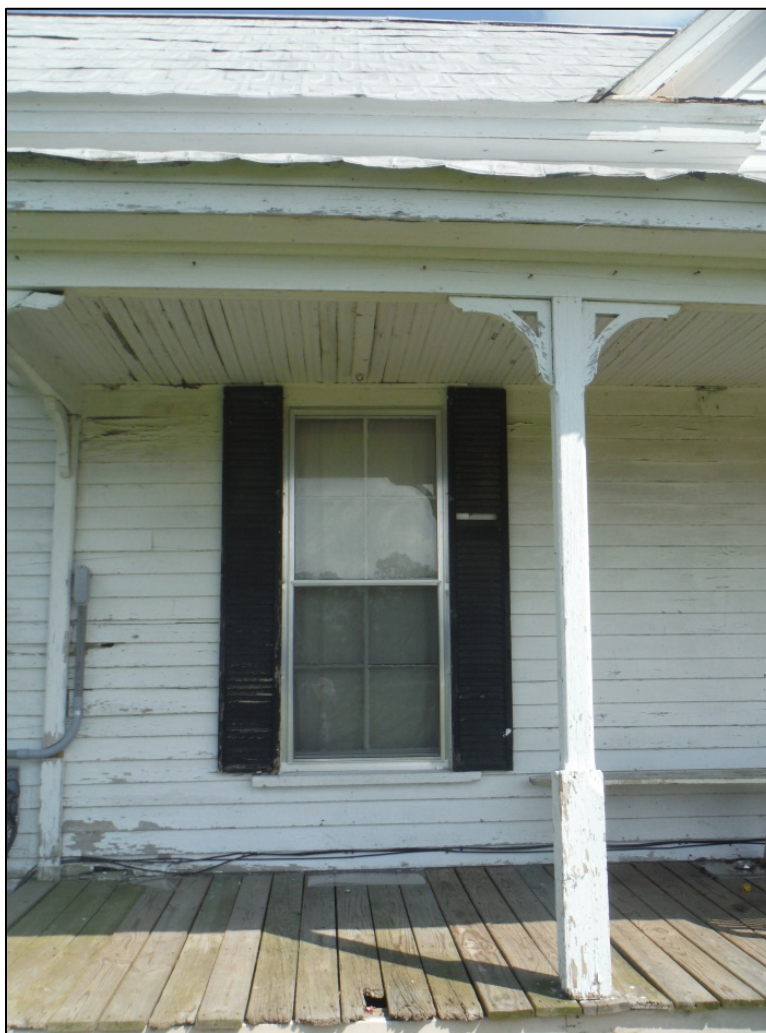
Decorative detailing on the house exhibits elements of multiple architectural styles, which was common for farmhouses in Eastern North Carolina. The chamfered porch supports and decorative brackets were elements of the mid-to-late-nineteenth century Gothic Revival and Italianate styles; the quatrefoil louvered gable vents are also most often identified with the Gothic Revival style (Figures 20 and 21). The boxed eave with a wide overhang and wide frieze and classic cornice returns in the gables, including the gable ends and central front gable, are elements of the Greek and Colonial revival styles. The corbelled chimney tops often feature in revivalist styles. The application of high-style architectural elements to a vernacular form was a practice that was common throughout the late-nineteenth and early-twentieth centuries, resulting in the broad, so-called “Folk Victorian” architectural category, into which this house falls.

Figure 20. View of Jones Farm house, porch and front window detail, facing east.

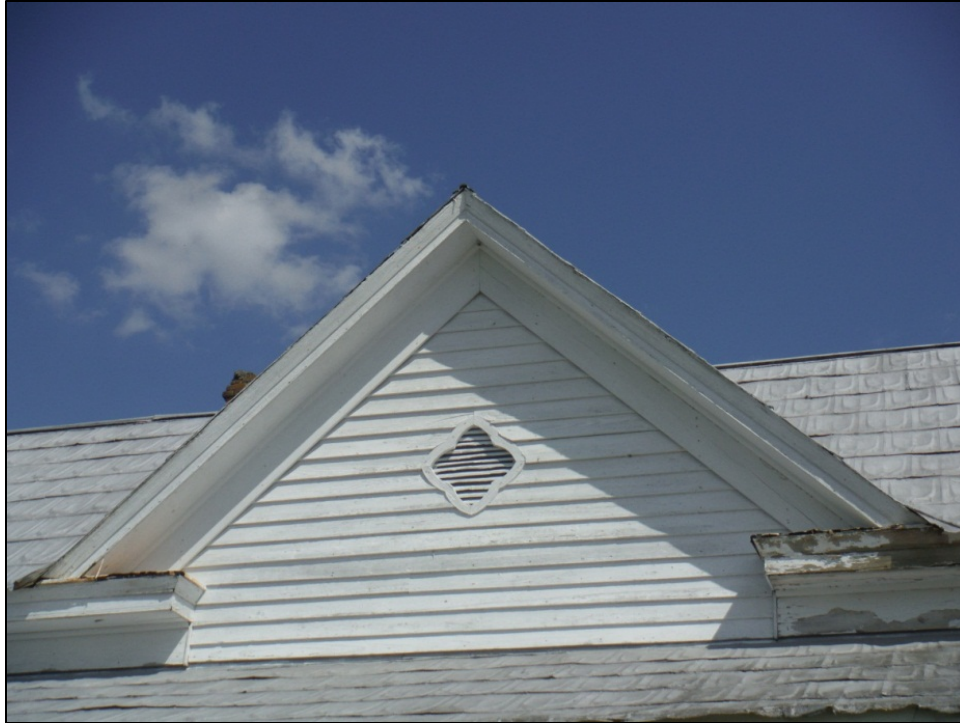
Figure 21. View of Jones Farm house, front gable detail, facing east.

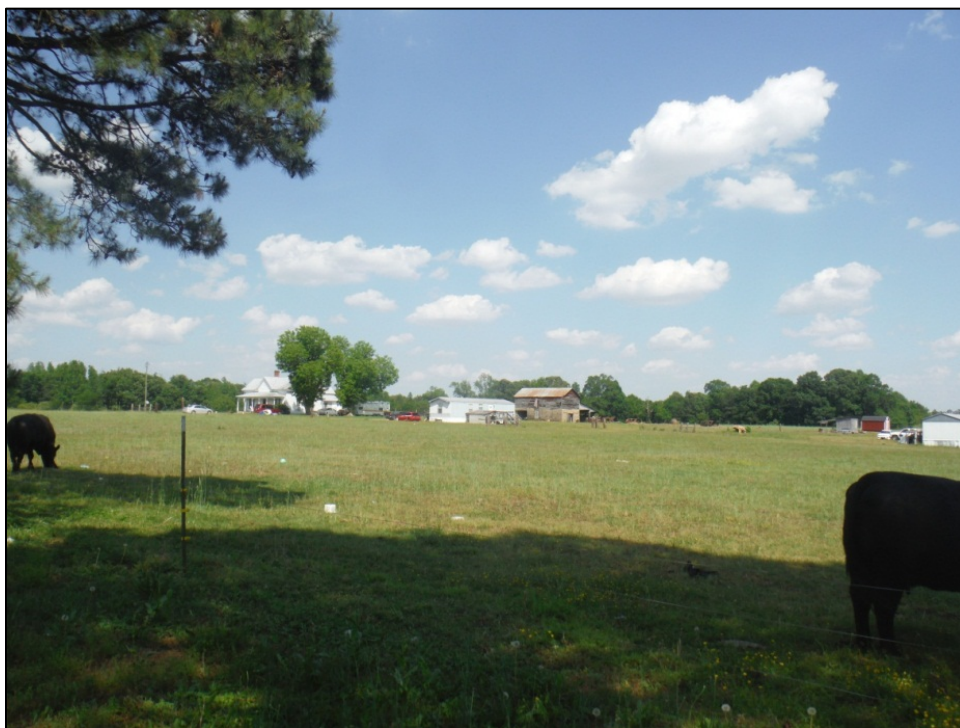
Figure 22. View of Jones Farm house and barn, facing northeast.

Currently, the Jones Farm house is surrounded by open agricultural fields, primarily used for the grazing of cattle; outbuildings of various ages are also present on the Jones Farm property (Figures 14 and 22).

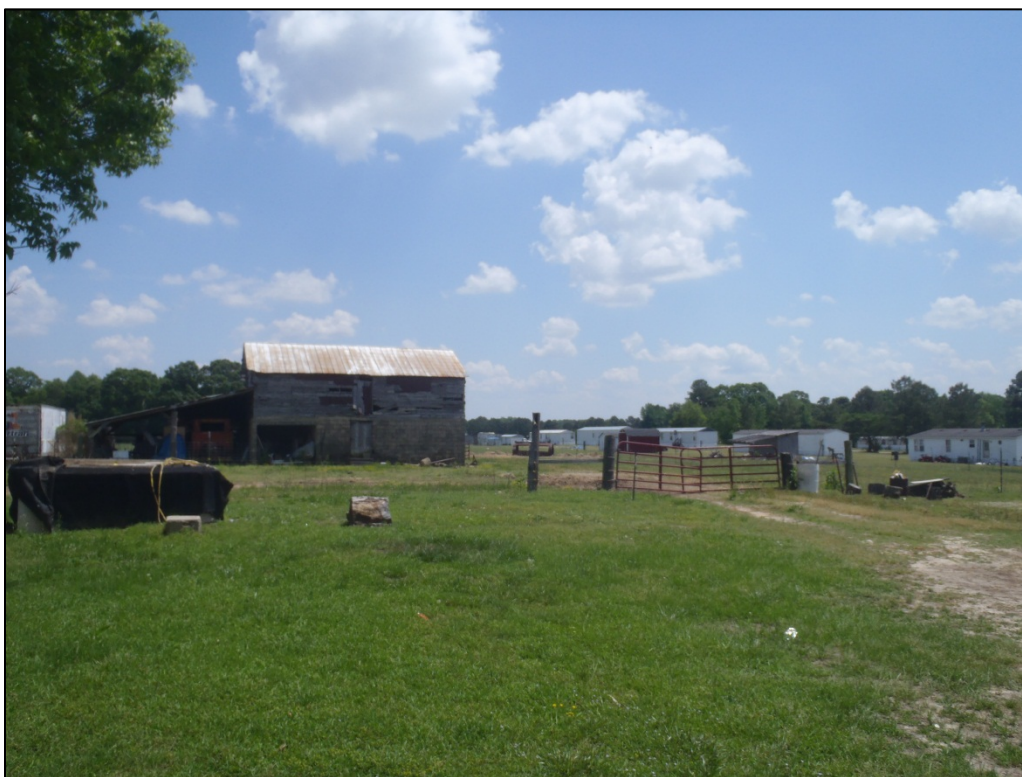
East of the house is a large, two-story, gable-roofed barn, with a standing-seam-metal roof, that dates to the early-twentieth century. The first story is constructed of concrete block, while the upper story is framed, covered with horizontal wooden siding. The western elevation of the barn features an open garage bay, currently used for storage, and a raised central doorway on the lower level; the upper level has a hayloft door that has deteriorated and is warping away from the hinges (Figure 23). A large, shed-roofed, open rafter projection, supported by roughly shaped barked logs, extends from the north elevation (Figure 24). The south elevation has a wide, wooden cased opening, with a partial door covering it; two shed roofed, metal bays, supported by rough-hewn posts and currently used for storage extend from the east elevation (Figure 25). The barn is in poor condition, with cracks and shifting visible in the concrete-block first story and siding boards missing from the wooden upper story.

Figure 23. View of Jones Farm barn and landscape, facing east.

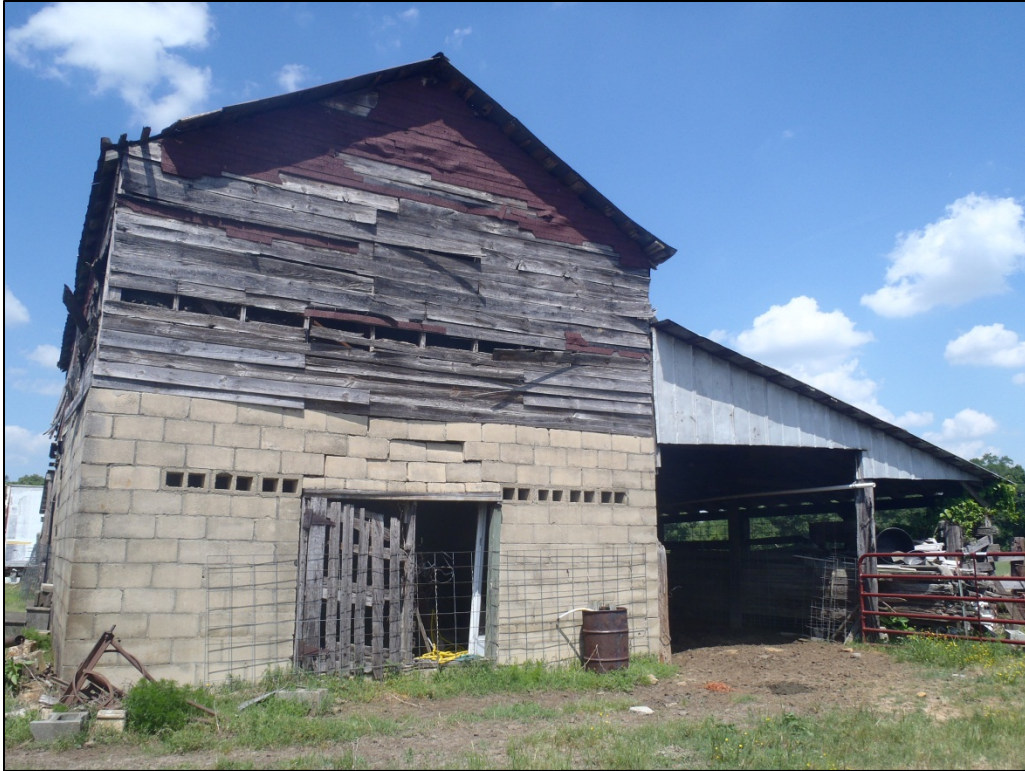
Figure 24. View of Jones Farm barn, facing northeast.

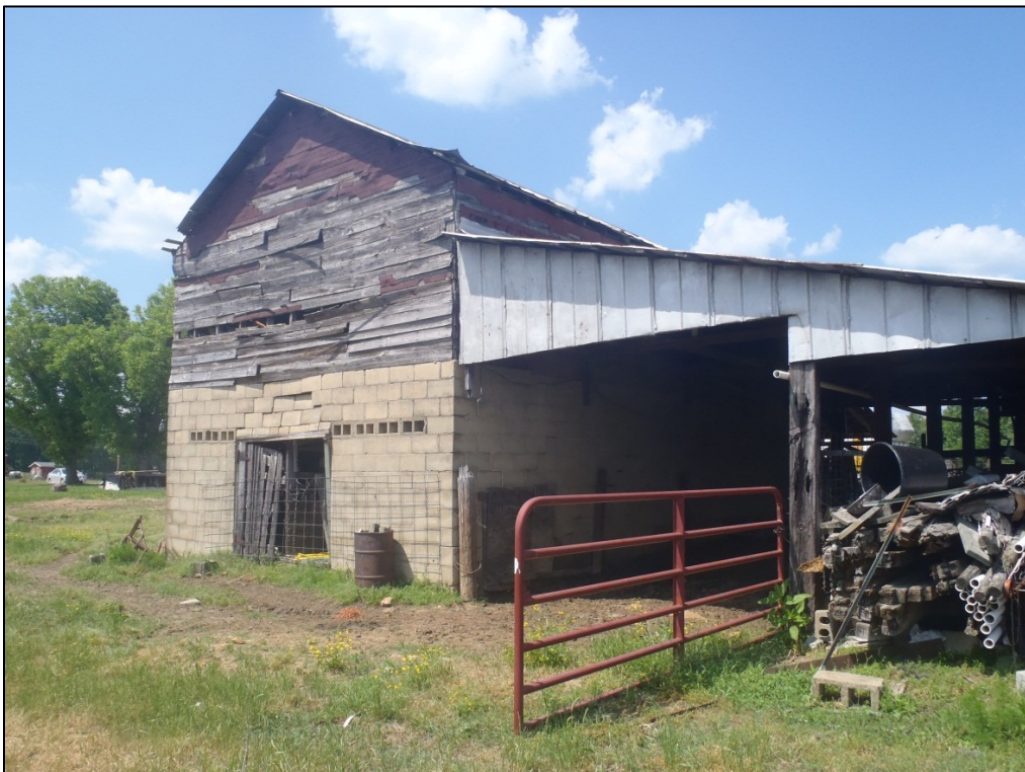
Figure 25. View of Jones Farm barn, facing northwest.

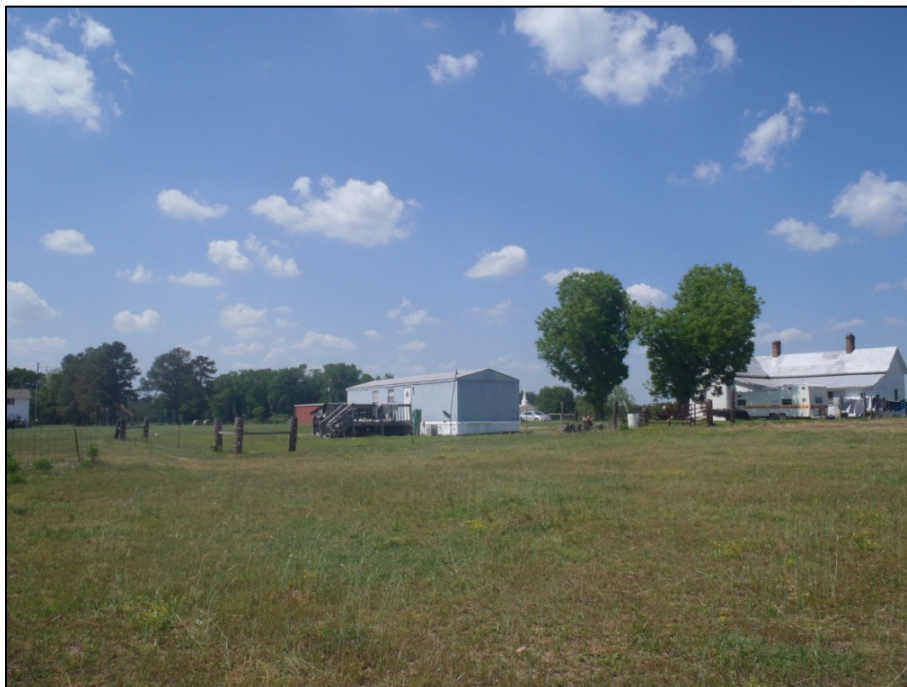
Figure 26. View of Jones Farm house, trailer, and landscape, facing northwest.

South of the house and southwest of the barn is a trailer, which was placed on the property sometime in the 1990s (Figures 22 and 26).

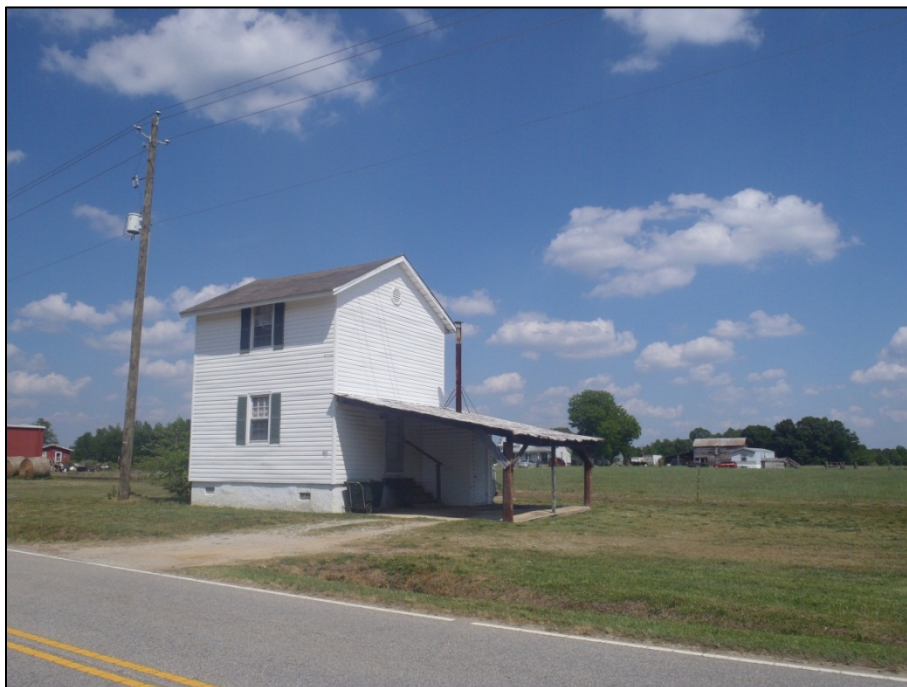
Southwest of the main residence, close to Swift Creek Road, is a former tobacco barn (Figure 14 and 27). This two-story structure was converted to a residence in the 1990s (personal interview with Kenneth Jones, 2014).

Figure 27. View of Jones Farm converted tobacco barn, facing northeast.

The former barn, which dates from the early-twentieth century, has a gable roof and sits on a stucco-covered brick foundation. The lean-to shed projection on the south elevation, which has a standing-seam-metal roof, has been repurposed as a carport. The entry door is on the southeast corner of the structure, within a shed-roofed enclosure that houses the drying furnace. The metal chimney of the drying furnace is visible above the roof. A raised rear deck is accessed by a first-story door in the east elevation of the house (Figure 28). The converted tobacco barn residence is a single bay wide, with two windows, one on each story, on the front elevation and a single window, located above the rear doorway, on the back elevation. The vinyl sash windows are six-over-six light configuration; the building is sheathed in vinyl siding. The owner indicated that the structure has a single bedroom, located on the second story, and a kitchen, small living room, and bathroom located on the ground floor (personal interview with Kenneth Jones, 2014).

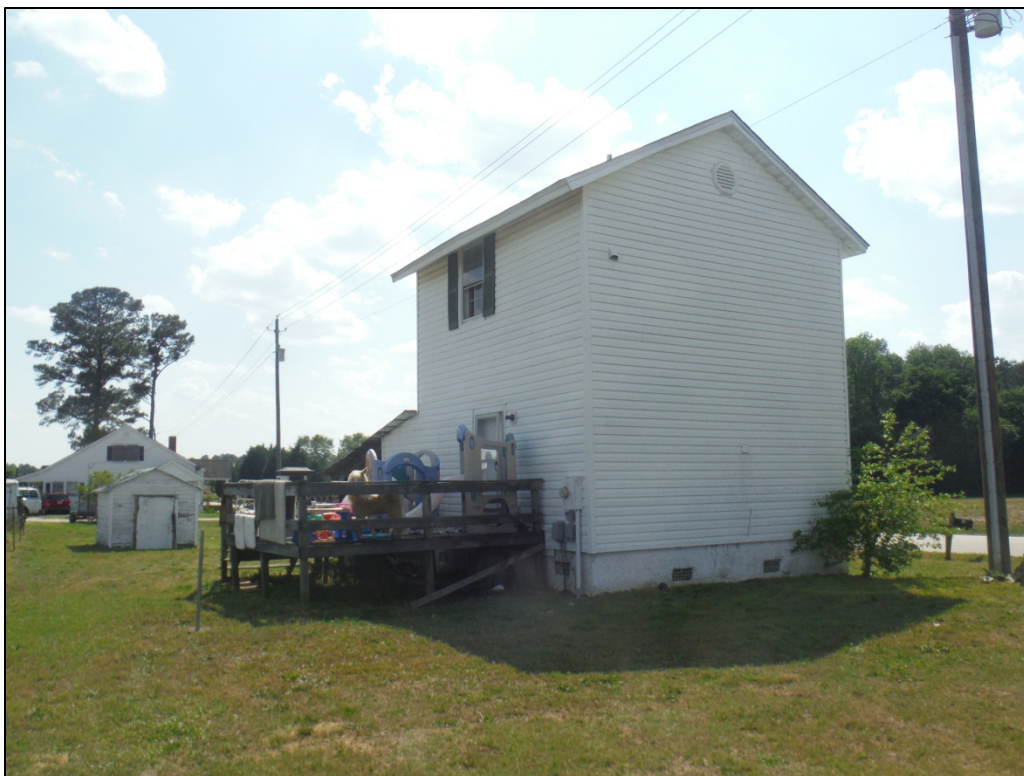
South of the converted tobacco barn is a small, gable-roofed storage building that dates to the early-twentieth century. The wooden frame building, which is sheathed in horizontal wooden siding, has its gable ends oriented parallel to Swift Creek Road (Figures 28 and 29). The roof, which has visible rafter tails, has a standing-seam-metal roof. There is a doorway, with a plain plywood door, on the north elevation.

Figure 28. View of Jones Farm converted tobacco barn and shed, facing south.

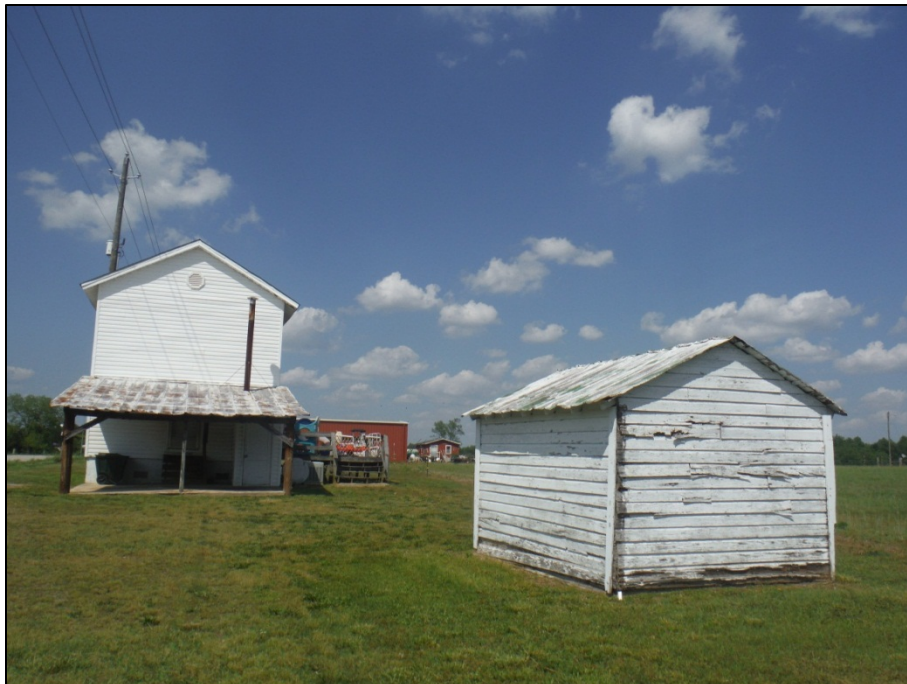
Figure 29. View of Jones Farm converted tobacco barn and shed, facing north.

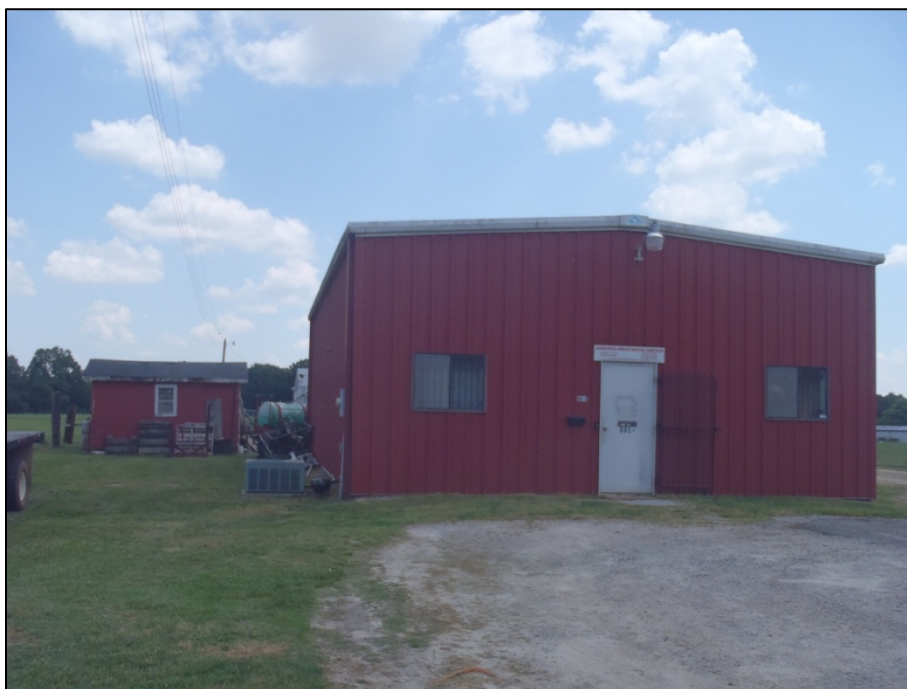
Figure 30. View of Jones Farm metal office building and shed, facing east.

West of the main residence, close to Swift Creek Road, is a large modern metal building, with a shallow, front-gabled roof (Figure 14 and 30). The rectangular building has a central door, which is flanked by a two-pane, horizontal sliding window on either side. An exterior light on a curved pole is mounted at the apex of the gable. The building is the office for Jones Real Estate Rental Service, which is a business venture of the property owner. The metal building is the dominant visible feature of the property when viewed from Swift Creek Road.

East of the metal building is a small, front-gabled, wooden storage building that dates from the early-twentieth century (Figure 30). The building sits on stone piers and has vertical wooden siding. It has an off-center door and a single window on its southern elevation. Both the eastern and western elevations feature a single, centered window (Figure 31). The roof has a wide eave overhang and is sheathed in composite shingles. The windows are made of aluminum, with one-over-one light configuration, and have metal bars mounted on the inside. Surrounding the Jones Farm structures are approximately 62 acres of land, which is divided into multiple fields that are separated by electric wire fencing (Figure 32). The fields are utilized as pastureland for cattle, which is the only evident agricultural activity on the land. The northeastern portion of the property remains as woodlands.

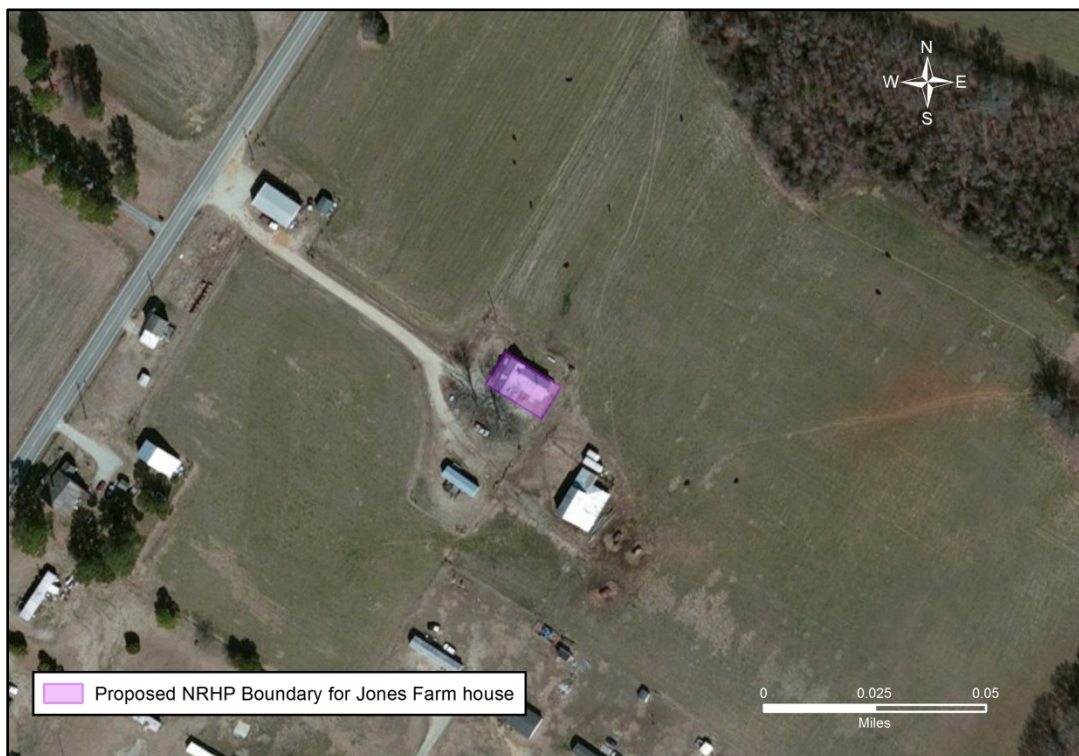
The house is recommended as eligible for the NRHP under Criterion C, for its association with the architectural elements produced by the Wilson and Waddell mill and as a good example of the common Triple-A-style house, featuring applied decorative details from its period of construction. The date of significance on the property is circa-1890, its construction date, and the proposed boundaries include only the area immediately surrounding the footprint of the house (Figure 38).

Figure 38. Aerial map showing the proposed NRHP boundaries for the Jones Farm house.

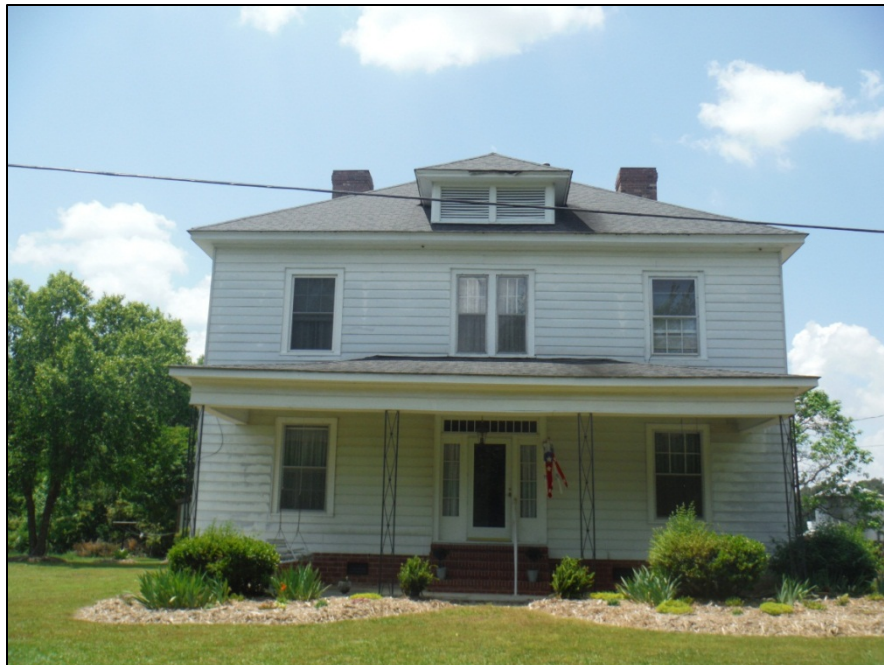
Figure 40. View of Parrish Farms house, front elevation, facing west.

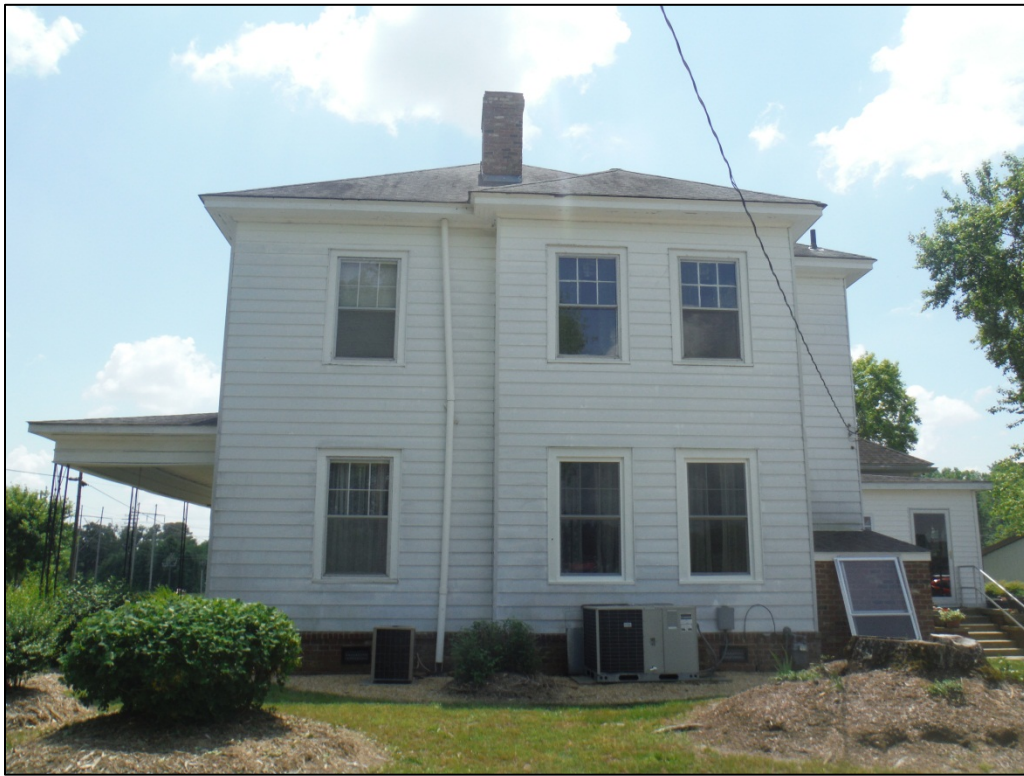
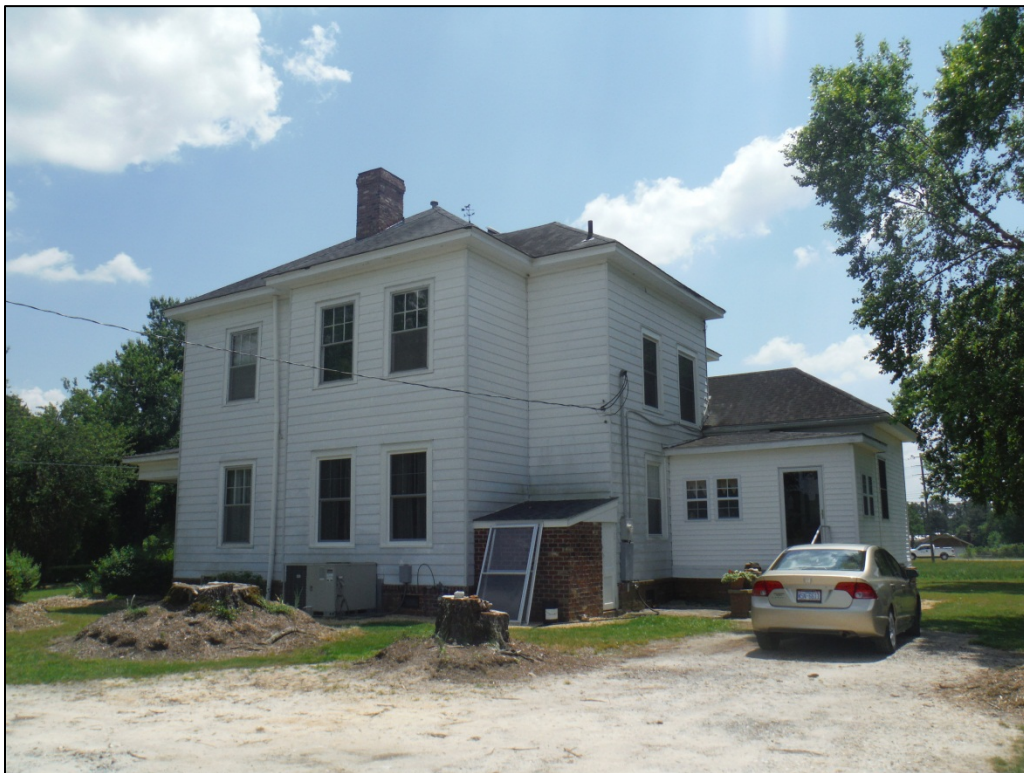
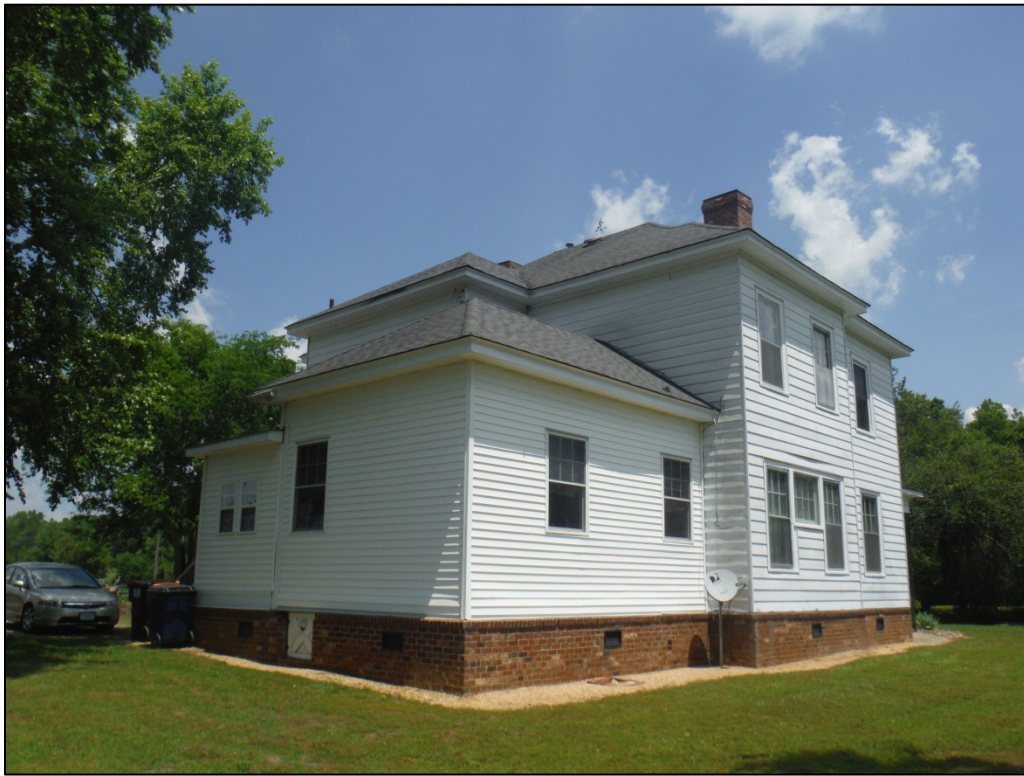
Behind the front section of the house, three cross-hips intersect: two-bay projections from both the north and south elevations and a two-bay projection at the rear of the house (Figures 41–44). This arrangement gives the illusion of an American Foursquare style home from the front elevation, while the actual house is much larger. A single-story, hipped-roof addition has been appended to the rear elevation of the house, as has a small, shed-roofed addition that could be the enclosure of a rear porch (Figure 45).

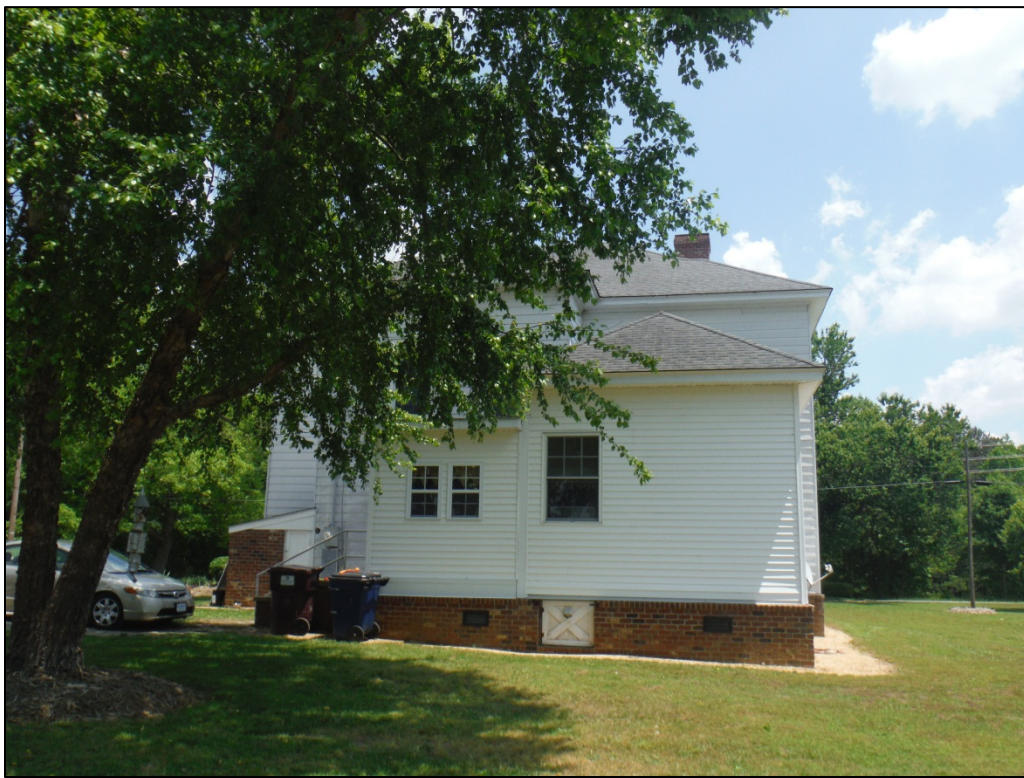
Figure 45. View of Parrish Farms house, rear elevation, facing east.

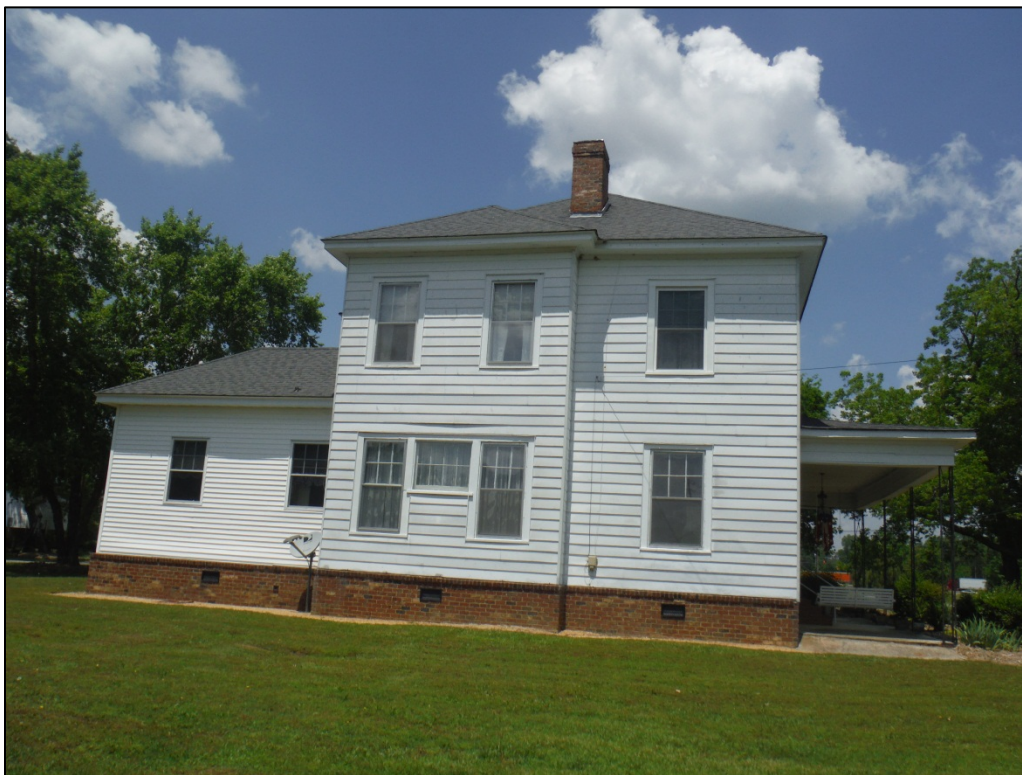
Figure 46. View of Parrish Farms house, south elevation, facing north.

Fenestration on the house consists primarily of wooden, six-over-one sash windows, although the south elevation has an eight light casement window located between two of its first story windows, creating an irregular tripartite configuration (Figure 46). The windows on the single story rear addition are also six-over-one sash, but are made of vinyl, with smaller four-over-four sash windows located on the enclosed rear porch. The house is sheathed in aluminum siding and the roof, which has wide eave overhangs, is covered with composition shingles. The owner could not be contacted and no information on the interior condition of the house was obtained.

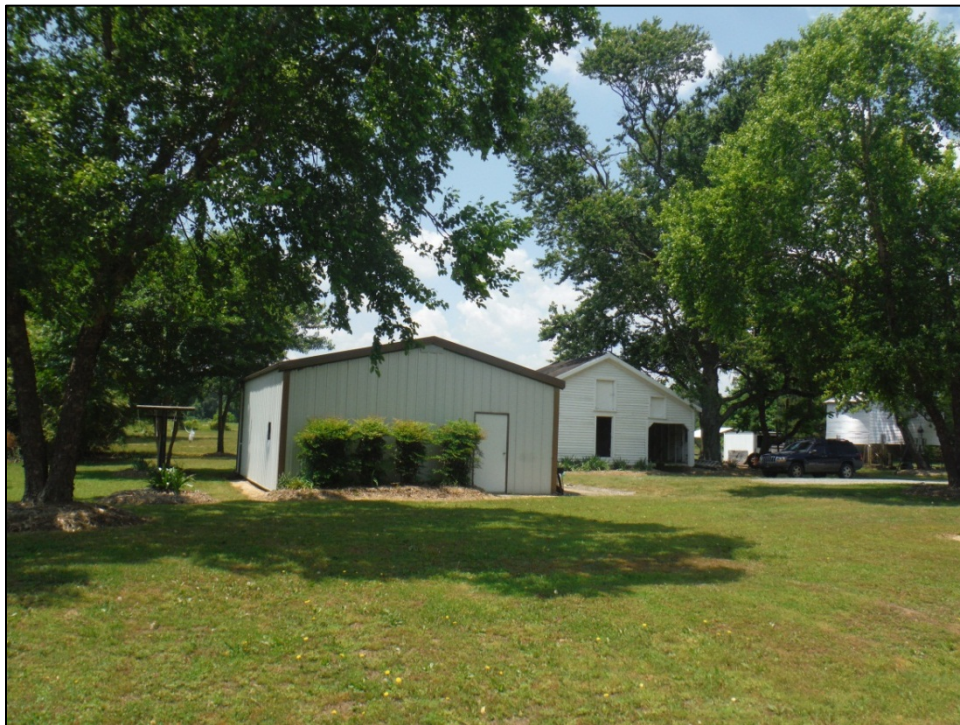
Closest to the house, directly to the west, is a modern metal garage (Figure 50). The garage has a gabled roof, with two overhead doors in the northern elevation and a human-sized door in the eastern elevation (Figure 51).

Figure 51. Outbuildings at Parrish Farms property, facing west.

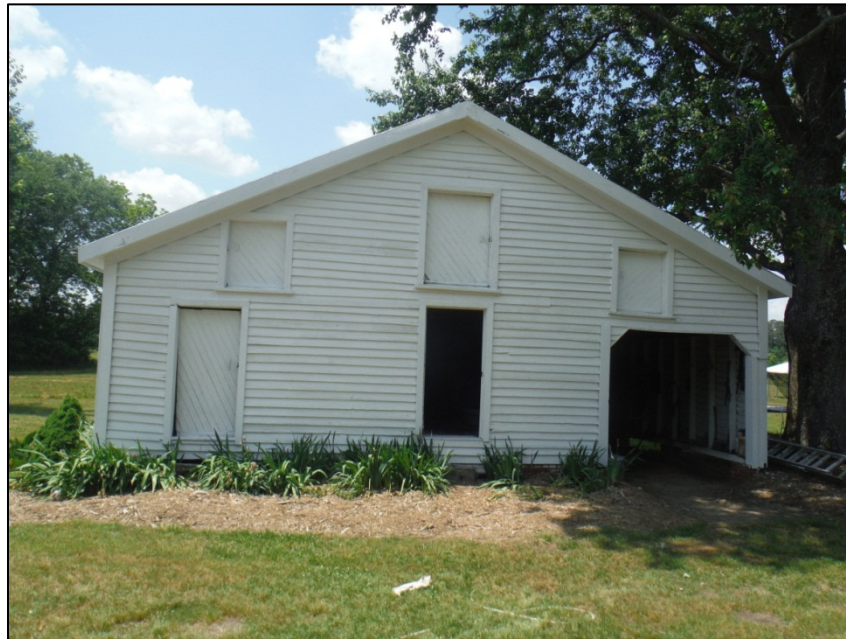
Figure 52. Barn at Parrish Farms property, facing west.

To the west of the garage is a two-story, wooden barn structure, dating to the early-twentieth century, which is currently used for storage and mechanical equipment (Figure 52). The barn has a front gabled roof, with a central doorway; to the north is a bay opening and to the south is another doorway. The upper story of the front elevation has four loft openings. The rear of the barn/storage building has a small, six-pane wooden sash window centered in it and a flat-roofed lean-to projection, supported by square wooden posts (Figure 53). The building is sheathed in horizontal wooden siding and has a standing-seam-metal roof.
