SUBJECT: Historic Structures Survey Report for the US 70 Improvements from West of SR 2566
To West of SR 1915, W-5600, Johnston County, ER 14-2332

**HISTORIC ARCHITECTURAL ANALYSIS OF
FIVE PROPERTIES IN THE W-5600 PROJECT AREA
IMPROVEMENTS TO US 70 FROM WEST OF SR 2566
(SADISCO ROAD) TO WEST OF SR 1915 (TURNAGE ROAD)
JOHNSTON COUNTY, NORTH CAROLINA**

FINAL REPORT
TIP No. W-5600; WBS No. 50056.1.1
Federal Aid No. HSIP-0070(163); Tracking No. 12-08-0007

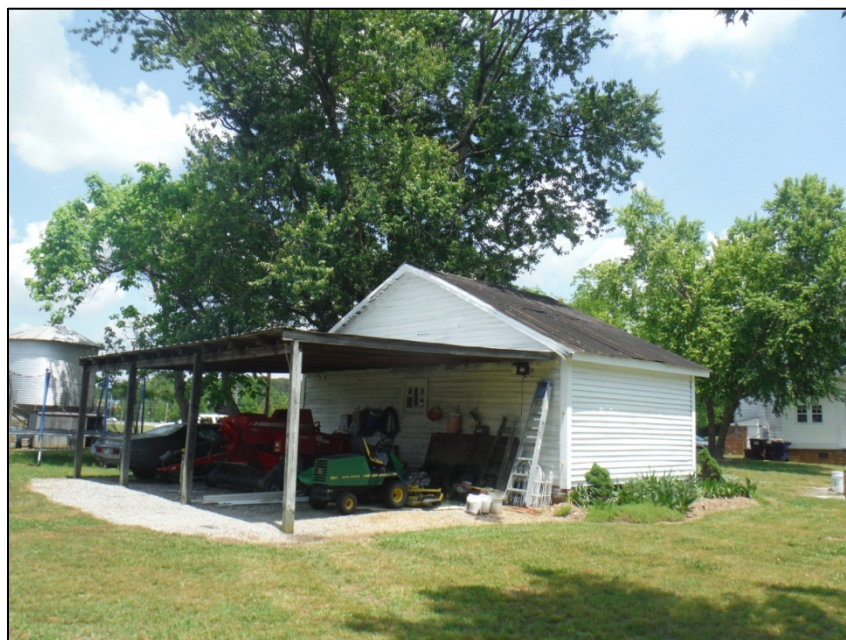
Figure 53. Converted barn at Parrish Farms property, facing north.

To the west of the garage is a two-story, wooden barn structure, dating to the early-twentieth century, which is currently used for storage and mechanical equipment (Figure 52). The barn has a front gabled roof, with a central doorway; to the north is a bay opening and to the south is another doorway. The upper story of the front elevation has four loft openings. The rear of the barn/storage building has a small, six-pane wooden sash window centered in it and a flat-roofed lean-to projection, supported by square wooden posts (Figure 53). The building is sheathed in horizontal wooden siding and has a standing-seam-metal roof.

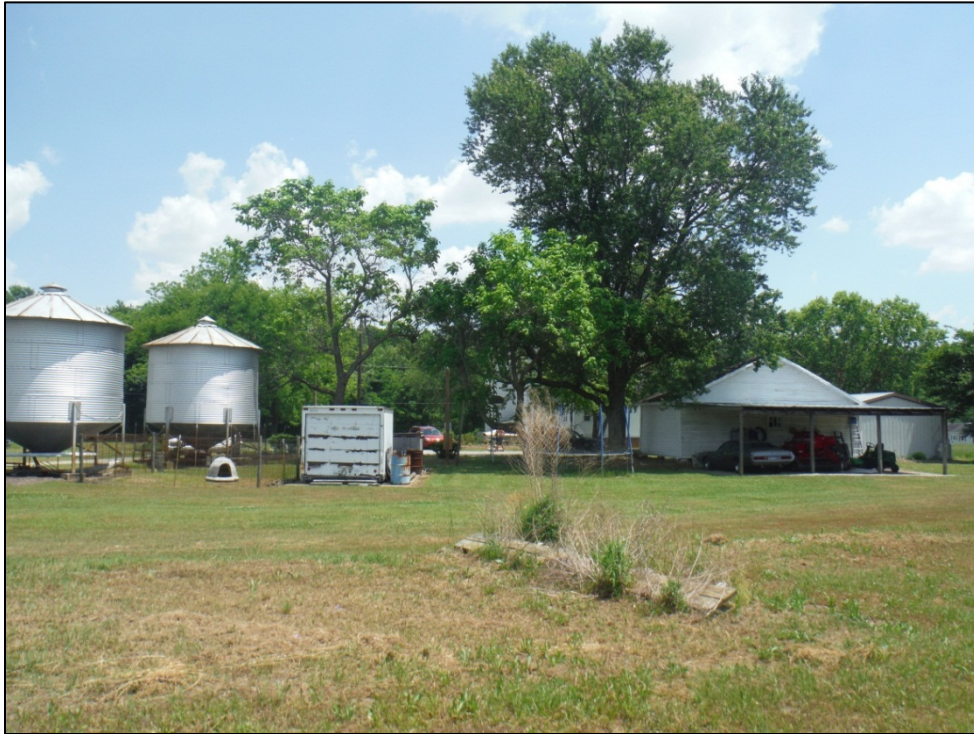
North of the barn are two, freestanding, metal grain silos, which date to the late 1960s, and an open metal shelter (Figures 54 and 55).

Figure 54. Silos and outbuildings at Parrish Farms property, facing east.

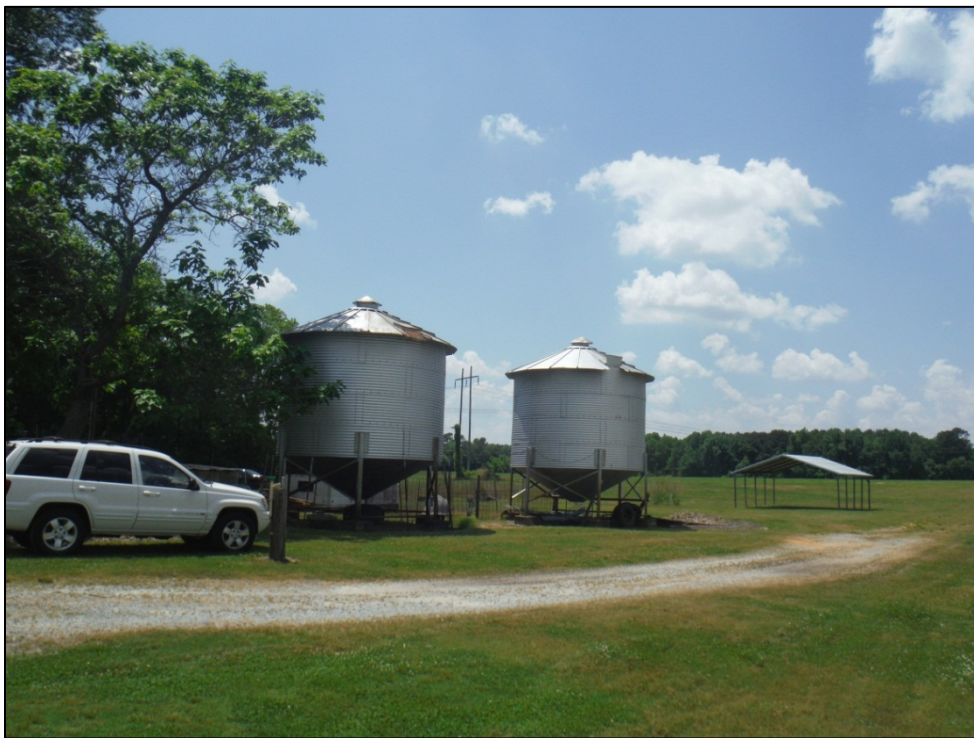
Figure 55. Silos and metal shelter at Parrish Farms property, facing southwest.

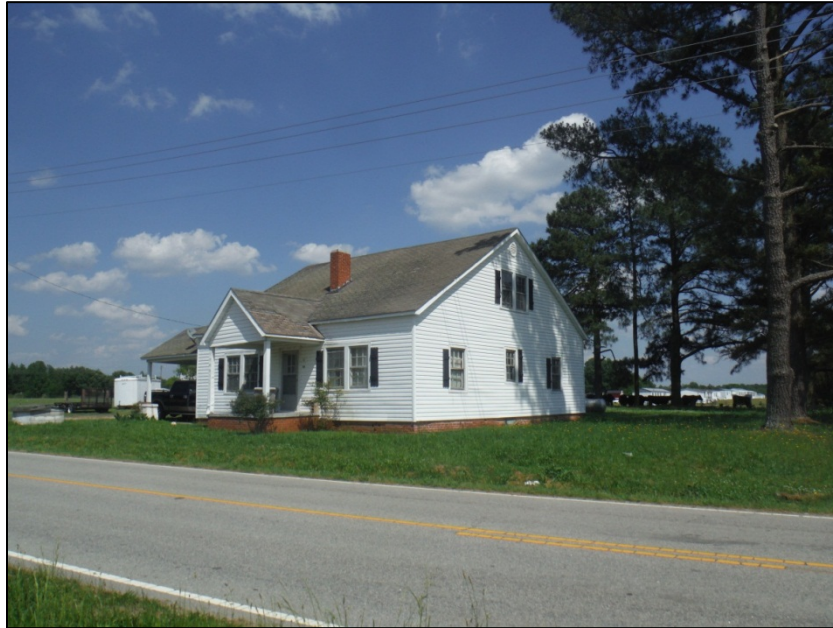
Figure 63. View of the Jones House, front elevation, facing northeast.

The south elevation of the house has three single six-over-six sash windows on the first story, with a paired six-over-six sash window centered in the gable; the rear of the house also has single six-over-six sash windows, as well as a shed-roofed porch and a truncated exterior brick chimney (Figures 63, 64, and 65). The north elevation has an entry door, located beneath a gabled carport that is supported by square posts, with two paired six-over-six sash windows to the east and a paired six-over-six sash window, which is covered in plywood, centered in the gable (Figure 66). The house is currently sheathed in vinyl siding, which was completed by the current owner in the 1970s; no information on the interior condition of the house was shared by the owner (Kenneth Jones personal interview, 2014).

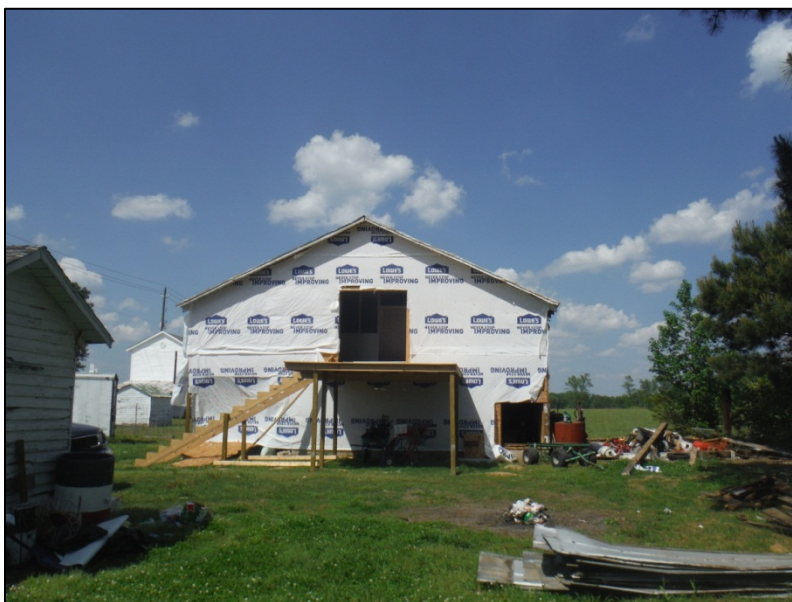
Figure 67. View of the Jones House barn, facing north.

The property associated with the Jones House and Barn is currently just over three acres, although it is part of a historically larger parcel of land that was subdivided in the 1990s and 2000s. The house is centered in the parcel, close to Swift Creek Road; surrounding the house are outbuildings of various ages and former agricultural fields, which are used for grazing cattle (Figure 62). To the north of the house is a large gabled, wooden barn structure dating to the 1920s to early-1930s (Figure 67). The two-story barn has a large loft doorway opening and is currently undergoing renovations. The roof is sheathed in standing-seam-metal and there are visible rafter tails (Figure 68). The exterior is being wrapped in a vapor barrier, and a raised deck has been constructed to allow entry into the loft door. The interior is being divided using studded walls and drywall, indicating conversion into a finished space.

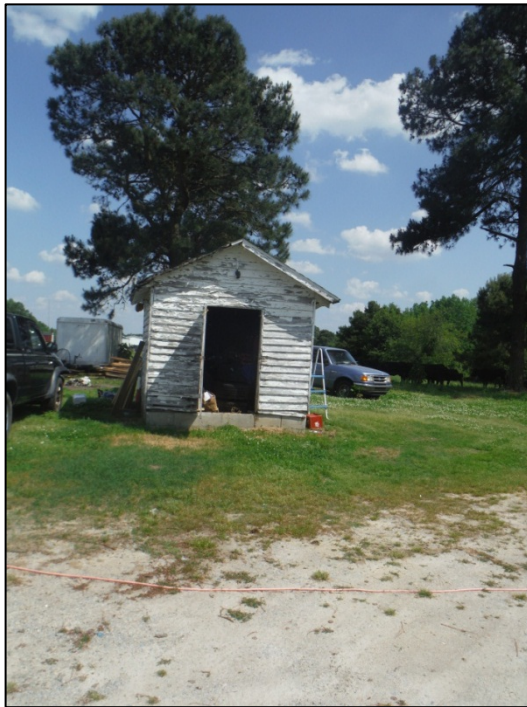
East of the house, to the south of the barn, is a small, wooden, gabled shed building (Figures 69 and 70). The shed, which dates to the early-twentieth century, sits on a concrete block foundation and has a doorway centered in its west elevation. The roof is sheathed with composition shingles and it has visible rafter tails.

Figure 69. View of Jones House shed, facing east.

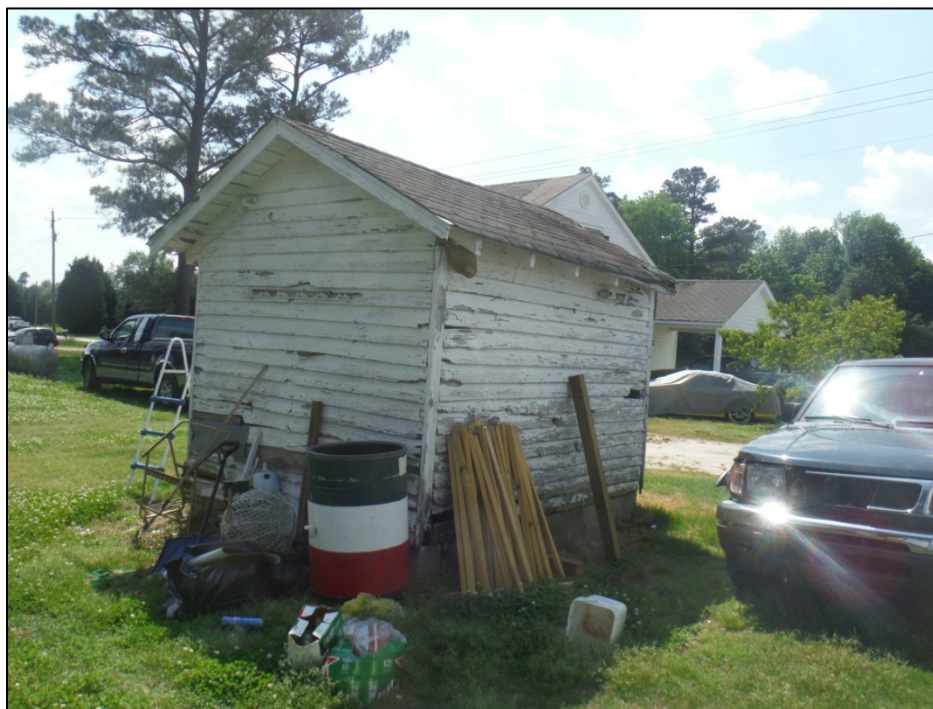
Figure 70. View of Jones House shed, facing south southwest.

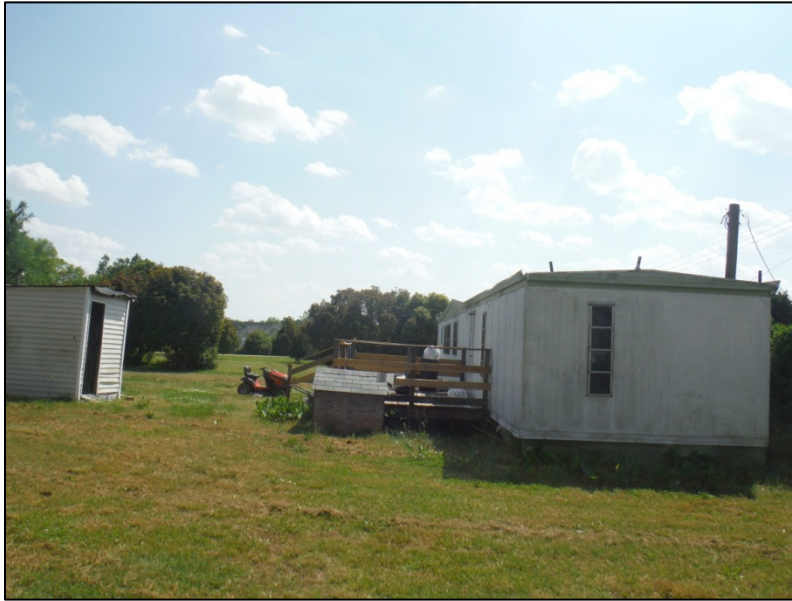
Figure 71. View of trailer and storage building on the Jones House property, facing south.

Southeast of the house is a trailer and a small, shed roofed, frame storage building, both dating to the early 1980s (Figure 71).

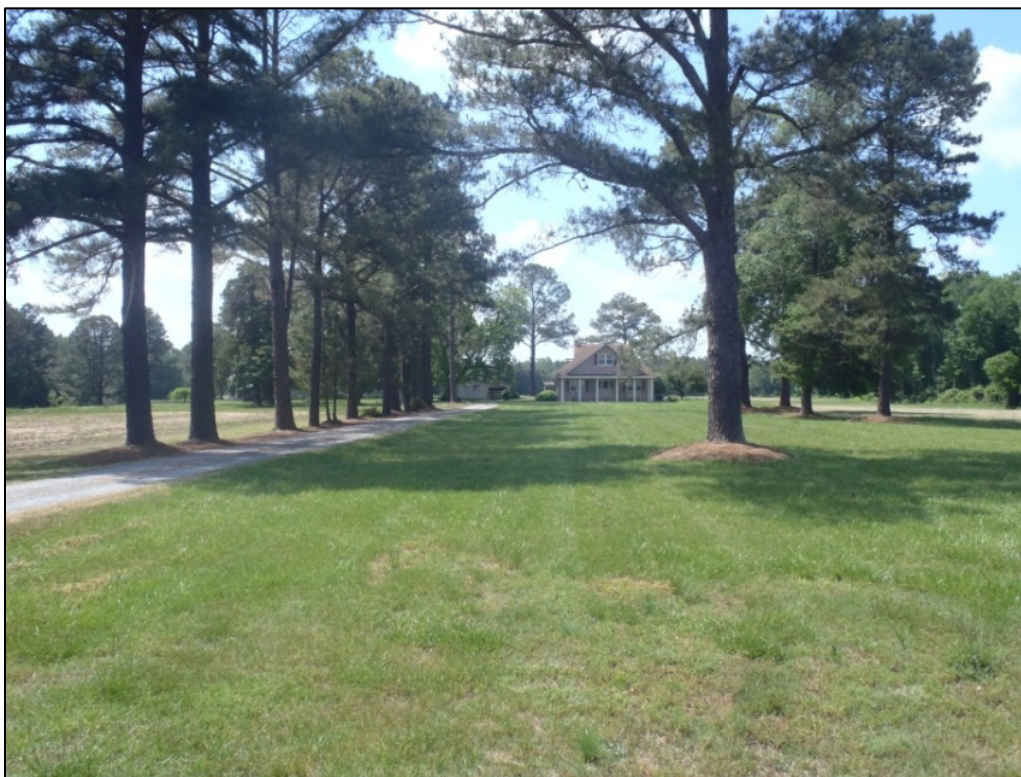
Figure 72. View of the Langston House and Outbuildings property (PIN 168600-74-2405) from Swift Creek Road, facing west.

The Langston House and Outbuildings (PIN 168600-74-2405) property is located at 814 Swift Creek Road (Figures 2 and 3) and consists of a one-and-one-half-story house, a carport/storage building, a shed, and a large barn/storage building (Figure 72 and 73). The house dates to the early-twentieth century, although it underwent significant remodeling in the 1960s. The owner did not allow interior access, but confirmed that the house's original plan had been altered (personal interview with Marjorie Langston, 2014).

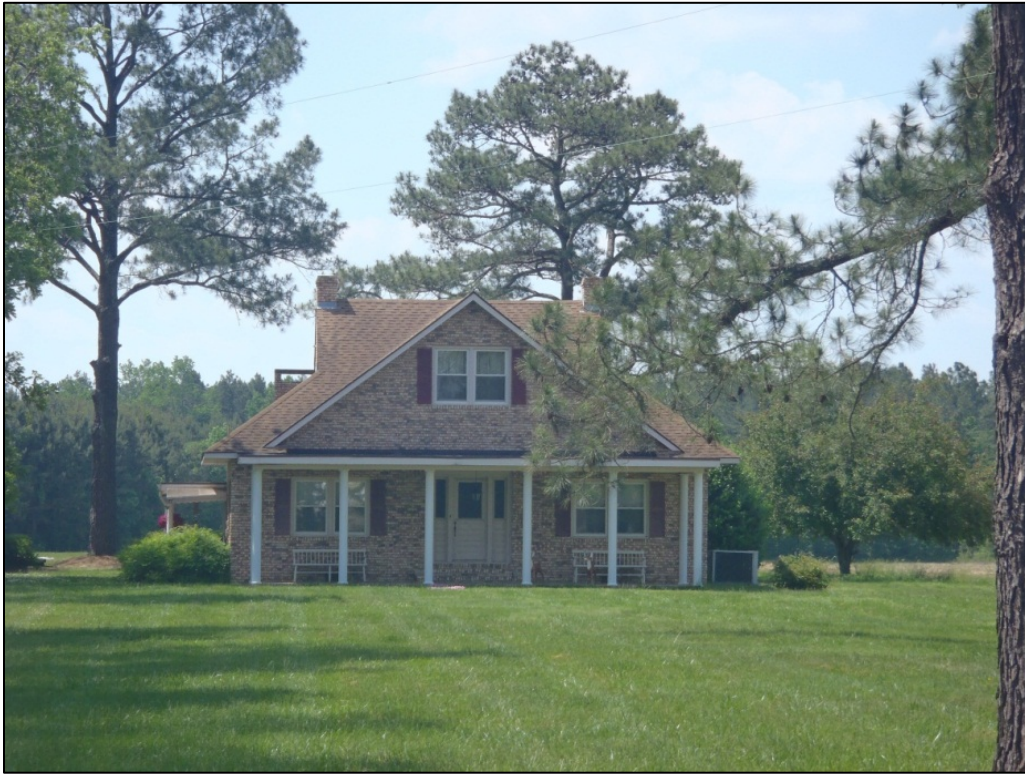
Figure 74. View of Langston House, front elevation, facing west.

The house, which is of frame construction with brick veneer, has an L-shaped floor plan with an irregular roofline. The main section of the house is rectangular, with a Dutch hip roof (gable-on-hip) and front gabled section that spans the entire front elevation (Figures 74 and 75). A flat roofed portico, supported by Tuscan columns, spans the front elevation. Centered beneath the porch is an entry door, with single-pane sidelights; the raised height of the door, which is accessed by brick stairs, indicates that the current portico may be a replacement for an earlier raised porch. Paired one-over-one vinyl sash windows flank the doorway and a paired one-over-one sash window is centered in the gable. Brick chimneys are visible in the Dutch gables, above the hipped portion of the roof.

The house has been significantly altered during the mid-twentieth century, making its original form undiscernible. The addition of brick veneer, removal of the original porch, replacement of windows, and the multiple additions have compromised the integrity of design.

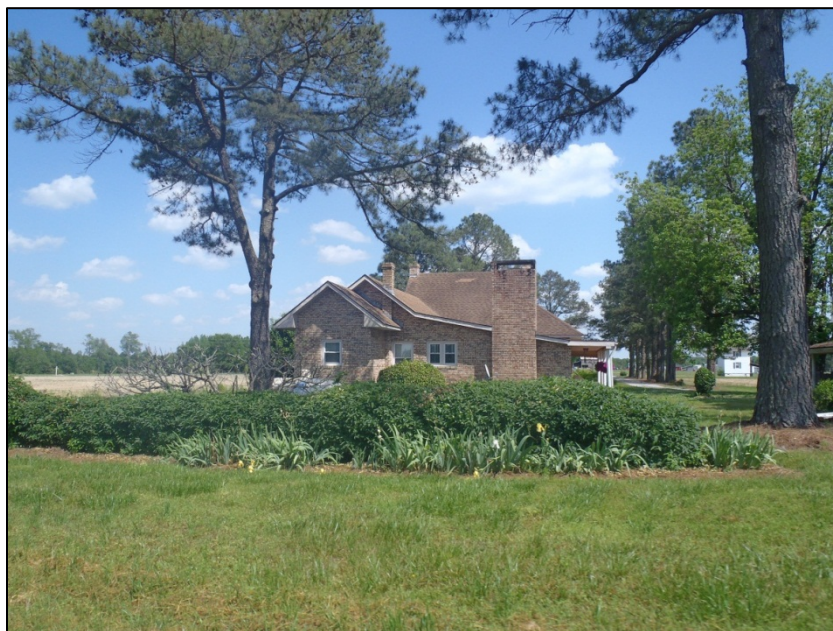
Figure 76. View of Langston House, rear elevation, facing east.

A single-story, gabled addition extends from the rear of the main block, with a second gabled room addition attached to its rear elevation; a shed-roofed extension, formed between the ell of the main house and the addition, has also been enclosed (Figure 76).

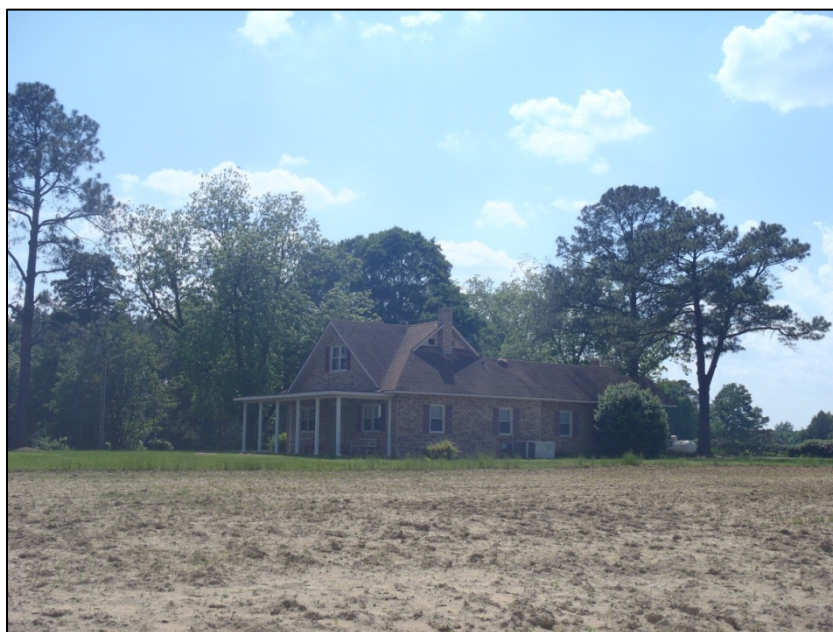
Figure 77. Oblique view of Langston House, facing southwest.

A flat-roofed patio, supported by Tuscan columns, is also visible along this addition, as is a prominent exterior chimney. Fenestration on the house and additions consists of vinyl sash windows with one-over-one light configuration. The house sits back from Swift Creek Road, surrounded by deciduous trees and untilled former farmland (Figure 77).

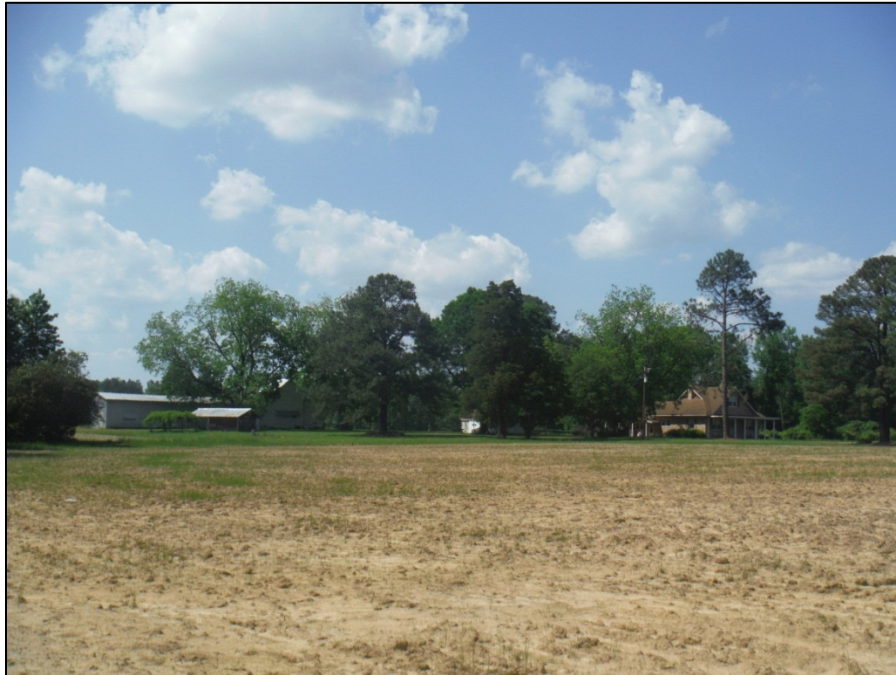
Figure 78. View of Langston House, with outbuildings and landscape, facing northwest.

The Langston House and Outbuildings are situated on approximately 57.5 acres of land, much of which was once used for agriculture but now lay fallow. Three outbuildings remain on the property, located southeast of the house (Figure 78). A small, rectangular frame structure, with a gable roof, is located at the end of the property's driveway, behind a small stand of trees; it dates to the early-twentieth century (Figure 79). The building has an off-center door and a two light, horizontal sliding window on its east elevation.

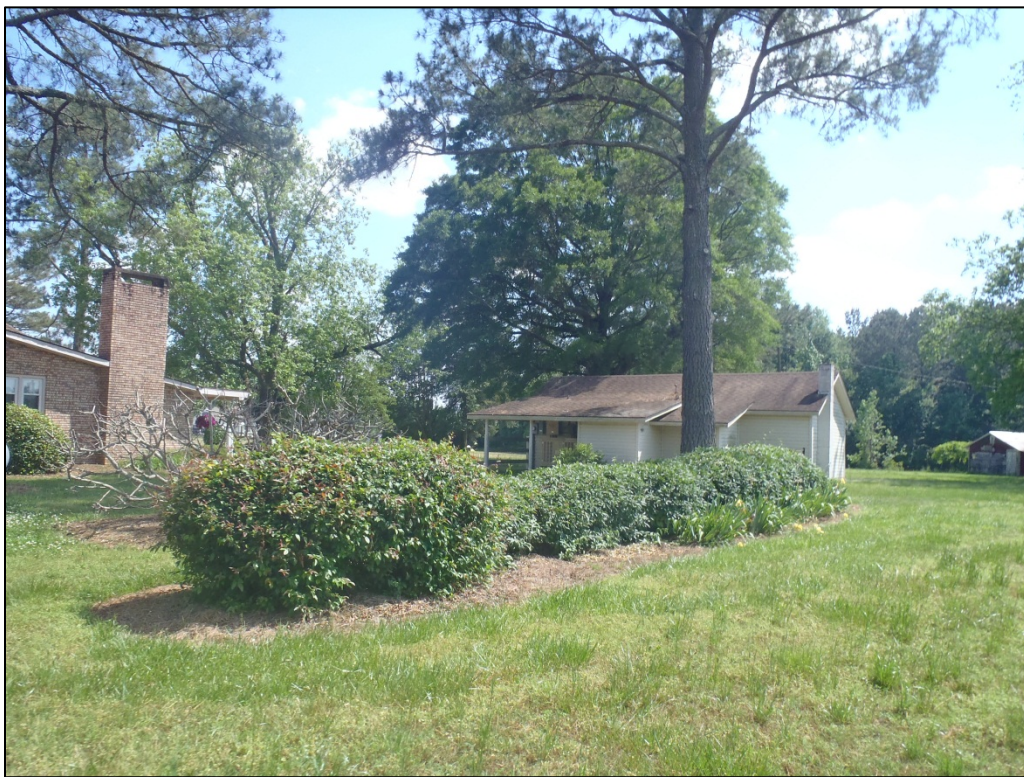
Figure 80. Garage at Langston House property, oblique view, facing east.

Symmetrical shed-roofed projections, supported by round posts, extend from both the north and south elevations; a portion of the northern projection has been enclosed and a smaller shed-roofed addition has been added behind it (Figure 80). The rear elevation of the building has an exterior chimney and a two-over-two aluminum sash window. The building, which is now covered in vinyl siding and has a composition shingle roof, is currently used as a carport and storage area, although its original use was likely as a workshop or multi-purpose building when the property was utilized for farming.

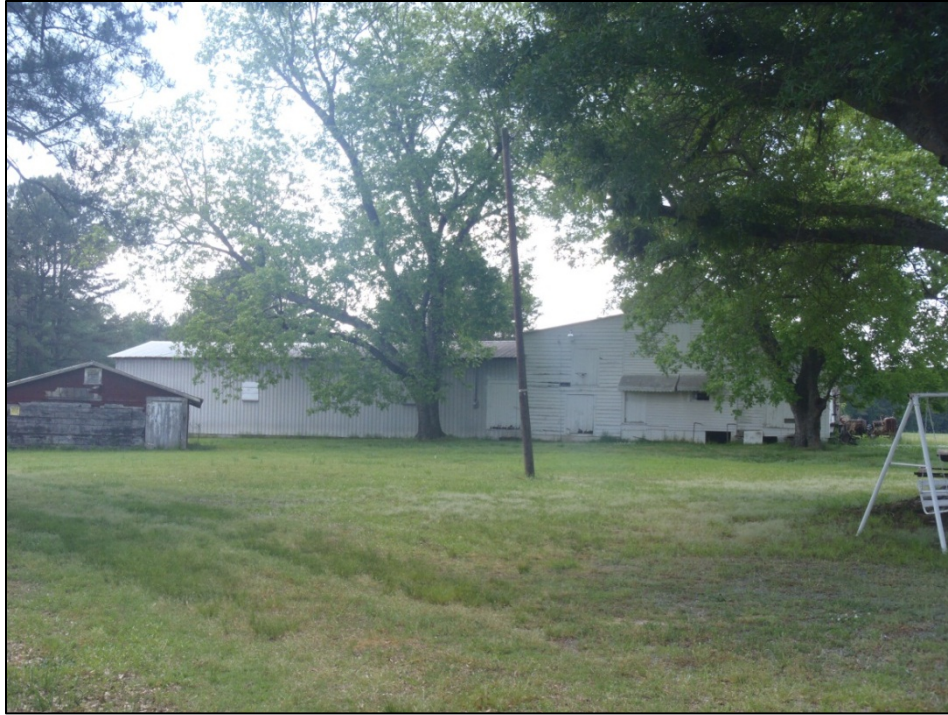
Located west of the carport/storage building is a large barn structure that was built in multiple stages during the early-twentieth century. The central block is a front-gabled, frame structure sitting on a block-pier foundation (Figure 81). Abutting the north elevation of this structure is a smaller, older gabled, wooden barn, sitting on a stone pier foundation, which is without a roof on its rear portion and beginning to deteriorate (Figure 82). To the south of the central barn block is a shed-roofed extension of the barn, which may have originally been open but is now enclosed. There are multiple doorways on the first story, as well as loft doors on the upper story; a single human-sized door is located within the central block. The front portion of this part of the barn is sheathed with horizontal wooden siding, of various widths, while the back and north sides are covered with a combination of horizontal siding and vertical metal siding.

Figure 81. Barn and shed at Langston House property, facing southwest.

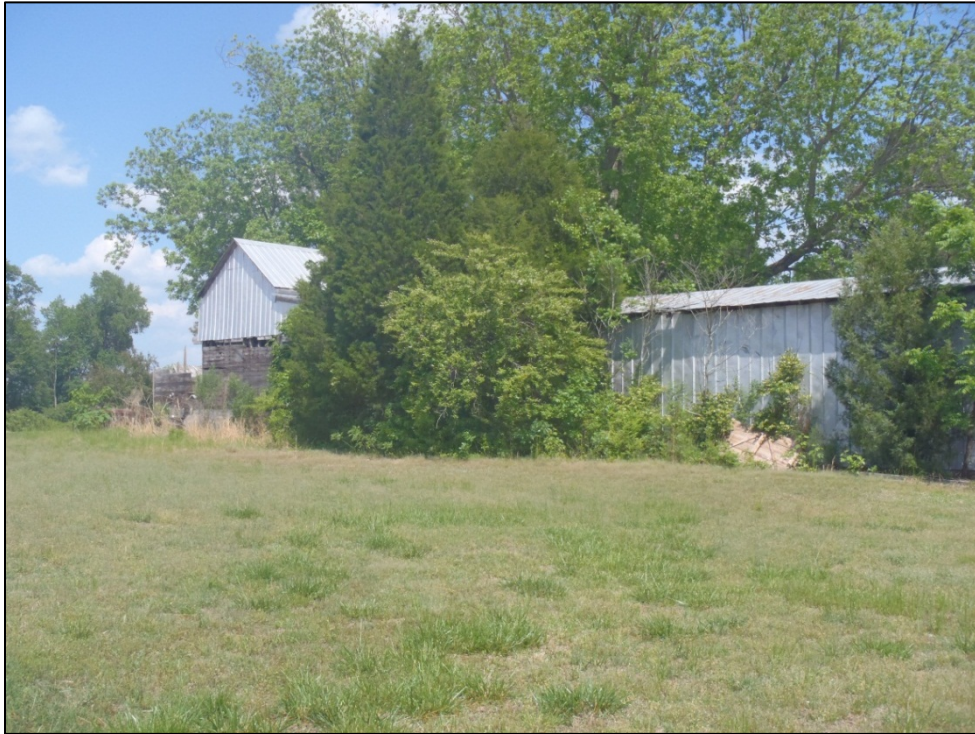
Figure 83. Barn at Langston House property, rear elevation, facing northeast.

Appended directly to the south side of this barn structure, perpendicular to the wooden structure, is a single-story, rectangular metal storage building with a gabled roof (Figures 81, 83, and 84).

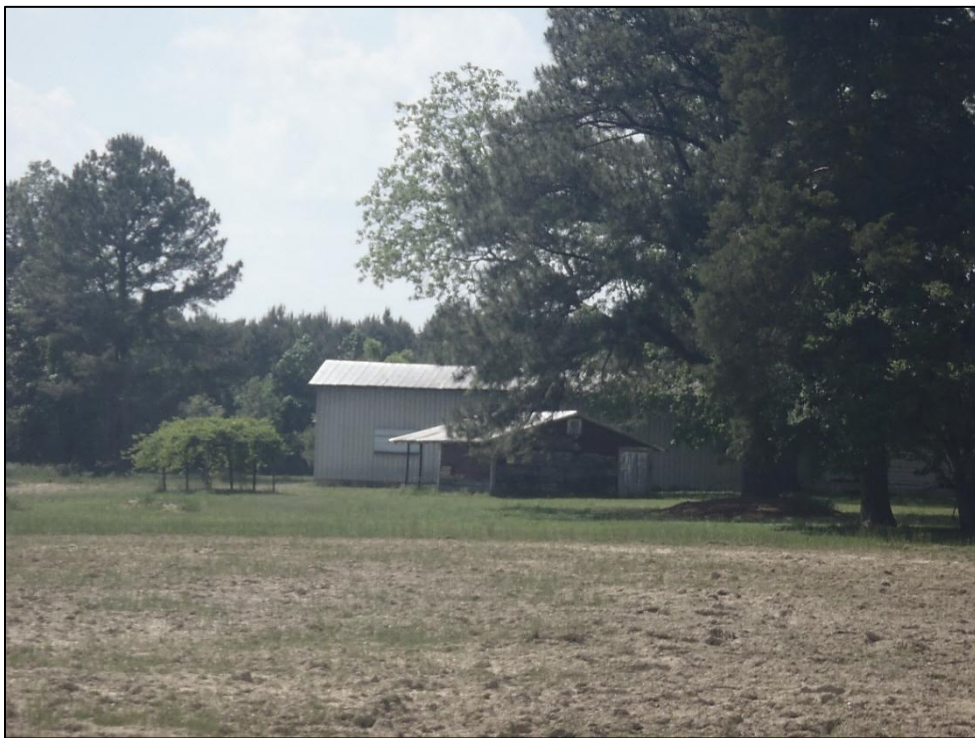
Figure 84. Barn and shed at Langston House property, facing east.

East of the metal storage building that is attached to the barn, is a single-story, frame structure with a low-pitched gable roof (Figures 84 and 85). The central portion of the building is enclosed, with a vent centered in the gable, while on either side is a shed-roofed projection created from the extension of the main roof. The projection on the northwest elevation of the building has been enclosed. The wooden siding on the building has been patched, potentially covering an additional doorway, and is in poor condition. The building, which has a standing-seam-metal roof, is currently used for storage but may have been an implement shed when the property was used as a farm.

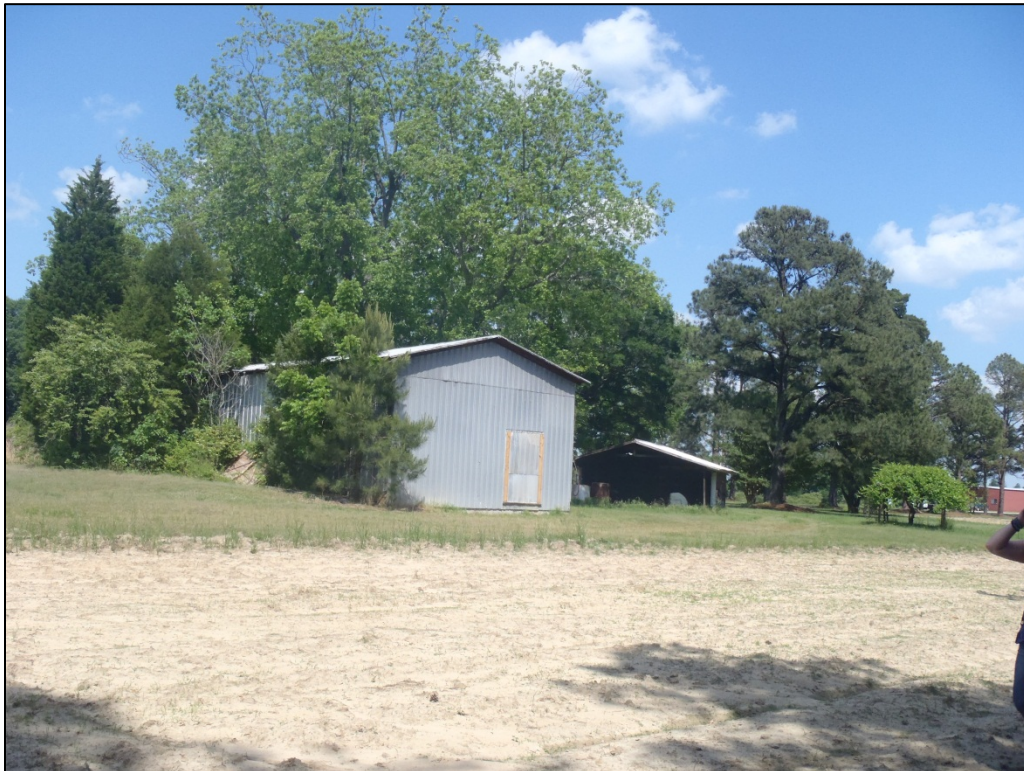
Figure 85. Barn and shed at Langston House property, facing northeast.

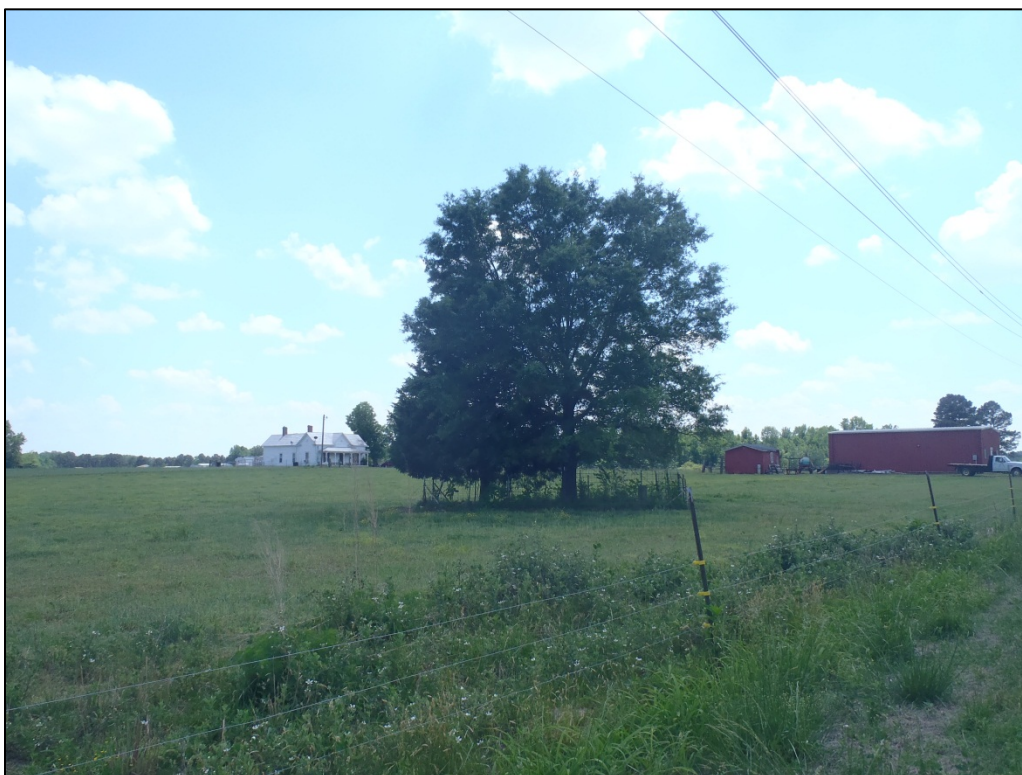
Figure 87. View of the Lassiter Cemetery (PIN 168600-84-3292) from Swift Creek Road, facing southeast.

The Lassiter Cemetery (PIN 168600-84-3292) is a 0.08-acre outparcel, located just east of Swift Creek Road and surrounded by the Jones Farm property (Figures 2 and 3). The cemetery is rectangular, oriented on a roughly northeast-southwest axis, and is surrounded by a modern wire fence supported by metal stakes (Figure 87). The cemetery contains three graves, marked by two headstones and three footstones; the headstones are smooth marble with inscriptions, while the footstones are rough cut marble (Figure 92). Within the boundary of the fence, there are also two deciduous trees and the remnants of an older, decorative wire fence, including support posts and a metal gate (Figures 88 and 89).

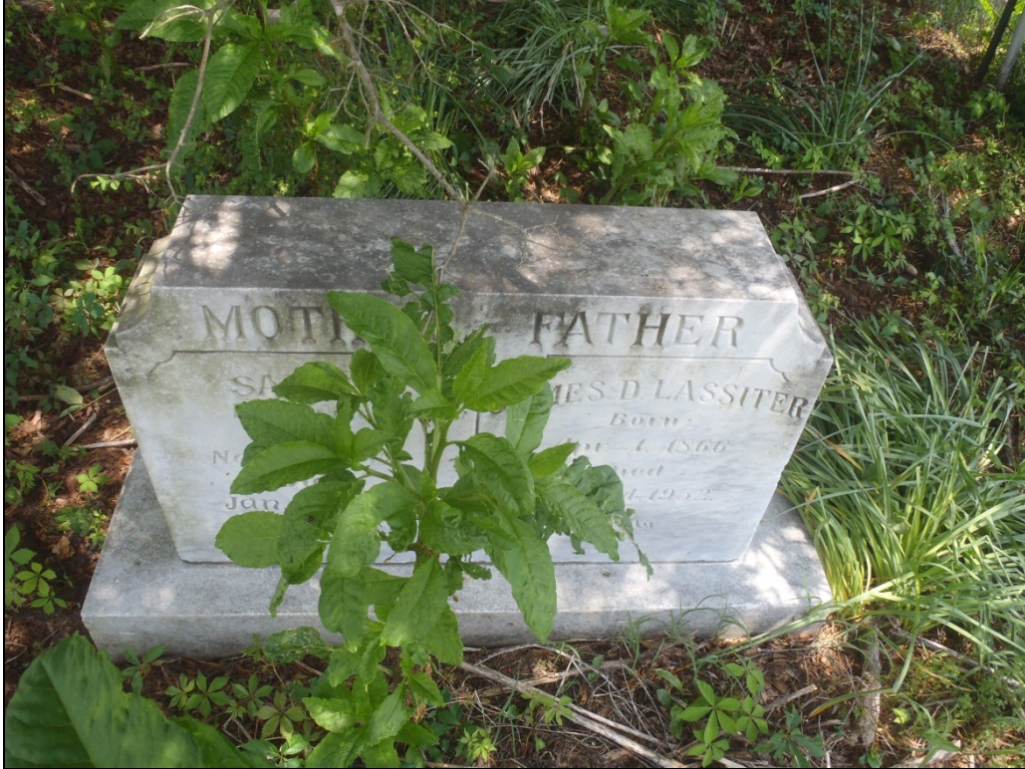
Figure 90. View of James D. and Sarah Lassiter grave in Lassiter Cemetery, facing south northeast.

The largest grave marker in the cemetery, which is situated at the southern edge of the parcel, is the die on base marble stone of James D. (Daniel) and Sarah Lassiter, who were the owners of the surrounding farm property in the early-twentieth century (Figure 90). The couple died in 1932 and 1945, respectively. The smaller grave marker is a simple marble tablet, for the infant son of David and Mabel Lassiter, who died in 1932; David Lassiter was the youngest son of James and Sarah Lassiter (Figure 91).
