RE: Construct South Parallel Taxiway & Other Airport Improvements, Statesville Regional Airport,  
Iredell County, ER 15-1393

# Historic Structure Survey Report

## Statesville Regional Airport

Iredell County, North Carolina

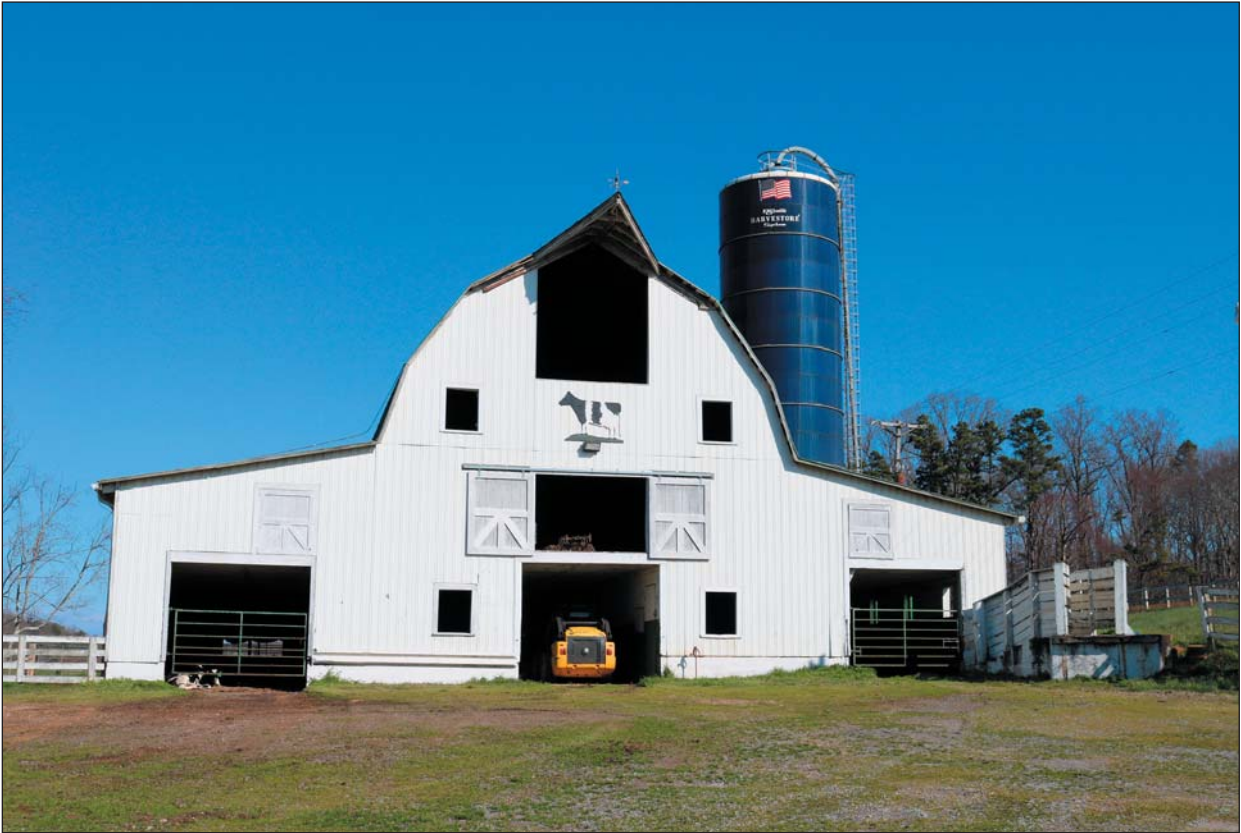
Figure 5.  
Stamey Farm Barn Façade and Southern Elevation, Looking North

The Stamey Farm Barn (ID1858) is about 650 feet north of Hickory Highway on a parcel of about 333 acres (Figures 5 and 6). The associated pasture and feeding areas are partitioned with four-rail wooden fencing. Fencing of the same type lines the access road to the southern elevation and main entrance to the building. A modern, low-oxygen tower silo sits at its northwestern elevation. West of the pastures are forested areas near Back Creek. Pasture and woodlands occupy several hundred acres to the east and connect to the other Stamey Farm complex.

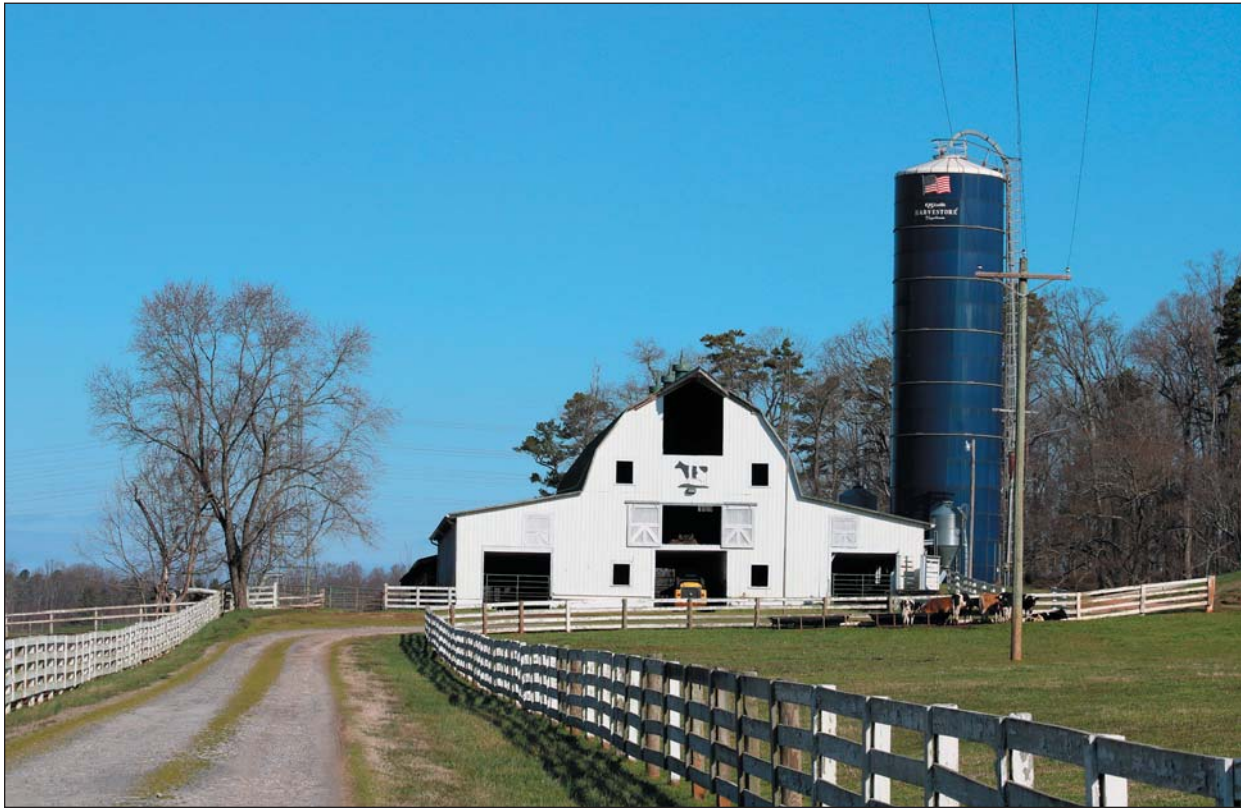
Figure 7.  
Stamey Farm Barn Approach from Right of Way of US Highway 70, Facing North

The Stamey Farm Barn (ID1858) is a center-aisle dairy barn with 18 stalls and hay-loft access in the gable-end of its gambrel roof (Figures 7-14). The barn is partly banked and the stall windows of the eastern elevation are level with the ground (Figure 8). The barn is constructed of shiplap wood and has a metal roof with metal ventilation shafts. The façade has been covered with raised-seam metal siding, but the original shiplap remains underneath (Figure 9). The first story hayloft has a box-rail, double board and batten doors. The second story loft access lacks doors. Board and batten doors in each side shed extension provide loft access (Figure 10). The openings to the shed extensions have seven-rail metal cattle gates. The center-aisle opening has no doors. There are nine windows on the eastern and western elevations that have removeable protective insulators. The historic board and batten doors on both elevations are present. The rafters of the eaves are visible. A detached low-oxygen forage silo is near the northeastern corner of the building (Figure 11). Pastures for dairy cows are aligned in front of the barn and parallel to Hickory Highway (US Highway 70) (Figures 13-14).

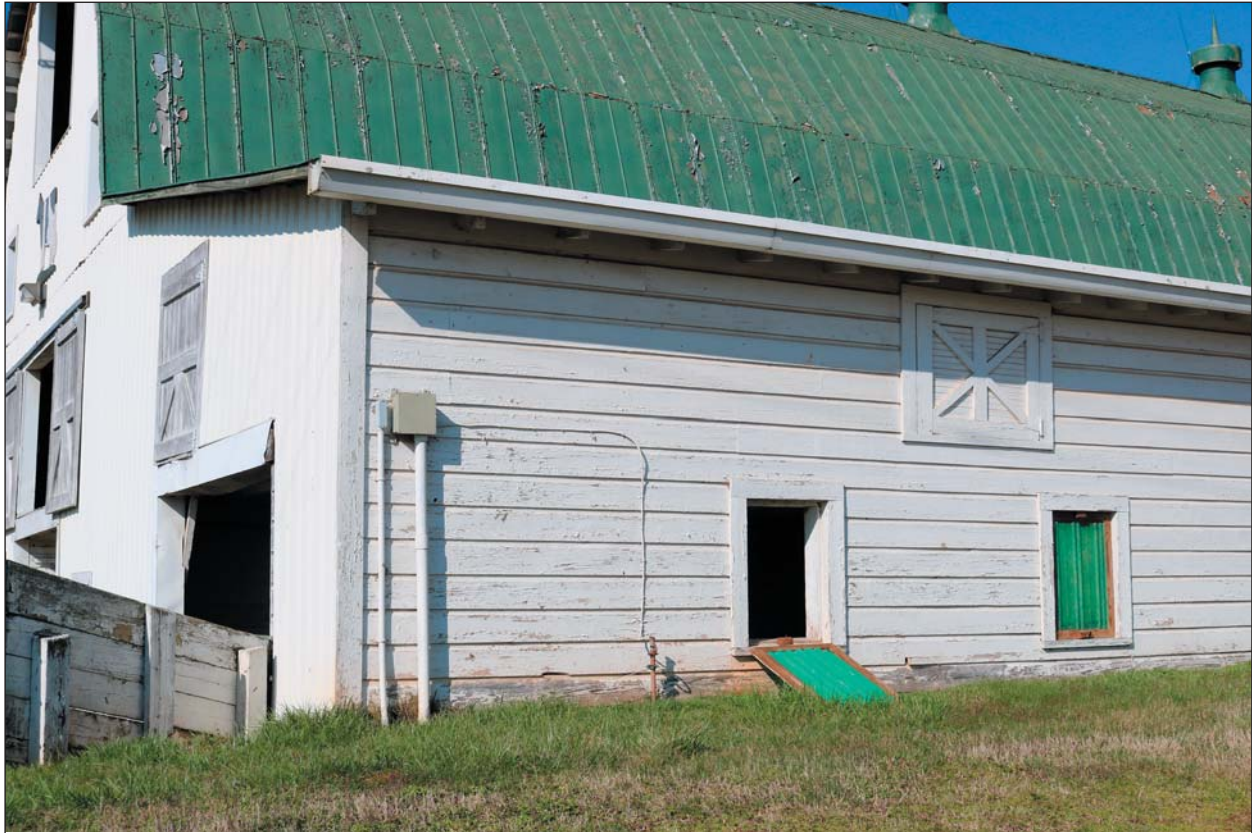
Figure 9.  
Stamey Farm Barn, Detail of Southeastern Elevation's Cladding and Shuttered Windows

The Stamey Farm Barn (ID1858) retains its historic setting off of Hickory Highway, southeast of the SRA. The original form and massing of the barn are intact. The uncommon, historic shiplap of the barn's exterior is present, the layout of the barn is intact, the barn loft access doors on the eastern and western elevations are intact. The interior of the center aisle's materials and method of construction are evident. Some historic windows do not have the board and batten doors and may be stored elsewhere, which is a common practice when ventilation is needed. The raised seam metal siding has been added to the façade, but the original shiplap is underneath. The barn faces south, and it is common in the Southeast to reinforce the exterior with another material to prevent strong southerly storm winds from damaging the main livestock areas. The historic metal roofing with ventilation shafts remains.

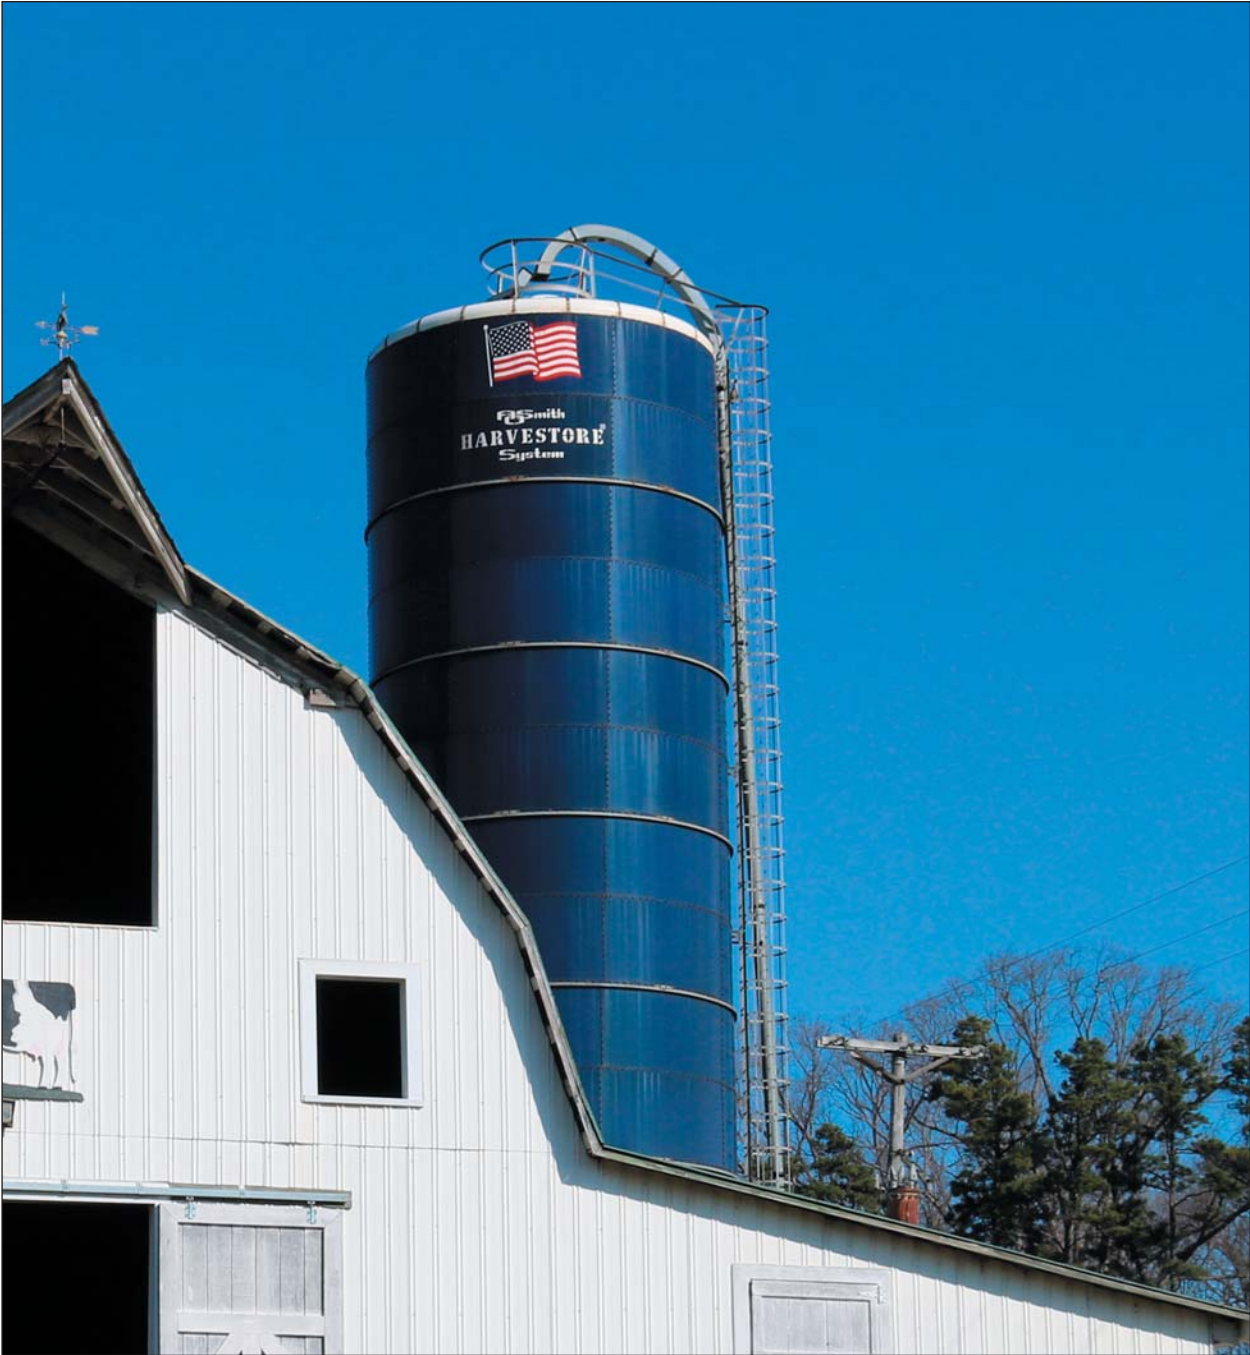
Figure 11.  
Stamey Farm Barn Silo, Facing North

The newly built Stamey Farm Barn low-oxygen silo is situated at the northeastern corner of the barn. It is constructed of steel on a concrete foundation (See Figure 11).

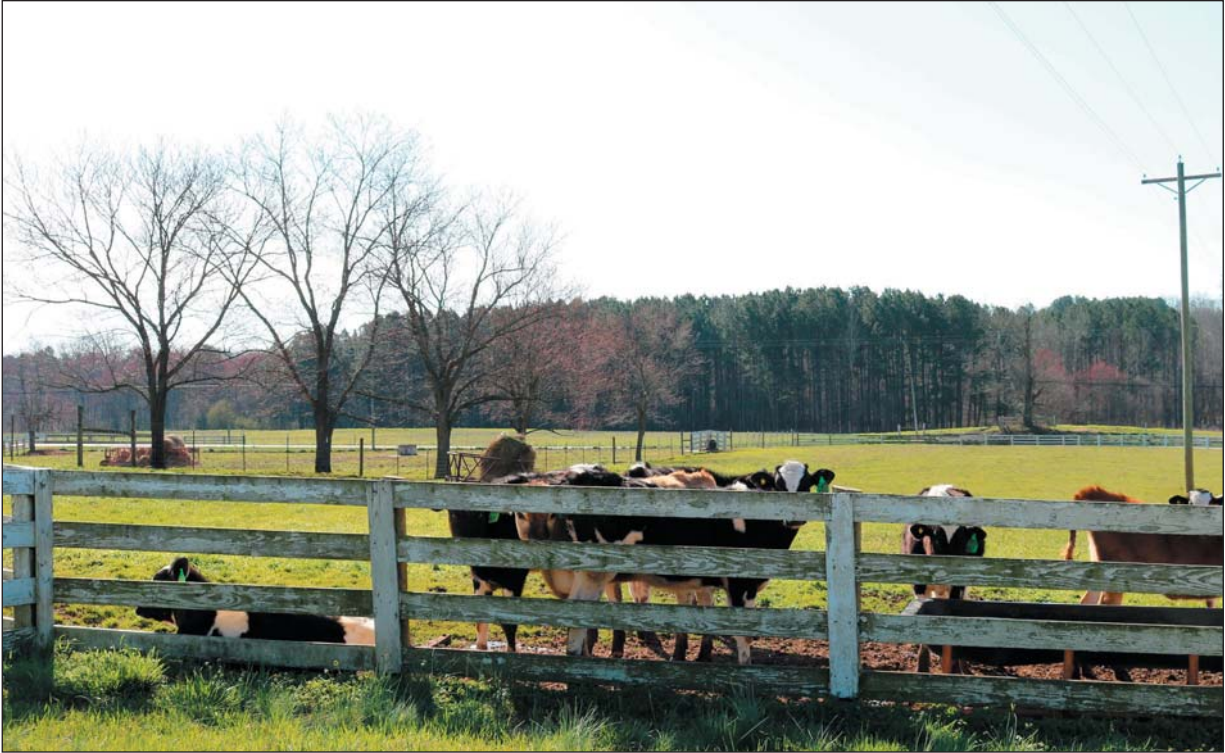
Figure 13.  
Stamey Farm Barn, Southern Pasture, Facing South

Most of the pastures and fencing associated with the Stamey Farm Barn lie east, south, and west of the barn, with a feed lot fenced close to the western elevation (See Figure 13). The fencing is wood plank with four rails and square four-by-eight posts spaced roughly every six feet.

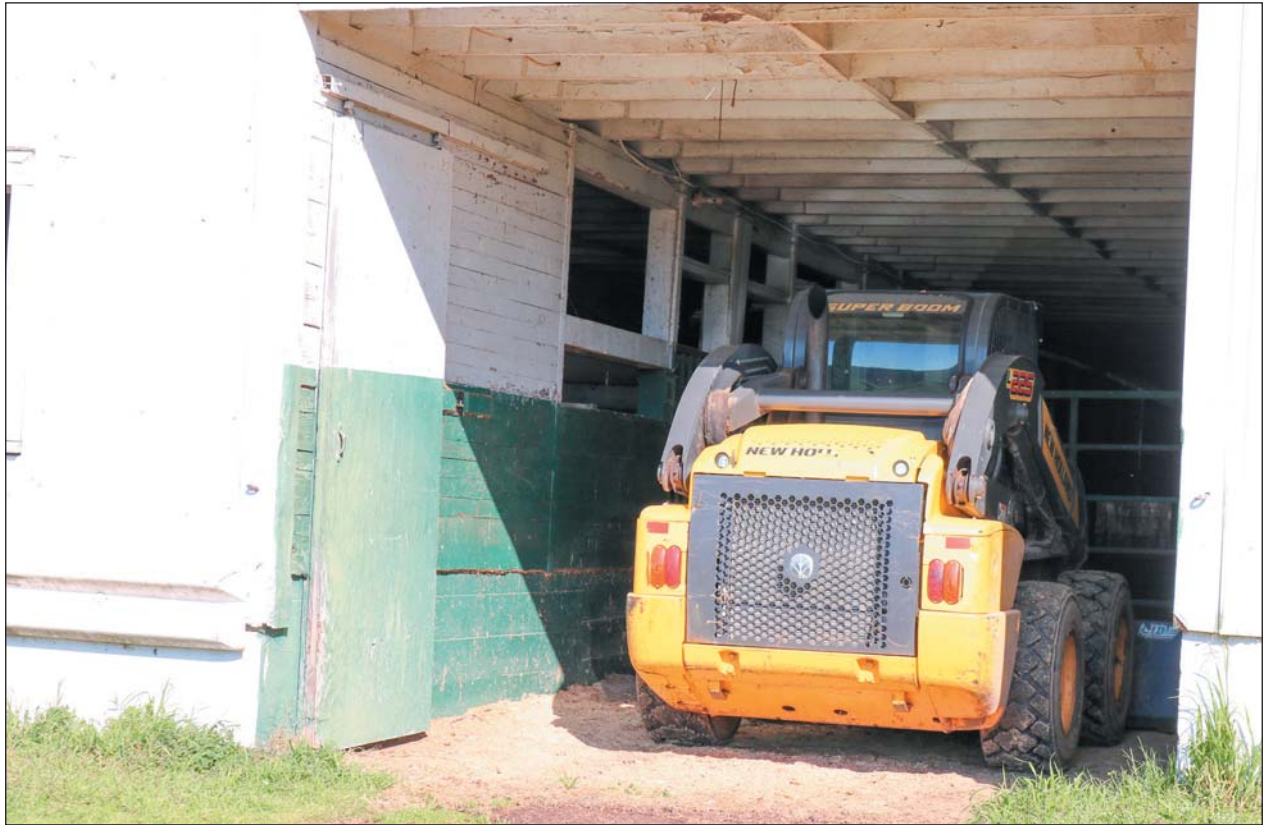
Figure 15.  
Stamey Farm Barn Interior View Through Center Aisle Doors, Facing North

The barn's interior could be seen through the center-aisle opening, (Figure 15). The historic board and plank interior is intact with historic box-rail, single panel doors and exposed loft joists. The historic steelwork of the bale winch and framework is visible through the third-story loft opening (Figure 16).

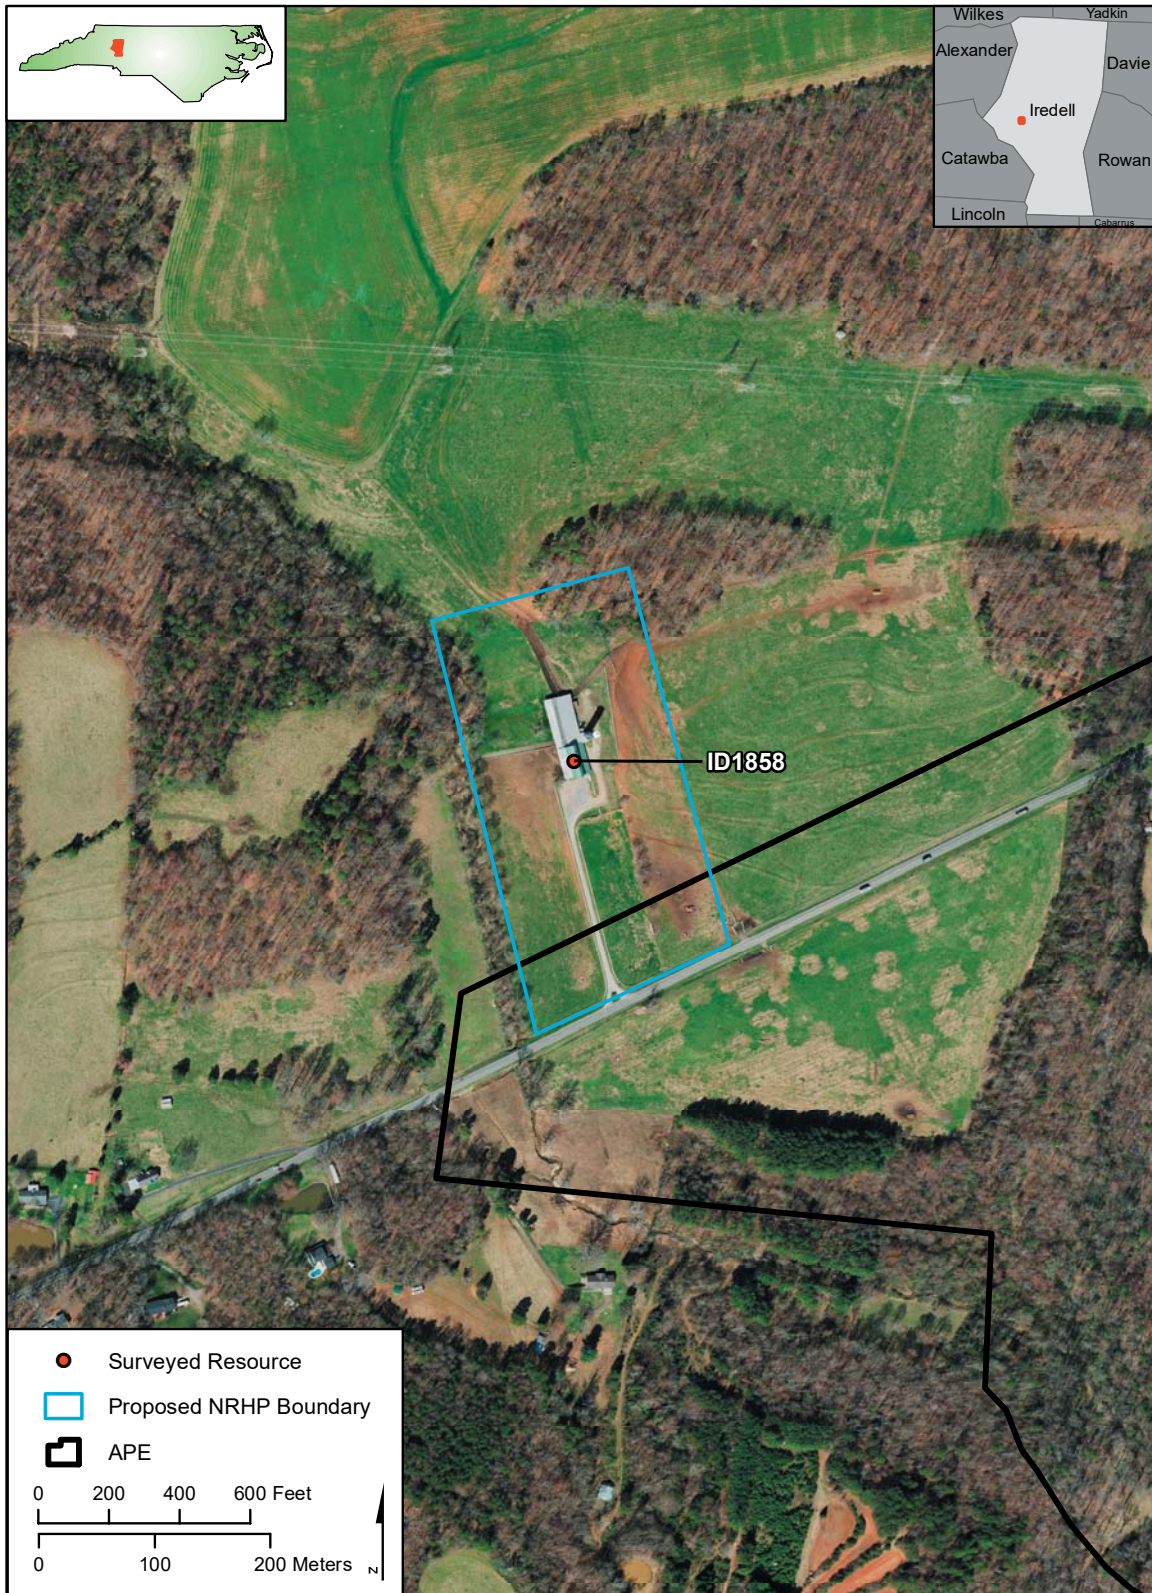
Figure 23.  
Recommended National Register District Boundaries for the Stamey Farm Barn

The recommended NRHP boundaries for the individual resource encompass a 300-foot buffer on all sides of the resource and continue to the highway along the driveway (Figure 23). This buffer is recommended to preserve a portion of its setting and is based upon a prior environmental review 04-0367 that suggests a similar buffer for the Iredell County Test Barn (ID1080).

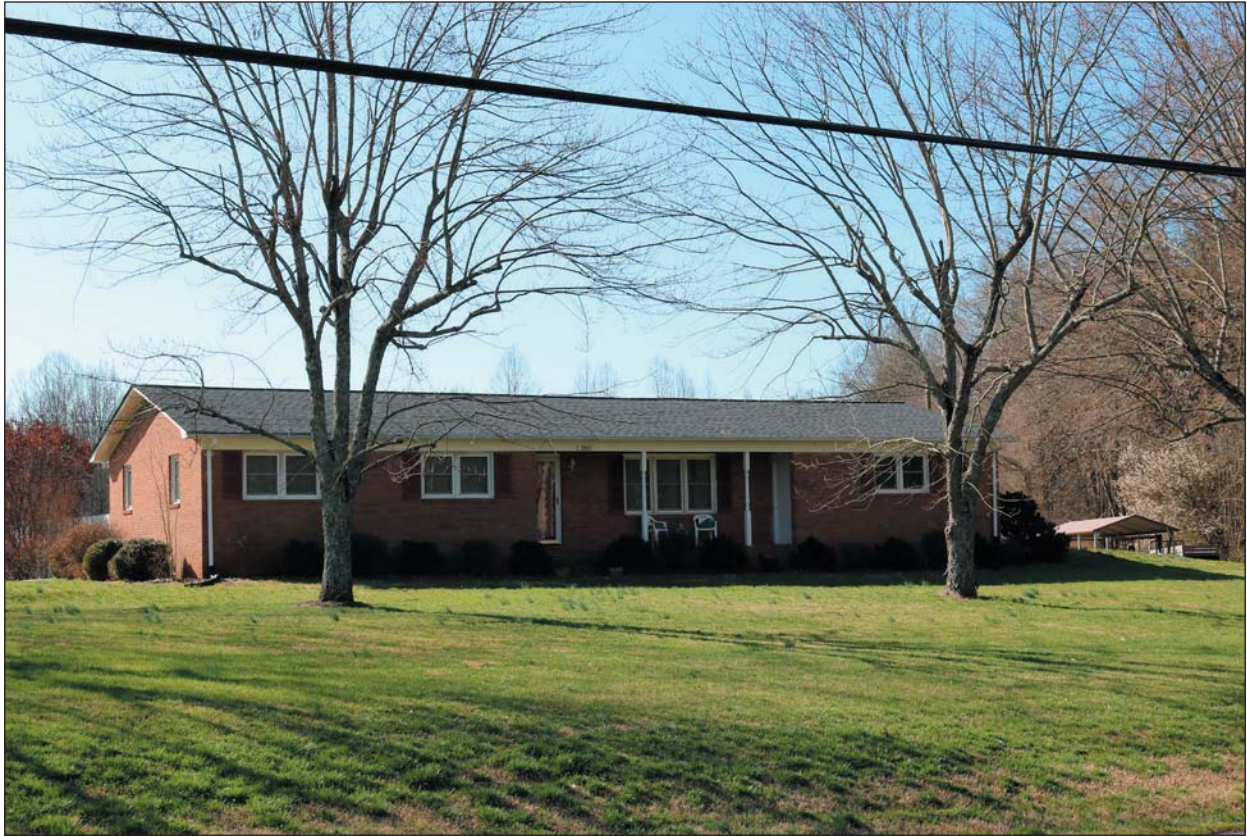
Figure 24.  
The Jeffrey L. Morrow House, Northeastern Oblique

The Jeffrey L. Morrow House (ID1859) is a single-story, brick, linear Ranch-style house. It occupies a 5.0-acre parcel on the south side of Hickory Highway in the Shiloh Township of Iredell County (Figure 24). The dwelling sits upon a rise on a narrow parcel with a lawn, three mature trees placed symmetrically between the dwelling and the road, and small shrubs close to the foundation. A paved driveway extends to the western elevation of the house and also a carport and outbuilding on the western side of the drive. The eastern edge of the parcel is open to the adjacent parcel, while forest with mature trees and dense underbrush borders the western edge. The ground rises from the edge of the highway, which hinders observations of the parcel from the right of way and obscures any view of two small outbuildings visible on Google Earth.

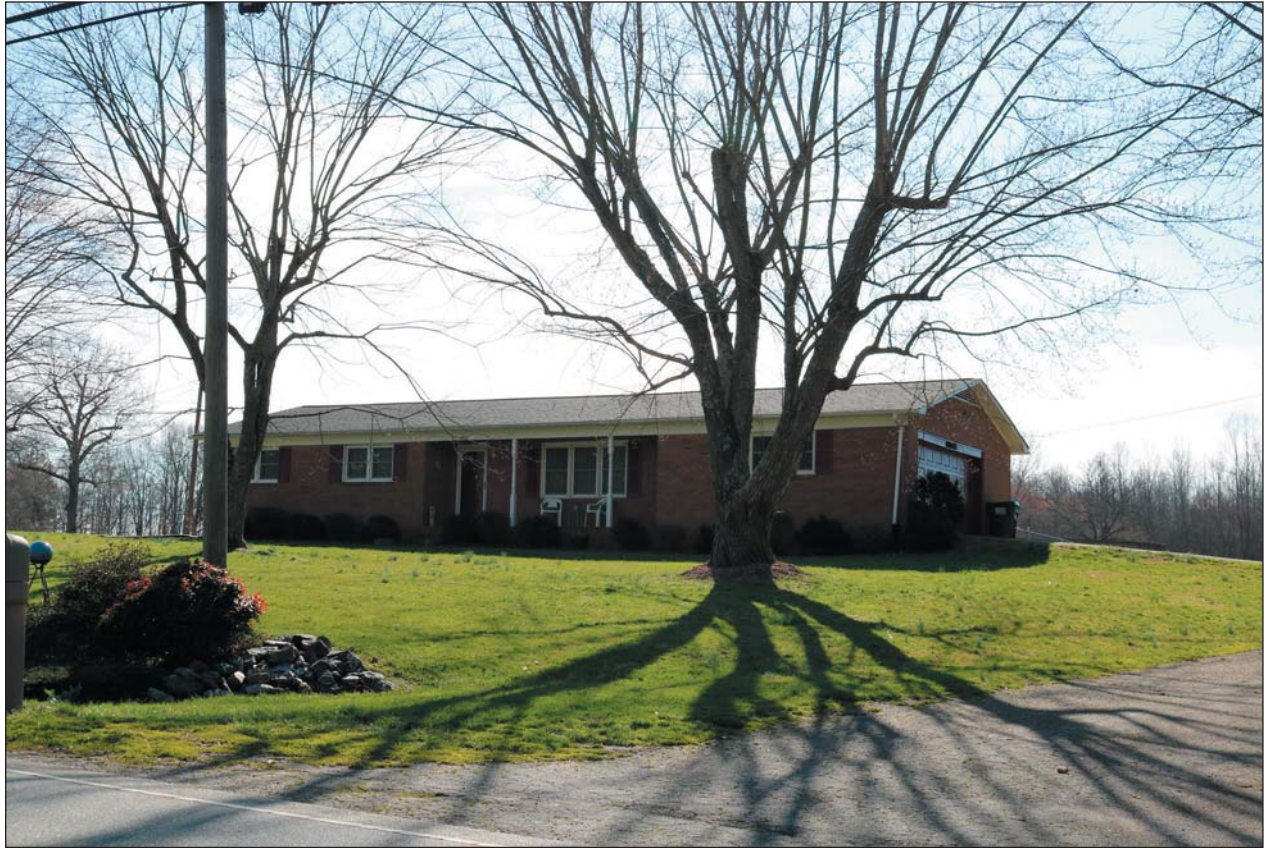
Figure 25.  
Jeffrey L. Morrow House, Northwestern Oblique

The side-gable house is clad in running bond brick. It has non-historic one-over-one, double-hung windows and an inset central porch with turned-post supports (Figure 25). The entryway door is a six-panel with a four-pane fanlight. The foundation is also running bond brick. There is another entryway door at the western edge of the porch, consisting of a single-panel wooden door without decoration. There are three pairs of one-over-one windows on the façade. These have decorative shutters and are situated high near the wide plain cornice. A band of three one-over-one windows on the façade's recessed porch also have decorative shutters. A shallow set of brick steps without railing provides access to the porch.

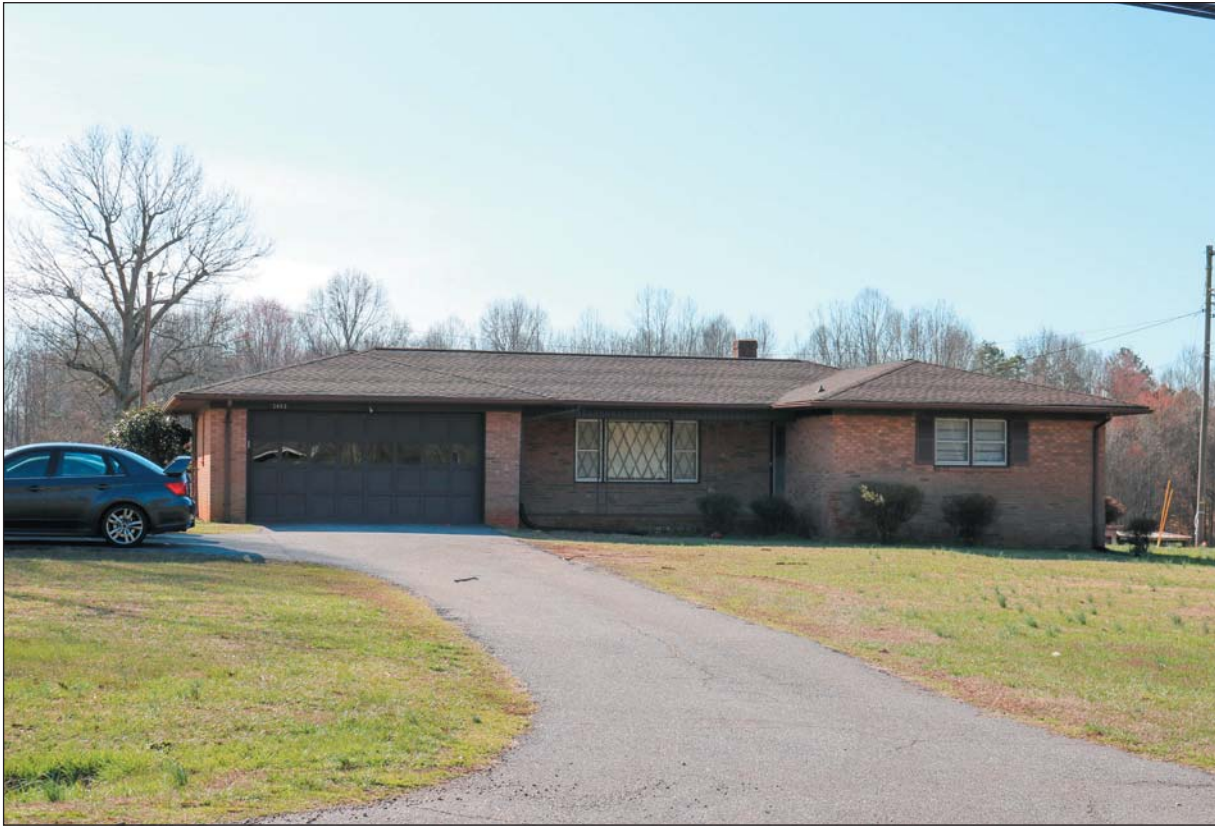
Figure 27.  
The Seng Vang and Pa M Khang House Facade

The L-shaped plan, hipped-roof house is clad in running bond brick and has historic wooden two-over-two horizontal pane double-hung windows (Figure 27). A shortened courtyard is created by the projected ell on the west portion of the façade and shallowly projected ell containing the garage is occupied by a short and broad bricked stoop and patio covered by broad eaves. Also sheltered by the eaves is a decorative tripartite window that overlooks the courtyard. The central light is flanked by two one-over-one windows, and all are covered in lattice work. The entryway door is historic and has the popular vertically aligned three-square-light door found in many Mid-Century Modern homes. Another entryway at the eastern elevation has a historic door with two-lights. A small bricked flue is evident on the southern elevation.

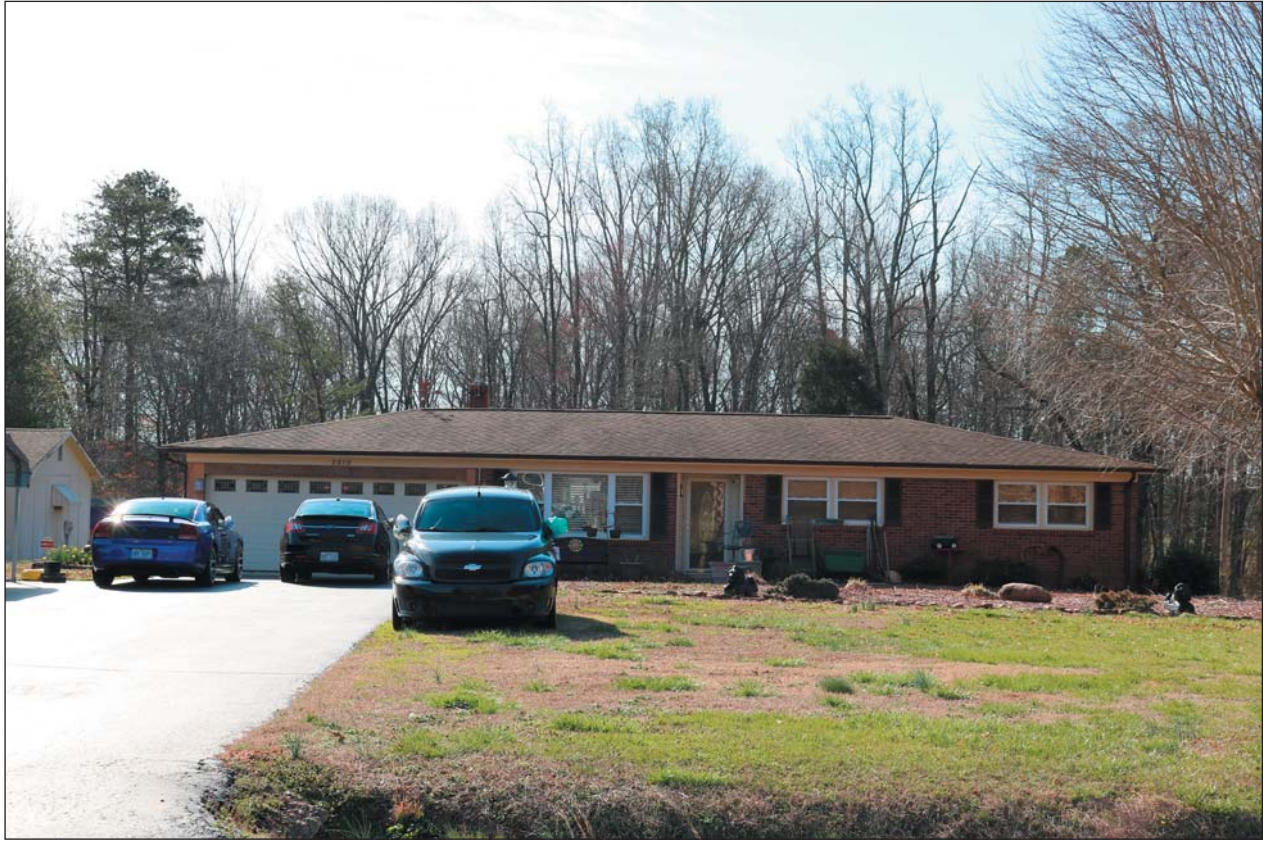
Figure 29.  
The Patrick Dishman House, Southern Elevation

The linear plan, hipped-roof house is similar to the Seng Vang and Pa M Khang House (ID1861) that was built four years later. The dwelling is clad in running bond brick and has replacement one-over-one double-hung windows with shutters set in pairs at the eave cornice (Figure 29). The broad eave also shelters a simple replacement tripartite window overlooking the front yard. The central light is flanked by two one-over-one windows. The entryway door is set in the center of the form and is also a replacement with an oval decorative glass pane set into a single panel. A small bricked flue is evident on the southern elevation. The form portions are segmented so as to create an asymmetrical design. The door is central to the main form but offset in the living area of the plan as the garage takes up the other side of the form. The tripartite window on one side of the entryway door and two, one-over-one windows set at the other side break up the underlying characteristic of the linear form.

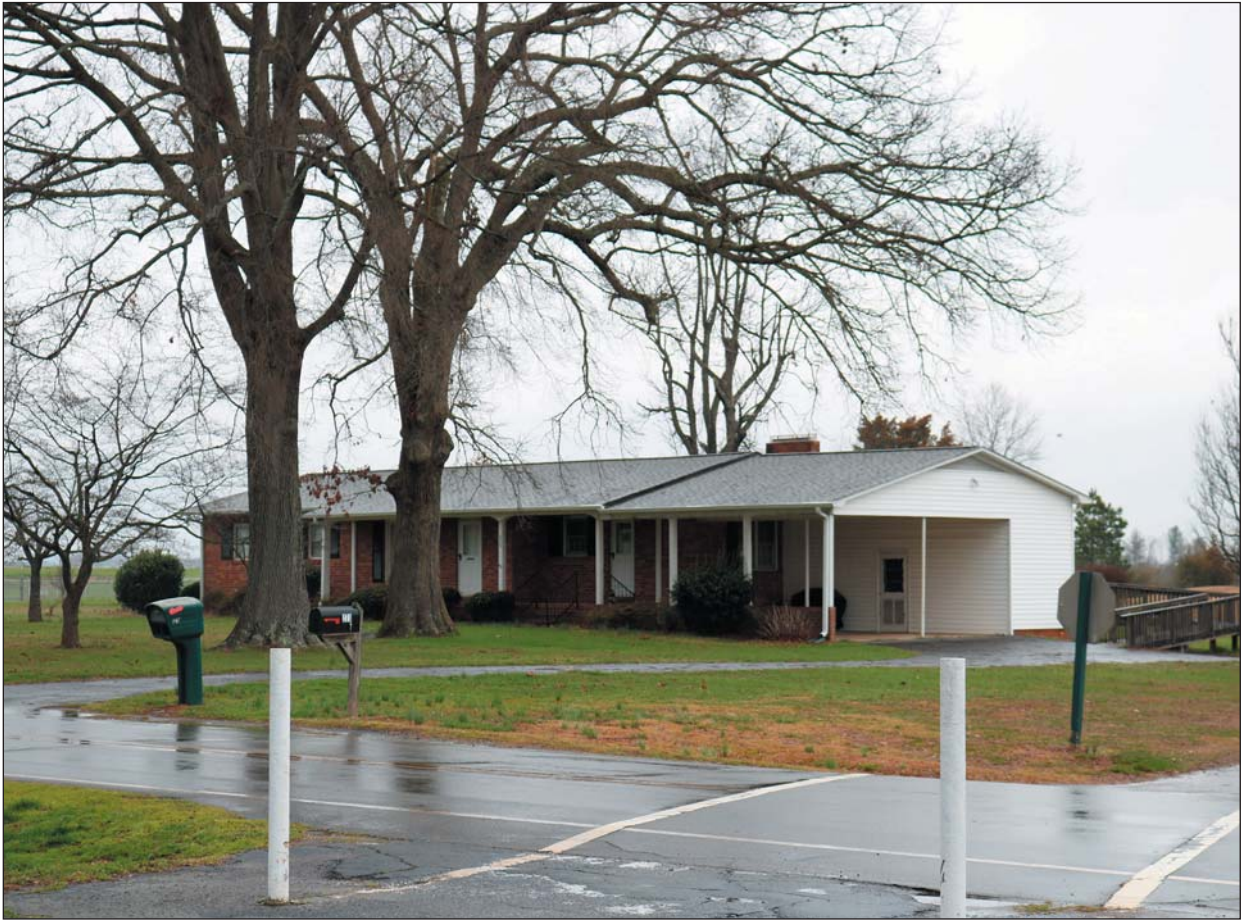
Figure 39.  
The Jessica Keel House, Southeast Oblique

The linear plan dwelling is similar to other Ranch-style homes in the area. Although the Jessica Keel House (ID1863) follows a linear plan, there are design elements that break up the symmetry of the façade (Figure 39). The side-gabled building has a rectangular linear form but with a cut-away recessed patio. A stepped roof design appears to divide the building into a central form with east and west wings, but this does not reflect the actual house plan. The form has a centralized recessed patio with two entryways under the stepped roof. The roof is supported by square posts and curved architraves. The main entryway has a six-panel door with cross pattern and a historical two-panel single-light storm door with brass mail slot. Flanking the door is a large wooden frame and muntin 30-light picture window with shutters (Figure 40). The patio is outside the secondary

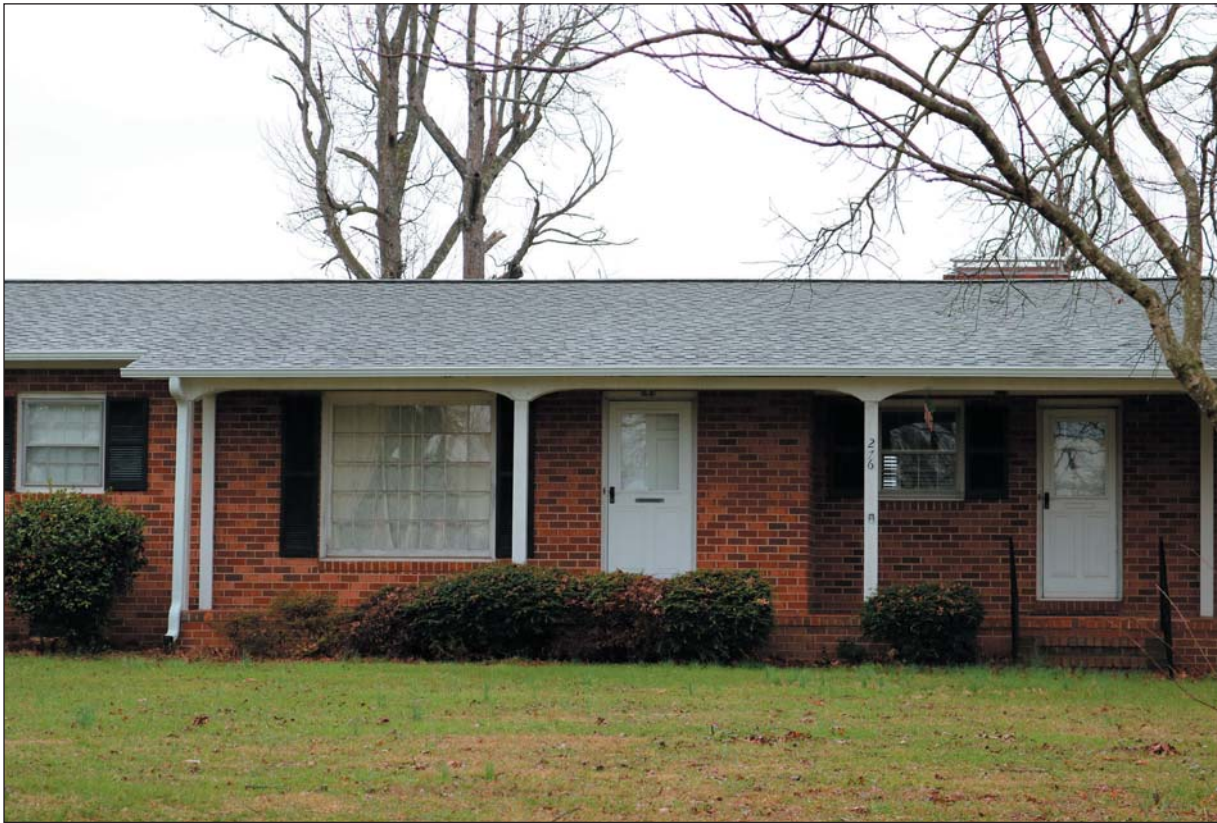
Figure 40.  
The Jessica Keel House, Façade Detail

entryway, which has a historical door and storm door similar to the main entryway. The patio has a decorative metal balustrade lining a four-step stoop. The main bays of the home have eight-over-eight wooden sash double hung windows with shutters and are set near the eave line. The west wing roof extends into the engaged carport roof. The carport extension of the form is clad in vinyl siding. The carport is also supported by square posts, but these end in a running bond half-knee wall. The carport also has an entryway with a historical decorative screen door and two-panel two-light entryway door. There is a broad running bond brick chimney oriented parallel to the ridgeline. At the end of the driveway and western edge of the carport is an accessibility ramp extending toward the rear of the dwelling. The ramp is wood with square balusters.

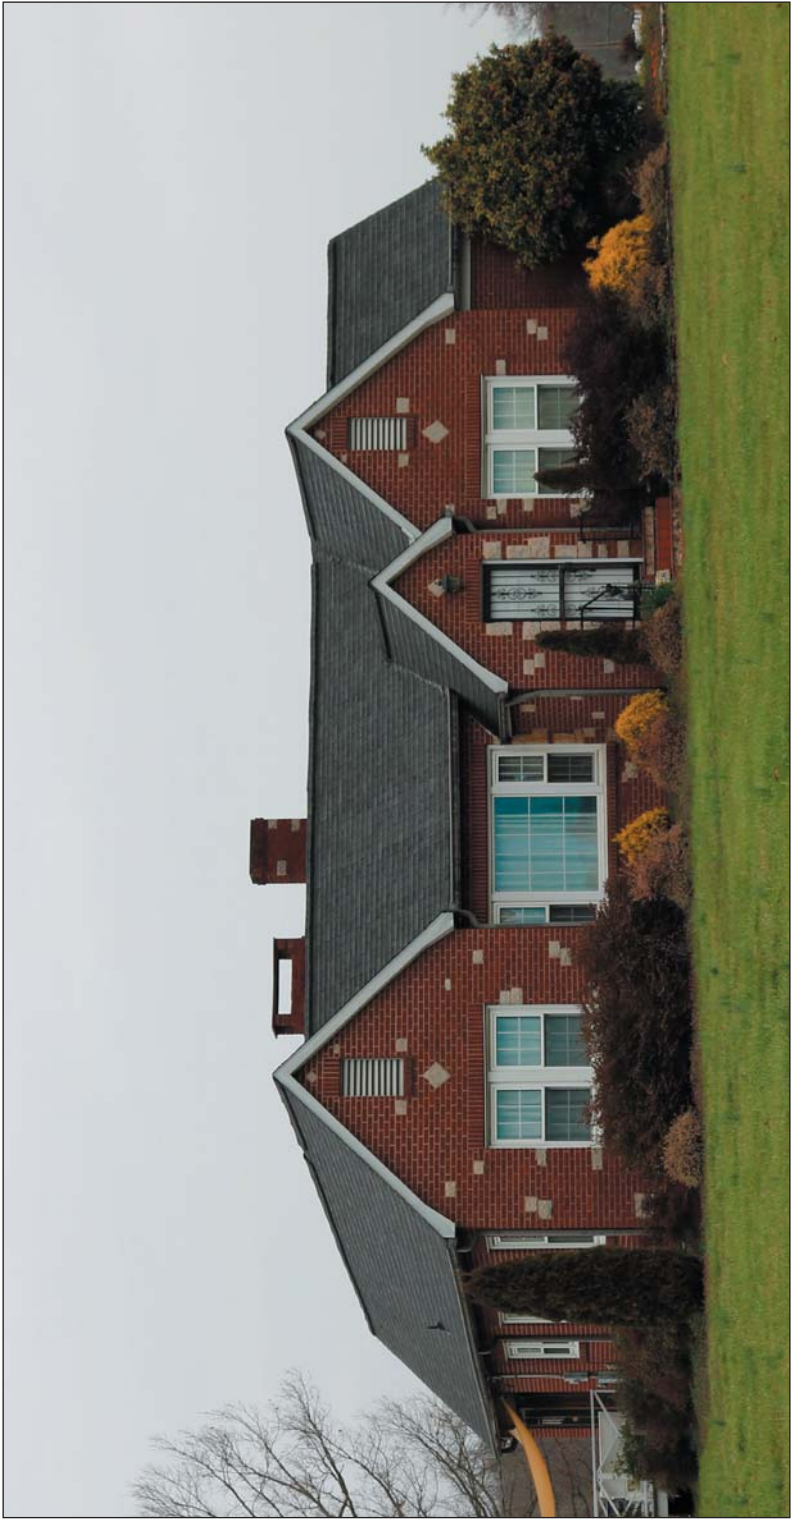
Figure 43.  
The Moose-Rogers House, Facing Northeast

The Moose-Rogers House (ID1864) is a double-ell cottage with half-courtyard that is newly clad in running bond brick with rusticated stone accents (Figure 43). The non-historical six-over-six vinyl sash windows are deeply set into the masonry and have a stretcher bond course lintel. The courtyard wall has a tripartite picture window flanked by six-over-six double-hung windows. The central pane has 15-false panes. Each ell has paired vinyl six-over-six double-hung windows. There is a projecting front-gable entryway with an asymmetrical roof next to the eastern ell. The entryway has a metal lamp above the lintel and a decorative metalwork security door covering a six-panel door. The three-step stoop has a decorative metal balustrade. The eaves have been covered in aluminum siding. Two chimneys at the rear elevation are both running bond brick. The western chimney is wide and oriented and parallel to the roof ridgeline, while the eastern chimney is narrower and has the same stonework details as the façade cladding. The western elevation has a wooden deck and another entryway. The western elevation has a garage addition that was added in 1988 (United States Geological Survey 1951). The front-gable garage has a rolling garage door and its sidewalls have banks of single-pane UV windows (Figure 44).

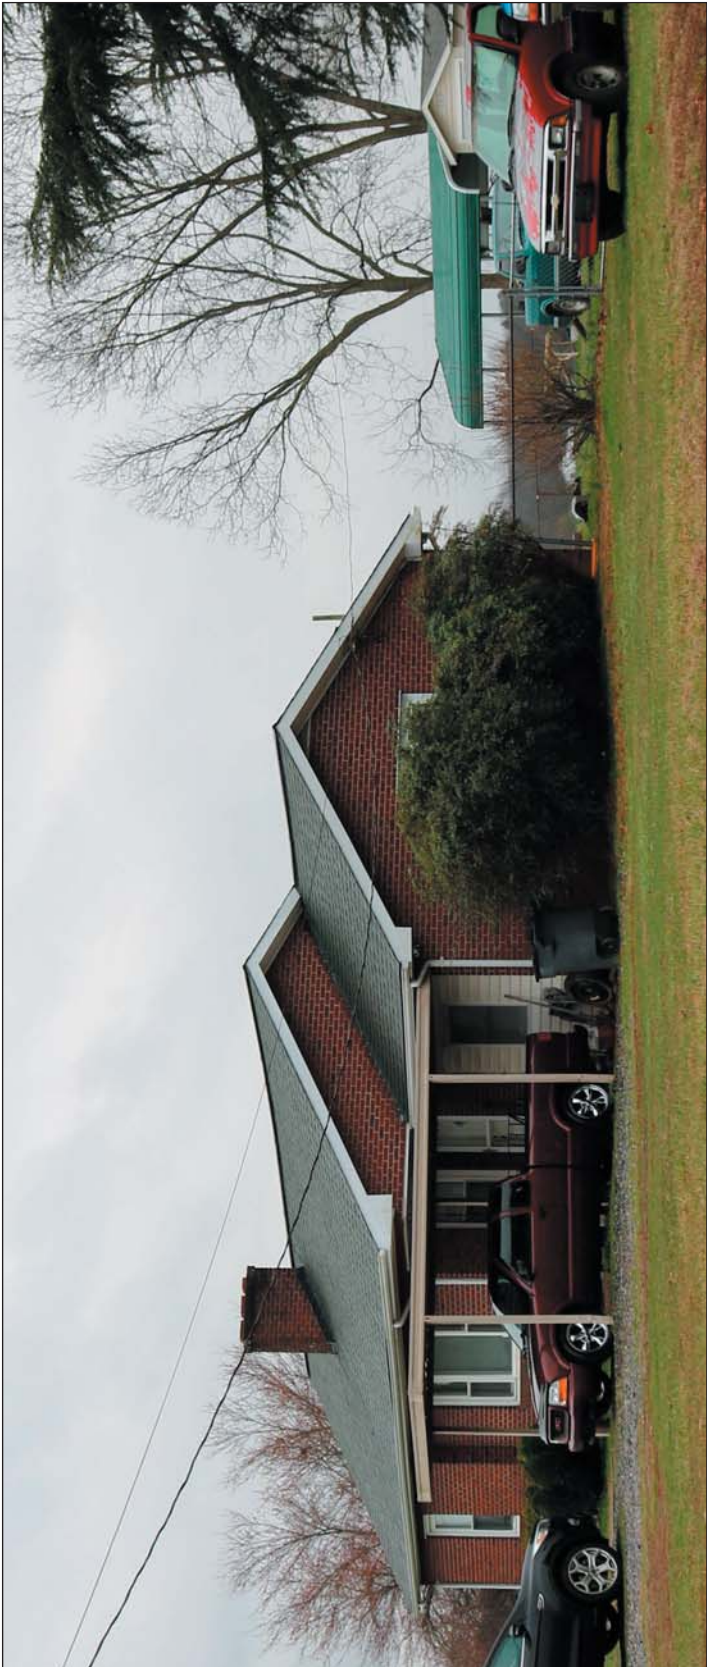
Figure 47.  
The Jean P. Deal House, Facing Southeast

The dwelling has an eight-post, metal-roofed, detached carport located inside the fenced back yard. Adjacent to the carport is a front-gable metal outbuilding with metal roof that faces the rear of the dwelling (see Figure 47).

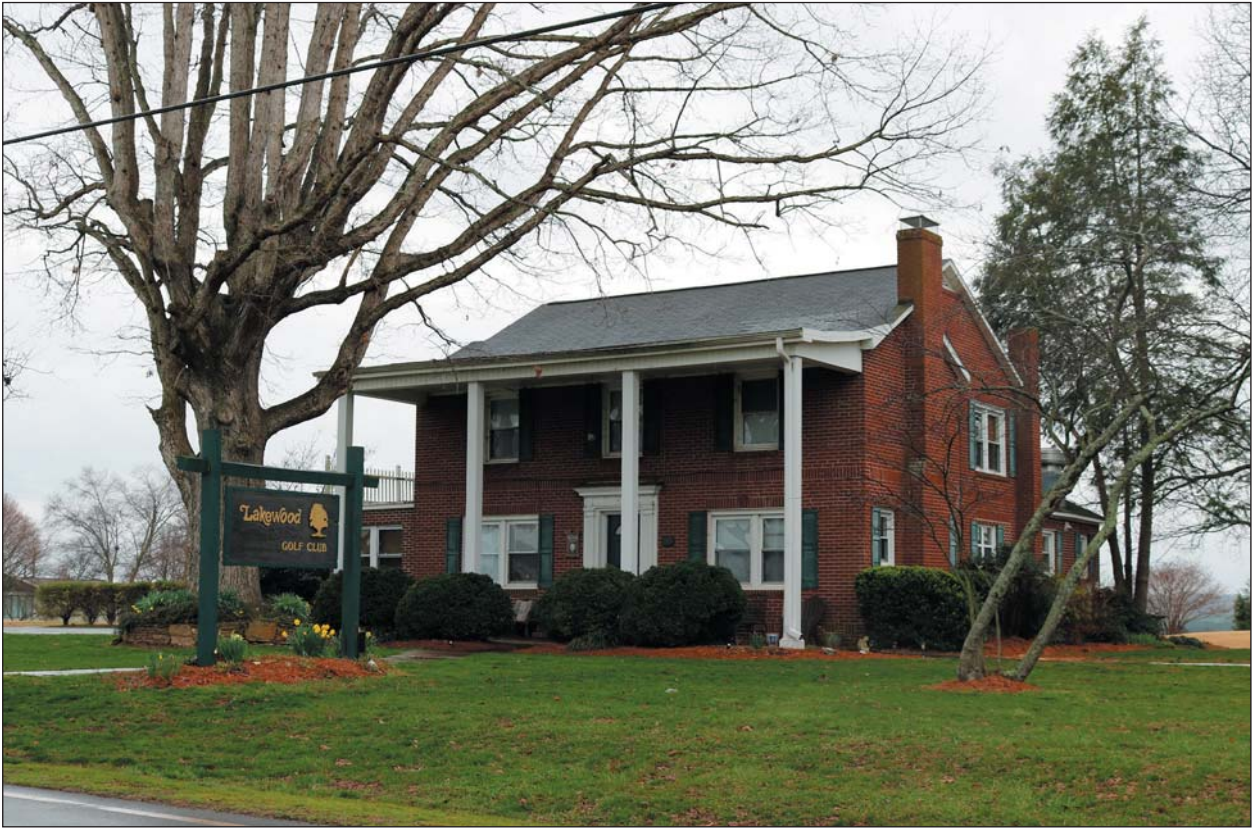
Figure 51.  
Northwestern Elevation of the Lakewood Golf Course Clubhouse

The c.1905 farmhouse has been significantly altered, had significant additions, and no historic material remains except for the basic form of the house. The form and proportions of the Lakewood Golf Course Clubhouse hint at elements of a late nineteenth-century to turn of the twentieth-century plantation house design. The alterations and additions to the former dwelling obscure all but traces of them. Where deeds and tax records do not reveal when these alterations occurred, the physical traits of the building reveal an approximate age of most of the changes. The clubhouse is a brick veneered two-story side-gable building with a two-story open porch supported by square columns (Figure 51). There are non-historic one-over-one windows on the second story façade and paired one-over-one non-historic windows on the first story façade. The entryway has an ornamented surround and a non-historic four-panel door with fanlight. The eastern and western elevations have non-historic one-over-one windows set in pairs. At the western elevation, more of the original form and proportions of a circa 1890 construction are apparent. The western elevation has two brick chimneys. A historic addition at the rear indicates that an added kitchen space was once present. The eastern elevation shows evidence that at one point, this former center-hall-plan I-house had a significant addition to the rear, with several feet of expanded roofline and a chimney (Figure 52). A one-story wing also was added after the I-house was veneered, as seen through differences in the brick. This addition is used as entertainment space for clubgoers. The one-story wing has four-over-four vinyl windows and an awning over the single-pane glass door. The porch's original materials have been replaced with vinyl and synthetic materials.
