RE: Construct South Parallel Taxiway & Other Airport Improvements, Statesville Regional Airport,  
Iredell County, ER 15-1393

# Historic Structure Survey Report

## Statesville Regional Airport

Iredell County, North Carolina

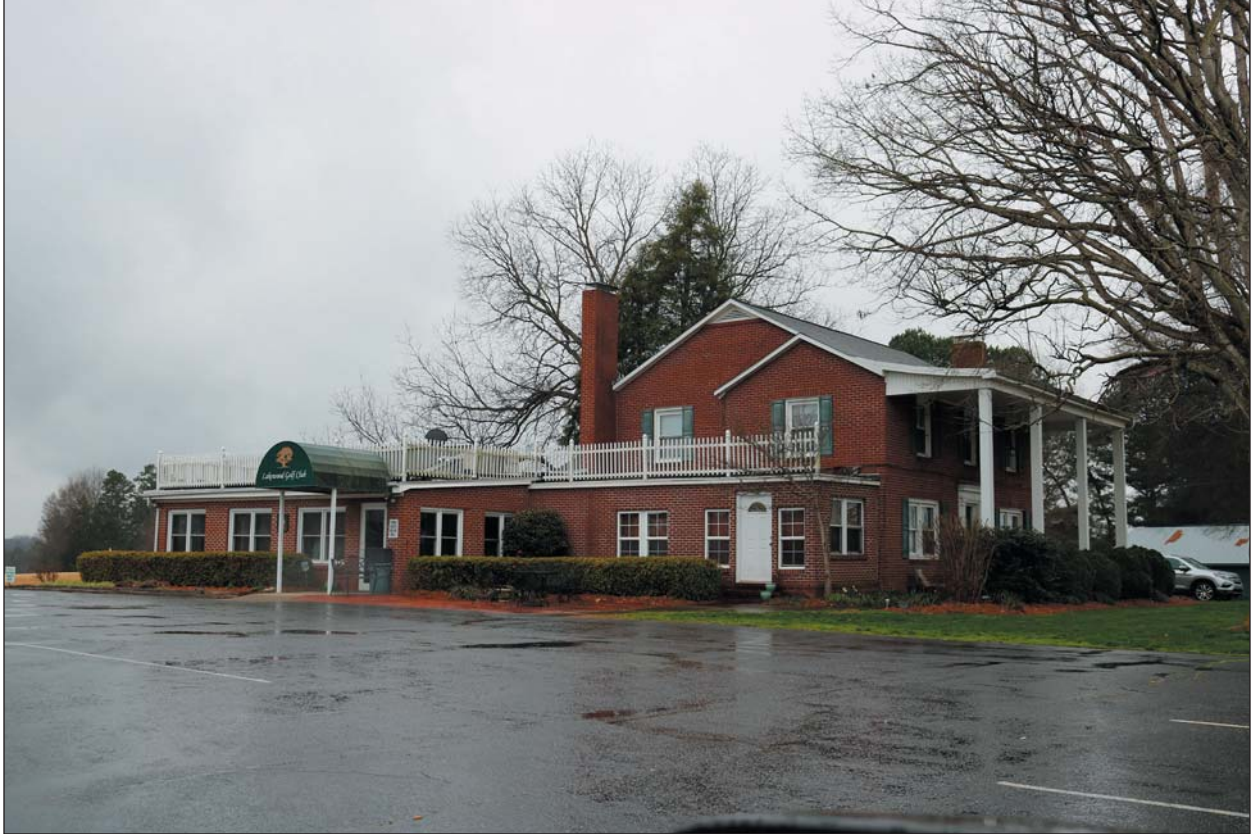
Figure 52.  
Eastern Elevation of the Lakewood Golf Course Clubhouse

The c.1905 farmhouse has been significantly altered, had significant additions, and no historic material remains except for the basic form of the house. The form and proportions of the Lakewood Golf Course Clubhouse hint at elements of a late nineteenth-century to turn of the twentieth-century plantation house design. The alterations and additions to the former dwelling obscure all but traces of them. Where deeds and tax records do not reveal when these alterations occurred, the physical traits of the building reveal an approximate age of most of the changes. The clubhouse is a brick veneered two-story side-gable building with a two-story open porch supported by square columns (Figure 51). There are non-historic one-over-one windows on the second story façade and paired one-over-one non-historic windows on the first story façade. The entryway has an ornamented surround and a non-historic four-panel door with fanlight. The eastern and western elevations have non-historic one-over-one windows set in pairs. At the western elevation, more of the original form and proportions of a circa 1890 construction are apparent. The western elevation has two brick chimneys. A historic addition at the rear indicates that an added kitchen space was once present. The eastern elevation shows evidence that at one point, this former center-hall-plan I-house had a significant addition to the rear, with several feet of expanded roofline and a chimney (Figure 52). A one-story wing also was added after the I-house was veneered, as seen through differences in the brick. This addition is used as entertainment space for clubgoers. The one-story wing has four-over-four vinyl windows and an awning over the single-pane glass door. The porch's original materials have been replaced with vinyl and synthetic materials.

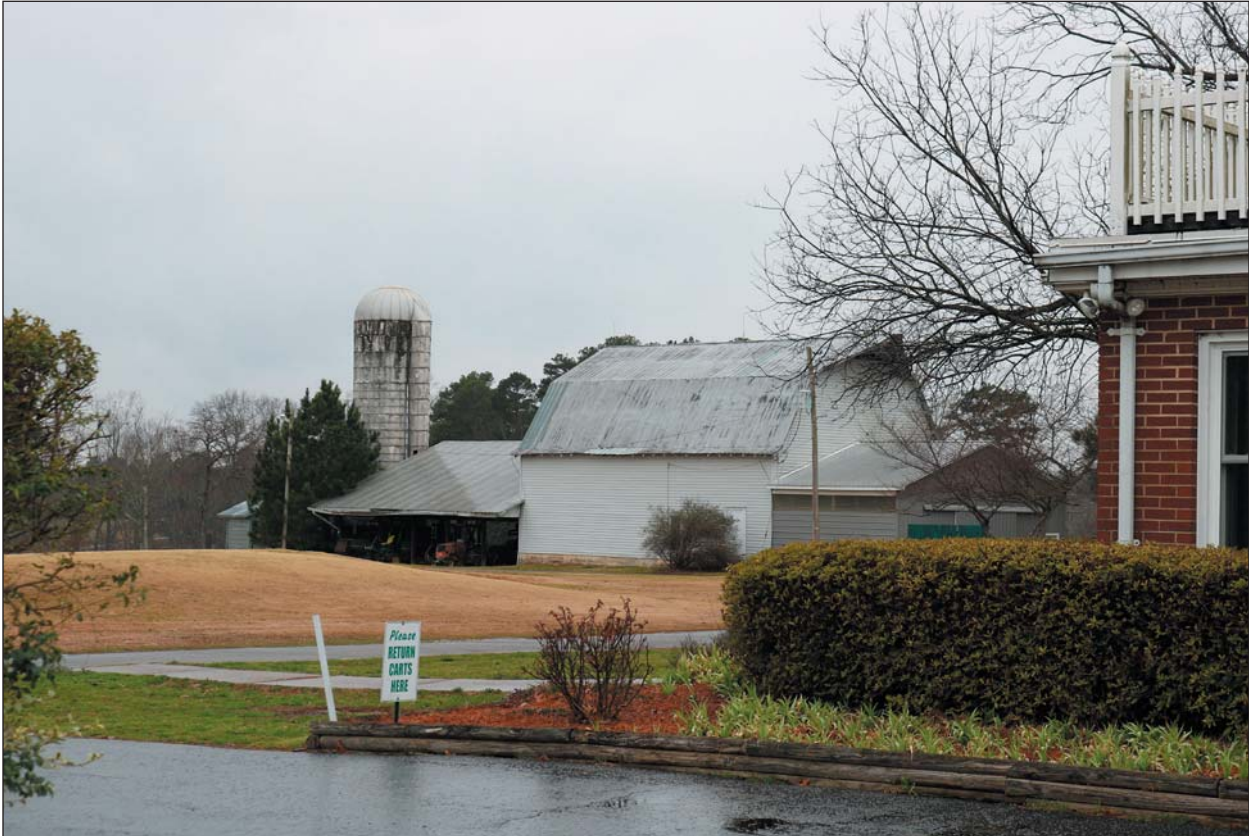
Figure 53.  
Barn, Silo, and Sheds

The center-aisle barn has a metal gambrel roof and has been completely clad in vinyl siding (Figure 53). The access to the loft has been enclosed and the entrance nearest the clubhouse covered by a metal-sided and metal-roofed front gable utility addition with a sliding door. There is a five-panel wooden door on the western elevation. On the southern elevation of the barn there is a large metal-roofed open shed addition with wooden posts that houses mowers and other equipment for the course. The circa 1930 silo stands south of the shed addition and appears unused. East of the silo and behind the shed addition is a small metal-sided and metal-roofed utility shed that faces the maintenance shed addition of the barn.

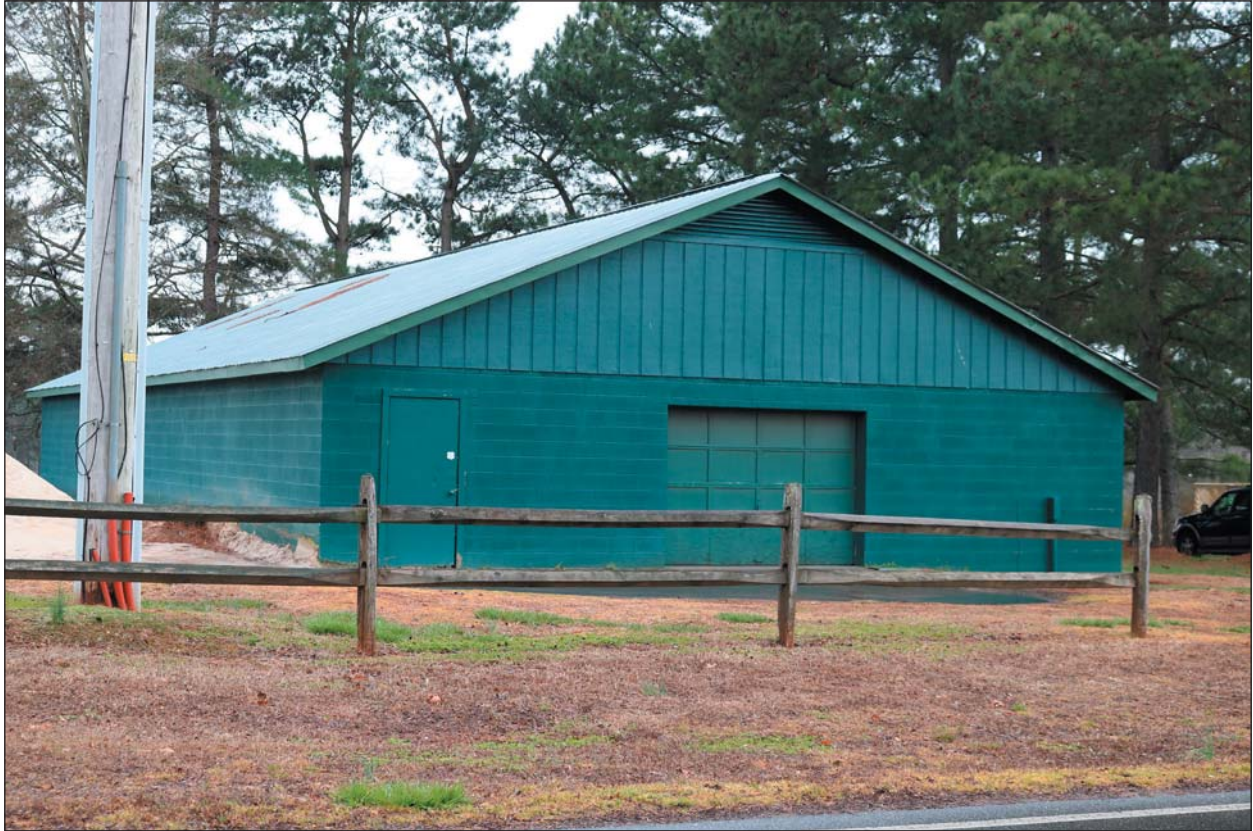
Figure 54.  
Maintenance Garage

Based on historic aerial photographs, the concrete-block maintenance shed was built between 1961 and 1993. Since the golf course was opened in 1966, it is likely that the concrete building was erected concurrently or shortly afterwards. The vertical board siding of the gable end, the sixteen-panel rolling garage door suggests an earlier date than the 1980s and 90s.

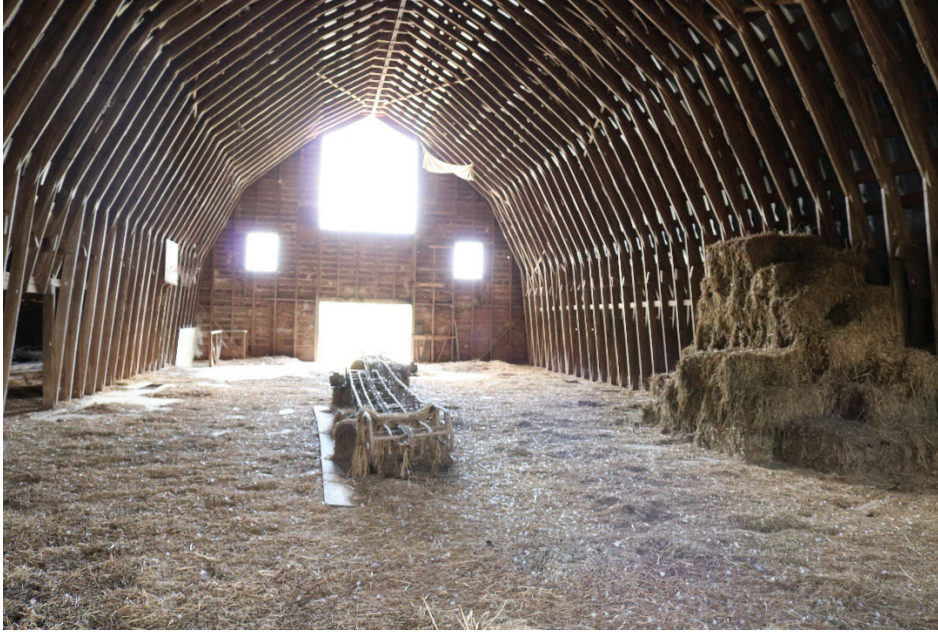
Figure 1. Stamey Barn Upper Loft

The upper loft of the Stamey Barn shows the extant hay loading machinery, tracking, USDA Barn Plan truss work, and the intact interior end-wall of the façade.

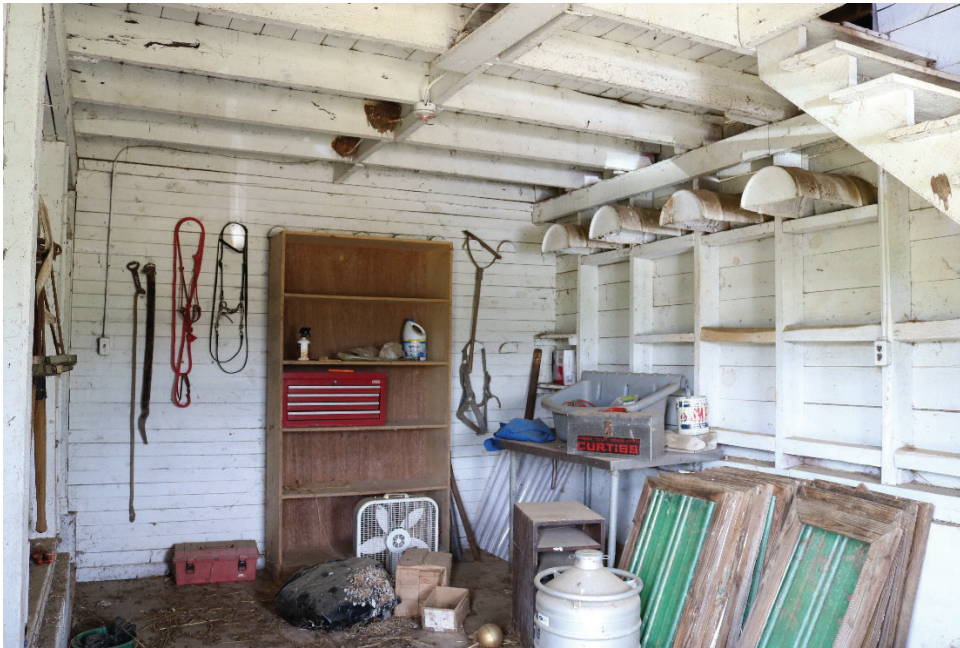
Figure 2. Stamey Barn Tack Room

The Stamey Barn Tack Room retains its original woodwork. The wide interior boards are v-notch, or tongue-and-groove. The original half-barrels mounted on the wall were for hanging bridles and halters. The original windows for the barn are seen at bottom left with removable fiberglass inserts.

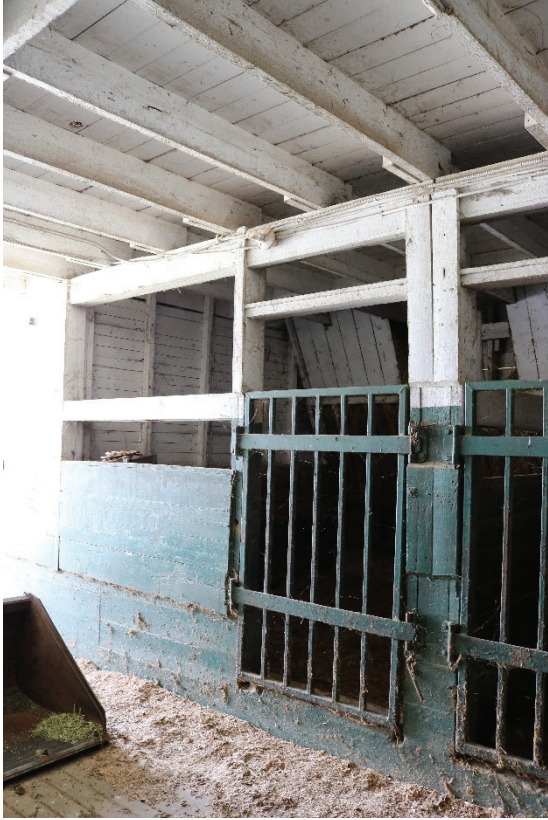
Figure 3. Stamey Barn Original Stalls

The photograph shows the original stalls and gating with intact mangers seen in the background. The horizontal board of the aisle walls are tongue-and-groove.

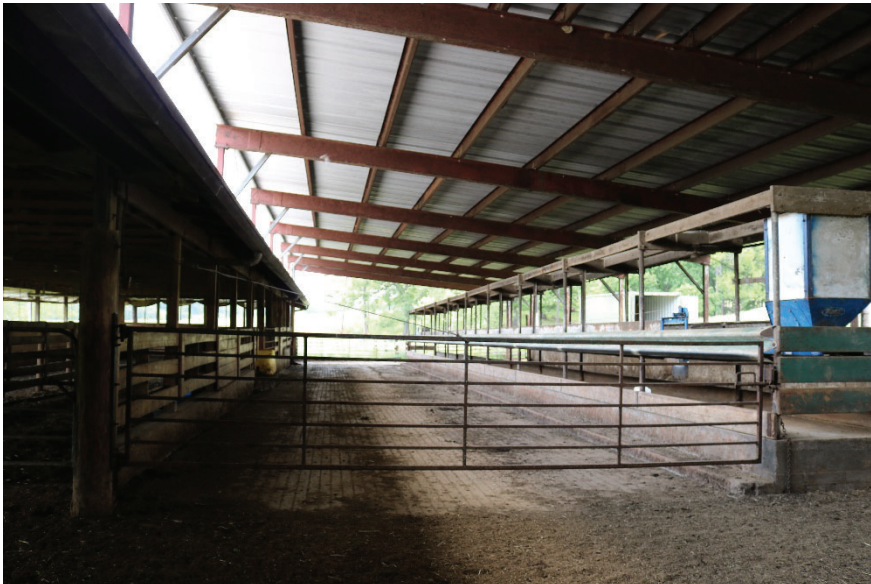
Figure 4-A. Stamey Barn Feeding Sheds at Rear Elevation, Facing North

The photograph shows the feeding shed additions that are not engaged with the main form of the Stamey Barn.

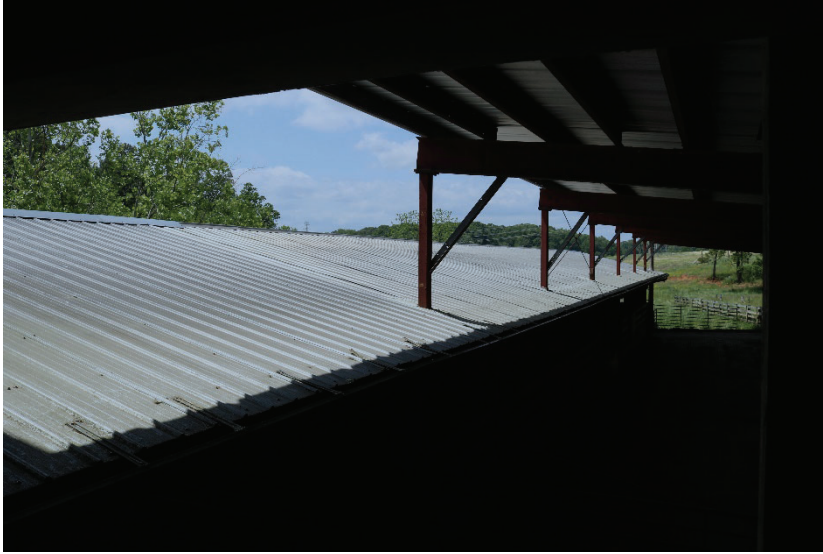
Figure 4-B. The Stamey Barn Feeding Sheds, View from the Upper Loft Facing North

The photograph shows the roof of the two separate feeding sheds which are not engaged with the main form of the Stamey Barn. The view shows the back pasture and fencing.

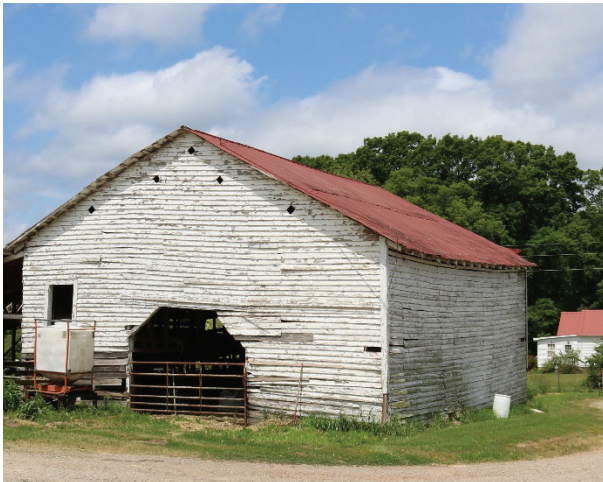
Figure 5. The Dobson Dairy Farm, Former Dairy Barn, Facing North

The photograph shows the condition of the c.1904 former dairy barn. The photo is cropped at the request of the owner Jim Dobson.

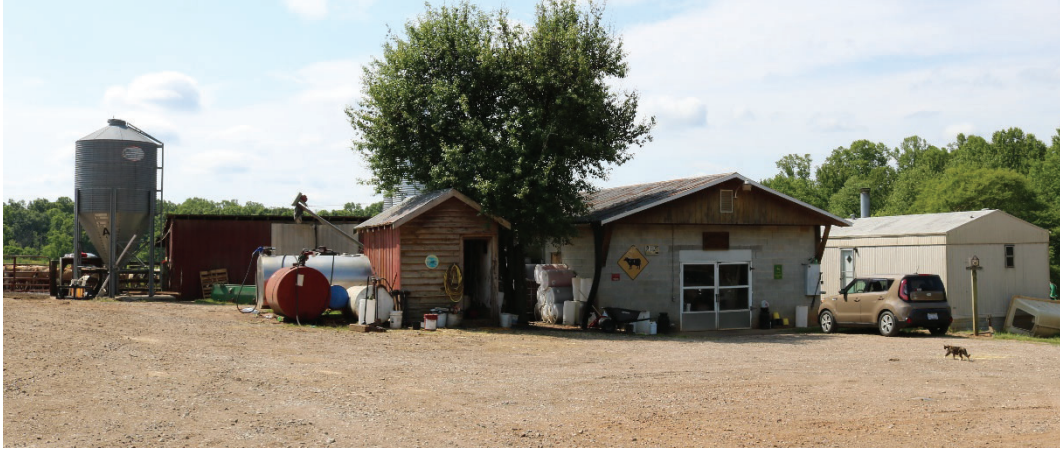
Figure 6. The Dusty Road Farm Dairy Processing Barn, Facing South

The photograph shows the c.1950s dairy processing barn, shed-roofed, open-entry barn in background, and other farm equipment. The large, frame barn is no longer extant.

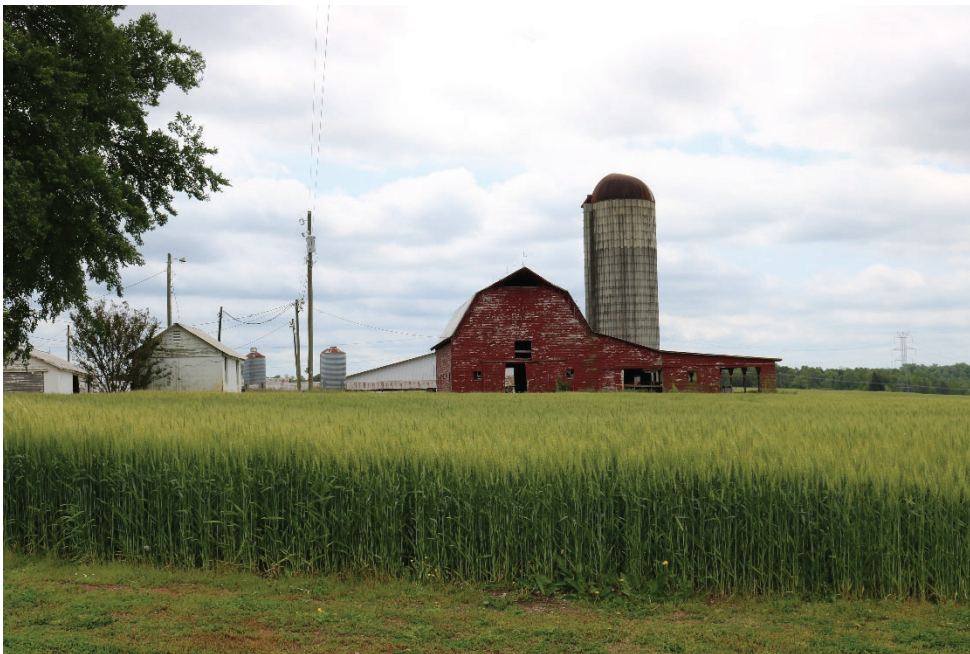
Figure 7. The Farm Complex on Snow Creek Road (ID-1082)

The photograph shows the c.1920s, gambrel-roof barn and silo on Snow Creek Road. The barn was surveyed as part of several buildings on the road and does not have a designated name. The barn is constructed of planed plank.
