Re: Revised Architectural Survey Report, MVP Southgate Project, Construct Interstate Pipeline, Rockingham and Alamance County, ER 18-1041

Thank you for your letter of October 11, 2019, transmitting the draft "Historic Architectural Survey for the MVP Southgate Pipeline Project". We have reviewed the report and offer the following comments.

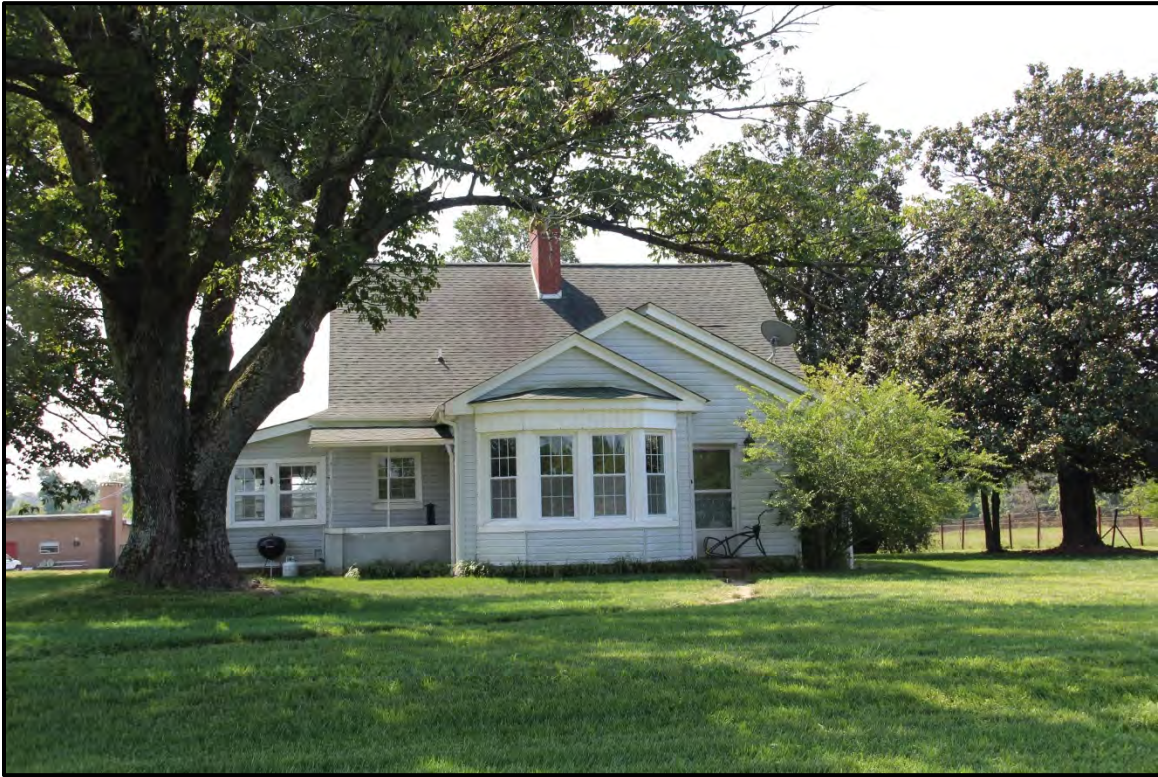
NRHP Assessment. Architectural resource RK1655 does not exhibit a distinctive architectural style or workmanship. In addition, the farmhouse has been altered through the replacement of the original window sashes, the application of vinyl siding, and the enclosure of the façade porch. As a result of the alterations to the farmhouse, the farm no longer conveys its original ca. 1940 appearance, thereby rendering the property ineligible for its agricultural associations. Based on the lack of architectural merit, as well as the inability to associate the farm and/or its original owner(s) with an important historical event or series of events, it is TRC's opinion that architectural resource RK1655 is not eligible for the NRHP.

Figure 5.1. Architectural resource RK1655; view is southeast featuring the façade.

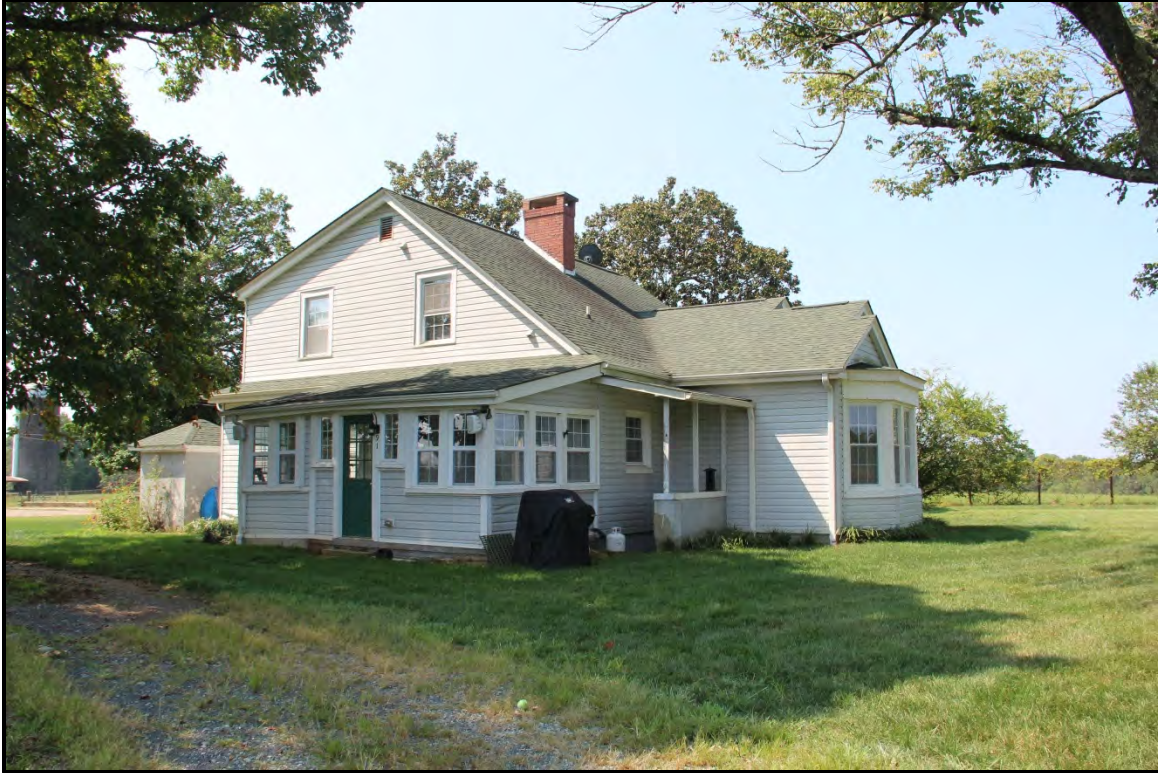
The farmhouse is a one and one-half-story, wood-frame building features a side-gabled roof, an interior brick chimney, an exterior clad with vinyl siding, a continuous brick foundation, and double hung 6/6 vinyl sash windows. Facing north, the façade is marked by multiple projecting gable bays that are clad with vinyl siding. The front-facing gable contains a canted bay with four double-hung 6/6 vinyl sash windows. A door is positioned west of the canted bay on a preceding gable bay. Situated east of the projecting bay is a partial-width porch that may have led to the original entrance to the house. The porch is shielded by a metal shed roof that is supported by two wood posts. Attached to the east elevation of the house is a shed-roof wing that is pierced by a series of double-hung 6/6 vinyl sash windows.

Figure 5.2. Architectural resource RK1655; view is southwest featuring the façade and east elevation of the primary residence with the ca. 1940 pump house located to the rear.

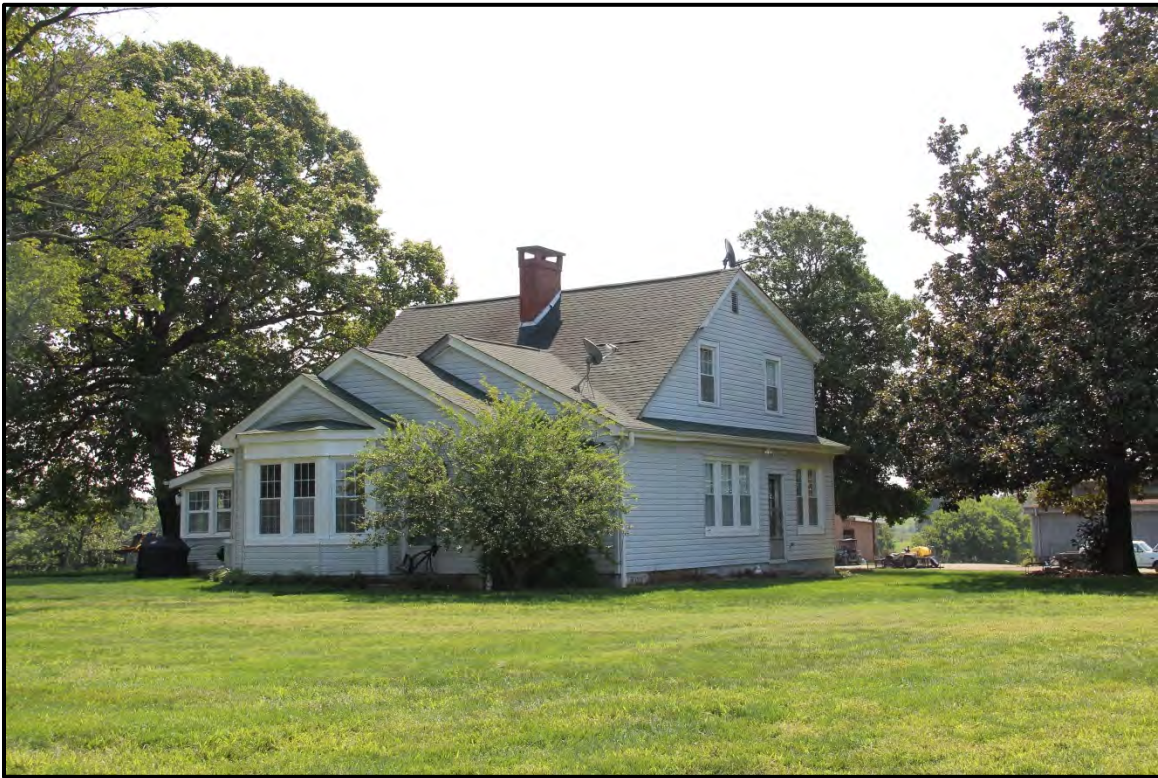
Figure 5.3. Architectural resource RK1655; view is southeast featuring the façade and west elevation.

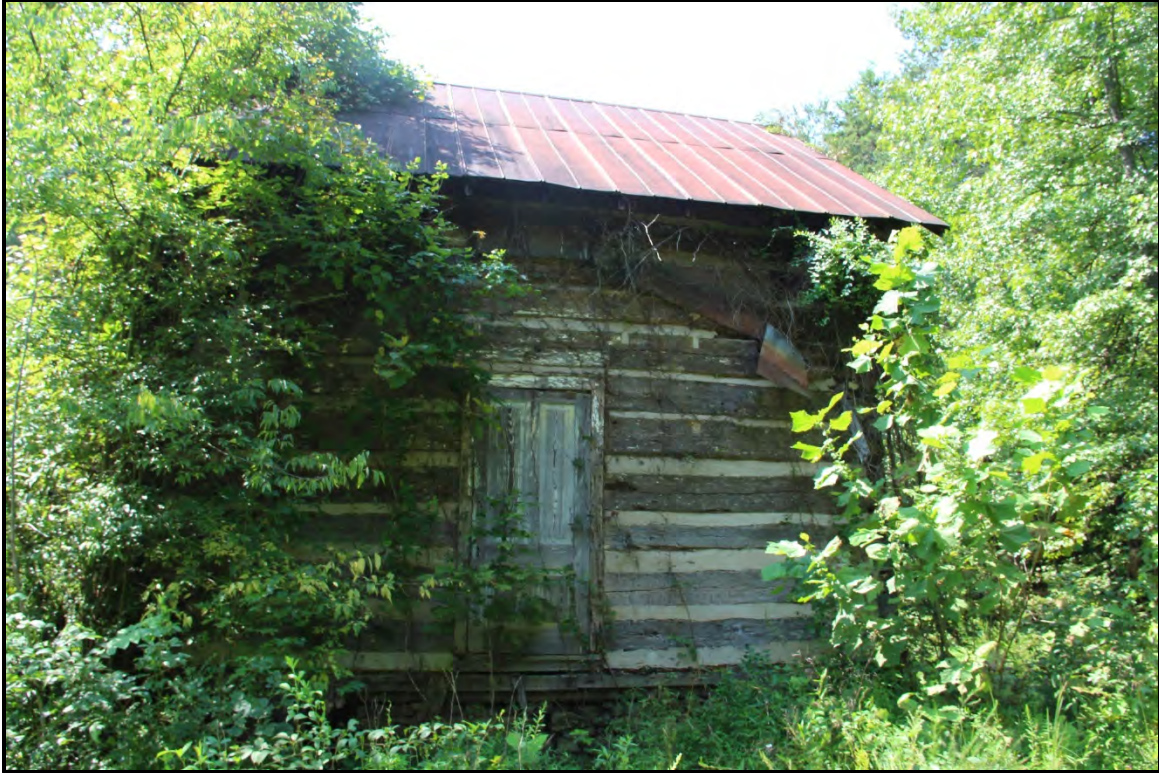
The one and one-half-story, single-pen building features a side-gabled roof covered with standing seam metal, an exterior composed of hewn logs joined together with v-notching, and a stone pier foundation. The daubing applied to the structure appears modern, which suggests that the building was maintained until the late twentieth century. Facing northeast, the façade is marked by an off-centered door opening containing a wood panel door. Attached to the southeast elevation is an exterior end stone chimney with a brick stack. Flanking the chimney to the west is a window opening that contains no sashes. Weatherboard siding is applied over the gable field of the half story. The northwest elevation is pierced by a centrally placed window that contains a board and batten wood shutter. An additional window opening in the half story has been partially enclosed with weatherboard siding and includes a 1/1 metal sash window. As with the southeast elevation, the gable field on the northwest elevation is clad with weatherboard siding.

NRHP Assessment. Architectural resource RK1656 is an example of a late nineteenth century single-pen log house (with an attached log extension) that appears to have been reconstructed and/or extensively remodeled. Alterations include the addition of the half story, the reconstruction of the interior box staircase and fireplace surround. In addition, modern chinking has been applied to the exterior of the building. Based on the lack of architectural merit, as well as the inability to associate the house and/or its original owner(s) with an important historical event or series of events, it is TRC's opinion that architectural resource RK1656 is not eligible for the NRHP.

Figure 5.9. Architectural resource RK1656; view is southwest featuring the façade.

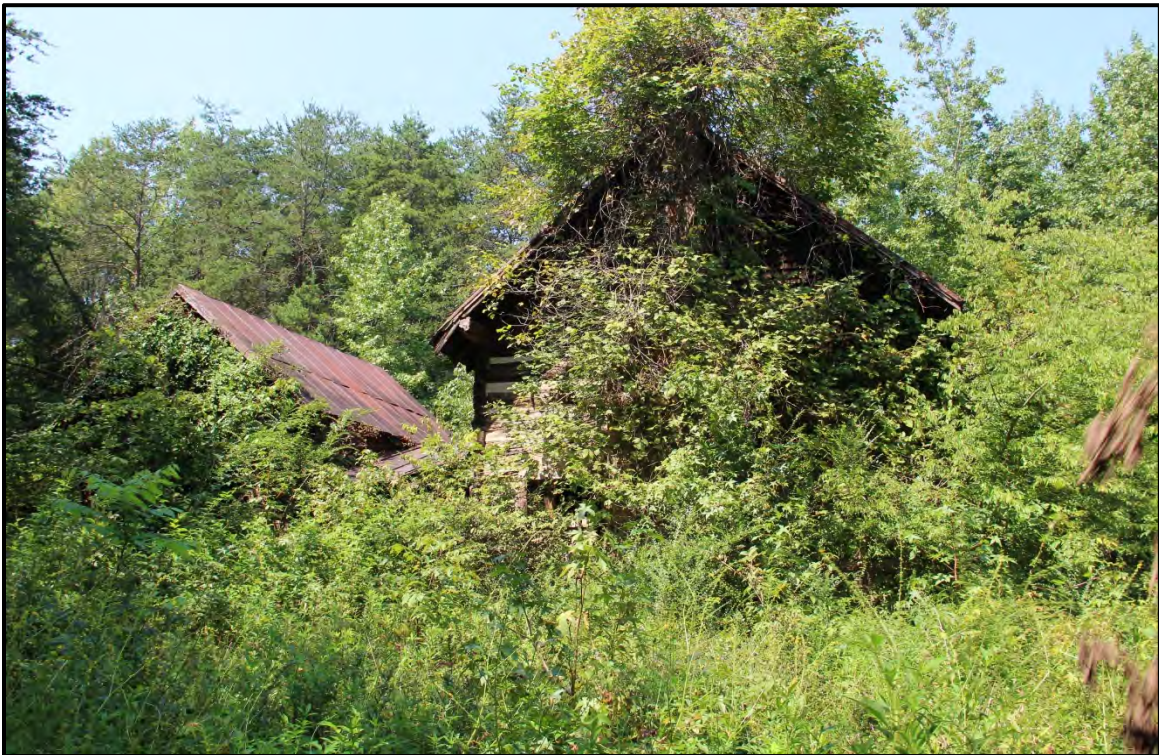
Attached to the rear elevation is an open breezeway topped with a standing seam metal roof that connects the house to a single-pen log extension. The extension features a side-gabled roof covered with standing seam metal, an exterior composed of hewn logs joined together with v-notching, and a stone pier foundation. The daubing applied to the extension appears modern, which further indicates that the building was maintained up until the late twentieth century. A door opening is located on the southwest elevation of the extension. Positioned on the southwest slope of the roof is an interior brick chimney.

Figure 5.10. Architectural resource RK1656; view is north featuring the southeast elevation and the rear extension.

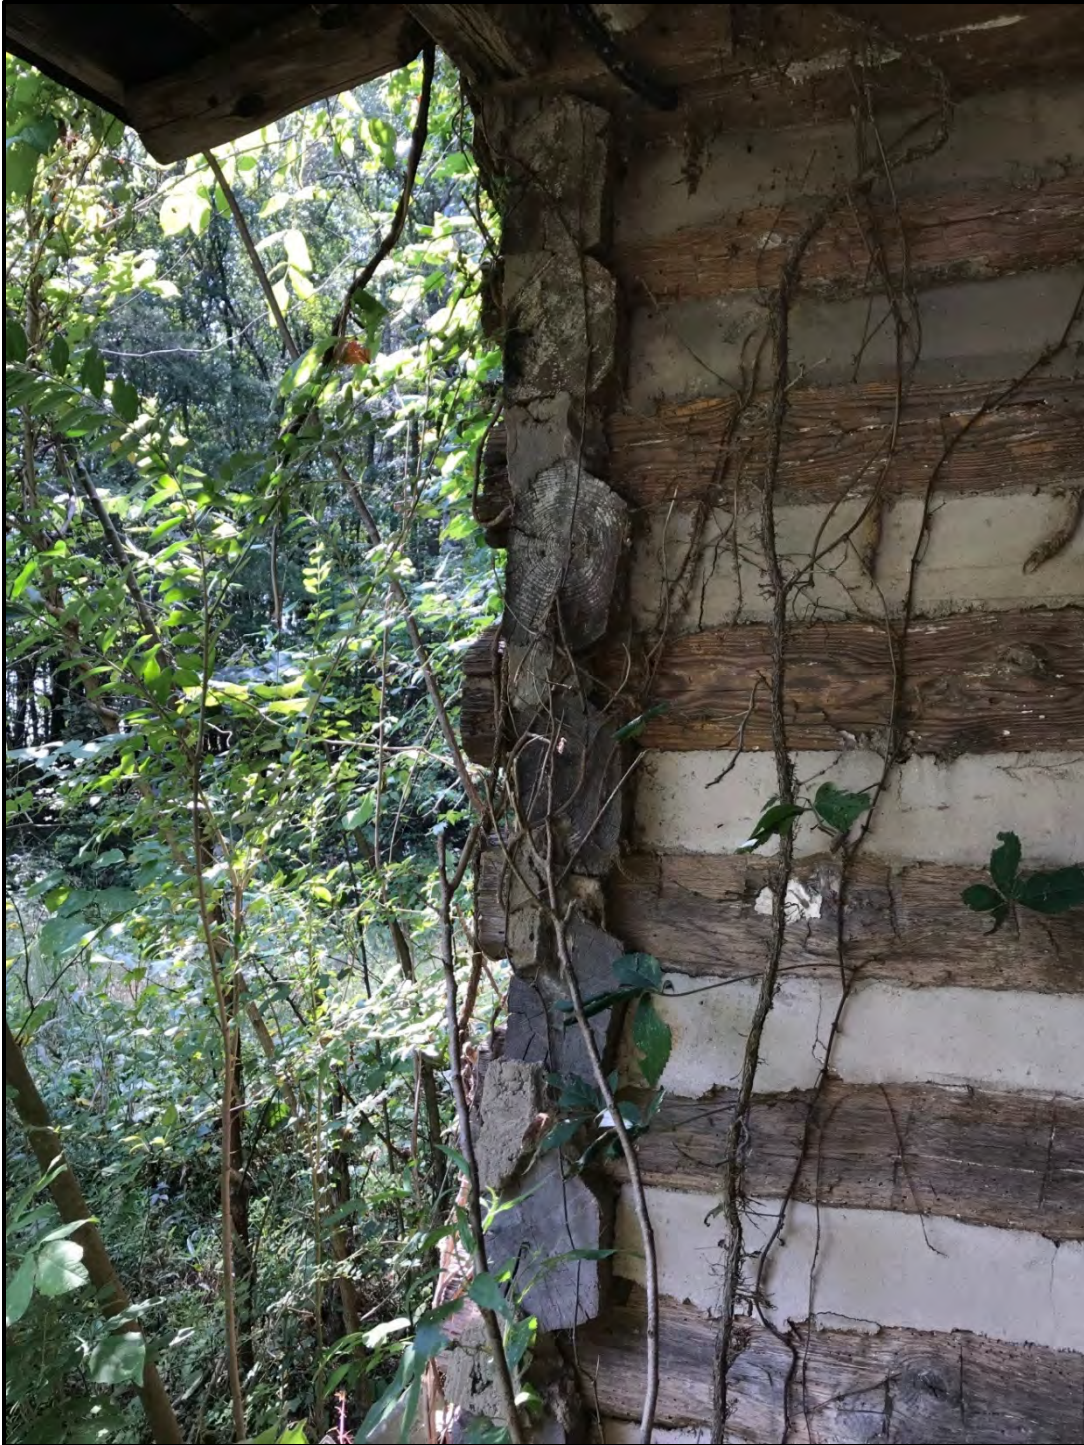
Figure 5.12. Architectural resource RK1656; view is north featuring v-notching at the southwest corner of the main block.

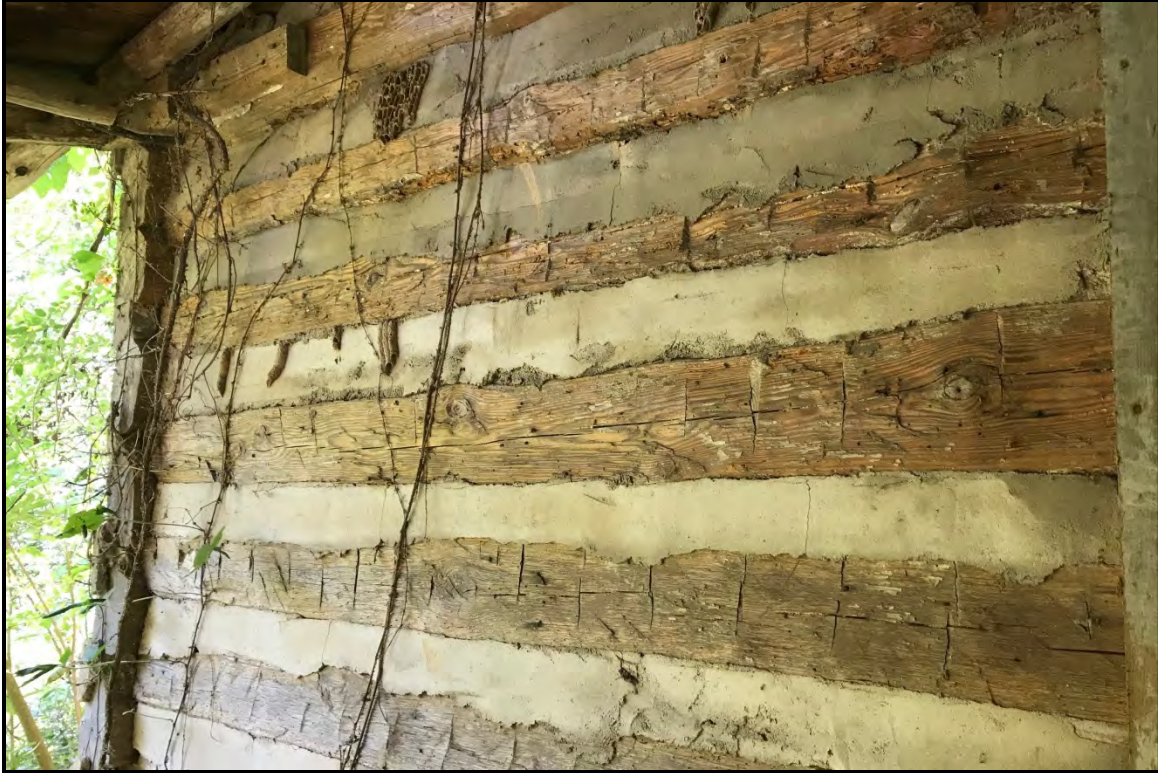
Figure 5.13. Architectural resource RK1656; hewn logs along the southwest (rear) elevation.

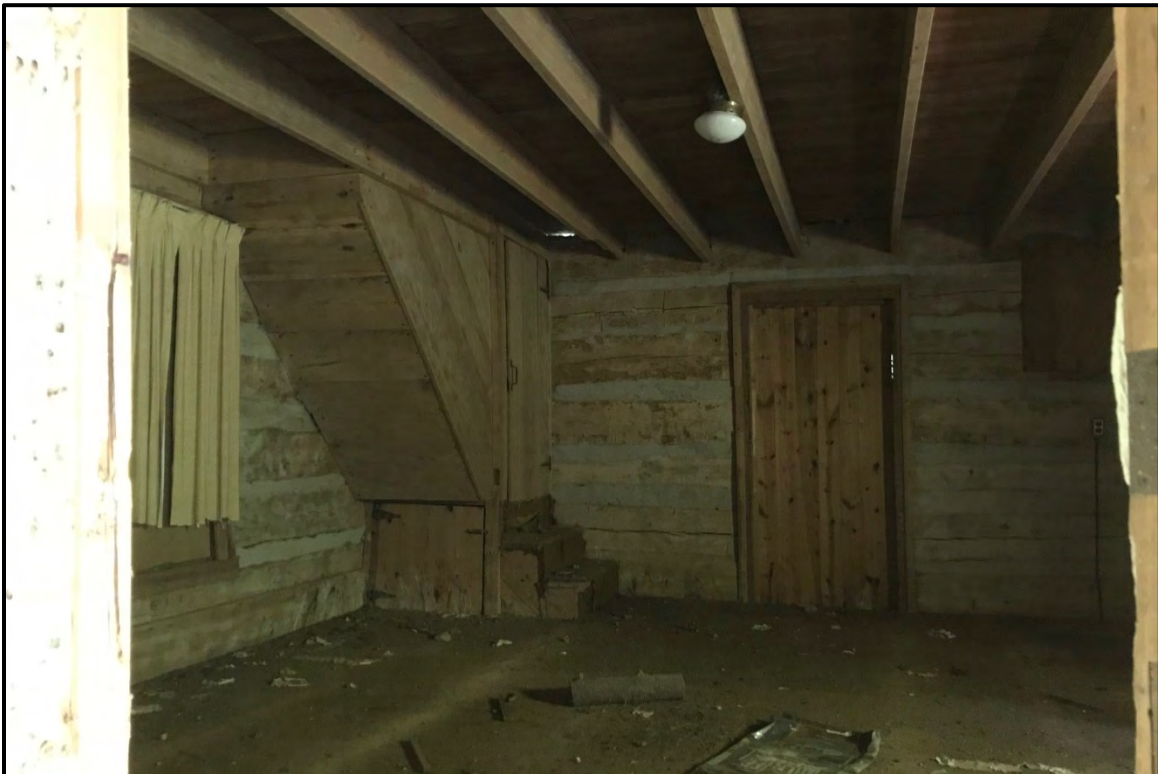
Figure 5.14. Architectural resource RK1656; interior view of the box stair on the first floor; view is northeast.

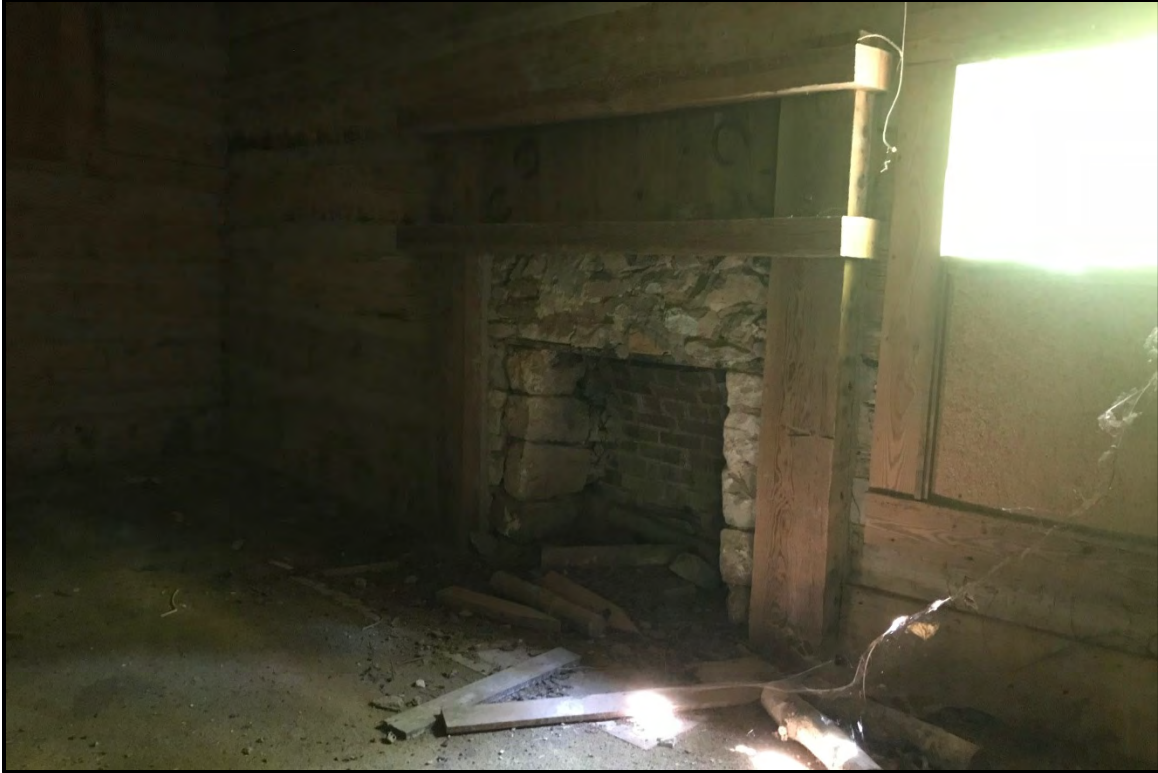
Figure 5.15. Architectural resource RK1656; interior view of the fireplace mantel on the first floor; view is east.

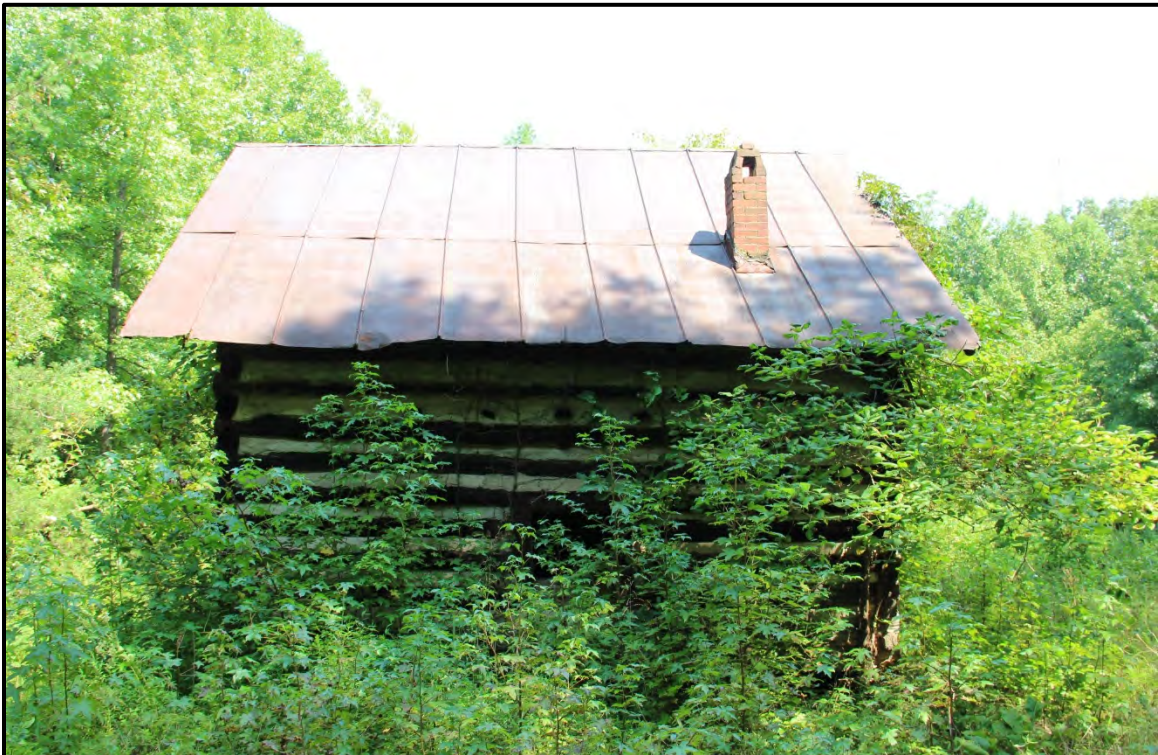
Figure 5.16. Architectural resource RK1656; view is northeast featuring the southwest (rear) elevation of the attached extension.

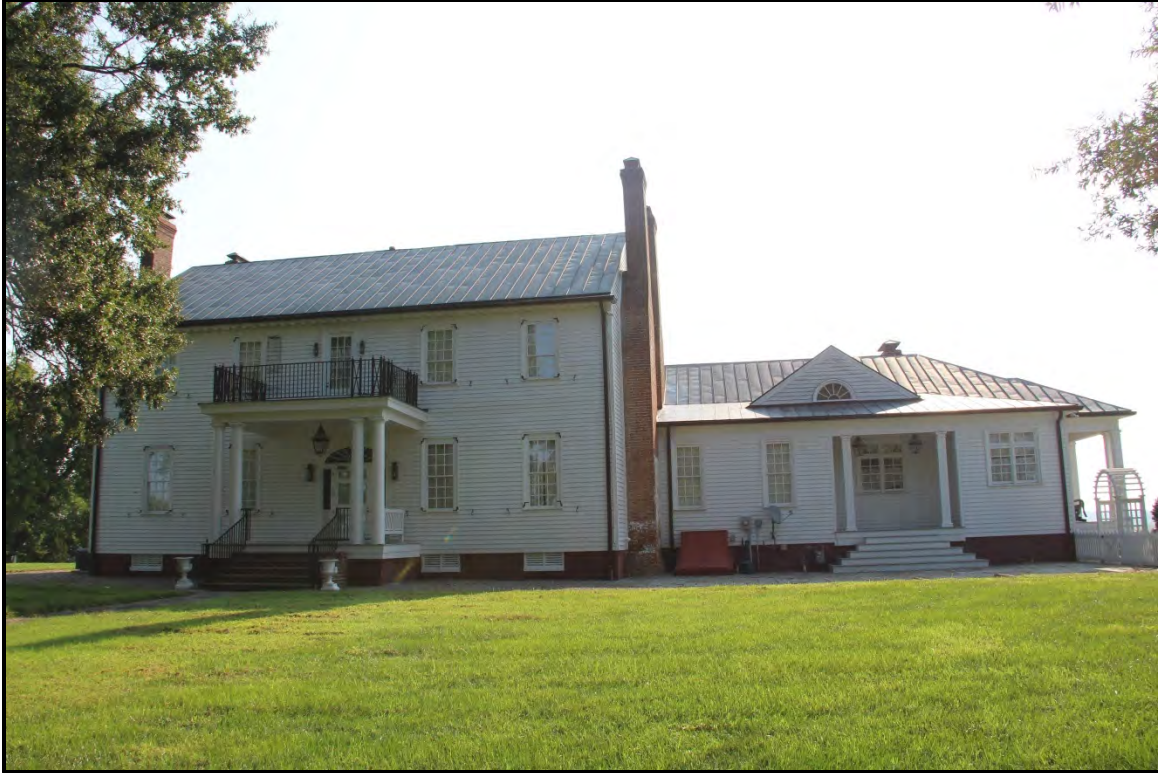
Figure 5.17. Willow Oaks Plantation House; view is northeast featuring the façade.

A one-story, center bay, portico provides access to the main entrance. A review of photographs taken when the house was nominated to the NRHP reveals that the portico has been completely reconstructed since the time of its listing (see Figure 5.17). The current portico contains a wood deck atop a brick foundation that

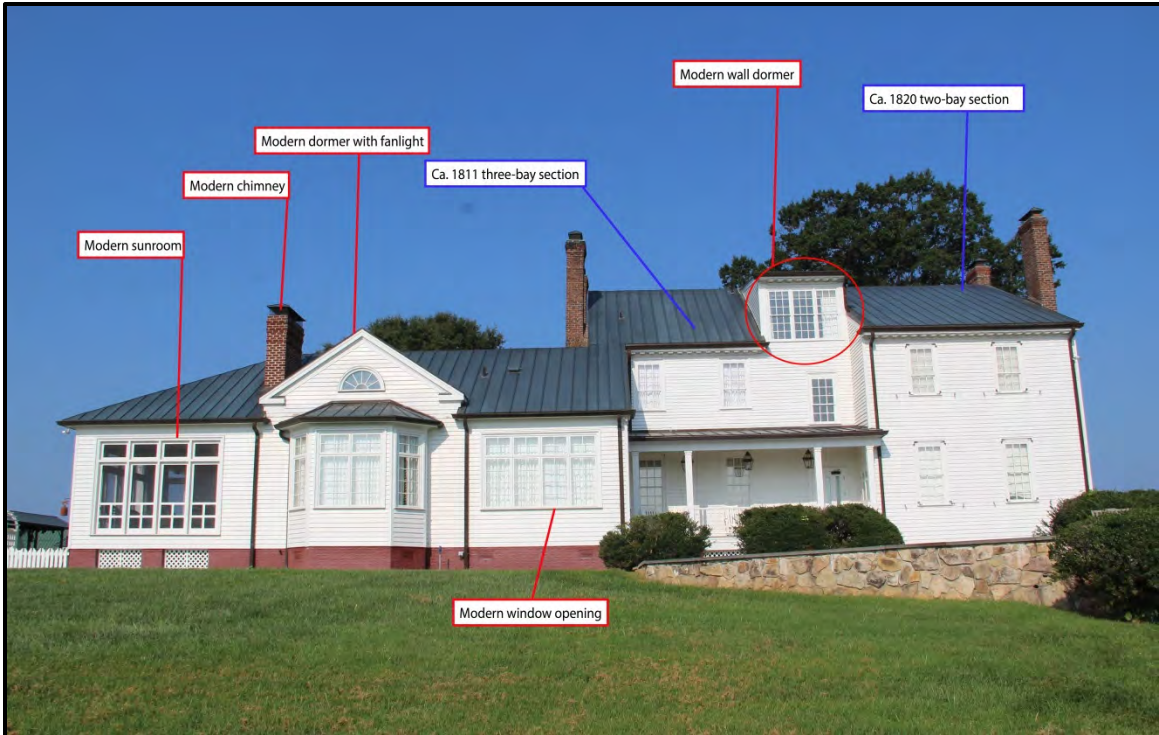
Figure 5.21. Willow Oaks Plantation House; view is west featuring the east (rear) elevation depicting the location of the house's building episodes and modern alterations.

The east (rear) elevation of the house reveals the original three-bay section that is reported to have been constructed during William Brodnax's tenure. This portion of the house includes a wood door with three vertical lights that is flanked to the south by two double-hung 9/9 modern wood sash windows. A reconstructed shed-roof porch spans the width of the three-bay section. The porch contains a wood deck and four square-shaped wood posts. Located on the interior north wall of the porch (on the two-bay addition that is attributed to Robert Brodnax) is a single leaf wood paneled door. A review of photographs taken of this elevation of the house in 1980 reveals that the porch at the time of the property's listing featured chamfered wood posts with decorative brackets characteristic of Folk Victorian architecture. Additionally, the porch included a jigsaw cut wood balustrade porch railing (DigitalNC 2018) (see Figure 5.21).

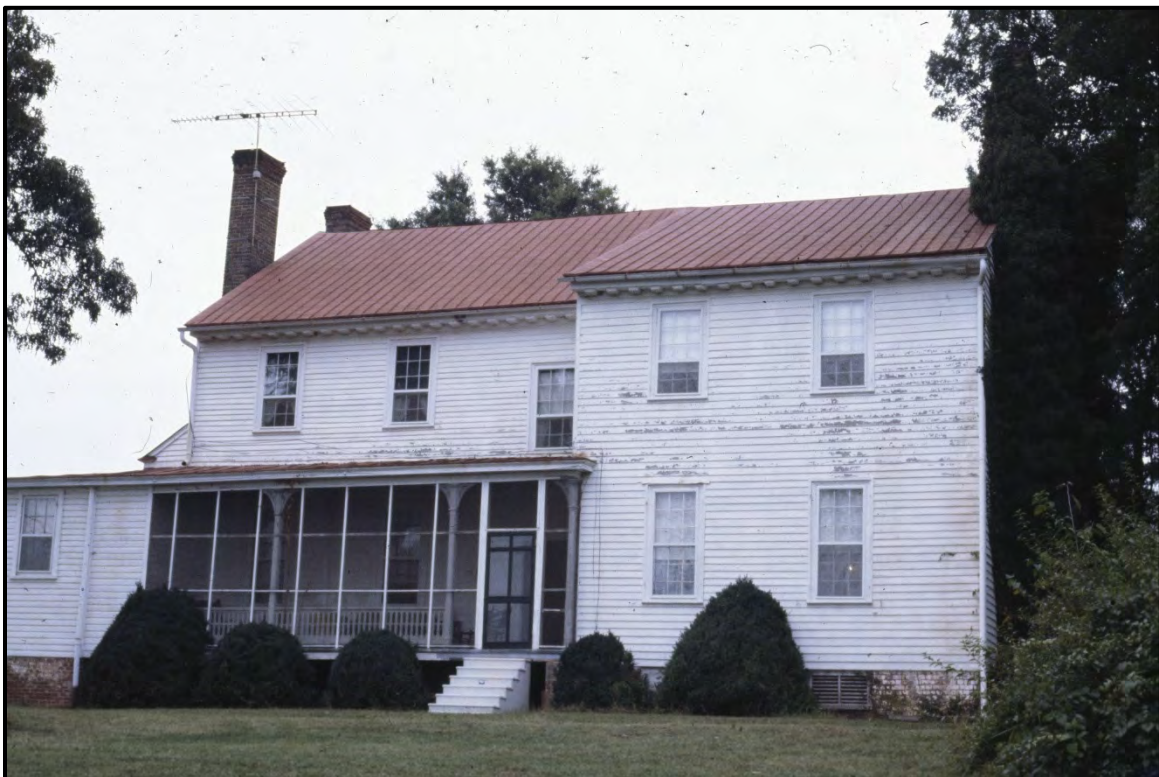
Figure 5.22. Willow Oaks Plantation House; view is west featuring the east (rear) elevation depicting the location of the house's building episodes and modern alterations (image courtesy of DigitalNC.org).

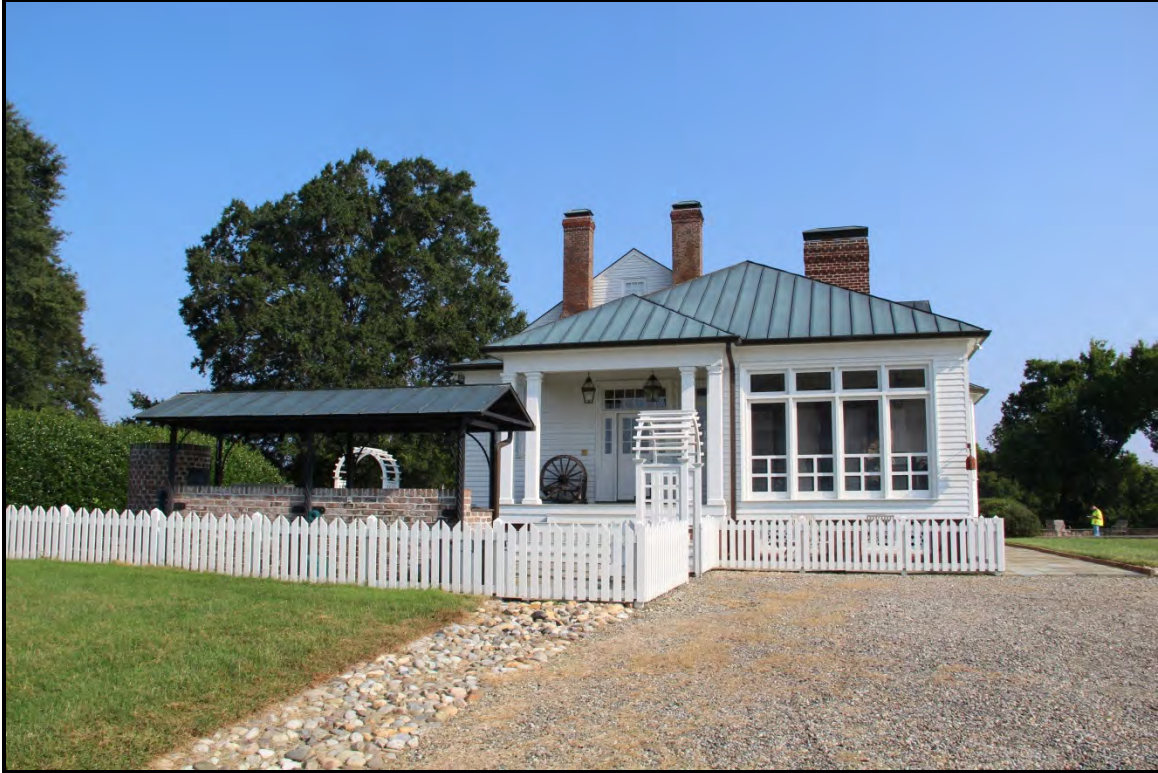
Figure 5.23. Willow Oaks Plantation House; view is north featuring the south elevation wing.

Attached to the south elevation of the house is a single-story, hipped-roof wing that was present at the time of the property's listing on the NRHP. The wing features an exterior clad with weatherboard wood siding on a wood-frame, a modern interior brick chimney, and a brick foundation. In the early 2000s, the wing was extensively remodeled to include a sunroom, a new door surround on the south elevation entrance, and a series of eight-light fixed wood sash windows topped with four-light wood transoms. As part of the renovation, some of the original window openings were enlarged and the roof was raised. This sash type also occurs on a canted bay that is located on the wing's east elevation. The wing's primary façade (west elevation) is marked by a recessed porch that is integral with the roof. The porch is adorned with modern wood columns and provides access to two doors. Flanking the porch to the north are two window openings containing modern 9/9 double-hung wood sashes. Both the east and west elevations of the wing feature a modern gable dormer with a fanlight. Finally, the half story of the main block contains a modern 6/6 double-hung wood sash window.

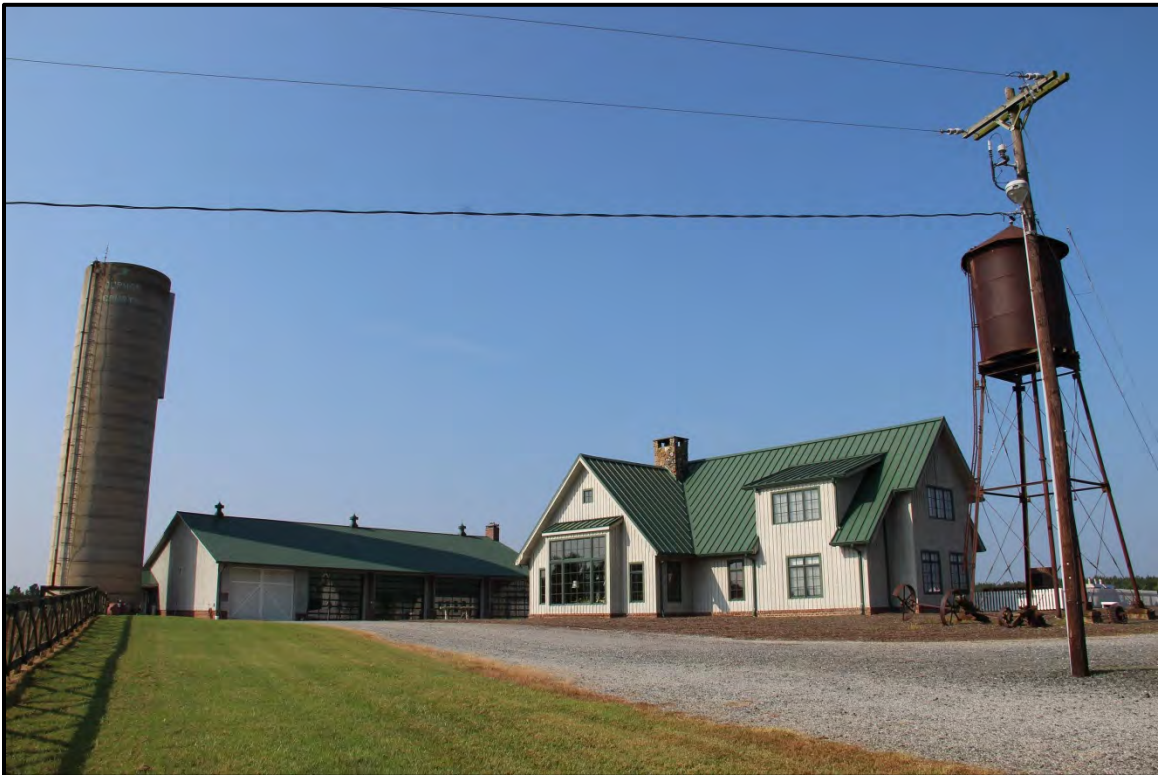
Figure 5.26. Willow Oaks Plantation House; view is southwest featuring the modern hunting lodge, ca. 1960 silo, ca. 2004 agricultural building, and ca. 1920 water tank.

- A disused concrete silo that no longer features a roof. County parcel data indicates that the silo was built in 1960 (Rockingham County, NC GIS 2018) (see Figure 5.26);

- A ca. 1920 water tower. The steel-frame structure features a cylindrical tank that is capped with a conical metal roof. The tank is supported by four steel legs that are reinforced with x-bracing (see Figure 5.26).

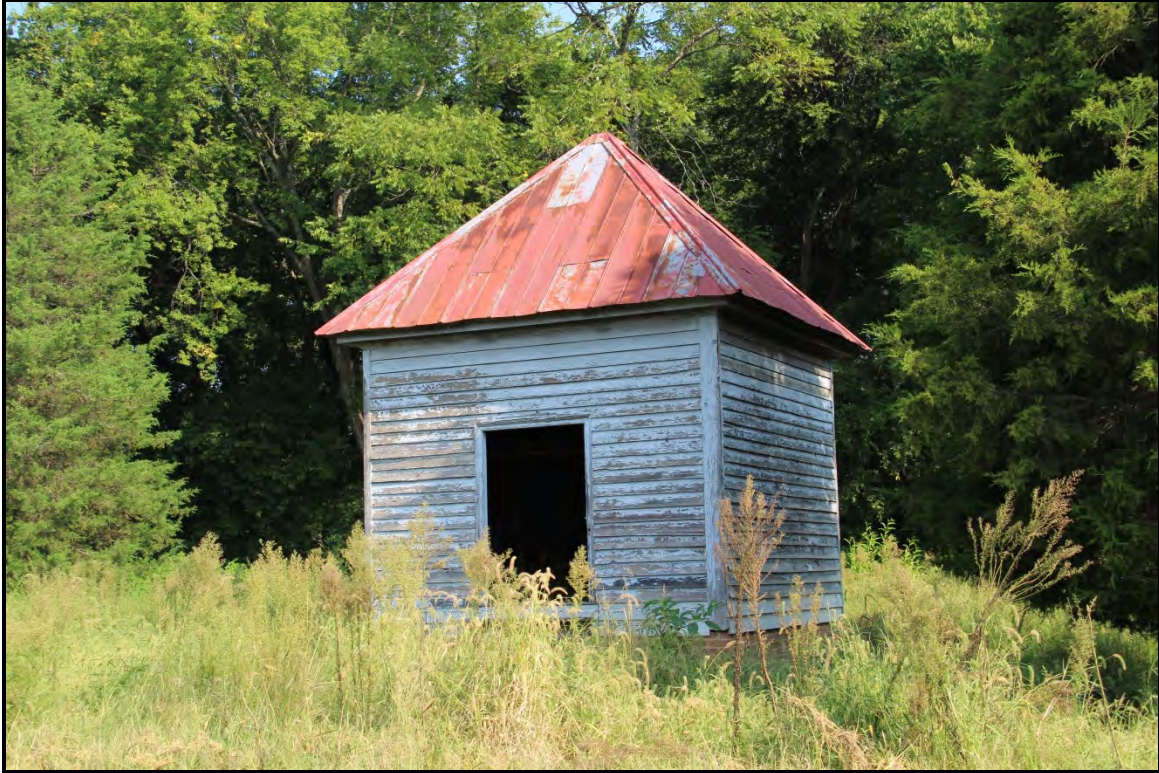
Figure 5.33. Willow Oaks Plantation ca. 1900 smokehouse; view is northwest.

- A ca. 1900 smokehouse that no longer appears to be in use. This resource is identified in the NRHP form as a contributing structure to the listed property (Butler et al. 1975). The wood-frame structure features a pyramidal roof covered with standing seam metal, an exterior clad with beaded weatherboard siding, and a brick foundation. A door opening without a leaf is located on the west elevation (see Figure 5.33);

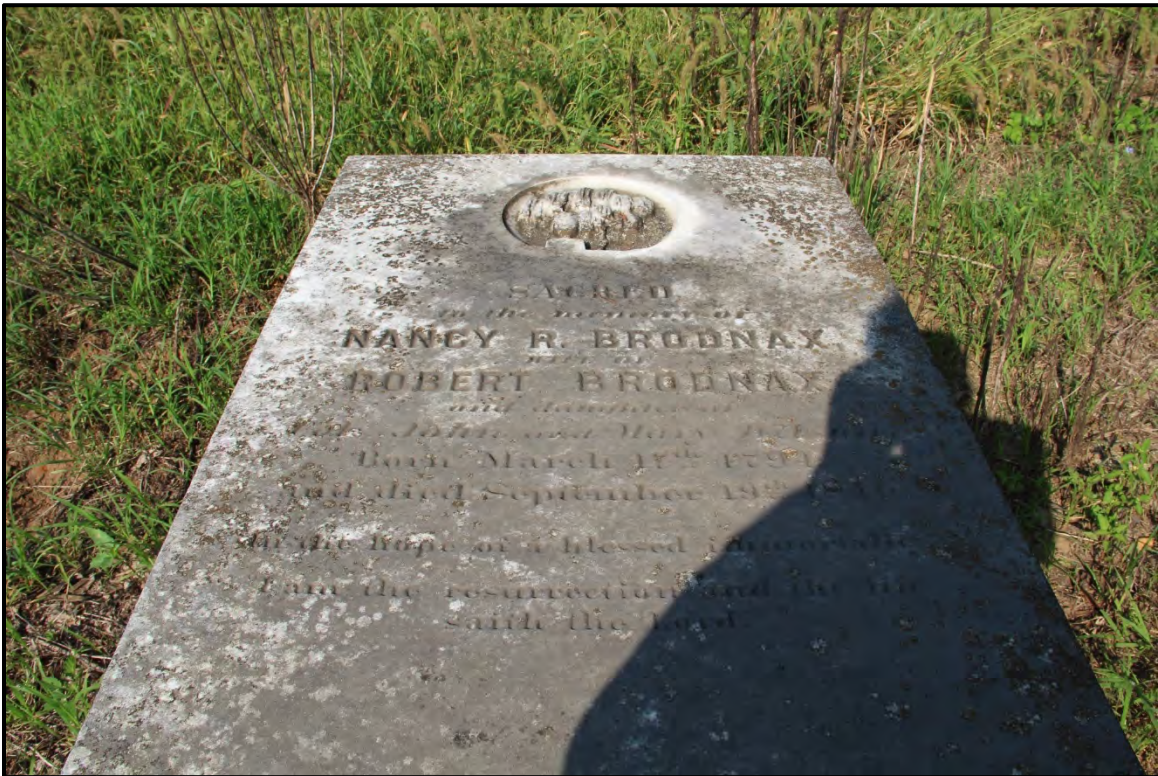
Figure 5.36. Willow Oaks Plantation; table tomb of Nancy R. Brodnax; view is west.

- A small cemetery containing the graves of Brodnax family members. The cemetery includes two table tombs that each feature a flat marble tablet that is supported by six chamfered pillars. In addition, the cemetery includes an upright marble tablet with a dome and shoulders (see Figures 5.34–5.36);

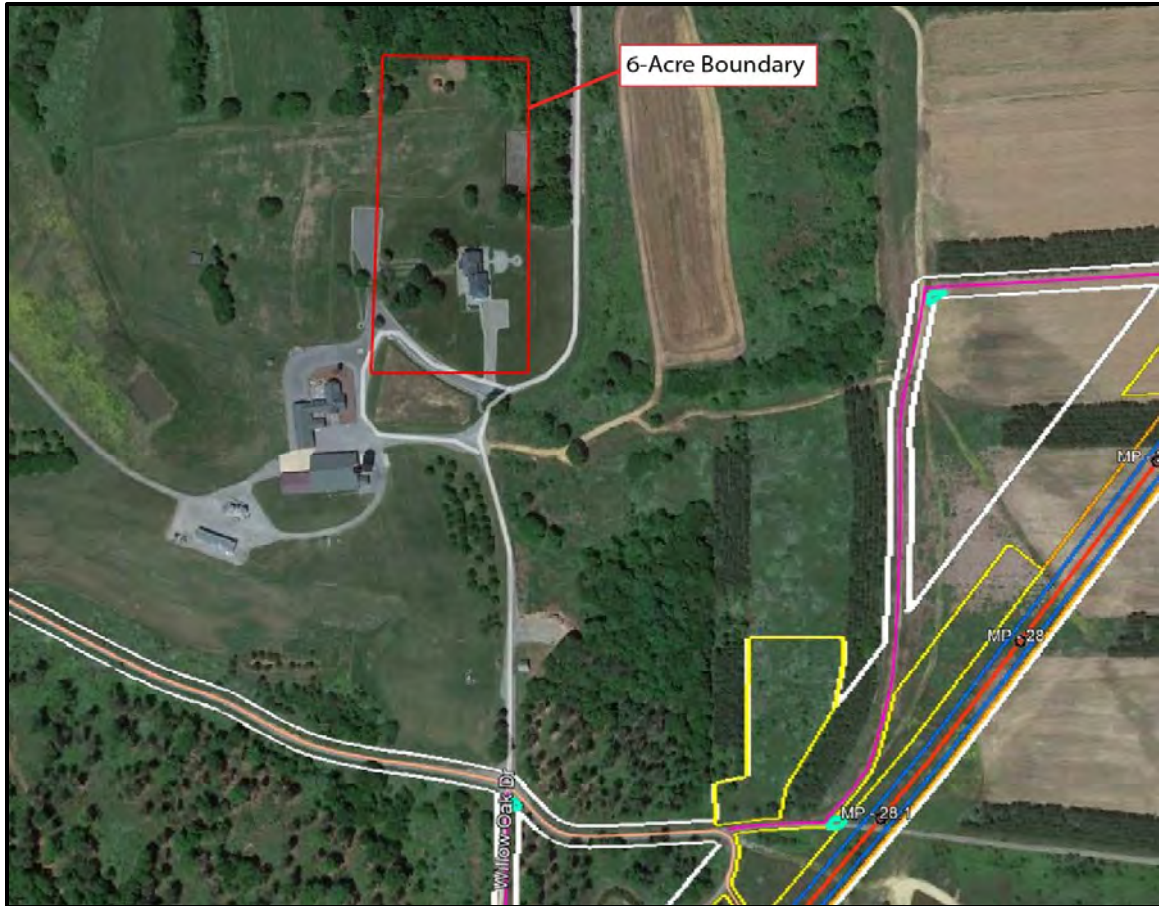
Assessment of Potential Effects. Based on current Project plans, the six-acre grounds immediately surrounding Willow Oaks containing the house, the Brodnax Family cemetery, and the ca. 1900 smokehouse are located approximately 0.17 miles northwest of proposed access road TA-RO-075, which is the nearest component of the Project to the architectural resource (Figure 5.38). From this area, visual lines-of-sight to the Project area will be partially obstructed by the existing terrain, which features rolling hills and mature tree growth located between the eastern edge of the property's unofficial NRHP boundary and the Project area (see Figure 5.25).

Figure 5.38. Aerial imagery of the Willow Oaks Plantation illustrating a 6-acre boundary encapsulating the plantation house, family cemetery, ca. 1900 smokehouse, and the original walkway to the main entrance (image courtesy of Google Earth).

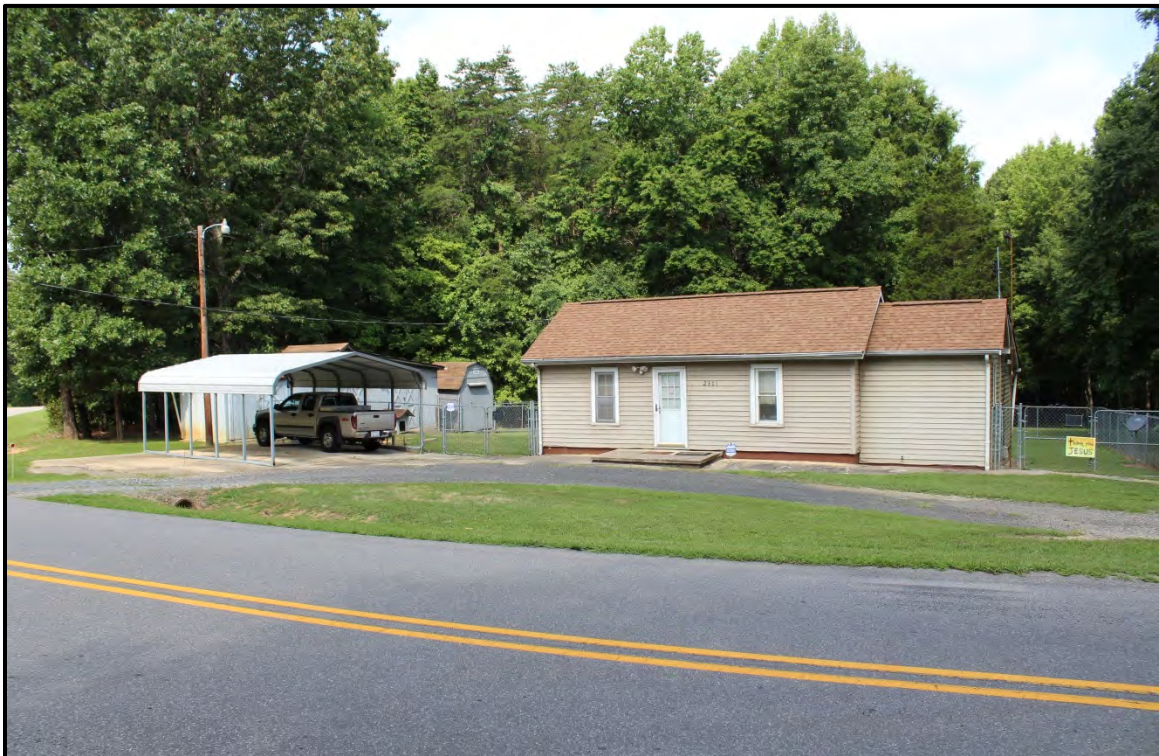
The one-story, wood-frame building features a roof covered with asphalt shingles, wood frame with a vinyl siding exterior, a concrete block foundation, and double hung 1/1 and 4/4 vinyl sash windows. A center-bay concrete stoop provides access to the main entrance. Attached to the north elevation is a side-gable wing.

NRHP Assessment. Architectural resource RK1657 does not exhibit a distinctive architectural style or workmanship. In addition, the house has been altered through the application of vinyl siding and the replacement of the original window sashes. Based on the lack of architectural merit, as well as the inability to associate the house and/or its original owner(s) with an important historical event or series of events, it is TRC’s opinion that architectural resource RK1657 is not eligible for the NRHP.

Figure 5.39. Architectural resource RK1657; view is southwest featuring the façade of the primary residence and the associated carport.

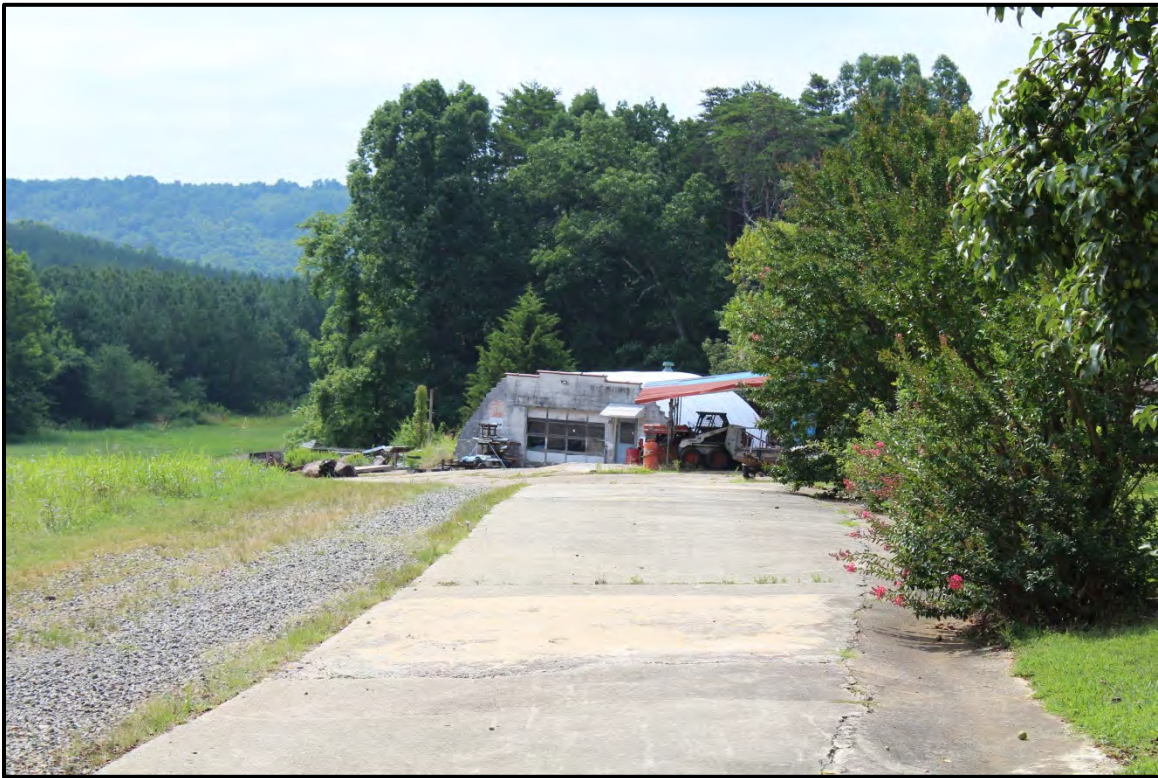
Located south of the house is a Quonset Hut that functions as a shop building and has a reported construction date of 1957 (Rockingham County, NC GIS 2018). The metal frame structure features a barrel roof composed of corrugated metal. The primary façade is dressed with concrete blocks and topped by tile coping. The structure includes a vehicle bay containing an overhead wood door with eight lights. Located west of the vehicle bay is a metal pedestrian door with a single light in its upper portion. The door is shielded by a metal shed canopy (Figure 5.41).

Figure 5.41. Architectural resource RK1658; view is south featuring the machine shop.
