Re: Revised Architectural Survey Report, MVP Southgate Project, Construct Interstate Pipeline, Rockingham and Alamance County, ER 18-1041

Thank you for your letter of October 11, 2019, transmitting the draft "Historic Architectural Survey for the MVP Southgate Pipeline Project". We have reviewed the report and offer the following comments.

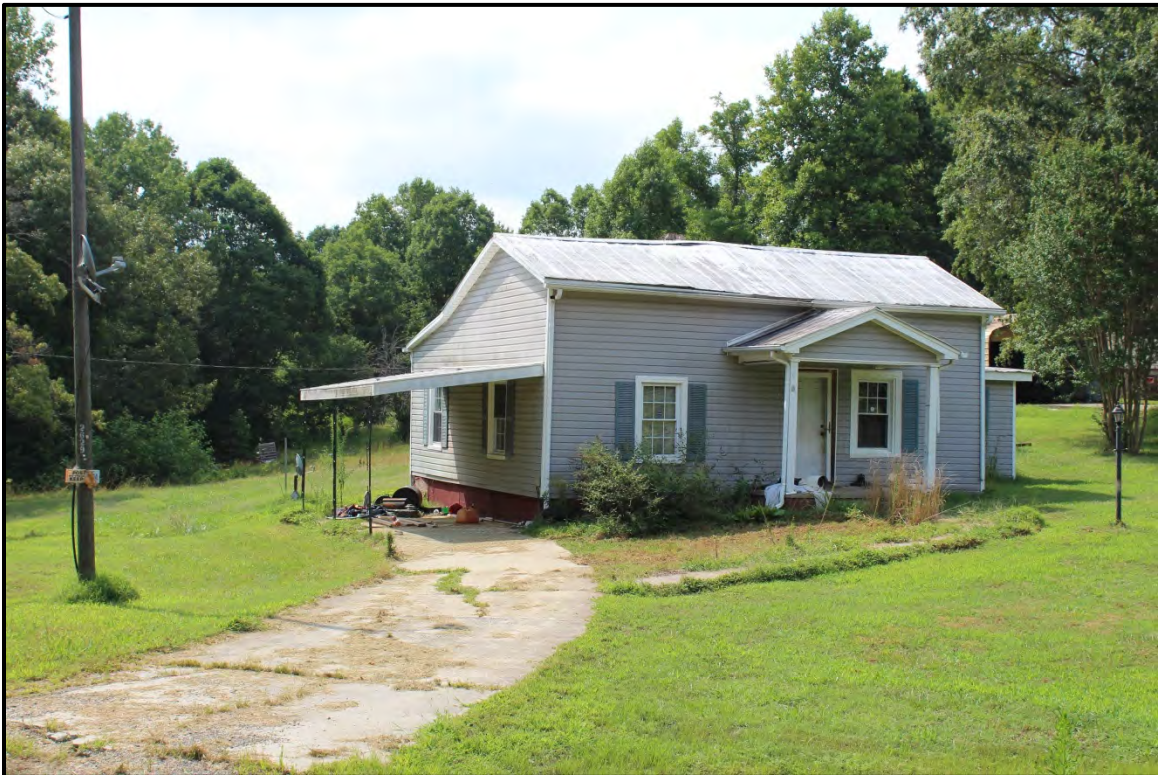
The one-story, wood-frame building features a side-gabled roof, a wood frame with vinyl siding exterior, and a concrete block foundation. Fenestration consist of 6/6, double-hung vinyl sash windows. A center bay stoop with a concrete slab provides access to the main entrance. The stoop is shielded with a projecting gable roof that is supported by two posts comprised of synthetic material. An open, single-bay carport is attached to the northeast elevation.

NRHP Assessment. Architectural resource RK1659 does not exhibit a distinctive architectural style or workmanship. In addition, the house has been altered through the application of vinyl siding and the construction of the carport to the northeast elevation. Based on the lack of architectural merit, as well as the inability to associate the house and/or its original owner(s) with an important historical event or series of events, it is TRC’s opinion that architectural resource RK1659 is not eligible for the NRHP.

Figure 5.42. Architectural resource RK1659; view is south featuring the façade and northeast elevation.

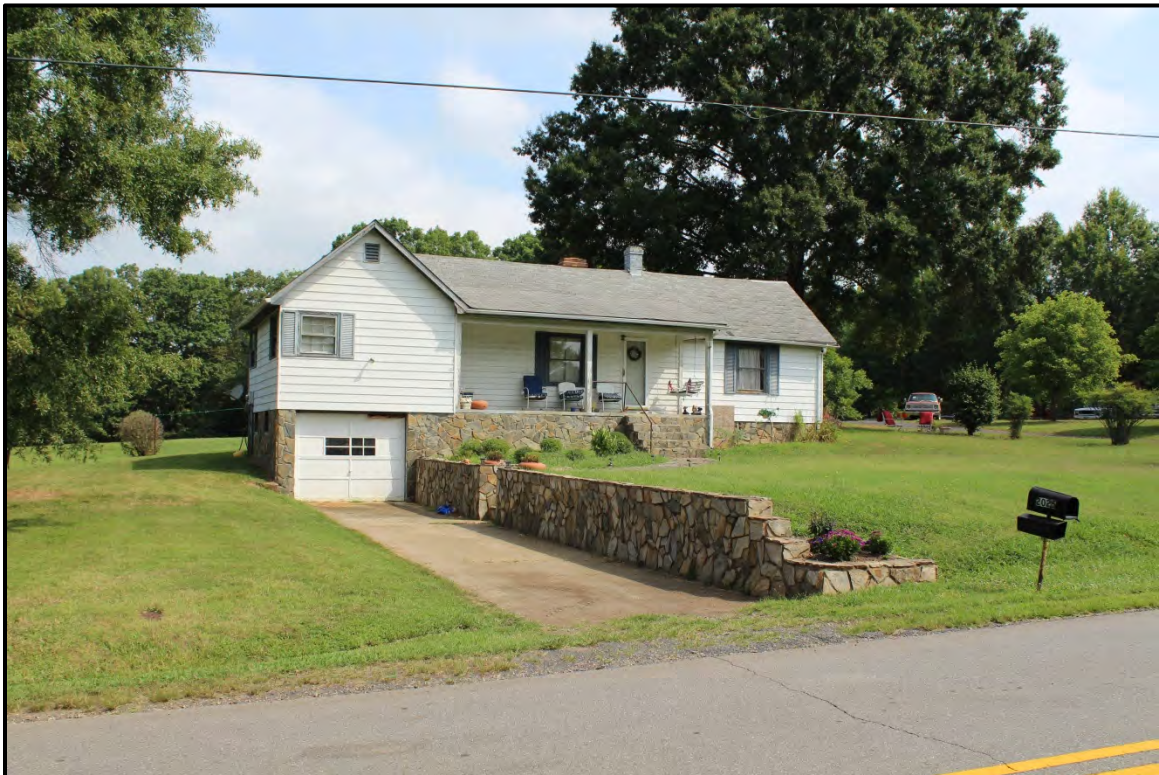
The one-story, wood-frame building features a gable-front and side-gable roof, an interior brick chimney, a wood frame with aluminum siding exterior, and a raised foundation clad with a faux stone veneer. Fenestration consist of 6/6, 1/1, and 2/2 double-hung wood sash windows. A partial-width porch with a concrete slab provides access to the main entrance. The porch is shielded with a shed roof that is supported by two wood posts. A single-bay garage containing an overhead wood door is positioned at the basement level along the primary façade.

NRHP Assessment. Architectural resource RK1660 does not exhibit a distinctive architectural style or workmanship. In addition, the house has been altered through the application of vinyl siding and the addition of the front-gabled wing. Based on the lack of architectural merit, as well as the inability to associate the house and/or its original owner(s) with an important historical event or series of events, it is TRC’s opinion that architectural resource RK1660 is not eligible for the NRHP.

Figure 5.43. Architectural resource RK1660; view is north featuring the façade.

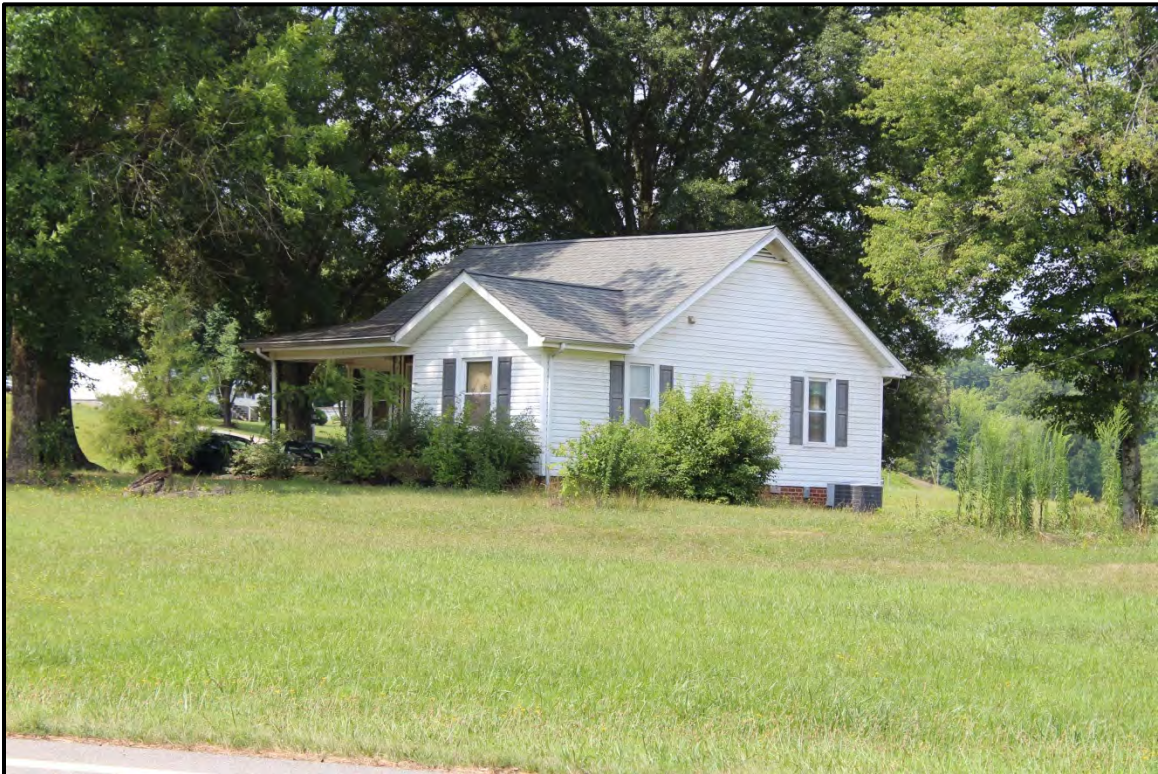
The one-story, wood-frame building has a side-gabled roof, exterior synthetic siding, and a brick foundation. Windows are replacement 1/1. Doors are also replacement; these modifications date to ca. 2010.

Figure 5.44. Architectural resource RK1661; view is southwest featuring the front-gabled wing and north elevation.

NRHP Assessment. Architectural resource RK1661 does not exhibit distinctive characteristics of architectural style or workmanship. Additionally, the building's architectural integrity has been compromised through the application of synthetic siding and replacement of doors and windows. Based on the lack of architectural merit, as well as the inability to associate the house and/or its original owner(s) with an important historical event or series of events, it is TRC's opinion that architectural resource RK1661 is not eligible for the NRHP.

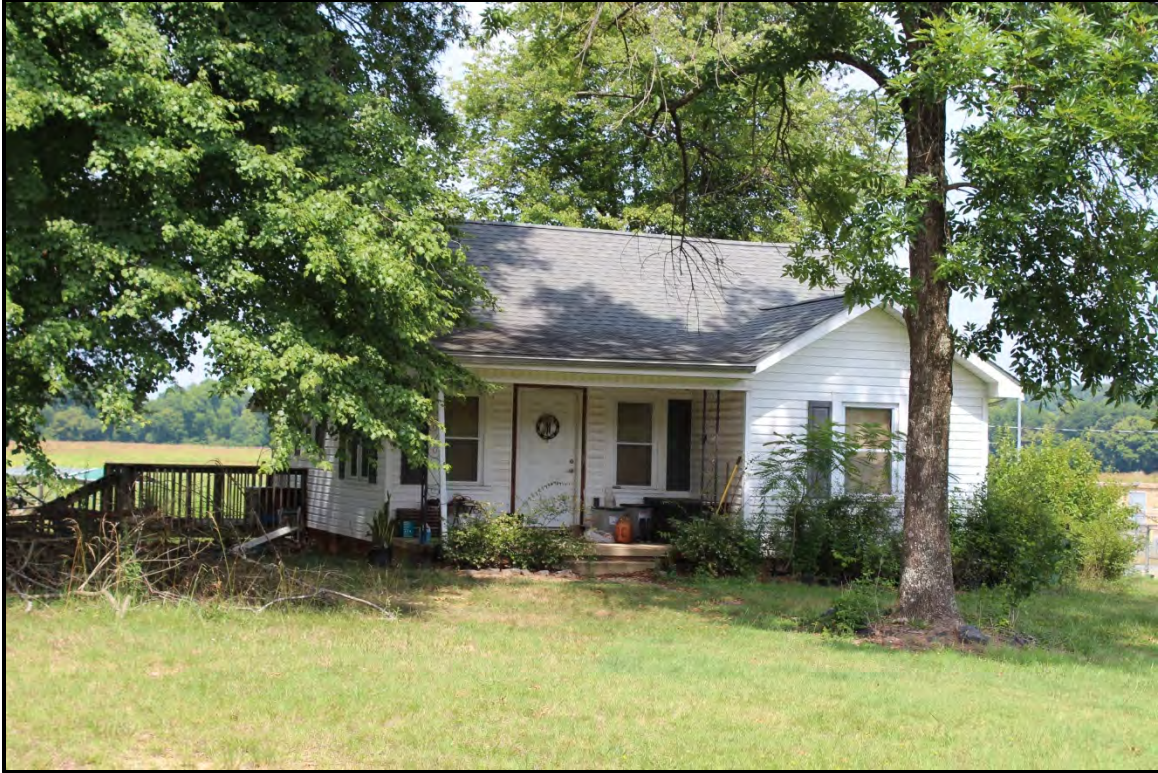
Figure 5.45. Architectural resource RK1661; view is northwest featuring the façade and south elevation.

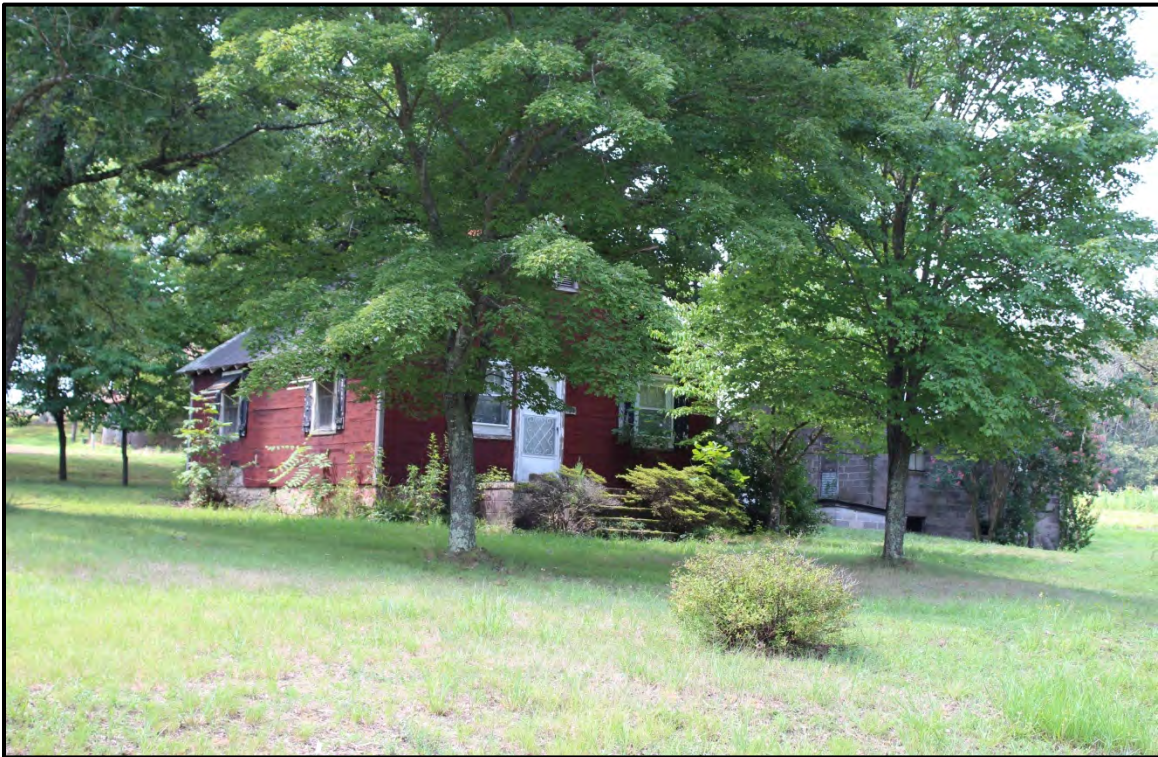
The one and one-half-story, wood-frame building has an original paneled door, an exterior clad with asphalt shingle siding, 6/6 windows, and a continuous concrete foundation. Attached to the rear (west) elevation is a shed addition clad with horizontal board siding.

Figure 5.46. Architectural resource RK1662; view is southwest featuring the façade and east elevation.

NRHP Assessment. Architectural resource RK1662 does not exhibit distinctive characteristics of architectural style or workmanship. Based on the lack of architectural merit, as well as the inability to associate the house and/or its original owner(s) with an important historical event or series of events, it is TRC's opinion that architectural resource RK1662 is not eligible for the NRHP.

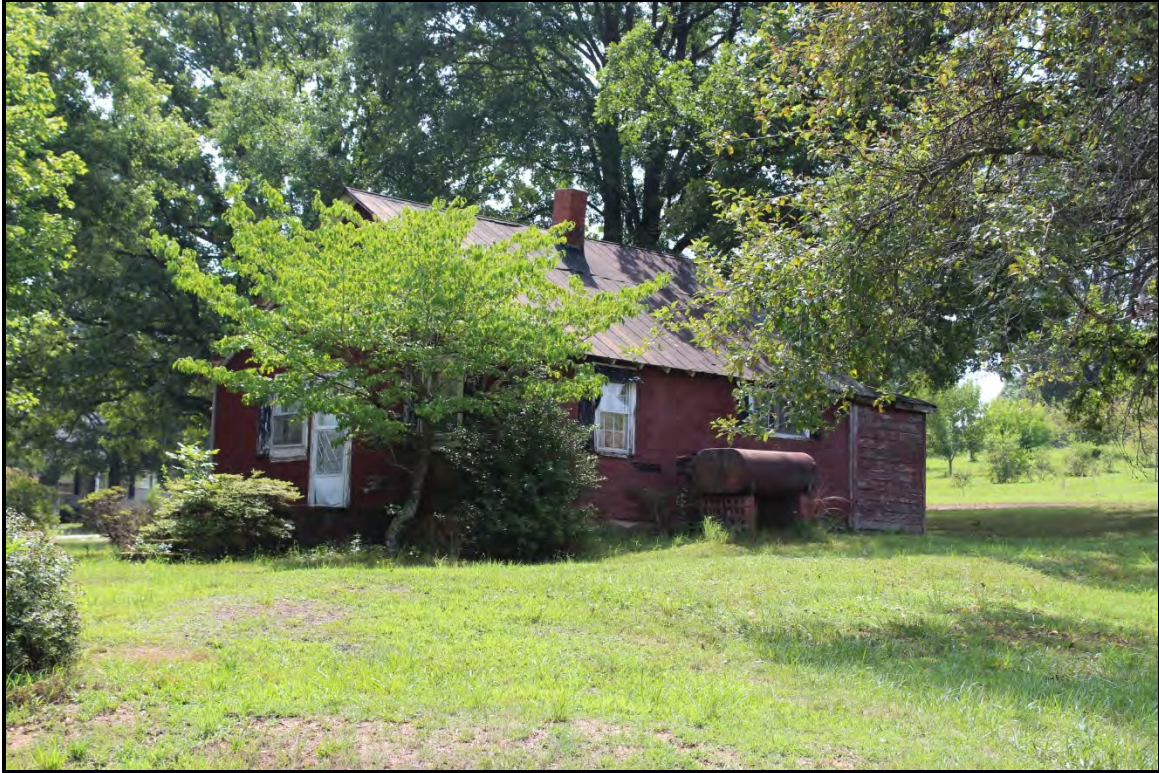
Figure 5.47. Architectural resource RK1662; view is southeast featuring the façade and west elevation.

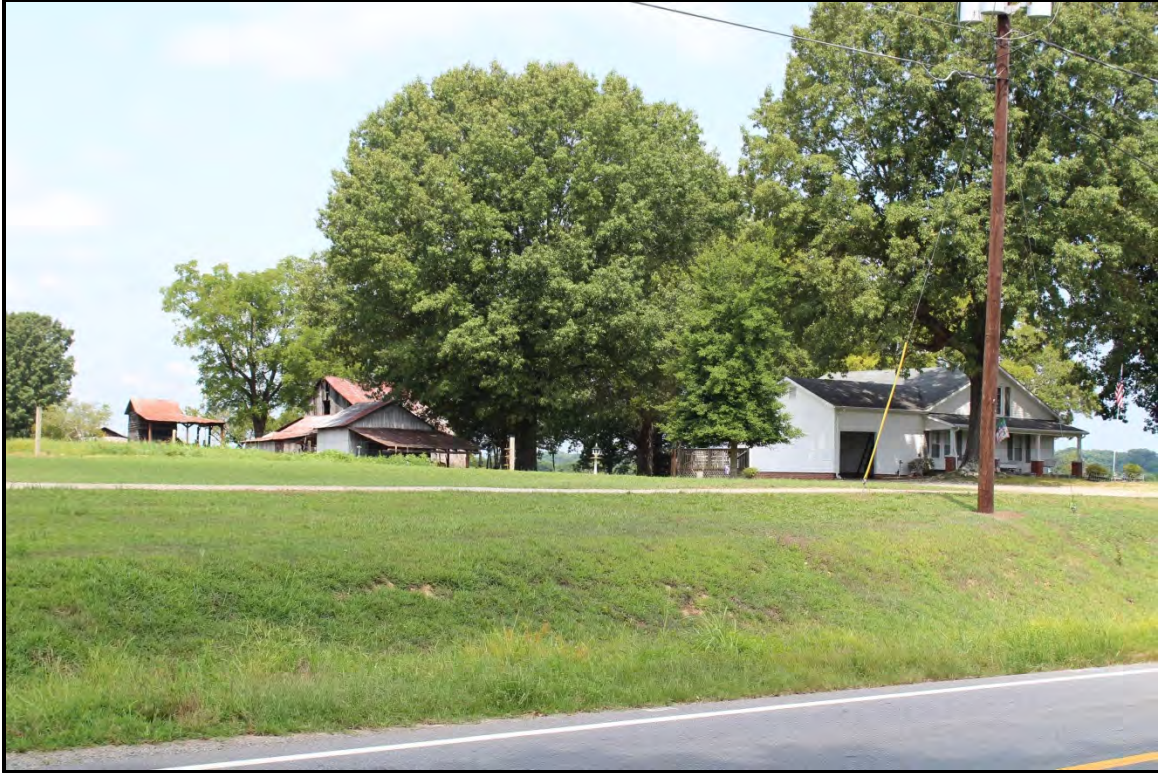
The farmstead includes several outbuildings, as described below and shown in Figures 5.48, 5.49, 5.52, and 5.53. The one and one-half-story farmhouse (Figures 5.48, 5.50 and 5.51) has a roof covered with asphalt shingles, exterior synthetic siding, a full shed porch, a brick foundation, and replacement 1/1 vinyl sash windows. At the southeast elevation is an attached cross-gabled garage wing constructed in 1950. The garage is also clad with vinyl siding.

Figure 5.48. Architectural resource RK1663; overview of farmstead looking northwest featuring the residence and associated outbuildings.

NRHP Assessment. Architectural resource RK1663 does not exhibit a distinctive architectural style or workmanship. The primary residence has been altered through the addition of exterior synthetic siding, the replacement of original windows, and the construction the southeast garage wing. As a result, the farm no longer conveys its early twentieth century appearance, thereby rendering the property ineligible for its agricultural associations. Based on the farmstead’s overall lack of architectural merit, as well as the inability to associate the property and/or its original owner(s) with an important historical event or series of events, it is TRC’s opinion that architectural resource RK1663 is not eligible for the NRHP.

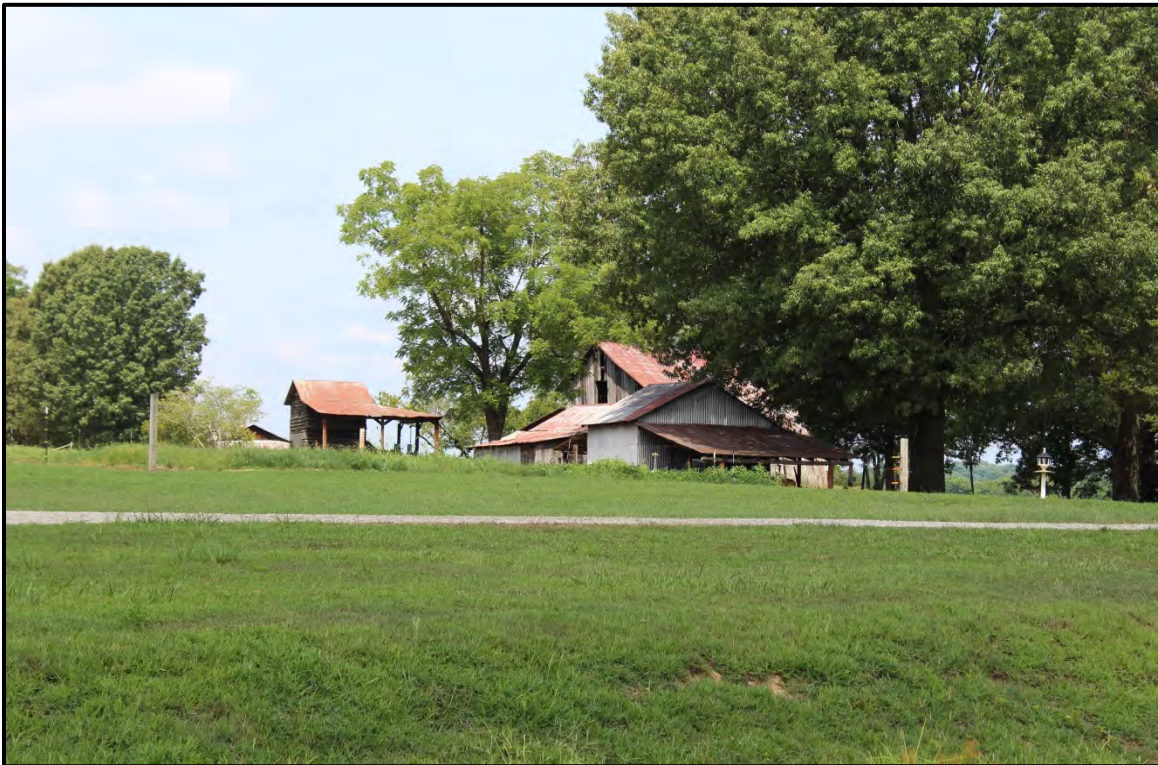
- A log tobacco barn with a metal open shed storage wing (early 20th century);
- A two-story vertical board frame barn (early 20th century);
- A one-story vertical board barn (early 20th century);
- A one-story storage shed/barn with side open plan storage wings and corrugated metal siding (early to-mid 20th century);
- A one-story gable-front plan shed with horizontal board siding (mid-to late 20th century);
- A one-story board and batten barn with a concrete foundation (mid-20th century).

Figure 5.49. Architectural resource RK1663; view is northwest featuring associated outbuildings.

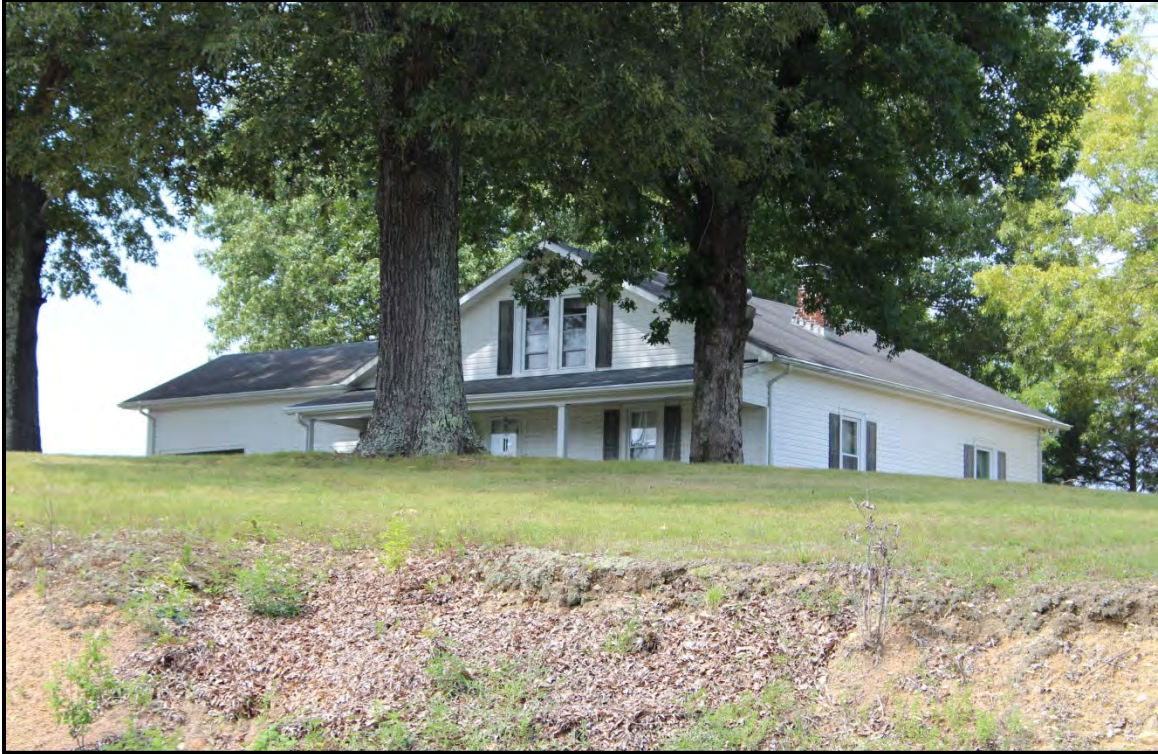
Figure 5.50. Architectural resource RK1663; view is southwest featuring the façade and north elevation.

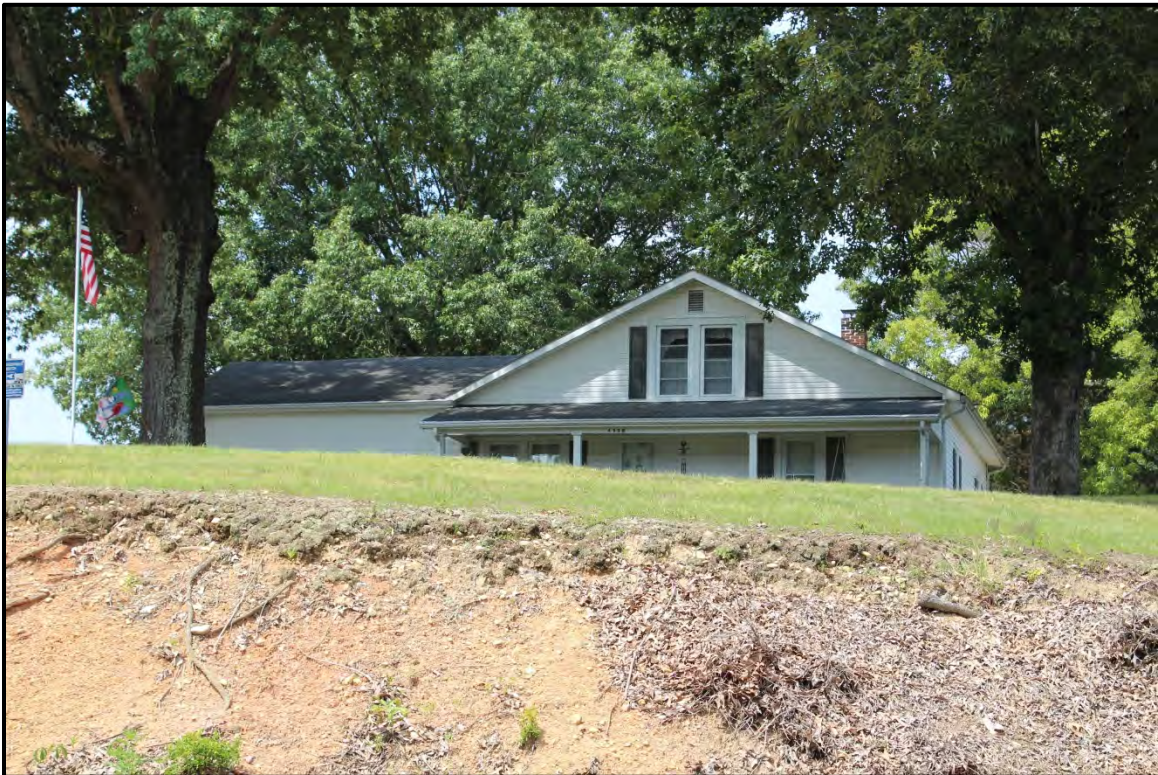
Figure 5.51. Architectural resource RK1663; view is west featuring the façade.

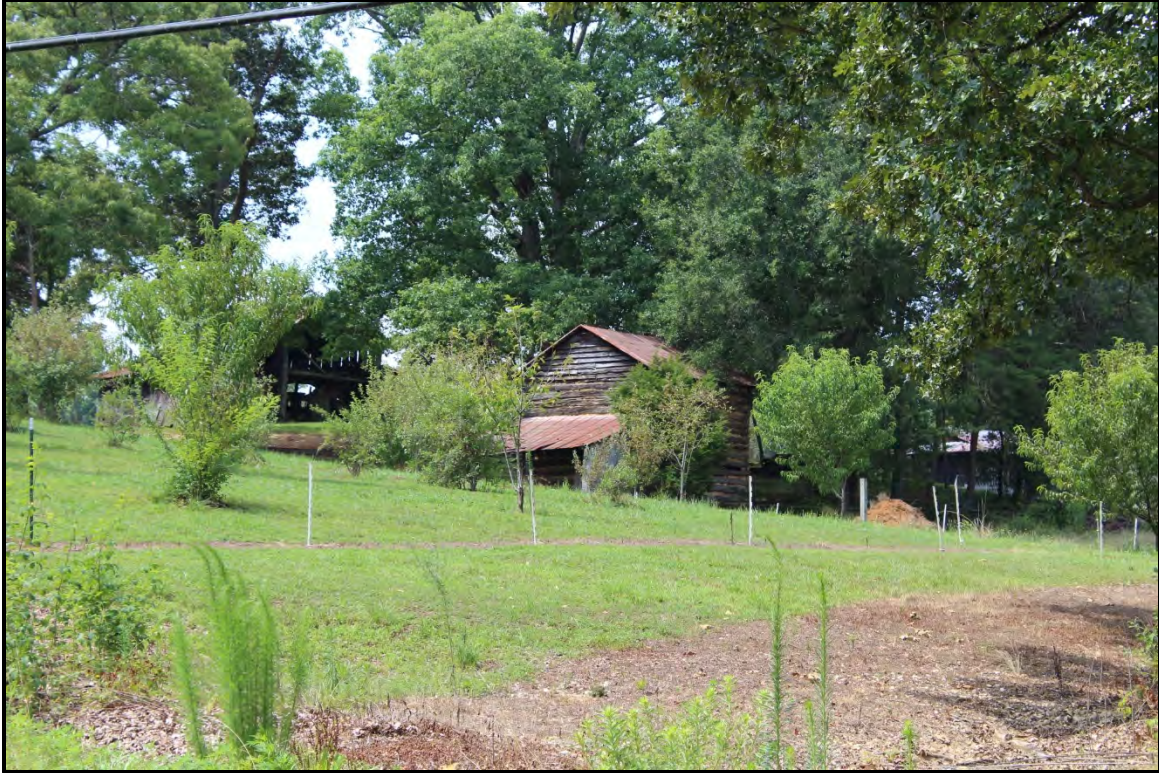
Figure 5.52. Architectural resource RK1663, log tobacco barn; view is southwest.

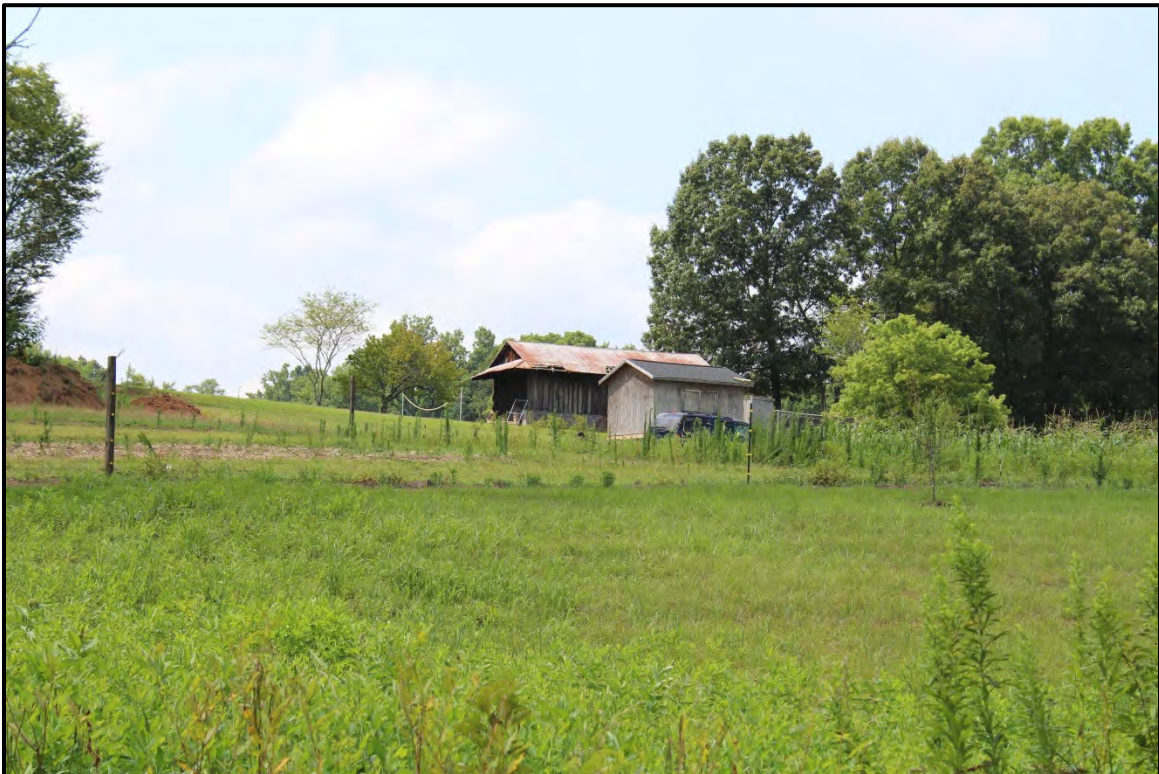
Figure 5.53. Architectural resource RK1663; frame shed and barn; view is southwest.

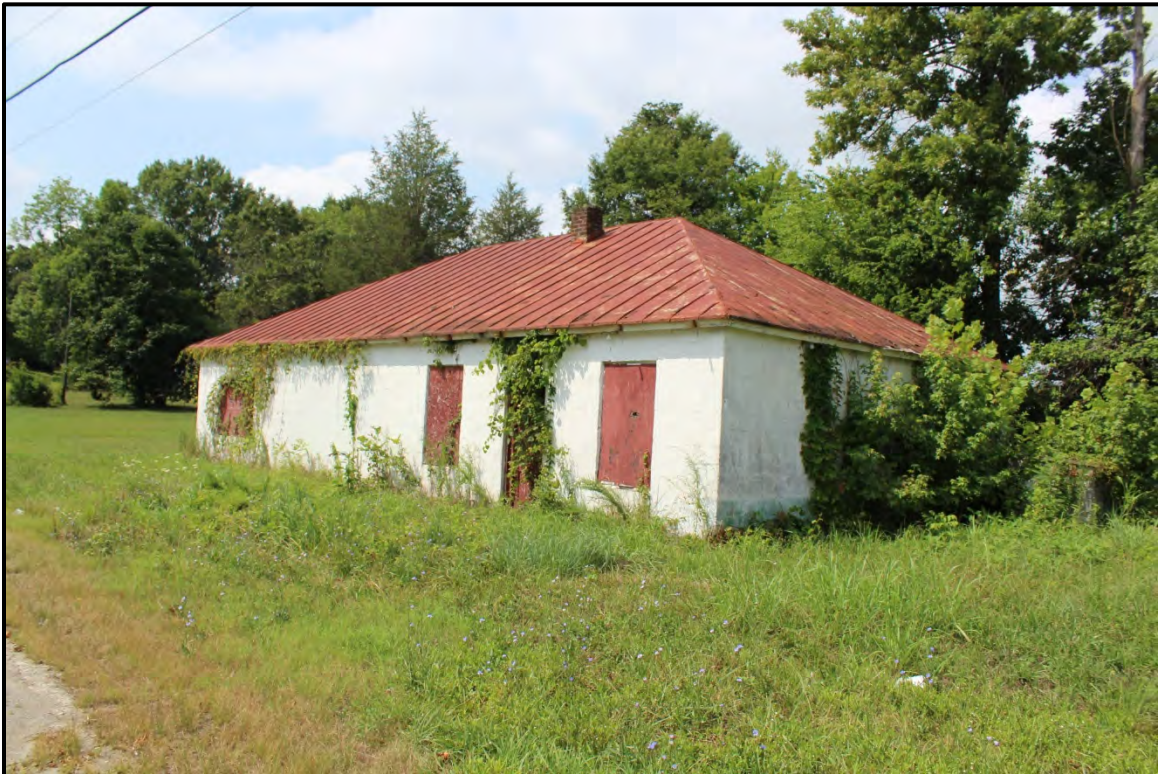
The one-story concrete block building features a rectangular plan with a roof covered with standing seam metal, an interior brick chimney, concrete block walls and a concrete block foundation. Windows and doors are covered with plywood. A south corner shed wing, also constructed of concrete block, appears originally to have housed a public restroom.

Figure 5.54. Architectural resource RK1664; view is southwest featuring the façade and northwest elevation.

NRHP Assessment. Architectural resource RK1664 does not exhibit distinctive characteristics of architectural style or workmanship. Based on the lack of architectural merit, as well as the inability to associate the property and/or its original owner(s) with an important historical event or series of events, it is TRC's opinion that architectural resource RK1664 is not eligible for the NRHP.

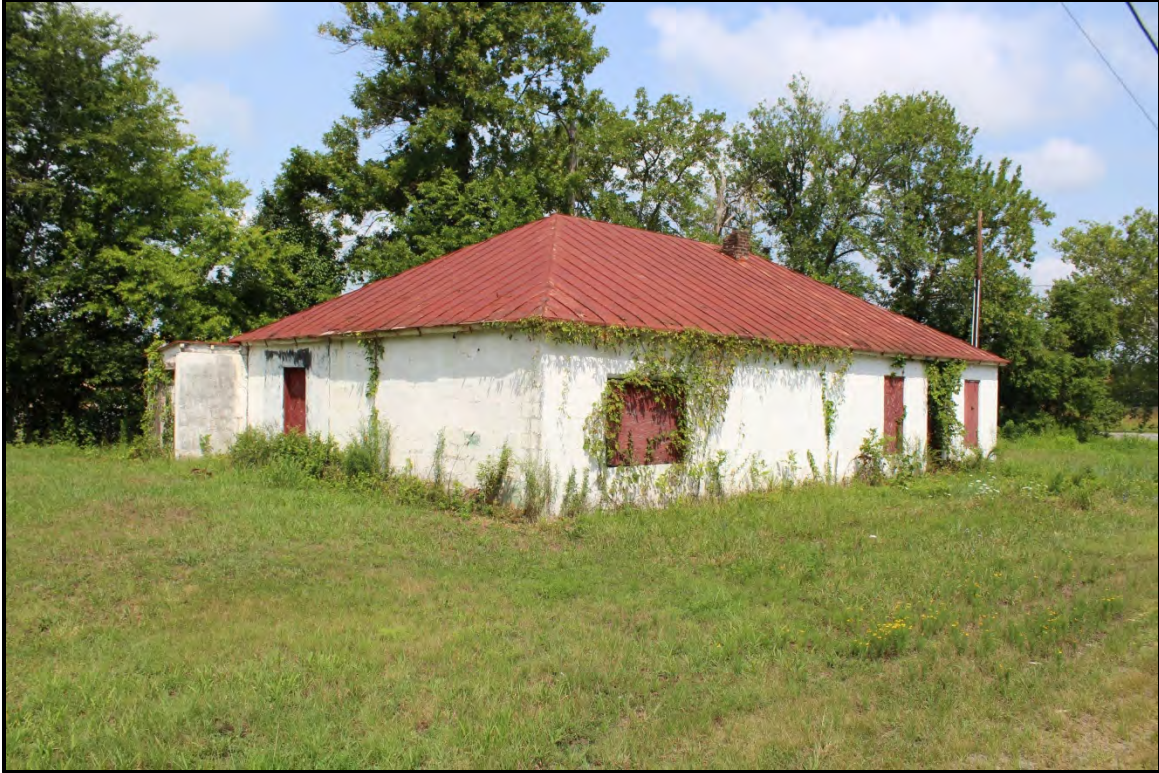
Figure 5.55. Architectural resource RK1664; view is northwest featuring the façade and southeast elevation.

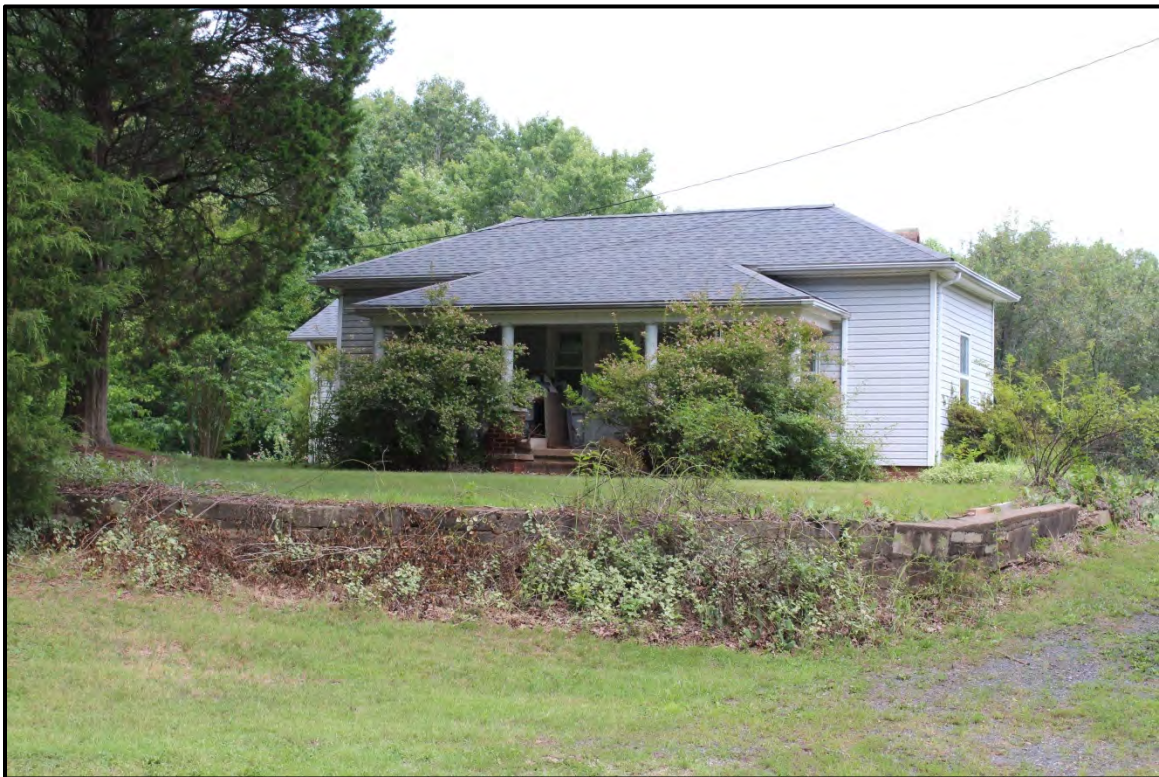
NRHP Assessment. Architectural resource RK1665 does not exhibit a distinctive architectural style or workmanship. In addition, the building’s architectural integrity has been compromised through the application of synthetic siding and replacement of original doors and windows. Based on the lack of architectural merit, as well as the inability to associate the house and/or its original owner(s) with an important historical event or series of events, it is TRC’s opinion that architectural resource RK1665 is not eligible for the NRHP.

Figure 5.56. Architectural resource RK1665; view is northwest, featuring the façade and northeast elevation.

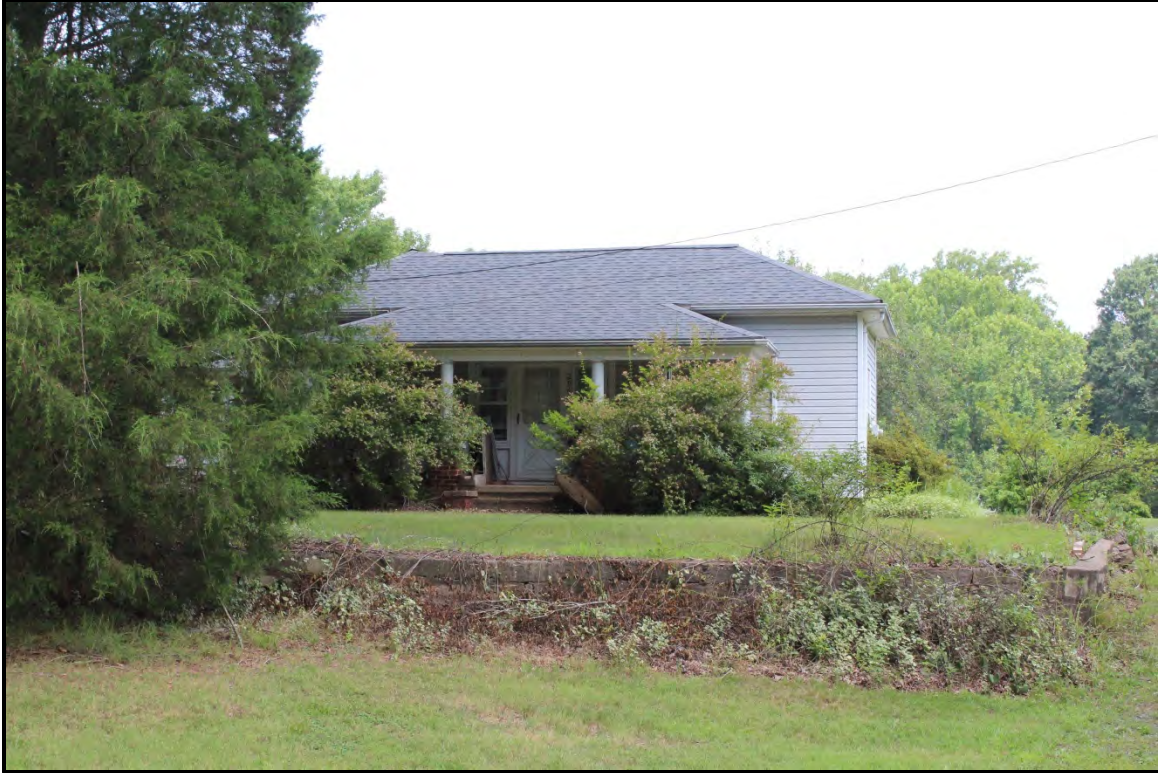
The one-story, wood-frame building is capped with a roof covered with asphalt shingles and features an exterior clad with vinyl siding. The building rests on a brick foundation. Windows are replacement 1/1 and original 3/1 design. The primary door is a ca. 2010 replacement.

Figure 5.57. Architectural resource RK1665; view is northwest, featuring the façade.

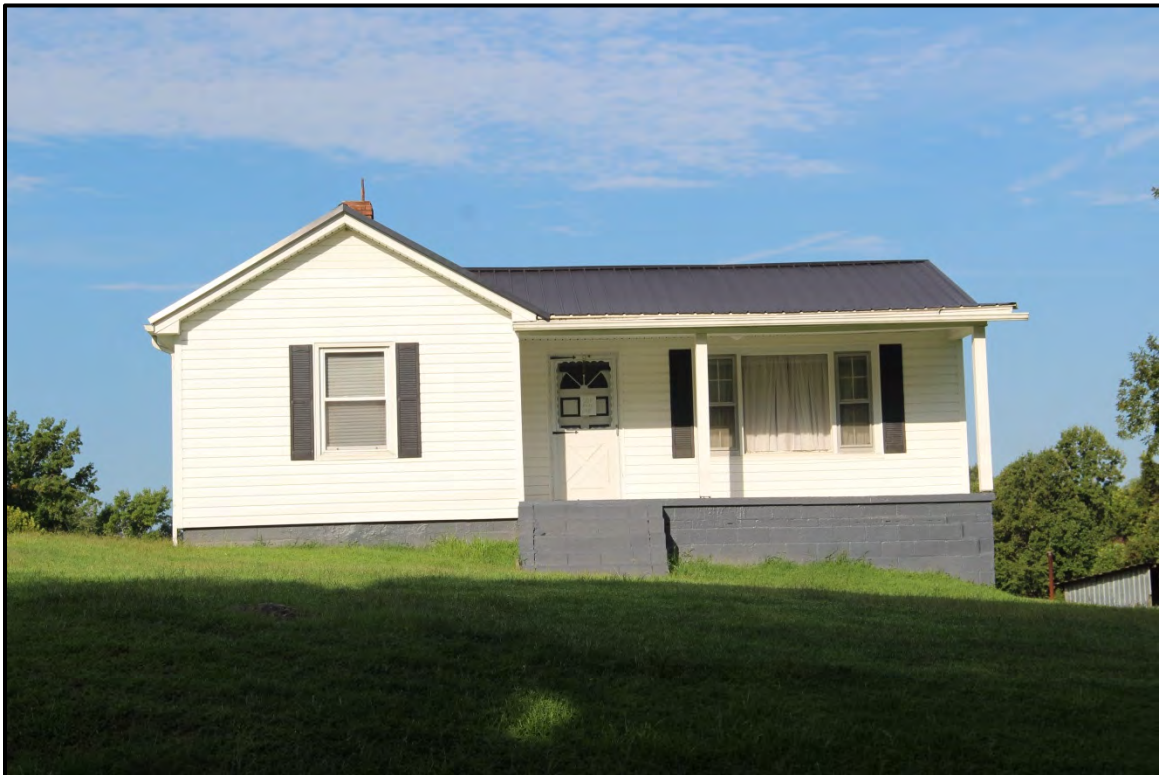
The one-story, wood-frame building features a gabled roof, exterior vinyl siding and a concrete block foundation. Fenestration consists of 1/1 double-hung vinyl sash, with exception of the picture style window on the façade (northeast elevation). The primary door is a replacement paneled design with a fanlight. The projecting gable wing (southeast elevation) holds three window bays; the northwest elevation holds one window bay. A prefabricated carport is situated southwest of the house.

Figure 5.58. Architectural resource RK1666; view is southwest featuring the façade.

NRHP Assessment. Architectural resource RK1666 does not exhibit a distinctive architectural style or workmanship. In addition, the building’s architectural integrity has been compromised through the application of synthetic siding and the replacement of original doors and windows. Based on the lack of architectural merit, as well as the inability to associate the house and/or its original owner(s) with an important historical event or series of events, it is TRC’s opinion that architectural resource RK1666 is not eligible for the NRHP.

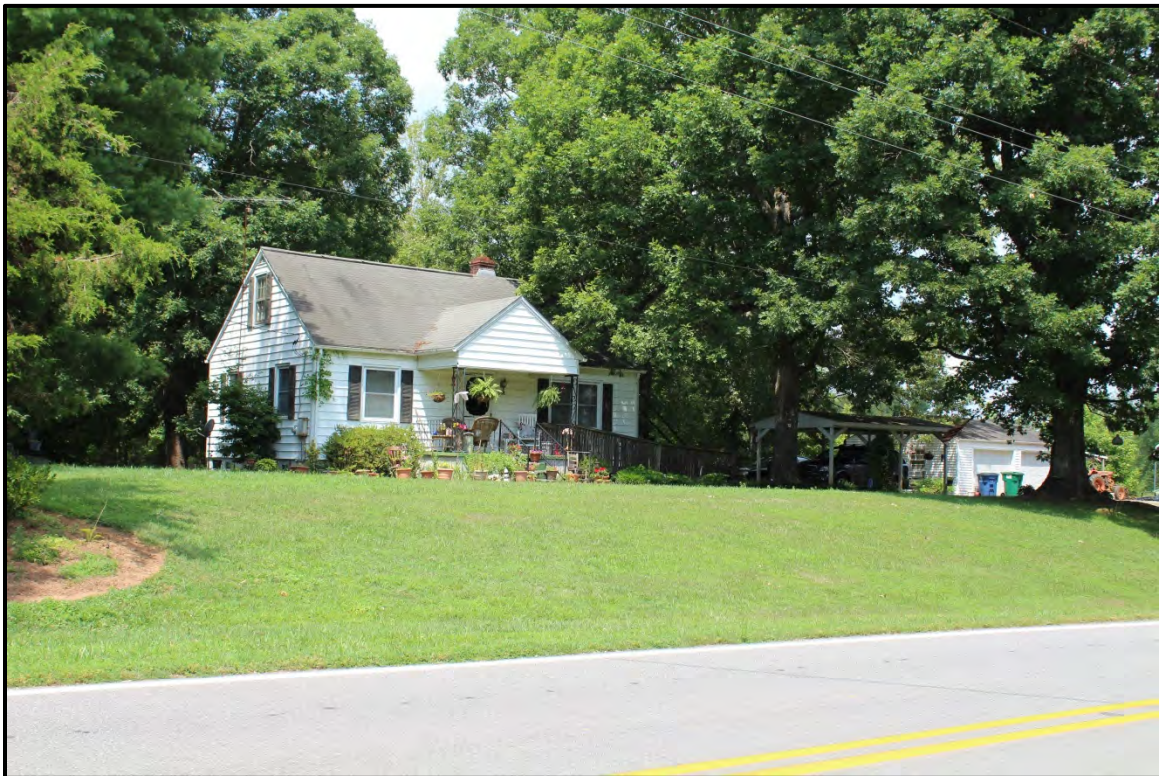
NRHP Assessment. Architectural resource RK1667 does not exhibit distinctive characteristics of architectural style or workmanship. Additionally, the building's architectural integrity has been compromised through the addition of aluminum siding and replacement of first-story windows. Based on the lack of architectural merit, as well as the inability to associate the house and/or its original owner(s) with an important historical event or series of events, it is TRC's opinion that architectural resource RK1667 is not eligible for the NRHP.

Figure 5.59. Architectural resource RK1667; view is northwest featuring the façade and south elevation.

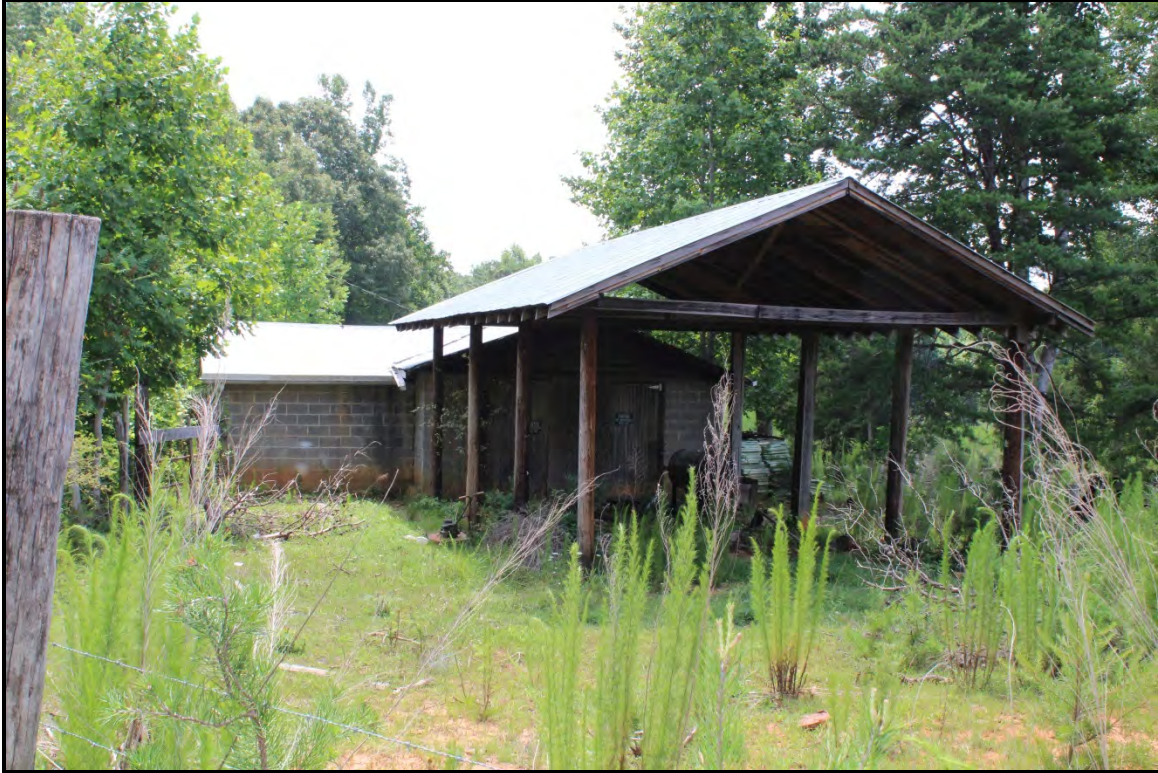
The one-story building has a gabled roof, exterior concrete block walls and a concrete block foundation. Windows are covered with wood. The northwest elevation is marked with a pair of swinging wood doors composed of plywood. The southeast elevation holds a replacement ca. 2010 paneled door. Attached to the northwest elevation, and integral with the main roof, is an open pole shed. The gable-roofed structure is supported by a series of wood poles.

Figure 5.60. Architectural resource RK1668; view is southeast featuring the primary façade and attached pole shed.

NRHP Assessment. Architectural resource RK1668 does not exhibit distinctive characteristics of architectural style or workmanship. Based on the lack of architectural merit or integrity, as well as the inability to associate the outbuilding and/or its original owner(s) with an important historical event or series of events, it is TRC’s opinion that architectural resource RK1668 is not eligible for the NRHP.

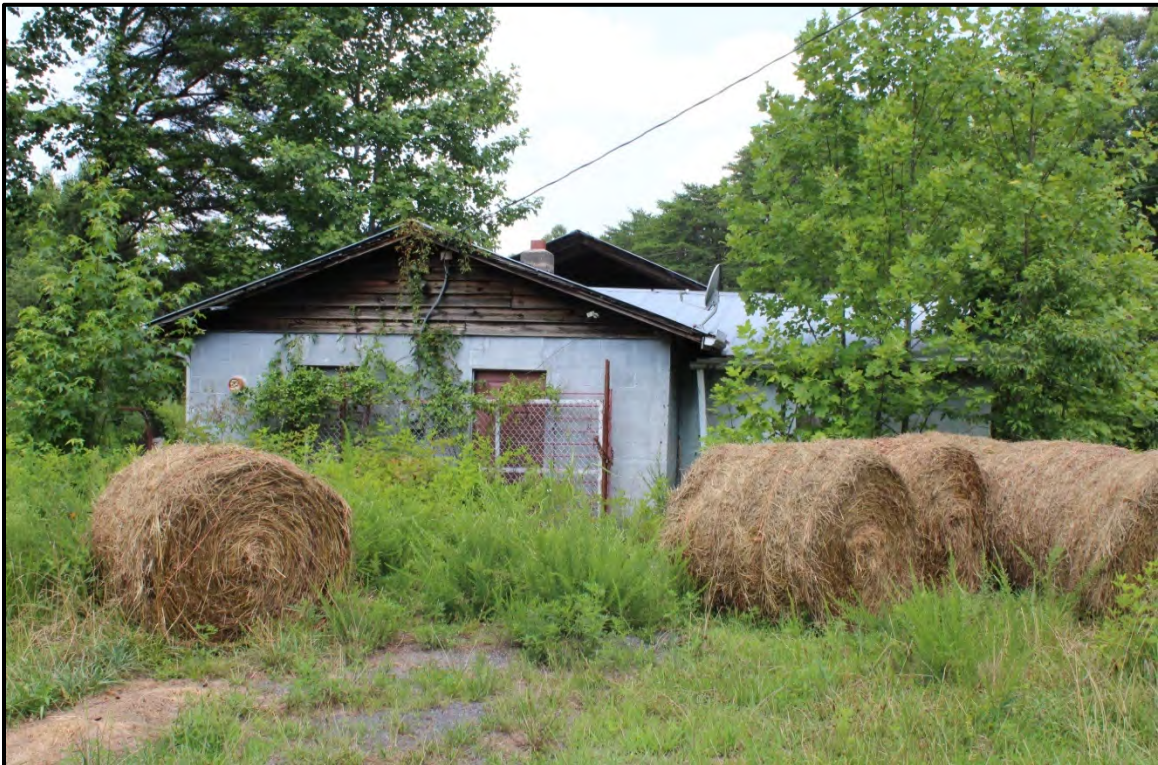
Figure 5.61. Architectural resource RK1668; view is northwest featuring the southeast elevation facing Quesinberry Road.

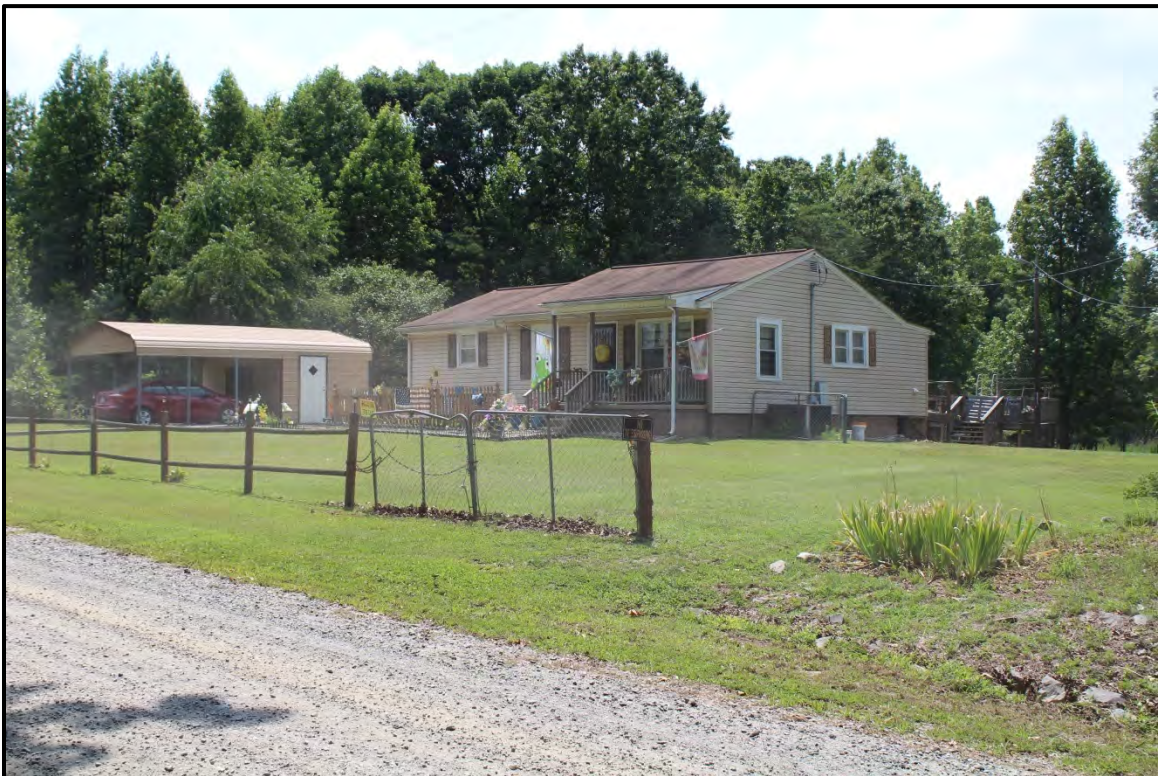
The one-story, wood-frame building features a side-gabled roof, an exterior clad with vinyl siding, and a concrete foundation. Windows are replacement 1/1. Doors are also replacement. Northeast of the house is a prefabricated carport with an attached shed.

Figure 5.62. Architectural resource RK1669; view is southeast featuring the façade, west elevation and carport/shed.

NRHP Assessment. Architectural resource RK1669 does not exhibit distinctive characteristics of architectural style or workmanship. Additionally, the building’s architectural integrity has been compromised through the application of synthetic siding and the replacement of original doors and windows. Based on the lack of architectural merit and integrity, as well as the inability to associate the house and/or its original owner(s) with an important historical event or series of events, it is TRC’s opinion that architectural resource RK1669 is not eligible for the NRHP.
