Re: Revised Architectural Survey Report, MVP Southgate Project, Construct Interstate Pipeline, Rockingham and Alamance County, ER 18-1041

Thank you for your letter of October 11, 2019, transmitting the draft "Historic Architectural Survey for the MVP Southgate Pipeline Project". We have reviewed the report and offer the following comments.

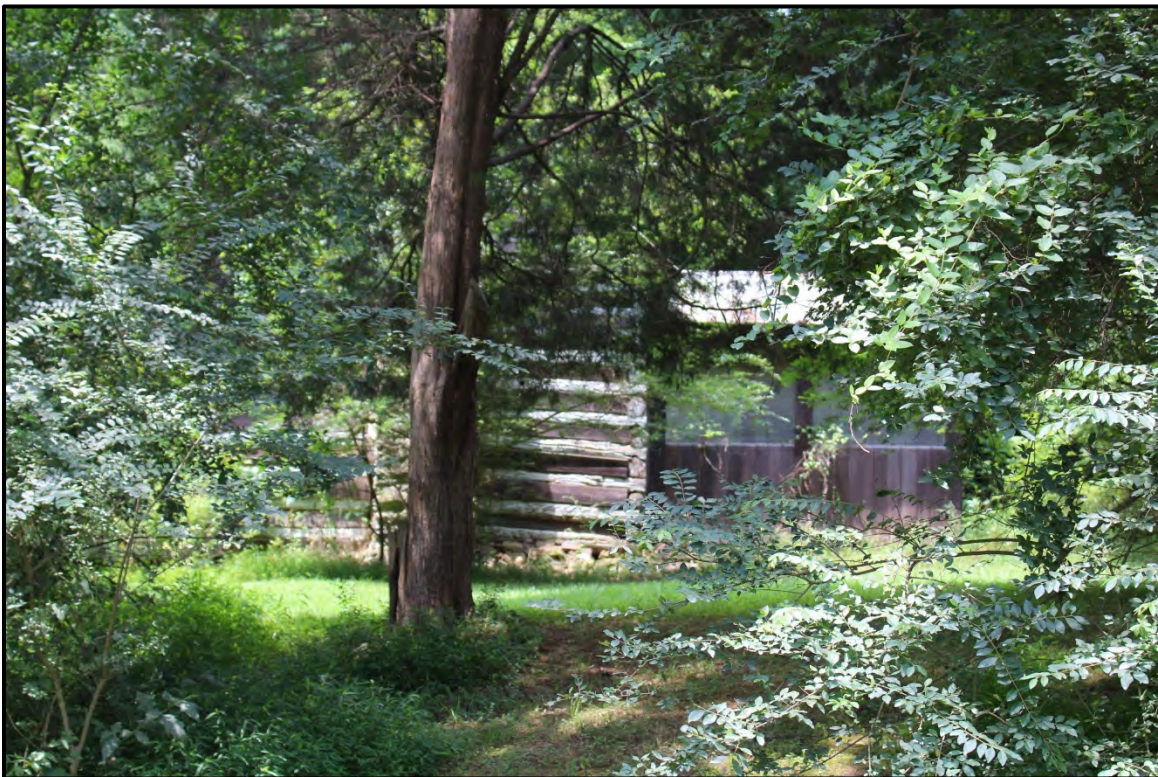
NRHP Assessment. Architectural resource RK1670 does not exhibit distinctive characteristics of architectural style or workmanship. Based on the lack of architectural merit and integrity, as well as the inability to associate the house and/or its original owner(s) with an important historical event or series of events, it is TRC’s opinion that architectural resource RK1670 is not eligible for the NRHP.

Figure 5.63. Architectural resource RK1670; view is northwest featuring the log construction and north (rear) elevation gabled-roof porch addition.

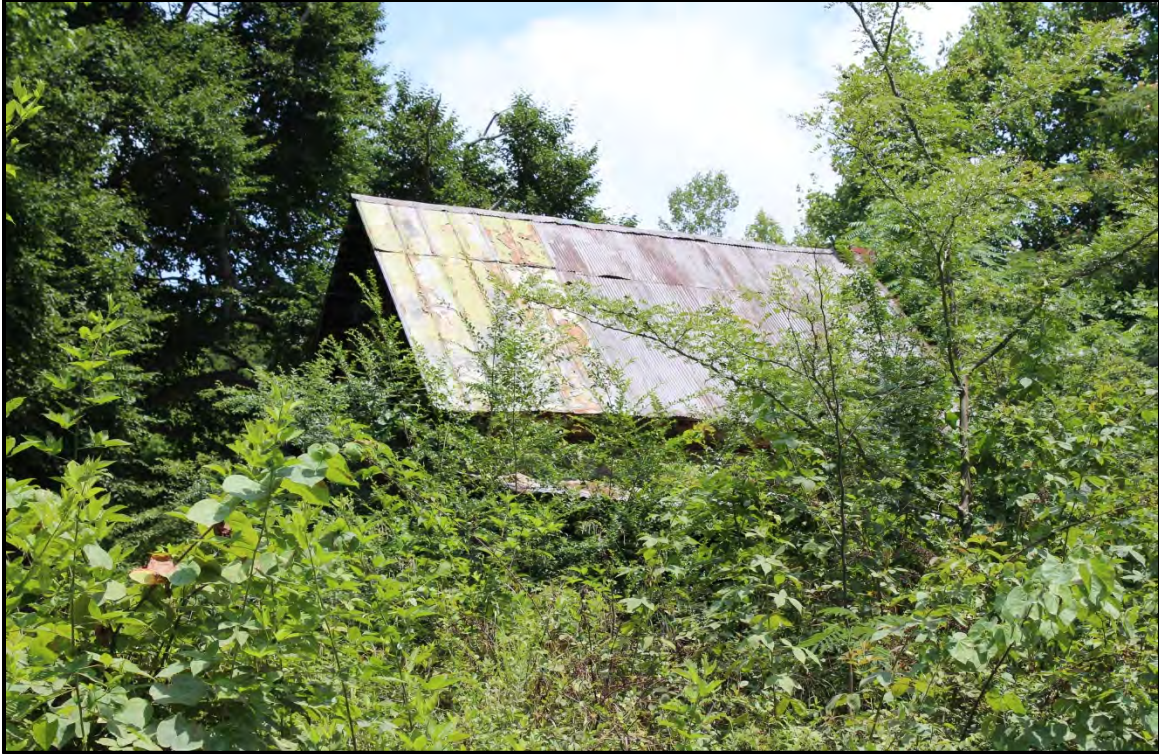
The one and one-half-story single-pen log building has a gabled roof clad with metal, v-notched log walls, and a stone foundation. Attached to the north (rear) elevation is a gable-roof porch addition that is clad with wood panel siding. The porch addition is pierced by four large window openings that appear to be covered with metal screens. Windows and doors on the main block are modern replacements. The building has an exterior end stone and brick chimney. Photos are largely obscured by dense foliage that surrounds the house.

Figure 5.64. Architectural resource RK1670; view is northeast featuring the façade and southwest elevation.

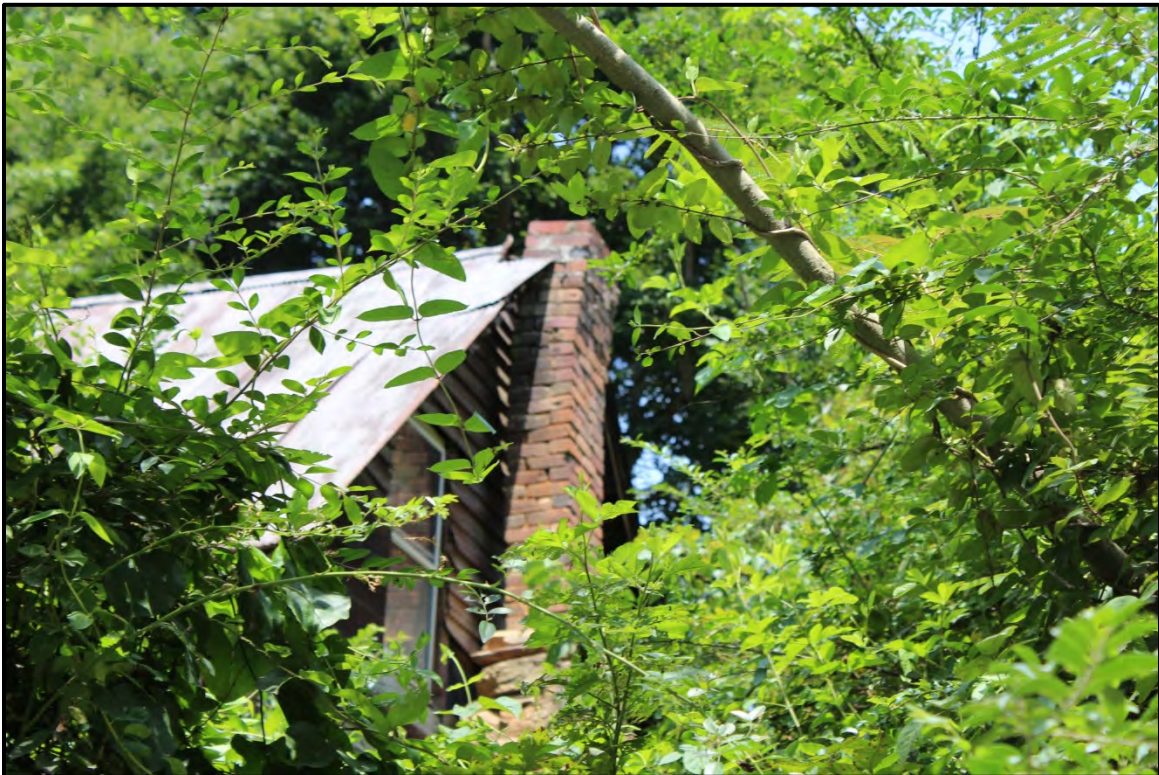
Figure 5.65. Architectural resource RK1670; photo features chimney (top) on the northeast elevation.

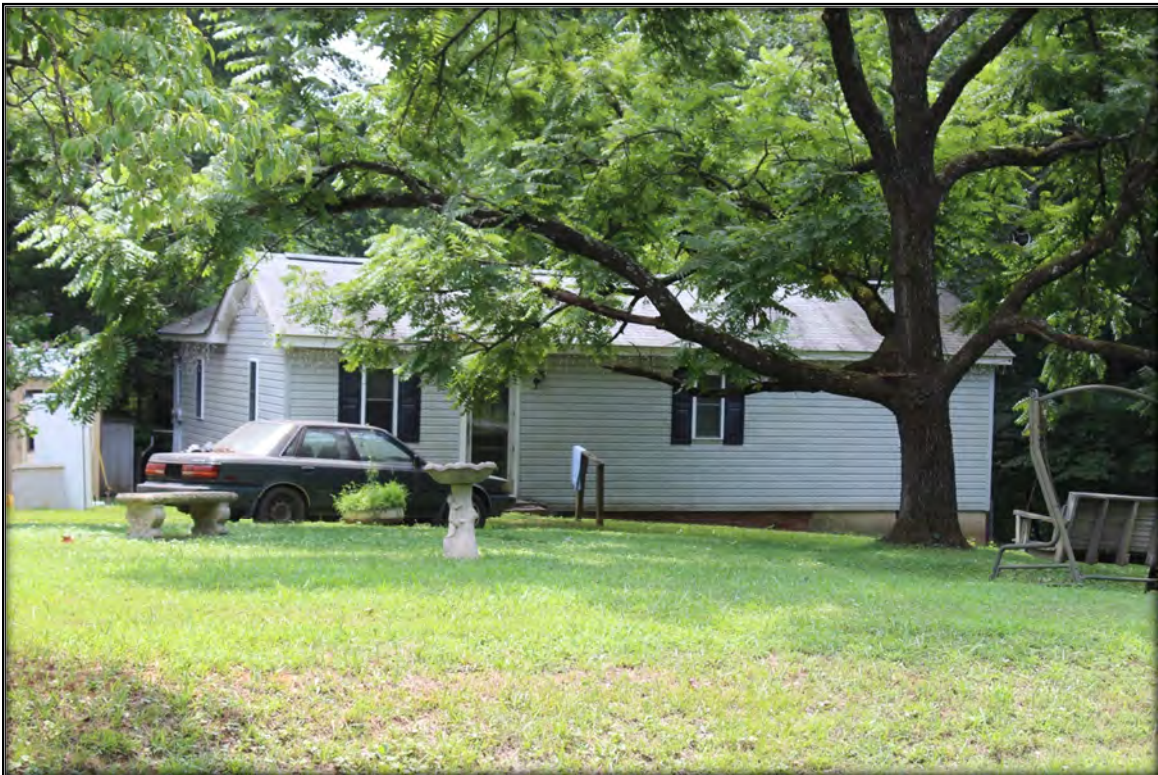
The one-story building has a roof covered with asphalt shingles, exterior vinyl siding, and a brick and concrete foundation. Windows are replacement 1/1. The primary entry is off-center on the façade and retains an original multi-light paneled door. Modifications date to ca. 2010. Southeast of the house is a vertical board outbuilding with a metal gabled roof.

Figure 5.66. Architectural resource RK1671; view is south featuring the façade and east elevation.

NRHP Assessment. Architectural resource RK1671 does not exhibit distinctive characteristics of architectural style or workmanship. Additionally, the building's architectural integrity has been compromised through the application of synthetic siding and replacement of windows. Based on the lack of architectural merit and integrity, as well as the inability to associate the house and/or its original owner(s) with an important historical event or series of events, it is TRC's opinion that architectural resource RK1671 is not eligible for the NRHP.

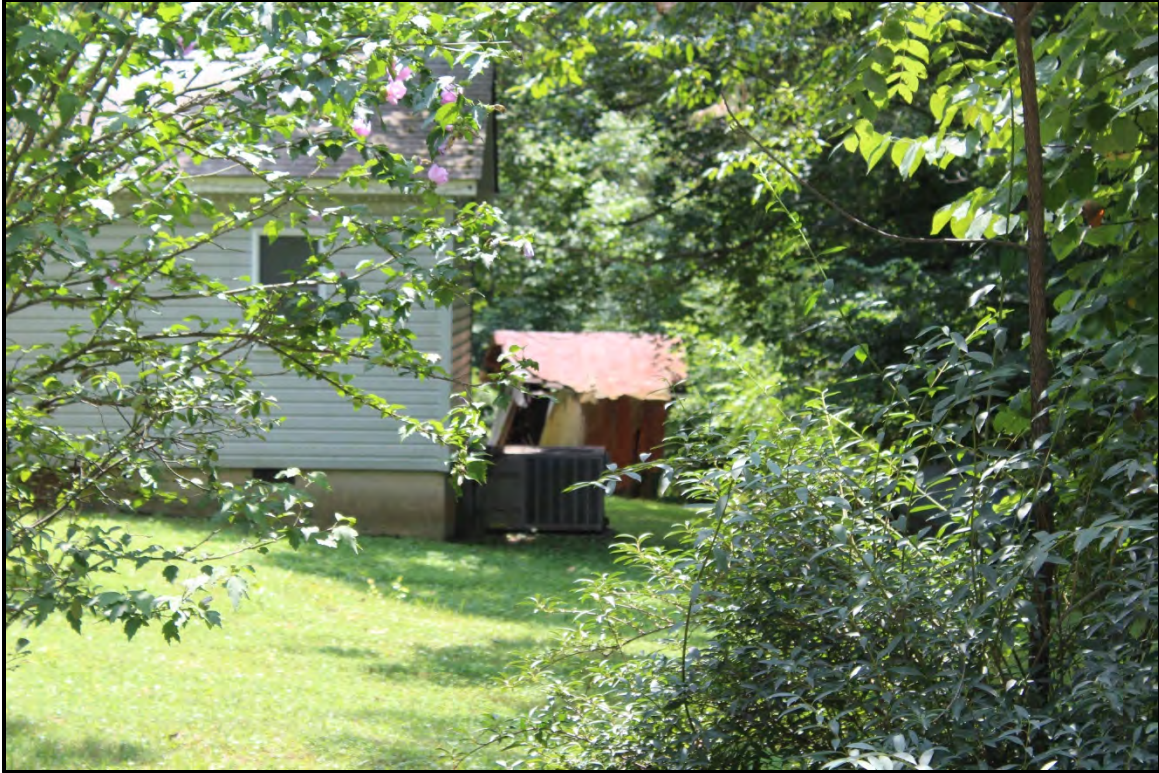
Figure 5.67. Architectural resource RK1671; view is southeast featuring the wood-frame outbuilding.

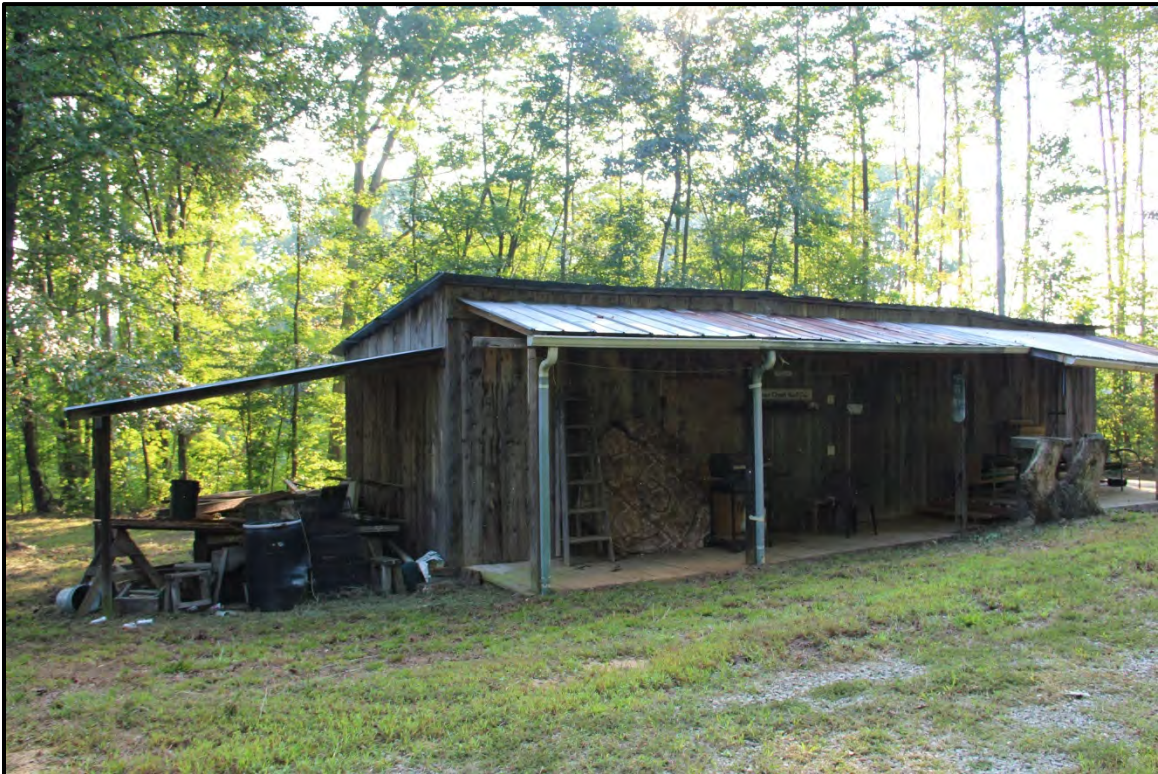
The one-story, wood-frame building features a shed roof, an exterior clad with vertical wood boards, and a wood pier foundation. The east (rear) elevation is clad with board-and-batten siding. Windows are covered with wood board panels. A full-width porch with a wood deck provides access to the main entrance. The porch is shielded by a shed roof that is supported by a series of wood posts. Attached to the north elevation is an open storage bay that is capped with a shed roof that is supported by wood posts.

Figure 5.68. Architectural resource RK1672; view is southeast featuring the façade and north elevation.

NRHP Assessment. Architectural resource RK1672 does not exhibit distinctive characteristics of architectural style or workmanship. Based on the lack of architectural merit, as well as the inability to associate the house and/or its original owner(s) with an important historical event or series of events, it is TRC’s opinion that architectural resource RK1672 is not eligible for the NRHP.

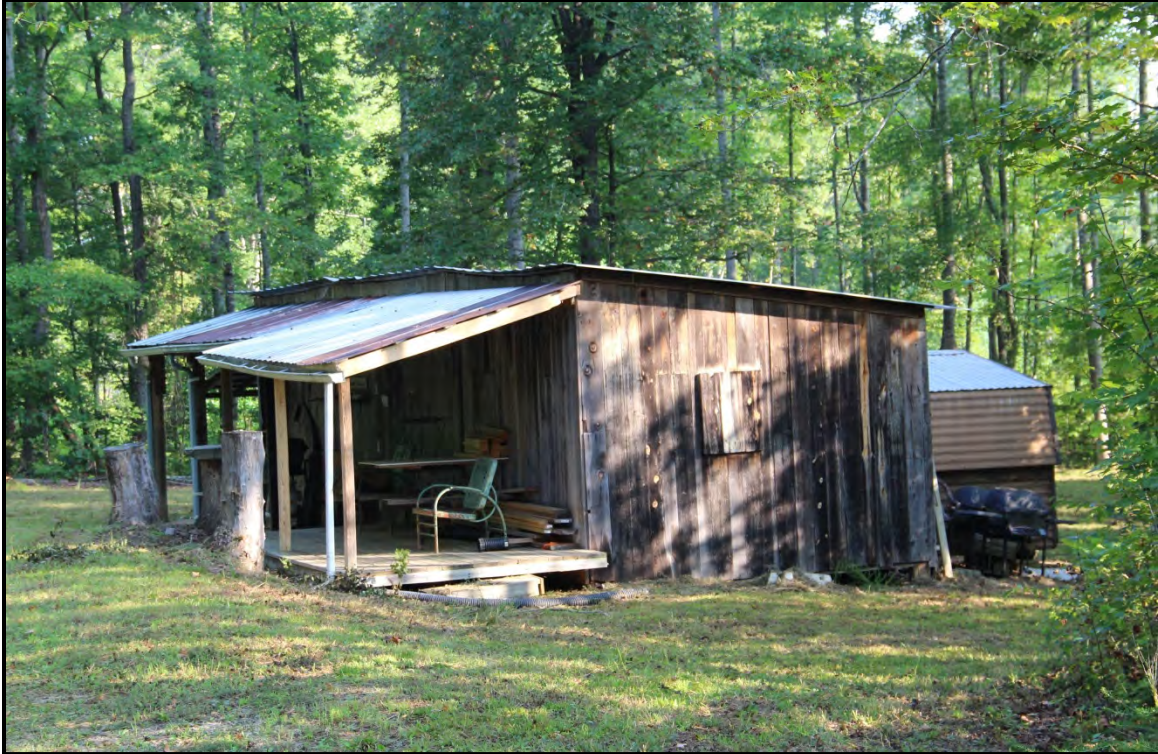
Figure 5.69. Architectural resource RK1672; view is north, featuring the façade and south elevation.

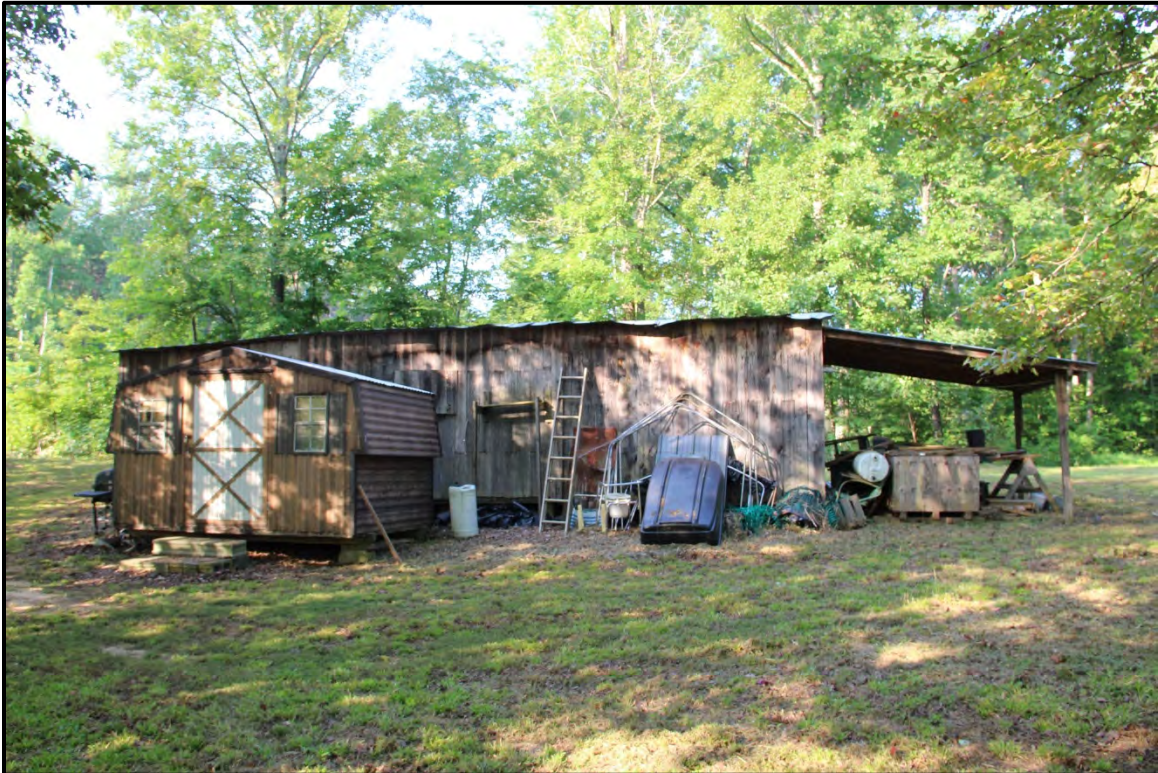
Figure 5.70. Architectural resource RK1672; view is southwest featuring the east (rear) elevation, the open storage wing, and prefabricated shed.

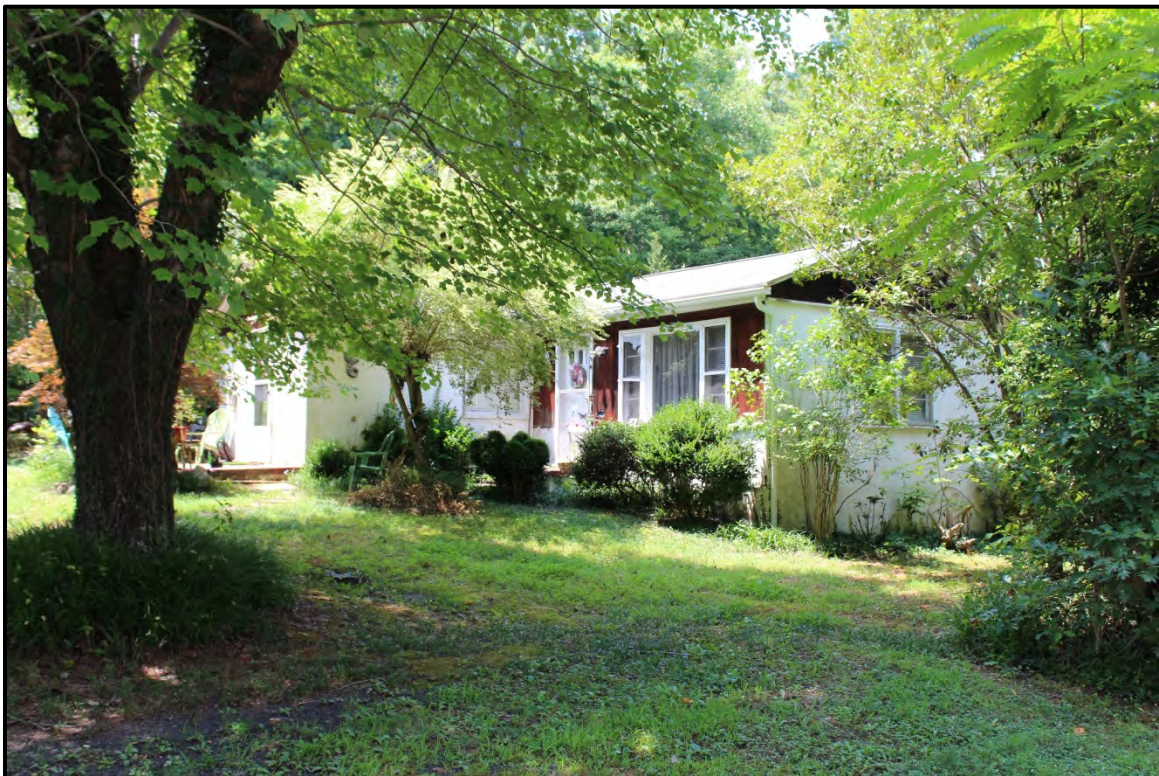
NRHP Assessment. Architectural resource RK1673 does not exhibit distinctive characteristics of architectural style or workmanship. Based on the lack of architectural merit, as well as the inability to associate the house and/or its original owner(s) with an important historical event or series of events, it is TRC’s opinion that architectural resource RK1673 is not eligible for the NRHP.

Figure 5.71. Architectural resource RK1673; view is southwest featuring the façade and north elevation.

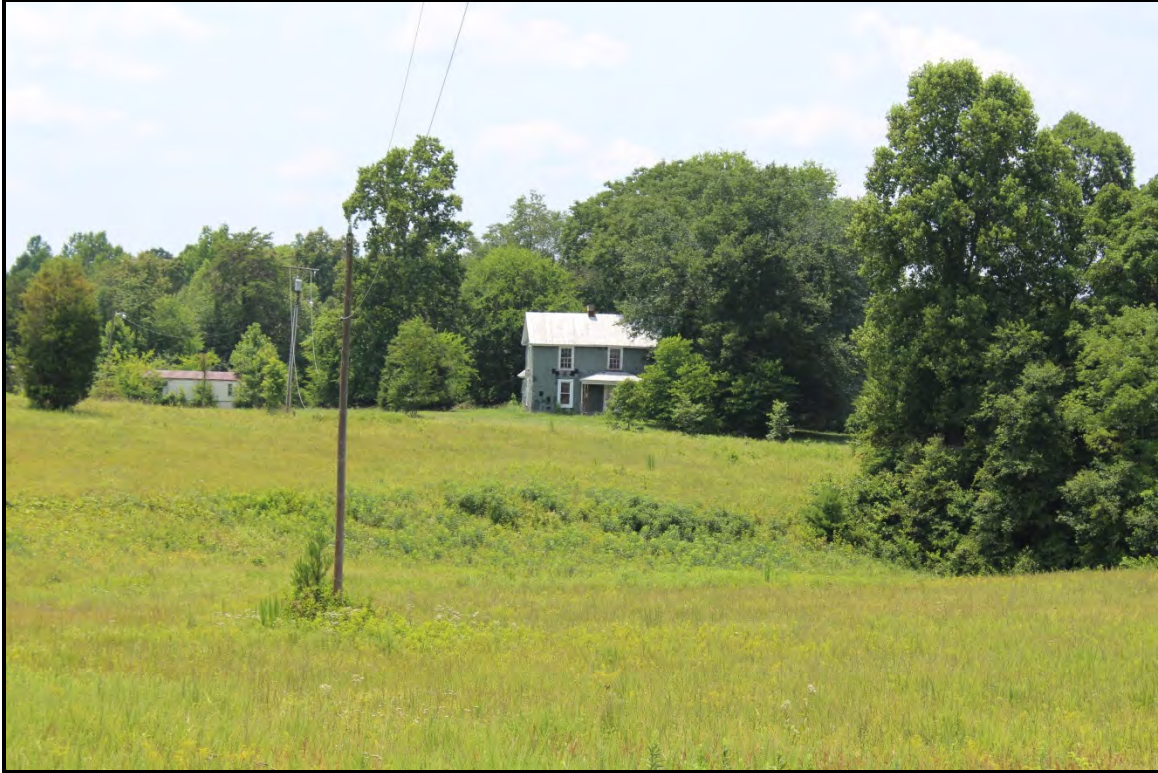
Description. Architectural resource RK1396 is a previously recorded residence that is located at 1674 Moir Mill Road, Reidsville 27320 on parcel number 146375 (Rockingham County, NC GIS 2018) (see Figure 1.2c; Figure 5.72). The property consists of a plain/traditional style residence that county parcel data report as having been constructed in 1925 (Rockingham County, NC GIS 2018). However, the property’s survey form places the construction date of the house to ca. 1900, which TRC believes is a more accurate date based on the building’s plan and massing (Woodard 2002a). Due to lack of landowner permission to access properties that are not directly affected by the Project, photographic coverage of architectural resource RK1396 was limited to the public right-of-way along Moir Mill Road.

Figure 5.72. Architectural resource RK1396; view is west featuring the façade.

NRHP Assessment. Architectural resource RK1396 does not exhibit a distinctive architectural style or workmanship. In addition, the house has been altered through the application of asphalt shingle siding. Based on the lack of architectural merit, as well as the inability to associate the house and/or its original owner(s) with an important historical event or series of events, it is TRC’s opinion that architectural resource RK1396 is not eligible for the NRHP.

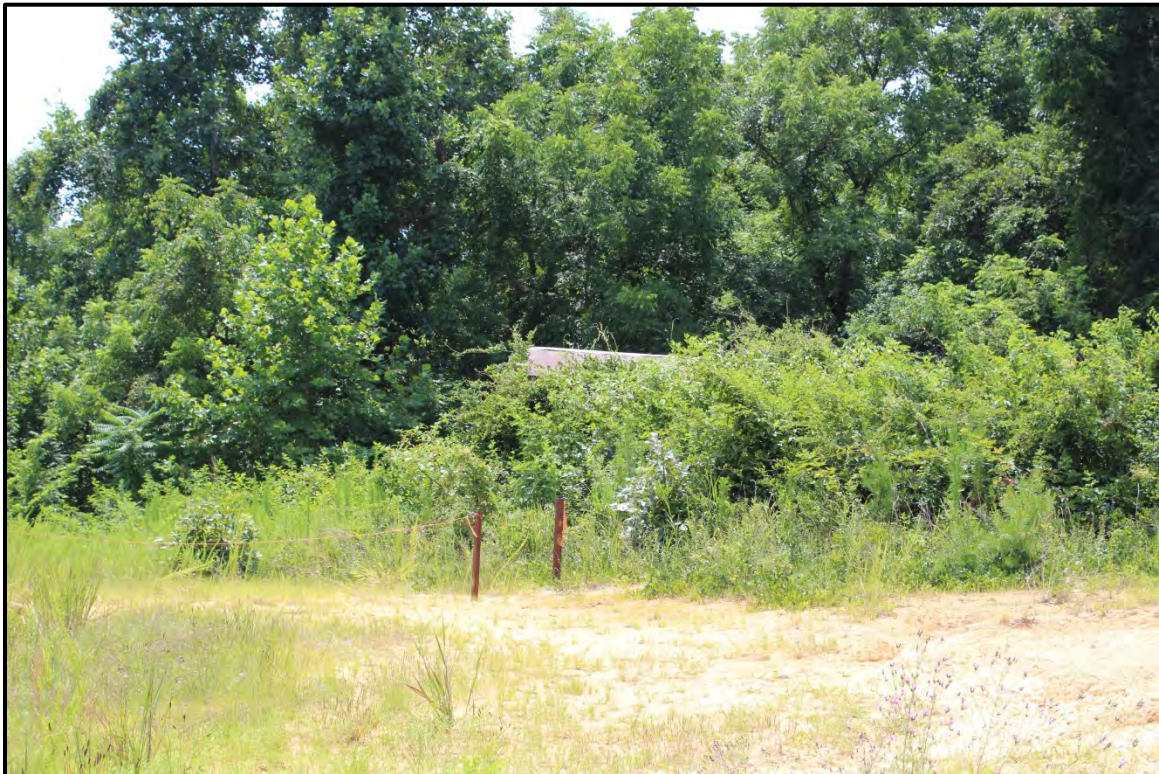
Based limited views of the resource, the tobacco barns are of log construction and are capped with gabled roofs covered with standing seam metal.

Figure 5.73. Architectural resource RK1674; view is south featuring the overgrown tobacco barns.

NRHP Assessment. Architectural resource RK1674 does not exhibit a distinctive architectural style or workmanship. Persistent neglect of the structures has resulted in the collapse of one of the tobacco barns. As a result, the property does not retain its architectural integrity. Based on the lack of architectural merit and inability to associate the outbuildings and/or its original owner(s) with an important historical event or series of events, it is TRC’s opinion that architectural resource RK1674 is not eligible for the NRHP.

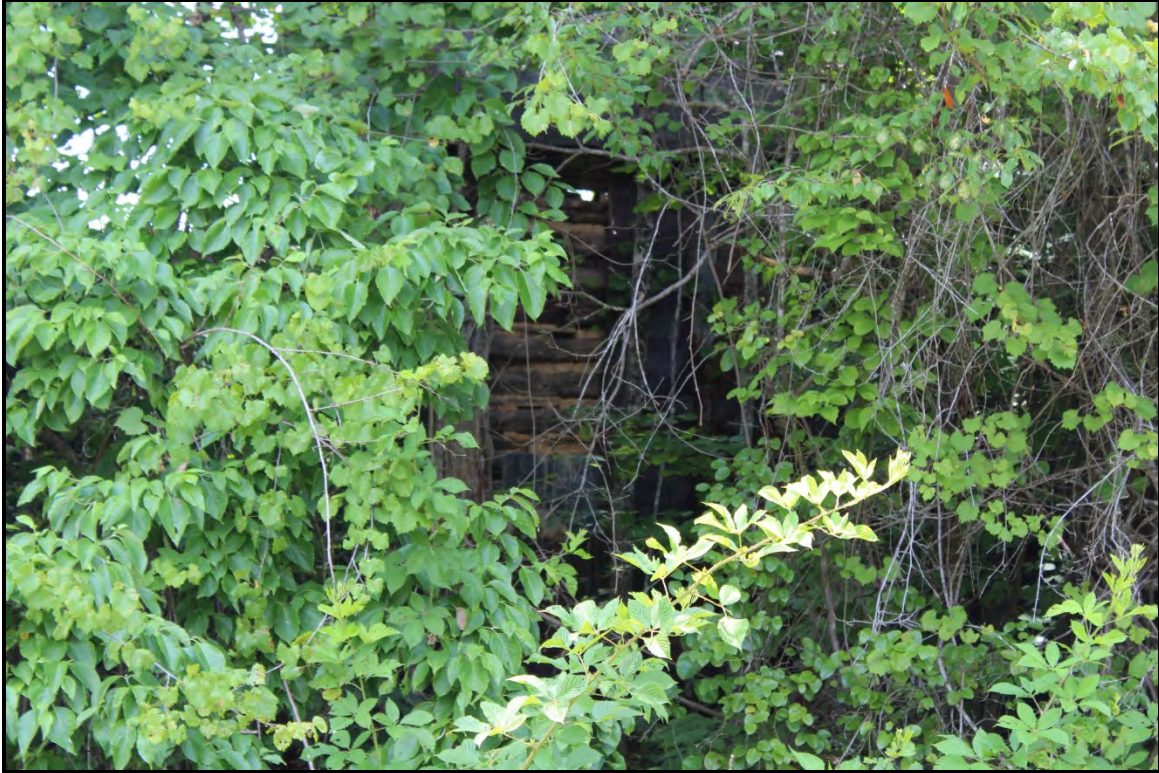
Figure 5.74. Architectural resource RK1674; view features an exterior log wall of a tobacco barn.

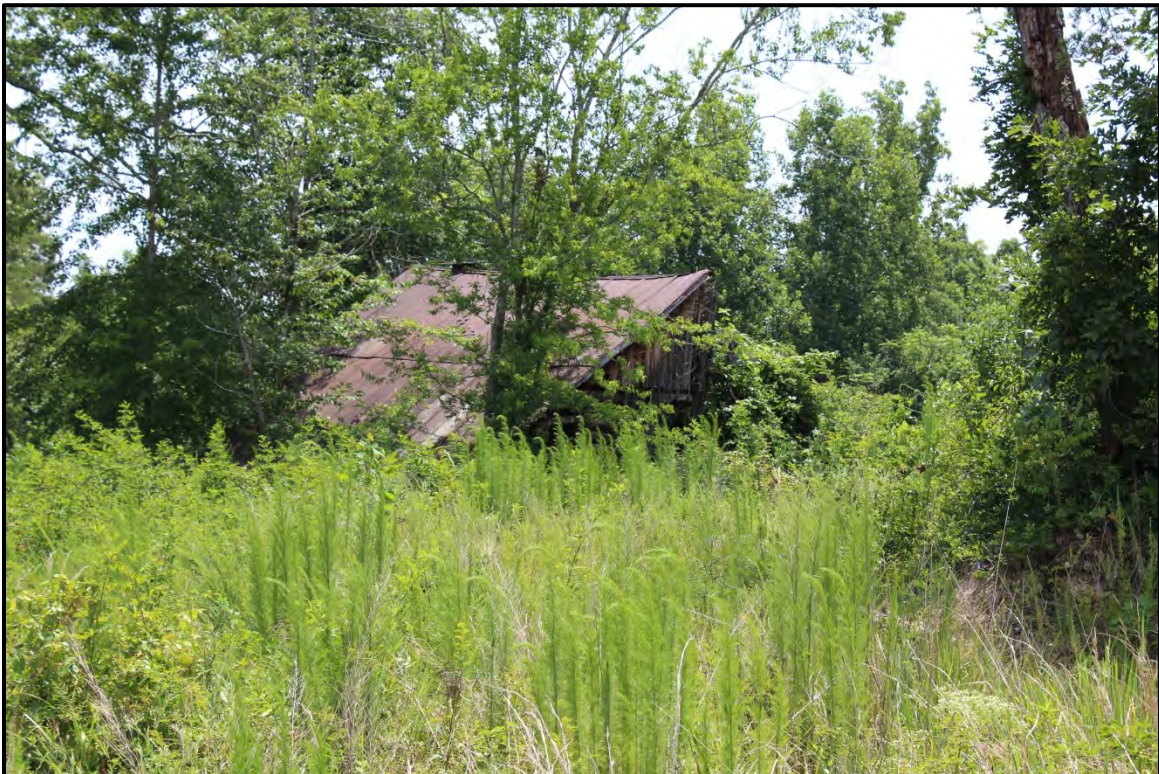
Figure 5.75. Architectural resource RK1674; view features the collapsed tobacco barn.

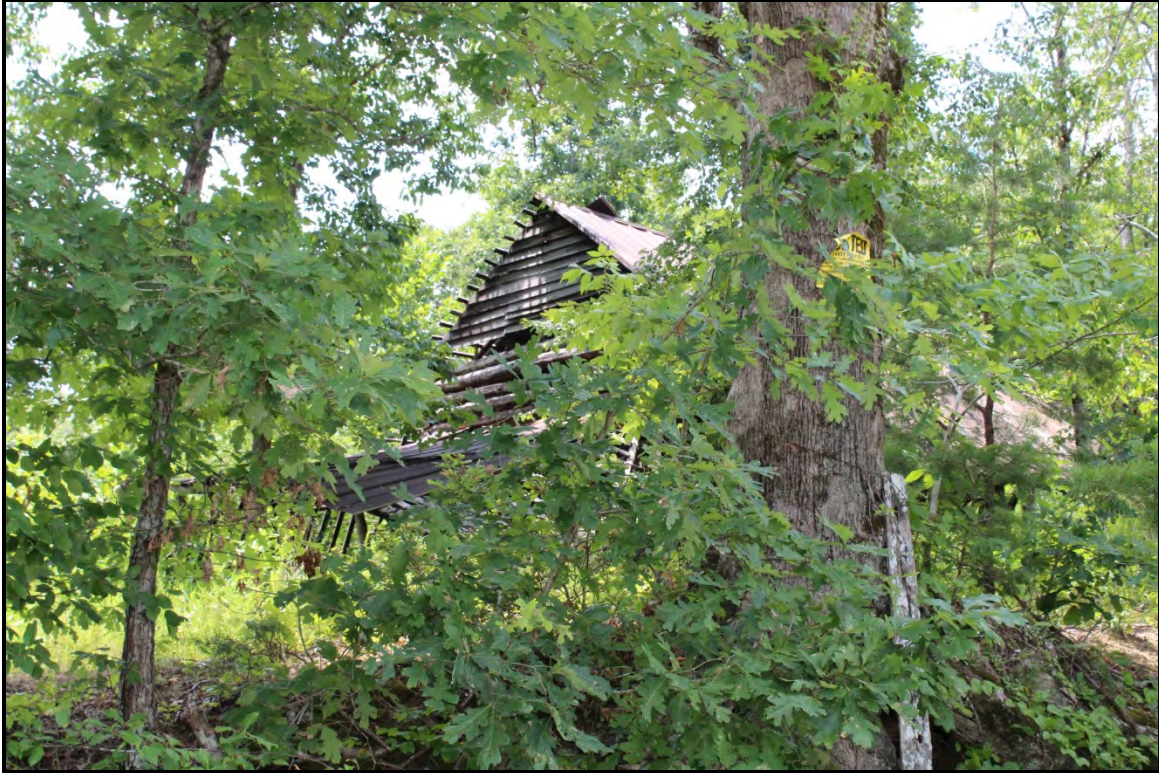
Figure 5.76. Architectural resource RK1674; view of partially collapsed tobacco barn.

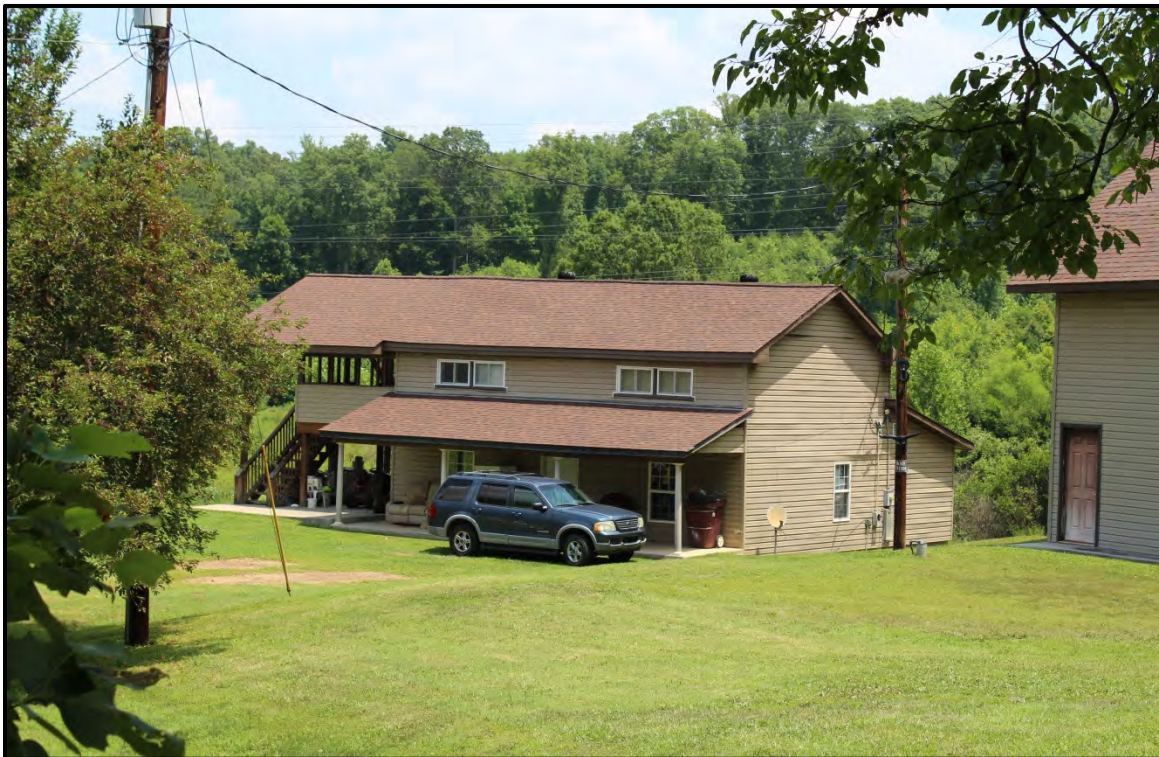
The one and one-half-story house has a roof covered with asphalt shingles, an exterior clad with vinyl siding, and a concrete foundation. Windows are replacement (lower story) and original two-light (upper story). The façade features a shed porch (not original). The primary door has been replaced. An open two-story carport wing on the west end of the house is not original, although the east (rear) elevation shed extension appears original.

Figure 5.77. Architectural resource RK1675; view is northeast featuring the façade and south elevation.

NRHP Assessment. Architectural resource RK1675 does not exhibit distinctive characteristics of architectural style or workmanship. In addition, the house has been altered through the application of vinyl siding, the reconstruction of the façade porch, and the installation of vinyl sashes. Based on the lack of architectural merit, as well as the inability to associate the house and/or its original owner(s) with an important historical event or series of events, it is TRC’s opinion that architectural resource RK1675 is not eligible for the NRHP.

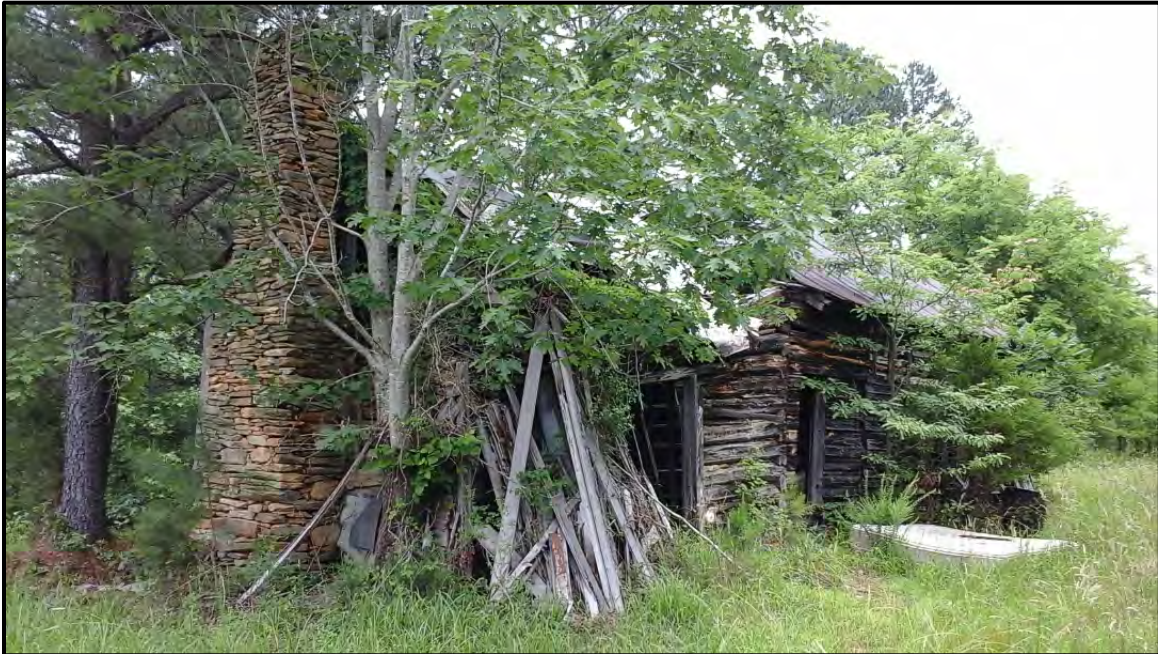
Description. Architectural resource RK1678 is a mid-to-late-nineteenth century log house located on the south side of Hamlet Road, Reidsville 27320 on parcel number 174528 (Rockingham County, NC WebGIS 2018) (see Figure 1.2c, Figures 5.78–5.80). The double-pen plan building has a side-gabled roof covered with standing seam metal, exterior log walls partially clad with what appears to be asbestos siding, and a pier stone foundation. Windows are largely missing though evidence of multi-sash double-hung design is retained in some examples. On the north elevation is an exterior end stacked stone chimney. There are entry bays on the façade, indicating a two-pen interior plan. One bay retains what appears to be an original wood door. The house is abandoned and deteriorated with loss of windows, doors, siding and indications of structural instability.

Figure 5.78. Architectural resource RK1678; view is southeast featuring the north and west (rear) elevations.

NRHP Assessment. Architectural resource RK1678 is a mid-to-late-nineteenth century log house that suffers loss of integrity due to prolonged neglect resulting in significant deterioration. Log construction is not uncommon in the Project area and this example does not indicate unique architectural significance in relation to workmanship and materials. Based on the house's loss of architectural integrity, as well as the inability to associate the house and/or its original owner(s) with an important historical event or series of events, it is TRC's opinion that architectural resource RK1678 is not eligible for the NRHP.

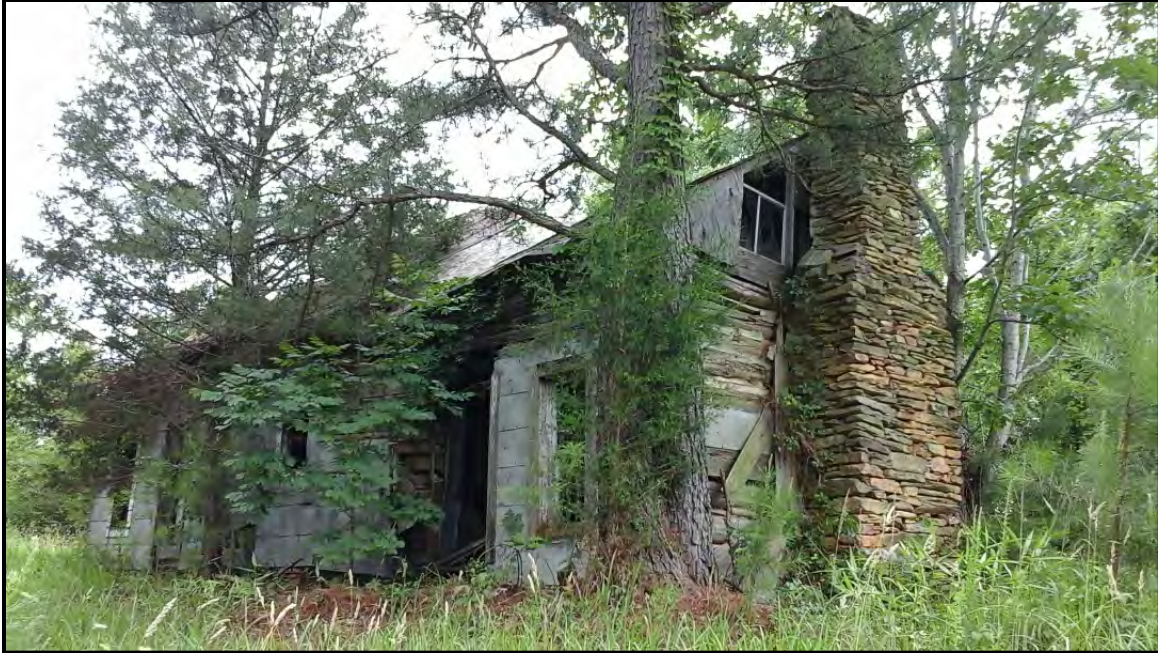
Figure 5.79. Architectural resource RK1678; view is south featuring the façade and north elevation.

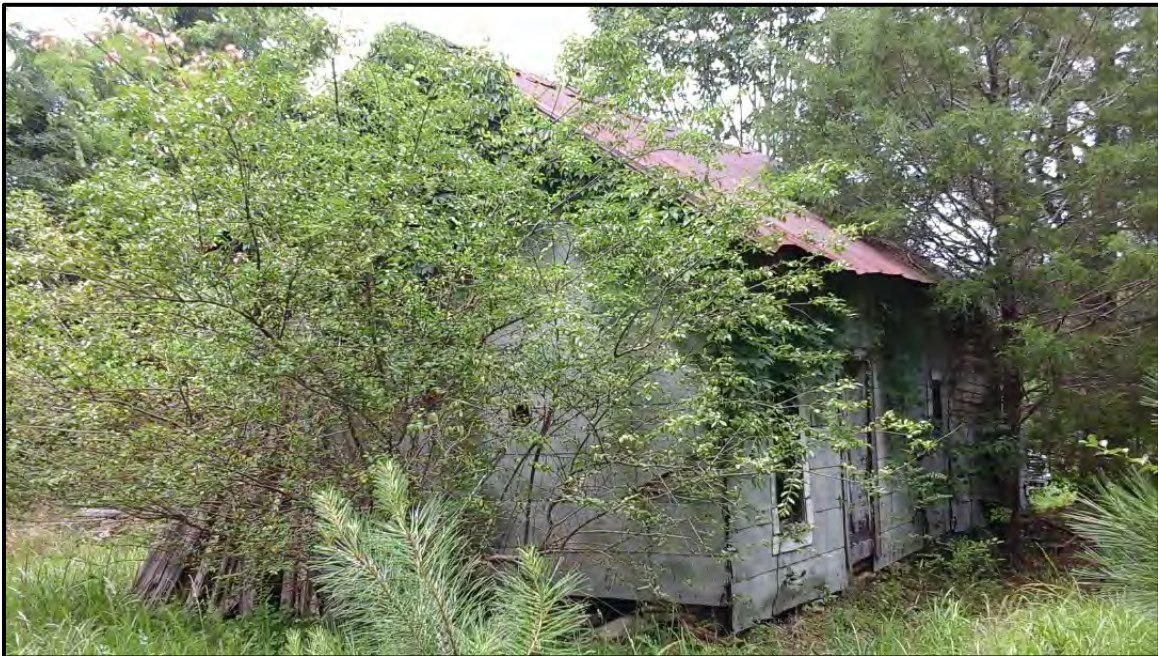
Figure 5.80. Architectural resource RK1678; view is north featuring the façade and south elevation.

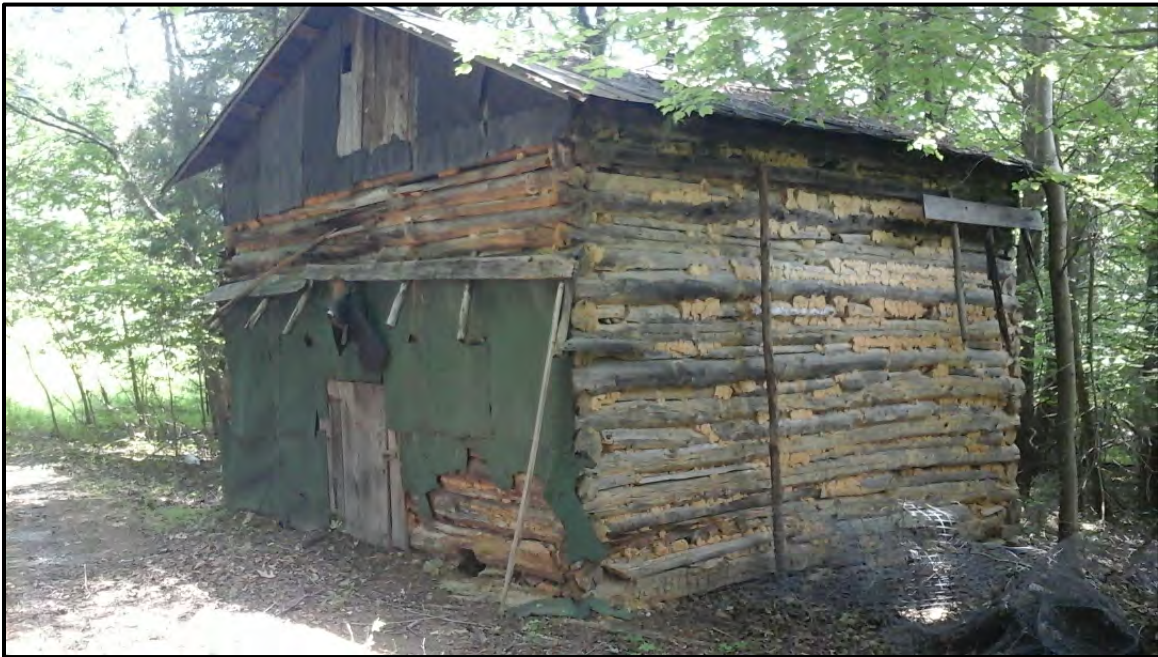
The log outbuilding has a gabled roof covered with standing seam metal, hand-hewn logs joined with v-notching, and gable fields sheathed with vertical wood boards. Asphalt paper is partially intact on the façade, which contains a door composed of vertical wood boards.

Figure 5.81. Architectural resource RK1676; view is of the primary and side elevations.

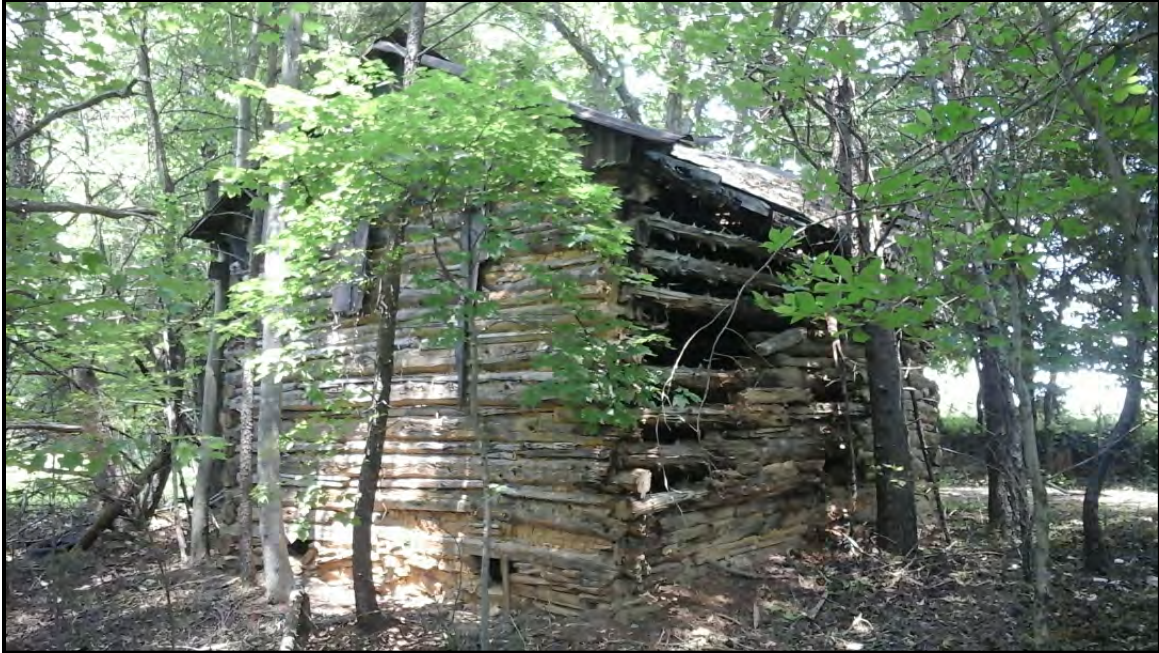
Figure 5.82. Architectural resource RK1676; view is of the rear and side elevations.

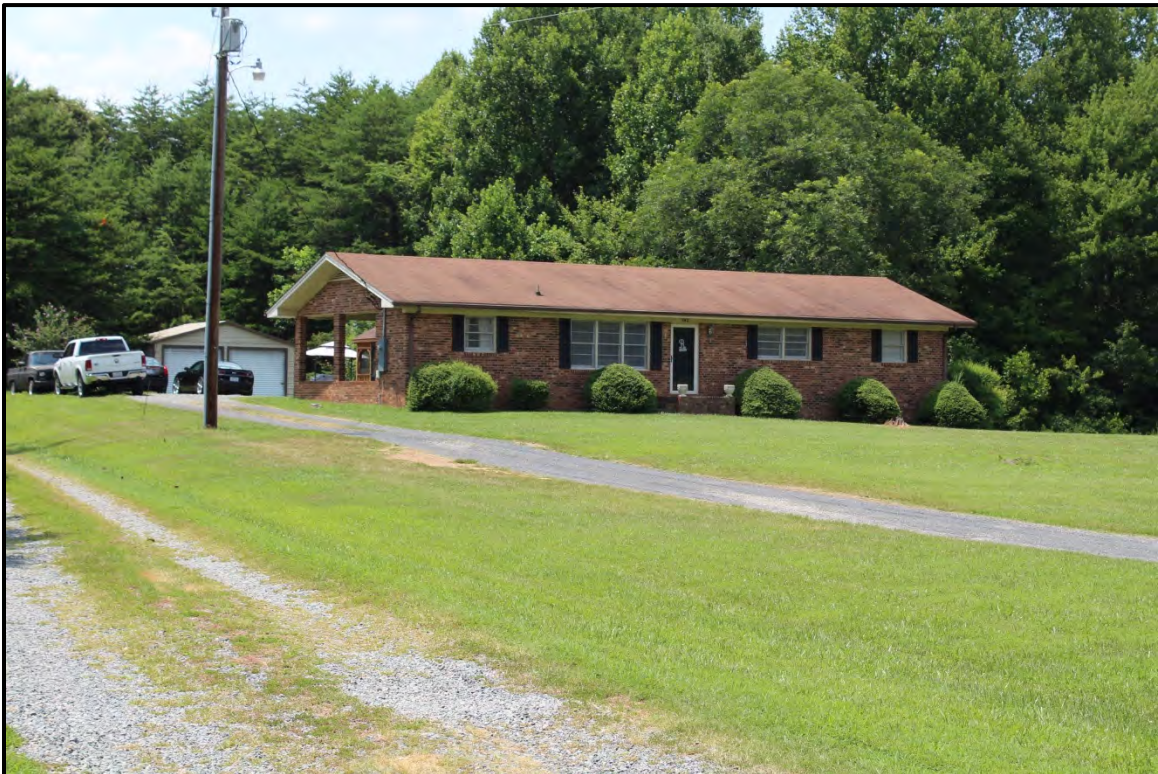
The wood-frame building has a side-gabled roof, exterior brick walls, and a brick foundation. Windows are original horizontal sash design. The façade features a centered paneled door. At the southwest corner is a rear original open carport. A prefabricated ca. 1980 garage is situated west of the house.

Figure 5.83. Architectural resource RK1677; view is northwest featuring the façade and south elevation.

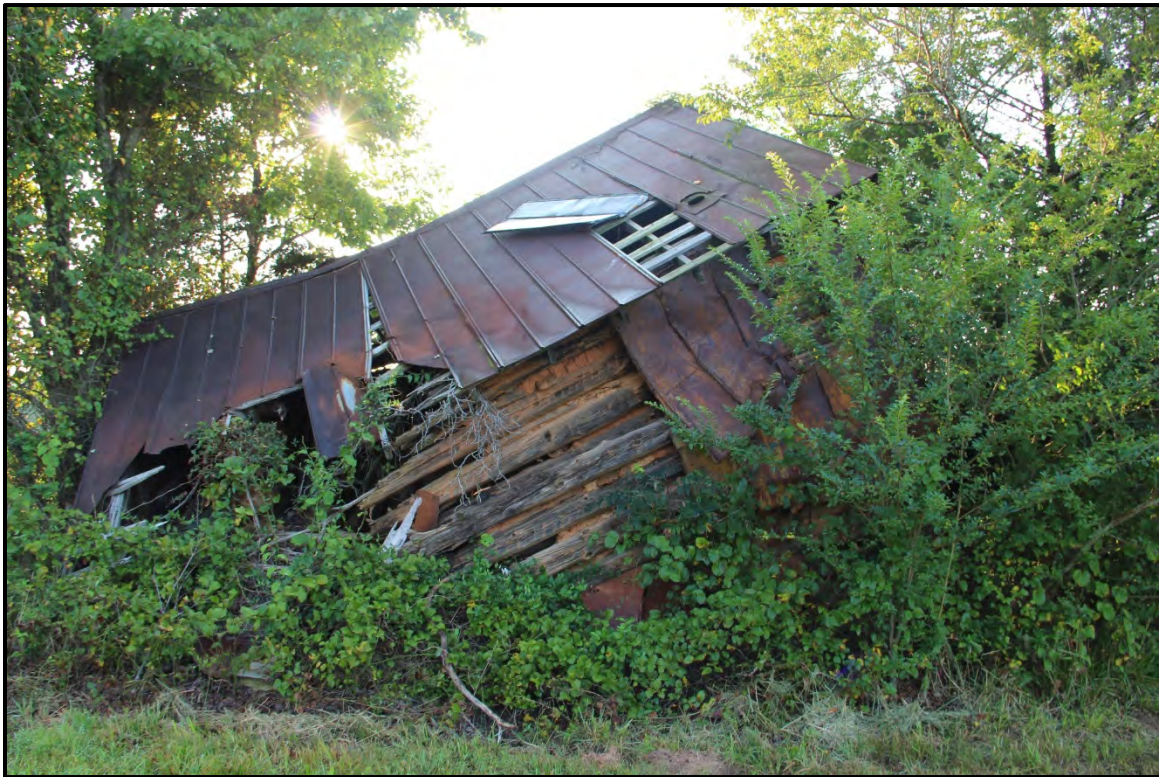
Description. Architectural resource RK1681 is a collapsed log tobacco barn that is located in a field on the south side of Hamlet Road, Reidsville 27320 (see Figure 1.2d, Figure 5.84). The structure lies within parcel number is 155980 (Rockingham County, NC WebGIS 2018). Based on stylistic evidence and the date of area farmsteads, the structure appears to have been constructed ca. 1920. The barn has a metal clad gabled roof and exterior log v-notched walls.

NRHP Assessment. Architectural resource RK1681 does not exhibit distinctive characteristics of architectural style or workmanship. Furthermore, the building is in ruins, which compromises its architectural integrity. Based on the lack of architectural merit, as well the inability to associate the barn and/or its original owner(s) with an important historical event or series of events, it is TRC’s opinion that architectural resource RK1681 is not eligible for the NRHP.

Figure 5.84. Architectural resource RK1681.
