Re: Revised Architectural Survey Report, MVP Southgate Project, Construct Interstate Pipeline, Rockingham and Alamance County, ER 18-1041

Thank you for your letter of October 11, 2019, transmitting the draft "Historic Architectural Survey for the MVP Southgate Pipeline Project". We have reviewed the report and offer the following comments.

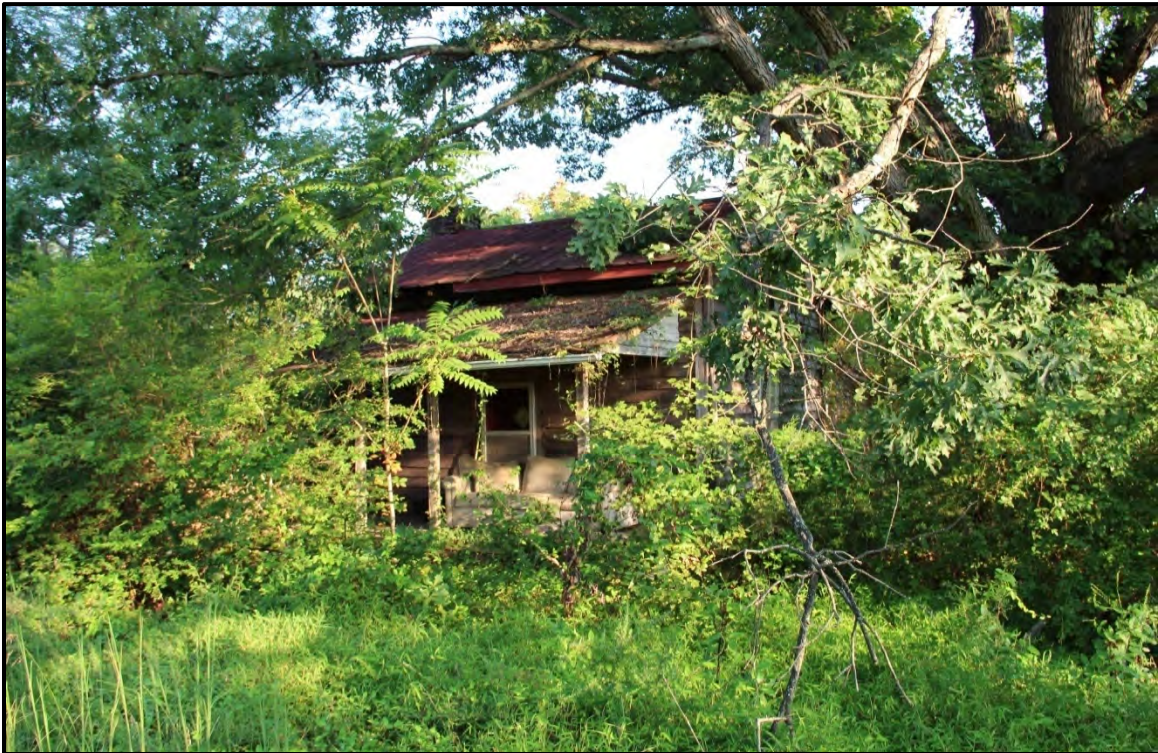
The one and one-half-story, wood-frame house features a roof covered with standing seam metal, an exterior end stone chimney, and an exterior clad with weatherboard siding. Fenestration includes 4/4 double-hung wood sash windows. A reconstructed full-width entry porch provides access to the main entrance and is composed of a shed roof supported by wood posts and a wood plank deck. A full-width shed extension is attached to the north (rear) elevation. Located east of the house is a mid-twentieth century shed (Rockingham County, NC WebGIS 2018).

NRHP Assessment. Architectural resource RK1768 does not exhibit a distinctive architectural style or workmanship. In addition, the house has been altered through the reconstruction of the façade porch and the installation of non-historic window sashes. Based on the lack of architectural merit, as well as the inability to associate the house and/or its original owner(s) with an important historical event or series of events, it is TRC’s opinion that architectural resource RK1768 is not eligible for the NRHP.

Figure 5.85. Architectural resource RK1768; view is northwest and features the façade and east elevation.

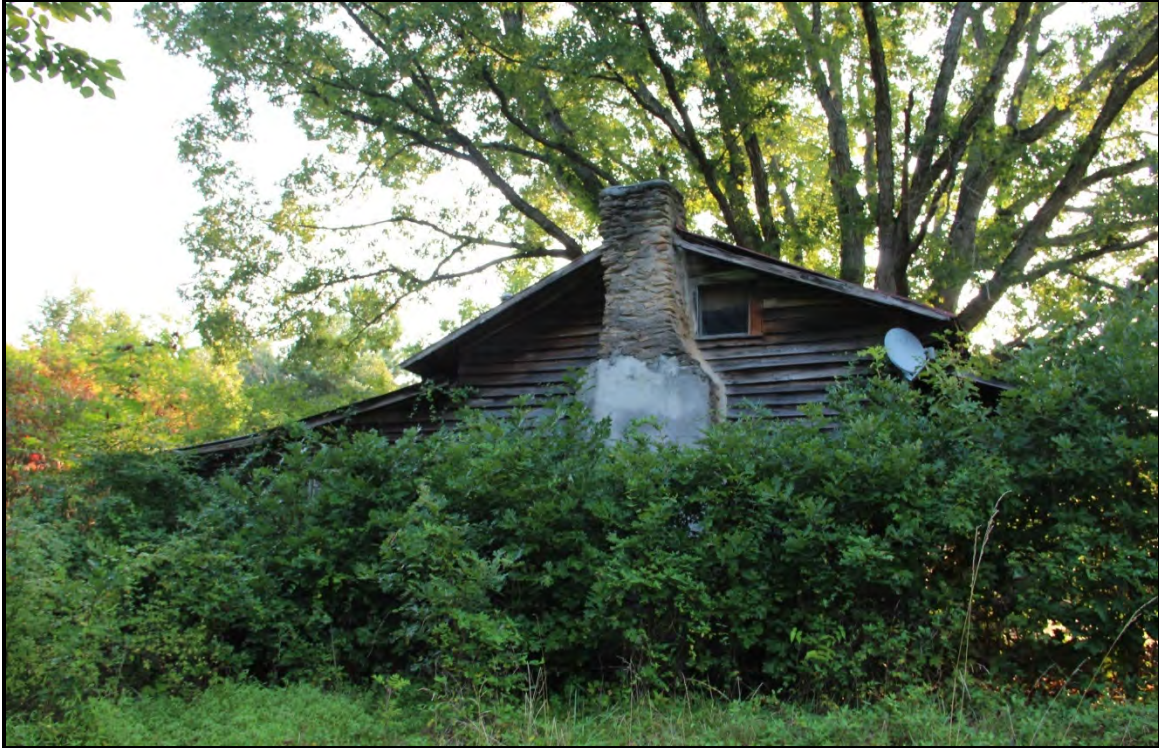
Figure 5.86. Architectural resource RK1768; view is east and features the west elevation.

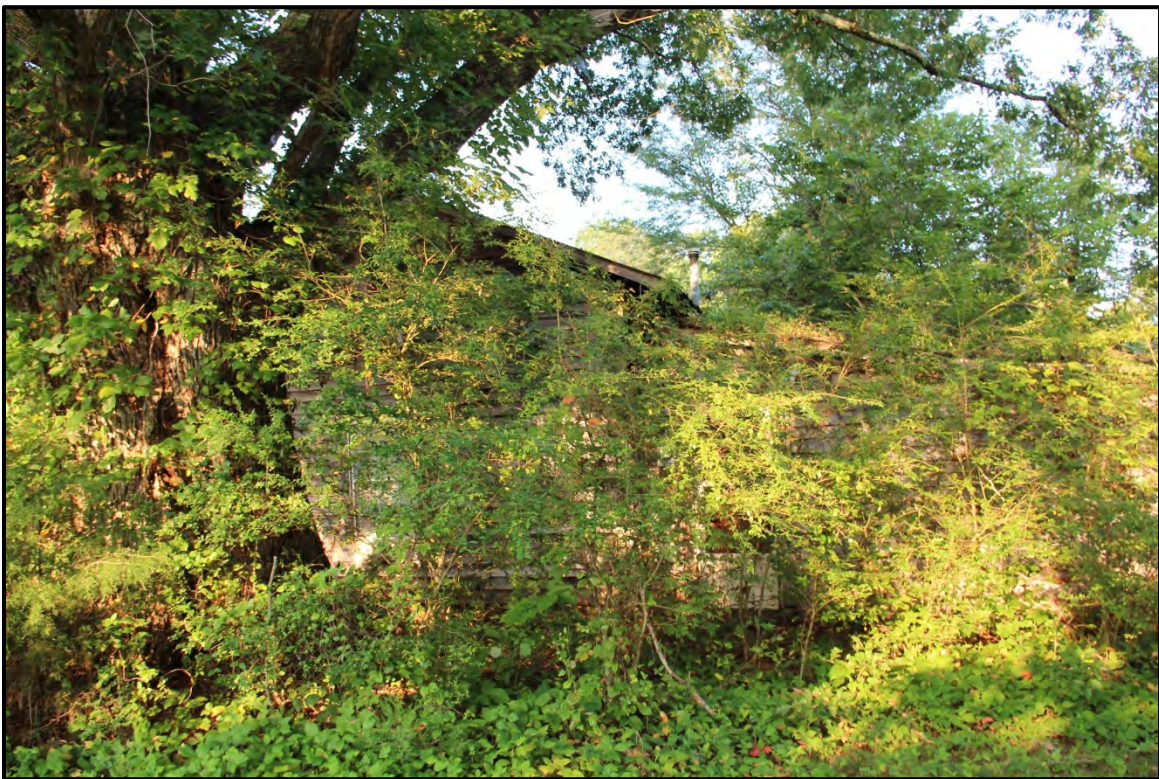
Figure 5.87. Architectural resource RK1768; view is west and features the east elevation.

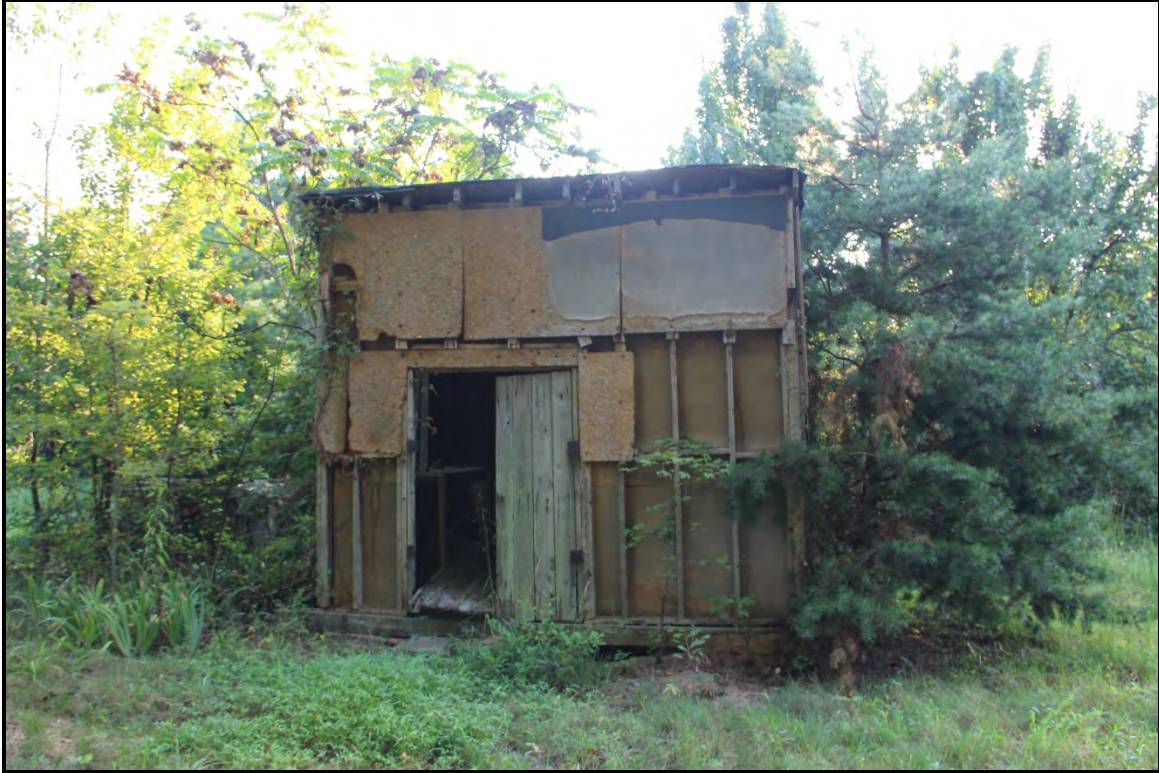
Figure 5.88. Architectural resource RK1768; view is east and features the shed.

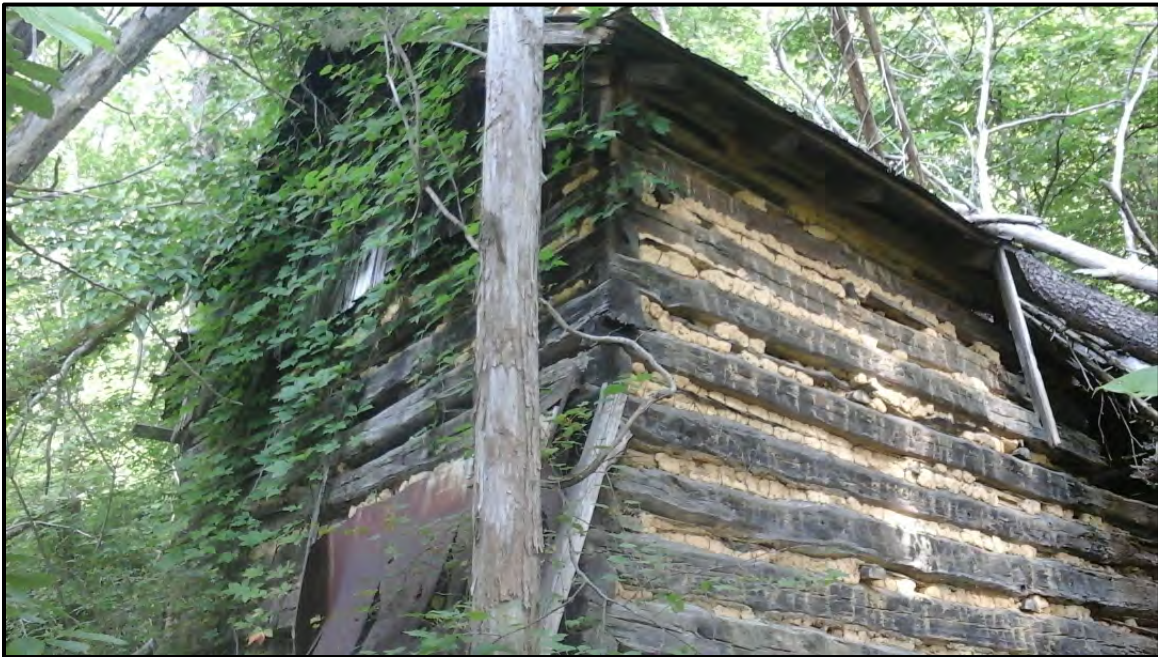
The structure features a gabled roof covered with standing seam metal, hand-hewn logs joined together with v-notching, and gable fields clad with vertical wood boards.

Figure 5.89. Architectural resource RK1679; view is northwest.

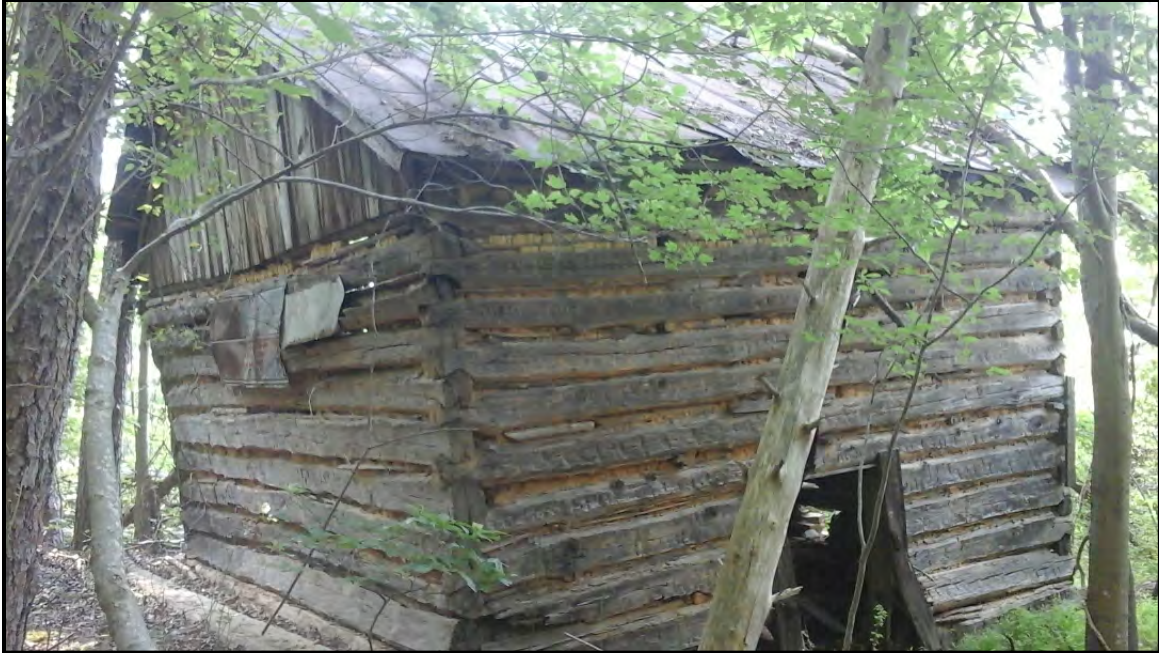
Figure 5.90. Architectural resource RK1679; view is northeast.

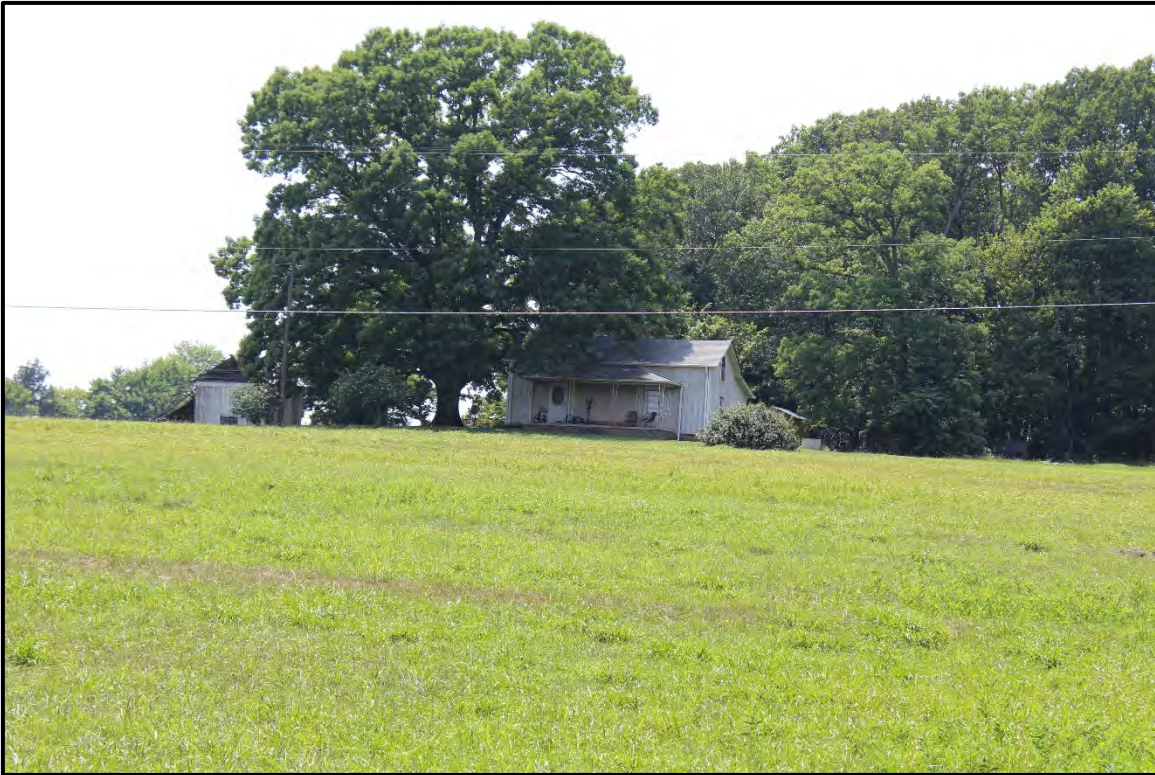
The farmhouse is a one and one-half-story, wood-frame building featuring a roof covered with asphalt shingles, an exterior clad with plywood siding, a concrete block foundation, and double hung horizontal 2/2 wood sash windows. A partial-width porch with a concrete deck provides access to the main entrance. The porch is shielded by a hipped roof that is supported by four decorative metal posts. The house appears to include a shed-roof addition that is attached to the west (rear) elevation.

Figure 5.91. Architectural resource RK1682, view is southwest featuring the principal farmhouse.

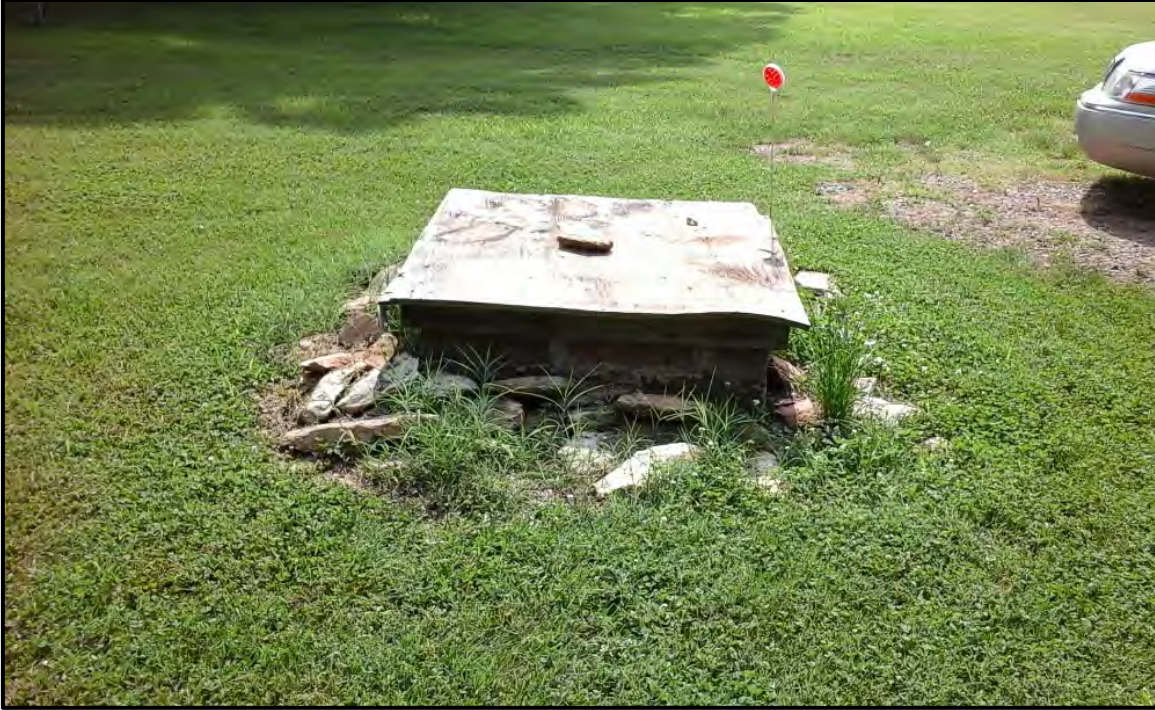
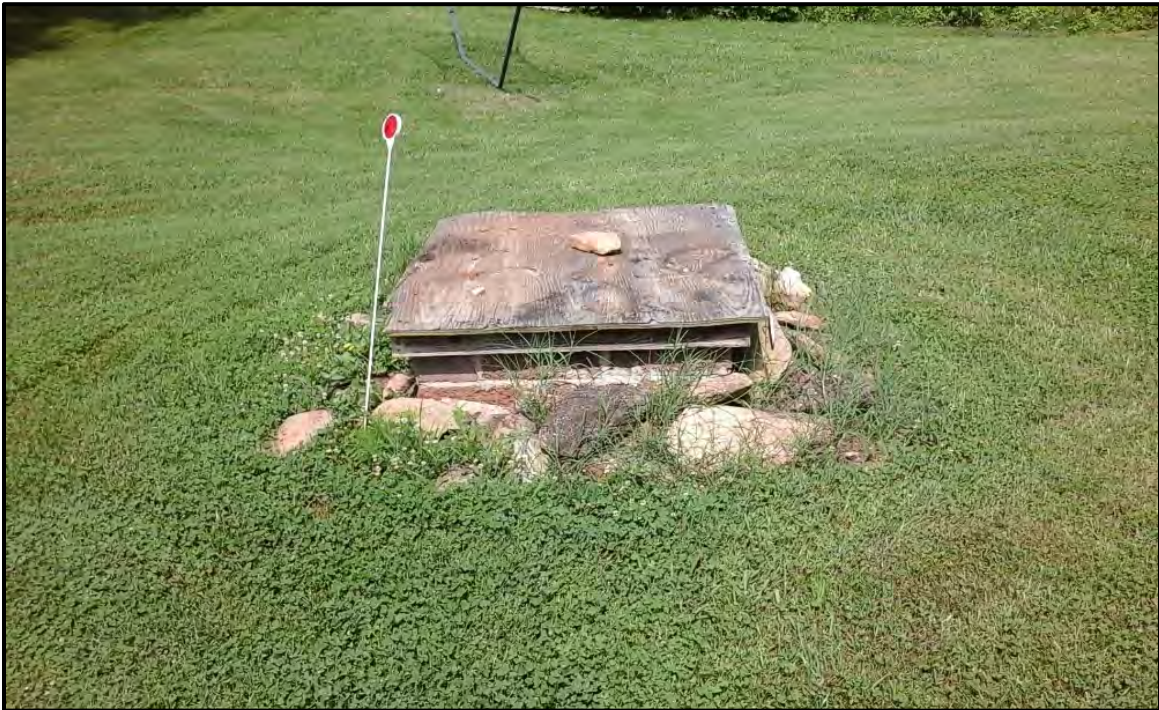
- A ca. 1932 well. The structure appears to be lined with brick and is covered by a plywood board attached to a wood frame (Figures 5.92 and 5.93);
- A ca. 1932 log tobacco barn. The structure features a gabled roof covered with standing seam metal, and exterior partly clad with exterior metal siding, exposed hand-hewn logs joined together by square notching, and a fieldstone foundation. Attached to the south elevation is an open shed-roof extension (Figures 5.94 and 5.95);

Figure 5.92. Architectural resource RK1682; view is north featuring the ca. 1932 well.

Figure 5.93. Architectural resource RK1682; view is west featuring the ca. 1932 well.

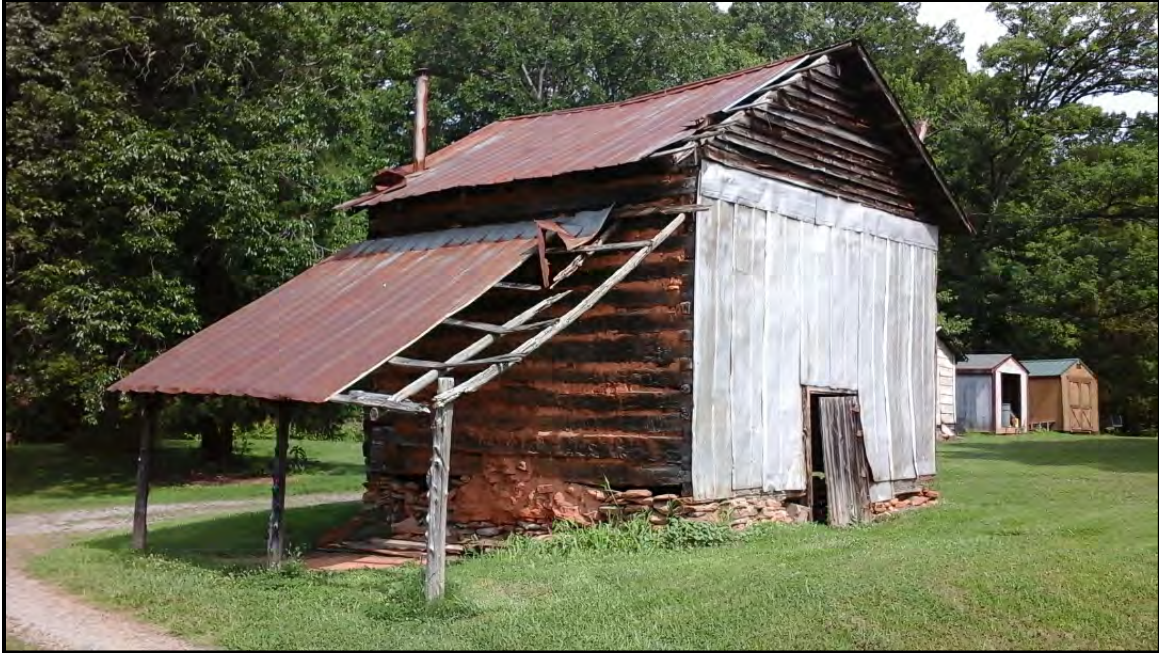
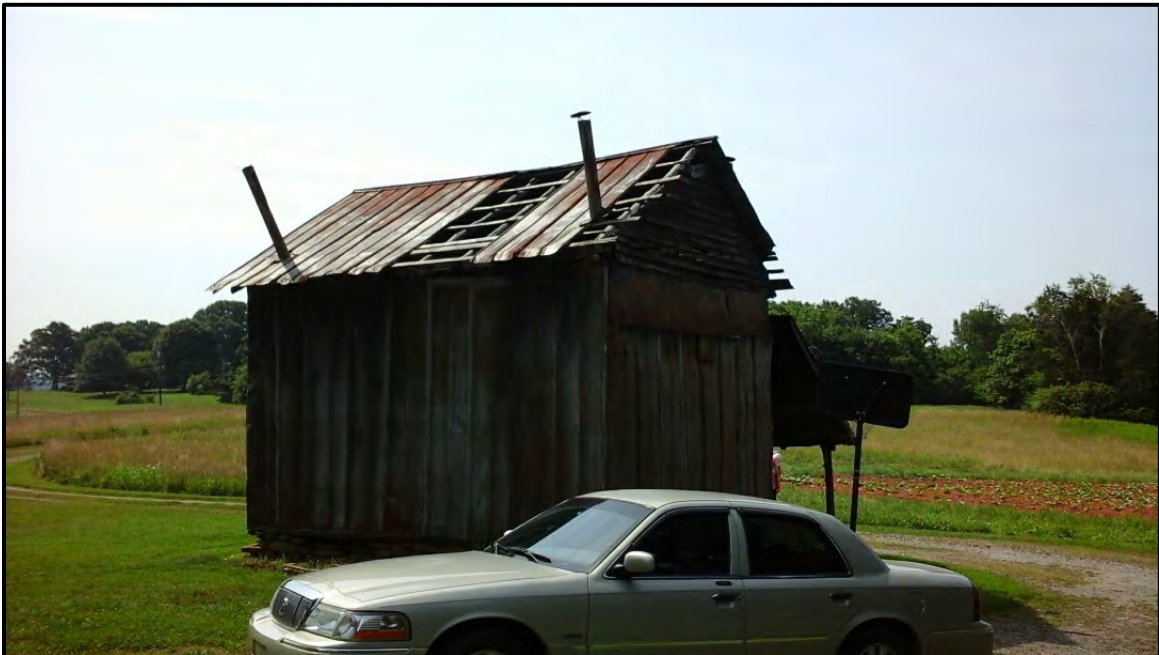
Figure 5.94. Architectural resource RK1682; view is northwest featuring the ca. 1932 log tobacco barn.

Figure 5.95. Architectural resource RK1682; view is southeast featuring the ca. 1932 log tobacco barn.

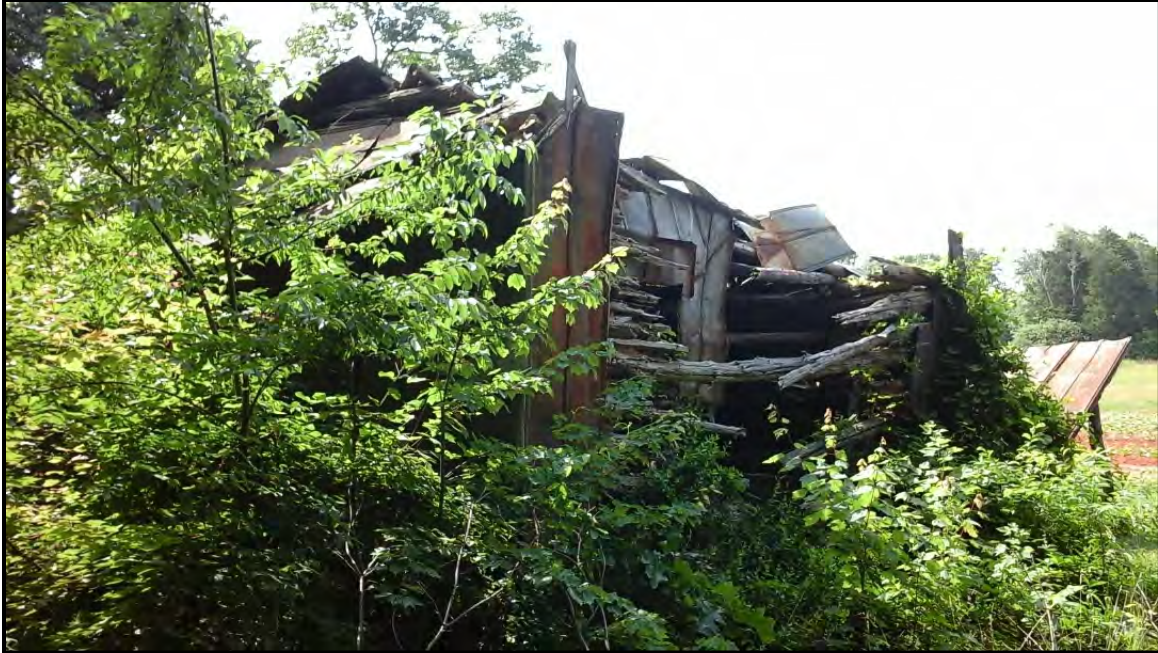
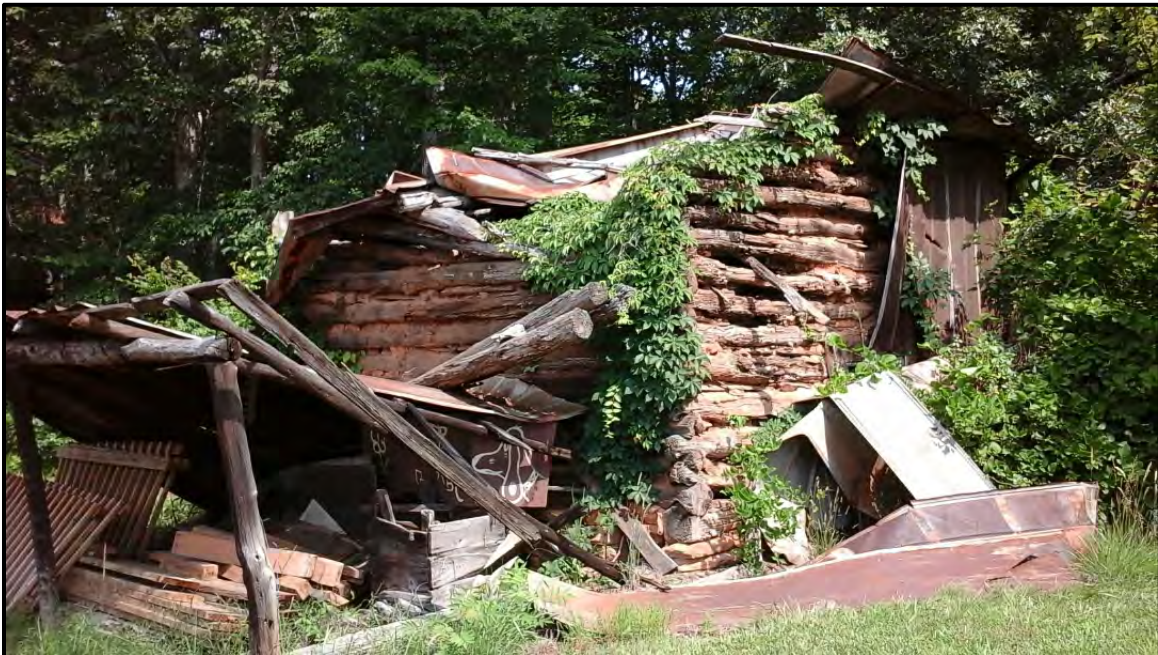
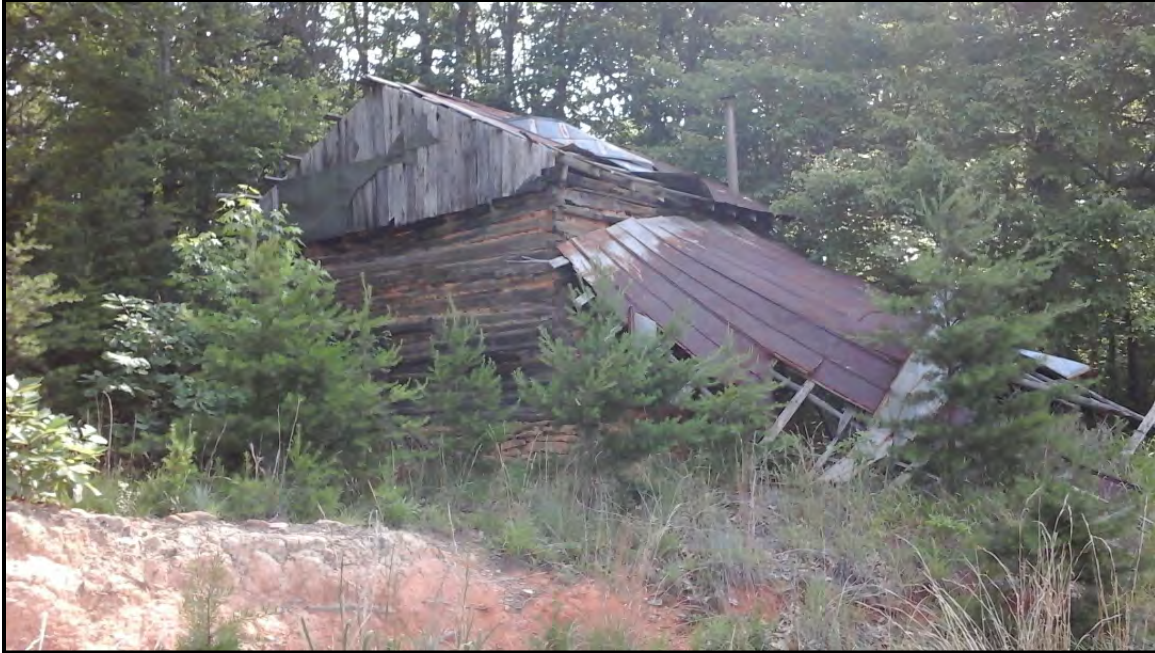
- The collapsed remains of two log tobacco barns (collapsed structures 1 and 2) that appears to date to the early twentieth century (Figures 5.96–5.98);

Figure 5.96. Architectural resource RK1682; view is southwest featuring collapsed Tobacco Barn #1.

Figure 5.97. Architectural resource RK1682; view is northeast featuring collapsed Tobacco Barn #1.

Figure 5.98. Architectural resource RK1682; view is southwest featuring collapsed Tobacco Barn #2.

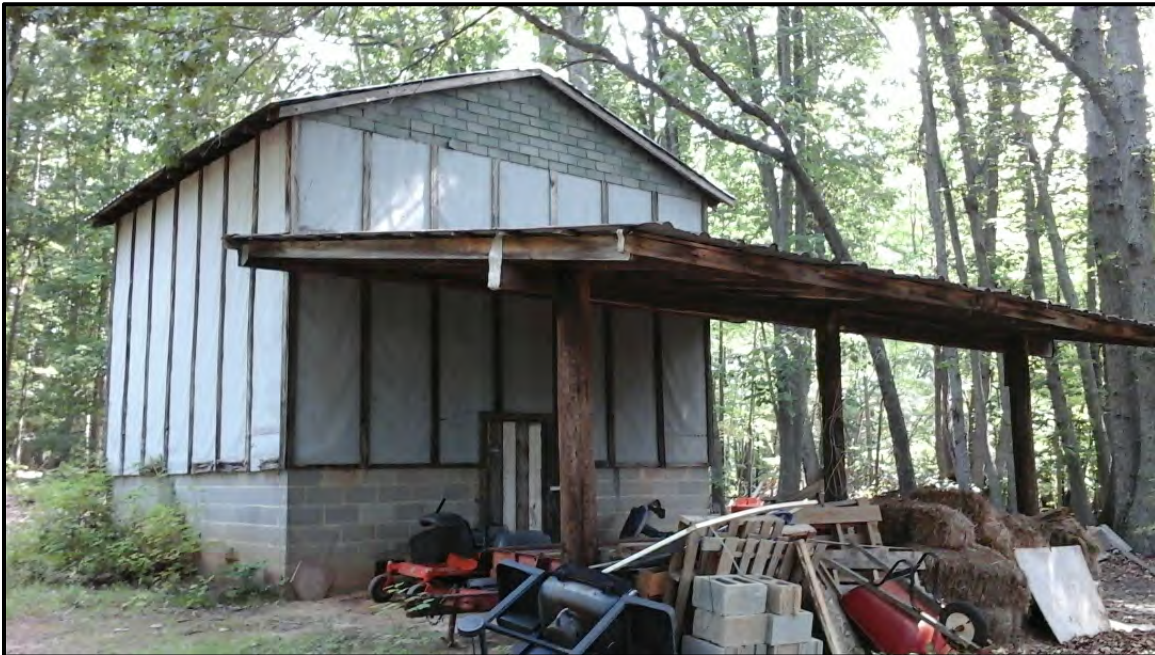
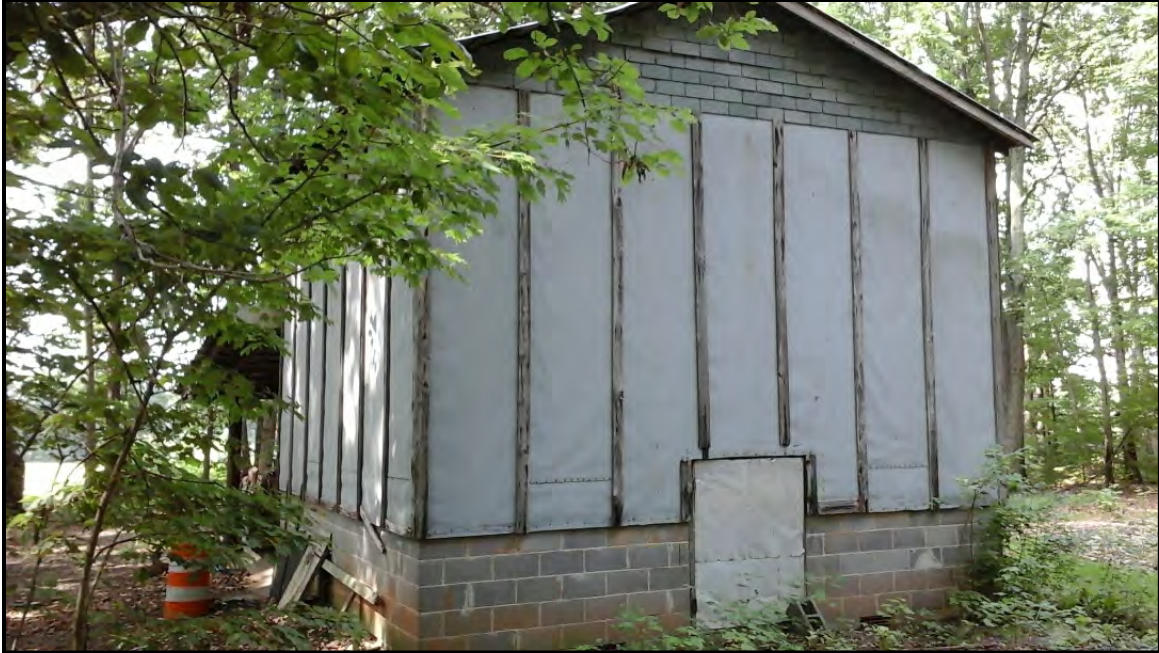
- A ca. 1960 log tobacco barn (Rockingham County, NC WebGIS 2018). The wood-frame structure features a gabled roof covered with standing seam metal, and exterior clad with tar paper and asphalt shingles, and a concrete block foundation. Attached to the west elevation is an open shed-roof extension (Figures 5.99 and 5.100);

Figure 5.99. Architectural resource RK1682; view is east featuring the 1960 tobacco barn.

Figure 5.100. Architectural resource RK1682; view is northwest featuring the 1960 tobacco barn.

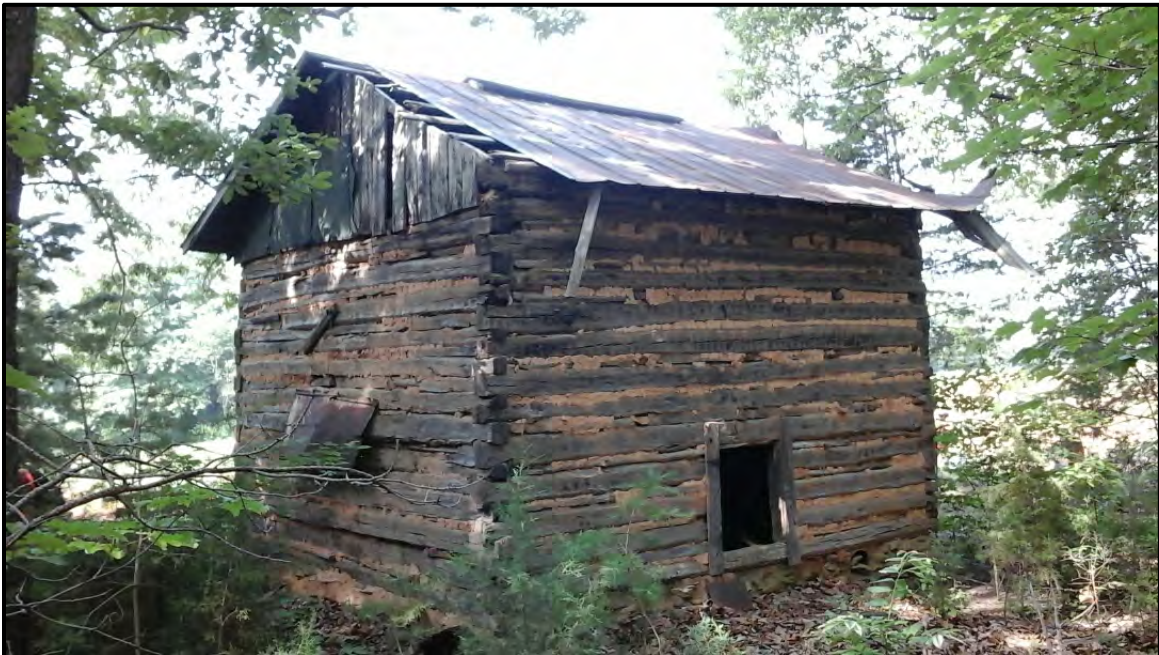
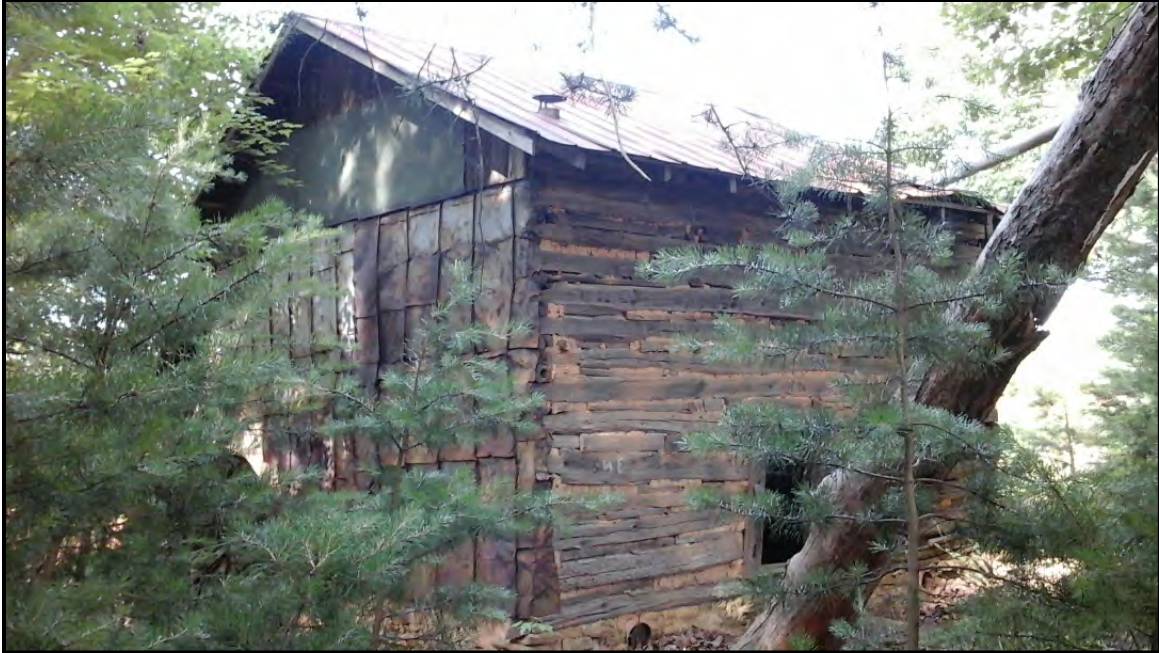
- A ca. 1932 log tobacco barn. The structure features a side-gabled roof covered with standing seam metal, and exterior partly clad with exterior metal siding, exposed hand-hewn logs joined together by square notching, and a fieldstone foundation. Door openings are located on the east and west elevations (Figures 5.101 and 5.102);

Figure 5.101. Architectural resource RK1682; view is southwest featuring the ca. 1932 side-gabled roof tobacco barn.

Figure 5.102. Architectural resource RK1682; view is northeast featuring the ca. 1932 side-gabled roof tobacco barn.

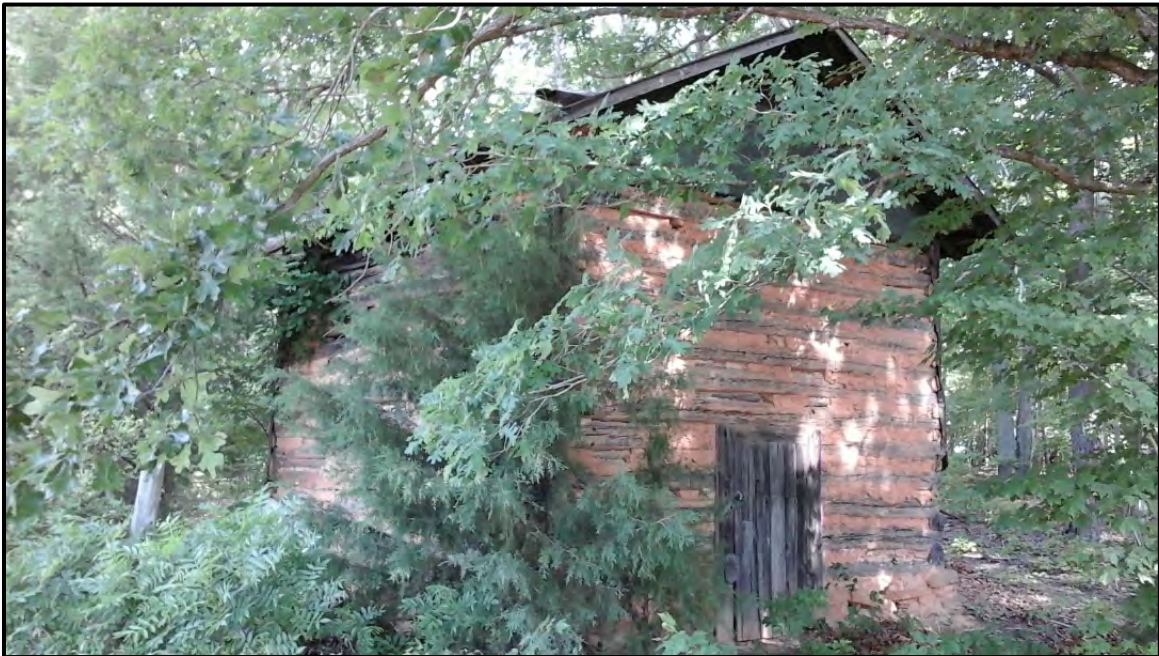
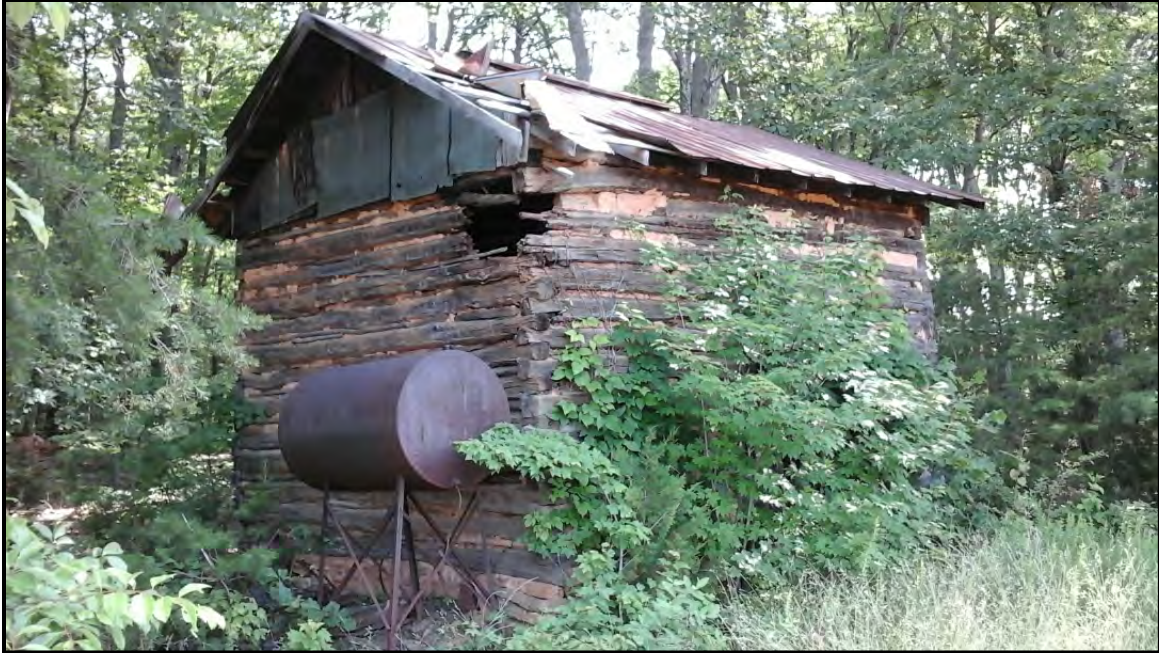
- A ca. 1932 log tobacco barn. The structure features a front-gabled roof covered with standing seam metal, and exterior partly clad with exterior metal siding, exposed hand-hewn logs joined together by square notching, and a fieldstone foundation. A door opening is located on the south elevation (Figures 5.103 and 5.104);

Figure 5.103. Architectural resource RK1682; view is northeast featuring the ca. 1932 gable-front roof tobacco barn.

Figure 5.104. Architectural resource RK1682; view is southwest featuring the ca. 1932 gable-front roof tobacco barn.

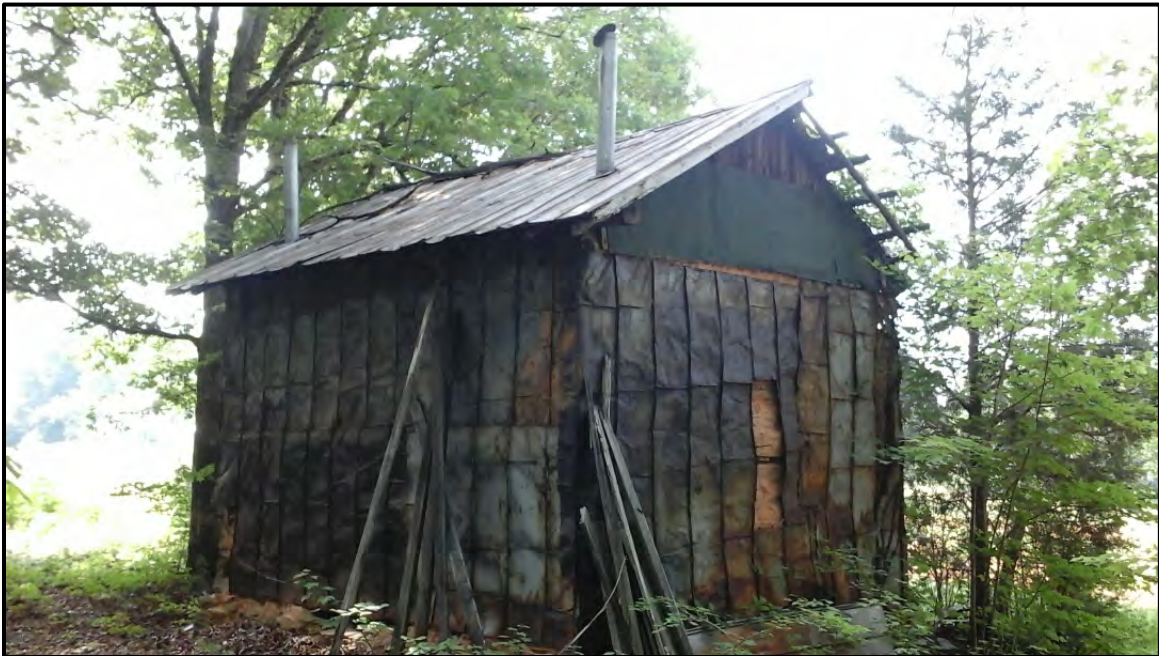
- A mid-twentieth century log tobacco barn. The structure features a gabled roof covered with standing seam metal, an exterior clad with metal siding, and a fieldstone foundation (Figure 5.105).

Figure 5.105. Architectural resource RK1682; view is southwest featuring the mid-twentieth century tobacco barn.

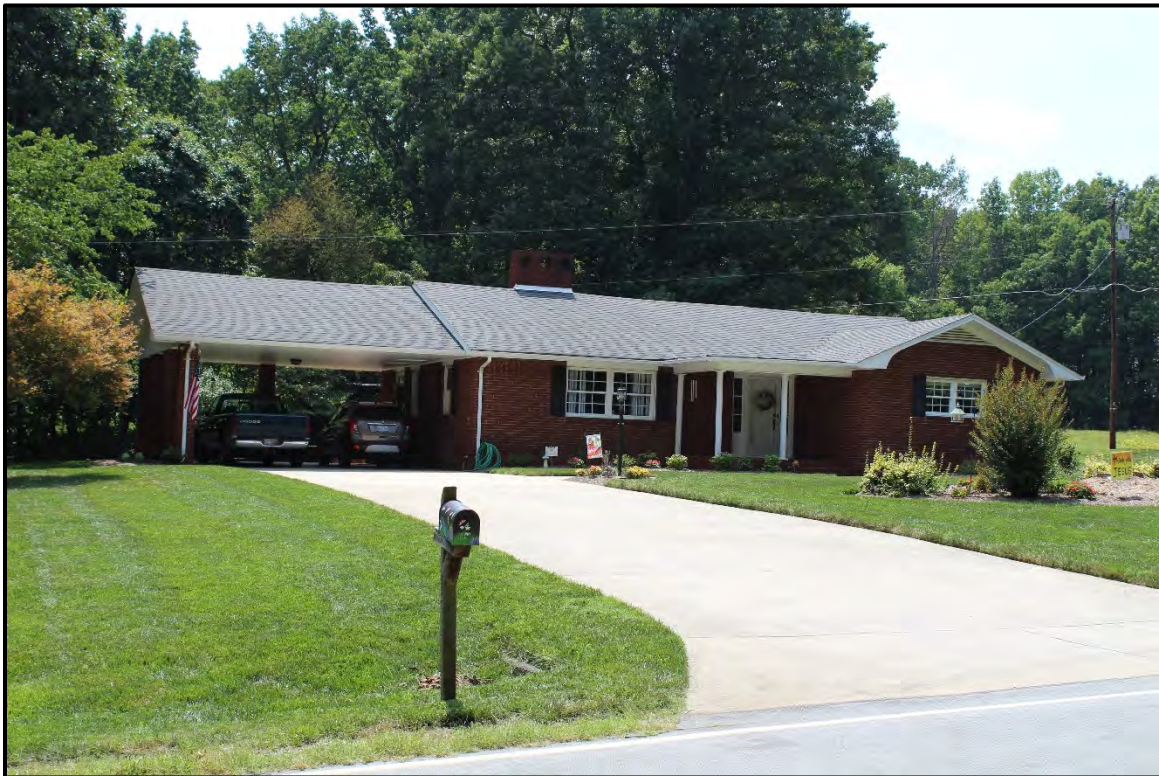
NRHP Assessment. Architectural resource RK1683 does not exhibit distinctive characteristics of architectural style or workmanship. In addition, the house has been altered through the replacement of the original window sashes. Based on the lack of architectural merit, as well as the inability to associate the house and/or its original owner(s) with an important historical event or series of events, it is TRC's opinion that architectural resource RK1683 is not eligible for the NRHP.

Figure 5.106. Architectural resource RK1683; view is northwest featuring the façade and carport attached to the south elevation.

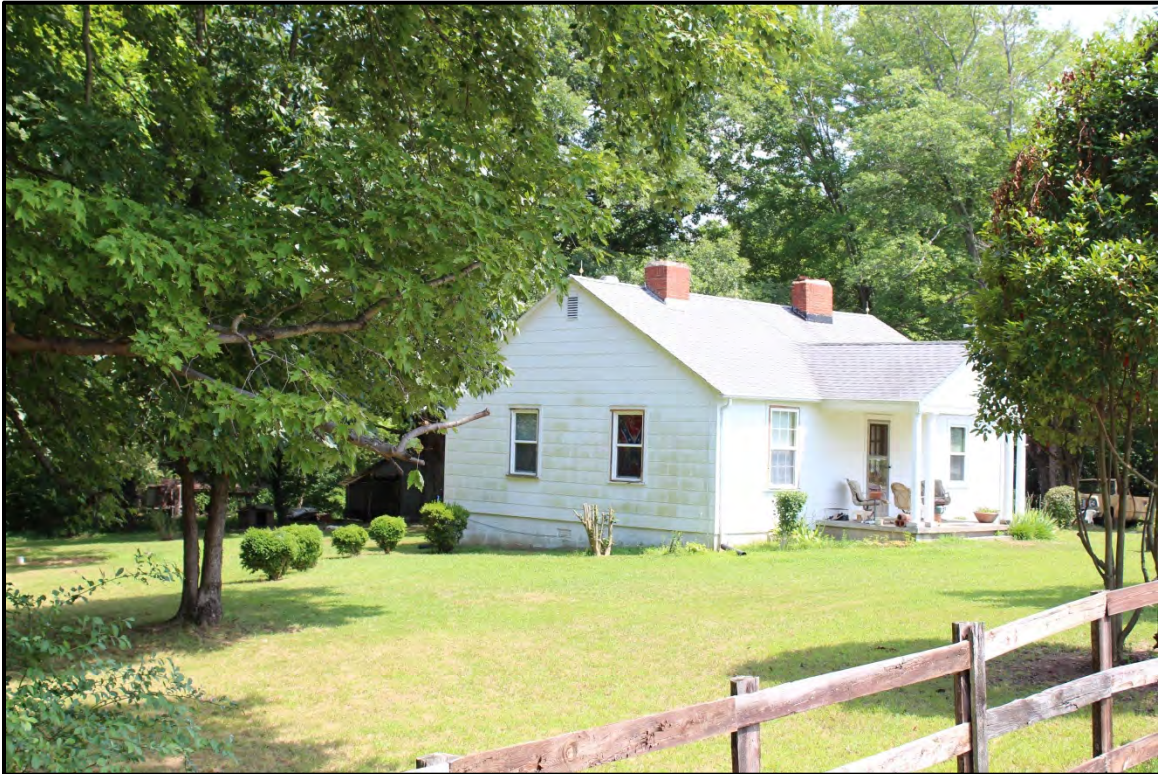
The one-story, wood-frame building features a side-gabled roof, exterior asbestos shingle siding and a concrete foundation. Windows are 6/6 and 1/1 vinyl sashes. The façade features a central gabled porch with paired columns. Within the porch bay, the primary entry holds an original multi-light door.

Figure 5.107. Architectural resource RK1687; view is southeast featuring the façade and north elevation.

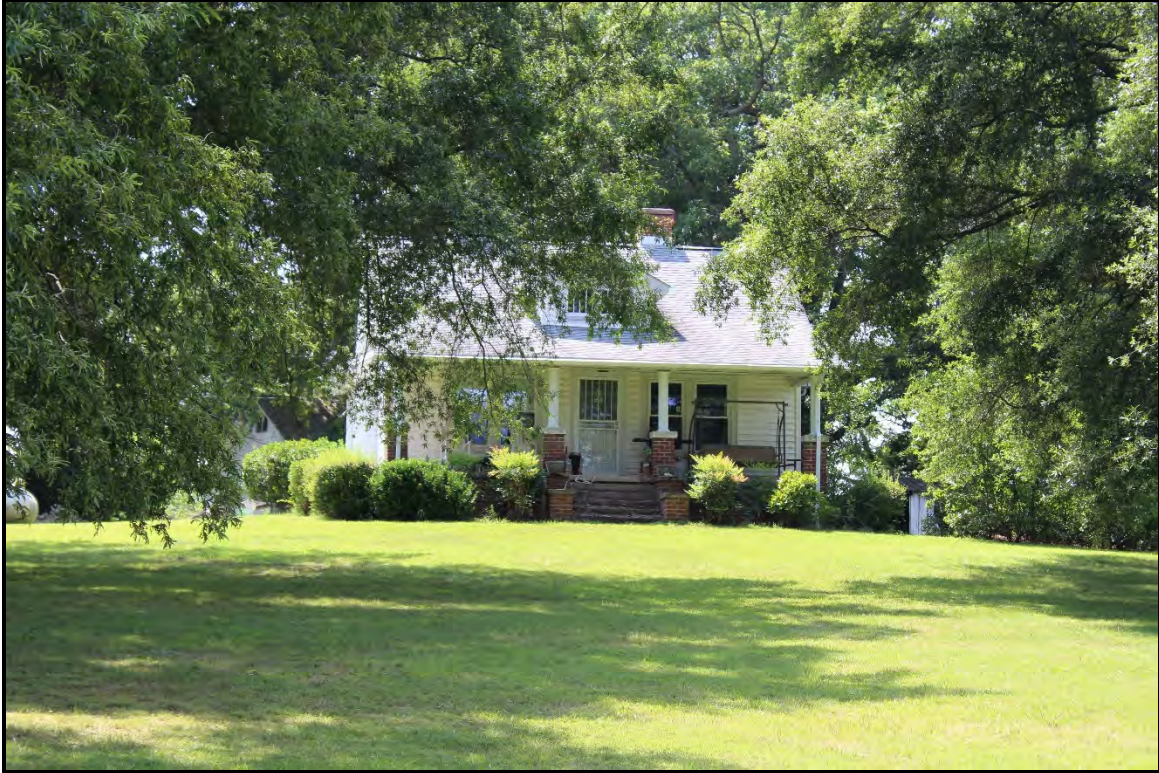
The one and one-half-story, wood-frame building features a side-gabled roof, exterior vinyl siding and a brick foundation. Windows are replacement 1/1 and original vertical sash casement design. The façade features a full shed porch supported by replacement vinyl columns on original brick piers (Figure 5.108). Outbuildings include a corrugated metal garage with shed open wing, vertical board two-story barn with a metal clad gabled roof (Figure 5.109) and a tobacco barn clad with metal siding with a metal clad gabled roof and concrete foundation (Figure 5.110).

Figure 5.108. Architectural resource RK1684; view is west featuring the façade of the farmhouse.

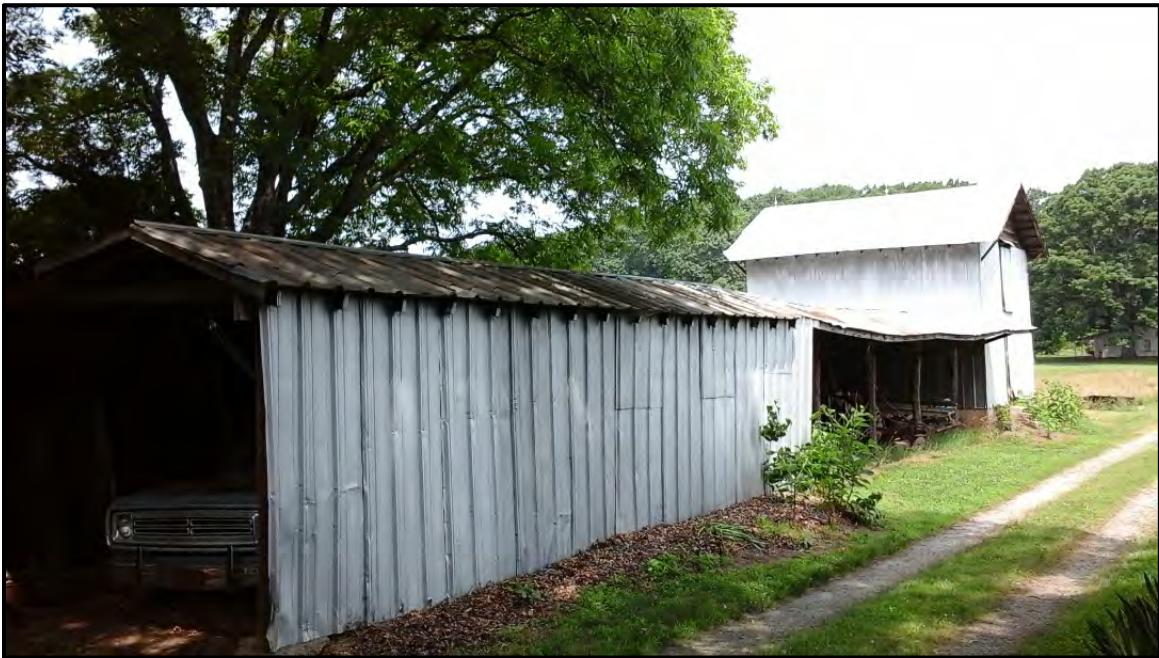
Figure 5.109. Architectural resource RK1684; view is northwest featuring the vehicle and equipment shed connected to the tobacco barn.
