Re: Revised Architectural Survey Report, MVP Southgate Project, Construct Interstate Pipeline, Rockingham and Alamance County, ER 18-1041

Thank you for your letter of October 11, 2019, transmitting the draft "Historic Architectural Survey for the MVP Southgate Pipeline Project". We have reviewed the report and offer the following comments.

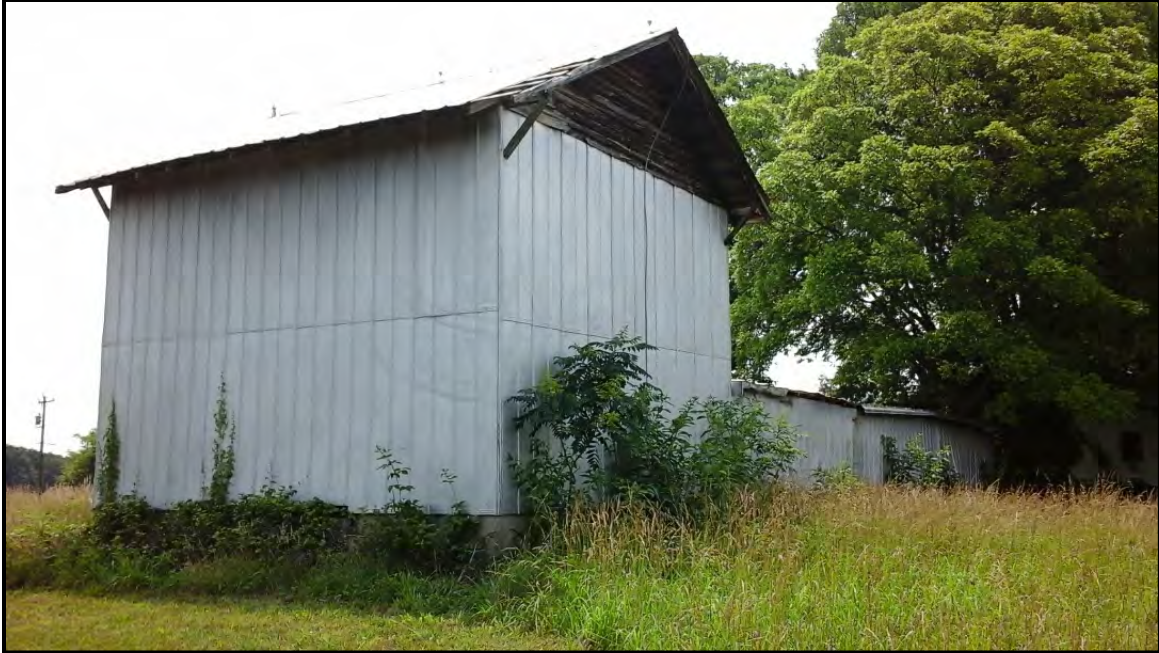
The one and one-half-story, wood-frame building features a side-gabled roof, exterior vinyl siding and a brick foundation. Windows are replacement 1/1 and original vertical sash casement design. The façade features a full shed porch supported by replacement vinyl columns on original brick piers (Figure 5.108). Outbuildings include a corrugated metal garage with shed open wing, vertical board two-story barn with a metal clad gabled roof (Figure 5.109) and a tobacco barn clad with metal siding with a metal clad gabled roof and concrete foundation (Figure 5.110).

Figure 5.110. Architectural resource RK1684; view is southeast featuring tobacco barn.

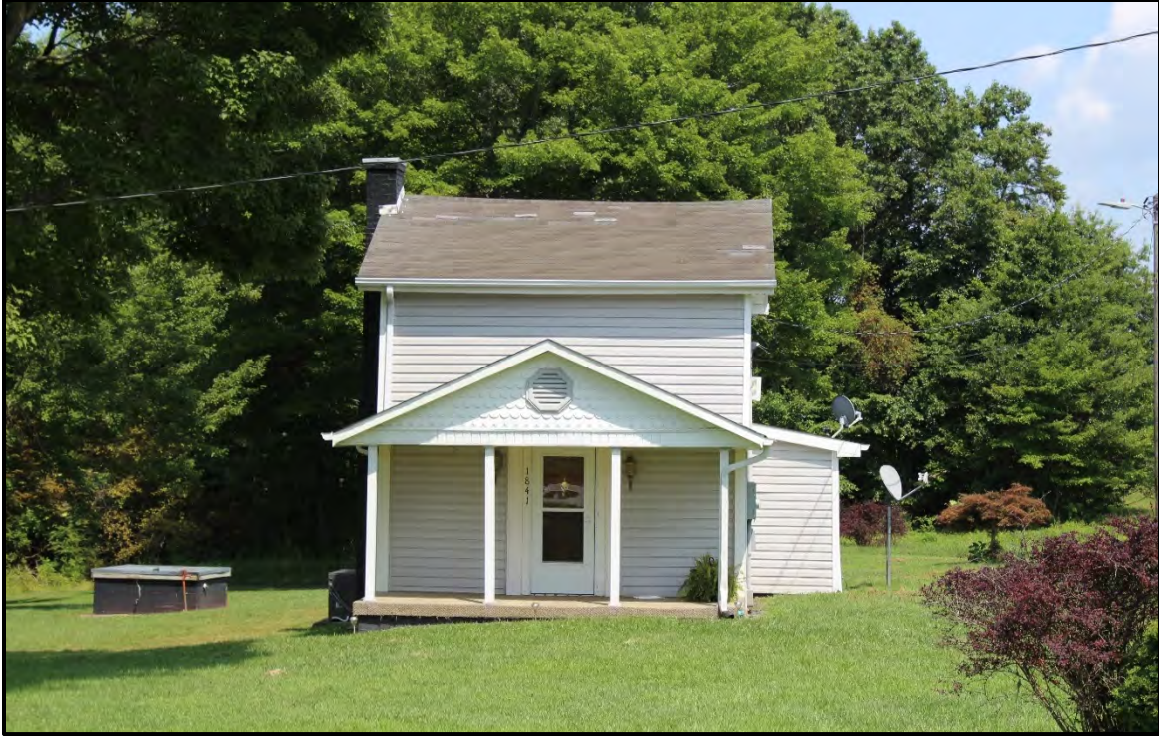
The one and one-half-story, wood-frame building house features a side-gabled roof, exterior vinyl siding and a concrete block foundation. Windows are replacement 1/1. The house has a primary gabled porch (altered or replaced). At the north elevation is an exterior end brick chimney. The building has a one-story gabled-wing (east elevation) and shed wing (south elevation) (Figures 5.111 and 5.112). The property also includes a log tobacco barn (Figures 5.113 and 5.114). The barn has v-notched log walls, an original wood panel door and an open shed wing.

Figure 5.111. Architectural resource RK1685; view is east featuring façade of house and south shed wing.

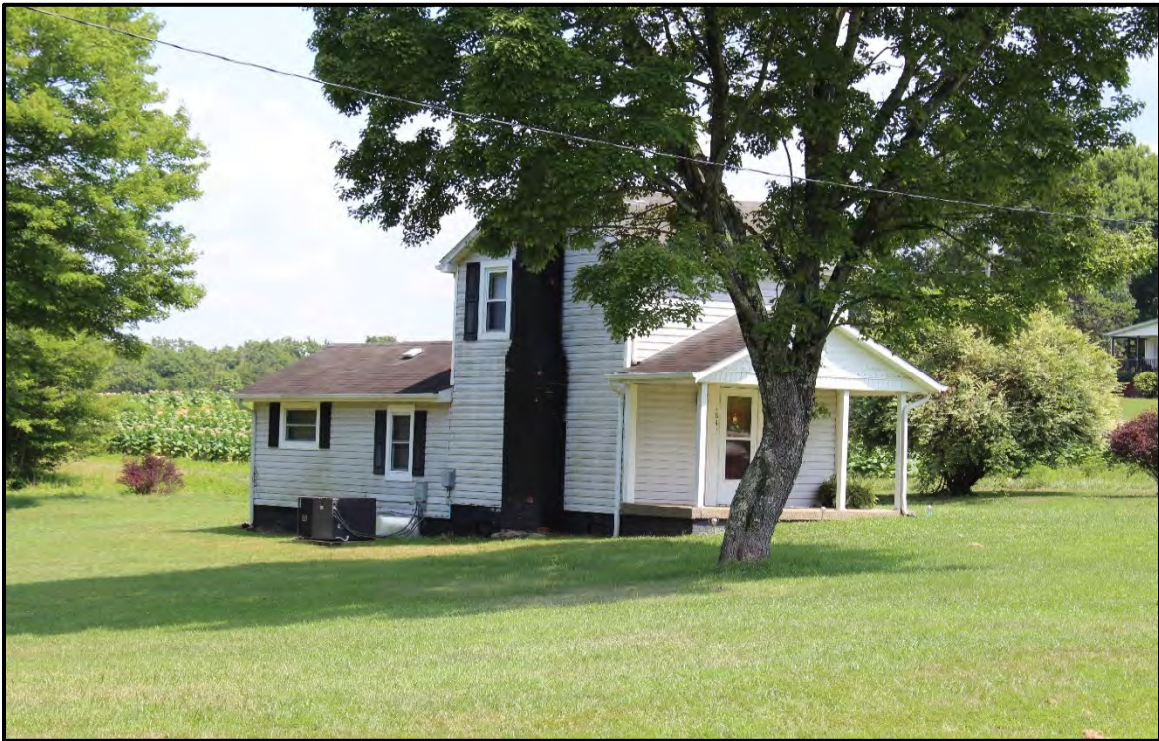
Figure 5.112. Architectural resource RK1685; view is southeast featuring façade, north elevation and rear gabled wing.

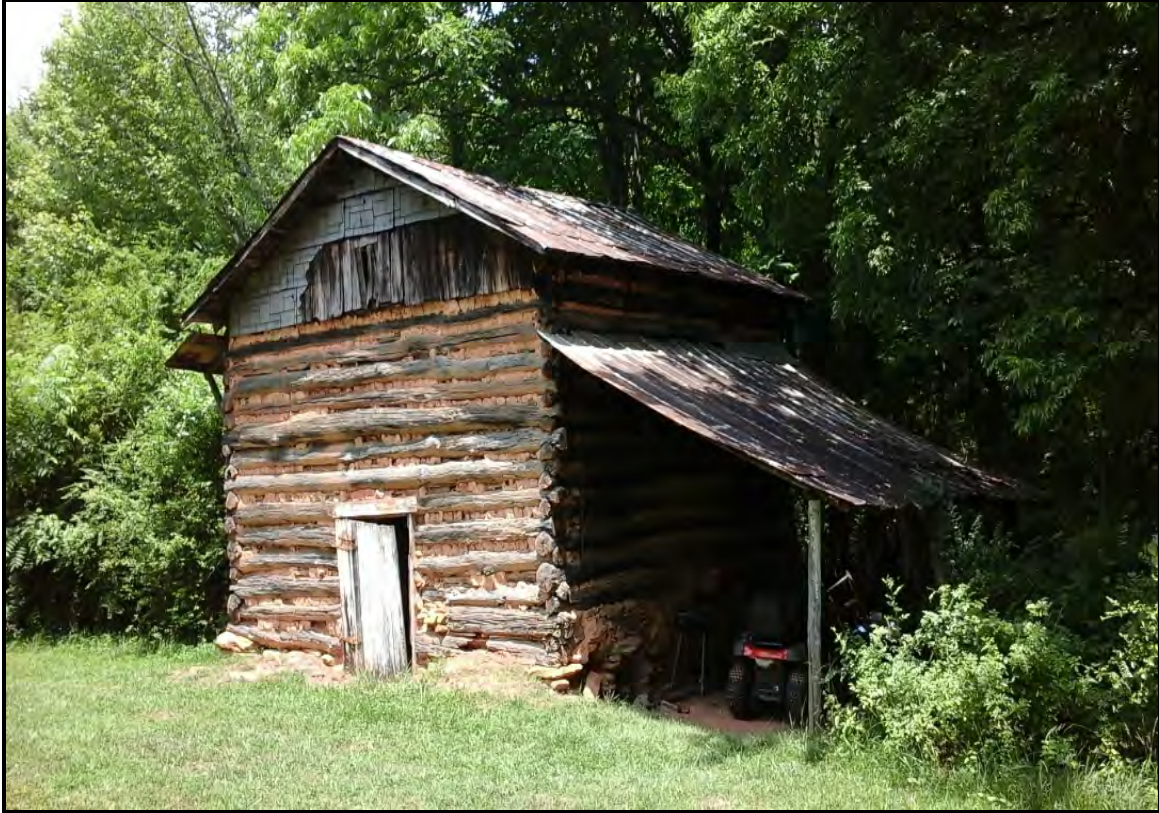
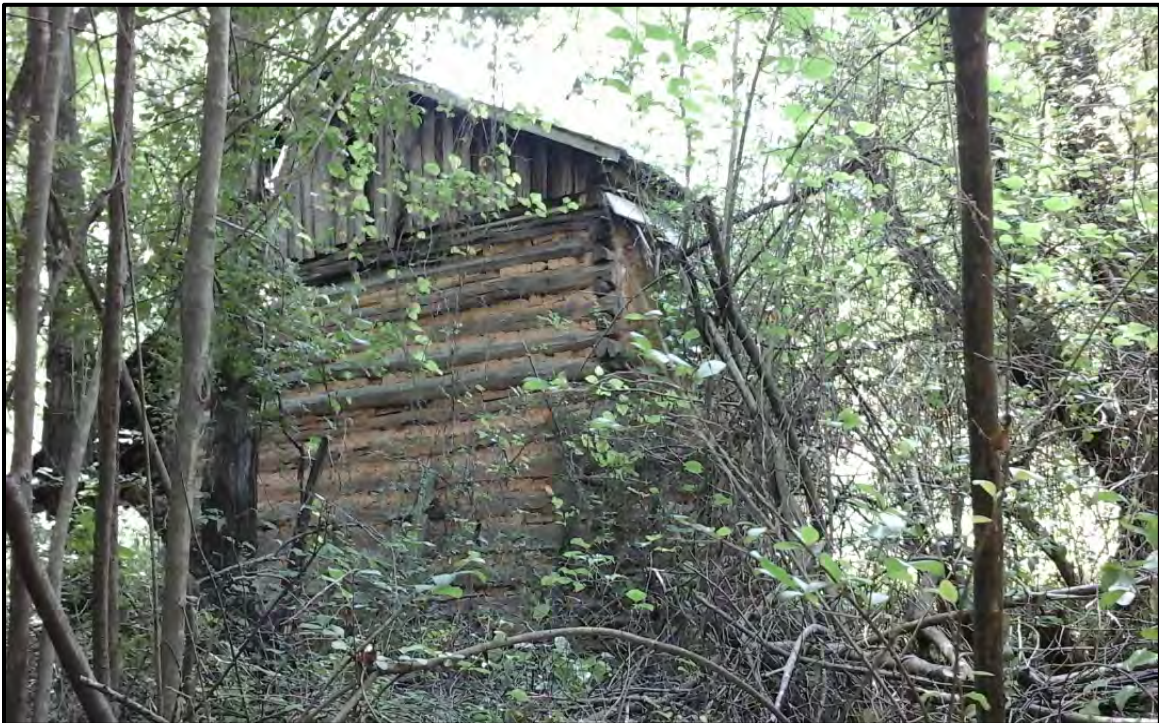
Figure 5.113. Architectural resource RK1685; view is northwest featuring tobacco barn façade and shed wing.

Figure 5.114. Architectural resource RK1685; view is southeast featuring tobacco barn rear elevation.

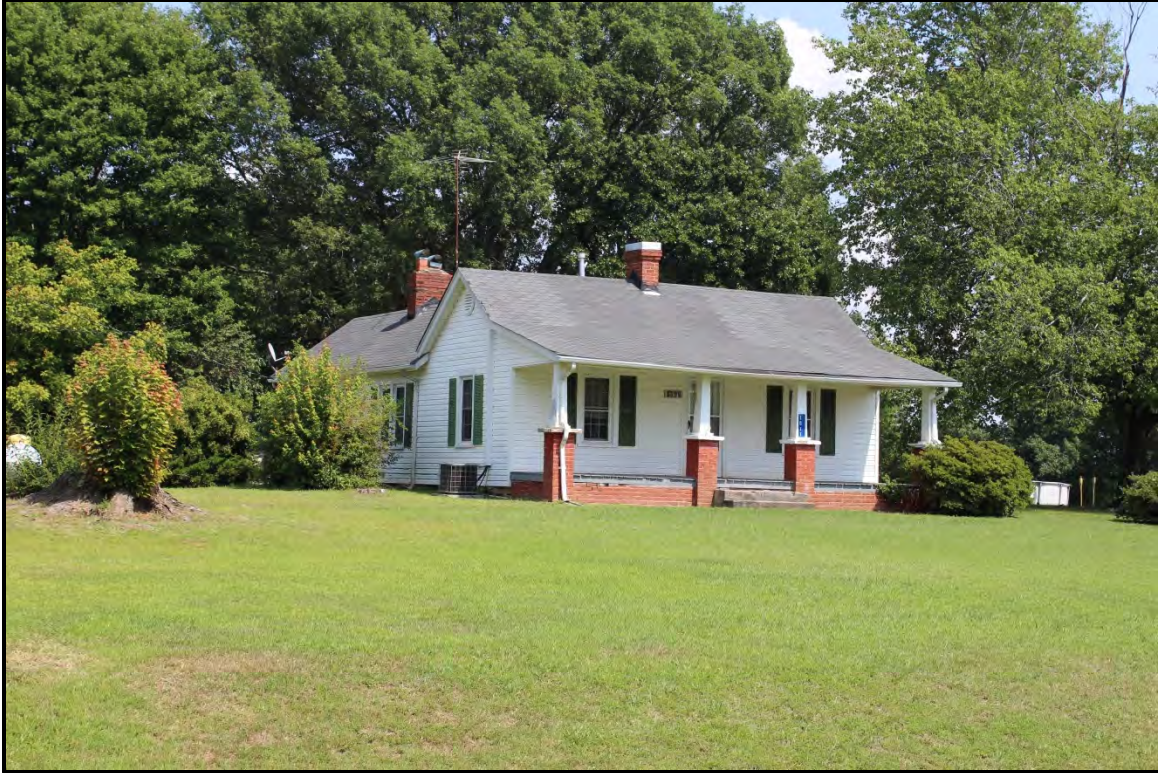
The farmhouse is a one-story, wood-frame building that features a side-gabled roof covered with asphalt shingles, an interior brick chimney, exterior vinyl siding, and a concrete foundation. Windows are replacement 6/6. The house has a primary gabled shed porch with tapered posts on brick piers (original). Within the porch bay is an original multi-light paneled door. The building has a rear one-story gabled ell that includes an interior brick chimney (Figure 5.114). The property also includes a wood-frame barn and two log tobacco barns (Figure 5.115)

Figure 5.115. Architectural resource RK1686; view is southeast, featuring façade and north elevation.

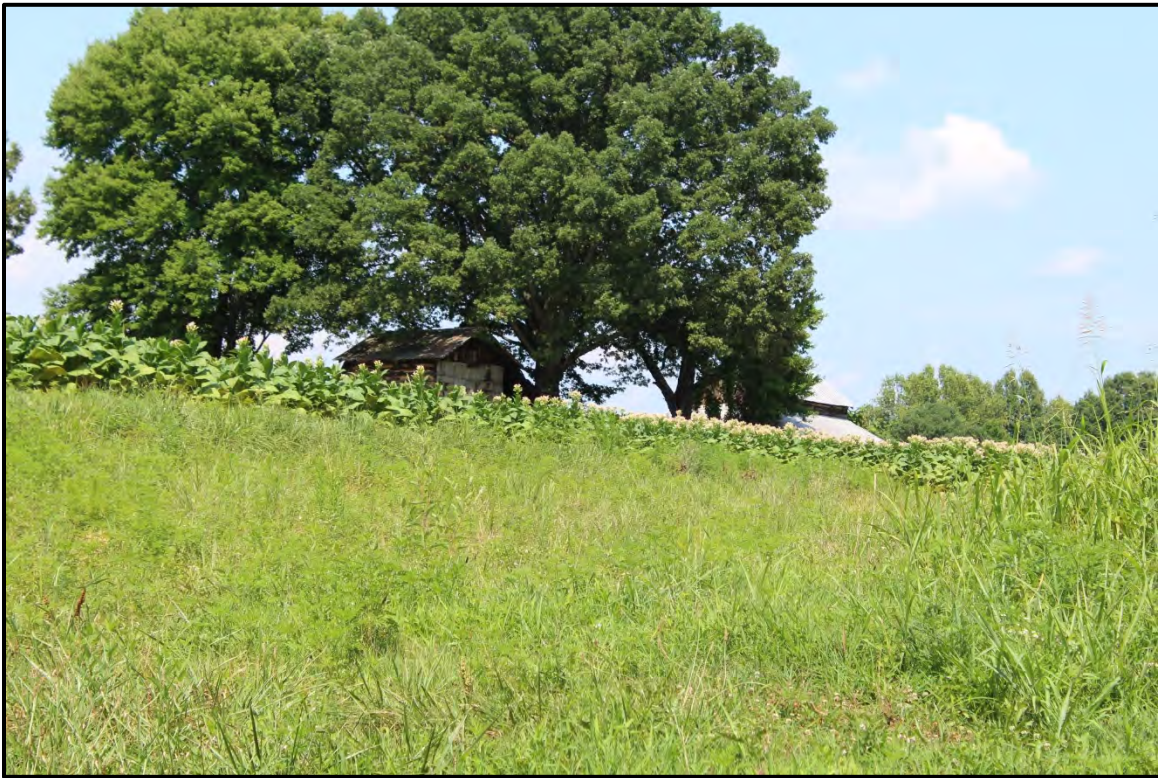
Figure 5.116. Architectural resource RK1686; view is southeast, featuring the agricultural buildings.

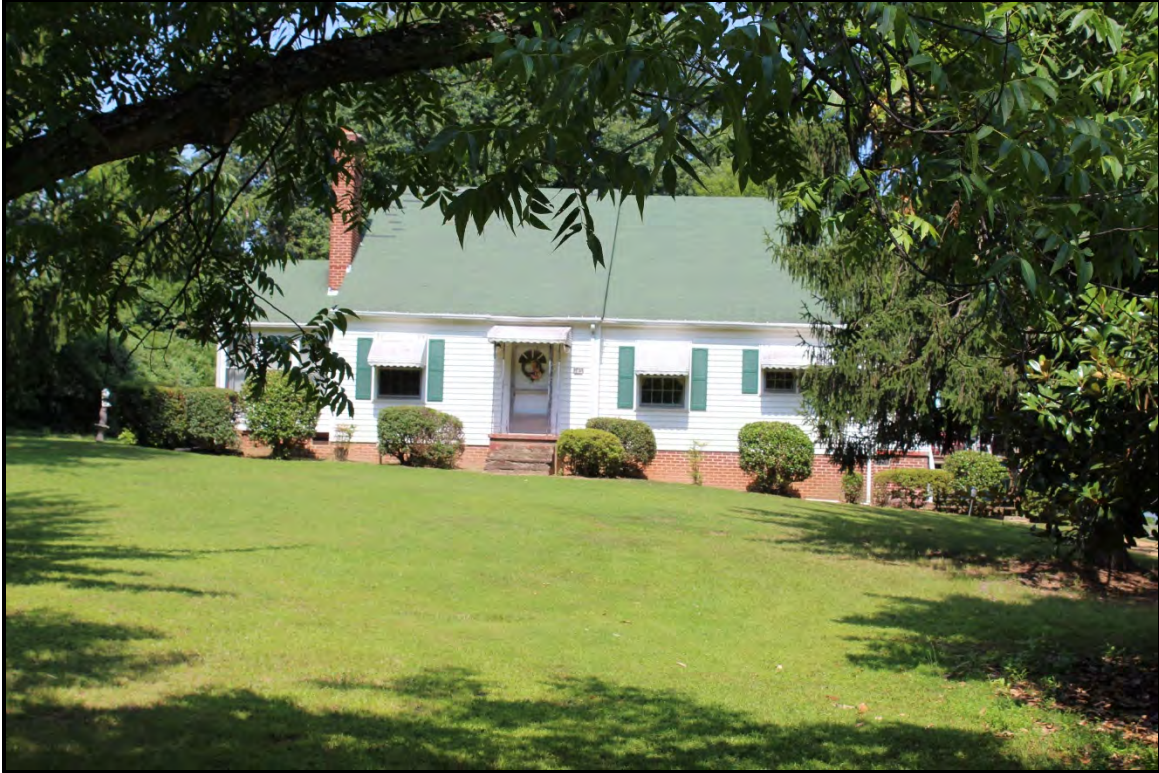
The one and one-half-story, wood-frame building features a side-gabled roof covered with asphalt shingles, an exterior clad with vinyl siding, a raised brick foundation, and double hung 8/8 wood sash windows. The façade features a central entry bay and brick stoop. Connected to the north elevation is a side-gabled wing and a brick chimney (Figure 5.117).

Figure 5.117. Architectural resource RK1688; view is east, featuring the façade.

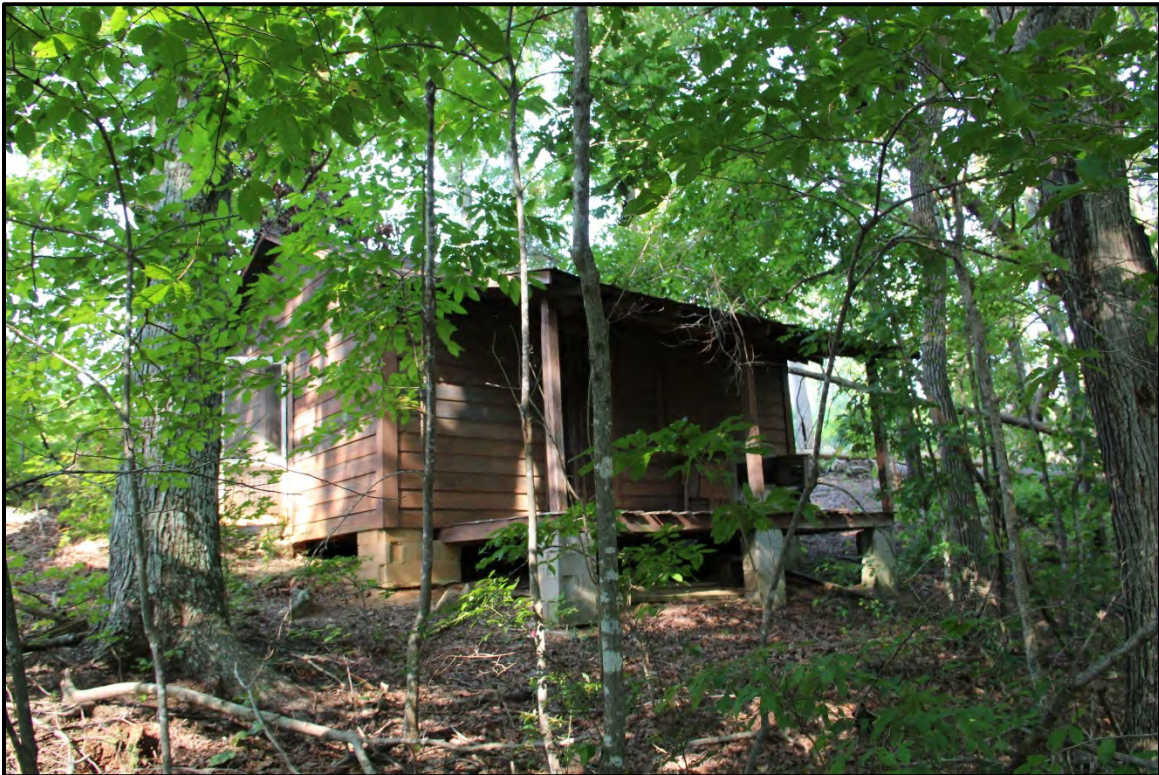
- A ca. 1960 one-story cabin. The wood-frame building features a side-gabled roof covered with standing seam metal, an exterior clad with wood drop siding, and a concrete block pier foundation. Windows are covered with wood board panels. A full-width porch containing a wood deck provides access to the main entrance. The porch is shielded by a shed roof that is supported by three square wood posts (Figure 5.118);
- A ca. 1960 privy. The wood-frame structure features a shed roof covered with corrugated metal and an exterior clad with vertical wood boards. A wood batten door on the west elevation provides access to the structure (Figure 5.119).

Figure 5.118. Architectural resource RK1688; view is northwest featuring the ca. 1960 cabin.

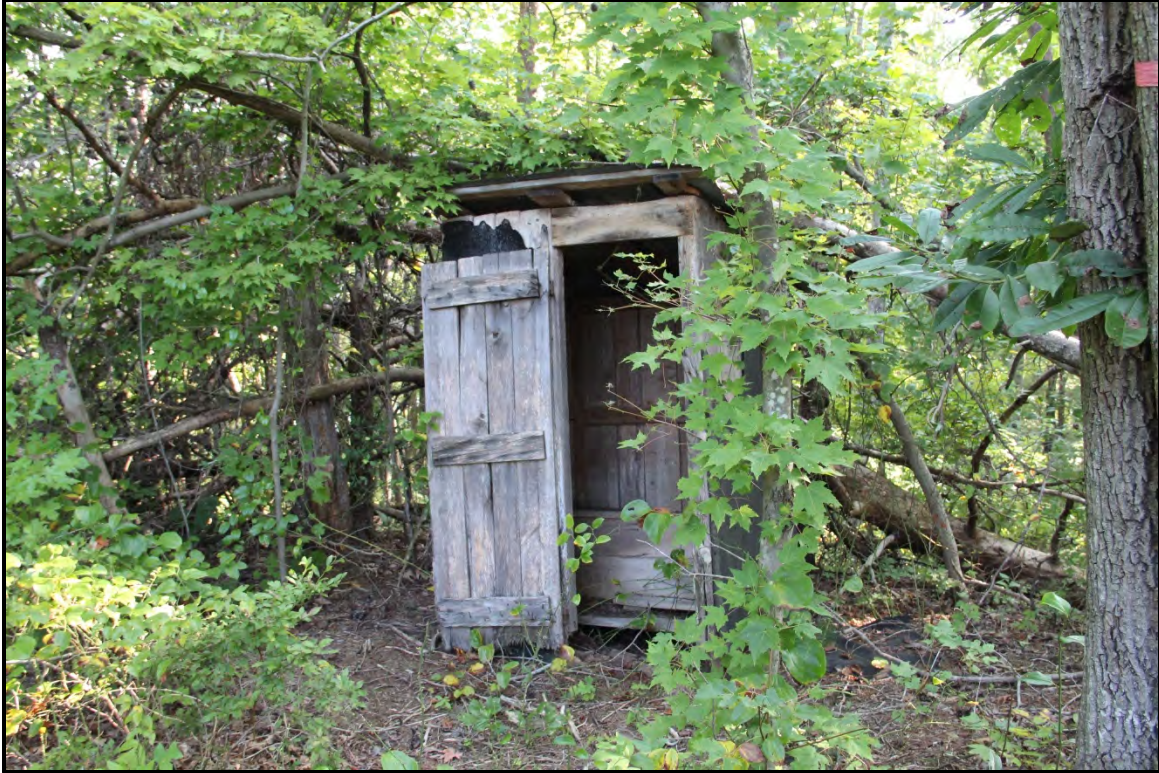
Figure 5.119. Architectural resource RK1688; view is east featuring the ca. 1960 privy.

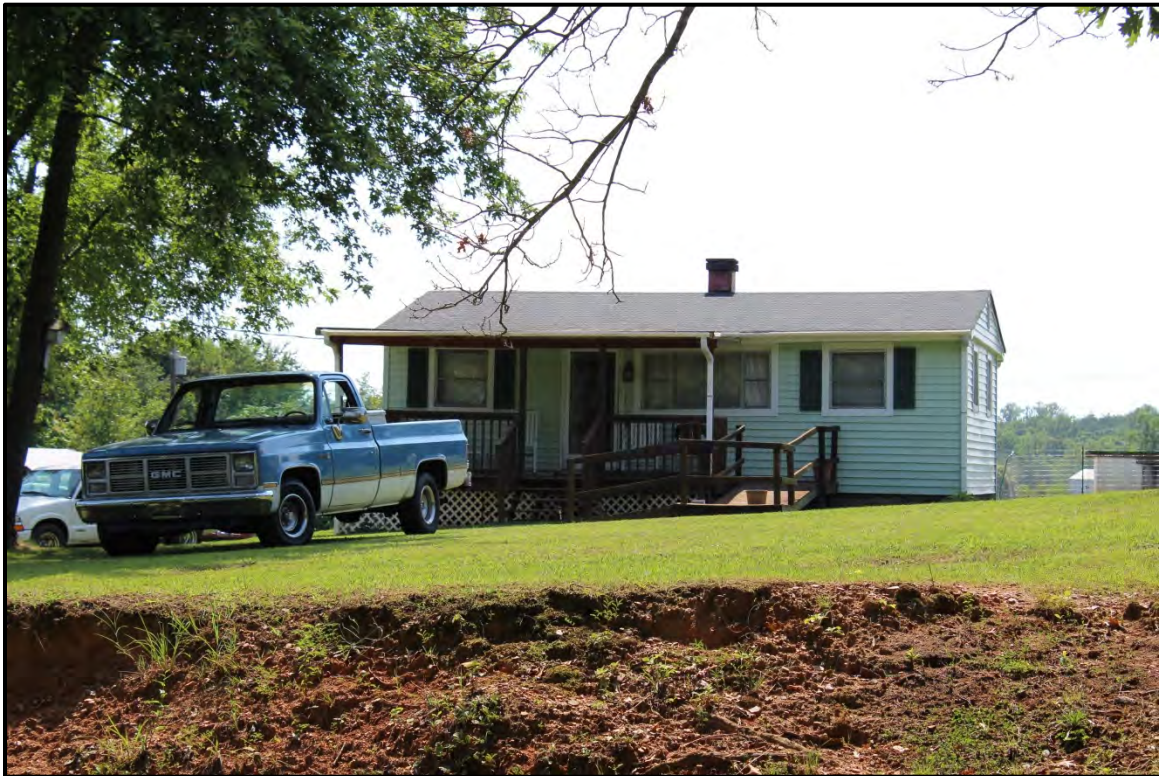
NRHP Assessment. Architectural resource RK1690 does not exhibit distinctive characteristics of architectural style or workmanship. In addition, the house has been altered through the application of vinyl siding. Based on the lack of architectural merit, as well as the inability to associate the house and/or its original owner(s) with an important historical event or series of events, it is TRC’s opinion that architectural resource RK1690 is not eligible for the NRHP.

Figure 5.120. Architectural resource RK1690; view is southwest, featuring the façade and north elevation.

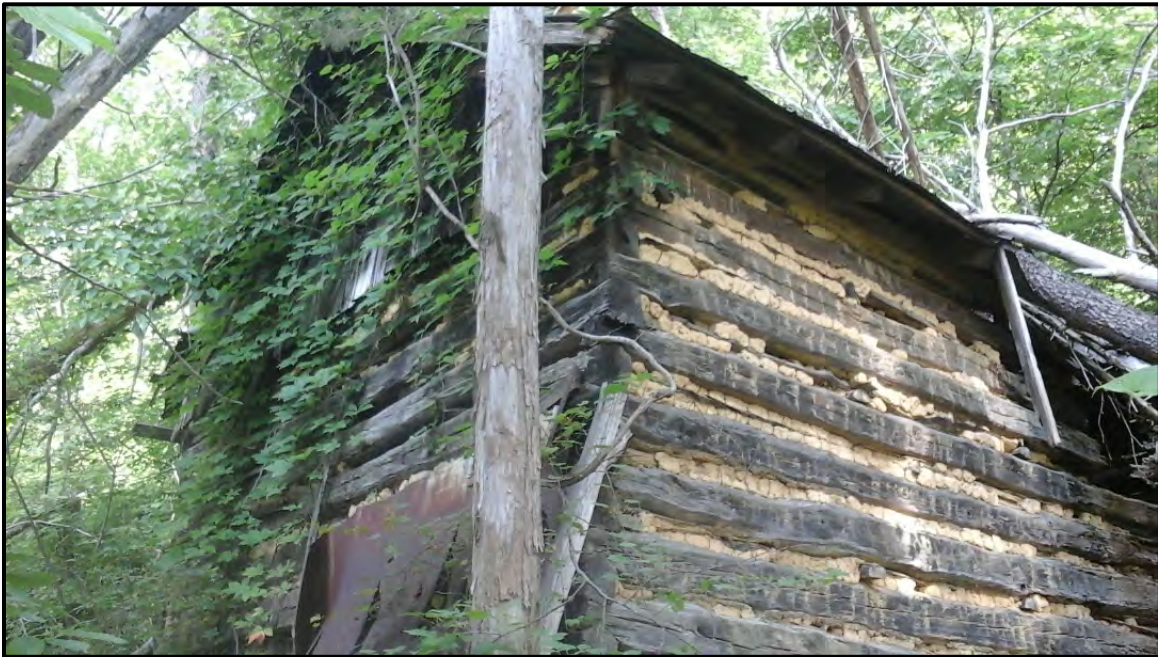
Description. Architectural resource RK1689 is a log tobacco barn located at 1000 Crutchfield Road, Reidsville 27320 on parcel number 156183 (Rockingham County, NC WebGIS 2018) (see Figure 1.2d, Figures 5.121 and 5.122). The barn was constructed ca. 1920, based on stylistic evidence and the dates of area farmsteads. The structure has a gabled roof covered with standing seam metal, hand-hewn logs joined together with v-notching, and a stone foundation. The doors are missing, and the building is leaning due to instability/neglect.

Figure 5.121. Architectural resource RK1689; view of upper wall and log detail.

NRHP Assessment. Architectural resource RK1689 does not exhibit distinctive characteristics of architectural style or workmanship. The barn is one of many examples in the Project area. Based on the lack of architectural merit, coupled with the absence of associated agricultural buildings and/or a farmhouse, this barn, by itself, fails to exemplify the historical associations of the property. Additionally, research failed to associate the barn and/or its original owner(s) with an important historical event or series of events. Based on this information, it is TRC's opinion that architectural resource RK1689 is not eligible for the NRHP.

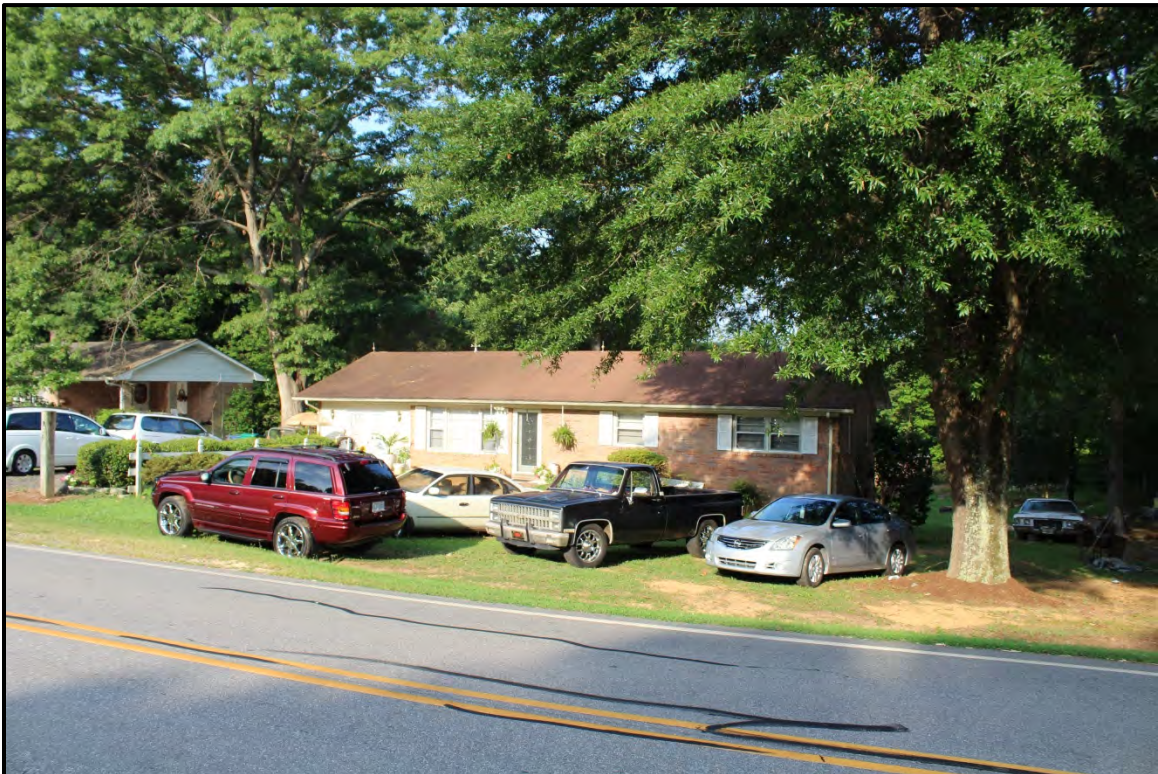
The wood-frame building has a side-gabled roof, an exterior clad with a brick veneer, and a concrete foundation. Windows are original horizontal sash design. The façade features a picture style window offset by an original paneled door.

Figure 5.123. Architectural resource RK1691; view is southwest featuring the façade and north elevation.

NRHP Assessment. Architectural resource RK1691 does not exhibit distinctive characteristics of architectural style or workmanship. Based on the lack of architectural merit, as well as the inability to associate the house and/or its original owner(s) with an important historical event or series of events, it is TRC's opinion that architectural resource RK1691 is not eligible for the NRHP.

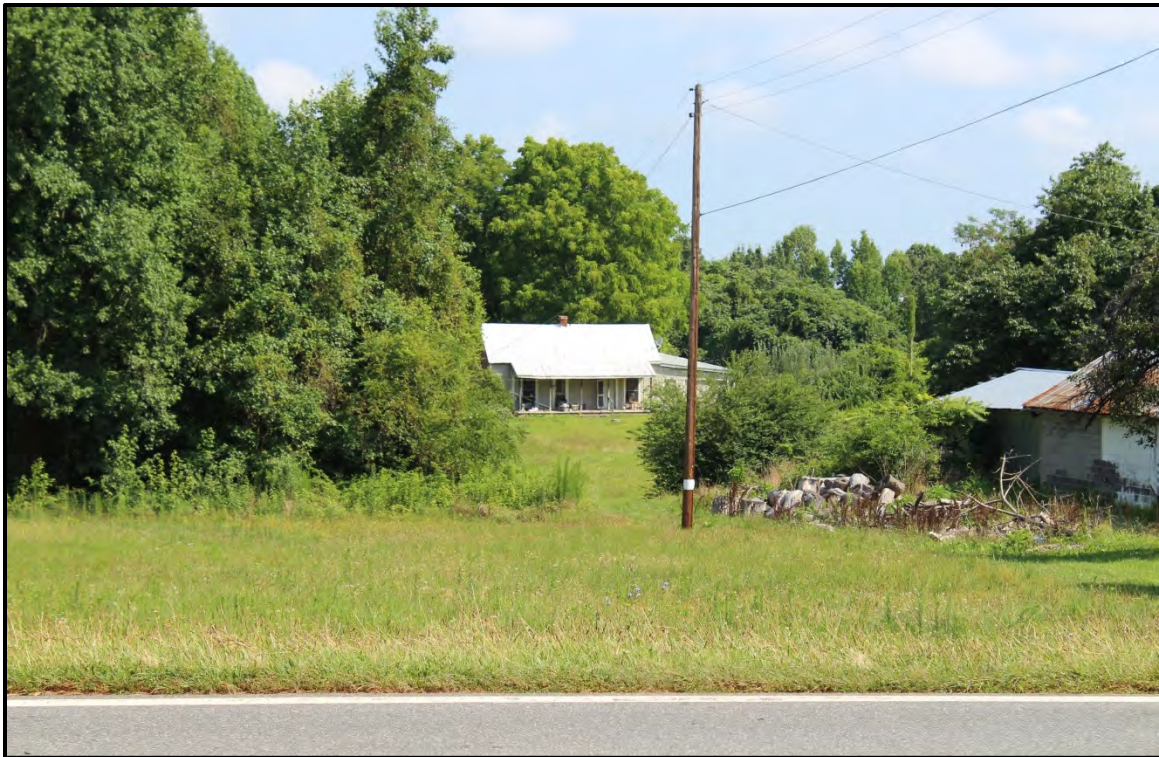
The one-story, wood-frame building has a side-gabled roof clad with standing seam metal, an exterior clad with vinyl siding, and a concrete foundation. Windows are original 4/1. The façade features a partial-width shed roof porch. Within the porch bay are two entries; one holds an original three-light paneled door (south) and the other (north) a replacement paneled door. At the northeast elevation is a one-story hipped-roof wing.

Figure 5.124. Architectural resource RK1693 (in background); view is northwest featuring the façade and hipped wing.

NRHP Assessment. Architectural resource RK1693 does not exhibit distinctive characteristics of architectural style or workmanship. In addition, the house has been altered through the application of vinyl siding, the replacement of the original porch columns, and the construction of the hipped-roof wing. Based on the lack of architectural merit, as well as the inability to associate the house and/or its original owner(s) with an important historical event or series of events, it is TRC's opinion that architectural resource RK1693 is not eligible for the NRHP.

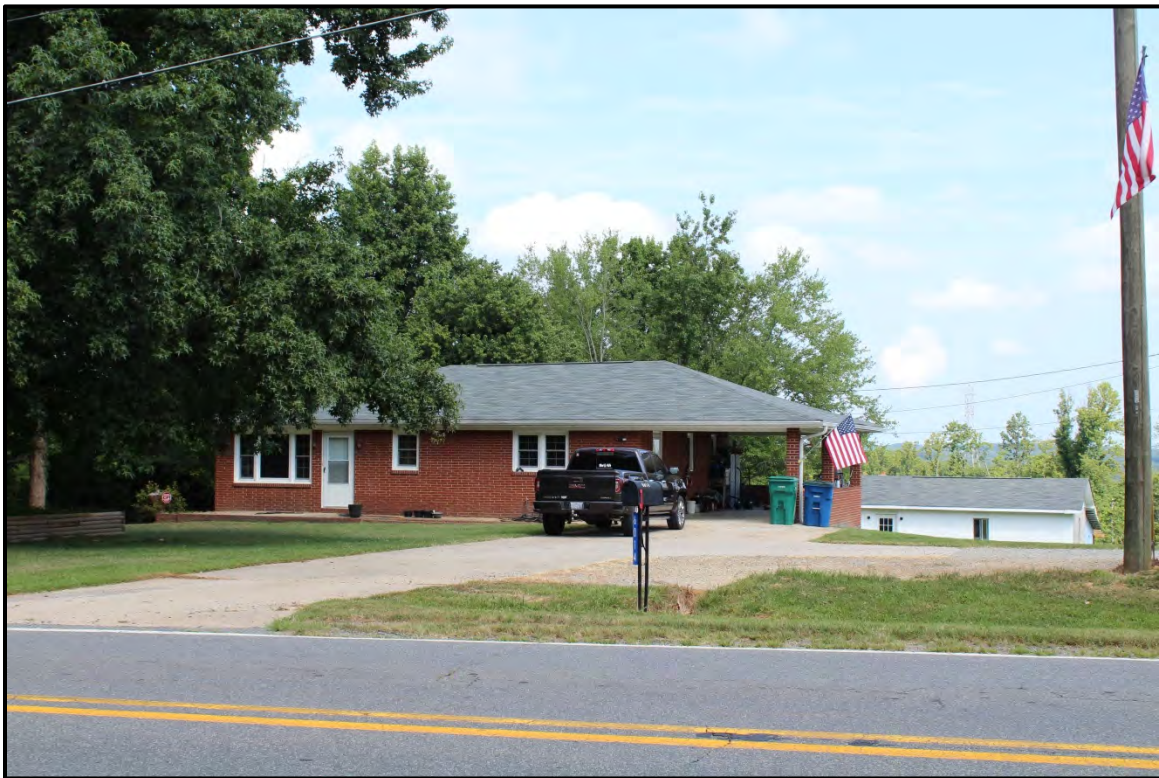
NRHP Assessment. Architectural resource RK1694 does not exhibit distinctive characteristics of architectural style or workmanship. In addition, the house has been altered through the replacement of the original window sashes. Based on the lack of architectural merit, as well as the inability to associate the house and/or its original owner(s) with an important historical event or series of events, it is TRC’s opinion that architectural resource RK1694 is not eligible for the NRHP.

Figure 5.125. Architectural resource RK1694; view is northwest featuring the façade, north elevation and garage/outbuilding in the background.

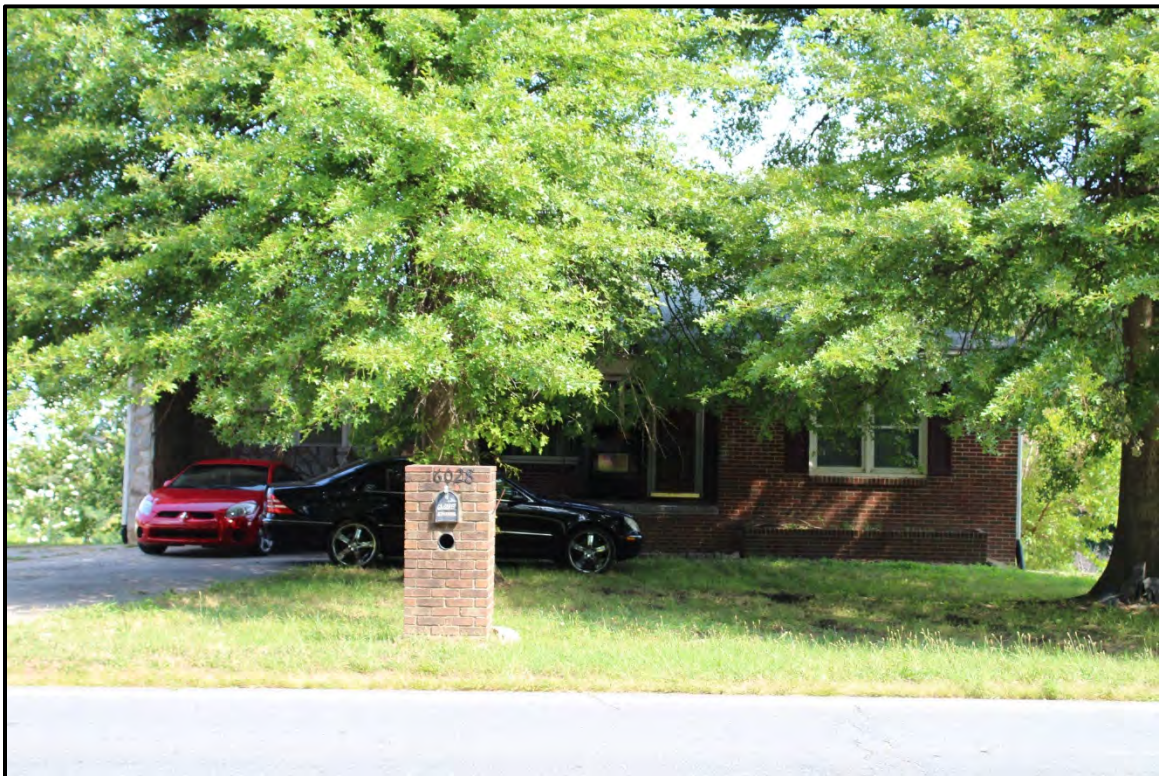
NRHP Assessment. Architectural resource RK1695 does not exhibit distinctive characteristics of architectural style or workmanship. In addition, the house has been altered through the replacement of the original window sashes and the enclosure of the carport. Based on the lack of architectural merit, as well as the inability to associate the house and/or its original owner(s) with an important historical event or series of events, it is TRC’s opinion that architectural resource RK1695 is not eligible for the NRHP.

Figure 5.126. Architectural resource RK1695; view is northwest featuring the façade.

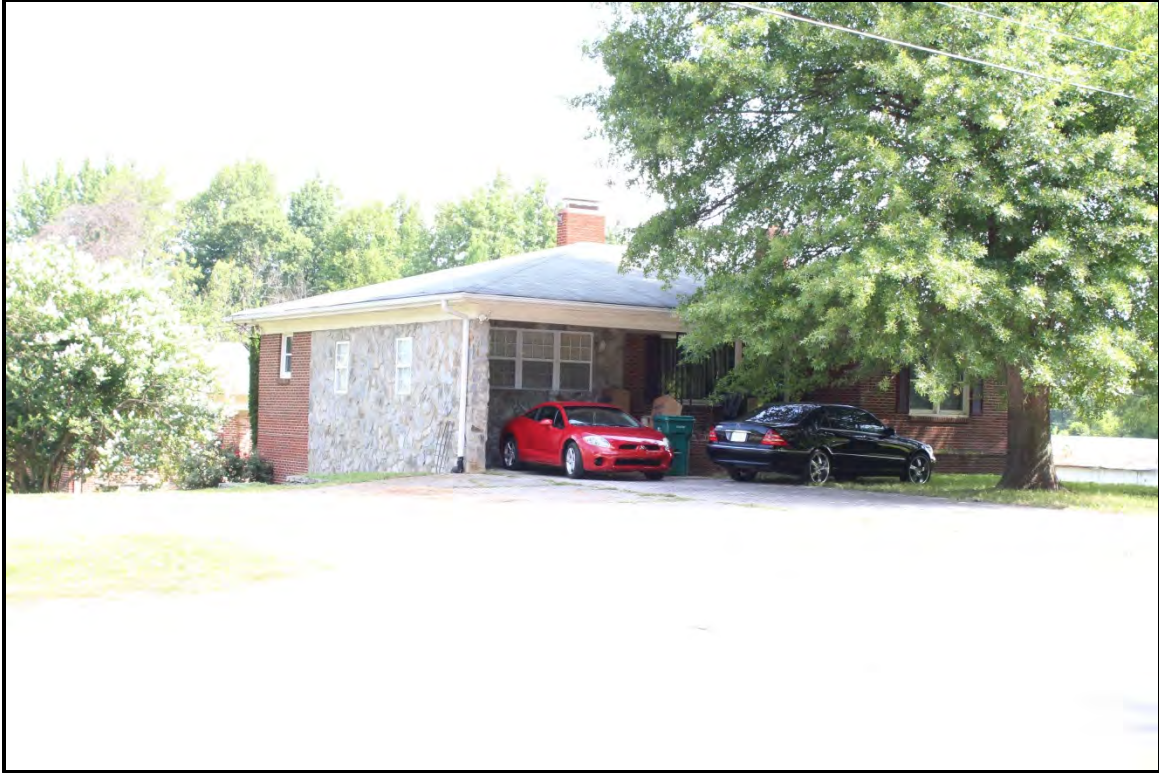
The wood-frame building has a hipped roof, an exterior clad with a brick veneer, and a brick covered foundation. Windows are replacement 6/1, 6/6 and 1/1 design. The façade features a recessed porch with a picture style (single fixed light) window. The south end of the house features an original carport. Southeast and southwest walls encompassing the carport are clad with stone veneer.

Figure 5.127. Architectural resource RK1695; view is northeast featuring the façade and southwest elevation.

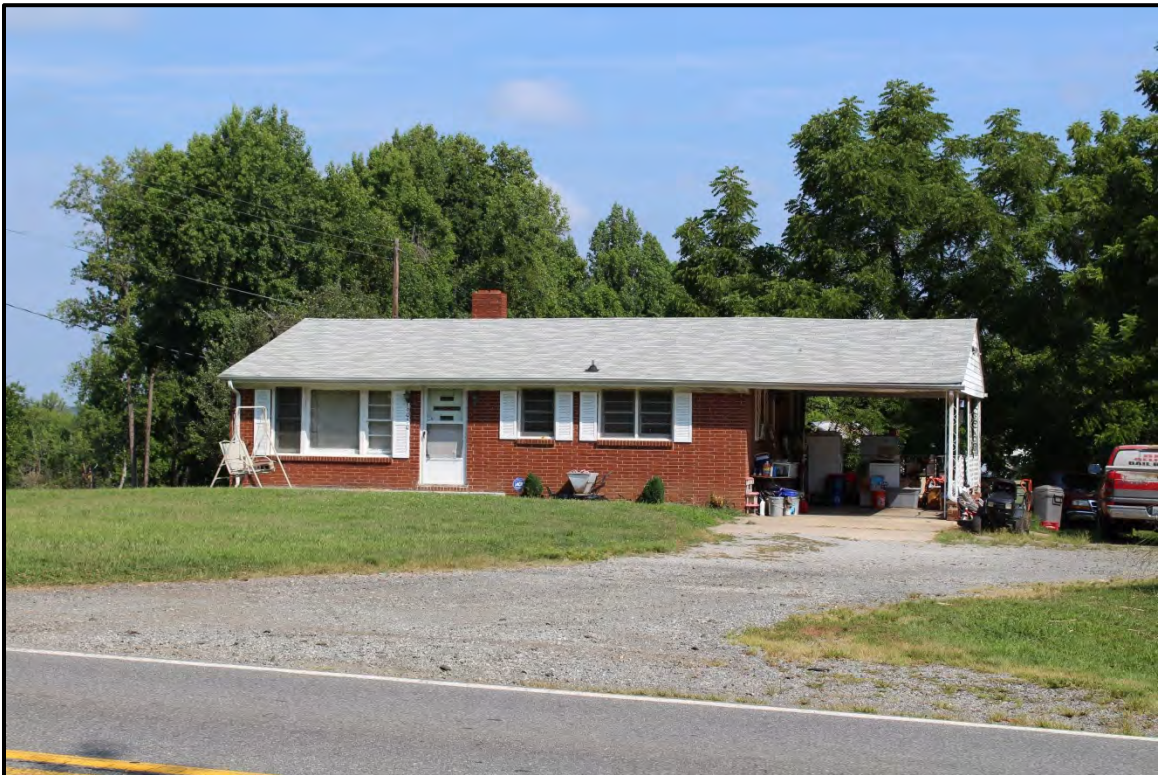
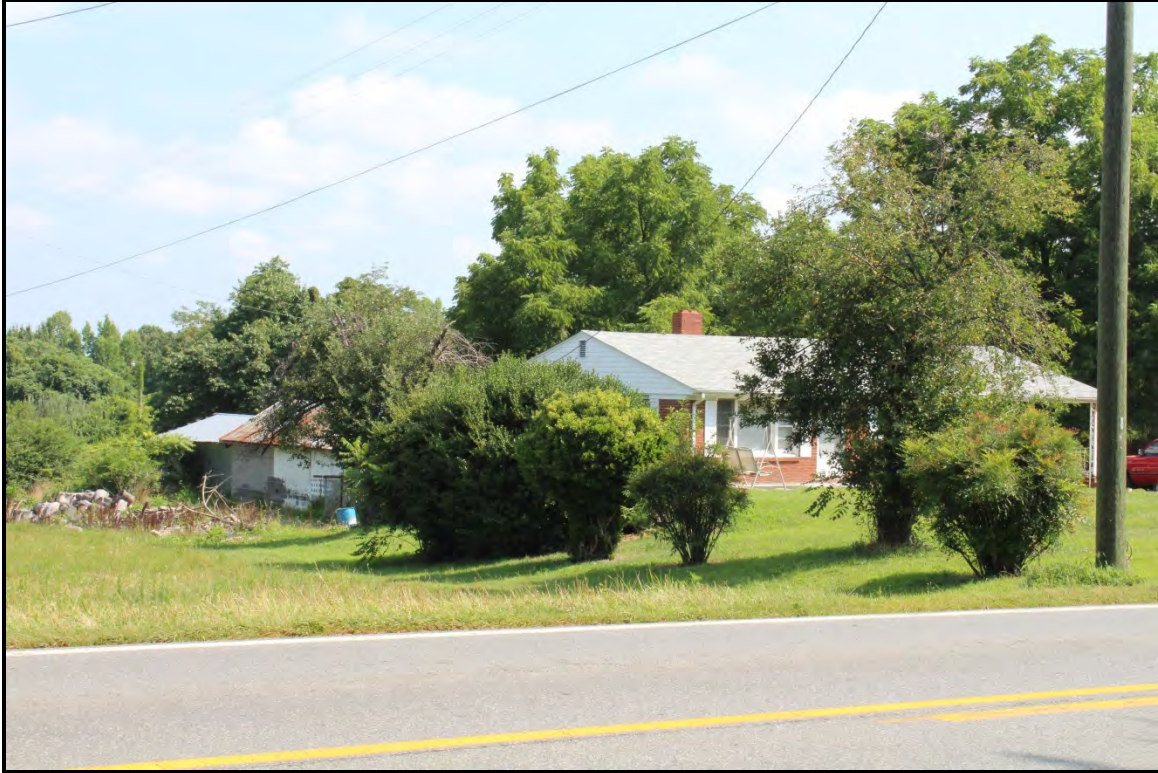
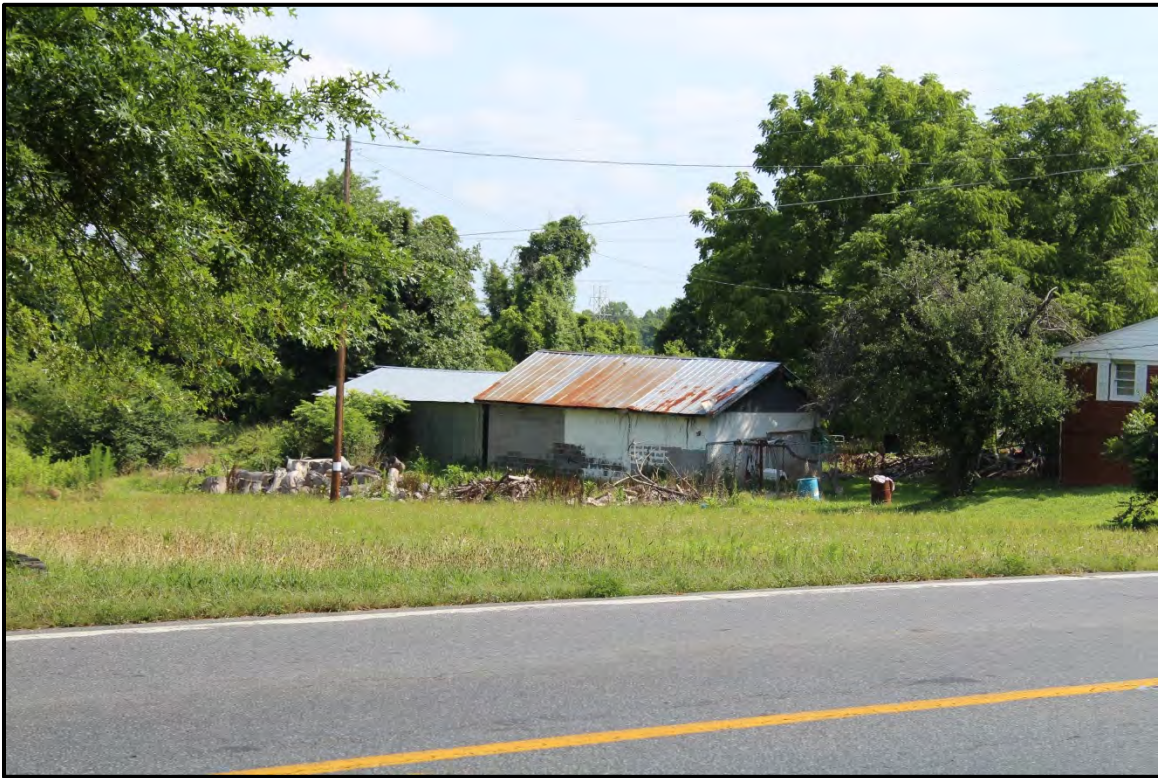
The wood-frame building has a side-gabled roof, an exterior clad with a brick veneer, and a brick covered foundation. Windows are original horizontal sash design. The façade features a picture style window offset by an original horizontal light door. The northeast end of the house features an original carport with original wrought iron supports. Southwest of the house are a vertical board and concrete block outbuildings (Figures 5.128 and 5.129).

Figure 5.128. Architectural resource RK1696; view is northwest featuring the façade and carport.

Figure 5.129. Architectural resource RK1696; view is north featuring the property (house and outbuildings).

Figure 5.130. Architectural resource RK1696; view is north featuring two outbuildings.

NRHP Assessment. Architectural resource RK1696 does not exhibit distinctive characteristics of architectural style or workmanship. In addition, vinyl siding has been applied to the gable ends. Based on the lack of architectural merit, as well as the inability to associate the house and/or its original owner(s) with an important historical event or series of events, it is TRC’s opinion that architectural resource RK1696 is not eligible for the NRHP.
