Re: Revised Architectural Survey Report, MVP Southgate Project, Construct Interstate Pipeline, Rockingham and Alamance County, ER 18-1041

Thank you for your letter of October 11, 2019, transmitting the draft "Historic Architectural Survey for the MVP Southgate Pipeline Project". We have reviewed the report and offer the following comments.

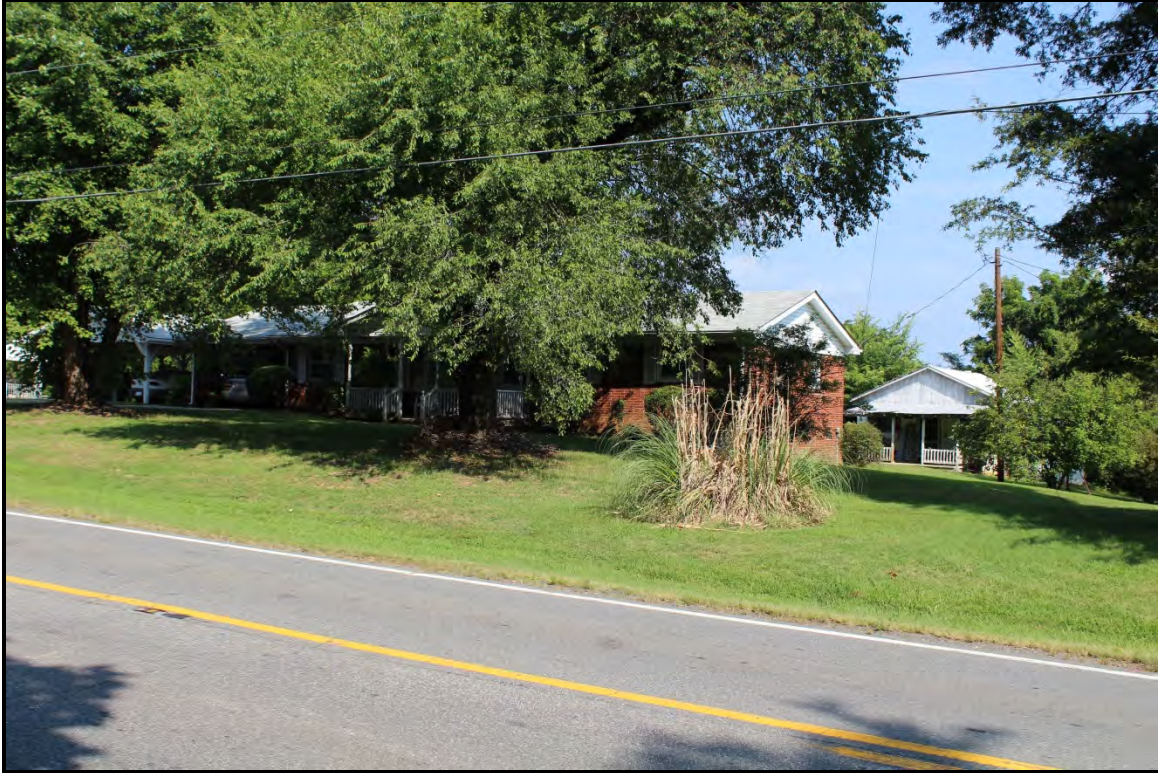
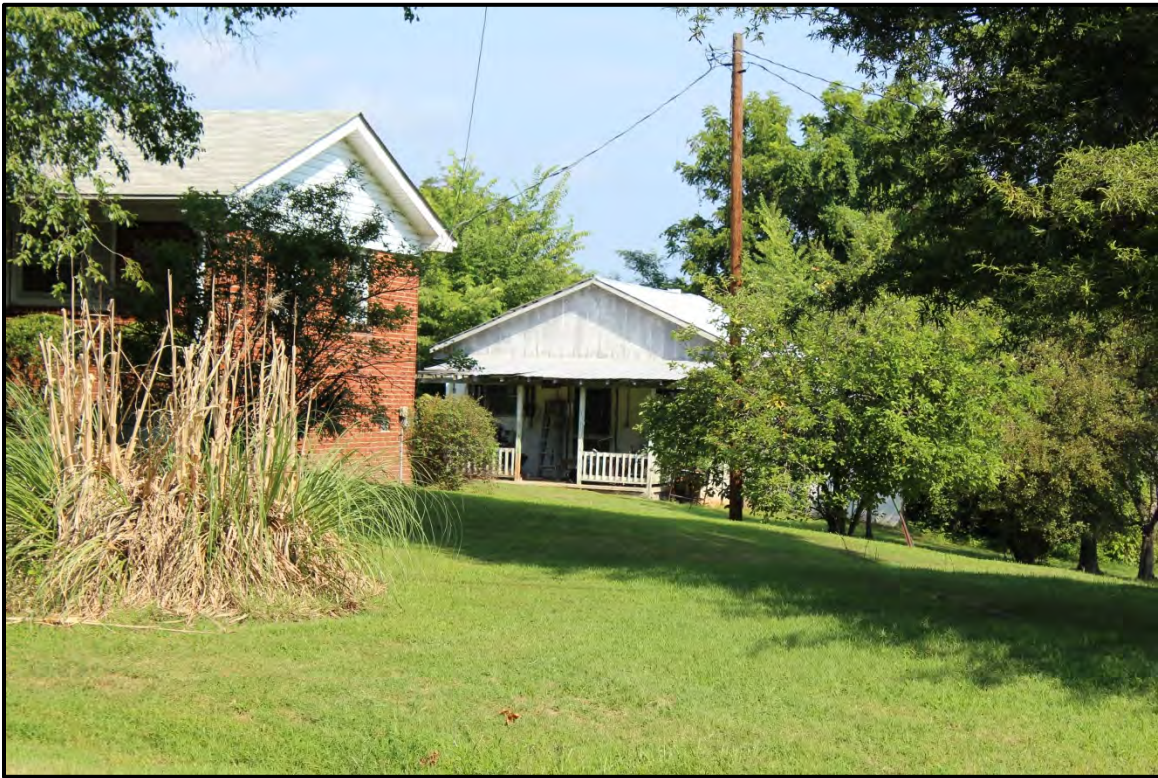
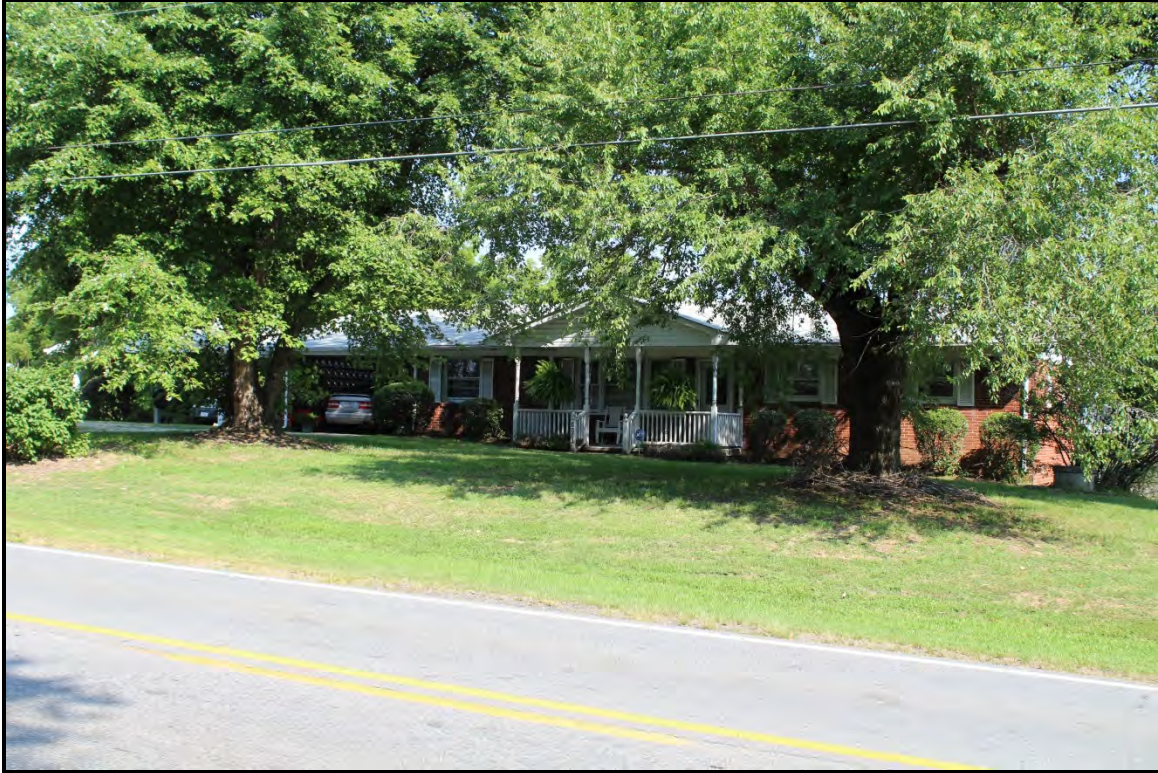
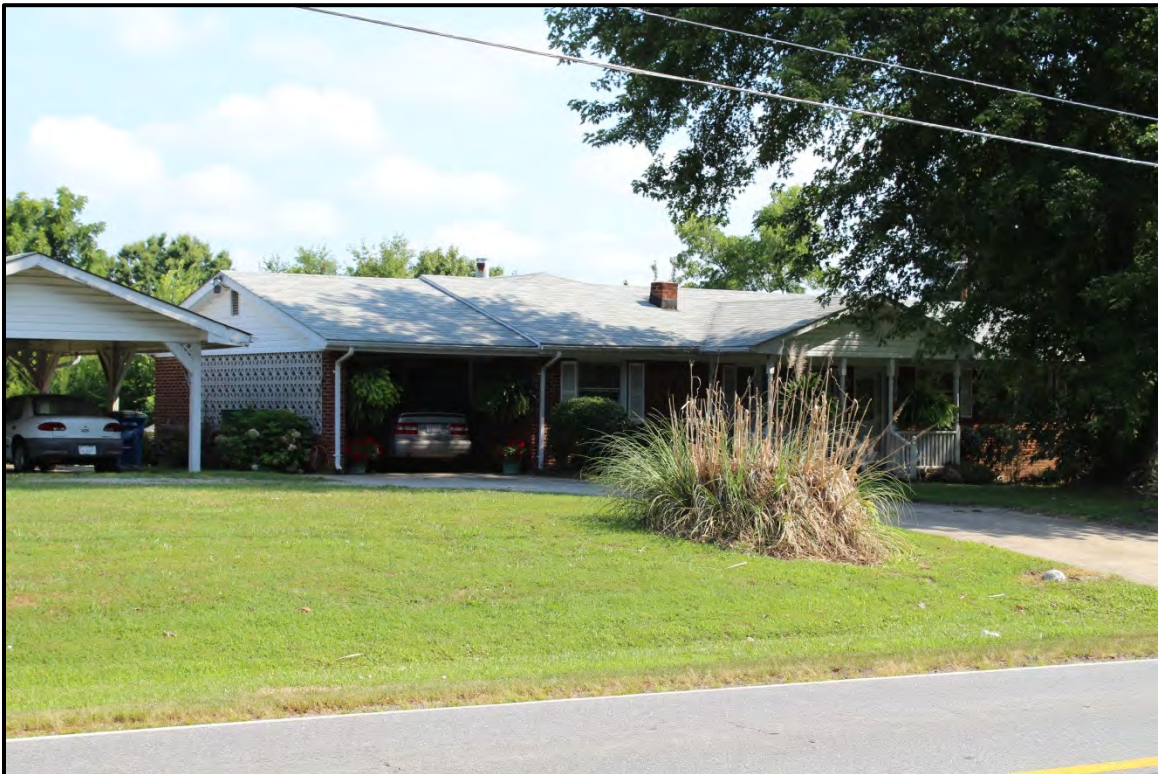
The wood-frame house has a side-gabled roof, an exterior clad with a brick veneer, and a brick covered foundation. Windows are original 2/2 horizontal sash design. The façade features a non-historic porch with a front-gabled roof that is supported by turned posts. Within the porch, the entry bay holds a replacement door and picture window. The building has an original carport at the southwest end which retains an original decorative concrete wall (Figures 5.131, 5.133, and 5.134). Southwest of the house is a contemporary carport (Figure 5.134). North of the house is a smaller board-and-batten front-gabled roof building that appears to be a secondary residence (Figures 5.131 and 5.132).

Figure 5.131. Architectural resource RK1697; view is southwest featuring the façade and secondary residence.

Figure 5.132. Architectural resource RK1697; view is north featuring the secondary residence.

Figure 5.133. Architectural resource RK1697; view is northwest featuring the façade.

Figure 5.134. Architectural resource RK1697; view is northeast featuring the attached and detached carports.

NRHP Assessment. Architectural resource RK1697 does not exhibit distinctive characteristics of architectural style or workmanship. In addition, the house has been altered through the construction of the façade porch. Based on the lack of architectural merit, as well as the inability to associate the house and/or its original owner(s) with an important historical event or series of events, it is TRC's opinion that architectural resource RK1697 is not eligible for the NRHP.

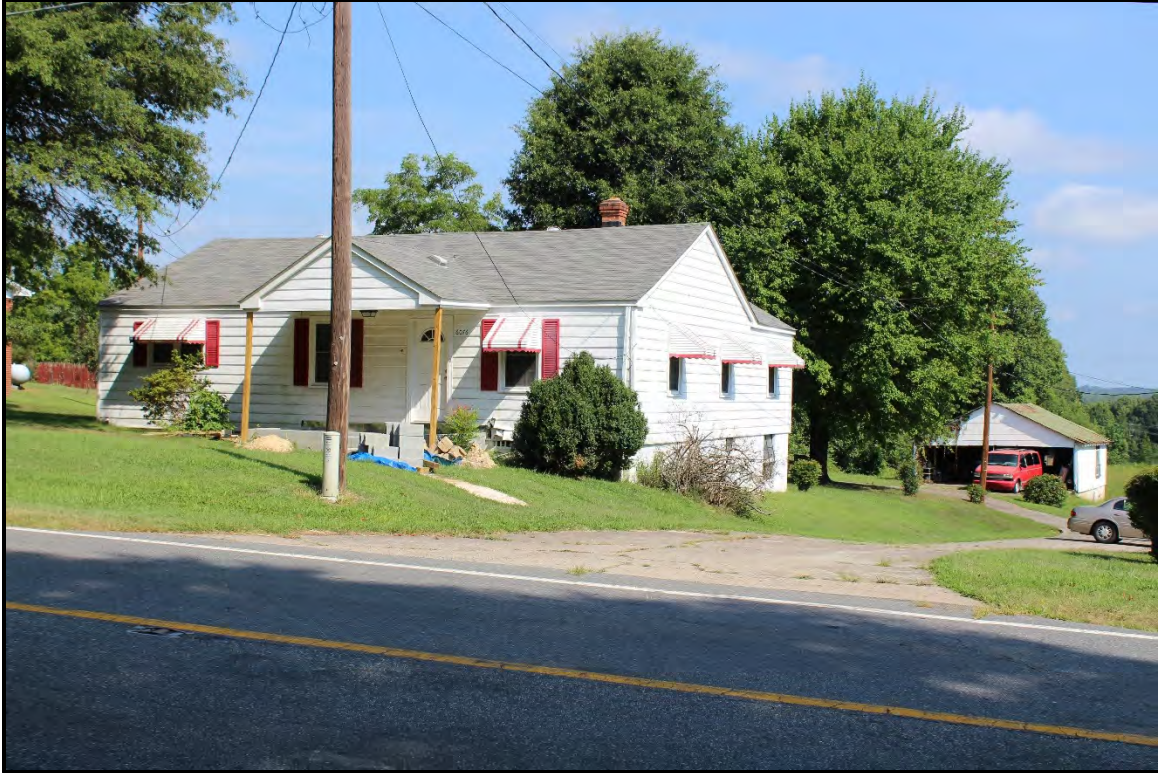
The one-story, wood-frame building has a side-gabled roof covered with asphalt shingles, an exterior clad with aluminum siding, a concrete block foundation, and an exposed rear bank basement level. The south façade has an offset front entrance with a replacement paneled door with a fanlight that is covered by a central, front-gabled porch. At the time of the survey the porch posts and deck were being replaced with modern materials. The entrance is flanked on either side by single, 6/6 wood sash windows with faux shutters. The fenestration throughout the remainder of the house's main level features 6/6 wood sash windows, which are covered by aluminum awnings on the south façade and east and west elevations. There are multi-light awning windows on the east elevation of the basement level. The house has a single interior brick chimney. No additional details of the north (rear) elevation could be observed due to limited access. In the rear (north) yard is a one-story garage with two bays that was built in 1974 according to county tax records (Rockingham County, NC WebGIS 2018). The garage has a front-gable roof with exposed rafter tails, and the roof is clad in metal. The garage has aluminum siding and concrete block foundation.

Figure 5.135. Architectural resource RK1698; oblique view northwest showing south façade, east elevation, and garage.

NRHP Assessment. Architectural resource RK1698 not exhibit distinctive characteristics of architectural style or workmanship. In addition, the house has been altered through the application of aluminum siding and the replacement of the original porch columns. Based on the lack of architectural significance, as well as the inability to associate the house and/or its original owner(s) with an important historic event or series of events, it is TRC's opinion that architectural resource RK1698 is not eligible for the NRHP.

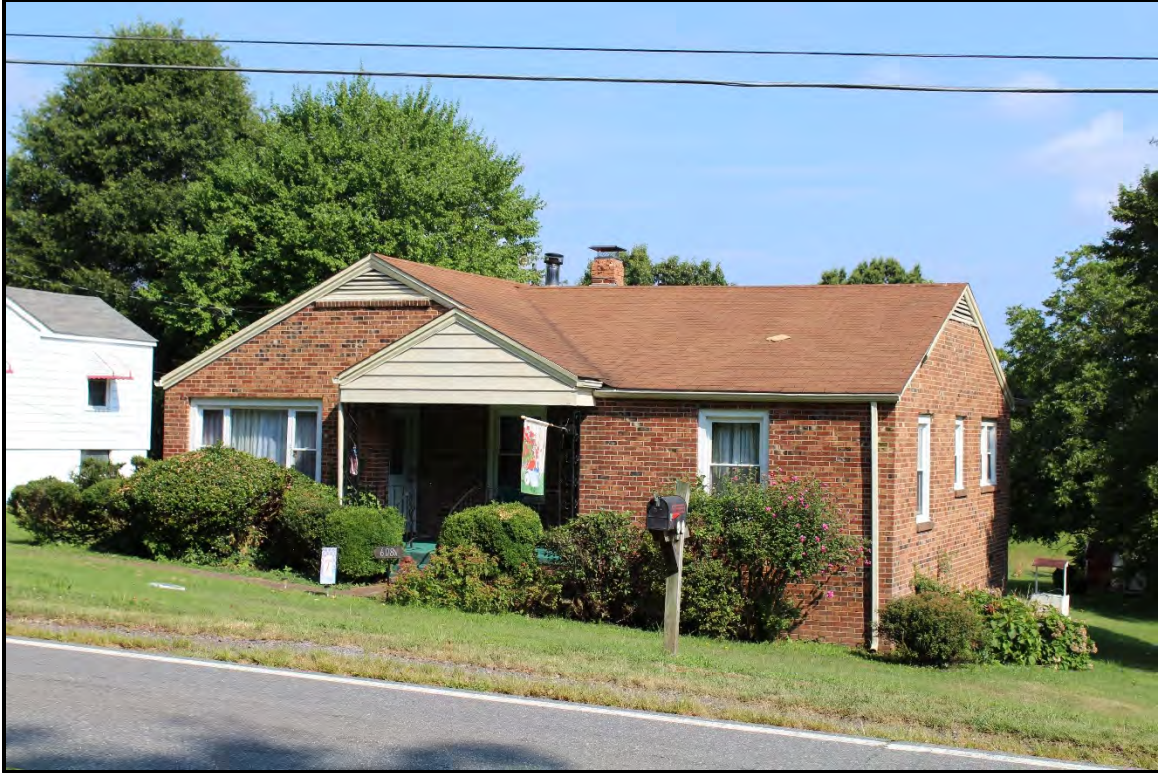
The one-story, wood-frame building faces south toward the road and has a front-gabled roof clad in asphalt shingles with a lower side gabled wing, a brick veneer exterior, and a foundation clad in brick veneer. The recessed front porch has a front-gable roof supported by decorative iron posts that covers the main entrance and a 1/1 vinyl sash window. The front-gable portion of the house features a louvered vent at the gable peak and a three-part picture window with vinyl sashes. Windows throughout the house consists of 1/1 vinyl sashes. There is an interior central brick chimney. On the north (rear) elevation is an addition that is not visible from the public right-of-way that county tax records indicate was built in 1967. The property also includes a detached garage that tax records indicate was built in 1973 (Rockingham County, NC WebGIS 2018).

Figure 5.136. Architectural resource RK1699; oblique view north showing south façade and east elevation.

NRHP Assessment. Architectural resource RK1699 does not exhibit distinctive characteristics of architectural style or workmanship. In addition, the house has been altered through the replacement of the original window sashes and the application of aluminum siding to the gable fields. Based on the lack of architectural significance, as well as the inability to associate the house and/or its original owner(s) with an important historic event or series of events, it is TRC’s opinion that architectural resource RK1699 is not eligible for the NRHP.

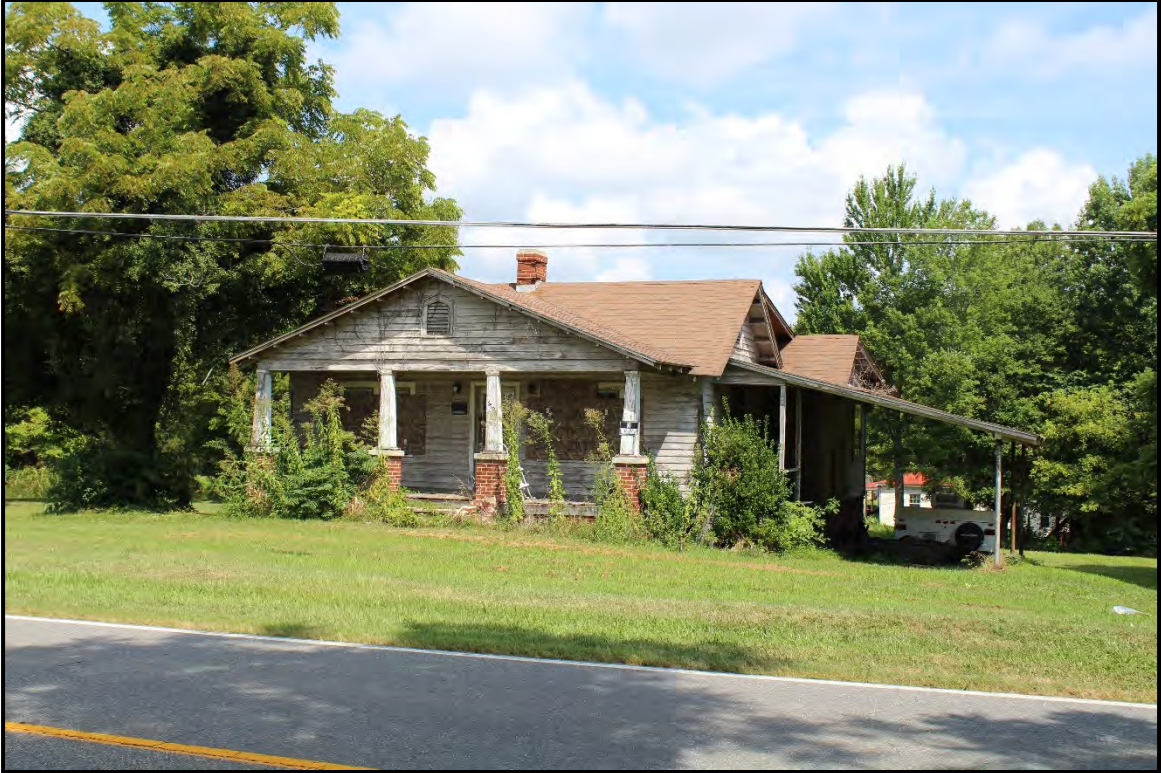
The first building is an abandoned one-story Craftsman/bungalow-style house that was built in 1930 according to county tax records (Rockingham County, NC WebGIS 2018) (Figure 5.137). Located approximately 45 feet northwest of the highway, this house has a side-gabled roof clad in asphalt shingles and exposed rafter tails, drop lap wood siding, and a brick foundation. Across the façade is a full-length front porch with a front-gabled roof supported by four wood battered columns set on brick and concrete piers. There is a pointed arch louvered vent in the gable end of the porch. The porch shelters a three-bay façade composed of a central entrance with a nine-light paneled door flanked by two pairs of 6/6 windows that are boarded over. On the east elevation is a shed-roof carport supported by metal posts. The house has a single interior central brick chimney.

Figure 5.137. Architectural resource RK1700; view is north featuring the façade.

NRHP Assessment. Architectural resource RK1700 is an inactive farmstead anchored by a Craftsman/bungalow-influenced house that does not exhibit distinctive characteristics of architectural style or workmanship. The main residence on the property is a common 1930s-era bungalow that does not possess individual architectural significance. In addition, the farm no longer conveys its early-to-mid-twentieth century appearance, due to the lack original outbuildings, thereby rendering the property ineligible for its agricultural associations. Based on the lack of architectural significance, as well as the inability to associate the farm and/or its original owner(s) with an important historic event or series of events, it is TRC's opinion that architectural resource RK1700 is not eligible for the NRHP.

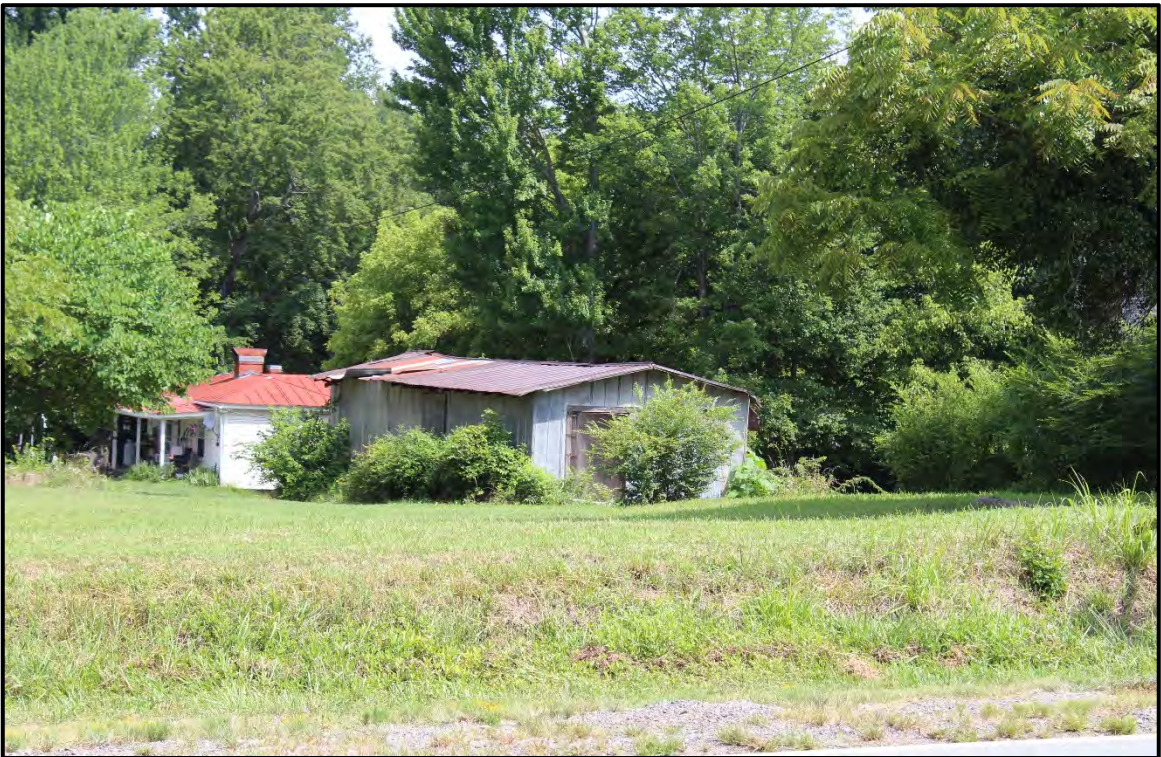
The second house on this parcel is located approximately 180 feet northwest of the first (Figure 5.138). It is a circa-1930 one-story house that faces west toward a paved driveway and has a low-pitched hipped roof clad in standing-seam metal. It has a three-bay façade with a central entrance flanked by 6/6 windows of a sash type that could not be determined. The house has a T-shaped plan and is clad in vinyl siding, and it has a brick foundation. The central entrance is covered by a partial-width front porch with a hipped roof clad in standing-seam metal that is supported by square wood posts.

Figure 5.138. Architectural resource RK1700; view is northwest showing house in background and metal shed in foreground.

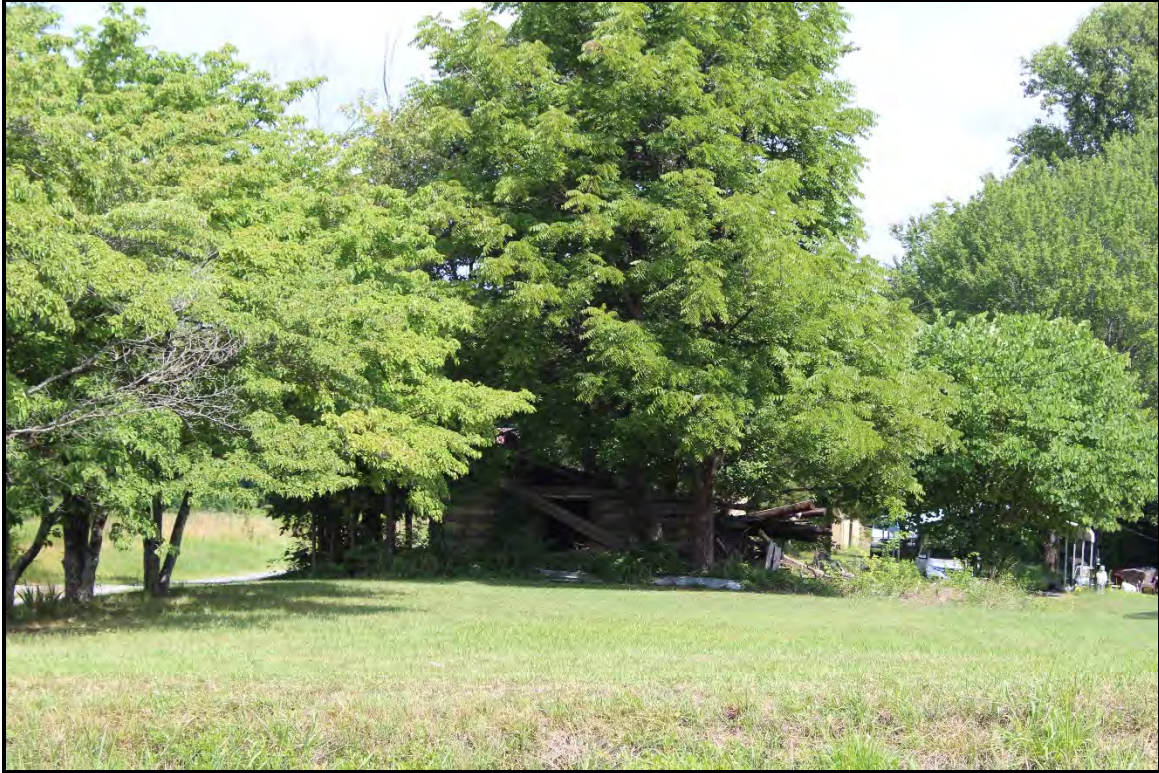
There are three outbuildings at this property, including a collapsed log tobacco barn that is overgrown with vegetation to the southwest of the house (Figure 5.139); a wood-frame shed with a front-gabled metal roof and metal siding to the south of the house (Figure 5.138); and a modern open-sided metal carport to the immediate west of the house that is obscured by trees.

Figure 5.139. Collapsed and overgrown log tobacco barn at resource RK1700; view is north.

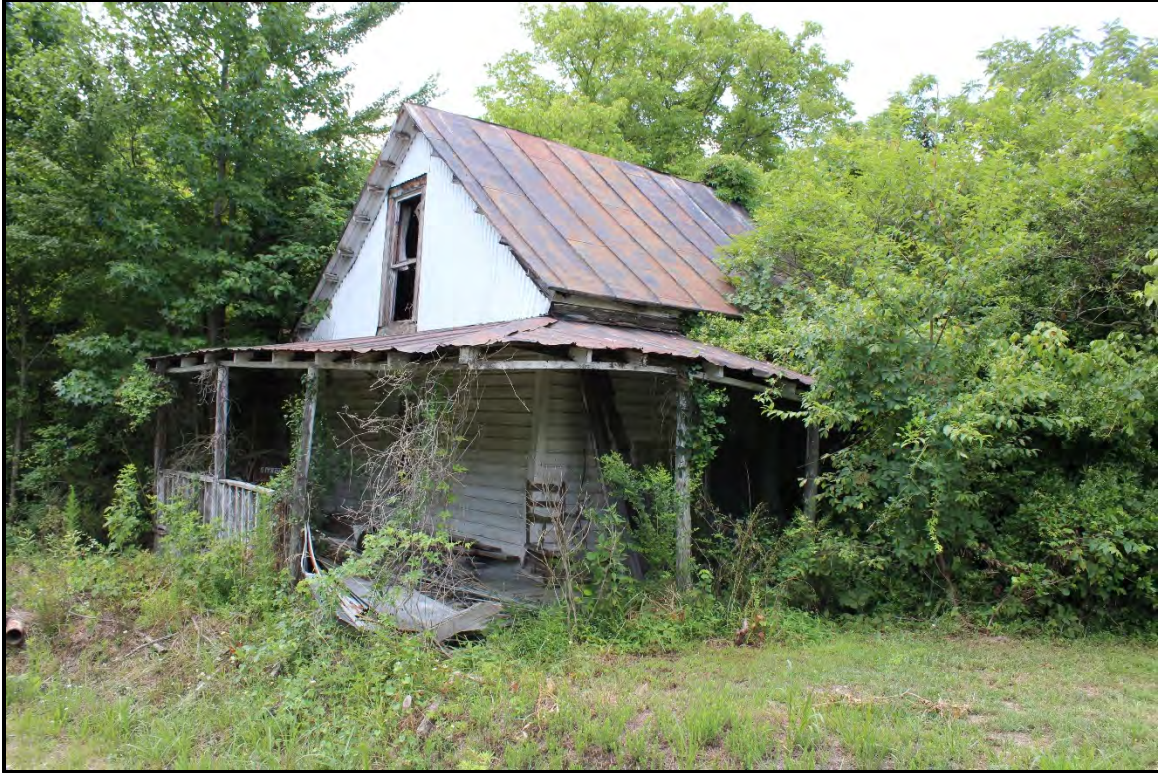
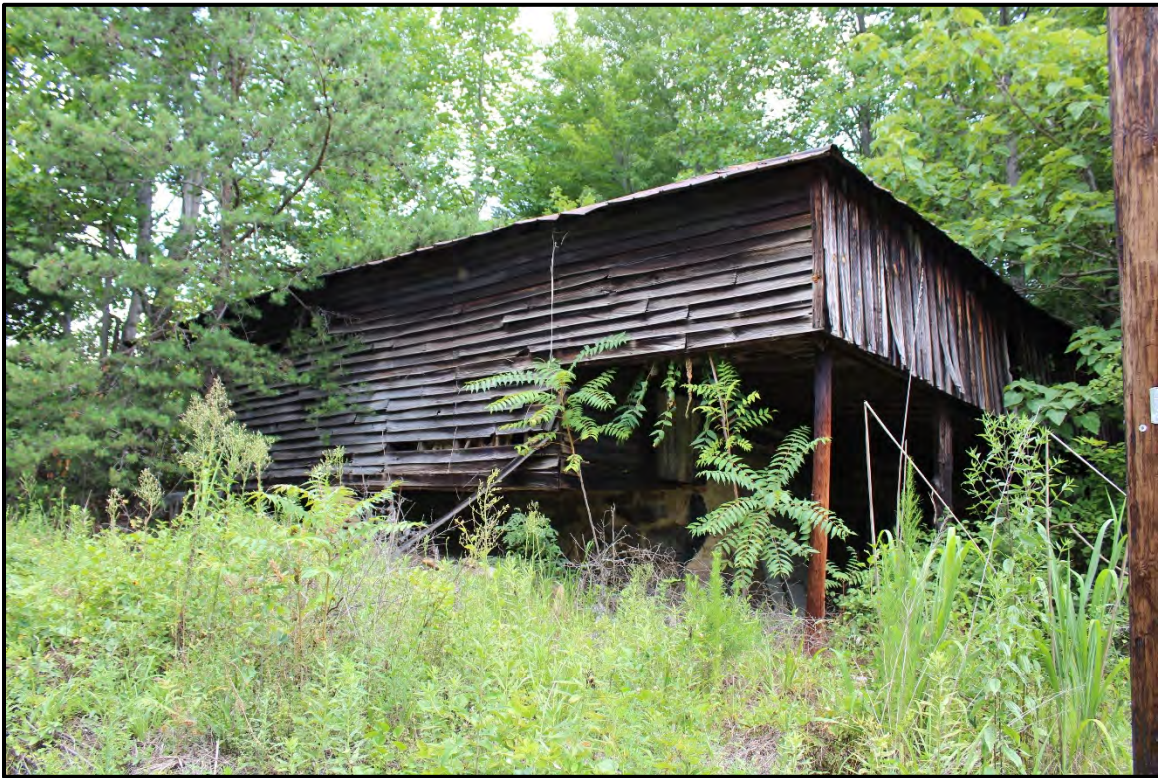
The one-story, wood-frame, building faces north toward the highway and has a roof covered with standing-seam metal and an exterior clad with wood-drop siding. The foundation and full extent of the house were not visible due to overgrown vegetation and debris. The north façade has an offset front entrance with a wood paneled door and two 6/6 wood sash windows. There are exposed rafter tails and corrugated metal sheeting in the exposed eastern gable end of the house, which also has a wraparound front porch with a metal shed roof supported by square wood posts. The house has rear ell portion with a standing-seam metal roof. Across the access drive to the east is a wood frame tobacco barn that was built in 1940 according to county tax records (Rockingham County, NC WebGIS 2018). It has a hipped roof covered with standing seam metal, an exterior clad with both vertical and horizontal plank siding, and a stone foundation.

Figure 5.140. Architectural resource RK1701; oblique view south showing the exposed eastern gable end and porch.

Figure 5.141. Architectural resource RK1701; view is southeast featuring the tobacco barn.

NRHP Assessment. Architectural resource RK1701 does not exhibit distinctive characteristics of architectural style or workmanship. In addition, the integrity of the resource is poor due to neglect, which has resulted in the loss original window sashes and the partial collapse of the building. Based on the lack of architectural significance and the inability to associate the house and/or its original owner(s) with one or more important historic events, it is TRC's opinion that architectural resource RK1701 is not eligible for the NRHP.

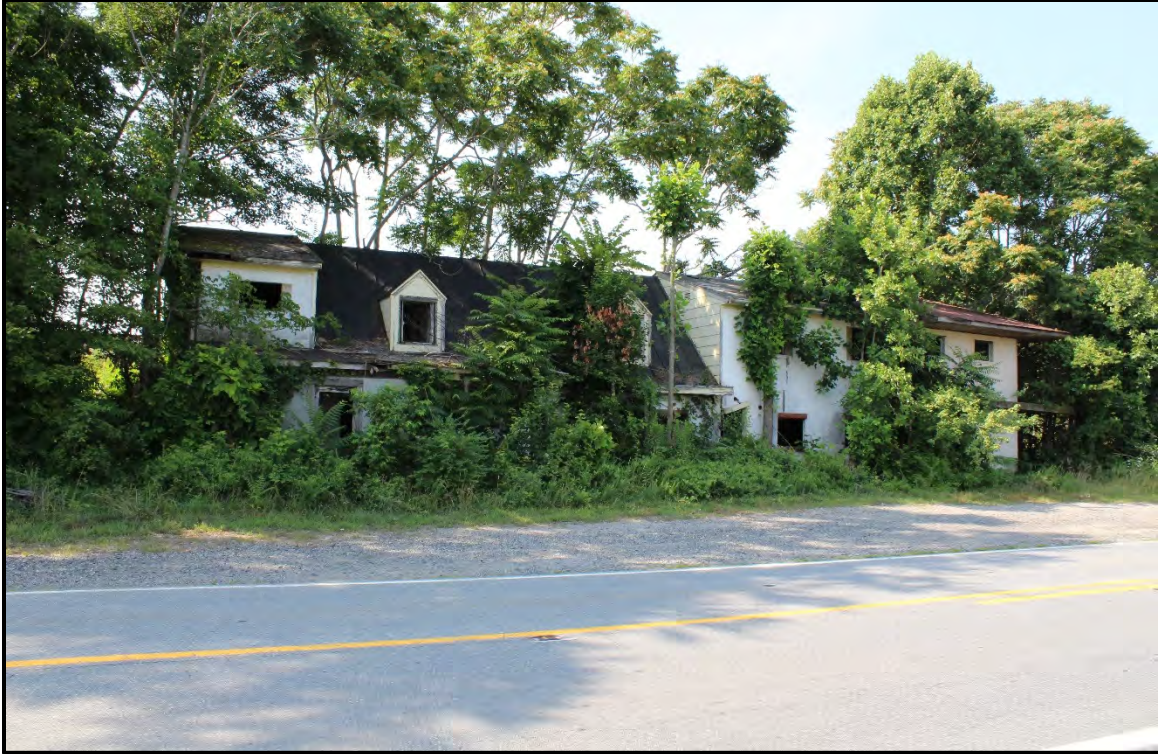
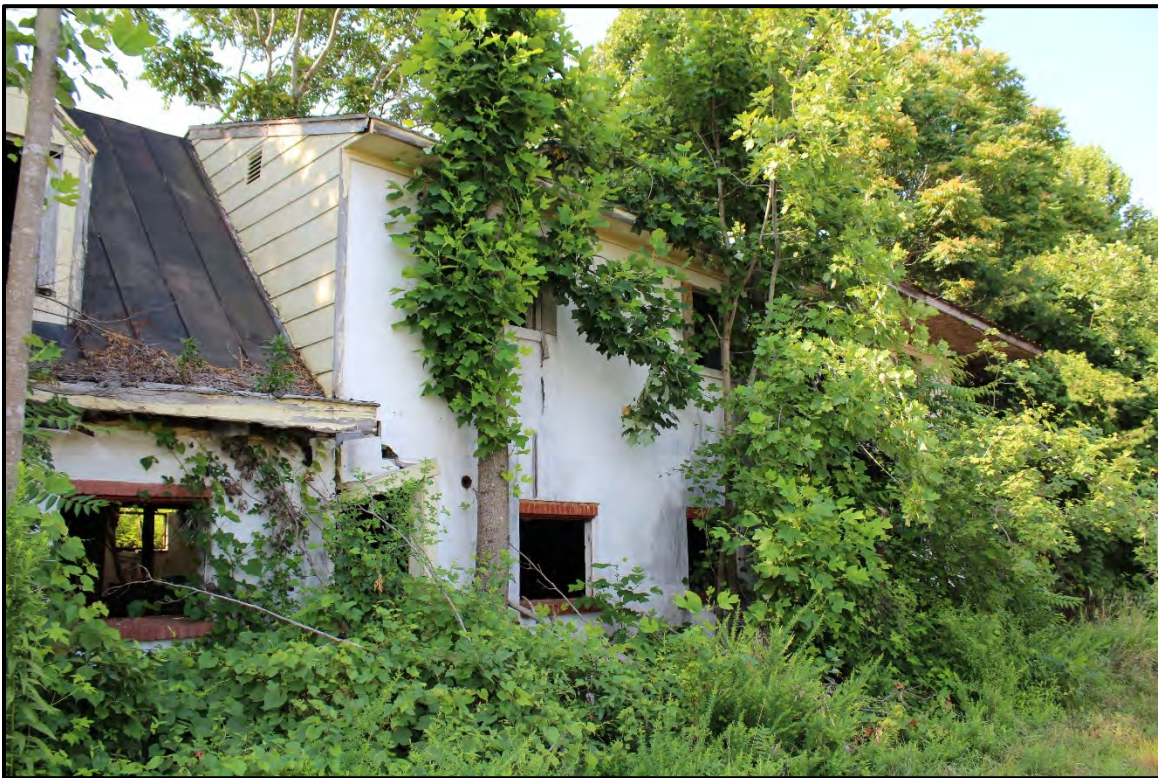
Details of the building's exterior materials and arrangement are obscured by overgrown vegetation, and the window sashes are missing throughout the building. Overall, the resource is a two-story building with three primary sections, all of which have side-gabled roofs. The earliest portion is the two-story central section with a three-bay façade, drop lap siding under asbestos shingles, and a side-gabled roof clad in standing-seam metal that has two front-gable dormers. On the east end of this central section is a two-story, single-bay addition with a shed-roof dormer. On the west end of the building is a two-story portion with concrete block masonry construction, four bays, and window openings featuring brick lintels and sills.

Figure 5.142. Architectural resource RK1702; view is southwest featuring the façade.

Figure 5.143. Architectural resource RK1702; detail view featuring the two-story masonry addition.

NRHP Assessment. Architectural resource RK1702 does not exhibit distinctive characteristics of architectural style or workmanship. Additionally, the building's architectural integrity has been compromised by neglect and deterioration that have resulted in the loss of original materials, such as all its windows. Based on the lack of architectural merit, as well as the inability to associate the house and/or its original owner(s) with an important historical event or series of events, it is TRC's opinion that architectural resource RK1702 not eligible for the NRHP.

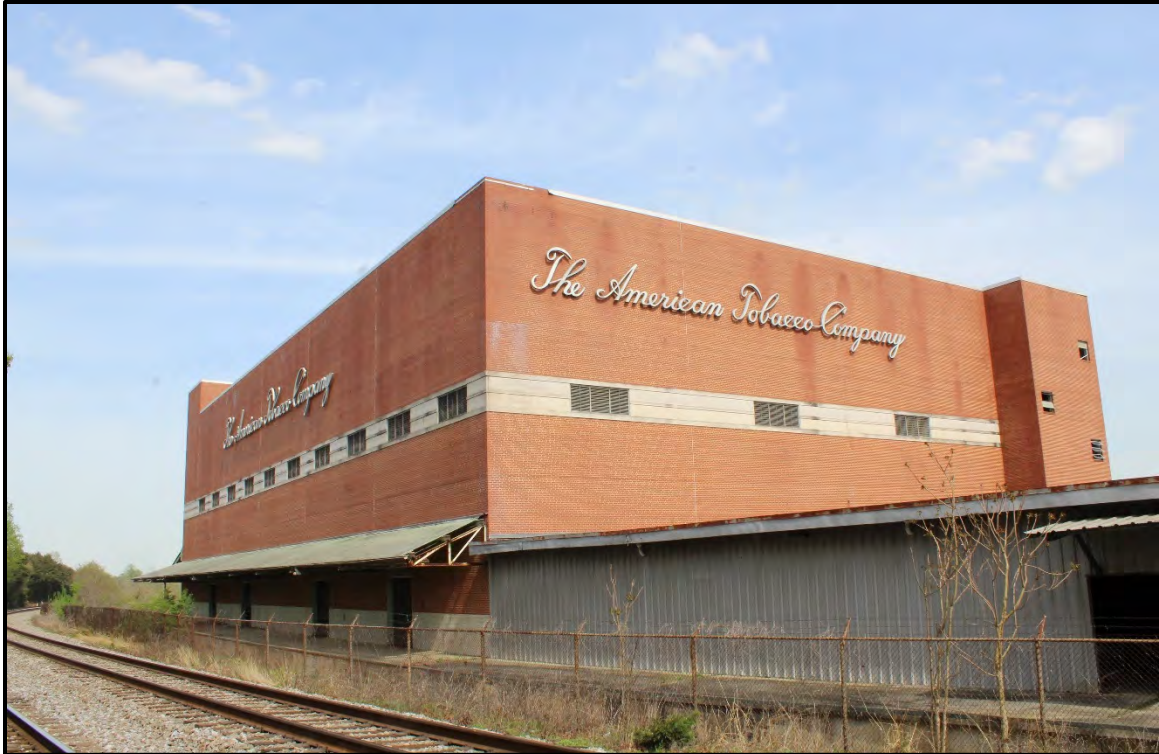
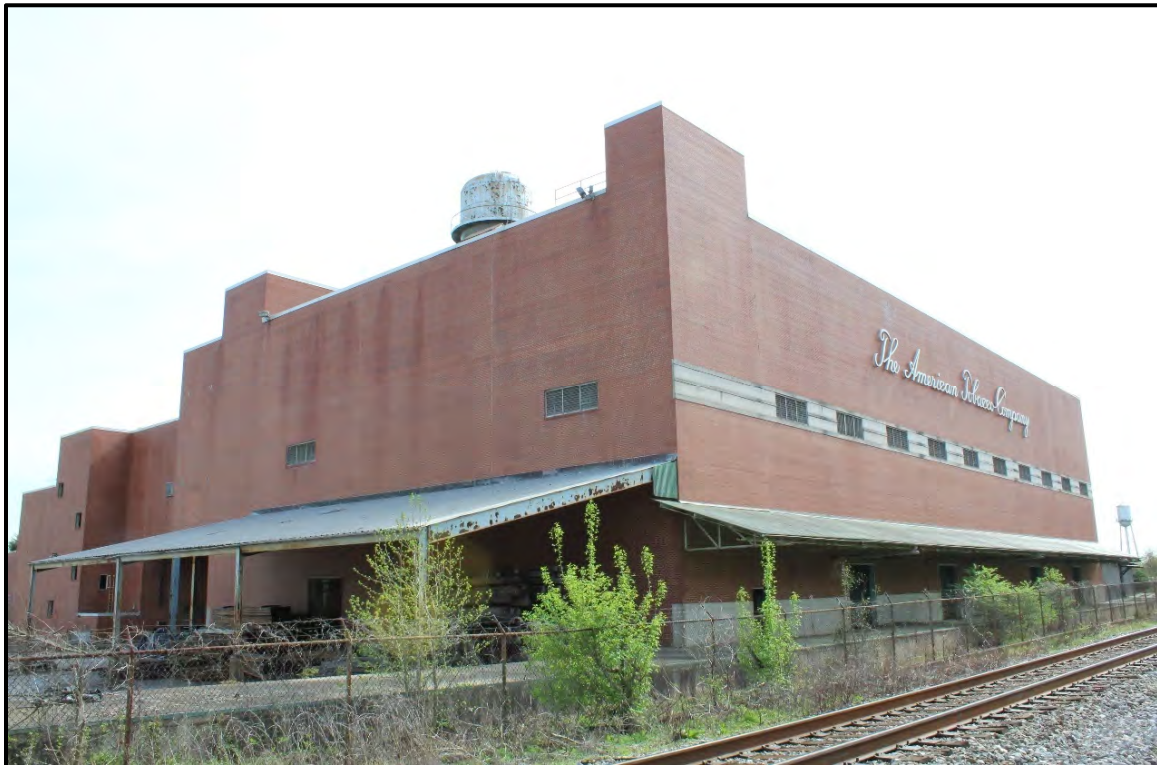
Located on the south side of the railroad line along its north side, the main plant building is four stories tall with an L-shaped plan, a flat roof, and a common bond brick exterior. A horizontal stone belt course pierced with louvered windows runs around the middle of the building exterior and divides the top and bottom halves. A company sign attached to the north and west elevations of the building states the company’s name “The American Tobacco Company” in cursive text. There are loading docks on the north elevation of the building and a one-story metal warehouse attached to the west elevation. There is a water tower on the roof. The surrounding extant warehouses are in various states of disrepair and collapse. They feature both steel-frame and masonry construction with low-pitched gable roofs, metal exteriors, rectangular plans, concrete slab foundations, and large bay doors. There is a second water tower at the northwest corner of the parcel (Figure 5.152).

Figure 5.144. Architectural resource RK1704; view is east featuring the north and west elevations of the main manufacturing plant building.

Figure 5.145. Architectural resource RK1704; view is west featuring the east and north elevations of the main manufacturing plant building.

NRHP Assessment. Architectural resource RK1704 is a 90-acre parcel that features the remnants of The American Tobacco Company’s Reidsville manufacturing facility. At the time of the plant’s closure in the late 1990s, the complex featured a multi-story administrative building, two water tanks, and at least 62 tobacco warehouses. Additional auxiliary buildings and structures were likely part of the complex, however, due to limited access and information on the plant, these support elements could not be verified. Since the time of the plant’s closure, the complex has remained vacant, which made it susceptible to deterioration and vandalism. Presently, the grounds are largely obscured with heavy vegetation and are marked by several concrete slabs that indicate the former locations of demolished tobacco warehouses. A review of historical aerial imagery indicates that of the approximately 62 warehouses that once stood on the plant grounds less than 25 percent, or 15 warehouses, are extant. In addition, a water tower once located at the southeastern end of the plant grounds has also been demolished. Overall, the historic integrity of the complex has been severely compromised due to the extensive loss of the warehouses and other support structures. As a result, the facility no longer conveys its mid-twentieth century appearance, thereby rendering the property ineligible for its association with tobacco manufacturing. For these reasons, it is the opinion of TRC that architectural resource RK1704 is not eligible for the NRHP.
