Re: Revised Architectural Survey Report, MVP Southgate Project, Construct Interstate Pipeline, Rockingham and Alamance County, ER 18-1041

Thank you for your letter of October 11, 2019, transmitting the draft "Historic Architectural Survey for the MVP Southgate Pipeline Project". We have reviewed the report and offer the following comments.

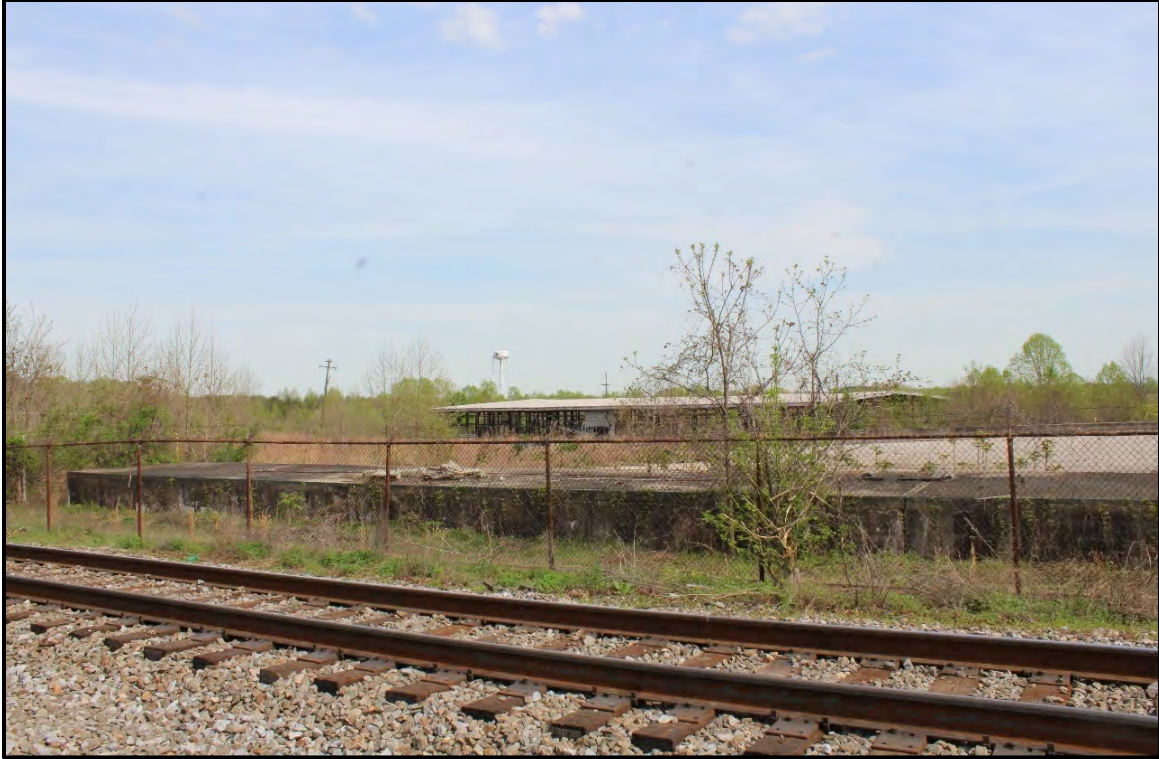
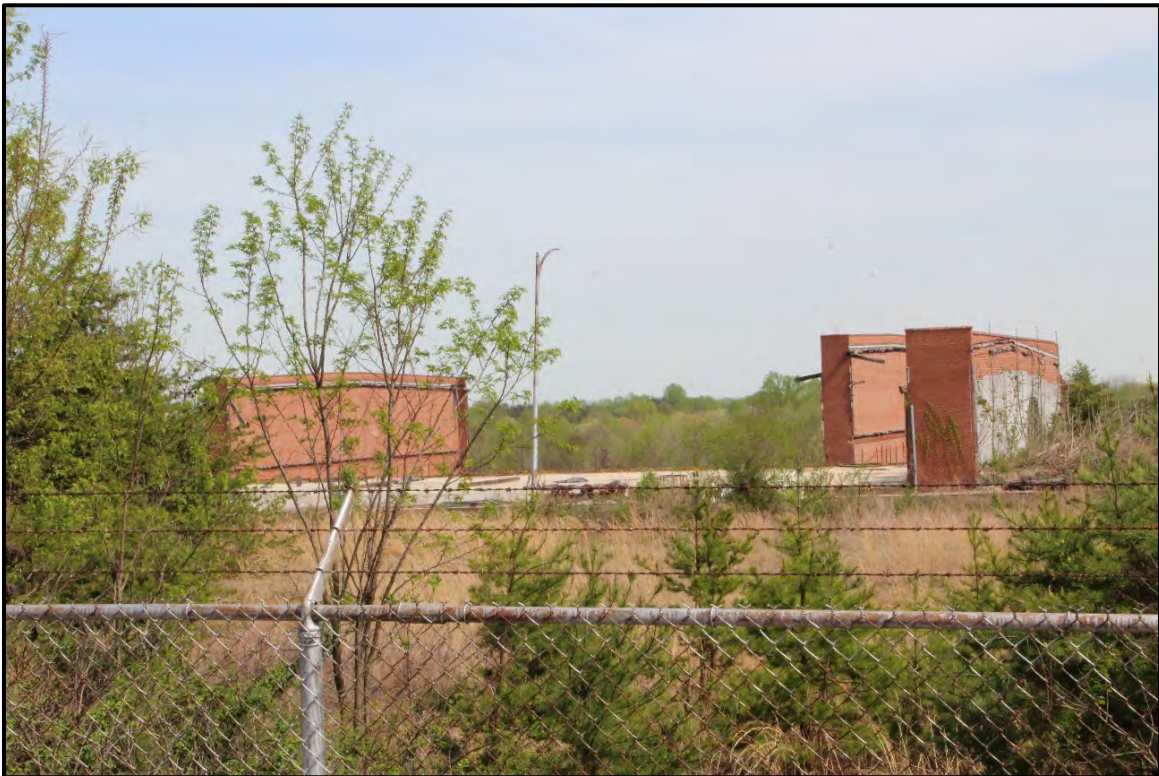
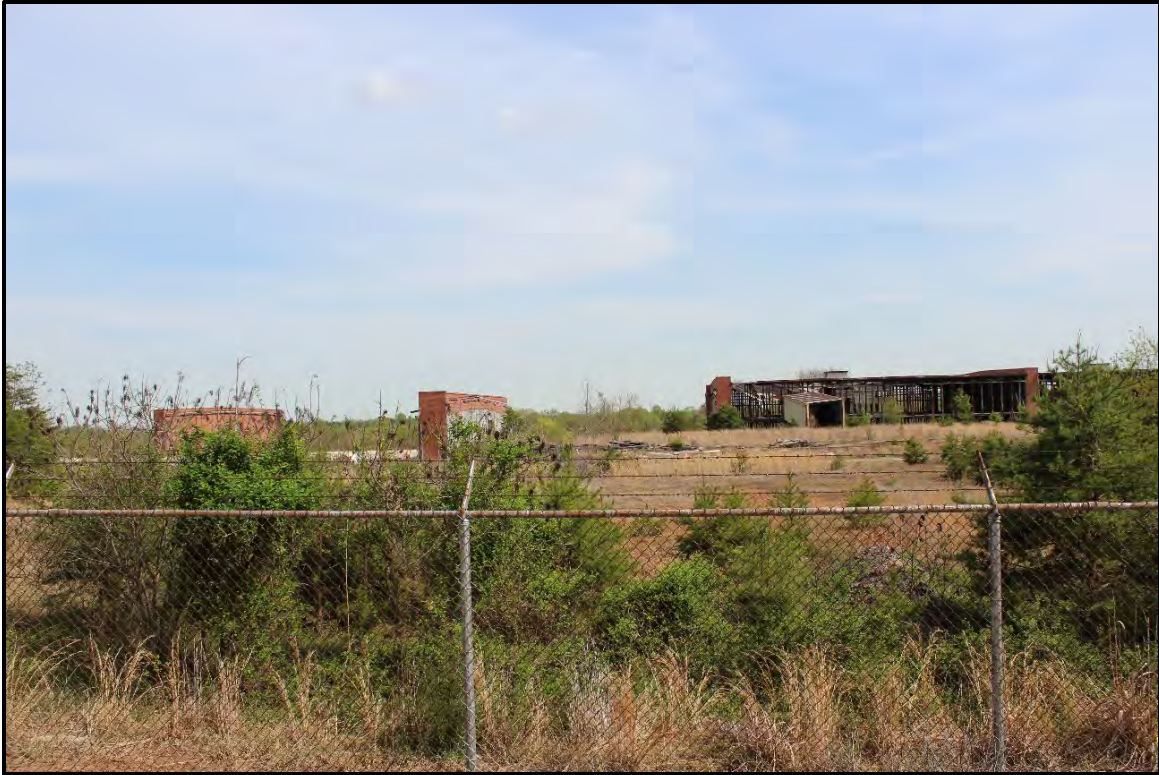
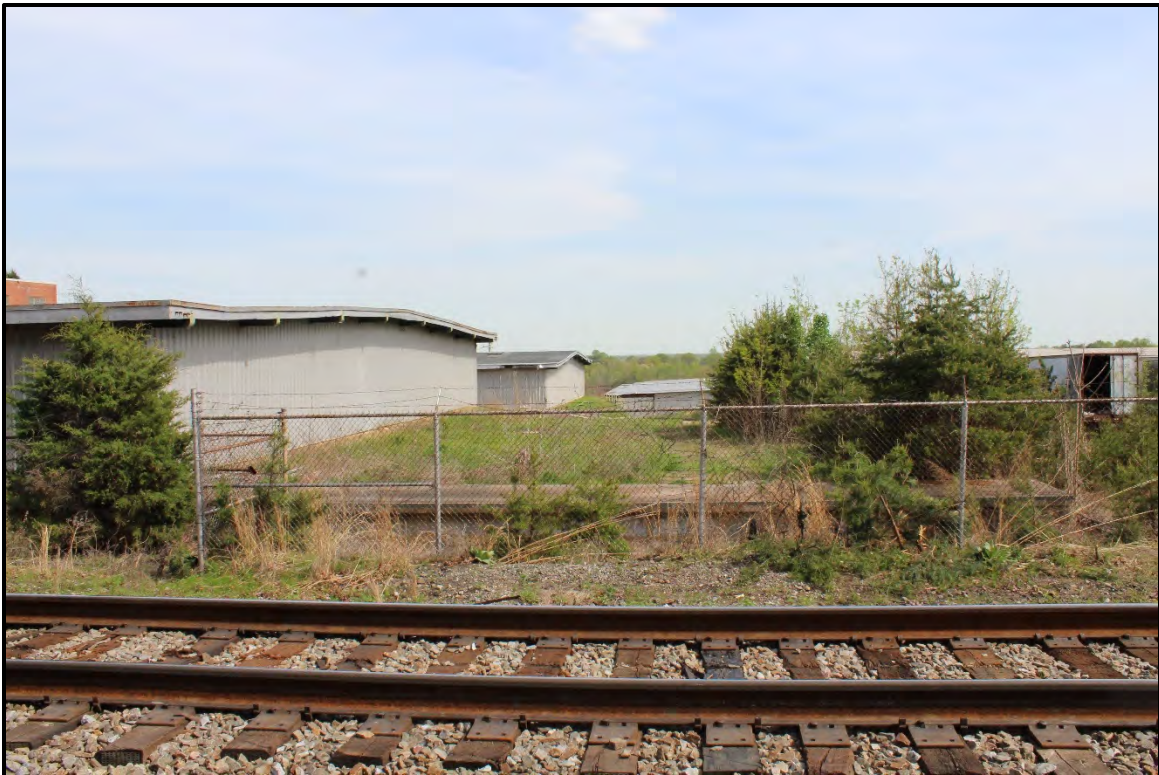
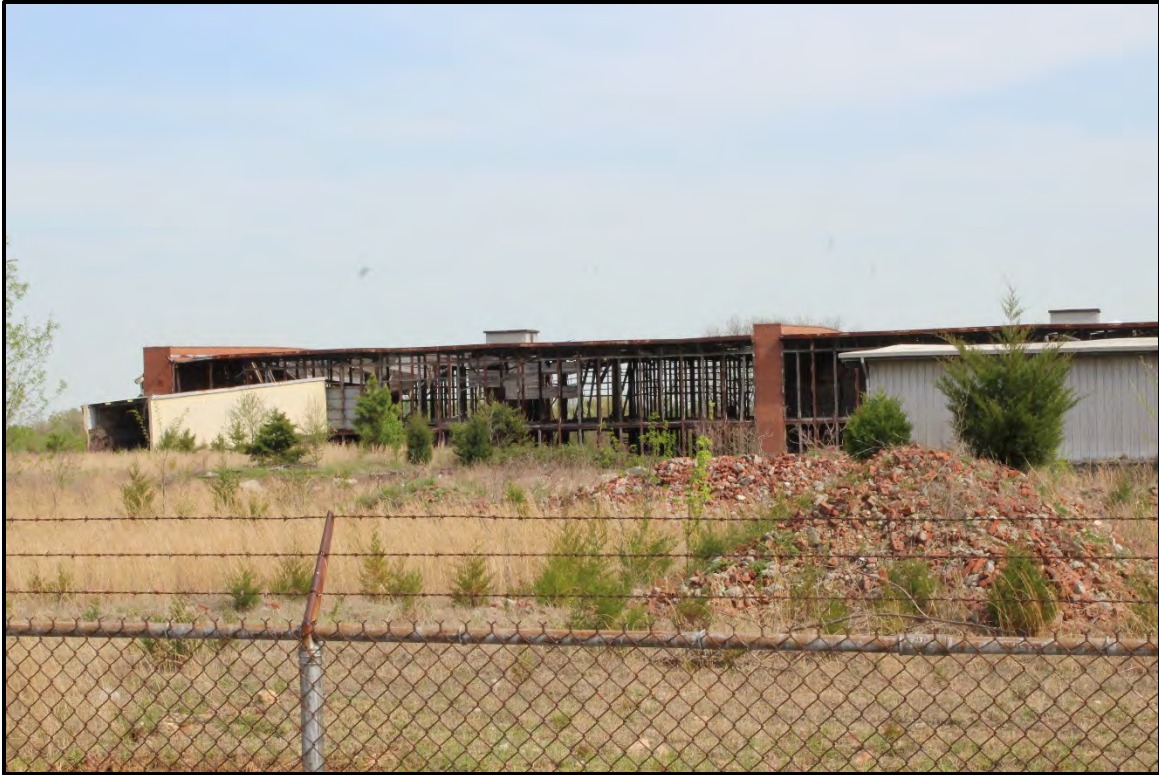
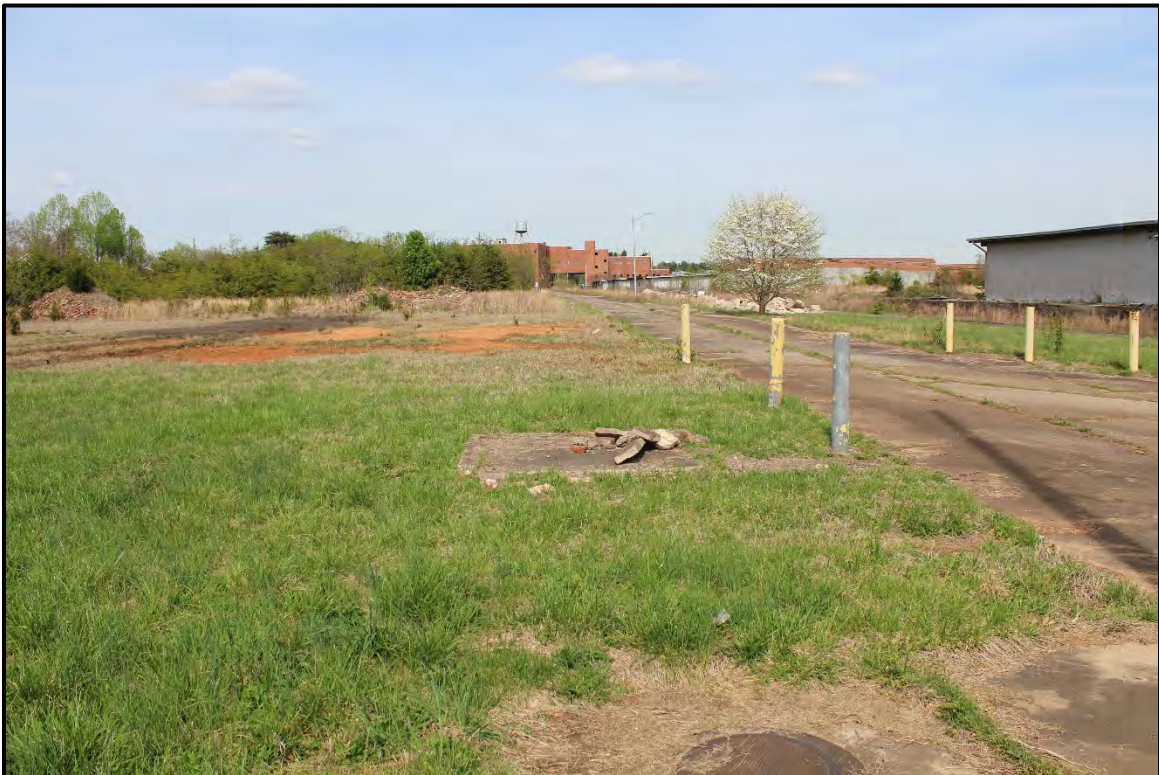
The property is anchored by a multi-story, concrete block manufacturing plant building clad with brick veneer. According to Rockingham County tax records, this building was constructed in 1963 (Rockingham County, NC WebGIS 2018). Associated with the property are approximately 15 extant tobacco warehouses. Historic aerial imagery from Google Earth shows that the facility contained approximately 62 warehouses in 1993 (Figures 5.147 and 5.148). Since that time the plant has closed and most of the warehouses and other support buildings have been demolished (Figures 5.146–5.151).

Figure 5.146. Architectural resource RK1704; view is south featuring a loading dock and dilapidated warehouse in the background.

Figure 5.147. Architectural resource RK1704; view is south featuring warehouse ruins.

Figure 5.148. Architectural resource RK1704; view is south featuring warehouse ruins and building pads.

Figure 5.149. Architectural resource RK1704; view is south featuring intact warehouses.

Figure 5.150. Architectural resource RK1704; view is southeast featuring warehouse ruins.

Figure 5.151. Architectural resource RK1704; view is east featuring former warehouse building lots.

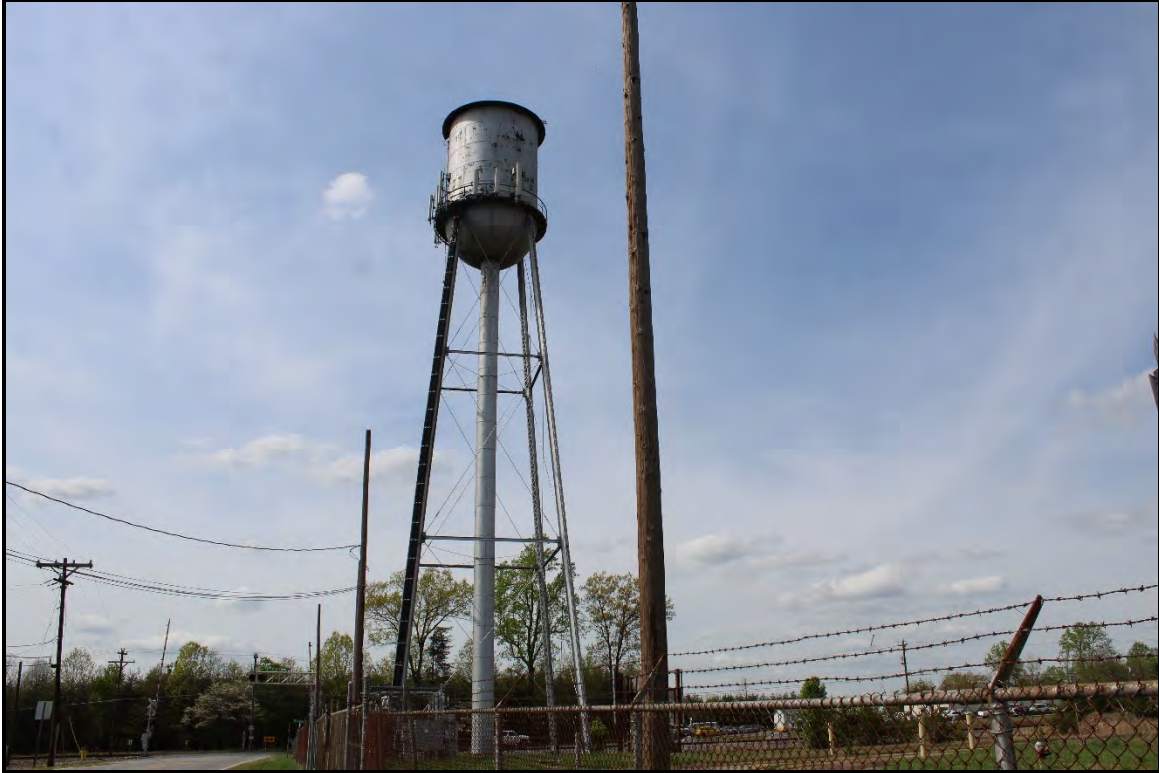
Located on the south side of the railroad line along its north side, the main plant building is four stories tall with an L-shaped plan, a flat roof, and a common bond brick exterior. A horizontal stone belt course pierced with louvered windows runs around the middle of the building exterior and divides the top and bottom halves. A company sign attached to the north and west elevations of the building states the company’s name “The American Tobacco Company” in cursive text. There are loading docks on the north elevation of the building and a one-story metal warehouse attached to the west elevation. There is a water tower on the roof. The surrounding extant warehouses are in various states of disrepair and collapse. They feature both steel-frame and masonry construction with low-pitched gable roofs, metal exteriors, rectangular plans, concrete slab foundations, and large bay doors. There is a second water tower at the northwest corner of the parcel (Figure 5.152).

Figure 5.152. Architectural resource RK1704; view north featuring the water tower at the northwest corner of the parcel.

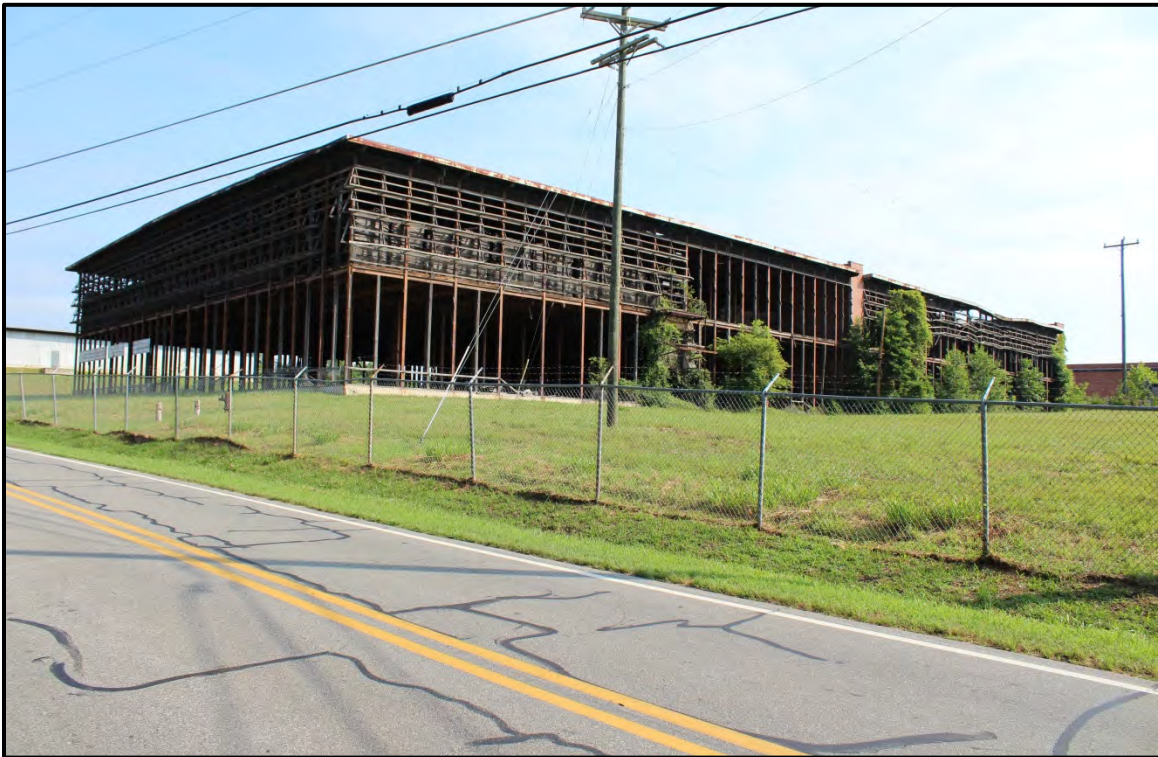
Figure 5.153. Architectural resource RK1704; oblique view northeast toward a partially demolished former warehouse.

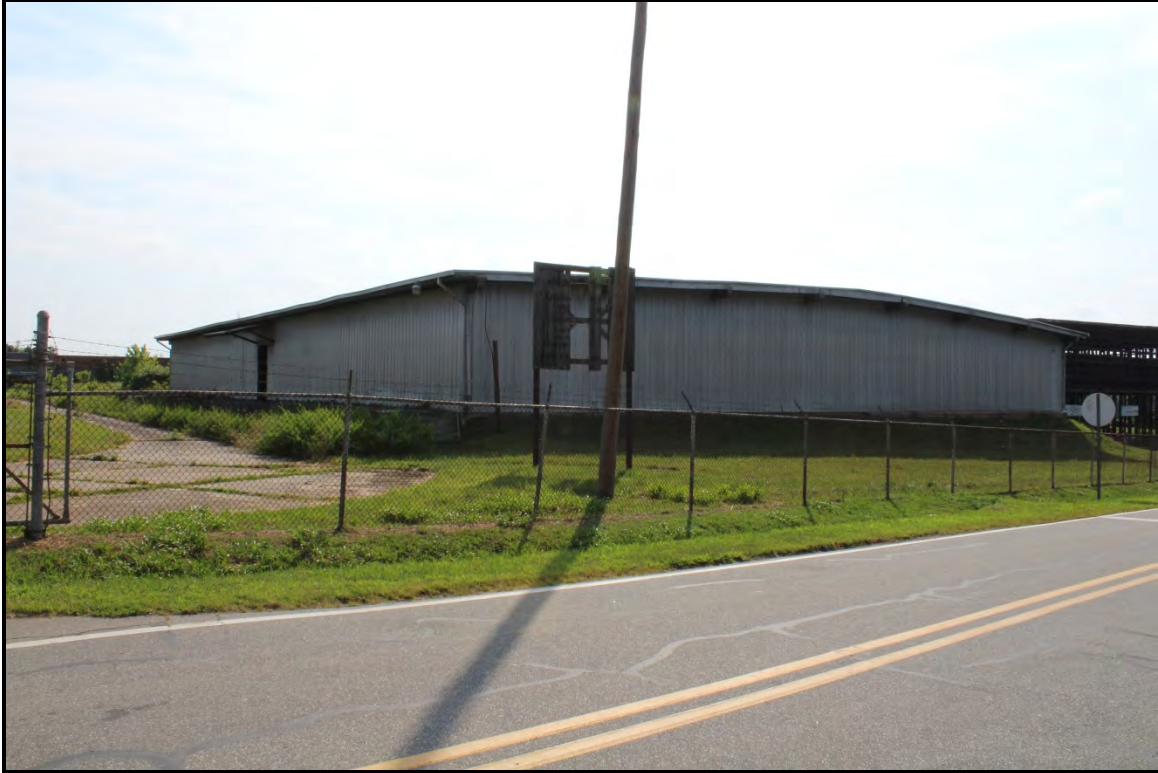
Figure 5.154. Architectural resource RK1704; view is southeast toward a typical one-story metal warehouse.

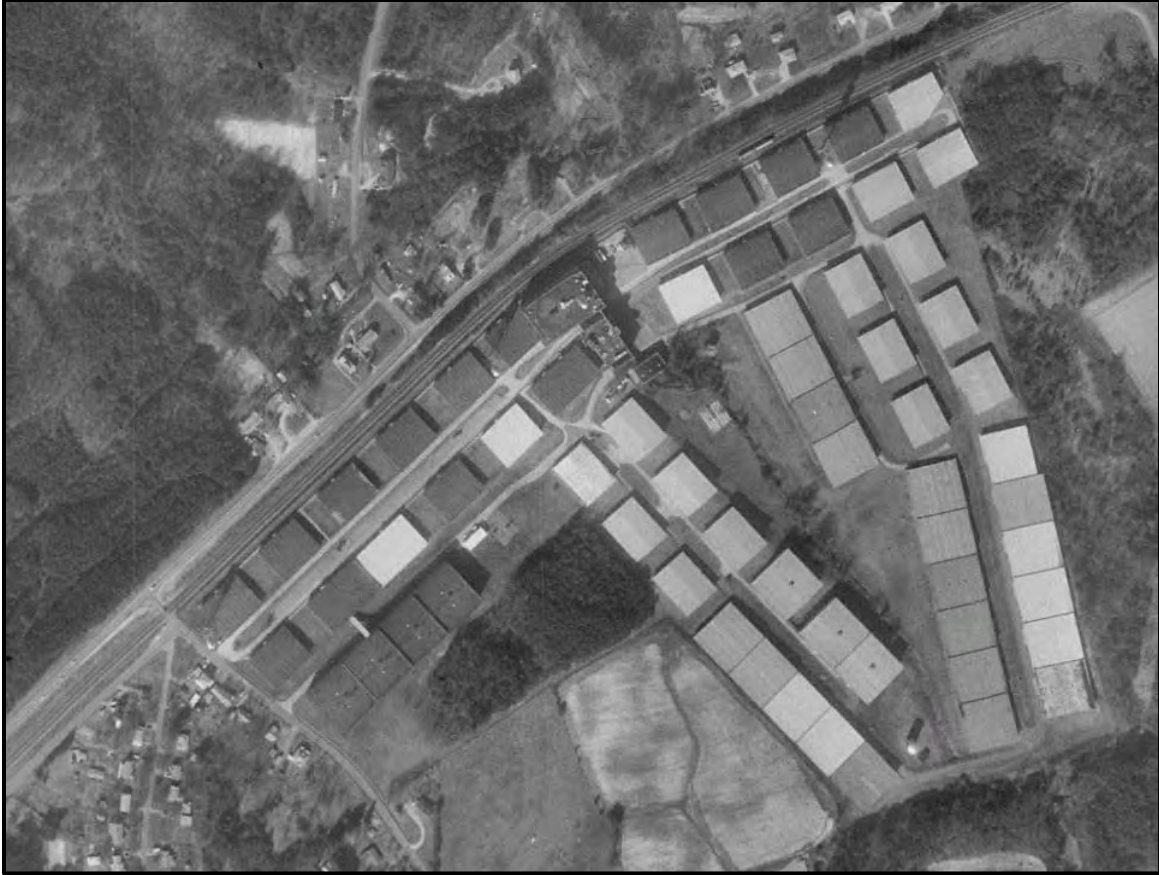
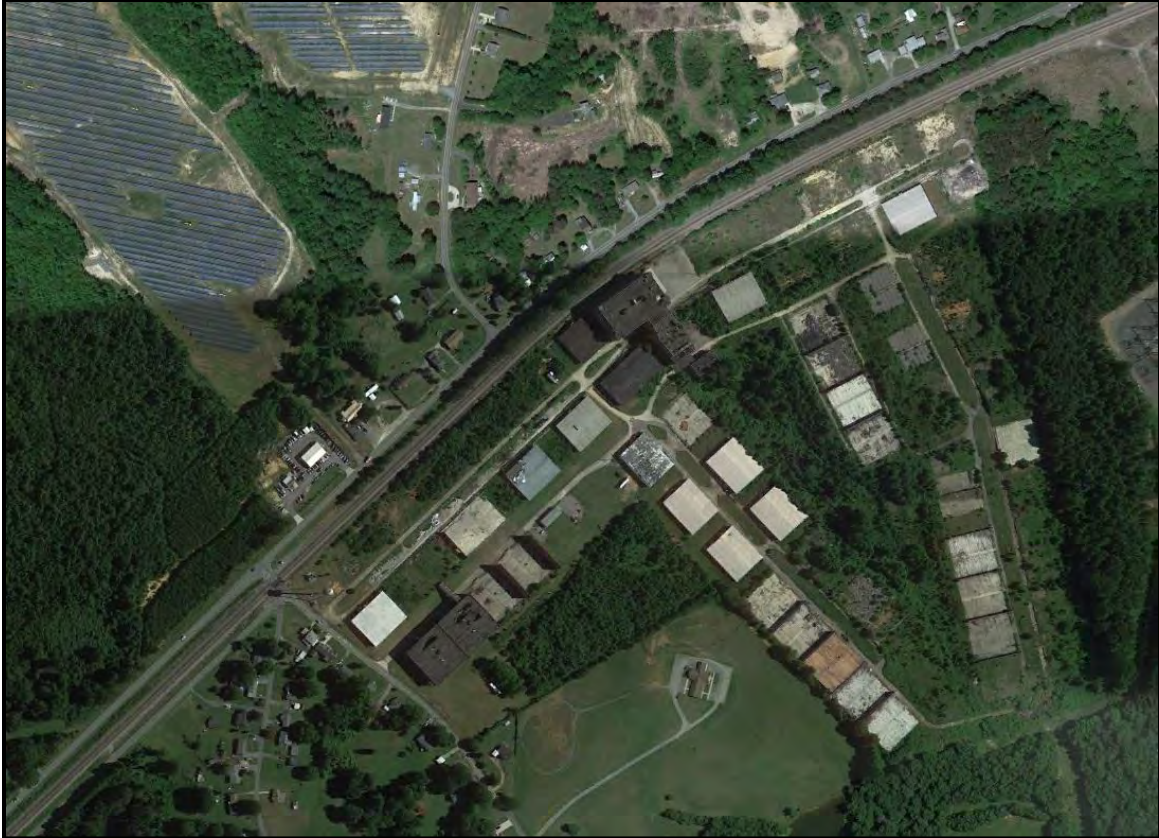
Description. Architectural resource RK1704 is a vacant manufacturing plant located at 125 Narrow Gauge Road, Reidsville 27320 on parcel number 158759 (Rockingham County, NC WebGIS 2018) (see Figure 1.2e; Figures 5.144–5.156). This resource is the 90-acre abandoned American Tobacco Company manufacturing plant, which according to county tax records was built in stages between the 1920s and the 1960s (Rockingham County, NC WebGIS 2018). TRC’s evaluation of the property was limited to the public right-of-way along Narrow Gauge Road, as the property is fenced off and closed. Additional information about the property and its layout was gathered through aerial imagery.

Figure 5.155. 1993 Google Earth aerial imagery depicting The American Tobacco Company manufacturing grounds prior to its closure.

Figure 5.156. 2018 Google Earth aerial imagery depicting The American Tobacco Company manufacturing grounds after its closure and resulting demolition.

NRHP Assessment. Architectural resource RK1704 is a 90-acre parcel that features the remnants of The American Tobacco Company’s Reidsville manufacturing facility. At the time of the plant’s closure in the late 1990s, the complex featured a multi-story administrative building, two water tanks, and at least 62 tobacco warehouses. Additional auxiliary buildings and structures were likely part of the complex, however, due to limited access and information on the plant, these support elements could not be verified. Since the time of the plant’s closure, the complex has remained vacant, which made it susceptible to deterioration and vandalism. Presently, the grounds are largely obscured with heavy vegetation and are marked by several concrete slabs that indicate the former locations of demolished tobacco warehouses. A review of historical aerial imagery indicates that of the approximately 62 warehouses that once stood on the plant grounds less than 25 percent, or 15 warehouses, are extant. In addition, a water tower once located at the southeastern end of the plant grounds has also been demolished. Overall, the historic integrity of the complex has been severely compromised due to the extensive loss of the warehouses and other support structures. As a result, the facility no longer conveys its mid-twentieth century appearance, thereby rendering the property ineligible for its association with tobacco manufacturing. For these reasons, it is the opinion of TRC that architectural resource RK1704 is not eligible for the NRHP.

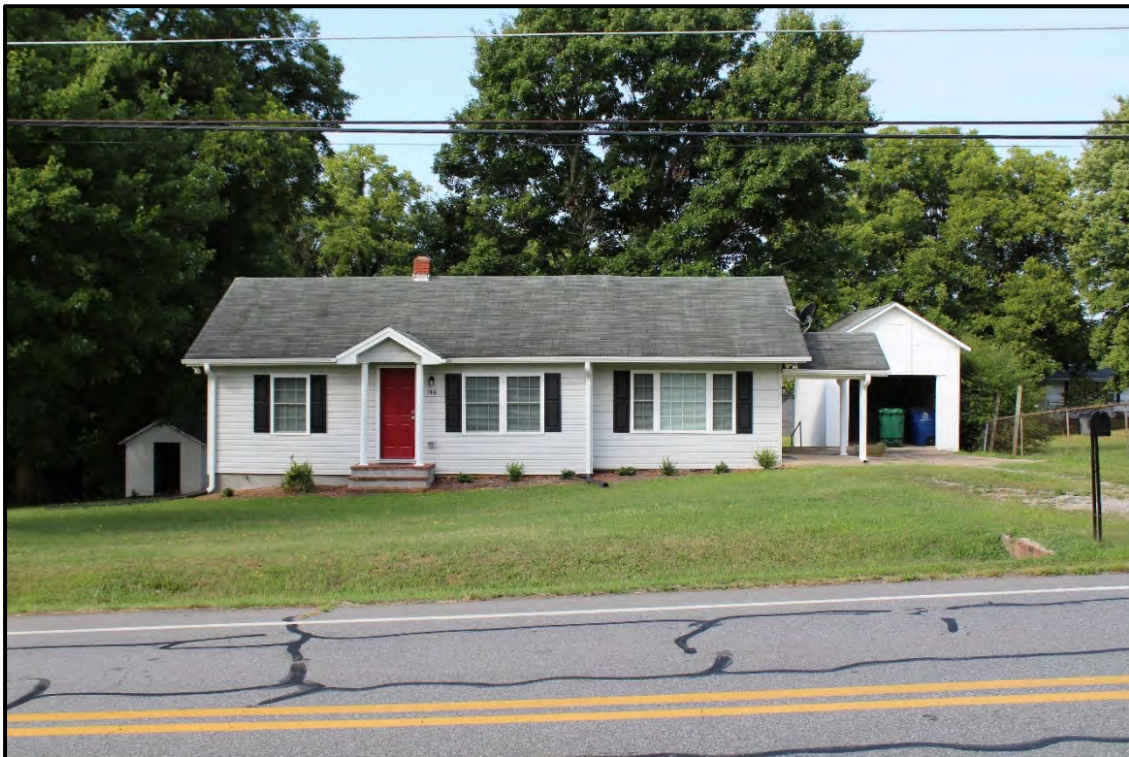
The one-story, wood-frame building features a side-gabled roof covered with asphalt shingles, an interior brick chimney, an exterior clad with vinyl siding, and a continuous concrete block foundation. It has 6/6 replacement vinyl sash windows throughout. An offset stoop with brick and concrete foundation provides access to the main entrance. Attached to the north elevation is a gable-roofed stoop supported by wood posts sheltering a side entrance. There is a single-bay, wood frame garage behind the southwest corner of the house.

NRHP Assessment. Architectural resource RK1705 does not exhibit a distinctive architectural style or workmanship. In addition, the house has been altered through the application of vinyl siding, the reconstruction of the entry porch, and the replacement of the original window sashes. Based on the lack of architectural merit, as well as the inability to associate the house and/or its original owner(s) with an important historical event or series of events, it is TRC’s opinion that architectural resource RK1705 is not eligible for the NRHP.

Figure 5.157. Architectural resource RK1705; view is southwest featuring the façade.

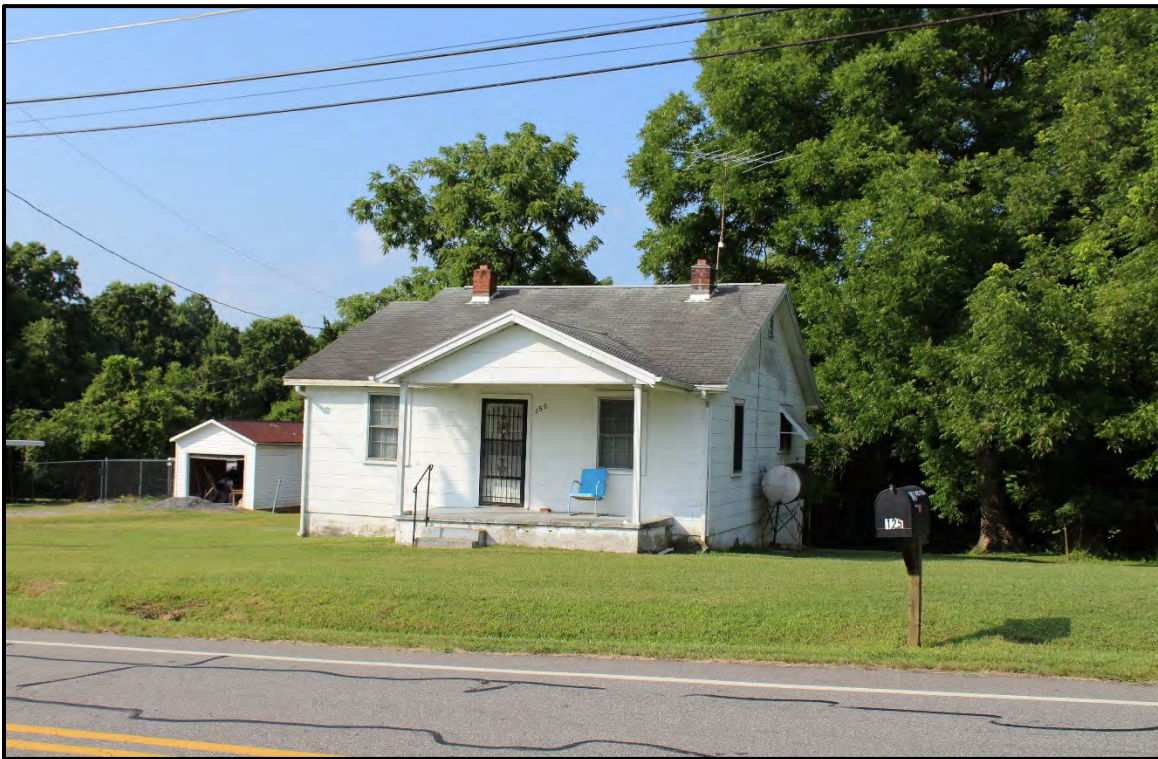
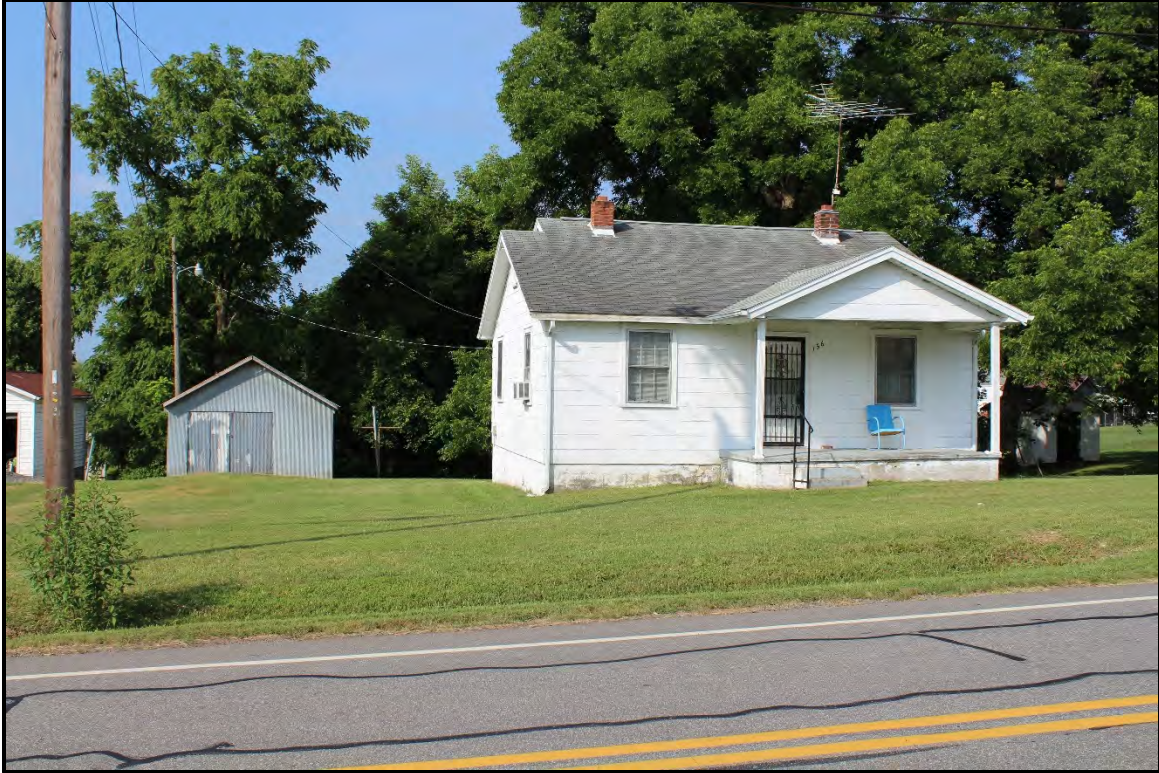
The one-story, wood-frame building features a side-gabled roof, asbestos shingle siding, and a continuous concrete block foundation. It has 6/6 wood sash windows throughout. Access to the central front entrance is via a partial-width front porch that has a front-gabled roof supported by wood posts. There are two interior brick chimneys. The house has two modern storage shed outbuildings in the rear yard.

NRHP Assessment. Architectural resource RK1706 does not exhibit a distinctive architectural style or workmanship. In addition, the house has been altered through the replacement of the original porch posts. Based on the lack of architectural merit, as well as the inability to associate the house and/or its original owner(s) with an important historical event or series of events, it is TRC's opinion that architectural resource RK1706 is not eligible for the NRHP.

Figure 5.158. Architectural resource RK1706; view is southwest featuring the façade and northwest elevation.

Figure 5.159. Architectural resource RK1706; view is northwest showing the façade and southwest elevation.

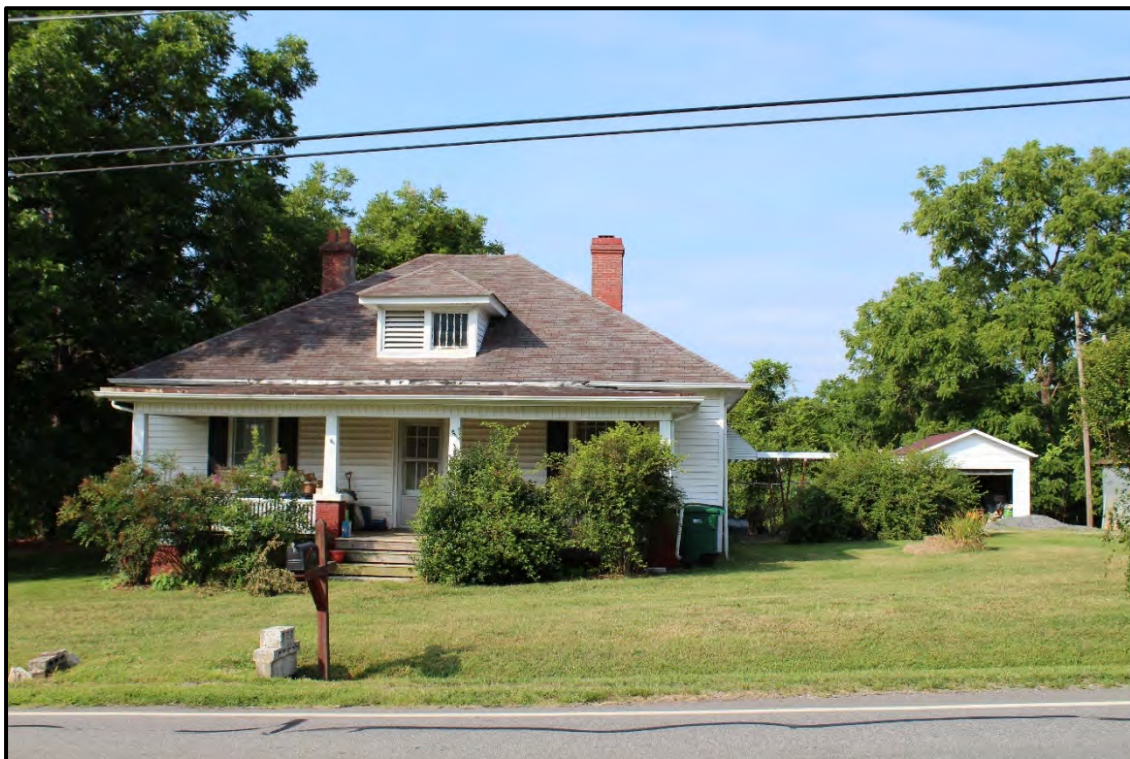
The one-story, wood-frame building features a roof covered with asphalt shingles, an exterior clad with vinyl siding, and a continuous brick foundation. The hipped roof dormer on the façade has one original five-light vertical pane fixed window paired with a replacement louvered vent. The house has a partial-width front porch with a wood floor, brick pier foundation, and a shed roof supported by battered wood columns set on brick piers. The central front entrance has a nine-light glazed door flanked by 5/1 vertical light sash windows with faux shutters. There are two interior brick chimneys. There is a modern metal carport on the northwest elevation adjacent to a modern, single-bay detached garage.

NRHP Assessment. Architectural resource RK1707 does not exhibit a distinctive architectural style or workmanship. In addition, the house has been altered through the application of vinyl siding. Based on the lack of architectural merit, as well as the inability to associate the house and/or its original owner(s) with an important historical event or series of events, it is TRC’s opinion that architectural resource RK1707 is not eligible for the NRHP.

Figure 5.160. Architectural resource RK1707; view is southwest featuring the façade.

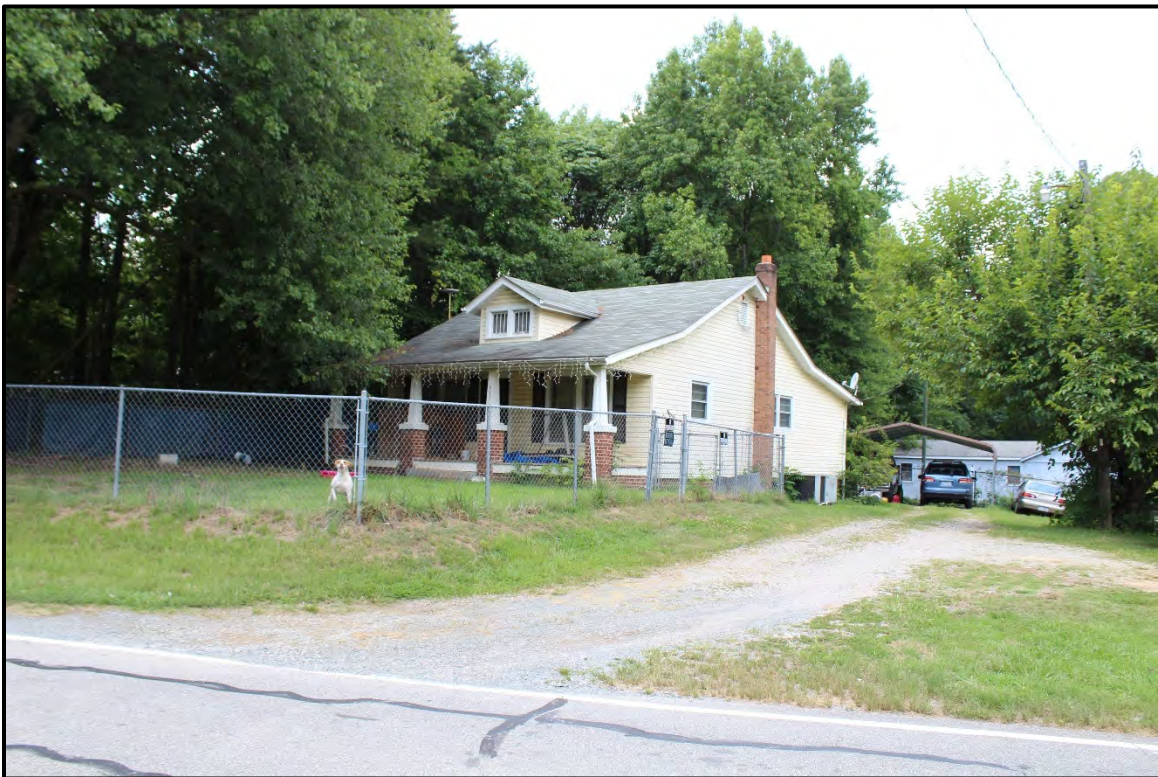
Description. Architectural resource RK1708 is a Craftsman/bungalow-style house located at 531 Narrow Gauge Road, Reidsville 27320 on parcel number 158464 (Rockingham County, NC WebGIS 2018) (see Figure 1.2e; Figure 5.161). According to Rockingham County tax records, the house was constructed in 1929 (Rockingham County, NC WebGIS 2018). Due to lack of landowner permission to access properties that are not directly affected by the project, photographic coverage of architectural resource RK1708 was limited to the public right-of-way along Narrow Gauge Road. The one and one-half-story, wood-frame, building features a side-gabled roof, an exterior clad with vinyl siding, and a continuous brick foundation. The gable dormer on the façade has two original five-light vertical pane fixed windows. The house has a full-length front porch with a wood floor, continuous brick foundation, and a shed roof supported by battered wood columns set on brick piers. The central front entrance is flanked by pairs of 4/1 vertical light sash windows with faux shutters. The house has an exterior end brick chimney on the east elevation. There are three modern storage shed outbuildings in the rear (north) yard.

NRHP Assessment. Architectural resource RK1708 does not exhibit a distinctive architectural style or workmanship. In addition, the house has been altered through the application of vinyl siding. Based on the lack of architectural merit, as well as the inability to associate the house and/or its original owner(s) with an important historical event or series of events, it is TRC's opinion that architectural resource RK1708 is not eligible for the NRHP.

Figure 5.161. Architectural resource RK1708; view is northwest showing the façade and east elevation.

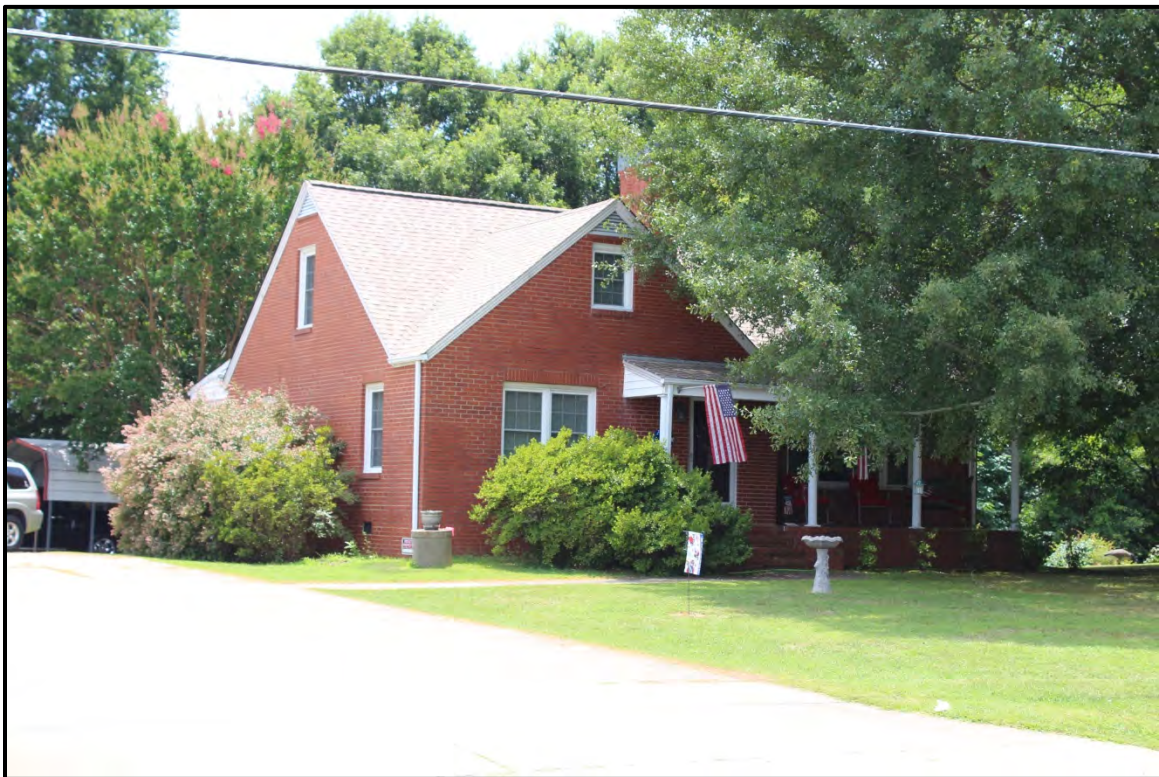
NRHP Assessment. Architectural resource RK1710 does not exhibit a distinctive architectural style or workmanship. In addition, the house has been altered through the replacement of the original window sashes and porch columns. Based on the lack of architectural merit, as well as the inability to associate the house and/or its original owner(s) with an important historical event or series of events, it is TRC’s opinion that architectural resource RK1710 is not eligible for the NRHP.

Figure 5.162. Architectural resource RK1710; view is southwest featuring the façade and east elevation.

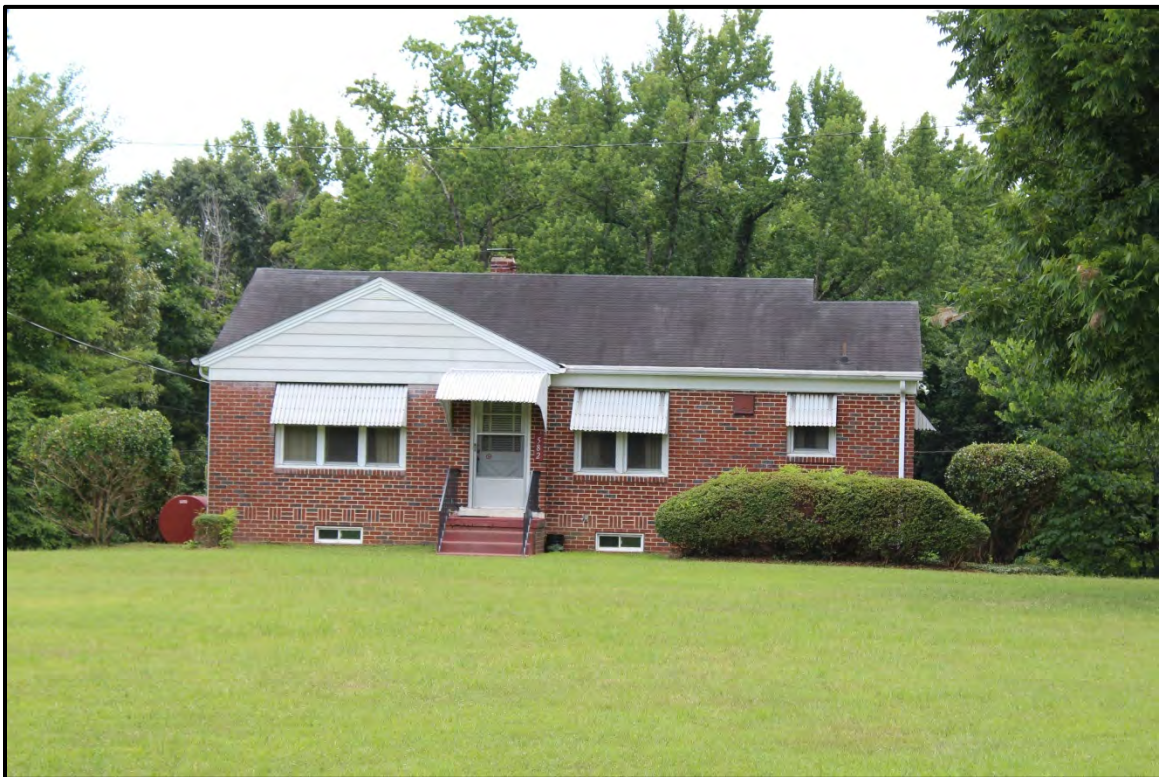
NRHP Assessment. Architectural resource RK1711 does not exhibit a distinctive architectural style or workmanship. In addition, the house has been altered through the application of aluminum siding on the projecting gable bay and the replacement of the original window sashes. Based on the lack of architectural merit, as well as the inability to associate the house and/or its original owner(s) with an important historical event or series of events, it is TRC’s opinion that architectural resource RK1711 is not eligible for the NRHP.

Figure 5.163. Architectural resource RK1711; view is south featuring the façade.

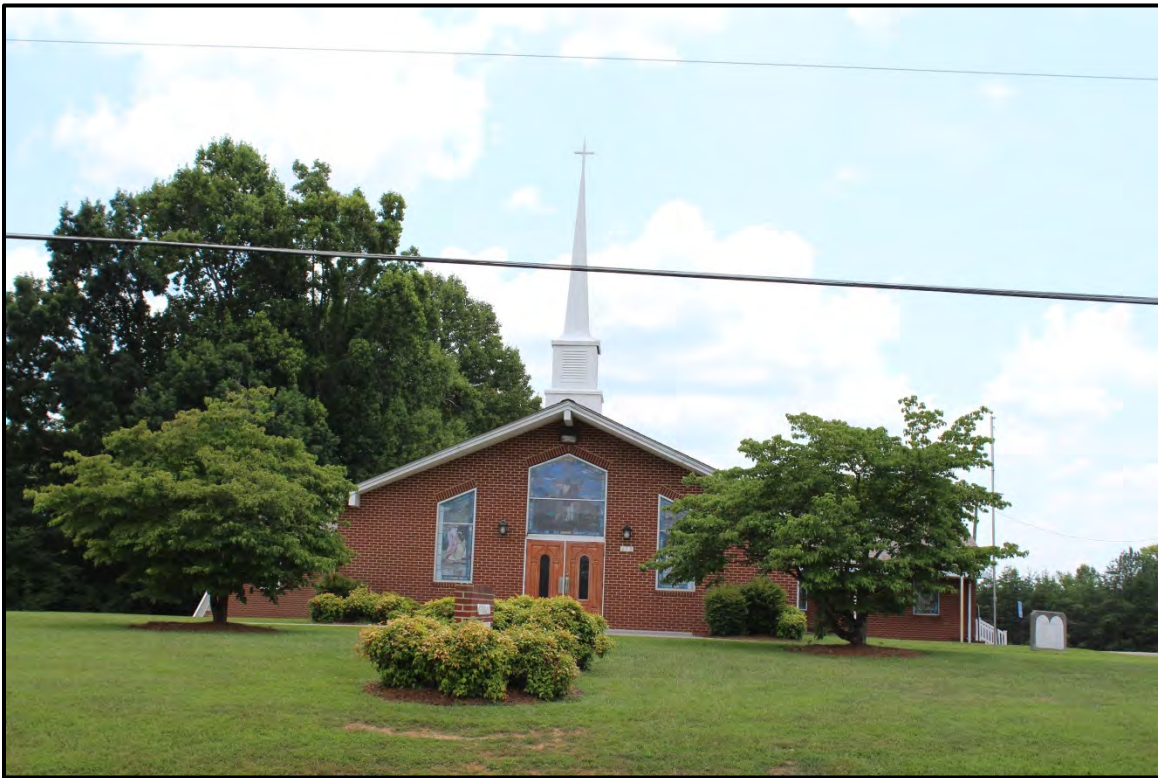
NRHP Assessment. Architectural resource RK1712 is a typical example of a mid-twentieth century church. In accordance with NRHP Criteria Consideration A, religious buildings are normally not eligible for the NRHP unless they derive their primary significance from architectural or artistic distinction or are considered to be of historical importance. The property cannot be associated with important historical event(s) or person(s). Due to lack of the historic and architectural significance it is TRC's opinion that architectural resource RK1712 is not eligible for the NRHP.

Figure 5.164. Architectural resource RK1712; view is south and features the façade.

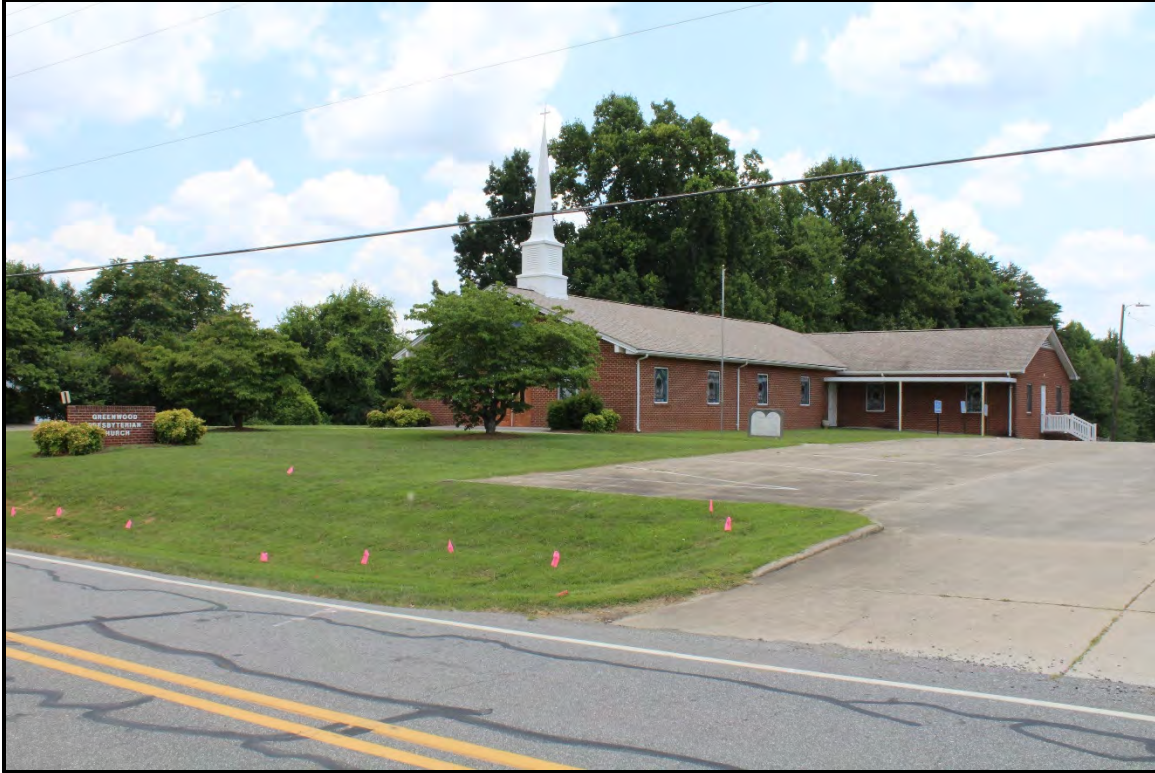
The one-story building features a roof covered with asphalt shingles, a steeple composed of synthetic material, a brick veneer exterior, and rear side-gable wings that give the building a T-shaped plan. The church has a central entrance, a wood frame steeple, and stained glass windows. To the west of the church is architectural resource RK1710, which functions as the church's parsonage.

Figure 5.165. Architectural resource RK1712; view southeast featuring the façade and west elevation.

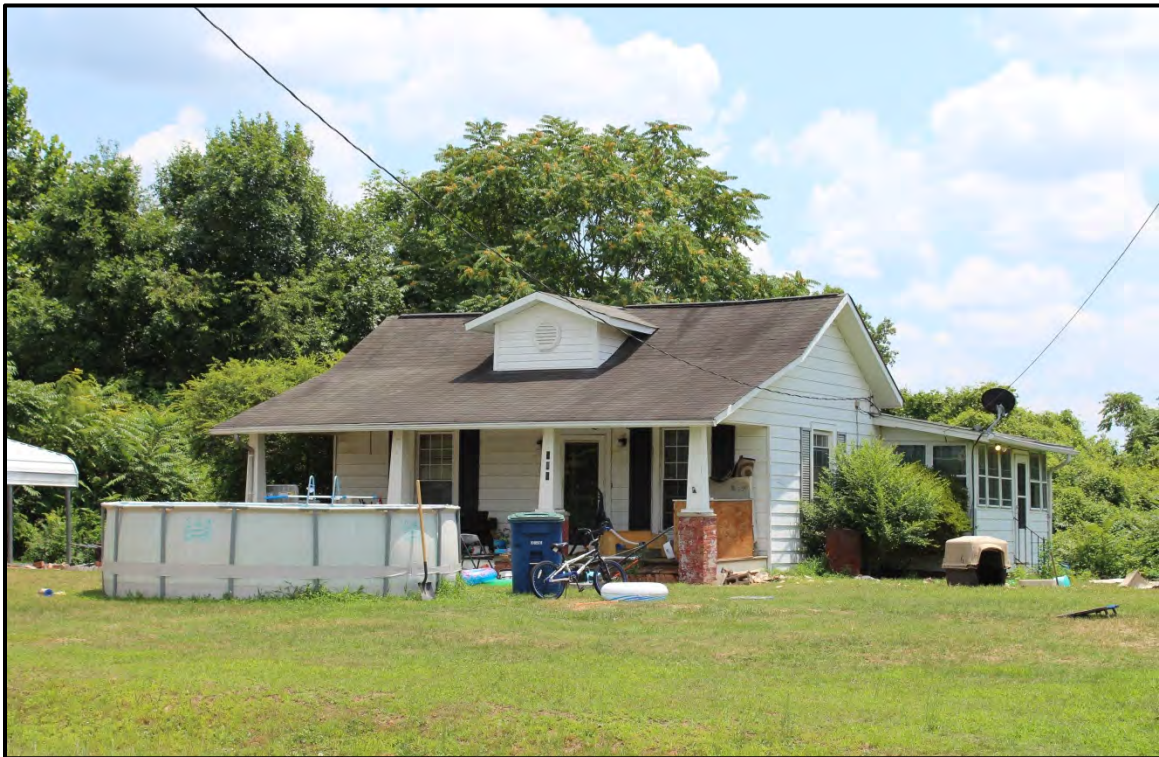
The one and one-half-story, wood-frame building features a side-gabled roof, an exterior clad with aluminum siding, and a rear shed-roof enclosed porch addition. The three-bay façade features a full-length porch with a shed roof supported by battered columns on brick piers and wood floor. The house has 9/9 vinyl sash replacement windows with faux shutters. The gable dormer window has been enclosed with a vinyl louvered vent.

NRHP Assessment. Architectural resource RK1713 does not exhibit a distinctive architectural style or workmanship. In addition, the house has been altered through the replacement of the original window sashes, the application of vinyl siding, and the enclosure of the gable dormer on the façade. Based on the lack of architectural merit, as well as the inability to associate the house and/or its original owner(s) with an important historical event or series of events, it is TRC’s opinion that architectural resource RK1713 is not eligible for the NRHP.

Figure 5.166. Architectural resource RK1713; view is southeast showing the façade and west elevation.
