Re: Revised Architectural Survey Report, MVP Southgate Project, Construct Interstate Pipeline, Rockingham and Alamance County, ER 18-1041

Thank you for your letter of October 11, 2019, transmitting the draft "Historic Architectural Survey for the MVP Southgate Pipeline Project". We have reviewed the report and offer the following comments.

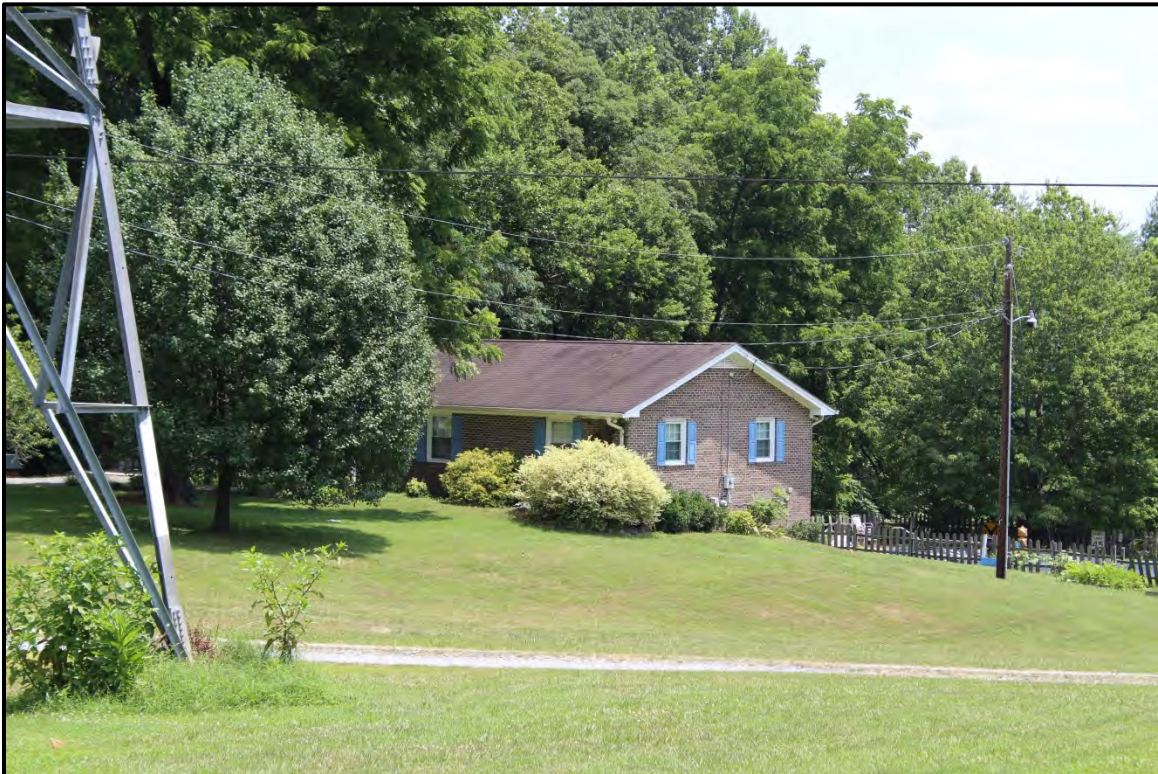
The wood-frame building features a side-gabled roof, an exterior clad with a brick veneer, and an exposed basement level. The façade was obscured by vegetation during survey, but 6/6 vinyl sash windows were visible.

NRHP Assessment. Architectural resource RK1714 does not exhibit a distinctive architectural style or workmanship. In addition, the house has been altered through the replacement of the original window sashes. Based on the lack of architectural merit, as well as the inability to associate the house and/or its original owner(s) with an important historical event or series of events, it is TRC’s opinion that architectural resource RK1714 is not eligible for the NRHP.

Figure 5.167. Architectural resource RK1714; view is southeast showing the façade and west elevation.

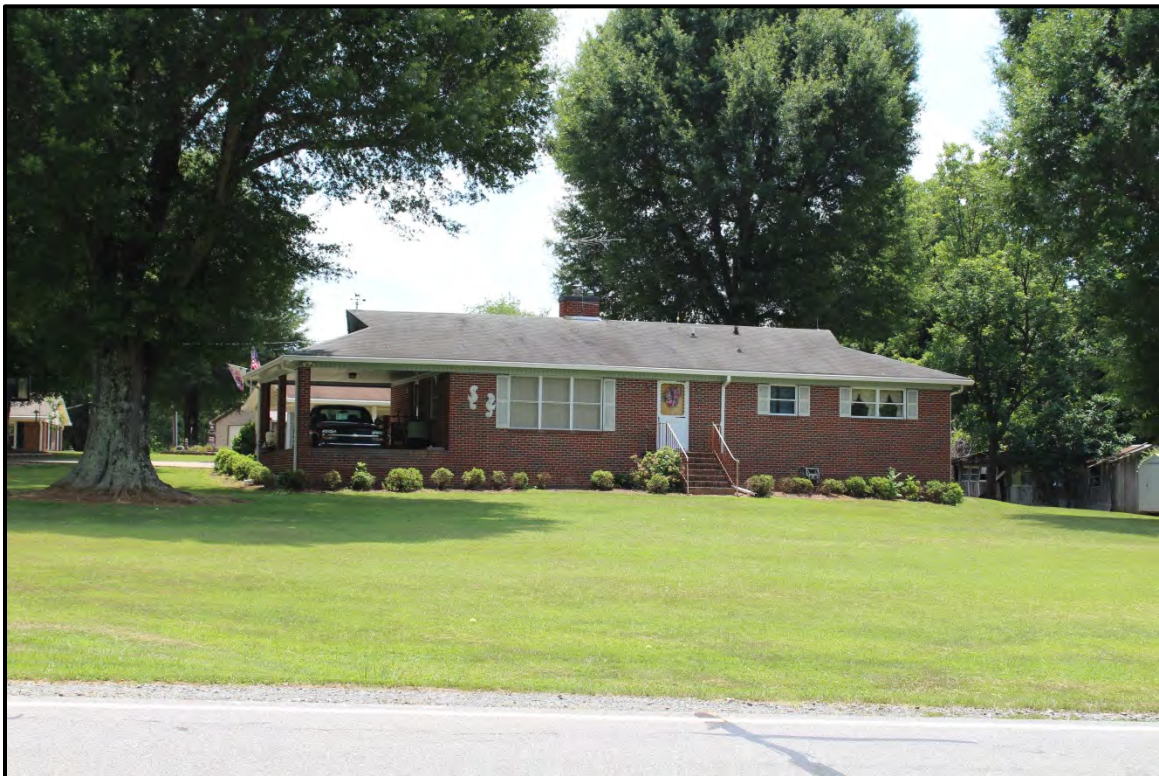
NRHP Assessment. Architectural resource RK1715 does not exhibit a distinctive architectural style or workmanship. In addition, the house has been altered through the replacement of the original window sashes. Based on the lack of architectural merit, as well as the inability to associate the house and/or its original owner(s) with an important historical event or series of events, it is TRC's opinion that architectural resource RK1715 is not eligible for the NRHP.

Figure 5.168. Architectural resource RK1715; view is southeast featuring the façade.

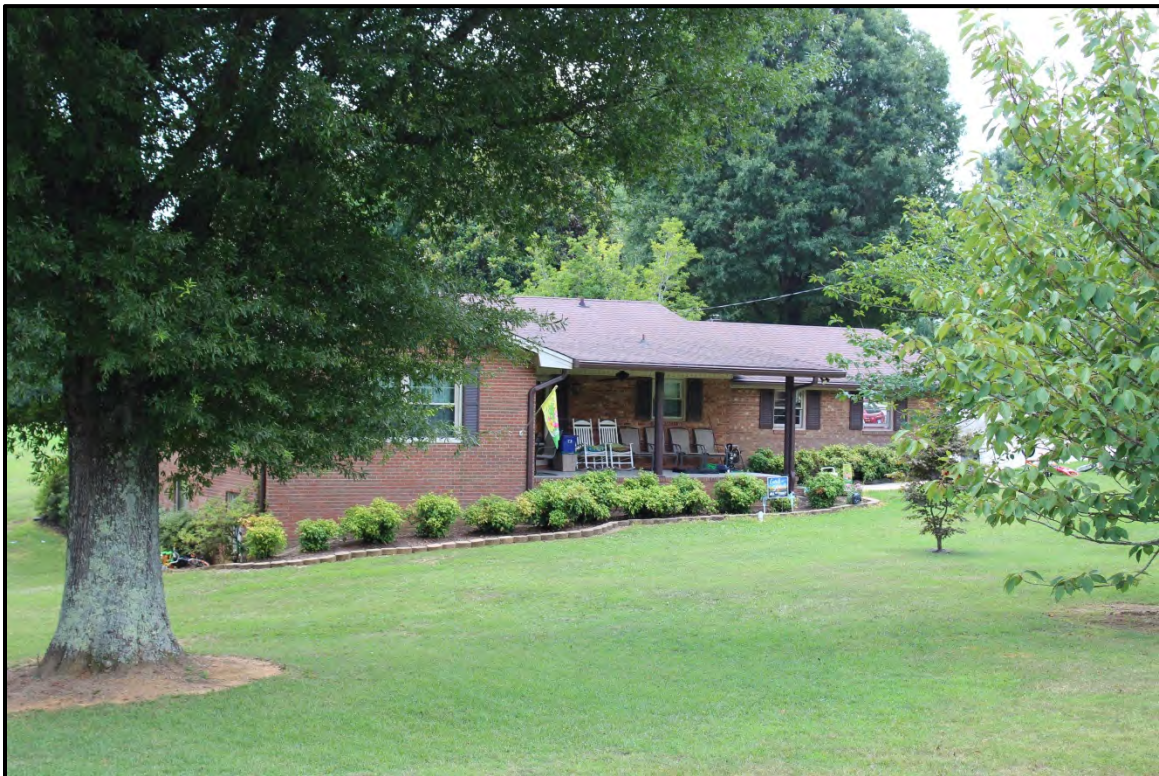
The wood-frame house features a side-gabled roof, an exterior clad with a brick veneer, and a brick foundation. Facing north, the façade reveals an off-center door that is flanked to the west by a 2/2 horizontal sash wood window. This sash type is repeated on a pair of windows located to the west on a projecting gable bay. Access to the façade door is through a partial-width porch with a concrete deck, a shed roof, and wood columns. Attached to the east elevation is a side-gabled wing that functions as a garage.

NRHP Assessment. Architectural resource RK1716 does not exhibit a distinctive architectural style or workmanship. Based on the lack of architectural merit, as well as the inability to associate the house and/or its original owner(s) with an important historical event or series of events, it is TRC's opinion that architectural resource RK1716 is not eligible for the NRHP.

Figure 5.169. Architectural resource RK1716; view south featuring the façade.

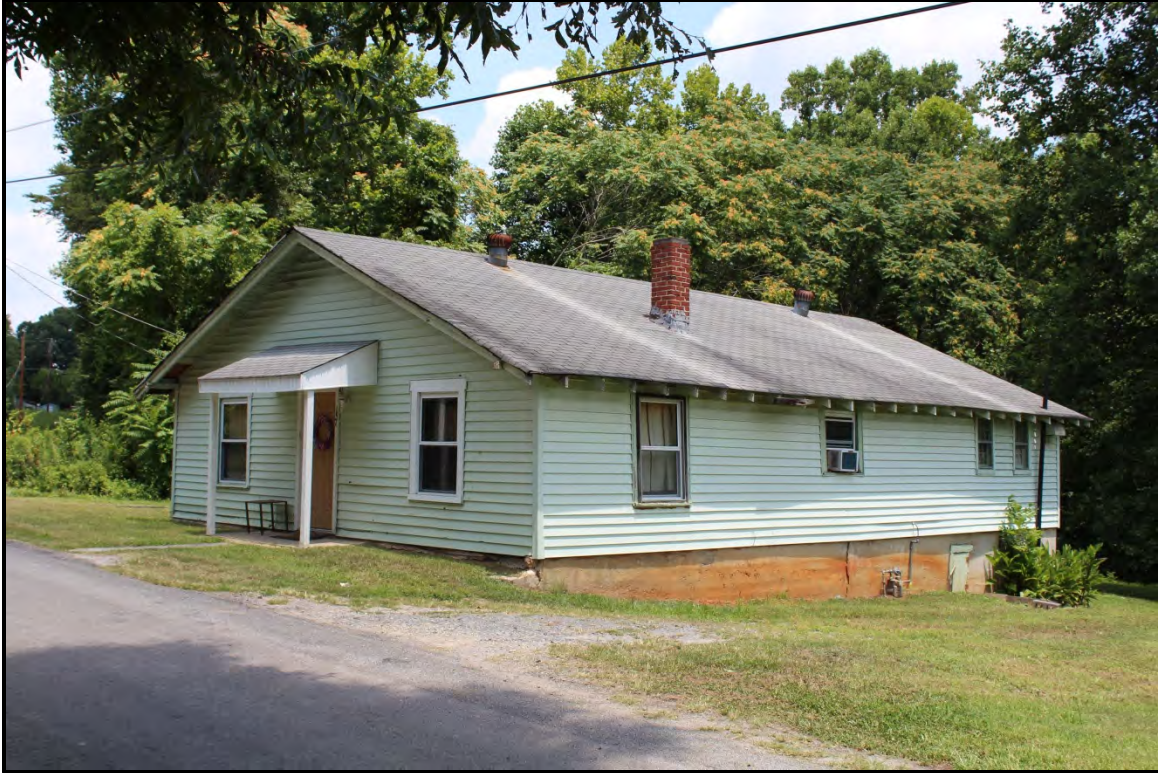
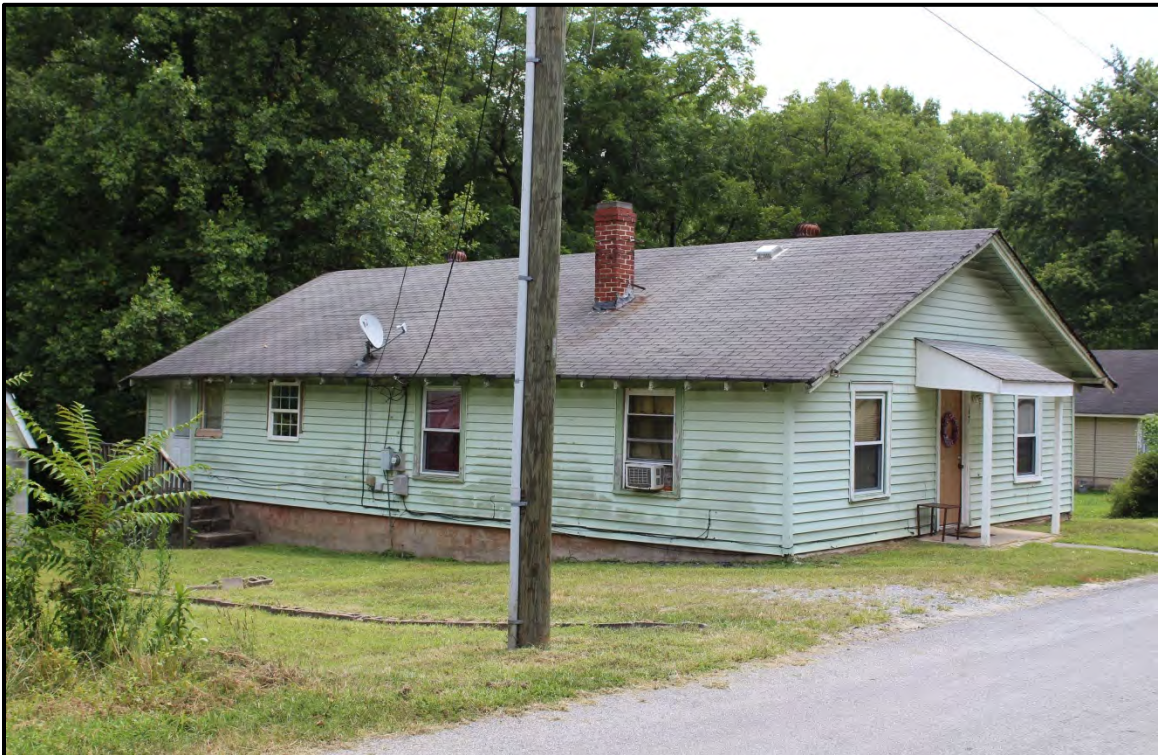
The one-story, wood-frame building features a roof covered with asphalt shingles, two interior brick chimneys, exposed rafter tails, vinyl siding, and a concrete block foundation. The central entrance on the northeast façade is covered by a partial-width porch with a shed-roof and square aluminum-clad posts. The entrance is flanked by two 1/1 vinyl sash windows, which are used throughout the rest of the house.

NRHP Assessment. Architectural resource RK1717 does not exhibit a distinctive architectural style or workmanship. In addition, the house has been altered through the application of vinyl siding, the replacement of the original window sashes, and the reconstruction of the façade porch. Based on the lack of architectural merit, as well as the inability to associate the house and/or its original owner(s) with an important historical event or series of events, it is TRC's opinion that architectural resource RK1717 is not eligible for the NRHP.

Figure 5.170. Architectural resource RK1717; view is north featuring the façade and southeast elevation.

Figure 5.171. Architectural resource RK1717; view is east showing the façade and northwest elevation.

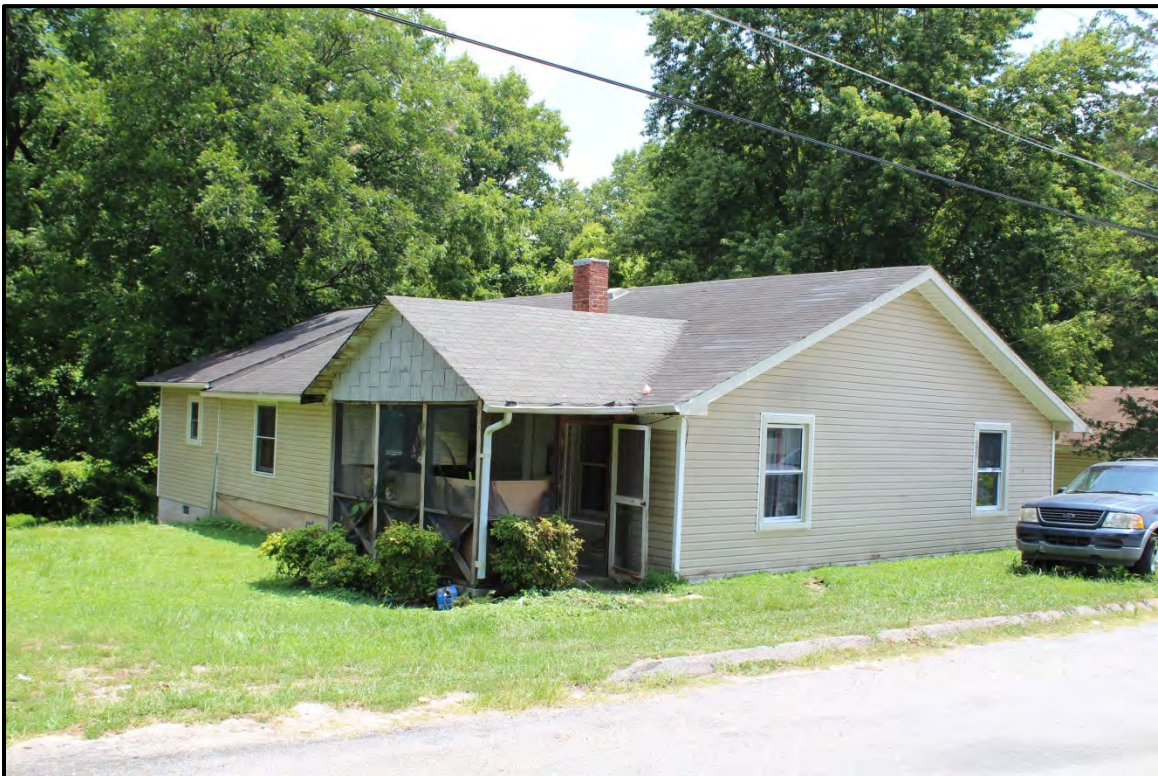
The one-story, wood-frame building features a roof covered with asphalt shingles, an interior brick chimney, vinyl siding, and a concrete block foundation. The main entrance is on the northwest elevation and is covered by a partial-width, gable roof screened porch with. The house has 1/1 vinyl sash replacement windows throughout.

NRHP Assessment. Architectural resource RK1718 does not exhibit a distinctive architectural style or workmanship. In addition, the house has been altered through the application of vinyl siding and the replacement of the original window sashes. Based on the lack of architectural merit, as well as the inability to associate the house and/or its original owner(s) with an important historical event or series of events, it is TRC's opinion that architectural resource RK1718 is not eligible for the NRHP.

Figure 5.172. Architectural resource RK1718; view is southeast featuring the façade and northwest elevation.

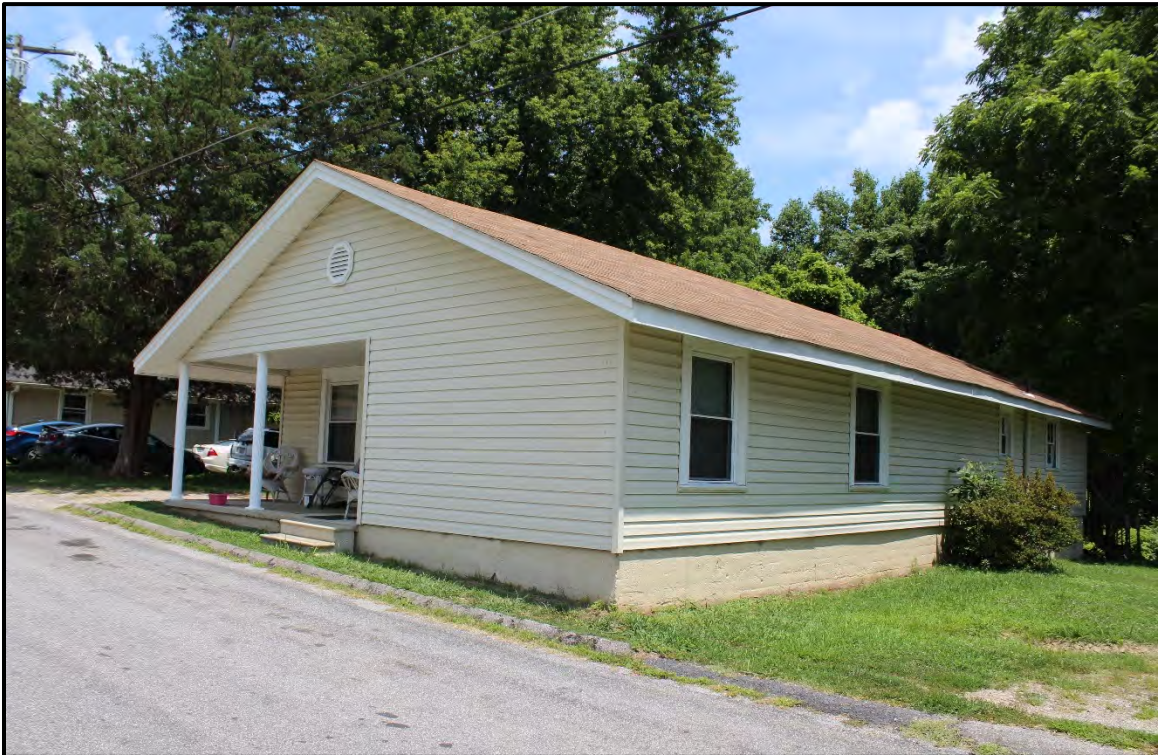
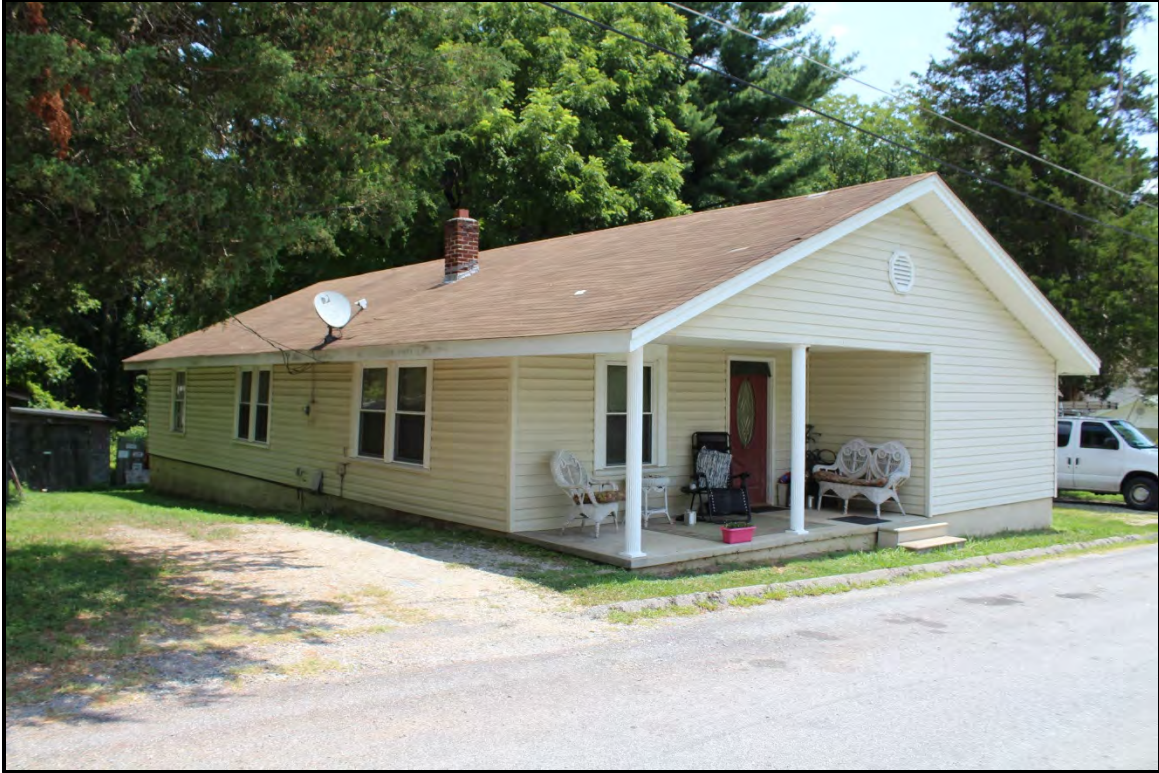
The one-story, wood-frame building features a roof covered with asphalt shingles, an exterior clad with vinyl siding, and a concrete block foundation. The façade has a partial-width recessed porch with aluminum clad columns. The house has single and paired 1/1 vinyl sash replacement windows throughout.

NRHP Assessment. Architectural resource RK1719 does not exhibit a distinctive architectural style or workmanship. In addition, the house has been altered through the application of vinyl siding, the replacement of the original window sashes, and the replacement of the porch columns. Based on the lack of architectural merit, as well as the inability to associate the house and/or its original owner(s) with an important historical event or series of events, it is TRC’s opinion that architectural resource RK1719 is not eligible for the NRHP.

Figure 5.173. Architectural resource RK1719; view is north showing the façade and southeast elevation.

Figure 5.174. Architectural resource RK1719; view is east showing the façade and northwest elevation.

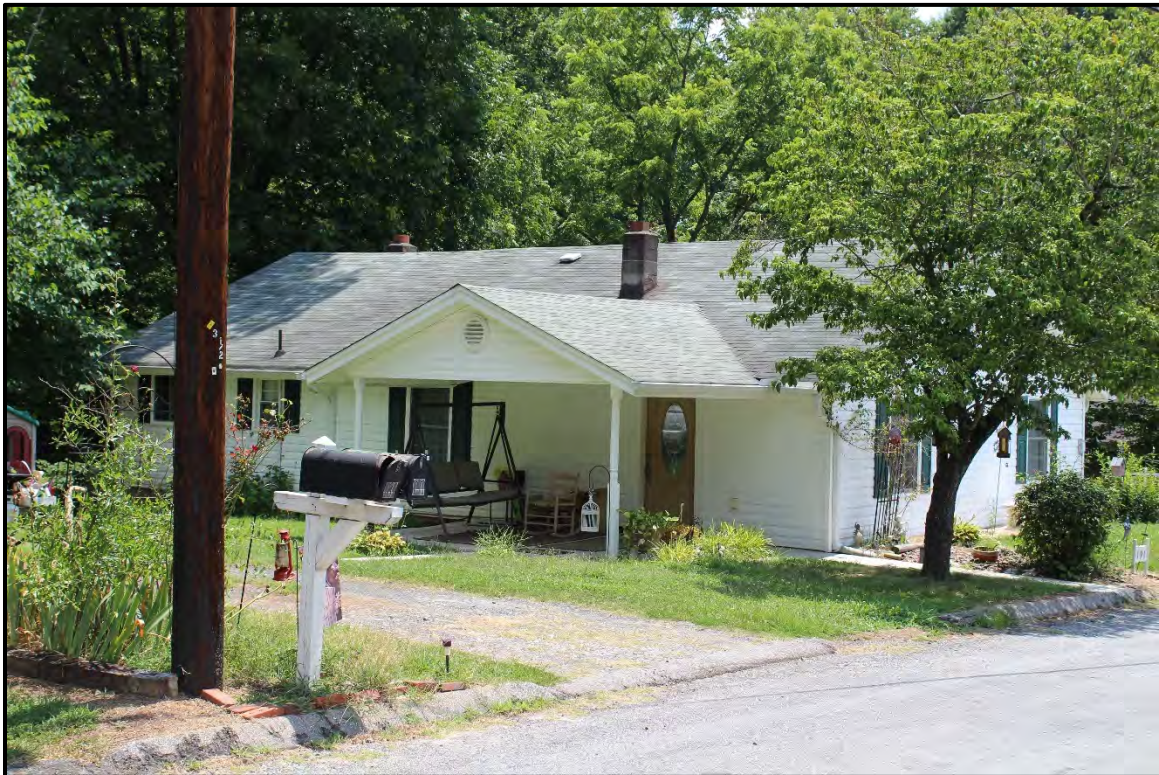
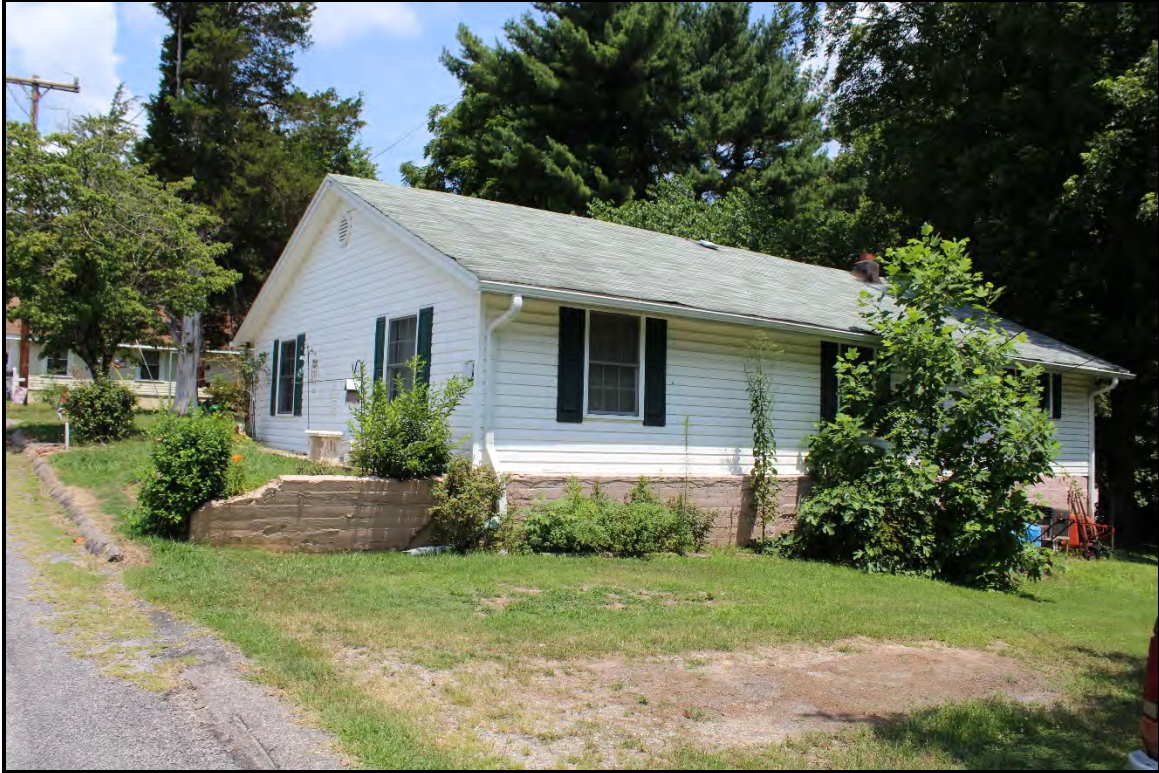
The one-story, wood-frame building features a roof covered with asphalt shingles, an exterior clad with vinyl siding, and a concrete block. The main entrance is on the northwest elevation and is covered by a gable-roof porch with wood posts and a concrete floor. The house has 6/6 vinyl sash replacement windows with faux shutters throughout. There are two interior concrete block chimneys.

NRHP Assessment. Architectural resource RK1720 does not exhibit a distinctive architectural style or workmanship. In addition, the house has been altered through the replacement of the original window sashes, the reconstruction of the façade porch, and the application of vinyl siding. Based on the lack of architectural merit, as well as the inability to associate the house and/or its original owner(s) with an important historical event or series of events, it is TRC's opinion that architectural resource RK1720 is not eligible for the NRHP.

Figure 5.175. Architectural resource RK1720; view is east showing the façade and southwest elevation.

Figure 5.176. Architectural resource RK1720; view is north featuring the southeast (rear) and southwest elevations.

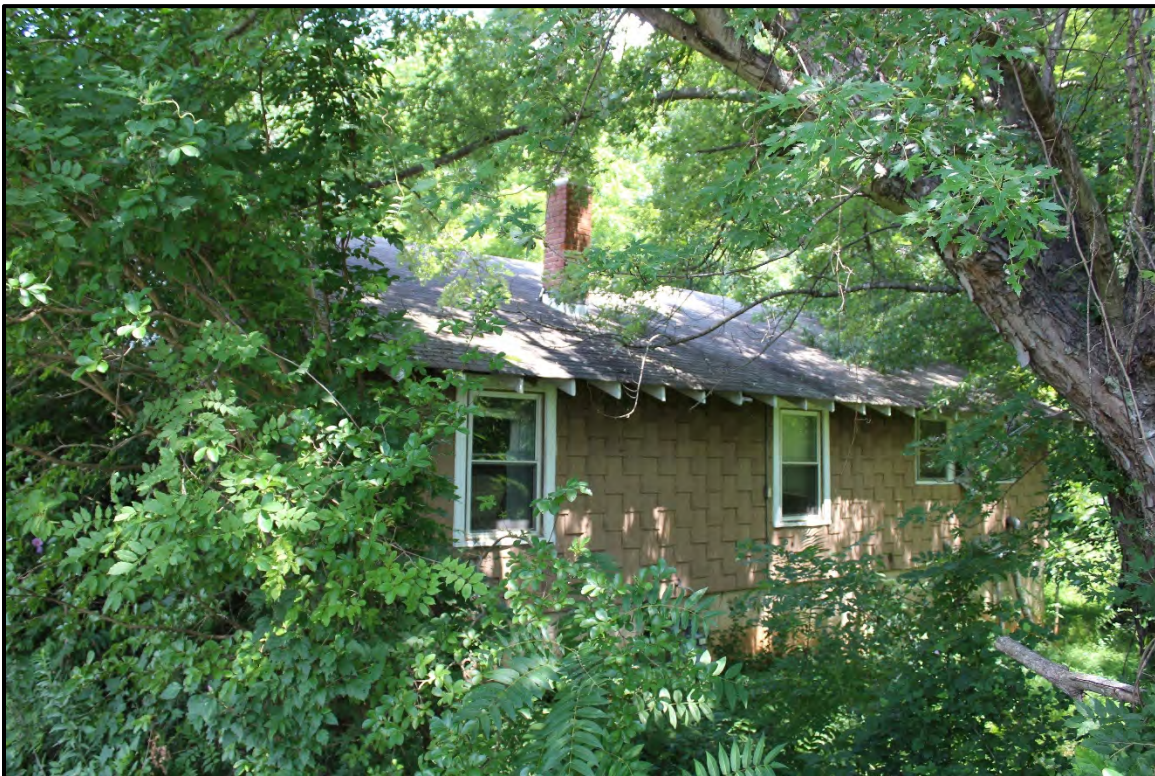
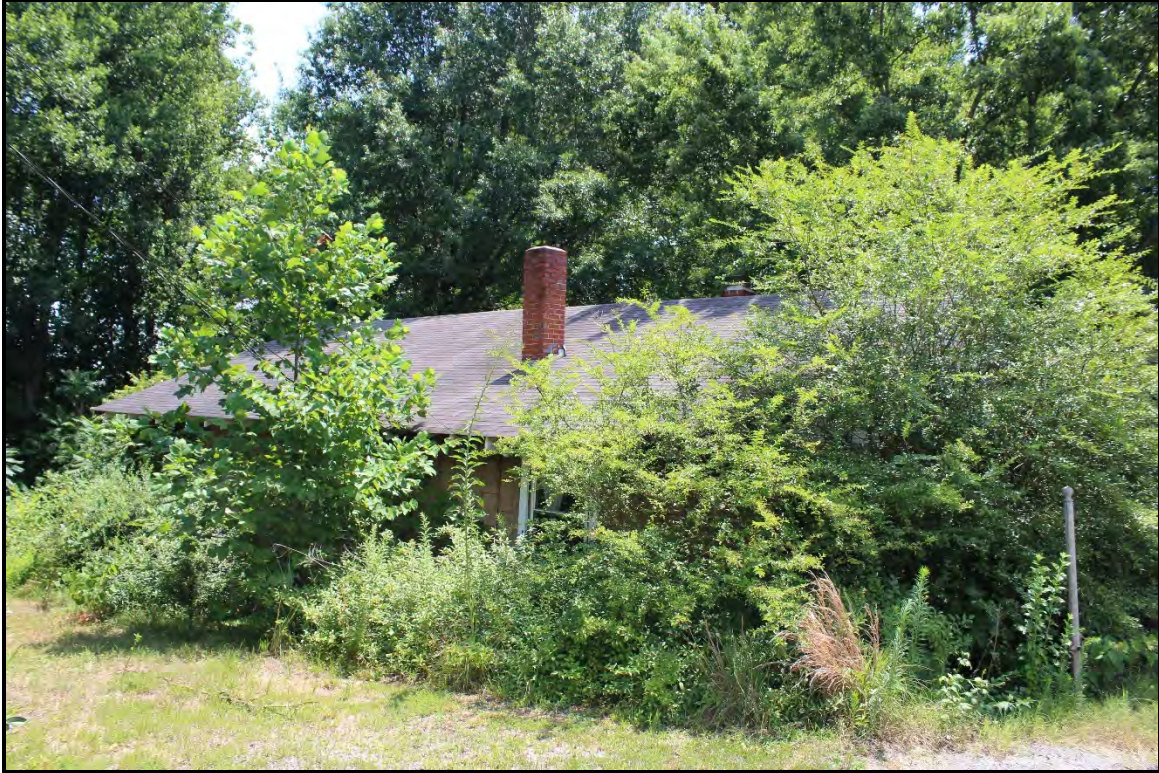
The one-story, wood-frame house is abandoned and overgrown with vegetation. Based on limited views of the house, it features a roof with exposed rafter tails, two interior brick chimneys, an exterior clad with staggered asphalt shingle siding, and a concrete block foundation. The main entrance is on the southwest façade but is obscured due to heavy vegetation. The house has 1/1 vinyl sash replacement windows.

NRHP Assessment. Architectural resource RK1721 does not exhibit a distinctive architectural style or workmanship. In addition, the house has been altered through the replacement of the original window sashes and the application of asphalt shingle siding. Based on the lack of architectural merit, as well as the inability to associate the house and/or its original owner(s) with an important historical event or series of events, it is TRC’s opinion that architectural resource RK1721 is not eligible for the NRHP.

Figure 5.177. Architectural resource RK1721; view is north featuring the southeast elevation.

Figure 5.178. Architectural resource RK1721; view is south featuring the northwest elevation.

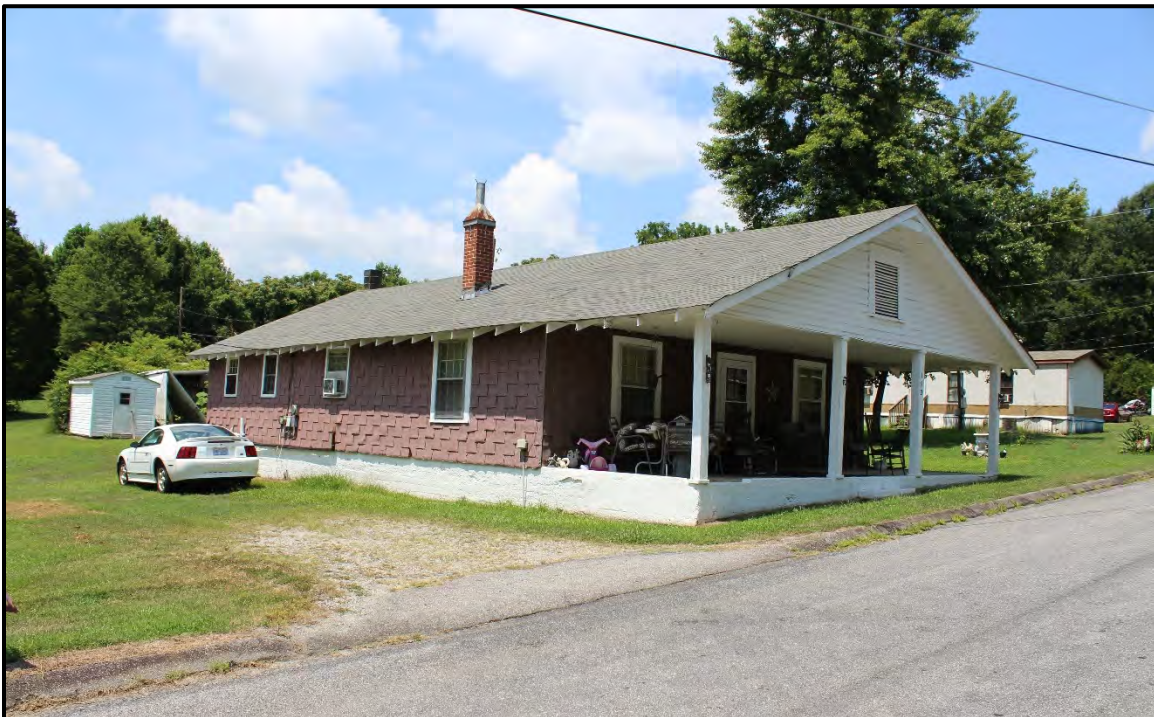
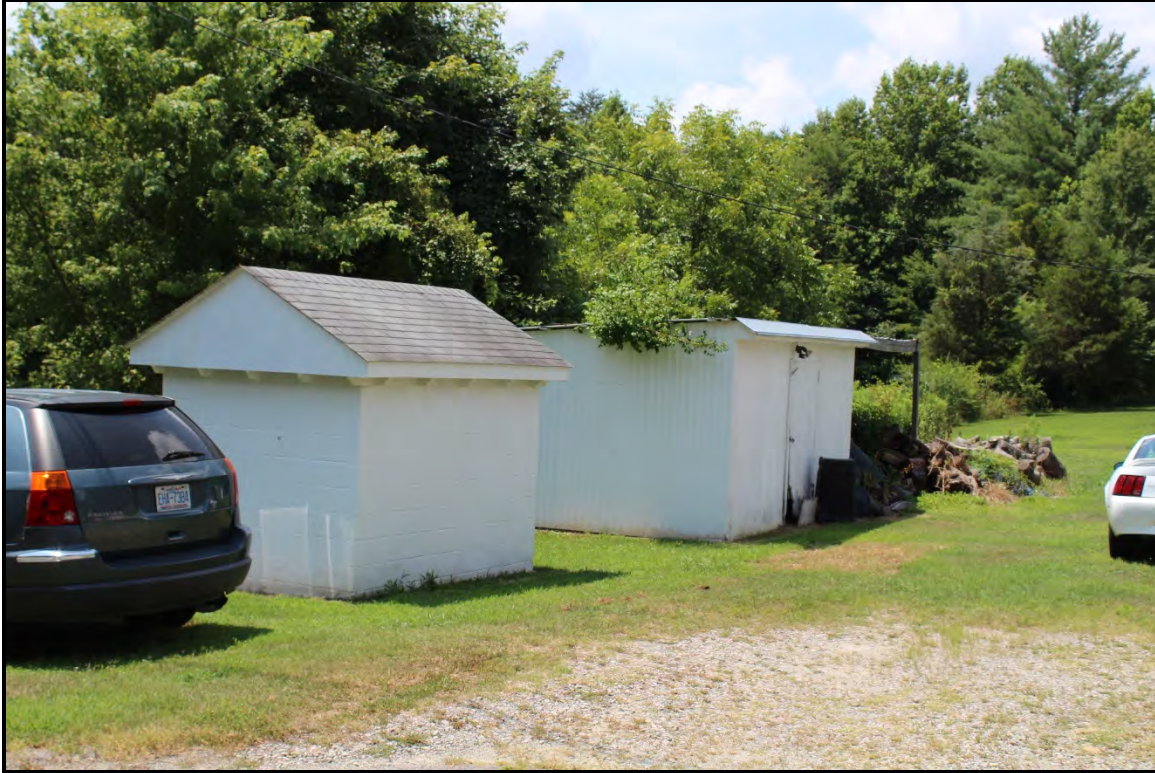
The one-story, wood-frame building features a roof with exposed rafter tails, two interior brick chimneys, an exterior clad with staggered asphalt shingle siding, and a concrete block foundation. The façade is marked by a full-width porch that is integral with the main roof. The porch contains a concrete deck and four square wooden posts that support the porch roof. Wood drop siding and a louvered attic vent are situated within the gable field. The porch shelters a central entrance with a four-light glazed door that is flanked by two 8/8 wood sash windows, which are used throughout the house. The house has two outbuildings, including a concrete block shed with gable roof and a metal frame shed with a shed roof.

NRHP Assessment. Architectural resource RK1722 does not exhibit a distinctive architectural style or workmanship. In addition, the house has been altered through the application of asphalt shingle siding. Based on the lack of architectural merit, as well as the inability to associate the house and/or its original owner(s) with an important historical event or series of events, it is TRC’s opinion that architectural resource RK1722 is not eligible for the NRHP.

Figure 5.179. Architectural resource RK1722; view is south featuring the façade and northwest elevation.

Figure 5.180. Architectural resource RK1722; view is southwest featuring the associated outbuildings.

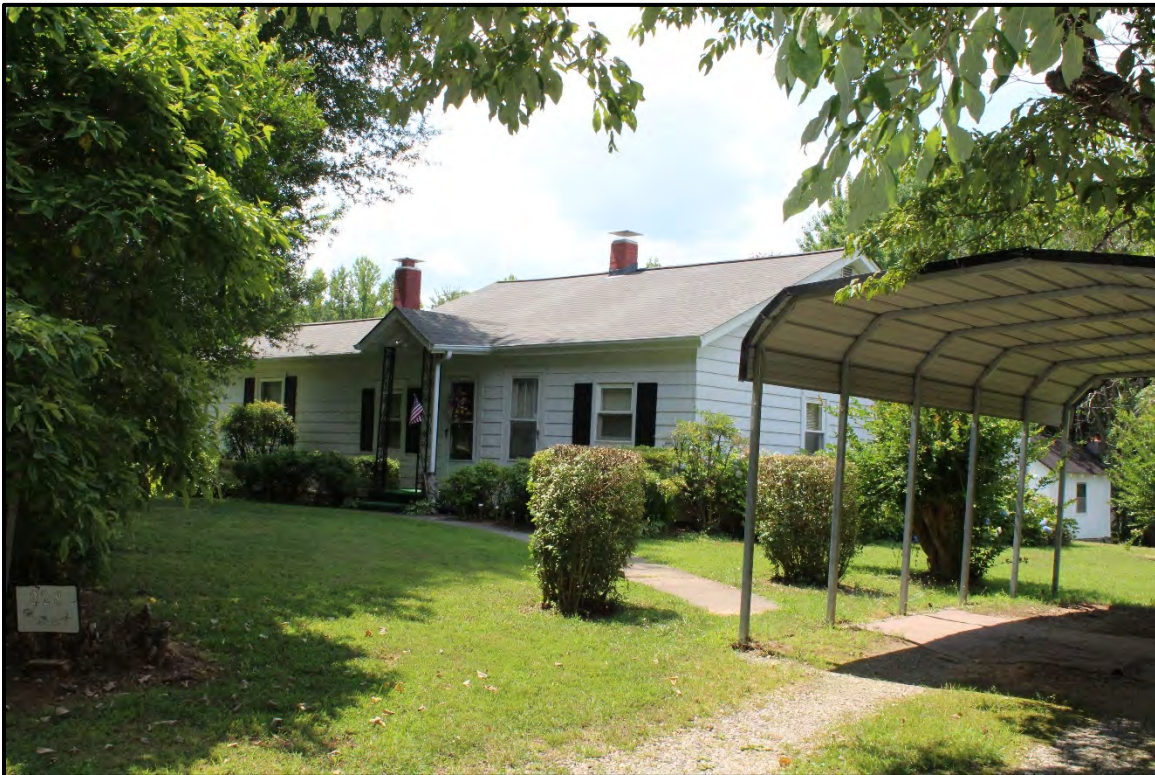
The one-story, wood-frame building features a side-gabled roof, an exterior clad with aluminum siding, and a concrete block foundation. There are two front entrances with vertical-light glazed doors, one of which is sheltered by a front-gabled stoop with decorative iron posts and a concrete floor. The house has 1/1 vinyl sash windows throughout. There are three small storage outbuildings, including one with concrete block construction and a gable roof, and two of frame construction with gable roofs.

NRHP Assessment. Architectural resource RK1723 does not exhibit a distinctive architectural style or workmanship. In addition, the house has been altered through the application of aluminum siding; the replacement of the original window sashes and porch columns. Based on the lack of architectural merit, as well as the inability to associate the house and/or its original owner(s) with an important historical event or series of events, it is TRC’s opinion that architectural resource RK1723 is not eligible for the NRHP.

Figure 5.181. Architectural resource RK1723; view is south showing the façade and northwest elevation.

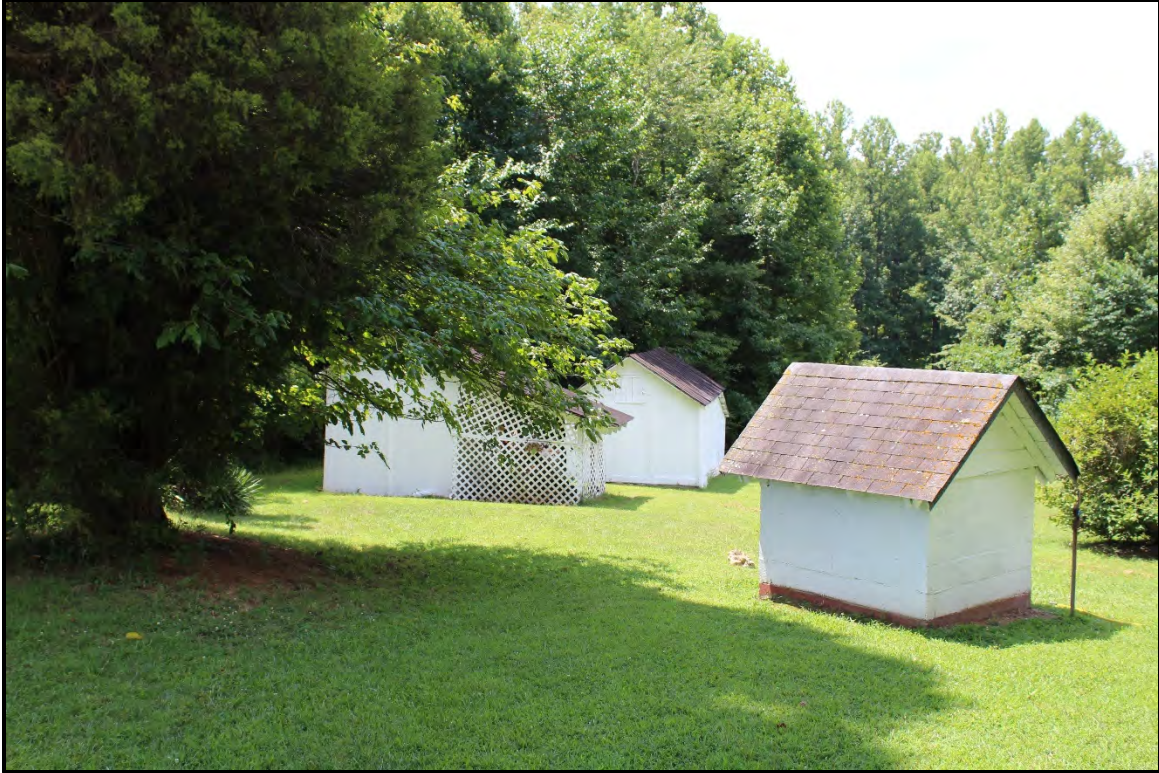
Figure 5.182. Architectural resource RK1723; view is south featuring the associated outbuildings.

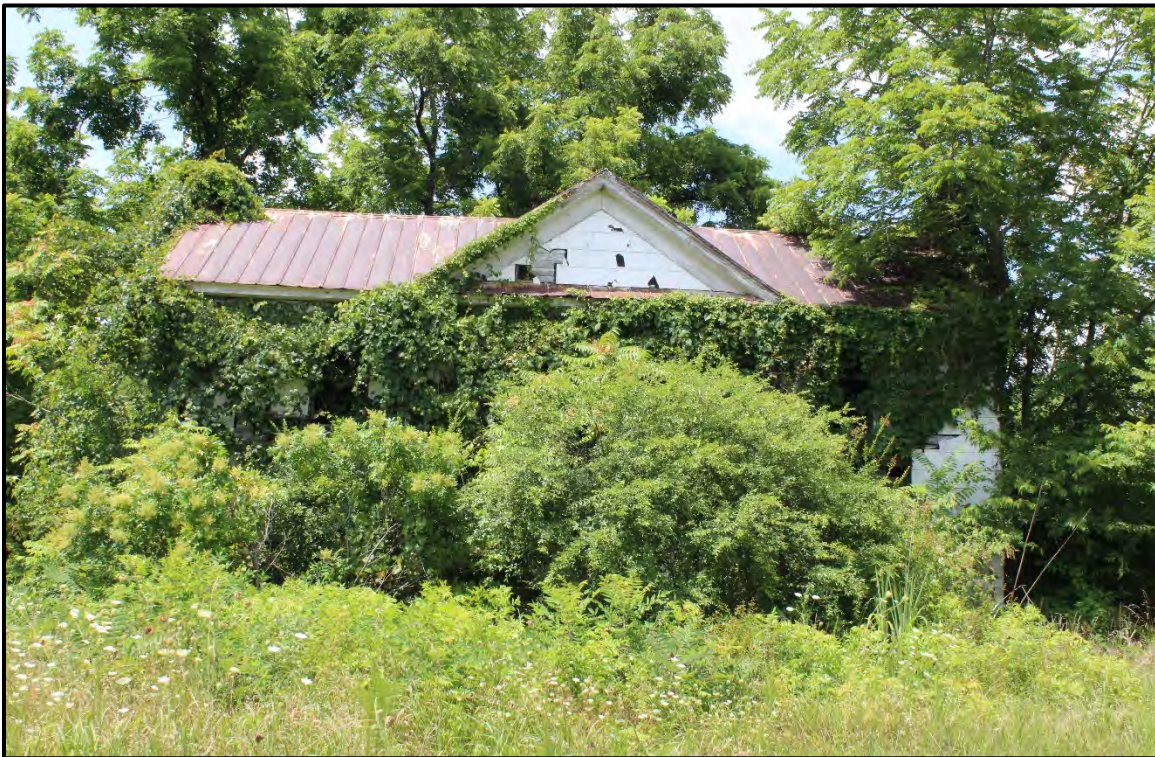
RK1724 contains a two-story “Triple A” type house with a standing-seam metal roof and asbestos shingles over clapboard siding. The remainder of the house is not visible due to overgrown vegetation. The second resource on the property is a one-story hipped-roof house with a collapsing front porch and an interior brick chimney. The remainder of the house is not visible due to overgrown vegetation. The third house appears to be a small tenant house with a side-gabled roof clad in standing-seam metal and a clapboard exterior. The remainder of the house is not visible due to overgrown vegetation.

NRHP Assessment. Architectural resource RK1724 is an abandoned early twentieth century farmstead that possesses poor architectural integrity due to neglect and deterioration. Based on the lack of architectural merit, as well as the inability to associate the house and/or its original owner(s) with an important historical event or series of events, it is TRC’s opinion that architectural resource architectural resource RK1724 is not eligible for the NRHP.

Figure 5.183. Architectural resource RK1724; view is southwest featuring the “Triple A” style house overgrown with vegetation.

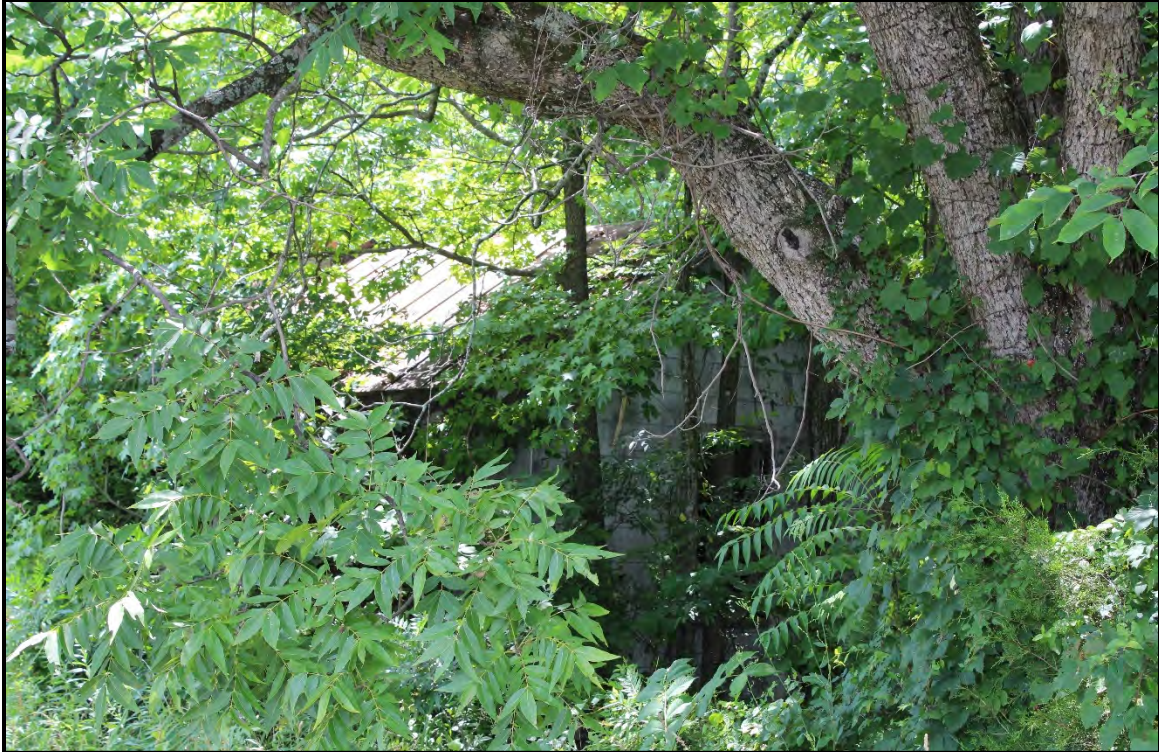
Figure 5.184. Architectural resource RK1724; view is southwest showing small, overgrown tenant house.

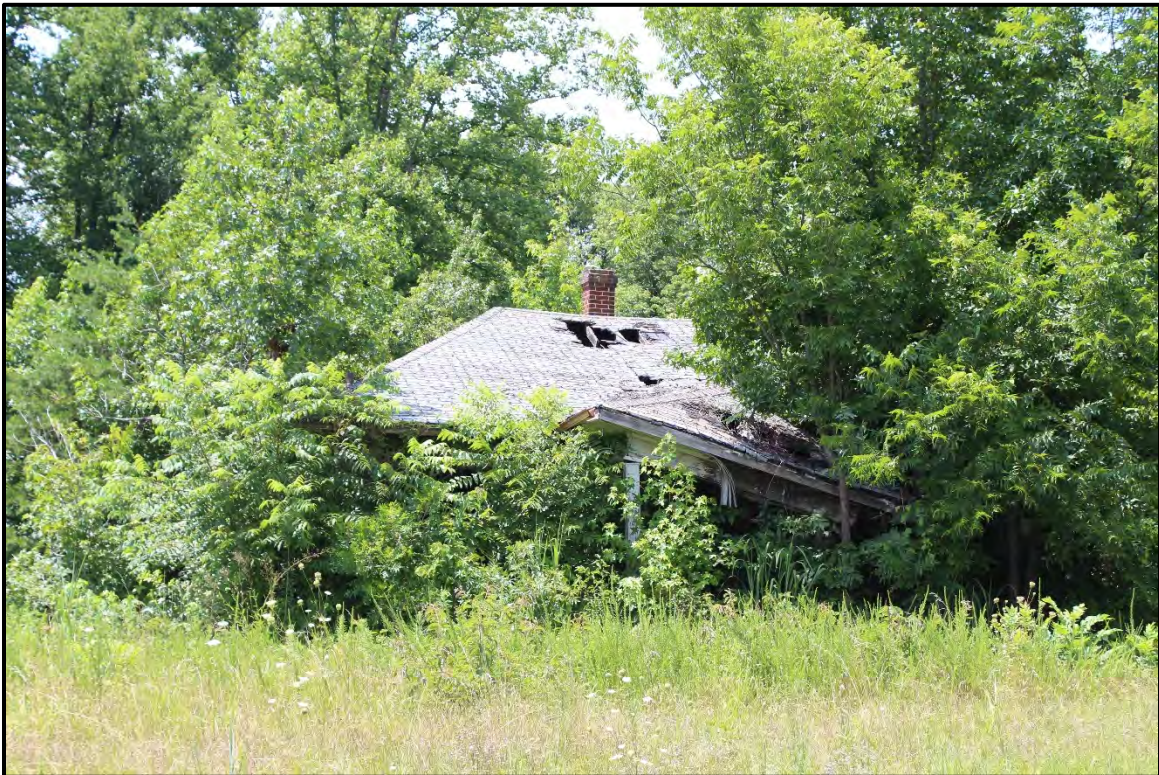
Figure 5.185. Architectural resource RK1724; view is southwest showing collapsed hipped-roofed house overgrown with vegetation.

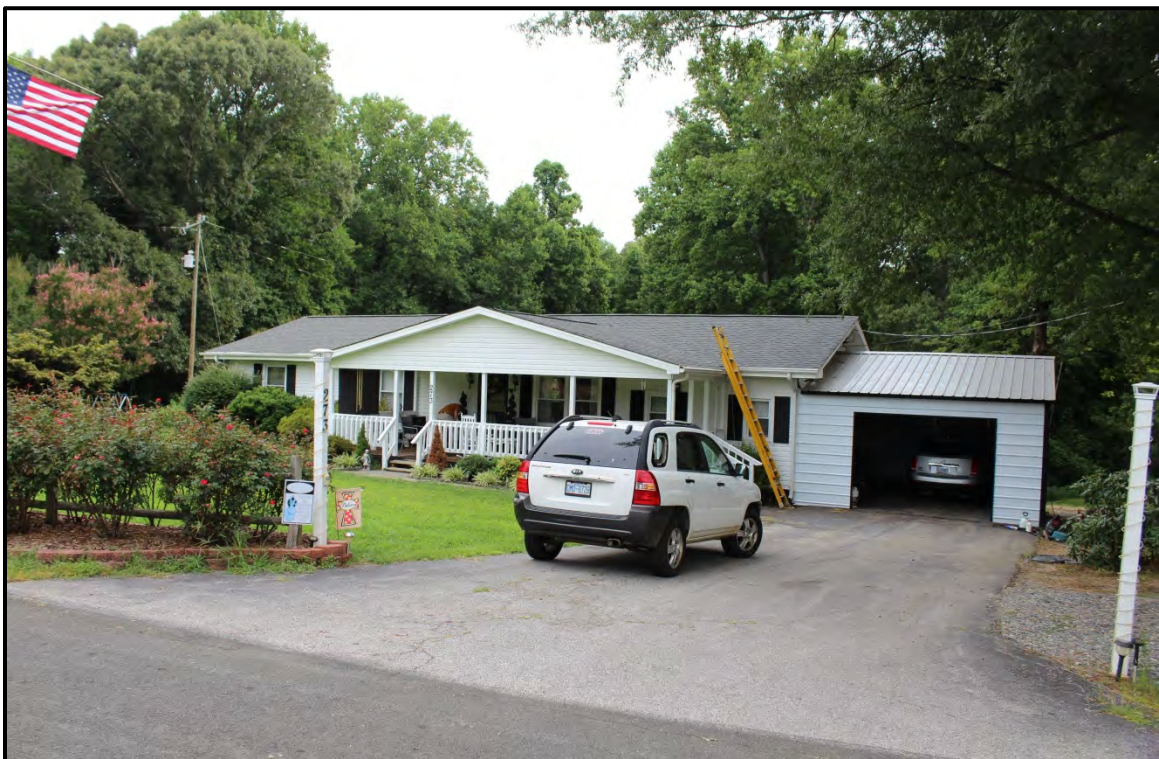
The one-story, wood-frame building features a side-gabled roof, an exterior clad with vinyl siding, and a concrete block foundation. Across the façade is a partial-width front porch with a front gable roof supported by square wood posts. The house has 1/1 vinyl sash windows throughout. There is a one-bay garage addition on the southeast elevation of the house. There are three small storage outbuildings, including one with concrete block construction and a gable roof, and two of frame construction with gable roofs. Just southeast of the house is a storage outbuilding with a combination of frame and metal structure and a metal roof.

NRHP Assessment. Architectural resource RK1725 does not exhibit a distinctive architectural style or workmanship. In addition, the house has been altered through the reconstruction of the façade porch, the application of vinyl siding, and the replacement of the original window sashes. Based on the lack of architectural merit, as well as the inability to associate the house and/or its original owner(s) with an important historical event or series of events, it is TRC’s opinion that architectural resource RK1725 is not eligible for the NRHP.

Figure 5.186. Architectural resource RK1725; view is northeast showing the façade.

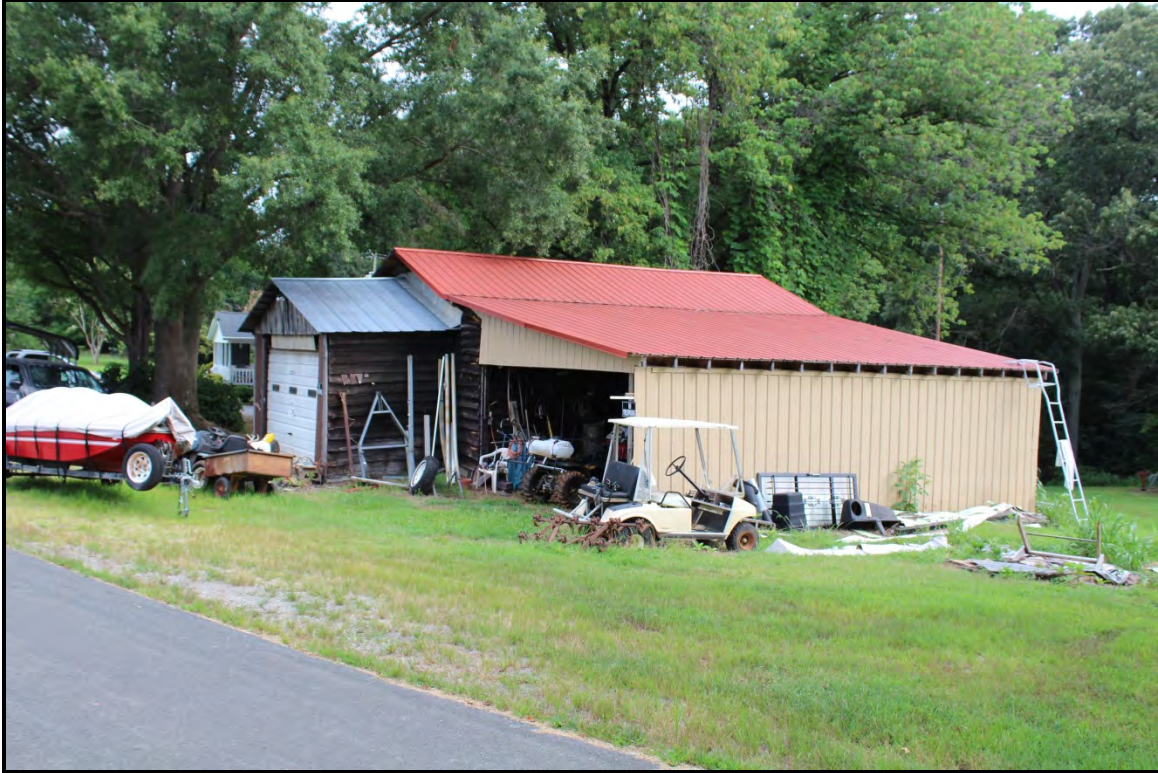
Figure 5.187. Architectural resource RK1725; view is north showing the associated outbuilding.
