Re: Revised Architectural Survey Report, MVP Southgate Project, Construct Interstate Pipeline, Rockingham and Alamance County, ER 18-1041

Thank you for your letter of October 11, 2019, transmitting the draft "Historic Architectural Survey for the MVP Southgate Pipeline Project". We have reviewed the report and offer the following comments.

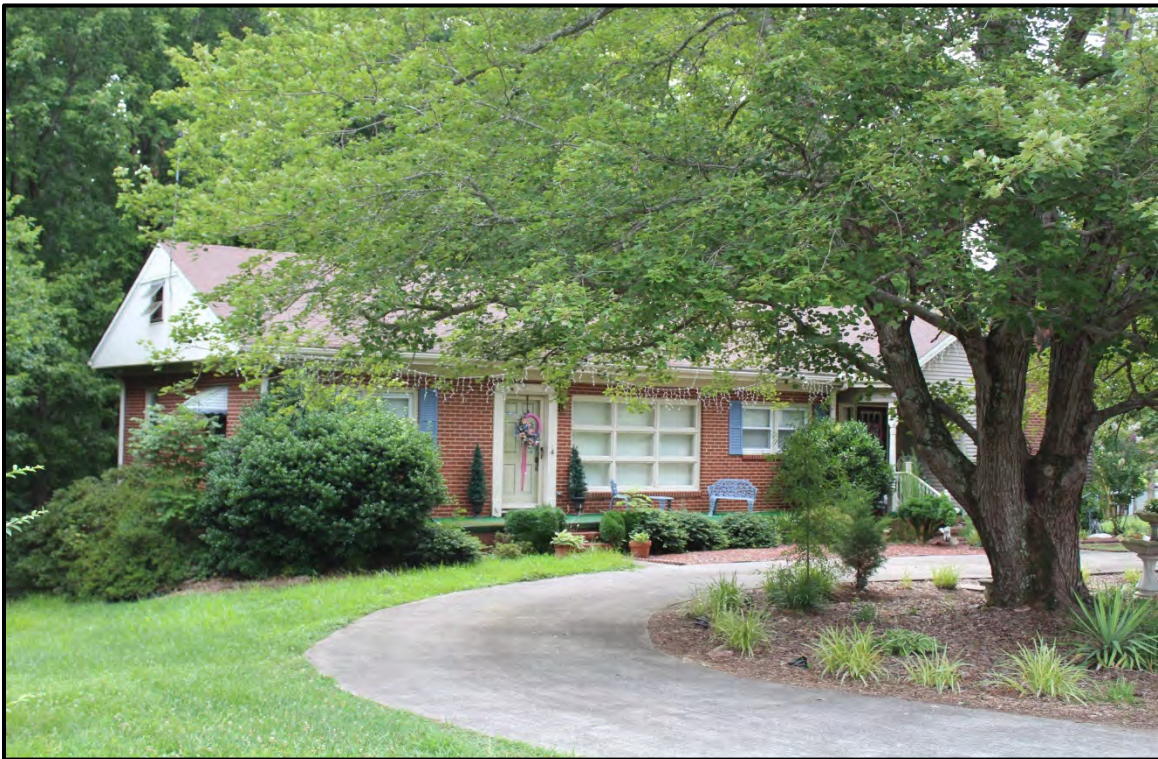
The wood-frame building features a side-gabled roof, an exterior clad with a brick veneer, and a continuous brick foundation. Attached to the southeast elevation is a modern addition with a gable-front roof that contains a second entrance covered by a recessed porch. There is a continuous uncovered brick porch across the façade that terminates at a gable-front portion at the southeast end. The house has 1/1 vinyl sash windows throughout.

NRHP Assessment. Architectural resource RK1726 does not exhibit a distinctive architectural style or workmanship. In addition, the house has been altered through the replacement of most of the original window sashes and the construction of the modern addition to the southeast elevation. Based on the lack of architectural merit, as well as the inability to associate the house and/or its original owner(s) with an important historical event or series of events, it is TRC's opinion that architectural resource RK1726 is not eligible for the NRHP.

Figure 5.188. Architectural resource RK1726; view is southeast featuring the façade and northwest elevation.

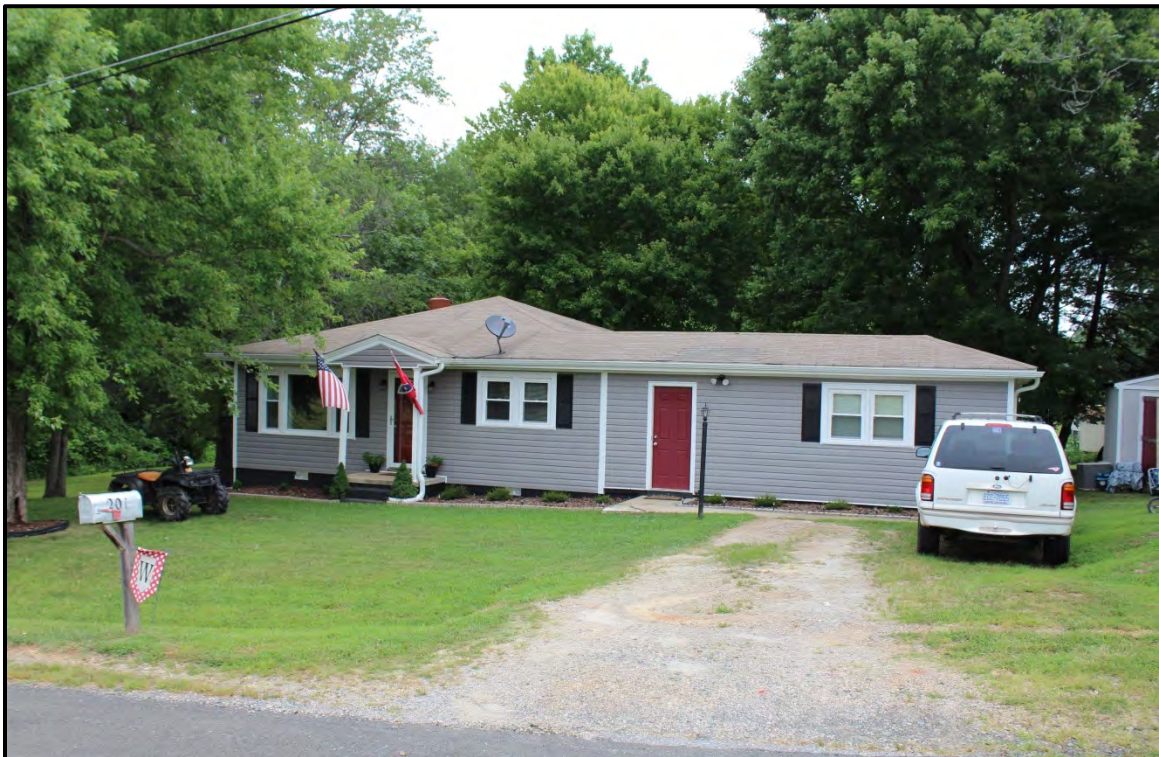
The one-story, wood-frame building features a hipped roof, an interior brick chimney, an exterior clad with vinyl siding, and a continuous concrete block foundation. The original main entrance is approached via a concrete stoop with a front-gabled roof supported by square wood posts. On the southeast end of the house is a modern addition with a hipped roof that contains a second, uncovered entrance. The house has a three-part picture window on the façade and paired of 1/1 vinyl sash replacement windows. There is a modern frame storage shed in the rear yard.

NRHP Assessment. Architectural resource RK1727 does not exhibit a distinctive architectural style or workmanship. In addition, the house has been altered through the replacement of the original window sashes, the construction of the modern addition to the southeast elevation, and the application of vinyl siding. Based on the lack of architectural merit, as well as the inability to associate the house and/or its original owner(s) with an important historical event or series of events, it is TRC’s opinion that architectural resource RK1727 is not eligible for the NRHP.

Figure 5.189. Architectural resource RK1727; view is northeast featuring the façade.

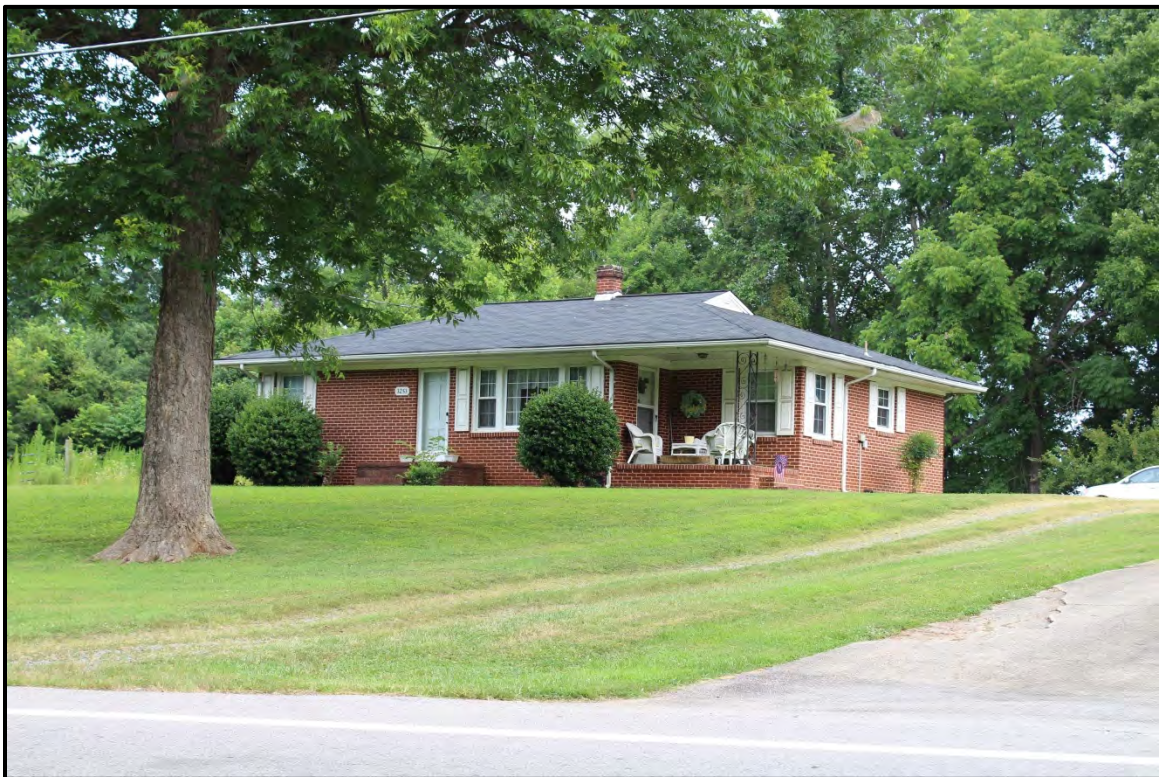
The wood-frame building features a side-gable-on-hip roof, a brick veneer exterior, and a continuous brick foundation. The southeast façade has an offset entrance approached via a brick stoop that is flanked by a replacement picture window with vinyl sashes. There are 6/6 vinyl sash windows throughout the rest of the house. The house has a single interior central brick chimney. There is a recessed corner front porch with a decorative iron column that shelters a secondary entrance.

NRHP Assessment. Architectural resource RK1728 does not exhibit a distinctive architectural style or workmanship. In addition, the house has been altered through the replacement of the original window sashes. Based on the lack of architectural merit, as well as the inability to associate the house and/or its original owner(s) with an important historical event or series of events, it is TRC’s opinion that architectural resource RK1728 is not eligible for the NRHP.

Figure 5.190. Architectural resource RK1728; view is northwest featuring the façade and northeast elevation.

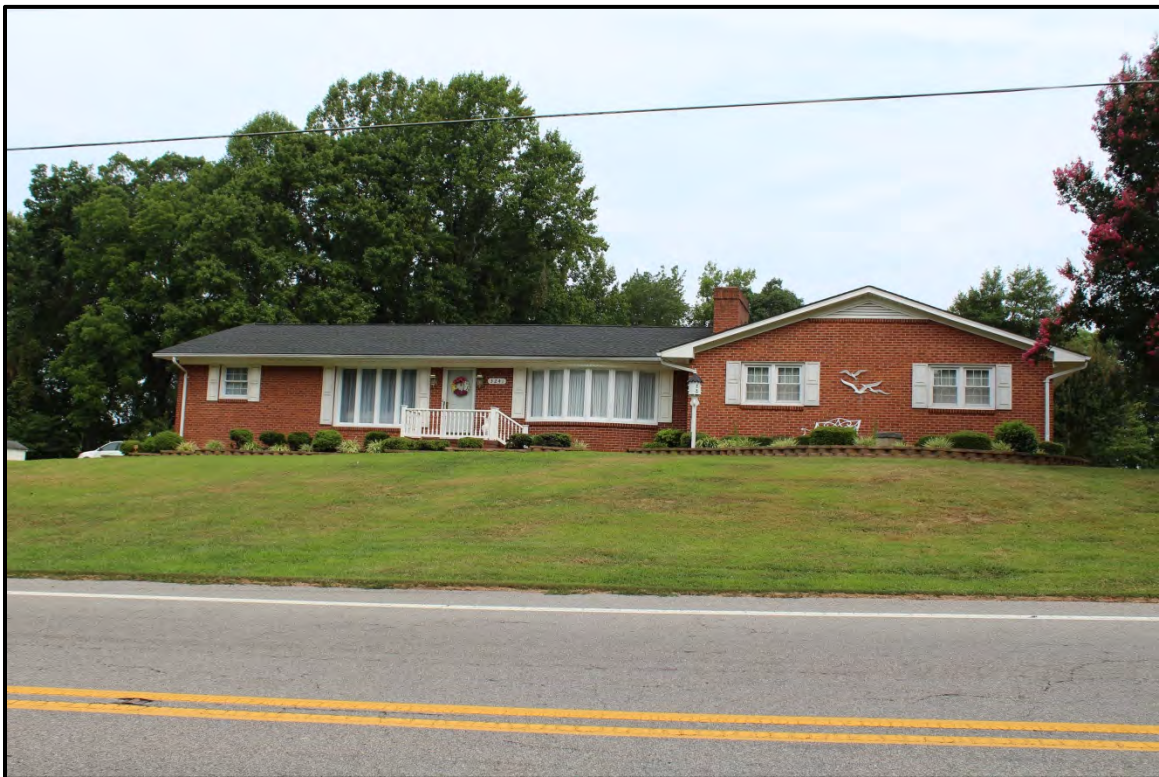
The wood-frame building features a gable-front-and-wing plan, a brick veneer exterior, and a continuous brick foundation. The southeast façade has an offset entrance with a replacement panel door approached via a brick stoop that is flanked by a four-light picture window on one side and a six-light bay picture window on the other. There are 6/6 vinyl sash windows throughout the rest of the house. The house has a single interior brick chimney.

NRHP Assessment. Architectural resource RK1729 does not exhibit a distinctive architectural style or workmanship. In addition, the house has been altered through the replacement of the original window sashes and the installation of modern balustrade on the porch. Based on the lack of architectural merit, as well as the inability to associate the house and/or its original owner(s) with an important historical event or series of events, it is TRC’s opinion that architectural resource RK1729 is not eligible for the NRHP.

Figure 5.191. Architectural resource RK1729; view is northwest featuring the façade.

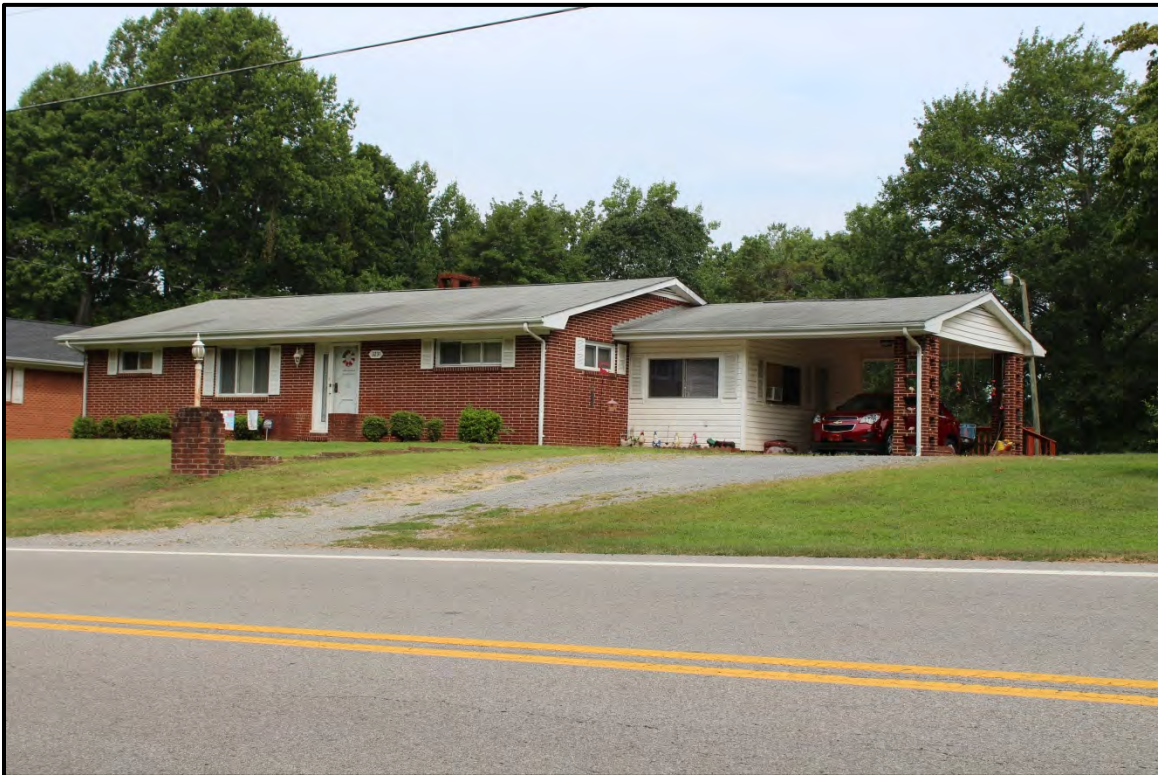
The wood-frame building features a side gabled roof, a brick veneer exterior, and a continuous brick foundation. The southeast façade has an offset entrance with an embossed door approached via a brick stoop. Flanking the entrance are a three-light horizontal sliding picture window and two-light sliding windows with vinyl faux shutters. On the northeast elevation is a partially enclosed carport supported by decorative brick columns. The house has a single interior brick chimney.

NRHP Assessment. Architectural resource RK1730 does not exhibit a distinctive architectural style or workmanship. In addition, the house has been altered through the partial enclosure of the carport and the replacement of the original window sashes. Based on the lack of architectural merit, as well as the inability to associate the house and/or its original owner(s) with an important historical event or series of events, it is TRC’s opinion that architectural resource RK1730 is not eligible for the NRHP.

Figure 5.192. Architectural resource RK1730; view is northwest featuring the façade and attached carport on the northeast elevation.

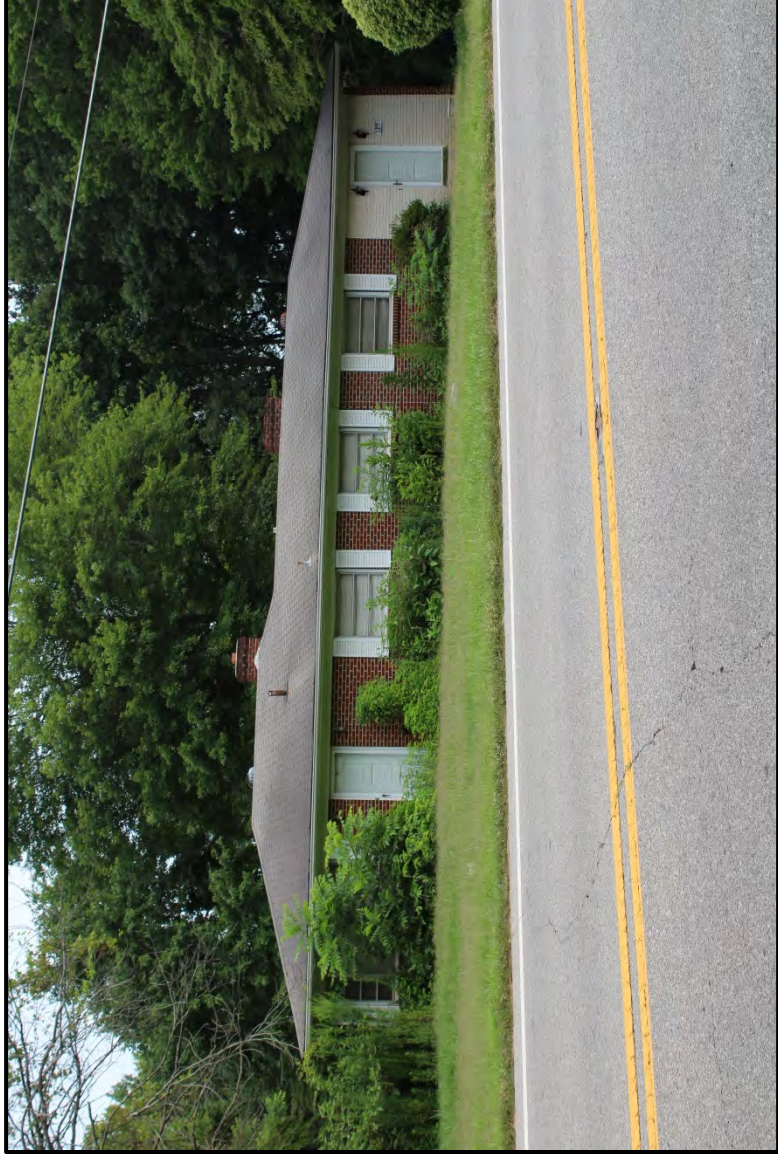
The wood-frame building features a hipped roof, a brick veneer exterior, and a continuous brick foundation. The façade has two separate entrances with paneled doors. The façade features a three-part picture window at the southwest end and horizontal three-light awning windows between the two front doors. There are two interior brick chimneys.

NRHP Assessment. Architectural resource RK1731 does not exhibit a distinctive architectural style or workmanship. In addition, the house has been altered through the enclosure of the carport. Based on the lack of architectural merit, as well as the inability to associate the house and/or its original owner(s) with an important historical event or series of events, it is TRC’s opinion that architectural resource RK1731 is not eligible for the NRHP.

Figure 5.193. Architectural resource RK1731; view is north featuring the façade.

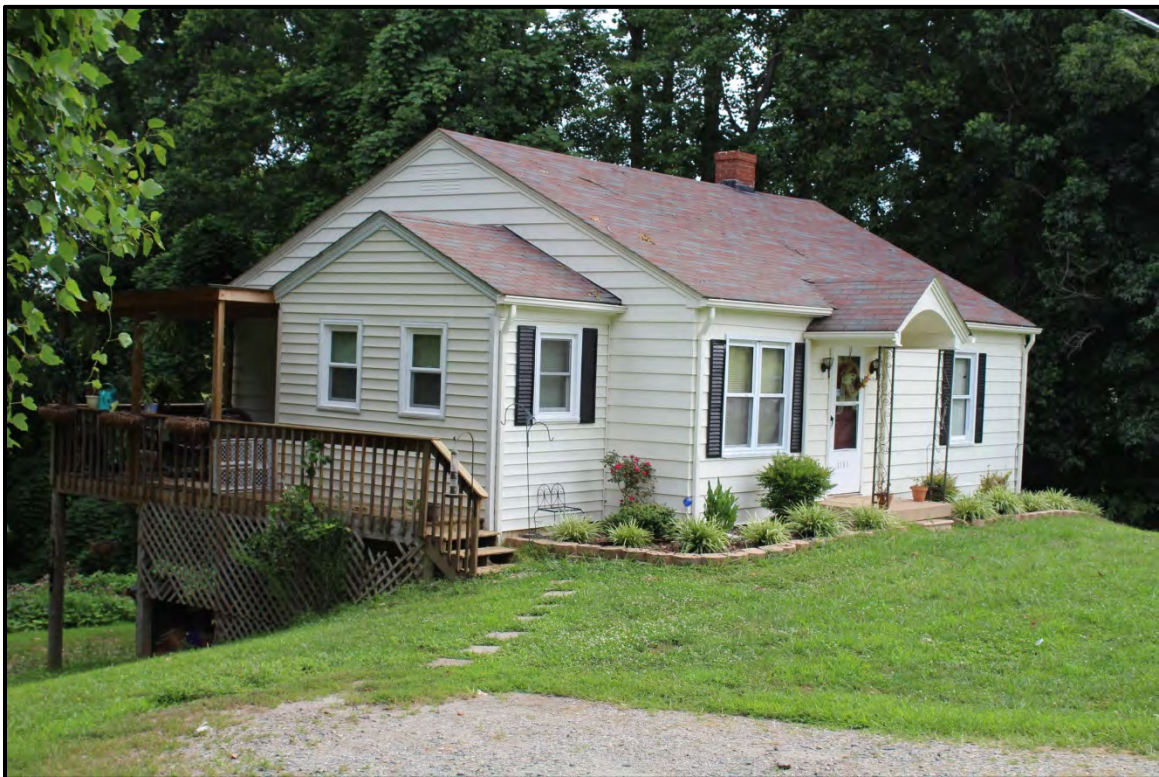
The one-story, wood-frame building features a side-gabled roof, an interior brick chimney, an exterior clad with vinyl siding, and a concrete block foundation. The central entrance is sheltered by an interior-arched gable porch hood with decorative iron posts and a concrete stoop. The entrance is flanked by single and paired 1/1 vinyl sash windows, which are used throughout the house. There is a side wing on the southwest elevation and wraparound rear wood deck.

NRHP Assessment. Architectural resource RK1732 does not exhibit a distinctive architectural style or workmanship. In addition, the house has been altered through the replacement of the original window sashes and the application of vinyl siding. Based on the lack of architectural merit, as well as the inability to associate the house and/or its original owner(s) with an important historical event or series of events, it is TRC's opinion that architectural resource RK1732 is not eligible for the NRHP.

Figure 5.194. Architectural resource RK1732; view is northeast featuring the façade and southwest elevation.

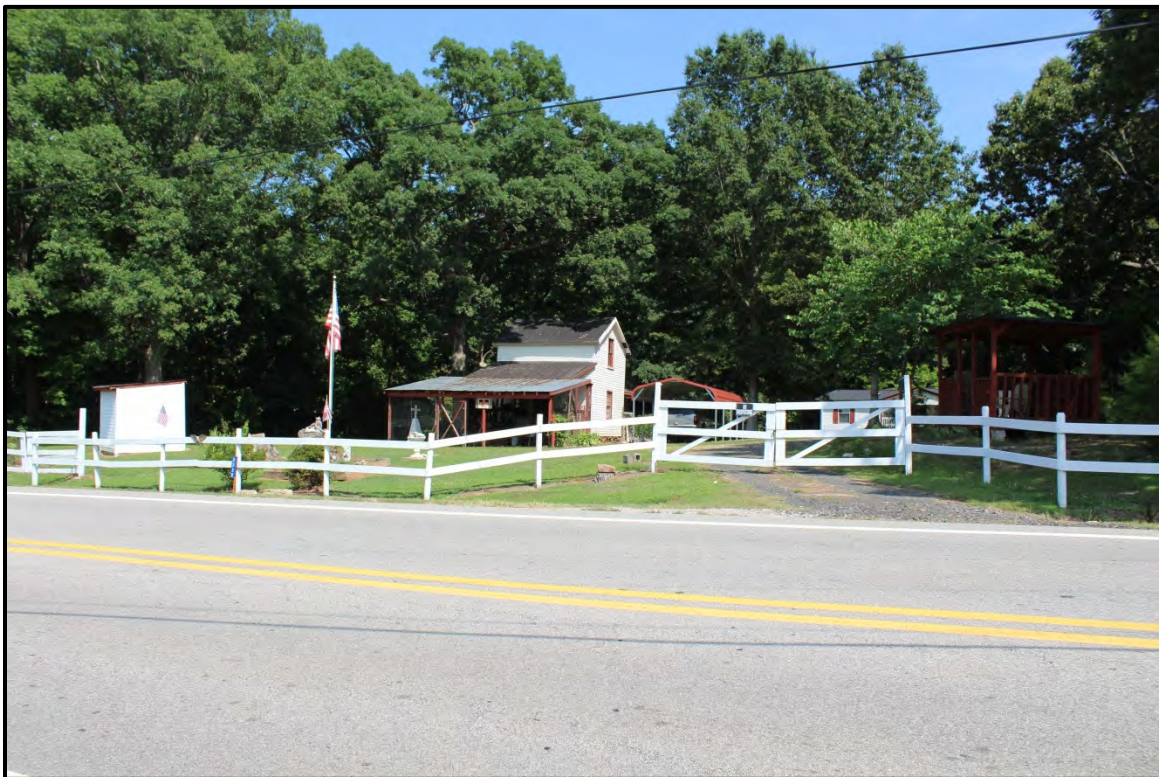
The one and one-half-story, wood-frame building features a side-gabled roof covered with standing seam metal, an exterior clad with vinyl siding, and a field stone foundation. Across the façade is an altered and extended full-length shed-roof porch supported by wood posts. The house has 6/6 wood sash windows and a rear ell. There is a modern metal detached carport on the southwest side of the house and a mobile home in the rear (south) yard.

NRHP Assessment. Architectural resource RK1733 does not exhibit a distinctive architectural style or workmanship. In addition, the building has been altered through the application of vinyl siding. Based on the lack of architectural merit, as well as the inability to associate the house and/or its original owner(s) with an important historical event or series of events, it is TRC’s opinion that architectural resource RK1733 is not eligible for the NRHP.

Figure 5.195. Architectural resource RK1733; view is southeast showing the façade and southwest elevation.

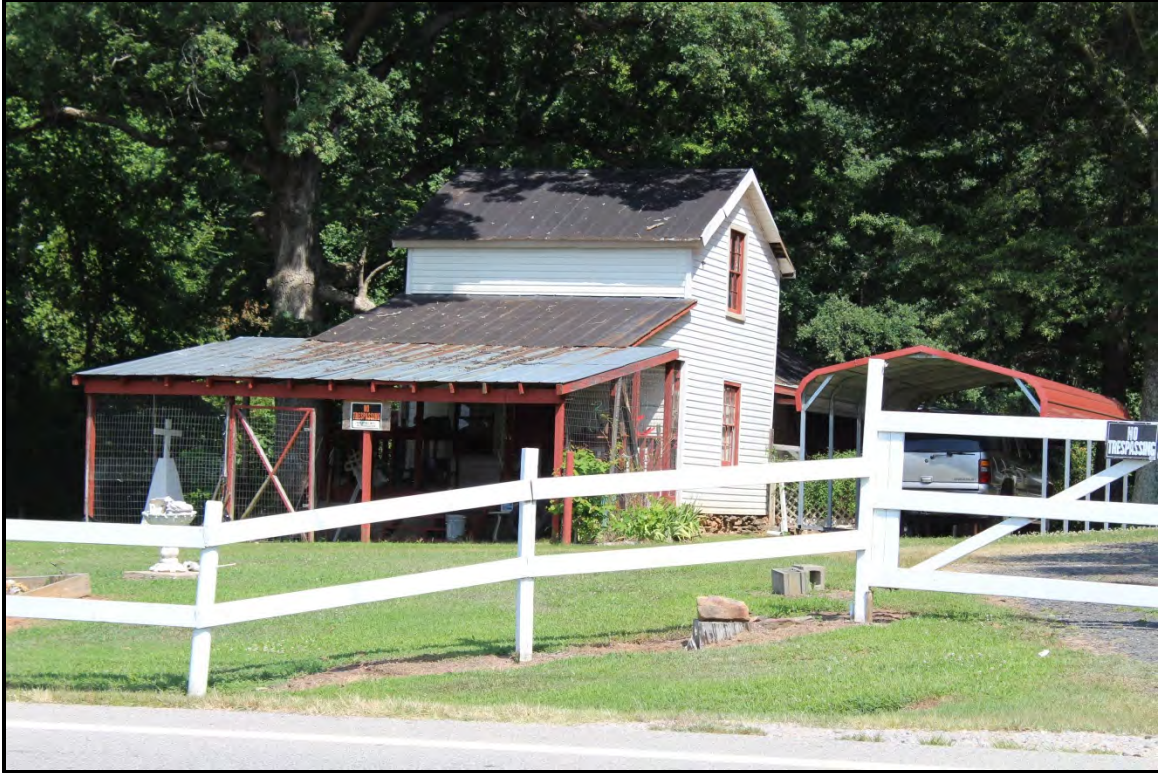
Figure 5.196. Architectural resource RK1733; view showing setting as well as façade and southwest elevation.

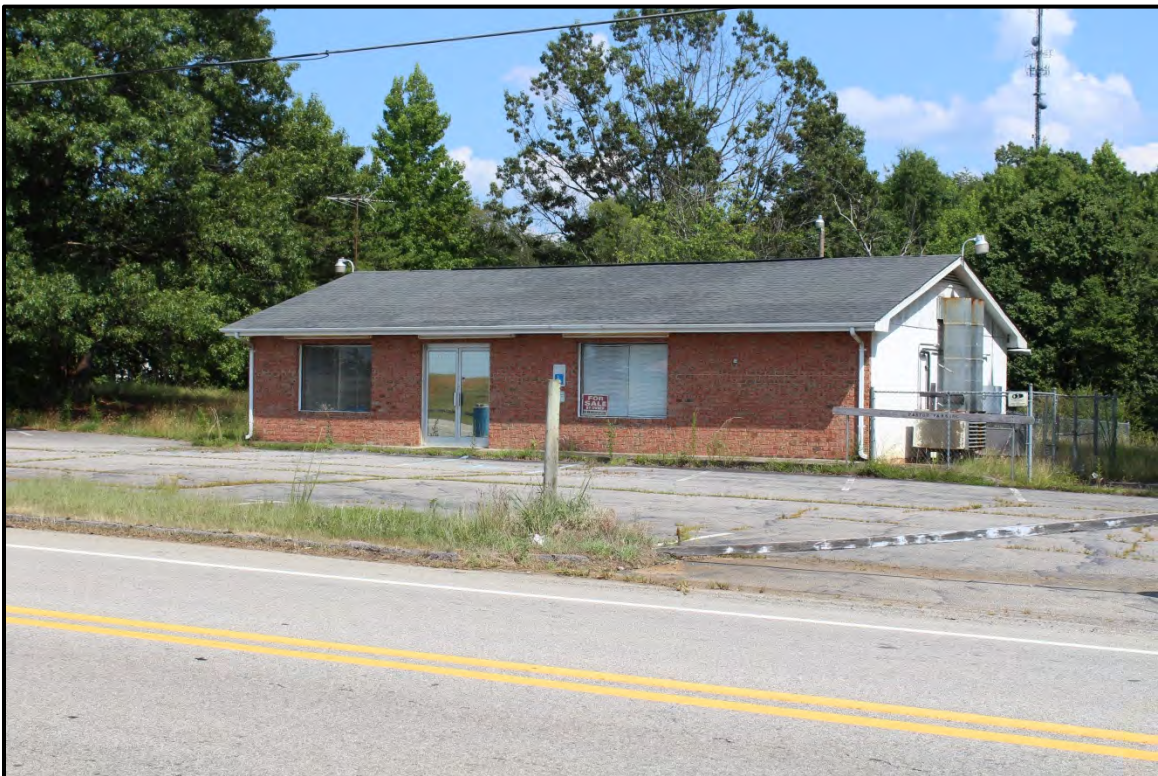
The one-story, wood-frame building features a side-gabled roof, concrete block construction with a brick veneer exterior, and a concrete slab foundation. There is an offset entrance with a double metal-frame door that is flanked by two fixed metal-frame picture windows. The building is fronted by a paved parking lot.

NRHP Assessment. Architectural resource RK1734 does not exhibit a distinctive architectural style or workmanship. Based on the lack of architectural merit, as well as the inability to associate the building and/or its original owner(s) with an important historical event or series of events, it is TRC’s opinion that architectural resource RK1734 is not eligible for the NRHP.

Figure 5.197. Architectural resource RK1734; view is southeast showing the façade and southwest elevation.

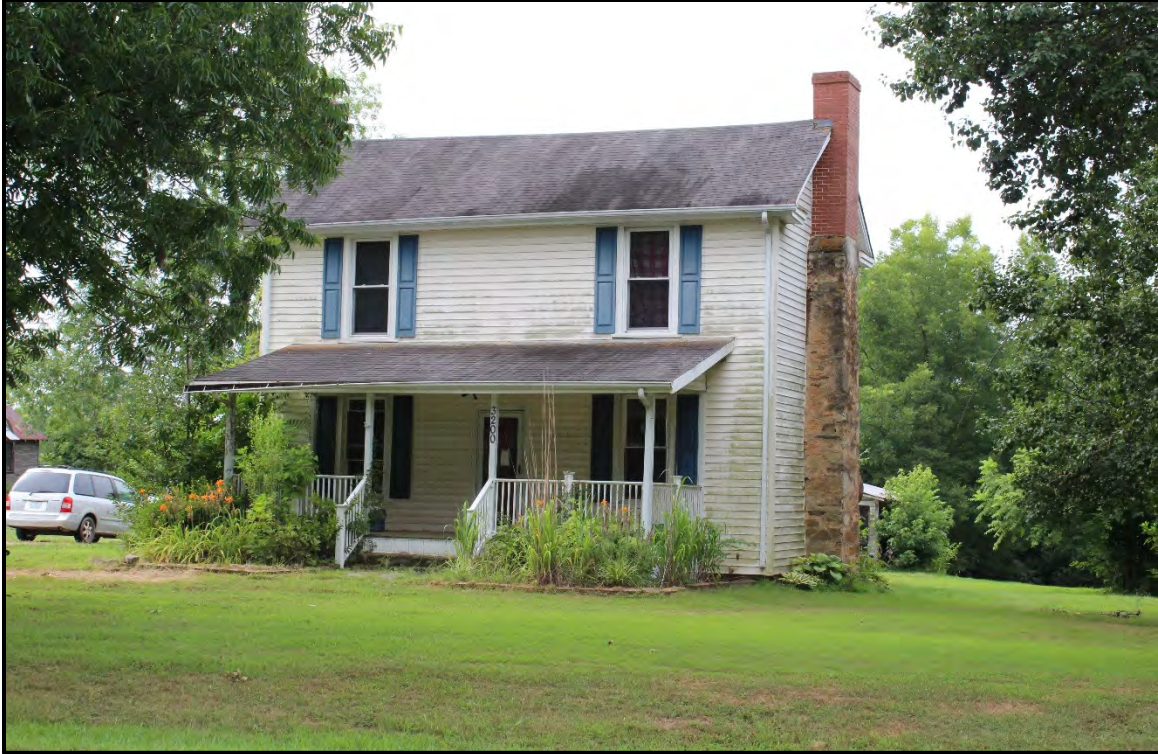
- A modern concrete block storage shed. The structure is capped with a gable-front roof covered with asphalt shingles (Figure 5.198);
- A ca. 1900 equipment shed. The wood frame structure features a gable-front roof covered with standing seam metal and an exterior clad with wide horizontal wood boards. Open bay shed wings are attached to the east and west elevations (Figure 5.199);

NRHP Assessment. Architectural resource RK1530 does not exhibit a distinctive architectural style or workmanship. In addition, the house has been altered through the application of vinyl siding, the replacement of the original window sashes, and the reconstruction of the façade porch. Based on the lack of architectural merit, as well as the inability to associate the house and/or its original owner(s) with an important historical event or series of events, it is TRC's opinion that architectural resource RK1530 is not eligible for the NRHP.

Figure 5.198. Architectural resource RK1530; view is southeast featuring the façade and west elevation.

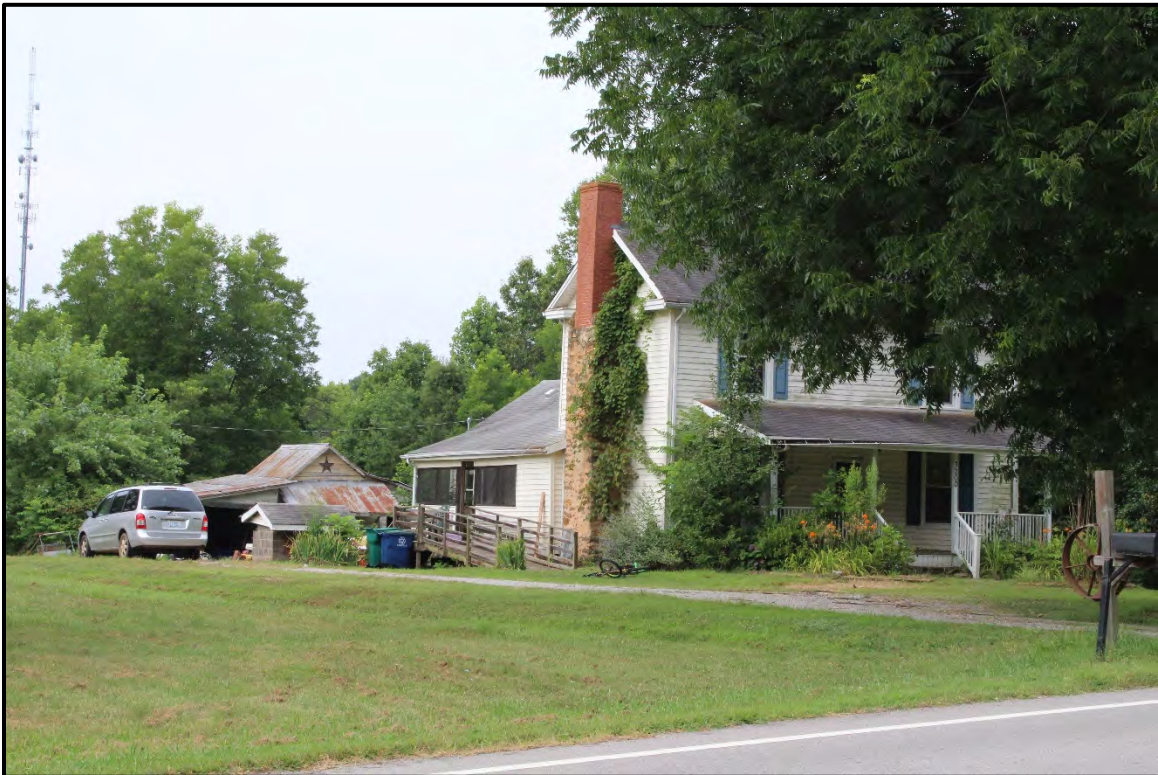
Figure 5.199. Architectural resource RK1530; view is southwest featuring the façade and east elevation of the house. The modern shed and ca. 1900 equipment shed are in the background.

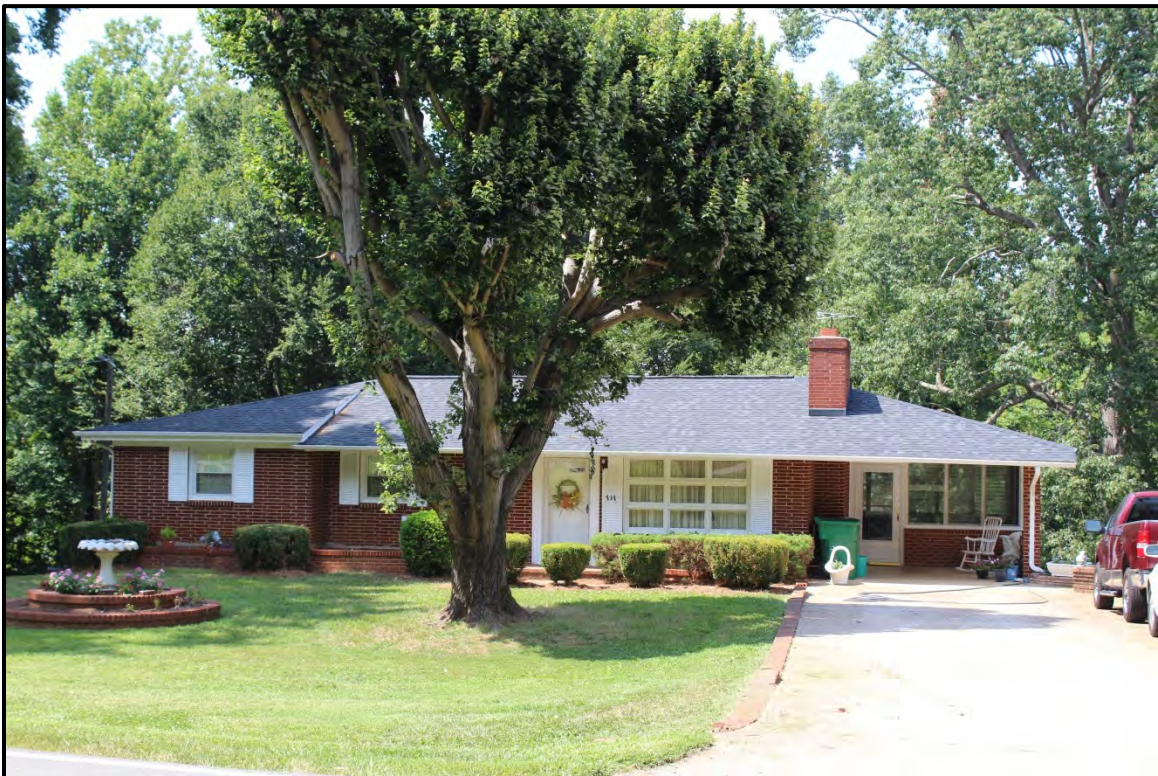
The wood-frame house is capped with a hipped roof and features an exterior clad with a brick veneer. The façade features brick planters along its length and a central entrance flanked by a nine-light picture window as well as two 6/6 replacement vinyl sash windows. There is an enclosed carport on the east end of the house now used as a sunroom. The house has an interior end brick chimney.

NRHP Assessment. Architectural resource RK1735 does not exhibit a distinctive architectural style or workmanship. In addition, the house has been altered through the installation of vinyl window sashes. Based on the lack of architectural merit, as well as the inability to associate the house and/or its original owner(s) with an important historical event or series of events, it is TRC’s opinion that architectural resource RK1735 is not eligible for the NRHP.

Figure 5.200. Architectural resource RK1735; view is north showing the façade.

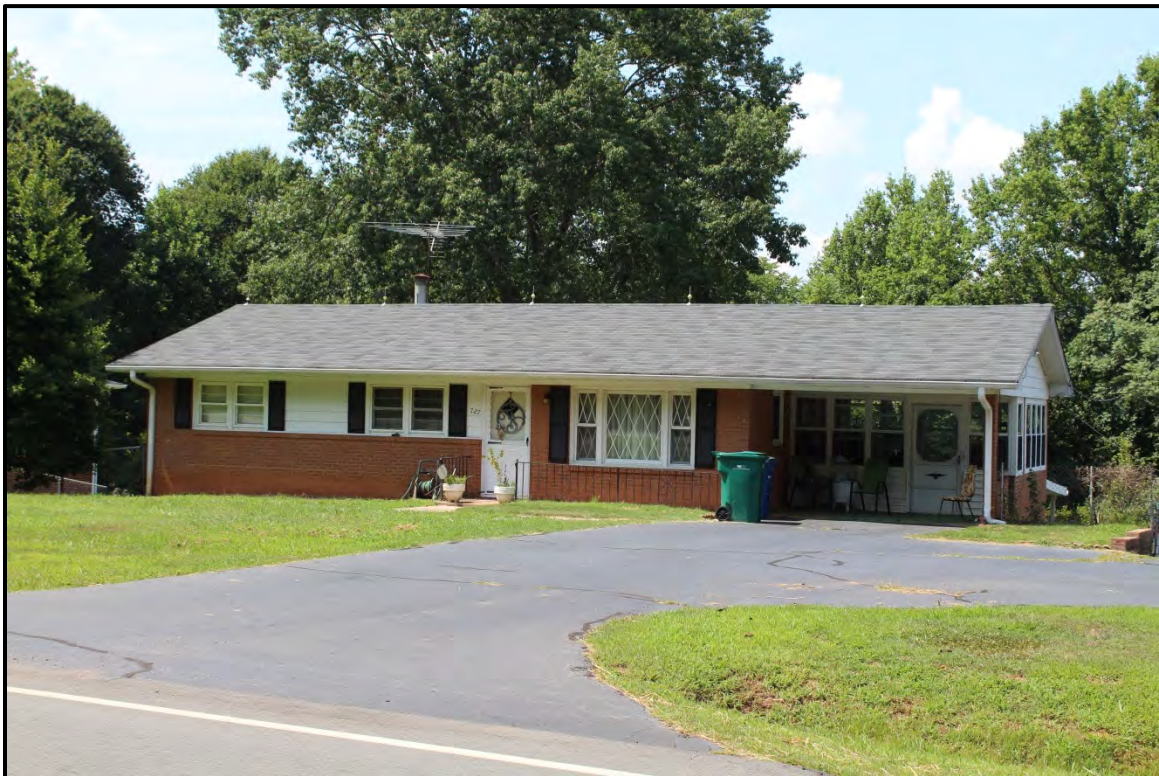
The wood-framed house features a side-gabled roof covered with asphalt shingles, an exterior clad with brick veneer, and a continuous brick foundation. Fenestration includes a three-part picture window with decorative muntins and horizontal 2/2, double-hung aluminum sashes. A carport is attached to the east elevation and has been partially enclosed to create additional living space.

NRHP Assessment. Architectural resource RK1736 does not exhibit a distinctive architectural style or workmanship. In addition, the house has been altered through the partial enclosure of the carport. Based on the lack of architectural merit, as well as the inability to associate the house and/or its original owner(s) with an important historical event or series of events, it is TRC’s opinion that architectural resource RK1736 is not eligible for the NRHP.

Figure 5.201. Architectural resource RK1736; view is northwest and features the façade and east elevation.

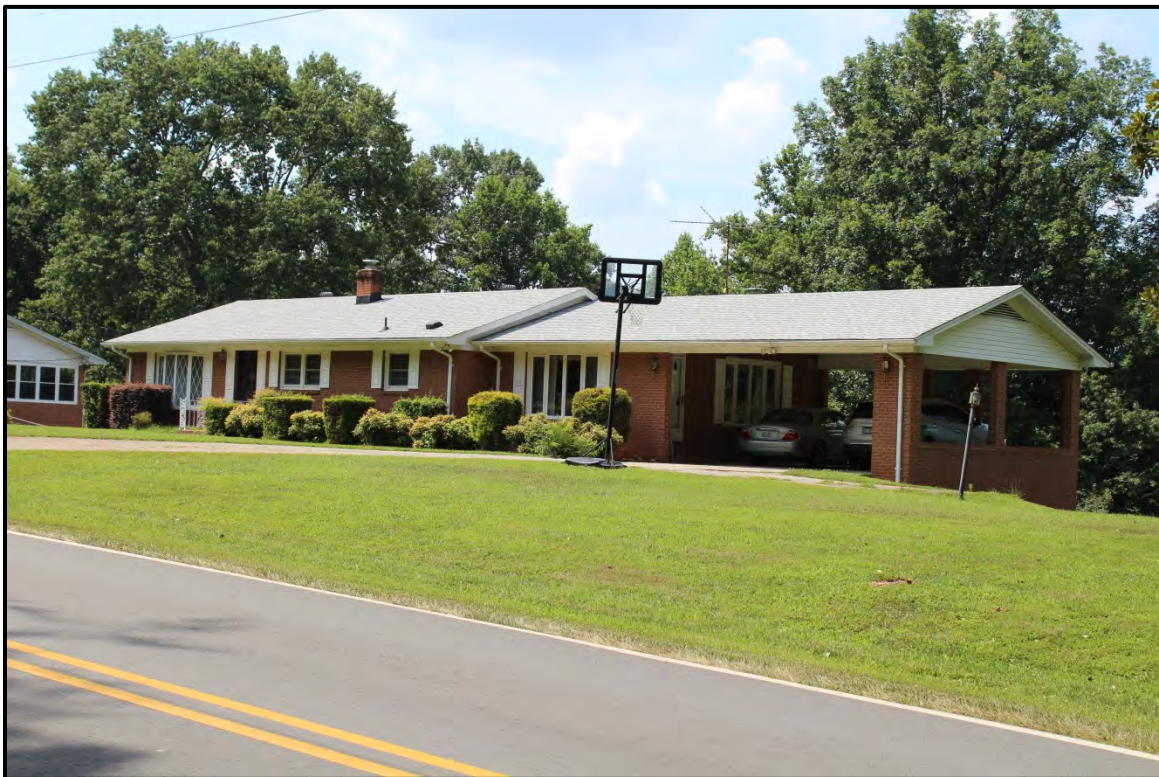
The wood-framed house features a side-gabled roof covered with asphalt shingles, an exterior clad with brick veneer, an interior central brick chimney, and a continuous brick foundation. Fenestration includes a four-light bay window containing vinyl sashes and horizontal 2/2, double-hung vinyl sashes. A gabled wing projects from the east elevation and is marked by a two-bay carport that is integral with the wing's roof, which is partially supported by brick columns set atop a low brick wall.

Figure 5.202. Architectural resource RK1737; view is northwest and features the façade and east elevation.

NRHP Assessment. Architectural resource RK1737 does not exhibit a distinctive architectural style or workmanship. In addition, the house has been altered through the replacement of the original window sashes. Based on the lack of architectural merit, as well as the inability to associate the house and/or its original owner(s) with an important historical event or series of events, it is TRC's opinion that architectural resource RK1737 is not eligible for the NRHP.

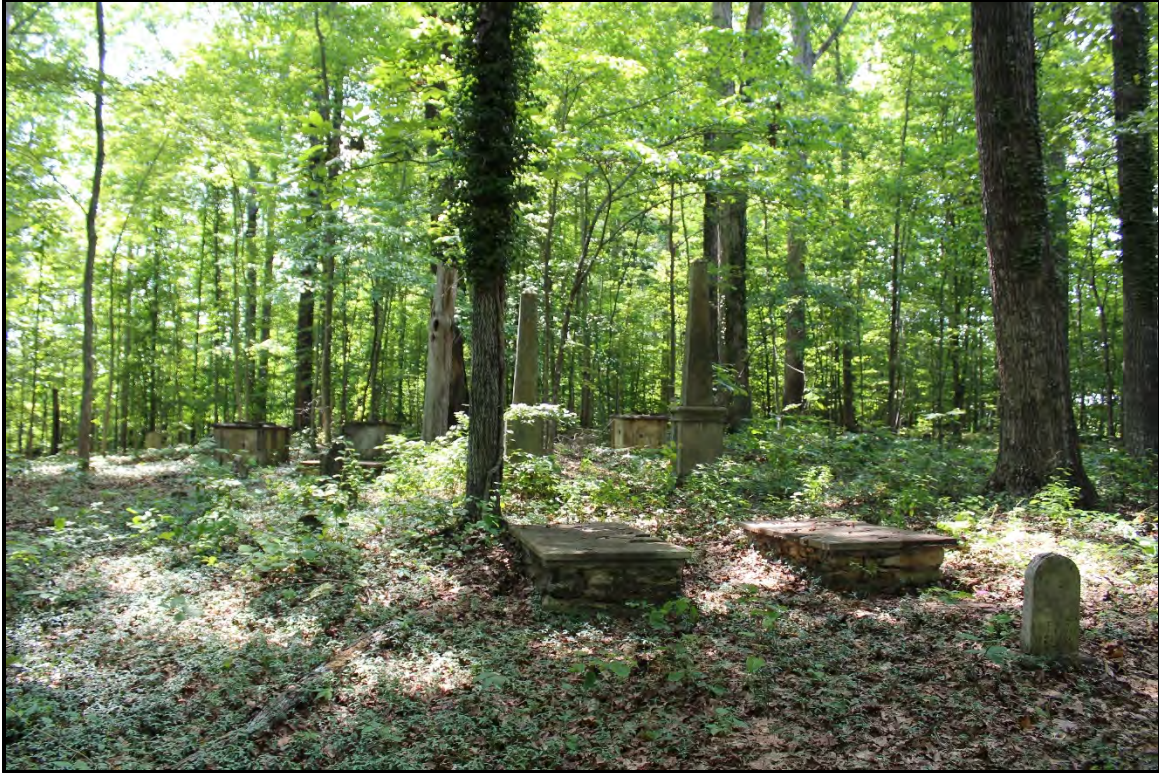
Figure 5.203. Overview of architectural resource RK1531; view is southeast.

Assessment of Potential Effects. Based on current Project plans, the grounds of the Settle Cemetery are located approximately 350 feet west of the proposed pipeline ROW (Figure 5.206). From this area, visual lines-of-sight to the Project area are obstructed by the existing terrain, which features rolling terrain and mature tree growth located between the eastern edge of the cemetery boundary and the Project area (see Figures 5.203 and 5.204).

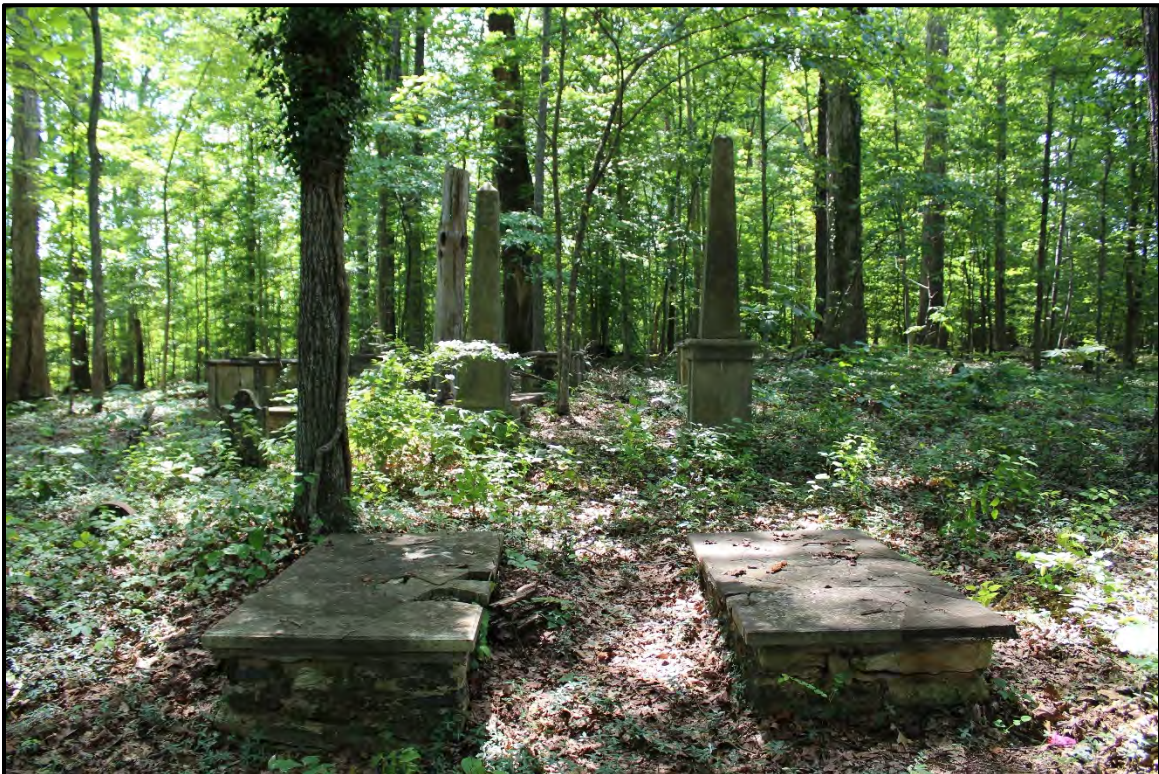
Stylistically, the grave markers found in the cemetery include two obelisks marking the graves of Henrietta and Thomas Settle, which are marked with bas relief carvings of a hand pointing to heaven (Woodard 2002). Burials of the Martin family include raised vaults with inscribed flat tablets composed of marble. Flat marble tablets also mark the burial of the other Settle family members, but these markers are not raised. The grave of Washington is an arched upright marble tablet.

Figure 5.204. Overview of architectural resource RK1531; view is east with Martin family vaults in the foreground.

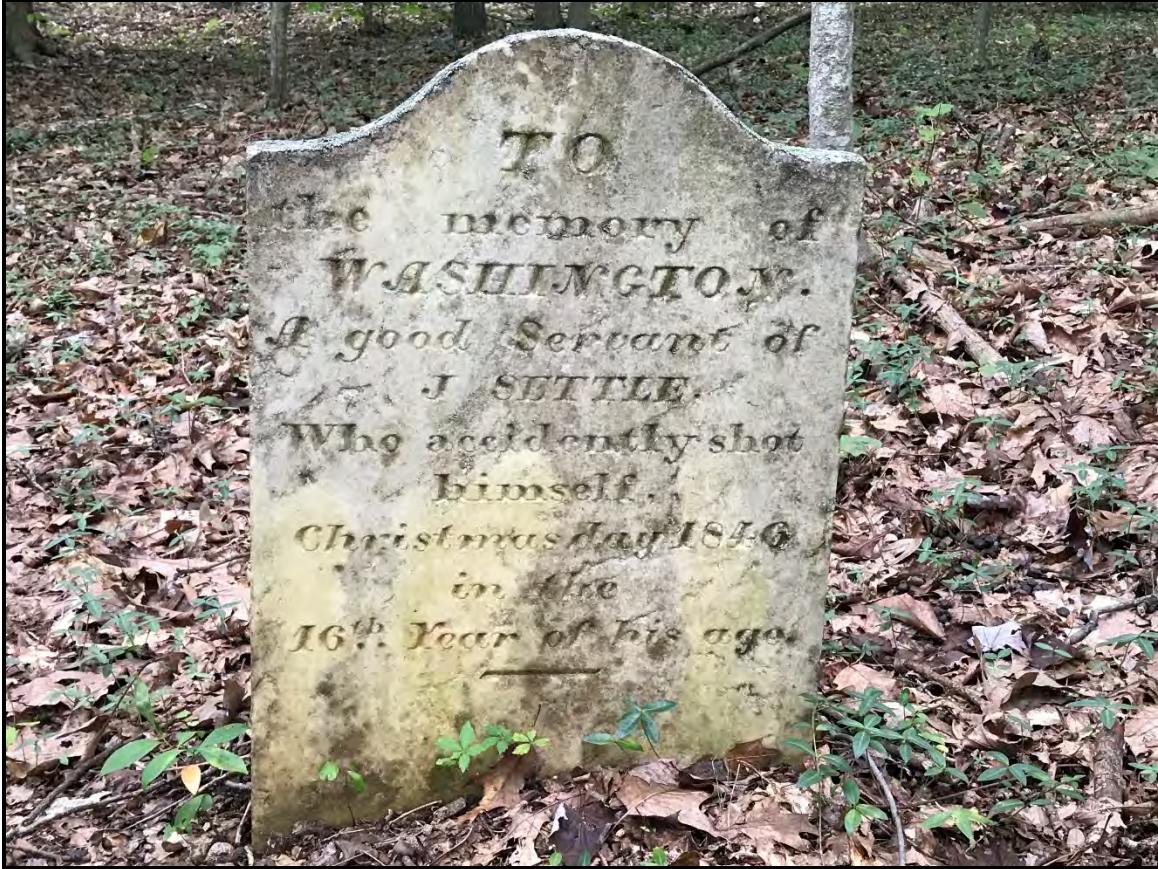
Figure 5.205. Architectural resource RK1531; grave marker of Josiah Settle's "servant" Washington; view is west.

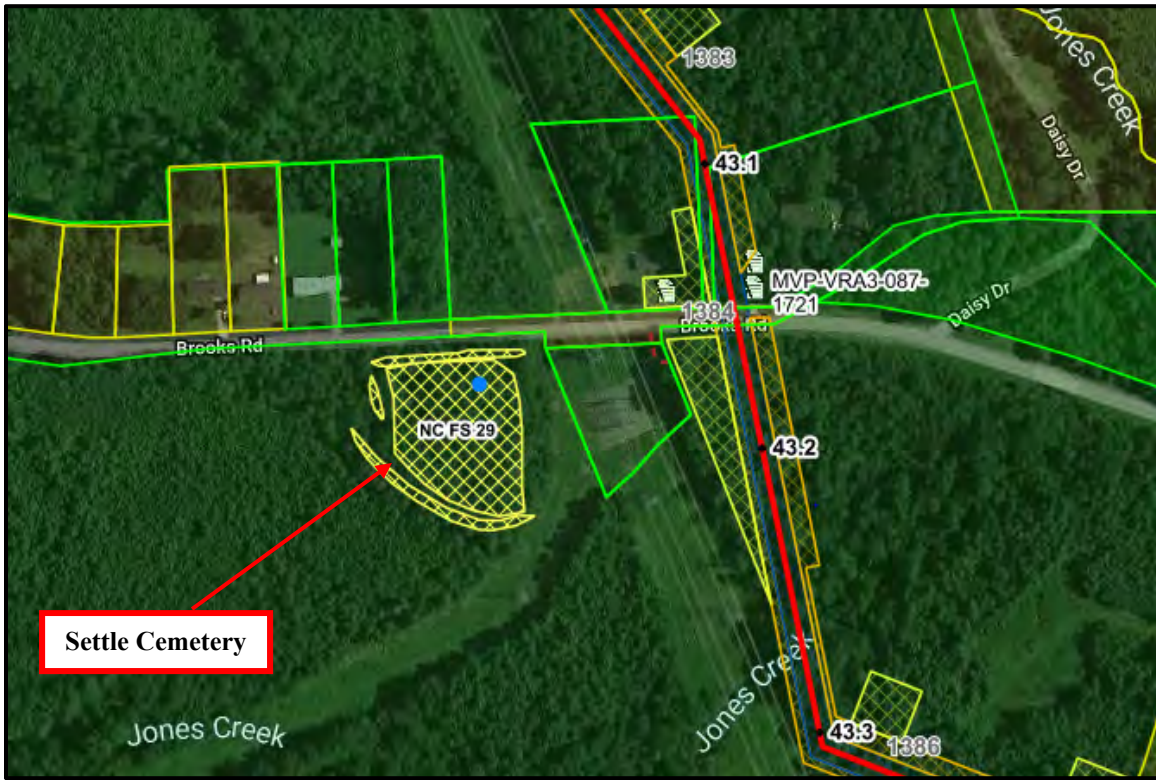
Figure 5.206. Aerial imagery depicting the location of the Settle Cemetery in relation to the proposed Project.

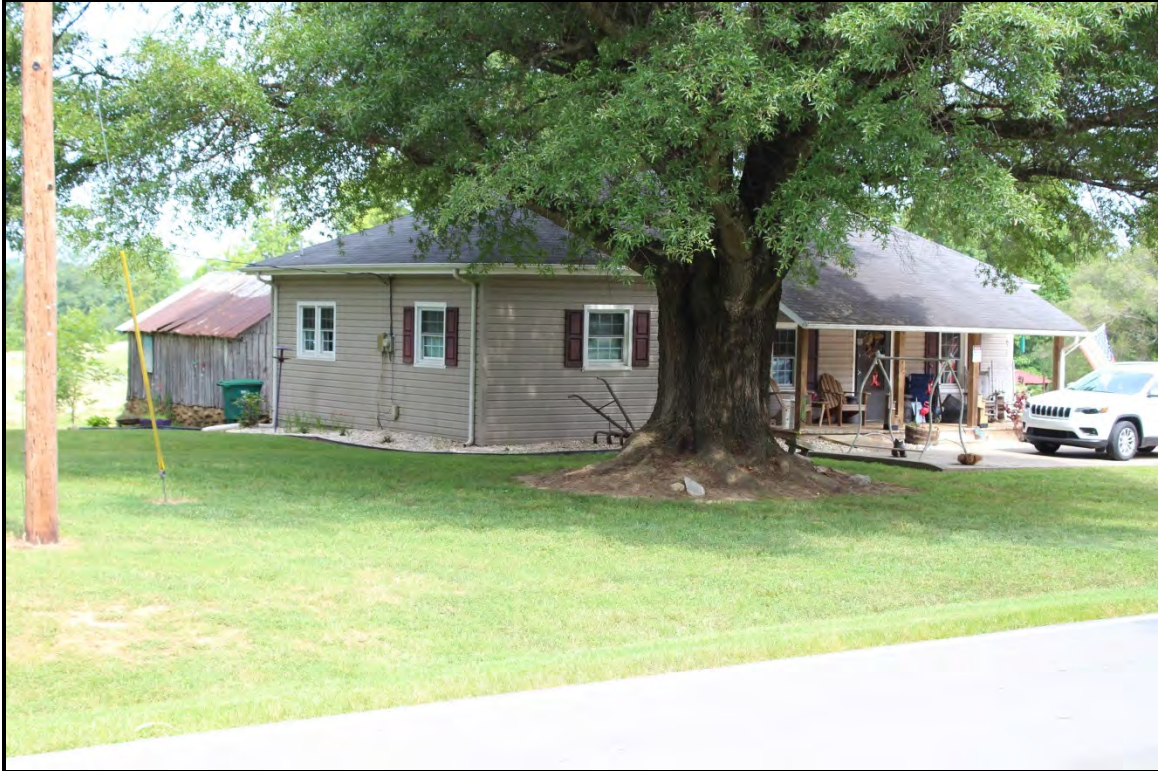
Figure 5.207. Architectural resource RK1738; view is northwest and features the façade and south elevation; ca. 1920 shed in background.

- A ca. 1920 shed. The wood-framed building features a side-gabled roof covered with metal sheeting, an exterior clad with vertical wood planks, and a continuous stone foundation (Figure 5.207);
- A late twentieth century shed. The wood-framed building features a gabled roof covered with metal sheeting, an exterior clad with vertical wood planks, and a concrete block pier foundation. A shed extension is attached to the east elevation (Figure 5.209);
- An early twentieth century barn. The wood-framed building features a gabled roof covered with metal sheeting, an exterior partially clad with weatherboard siding, and a pier foundation (Figure 5.210).
