Re: Revised Architectural Survey Report, MVP Southgate Project, Construct Interstate Pipeline, Rockingham and Alamance County, ER 18-1041

Thank you for your letter of October 11, 2019, transmitting the draft "Historic Architectural Survey for the MVP Southgate Pipeline Project". We have reviewed the report and offer the following comments.

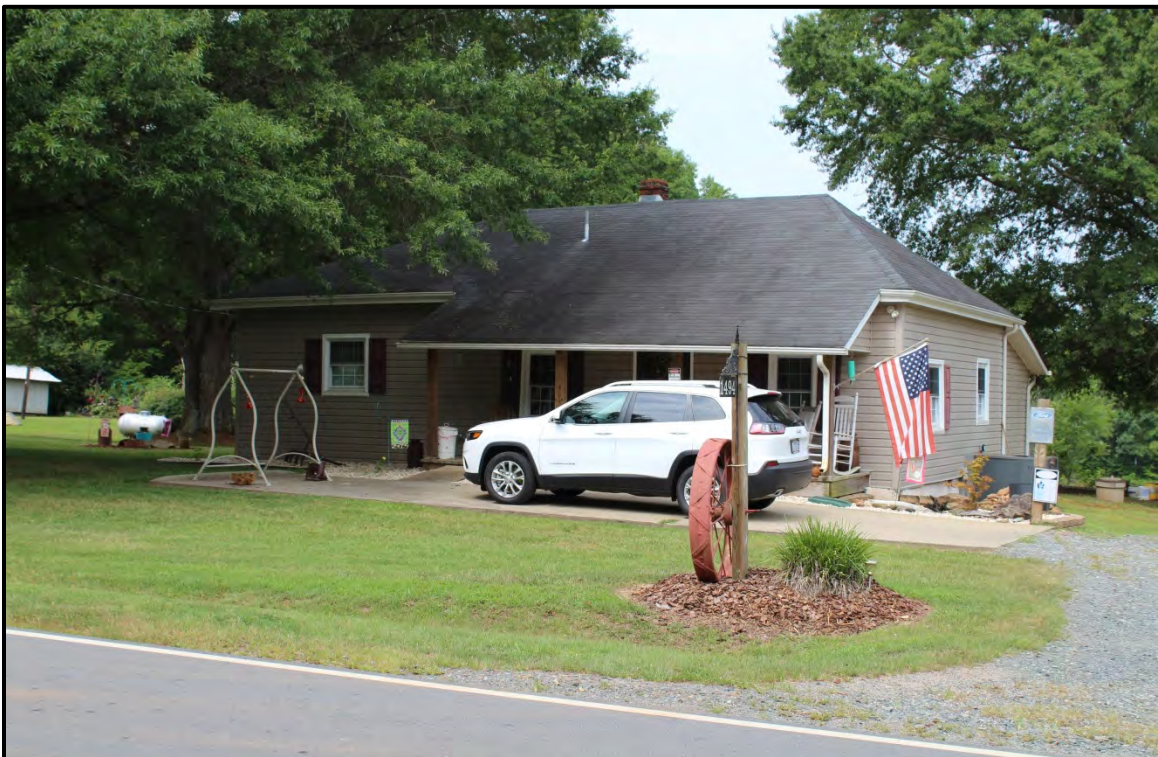
Figure 5.208. Architectural resource RK1738; oblique view featuring the façade and north elevation.

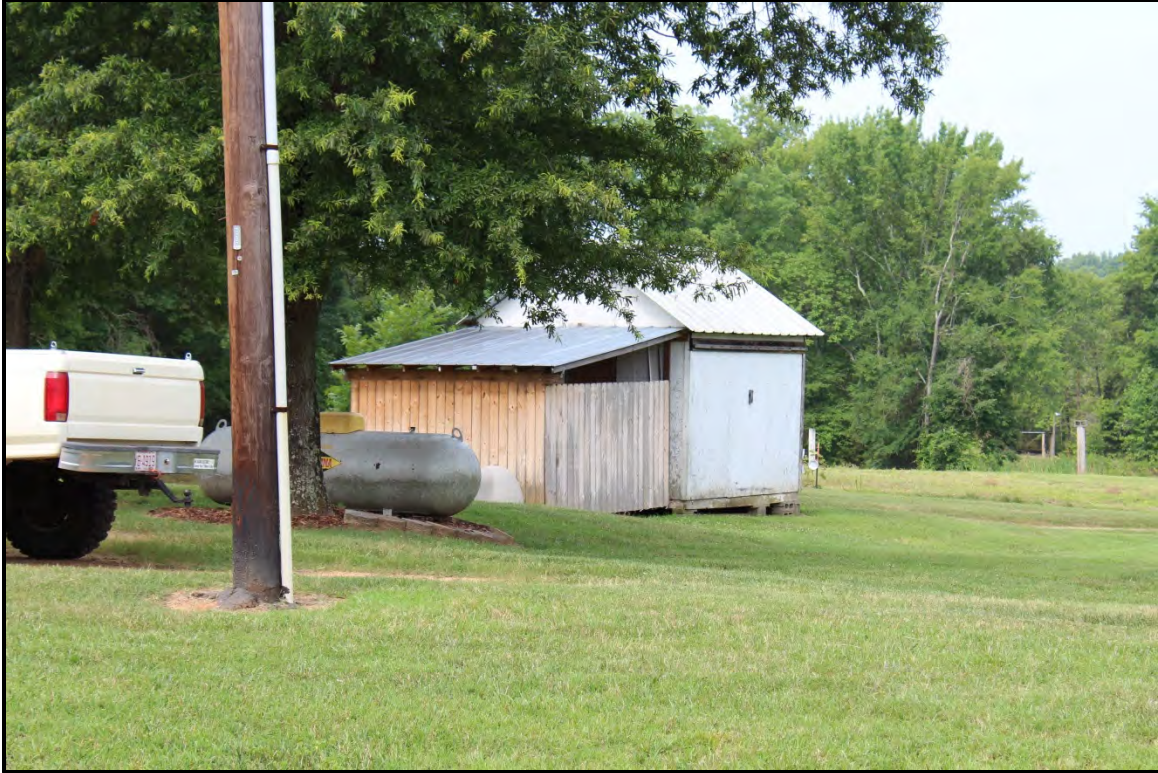
Figure 5.209. Architectural resource RK1738; oblique view featuring the late twentieth century shed.

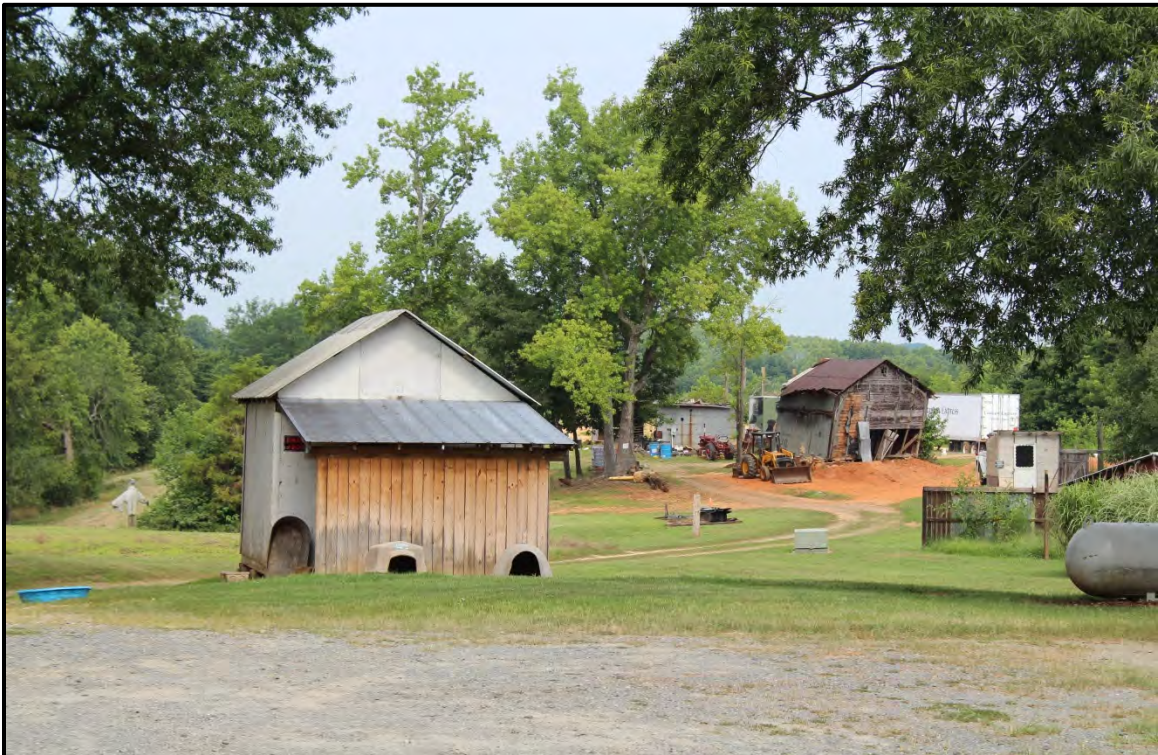
Figure 5.210. Architectural resource RK1738; view is northwest and features the late twentieth century shed and early twentieth century barn.

- A ca. 1920 shed. The wood-framed building features a side-gabled roof covered with metal sheeting, an exterior clad with vertical wood planks, and a continuous stone foundation (Figure 5.207);
- A late twentieth century shed. The wood-framed building features a gabled roof covered with metal sheeting, an exterior clad with vertical wood planks, and a concrete block pier foundation. A shed extension is attached to the east elevation (Figure 5.209);
- An early twentieth century barn. The wood-framed building features a gabled roof covered with metal sheeting, an exterior partially clad with weatherboard siding, and a pier foundation (Figure 5.210).

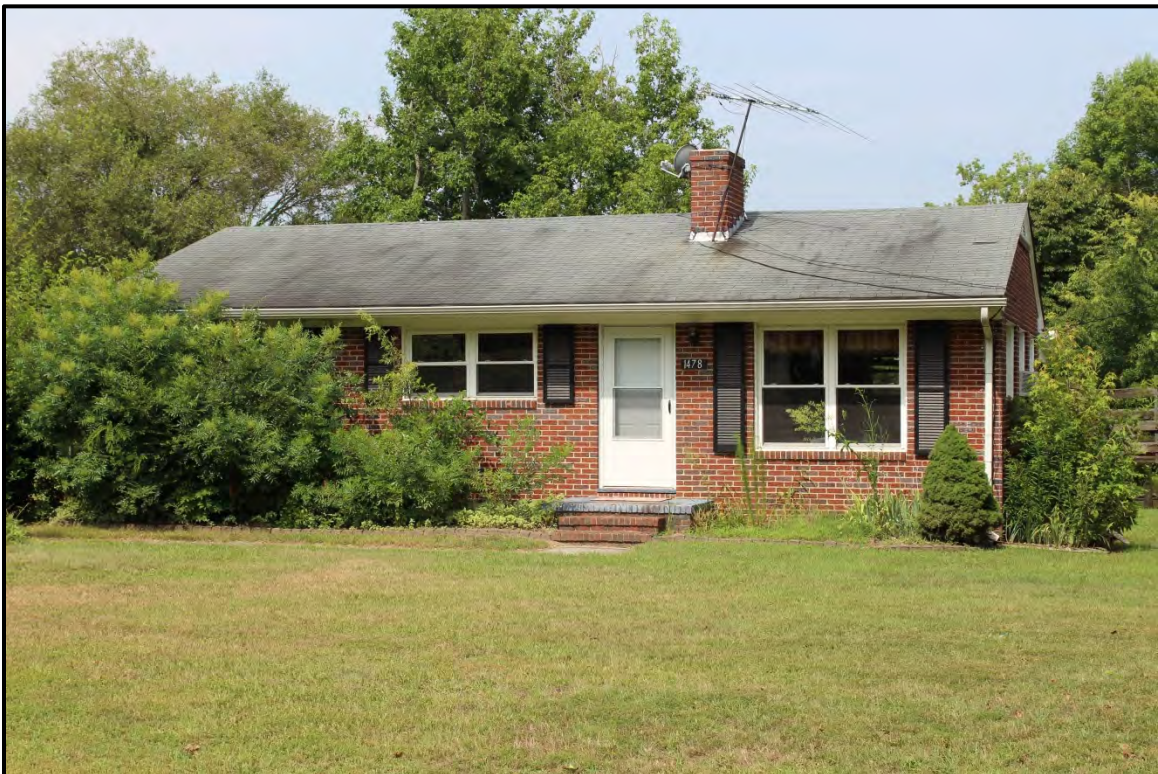
Description. Architectural resource RK1739 is a Ranch-style house located at 1478 Brooks Road, Reidsville 27320, on parcel 160084 (Rockingham County, NC WebGIS 2018) (see Figure 1.2f; Figure 5.211). According to Rockingham County tax records, the house was constructed in 1956 (Rockingham County, NC WebGIS 2018). Due to lack of landowner permission to access properties that are not directly affected by the Project, photographic coverage of architectural resource RK1739 was limited to the public right-of-way along Brooks Road. The wood-frame building features a side-gabled roof, interior brick chimney, wood frame with brick veneer-cladded exterior, and double hung 1/1 vinyl sash windows. A brick stoop with concrete slab deck provides access to the main entrance. Attached to the southwest elevation is a two-bay carport. The porch and carport roof are supported by brick columns.

Figure 5.211. Architectural resource RK1739; view is west and features the façade.

NRHP Assessment. Architectural resource RK1739 does not exhibit a distinctive architectural style or workmanship. In addition, the house has been altered through the replacement of the original window sashes. Based on the lack of architectural merit, as well as the inability to associate the house and/or its original owner(s) with an important historical event or series of events, it is TRC's opinion that architectural resource RK1739 is not eligible for the NRHP.

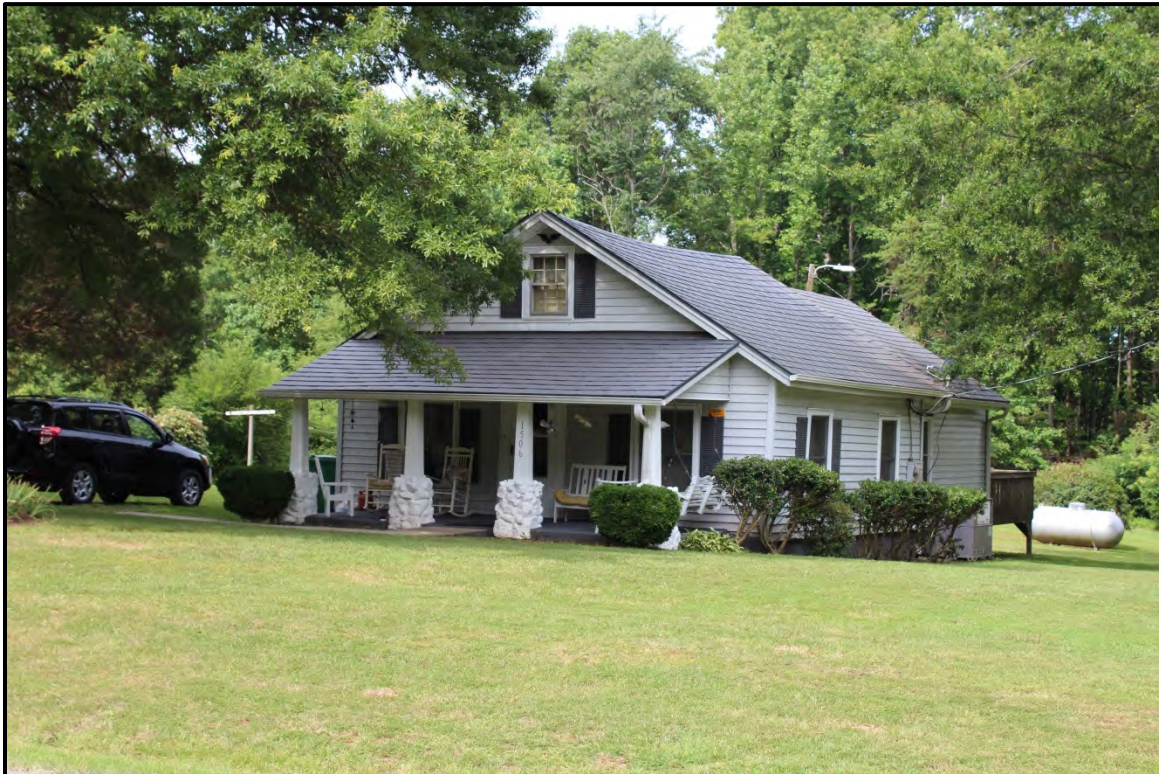
Description. Architectural resource RK1740 is a bungalow-influenced house located at 1506 Brooks Road, Reidsville 27320, on parcel Number 160033 (Rockingham County, NC WebGIS 2018) (see Figure 1.2f; Figure 5.212). According to Rockingham County tax records, the house was constructed in 1940 (Rockingham County, NC WebGIS 2018). Due to lack of landowner permission to access properties that are not directly affected by the Project, photographic coverage of architectural resource RK1739 was limited to the public right-of-way along Brooks Road. The one and one-half-story, wood-frame house features a front-gabled roof, wood frame with vinyl siding-clad exterior, and double hung 1/1 vinyl sash and 6/6 wood sash windows. A full-width porch with tapered wood columns set atop rough field plinth blocks and a concrete slab deck provides access to the main entrance. Attached to the west elevation is a modern wood deck.

Figure 5.212. Architectural resource RK1740; view is southwest and features the façade and north elevation.

NRHP Assessment. Architectural resource RK1740 does not exhibit a distinctive architectural style or workmanship. In addition, the house has been altered through the application of vinyl siding and the replacement of some of the original window sashes. Based on the lack of architectural merit, as well as the inability to associate the house and/or its original owner(s) with an important historical event or series of events, it is TRC’s opinion that architectural resource RK1740 is not eligible for the NRHP.

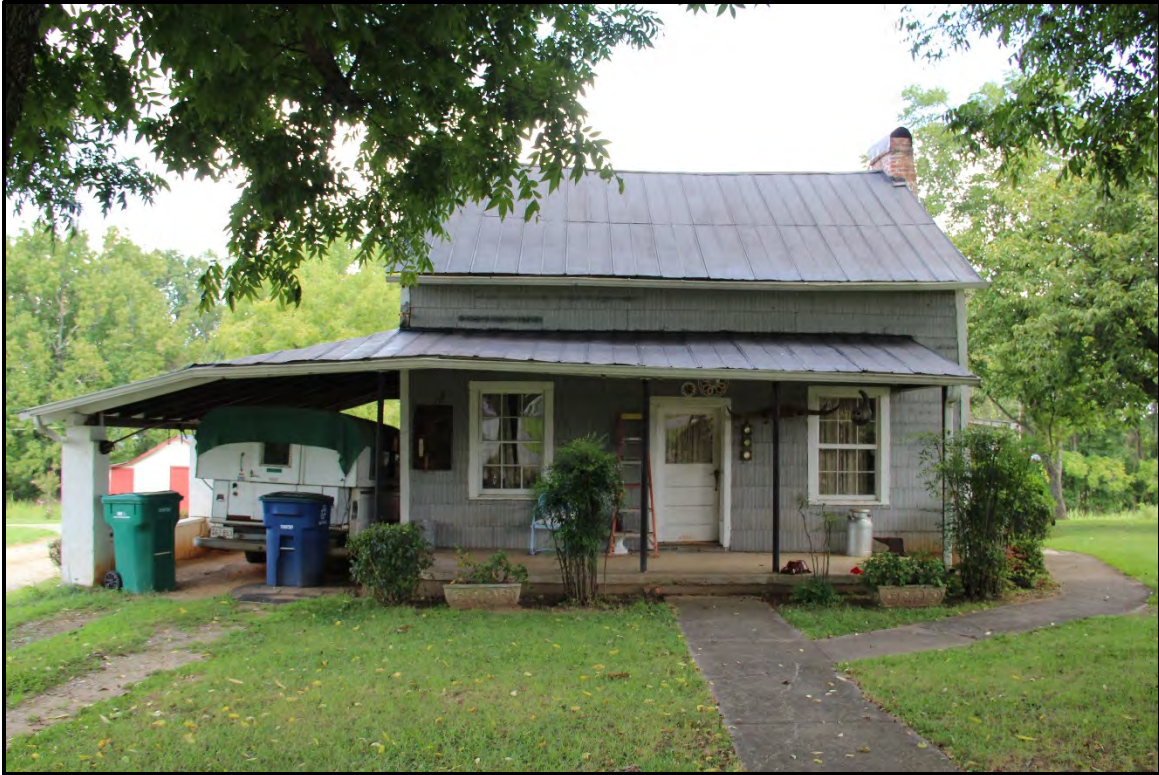
Figure 5.213. Architectural resource RK1741; view is north and features the façade.

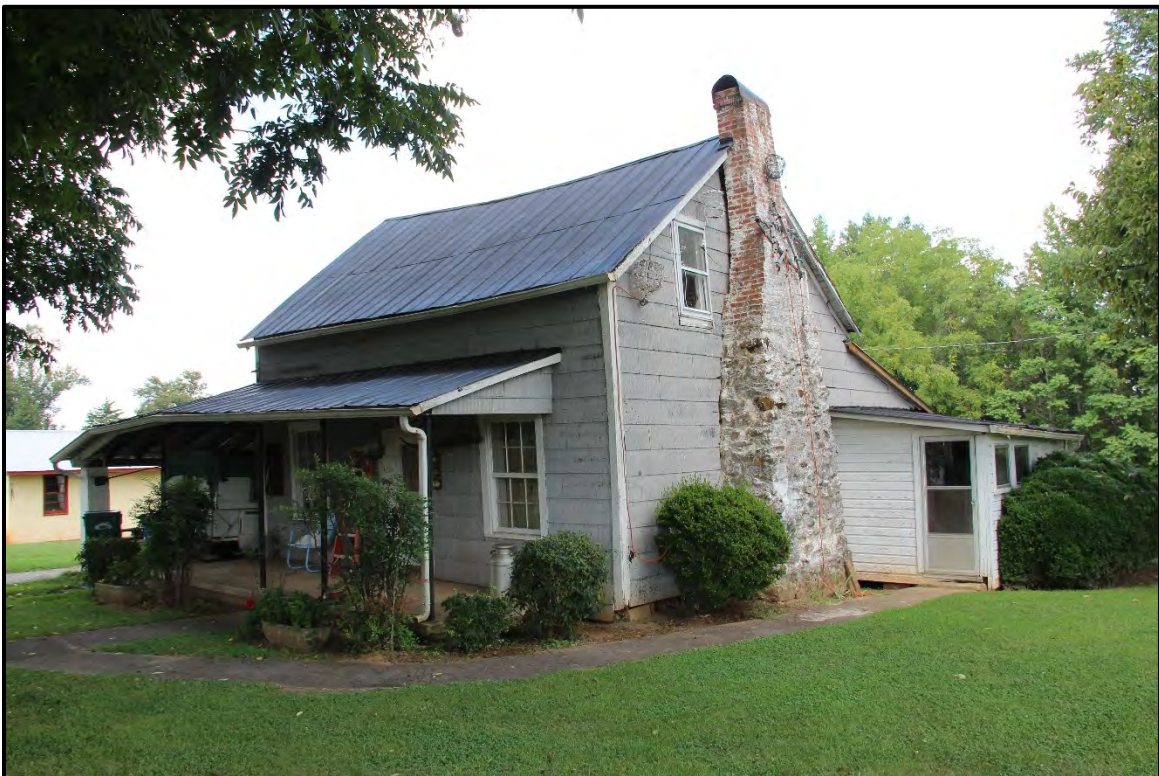
Figure 5.214. Architectural resource RK1741; view is northwest and features the façade and east elevation.

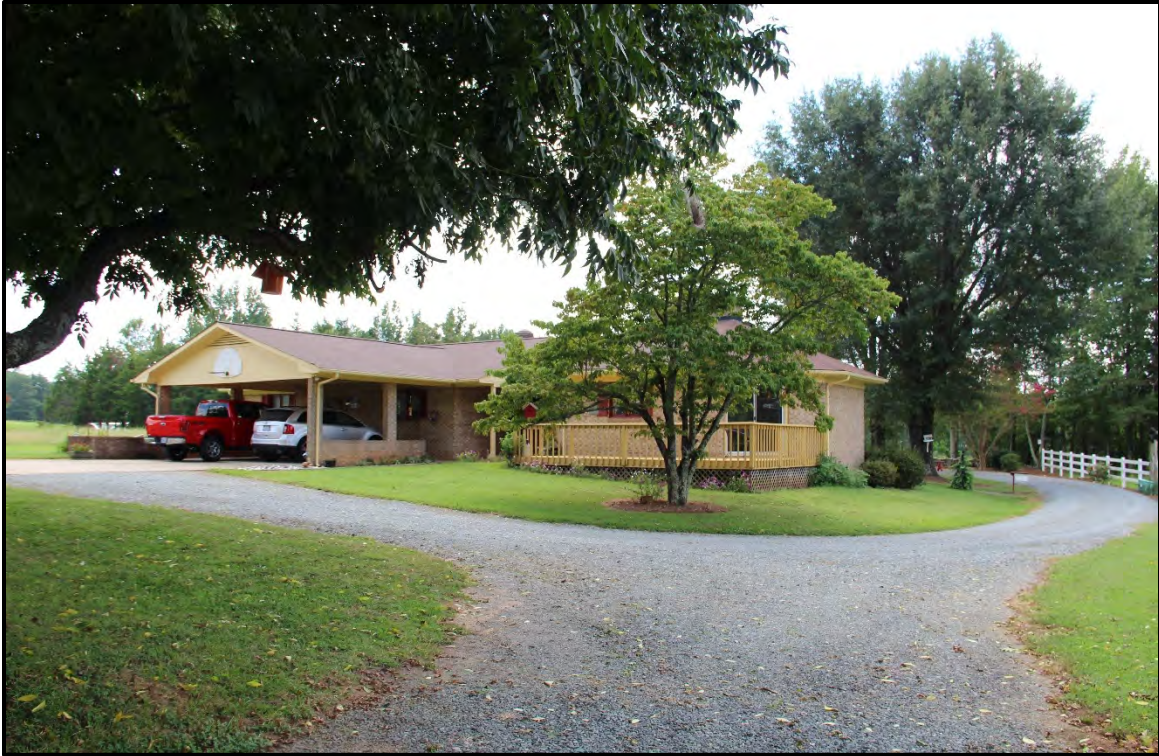
Figure 5.215. Architectural resource RK1741; view is northwest and features the façade and east elevation of the ca. 1976 house.

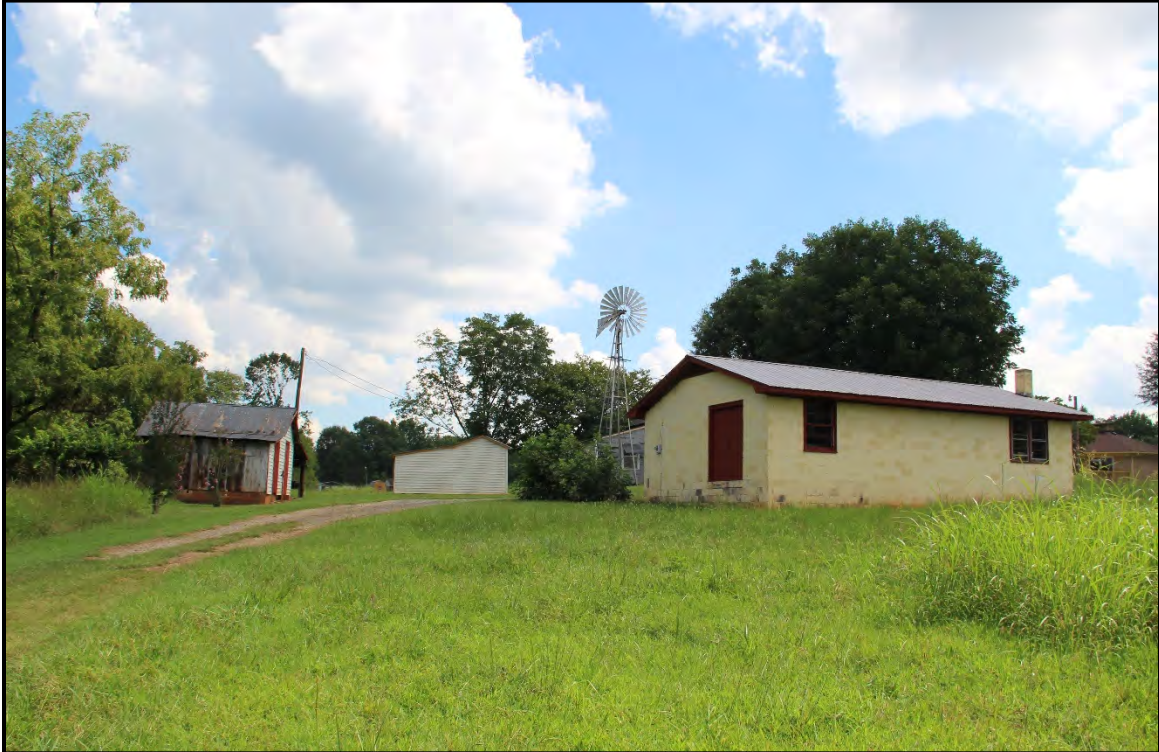
Figure 5.216. Architectural resource RK1741; view is southeast and features the associated outbuildings.

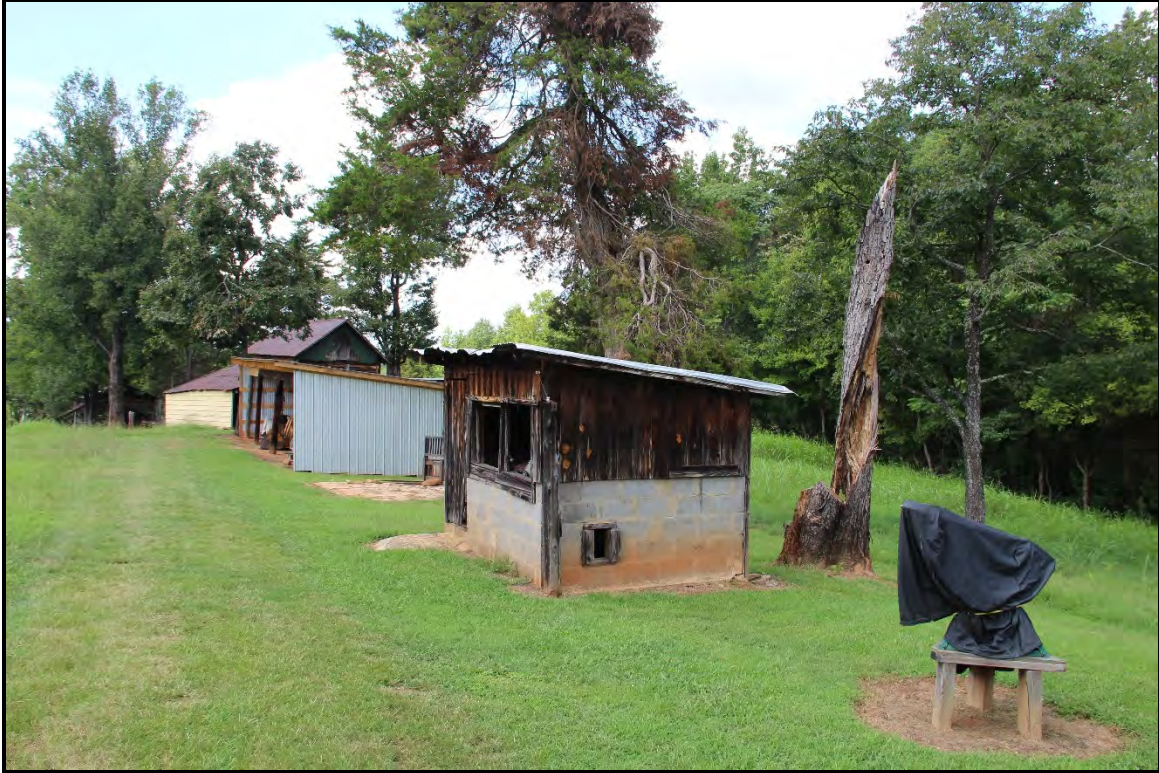
Figure 5.217. Architectural resource RK1741; view is west and features the associated outbuildings.

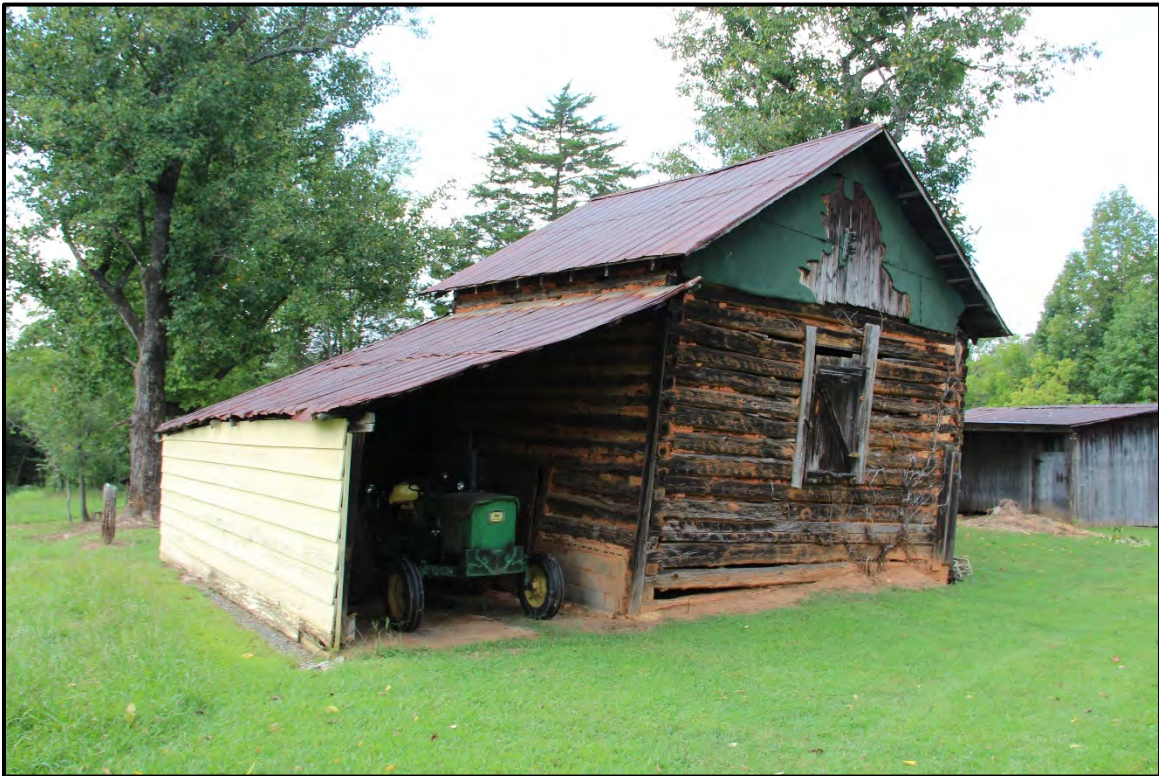
Figure 5.218. Architectural resource RK1741; view is northwest and features the log barn.

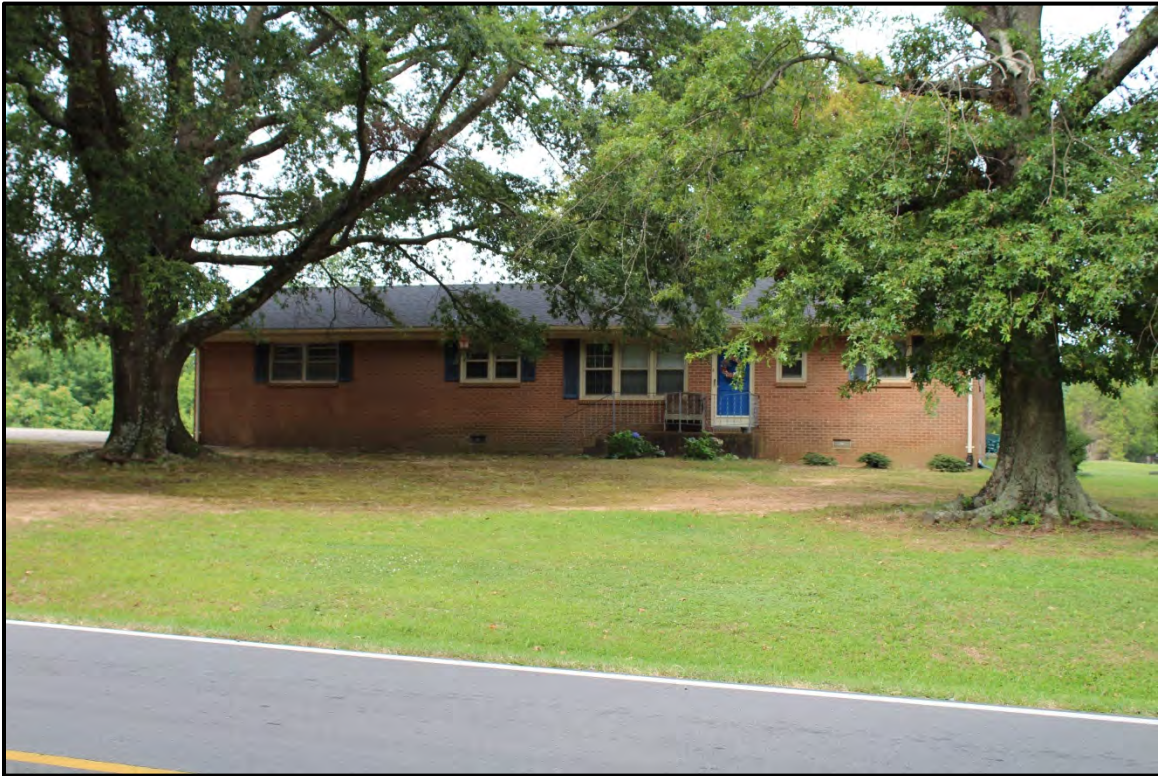
Description. Architectural resource RK1742 is a Ranch-style house located at 1650 Brooks Road, Reidsville 27320, on parcel number 160056 (Rockingham County, NC WebGIS 2018) (see Figure 1.2g; Figure 5.219). According to Rockingham County tax records, the house was constructed in 1966 (Rockingham County, NC WebGIS 2018). Due to lack of landowner permission to access properties that are not directly affected by the Project, photographic coverage of architectural resource RK1742 was limited to the public right-of-way along Brooks Road. The wood-frame building features a side-gabled roof covered with asphalt shingles, and exterior clad with a brick veneer, and a brick foundation. Fenestration includes double hung horizontal 2/2 and 6/6 vinyl sash windows. A brick and concrete stoop provides access to the main entrance.

Figure 5.219. Architectural resource RK1742; view is southwest and features the façade.

NRHP Assessment. Architectural resource RK1742 does not exhibit a distinctive architectural style or workmanship. In addition, the house has been altered through the replacement of some of the original window sashes. Based on the lack of architectural merit, as well as the inability to associate the house and/or its original owner(s) with an important historical event or series of events, it is TRC's opinion that architectural resource RK1742 is not eligible for the NRHP.

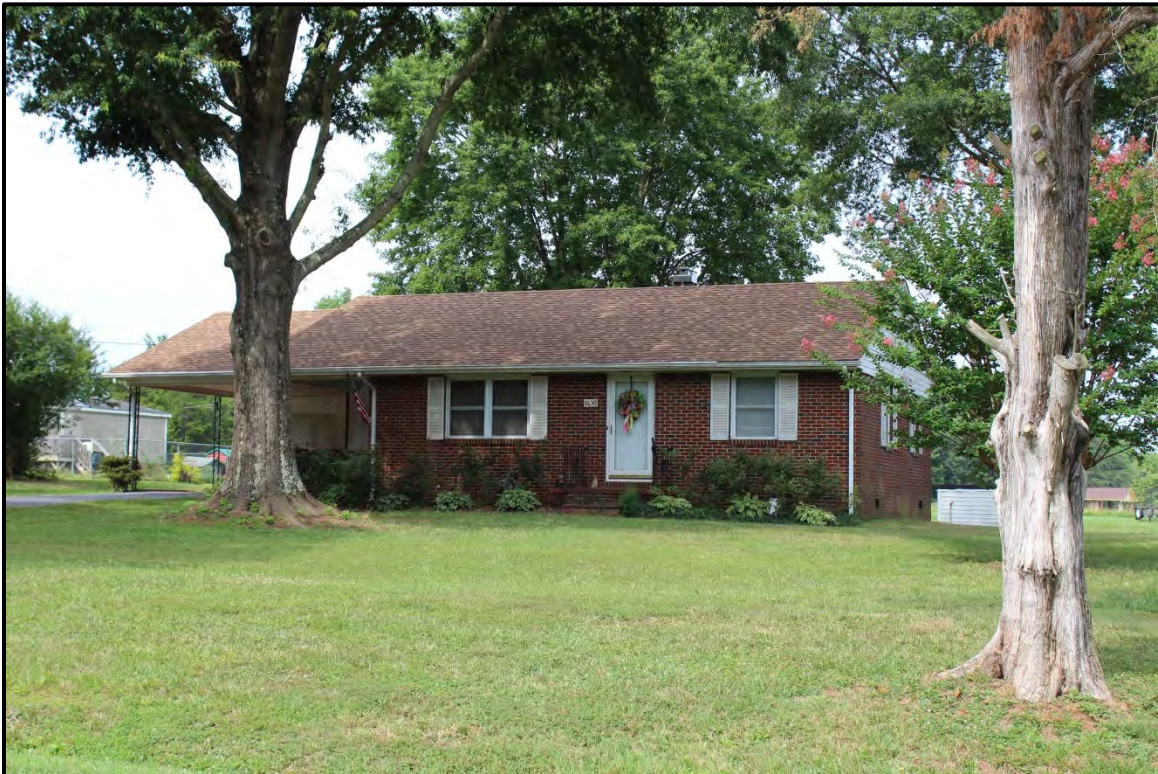
The wood-frame building features a side-gabled roof, an exterior clad with brick veneer, and double-hung 1/1 wood sash windows. A brick and concrete stoop provides access to the main entrance. Attached to the south elevation is a two-bay carport that features a gabled roof supported by ornamental metal columns.

Figure 5.220. Architectural resource RK1743; view is southwest and features the façade and north elevation.

NRHP Assessment. Architectural resource RK1743 does not exhibit a distinctive architectural style or workmanship. In addition, the house has been altered through the application of vinyl siding in the gable ends. Based on the lack of architectural merit, as well as the inability to associate the house and/or its original owner(s) with an important historical event or series of events, it is TRC's opinion that architectural resource RK1743 is not eligible for the NRHP.

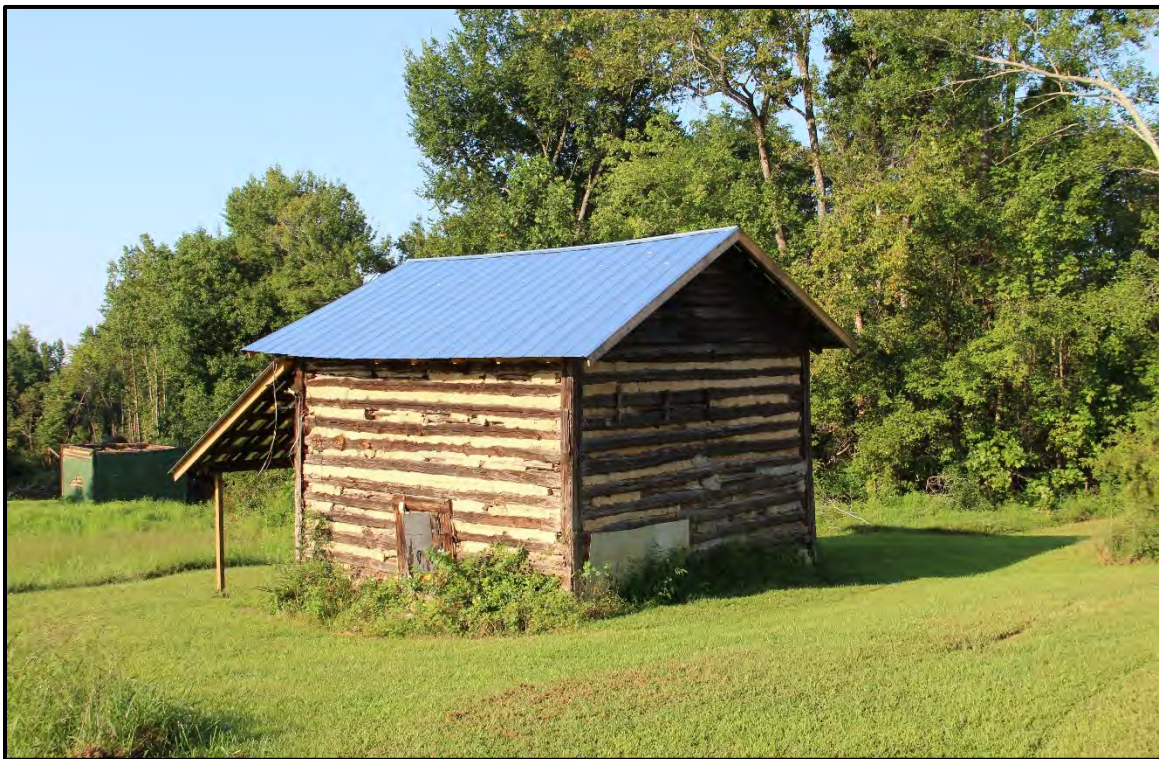
The tobacco barn is composed of hand-hewn logs and features a modern gabled roof covered with standing seam metal. Modern daub chinking has been applied to the exterior of the barn. Attached to the south elevation is a modern shed-roofed lean-to. A door on the east elevation provides interior access to the barn.

Figure 5.221. Architectural resource RK1744; view is southwest and features the north and east elevations.

NRHP Assessment. Architectural resource RK1744 does not exhibit a distinctive architectural style or workmanship. In addition, the structure has been altered through the reconstruction of the roof and the construction of the modern shed-roof lean-to. Based on the lack of architectural merit, as well as the inability to associate the structure and/or its original owner(s) with an important historical event or series of events, it is TRC's opinion that architectural resource RK1744 is not eligible for the NRHP.

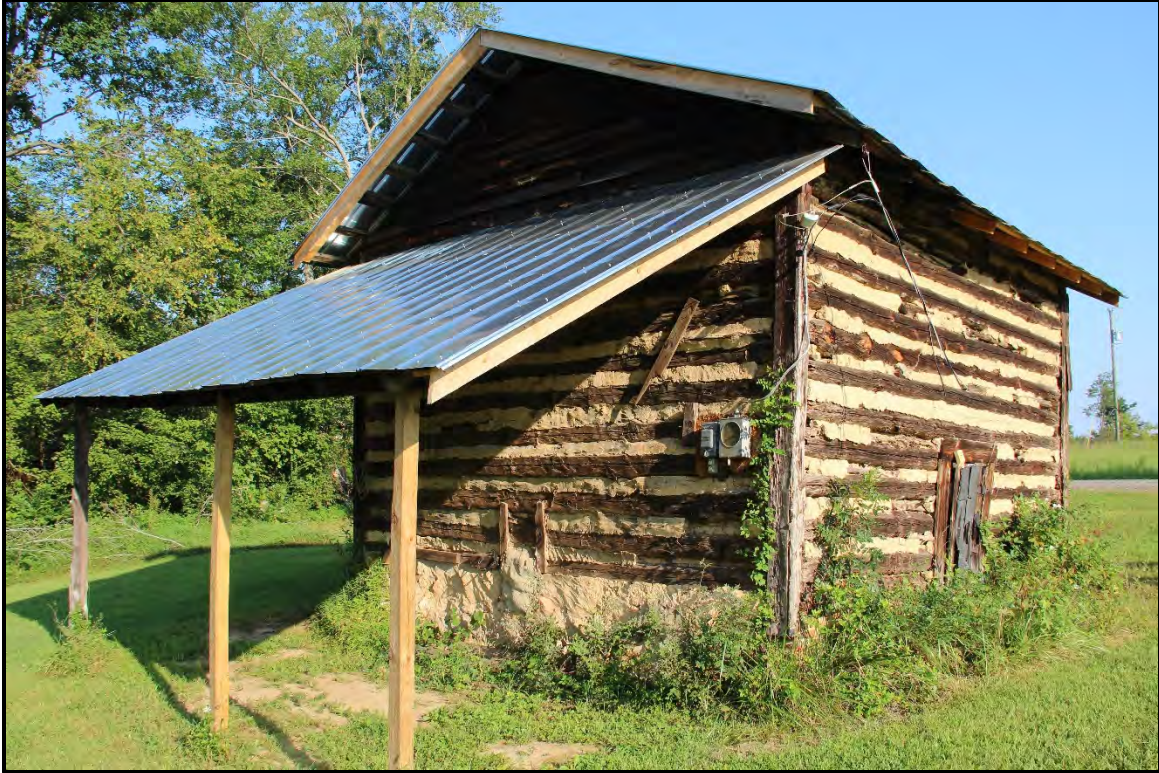
Figure 5.222. Architectural resource RK1744; view is northwest and features the south and east elevations.

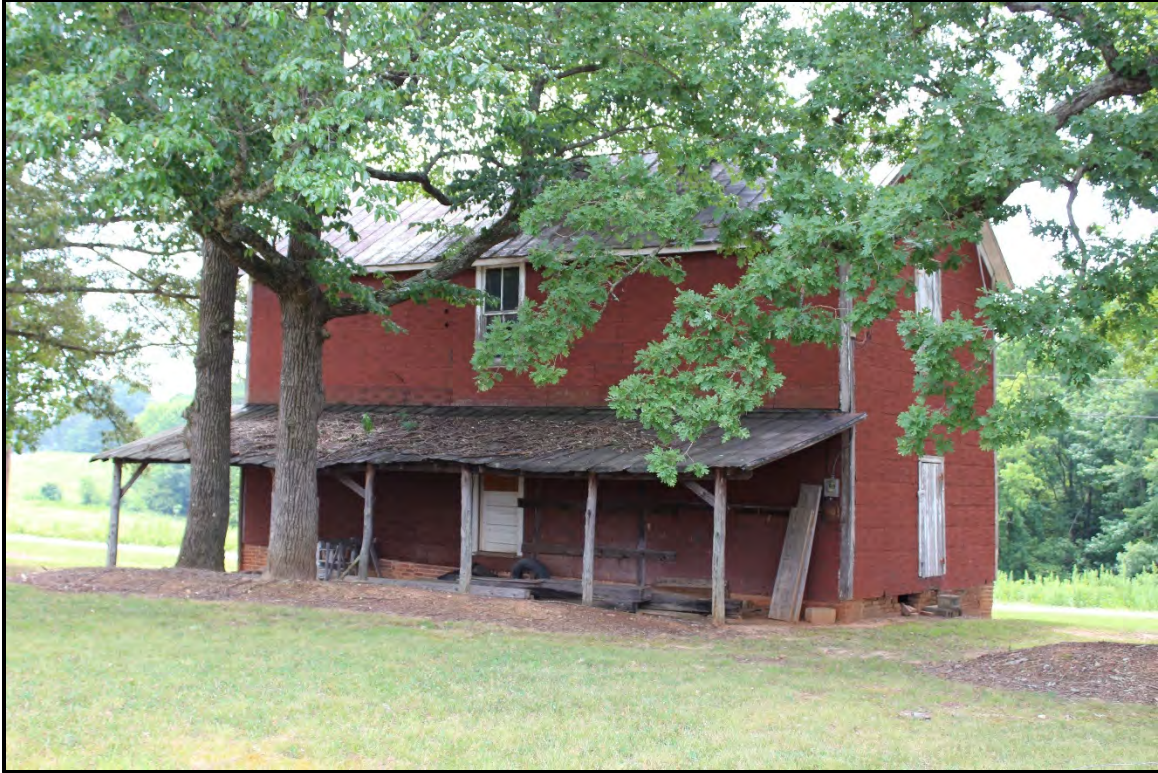
Figure 5.223. Architectural resource RK1534; view is southeast featuring the façade and west elevation of the 1900 residence.

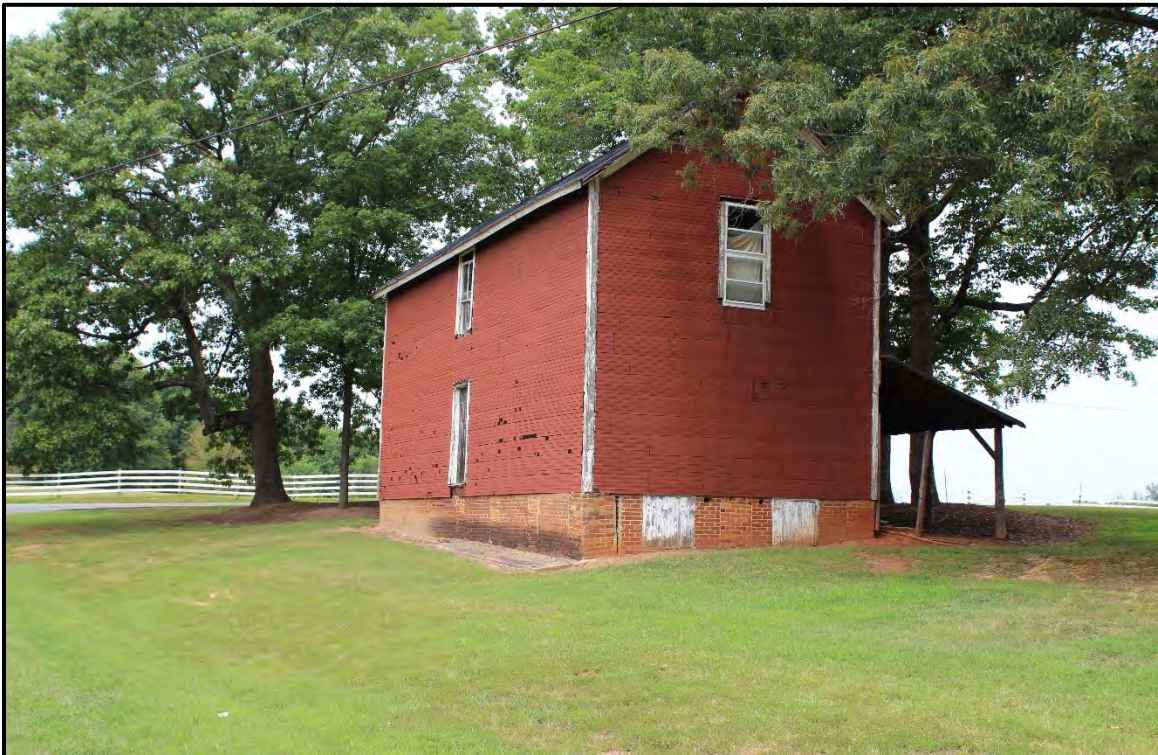
Figure 5.224. Architectural resource RK1534; view is northwest featuring the east and south (rear) elevations of the 1900 residence.

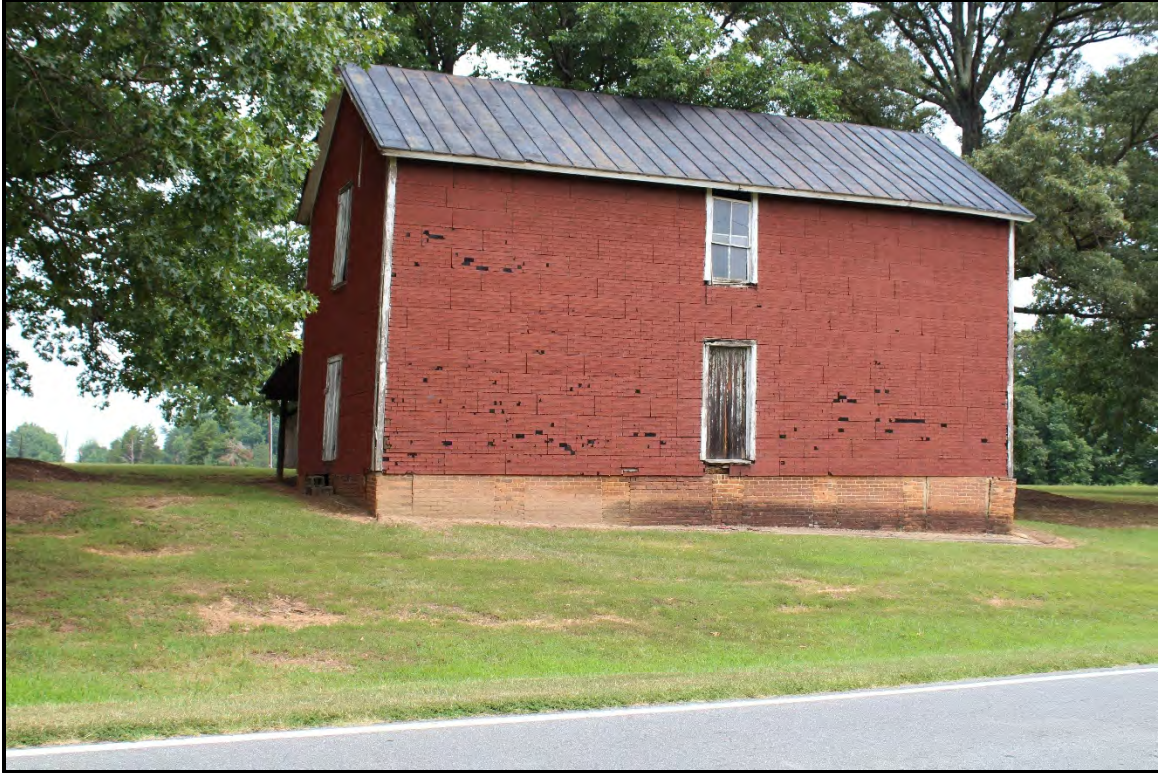
Figure 5.225. Architectural resource RK1534; view is north featuring the south (rear) and west elevations of the 1900 residence.

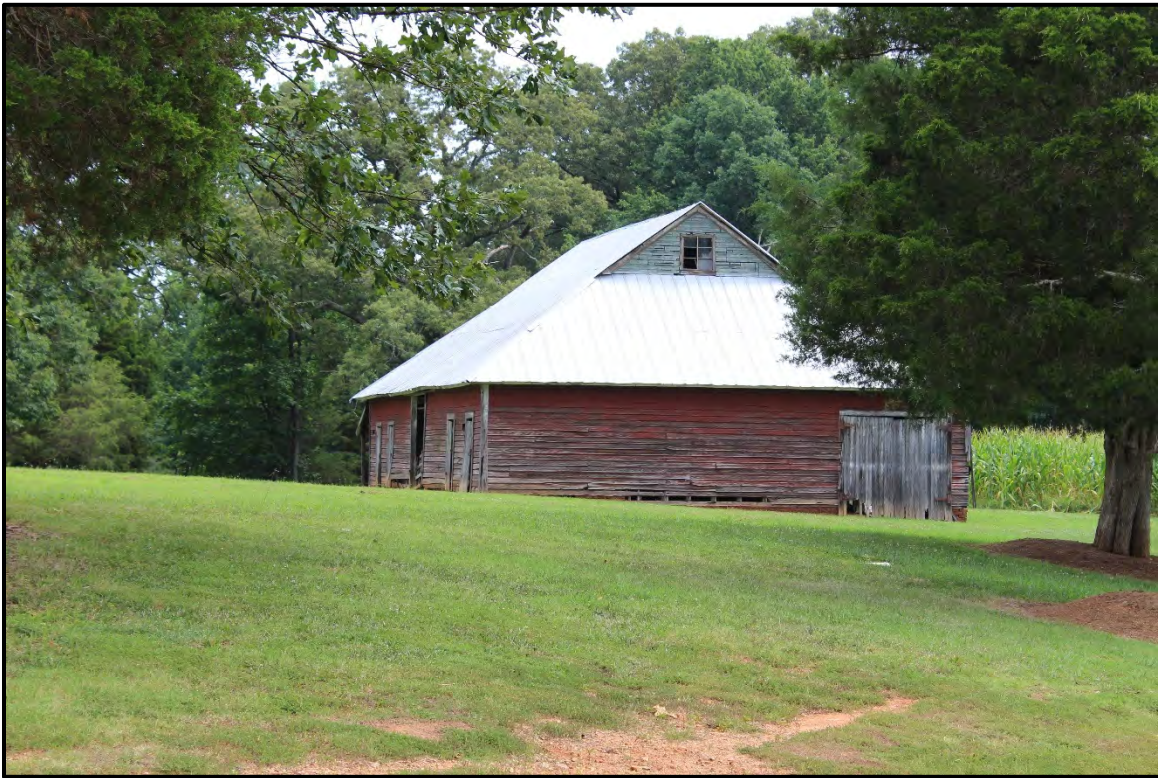
Figure 5.226. Architectural resource RK1534; view is northeast featuring the 1950 livestock barn.

Located northeast of the building is a one and one-half-story livestock barn with a reported construction date of 1950 (Rockingham County, NC GIS 2018). The structure features a gable-on-hip roof, wood frame with weatherboard exterior, a brick foundation, and a 6-light fixed wood sash window. A centrally placed open bay is located on the north elevation. The bay is flanked on either side by two wood doors. An additional bay containing a pair of swinging wood doors is located on the east elevation (Figures 5.226 and 5.227).

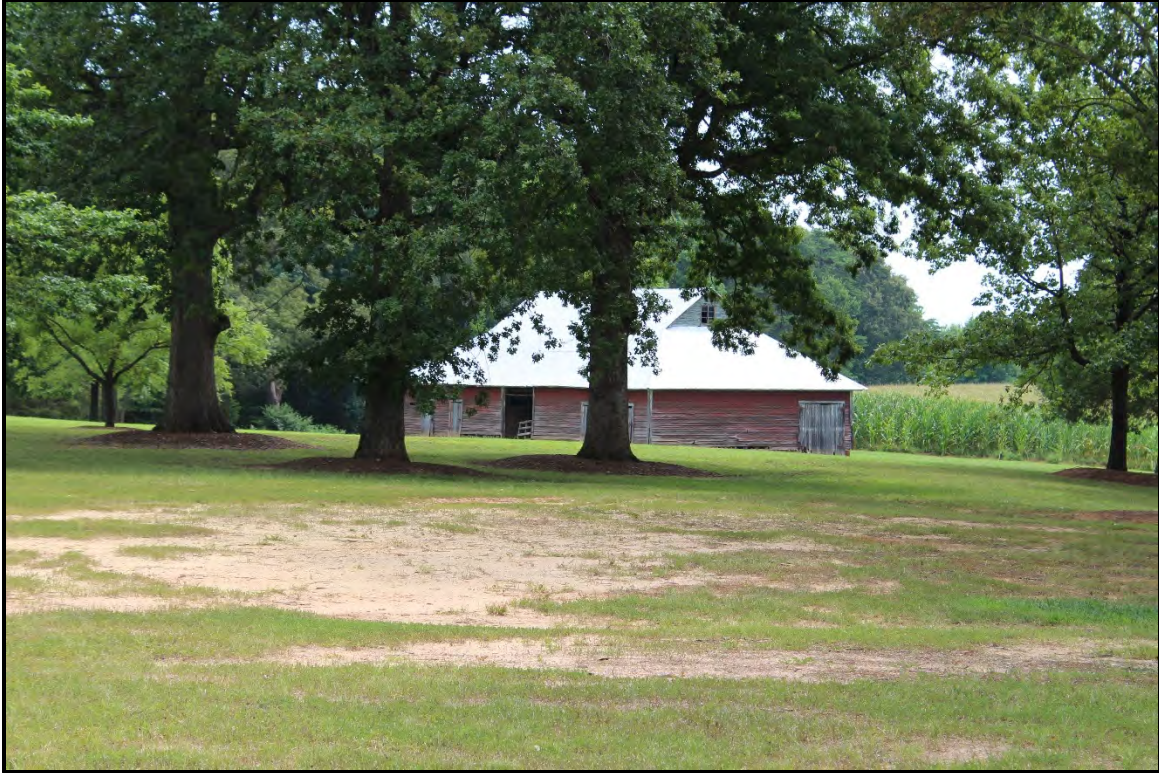
Figure 5.227. Architectural resource RK1534; view is southeast featuring the 1950 livestock barn.

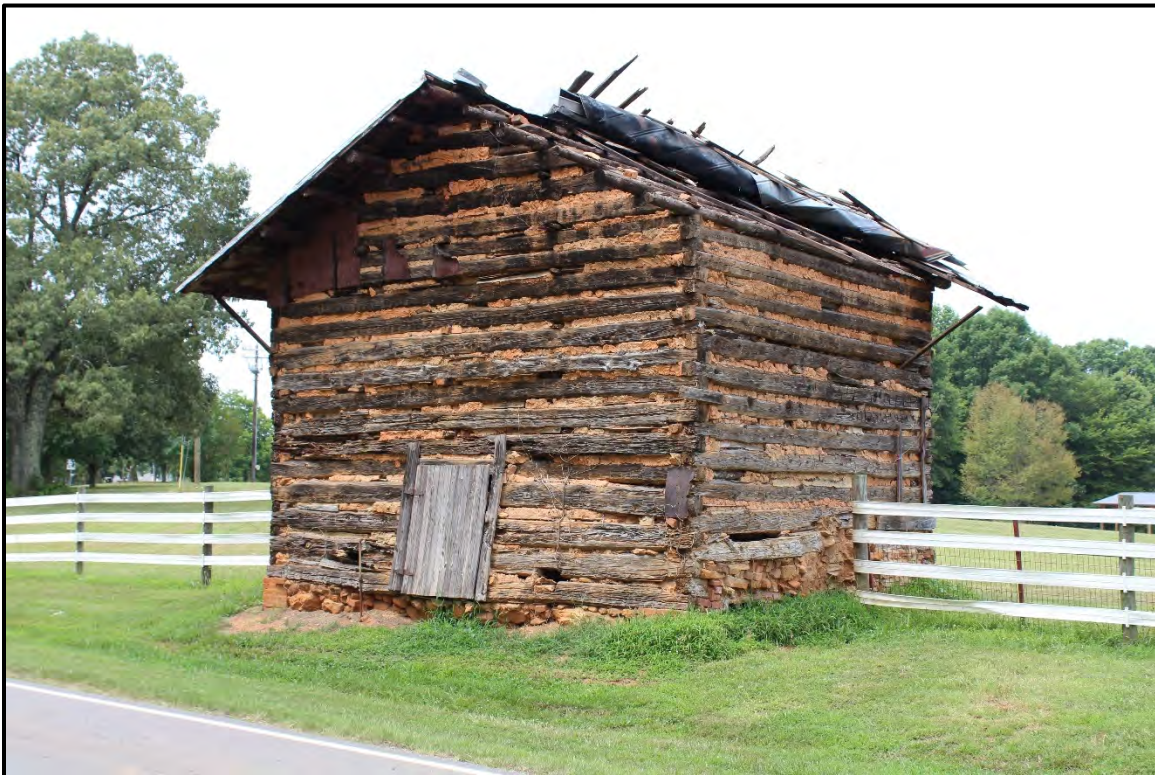
Figure 5.228. Architectural resource RK1534; view is southwest featuring the late nineteenth century tobacco barn.

The last surviving outbuilding identified in the 2002 survey is a one-story log tobacco barn that is situated on the west side of Brooks Road. This structure is currently located on a parcel that is no longer owned by the Cross family. The late nineteenth century structure features a gable roof covered with standing seam metal, a hewn log exterior joined by square notching, and a foundation composed of stacked stone and brick. Mud chinking has been applied to fill the voids between the logs. Positioned on the east elevation is a wood door that provides access to the structure (Figure 5.228);

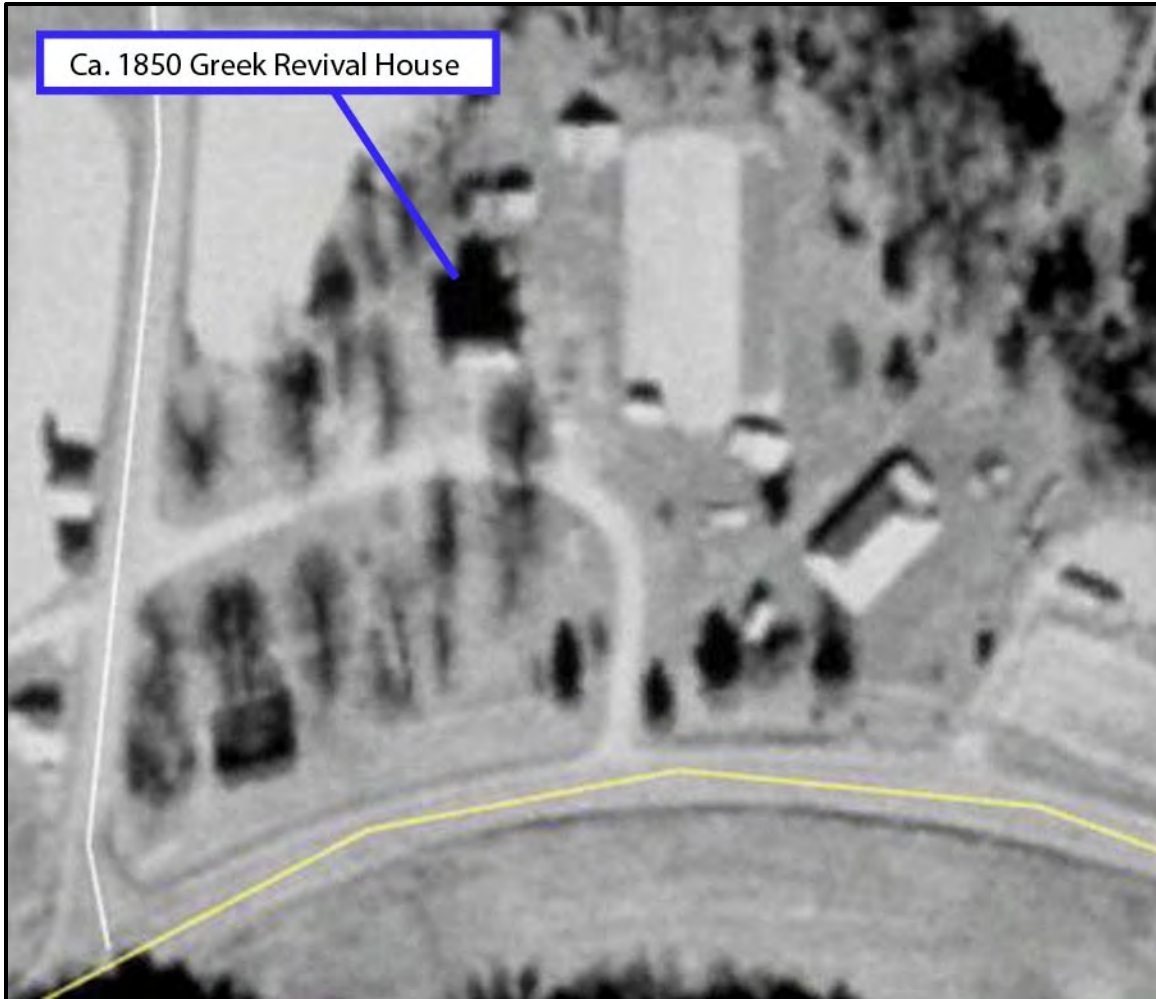
Figure 5.229. 1999 aerial imagery of RK1534 depicting the ca. 1850 Greek Revival residence and associated outbuildings.

Since its recordation in 2002 several associated outbuildings and structures have been destroyed, including two late nineteenth tobacco barns that were located on the west side of Brooks Road and a series of nine structures that functioned as sheds or storage cribs (Smith 2002c) (Figures 5.229 and 5.230).
