Re: Revised Architectural Survey Report, MVP Southgate Project, Construct Interstate Pipeline, Rockingham and Alamance County, ER 18-1041

Thank you for your letter of October 11, 2019, transmitting the draft "Historic Architectural Survey for the MVP Southgate Pipeline Project". We have reviewed the report and offer the following comments.

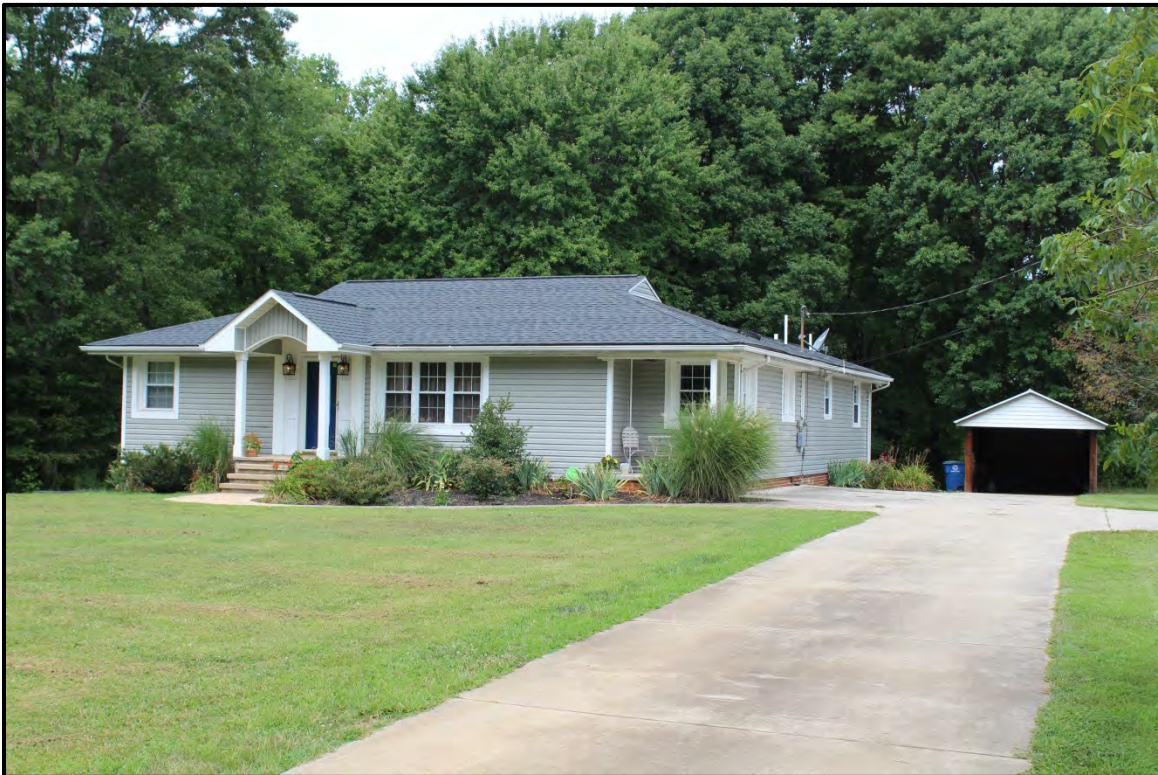
The one-story, wood-frame building features a gable-on-hip roof, an exterior clad with vinyl siding, and a continuous brick foundation. Fenestration includes double hung 6/6 vinyl sash windows. A reconstructed single-bay entry porch provides access to the main entrance. A recessed corner porch is positioned at the building's southeast corner. A mid-twentieth century garage is located east of the house.

Figure 5.231. Architectural resource RK1745; view is west and features the façade and northeast elevation.

NRHP Assessment. Architectural resource RK1745 does not exhibit a distinctive architectural style or workmanship. In addition, the house has been altered through the application of vinyl siding, the reconstruction of the façade porch, and the replacement of the original window sashes. Based on the lack of architectural merit, as well as the inability to associate the house and/or its original owner(s) with an important historical event or series of events, it is TRC's opinion that architectural resource RK1745 is not eligible for the NRHP.

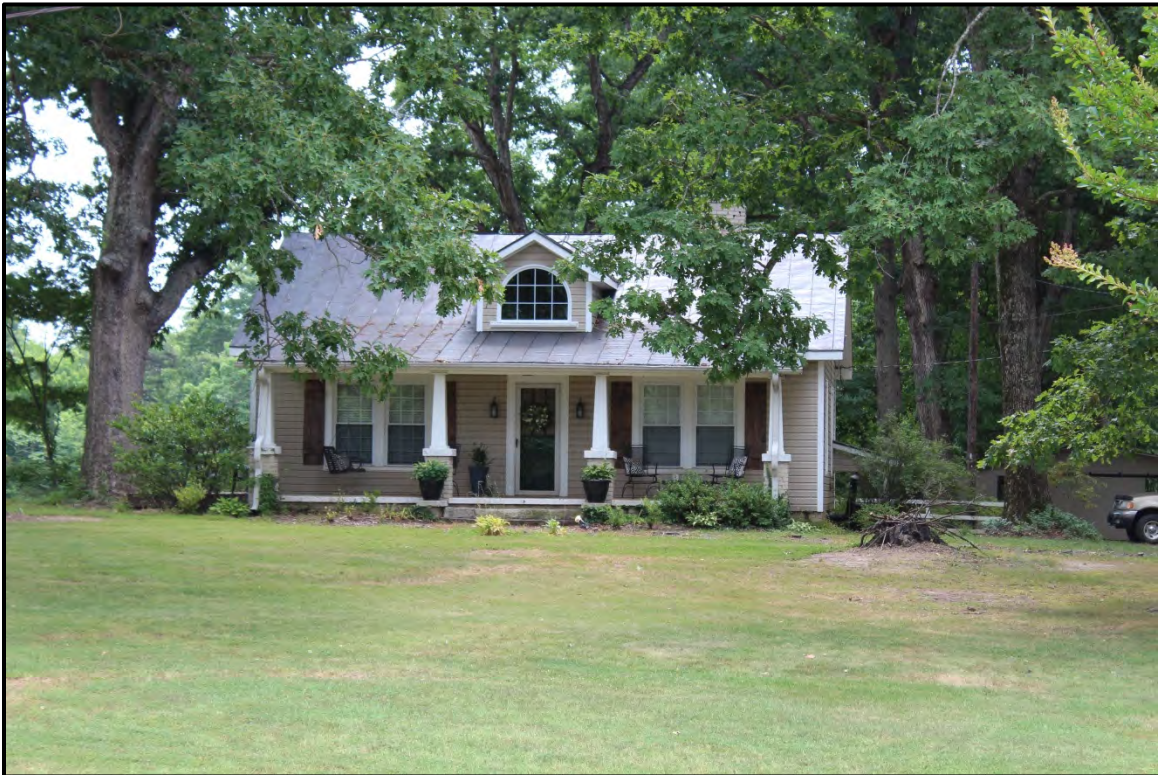
Figure 5.232. Architectural resource RK1746; view is southeast and features the façade.

NRHP Assessment. Architectural resource RK1746 does not exhibit a distinctive architectural style or workmanship. In addition, the house has been altered through the application of vinyl siding, the replacement of the original window sashes, and the modification to the gable dormer on the façade. Based on the lack of architectural merit, as well as the inability to associate the house and/or its original owner(s) with an important historical event or series of events, it is TRC’s opinion that architectural resource RK1746 is not eligible for the NRHP.

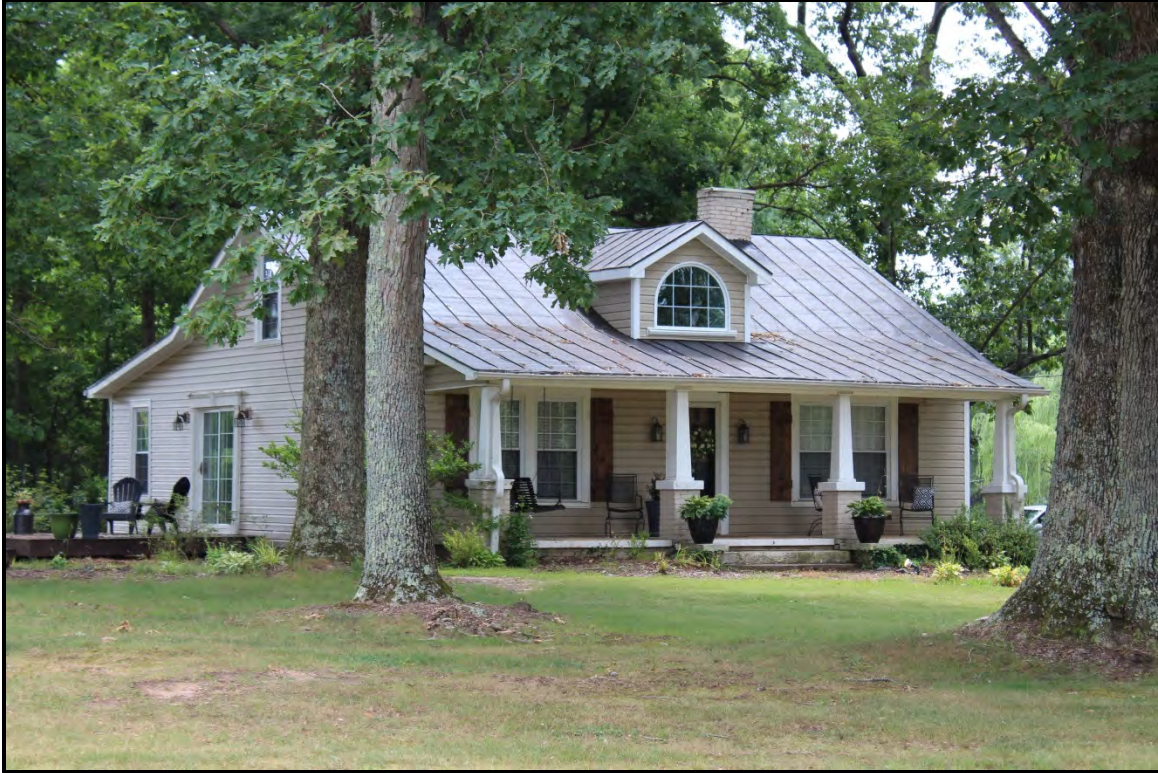
Figure 5.233. Architectural resource RK1746; view is south and features the façade and northeast elevation.

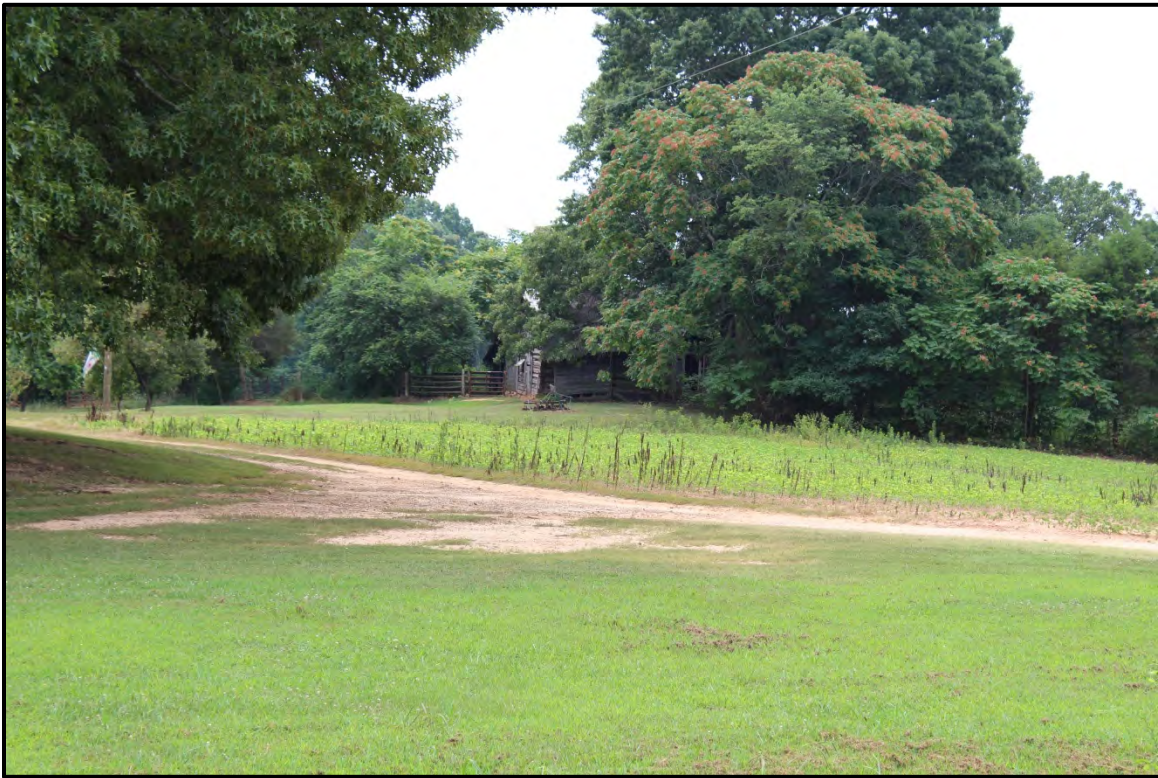
Figure 5.234. Architectural resource RK1746; view is south and features the barn.

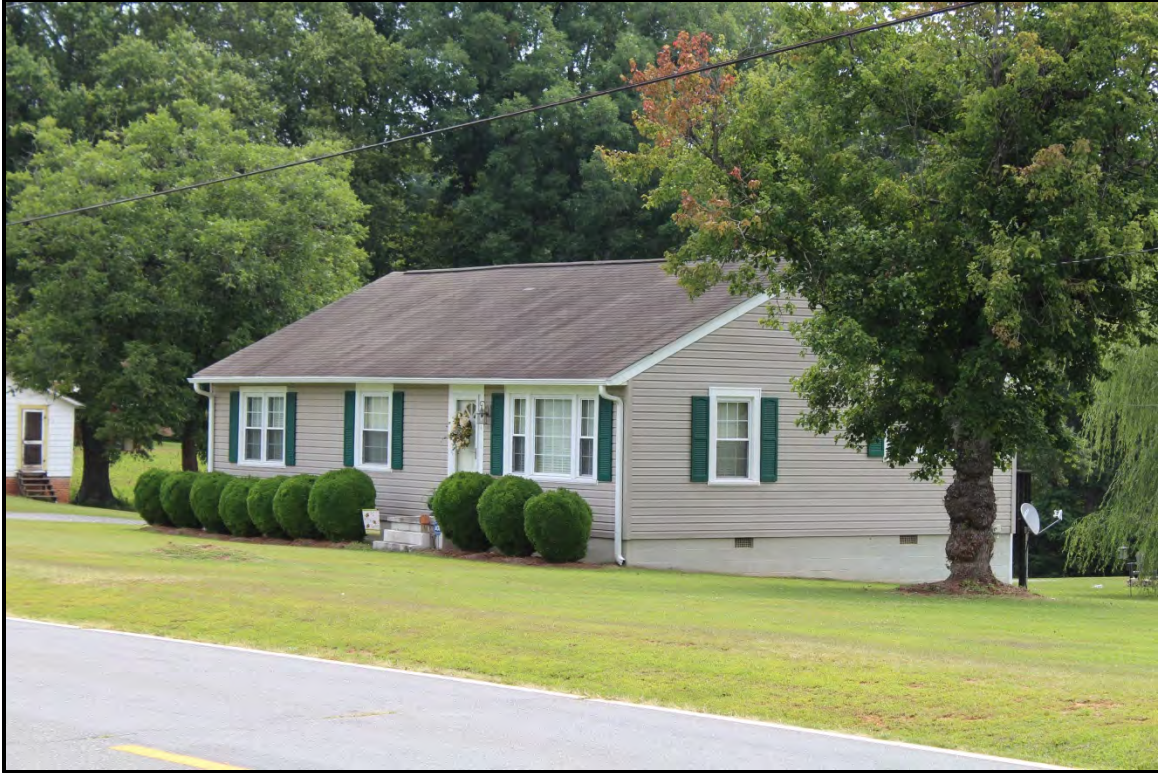
Figure 5.235. Architectural resource RK1747; view is east and features the façade and southwest elevation.

NRHP Assessment. Architectural resource RK1747 is an active farmstead anchored by a Minimal Traditional-style house that does not exhibit distinctive characteristics of architectural style or workmanship. The main residence on the property is a common example of a mid-twentieth century residence that does not possess individual architectural significance. In addition, the building has been altered through the application of vinyl siding and the replacement of the original window sashes. In addition, the historic setting of the property has been compromised with the presence of two parallel transmission line towers on the property, which are visible from the farmhouse and the core complex of associated outbuildings. For these reasons, the farm no longer conveys its mid-twentieth century appearance, thereby rendering the property ineligible for its agricultural associations. Based on the lack of architectural merit, as well as the inability to associate the farm and/or its original owner(s) with an important historical event or series of events, it is TRC’s opinion that architectural resource RK1747 is not eligible for the NRHP.

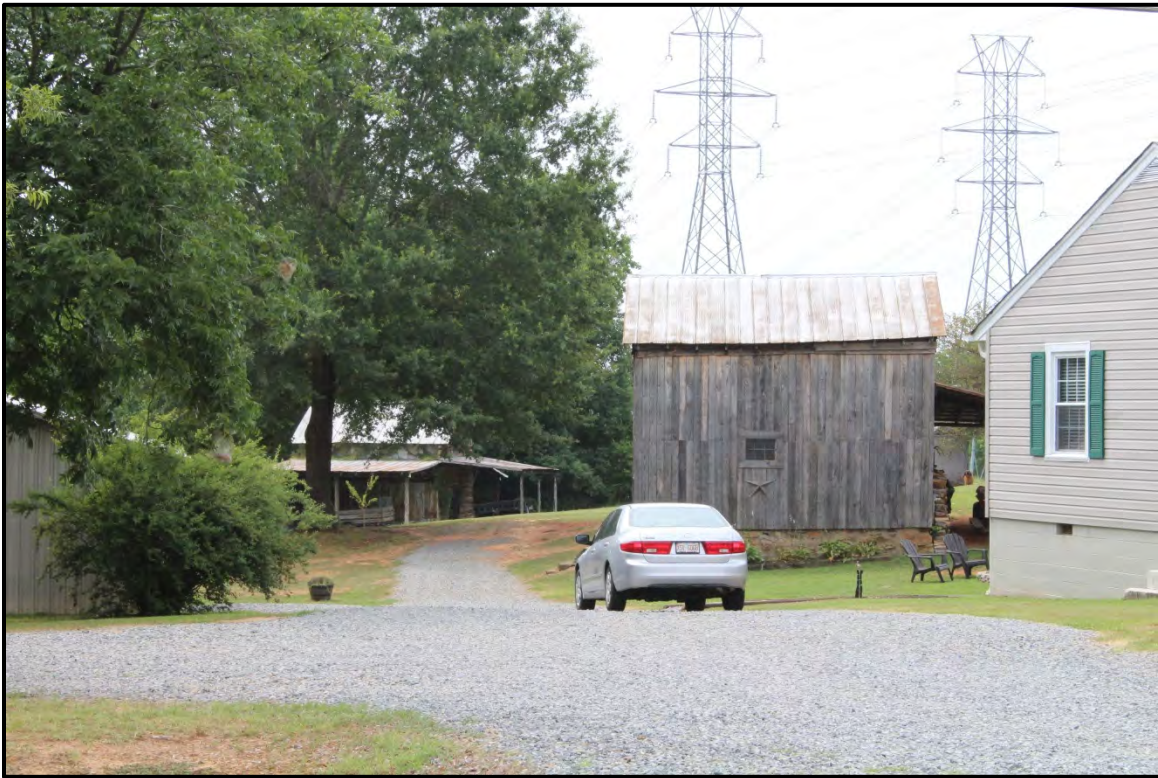
Figure 5.236. Architectural resource RK1747; view is south and features the tobacco barns.

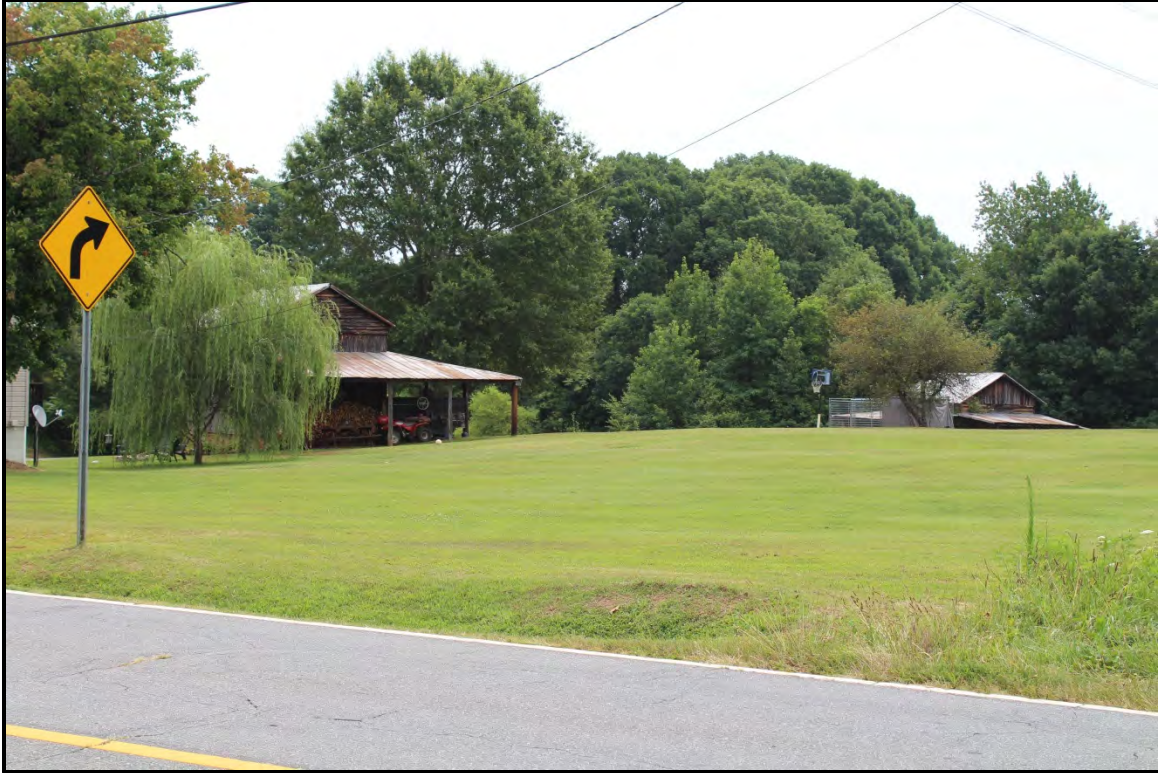
Figure 5.237. Architectural resource RK1747; view is southeast and features the tobacco barns.

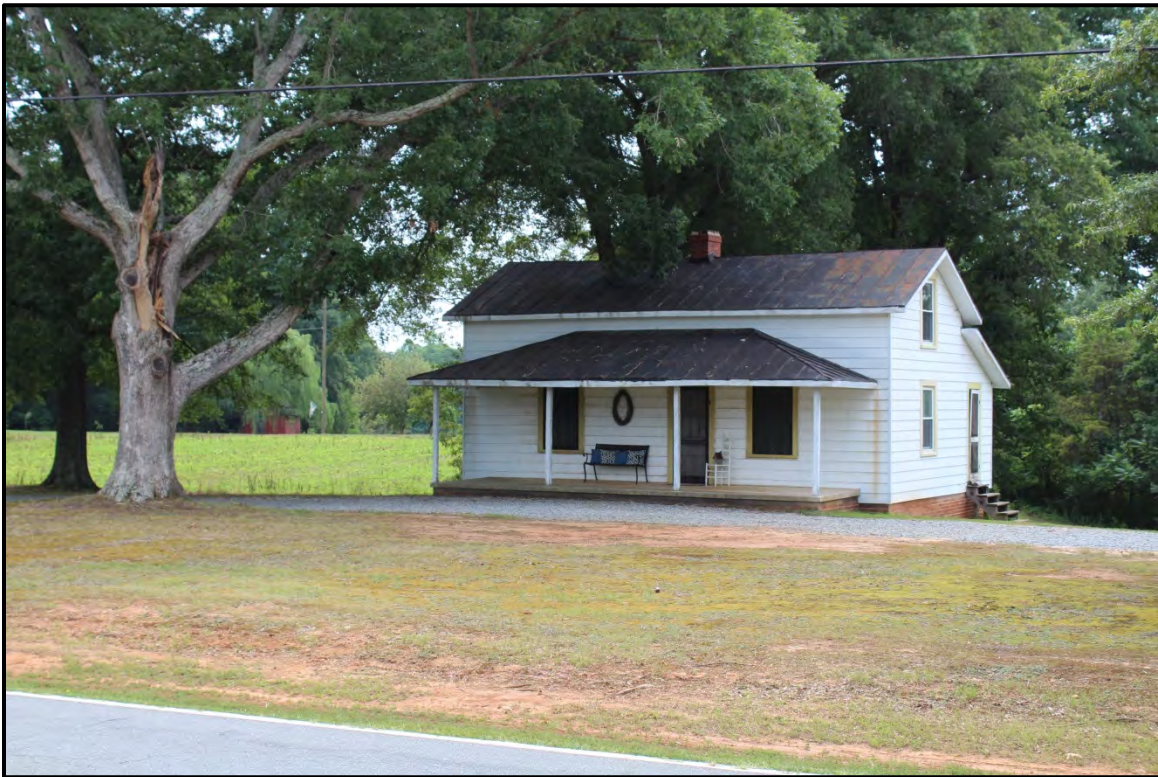
Figure 5.238. Architectural resource RK1748; view is east and features the façade and southwest elevation.

NRHP Assessment. Architectural resource RK1748 does not exhibit a distinctive architectural style or workmanship. In addition, the house has been altered through the replacement of the original window sashes, the application of aluminum siding, and the reconstruction of the façade porch. Based on the lack of architectural merit, as well as the inability to associate the house and/or its original owner(s) with an important historical event or series of events, it is TRC's opinion that architectural resource RK1748 is not eligible for the NRHP.

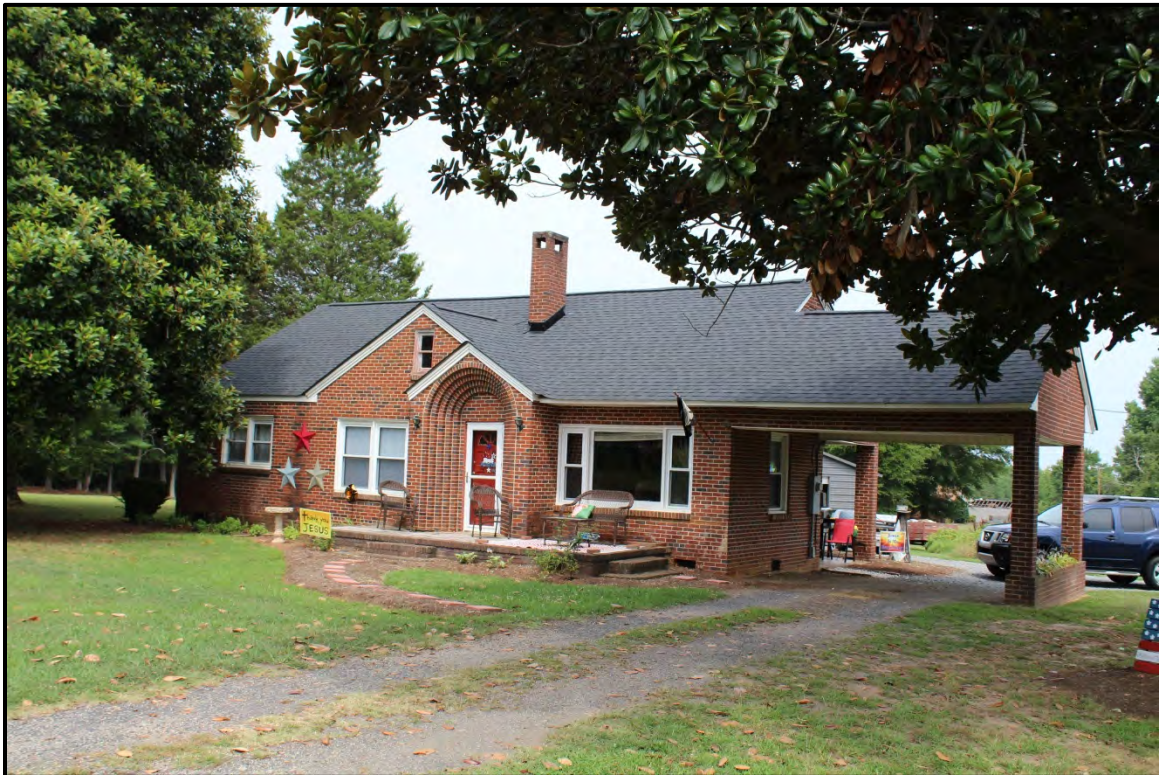
The one and one-half-story, wood-frame building features a side-gabled roof, an exterior clad with a brick veneer, a central interior brick chimney, and a continuous brick foundation. Fenestration includes double hung 1/1 vinyl and 1/1 wood sash windows. A cross-gabled bay contains an arched brick doorway that is accessed by a brick deck, which provides access to the main entrance. A two-bay carport is attached to the east elevation and is integral with the main roof extension, which is partially supported by brick piers.

Figure 5.239. Architectural resource RK1749; view is northwest and features the façade and northeast elevation.

NRHP Assessment. Architectural resource RK1749 does not exhibit a distinctive architectural style or workmanship. In addition, the house has been altered through the replacement of some of the original window sashes. Based on the lack of architectural merit, as well as the inability to associate the house and/or its original owner(s) with an important historical event or series of events, it is TRC's opinion that architectural resource RK1749 is not eligible for the NRHP.

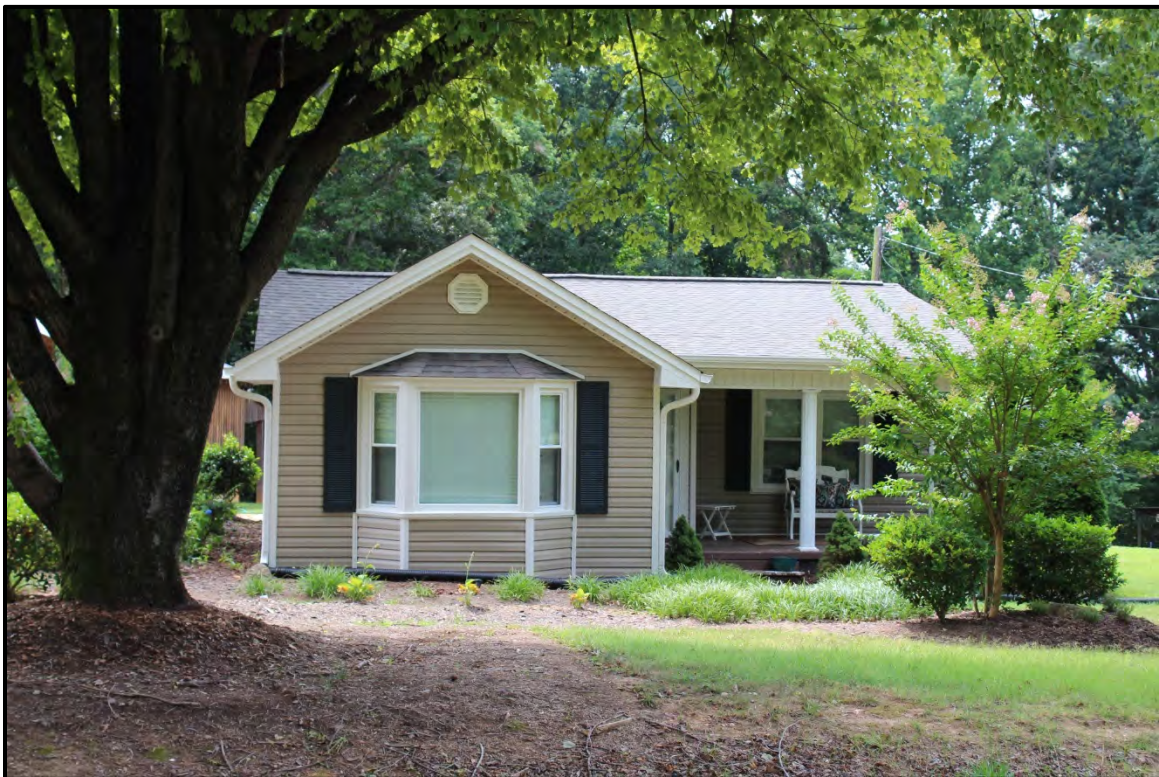
The one-story, wood-frame building features a side-gabled roof covered with asphalt shingles, and an exterior clad with vinyl siding. Fenestration includes double hung 1/1 vinyl sash windows and a tri-part vinyl sash bay window. A partial-width entry porch provides access to the main entrance and is comprised of a shed roof supported by aluminum columns and a concrete deck.

Figure 5.241. Architectural resource RK1751; view is southeast and features the façade.

NRHP Assessment. Architectural resource RK1751 does not exhibit a distinctive architectural style or workmanship. In addition, the house has been altered through the application of vinyl siding, the replacement of the original window sashes, and the reconstruction of the façade porch. Based on the lack of architectural merit, as well as the inability to associate the house and/or its original owner(s) with an important historical event or series of events, it is TRC’s opinion that architectural resource RK1751 is not eligible for the NRHP.

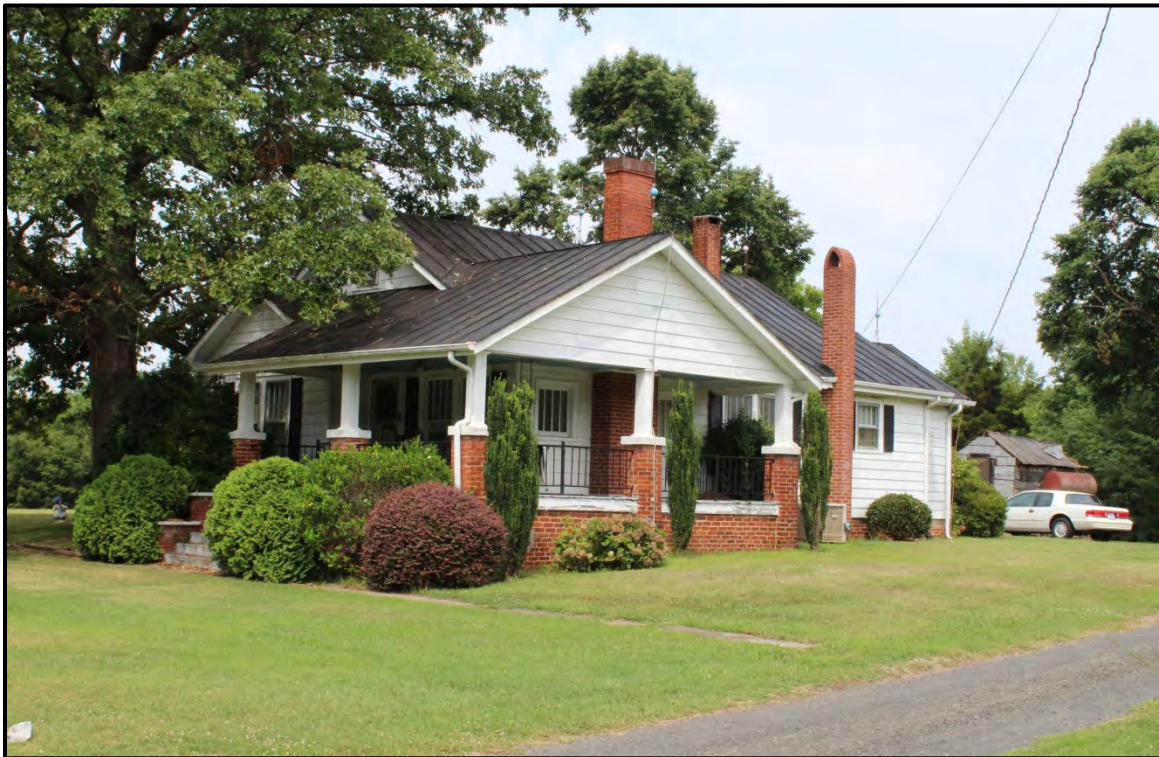
The one and one-half-story, wood-frame building features a gabled roof covered with metal sheeting, two exterior brick chimneys and one interior brick chimney, and an exterior clad with vinyl siding. Fenestration includes double hung 4/1 wood sash windows. A wraparound entry porch provides access to the main entrance and is comprised of a gabled roof supported by aluminum columns and a brick and concrete deck. Located north of the house are a ruinous brick shed, and two mid-twentieth century wood-framed sheds.

Figure 5.242. Architectural resource RK1752; view is northwest and features the façade and northeast elevation.

NRHP Assessment. Architectural resource RK1752 does not exhibit a distinctive architectural style or workmanship. In addition, the house has been altered through the application of aluminum siding. Based on the lack of architectural merit, as well as the inability to associate the house and/or its original owner(s) with an important historical event or series of events, it is TRC's opinion that architectural resource RK1752 is not eligible for the NRHP.

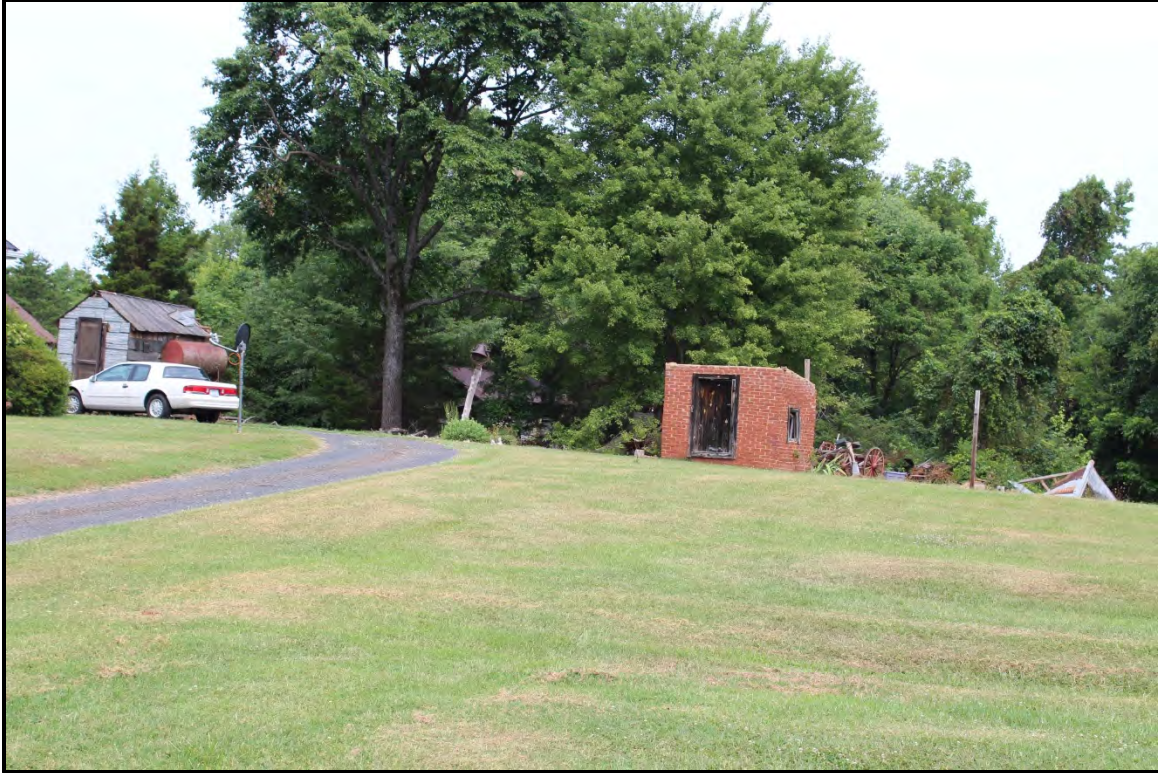
Figure 5.243. Architectural resource RK1752; view is northwest and features the outbuildings.

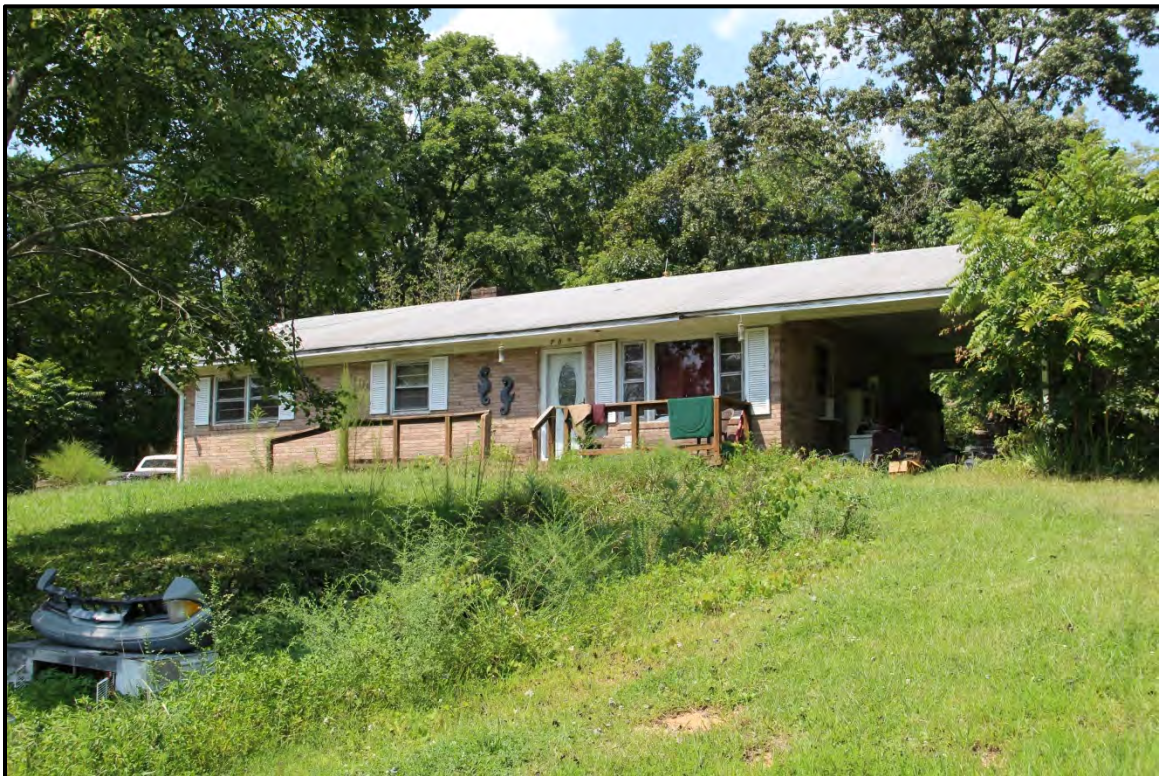
The wood-frame building features a side-gabled roof covered with asphalt shingles, an interior brick chimney, and an exterior clad with a brick veneer. Fenestration includes double-hung horizontal 2/2 aluminum sash windows. A modern wood deck provides access to the main entrance. A carport is attached to the east elevation and is integral with the main roof. Located northwest of the house is a prefabricated wood-framed shed.

Figure 5.244. Architectural resource RK1753; view is northwest and features the façade and northeast elevation.

NRHP Assessment. Architectural resource RK1753 does not exhibit a distinctive architectural style or workmanship. In addition, the house has been altered through the construction of the wood deck to the façade. Based on the lack of architectural merit, as well as the inability to associate the house and/or its original owner(s) with an important historical event or series of events, it is TRC’s opinion that architectural resource RK1753 is not eligible for the NRHP.

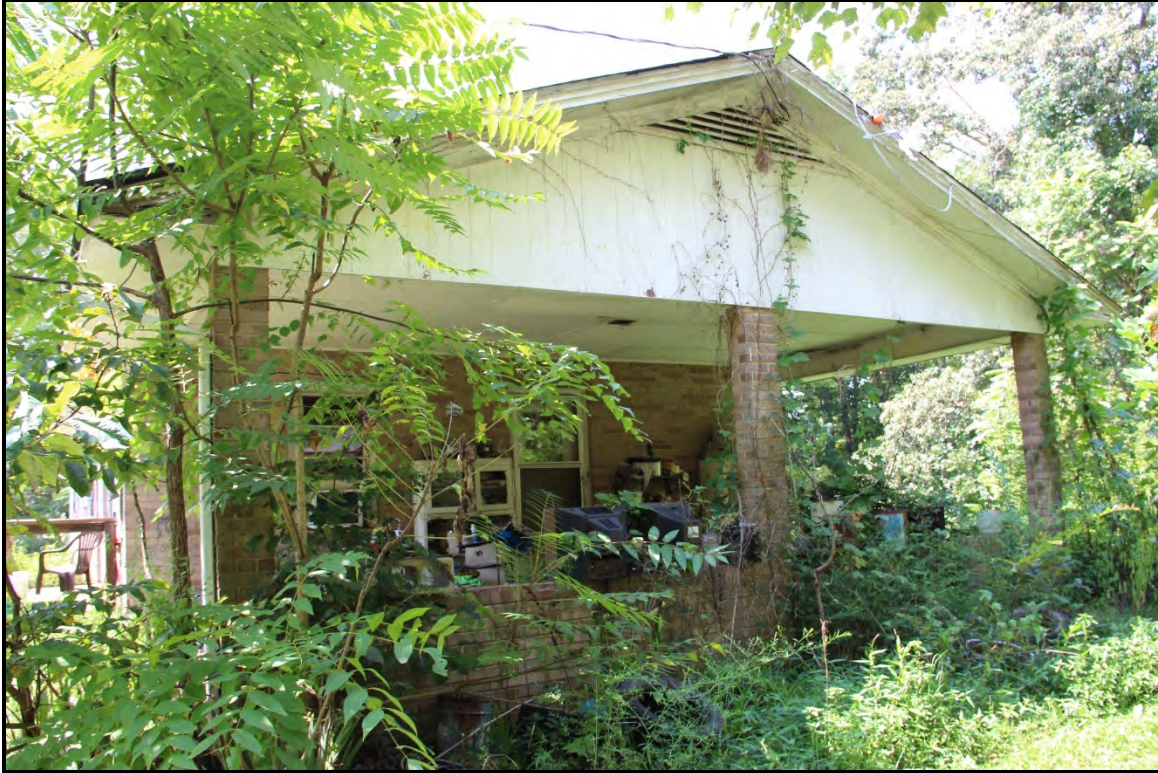
Figure 5.245. Architectural resource RK1753; view is west and features the northeast elevation carport.

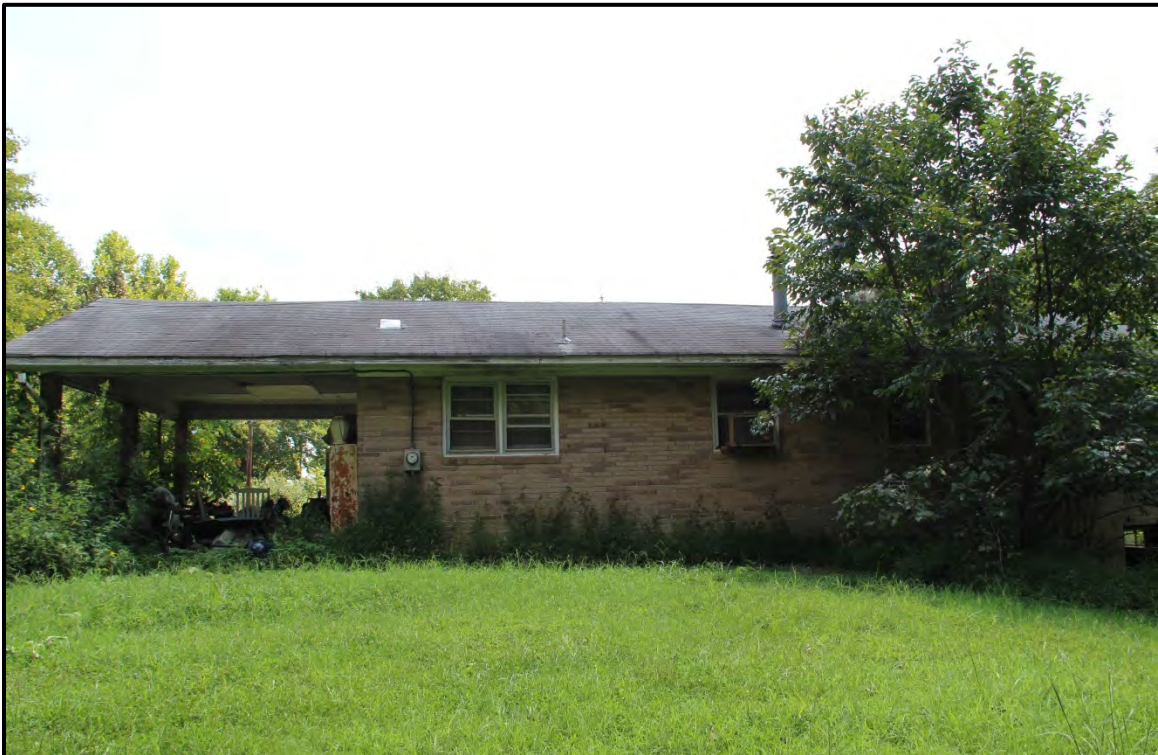
Figure 5.246. Architectural resource RK1753; view is southeast and features the northwest (rear) elevation.

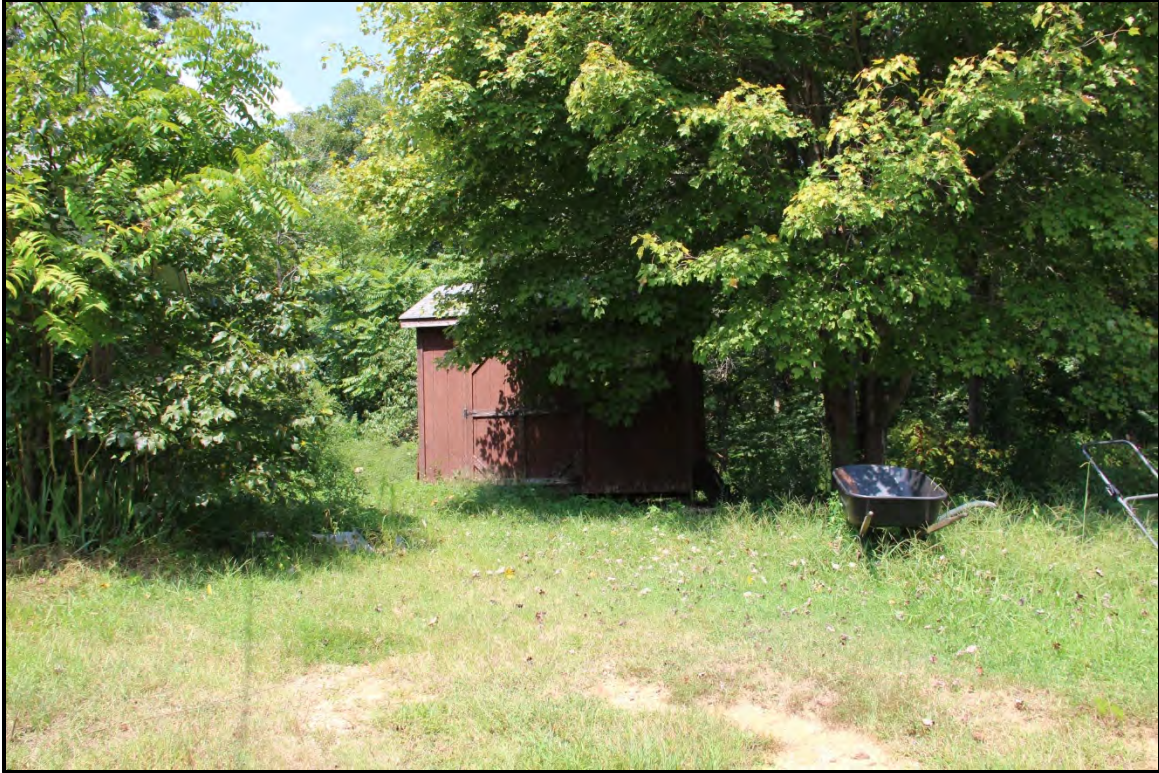
Figure 5.247. Architectural resource RK1753; view is northwest and features the shed.

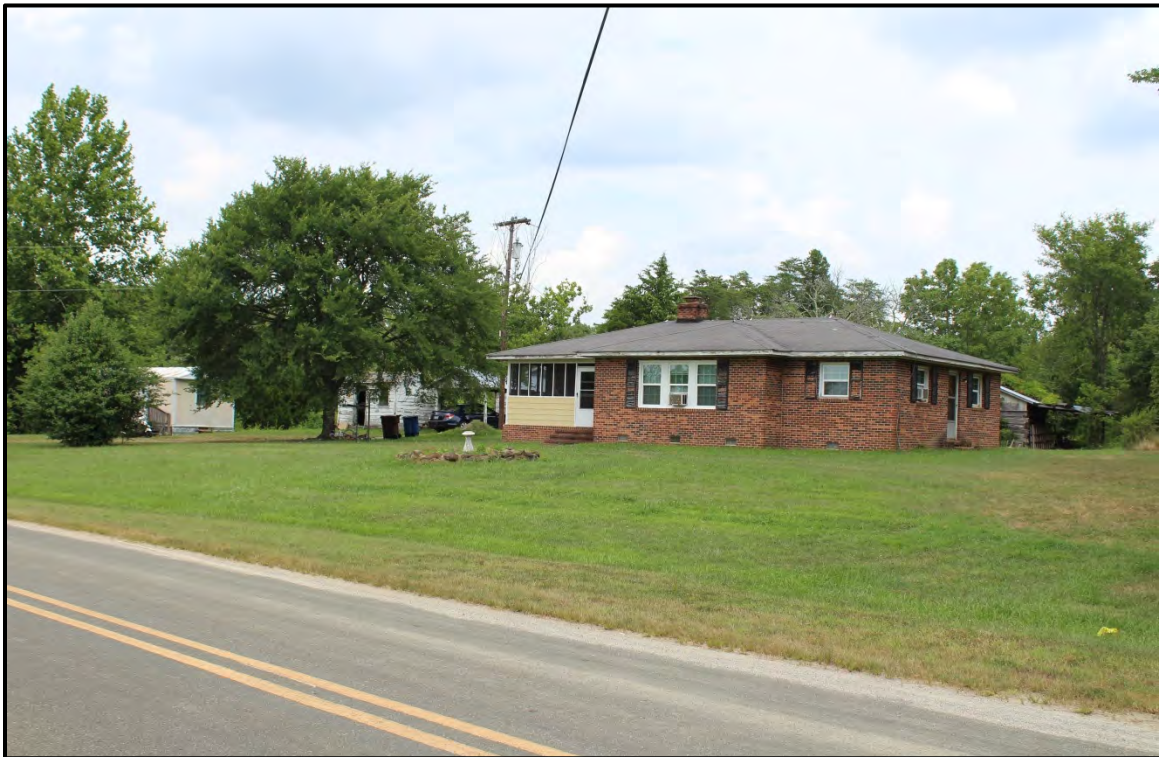
The wood-frame building features a hipped roof covered with metal sheeting, an interior brick chimney, and an exterior clad with a brick veneer. Fenestration includes double-hung 6/6 vinyl sash windows. An enclosed corner porch provides access to the main entrance, is integral with the main roof, and is accessed by a brick stoop. Located north of the house is a mid-twentieth century log barn assembled with half-dovetail corner notching. The barn features a modern gabled roof and a modern shed lean-to attached to the east elevation.

Figure 5.248. Architectural resource RK1754; view is northeast and features the façade and southeast elevation.

NRHP Assessment. Architectural resource RK1754 does not exhibit a distinctive architectural style or workmanship. In addition, the house has been altered through the replacement of the original window sashes. Based on the lack of architectural merit, as well as the inability to associate the house and/or its original owner(s) with an important historical event or series of events, it is TRC’s opinion that architectural resource RK1754 is not eligible for the NRHP.

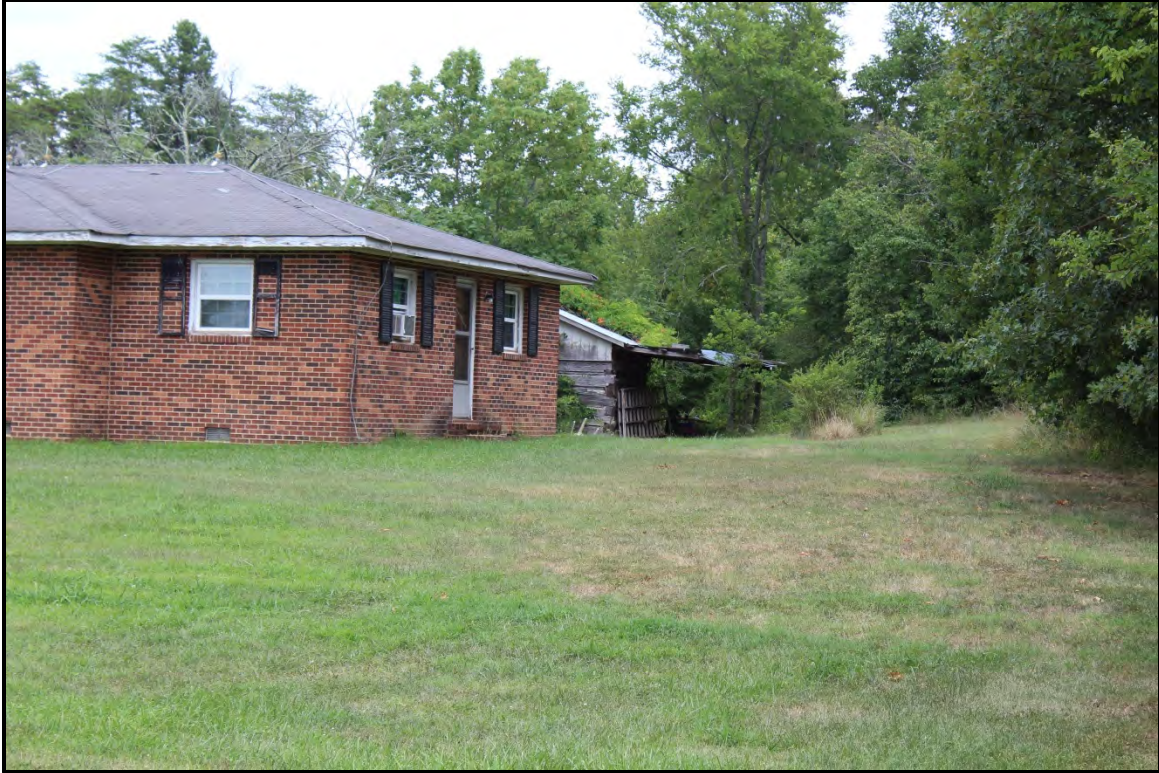
Figure 5.249. Architectural resource RK1754; view is north and features the log barn.

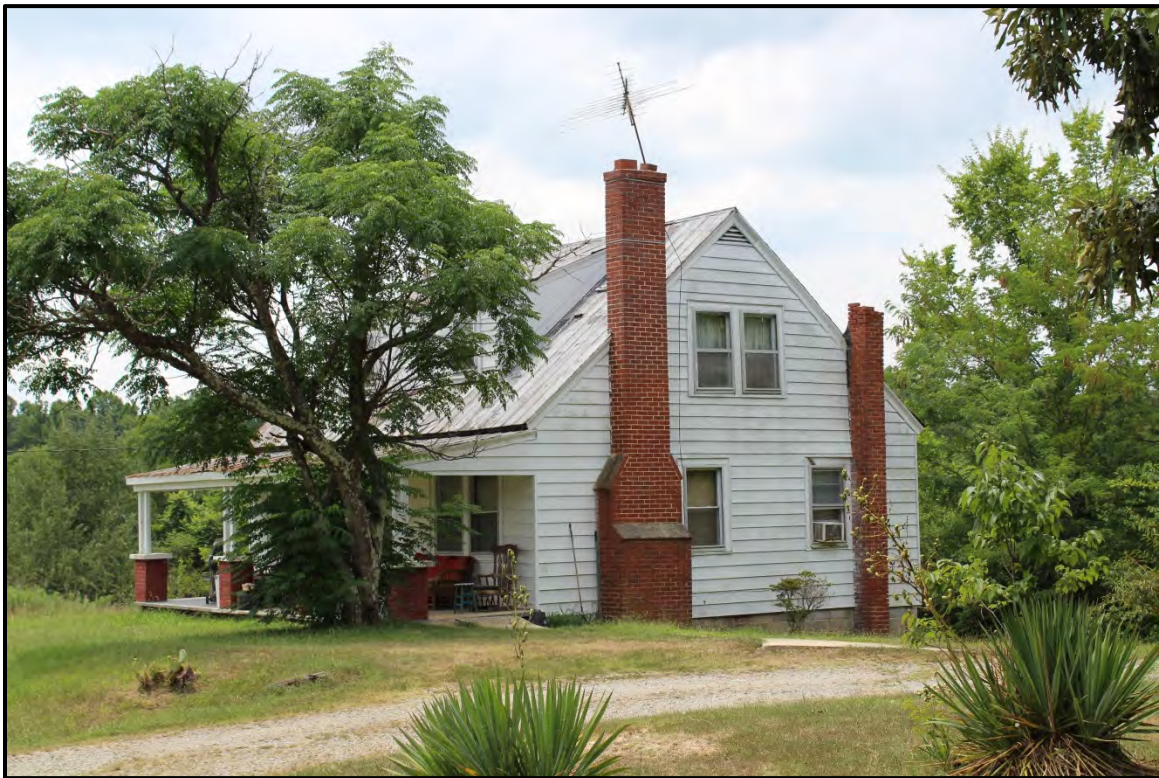
The one and one-half-story, wood-frame building features a roof covered with metal sheeting, two exterior end brick chimneys, and an exterior clad with aluminum siding. Fenestration includes double-hung 1/1 vinyl sash windows. A full-width porch provides access to the main entrance and is comprised of a shed roof supported by modern aluminum columns set atop brick plinth blocks and a concrete slab deck.

Figure 5.250. Architectural resource RK1755; view is southwest and features the façade and north elevation.

NRHP Assessment. Architectural resource RK1755 does not exhibit a distinctive architectural style or workmanship. In addition, the house has been altered through the application of aluminum siding and the replacement of the original window sashes. Based on the lack of architectural merit, as well as the inability to associate the house and/or its original owner(s) with an important historical event or series of events, it is TRC’s opinion that architectural resource RK1755 is not eligible for the NRHP.

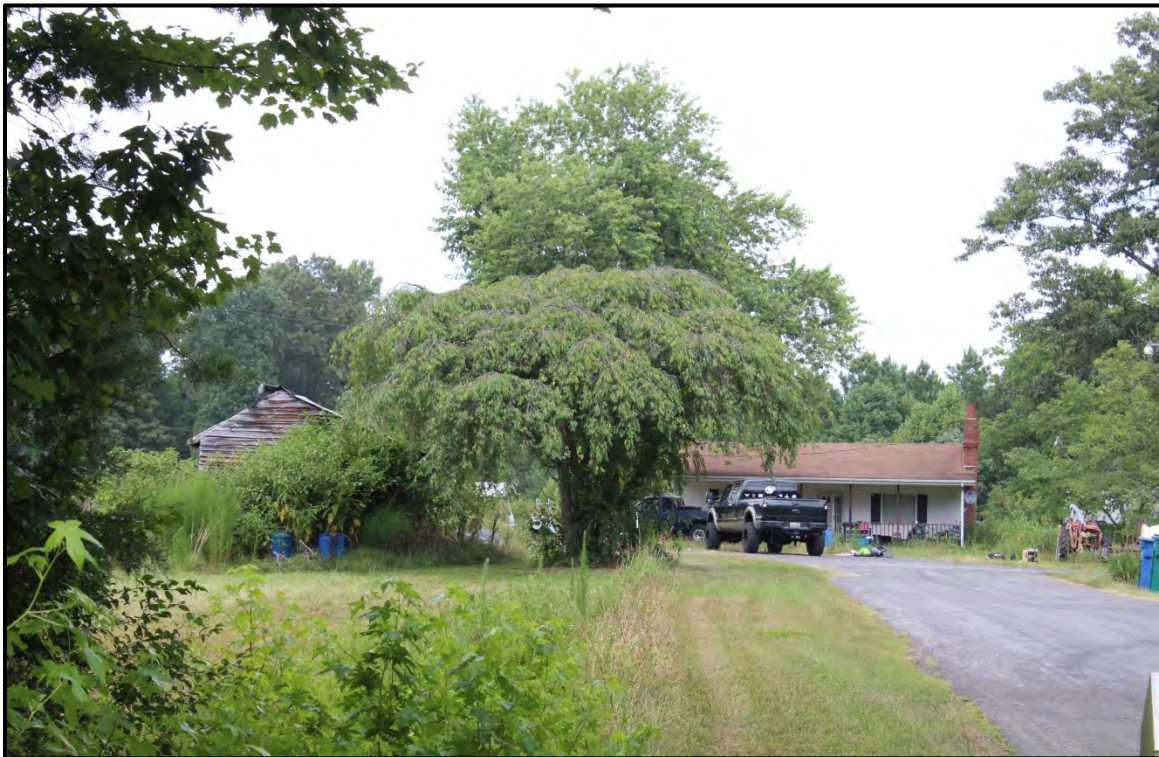
The one-story, wood-frame building features a side-gabled roof, an exterior end brick chimney, and an exterior clad with vinyl siding. Fenestration includes a fixed vinyl sash picture window. A full-width porch provides access to the main entrance and is comprised of a shed roof supported by modern wood posts. Located southwest of the house is a wood-framed tobacco barn that is reported to have been constructed in 1950 (Rockingham County, NC WebGIS 2018). Although not visible from the public right-of-way, the parcel also includes a 1980 agricultural storage building, a 1994 garage, a 1998 carport, a 2000 garage, and a 1968 mobile home (Rockingham County, NC WebGIS 2018).

Figure 5.251. Architectural resource RK1756; view is northeast and features the façade and ca. 1950 tobacco barn (on left).

NRHP Assessment. Architectural resource RK1756 does not exhibit a distinctive architectural style or workmanship. In addition, the house has been altered through the application of vinyl siding and the replacement of the original window sashes. Based on the lack of architectural merit, as well as the inability to associate the house and/or its original owner(s) with an important historical event or series of events, it is TRC's opinion that architectural resource RK1756 is not eligible for the NRHP.

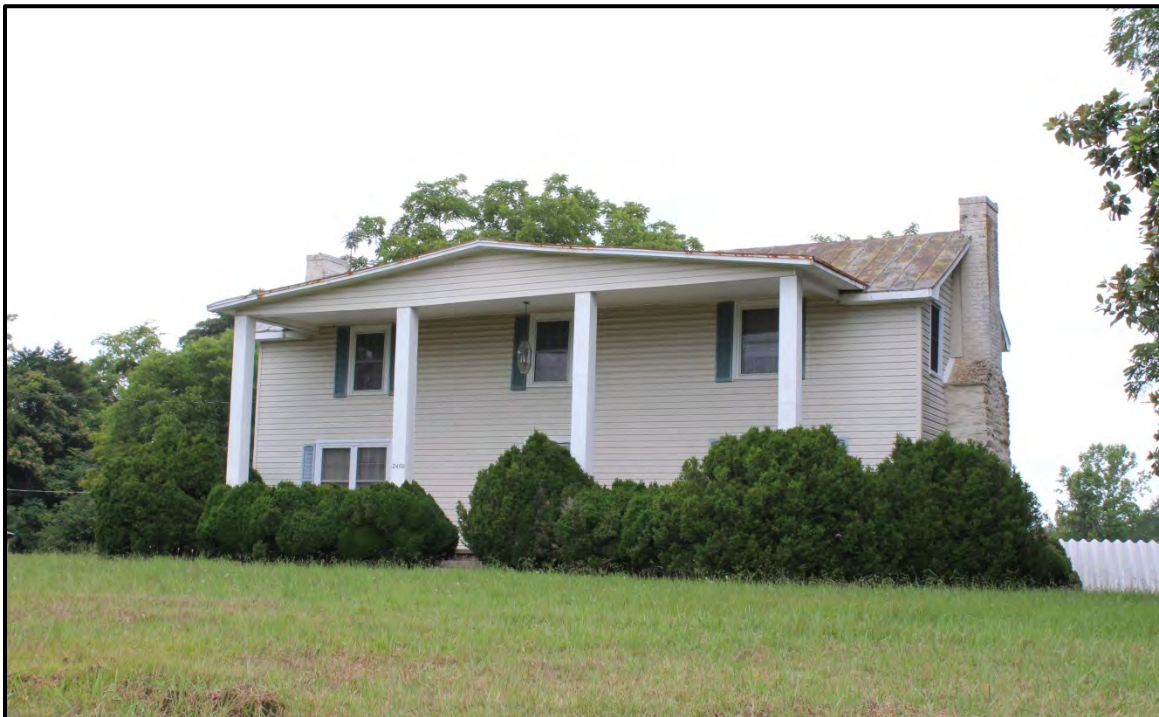
The two-story, wood-frame building features a side-gabled roof covered with metal sheeting, two exterior end stone and brick chimneys, and an exterior clad with vinyl siding. It is unknown if the house is log or wood-frame. Fenestration includes double-hung 6/6 vinyl sash windows. A reconstructed full-height, full-width porch provides access to the main entrance, and is comprised of a gabled roof supported by aluminum posts. Located north and west of the house are a collection of associated outbuildings that include two storage buildings reportedly constructed in 1940, three early twentieth century sheds, and a late nineteenth century log storage crib (Rockingham County, NC WebGIS 2018).

Figure 5.252. Architectural resource RK1757; view is northwest and features the façade and east elevation.

NRHP Assessment. Architectural resource RK1757 does not exhibit a distinctive architectural style or workmanship. In addition, the house has been altered through the application of vinyl siding, the replacement of the original window sashes, and the reconstruction of the façade porch. Based on the lack of architectural merit, as well as the inability to associate the house and/or its original owner(s) with an important historical event or series of events, it is TRC’s opinion that architectural resource RK1757 is not eligible for the NRHP.
