Re: Revised Architectural Survey Report, MVP Southgate Project, Construct Interstate Pipeline, Rockingham and Alamance County, ER 18-1041

Thank you for your letter of October 11, 2019, transmitting the draft "Historic Architectural Survey for the MVP Southgate Pipeline Project". We have reviewed the report and offer the following comments.

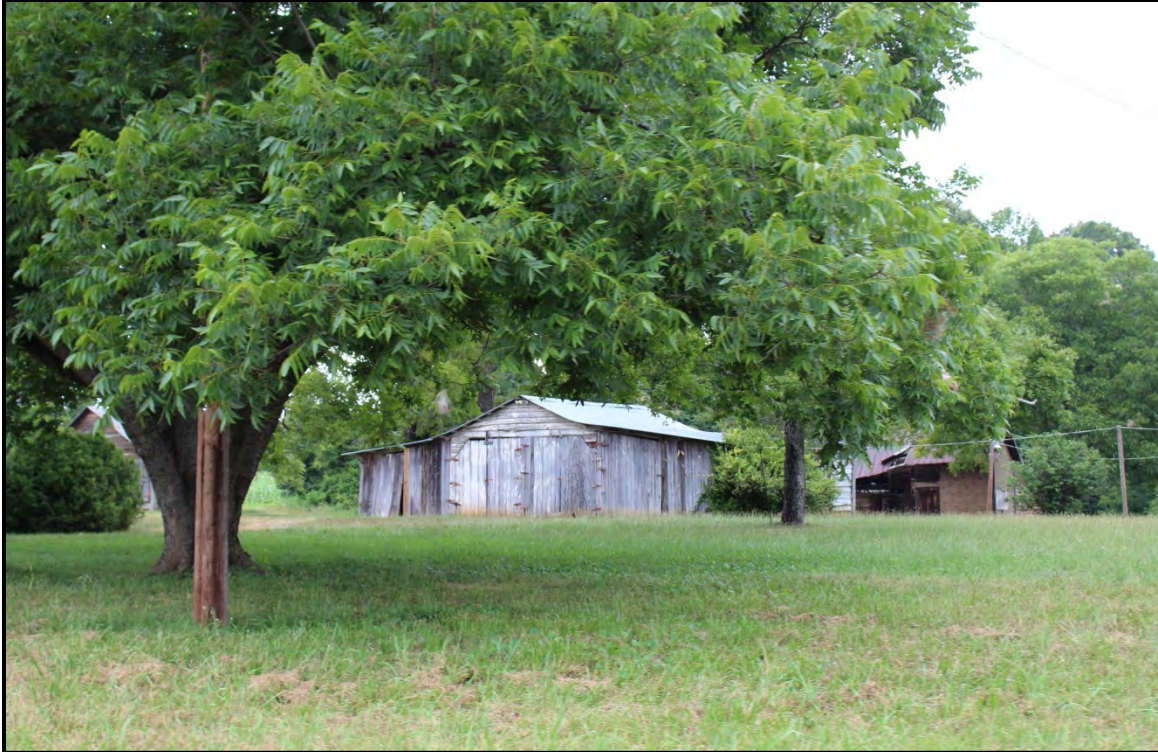
Figure 5.253. Architectural resource RK1757; view is northwest and features the associated outbuildings.

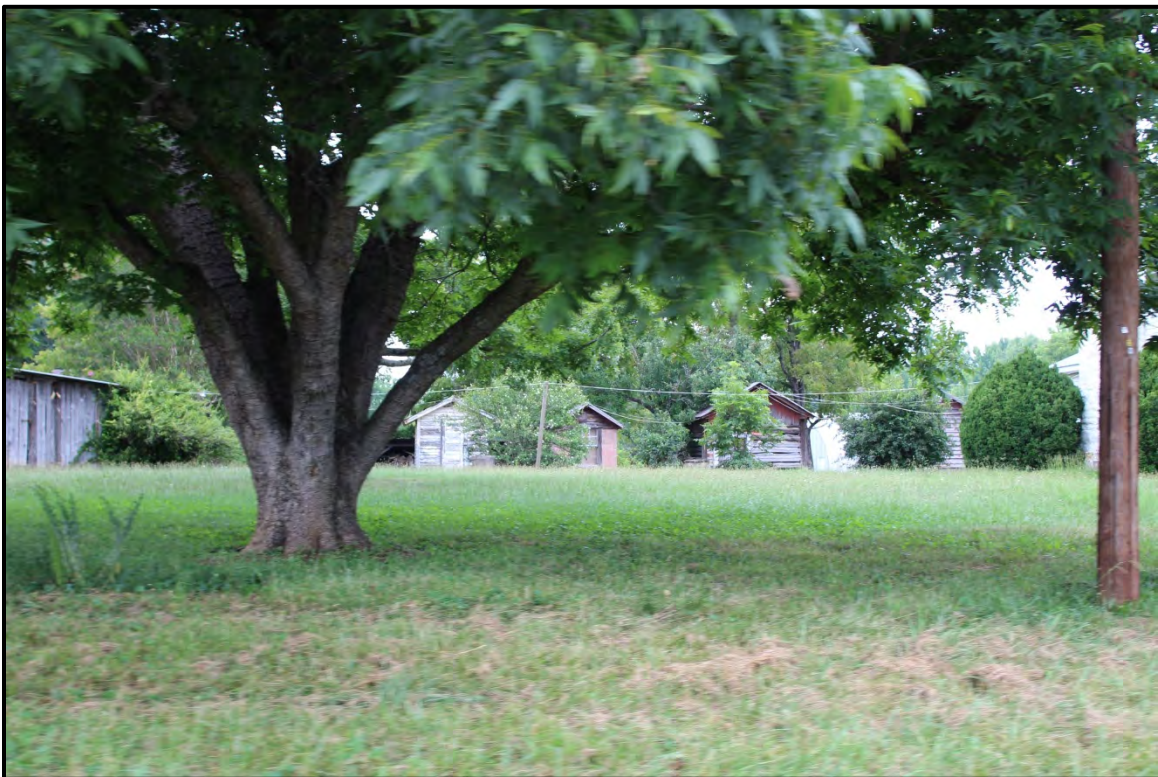
Figure 5.254. Architectural resource RK1757; view is north and features the early twentieth century sheds and log crib.

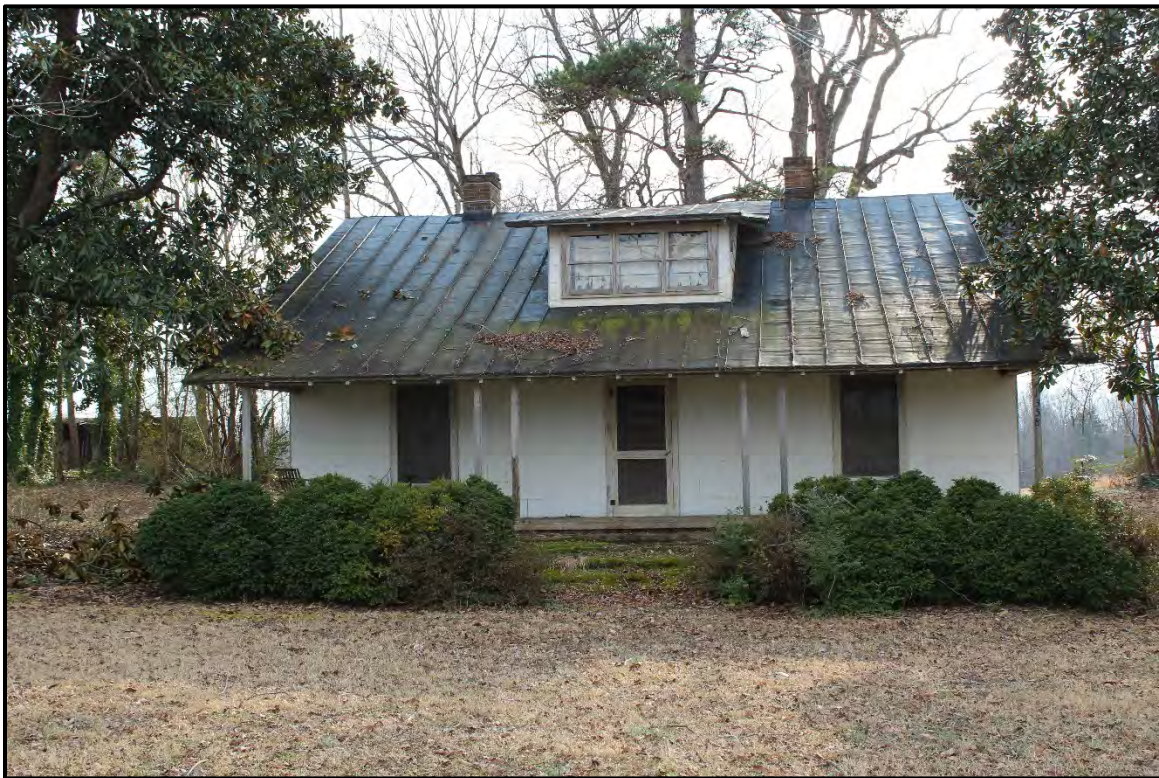
- RK1758 is recommended as ineligible for the NRHP, but the property retains a remarkable collection of outbuildings. It must be compared to other early-twentieth-century farms in the county for a determination of eligibility to be made.

Figure 5.255. RK1758 1926 farmhouse; view is southwest and features the façade.

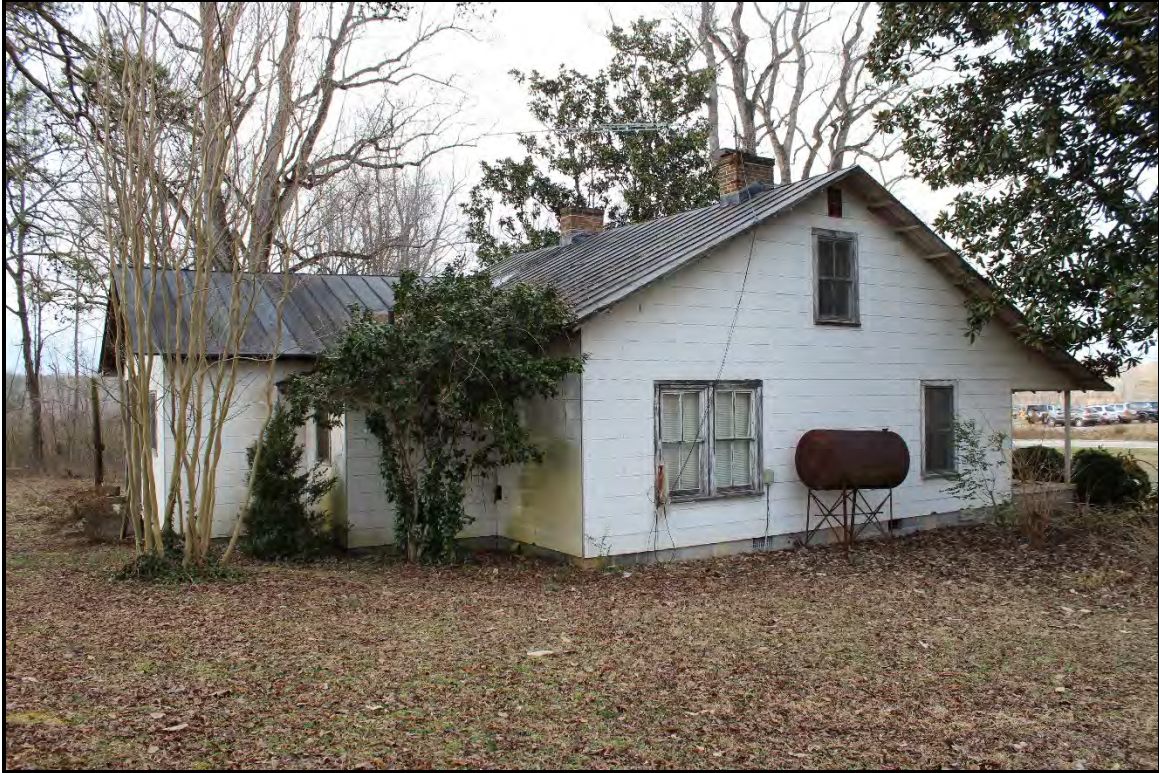
The one and one-half-story, wood-frame house features a side-gabled roof covered with metal sheeting, two interior brick chimneys, an exterior clad with asbestos shingles, and a continuous concrete block foundation. Fenestration includes double-hung 2/2 wood sash windows. A full-width entry porch provides access to the main entrance, and is integral with the main roof, which is partially supported by modern wood posts.

Figure 5.256. RK1758 1926 farmhouse; view is northwest and features the southeast elevation.

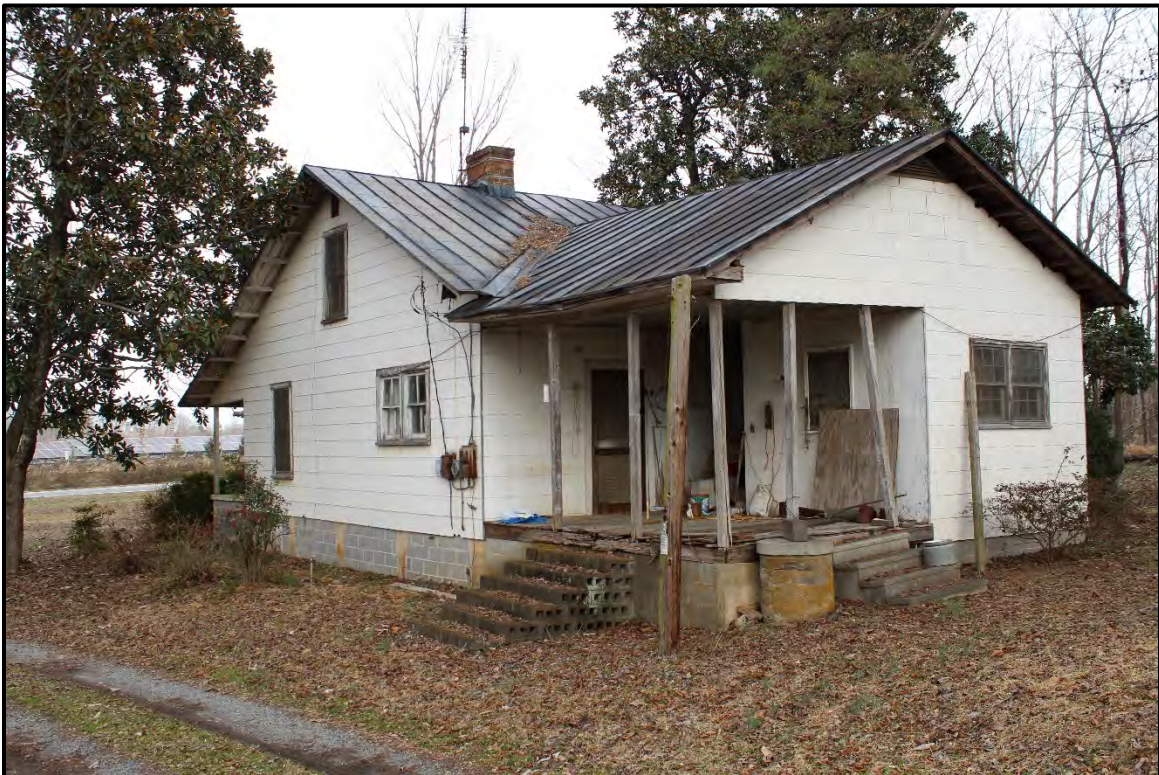
Figure 5.257. RK1758 1926 farmhouse; view is northeast featuring the northwest and southwest (rear) elevations.

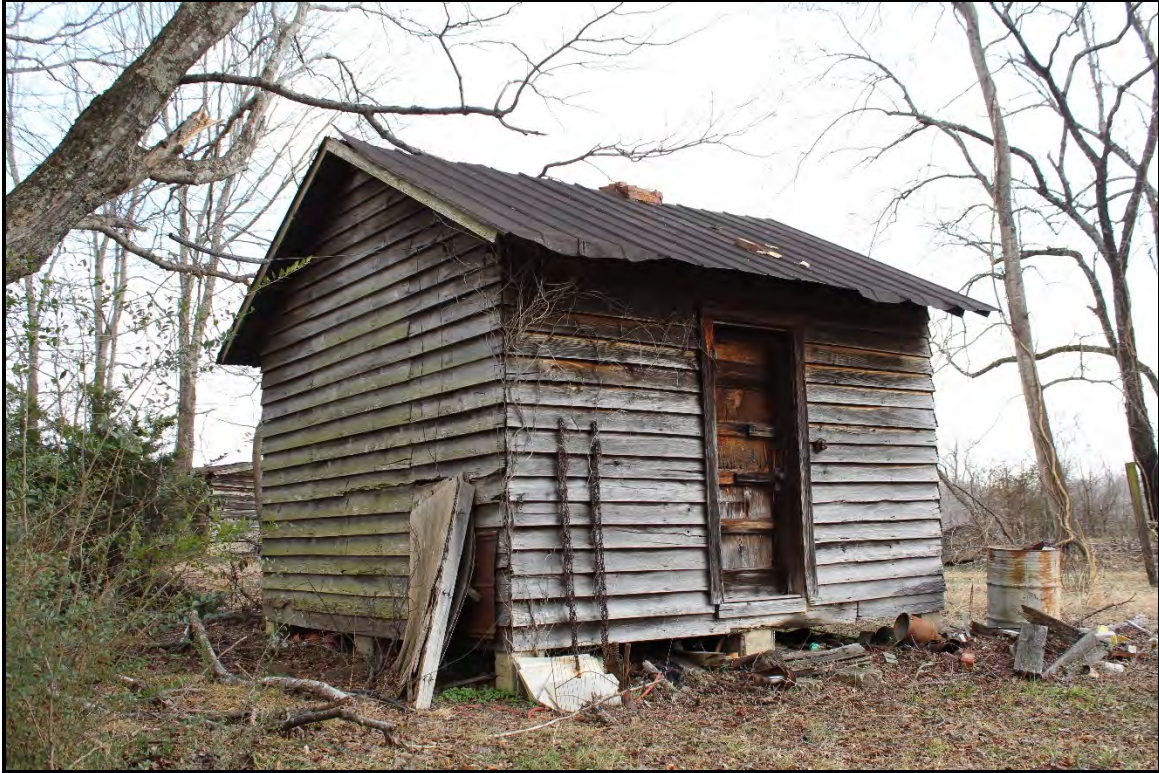
Figure 5.258. RK1758 work shop; view is southeast featuring the façade and north elevation.

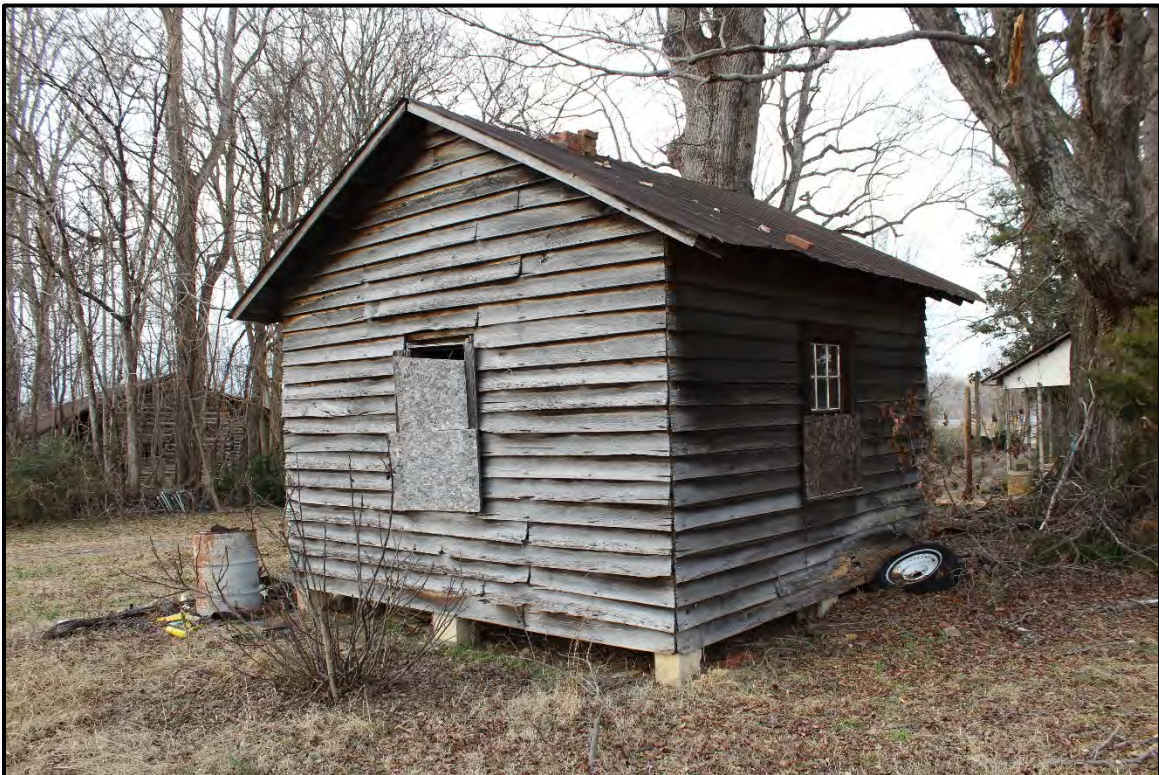
Figure 5.259. RK1758 work shop; view is northwest featuring the south (rear) and east elevation.

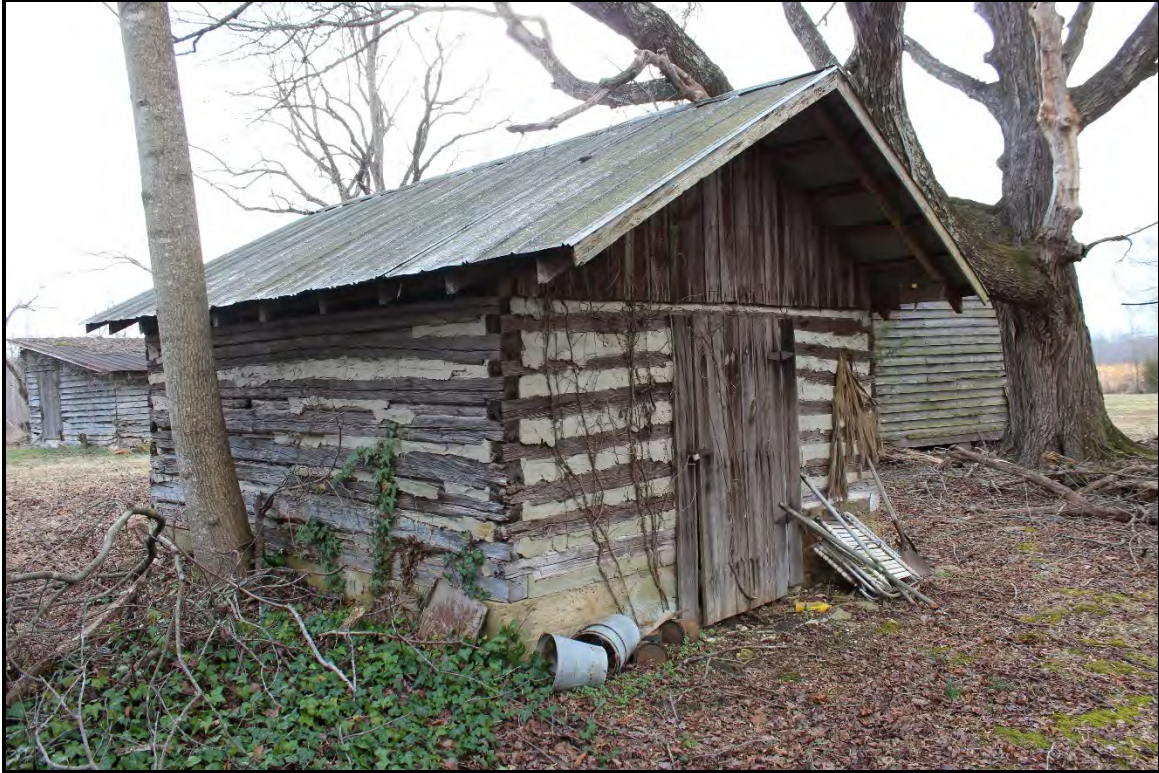
Figure 5.260. RK1758 smokehouse; view is southwest featuring the façade and east elevation.

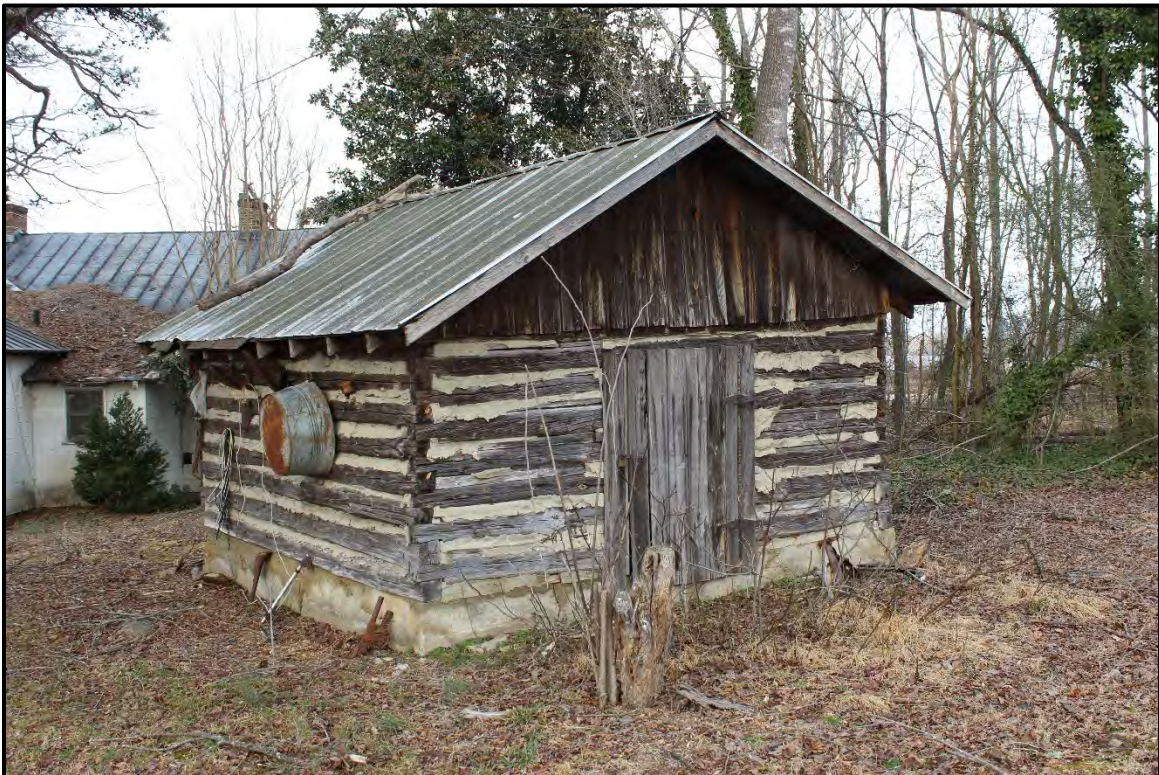
Figure 5.261. RK1758 smokehouse; view is northeast featuring the south (rear) and west elevations.

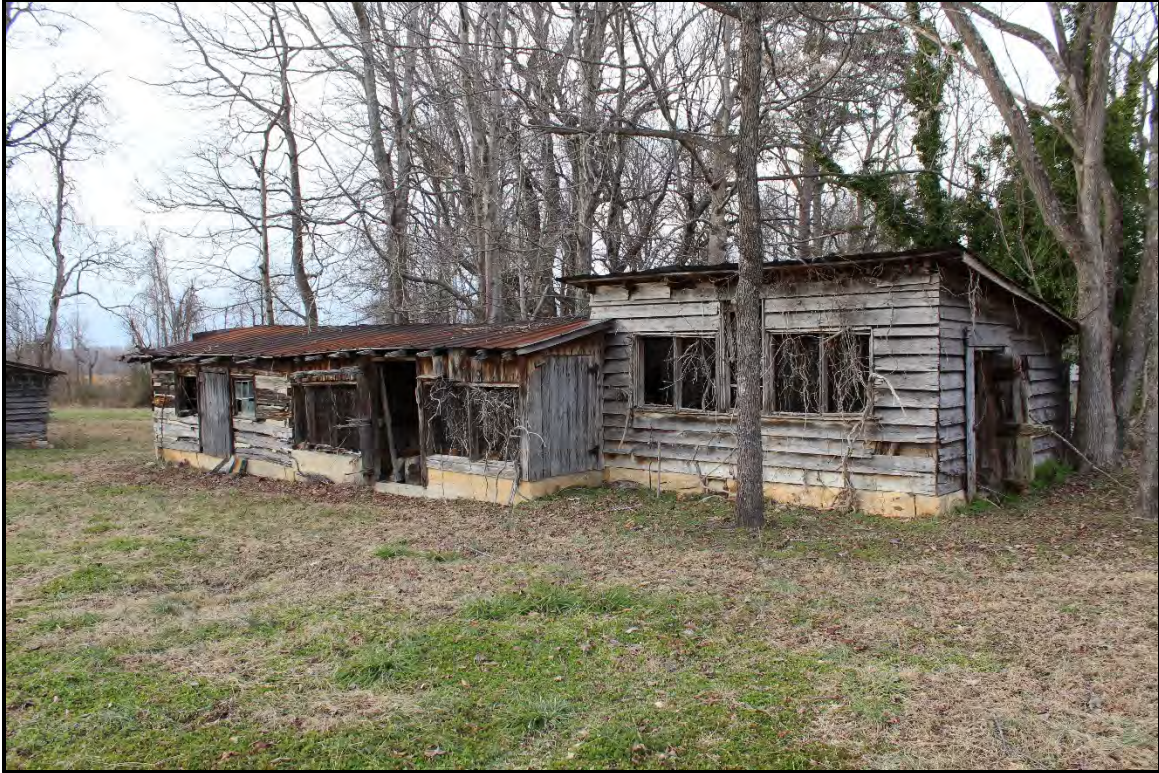
Figure 5.262. RK1758 chicken houses; view is northwest featuring the façade and northeast elevation.

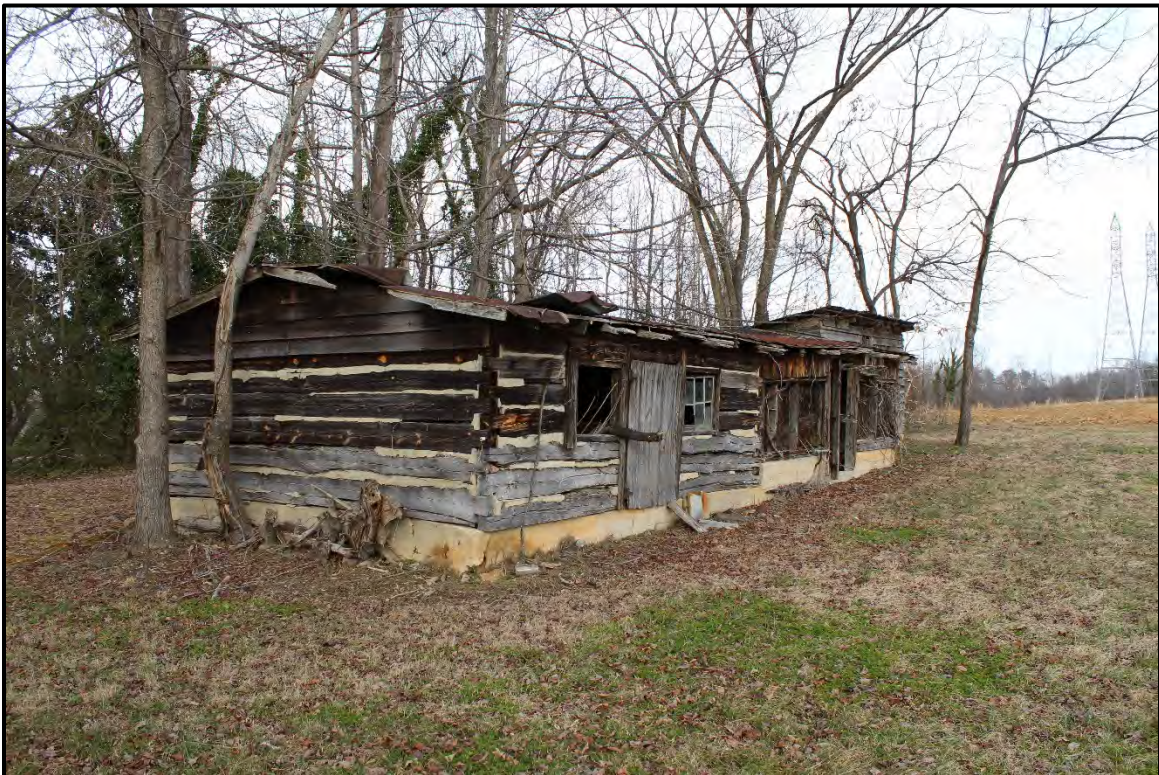
Figure 5.263. RK1758 chicken houses; view is northeast featuring the façade and southwest elevation.

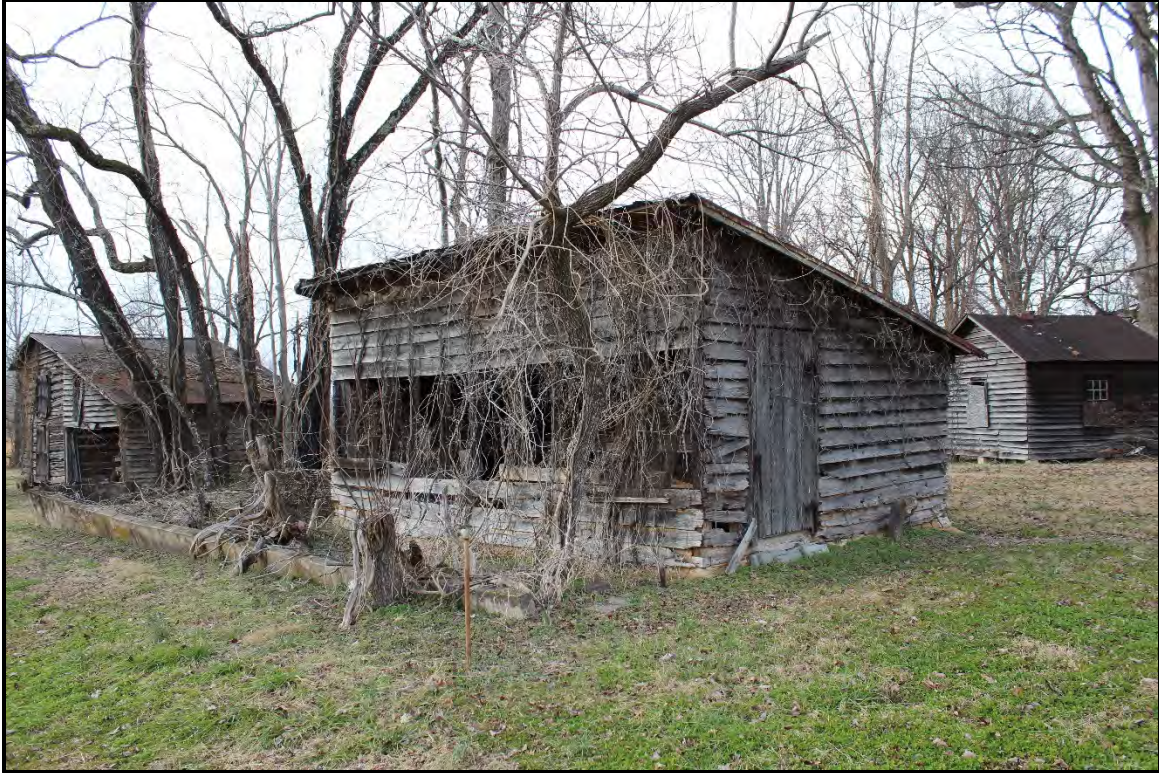
Figure 5.264. RK1758 dog kennel; view is northwest featuring the façade and northeast elevation.

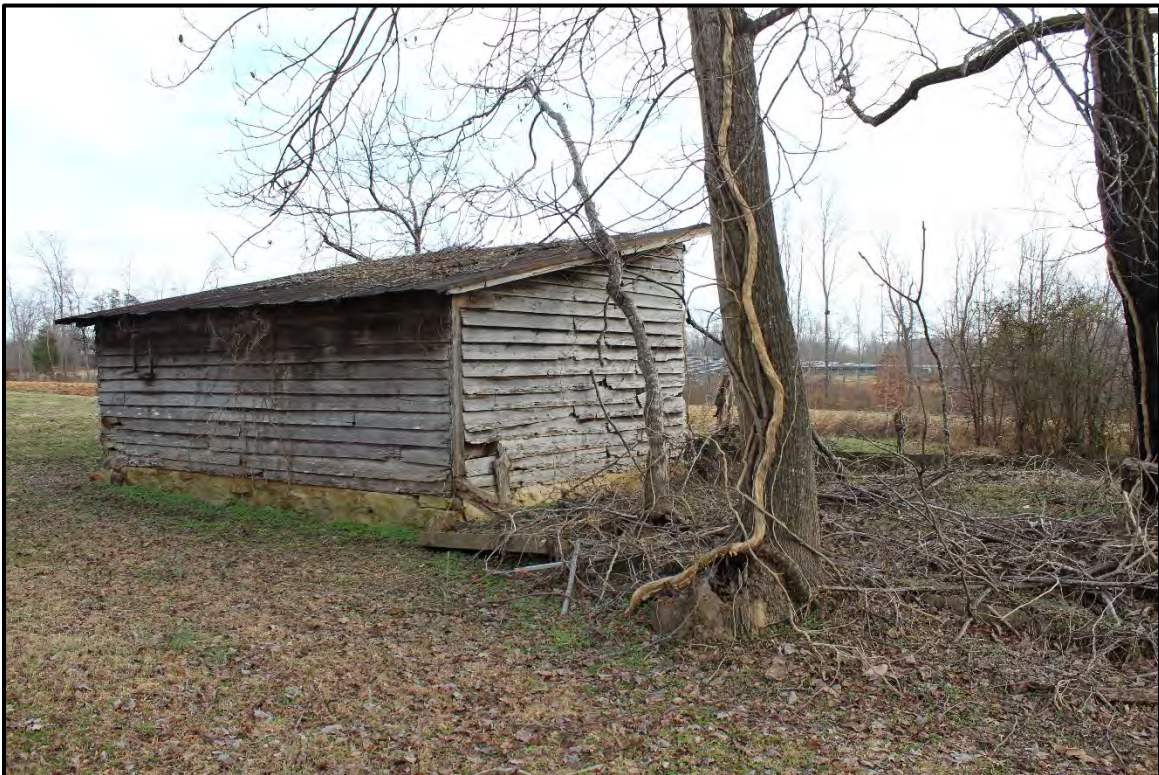
Figure 5.265. RK1758 dog kennel; view is southeast featuring the northwest (rear) and southwest elevations.

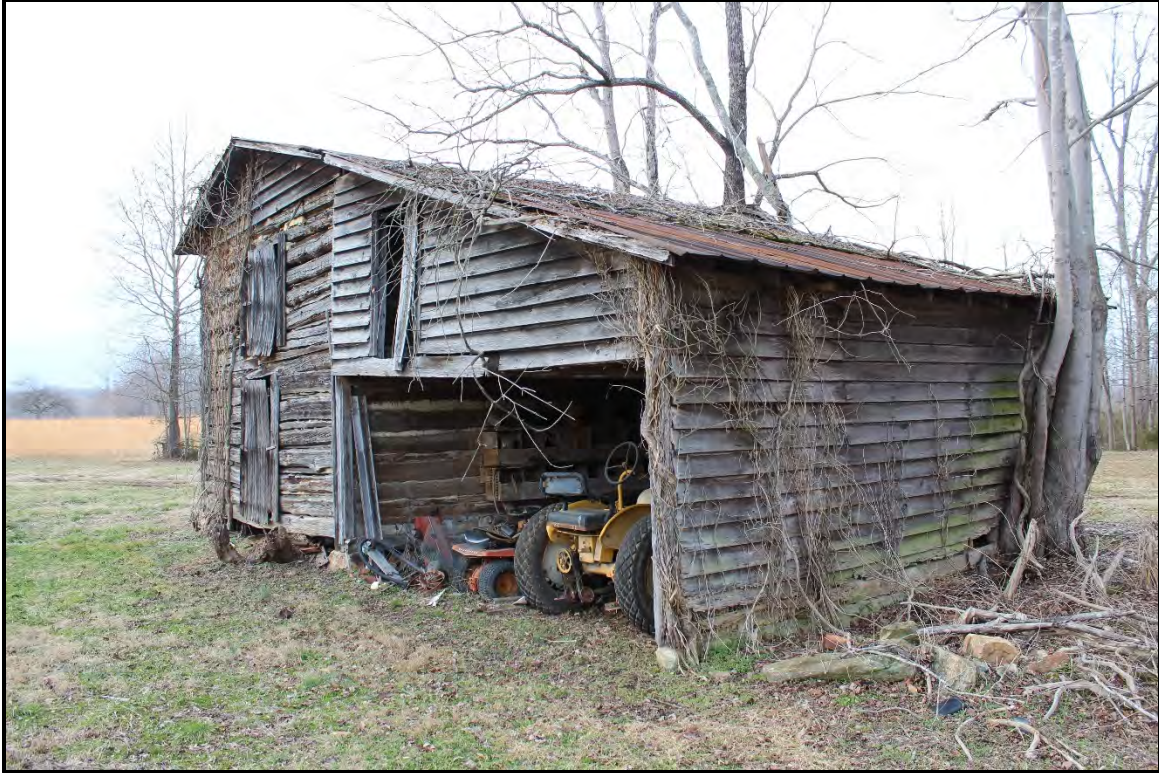
- A ca. 1930 granary/tractor shed. The log-frame structure features a front-gabled roof covered with standing seam metal, square notching, and a stone pier foundation. Facing southeast, the structure reveals a ground door and a loft door that are composed of vertical wood boards. Attached to the northeast elevation is a wood-frame tractor shed that is capped with shed roof covered with standing seam metal. The attached shed is clad with weatherboard siding and features an open bay. Located above the bay is a loft opening for storage (Figures 5.266 and 5.267);

Figure 5.266. RK1758 granary and tractor shed; view is northwest featuring the façade and northeast elevation.

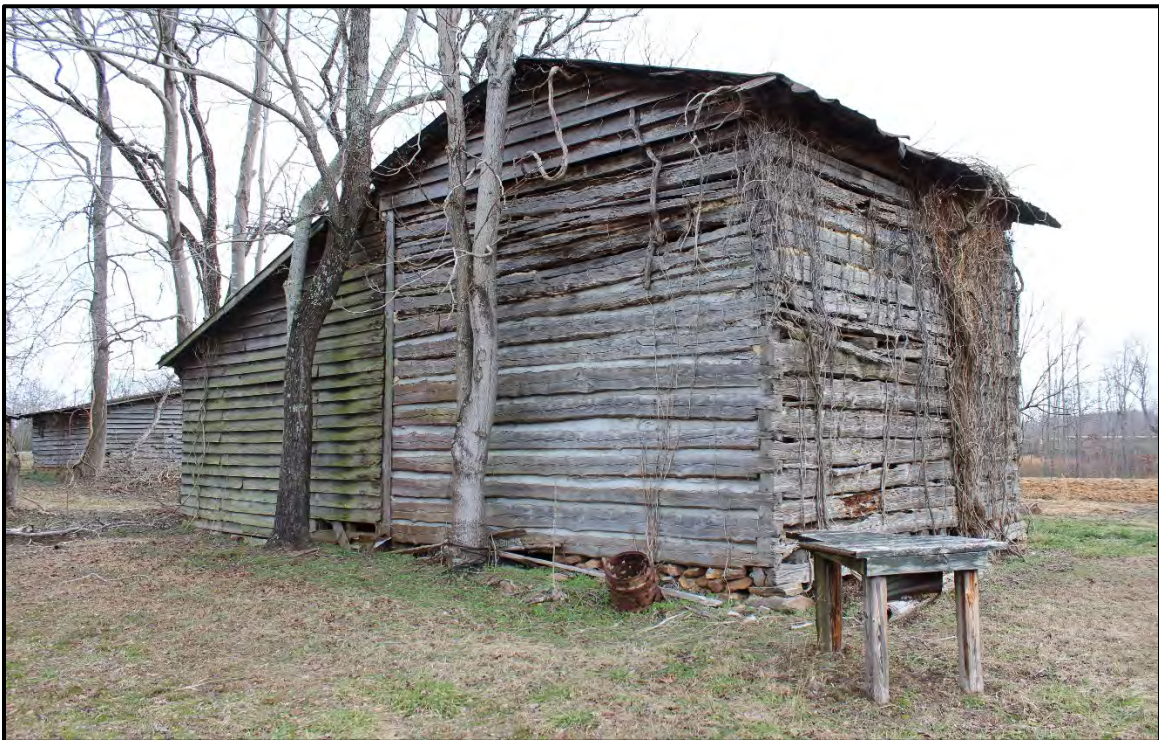
Figure 5.267. RK1758 granary and tractor shed; view is southeast featuring the northwest (rear) and southwest elevation.

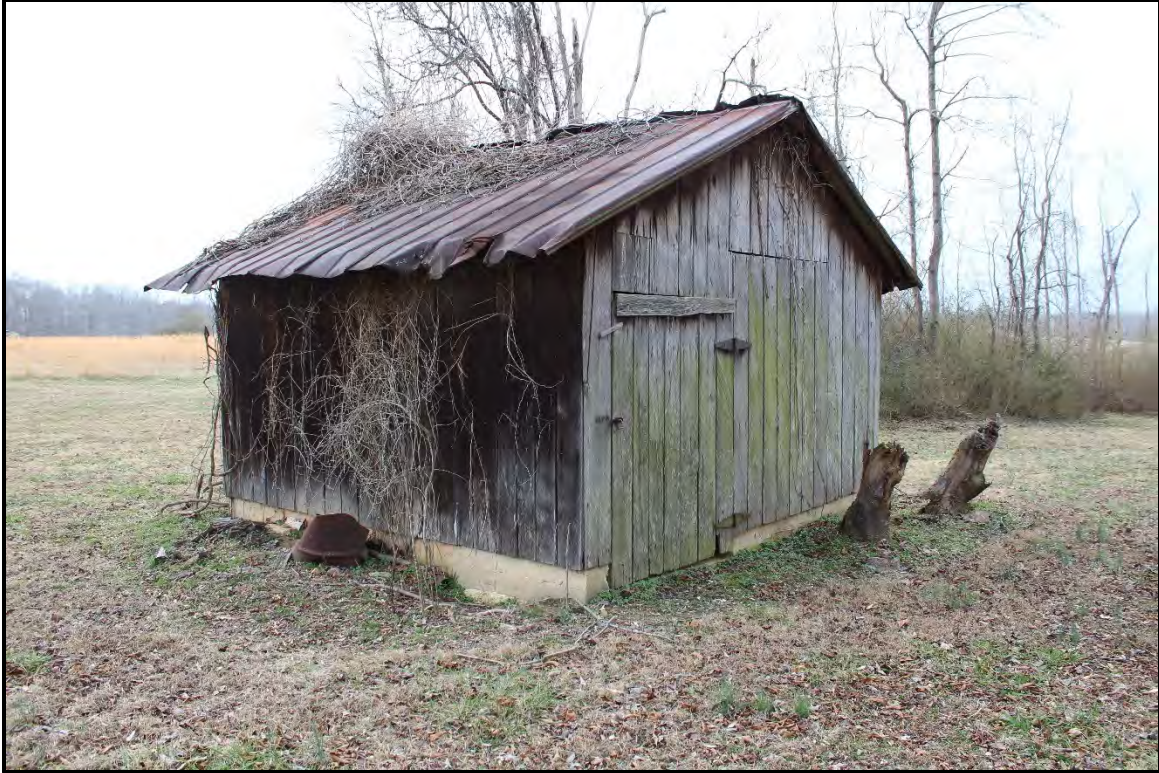
- A ca. 1940 hog house. The wood-frame structure is capped with a front-gabled roof covered with standing seam metal and is supported by a poured concrete foundation. Clad with vertical boards on the exterior, the structure contains a door on the west elevation that is composed of vertical wood boards (Figures 5.268 and 5.269);

Figure 5.268. RK1758 hog house; view is southwest featuring the façade and east elevation.

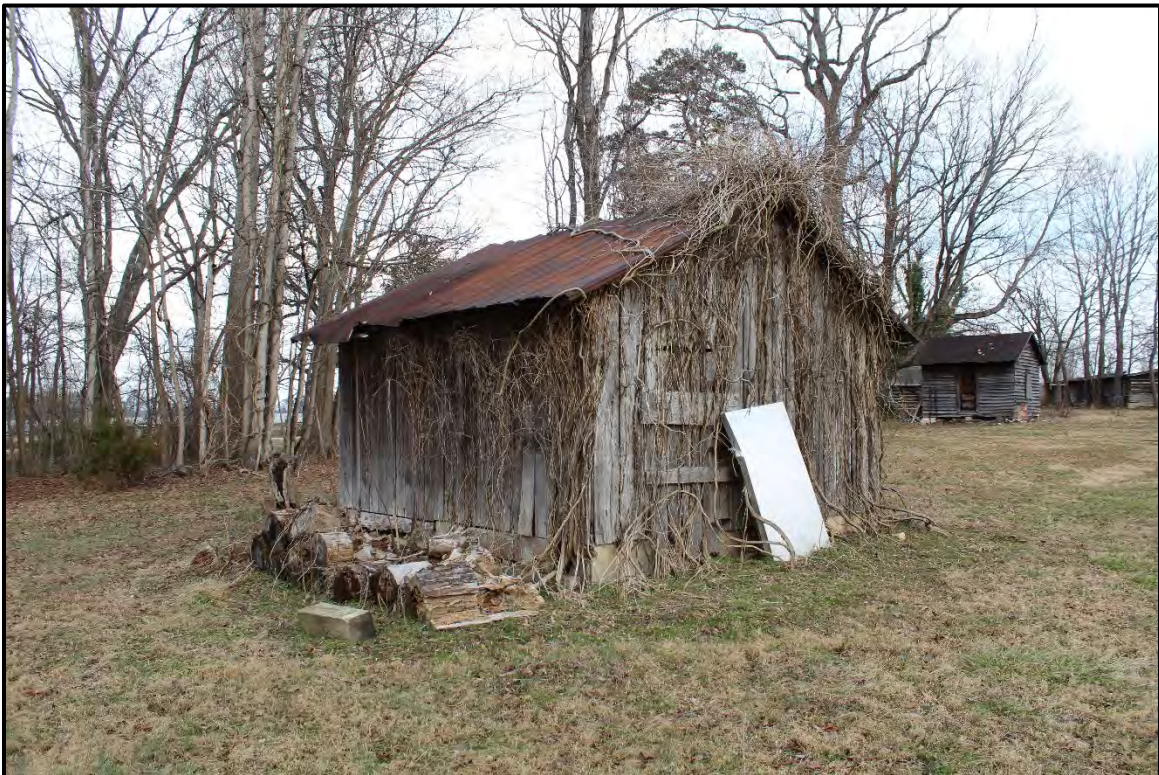
Figure 5.269. RK1758 hog house; view is northeast featuring the south (rear) and west elevation.

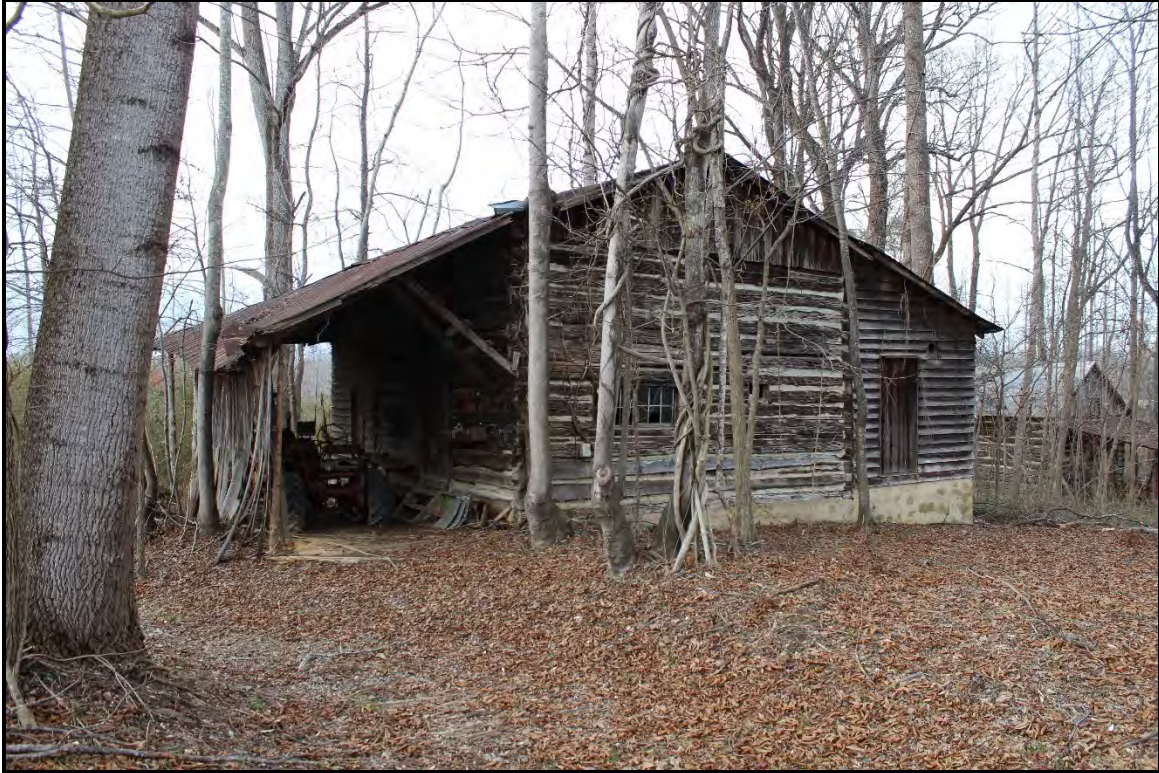
- A ca. 1930 pack house. The log-frame building is joined together by square notching and features a side-gabled roof covered with standing seam metal and a poured concrete foundation. Two doors are located on the southwest elevation and are shielded by an attached shed-roof bay. Connected to the northeast elevation is a wood-frame addition that is capped with a shed roof and features an exterior clad with weatherboard siding. The rear addition includes a door on its northeast elevation (Figures 5.270–5.272);

Figure 5.270. RK1758 pack house; view is northwest featuring the façade and southwest elevation.

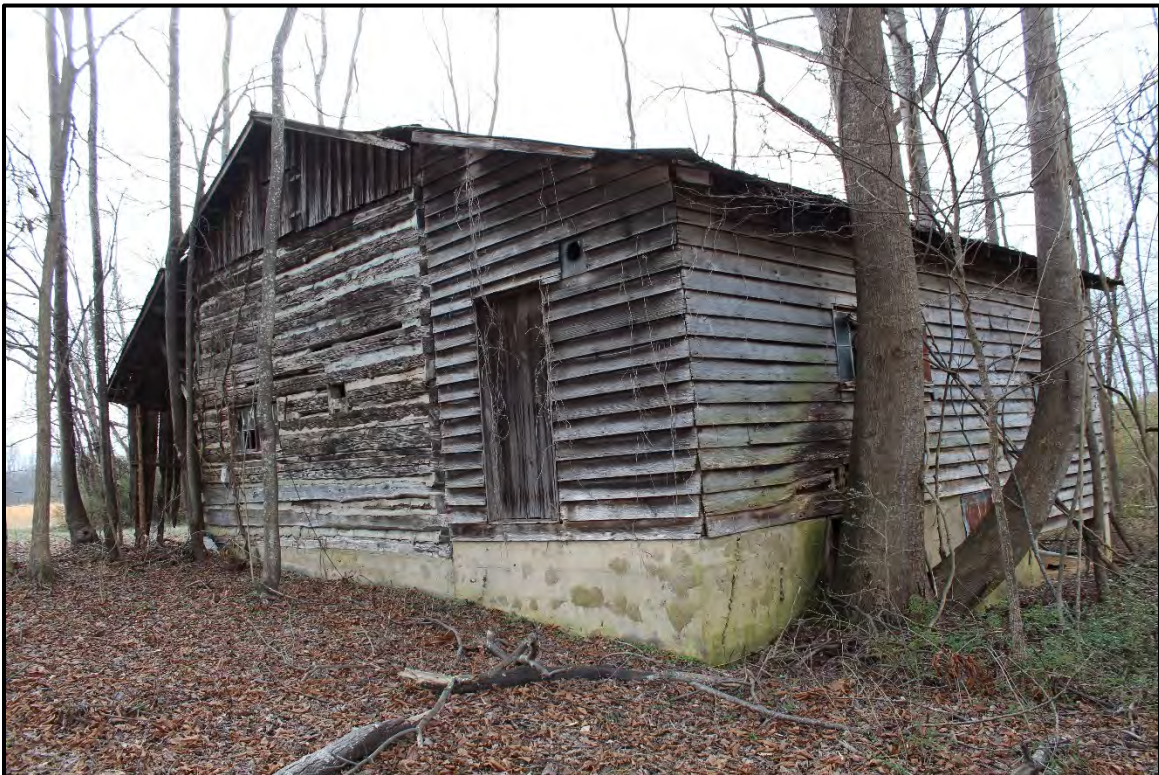
Figure 5.271. RK1758 pack house; view is southwest featuring the façade and northeast elevation.

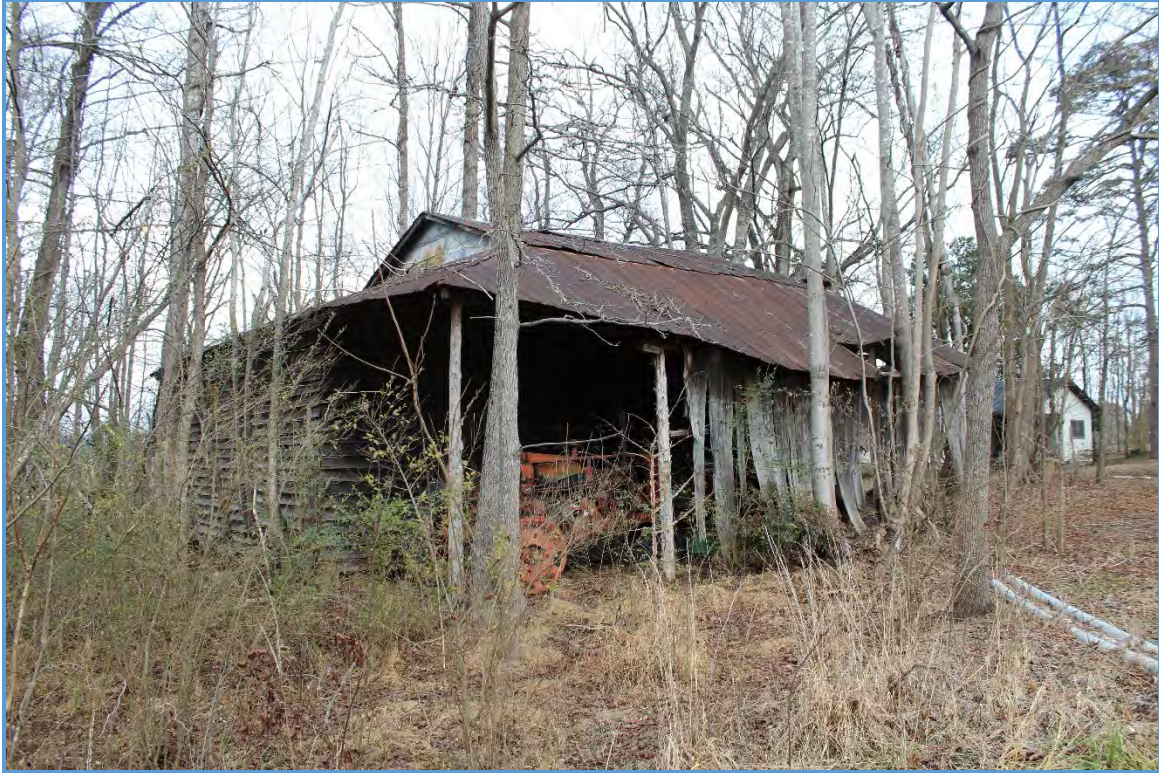
Figure 5.272. RK1758 pack house; view is northeast featuring the northwest and southwest elevations.

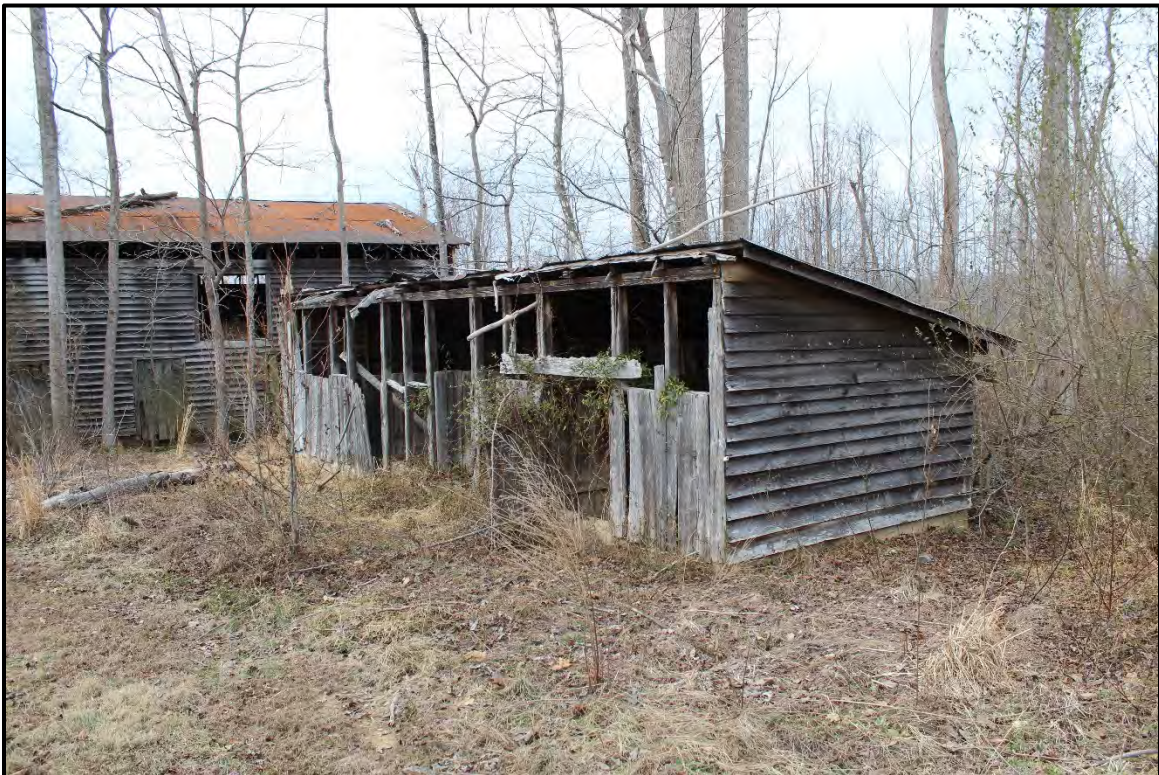
- A ca. 1930 stable. The wood-frame structure features a shed roof covered with standing seam metal, an exterior clad with weatherboard siding, and a poured concrete foundation. Three stall entrances are positioned along the southwest elevation (Figure 5.273 and 5.274);

Figure 5.273. RK1758 stables; view is northwest featuring the façade and southeast elevation.

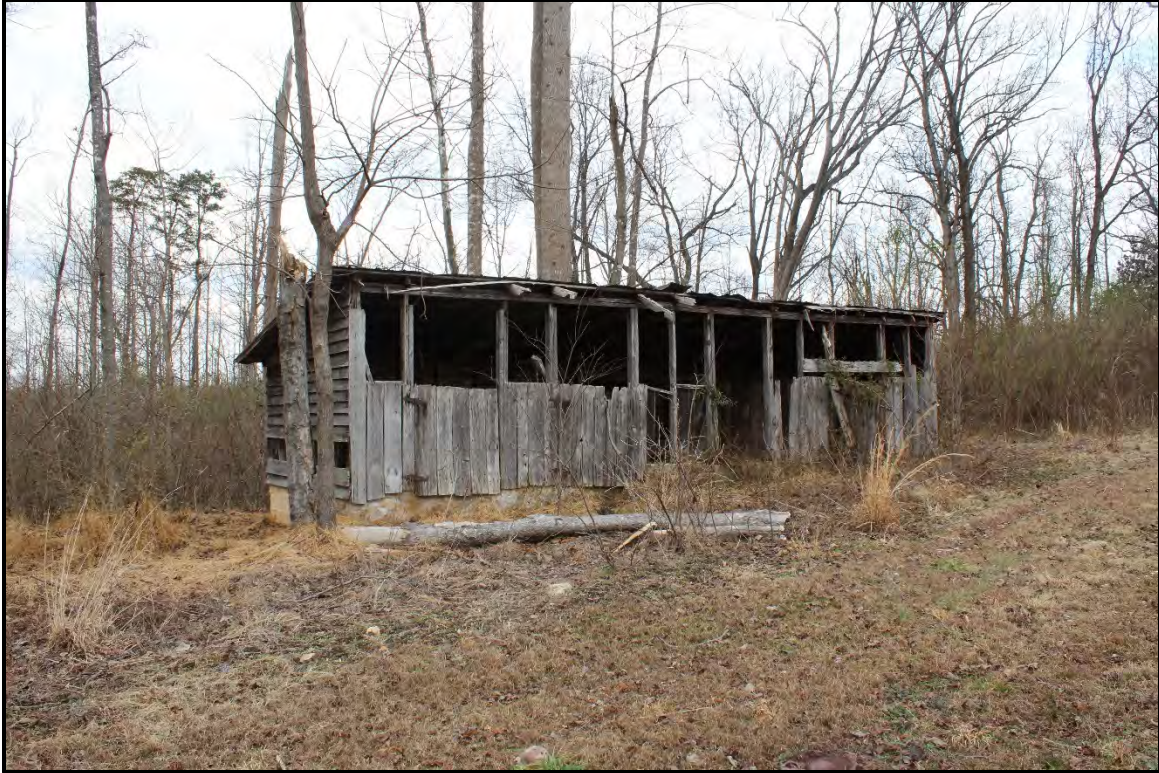
Figure 5.274. RK1758 stables; view is northeast featuring the façade and northwest elevation.

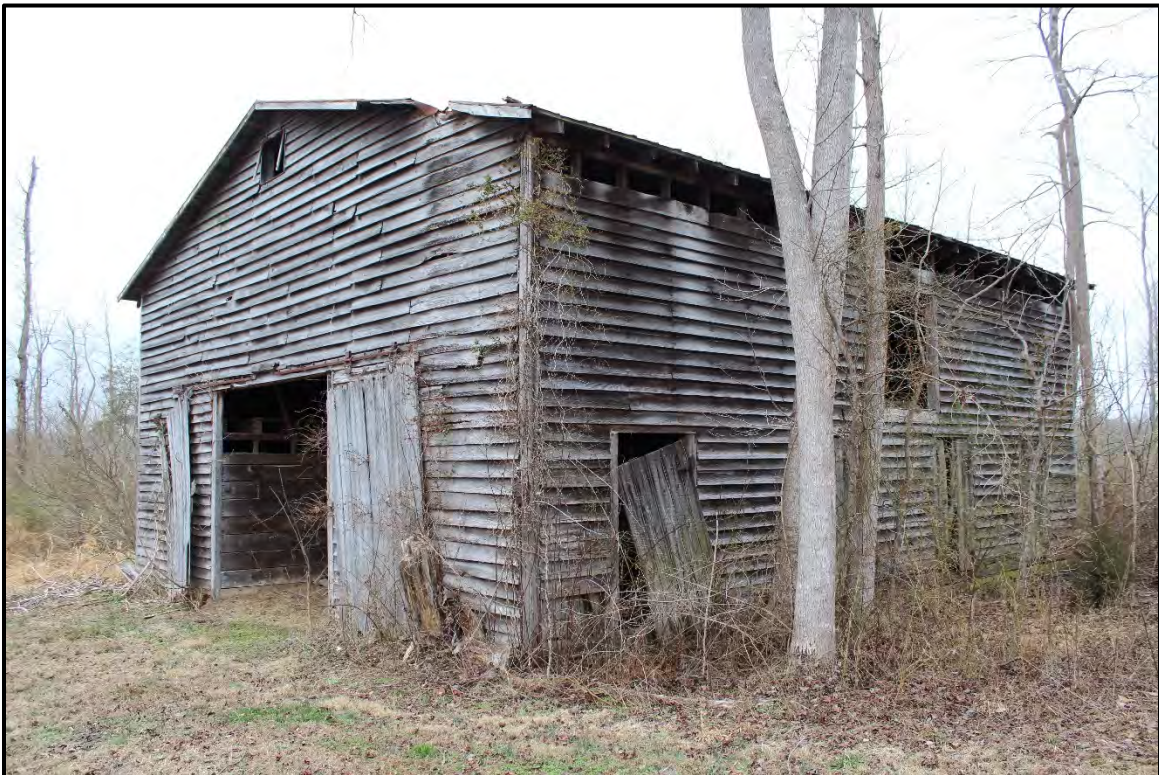
- A ca. 1930 feed barn. The wood-frame structure is capped with a front-gabled roof covered with standing seam metal and features an exterior clad with weatherboard siding. A poured concrete foundation supports the barn, which includes centrally placed bay openings on the southwest and northeast (rear) elevations. The bay openings are marked by sliding doors composed of vertical wood boards (Figures 5.275 and 5.276);

Figure 5.275. RK1758 feed barn; view is northwest featuring the façade and southeast elevation.

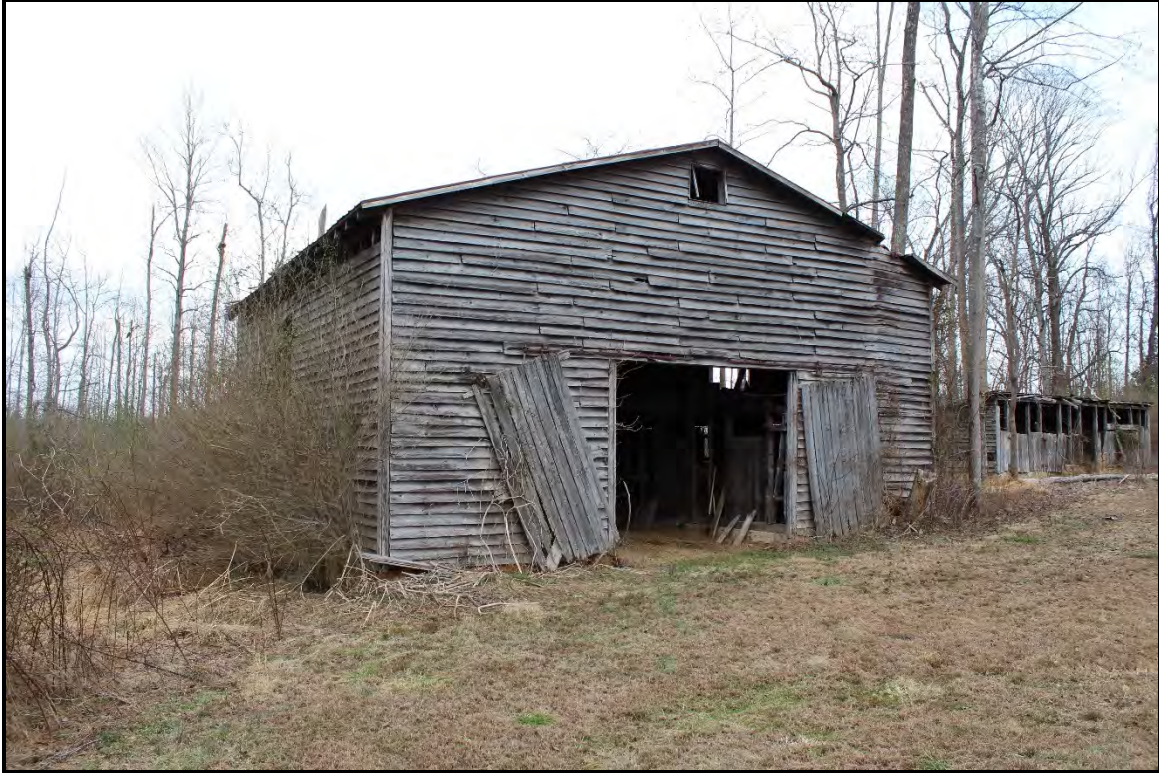
Figure 5.276. RK1758 feed barn; view is northeast featuring the façade and northwest elevation.
