Re: Revised Architectural Survey Report, MVP Southgate Project, Construct Interstate Pipeline, Rockingham and Alamance County, ER 18-1041

Thank you for your letter of October 11, 2019, transmitting the draft "Historic Architectural Survey for the MVP Southgate Pipeline Project". We have reviewed the report and offer the following comments.

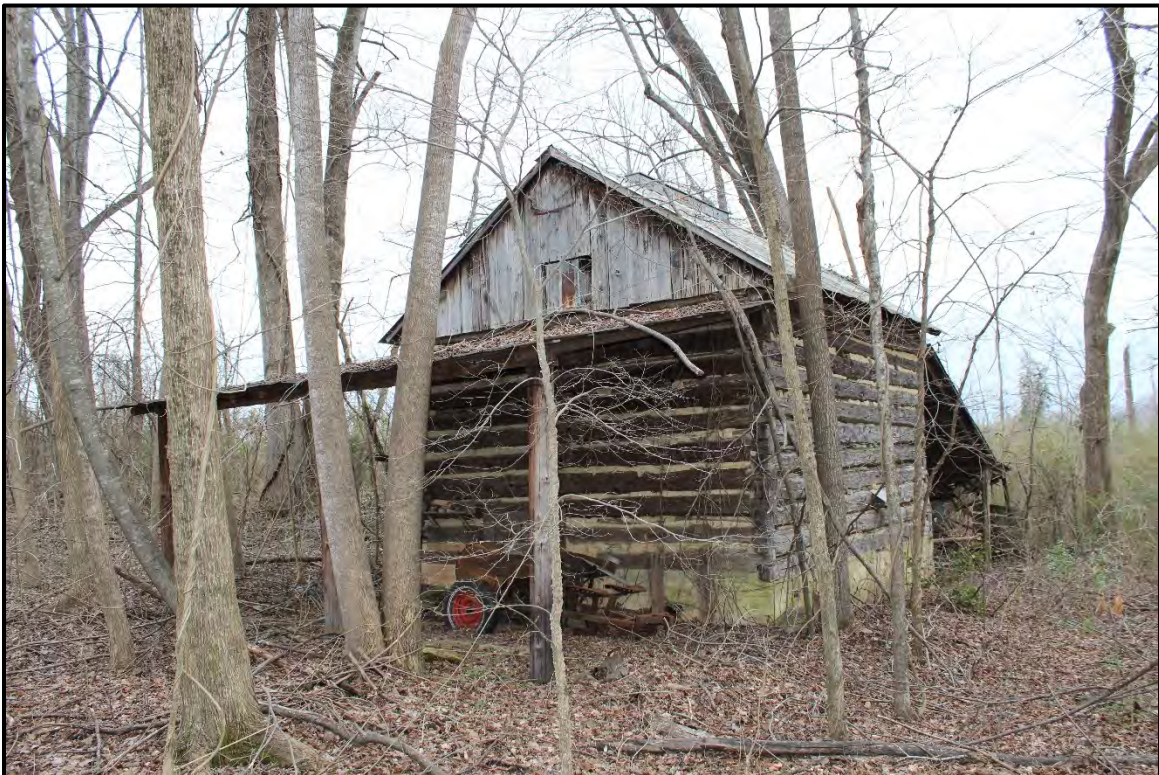
- A 1946 tobacco barn (Rockingham County, NC WebGIS 2018). Identified in this report as “tobacco barn #1”, the log-frame structure is joined together by square notching and is capped with a gable roof covered with standing seam metal. Located on the roof is a Parrington ridge vent. Additionally, the gable ends are sheathed with vertical wood boards. The structure is supported by a poured concrete foundation and includes wood doors on the northeast and southwest elevations. Attached to these elevations are open shed-roof bays that are supported by wood posts (Figures 5.277 and 5.278);

Figure 5.277. RK1758 tobacco barn #1; view is southwest featuring the façade and northeast elevation.

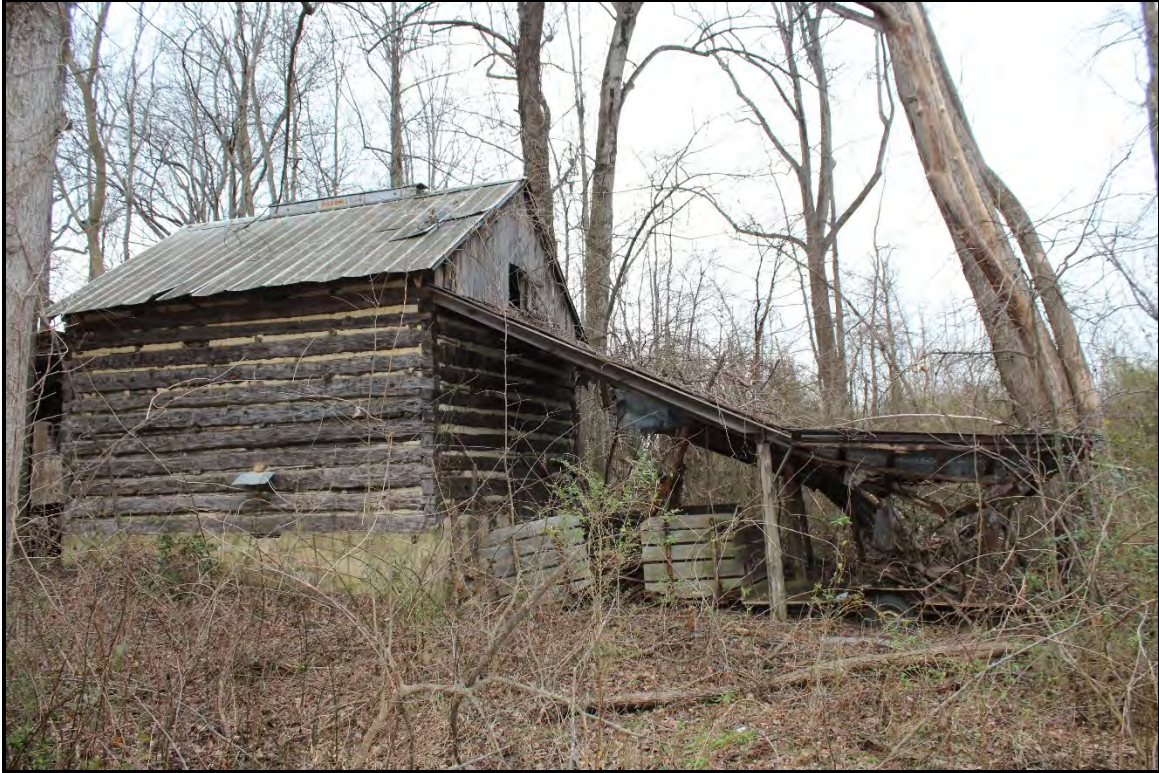
Figure 5.278. RK1758 tobacco barn #1; view is northeast featuring the façade and southwest elevation.

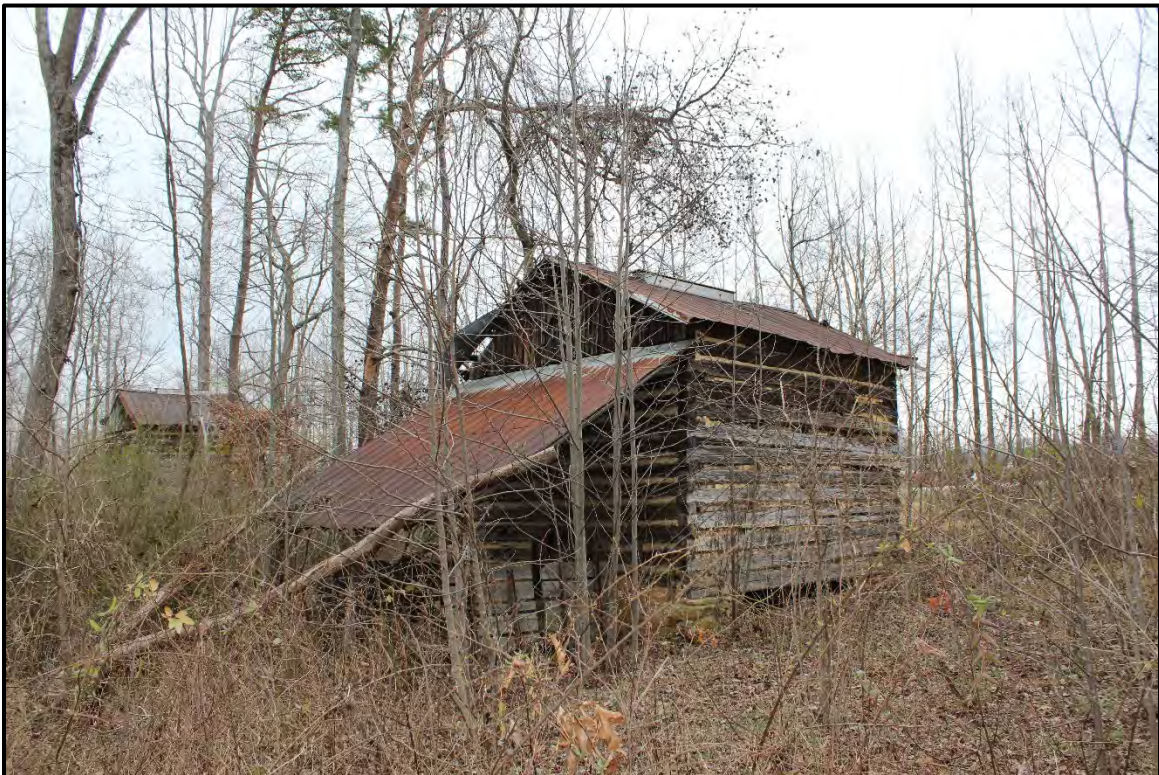
- A 1946 tobacco barn (Rockingham County, NC WebGIS 2018). Identified as “tobacco barn #2” in this report, the log-frame structure is joined together by square notching and is capped with a gable roof covered with standing seam metal. Located on the roof is a Parrington ridge vent. The structure is supported by a stone pier foundation and includes a wood door on the southwest elevation. Attached to this elevation is open shed-roof bay that is supported by wood posts (Figures 5.279 and 5.280);

Figure 5.279. RK1758 tobacco barn #2; view is northwest featuring the façade and southeast elevation.

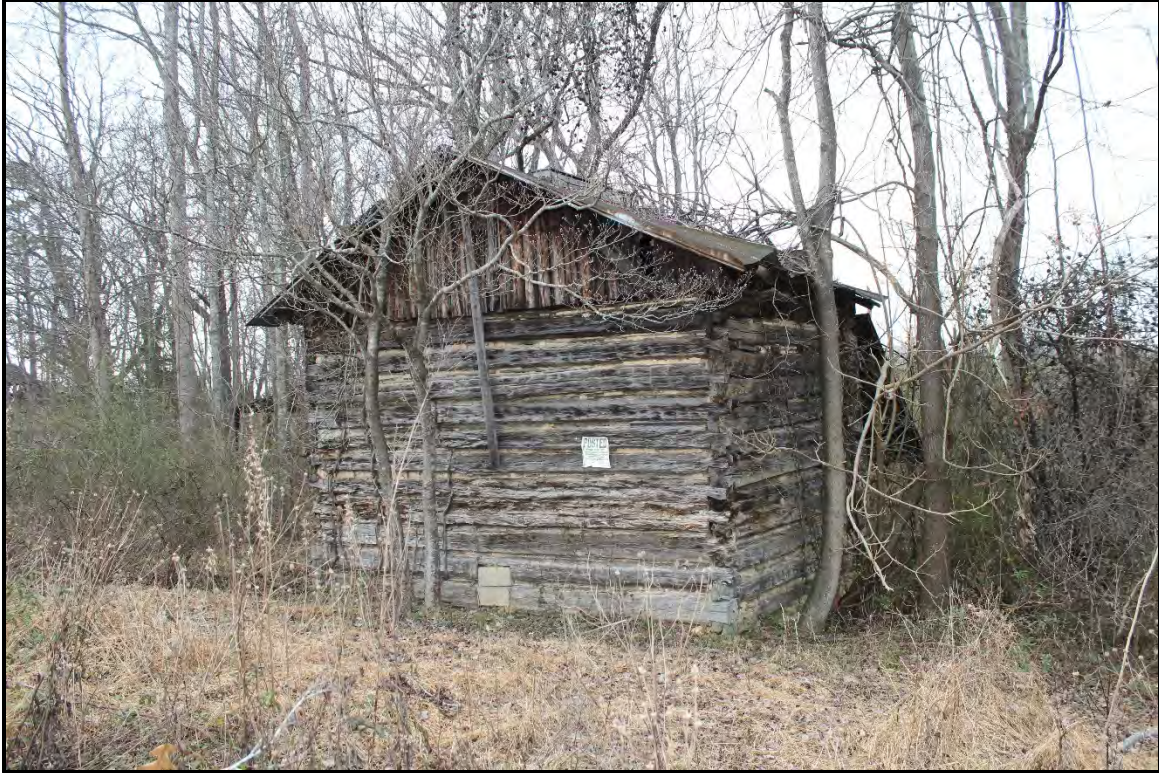
Figure 5.280. RK1758 tobacco barn #2; view is south featuring the northeast and northwest elevations.

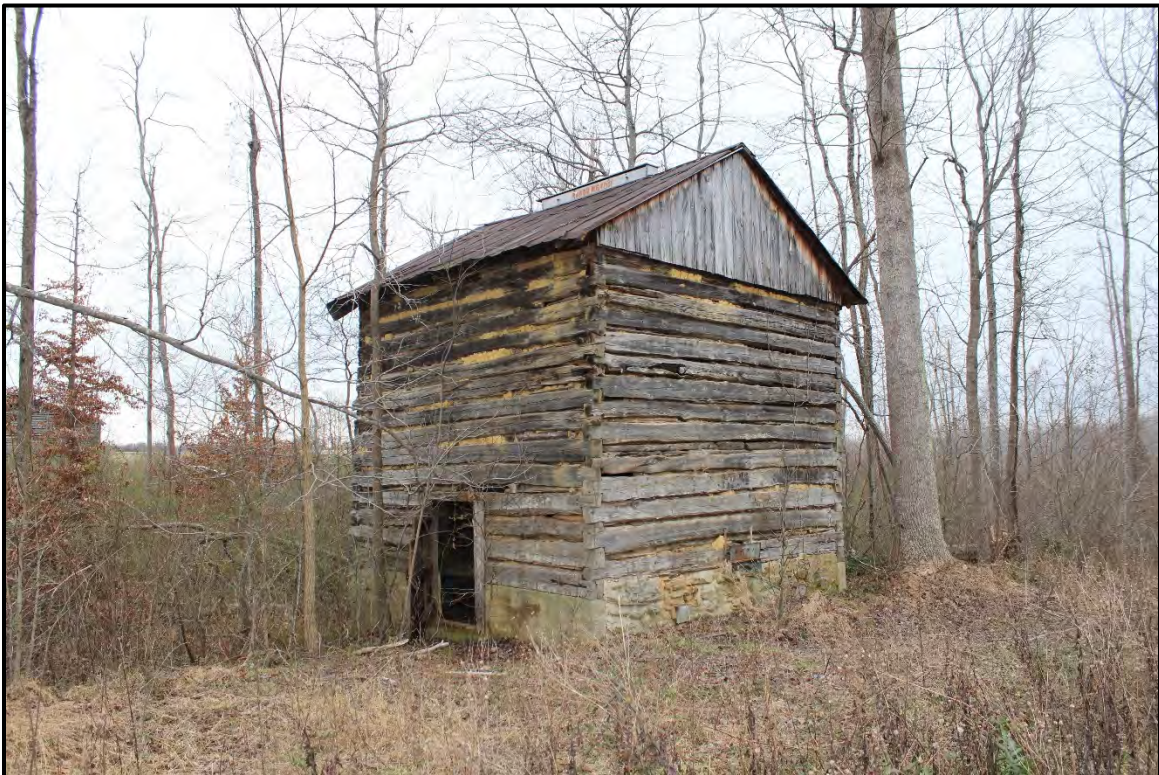
- A 1946 tobacco barn (Rockingham County, NC WebGIS 2018). Identified as “tobacco barn #3” in this report, the log-frame structure is joined together by square notching and is capped with a gable roof covered with standing seam metal. Located on the roof is a Parrington ridge vent. The structure is supported by a poured concrete and stone foundation and includes a wood door on the northeast elevation (Figures 5.281 and 5.282);

Figure 5.281. RK1758 tobacco barn #3; view is south featuring the façade and northwest elevation.

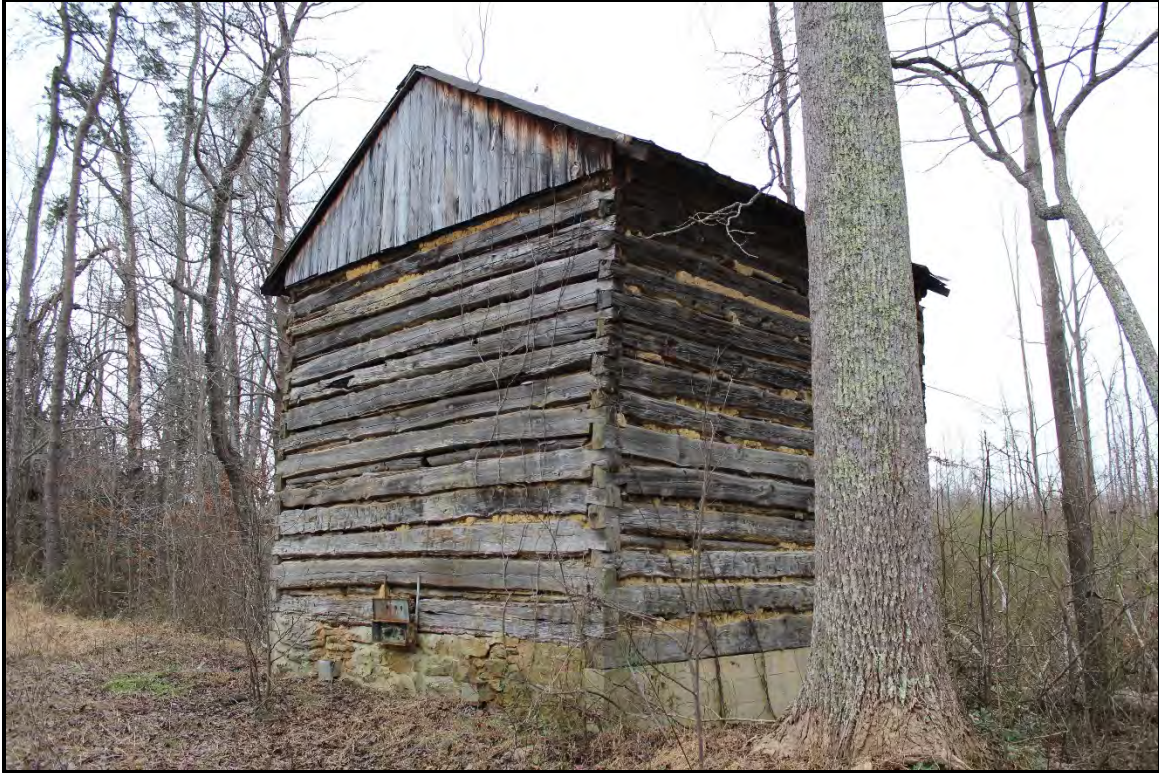
Figure 5.282. RK1758 tobacco barn #3; view is southeast featuring the northeast and northwest elevations.

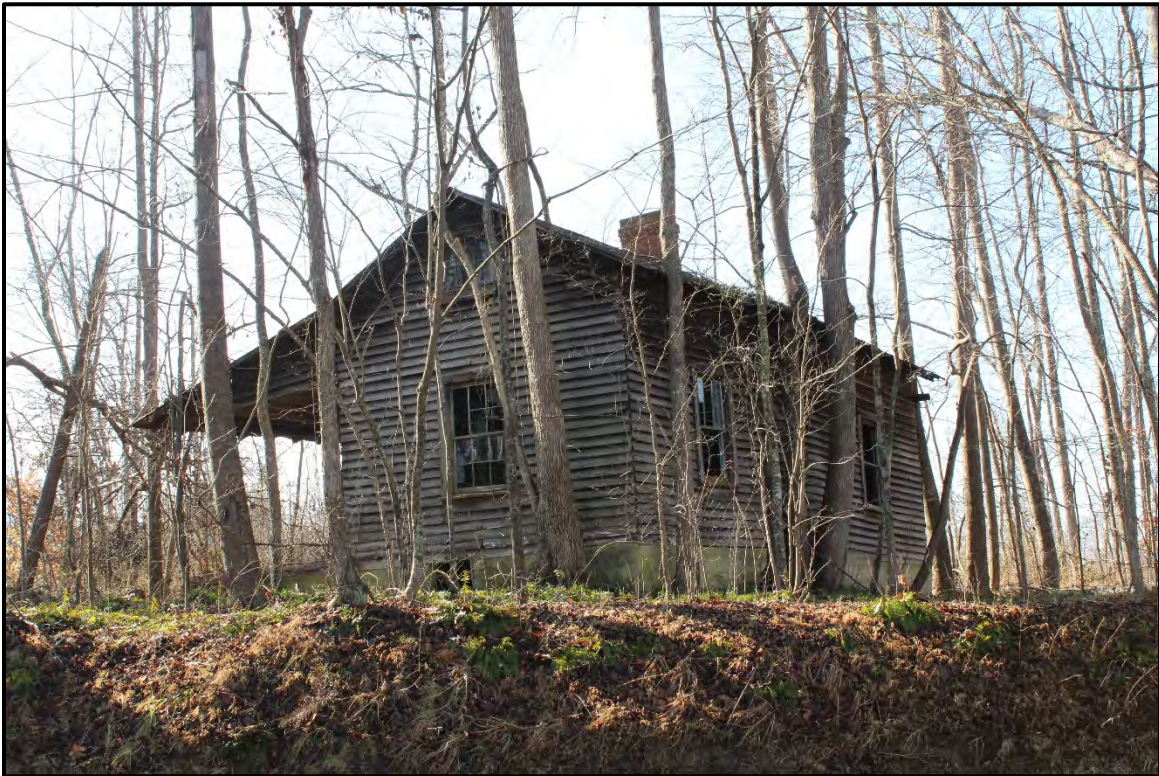
- A ca. 1930 tenant house. The one-story, wood-frame building features a gabled roof covered with standing seam metal, an interior brick chimney, an exterior clad with weatherboard siding, and a poured concrete foundation. A recessed corner porch is located on the southeast elevation and provides access to two doors. The house is pierced by a series of window openings containing the remnants of 6/6 double-hung wood sashes (Figure 5.283 and Figure 5.284).

Figure 5.283. RK1758 tenant house; view is south featuring the façade and northwest elevation.

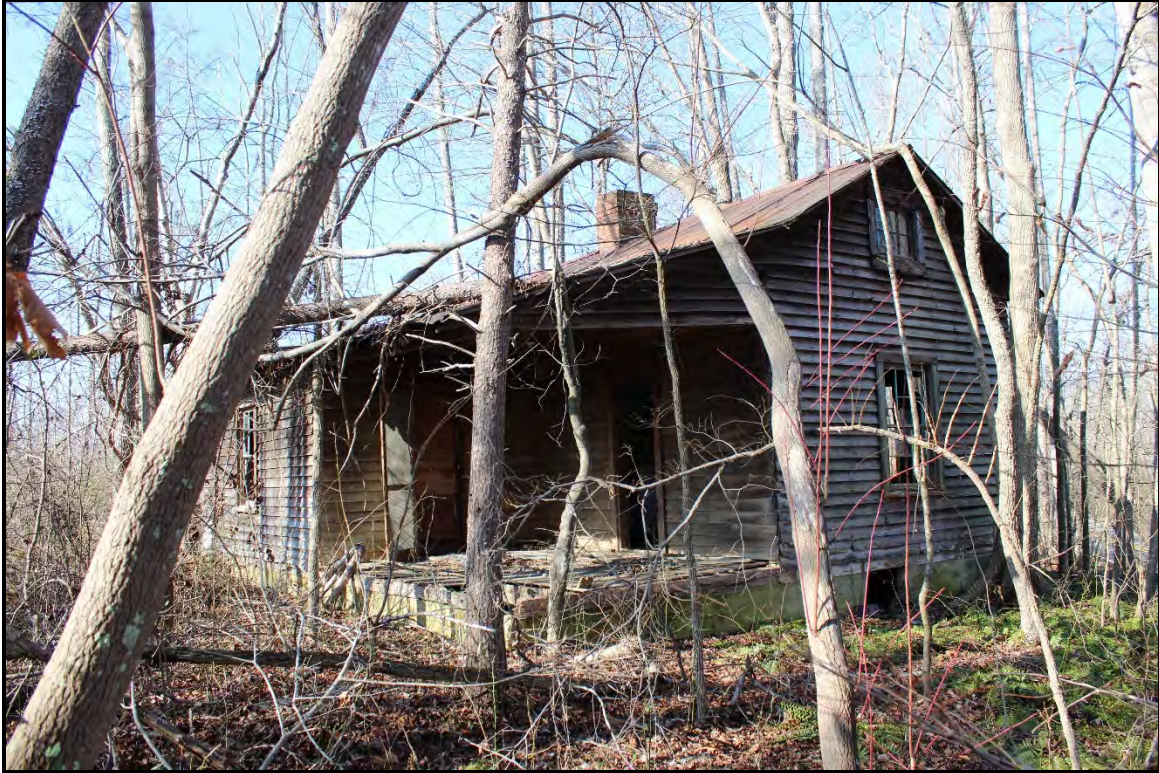
Figure 5.284. RK1758 tenant house; view is west featuring the façade and southeast elevation.

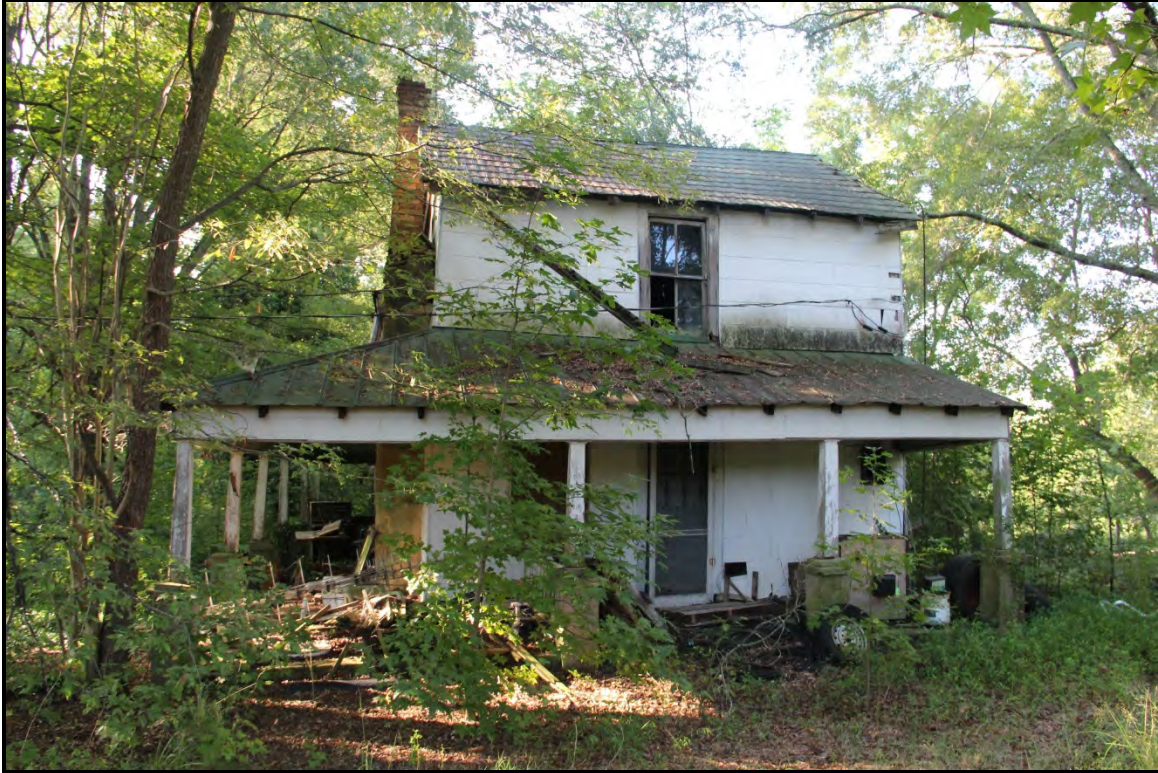
The farmhouse is a two-story, wood-frame building that features a side-gabled roof covered with pressed metal shingles, an exterior end stone and brick chimney, an interior central brick chimney, and an exterior clad with asbestos shingles. It is unknown if the house is log or wood-frame. Fenestration includes double-hung 2/2 and 6/6 wood sash windows. A wraparound entry porch provides access to the main entrance and is comprised of a hipped roof supported by tapered wood posts set atop concrete plinth blocks. A two-story gabled ell projects from the south (rear) elevation. Located south and west of the house are a utility building, a livestock shed, and a tractor shed that appear to date to from the mid-to-late twentieth century (Figures 5.292, 5.293, and 5.295). Two additional agricultural outbuildings were noted on the property, but their original function is unknown (Figure 5.294).

Figure 5.290. Architectural resource RK1759; view is south and features the façade.

NRHP Assessment. Architectural resource RK1759 is an inactive farmstead anchored by a plain/traditional-style house that does not exhibit distinctive characteristics of architectural style or workmanship. In addition, the integrity of the farmhouse is poor due to neglect. In addition, the historic setting of the property has been compromised with the through the introduction of modern electrical transmission line towers that bisect the property. For these reasons, the farm no longer conveys its late nineteenth century appearance, thereby rendering the property ineligible for its agricultural associations. For these reasons it is the opinion of TRC that architectural resource RK1759 is not eligible for the NRHP.

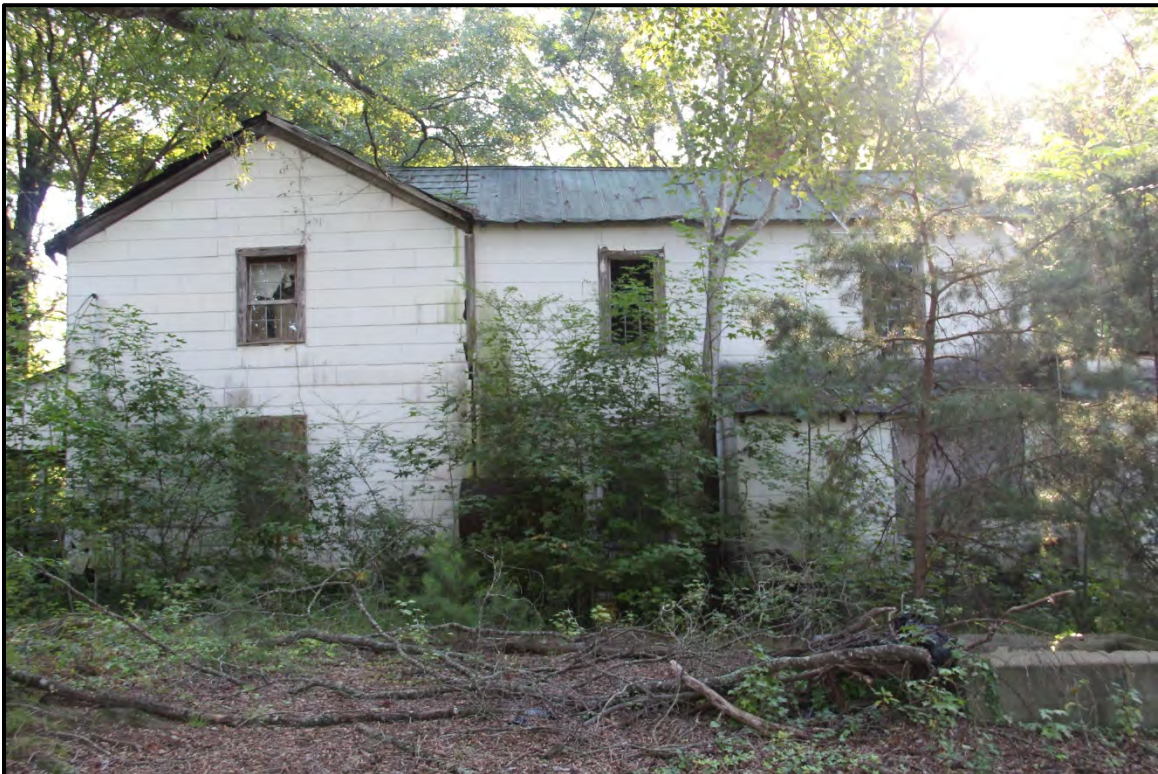
Figure 5.291. Architectural resource RK1759; view is east and features the west elevation.

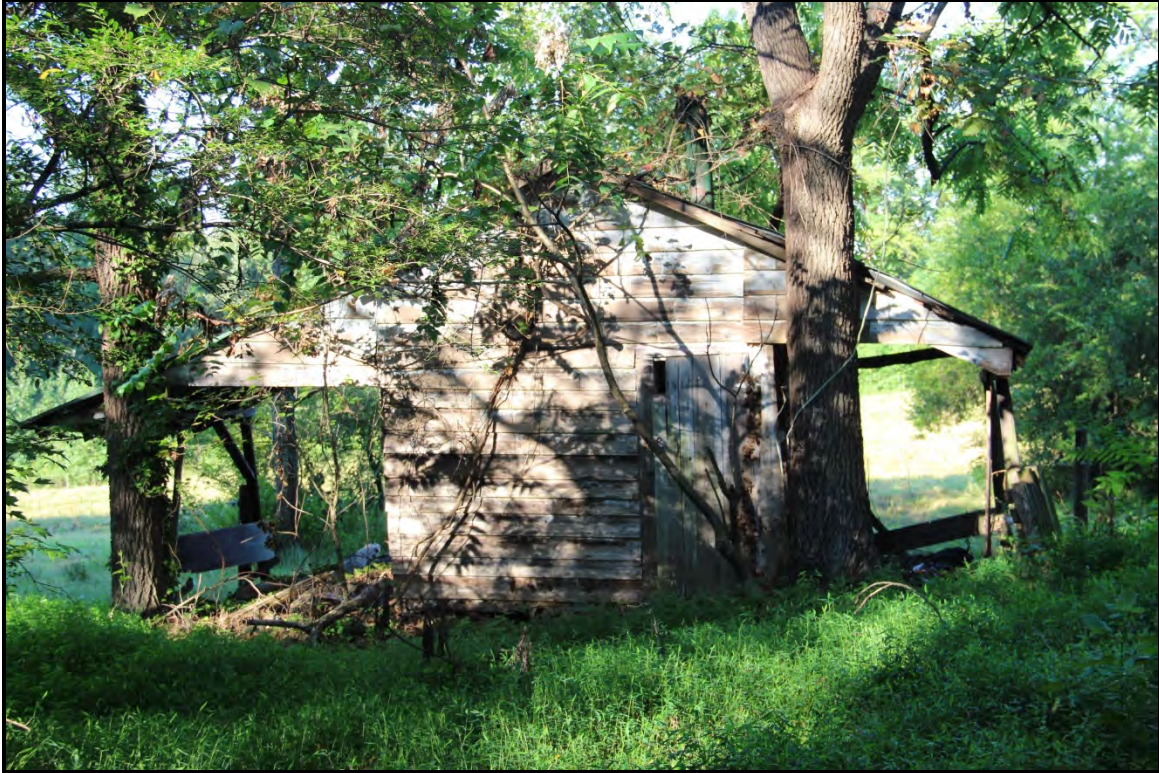
Figure 5.292. Architectural resource RK1759; view is southwest and features the utility building.

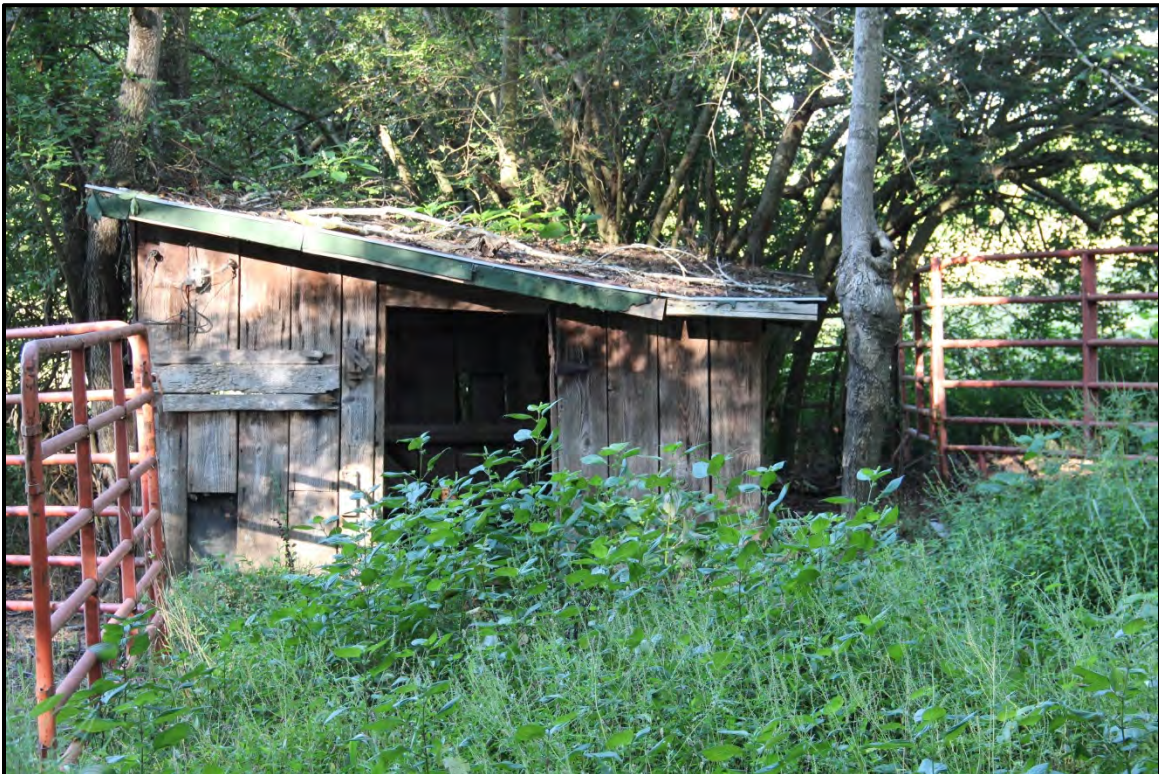
Figure 5.293. Architectural resource RK1759; view is south and features a livestock shed.

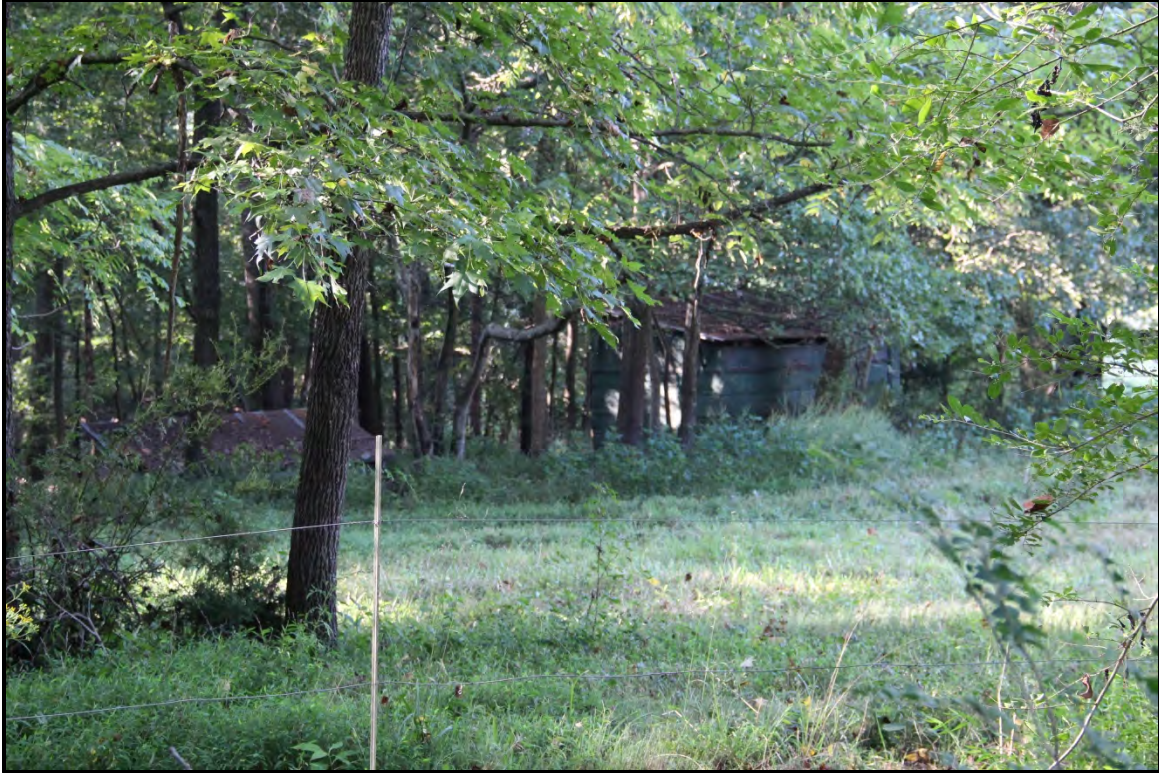
Figure 5.294. Architectural resource RK1759; view is west of two agricultural outbuildings.

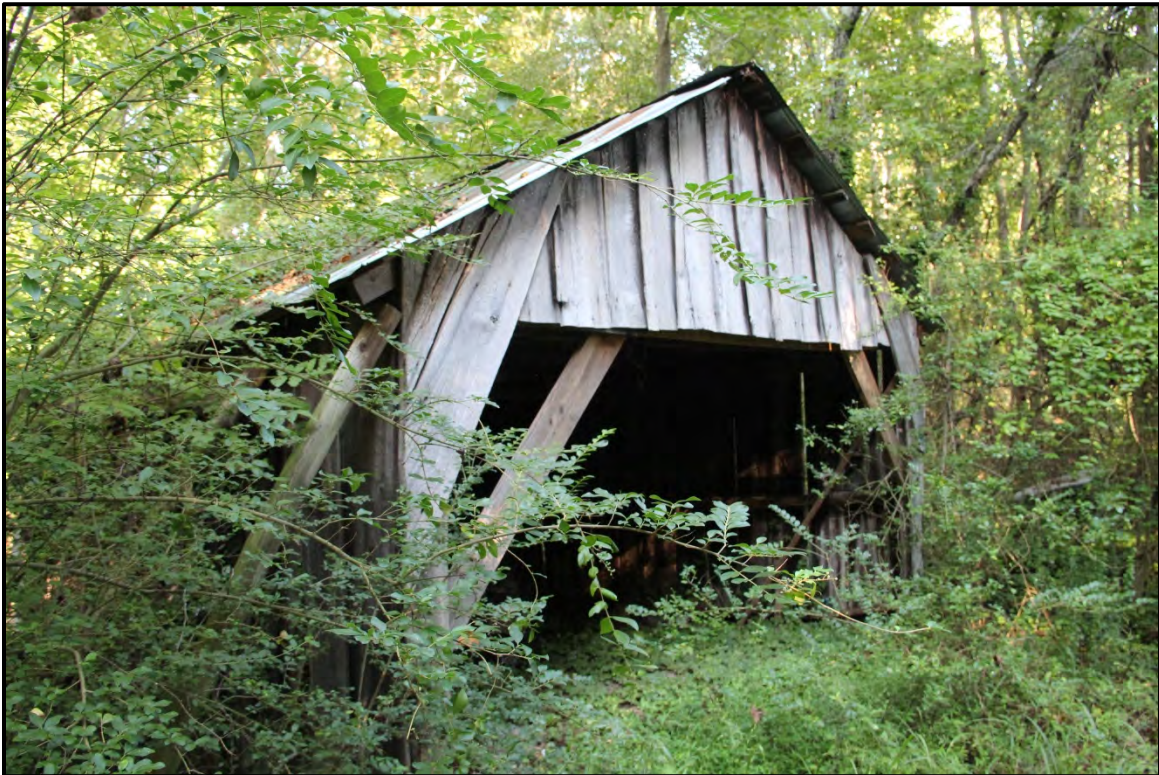
Figure 5.295. Architectural resource RK1759; view is northwest of the tractor shed.

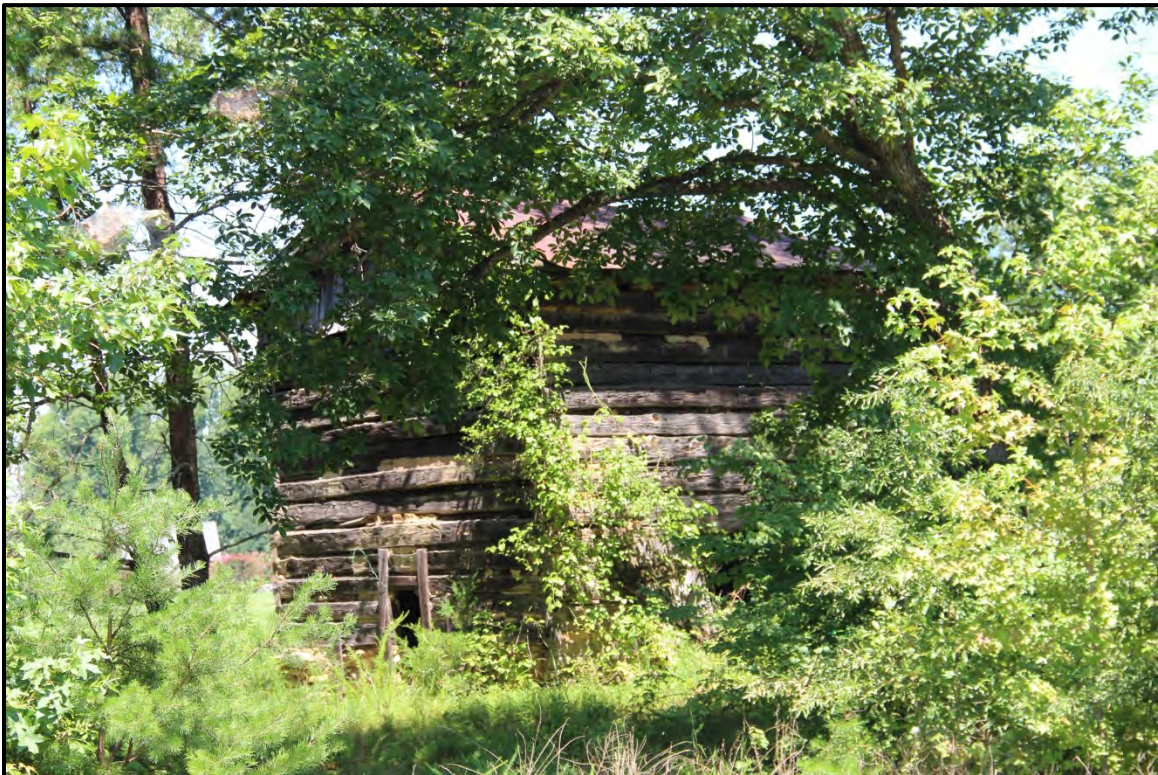
The tobacco barn is constructed of hand-hewn logs joined with square notching and features a gabled metal roof. Openings on the south and west elevations provide interior access to the barn (Figure 5.296). According to Rockingham County tax records, the tobacco barn was constructed in 1930 (Rockingham County, NC WebGIS 2018).

Figure 5.296. Architectural resource RK1760; view is northeast and features the south and west elevations.

NRHP Assessment. Architectural resource RK1760 does not exhibit a distinctive architectural style or workmanship. Based on the lack of architectural merit, as well as the inability to associate the structures and/or its original owner(s) with an important historical event or series of events, it is TRC's opinion that architectural resource RK1760 is not eligible for the NRHP.

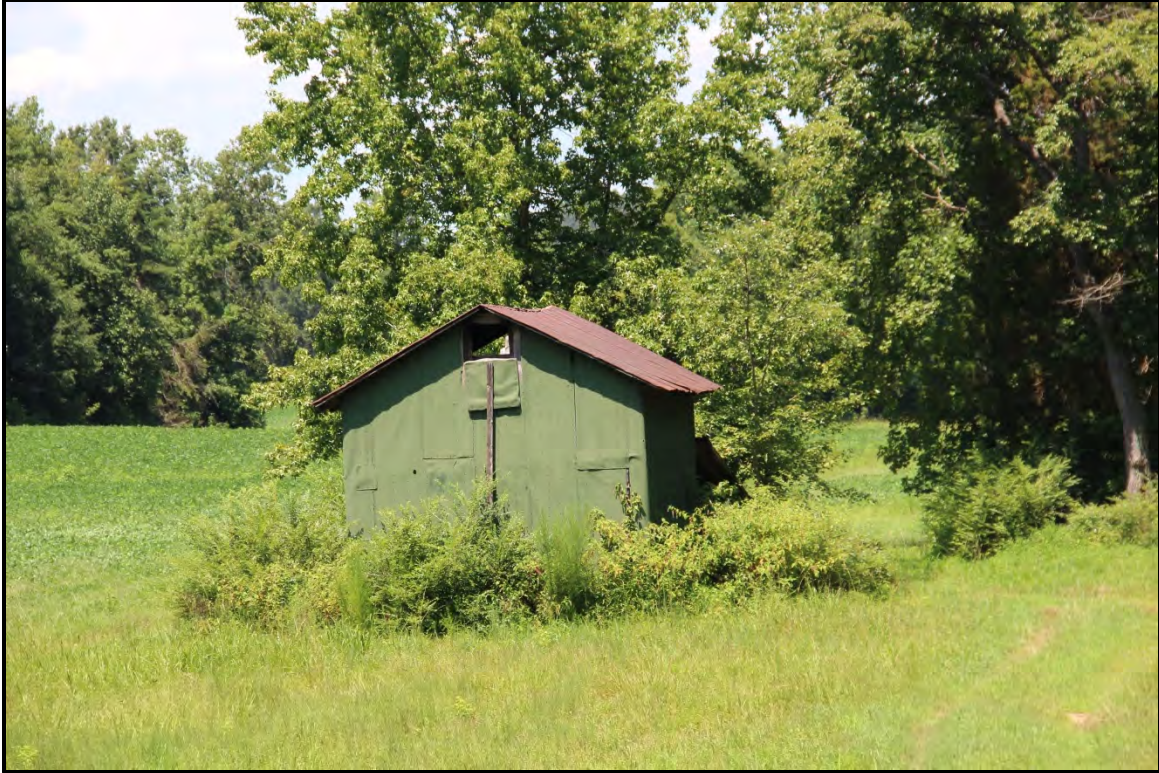
Figure 5.297. Architectural resource RK1760; view is north and features the late twentieth century shed.

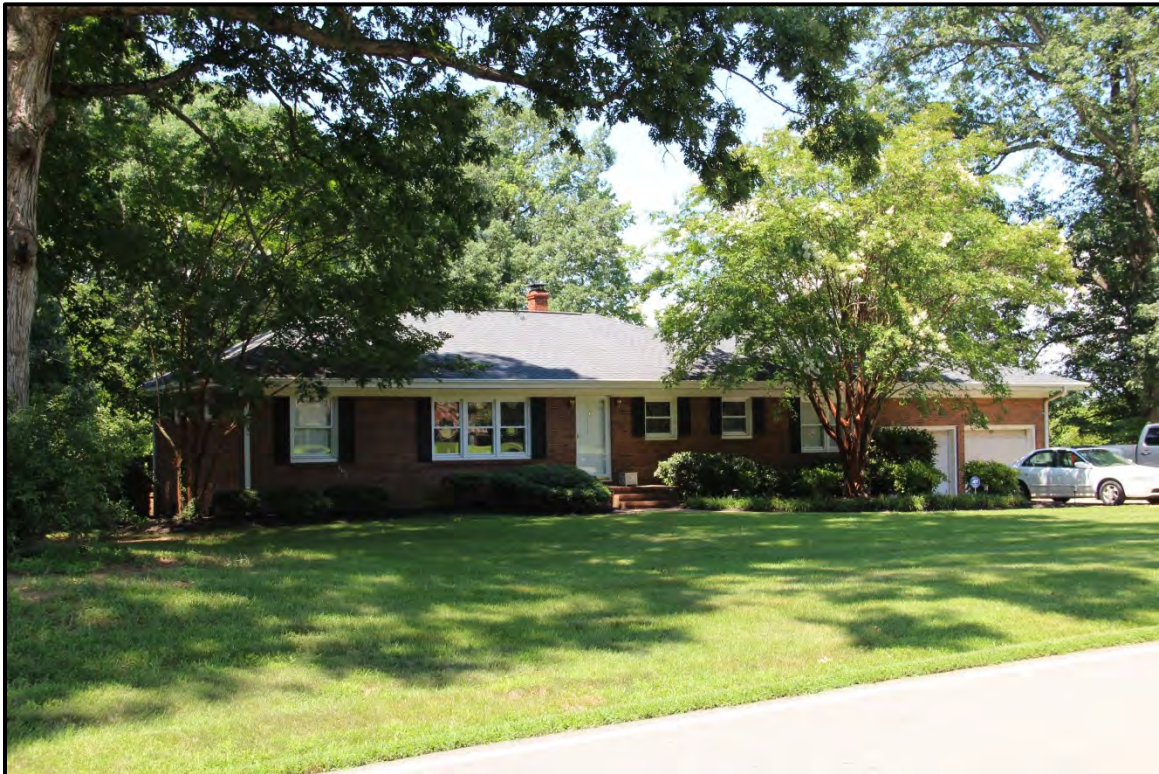
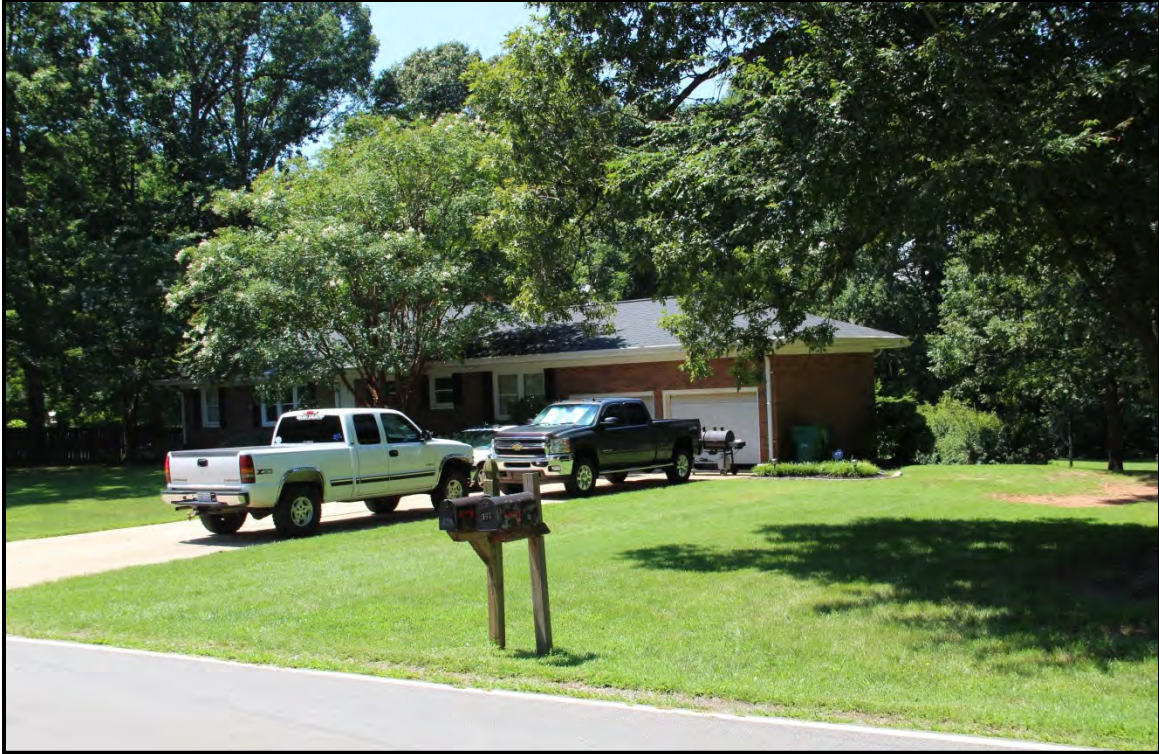
The wood-frame building features a hipped roof, an interior brick chimney, an exterior clad with a brick veneer, and a continuous brick foundation. Fenestration includes double-hung 1/1 vinyl sashes. A brick stoop provides access to the main entrance. The north elevation is marked by an attached two-bay garage.

NRHP Assessment. Architectural resource RK1761 does not exhibit a distinctive architectural style or workmanship. In addition, the house has been altered through the replacement of the original window sashes. Based on the lack of architectural merit, as well as the inability to associate the house and/or its original owner(s) with an important historical event or series of events, it is TRC’s opinion that architectural resource RK1761 is not eligible for the NRHP.

Figure 5.298. Architectural resource RK1761; view is northwest and features the façade and southwest elevation.

Figure 5.299. Architectural resource RK1761; view is southwest and features the façade and northeast elevation.

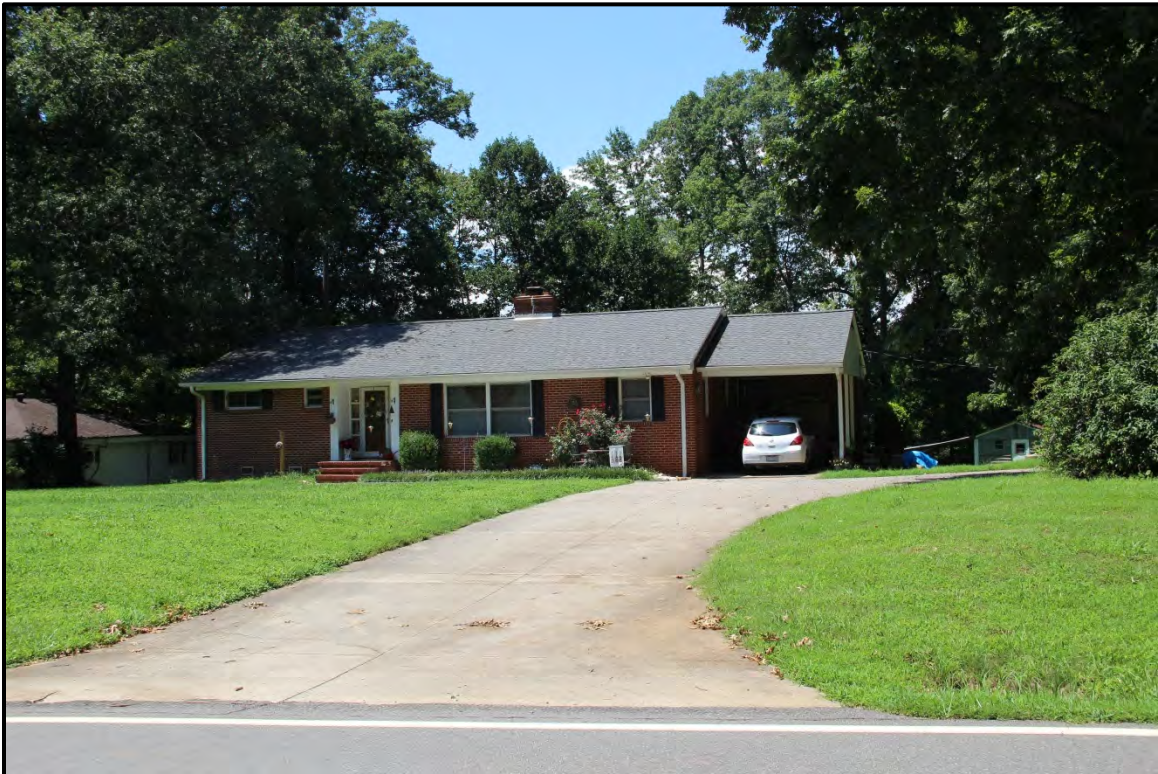
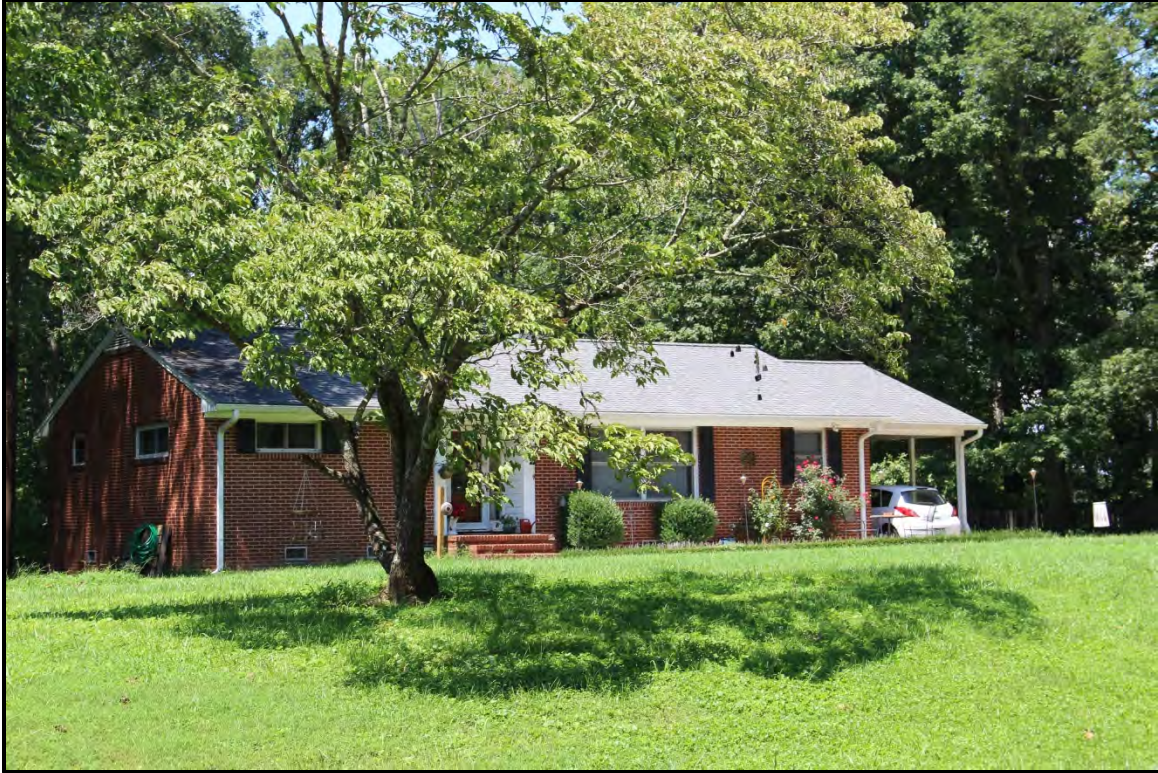
The wood-frame building features a side-gabled roof, an interior central brick chimney, an exterior clad with a brick veneer, and a continuous brick foundation. Fenestration includes double-hung 1/1 and two-light sliding aluminum sashes. A brick stoop provides access to the recessed main entrance. The north elevation is marked by an attached one-bay carport.

NRHP Assessment. Architectural resource RK1762 does not exhibit a distinctive architectural style or workmanship. Based on the lack of architectural merit, as well as the inability to associate the house and/or its original owner(s) with an important historical event or series of events, it is TRC's opinion that architectural resource RK1762 is not eligible for the NRHP.

Figure 5.300. Architectural resource RK1762; view is southwest and features the façade and northeast elevation.

Figure 5.301. Architectural resource RK1762; view is northwest and features the façade and southwest elevation.

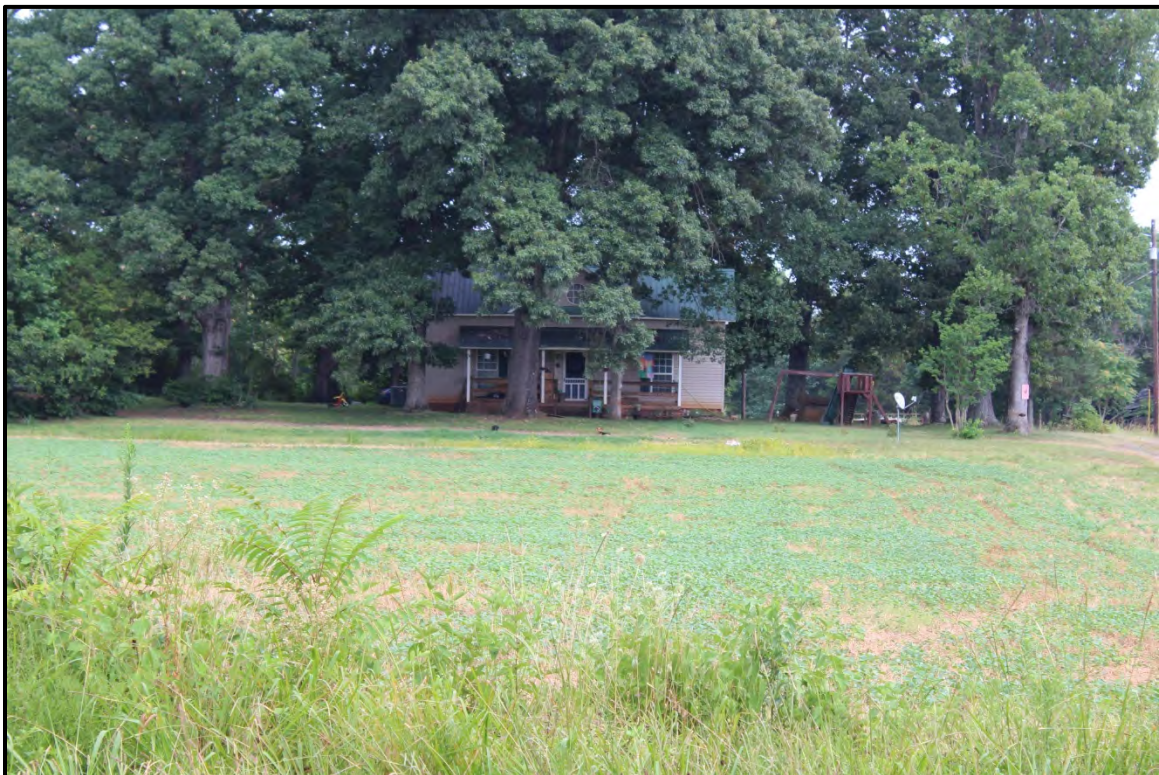
The one and one-half-story, wood-frame building features a side-gabled roof covered with standing seam metal, an exterior clad with vinyl siding, and a continuous concrete block foundation. Fenestration includes double-hung 9/9 vinyl sash windows. A partial-width reconstructed entry porch provides access to the main entrance. The porch is comprised of a shed roof supported by modern wood posts and a concrete deck.

NRHP Assessment. Architectural resource RK1763 does not exhibit a distinctive architectural style or workmanship. In addition, the house has been altered through the replacement of the original window sashes, the reconstruction of the façade porch, and the application of vinyl siding. Based on the lack of architectural merit, as well as the inability to associate the house and/or its original owner(s) with an important historical event or series of events, it is TRC’s opinion that architectural resource RK1763 is not eligible for the NRHP.

Figure 5.302. Architectural resource RK1763; view is east and features the façade.
