Re: Revised Architectural Survey Report, MVP Southgate Project, Construct Interstate Pipeline, Rockingham and Alamance County, ER 18-1041

Thank you for your letter of October 11, 2019, transmitting the draft "Historic Architectural Survey for the MVP Southgate Pipeline Project". We have reviewed the report and offer the following comments.

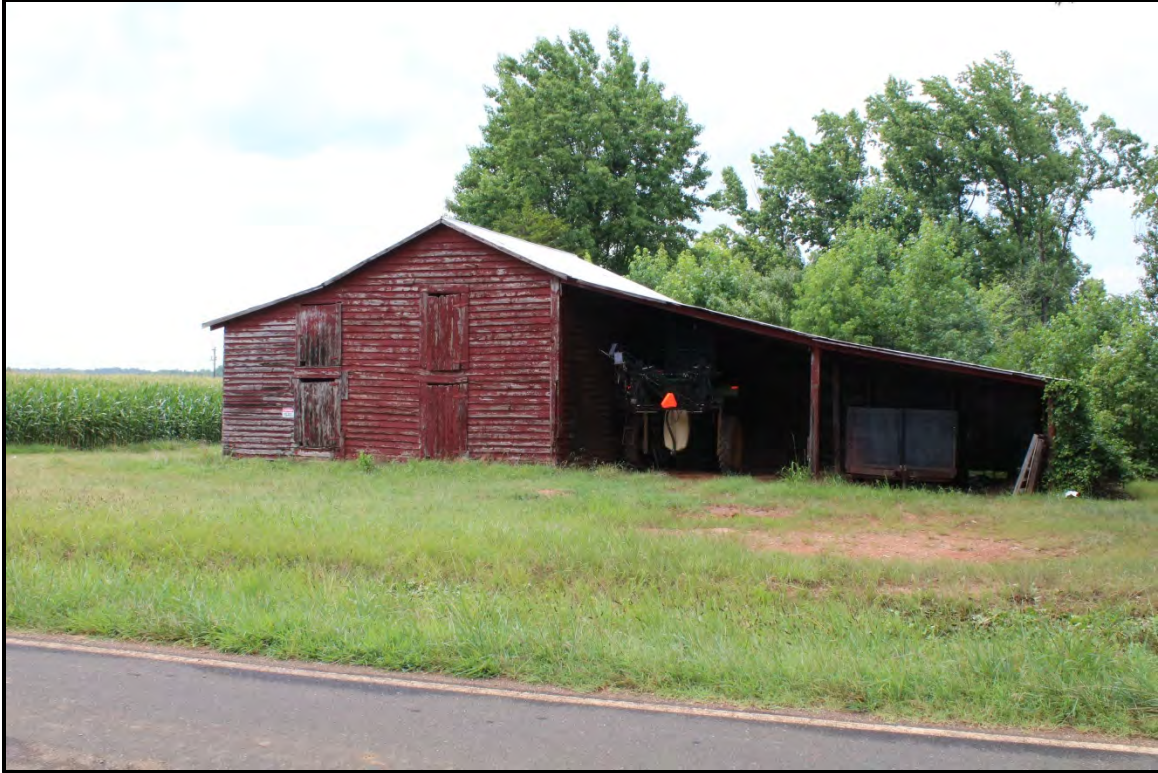
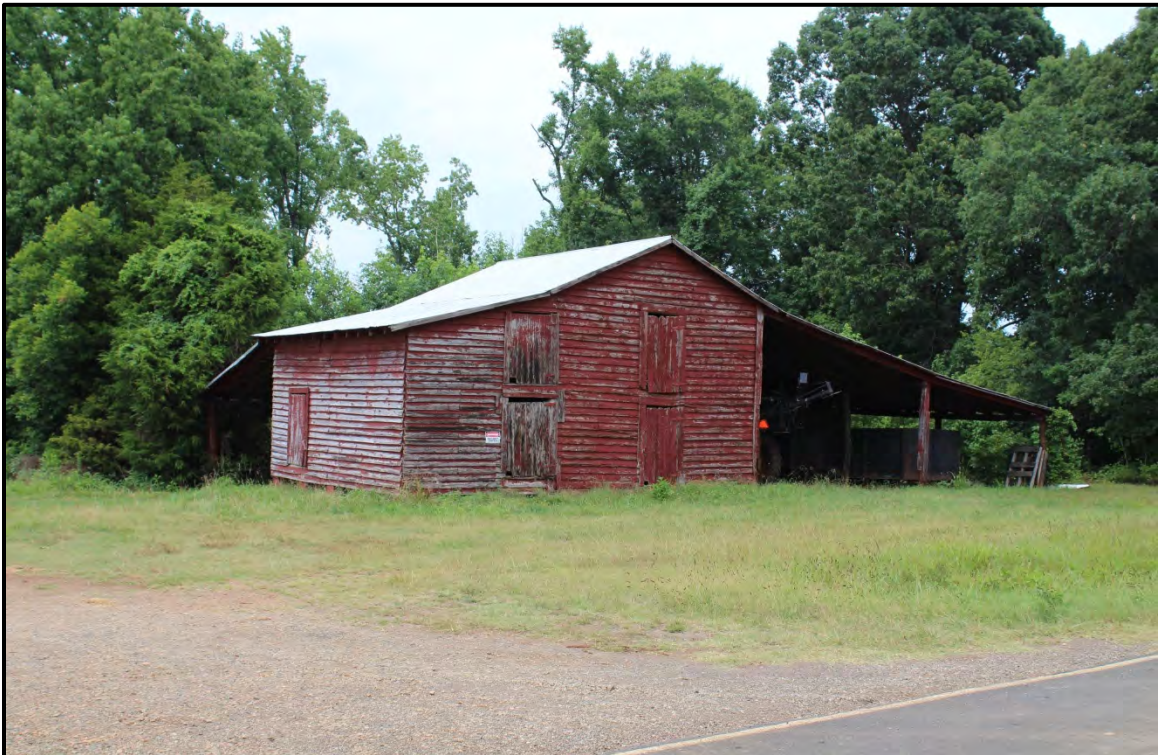
The 1960 agricultural shed is a wood-frame structure with an upper loft. The shed features a front-gabled roof covered with standing seam metal, an exterior clad with weatherboard siding, and a concrete block pier foundation. Doors are positioned on the south and east elevations. Two open bays on the east elevation provide machine storage (Figures 5.303 and 5.304).

Figure 5.303. Architectural resource RK1764; view is northwest and features the façade and east elevation.

Figure 5.304. Architectural resource RK1764; view is northeast and features the façade and west elevation.

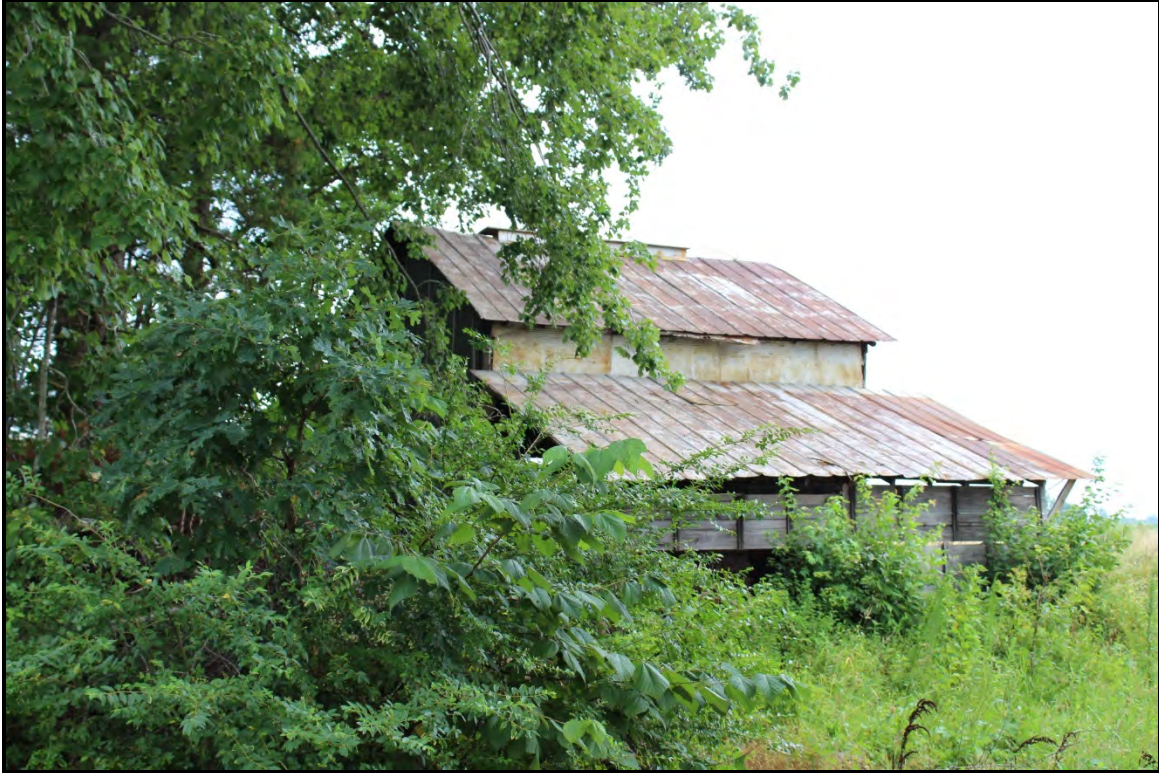
Located northwest of the shed is the 1962 tobacco barn. The tobacco barn appears to be wood-frame and capped with a front-gabled roof that is covered with standing seam metal (Figure 5.305).

Figure 5.305. Architectural resource RK1764; view is northwest and features the tobacco barn.

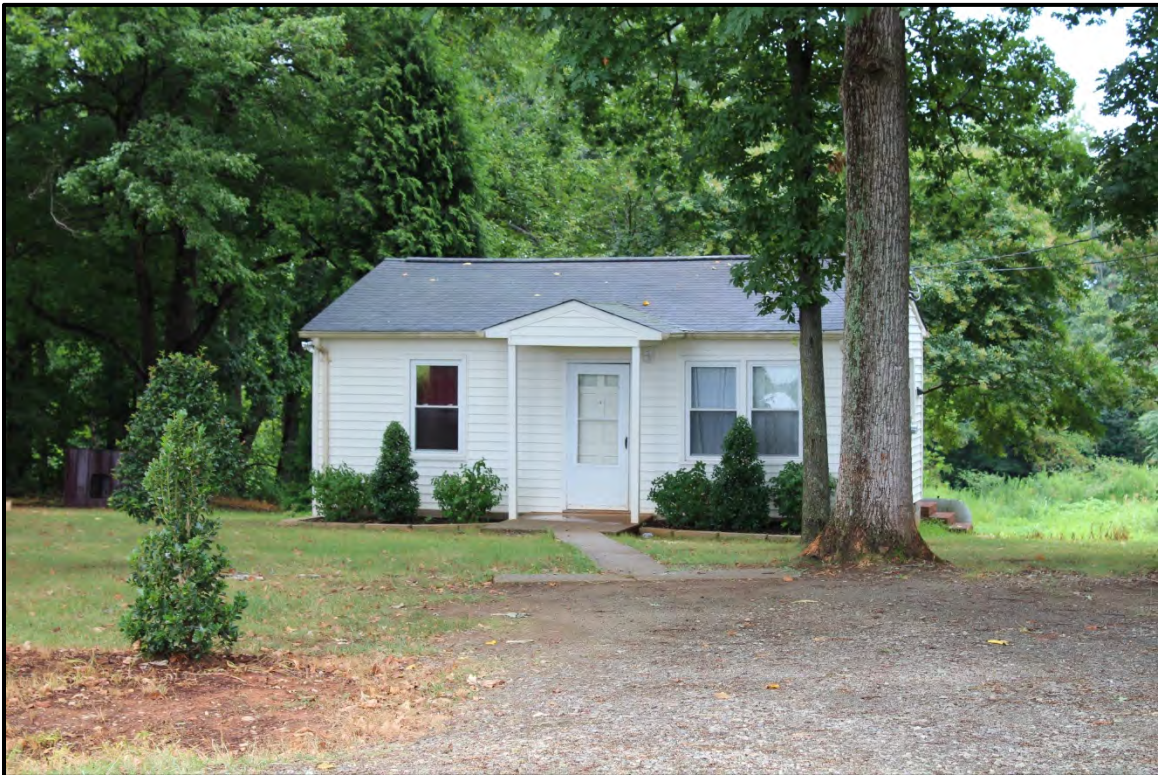
The one-story, wood-frame building features a side-gabled roof covered with asphalt shingles, an exterior clad with vinyl siding, and a concrete block foundation. Fenestration includes double-hung 1/1 vinyl sash windows. A reconstructed single-bay entry porch provides access to the main entrance. The porch is composed of a gabled roof supported by square wood posts and a concrete slab deck.

NRHP Assessment. Architectural resource RK1765 does not exhibit a distinctive architectural style or workmanship. In addition, the house has been altered through the application of vinyl siding, the replacement of the original window sashes, and the reconstruction of the entry portico. Based on the lack of architectural merit, as well as the inability to associate the house and/or its original owner(s) with an important historical event or series of events, it is TRC's opinion that architectural resource RK1765 is not eligible for the NRHP.

Figure 5.306. Architectural resource RK1765; view is northwest and features the façade.

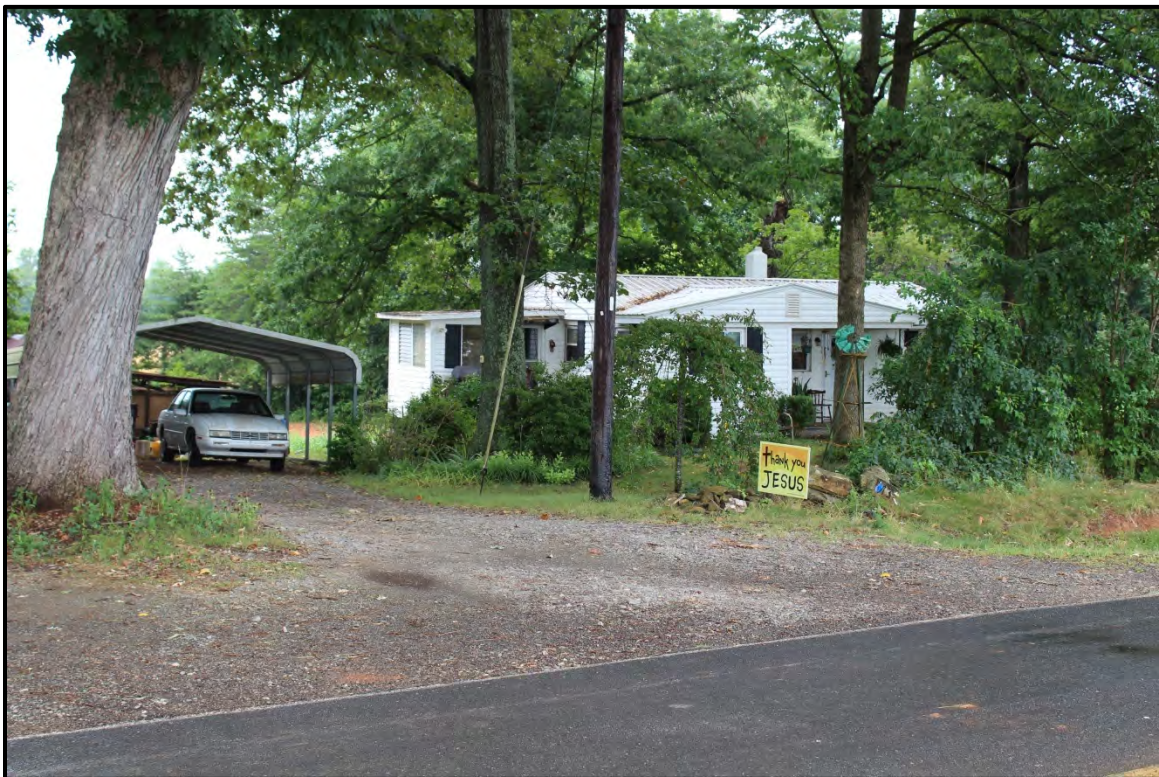
The one-story, wood-frame house features a side-gabled roof covered with standing seam metal, an exterior clad with vinyl siding, and an interior concrete block chimney. Fenestration includes double-hung 1/1 vinyl sash windows. A partial-width entry porch provides access to the main entrance and has been partially enclosed. The porch is composed of a gabled roof supported by an ornamental metal post and a wood plank deck. A shed-roofed addition is attached to the west elevation.

NRHP Assessment. Architectural resource RK1766 does not exhibit a distinctive architectural style or workmanship. In addition, the house has been altered through the application of vinyl siding and the replacement of the original window sashes. Based on the lack of architectural merit, as well as the inability to associate the house and/or its original owner(s) with an important historical event or series of events, it is TRC's opinion that architectural resource RK1766 is not eligible for the NRHP.

Figure 5.307. Architectural resource RK1766; view is northeast and features the façade and west elevation.

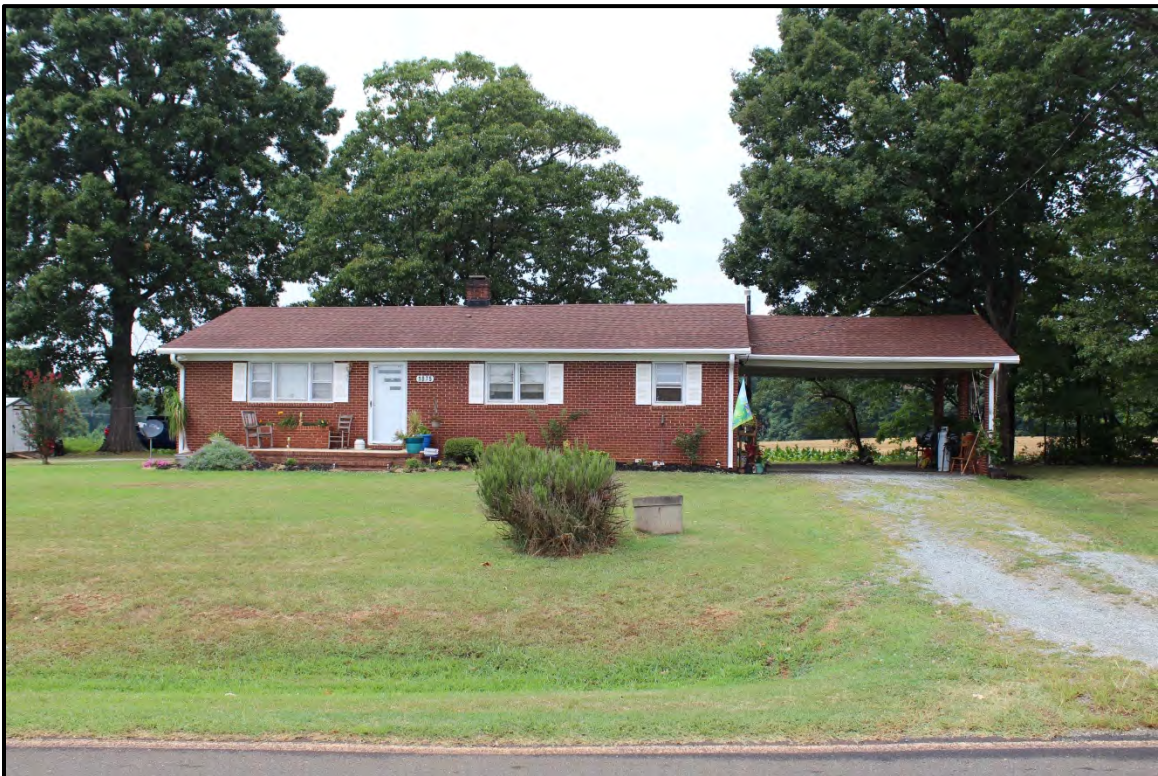
The wood-frame house that features a side-gabled roof covered with asphalt shingles, an interior central brick chimney, an exterior clad with a brick veneer, and a continuous brick foundation. Fenestration includes horizontal 2/2 double-hung wood sash windows. A brick and concrete stoop provides access to the main entrance. A two-bay carport is attached to the east elevation and is comprised of a gabled roof supported by brick piers.

NRHP Assessment. Architectural resource RK1767 does not exhibit a distinctive architectural style or workmanship. Based on the lack of architectural merit, as well as the inability to associate the house and/or its original owner(s) with an important historical event or series of events, it is TRC's opinion that architectural resource RK1767 is not eligible for the NRHP.

Figure 5.308. Architectural resource RK1767; view is north and features the façade.

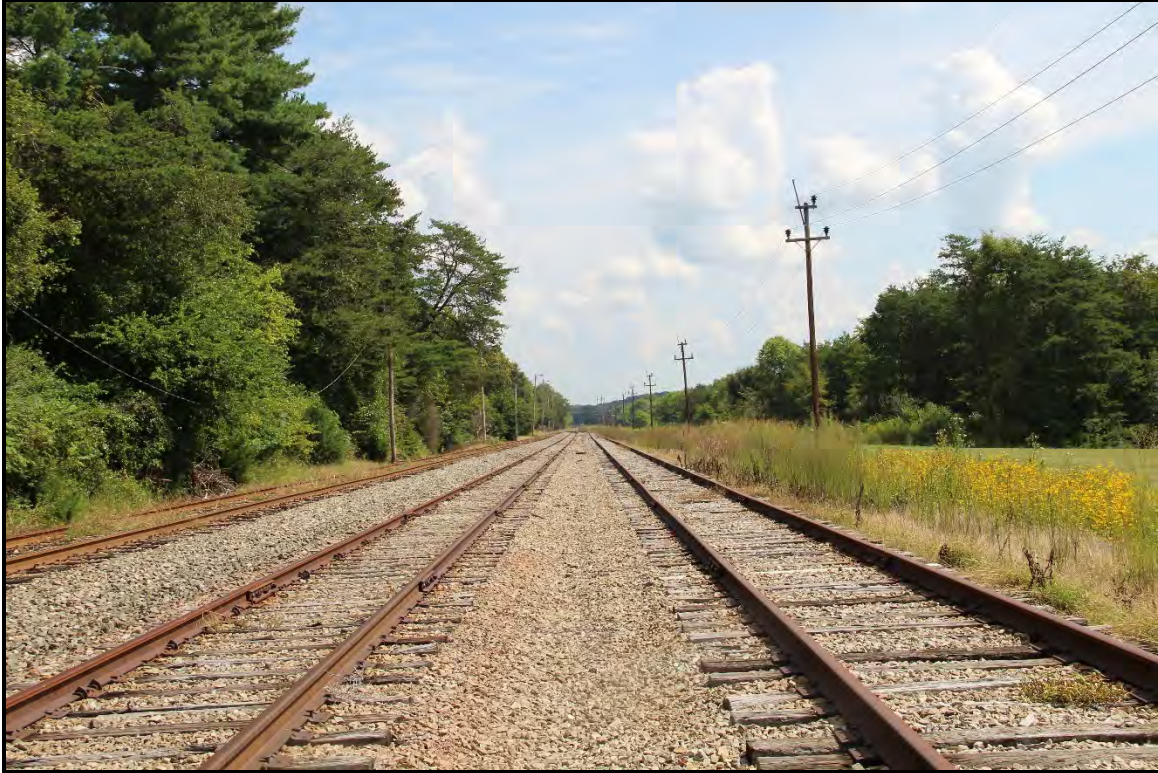
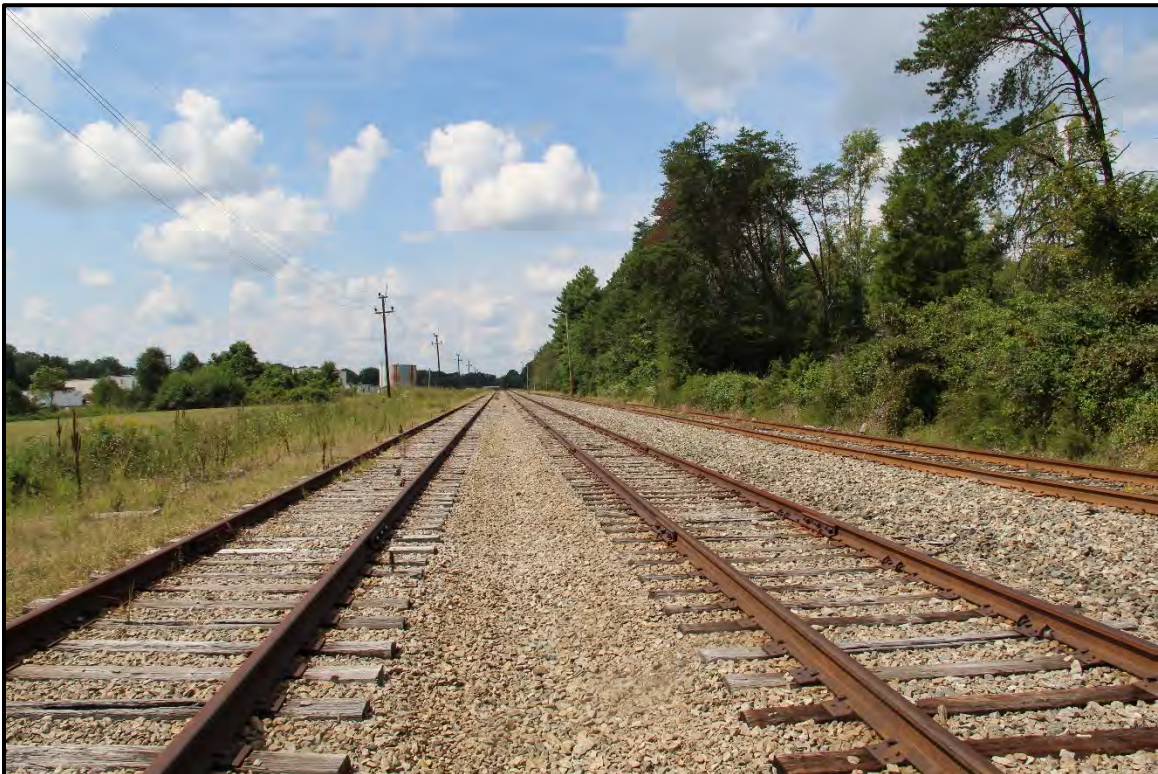
The railroad segment within the study area features a raised embankment covered with ballast that supports a modern track composed of wood cross ties and steel rails. The segment located within the indirect effects APE of CY-03 traverses an industrial and residential area within the town of Eden.

NRHP Evaluation. Architectural resource RK1769 is a segment of a nineteenth century railroad that has been continuously altered through routine maintenance for more than a century. As an actively managed rail line, the railroad bed has received regular repairs that have resulted in the replacement of the original tracks, cross-ties and ballast. As such, no materials associated with the original construction of the railroad remain. For these reasons, it is TRC's opinion that architectural resource RK1769 is not eligible for the NRHP.

Figure 5.309. Architectural resource RK1769 along the northern border of CY-03; view is east.

Figure 5.310. Architectural resource RK1769 along the northern border of CY-03; view is west.

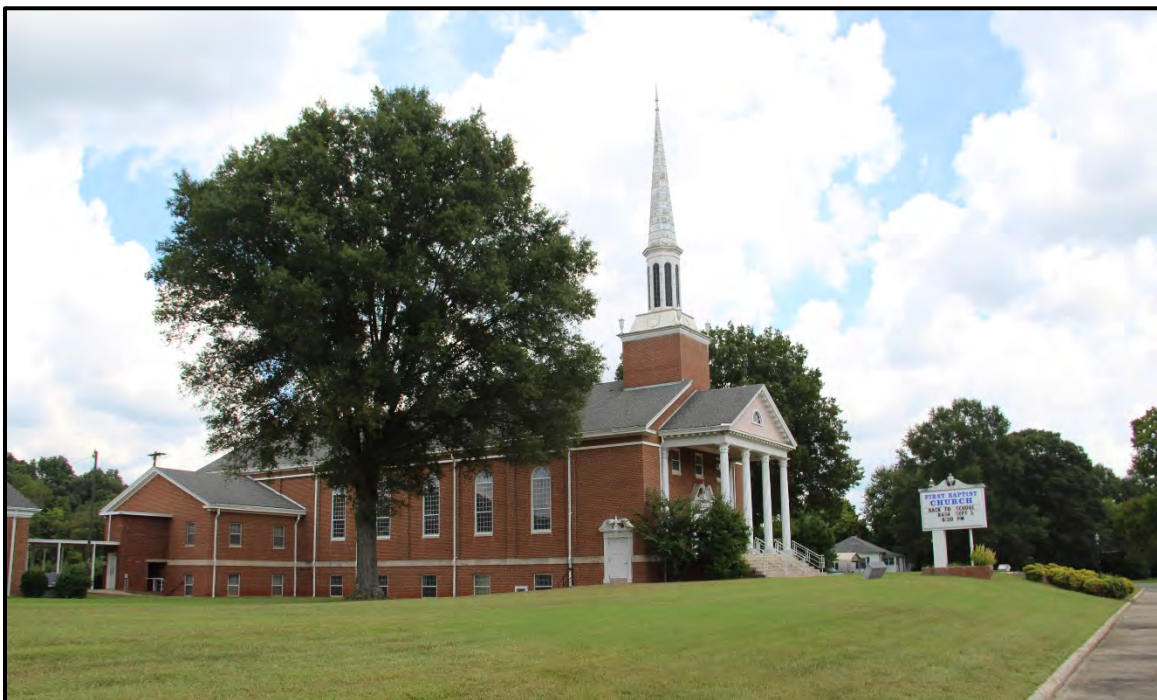
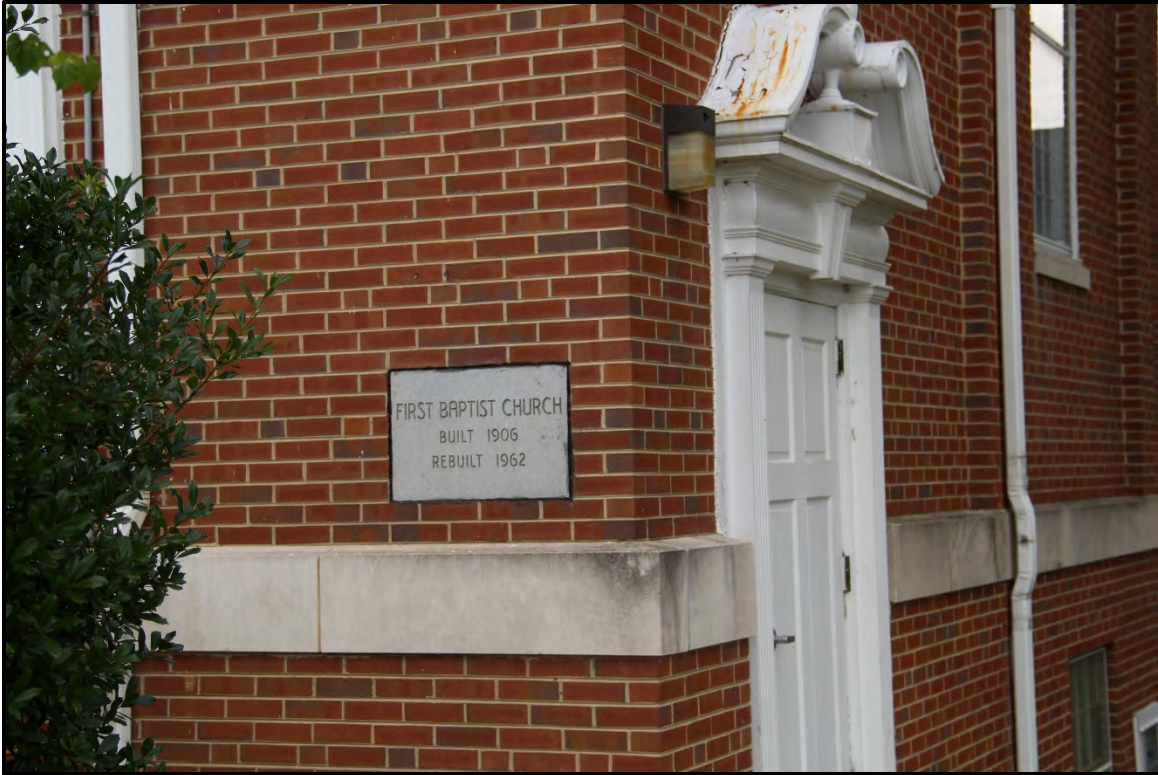
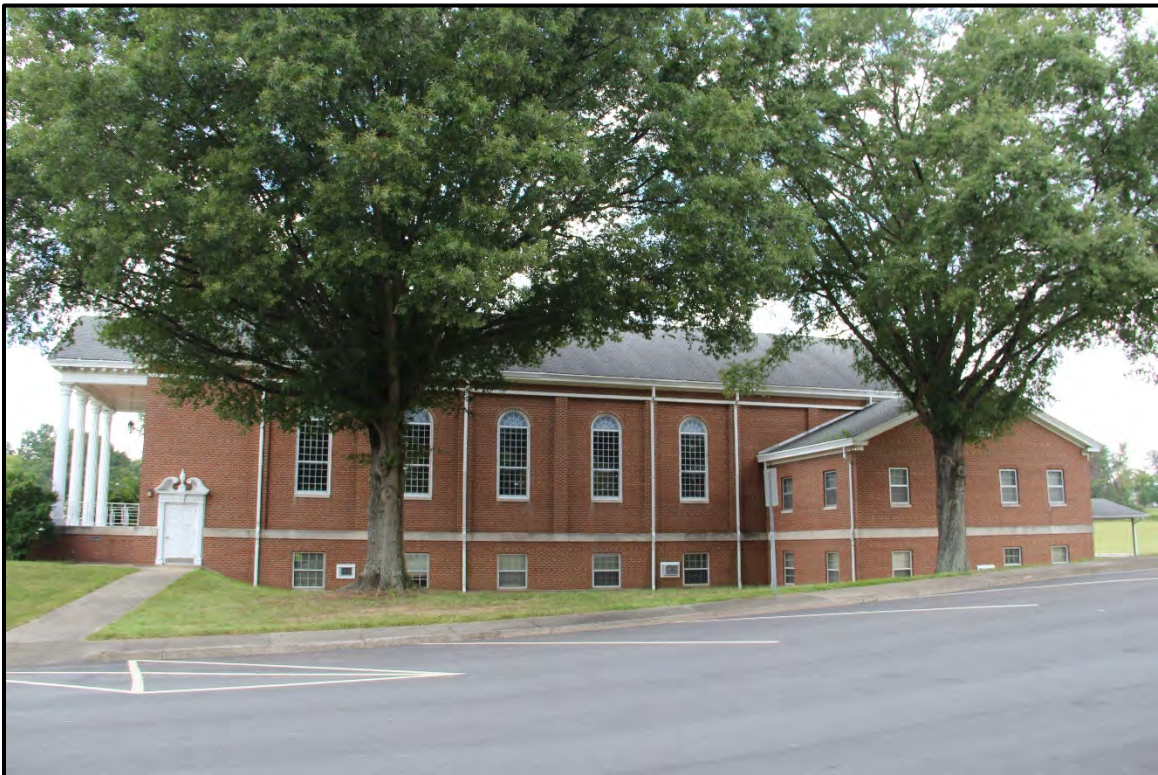
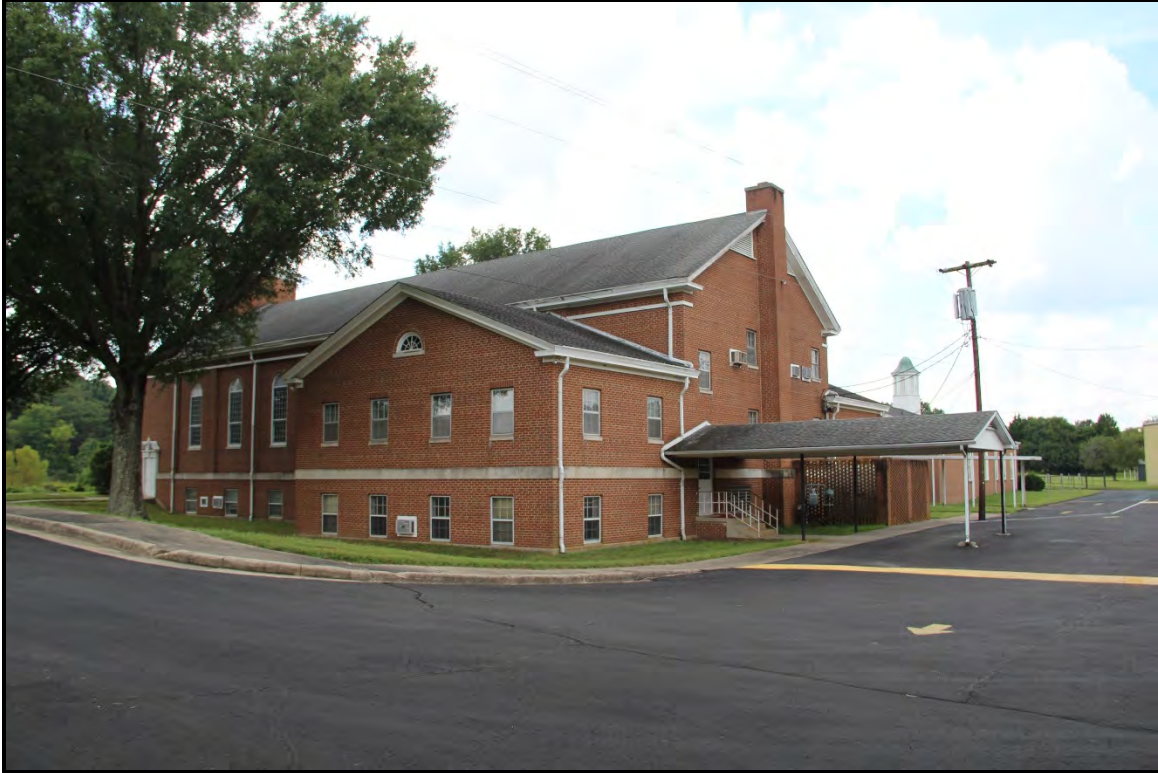
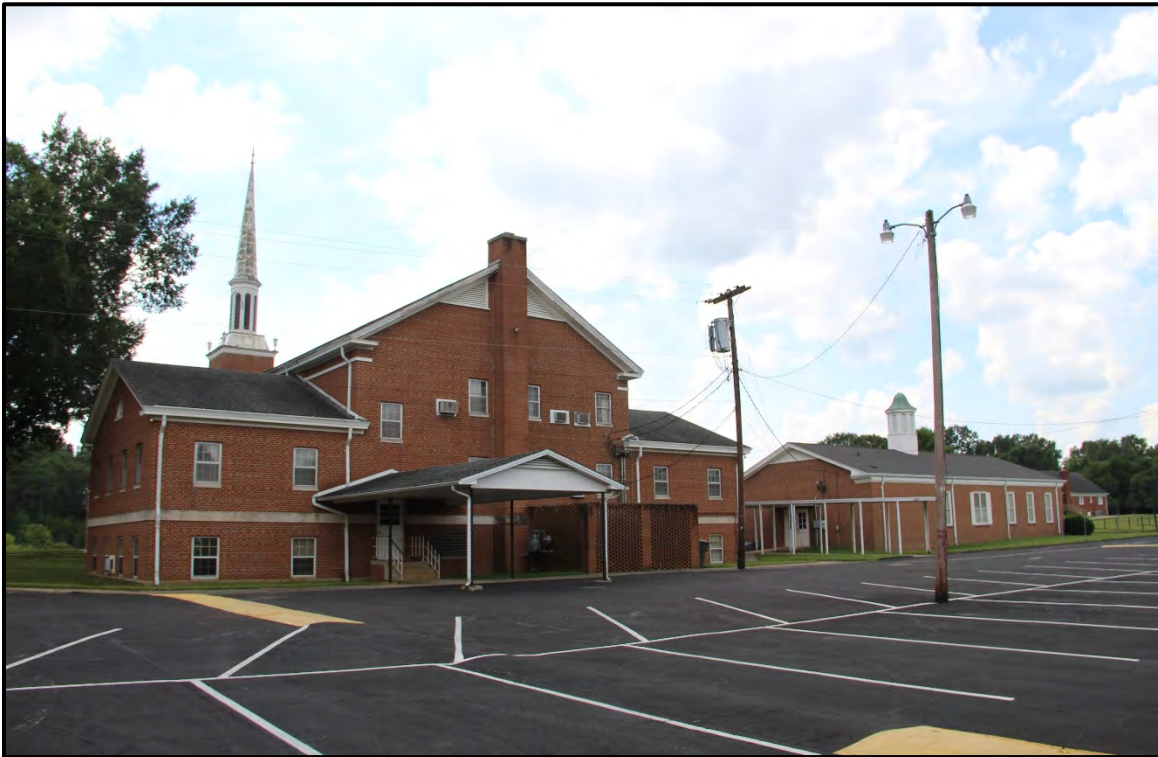
The two-story, concrete block-frame building features a front-gabled roof covered with asphalt shingles, an exterior clad with a brick veneer, and a raised foundation clad with brick. Facing south, the façade contains a central door opening containing a pair of wood panel doors that are topped by a seven-light wood transom. The façade doors are accented with a Classically-inspired surround marked with a broken piedmont that is supported by plain wood pilasters. Flanking the main entrance are single window openings with brick jack arches and concrete sills that contain 8/8, double-hung wood sashes. This sash type is repeated in three symmetrically placed windows along the second story, which are not accented with jack arches. A full-façade portico containing a concrete deck fronted by a series of concrete steps provides access to the main entrance. The portico is shielded by a projecting gable roof that is supported by four wood columns that contain fluting detailing and Corinthian-style capitals. These ornamental features are also found on two wood pilasters that flank the central bay. The employment of Classical detailing is visible in the portico's entablature and raking cornice, which are accented with dentils and mutules. Positioned within the gable field of the portico roof is a wood sash fanlight with 10 lights.

The east and west elevations of the building are divided into five window bays that are separated by brick pilasters. Each bay is pierced by a large, arched window opening that contains a 30/20 double-hung wood sash window that is topped by a multi-light wood fanlight. Positioned near the portico is a door opening that contains a wood paneled door that is set within a Classically-inspired door surround. The door surround is topped by a broken pediment that is supported by an entablature and pilasters. Additional fenestration along the elevations include a series of five windows containing 8/8 double-hung wood sashes along the ground level.

NRHP Assessment. Architectural resource RK1770 is an example of a Neoclassical style church that does not appear to have received significant exterior alterations since its date of construction in 1962. The interior of the church was not accessible at the time of the original survey, and the church is now outside the Project APE; as a result, TRC's NRHP evaluation is based exclusively on an exterior assessment of the building. In accordance with NRHP Criteria Consideration A, religious buildings are normally not eligible for the NRHP unless they derive their primary significance from architectural or artistic distinction or are considered to be of historical importance. However, it is TRC's opinion that architectural resource RK1770 is an excellent example of ecclesiastical architecture that exhibits high elements of the Neoclassical style. Overall, the church retains a strong degree of integrity through the retention of original character-defining details such as the pedimented entry portico, Classical columns, steeple, wood sashes, and broken pediment door hoods. In addition, the church maintains its original scale and massing, which have not been compromised through the construction of modern additions. For these reasons, it is the opinion of TRC that RK1770 is potentially eligible for the NRHP under Criterion C for its architectural significance.

Figure 5.311. Architectural resource RK1770; view is northeast featuring the façade and west elevation.

Figure 5.312. Architectural resource RK1770; view is north featuring the cornerstone.

Figure 5.313. Architectural resource RK1770; view is west featuring the east elevation.

Figure 5.314. Architectural resource RK1770; view is southwest featuring the east and north (rear) elevation of the church.

Figure 5.315. Architectural resource RK1770; view is southwest featuring the side-gable wings attached to the east and west elevations of the church.

- RK1770 must be compared to other Colonial Revival churches in the county. The investigator needs to make a better attempt at securing interior photos.

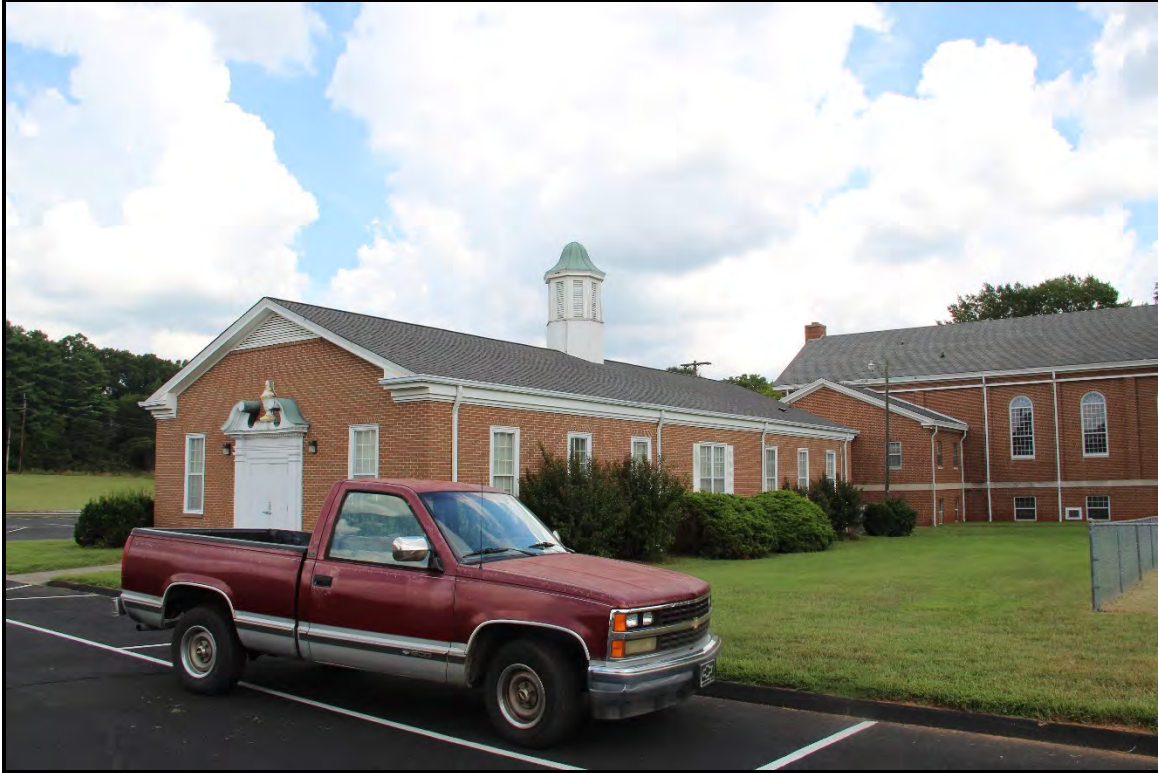
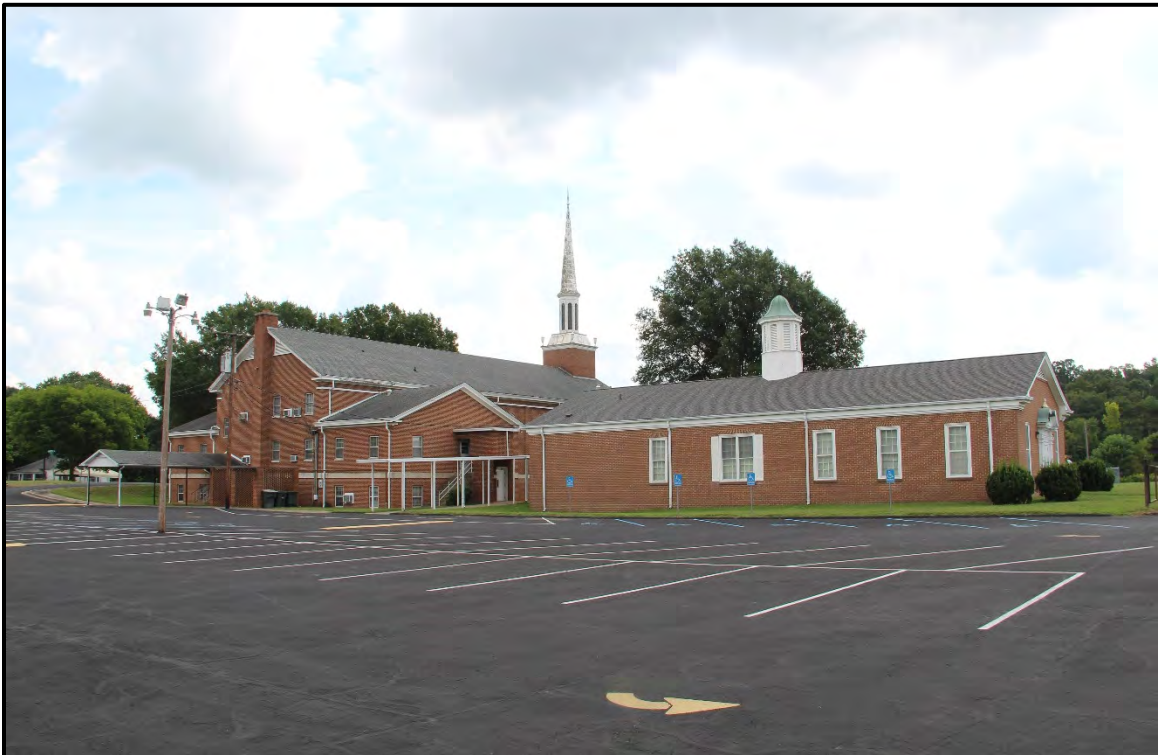
- A one-story, Neoclassical-style building that functions as a fellowship hall for the church congregation (Rockingham County, NC GIS 2018). The building was constructed in 1962 and features a masonry frame with a brick veneer-clad exterior, a side-gabled roof, and double hung 6/6 wood sash windows. The building includes an entrance on the west elevation that is set within a Classically-inspired door surround. The door surround is topped by a broken pediment that is

supported by an entablature and pilasters. Finally, the building is topped by an octagonal-shaped cupola that contains a bell-shaped roof (Figures 5.316 and 5.317);

Figure 5.316. Architectural resource RK1770; view is northeast featuring the primary façade and south elevation of the fellowship hall.

Figure 5.317. Architectural resource RK1770; view is southeast featuring the north and west elevations of the fellowship hall.

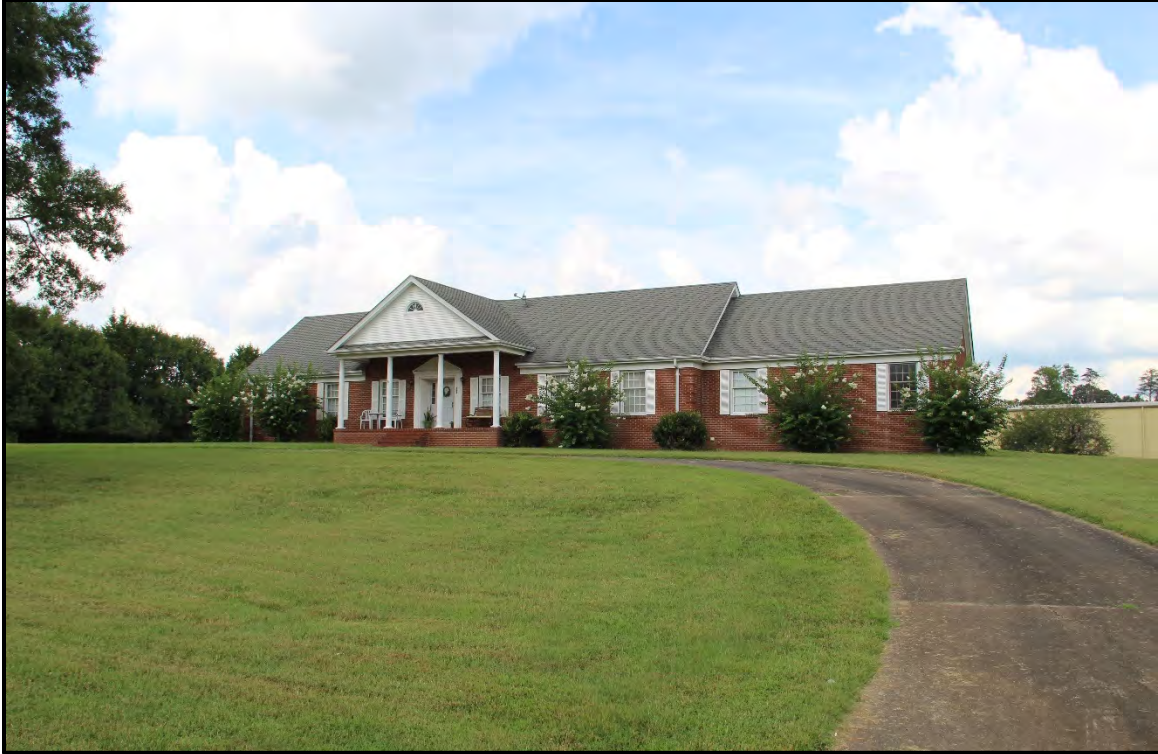
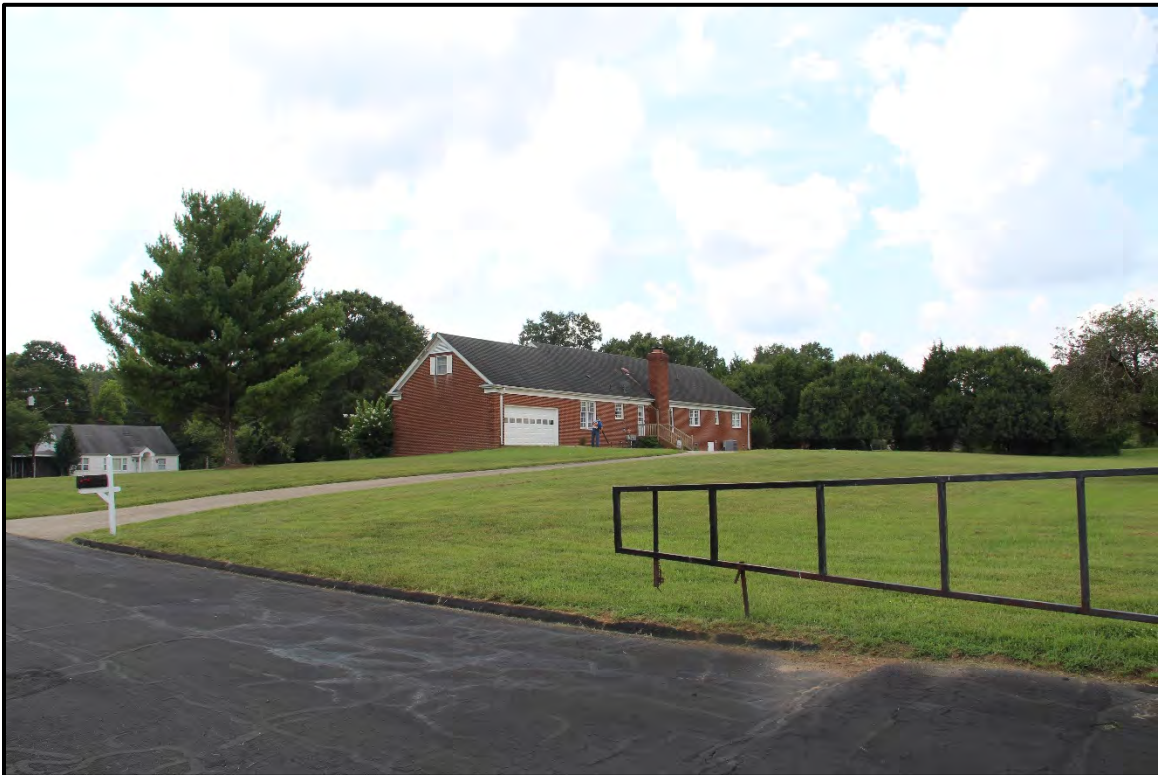
- A ca. 1962, Ranch-style house with Neoclassical detailing. The wood-frame building functions as the church's manse and features a side-gabled roof, an exterior clad with a brick veneer, and double-hung 8/9 wood sash windows. A center-bay porch with a brick deck provides access to the main entrance. The porch is shielded by a projecting gable roof that is supported by four wood columns with fluting detailing. The house includes an exterior brick chimney and a single-bay garage on its north (rear) elevation (Figures 5.318 and 5.319);
- A ca. 1970, one-story building that functions as an activity building for the church. The steel-frame building features a low-pitch gable-front roof, a metal panel exterior and a pair of steel doors on the east elevation (Figure 5.320);

Figure 5.318. Architectural resource RK1770; view is north featuring the façade of the church manse.

Figure 5.319. Architectural resource RK1770; view is southwest featuring the east and north (rear) elevations of the church manse.

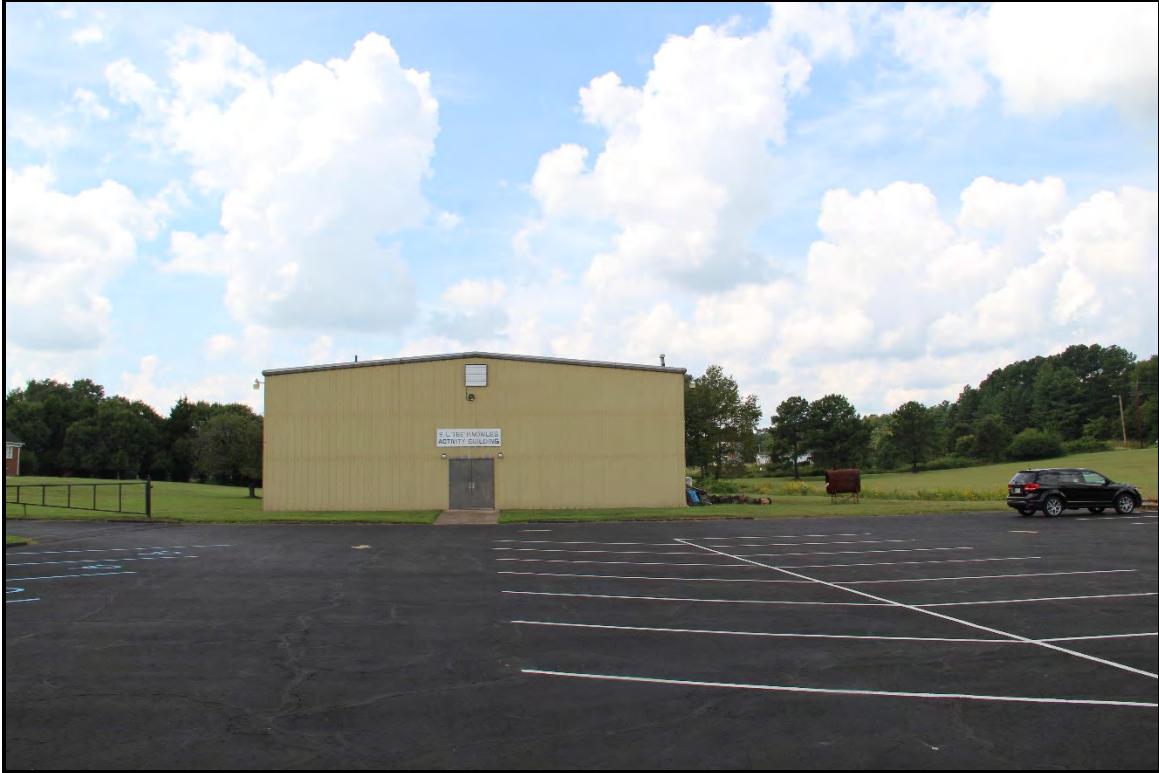
Figure 5.320. Architectural resource RK1770; view is west featuring the ca. 1970 activity building.

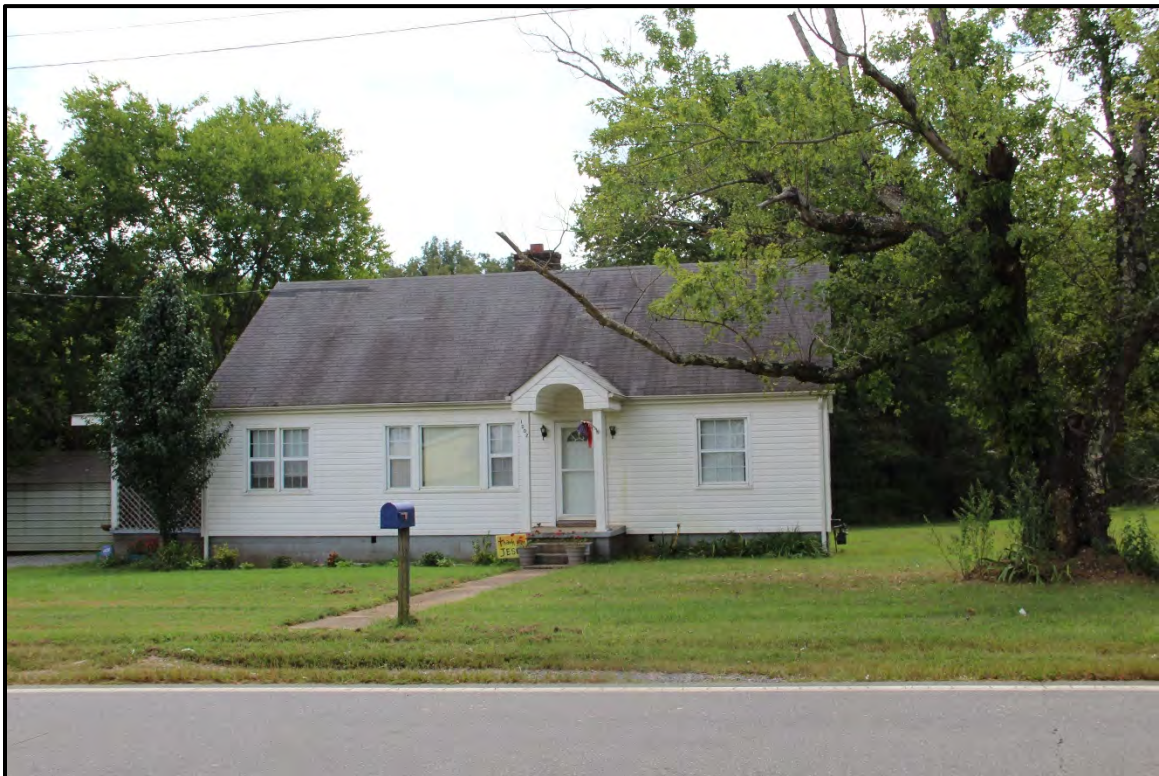
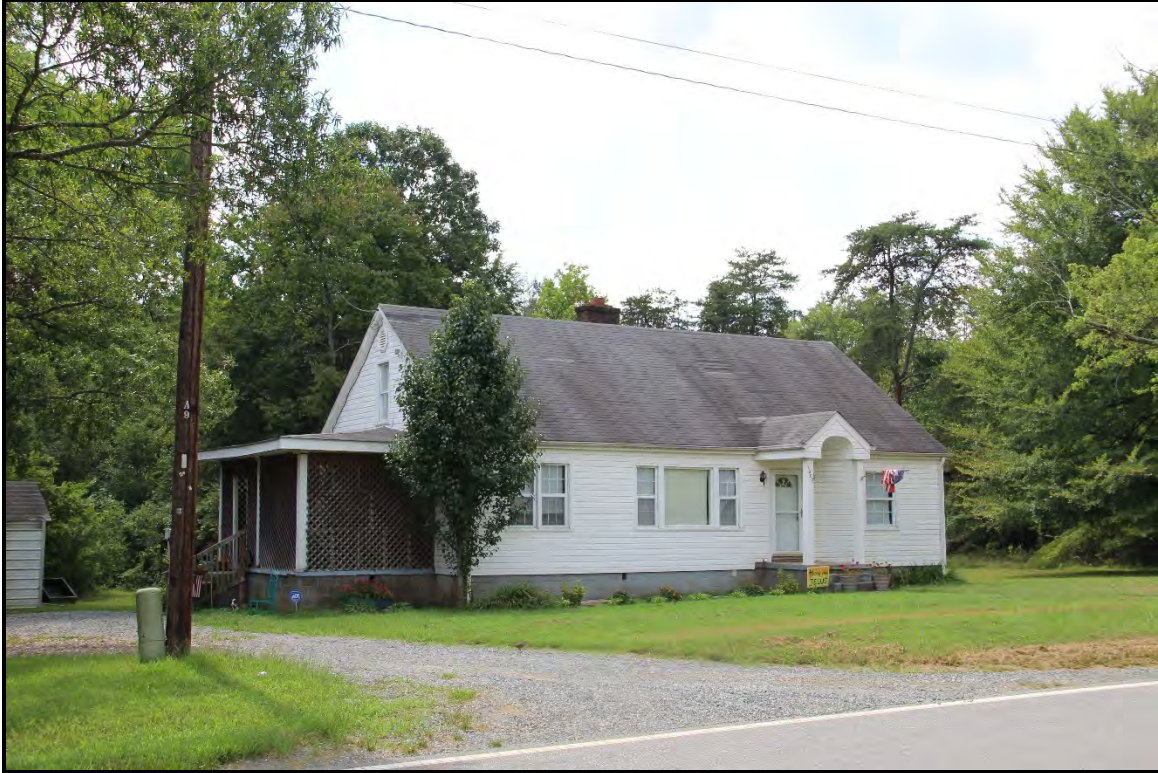
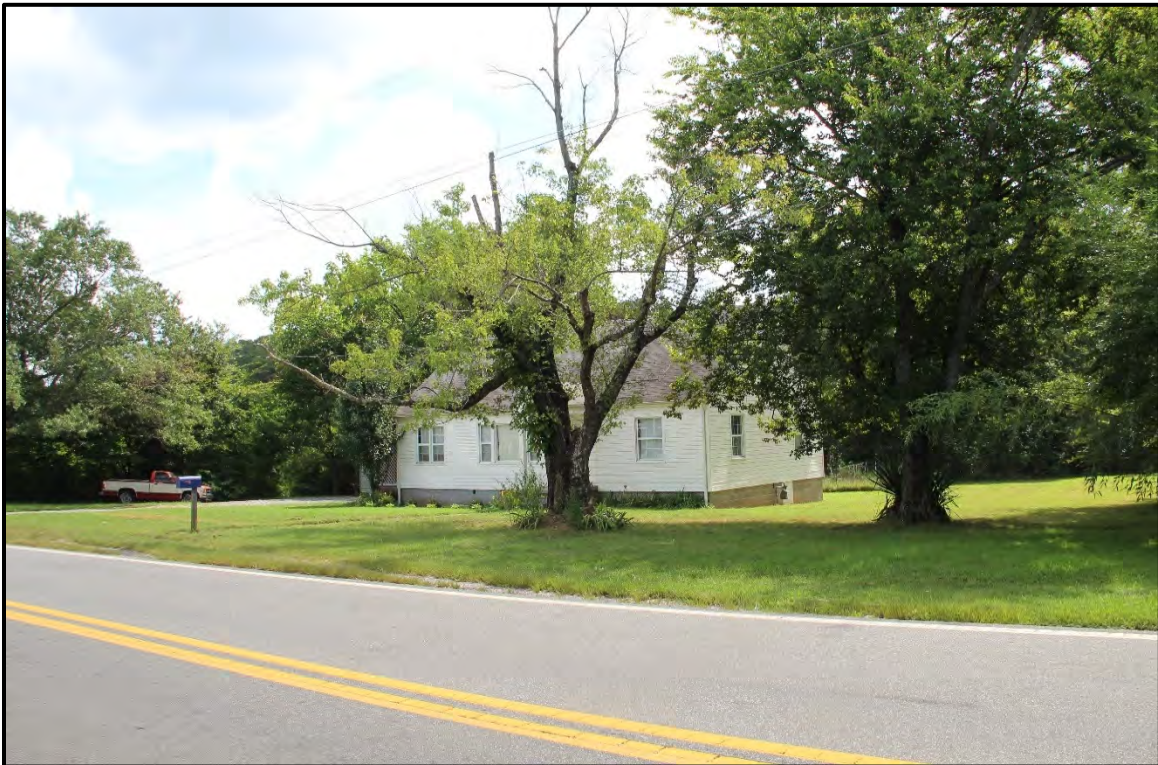
The one-story, wood-frame building features a side-gabled roof, an interior brick chimney, an exterior clad with vinyl siding, a concrete block foundation, and double-hung 6/6 vinyl sash windows. A center bay concrete slab stoop with a concrete block foundation provides access to the main entrance. The porch is shielded by a projecting gable roof that is supported by square posts composed of synthetic material.

NRHP Assessment. Architectural resource RK1771 does not exhibit a distinctive architectural style or workmanship. In addition, the house has been altered through the application of vinyl siding and the replacement of the original window sashes. Based on the lack of architectural merit, as well as the inability to associate the house and/or its original owner(s) with an important historical event or series of events, it is TRC’s opinion that architectural resource RK1771 is not eligible for the NRHP.

Figure 5.321. Architectural resource RK1771; view is south featuring the façade.

Figure 5.322. Architectural resource RK1771; view is southwest featuring the façade and east elevation.

Figure 5.323. Architectural resource RK1771; view is southeast featuring the façade and west elevation.
