Re: Revised Architectural Survey Report, MVP Southgate Project, Construct Interstate Pipeline, Rockingham and Alamance County, ER 18-1041

Thank you for your letter of October 11, 2019, transmitting the draft "Historic Architectural Survey for the MVP Southgate Pipeline Project". We have reviewed the report and offer the following comments.

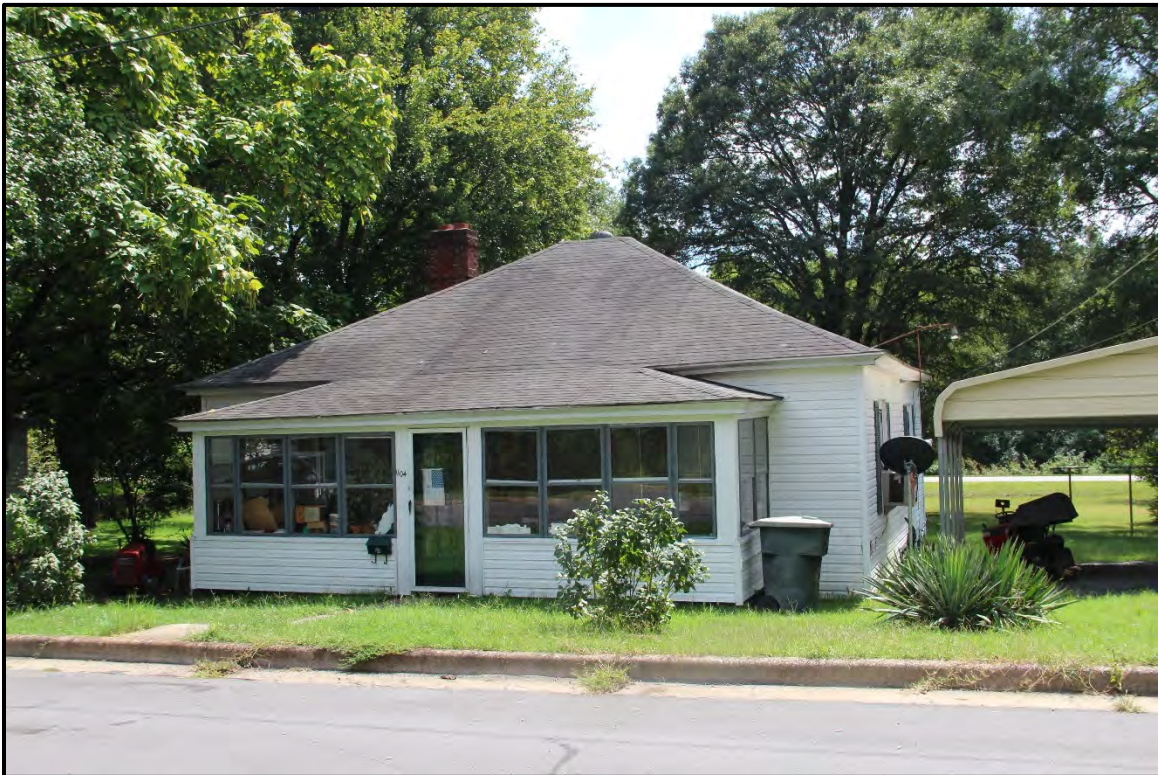
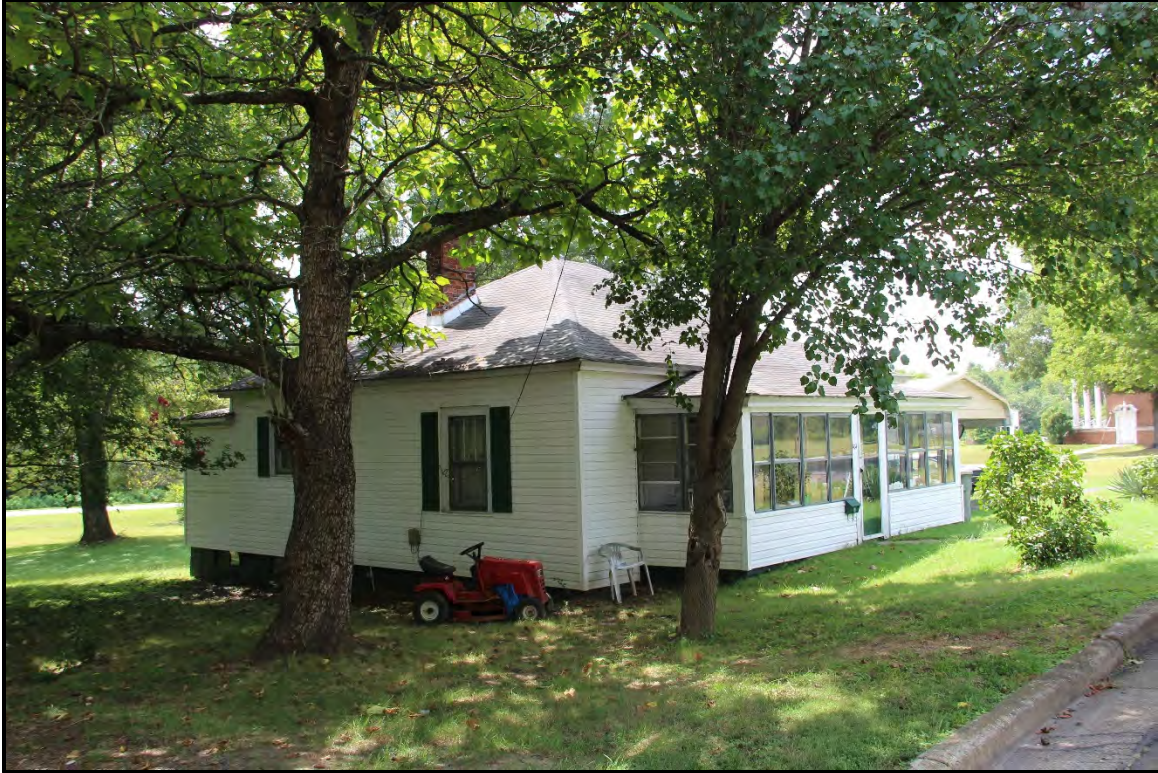
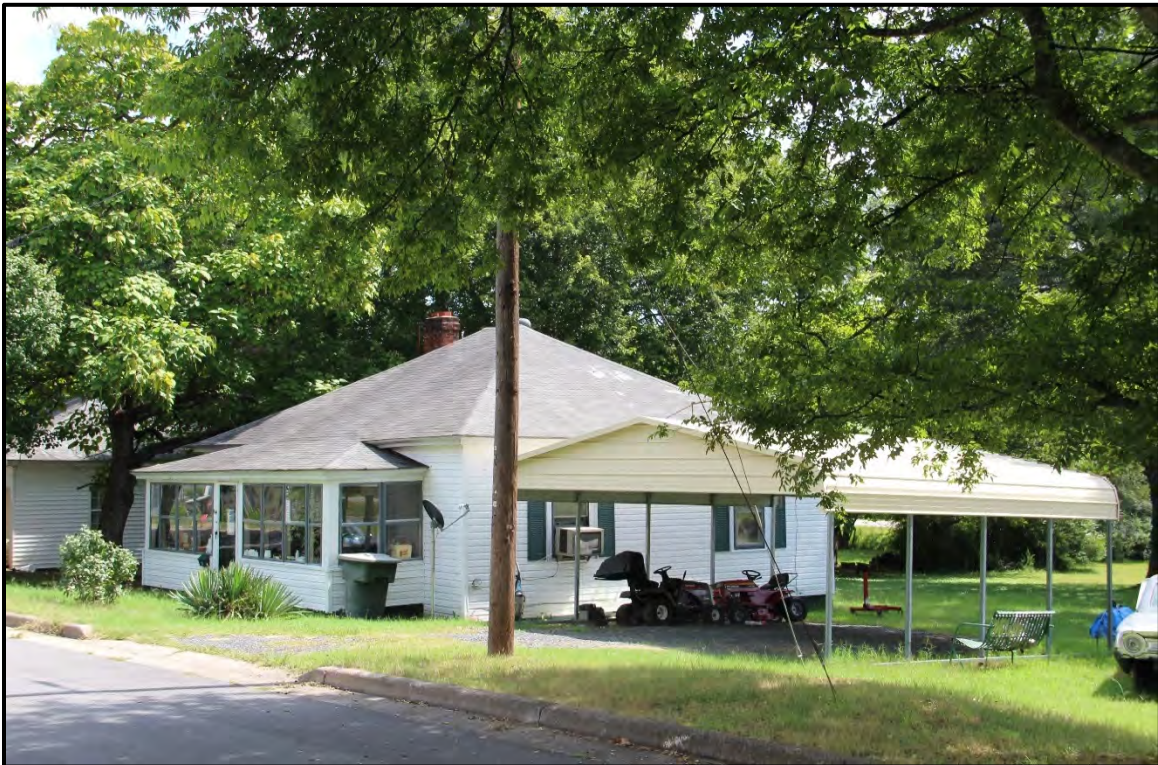
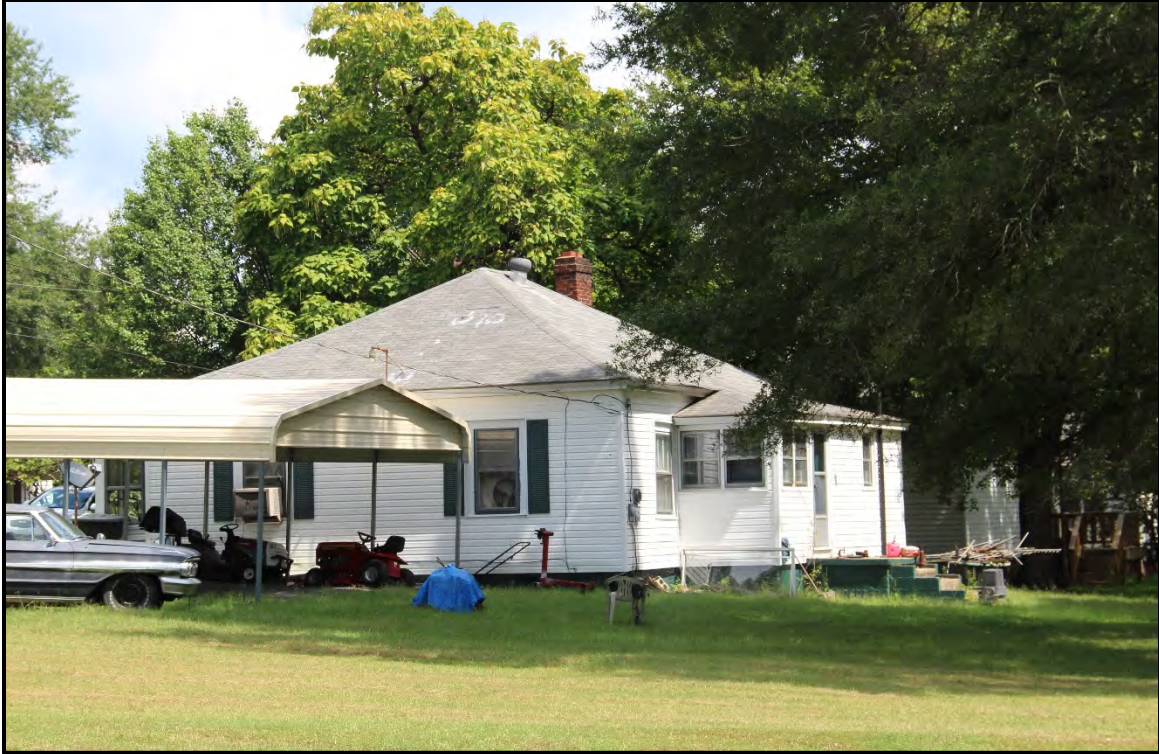
The one-story, wood-frame building features an interior brick chimney, an exterior clad with vinyl siding, a foundation comprised of brick piers and concrete block infill, and double-hung 3/1 wood sash windows. A partial-width porch that is enclosed with 1/1 metal sash windows and vinyl siding provides access to the main entrance. The porch is shielded by a hipped roof that is supported by square posts composed of synthetic material.

NRHP Assessment. Architectural resource RK1772 does not exhibit a distinctive architectural style or workmanship. In addition, the house has been altered through the application of vinyl siding. Based on the lack of architectural merit, as well as the inability to associate the house and/or its original owner(s) with an important historical event or series of events, it is TRC’s opinion that architectural resource RK1772 is not eligible for the NRHP.

Figure 5.324. Architectural resource RK1772; view is southeast featuring the façade.

Figure 5.325. Architectural resource RK1772; view is southwest featuring the façade and east elevation.

Figure 5.326. Architectural resource RK1772; view is southeast featuring the façade and west elevation.

Figure 5.327. Architectural resource RK1772; view is northeast featuring the west and south (rear) elevations.

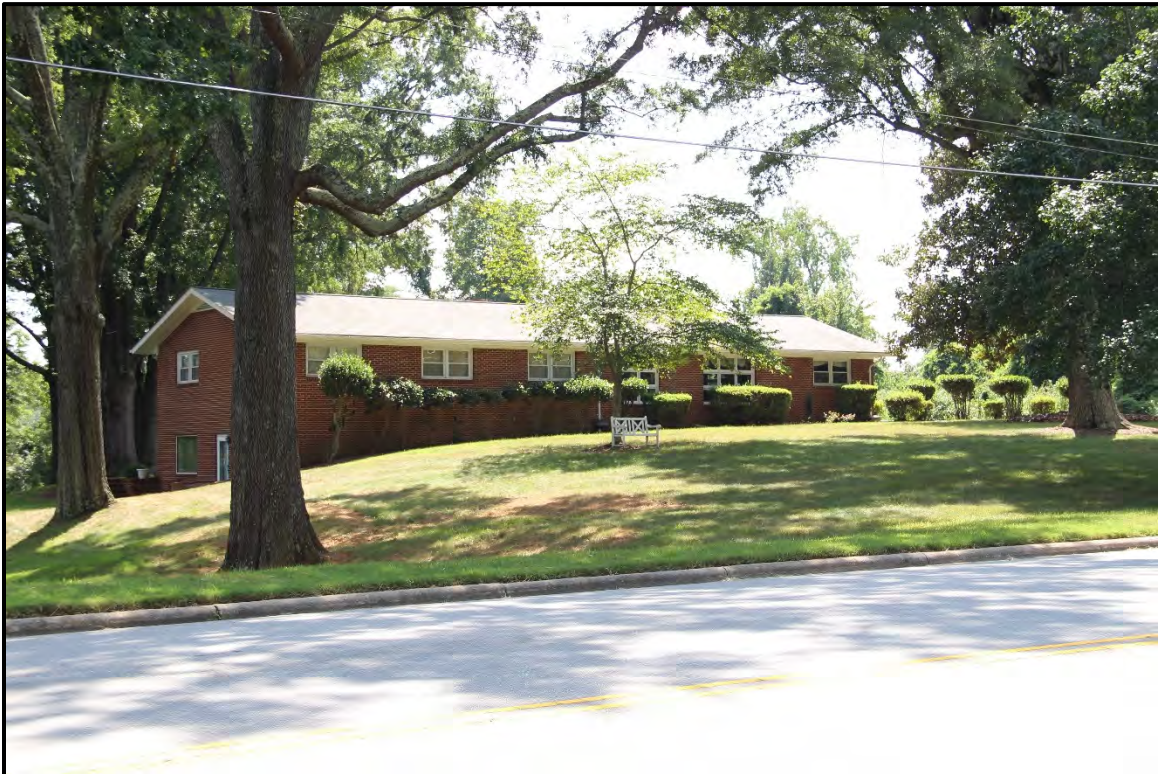
The wood-frame building features a side-gabled roof, a brick veneer-clad exterior, a brick foundation, and double-hung 1/1 vinyl sash windows. A carport located on the west elevation, and which is integral with the main roof, provides access to the main entrance.

NRHP Assessment. Architectural resource RK1773 does not exhibit a distinctive architectural style or workmanship. In addition, the house has been altered through the replacement of the original window sashes. Based on the lack of architectural merit, as well as the inability to associate the house and/or its original owner(s) with an important historical event or series of events, it is TRC's opinion that architectural resource RK1773 is not eligible for the NRHP.

Figure 5.328. Architectural resource RK1773; view is southwest featuring the façade and east elevation.

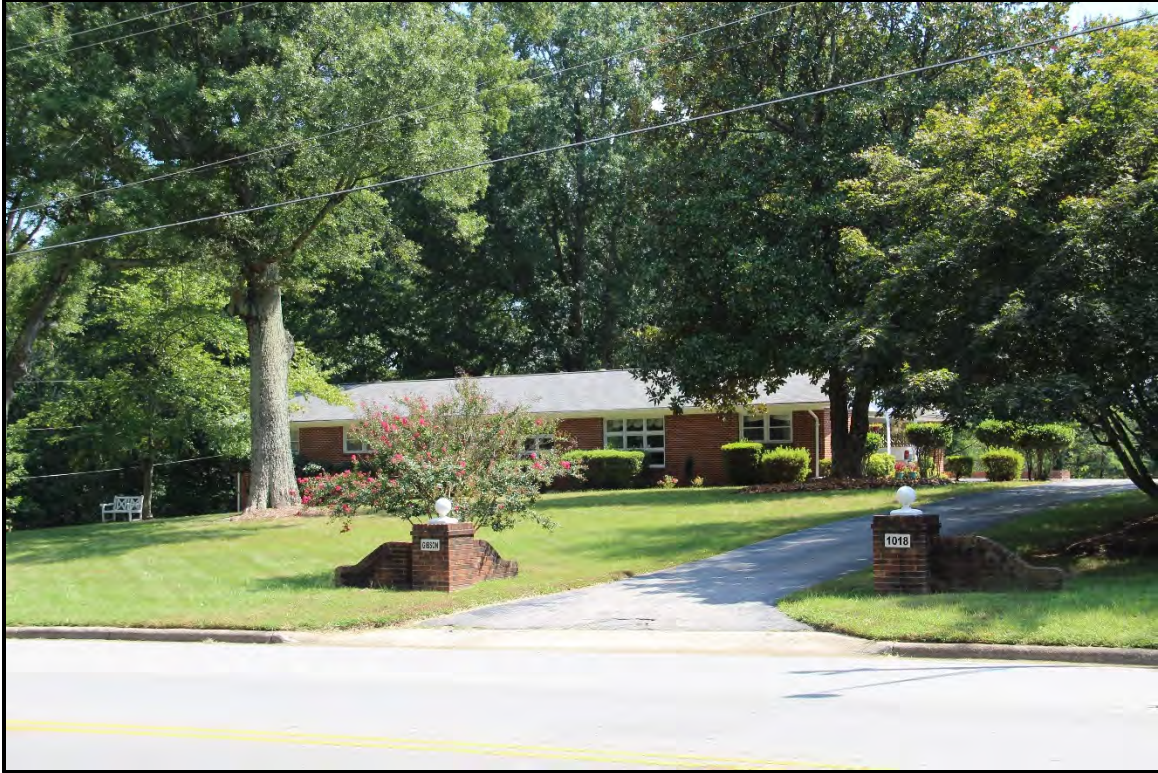
Figure 5.329. Architectural resource RK1773; view is southeast featuring the façade and west elevation.

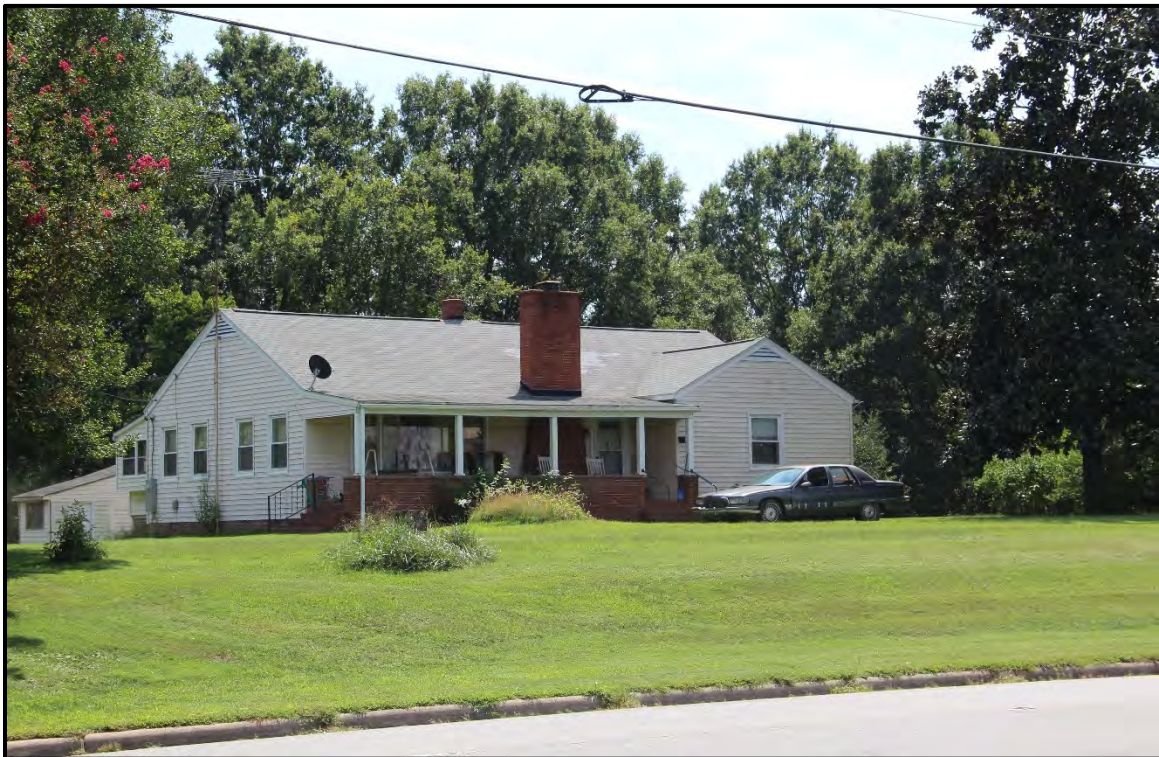
The one-story, wood-frame building features a side-gabled roof, an interior brick chimney, an exterior clad with vinyl siding, a brick foundation, and double-hung 1/1 vinyl sash windows. A partial-width porch with a brick deck provides access to the main entrance. The porch roof is supported by four posts composed of synthetic material. Attached to the façade is an exterior brick chimney.

NRHP Assessment. Architectural resource RK1774 does not exhibit a distinctive architectural style or workmanship. In addition, the house has been altered through the application of vinyl siding and the replacement of the original window sashes. Based on the lack of architectural merit, as well as the inability to associate the house and/or its original owner(s) with an important historical event or series of events, it is TRC’s opinion that architectural resource RK1774 is not eligible for the NRHP.

Figure 5.330. Architectural resource RK1774; view is southwest featuring the façade and east elevation.

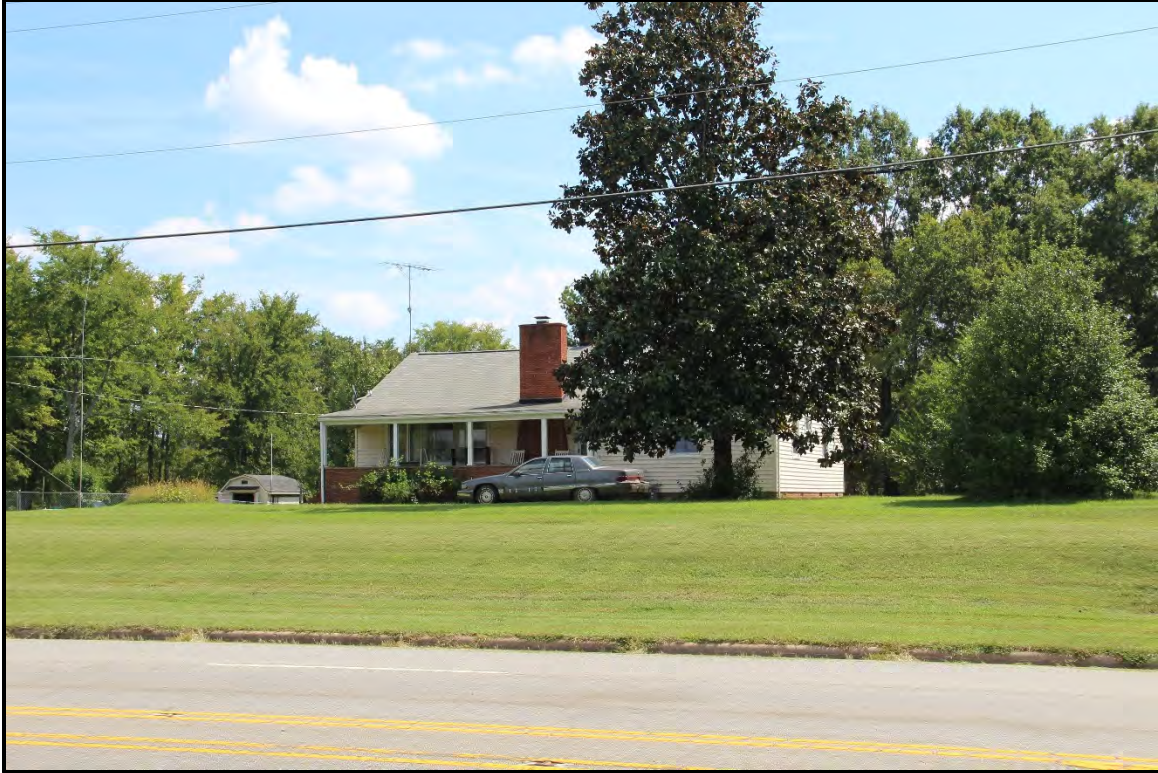
Figure 5.331. Architectural resource RK1774; view is southeast featuring the façade and west elevation.

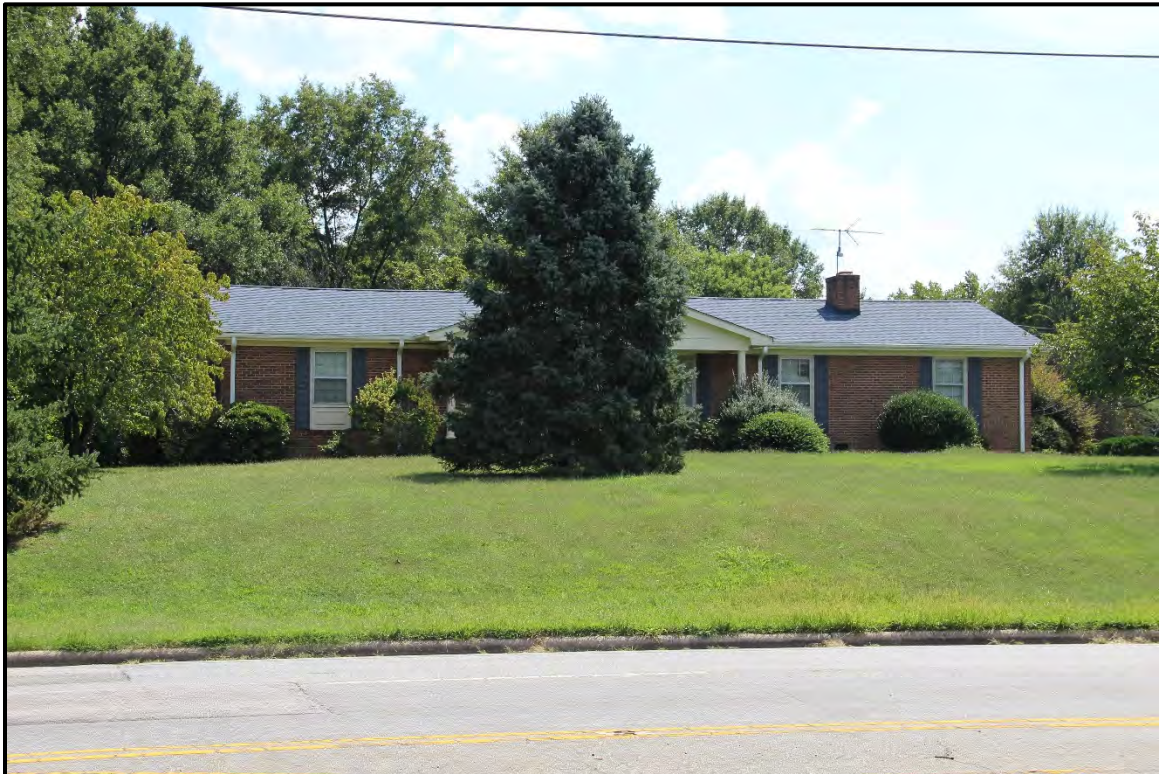
The wood-frame building features a side-gabled roof, an interior brick chimney, an exterior sheathed with a brick veneer, a brick foundation, and double-hung 6/6 wood sash windows. A partial-width porch with a brick deck provides access to the main entrance. The porch consists of a projecting gable roof that is supported by four aluminum columns.

Figure 5.332. Architectural resource RK1775; view is south featuring the façade.

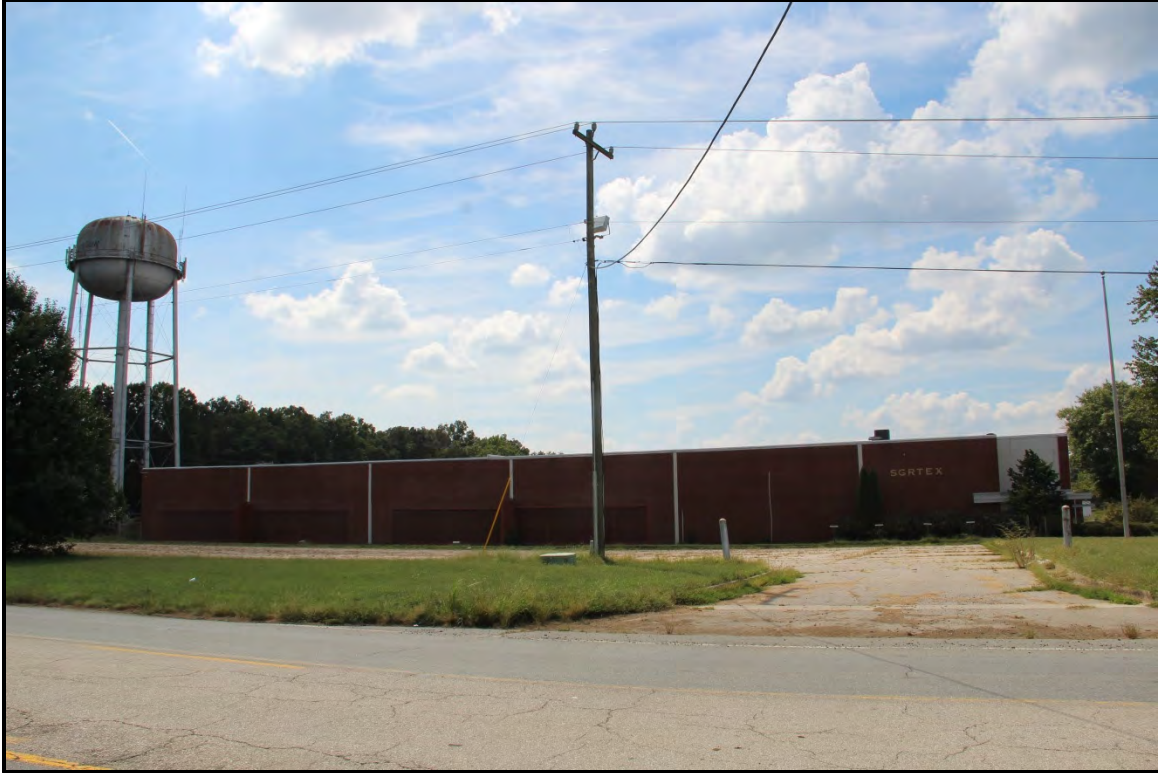
The one-story building features metal letters attached to the primary façade (east elevation) indicating that it is operated by SGRTEX (Figure 5.333). The concrete-frame structure features a flat roof, and a brick veneer-cladded exterior. The primary entrance is located at the northeast corner of the building and includes a metal-glass door that is flanked by window walls composed of single-panes set in an aluminum frame. A flat metal canopy roof shields the main entry.

Associated with the property is a water tank with a reported construction date of 1965 (Figures 5.333 and 5.335) (Rockingham County, NC GIS 2018).

Figure 5.333. Architectural resource RK1776; view is west featuring the primary façade.

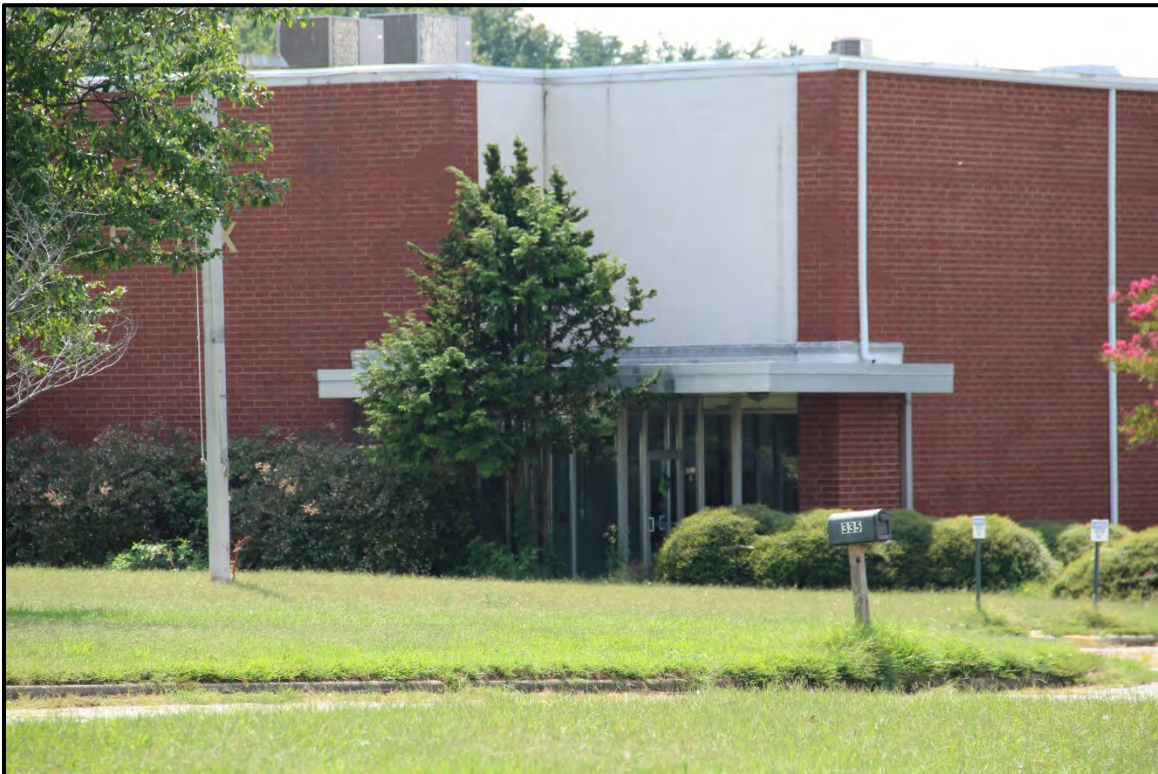
Figure 5.334. Architectural resource RK1776; view is southwest featuring the main entrance bay.

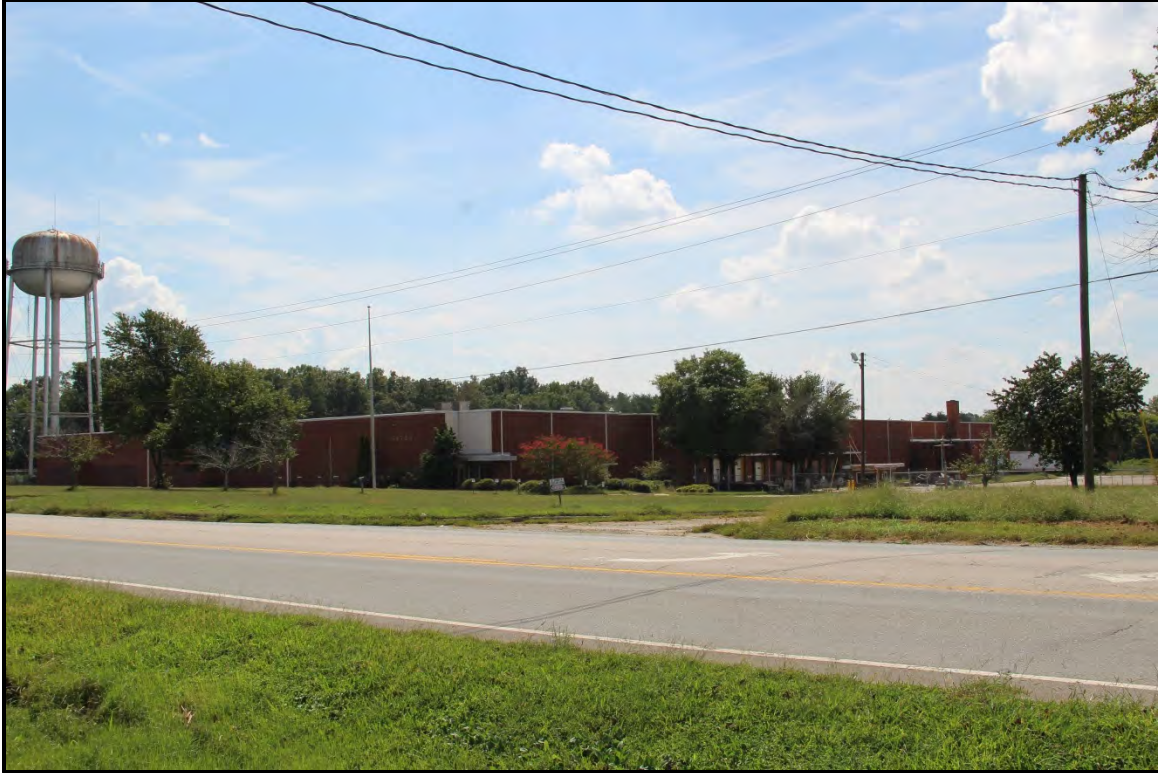
Situated along the north elevation are a series of loading bays that contain overhead metal doors and an exterior brick chimney (Figure 5.335).

Figure 5.335. Architectural resource RK1776; view is southwest featuring the primary façade, the north elevation loading bays, and the water tank.

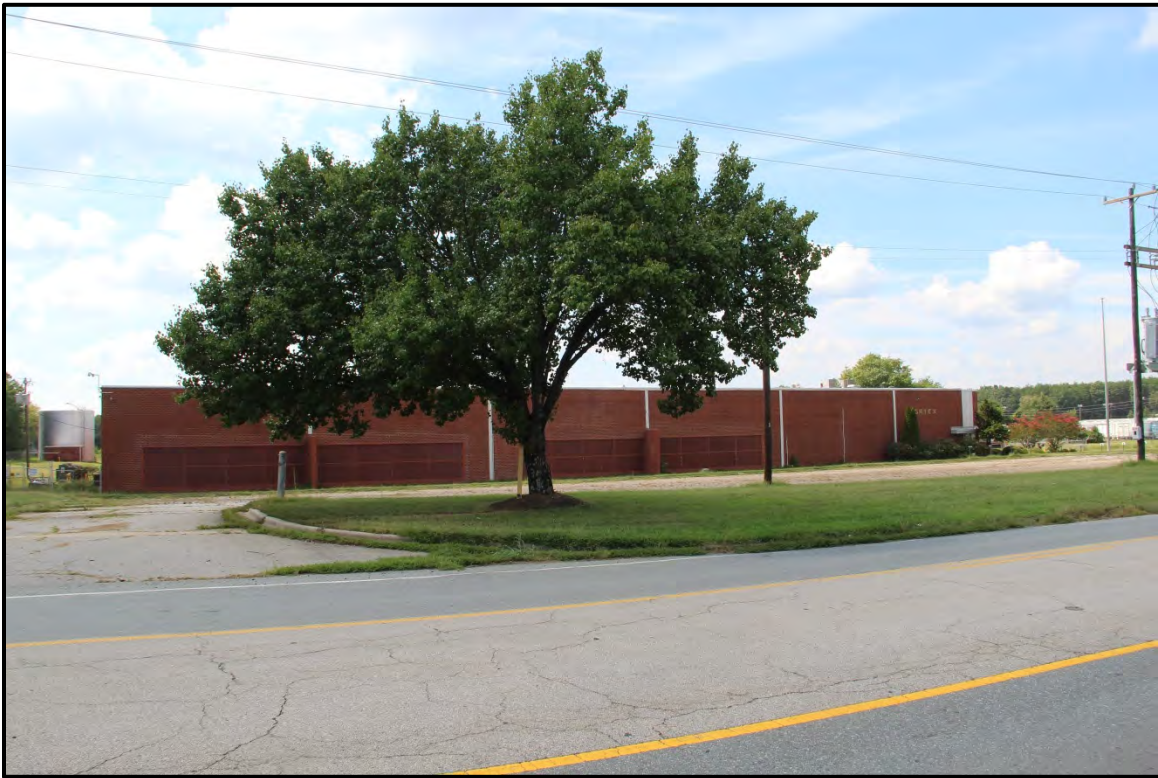
Figure 5.336. Architectural resource RK1776; view is northwest featuring the primary façade.

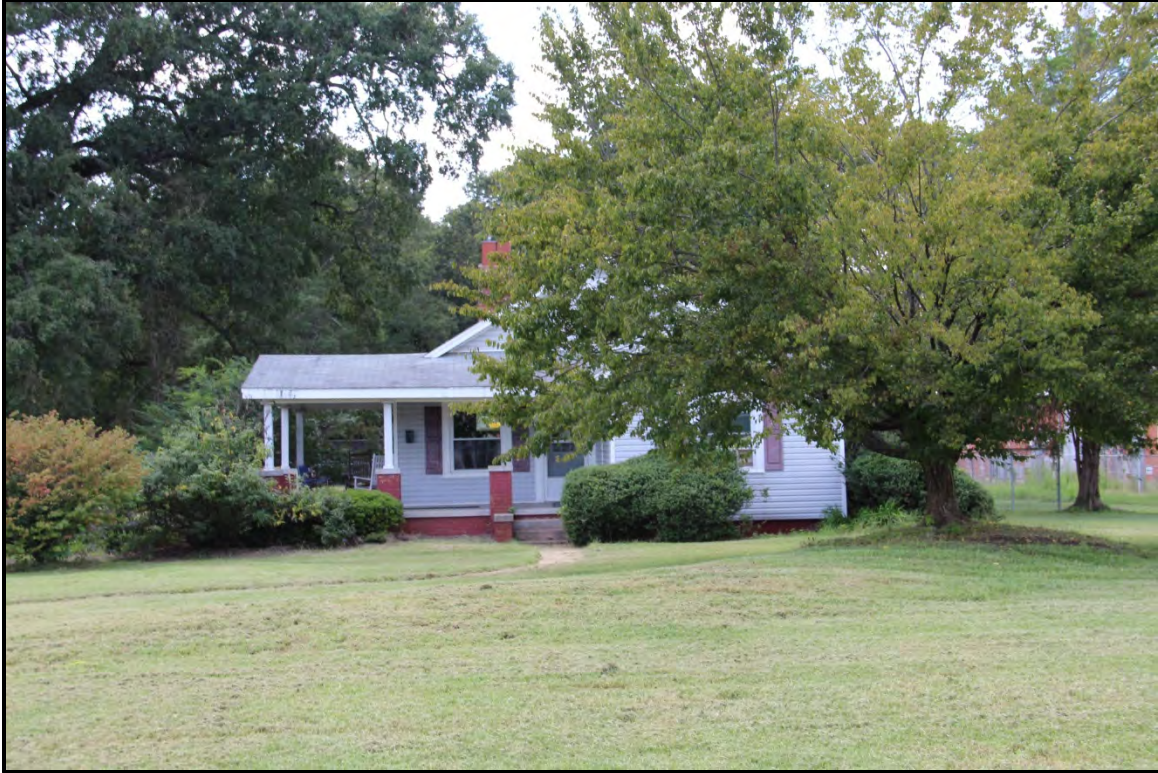
The one-story, wood-frame building features a front-gabled roof, two interior brick chimneys, an exterior clad with vinyl siding, a brick foundation, and double-hung 1/1 vinyl sash windows. A partial-width porch with a concrete deck provides access to the main entrance. The porch consists of a side gabled roof that is supported by synthetic columns, which rest atop brick plinth blocks.

Figure 5.337. Architectural resource RK1777; view is west featuring the façade.

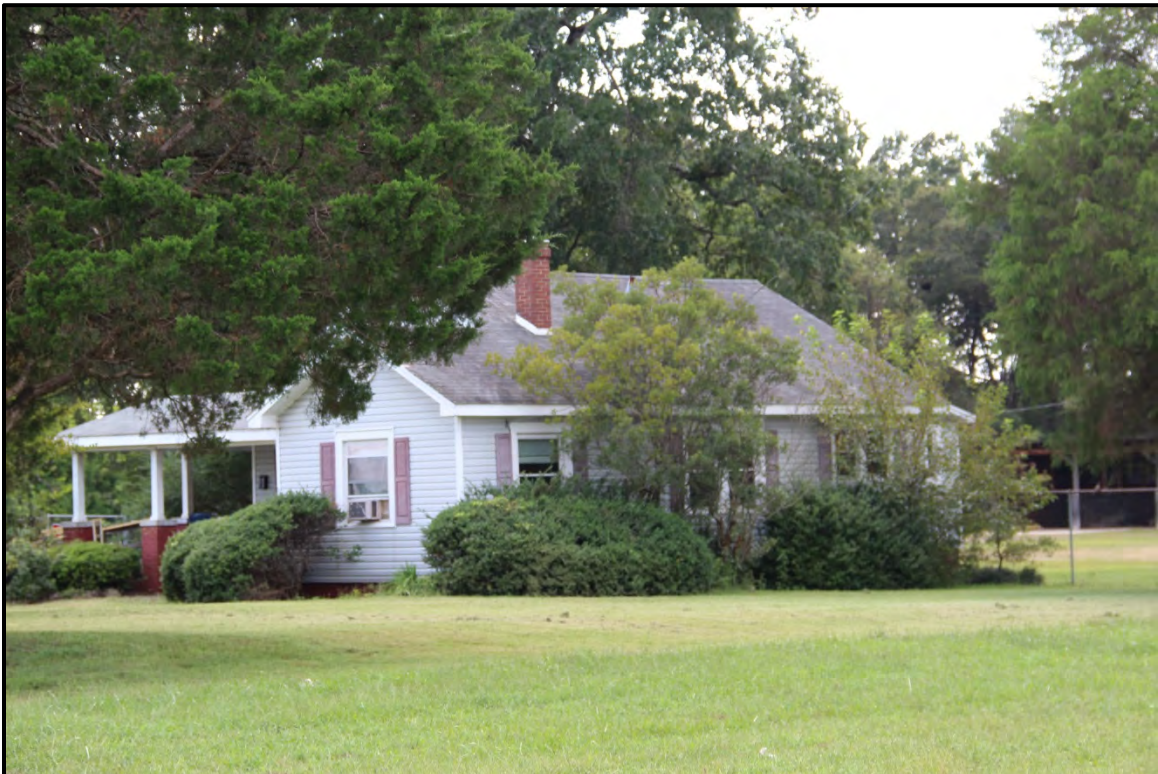
Figure 5.338. Architectural resource RK1777; view is southwest featuring the façade and north elevation.

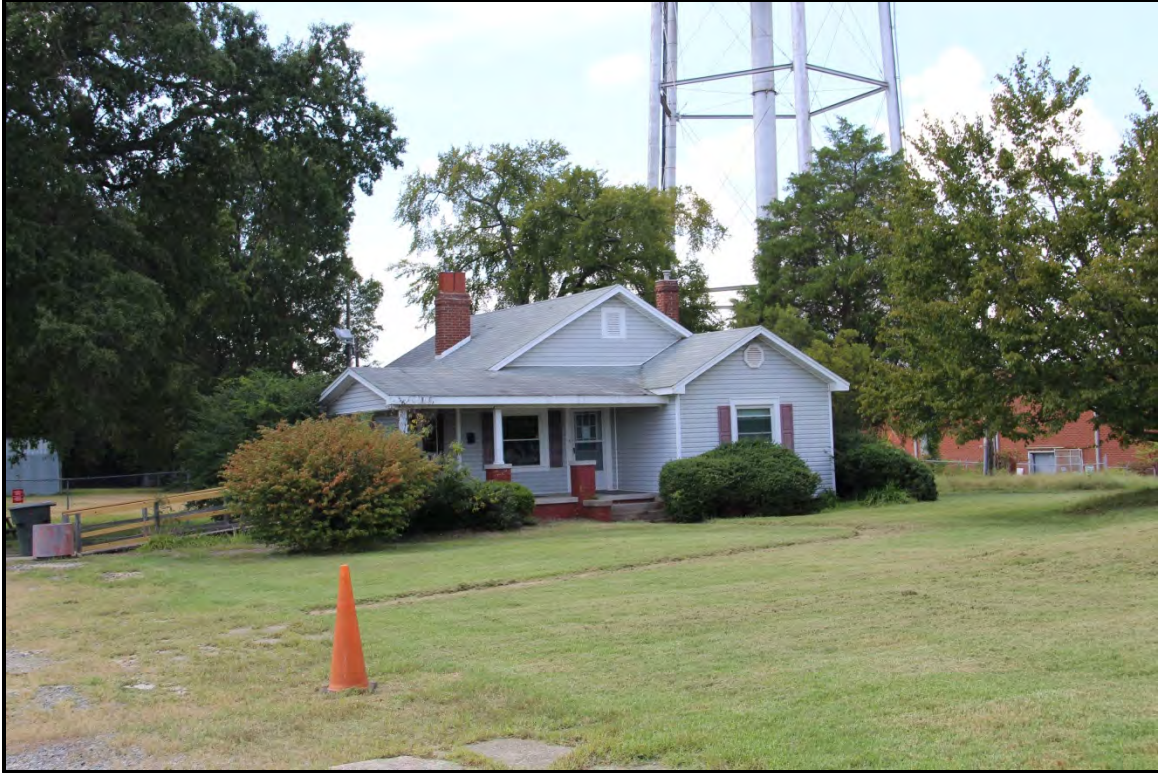
Figure 5.339. Architectural resource RK1777; view is southwest featuring the façade and south elevation.

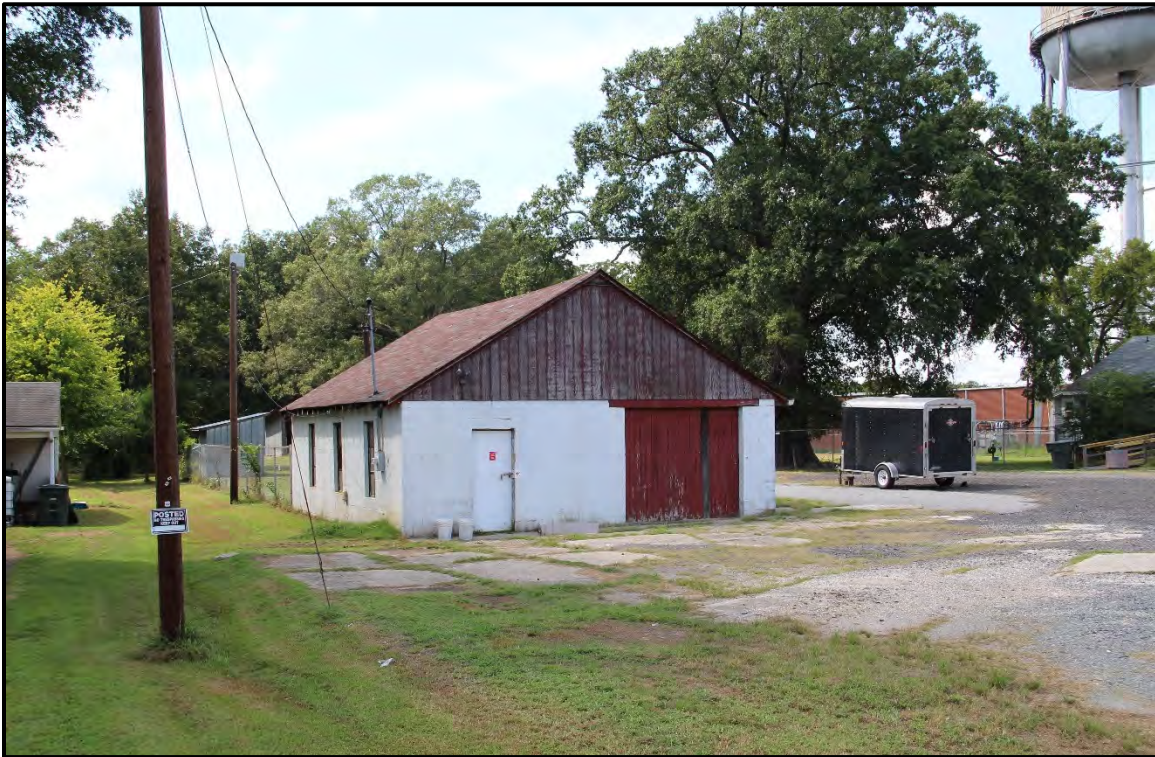
- A 1939 garage (Rockingham County, NC GIS 2018). The concrete block structure features a gable-front roof, modern wood paneling within the gable fields, a single bay with a sliding wood door, and a metal pedestrian door on the primary elevation (Figure 5.340);
- A 1995 storage shed (Rockingham County, NC GIS 2018). The wood frame structure features a shed roof and an exterior clad with metal panels (Figure 5.340).

Figure 5.340. Architectural resource RK1777; view is northwest featuring the ca. 1939 garage and the ca. 1995 shed in the background.

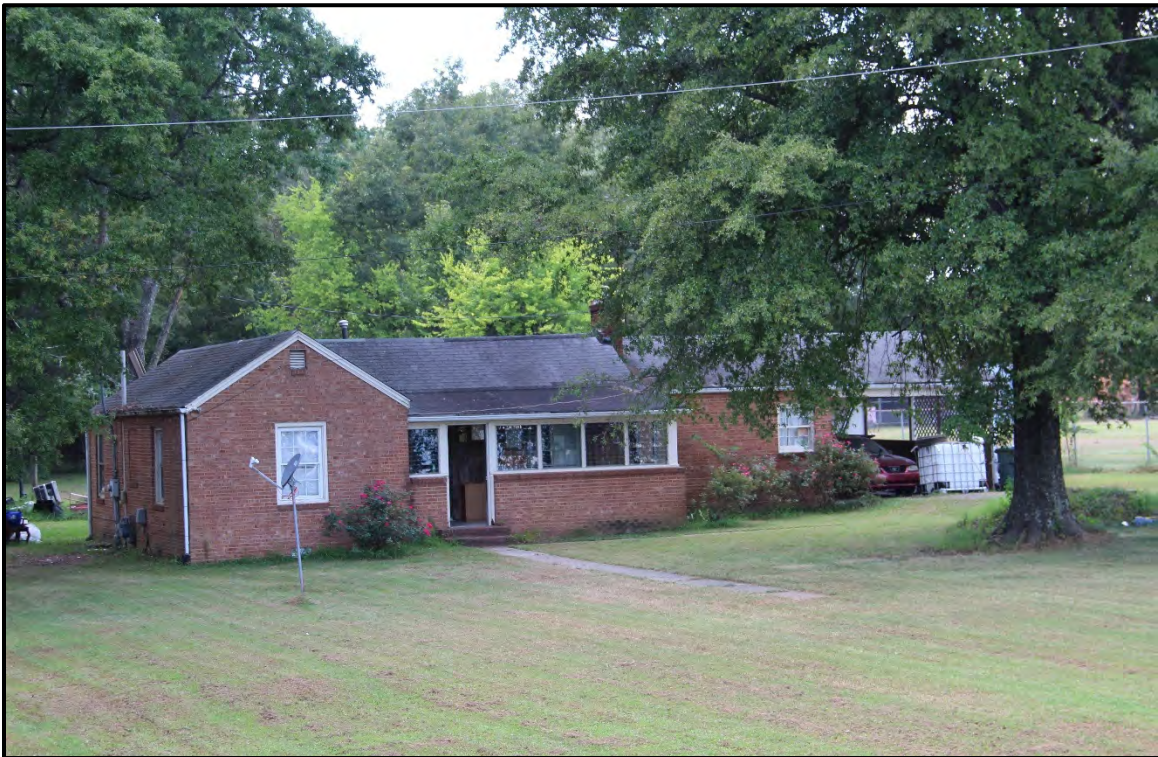
The one-story, wood-frame, building features a gabled- roof, an interior brick chimney, an exterior clad with a brick veneer, a brick foundation, and double-hung 6/6 vinyl and wood sash windows. A partial-width porch that is enclosed with jalousie windows provides access to the main entrance. The porch is also partially enclosed with a brick veneer and is capped with a shed roof. A modern side-gabled wing addition with an attached carport is connected to the north elevation. The wing addition is clad with a brick veneer exterior.

Figure 5.341. Architectural resource RK1778; view is northwest featuring the façade and south elevation.

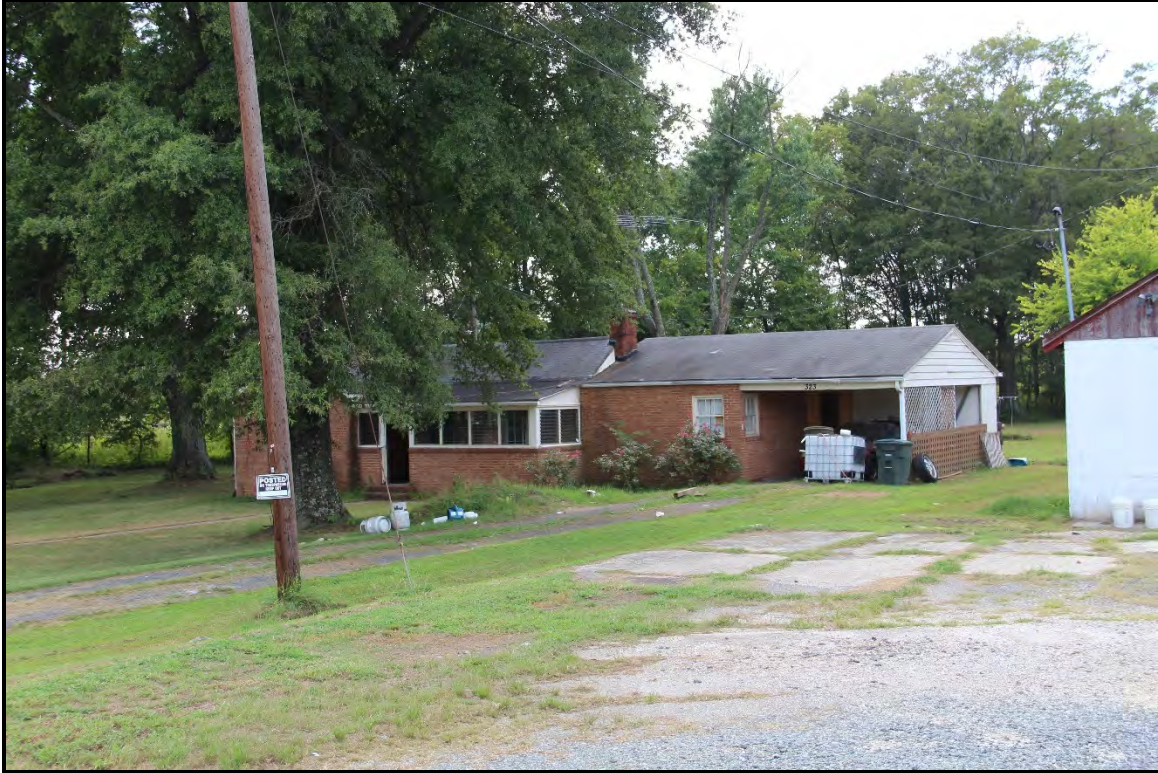
Figure 5.342. Architectural resource RK1778; view is southwest featuring the façade and north elevation.

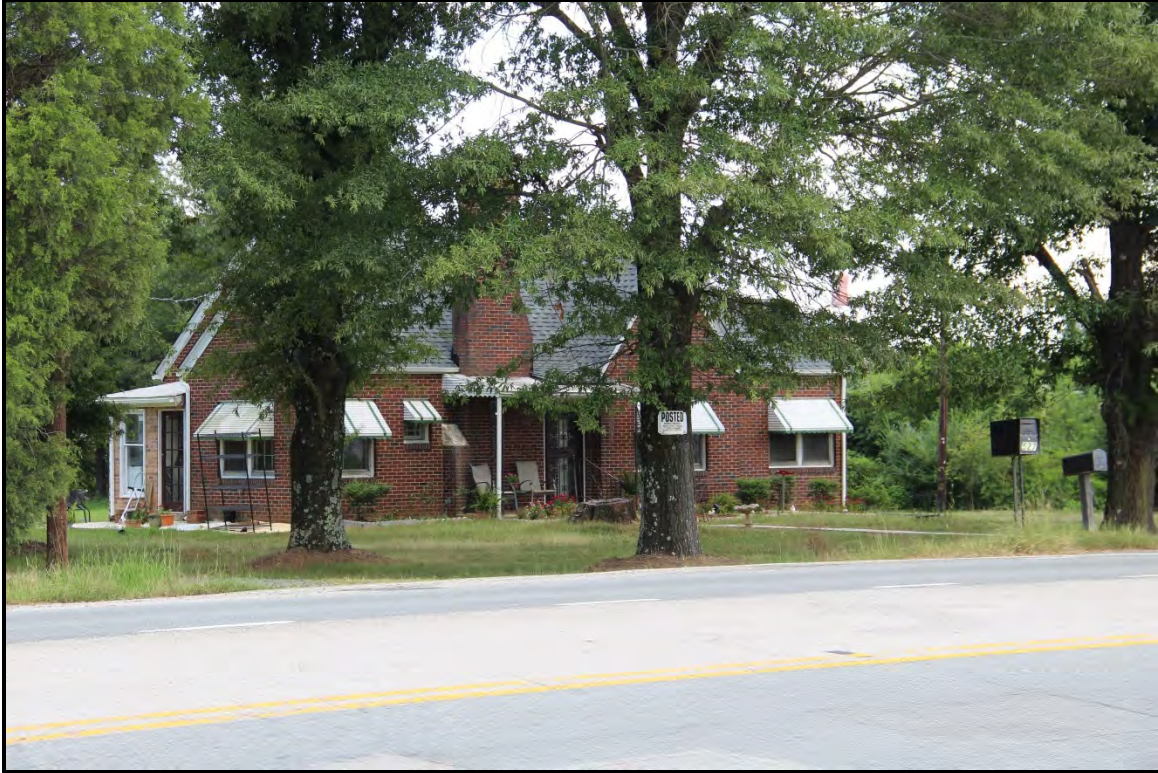
The one and one-half-story, wood-frame, building features a side-gable roof covered with asphalt shingles, an exterior brick chimney on the façade, an exterior clad with a brick veneer, and a brick foundation. Windows consists of 1/1 vinyl sash windows. A center bay porch with a concrete slab provides access to the main entrance. The porch is shielded with a metal shed roof that is supported by metal posts.

Figure 5.343. Architectural resource RK1779; view is southeast featuring the façade and north elevation.

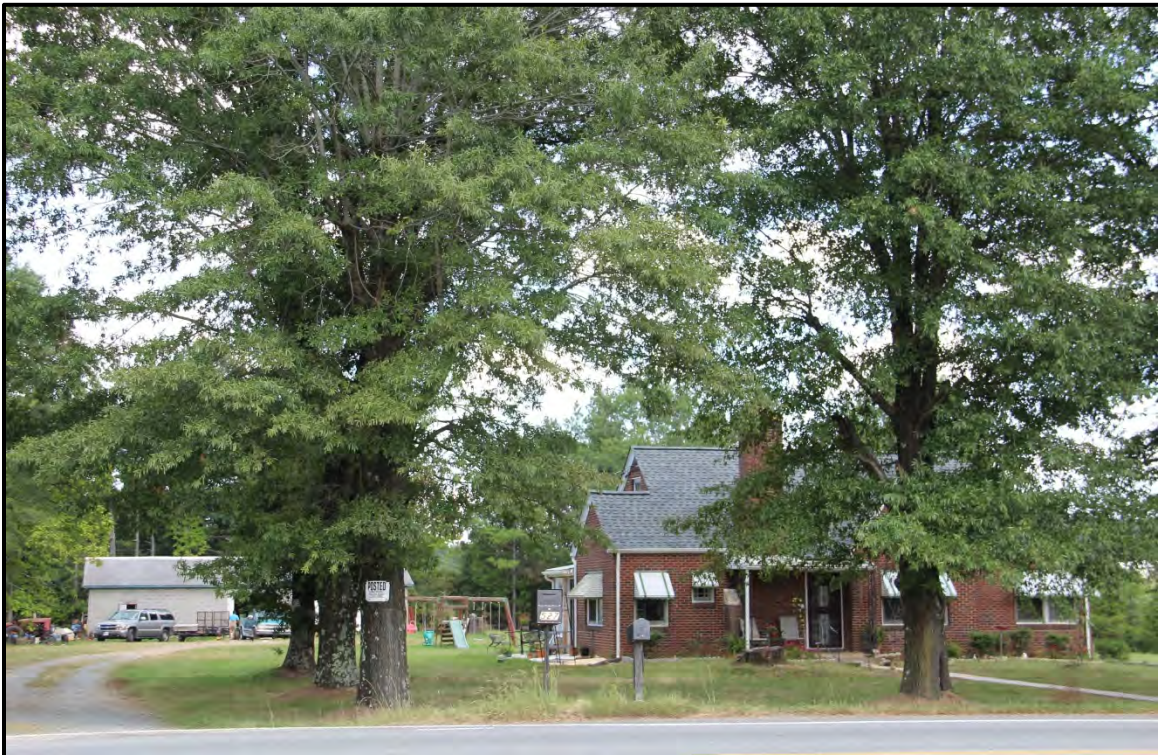
- A ca. 1950 warehouse (Rockingham County, NC GIS 2018). The concrete block building is capped with a side-gabled roof covered with asphalt shingles and includes a bay entrance on the west elevation (Figure 5.344);
- A modern storage building. The wood-frame building features a gable-front roof covered with asphalt shingles and an exterior clad with vinyl siding. A door is located on the west elevation. Attached to the north elevation of the building is a shed-roof-wing that is clad exterior vinyl siding and includes a pair of swinging wood doors on the west elevation (Figure 5.345).

Figure 5.344. Architectural resource RK1779; view is east featuring the façade and ca. 1950 warehouse.

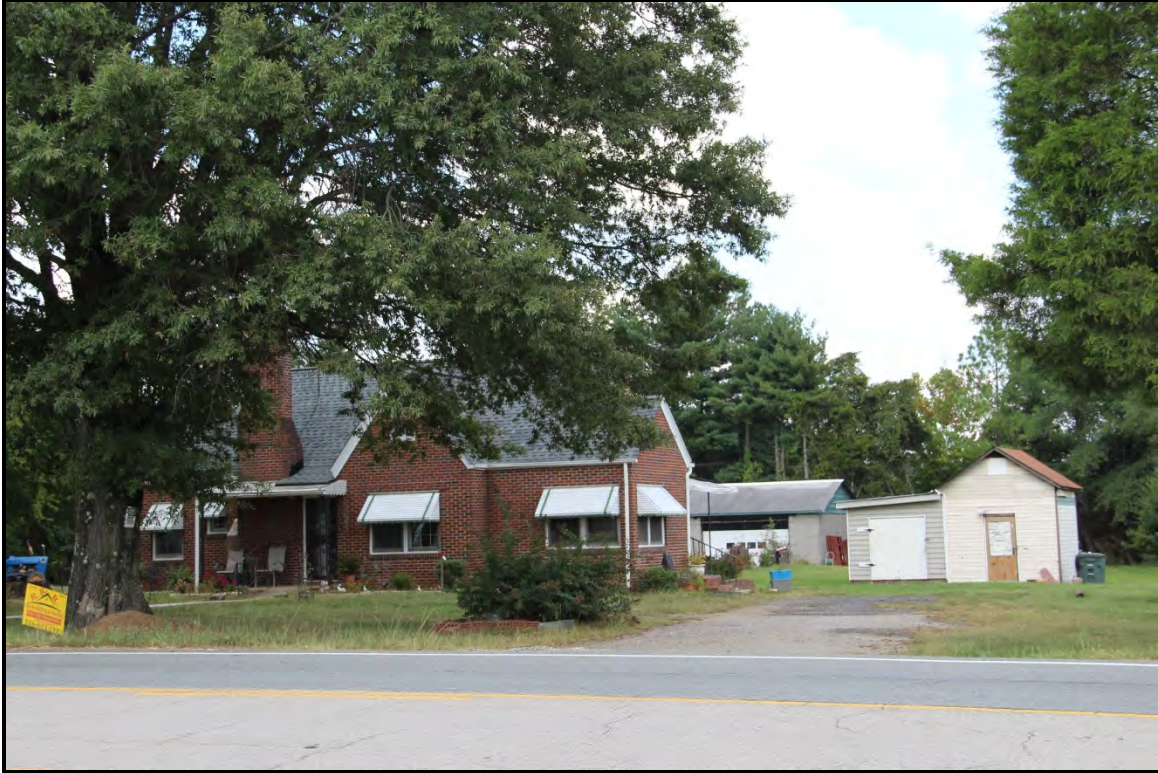
Figure 5.345. Architectural resource RK1779; view is northeast featuring the façade and south elevation of the primary residence, the ca. 1950 warehouse, and the modern storage shed.

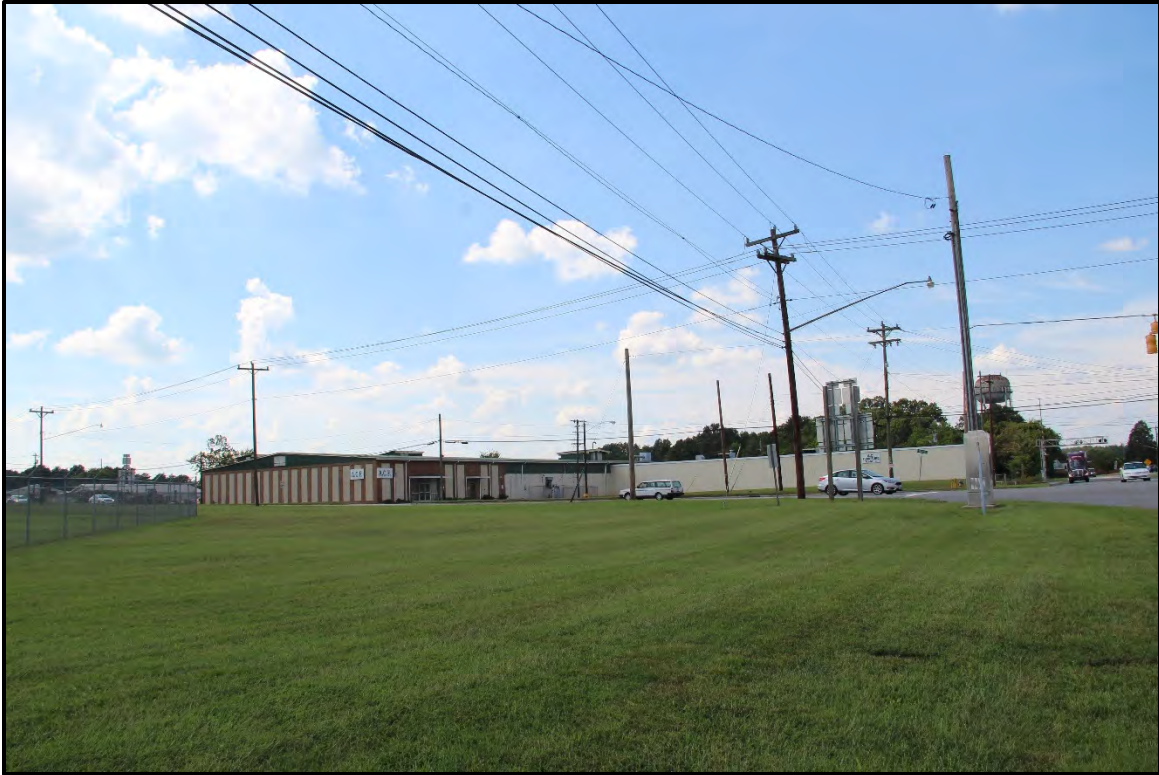
Figure 5.346. Architectural resource RK1780; view is northwest featuring the façade and south elevations of the 1960 plant building with the associated warehouse and loading bay additions.
