Re: Revised Architectural Survey Report, MVP Southgate Project, Construct Interstate Pipeline, Rockingham and Alamance County, ER 18-1041

Thank you for your letter of October 11, 2019, transmitting the draft "Historic Architectural Survey for the MVP Southgate Pipeline Project". We have reviewed the report and offer the following comments.

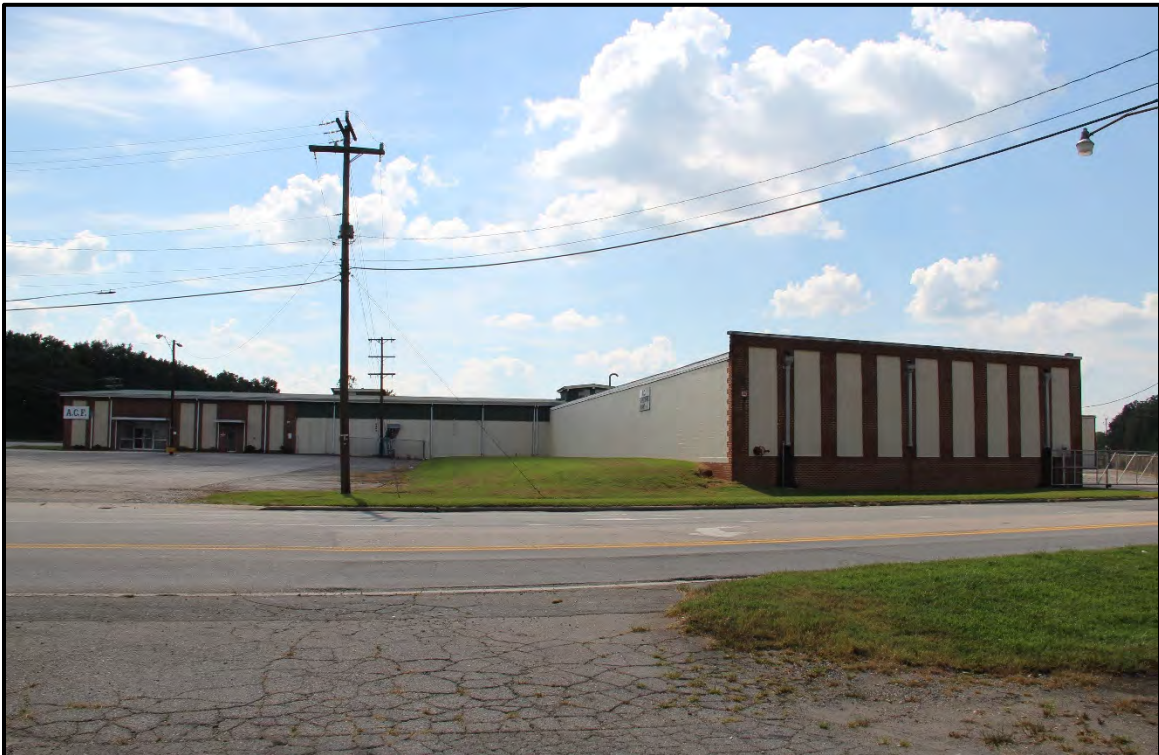
Figure 5.347. Architectural resource RK1780; view is west featuring the main entrance and the 1965 and 1966 warehouse additions.

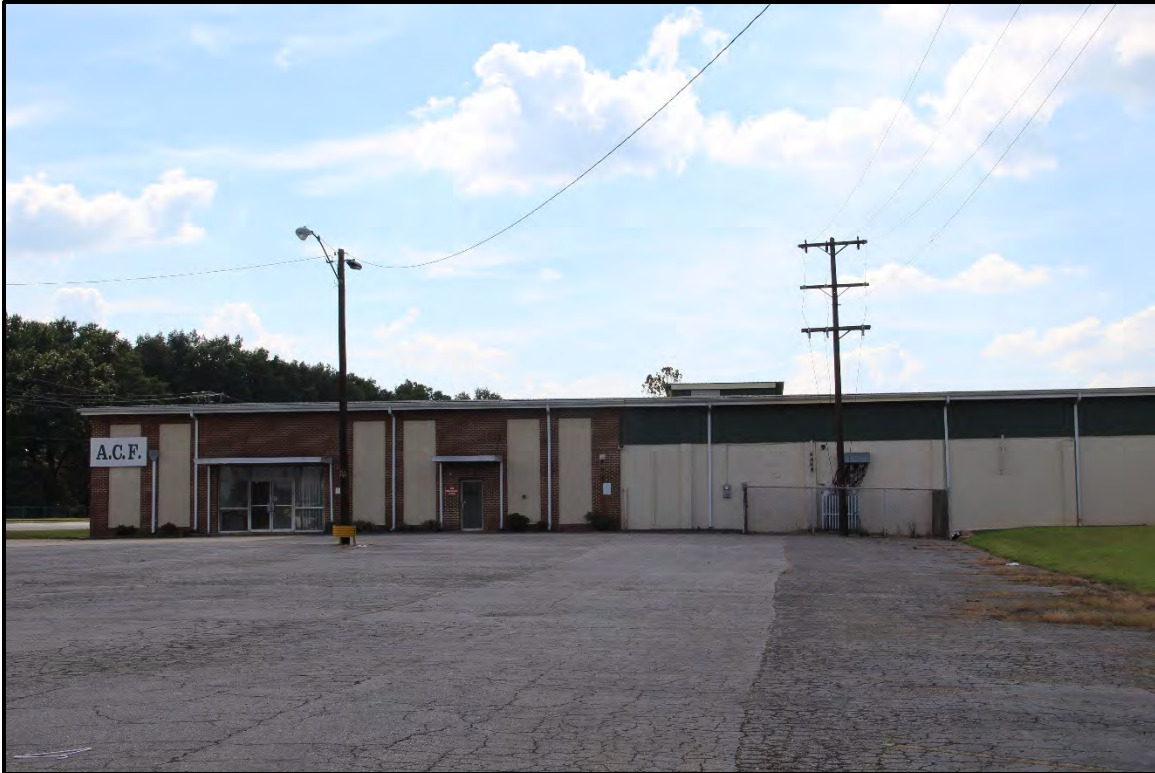
Figure 5.348. Architectural resource RK1780; view is west featuring the primary façade and main entrance of the 1960 plant building.

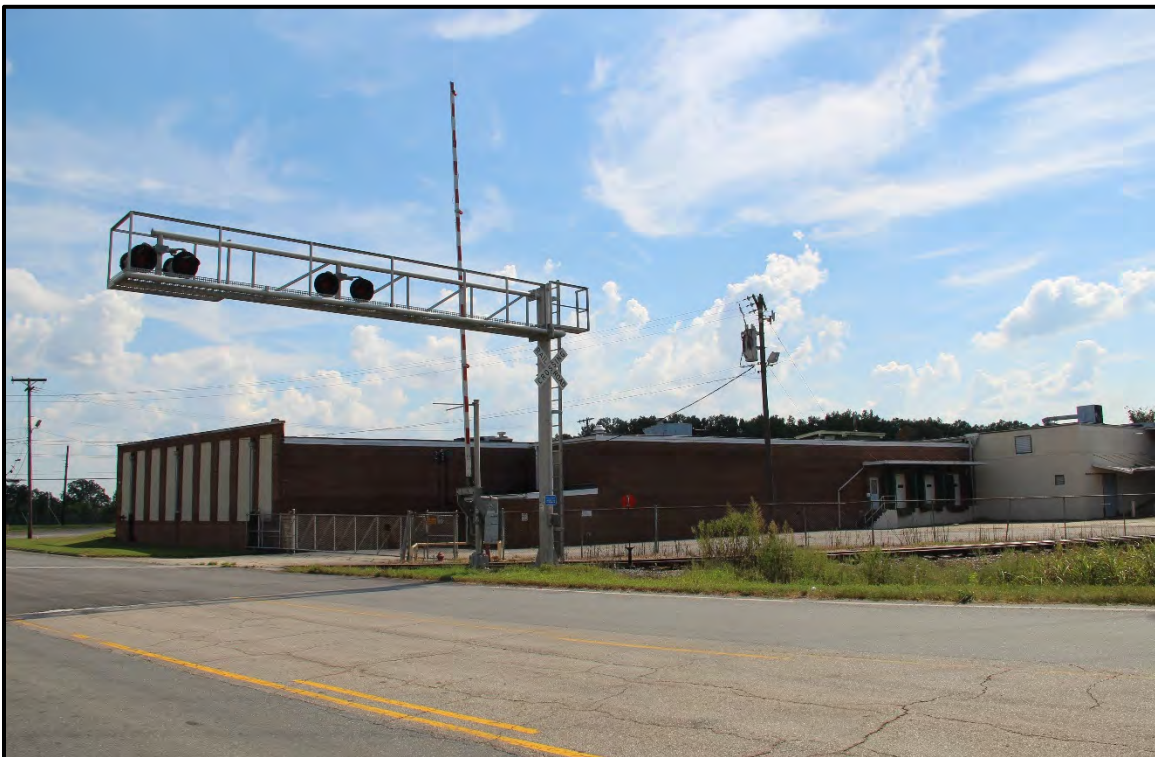
Attached to the north elevation of the original plant is the 1965 warehouse addition. The one-story, concrete block addition features a flat roof covered with a rubber membrane, and an exterior partially clad with a brick veneer along on its north elevation. Situated on the addition's east elevation is a loading bay for tractor trailers. Connected to the northeast elevation of the 1960 building are the 1966 and 1970 warehouse and docking bay additions. These additions share a common roof and are of masonry construction featuring an exterior partially clad with a brick veneer. Former window bays along the east elevation of the 1966 addition have been infilled with masonry. A series of three loading bays shielded by a flat metal canopy are positioned along the north elevation of the 1970 addition (Figure 5.349).

Figure 5.349. Architectural resource RK1780; view is southwest featuring the loading bays on the north elevation of the 1970 addition.

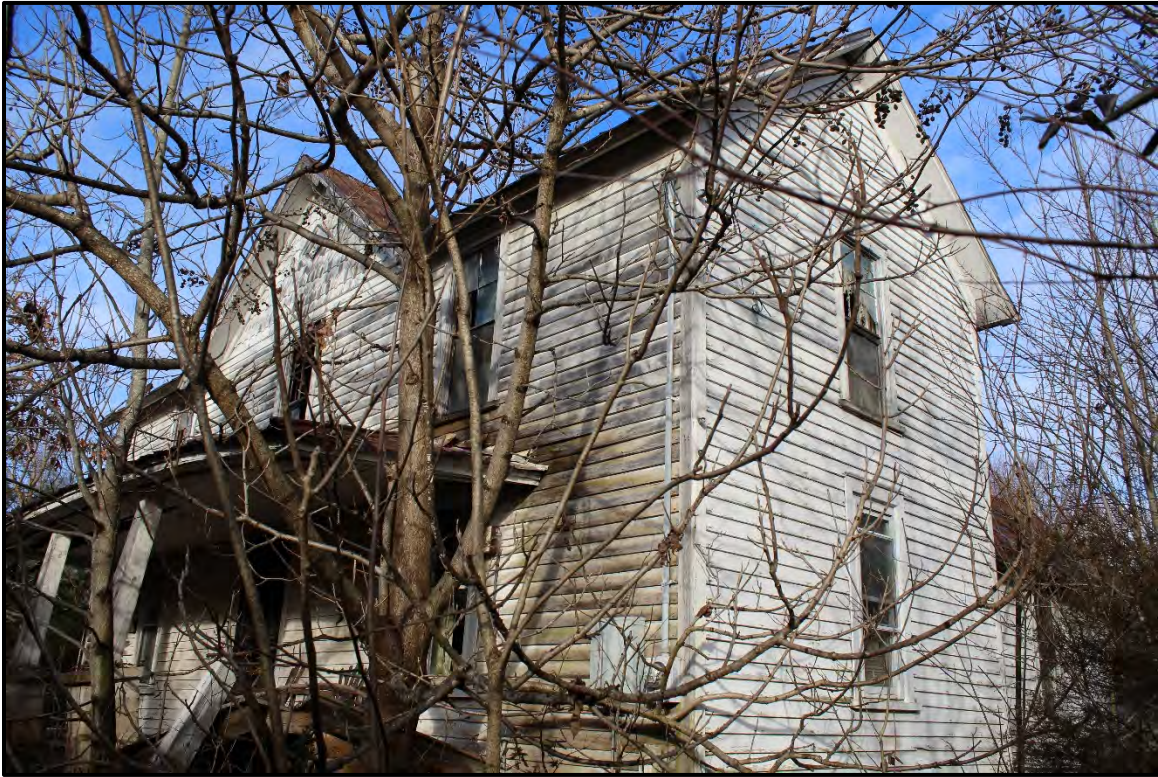
The two-story, wood-frame building features a side-gabled roof covered with standing seam metal, an exterior clad with weatherboard siding, and a pier foundation composed of a mixture of concrete blocks and fieldstones. Fenestration consists of 1/1 double-hung vinyl sashes in the first story and 4/4 double-hung wood sashes in the second story. Facing south, the façade reveals a central door opening that is flanked on either side by a single window. A collapsed partial-width porch provides access to the main entrance. The porch is shielded by a hipped roof that is supported by two wood posts atop concrete block plinth blocks. Three symmetrically placed windows are located on the second story. Accenting the façade is a centrally placed gable wall dormer that is sheathed with a combination of sawtooth and octagonal wood shingles. The wall dormer is also pierced by a diamond-shaped attic vent composed of wood. The west elevation is marked by an exterior end stone chimney with a brick stack. Attached to the north (rear) elevation is a one-story gabled-roof ell. Nestled between the ell and the main block is an interior brick chimney.

NRHP Assessment. Architectural resource AM1520 does not exhibit a distinctive architectural style or workmanship, and the property cannot be associated with important historical event(s) or person(s). Overall, the integrity of the resource is poor due to neglect and vandalism, which has led to the partial collapse of the façade porch, broken sashes, and loss of roofing material to the residence. In addition, the house has been altered through the replacement of the original window sashes on the first story. Finally, three large outbuildings located on the property have collapsed and are no longer identifiable. Due to the poor integrity of the house and associated outbuildings, it is TRC's opinion that architectural resource AM1520 is not eligible for the NRHP.

Figure 6.1. Architectural resource AM1520; view is northwest featuring the façade and east elevation.

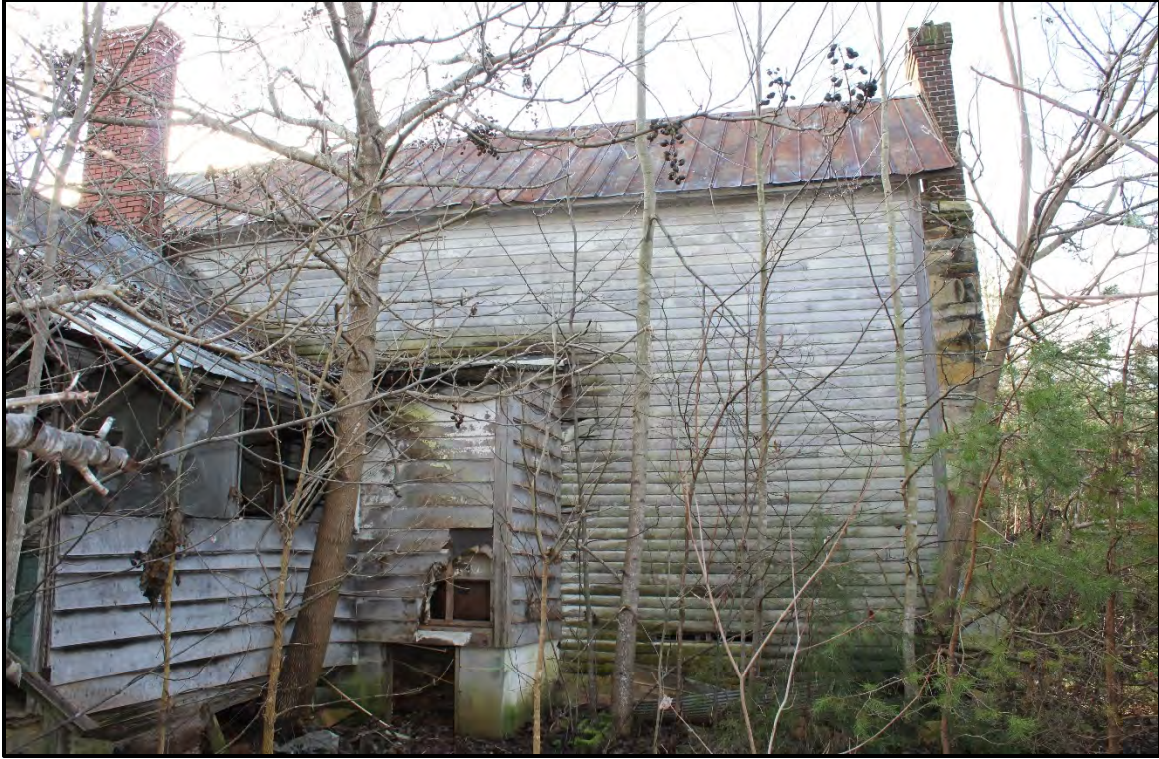
Figure 6.2. Architectural resource AM1520; view is south featuring the north (rear) elevation of the main block and attached ell.

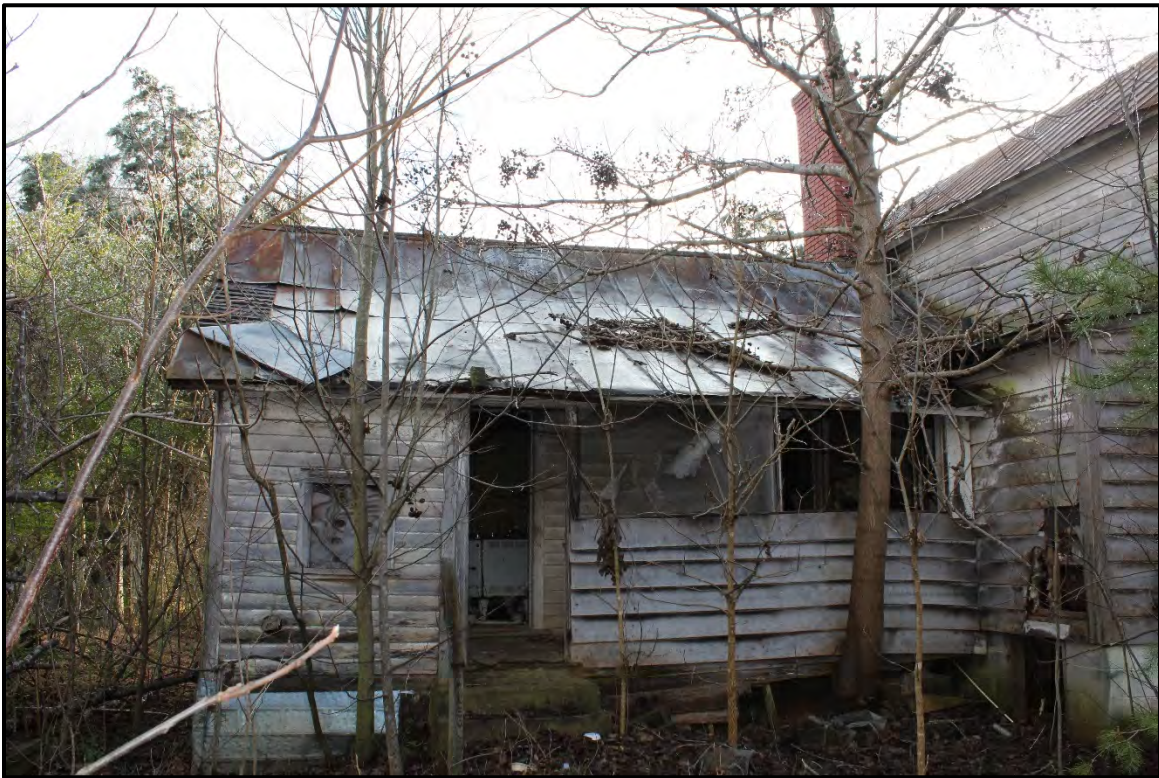
Figure 6.3. Architectural resource AM1520; view is southeast featuring the rear ell and interior brick chimney.

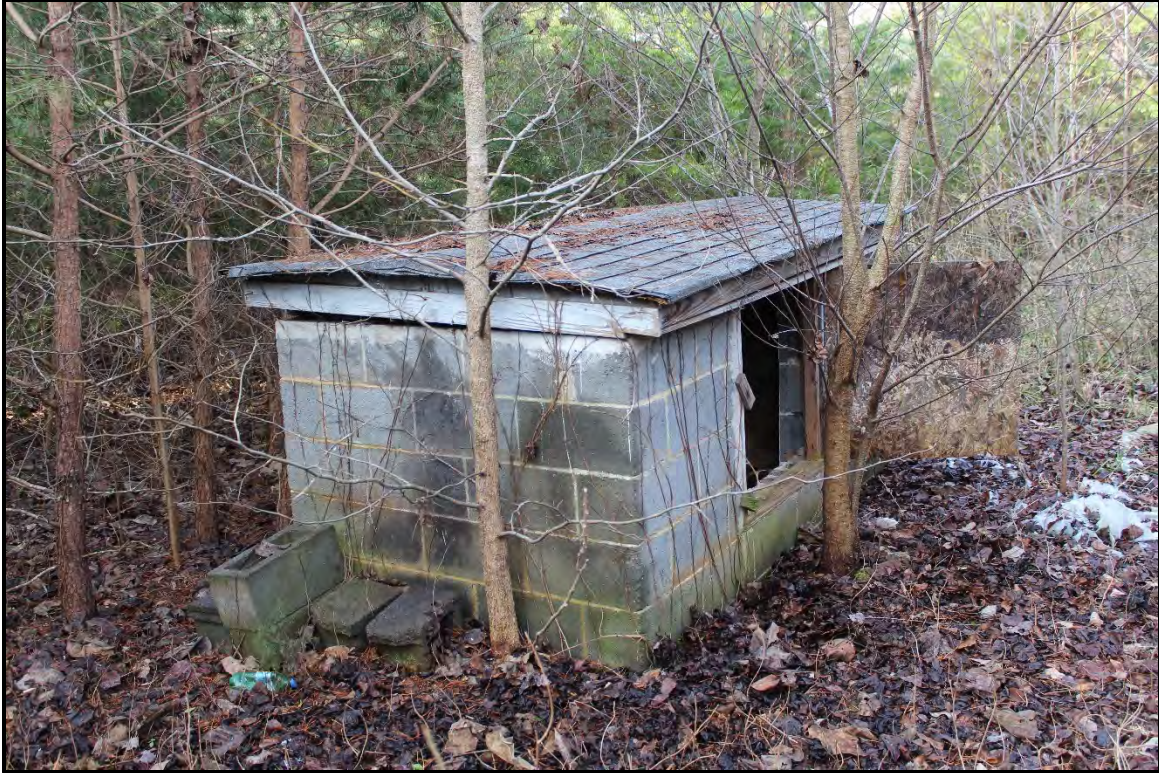
Figure 6.4. Architectural resource AM1520; view is southwest featuring the water pump shed.

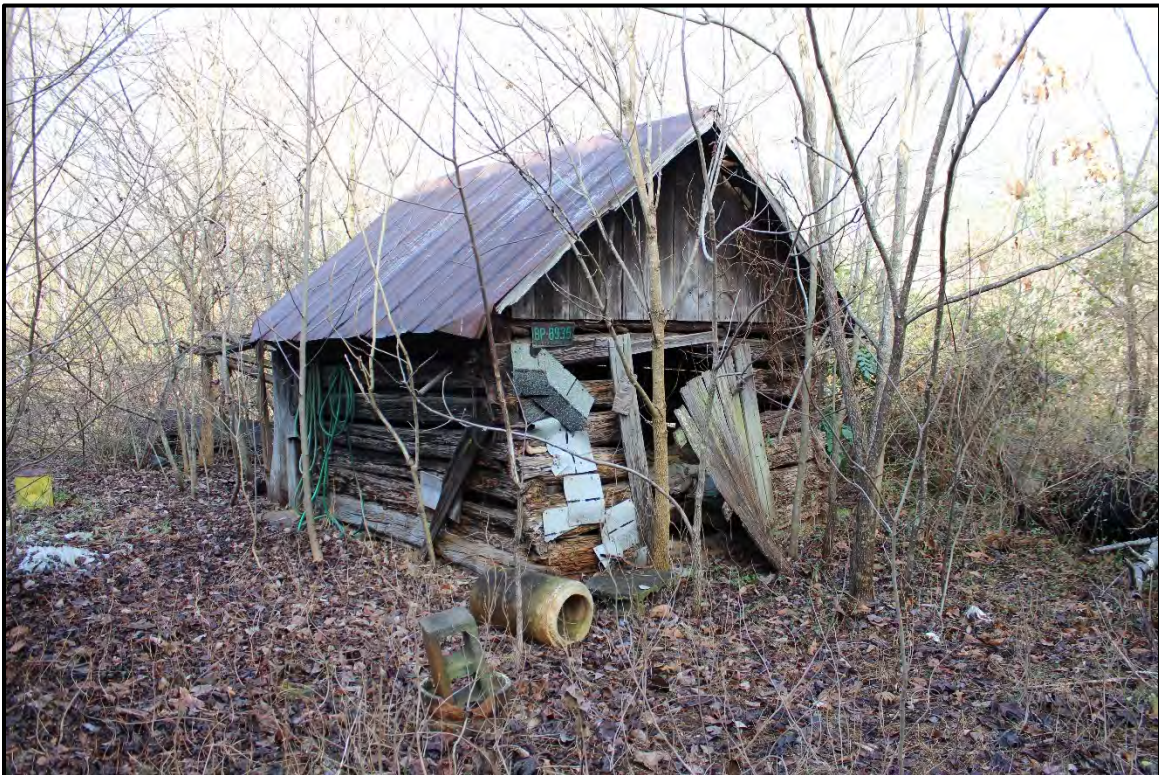
Figure 6.5. Architectural resource AM1520; view is northwest featuring the smokehouse.

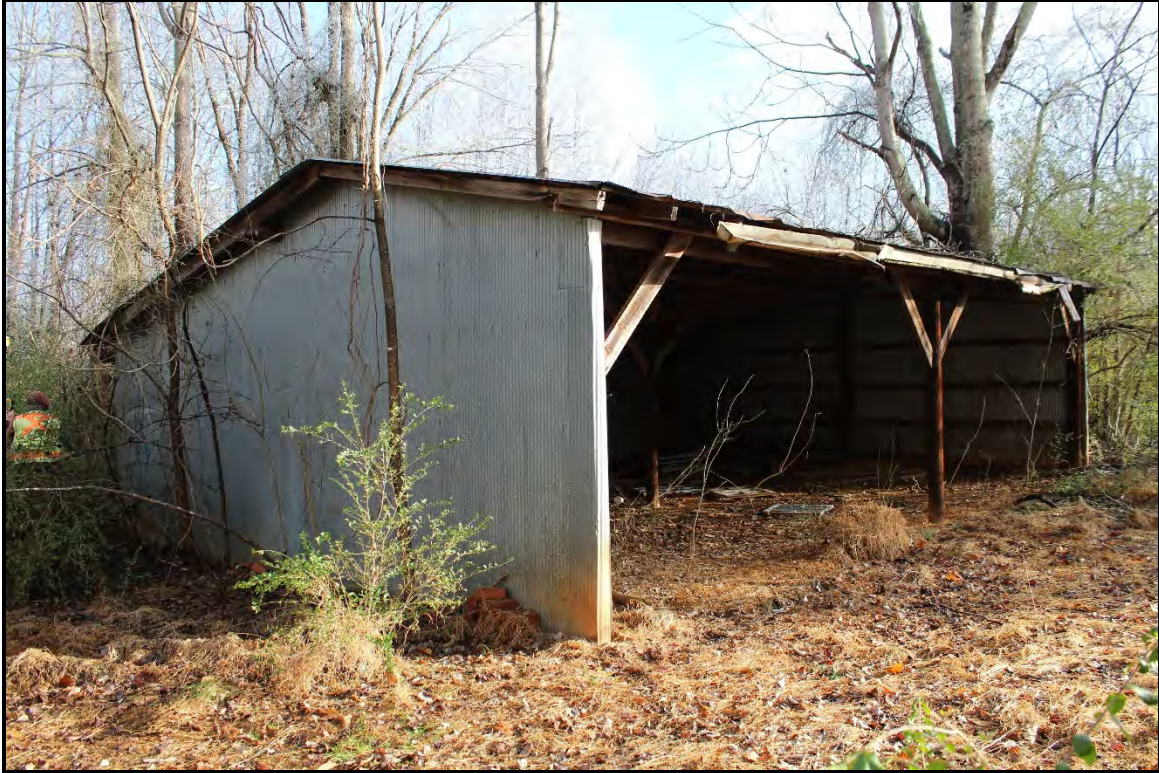
Figure 6.6. Architectural resource AM1520; view is northeast featuring the equipment shed.

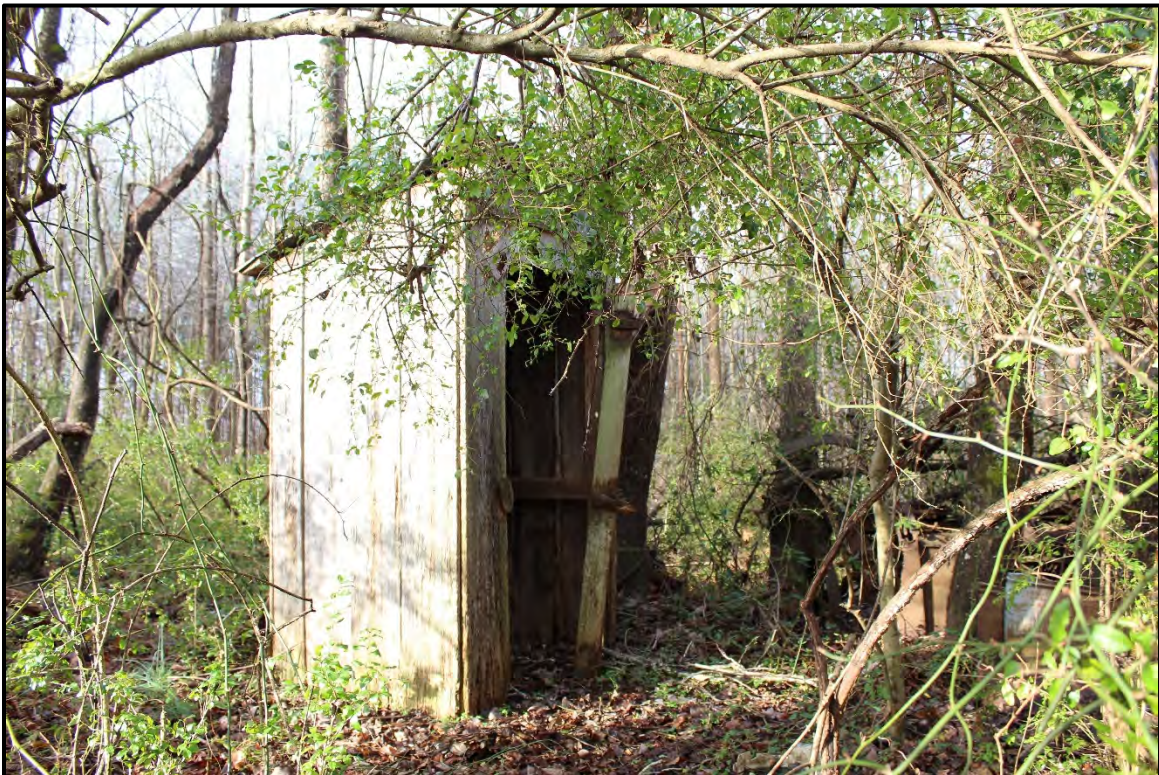
Figure 6.7. Architectural resource AM1520; view is west featuring the privy.

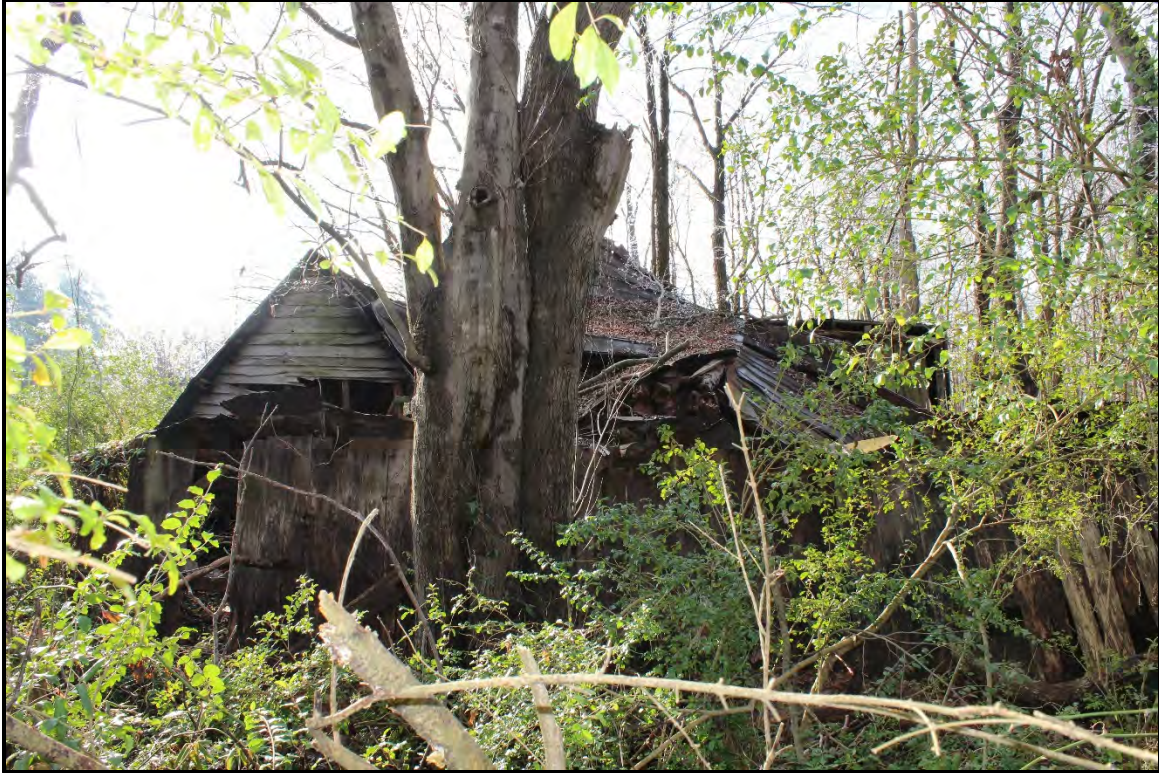
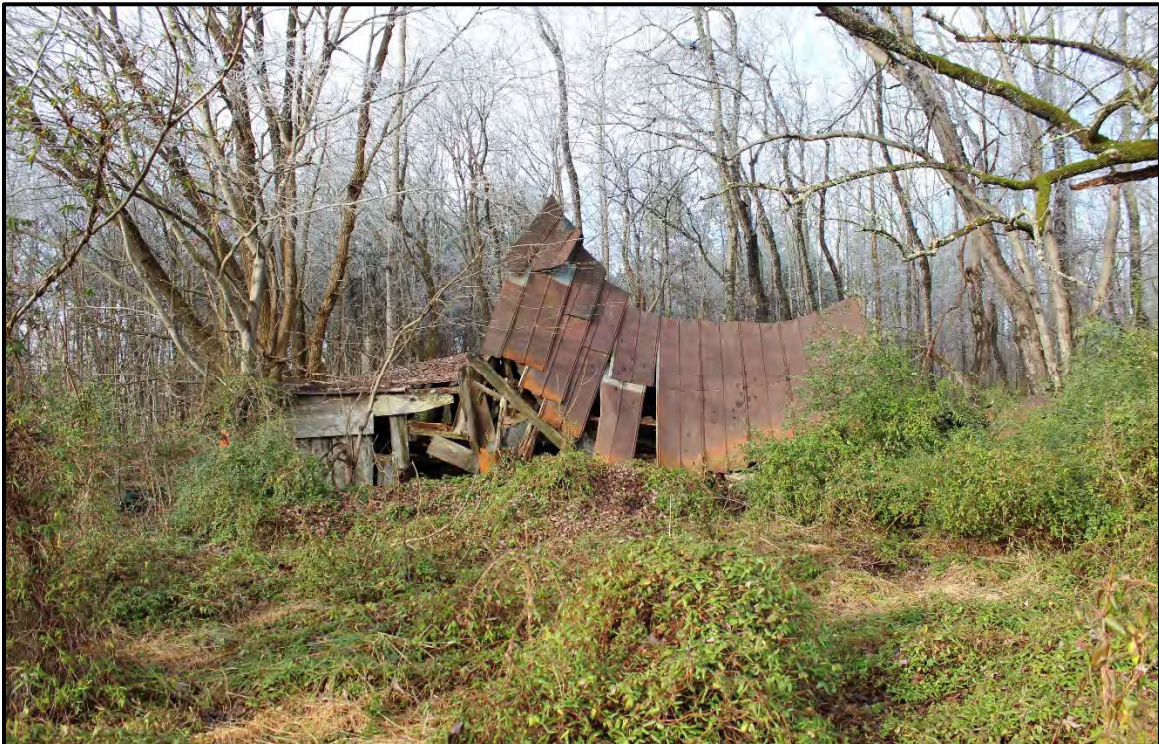
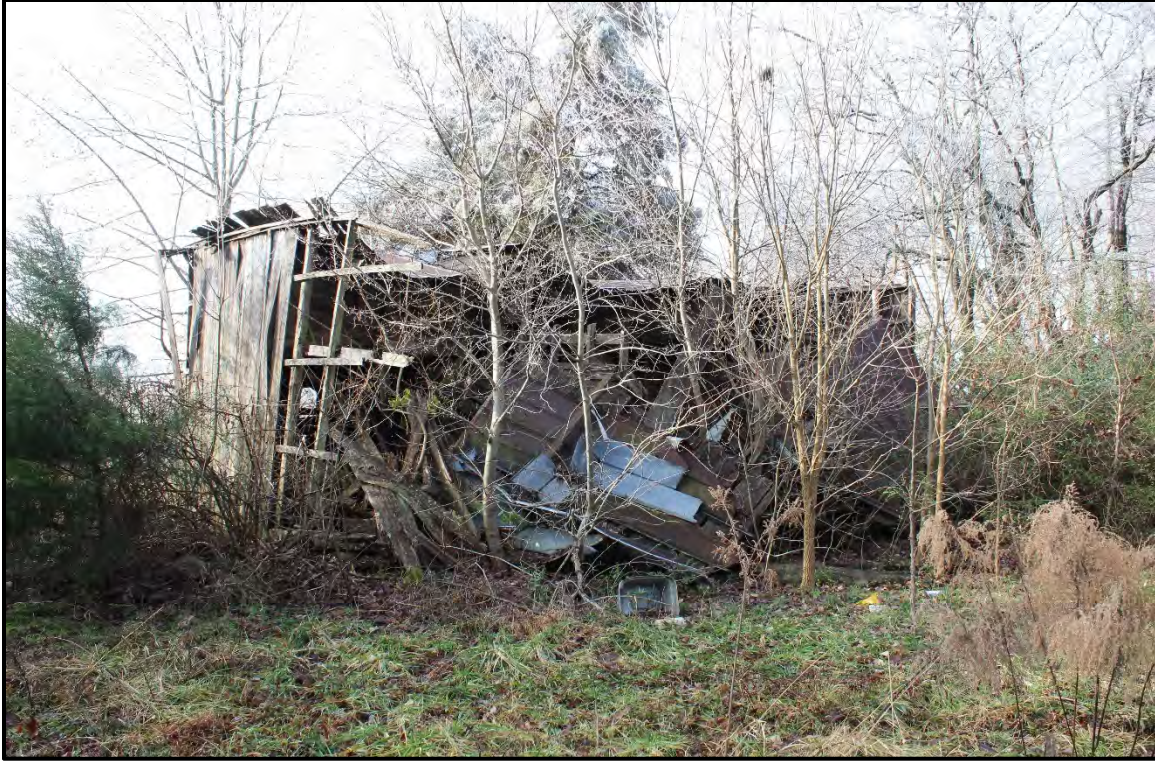
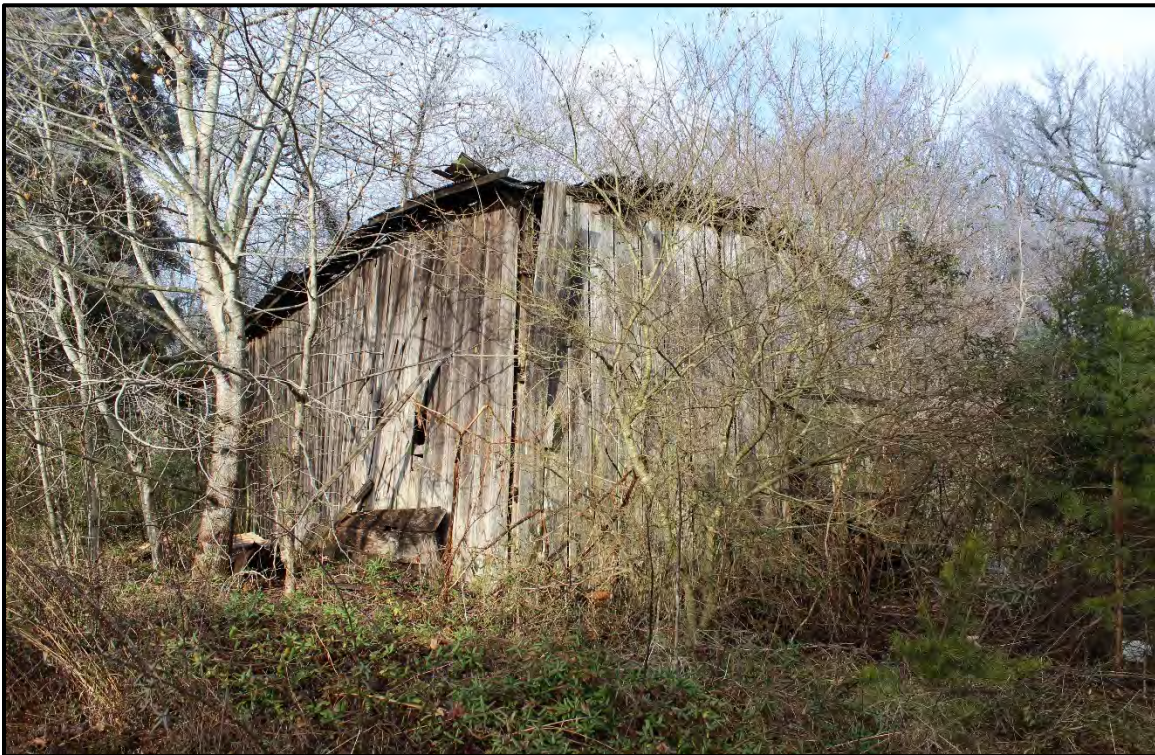
- The structural remains of three outbuildings of unknown function. Each of the buildings are of wood-frame construction and appear to have all been capped with gable roofs covered with standing seam metal. The exteriors are clad with a combination of weatherboard siding and vertical wood boards (Figures 6.8–6.11).

Figure 6.8. Architectural resource AM1520; view is west featuring one of three collapsed outbuildings.

Figure 6.9. Architectural resource AM1520; view is north featuring one of three collapsed outbuildings.

Figure 6.10. Architectural resource AM1520; view is south featuring the north elevation of a collapsed outbuilding near Troxler Mill Road.

Figure 6.11. Architectural resource AM1520; view is north featuring the southeast corner of the collapsed outbuilding near Troxler Mill Road.

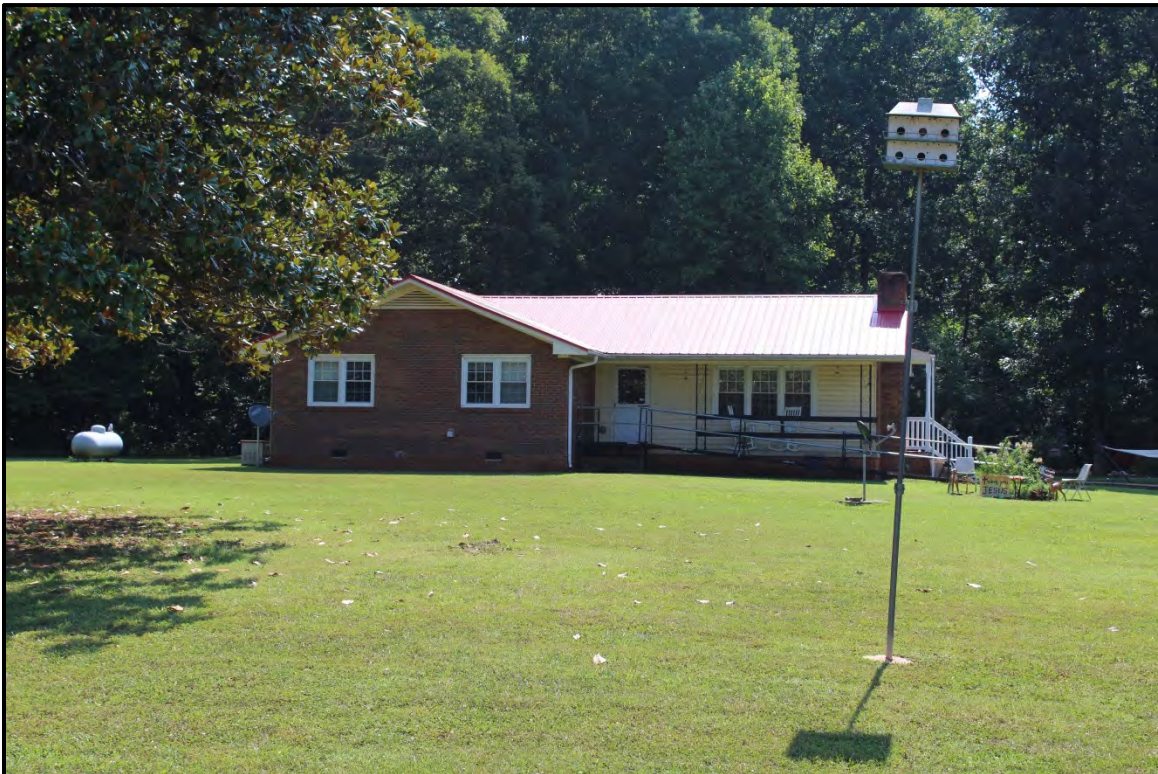
Figure 6.12. Architectural resource AM2490; view is east featuring the 1975 residence.

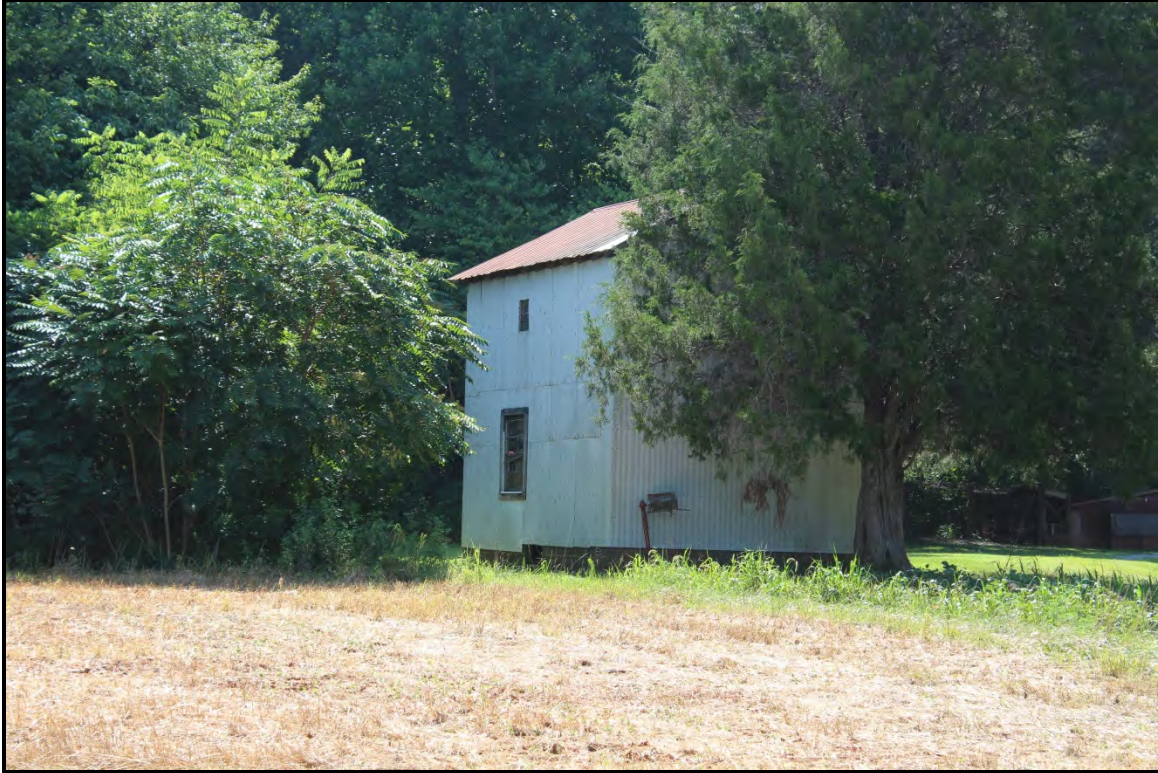
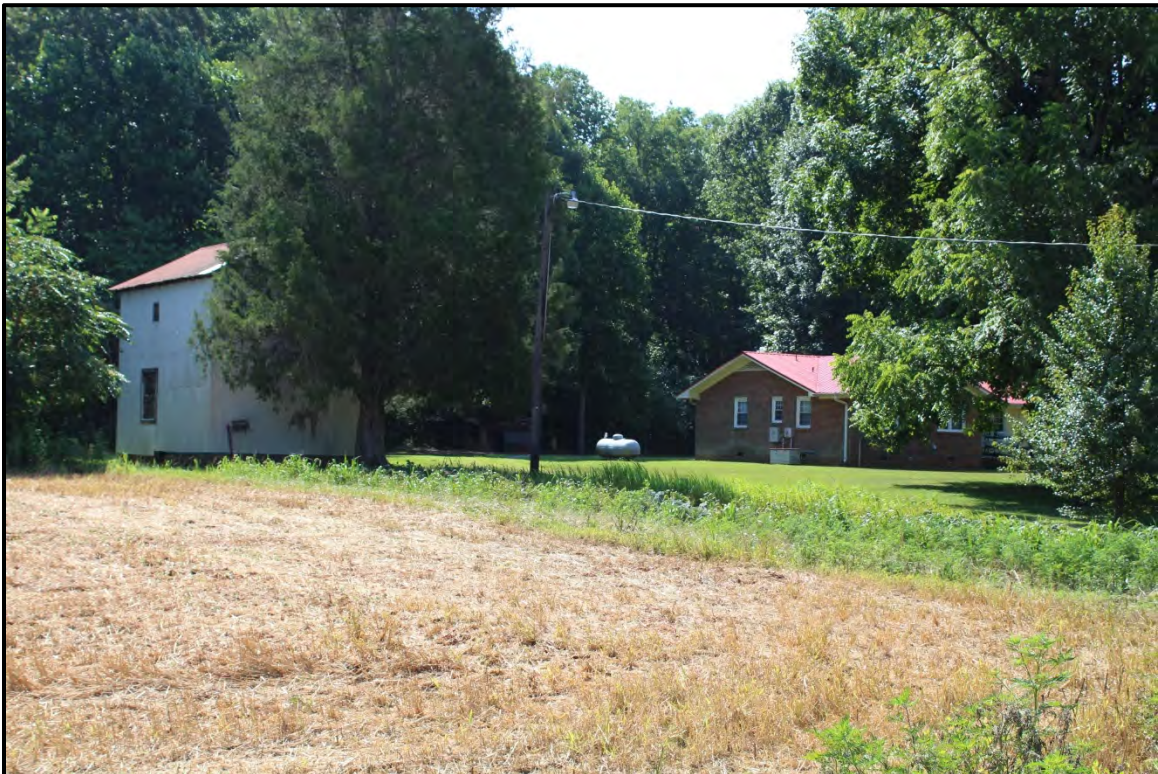
The tobacco barn features a gabled roof covered with standing seam metal, an exterior clad with metal siding, and a concrete block foundation. The structure appears to have been constructed ca. 1970, based on similar inventoried resources in the Project area (Figures 6.13 and 6.14).

Figure 6.13. Architectural resource AM2490; view is southeast featuring the tobacco barn.

Figure 6.14. Architectural resource AM2490; view is southeast showing the tobacco barn and ca. 1975 residence.

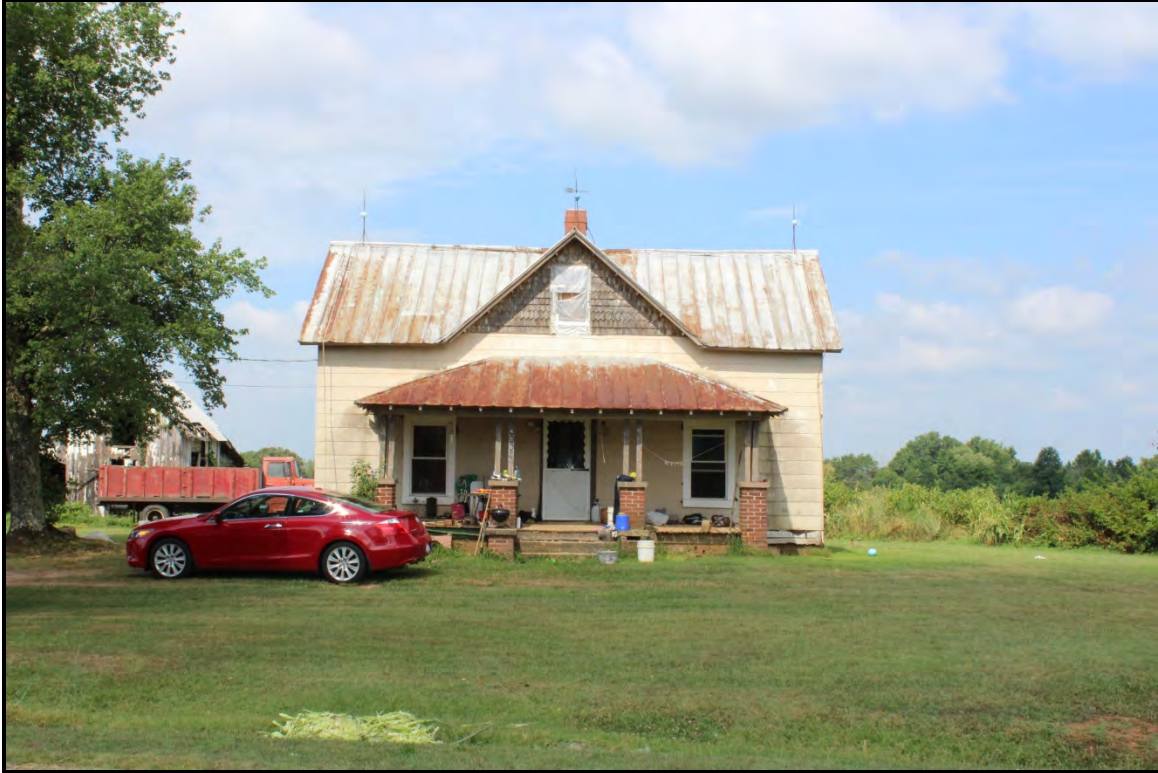
The farmhouse is a one and one-half-story, wood-frame building that features a side-gabled roof covered with standing seam metal, an interior brick chimney, an exterior clad with asbestos shingle siding, and a brick foundation. The front-facing gable has decorative wood shingle siding and is pierced by a window covered with plastic sheeting. The three-bay façade is marked by a central door that is flanked on either side by a 1/1 double-hung vinyl sash window. Attached to the façade is a partial-width porch with a hipped roof covered with standing seam metal. The porch roof is supported by three pairs of wood posts that rest atop brick plinth blocks. The porch contains a wood deck atop a brick foundation. The original 6/6 wood sash windows noted in the previous survey form have been mostly replaced with 1/1 vinyl windows (Barkhau 2002a). Outbuildings include a modern open-sided equipment shed on the north side of the house, four wood frame sheds, a pole barn equipment shed, and three recently installed grain silos. The log barns across Lee Lewis Road from the house that were noted in the previous survey form have been demolished.

Figure 6.15. Architectural resource AM1522; view is west featuring the farmhouse façade.

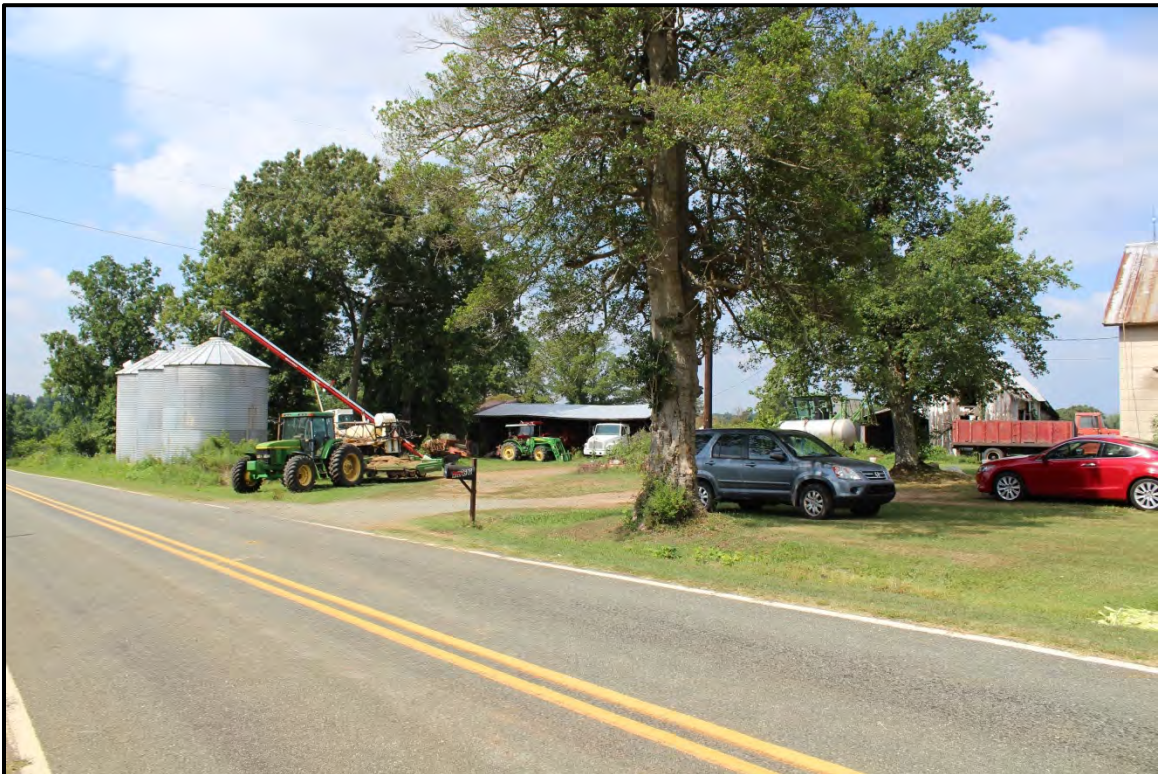
Figure 6.16. Architectural resource AM1522; view is southwest showing modern silos and outbuildings adjacent to the house.

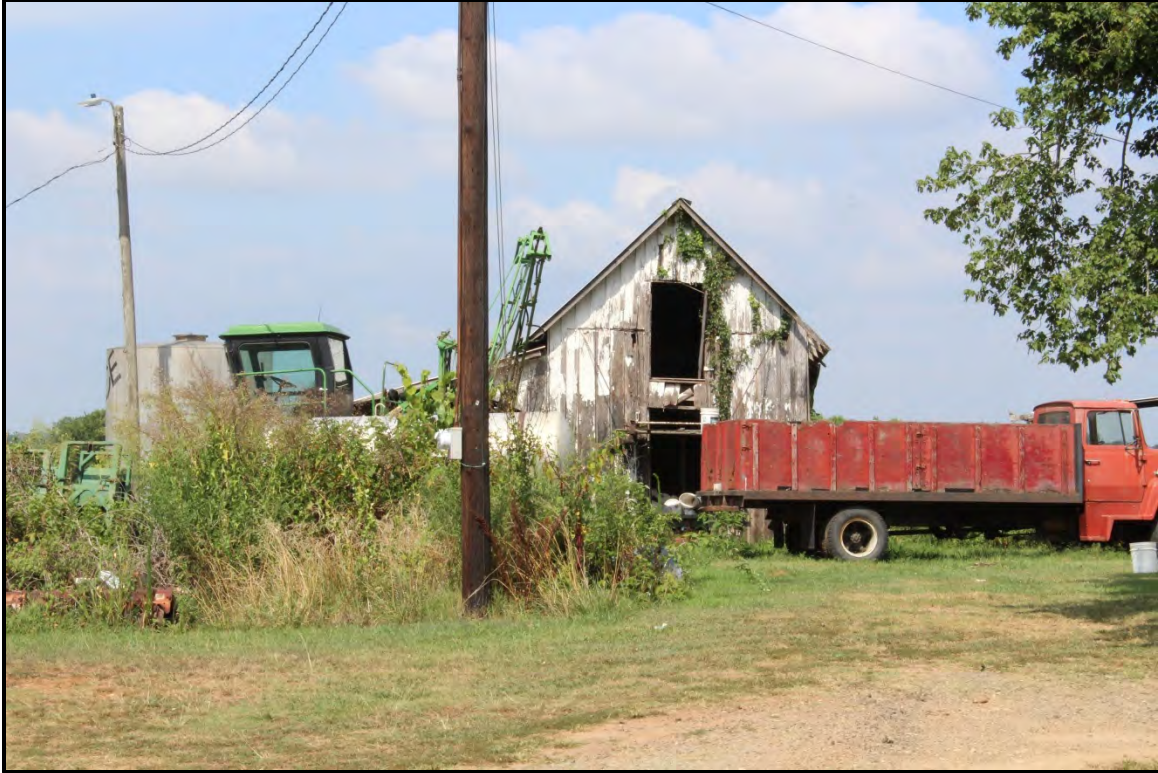
Figure 6.17. Architectural resource AM1522; view is west showing deteriorated storage shed.

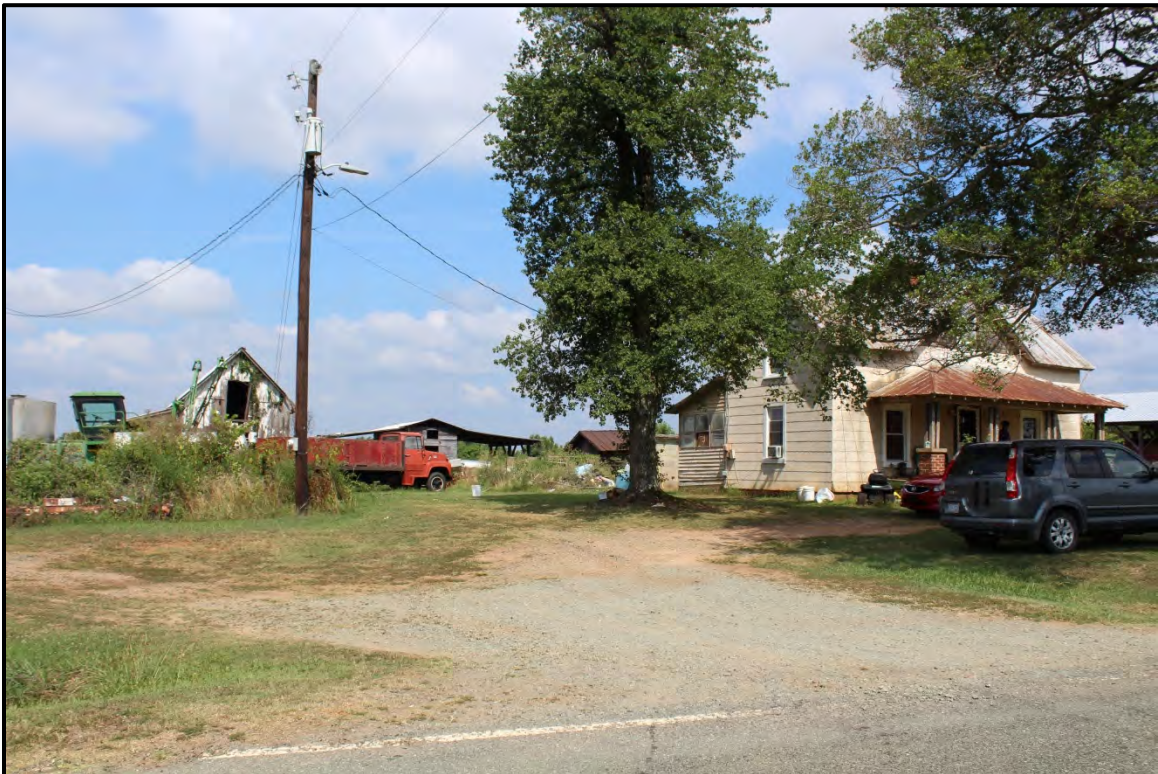
Figure 6.18. Architectural resource AM1522; view is northwest showing the farmhouse façade and south elevation. Note outbuildings in the background.

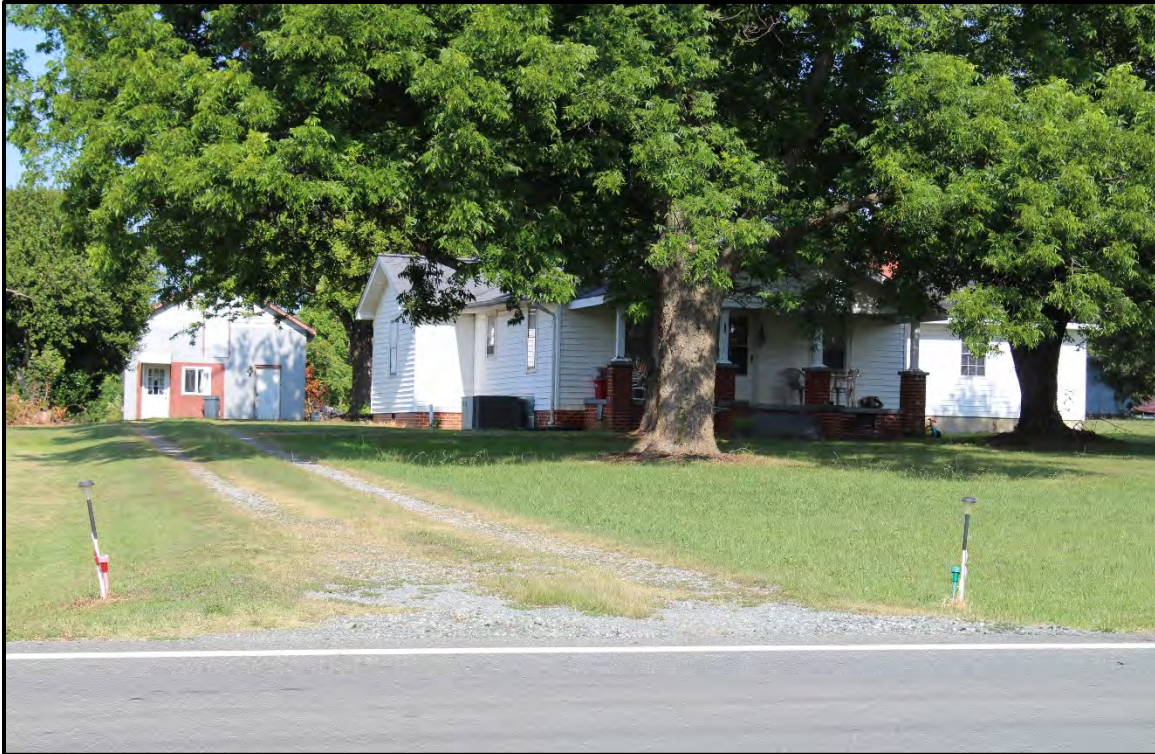
The one-story, wood-frame building features a front-gabled roof, an interior central brick chimney, an exterior clad with vinyl siding, and a brick foundation. Facing east, the façade is marked by a central door that is flanked on either side by a 6/1 wood sash window. Access to the façade door is through a front-gabled porch that contains a concrete deck atop a brick foundation. The porch roof is supported by four wood posts atop brick plinth blocks. Windows throughout the house are 6/1 wood sash, however, a modern side-gabled wing addition attached to the north elevation contains 6/6 vinyl sash windows. An exterior end brick chimney is located on the north elevation.

The parcel supports several outbuildings, including a vertical board shed with a metal gabled roof; a gable-front garage with horizontal board siding and exposed eave rafters; a frame shed with corrugated metal siding; and a gabled equipment shed with corrugated metal siding (Figures 6.19 and 6.21).

Figure 6.19. Architectural resource AM2491; view is northwest featuring the façade and south elevation.

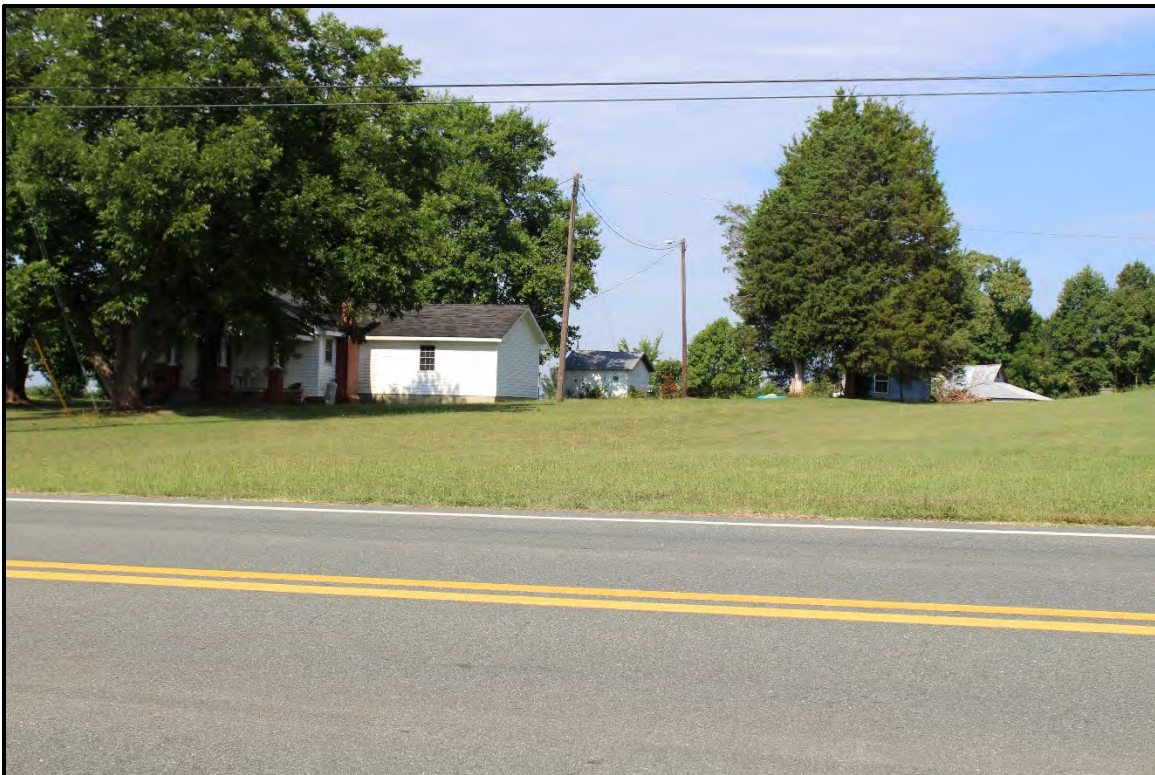
Figure 6.20. Architectural resource AM2491; view is southwest featuring the façade and north elevation. Note associated outbuildings in the background.
