Re: Revised Architectural Survey Report, MVP Southgate Project, Construct Interstate Pipeline, Rockingham and Alamance County, ER 18-1041

Thank you for your letter of October 11, 2019, transmitting the draft "Historic Architectural Survey for the MVP Southgate Pipeline Project". We have reviewed the report and offer the following comments.

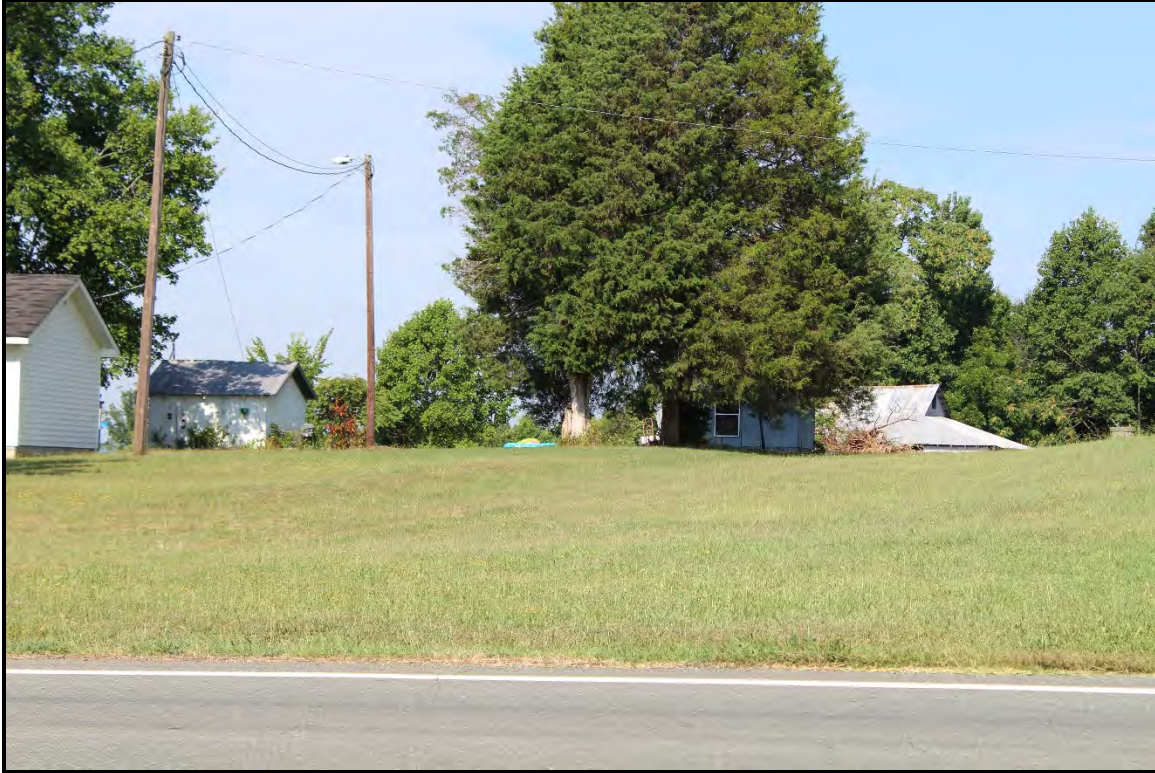
The parcel supports several outbuildings, including a vertical board shed with a metal gabled roof; a gable-front garage with horizontal board siding and exposed eave rafters; a frame shed with corrugated metal siding; and a gabled equipment shed with corrugated metal siding (Figures 6.19 and 6.21).

Figure 6.21. Architectural resource AM2491; view is southwest, featuring outbuildings.

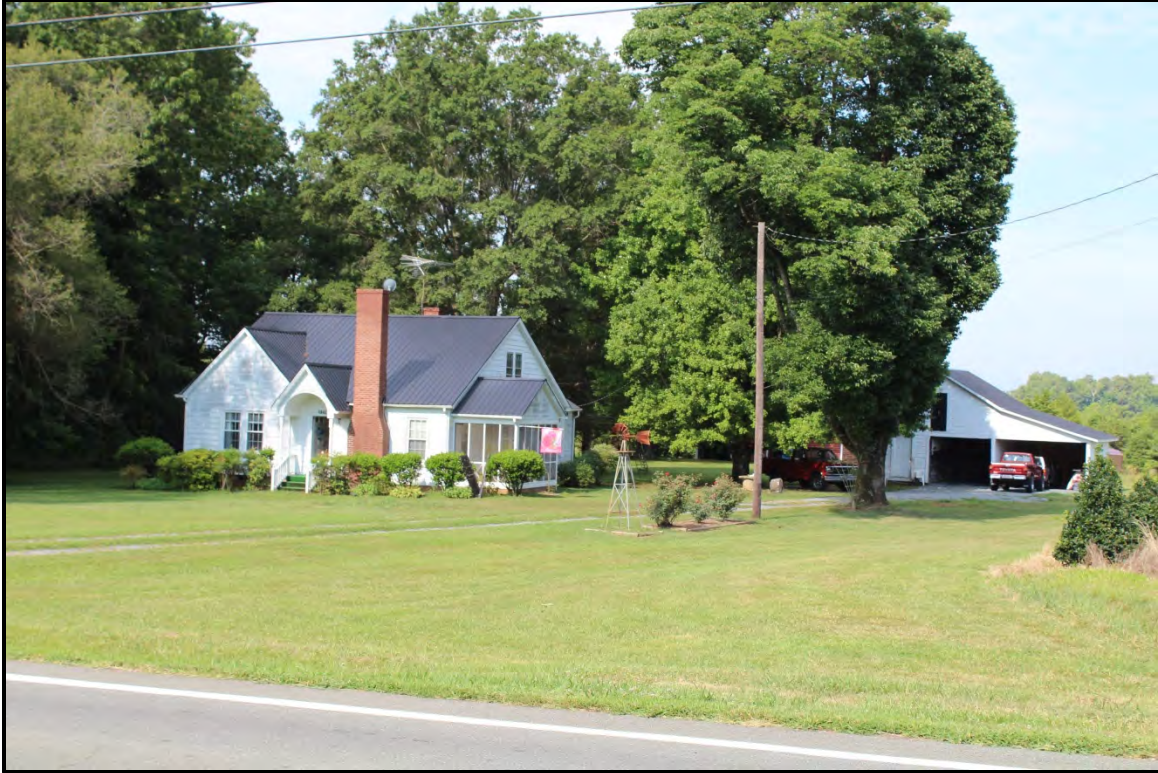
The one and one-half-story, wood-frame building features a side-gabled roof covered with standing seam metal, an exterior clad with aluminum siding, and a concrete foundation. Windows throughout the house have been replaced with 6/6 vinyl sashes. The façade features a gabled off-center porch with non-historic milled columns, offset by an exterior brick chimney. The entry bay retains an original three-light paneled door. Attached to the north elevation is an original one-story screened porch (Figure 6.22). The parcel also supports a combination garage/barn with shed wings and two agricultural-related outbuildings.

Figure 6.22. Architectural resource AM2492; view is southwest, featuring the house and barn/garage.

NRHP Assessment. Architectural resource AM2492 does not exhibit distinctive characteristics of architectural style or workmanship. In addition, the house has been altered through the application of aluminum siding, the installation of vinyl sash windows, and the replacement of the porch columns. Based on the lack of architectural merit, as well as the inability to associate the facility and/or its original owner(s) with an important historical event or series of events, it is TRC's opinion that architectural resource AM2492 is not eligible for the NRHP.

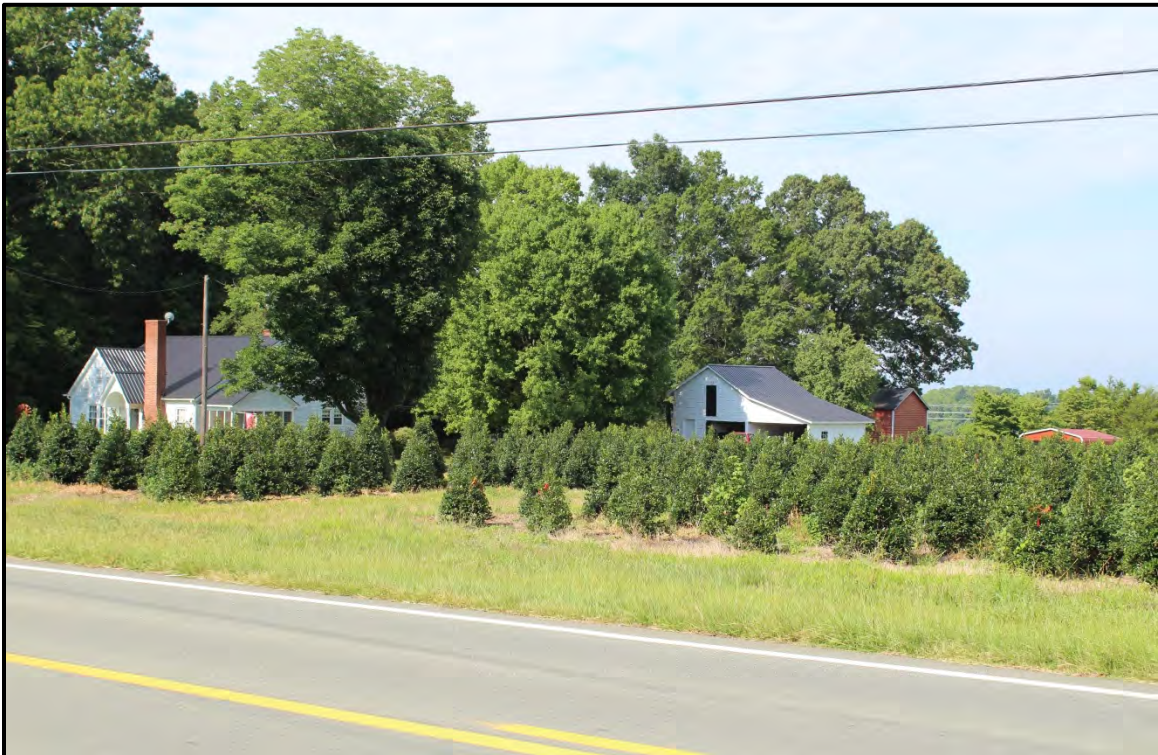
Figure 6.23. Architectural resource AM2492; view is southwest, featuring an overview of the property.

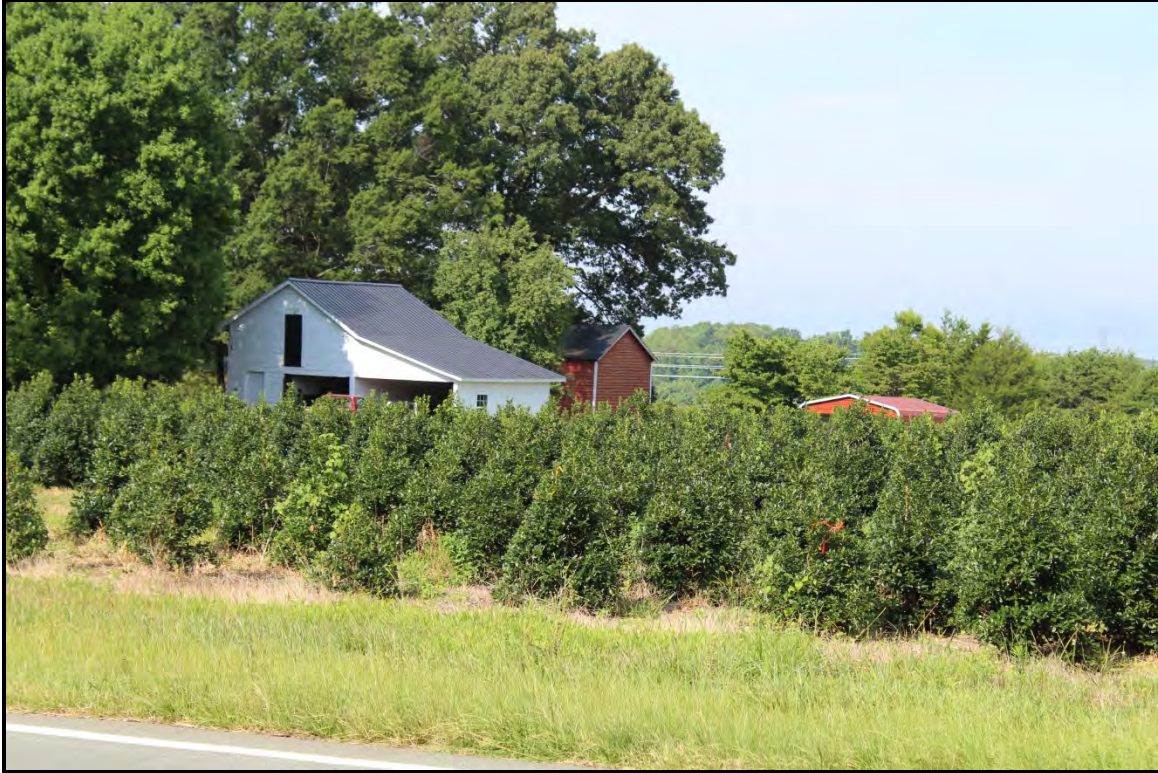
Figure 6.24. Architectural resource AM2492; view is southwest, featuring the outbuildings.

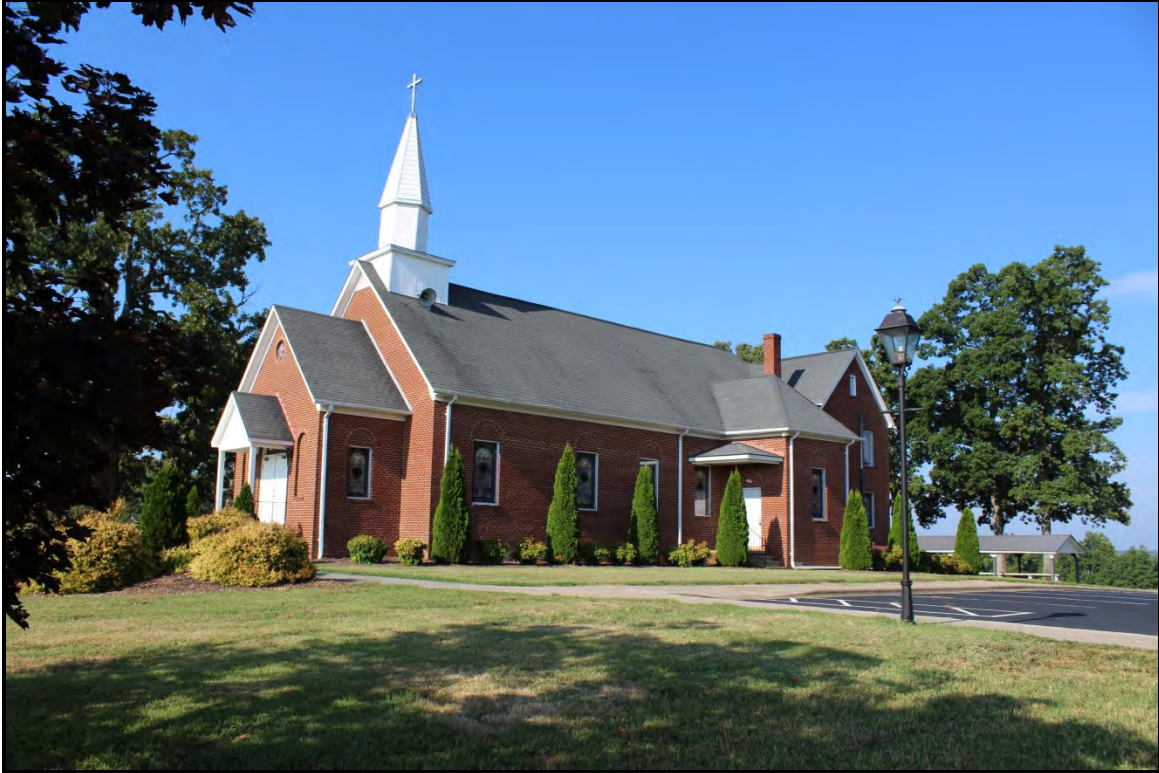
The two-story building has a roof covered with asphalt shingles, a brick veneer exterior, and an aisled nave type plan. Topping the building is a frame steeple. The façade is marked with a central double-door entrance within a projecting gable bay that is pierced by a round stained-glass window within the gable field. Fenestration along the north and south elevations consist of stained-glass windows. There is an education wing across the rear (west) elevation that gives the building a T-shaped footprint.

Figure 6.25. Architectural resource AM1523; oblique view showing east façade and north elevation.

NRHP Assessment. Architectural resource AM1523 is a typical example of a mid-twentieth century gable-front church. In accordance with NRHP Criteria Consideration A, religious buildings are normally not eligible for the NRHP unless they derive their primary significance from architectural or artistic distinction or are considered to be of historical importance. The property cannot be associated with important historical event(s) or person(s). Based on the lack of architectural merit, as well as the inability to associate the facility and/or its original owner(s) with an important historical event or series of events, it is TRC's opinion that architectural resource AM1523 is not eligible for the NRHP.

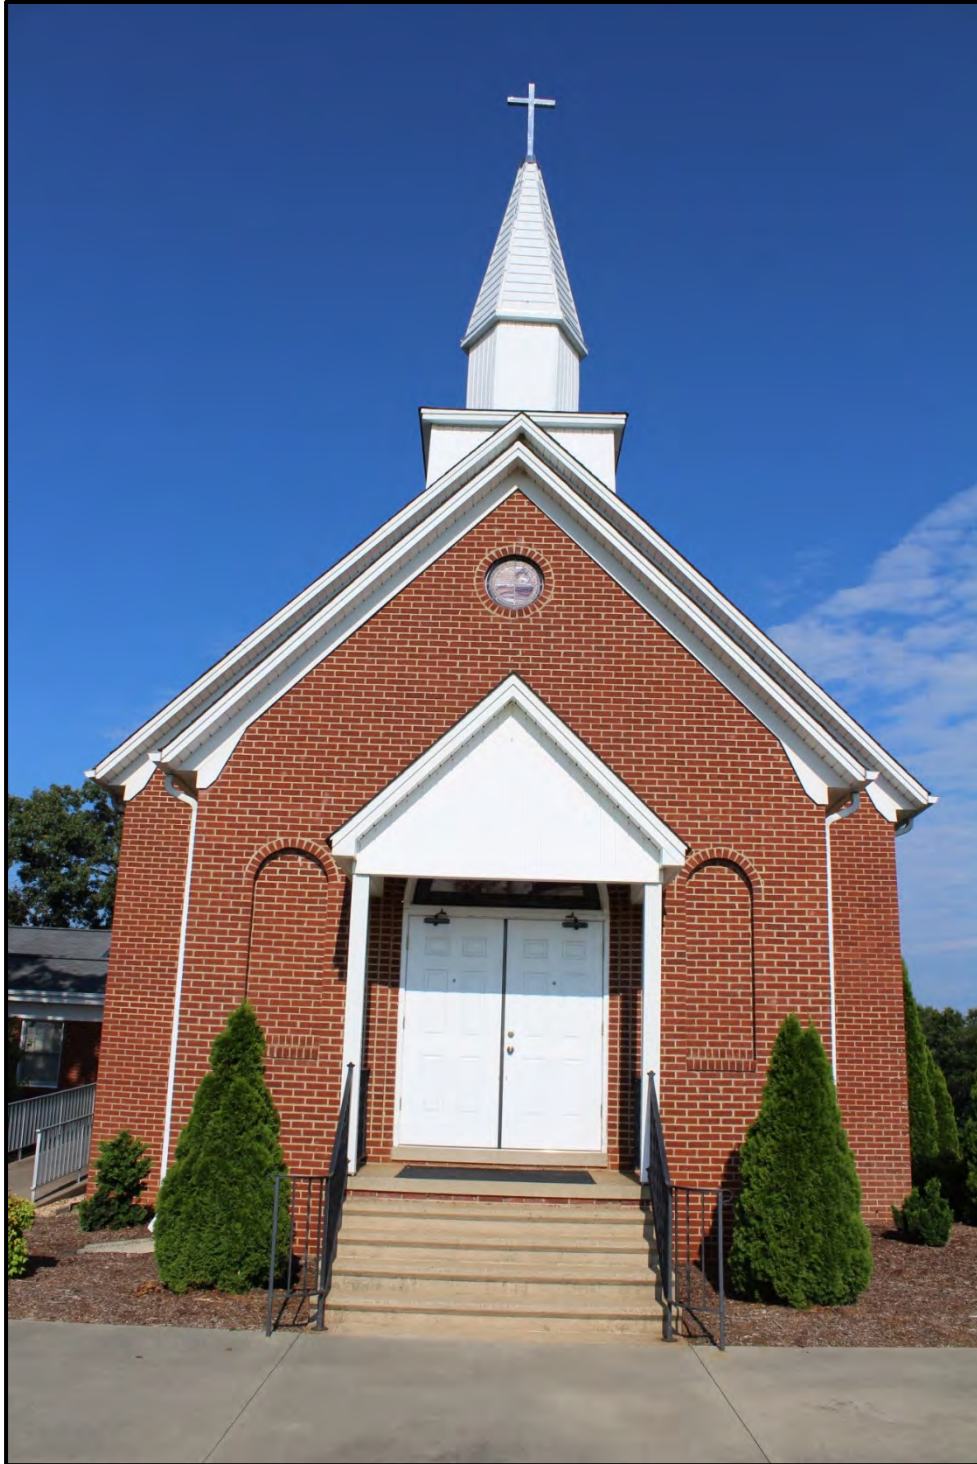
Figure 6.26. Architectural resource AM1523; view showing detail of east façade.

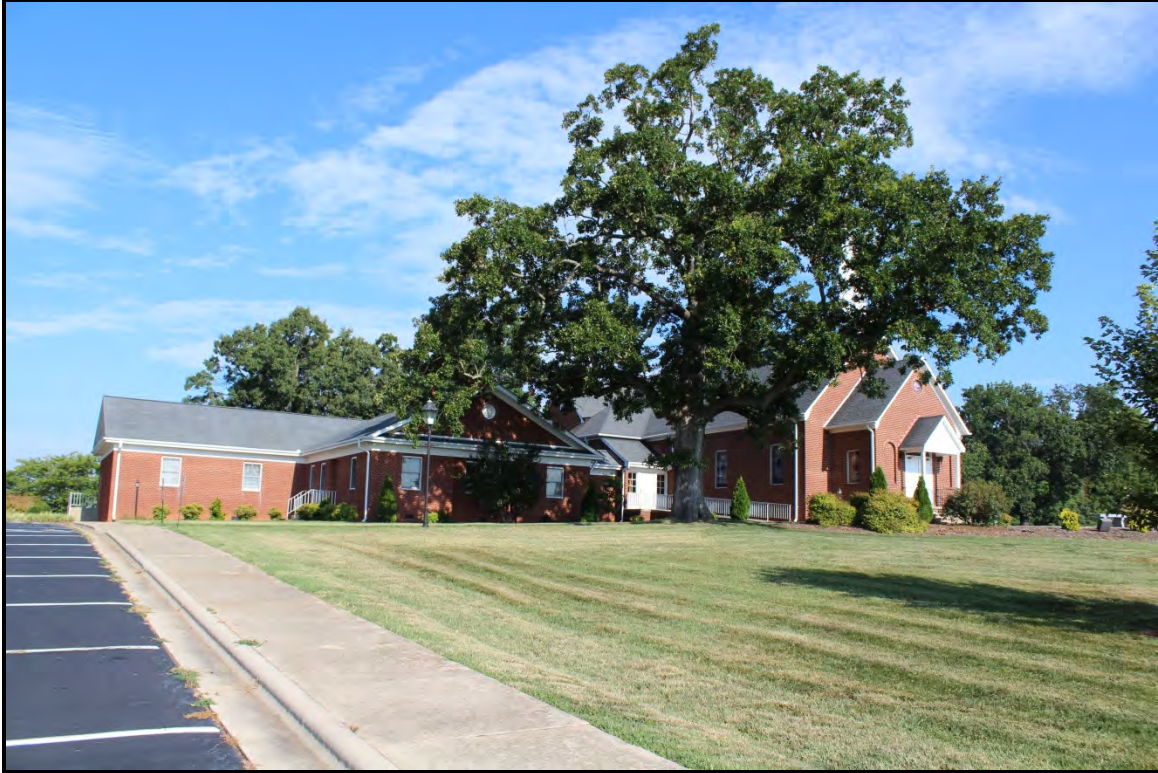
Figure 6.27. Architectural resource AM1523; oblique view showing east façade and circa-1990 wing addition.

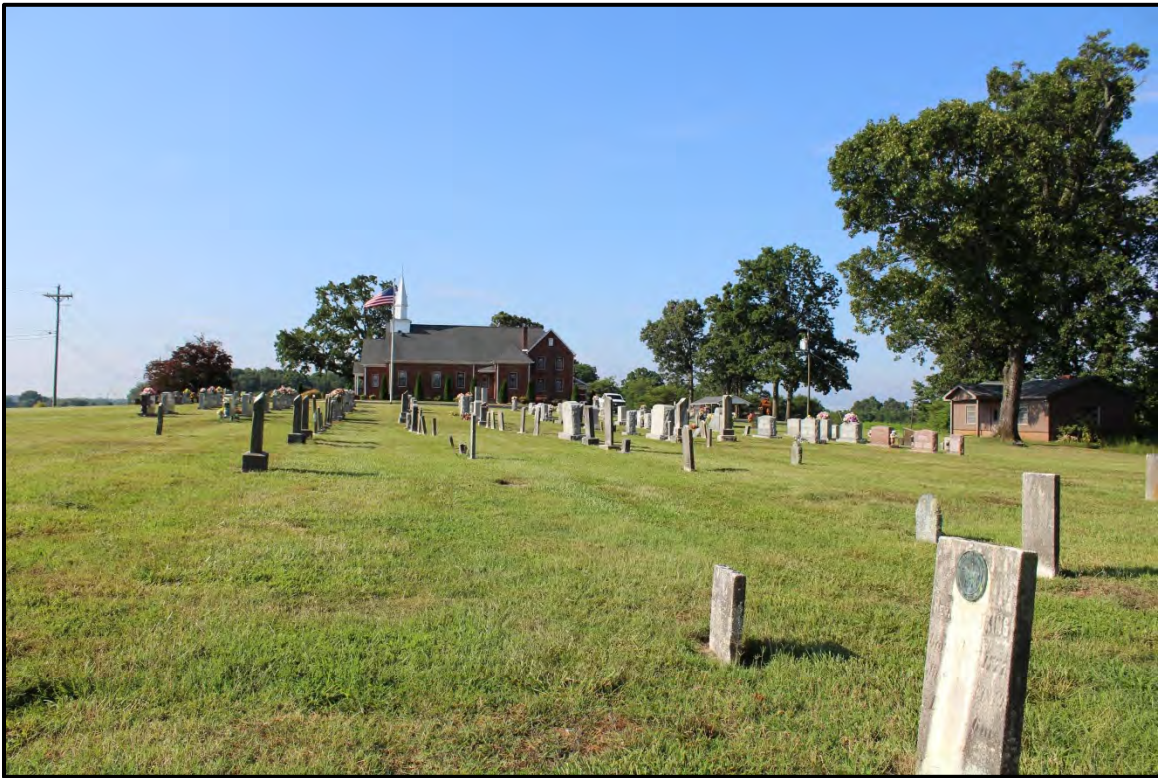
The Shiloh United Methodist Church cemetery is a typical example of a church cemetery that fails to exhibit unique features of architectural style or workmanship. In accordance with NRHP Criteria Consideration D, cemeteries are normally not eligible for the NRHP unless they derive their primary significance from graves of persons of significant importance, from age, from architectural distinction, or are considered to be of historical importance. Previous historical research failed to indicate that the cemetery played an integral role in local historical events. For these reasons, it is TRC's opinion that the cemetery is not eligible for the NRHP.

Figure 6.28. Architectural resource AM1523; view showing church cemetery.

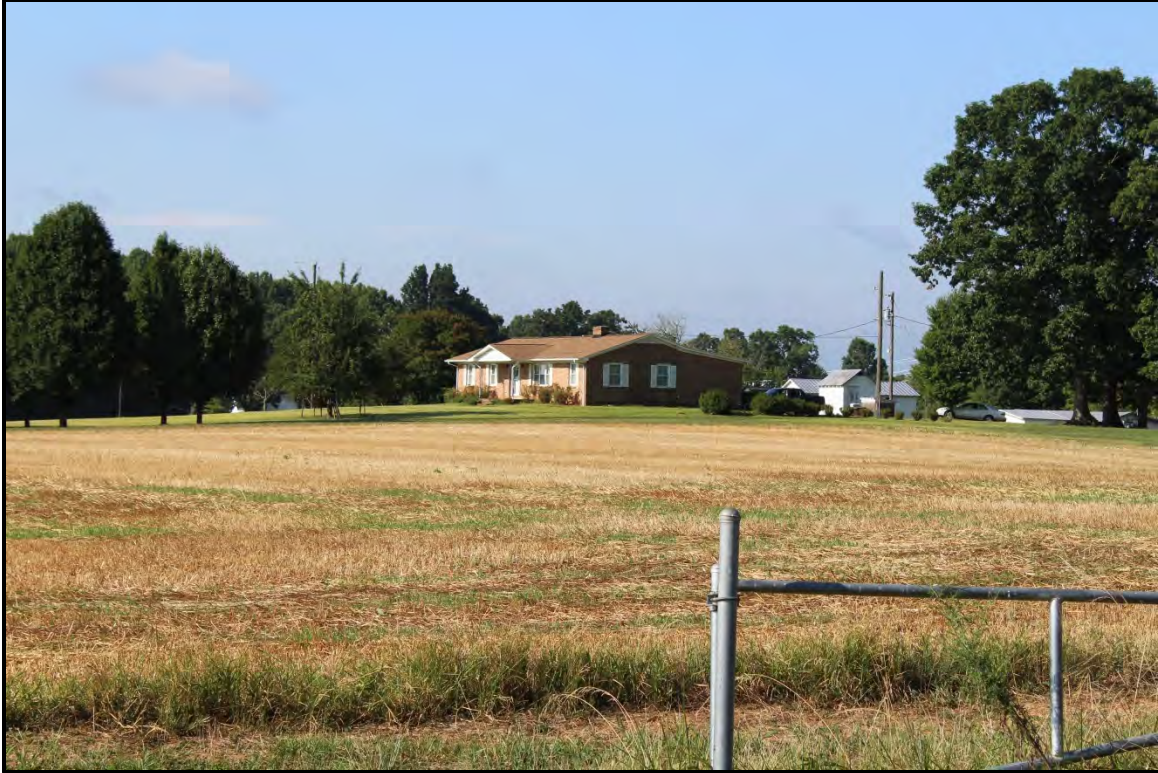
The wood-frame building features a low-pitched side-gabled roof covered with asphalt shingles, an exterior clad with a brick veneer, and a brick covered foundation. Windows are 1/1 double-hung vinyl sash. The façade features a one-story central gabled porch with wrought iron columns. Within the porch bay is a paneled central door. The house has a rear shed extension (Figure 6.29).

Figure 6.29. Architectural resource AM2493; view is southwest featuring the façade and north elevation.

NRHP Assessment. Architectural resource AM2493 does not exhibit distinctive characteristics of architectural style or workmanship. In addition, the house has been altered through the installation of vinyl sash windows. Based on the lack of architectural merit and inability to associate the house and/or its original owner(s) with an important historical event or series of events, it is TRC's opinion that architectural resource AM2493 is not eligible for the NRHP.

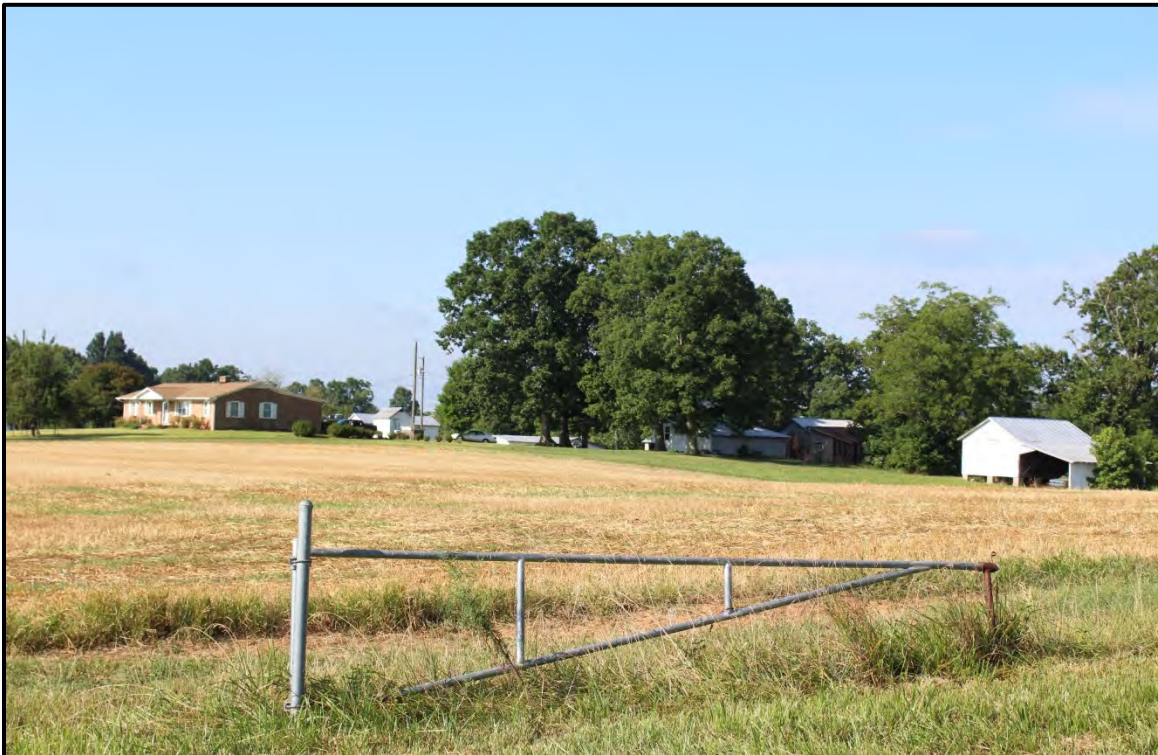
Figure 6.30. Architectural resource AM2493; view is southwest featuring an overview of the property.

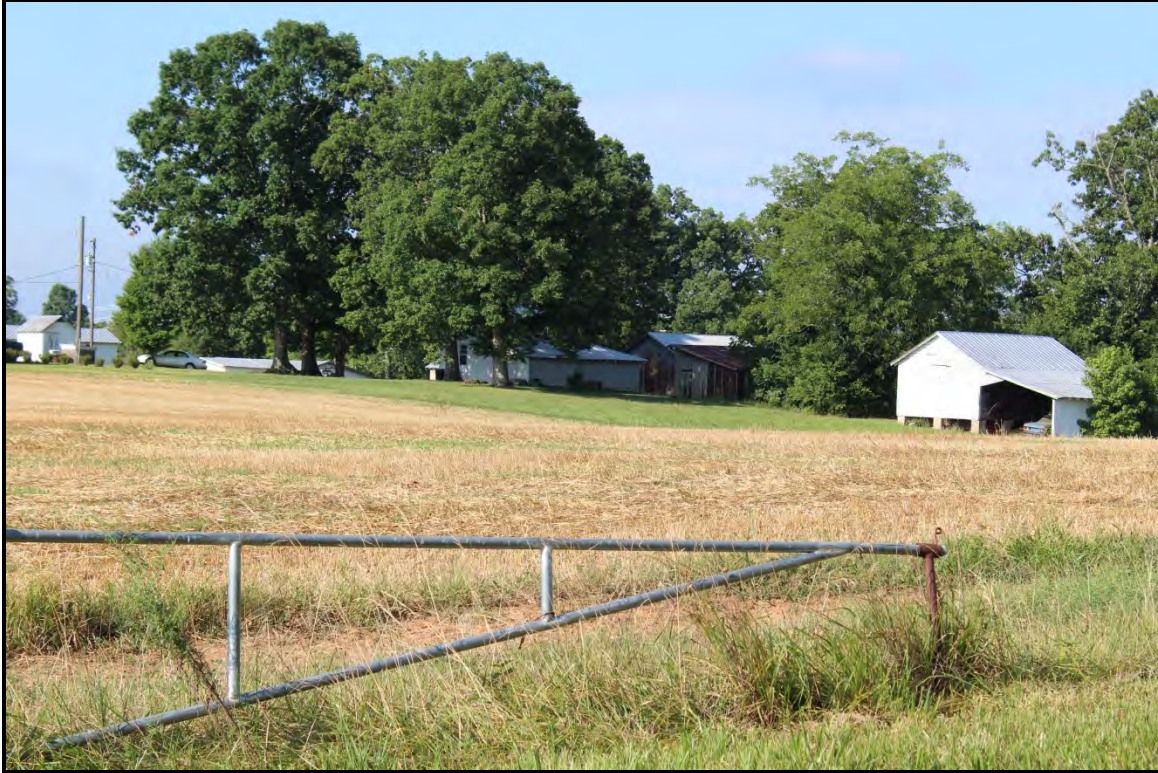
Several agricultural outbuildings are located near the house but are situated on a separate parcel. Within the current parcel, the property includes a mid-twentieth century storage shed, a late-twentieth century concrete block pump shed, a mid-twentieth century utility building, and two additional wood-frame structures that are capped with gabled roofs covered with standing seam metal. Most outbuildings appear older than the Ranch-style house as they feature exteriors clad with weatherboard siding. Barns are clad with vertical wood boards and capped with metal roofs (Figures 6.29–6.32). The property's outbuildings may have been historically associated with AM2494, which is a ca. 1900 residence located on Jug House Road.

Figure 6.31. Architectural resource AM2493; view is southwest, featuring outbuildings.

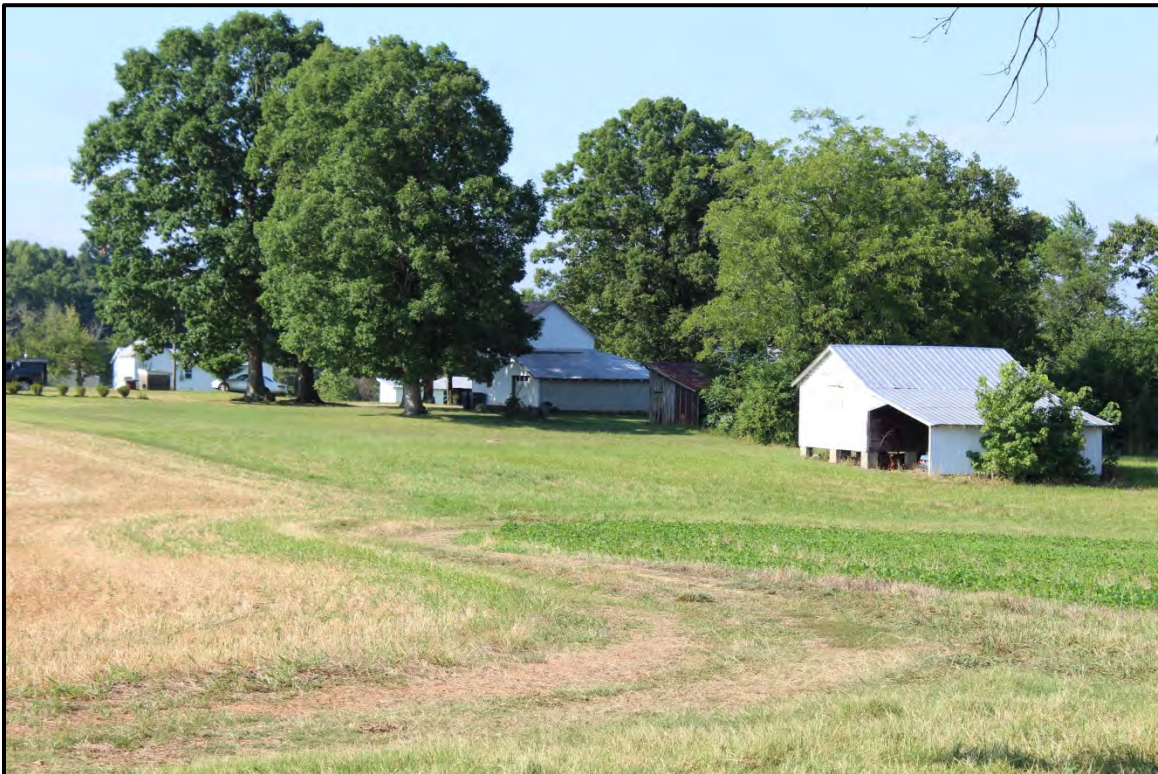
Figure 6.32. Architectural resource AM2493; view is southwest, featuring an overview of the property.

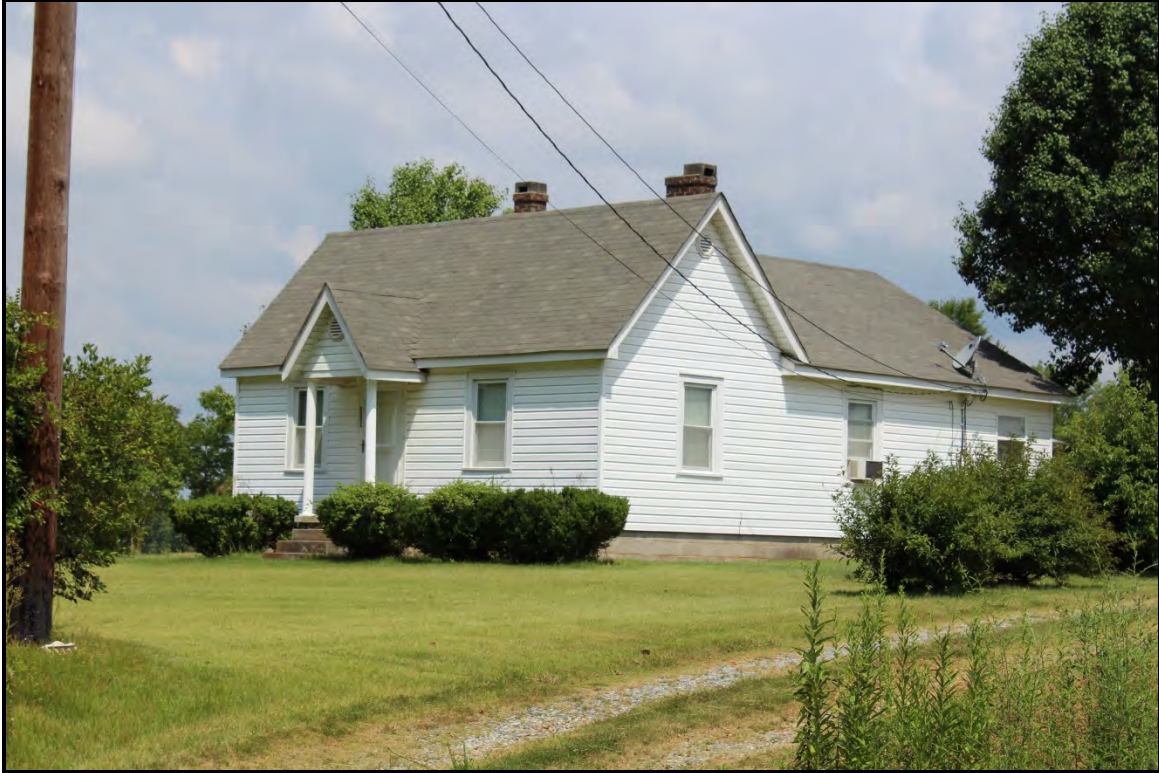
The one-story, wood-frame building has a steeply-pitched, side-gabled roof, two interior brick chimneys, an exterior clad with vinyl siding, and a concrete block foundation. Windows throughout the house have been replaced with 1/1 double-hung vinyl sashes. The façade features a non-historic central gabled portico with contemporary columns. The building has a rear one-story gabled wing. The parcel also supports a large prefabricated metal barn and corrugated metal shed.

Figure 6.33. Architectural resource AM2494; view is northwest, featuring the façade and northeast elevation/rear wing.

NRHP Assessment. Architectural resource AM2494 is an active farmstead anchored by a Folk Victorian-style house that does not exhibit distinctive characteristics of architectural style or workmanship. In addition, the building has been altered through the application of vinyl siding, the installation of vinyl sashes, the construction of the façade portico, and the construction of the rear addition. The historic setting of the property has been compromised with the construction of modern agricultural buildings on the property. For these reasons, the farm no longer conveys its early twentieth century appearance, thereby rendering the property ineligible for its agricultural associations. For these reasons it is the opinion of TRC that architectural resource AM2494 is not eligible for the NRHP.

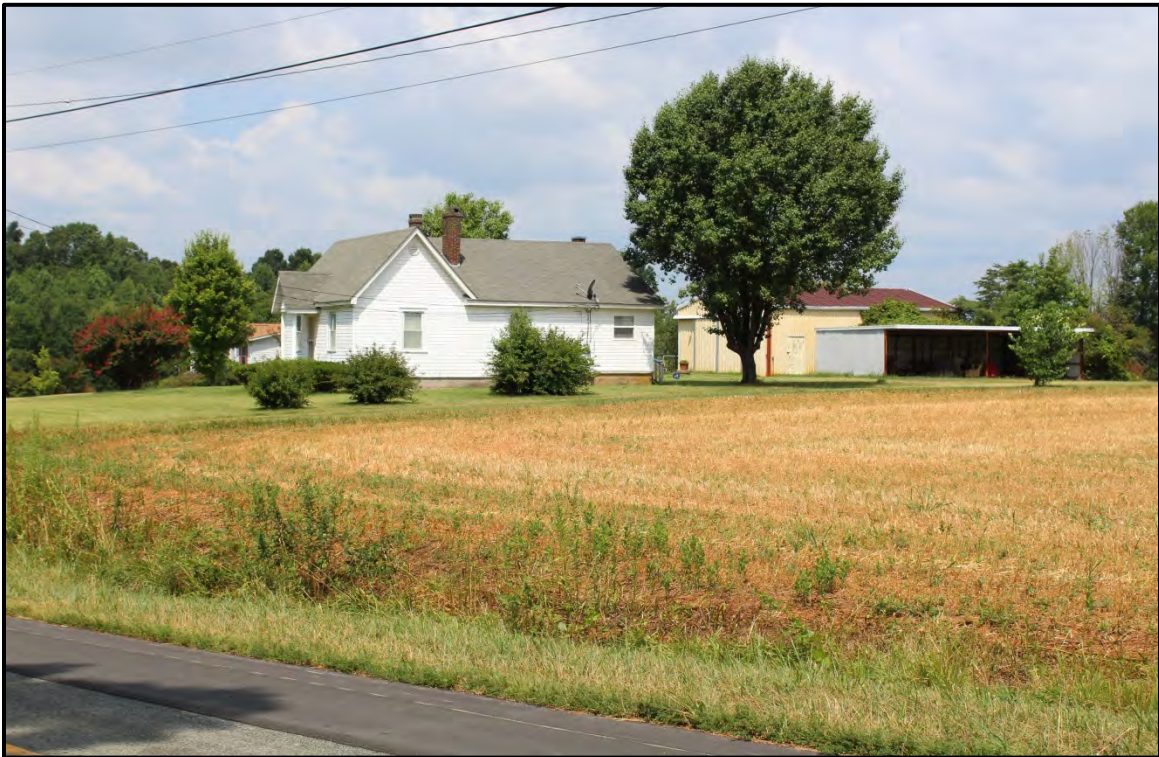
Figure 6.34. Architectural resource AM2494; view is west, featuring the house and modern outbuildings.

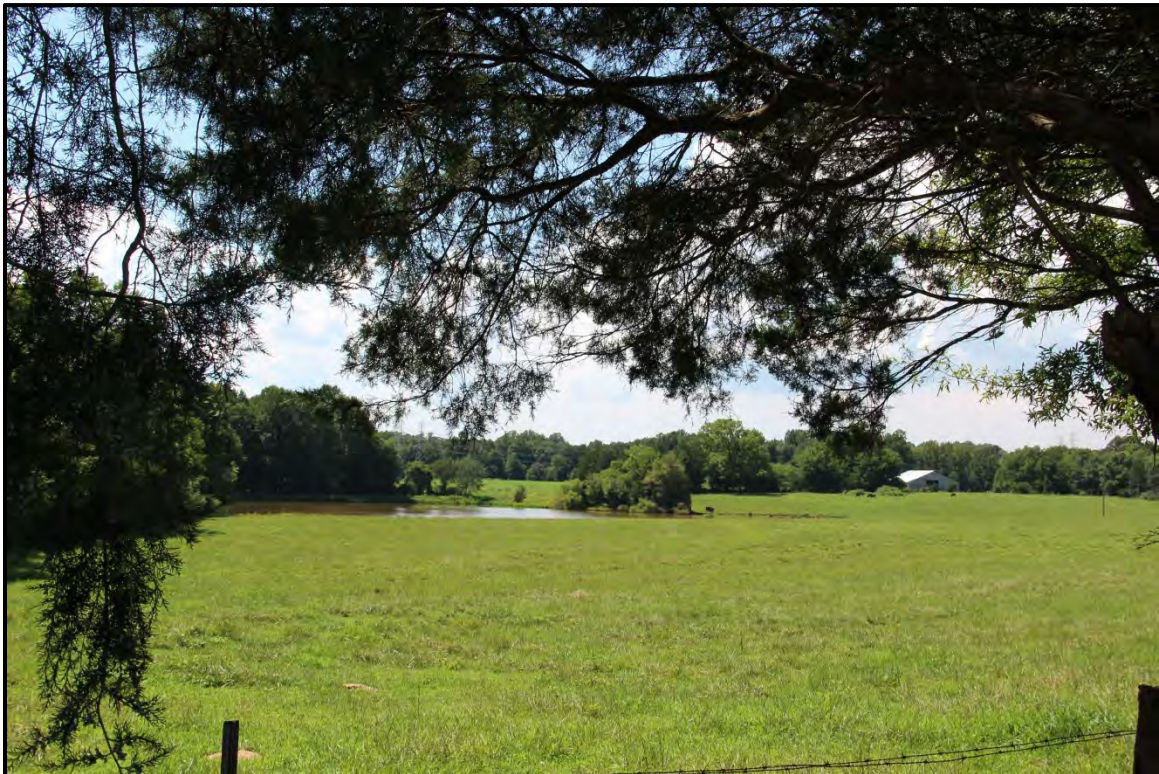
The barn is situated in a 107-acre parcel and appears to have been constructed ca. 1960 based on its form and building materials. The wood-frame barn has an open bay with a sliding track door and a gabled roof covered with standing seam metal.

Figure 6.35. Architectural resource AM2495; view is northwest, featuring the barn and associated property.

NRHP Assessment. Architectural resource AM2495 does not exhibit distinctive characteristics of architectural style or workmanship. Based on the lack of architectural merit and lack of associated house/outbuildings, as well as the inability to associate the barn and/or its original owner(s) with an important historical event or series of events, it is TRC's opinion that architectural resource AM2495 is not eligible for the NRHP.

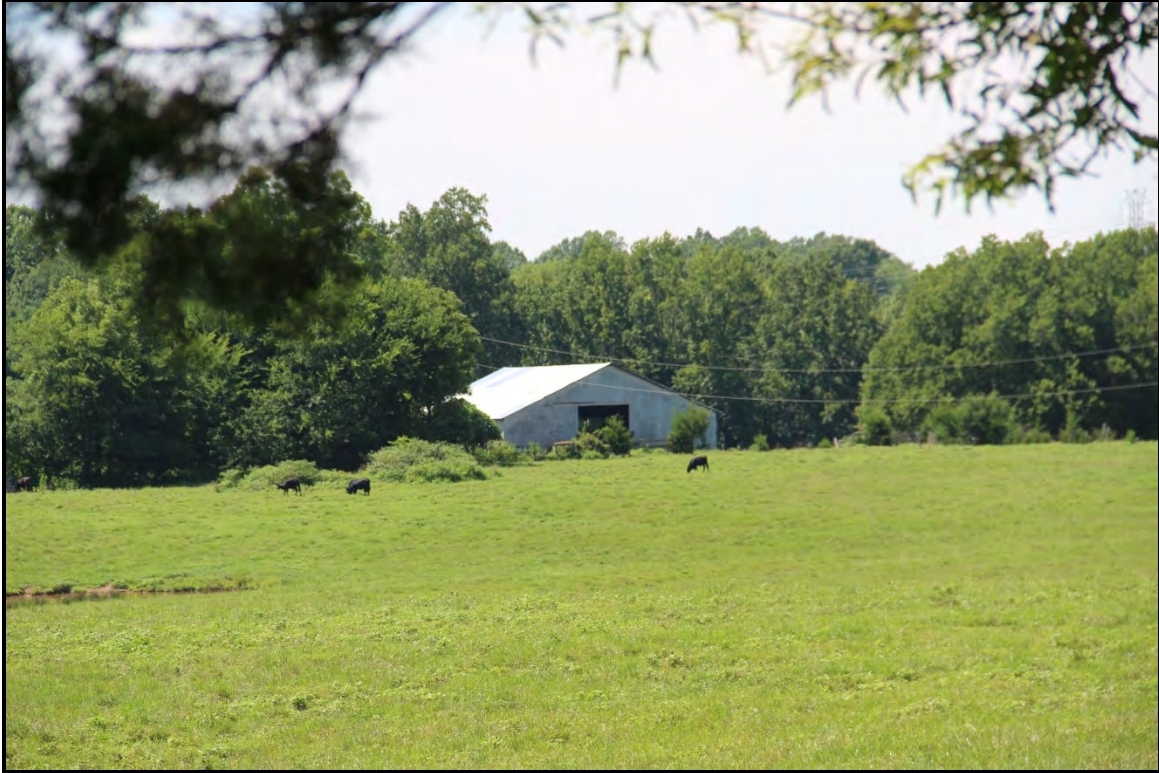
Figure 6.36. Architectural resource AM2495; view is northwest, featuring the primary elevation.

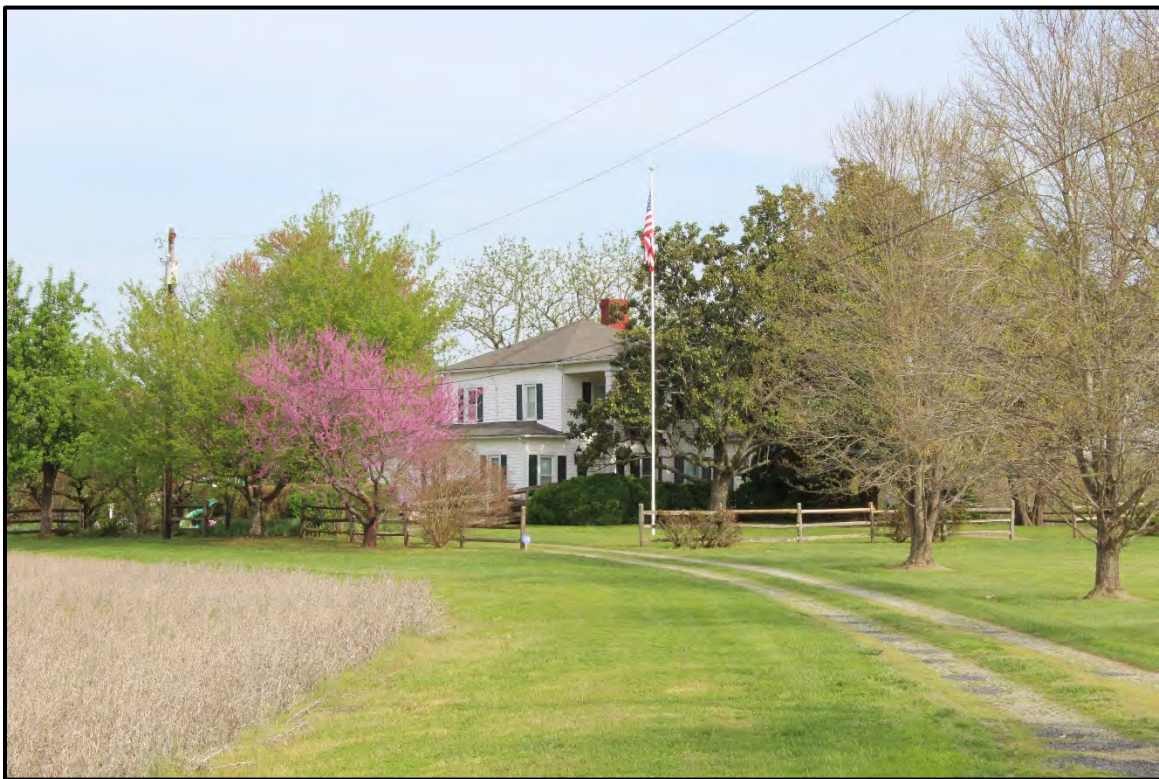
- AM1529 must be compared to other Colonial Revival houses with outbuildings in the county. The investigator needs to make a better attempt at securing interior photos.

Figure 6.37. Architectural resource AM1529; view is southeast featuring the façade and north elevation.

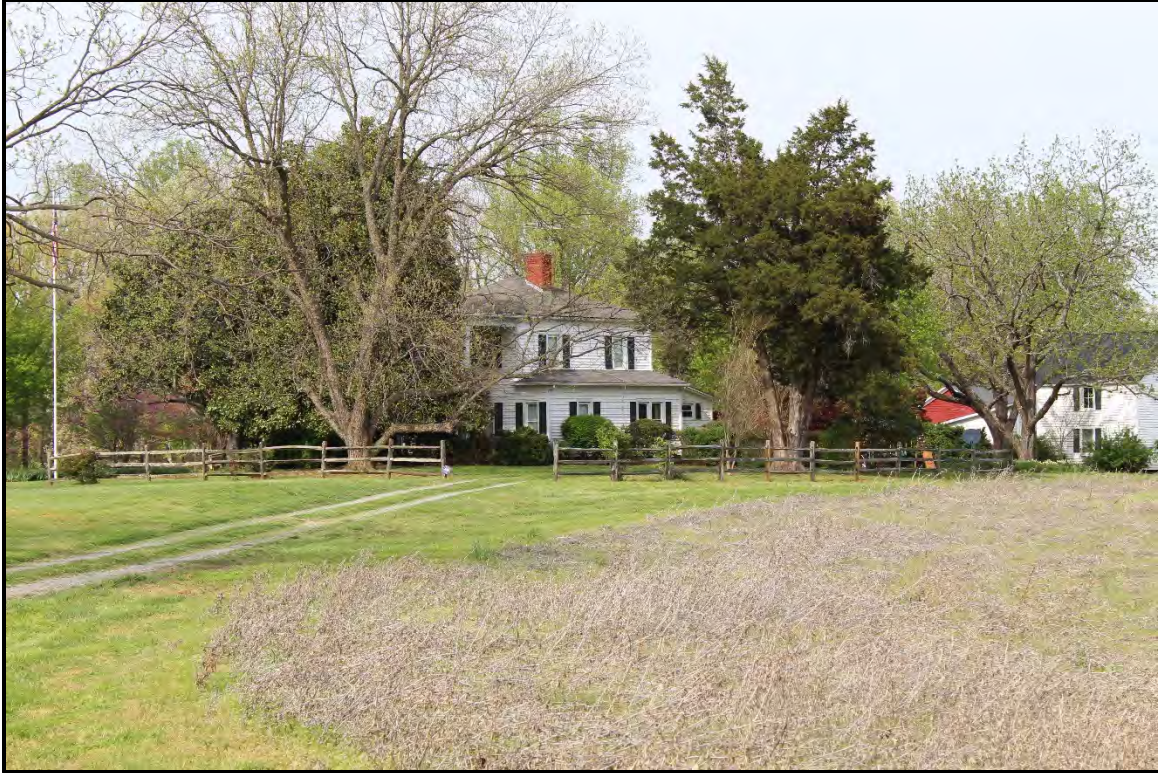
The two-story, wood-frame building features a pyramidal roof covered with asphalt shingles, an interior brick chimney, an exterior clad with vinyl siding, and 1/1 double-hung sash windows. Facing west, the façade is marked with an off-centered door that is accessible via a full-façade porch. The porch contains a flat roof that is supported by four columns. According to a countywide architectural survey of Alamance County, the house has been “heavily” remodeled and the existing porch replaced an original two-story portico (ACHPC 2014:157). However, it is not clear when these alterations took place. Attached to the north elevation is a hipped-roof wing.

Figure 6.38. Architectural resource AM1529; view is east featuring the façade.

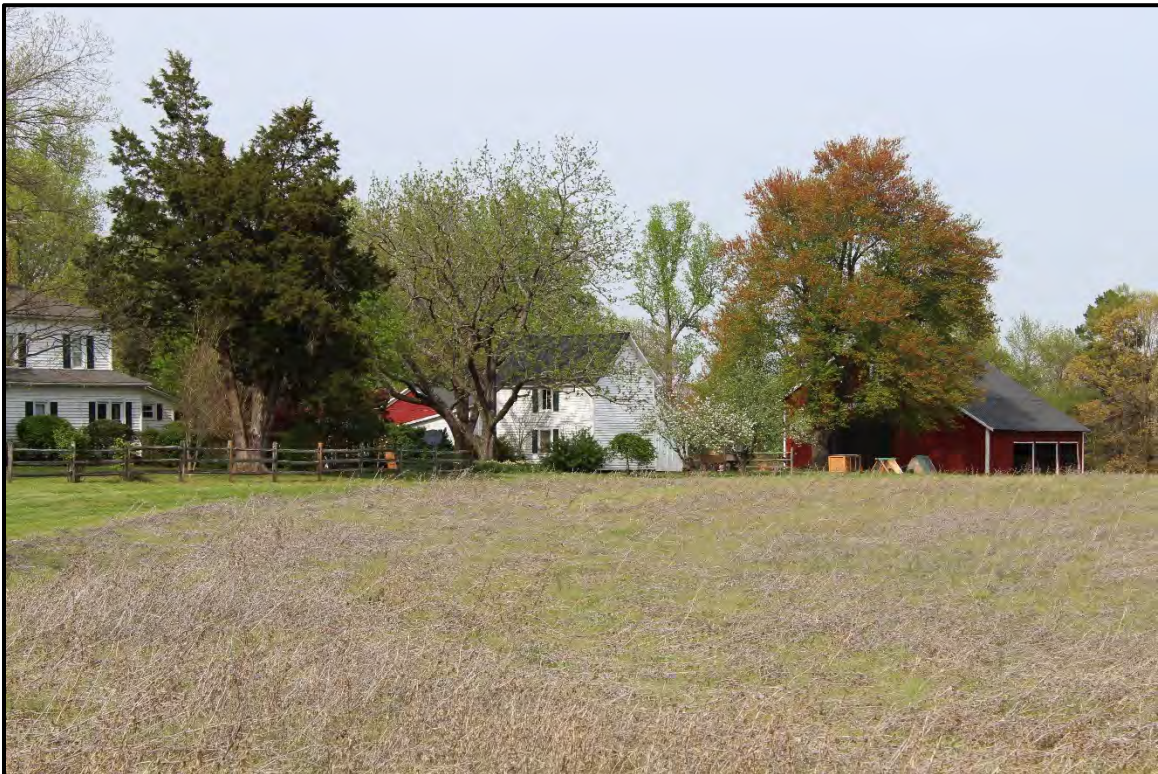
Figure 6.39. Architectural resource AM1529; view is northeast featuring the hay barn and potential seed storage building.

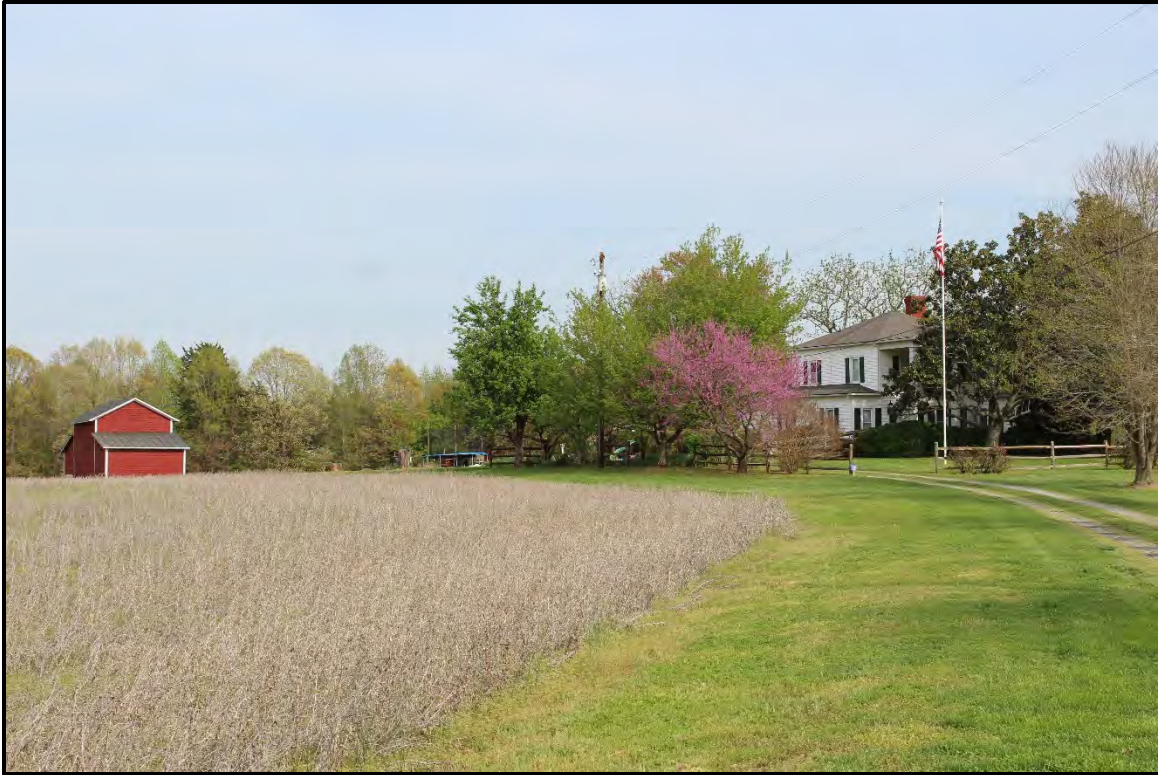
Figure 6.40. Architectural resource AM1529; view is southeast featuring the tobacco barn.

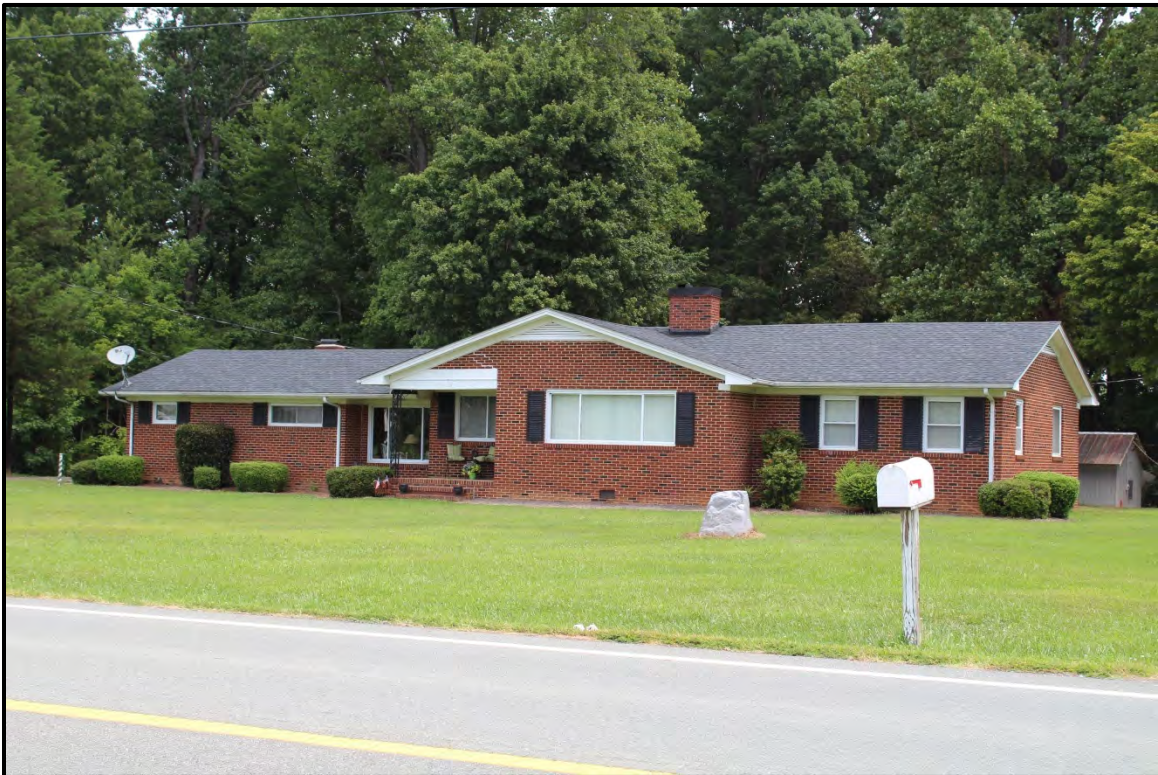
The wood-frame building features a side-gabled roof covered with asphalt shingles, an exterior clad with a brick veneer, and a brick foundation. Facing west, the façade is marked by a projecting gable bay that contains a recessed porch and a three-part picture window with vinyl sash. The remaining windows throughout the house are 1/1 vinyl sash. The north elevation holds a secondary entry. The property also features a contemporary carport and outbuilding east of the house.

Figure 6.43. Architectural resource AM2496; view is northeast featuring the façade and south elevation.

NRHP Assessment. Architectural resource AM2496 does not exhibit distinctive characteristics of architectural style or workmanship. In addition, the house has been altered through the installation of vinyl sashes. Based on the lack of architectural merit and inability to associate the house and/or its original owner(s) with an important historical event or series of events, it is TRC's opinion that architectural resource AM2496 is not eligible for the NRHP.
