Re: Revised Architectural Survey Report, MVP Southgate Project, Construct Interstate Pipeline, Rockingham and Alamance County, ER 18-1041

Thank you for your letter of October 11, 2019, transmitting the draft "Historic Architectural Survey for the MVP Southgate Pipeline Project". We have reviewed the report and offer the following comments.

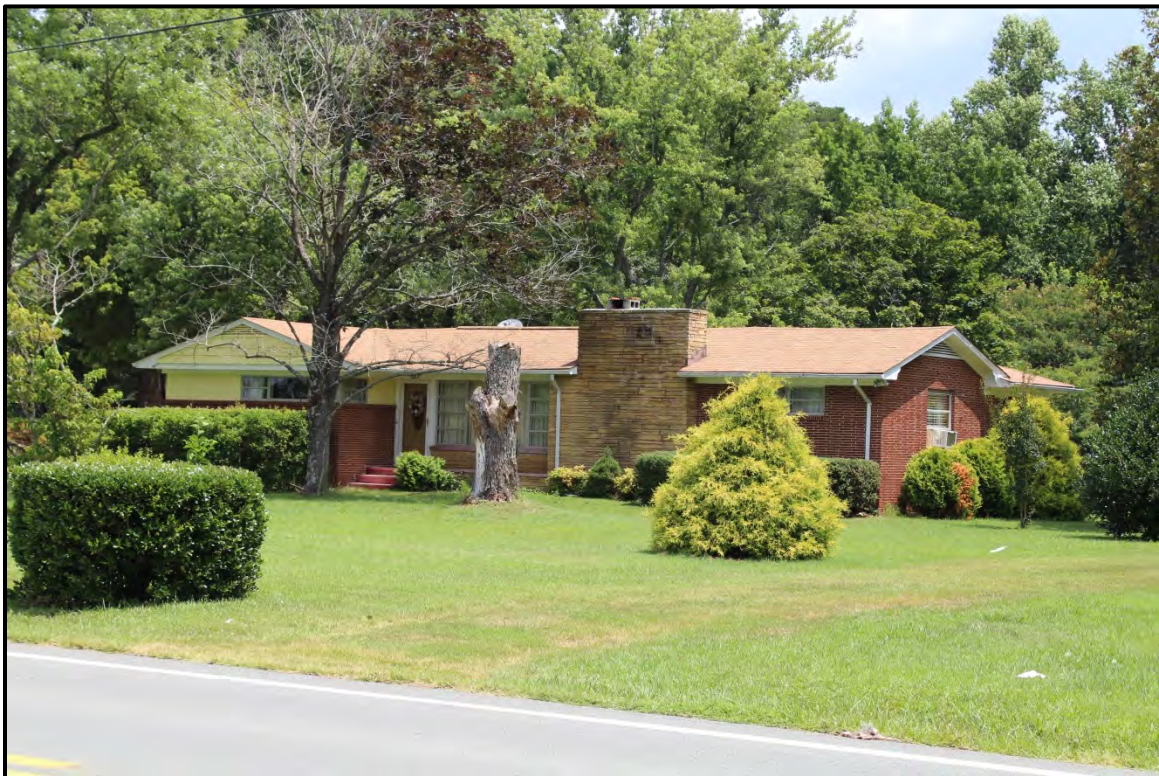
The wood-frame building features a side-gabled roof covered with asphalt shingles and an exterior clad with a brick veneer. The main entrance is situated off-center on the façade and holds a replacement door. Positioned south of the entry is an original picture window and a wide exterior stone chimney. Stone of similar cut/color is set below the picture window and along a planting border below the window. The north end of the house has a facing gable wing an upper narrow picture style window. The gable field has original asbestos siding. Remaining windows are horizontal 2/2 double-hung design.

Figure 6.44. Architectural resource AM2497; view is northeast featuring the façade and south elevation.

NRHP Assessment. Architectural resource AM2497 does not exhibit distinctive characteristics of architectural style or workmanship. Based on the lack of architectural merit, as well as the inability to associate the house and/or its original owner(s) with an important historical event or series of events, it is TRC's opinion that architectural resource AM2497 is not eligible for the NRHP.

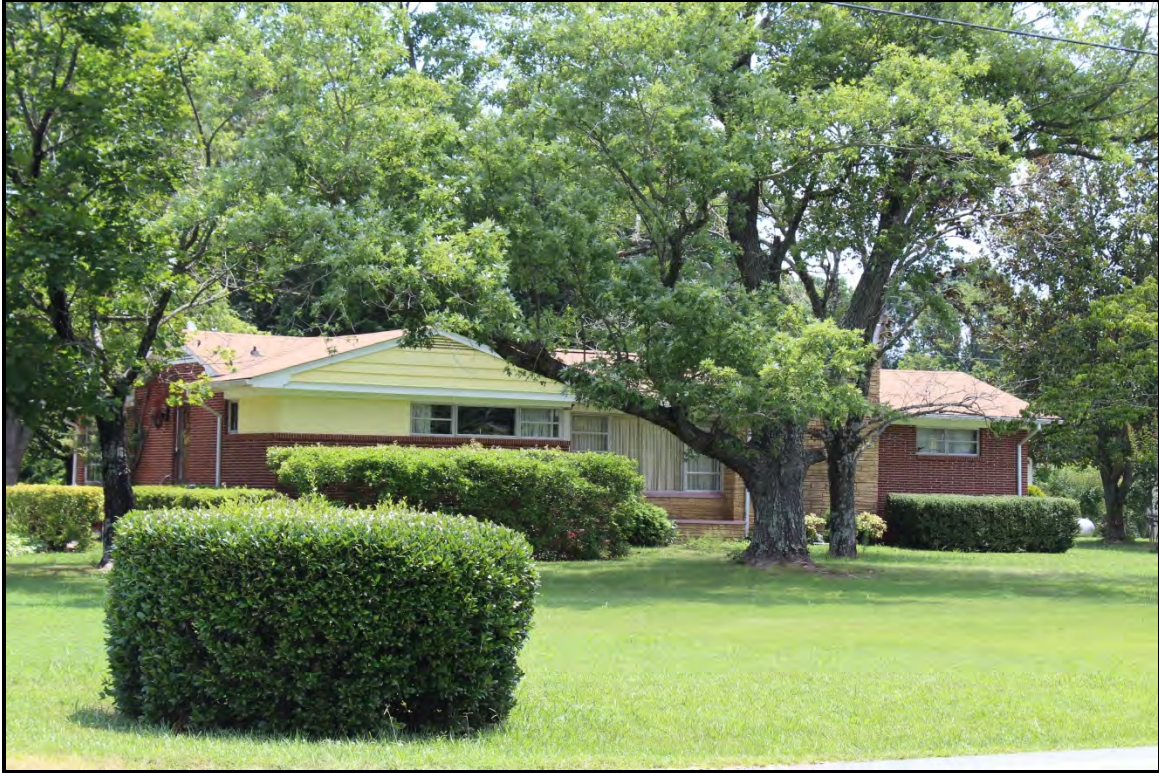
Figure 6.45. Architectural resource AM2497; view is southeast featuring the façade and north elevation.

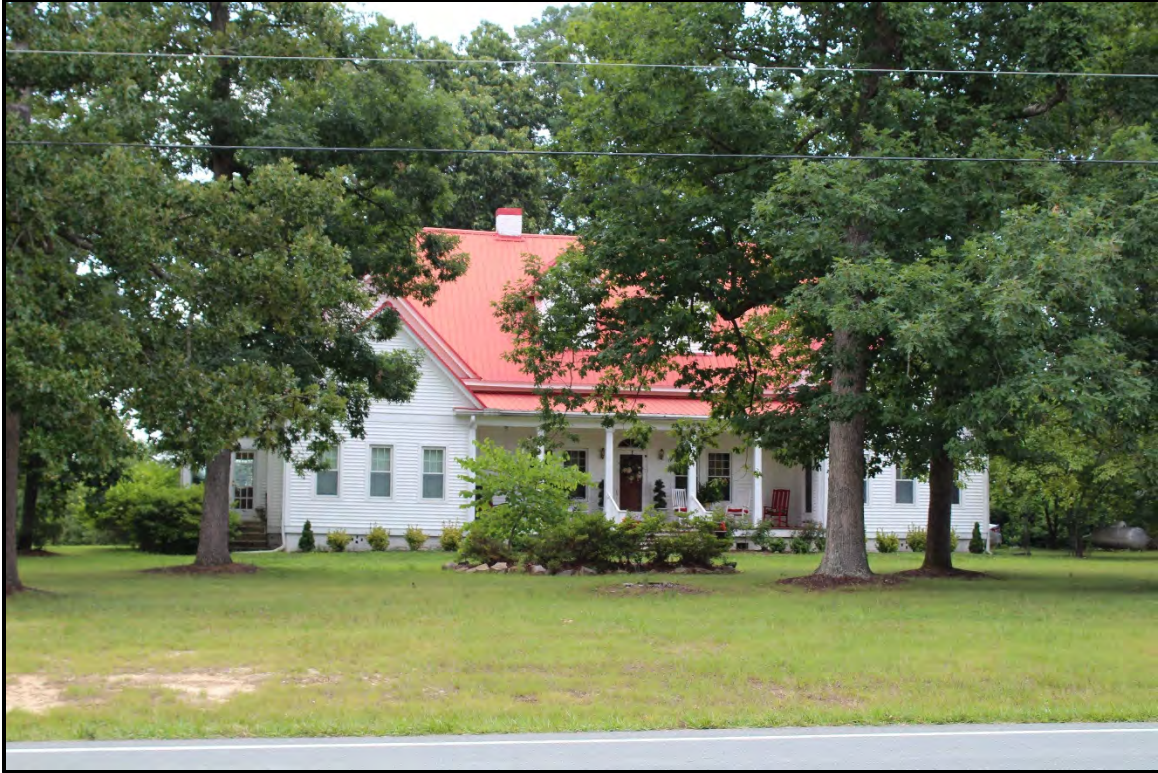
The one and one-half story, wood-frame building features a hipped-gabled roof covered with standing seam metal, an interior brick chimney, an exterior clad with vinyl siding, a foundation composed of brick, and 6/1 double-hung vinyl sash windows. Facing west, the façade is marked with a central door that is topped with a fanlight. A center bay porch containing a wood deck provides access to the main entrance. The porch is shielded by a shed roof that is supported by four posts that appear to be composed of synthetic material. Flanking the central bay are projecting gable bays that are accented with corner returns and three 6/1 double-hung vinyl sash windows.

Figure 6.46. Architectural resource AM0157; view is east featuring the façade.

NRHP Assessment. In accordance with NRHP Criteria Consideration B, moved properties are normally not eligible for the NRHP unless they are of architectural significance, or are the surviving structure most importantly associated with a historic event or person. The current building on the parcel does not exhibit a distinctive architectural style or workmanship and has received significant exterior alterations since its initial recordation in 1978. Due to its lack of historic and architectural significance it is TRC's opinion that architectural resource AM0157 is not eligible for the NRHP.

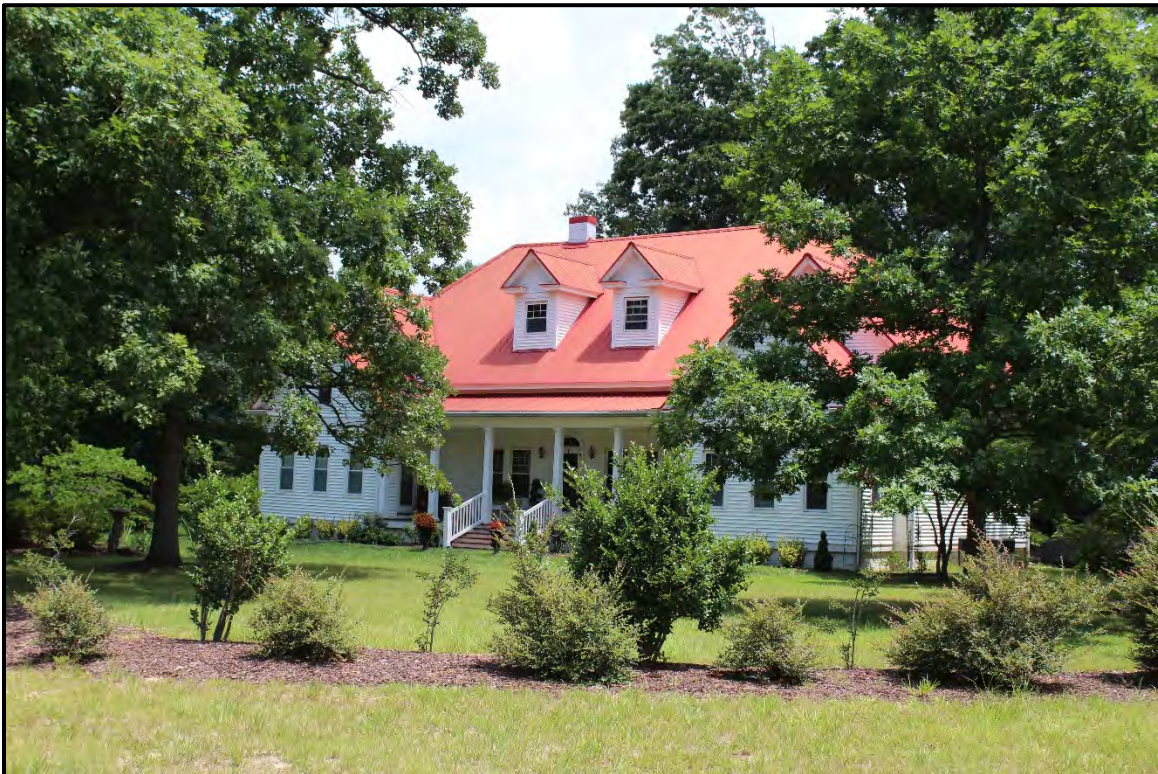
Figure 6.47. Architectural resource AM0157; view is north featuring the façade and a portion of the north elevation.

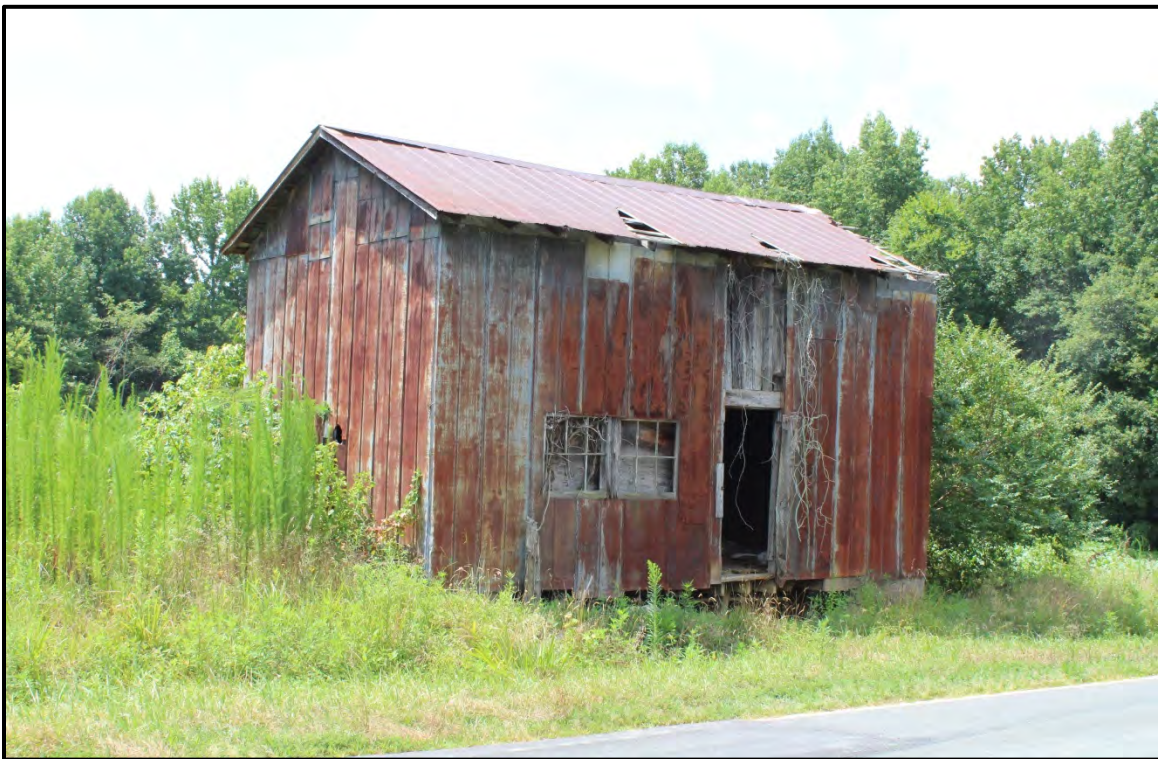
The Wood-frame structure features a side-gabled roof covered with standing seam metal, an exterior clad with metal siding, and a concrete block foundation. Facing north, the structure includes a pair of 6-light wood sash windows that are positioned east of a centrally placed door opening.

Figure 6.48. Architectural resource AM2499; view is northeast featuring the façade and west elevation.

NRHP Assessment. Architectural resource AM2499 does not exhibit distinctive characteristics of architectural style or workmanship. Based on the lack of architectural merit, as well as the inability to associate the structure and/or its original owner(s) with an important historical event or series of events, it is TRC's opinion that architectural resource AM2499 is not eligible for the NRHP.

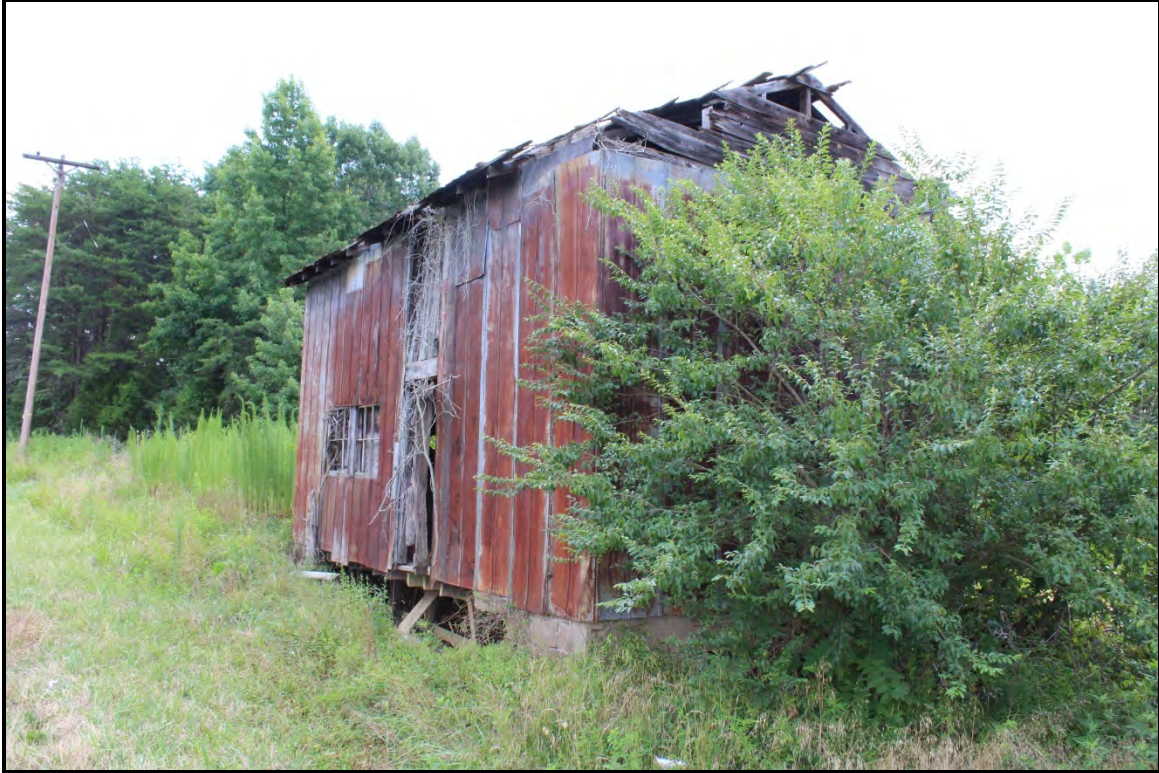
Figure 6.49. Architectural resource AM2499; view is west featuring the façade and east elevation.

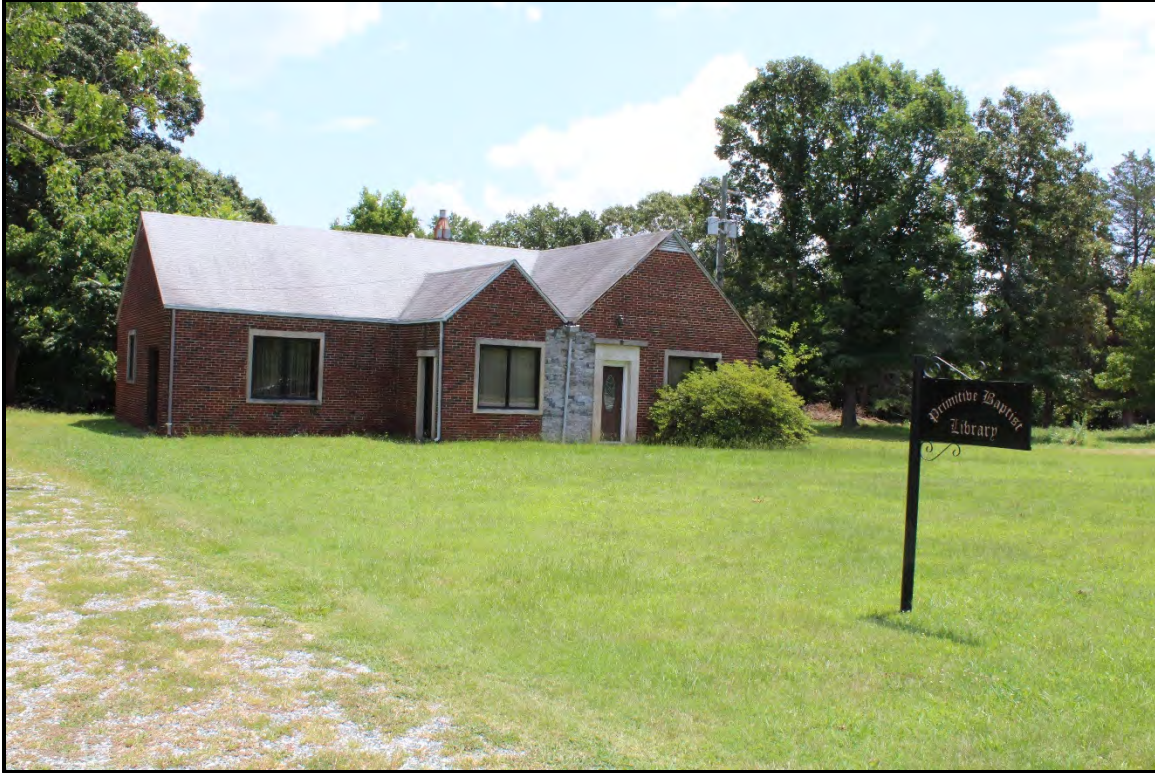
Figure 6.50. Architectural resource AM1527; view is southeast featuring the façade and north elevation of the library building.

NRHP Assessment. In 2002, the HPO added architectural resource AM1527 to the HPO Study List under Criterion C for its architectural significance (Crow 2002). Based on TRC’s architectural survey, the library and the associated book depository building do not appear to have been altered since they were added to the Study List. Architectural resource AM1527 appears to be a good local example of a late Tudor Revival style building. For these reasons, it is TRC’s opinion that AM1527 is potentially eligible for the NRHP under Criterion C for its significance as a local example of Tudor Revival architecture.

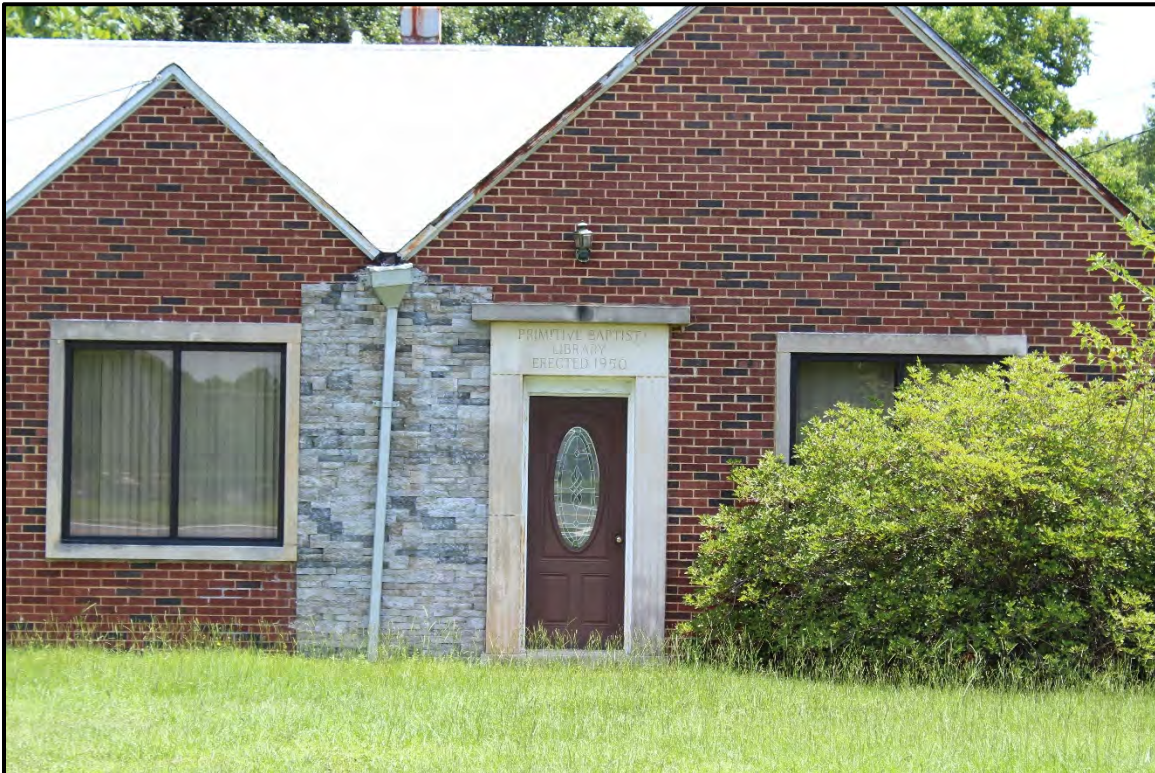
Figure 6.51. Architectural resource AM1527; detail view of the library door surround; view is east.

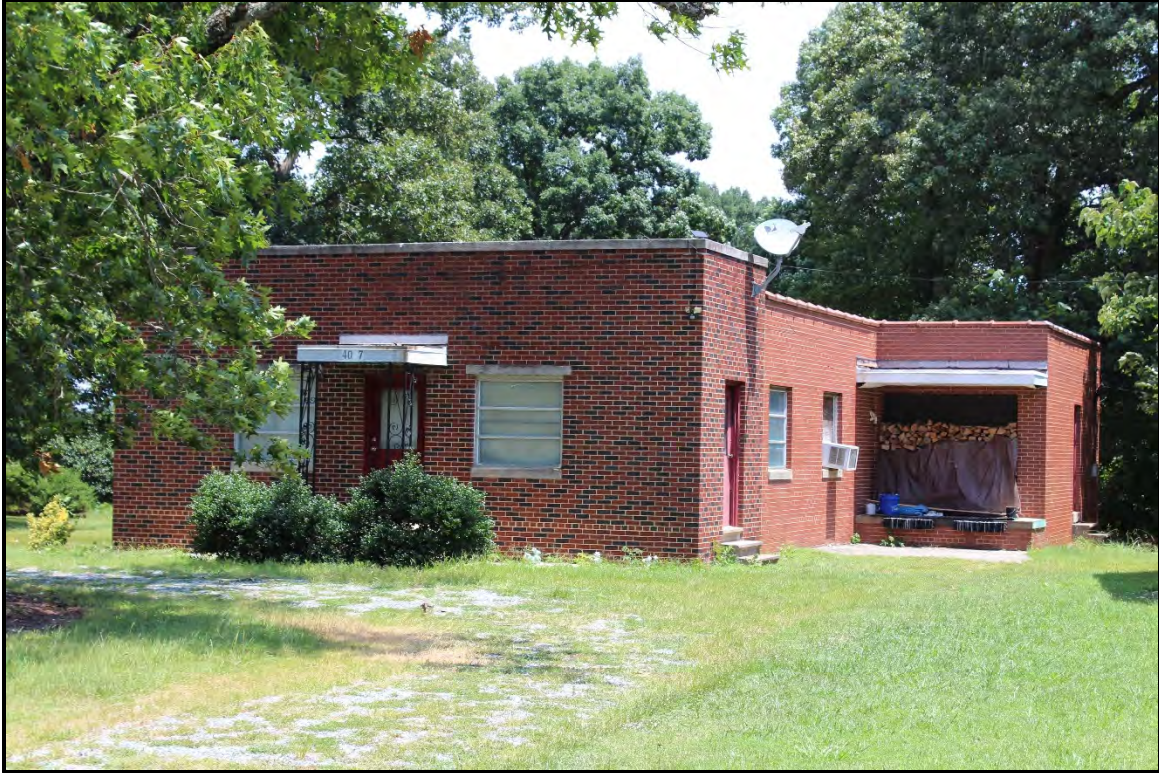
Located north of the library is a single-story building that appears to be associated with the library and may have functioned as a book depository (Figure 6.51). The masonry-frame building features a flat roof with clay tile coping, an exterior clad with a brick veneer, and a brick foundation. Facing west, the façade includes a central entrance that is flanked on either side by a three-light metal sash window. A center bay concrete stoop provides access to the main entrance. The stoop is shielded by a flat metal roof that is supported by two decorative metal posts. A loading dock containing a single bay is positioned on a south elevation wing.

Figure 6.52. Architectural resource AM1527; view is northeast featuring the façade and south elevation of the book depository building.

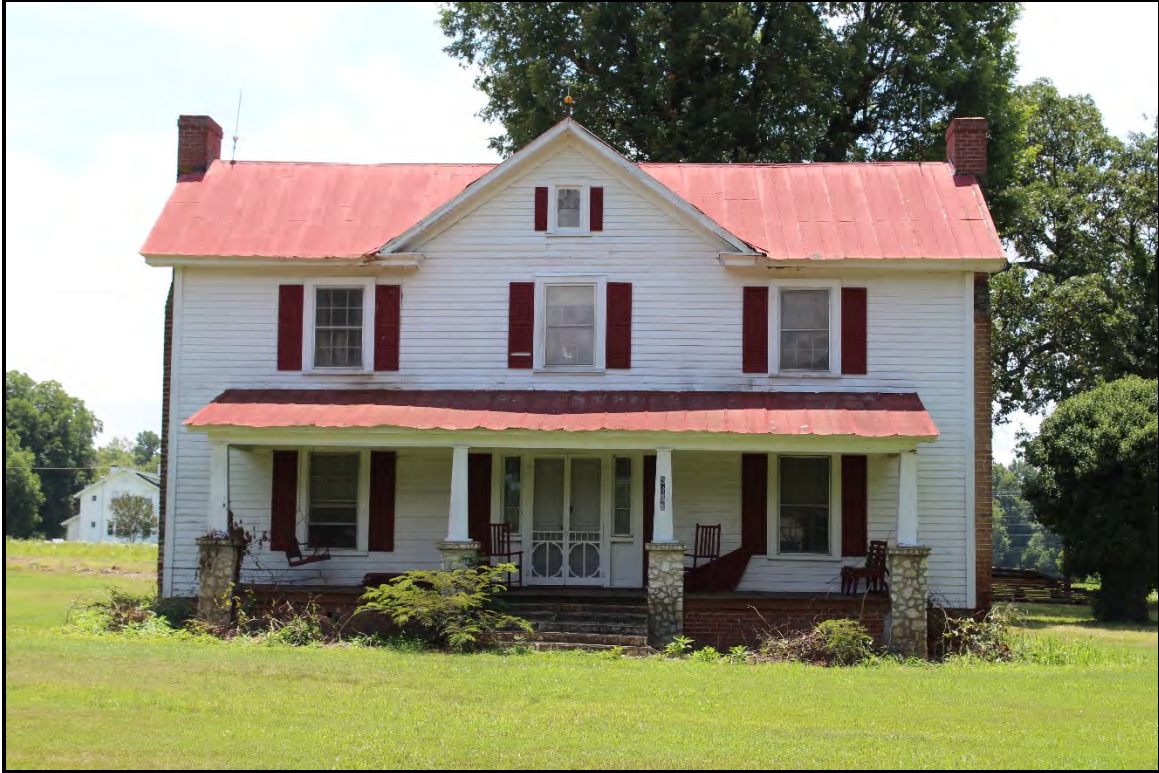
The two and one-half story, wood-frame building features a side-gabled roof covered with standing seam metal, an exterior clad with weatherboard siding, a foundation composed of brick, and 6/6 double-hung wood sash windows. Facing north, the façade is marked with a central door opening that contains a pair of paneled leaves. The door opening is accented with flanking sidelights with three panes above a lower panel. A single window opening flanks the main entrance, which is accessible via a full-width porch that contains a wood deck. The bungalow-influenced porch was likely added to the house in ca. 1930 and features a brick foundation and a shed roof that is supported by four tapered square posts atop plinth blocks composed of coursed fieldstone. Three window openings are symmetrically located along the second story. Situated in the half story is a centrally placed wall dormer with cornice returns and a 6/1 double-hung wood sash window. Both the east and west elevations of the house are marked by an exterior end brick chimney and cornice returns. Although access to the property was limited to the public right-of-way, TRC observed a two-story rear ell that appears to date to the original construction of the house.

Figure 6.54. Architectural resource AM0160; view is south featuring the façade.

NRHP Assessment. Architectural resource AM0160 does not exhibit distinctive characteristics of architectural style or workmanship. In addition, the house has been altered through the construction of the Craftsman-style porch on the façade following the property’s period of significance. Moreover, the integrity of the property has been diminished through the recent demolition of an associated barn. Based on the lack of architectural merit, as well as the inability to associate the house and/or its original owner(s) with an important historical event or series of events, it is TRC’s opinion that architectural resource AM0160 is not eligible for the NRHP.

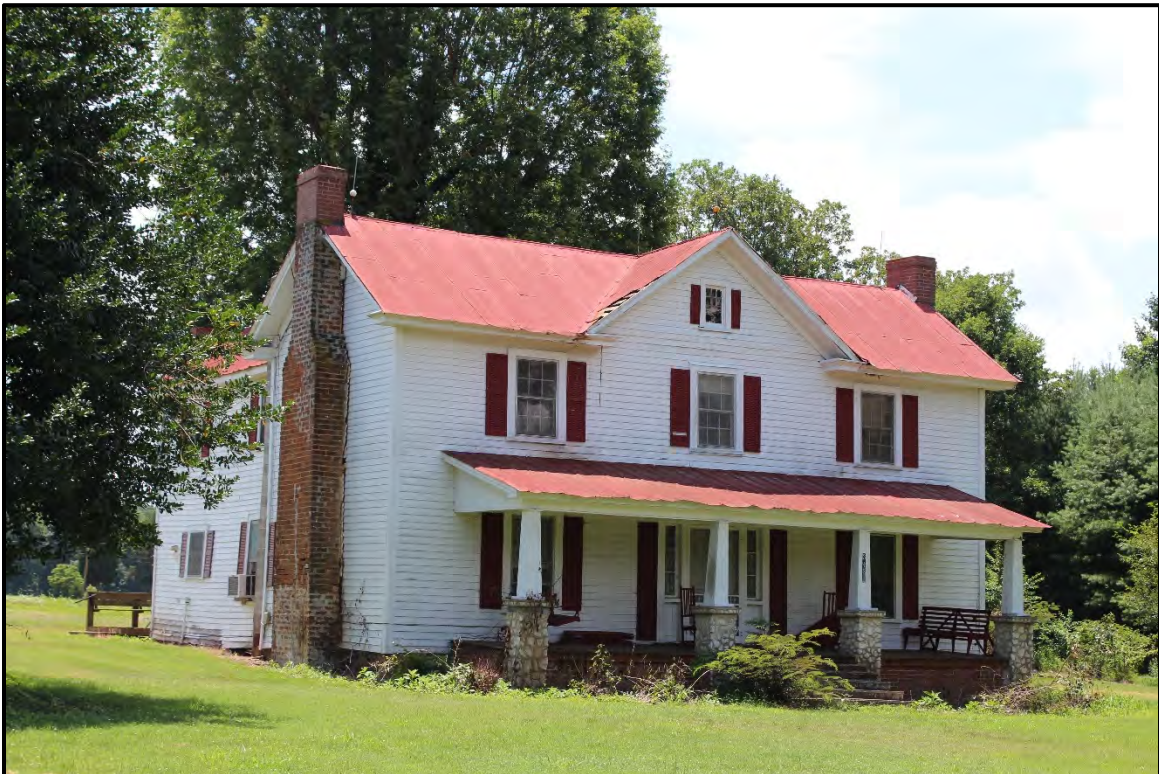
Figure 6.55. Architectural resource AM0160; view is southwest featuring the façade and the east elevation.

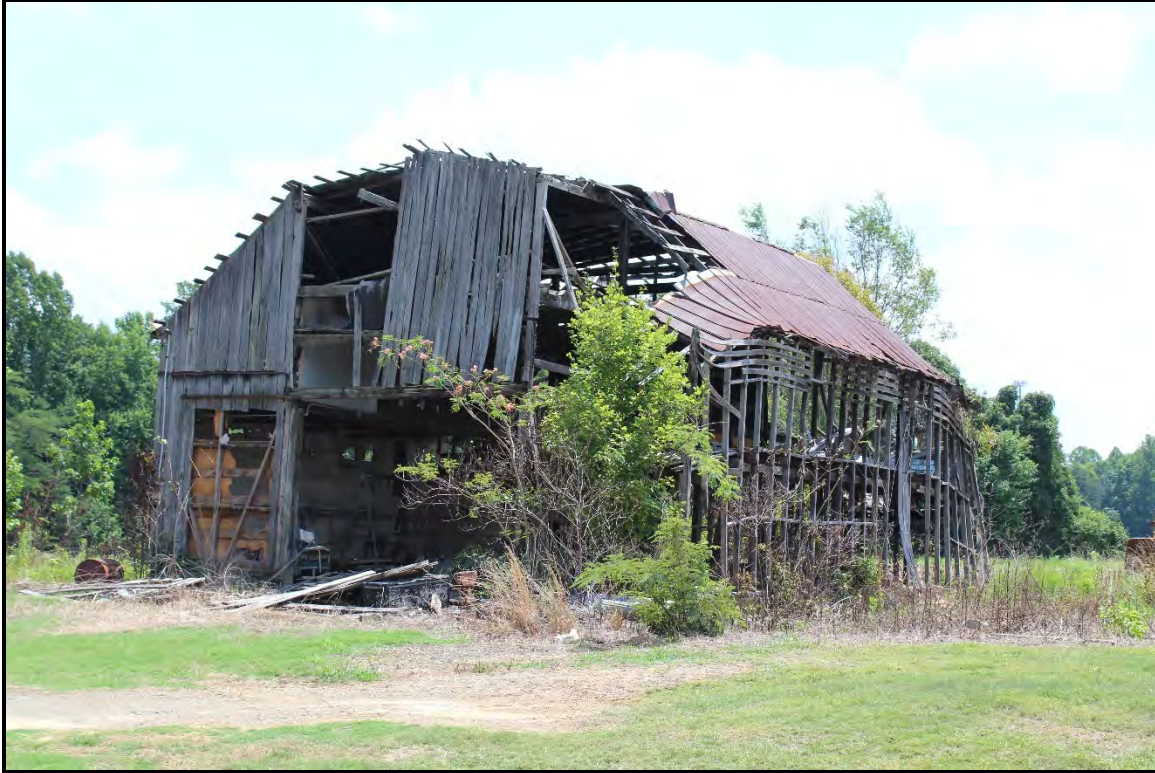
Figure 6.56. Architectural resource AM0160; 2018 photo of the demolished barn identified in the draft report.

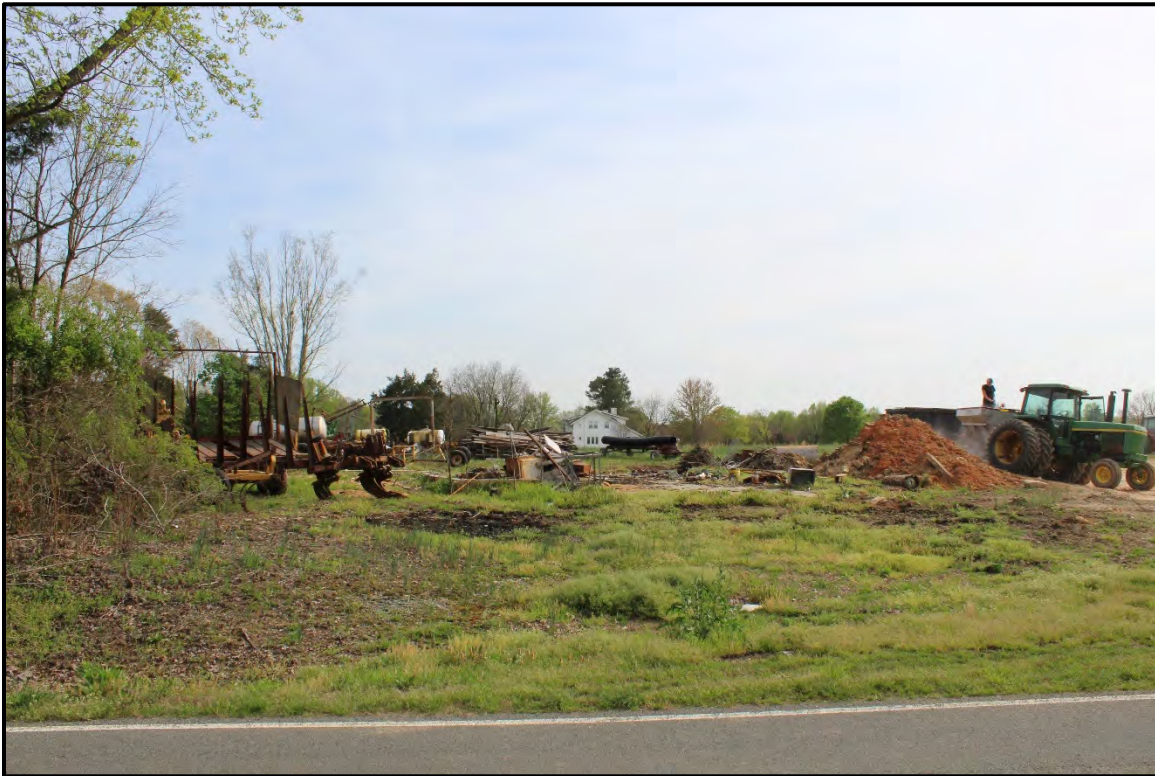
Figure 6.57. Architectural resource AM0160; site of the associated barn documented in 2018.

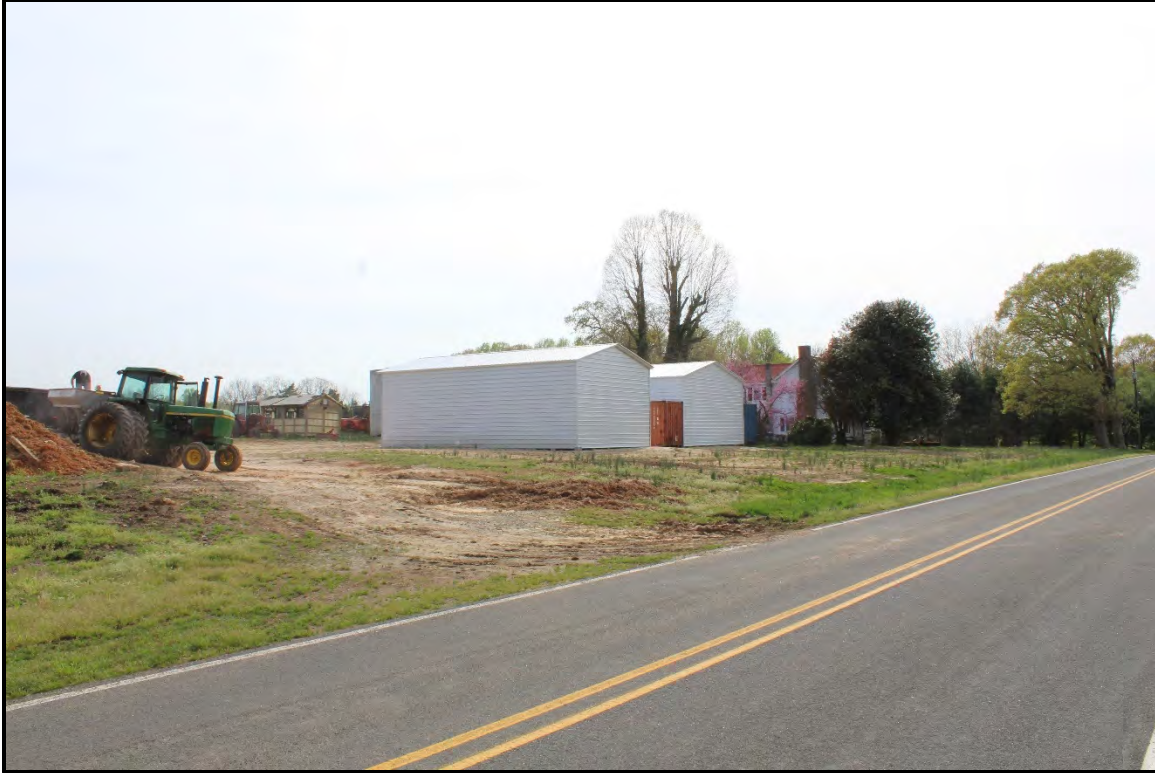
Figure 6.58. Architectural resource AM0160; view is southwest featuring modern warehouses adjacent to the house.

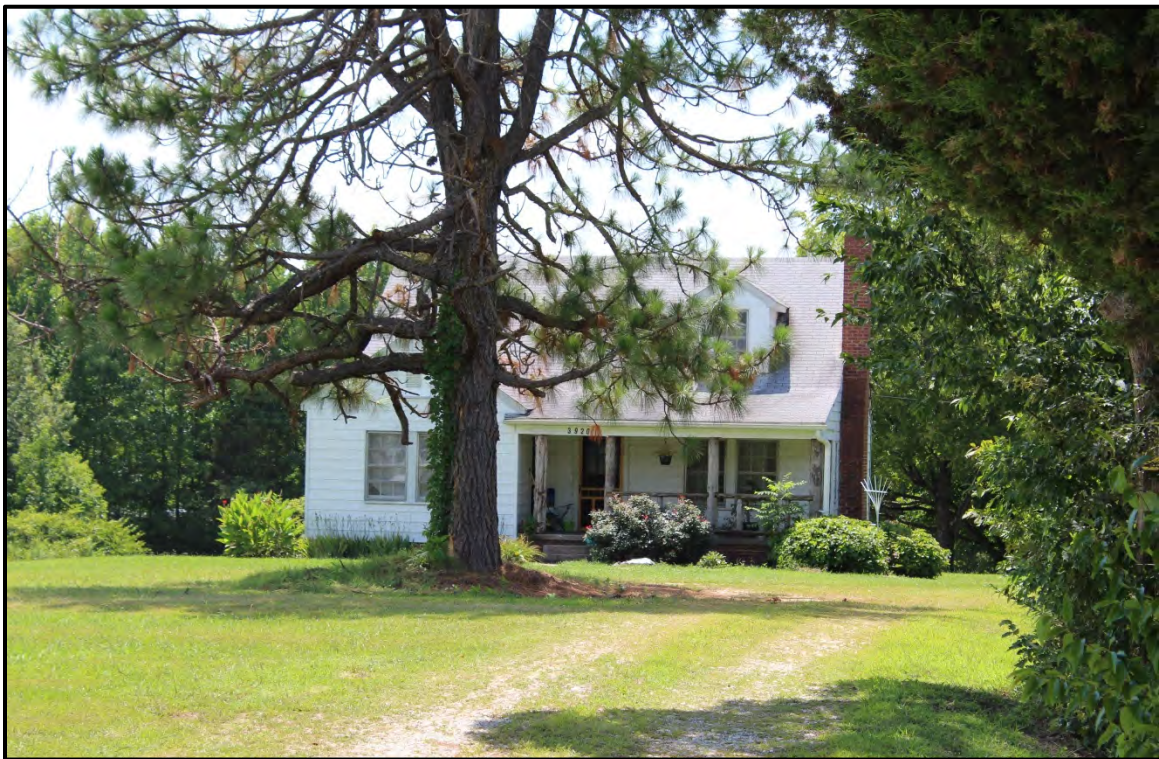
The one and one-half story, wood-frame building features a side-gabled roof covered with asphalt shingles, an exterior clad with aluminum siding, a brick foundation, and double hung 6/6 wood sash windows. Facing east, the façade includes a centrally placed entrance that is flanked to the north by a paired window. A partial-width porch with a concrete deck provides access to the façade door. The porch is shielded by a shed roof that is supported by four unfinished log columns. Located south of the porch is projecting gable bay with a paired window. Situated in the half story is a gable dormer with a single window. The north elevation has an exterior end brick chimney.

NRHP Assessment. Architectural resource AM2502 does not exhibit distinctive characteristics of architectural style or workmanship. In addition, the house has been altered through the application of aluminum siding and the replacement of the original porch columns. Based on the lack of architectural merit, as well as the inability to associate the house and/or its original owner(s) with an important historical event or series of events, it is TRC's opinion that architectural resource AM2502 is not eligible for the NRHP.

Figure 6.59. Architectural resource AM2502; view is west featuring the façade.

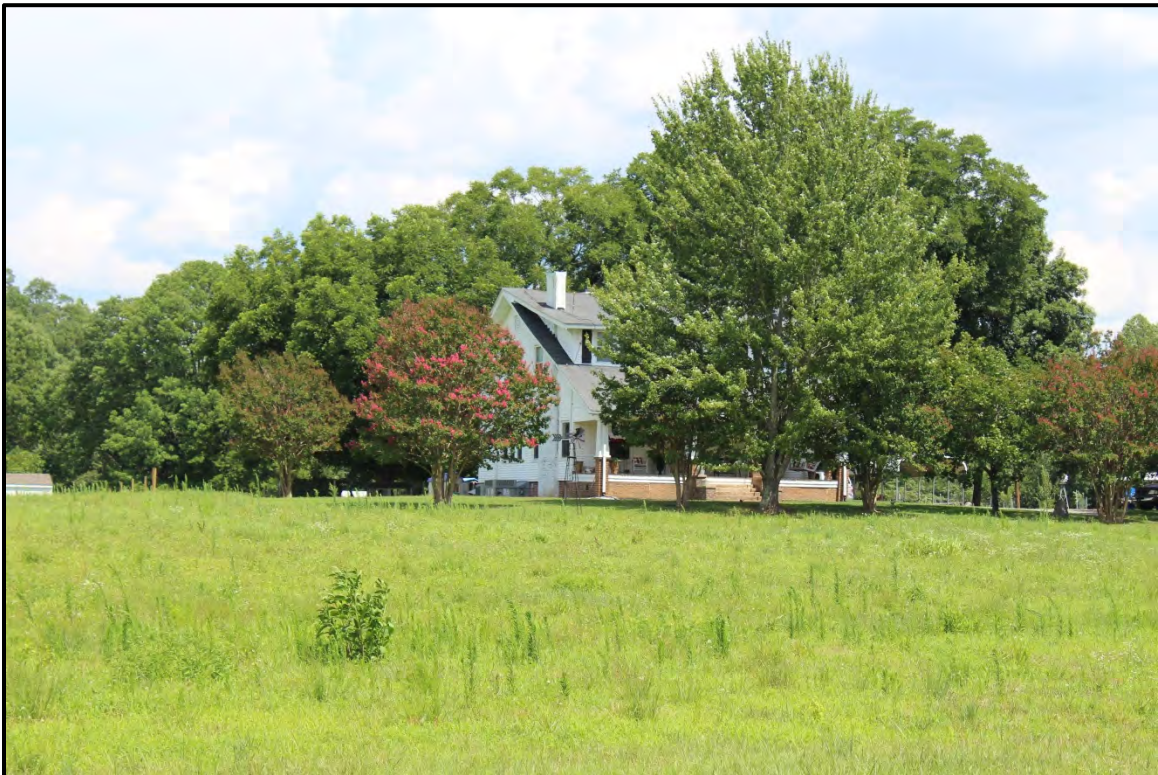
The two-story, wood-frame building features a side-gabled roof covered with asphalt shingles, two interior brick end chimneys, an exterior clad with vinyl siding, a brick foundation, and double hung 1/1 vinyl sash windows. Facing west, a full-width porch that is integral with the main roof provides access to the main entrance. The porch contains a concrete deck and tapered wood posts that rest atop brick plinth blocks. A full-width shed dormer pierced with a series of windows is located on the second story.

NRHP Assessment. Architectural resource AM2503 does not exhibit distinctive characteristics of its architectural style or workmanship. In addition, the house has been altered through the application of vinyl siding and the installation of vinyl sash windows. Based on the lack of architectural merit, as well as the inability to associate the house and/or its original owner(s) with an important historical event or series of events, it is TRC's opinion that architectural resource AM2503 is not eligible for the NRHP.

Figure 6.60. Architectural resource AM2503; view southeast featuring the façade and north elevation.

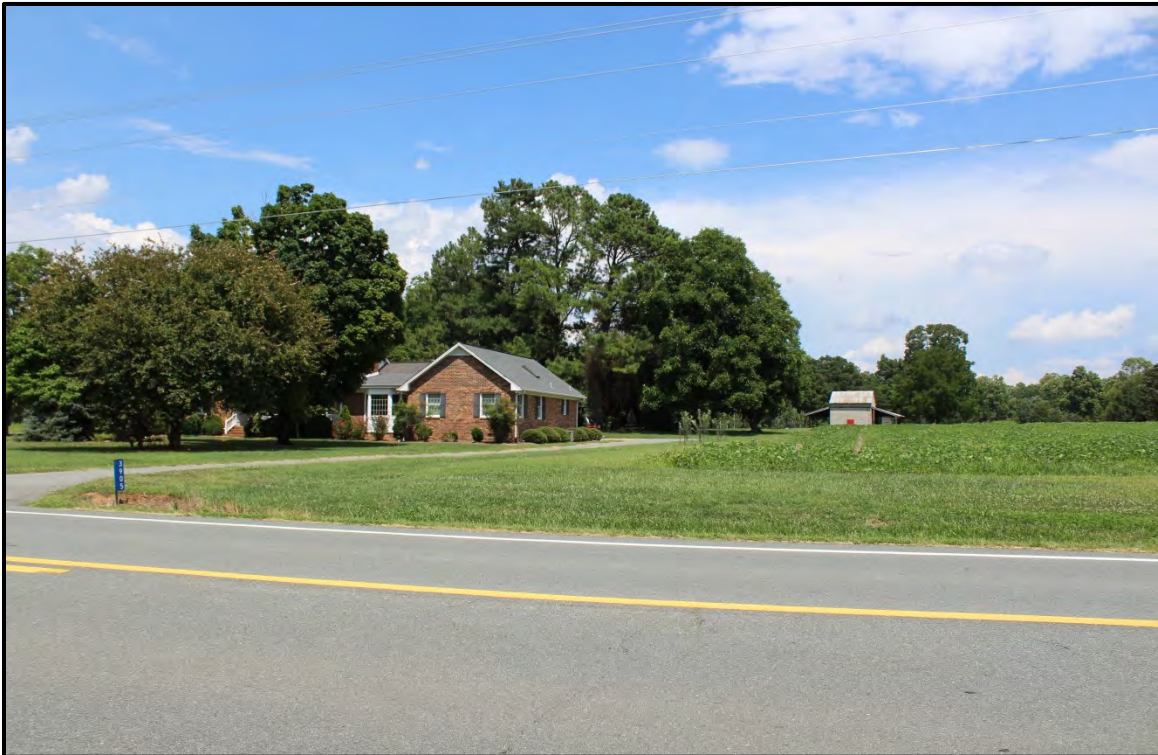
The one-story, wood-frame house features a gable-front-and-wing roof covered with asphalt shingles, an interior brick chimney, an exterior clad with a brick exterior, and a brick foundation. Windows are 8/8 vinyl sash. The façade features a recessed central porch offset on the north by a projecting multi-light window bay. The entry is off-center, and the porch elevation is clad with vinyl siding. Associated with the property is a concrete block tobacco barn with a gabled roof covered with standing seam metal. The barn has open shed wings attached to the north and south elevations.

NRHP Assessment. Architectural resource AM2500 does not exhibit distinctive characteristics of architectural style or workmanship. In addition, the house has been altered through the installation of vinyl sashes. Based on the lack of architectural merit, as well as the inability to associate the house and/or its original owner(s) with an important historical event or series of events, it is TRC’s opinion that architectural resource AM2500 is not eligible for the NRHP.

Figure 6.61. Architectural resource AM2500; view is northeast featuring the façade and south elevation.

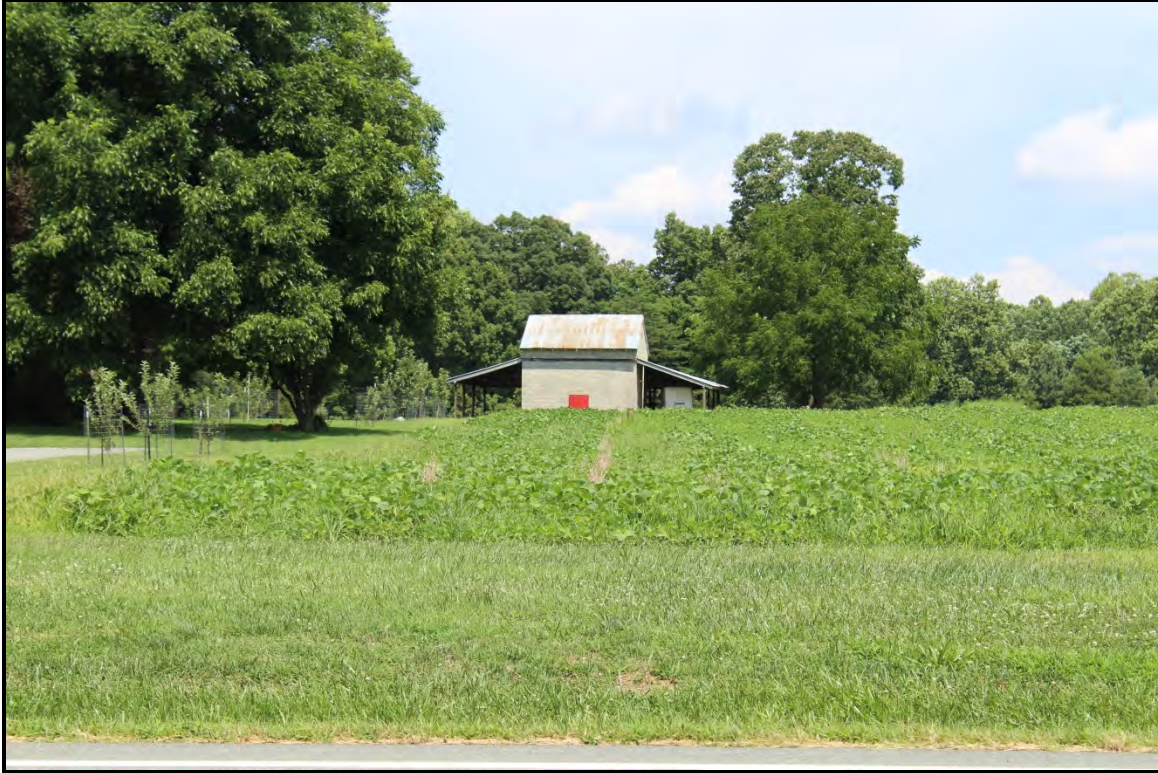
Figure 6.62. Architectural resource AM2500; view is east, featuring a mid-20th century barn.

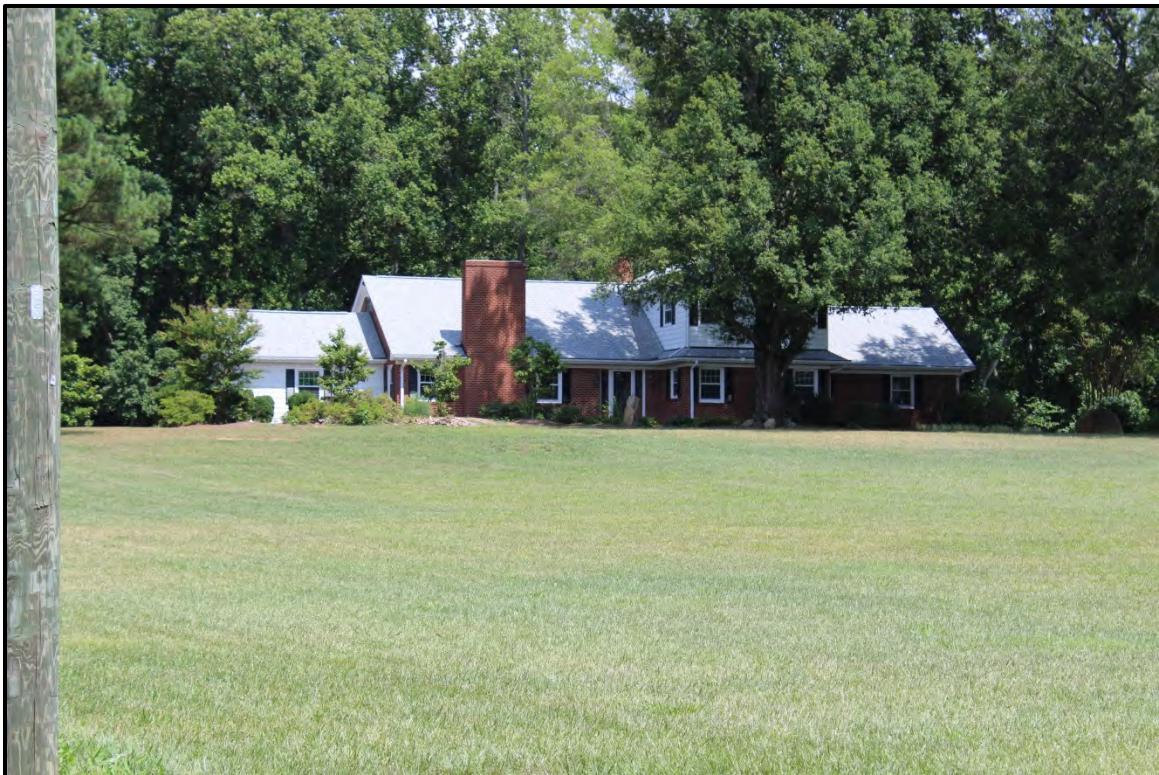
The wood-frame building features a side-gabled roof covered with asphalt shingles and an exterior clad with a brick veneer. Facing west, the façade is marked by a centrally placed two-story projecting bay. The central bay is capped with a front-gabled roof and is clad with vinyl siding on the second story. Located north of the center bay is the main entrance to the house followed by an exterior brick chimney. Windows throughout the house consists of 8/8 vinyl sashes.

NRHP Assessment. Architectural resource AM2501 does not exhibit distinctive characteristics of architectural style or workmanship. In addition, the house has been altered through the installation of vinyl sash windows and the construction of the second-story addition to the projecting central bay. Based on the lack of architectural merit and inability to associate the house and/or its original owner(s) with an important historical event or series of events, it is TRC's opinion that architectural resource AM2501 is not eligible for the NRHP.

Figure 6.63. Architectural resource AM2501; view is east featuring the façade.

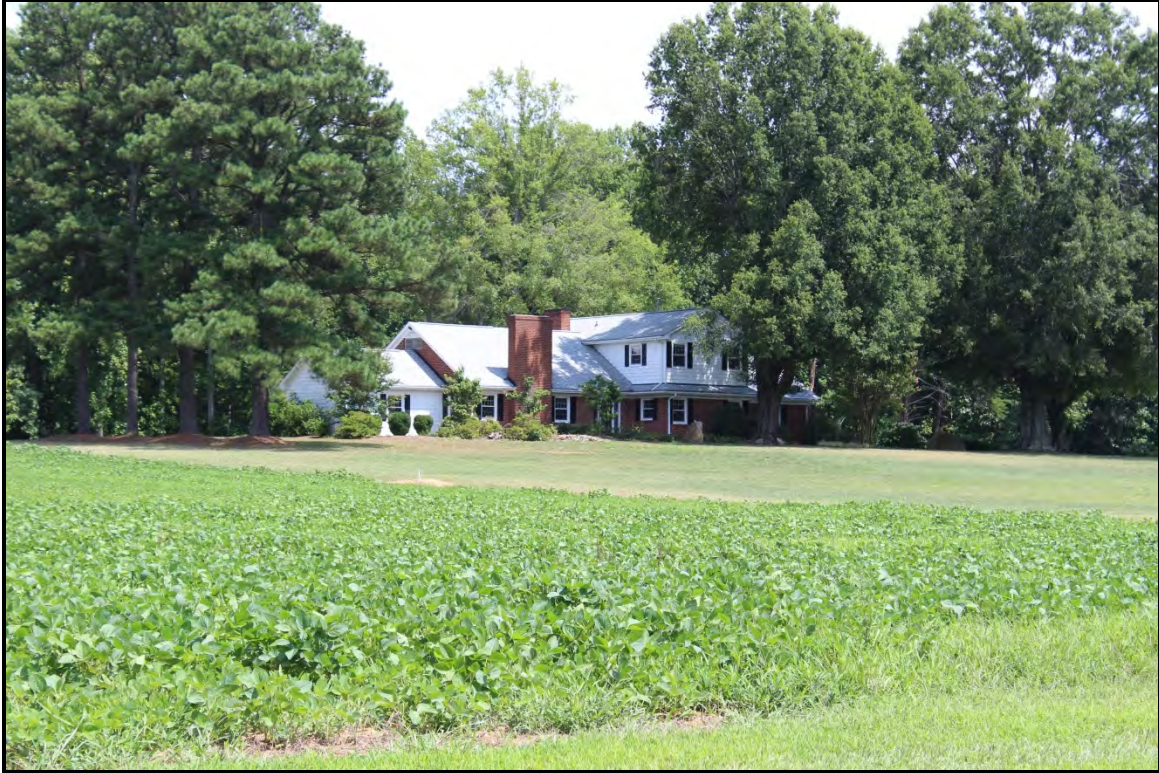
Figure 6.64. Architectural resource AM2501; view is southeast, featuring the façade and north elevation.

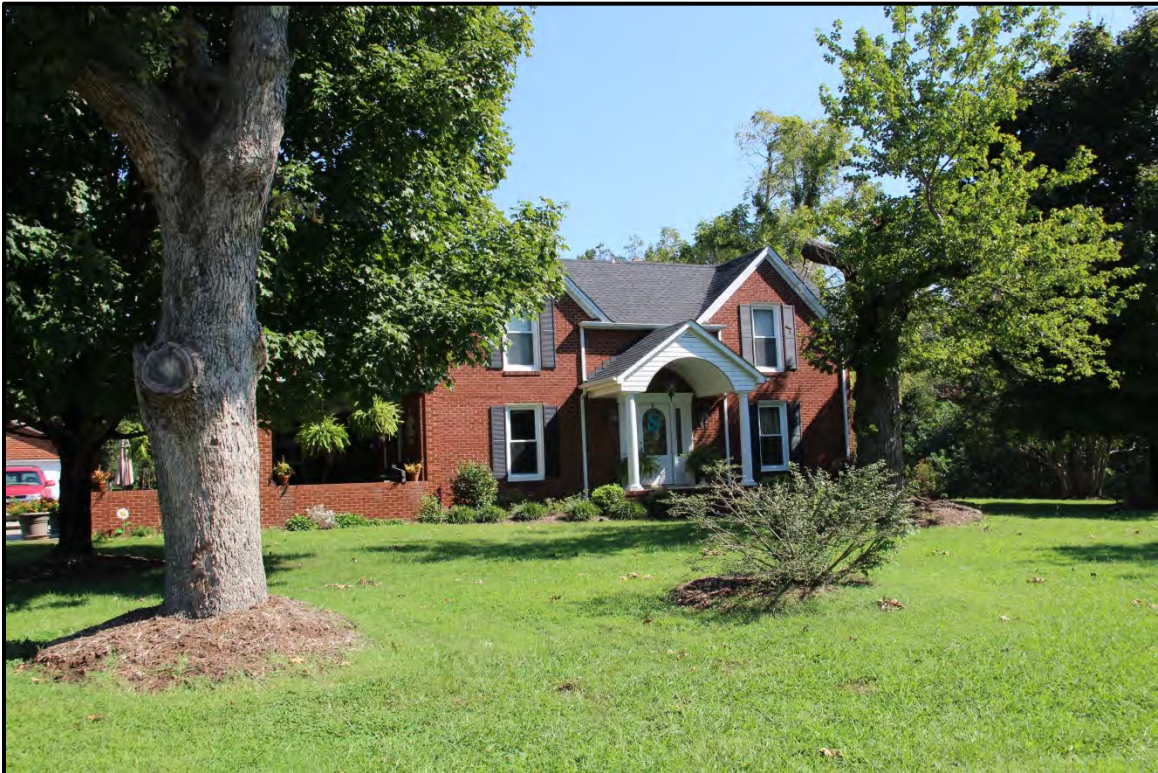
The two-story, wood-frame building has a side-gabled roof with two symmetrically placed gable wall dormers on the façade. The house is clad with a brick veneer and has a brick foundation. Windows are 1/1 replacement. The façade features a central one-story gabled porch with Tuscan columns. The entry within the porch holds an arched light paneled door flanked by slender sidelights. At the south end of the house is a brick porch which holds a secondary entry that faces north. The porch extends to the west, connecting to a contemporary one-story wing that has sliding glass doors and a multi-light door (north elevation). The rear (west) elevation has a single-story shed wing with replacement windows. Situated west of the house is a brick well house with a gabled roof. Outbuildings include a brick garage, a log two-story tobacco barn with a one-story open wing and metal clad gabled roof, and a single-story gable-front shed with horizontal siding and a metal clad roof.

Figure 6.65. Architectural resource AM2504; view northwest featuring the façade.

NRHP Assessment. Architectural resource AM2504 does not exhibit distinctive characteristics of architectural style or workmanship. In addition, the house has been altered through the application of a modern brick veneer, the installation of vinyl sash windows, and the construction of a rear addition. Based on the lack of architectural merit, as well as the inability to associate the house and/or its original owner(s) with an important historical event or series of events, it is TRC's opinion that architectural resource AM2504 is not eligible for the NRHP.
