Re: Revised Architectural Survey Report, MVP Southgate Project, Construct Interstate Pipeline, Rockingham and Alamance County, ER 18-1041

Thank you for your letter of October 11, 2019, transmitting the draft "Historic Architectural Survey for the MVP Southgate Pipeline Project". We have reviewed the report and offer the following comments.

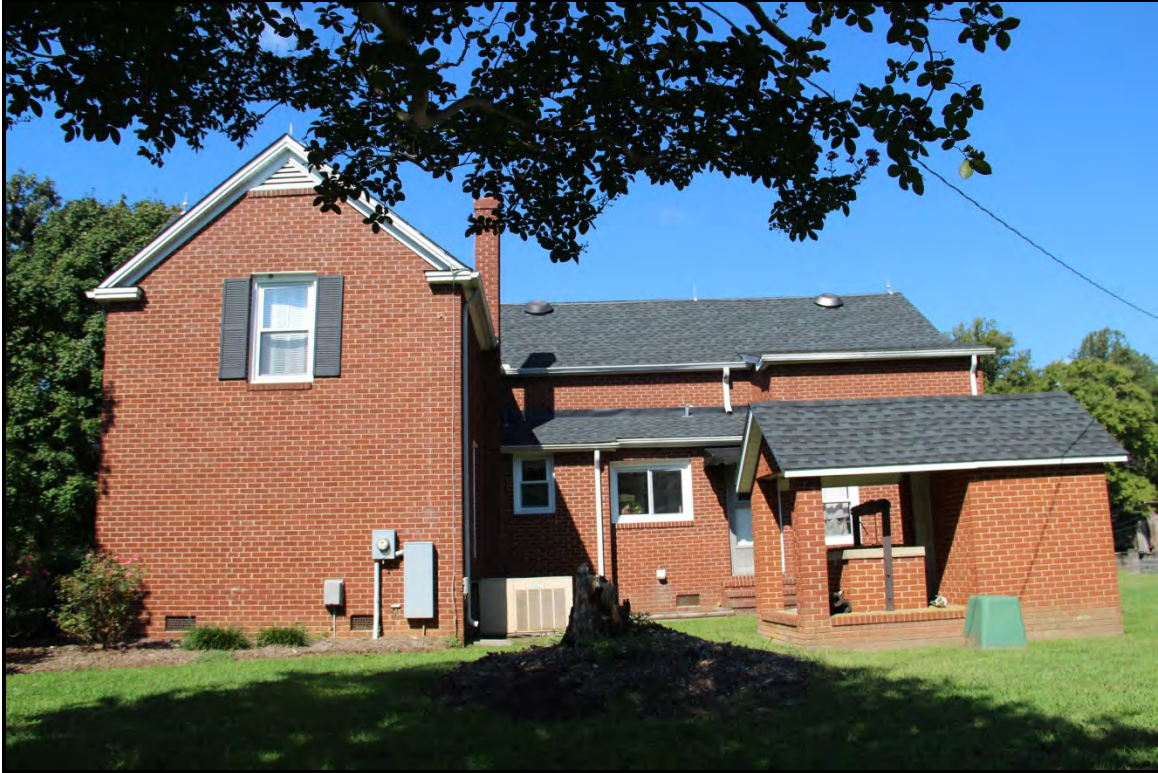
Figure 6.66. Architectural resource AM2504; view is east, featuring the rear elevation and well house.

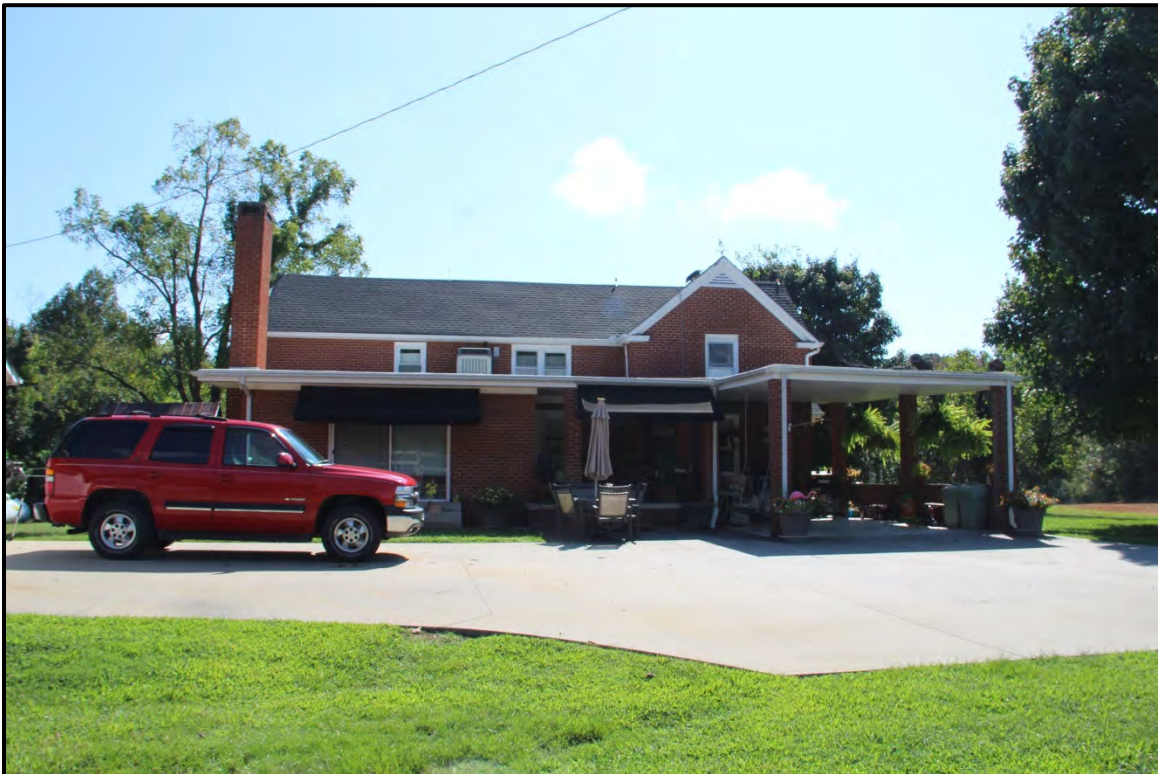
Figure 6.67. Architectural resource AM2504; view is south, featuring the north elevation.

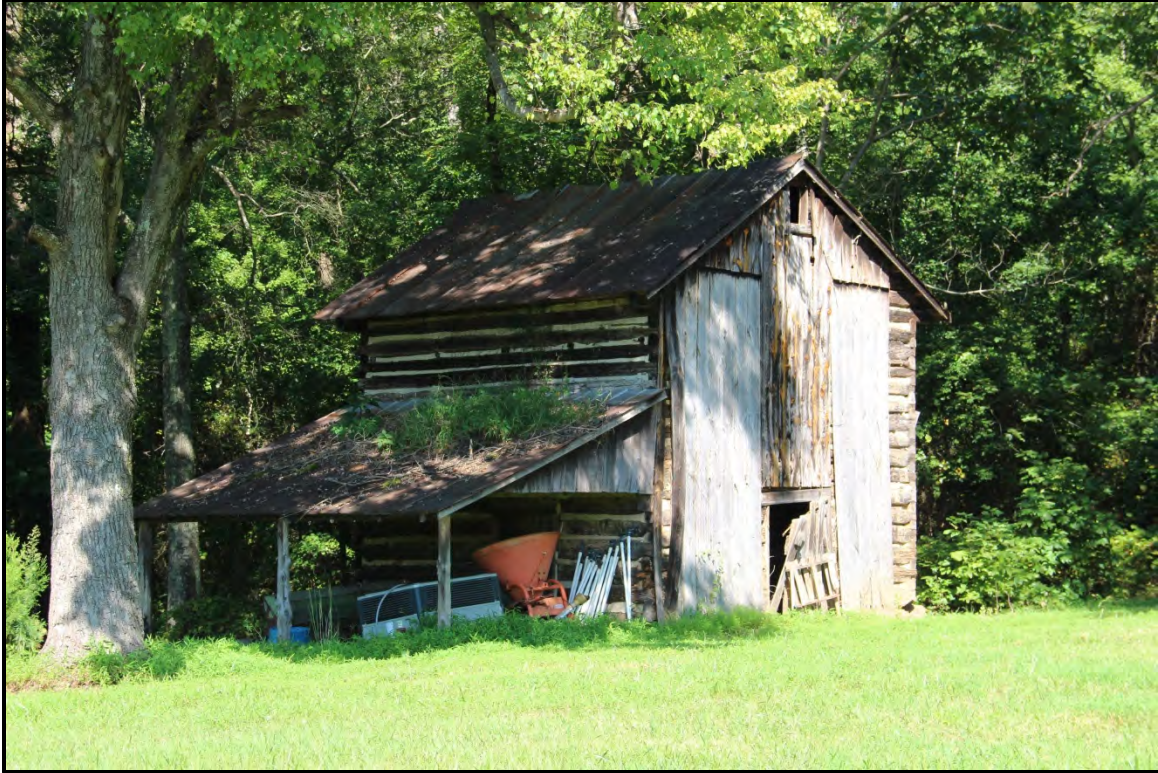
Figure 6.68. Architectural resource AM2504; view of log barn.

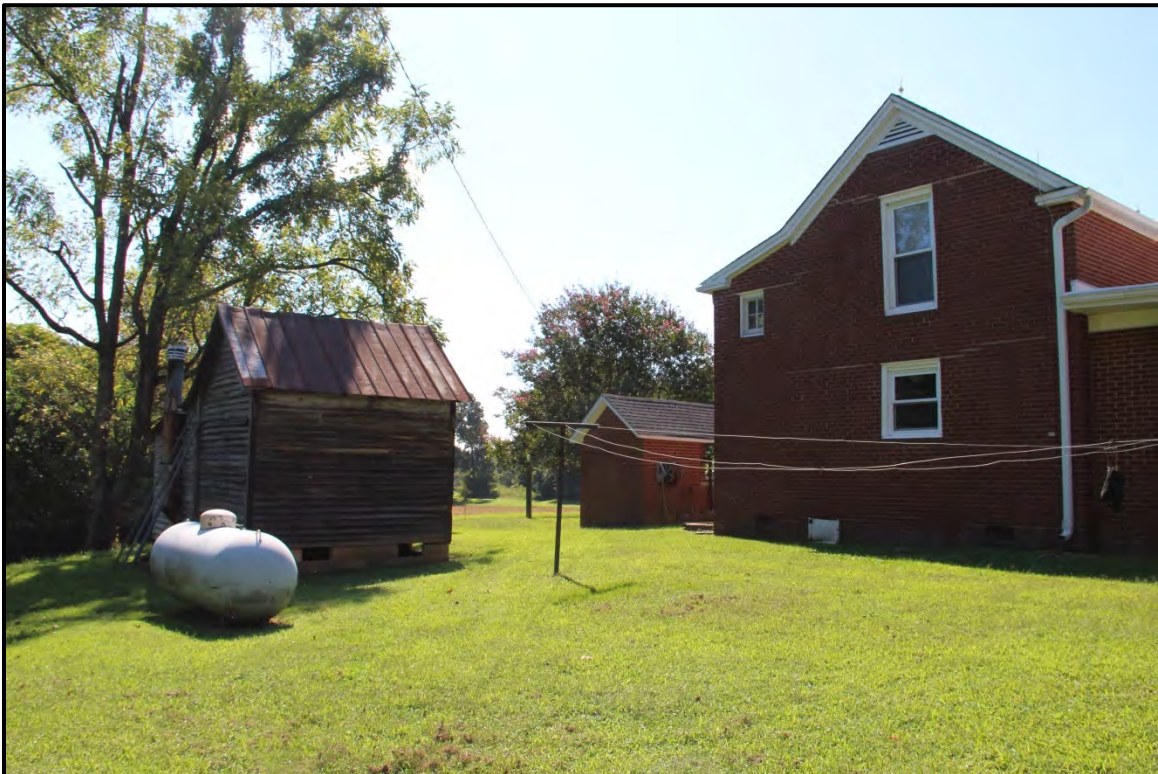
Figure 6.69. Architectural resource AM2504; view is southeast, featuring outbuildings and side elevation.

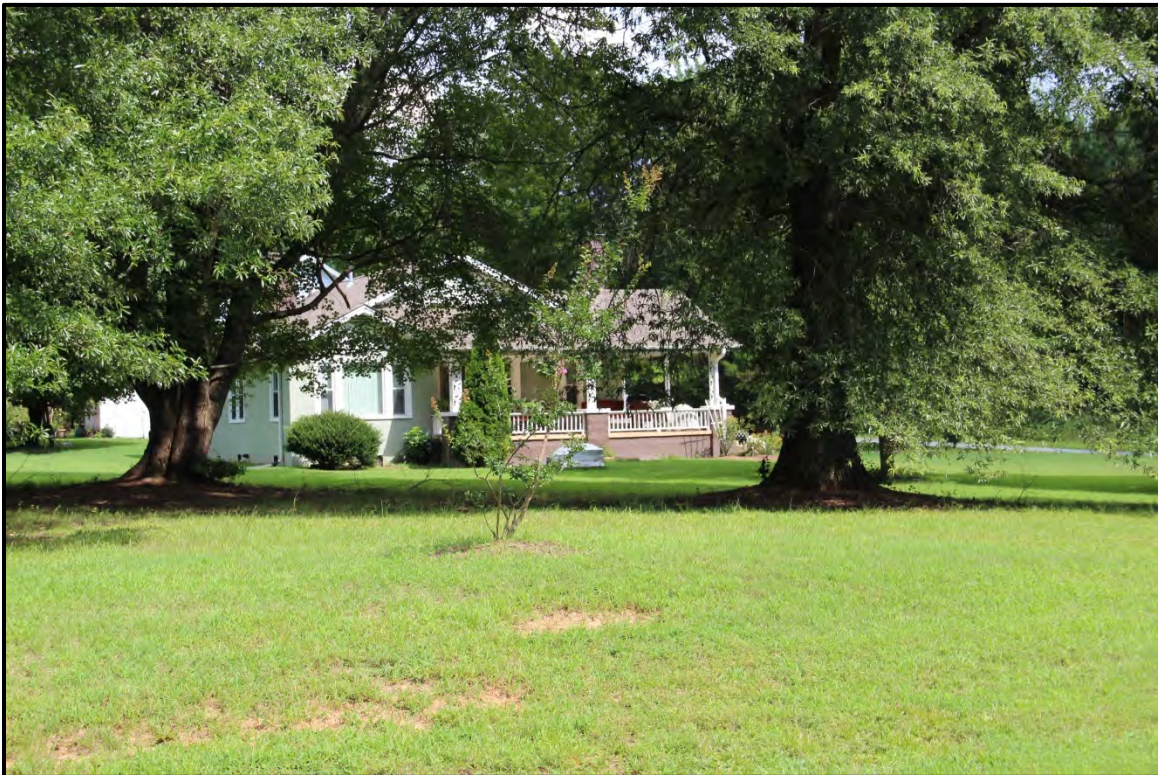
The one-story, wood-frame building features a gable-front roof covered with asphalt shingles, an interior brick chimney, and an exterior clad with stucco. The asymmetrical façade is dominated by a partial-width wraparound front porch with a side-gable roof, decorative iron posts set on parged plinths, and a poured concrete deck. There is a central entrance flanked by two, three-part picture windows with replacement 1/1 vinyl sashes. There are single and paired 1/1 vinyl sash windows throughout the rest of the house.

NRHP Assessment. Architectural resource AM2505 does not exhibit a distinctive architectural style or workmanship. In addition, the house has been altered through the installation of vinyl sash windows. Based on the lack of architectural merit, as well as the inability to associate the house and/or its original owner(s) with an important historical event or series of events, it is TRC’s opinion that architectural resource AM2505 is not eligible for the NRHP.

Figure 6.70. Architectural resource AM2505; view is east featuring the façade and north elevation.

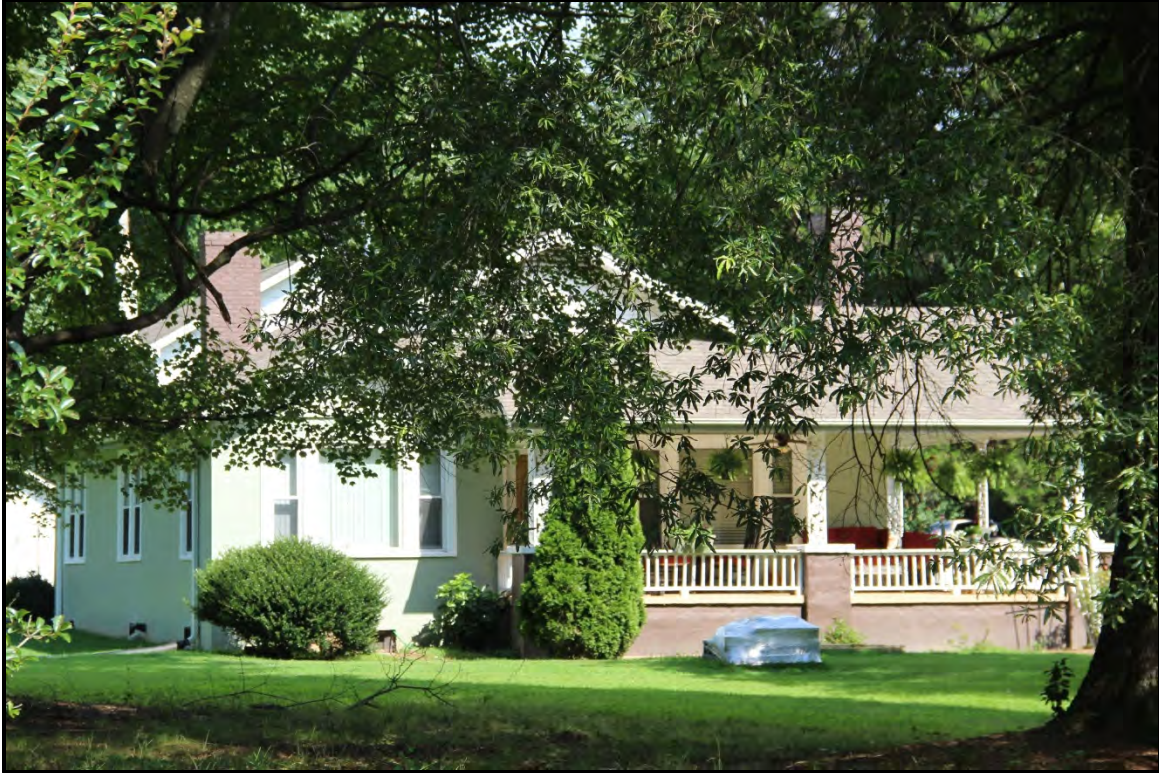
Figure 6.71. Architectural resource AM2505; zoomed-in view of the façade.

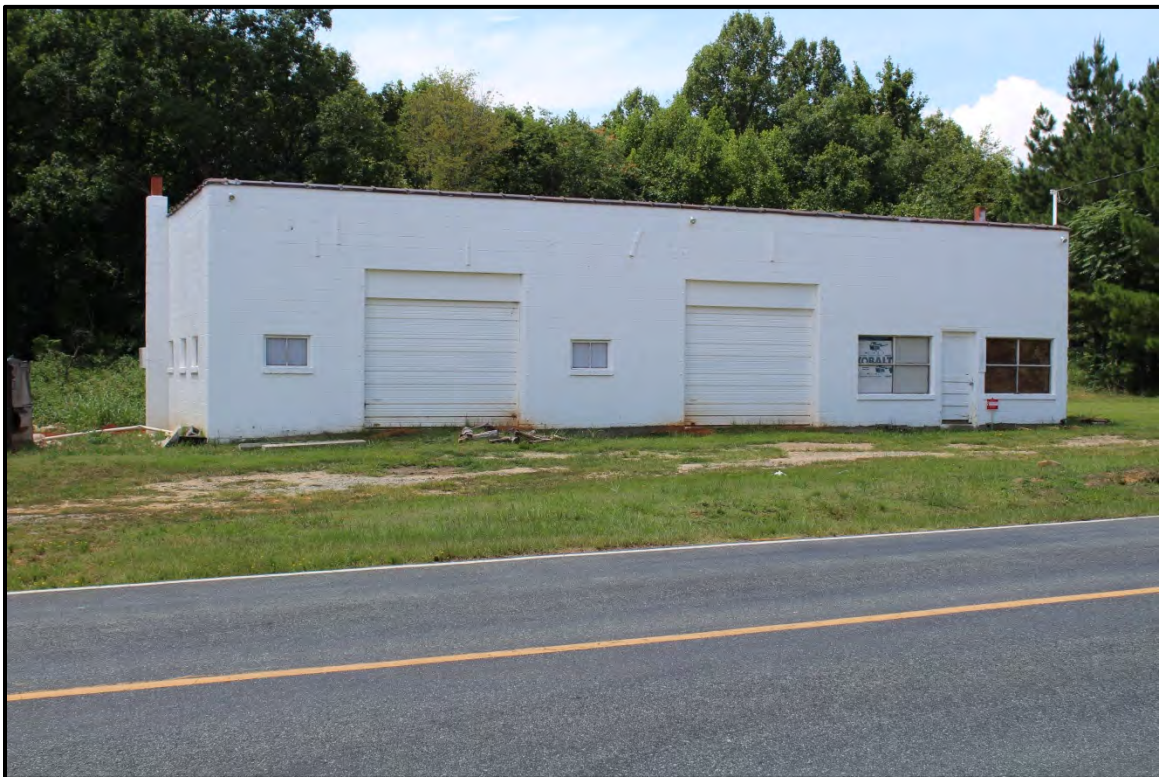
The one-story, concrete block building features a flat roof with terra cotta coping and a concrete slab foundation. Facing east, the façade has two garage bays containing overhead metal doors and a service office at the north end. The office area features a central entrance with a half-glass panel door flanked by four-light commercial windows. Between the garage bays and around the sides of the building are two-light horizontal sliding windows. There are exterior end concrete block chimneys on the north and south elevations. The pump island has been removed and the station is abandoned.

NRHP Assessment. Architectural resource AM2507 does not exhibit a distinctive architectural style or workmanship. Based on the lack of architectural merit, as well as the inability to associate the house and/or its original owner(s) with an important historical event or series of events, it is TRC's opinion that architectural resource AM2507 is not eligible for the NRHP.

Figure 6.72. Architectural resource AM2507; view is northwest featuring the façade.

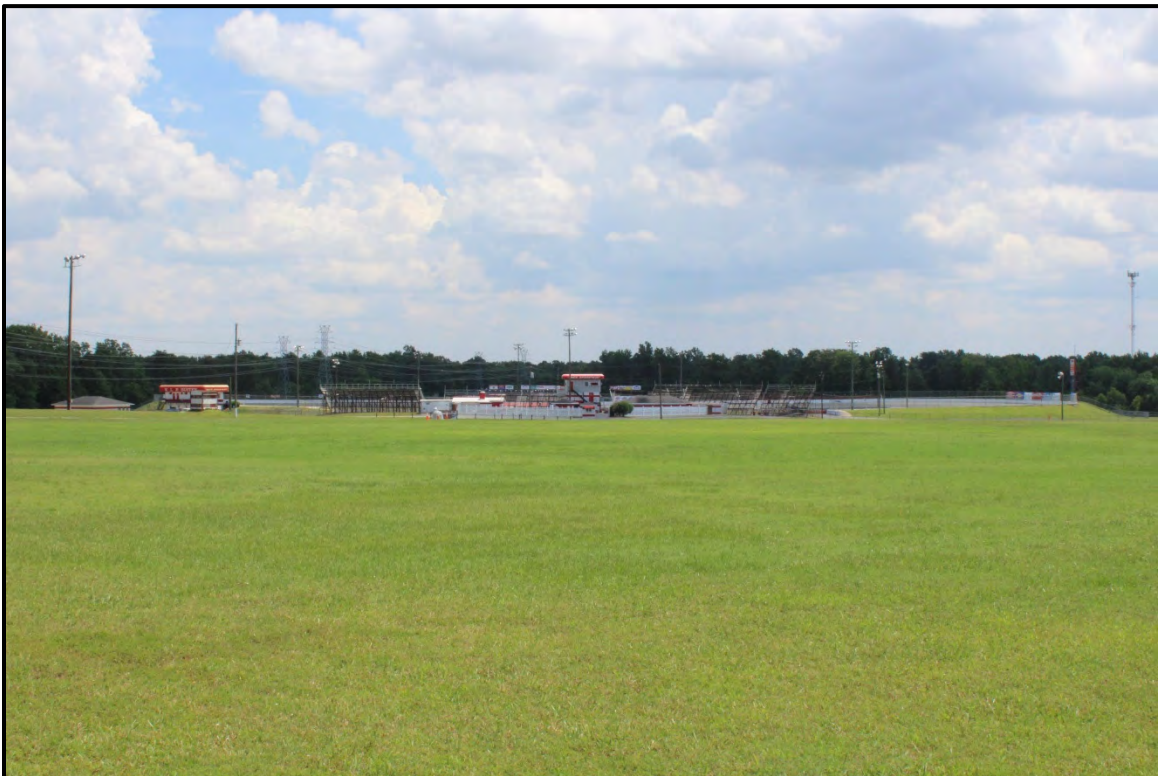
AM2506 contains a four-tenths of a mile asphalt track and a collection of buildings and structures, including a ticket booth, restrooms, concession stands, grandstands, VIP suites, and retaining walls. Originally built as a one-third mile dirt track in 1956, the track was expanded in size in 1984 and then paved in 1989. The track was expanded to its current length and many of its support buildings constructed in 1998 (Salvo 2006).

NRHP Assessment. Architectural resource AM2506 is associated with the history of automobile racing in Alamance County since the 1950s, but has been substantially altered since that time and does not retain integrity. The property does not exhibit a distinctive architectural style or workmanship. Due to a lack of physical integrity and architectural significance it is TRC’s opinion that architectural resource AM2506 is not eligible for the NRHP.

Figure 6.73. Architectural resource AM2506; view is southeast showing racetrack grounds.

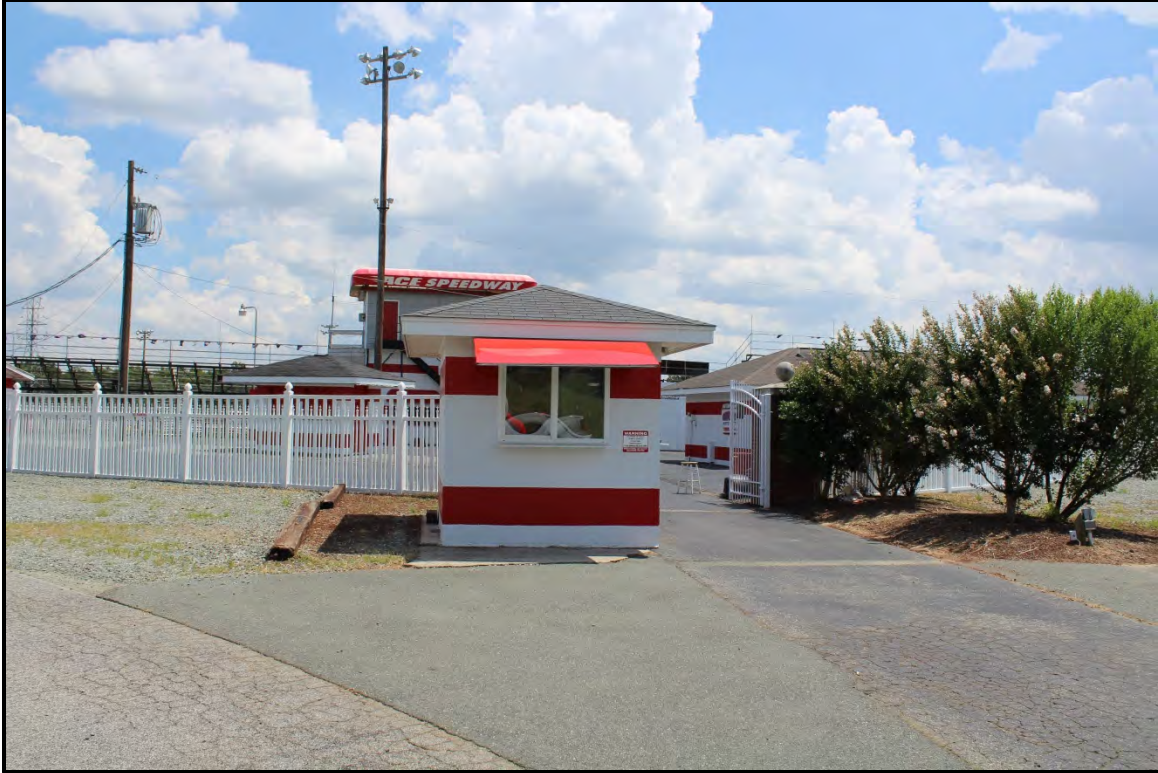
Figure 6.74. Architectural resource AM2506; view is southeast showing the ticket booth.

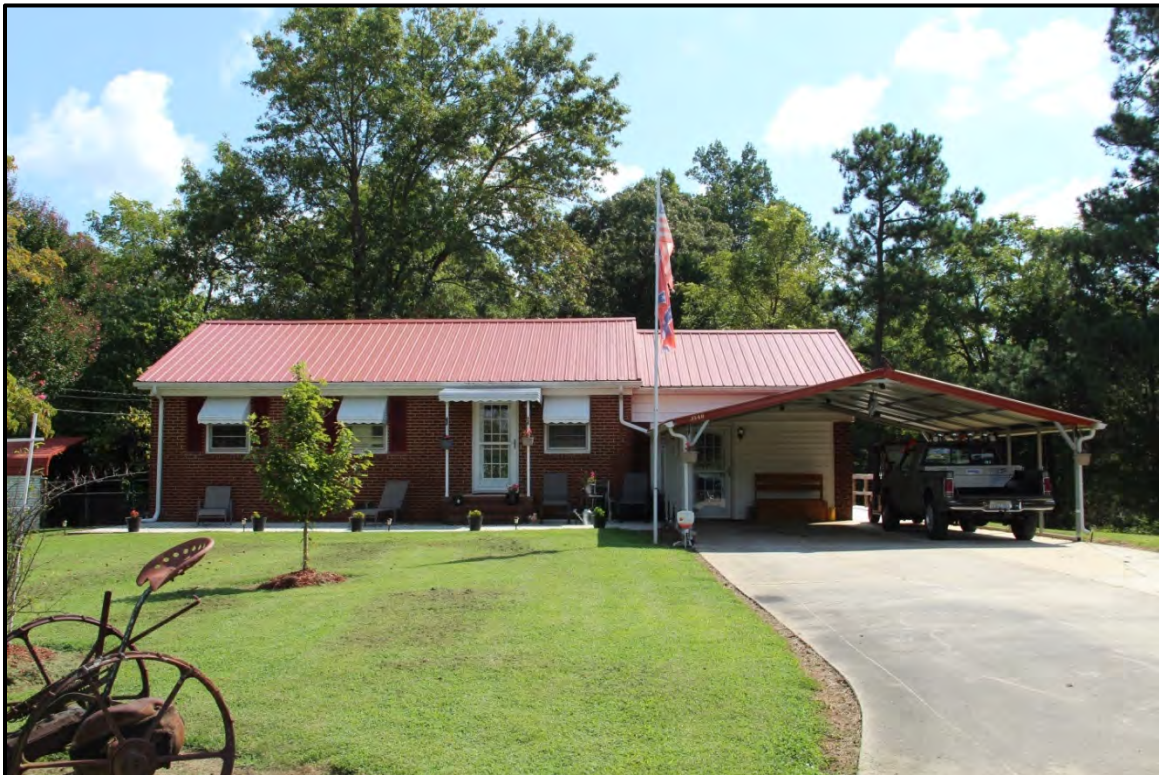
with the wood-frame building features a side-gabled roof covered with standing seam metal and a brick veneer exterior. The façade features an offset entrance with a modern French door, a brick stoop sheltered by a metal awning, and three 2/2 horizontal sash windows covered with metal awnings. At the south end of the house the original carport has been enclosed with vinyl siding and a French-style door. Fronting the former carport is a detached modern metal carport. There are two storage outbuildings in the rear yard consisting of a garage with a shed metal roof and an exterior clad with metal siding; and a storage shed capped with a gabled roof covered with standing seam metal.

NRHP Assessment. Architectural resource AM2508 does not exhibit a distinctive architectural style or workmanship. In addition, the house has been altered through the enclosure of the carport. Based on the lack of architectural merit, as well as the inability to associate the house and/or its original owner(s) with an important historical event or series of events, it is TRC’s opinion that architectural resource AM2508 is not eligible for the NRHP.

Figure 6.75. Architectural resource AM2508; view is east showing the façade and modern carport.

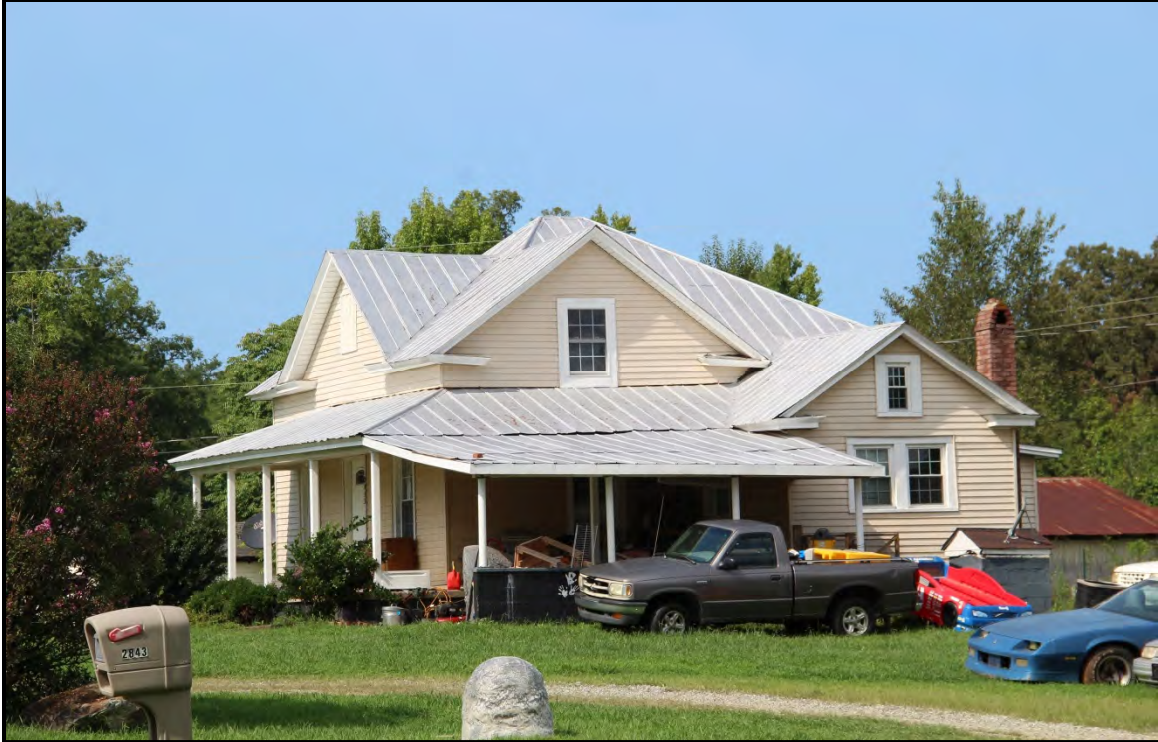
The one and one-half-story, wood-frame building features a hipped roof with lower cross gables covered with standing seam metal, an exterior clad with vinyl siding, and a concrete block foundation. The façade is sheltered by a wraparound front porch supported by square and round posts. The front entrance has a modern replacement door, and all the windows are 6/6 replacement vinyl sash. There is a single rear exterior brick chimney. Outbuildings include a modern wood-frame shed with plywood exterior and a gambrel roof barn with a metal roof (Figure 6.77).

NRHP Assessment. Architectural resource AM2509 is a former farmstead that is currently utilized as an auto salvage yard. The property is anchored by a Folk Victorian-style farmhouse that does not exhibit distinctive characteristics of architectural style or workmanship. In addition, the building has been altered through the application of vinyl siding, the installation of vinyl sashes, the replacement of the original porch columns. The historic setting of the property has been compromised with the introduction of modern buildings associated with the property's use as an auto junk yard. For these reasons, the property no longer conveys its early twentieth century agricultural appearance, thereby rendering the property ineligible for its agricultural associations. For these reasons it is the opinion of TRC that architectural resource AM2509 is not eligible for the NRHP.

Figure 6.76. Architectural resource AM2509; view is southeast showing the façade and north elevation.

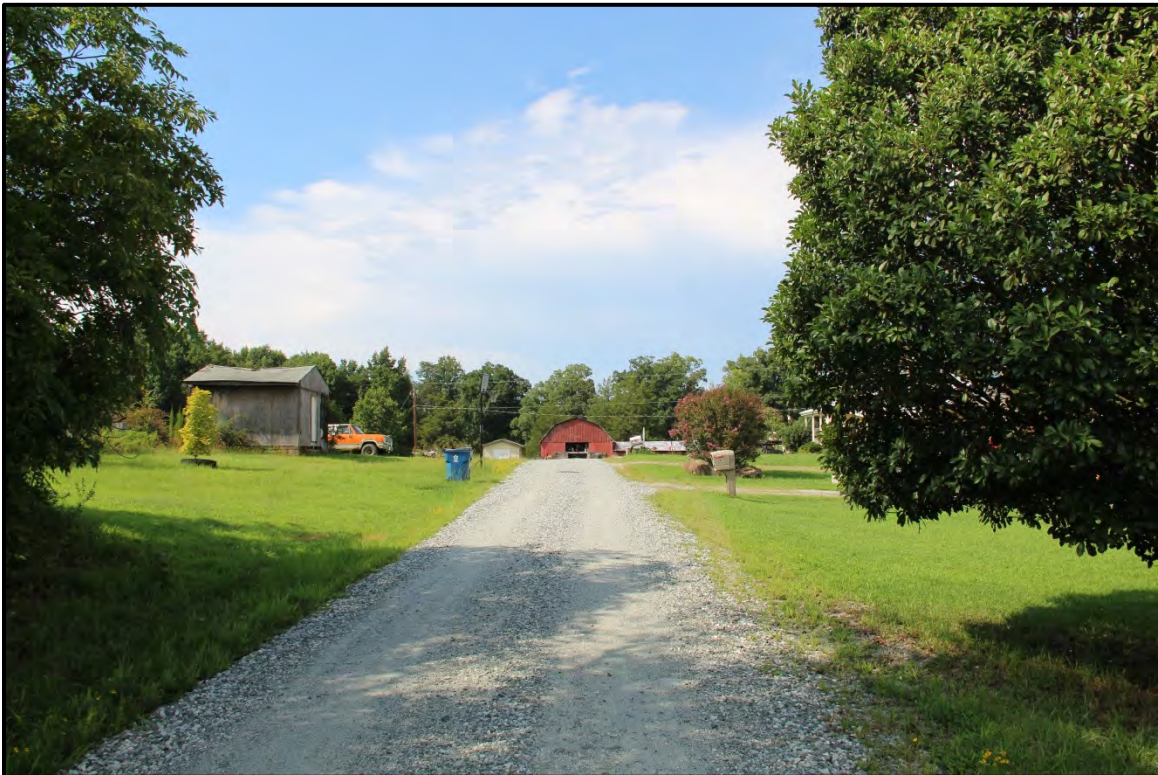
Figure 6.77. Architectural resource AM2509; view is north featuring the gambrel-roof barn and storage shed.

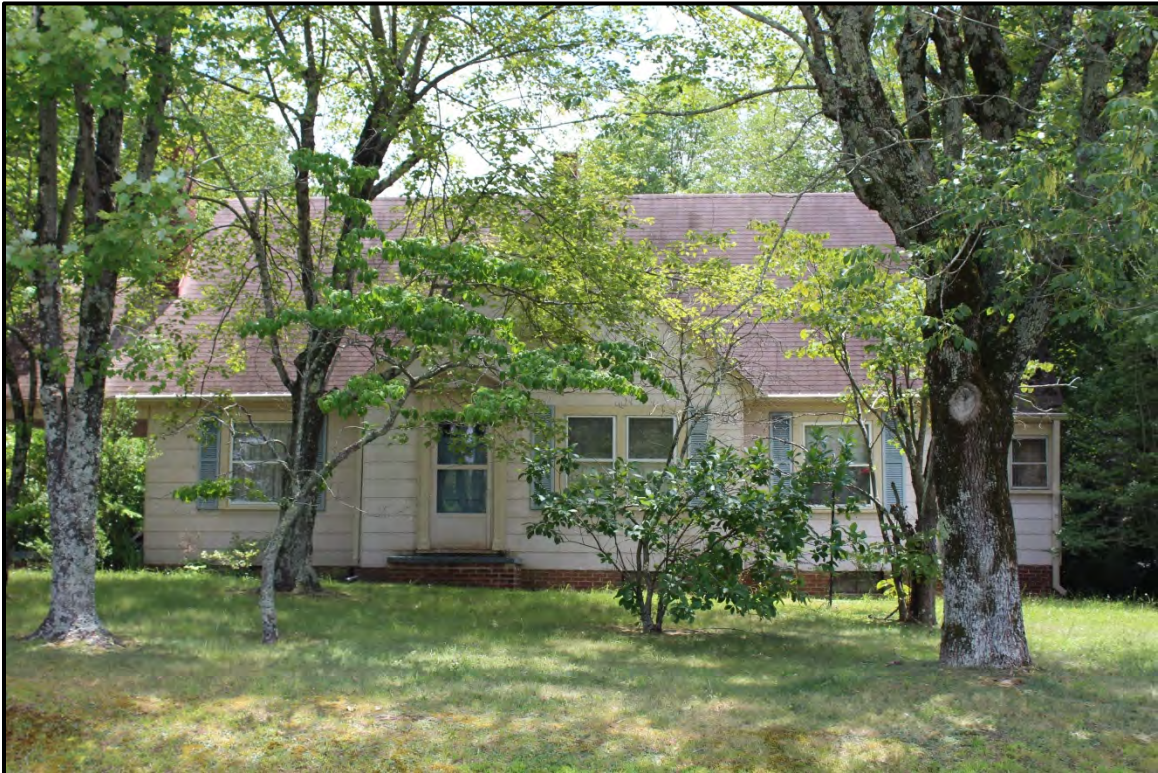
The one and one-half story, wood-frame building features a side-gabled roof covered with asphalt shingles, an interior brick chimney, an exterior clad with asbestos shingles, and a brick foundation. Facing north, the façade is marked by a centrally placed projecting gable bay that contains the main entrance and a pair of 6/6 wood sash windows. The main entrance surround is topped by a broken pediment and flanking pilasters. A brick stoop provides access to the façade entrance. Situated on either side of the central bay is an 8/8 double-hung wood sash window. Attached to the east elevation is a gable end brick chimney and a porch topped with a side-gabled roof.

NRHP Assessment. Architectural resource AM2510 does not exhibit a distinctive architectural style or workmanship. Based on the lack of architectural merit, as well as the inability to associate the house and/or its original owner(s) with an important historical event or series of events, it is TRC's opinion that architectural resource AM2510 is not eligible for the NRHP.

Figure 6.78. Architectural resource AM2510; view is south featuring the façade.

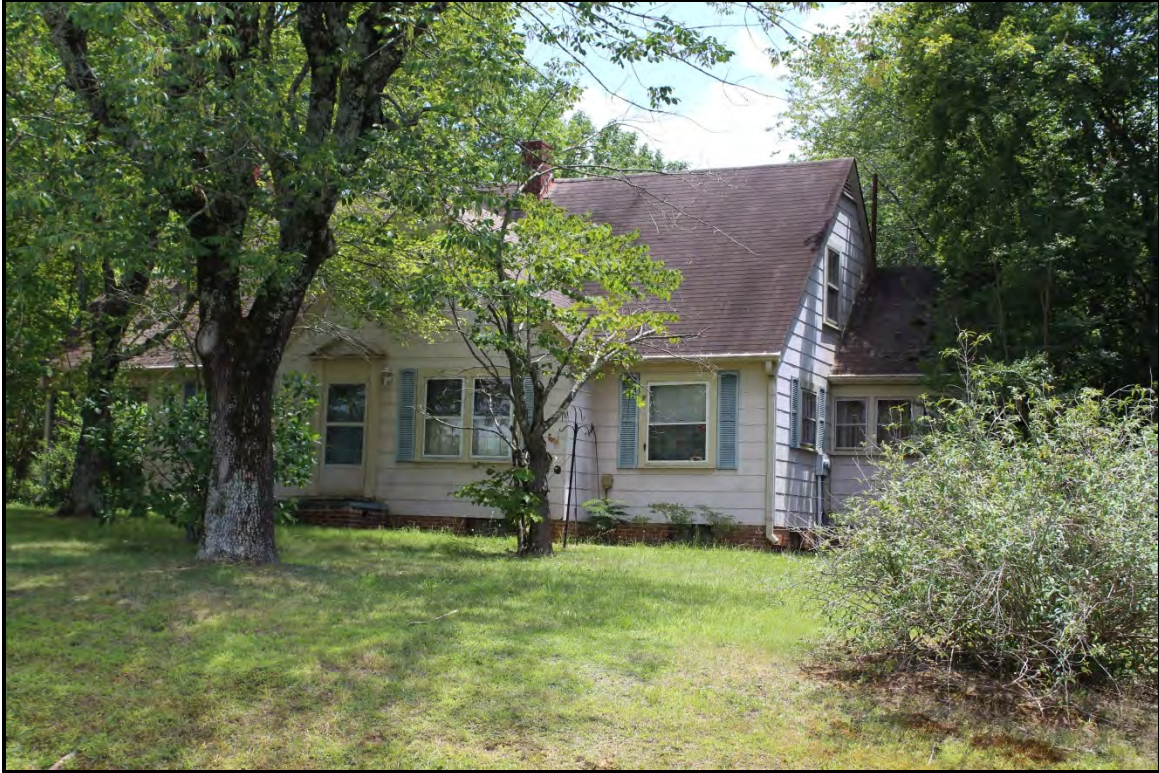
Figure 6.79. Architectural resource AM2510; view is southeast featuring the façade and west elevation.

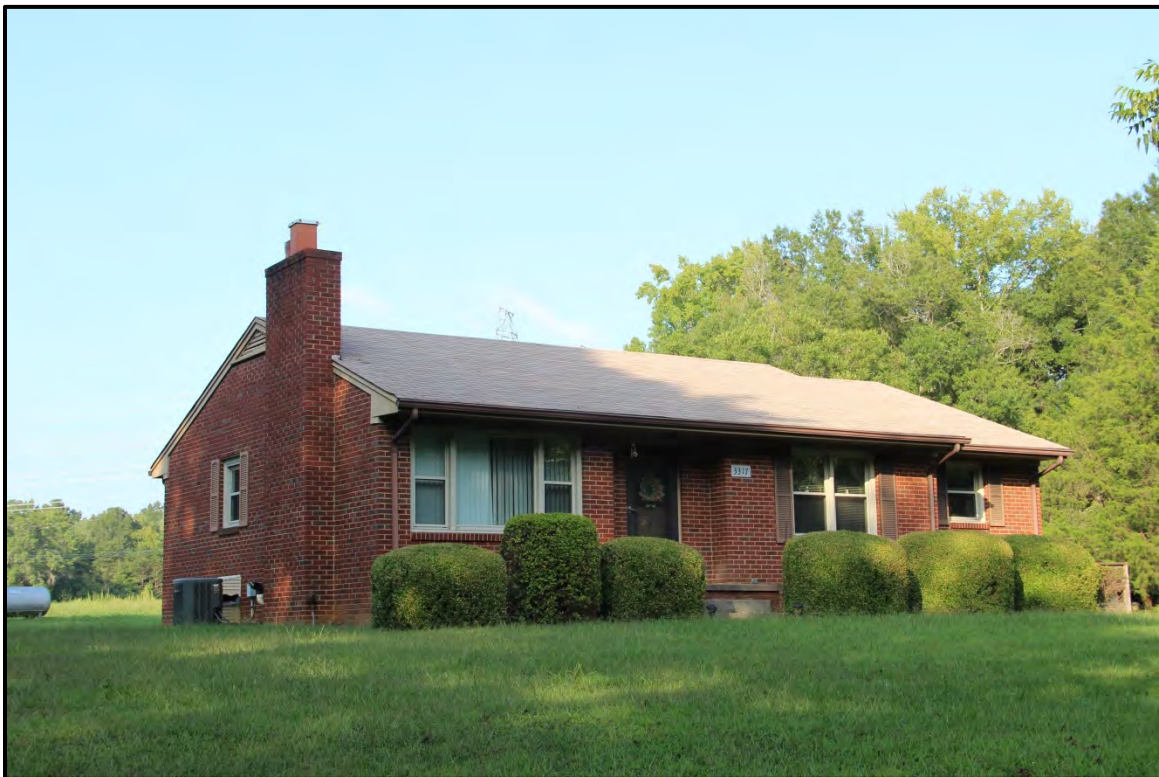
The wood-frame house features a side-gable roof covered with asphalt shingles and a brick veneer exterior. The façade features an offset recessed entrance with a brick stoop flanked by a three-part picture window and a pair of 1/1 double hung vinyl sash windows. There is an exterior end brick chimney on the west elevation. There are two modern metal carports in the rear yard and two frame storage shed outbuildings in the yard to the east of the house (Figure 6.81).

NRHP Assessment. Architectural resource AM2511 does not exhibit a distinctive architectural style or workmanship. In addition, the house has been altered through the installation of vinyl sash windows. Based on the lack of architectural merit, as well as the inability to associate the house and/or its original owner(s) with an important historical event or series of events, it is TRC's opinion that architectural resource AM2511 is not eligible for the NRHP.

Figure 6.80. Architectural resource AM2511; view is northeast featuring the façade and west elevation.

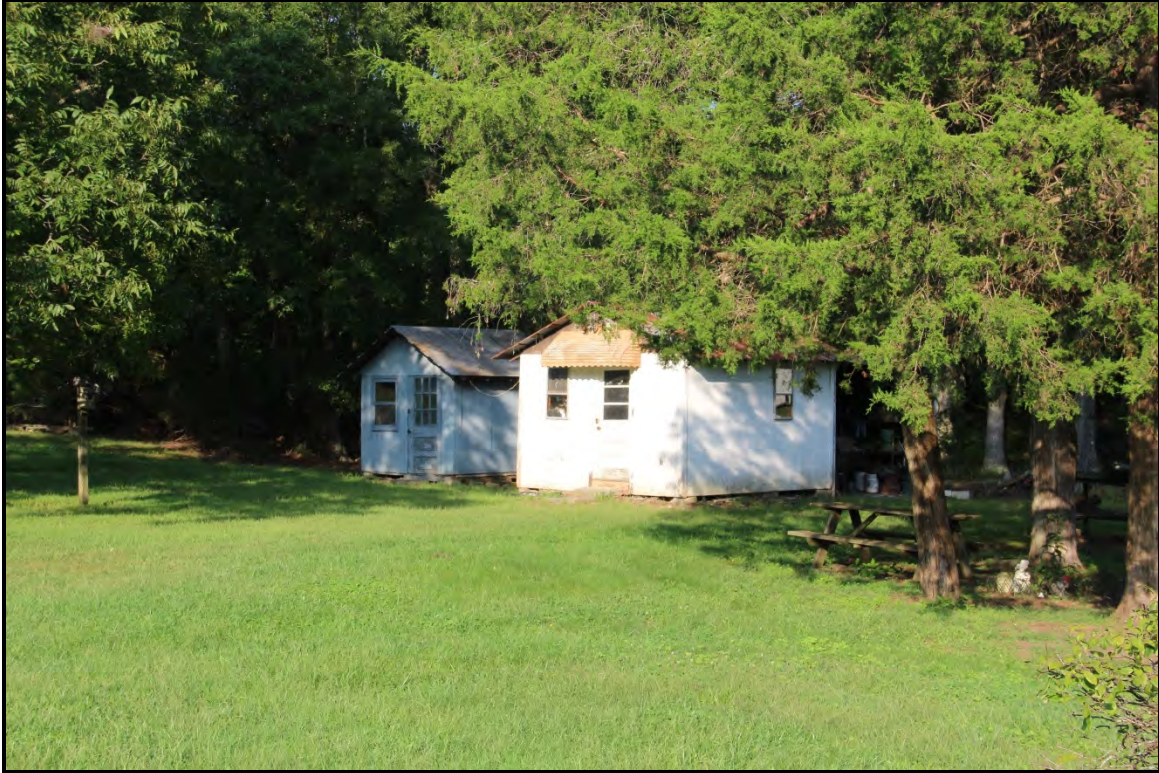
Figure 6.80. Architectural resource AM2511; view is southeast featuring the shed outbuildings.

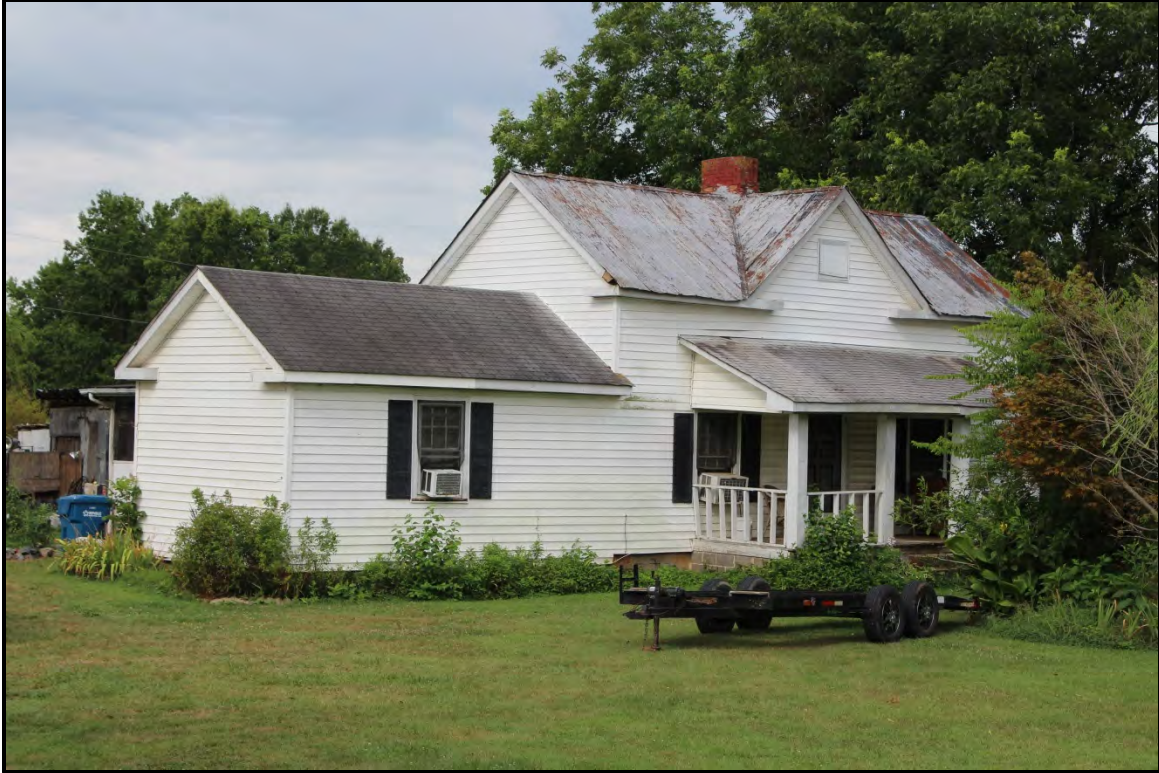
The one and one-half-story, wood-frame building features a side-gabled roof covered with standing seam metal, an interior brick chimney, an exterior clad with vinyl siding, and a concrete block foundation. Attached to the east elevation of the house is a side-gabled wing. The three-bay façade of the main block has a central entrance flanked by 6/6 wood sash windows. The entrance is sheltered by a partial-width shed-roof porch supported by square wood posts set on a wood deck. There is an enclosed attic vent on the front facing gable end.

Figure 6.82. Architectural resource AM2512; view is west featuring the façade and east elevation.

NRHP Assessment. Architectural resource AM2512 does not exhibit a distinctive architectural style or workmanship. In addition, the house has been altered through the application of vinyl siding, the construction of the east elevation wing, and the reconstruction of the façade porch. Based on the lack of architectural merit, as well as the inability to associate the house and/or its original owner(s) with an important historical event or series of events, it is TRC's opinion that architectural resource AM2512 is not eligible for the NRHP.

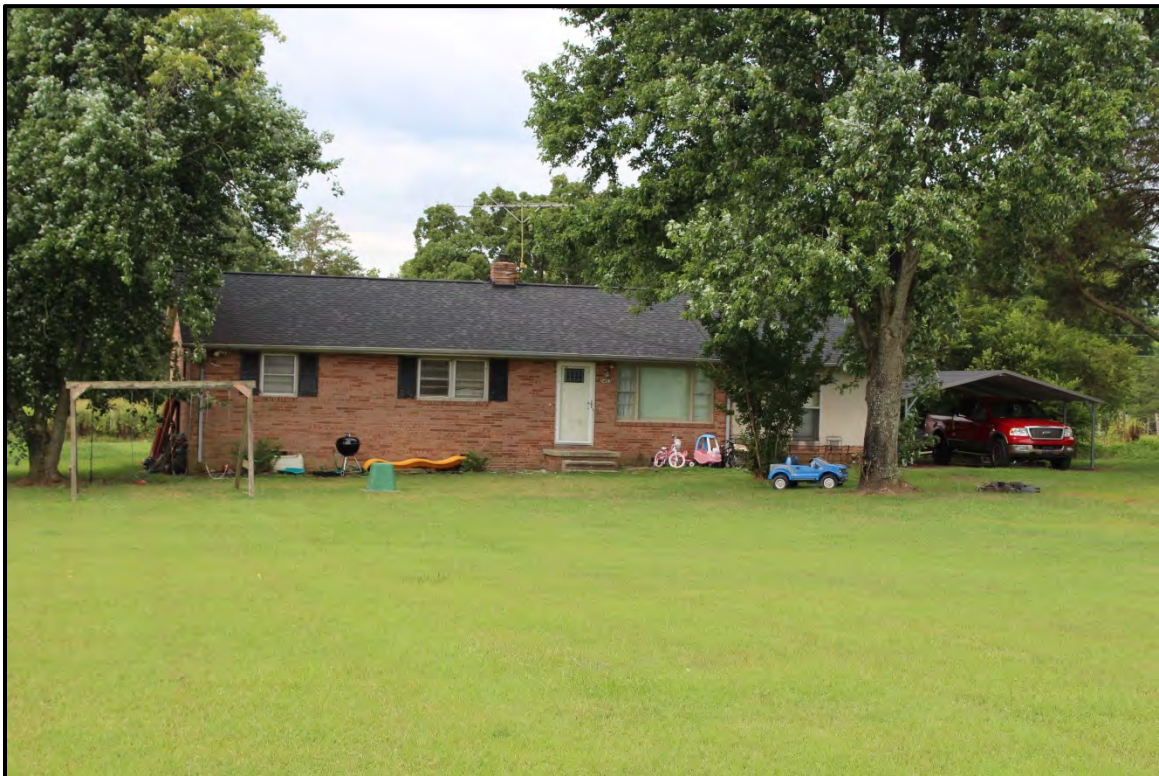
The wood-frame house features a side-gabled roof covered with asphalt shingles, an interior brick chimney, and a brick veneer exterior. The façade has an offset entrance with a brick and concrete stoop, a three-part picture window, and 2/2 horizontal sash windows with vinyl faux shutters. The original carport, which is integral with the main roof, has been enclosed. Just west of the house is a modern metal carport.

Figure 6.83. Architectural resource AM2513; view is southwest featuring the façade.

NRHP Assessment. Architectural resource AM2513 does not exhibit a distinctive architectural style or workmanship. In addition, the house has been altered through the installation of vinyl sash windows. In addition, the house has been altered through the enclosure of the original carport. Based on the lack of architectural merit, as well as the inability to associate the house and/or its original owner(s) with an important historical event or series of events, it is TRC's opinion that architectural resource AM2513 is not eligible for the NRHP.

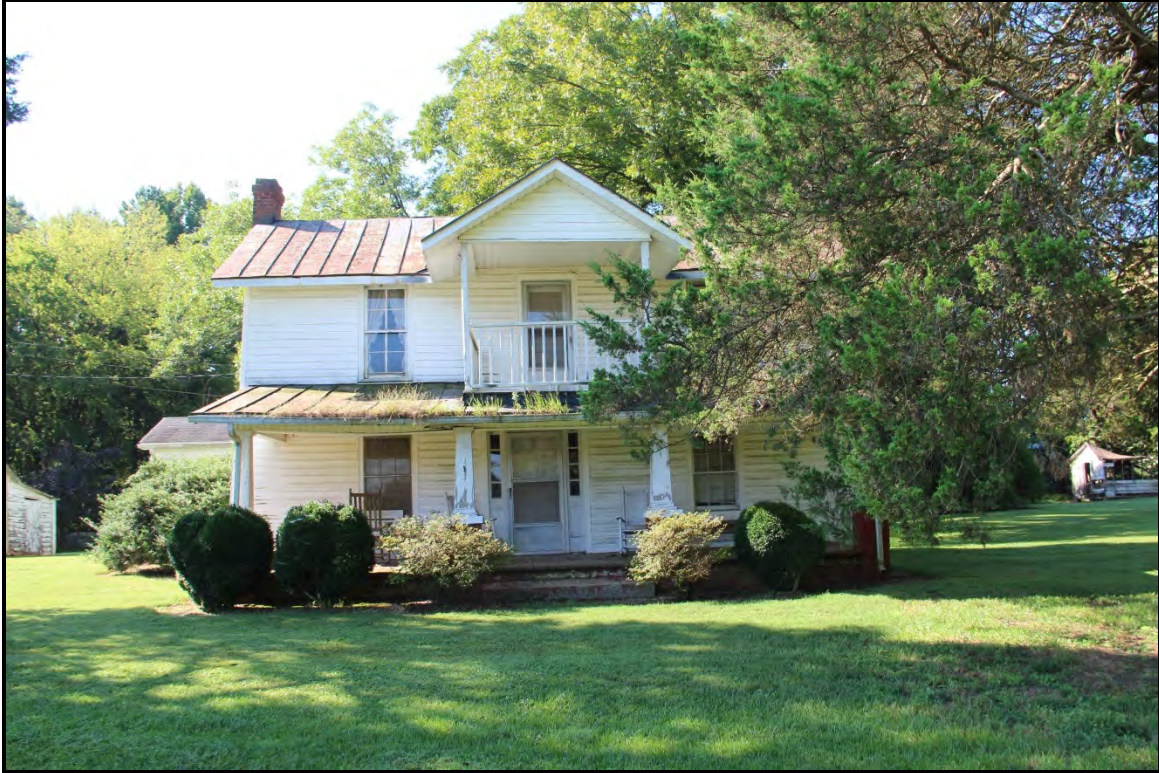
The wood-frame residence features a side-gabled roof covered with standing-seam metal, an exterior clad with vinyl siding, and a foundation composed of fieldstones. Facing north, the façade contains a central door opening with a multi-panel single leaf. The door opening is accented with multi-light sidelights above a wood panel. Flanking either side of the main entrance is a 6/6 double-hung wood sash window. Access to the façade door is through a full-width porch that contains a wood deck atop a brick foundation. The porch deck is shielded by a shed roof that is supported by four tapered wood posts atop brick plinth blocks. Situated along the second story is an off-centered door that leads to a modern balcony. The balcony is built on top of the façade porch and is covered by a projecting gable roof. The porch includes wood balustrades and two posts that support the balcony roof. Positioned on either side of the balcony is a 4/4 double-hung wood sash window.

Figure 6.84. Architectural resource AM2514; view is south featuring the façade.

NRHP Assessment. Architectural resource AM2514 is an inactive farmstead anchored by an early twentieth century I-house that does not exhibit distinctive characteristics of architectural style or workmanship. Alterations to the house include the application of vinyl siding, the construction of the second story porch above the façade porch, and the concealment of original window openings. In addition, the integrity of the farm is poor due to neglect, which has resulted in the partial collapse of some of the surviving outbuildings. In addition, the historic setting of the property has been compromised with the introduction of a modern mobile home on the property. For these reasons, the farm no longer conveys its early twentieth century appearance, thereby rendering the property ineligible for its agricultural associations. For these reasons it is the opinion of TRC that architectural resource AM2514 is not eligible for the NRHP.

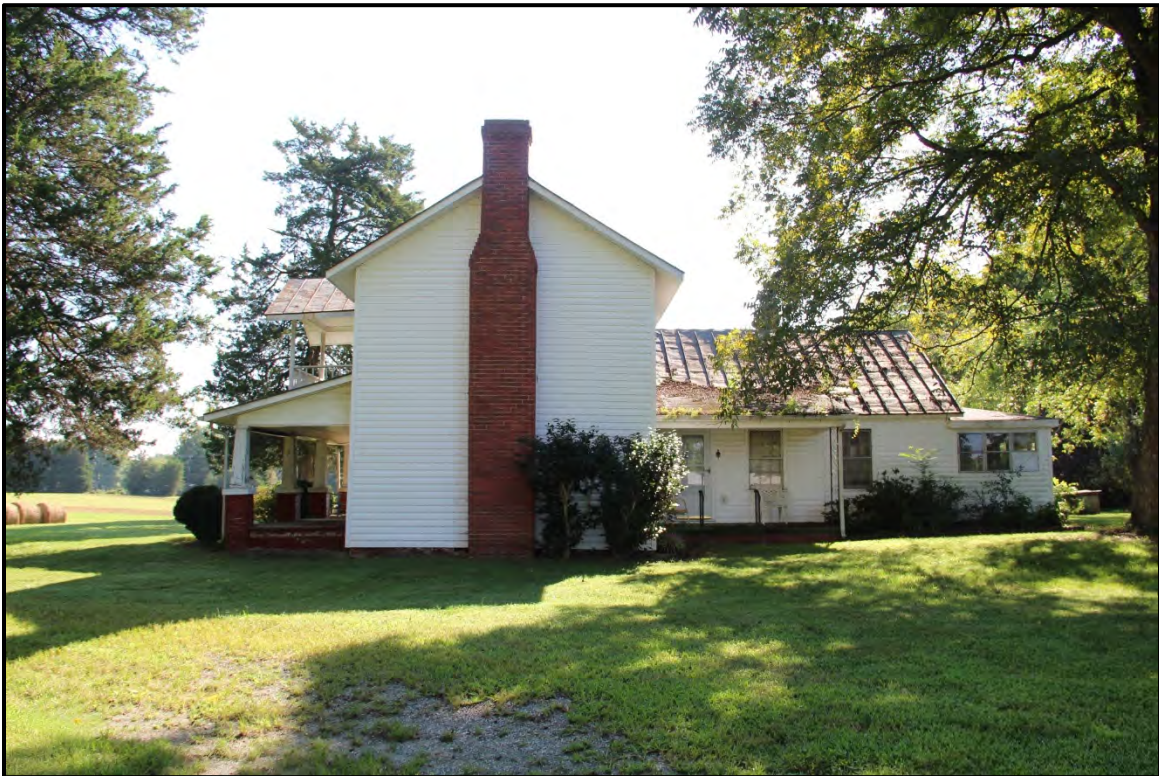
Figure 6.85. Architectural resource AM2514; view is east featuring the west elevation and rear ell.

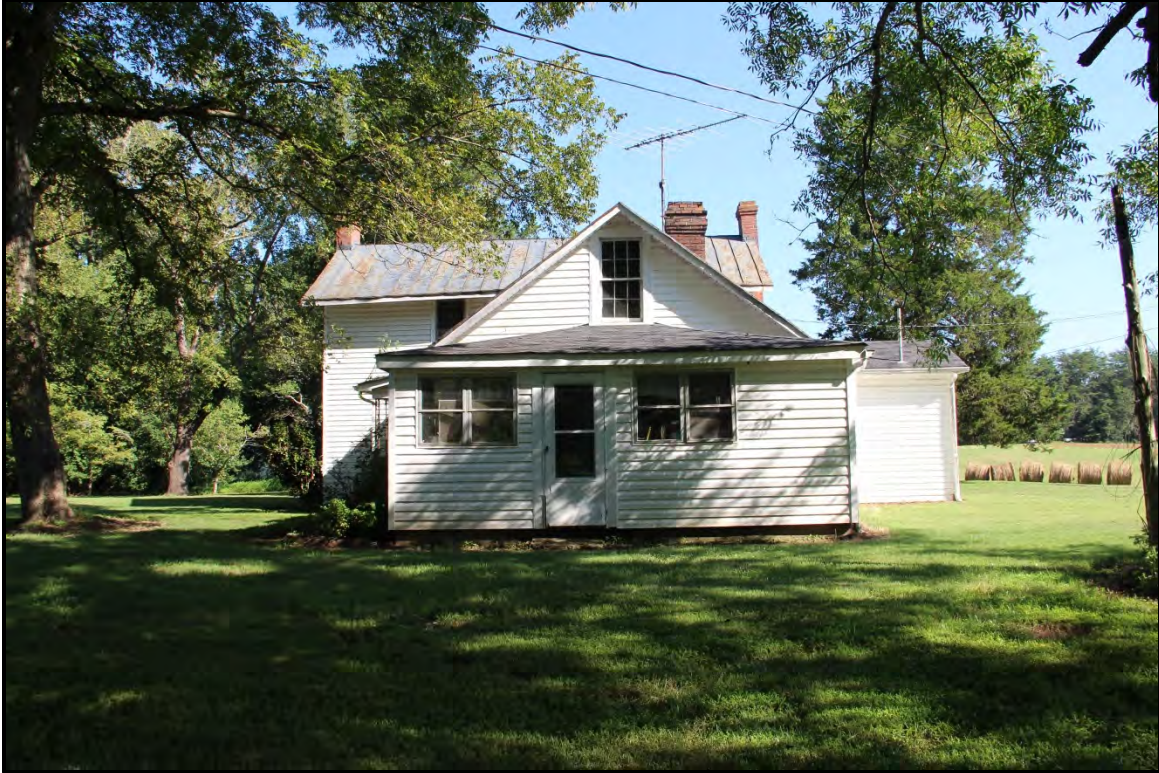
Figure 6.86. Architectural resource AM2514; view is north featuring the rear ell.
