Re: Revised Architectural Survey Report, MVP Southgate Project, Construct Interstate Pipeline, Rockingham and Alamance County, ER 18-1041

Thank you for your letter of October 11, 2019, transmitting the draft "Historic Architectural Survey for the MVP Southgate Pipeline Project". We have reviewed the report and offer the following comments.

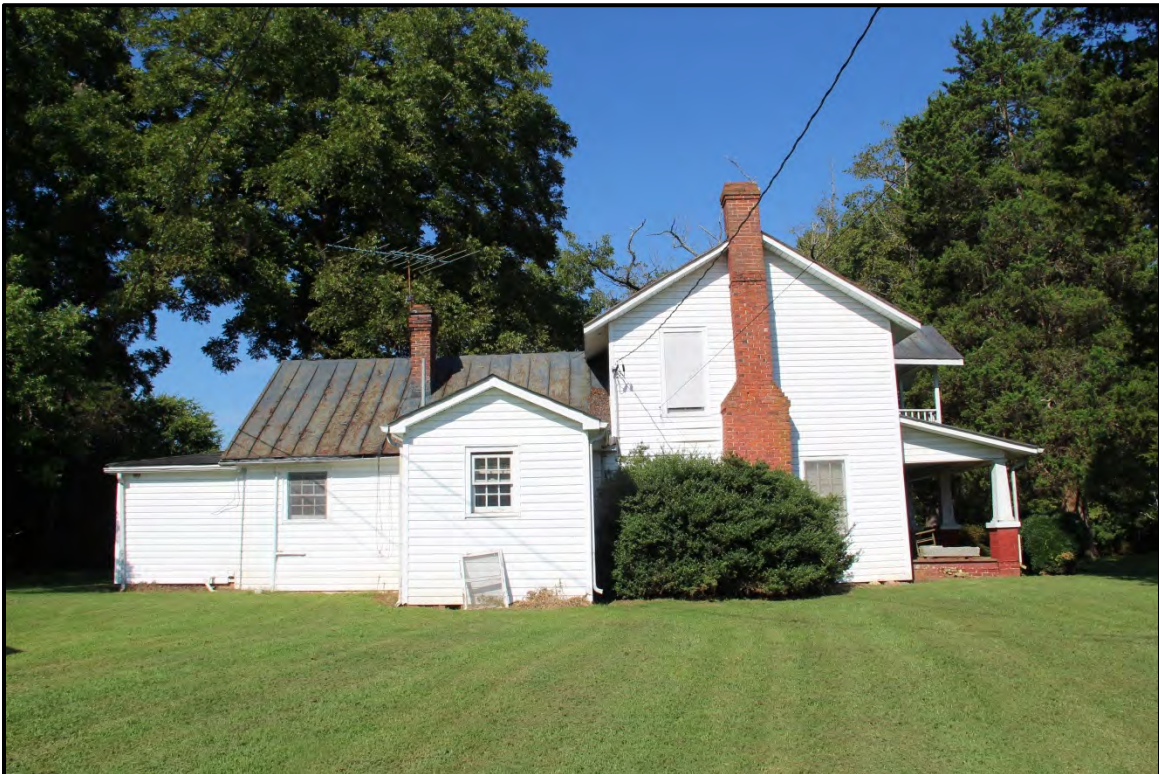
Figure 6.87. Architectural resource AM2514; view is west featuring the east elevation of the main block and rear ell.

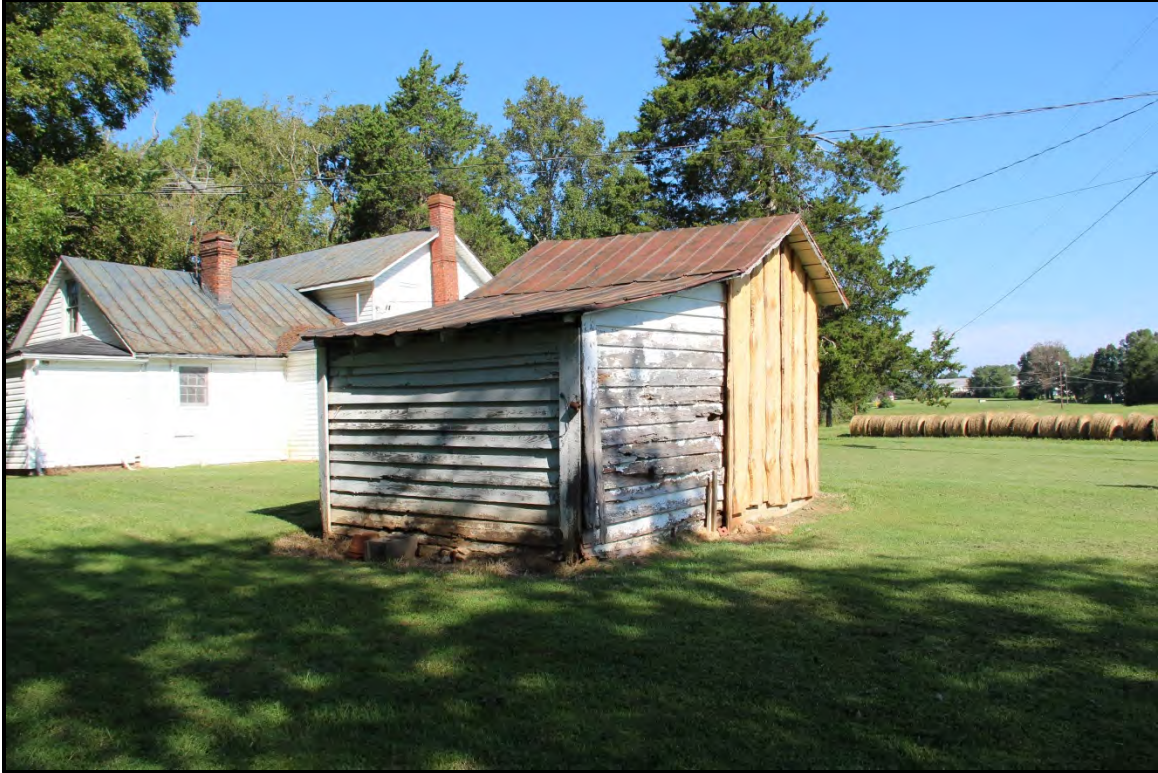
Figure 6.88. Architectural resource AM2514; view is northwest featuring a shed.

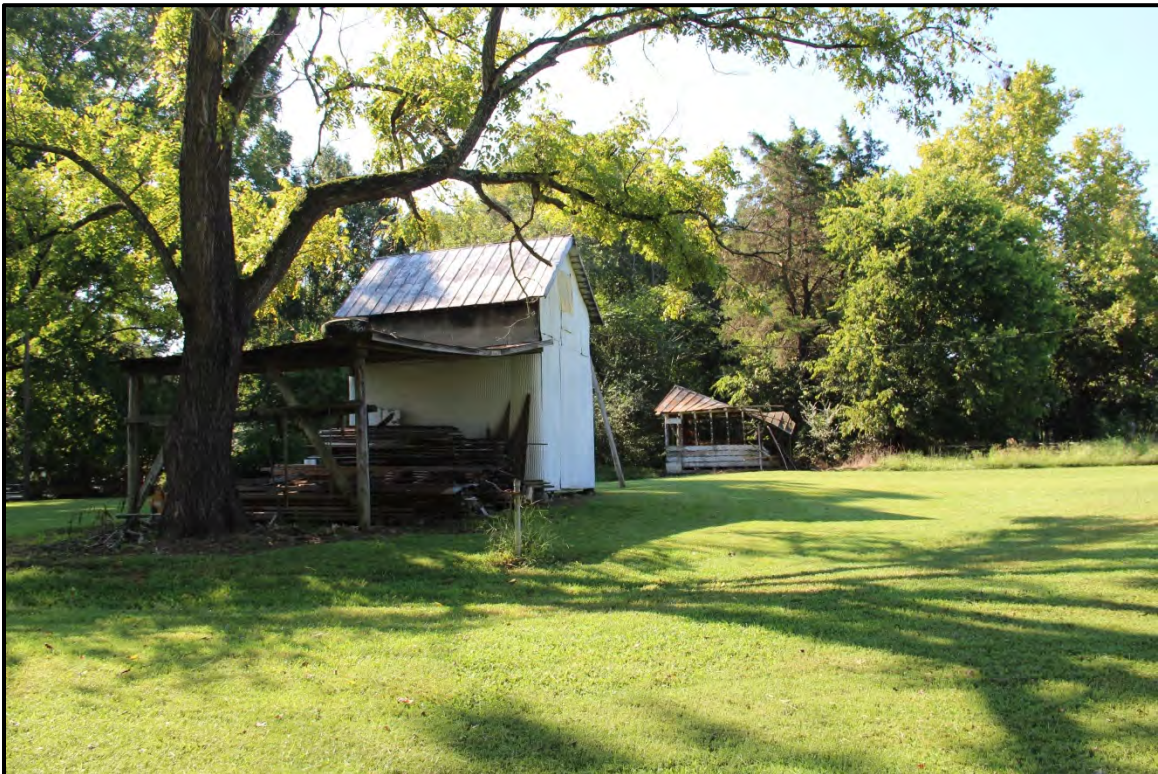
- A mid-twentieth century storage shed. The wood-frame structure features a gabled roof covered with standing seam metal, an exterior clad with metal siding, and a concrete block foundation. Attached to the south elevation is a shed-roof extension that is clad with weatherboard siding. A door is located on the west elevation (Figure 6.88);
- A mid-twentieth century tobacco barn. The wood-frame structure features a gabled roof covered with standing seam metal, an exterior clad with corrugated metal panels, and a concrete block foundation. Attached to the east elevation is a modern, open-bay, extension that is capped with a flat roof, which is supported by wood posts (Figure 6.89);

- A mid-twentieth century chicken house. The partially-collapsed wood-frame structure features a gabled roof covered with standing seam metal and an exterior partially clad with weatherboard siding (Figure 6.89);

Figure 6.89. Architectural resource AM2514; view is southwest featuring the tobacco barn and partially collapsed chicken house in the background.

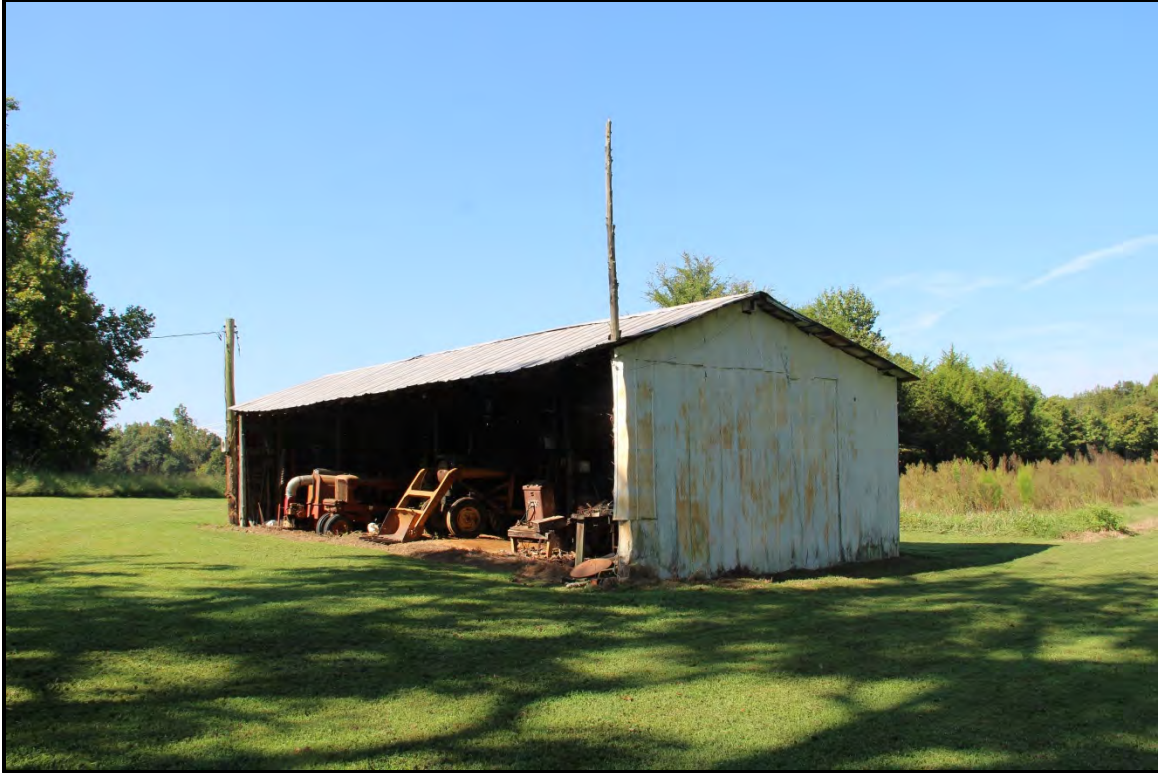
- A late twentieth century tractor shed. The wood-frame structure features a side-gabled roof covered with standing seam metal and an exterior clad with metal panel siding. Facing east, the shed includes a single open bay (Figure 6.90);

Figure 6.90. Architectural resource AM2514; view is southwest featuring the tractor shed.

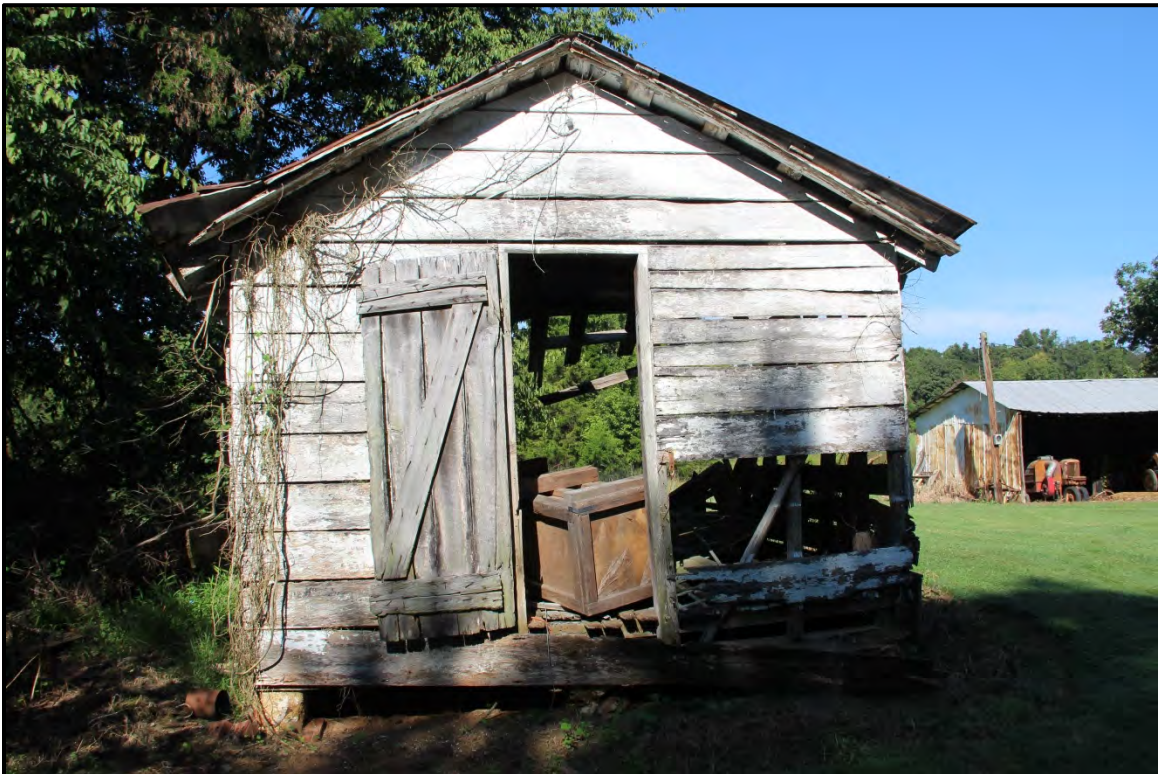
- A mid-twentieth century storage building. The partially-collapsed, wood-frame, structure features a front-gabled roof, an exterior clad with weatherboard siding, and a concrete block pier foundation (Figure 6.91);

Figure 6.91. Architectural resource AM2514; view is west featuring a partially collapsed storage shed.

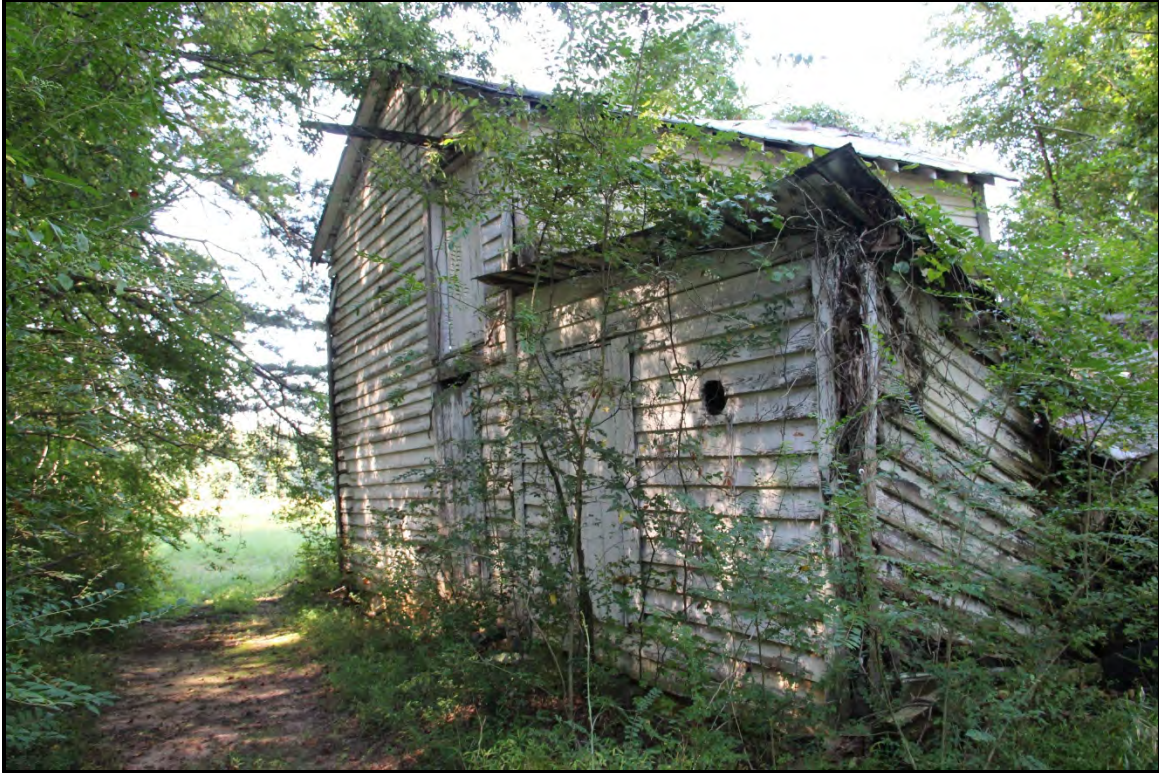
Figure 6.92. Architectural resource AM2514; view is southwest featuring the pack house.

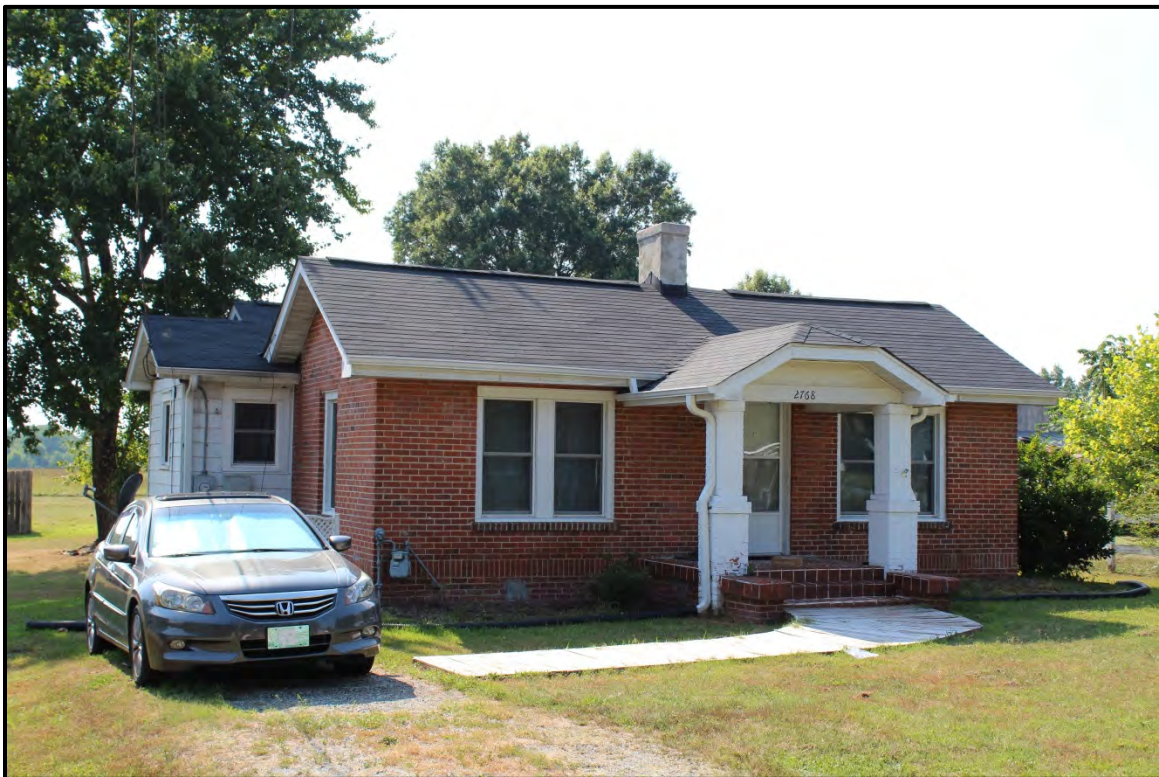
The one-story, wood-frame building features a side-gabled roof covered with asphalt shingles, an interior brick chimney, an exterior clad with a brick veneer, and a brick foundation. The façade holds a central door that is flanked on either side by a pair of 1/1 vinyl sash windows. The main entrance is marked with a brick stoop that is shielded with a clipped gable roof supported by brick columns. A rear addition with vinyl siding is attached to the west (rear) elevation.

Figure 6.93. Architectural resource AM2515; view is northwest featuring the façade.

NRHP Assessment. Architectural resource AM2515 does not exhibit a distinctive architectural style or workmanship. In addition, the house has been altered through the installation of vinyl sash windows. Based on the lack of architectural merit, as well as the inability to associate the house and/or its original owner(s) with an important historical event or series of events, it is TRC's opinion that architectural resource AM2515 is not eligible for the NRHP.

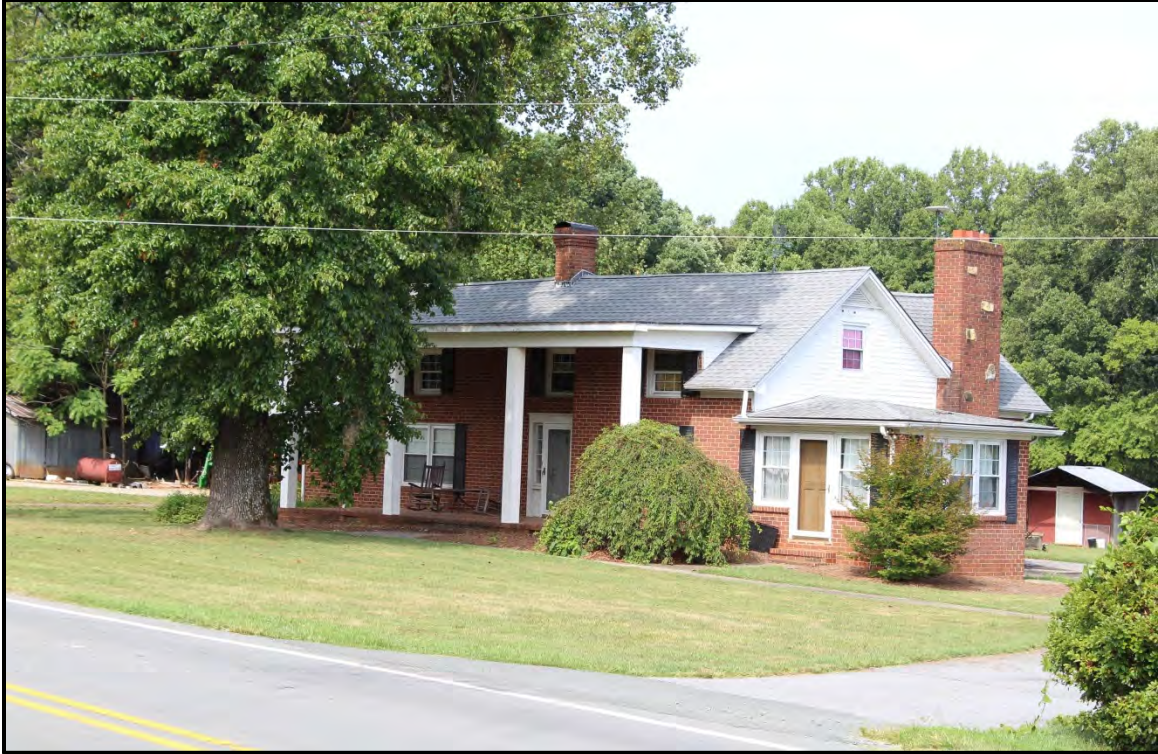
The wood-frame house features a roof covered with asphalt shingles, an interior central brick chimney, exterior end brick chimney, and a combination brick veneer and vinyl siding-clad exterior. Fenestration includes 6/6 double-hung vinyl sash windows. A reconstructed full-height, full-width entry porch provides access to the main entrance and is composed of a shed roof supported by aluminum columns and a brick deck. Modern additions are attached to the north, south, and west (rear) elevations. Located south and west of the house are a collection of outbuildings that include a modern brick carport, a late-twentieth century shed, a late-twentieth century barn, a mid-to-late-twentieth century tractor shed, an early-twenty-first century garage, a mid-twentieth century tobacco barn, and an early-twentieth century log tobacco barn.

Figure 6.94. Architectural resource AM2516; view is southwest and features the façade and north elevation.

NRHP Assessment. Architectural resource AM2516 is an active farmstead anchored by an early twentieth century I-house that does not exhibit distinctive characteristics of architectural style or workmanship. Alterations to the house include the application of vinyl siding, the construction of the second story porch above the façade porch, and the concealment of original window openings. In addition, the integrity of the farm is poor due to neglect, which has resulted in the partial collapse of some of the surviving outbuildings. In addition, the historic setting of the property has been compromised with the introduction of a modern mobile home on the property. For these reasons, the farm no longer conveys its early twentieth century appearance, thereby rendering the property ineligible for its agricultural associations. For these reasons it is the opinion of TRC that architectural resource AM2516 is not eligible for the NRHP.

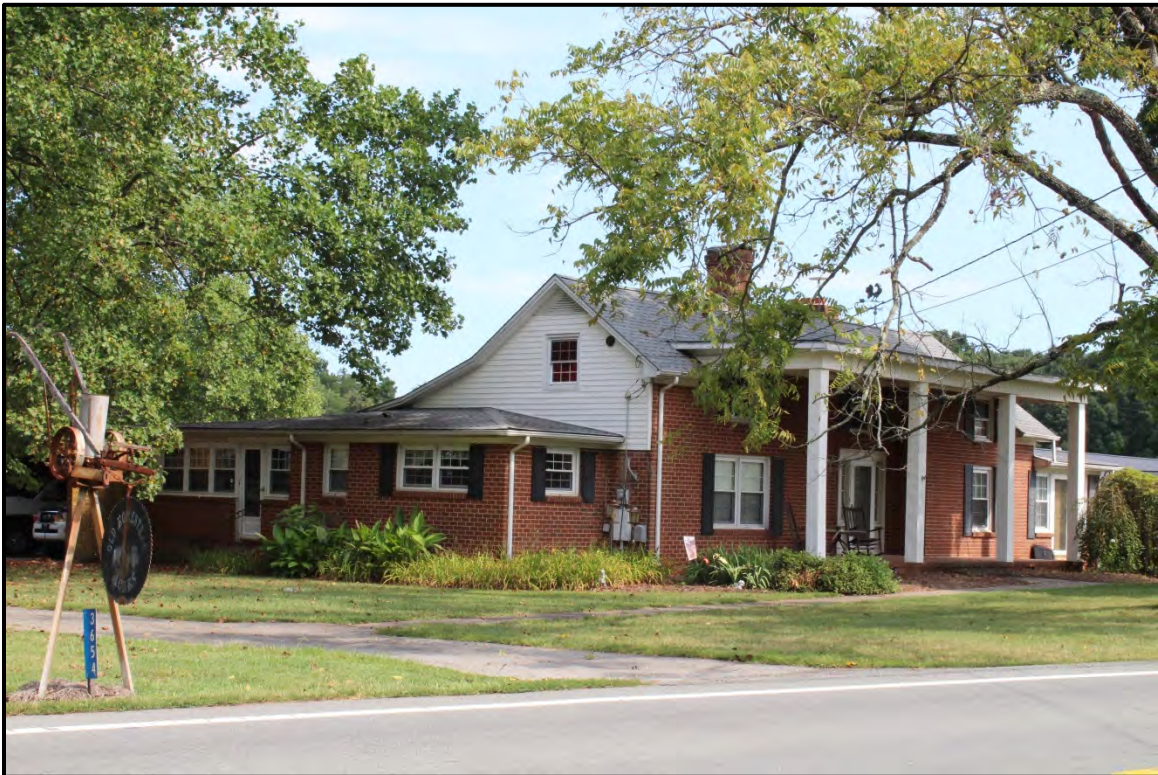
Figure 6.95. Architectural resource AM2516; view is northwest and features the façade and south elevation.

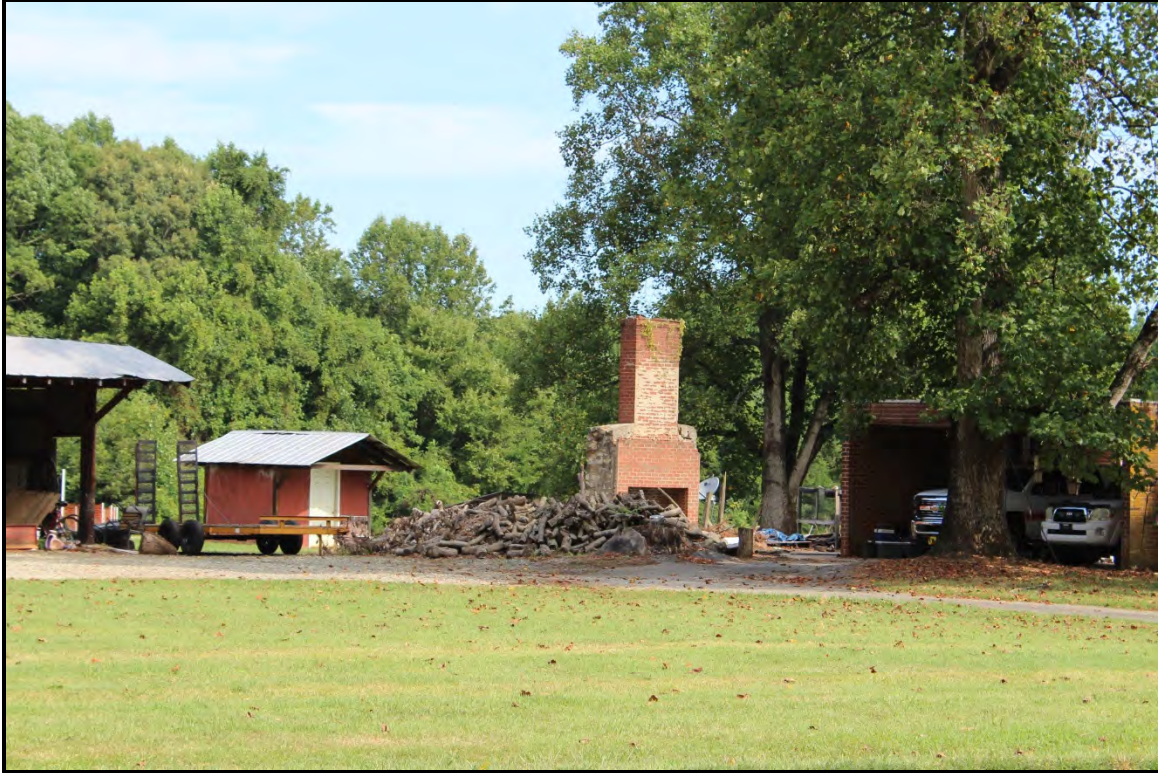
Figure 6.96. Architectural resource AM2516; view is west and features the late-twentieth century shed and carport.

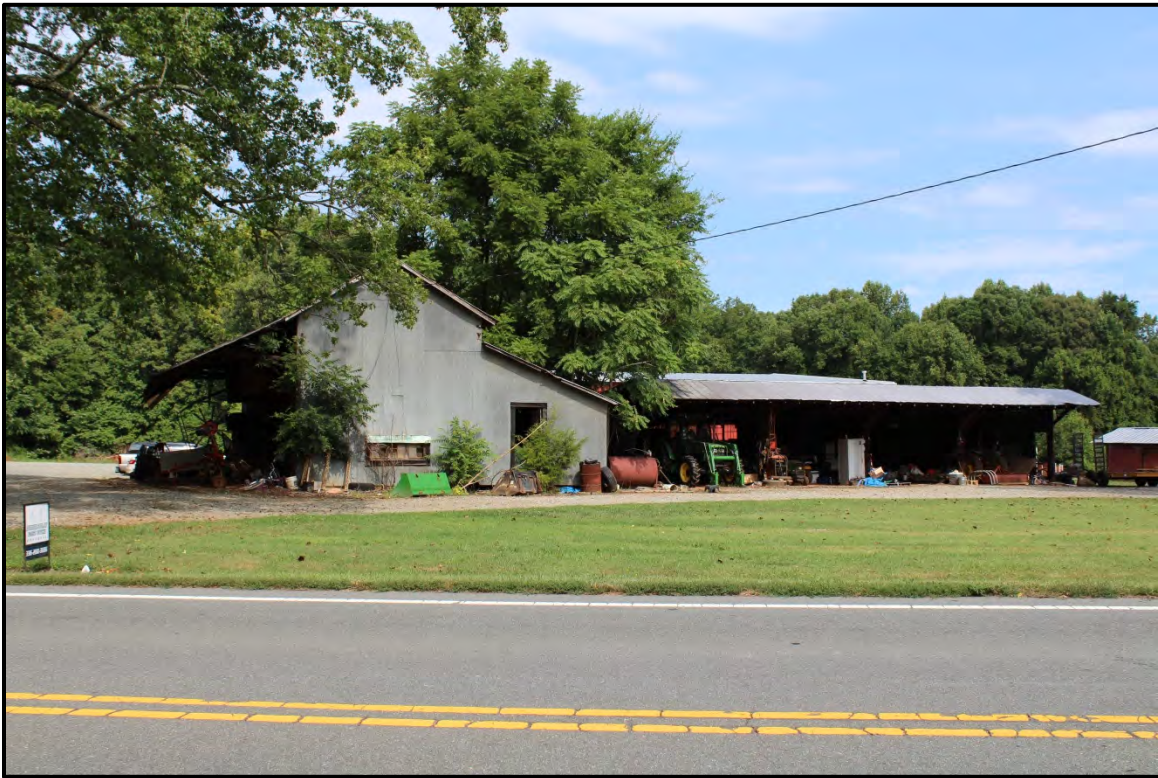
Figure 6.97. Architectural resource AM2516; view is west and features the barn and tractor shed.

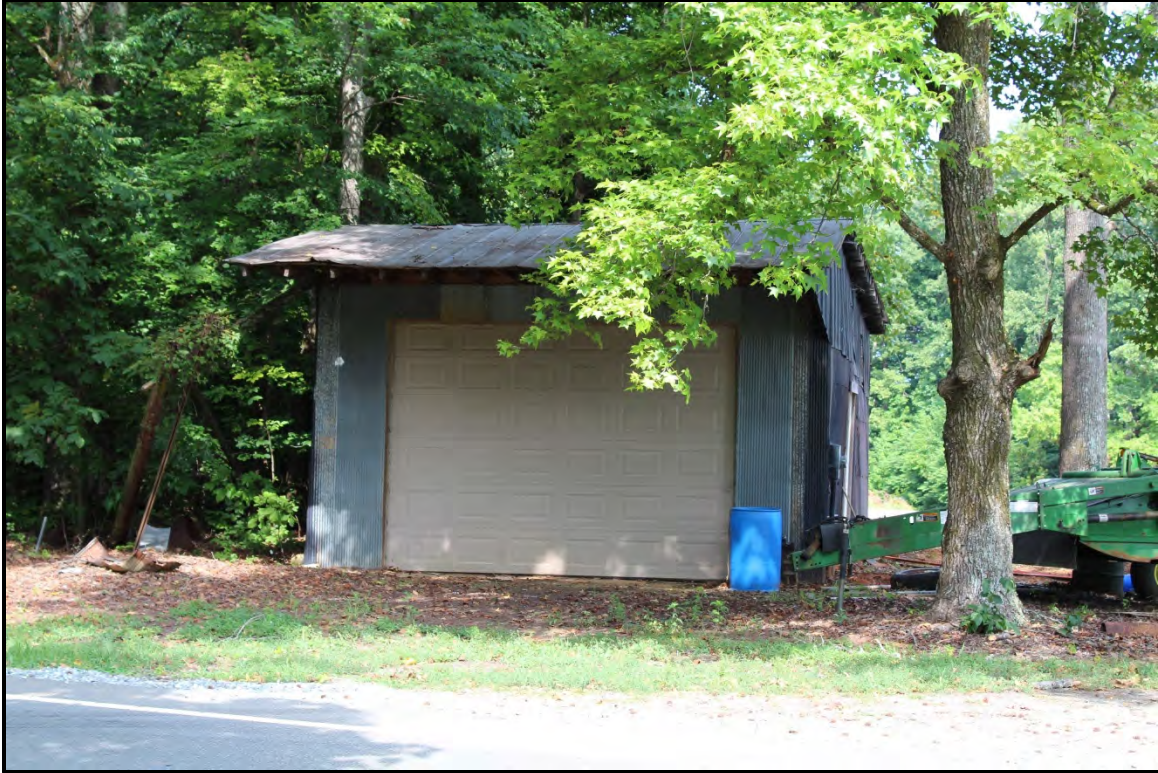
Figure 6.98. Architectural resource AM2516; view is southwest and features the garage.

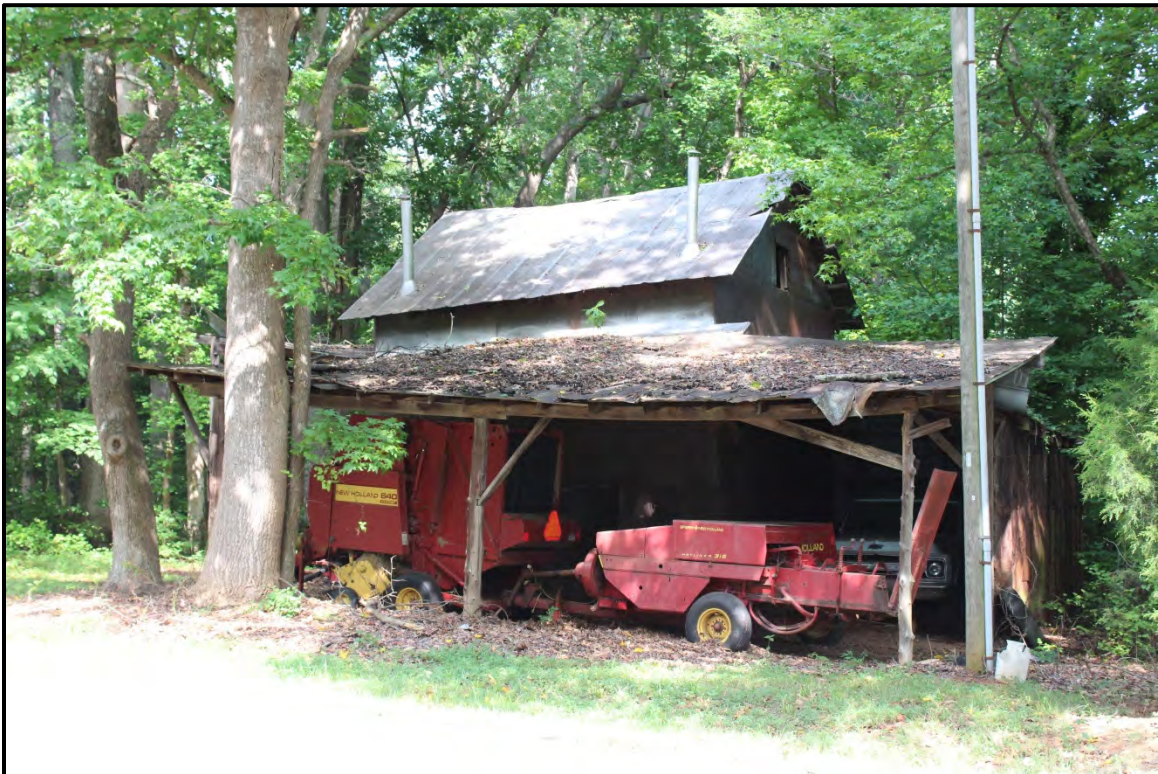
Figure 6.99. Architectural resource AM2516; view is southwest and features tobacco barn.

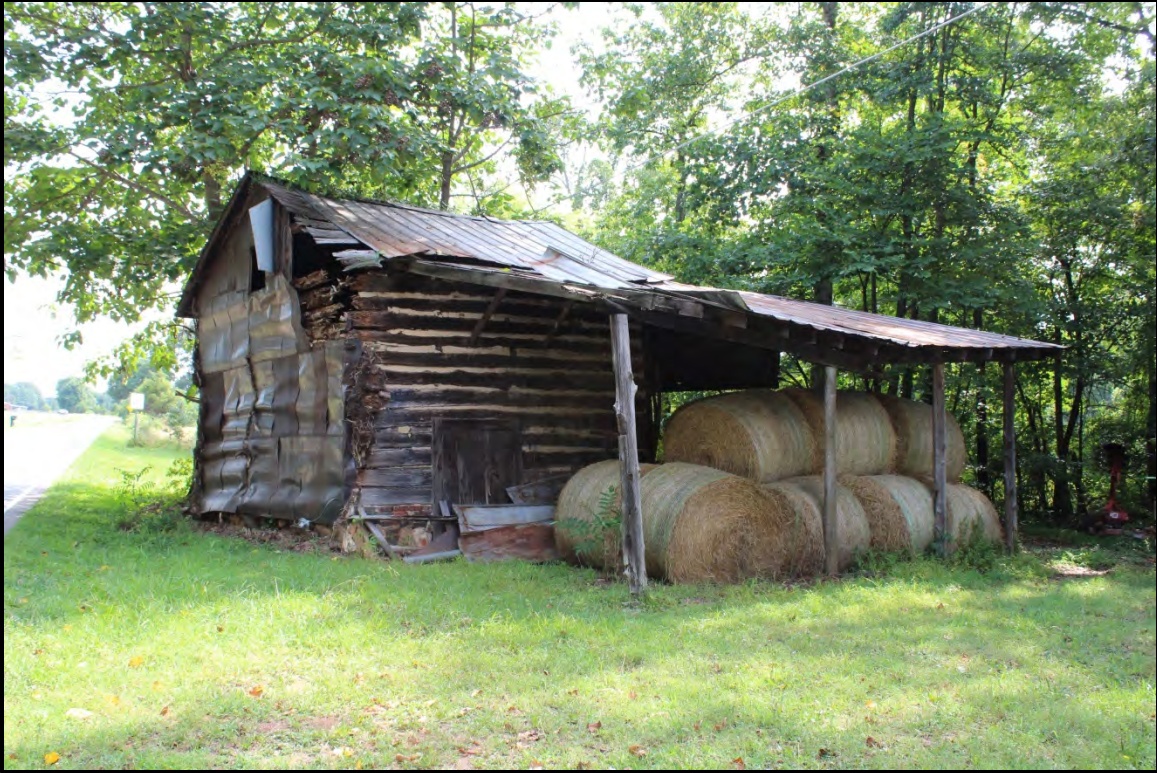
Figure 6.100. Architectural resource AM2516; view is southwest and features the log tobacco barn.

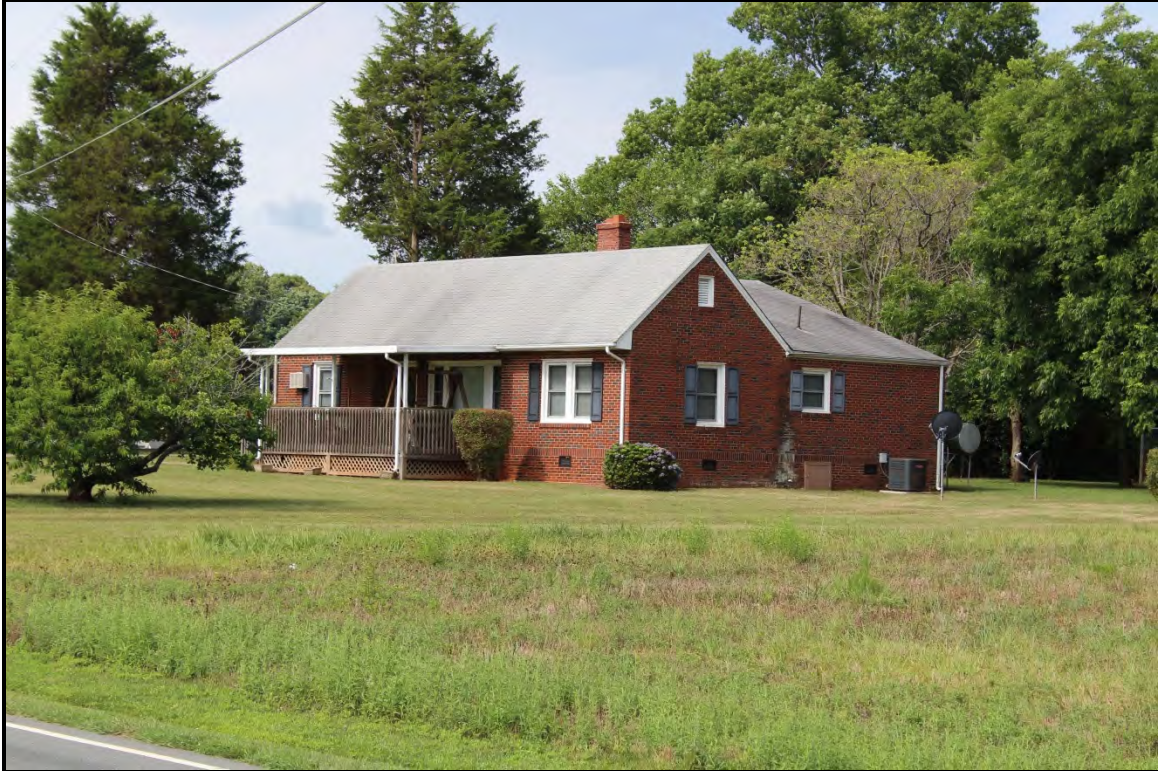
The wood-frame building features a side-gabled roof covered with asphalt shingles, an interior brick chimney, and a brick veneer-clad exterior. Fenestration includes 1/1 double-hung vinyl sash windows and a three-part picture window containing a central fixed vinyl sash. A modern wood deck provides access to the recessed entrance. The deck is shielded by a shed roof supported by aluminum posts. A gabled addition is attached to the west (rear) elevation. Located south of the house are a mid-twentieth century brick pump house and a mid-twentieth century wood-framed shed.

Figure 6.101. Architectural resource AM2517; view is southwest and features the façade and north elevation.

NRHP Assessment. Architectural resource AM2517 does not exhibit a distinctive architectural style or workmanship. In addition, the house has been altered through the installation of vinyl sash windows and the reconstruction of the façade porch. Based on the lack of architectural merit, as well as the inability to associate the house and/or its original owner(s) with an important historical event or series of events, it is TRC's opinion that architectural resource AM2517 is not eligible for the NRHP.

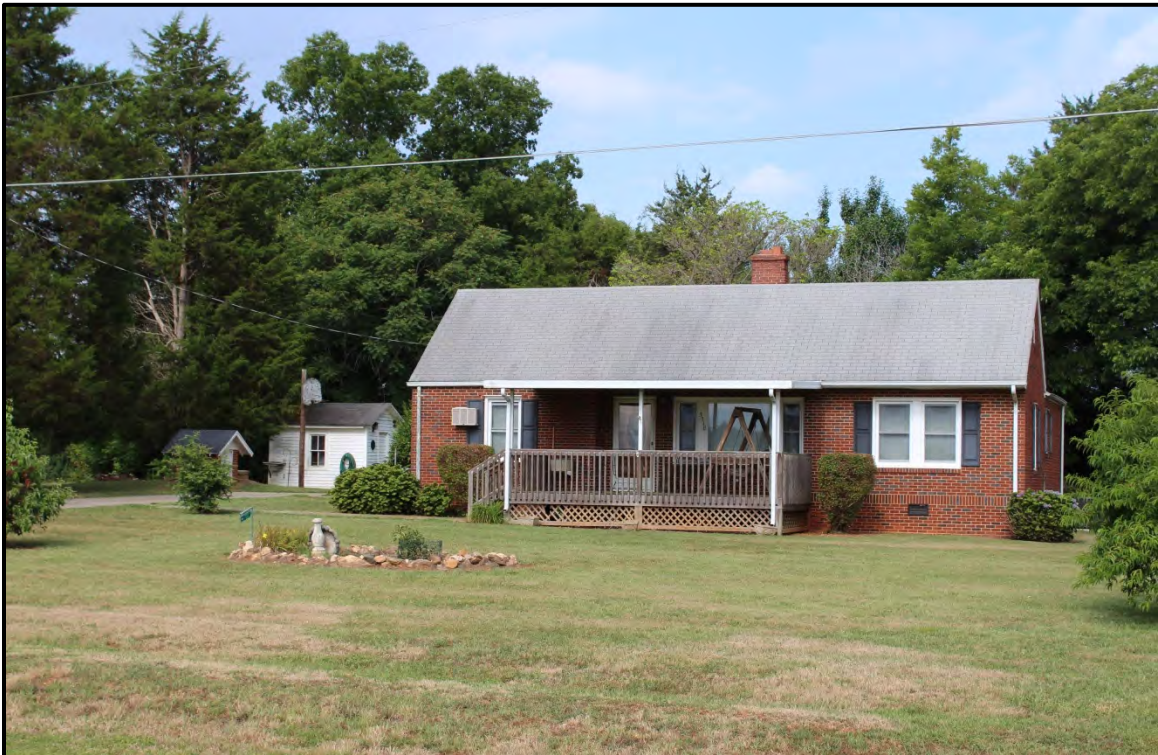
Figure 6.102. Architectural resource AM2517; view is southwest and features the façade and outbuildings.

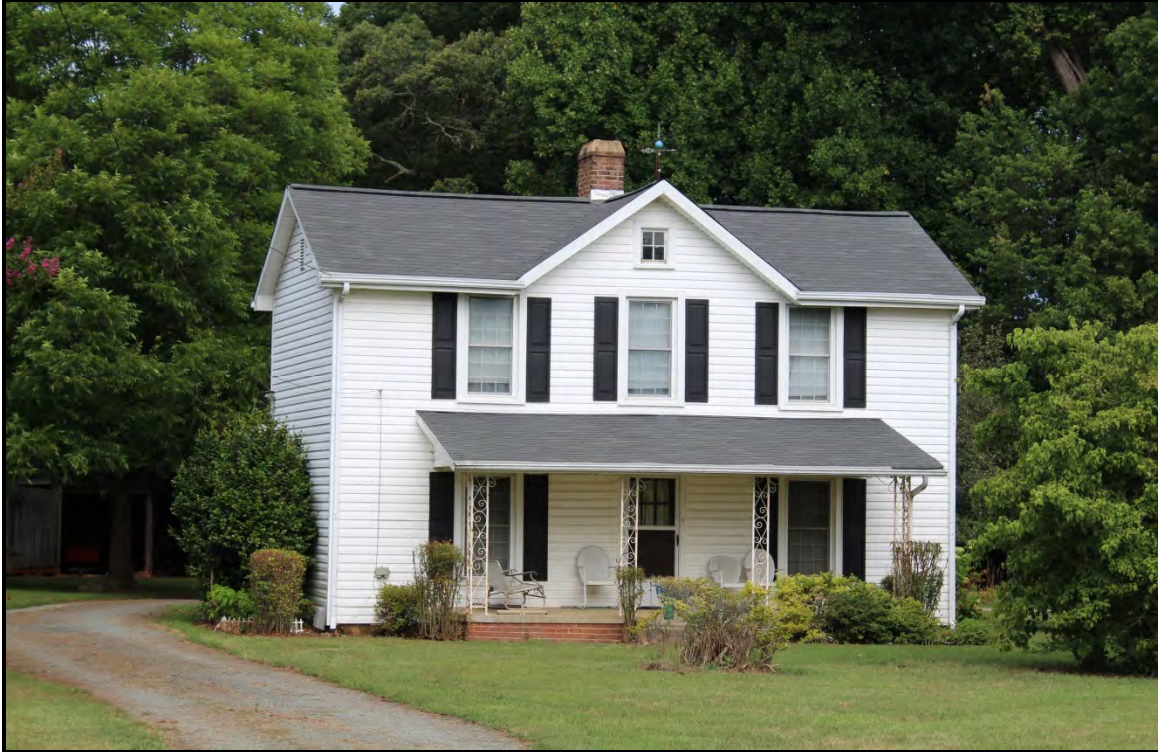
Figure 6.103. Architectural resource AM2518; view is northwest featuring the façade and south elevation.

NRHP Assessment. Architectural resource AM2518 is an inactive farmstead anchored by a two-story Triple-A-style house that does not exhibit distinctive characteristics of architectural style or workmanship. In addition, the house has been altered through the application of vinyl siding, the installation of vinyl sashes, and the reconstruction of the façade porch. As a result of these modern alterations, the farmhouse no longer conveys its early twentieth century appearance, thereby rendering the property ineligible for its agricultural associations. For this reason, it is the opinion of TRC that architectural resource AM2518 is not eligible for the NRHP.

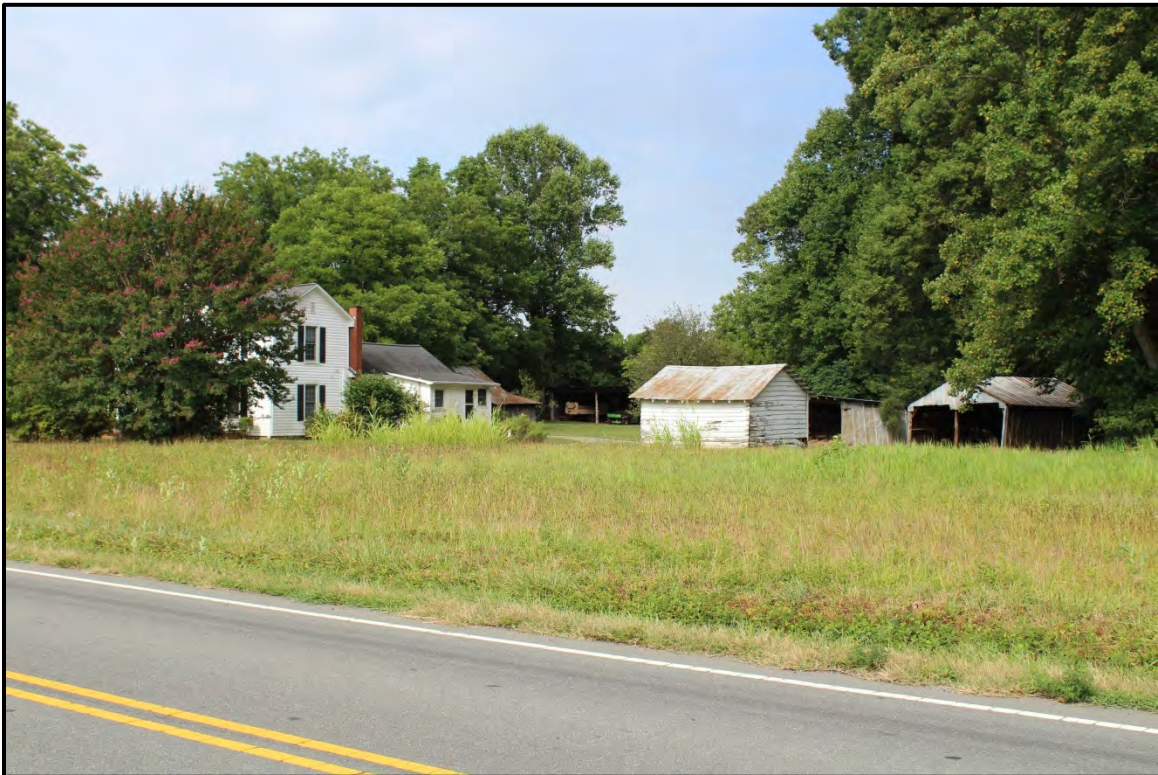
The two-story, wood-frame, building features a side-gabled roof covered with asphalt shingles, an interior central brick chimney, a modern exterior brick chimney, and an exterior clad with vinyl siding. Fenestration includes 6/6 double-hung vinyl sash windows and a 4-light operable wood sash window. A reconstructed full-width porch provides access to the main entrance. The porch is comprised of a shed roof supported by ornamental metal columns and a brick and concrete deck. A gabled-roof ell with a shed extension is attached to the west (rear) elevation. Located north and west of the house are a collection of outbuildings that include: a mid-twentieth century tractor barn, shed, a two-bay garage, tobacco barn, and an animal shed (Figures 6.104 and 6.106).

Figure 6.104. Architectural resource AM2518; view is southwest featuring the north elevation and associated outbuildings.

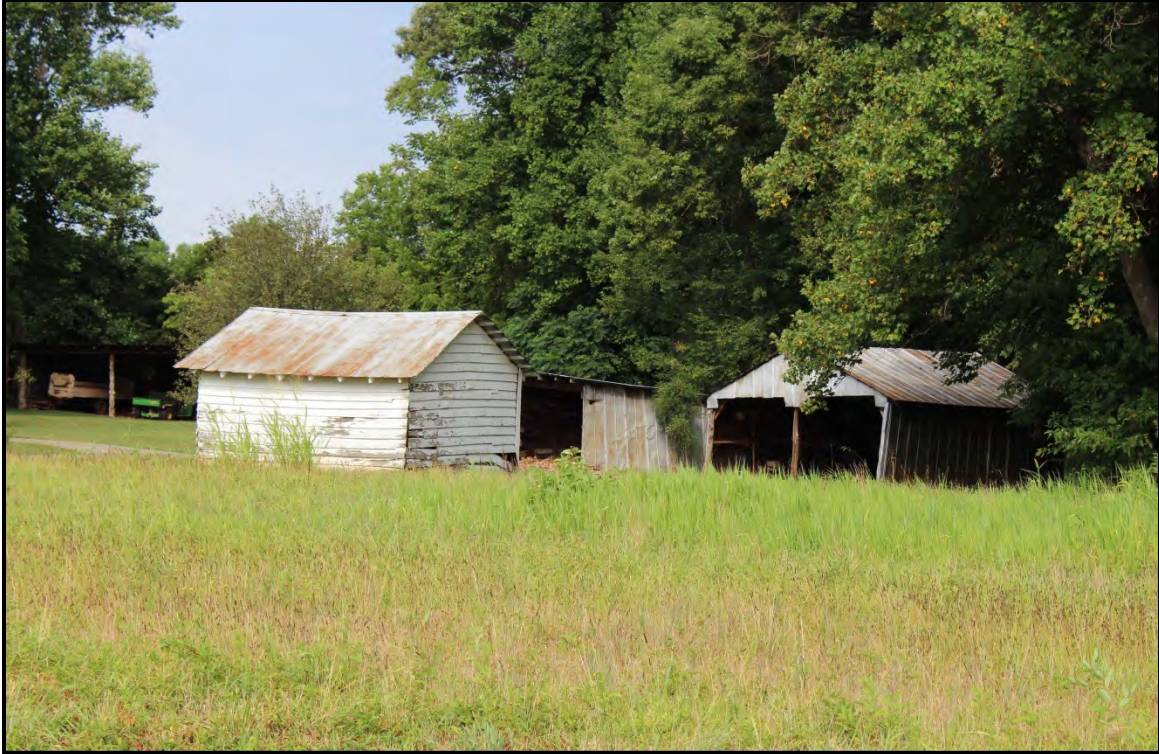
Figure 6.105. Architectural resource AM2518; view is southwest and features the tractor barn, shed, and garage.

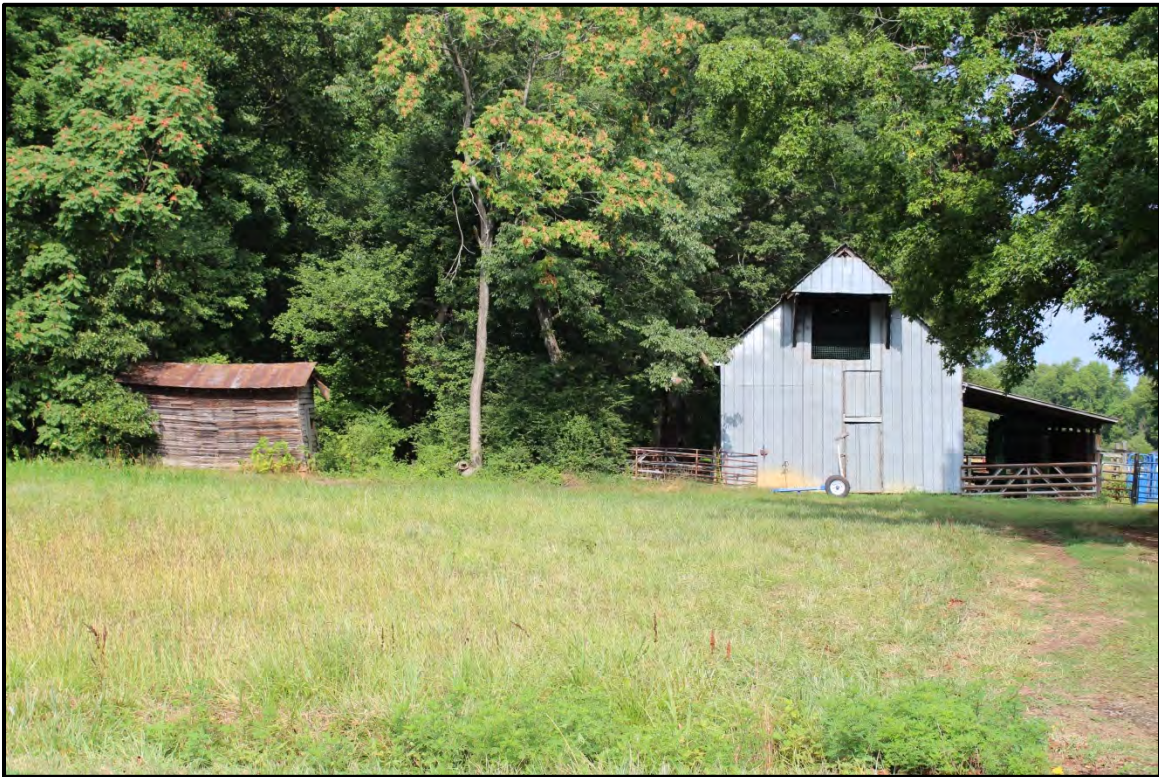
Figure 6.106. Architectural resource AM2518; view is west and features the animal shed and tobacco barn.

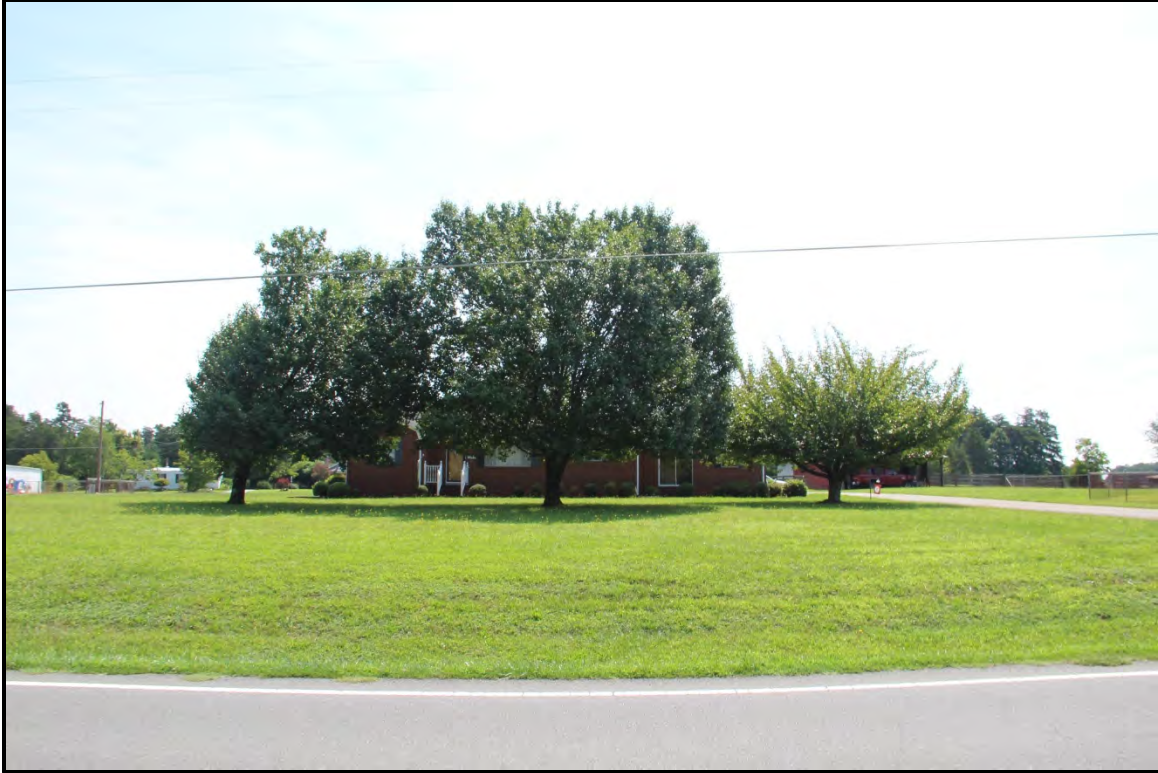
Figure 6.107. Architectural resource AM2519; view is east featuring the façade.

NRHP Assessment. Architectural resource AM2519 does not exhibit a distinctive architectural style or workmanship. Based on the lack of architectural merit, as well as the inability to associate the house and/or its original owner(s) with an important historical event or series of events, it is TRC's opinion that architectural resource AM2519 is not eligible for the NRHP.

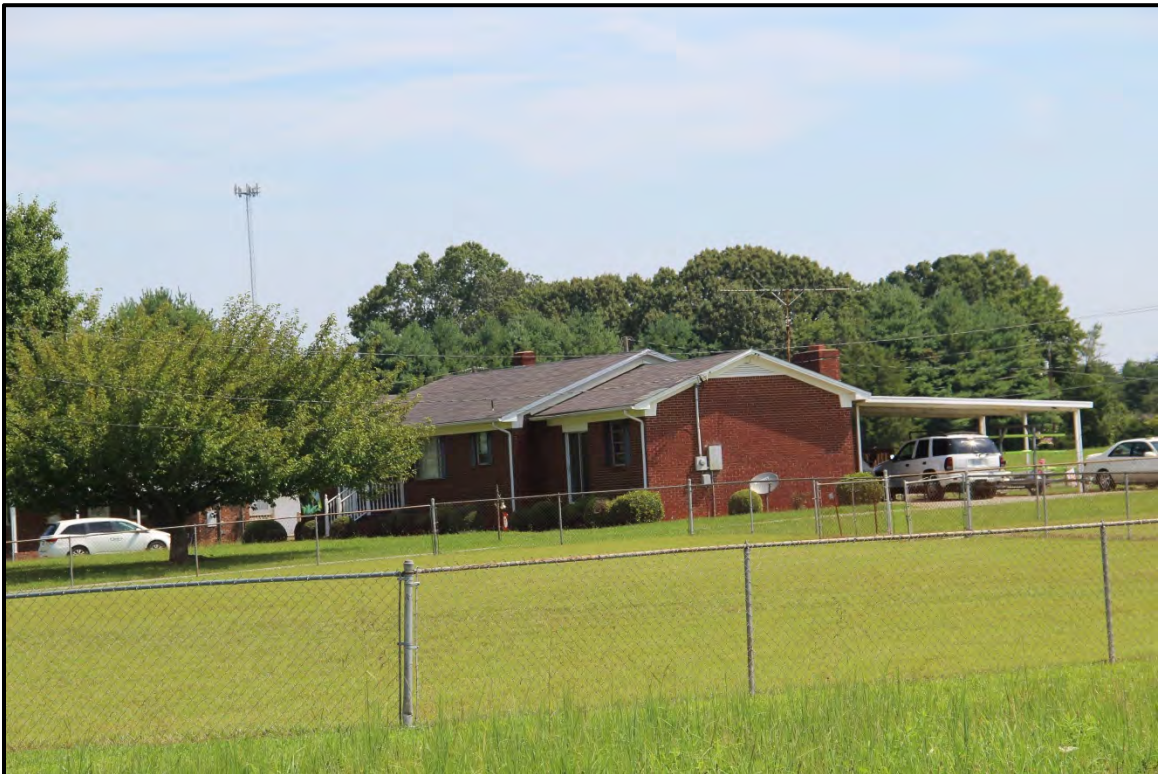
Figure 6.108. Architectural resource AM2519; view is northeast featuring the façade and south elevation.
