Re: Revised Architectural Survey Report, MVP Southgate Project, Construct Interstate Pipeline, Rockingham and Alamance County, ER 18-1041

Thank you for your letter of October 11, 2019, transmitting the draft "Historic Architectural Survey for the MVP Southgate Pipeline Project". We have reviewed the report and offer the following comments.

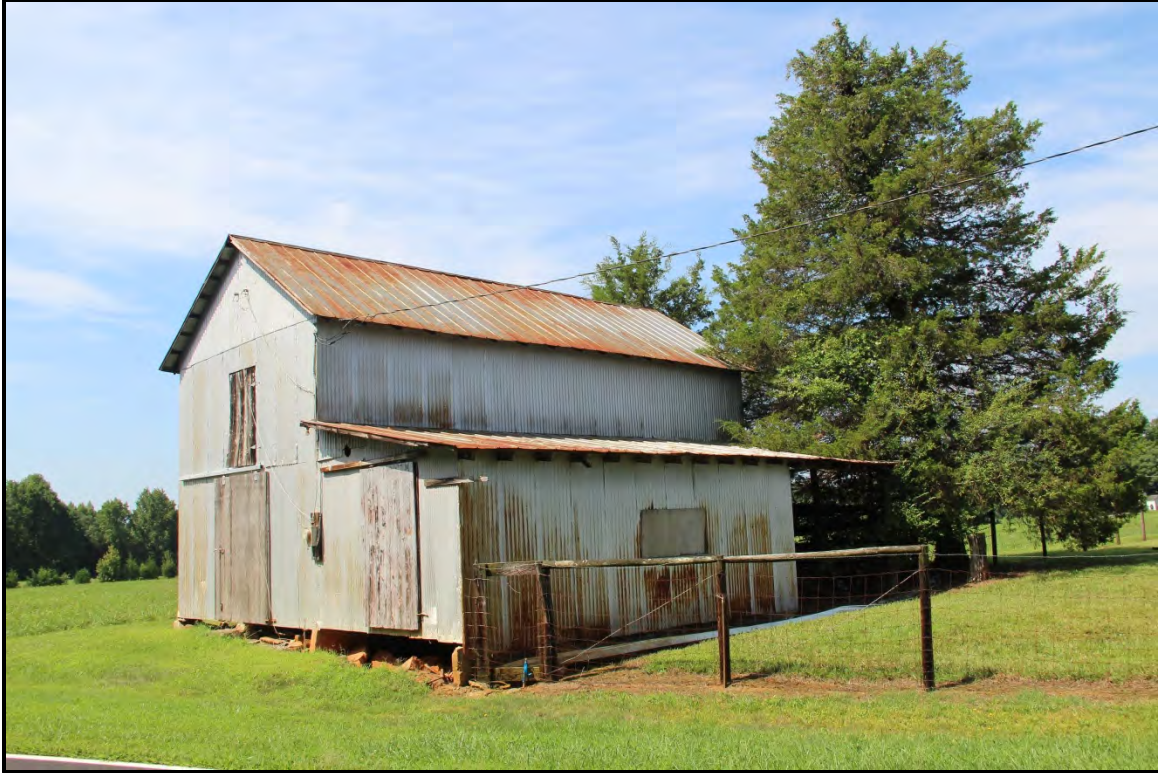
- A mid-twentieth century hay barn. The wood-frame structure features a side-gabled roof, metal siding, and a stone pier foundation. Attached to the northeast elevation is a shed roof extension that contains an open bay (Figure 6.109);
- A late-twentieth century tobacco barn. The wood-frame structure features a gabled roof, metal siding, and a concrete block foundation. A lean-to is attached to the roof on the primary elevation (Figure 6.110).

Figure 6.109. Architectural resource AM2519; view is southwest featuring the hay barn.

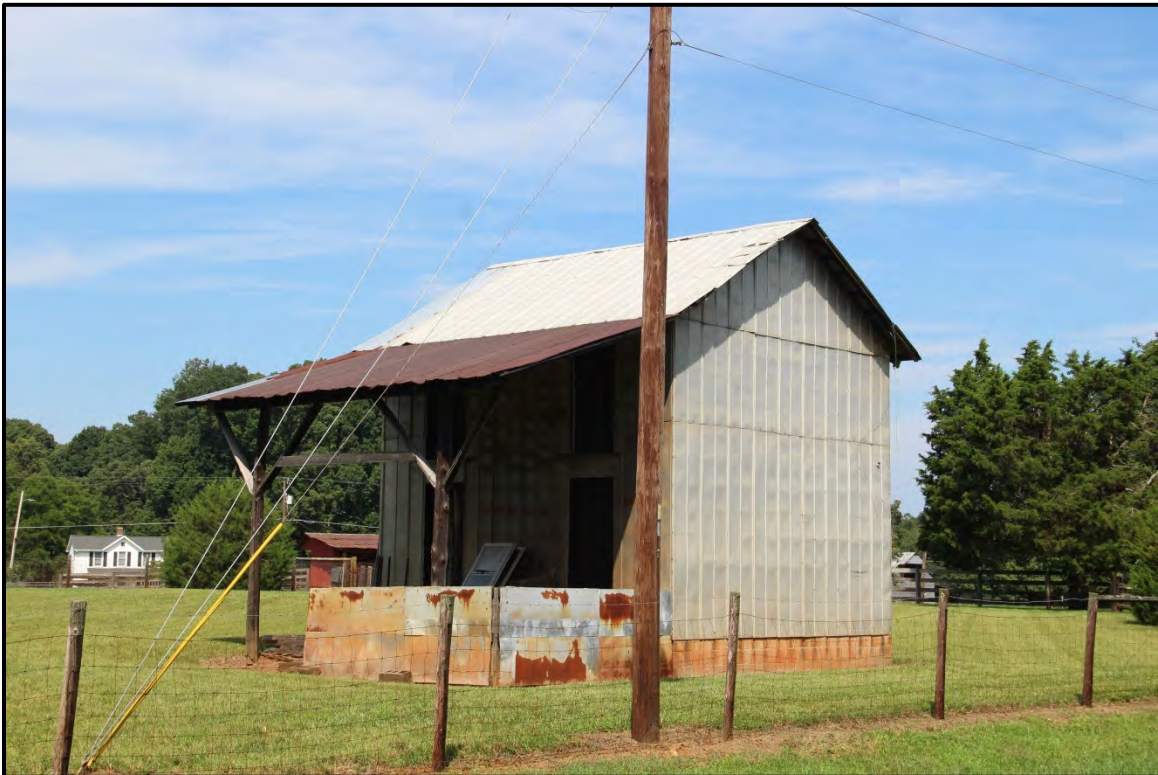
Figure 6.110. Architectural resource AM2519; view is northwest featuring the late-twentieth century tobacco barn.

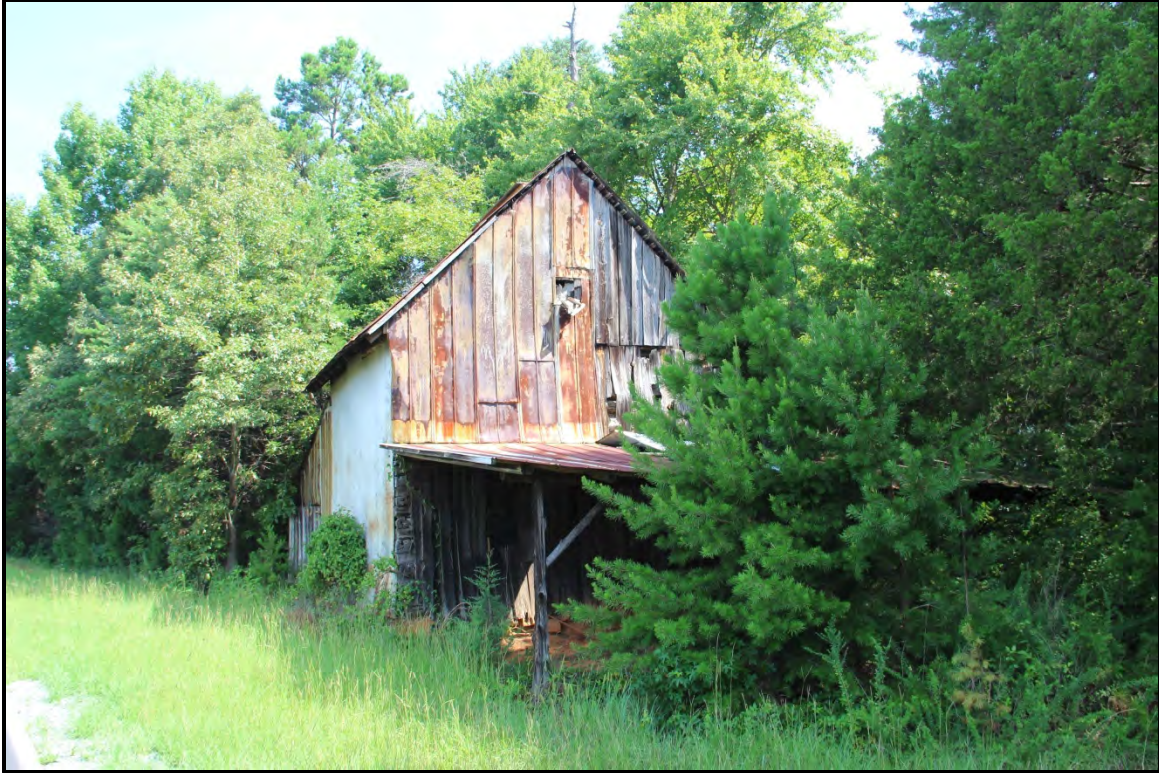
- A ca. 1940 tobacco barn. The wood-frame structure features a steeply pitched gabled roof and metal siding (Figure 6.111). Attached to the façade elevation is a lean-to shed.
- A ca. 1940 barn that is heavily obscured by vegetation (Figure 6.112). The wood-frame structure features a gabled roof, metal siding, and a shed roof section.

Figure 6.111. Architectural resource AM2520; view is northeast featuring the tobacco barn.

NRHP Assessment. Architectural resource AM2520 does not exhibit a distinctive architectural style or workmanship. Based on the lack of architectural merit, as well as the inability to associate the outbuildings and/or its original owner(s) with an important historical event or series of events, it is TRC's opinion that architectural resource AM2520 is not eligible for the NRHP.

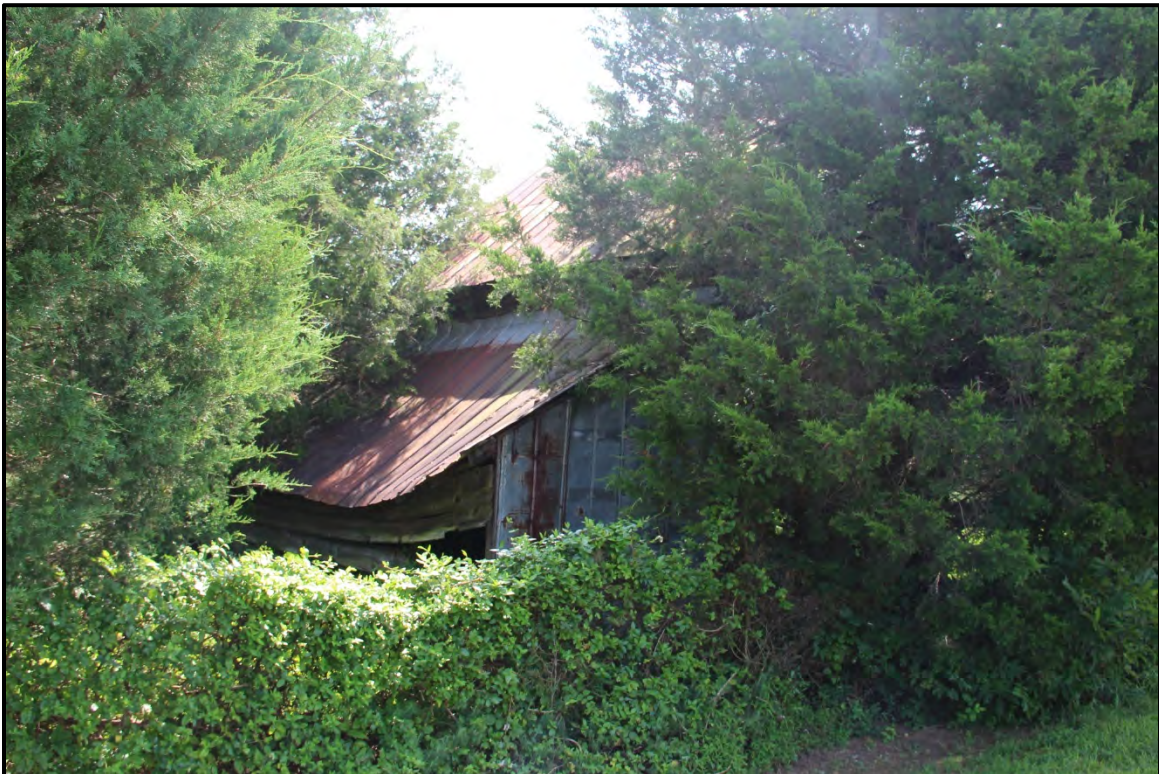
Figure 6.112. Architectural resource AM2520; view is southeast featuring the barn.

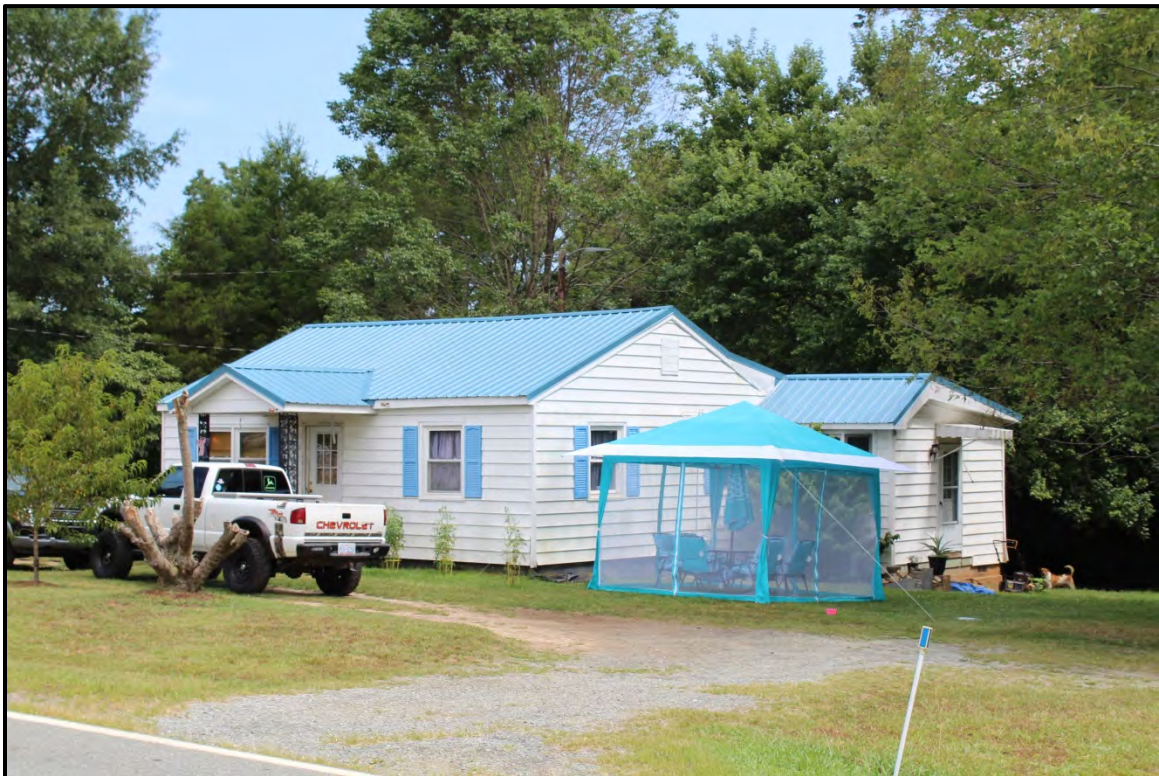
The one-story, wood-frame building features a side-gabled metal roof, an exterior clad with aluminum siding, and a concrete block foundation. The façade and side (southeast) elevation hold 1/1 vinyl sash windows. A concrete stoop supported by wrought iron style columns provides access to the main entrance. The property also includes a shed outbuilding located on the east elevation.

Figure 6.113. Architectural resource AM2521; view is northeast featuring the façade and southeast elevation.

NRHP Assessment. Architectural resource AM2521 does not exhibit a distinctive architectural style or workmanship. In addition, the house has been altered through the installation of vinyl sash windows and the application of aluminum siding. Based on the lack of architectural merit, as well as the inability to associate the house and/or its original owner(s) with an important historical event or series of events, it is TRC's opinion that architectural resource AM2521 is not eligible for the NRHP.

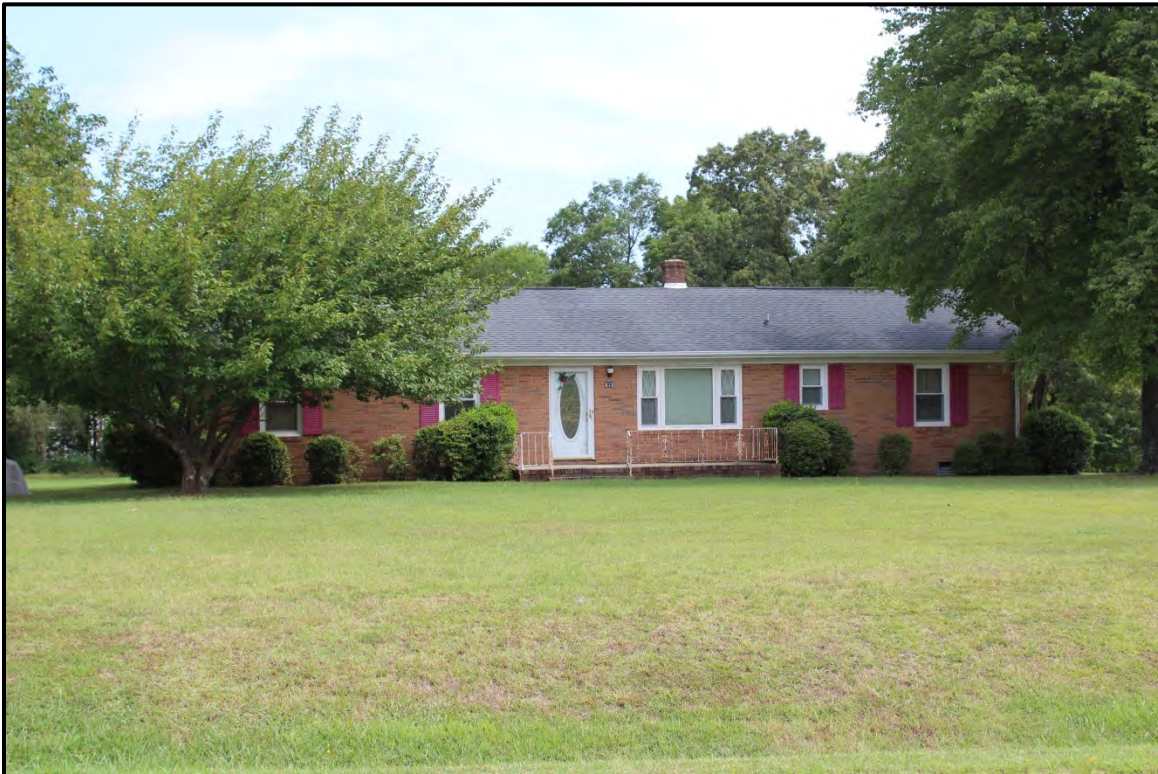
The wood-frame building features a side-gabled roof, an exterior clad with a brick veneer, an interior brick chimney, and a brick foundation. The façade elevation contains a centrally placed door that is flanked to the east by a three-part picture window. Remaining windows throughout the house are 1/1 double-hung vinyl sashes. A concrete and brick stoop with a metal railing provides access to the main entrance.

Figure 6.114. Architectural resource AM2522; view is north featuring the façade.

NRHP Assessment. Architectural resource AM2522 does not exhibit a distinctive architectural style or workmanship. In addition, the house has been altered through the installation of vinyl sash windows. Based on the lack of architectural merit, as well as the inability to associate the house and/or its original owner(s) with an important historical event or series of events, it is TRC's opinion that architectural resource AM2522 is not eligible for the NRHP.

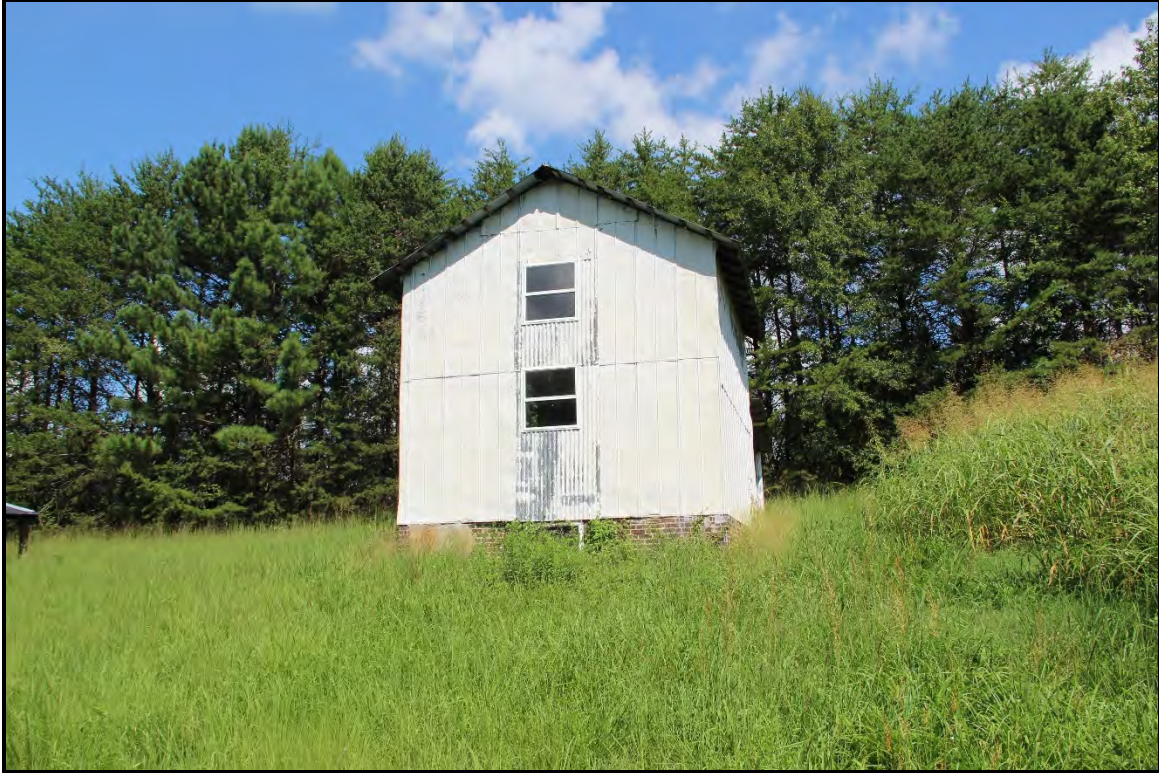
Tobacco Barn A is a wood-frame structure that features a gabled roof covered with standing seam metal, an exterior clad with corrugated metal panels, and a brick foundation. Attached to the north elevation of the structure is an open pole shed extension that provides access to a door. The structure includes two 1/1 double-hung metal sash windows on its south elevation (Figure 6.115).

Figure 6.115. Architectural resource AM2523; view is north featuring “Tobacco Barn A”.

NRHP Assessment. Architectural resource AM2523 does not exhibit a distinctive architectural style or workmanship. Based on the lack of architectural merit, as well as the inability to associate the tobacco barns and/or its original owner(s) with an important historical event or series of events, it is TRC’s opinion that architectural resource AM2523 is not eligible for the NRHP.

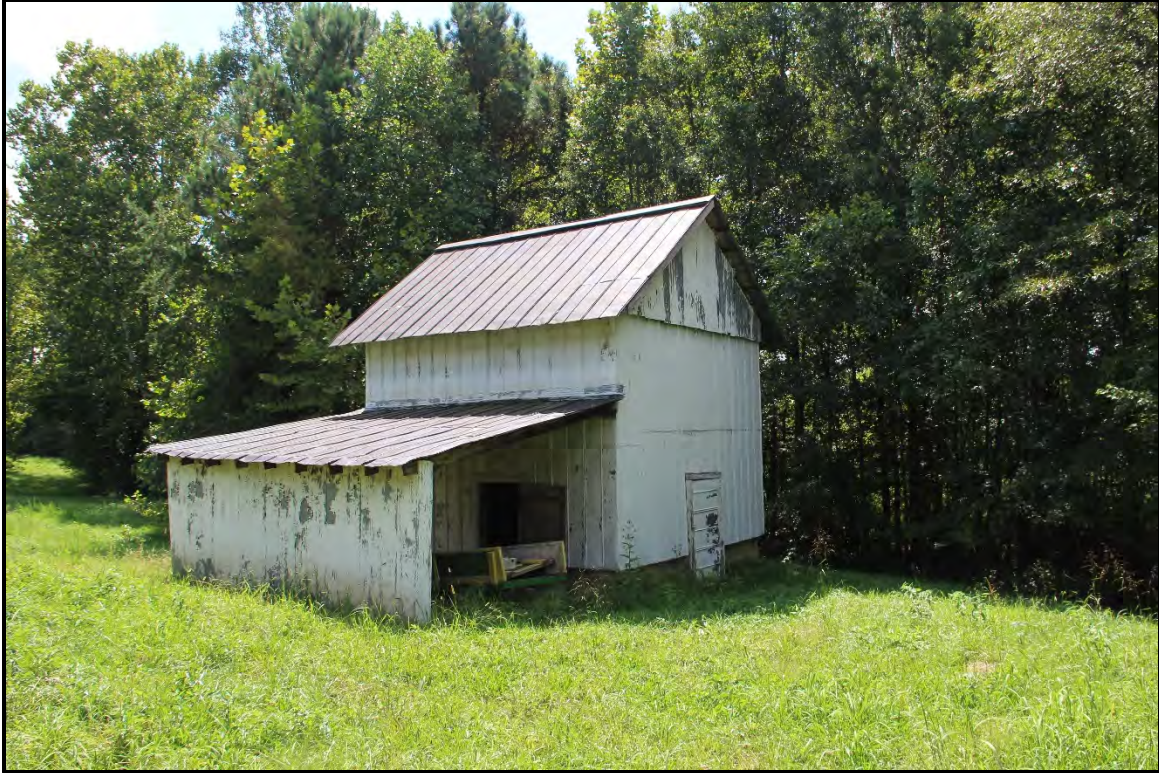
Tobacco Barn C is a wood-frame structure that features a gabled roof covered with standing seam metal, an exterior clad with metal panels, and a brick foundation. The structure includes a door on its west on its south elevation. Attached to the north elevation is a shed-roof extension that contains a single bay for equipment storage (Figure 6.117).

Figure 6.117. Architectural resource AM2523; view is south featuring “Tobacco Barn C”.

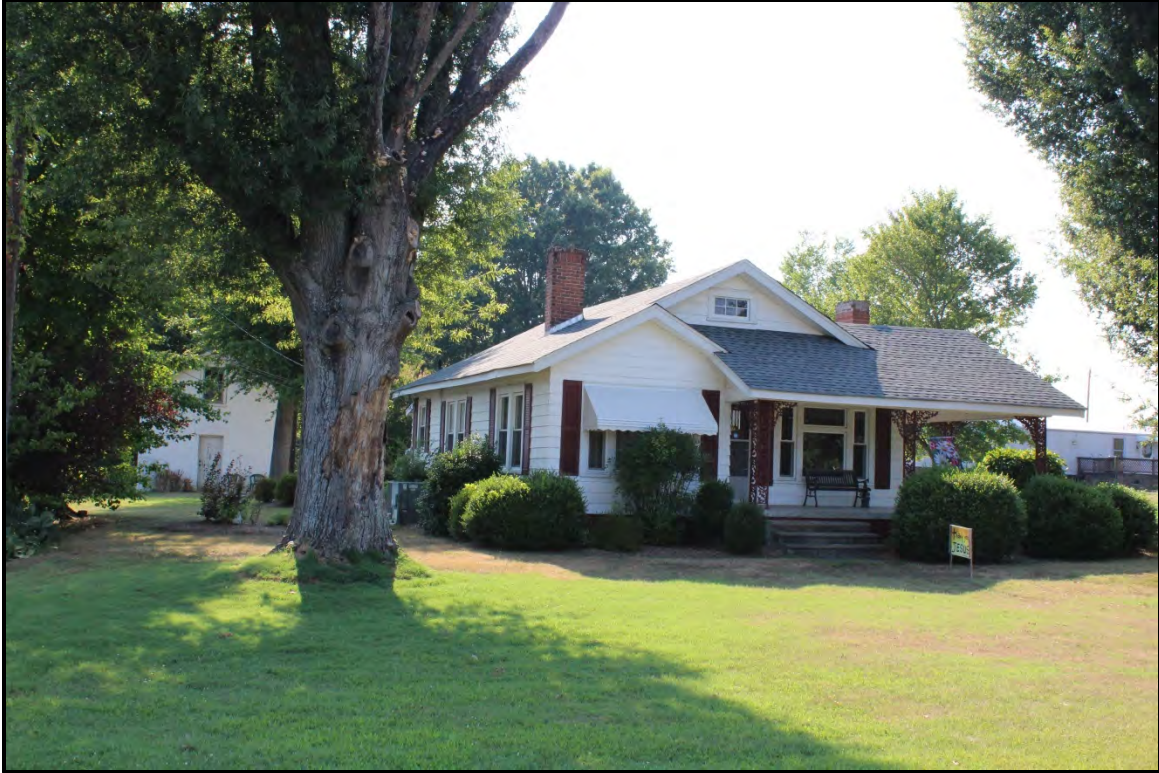
The one-story, wood-frame building features a front-gabled roof with asphalt shingles, two interior brick chimneys, an exterior clad with aluminum siding, and a brick foundation. Facing west, the façade includes a central door that is flanked to the north by a three-part picture window with vinyl sashes. Situated south of the door is a projecting gable bay that contains a similar three-part picture window. Located in the attic level is a six-light wood sash window. Remaining fenestration on the house consists of 1/1 vinyl sash windows with vinyl shutters. Located on the façade elevation is a concrete porch supported by decorative posts. A concrete block outbuilding with a front-gabled roof is situated southwest of the house.

NRHP Assessment. Architectural resource AM2524 does not exhibit a distinctive architectural style or workmanship. In addition, the house has been altered through the application of vinyl siding, the replacement of the original porch columns, and the installation of vinyl sash windows. Based on the lack of architectural merit, as well as the inability to associate the house and/or its original owner(s) with an important historical event or series of events, it is TRC's opinion that architectural resource AM2524 is not eligible for the NRHP.

Figure 6.118. Architectural resource AM2524; view is northwest featuring the façade and south elevation.

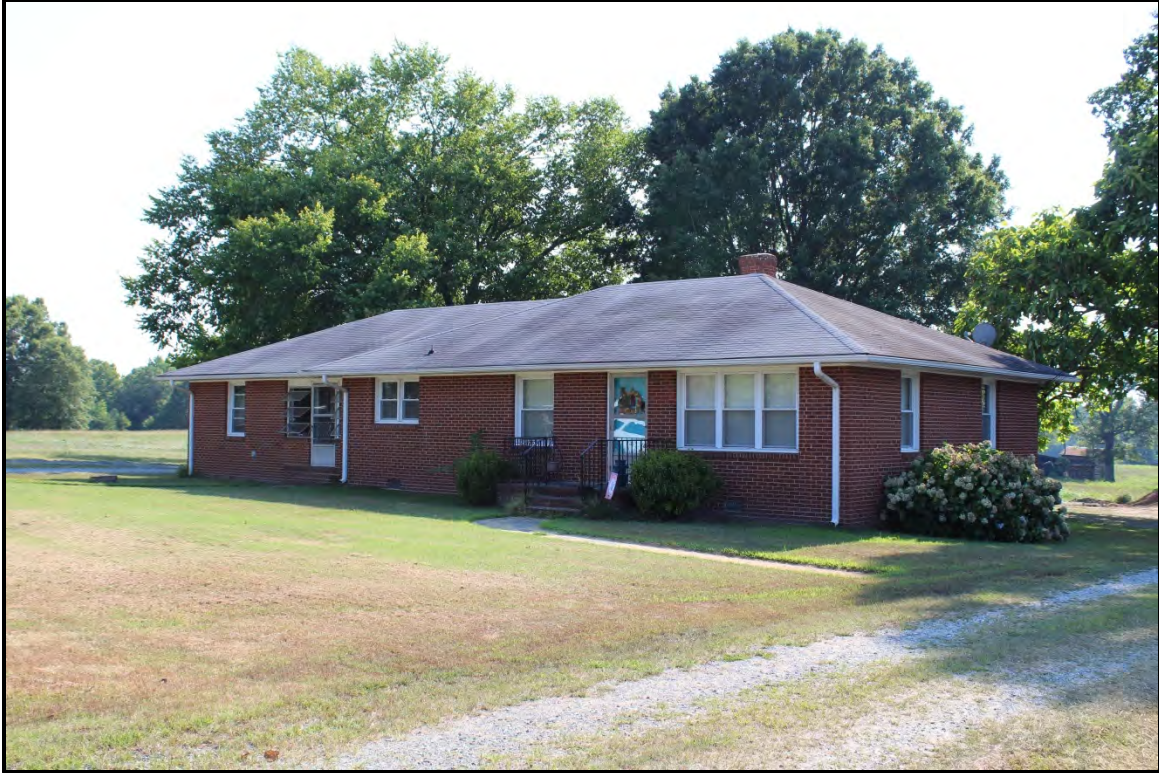
The wood-frame building features a hipped roof covered with asphalt shingles, an interior brick chimney, an exterior clad with a brick veneer, and a brick foundation. Facing east, the façade includes an off-centered door that is flanked to the north by a band of three windows containing 1/1 double-hung vinyl sashes. This sash type is repeated in a single window and in a paired window located south of the door. A brick and concrete stoop with a wrought iron style handrail leads to the main entrance.

NRHP Assessment. Architectural resource AM2525 does not exhibit a distinctive architectural style or workmanship. In addition, the house has been altered through the installation of vinyl sash windows. Based on the lack of architectural merit, as well as the inability to associate the house and/or its original owner(s) with an important historical event or series of events, it is TRC's opinion that architectural resource AM2525 is not eligible for the NRHP.

Figure 6.119. Architectural resource AM2525; view is southwest featuring the façade and north elevation.

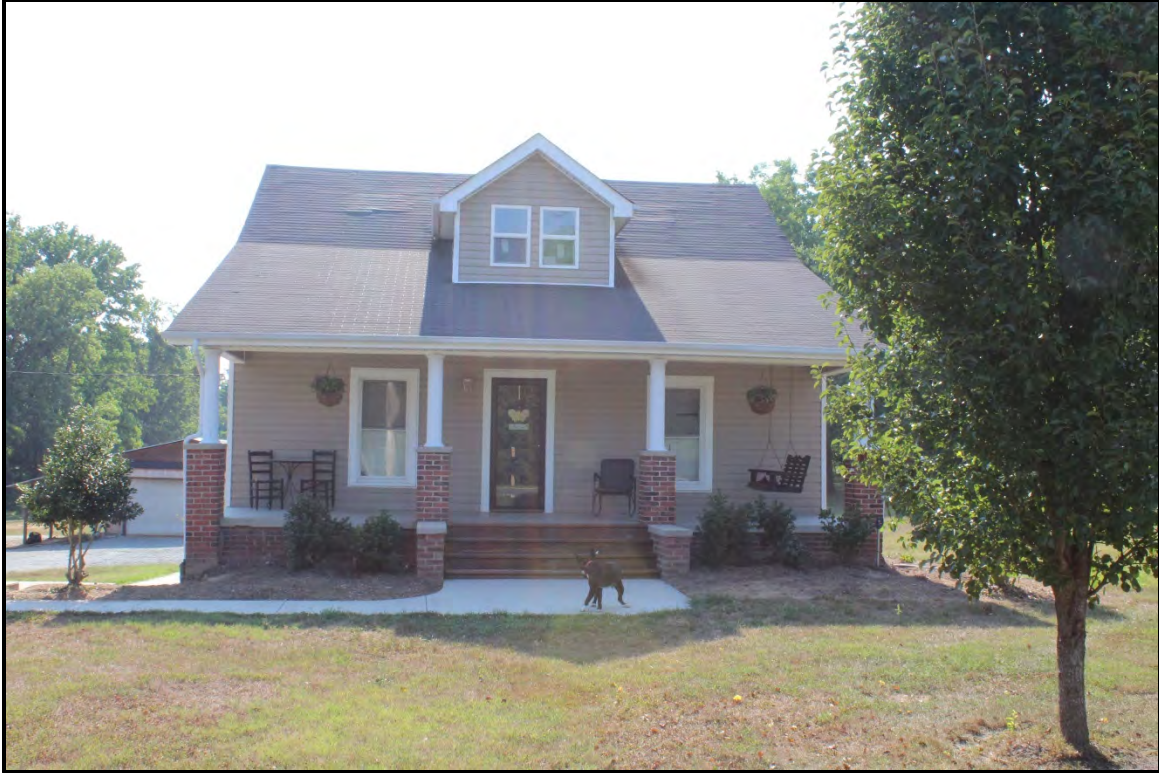
The one and one-half-story, wood-frame building features a side-gabled roof covered with asphalt shingles, an exterior clad with vinyl siding, and a brick foundation. Facing east, the façade is marked with a central door that is flanked on either side by a 1/1 double-hung vinyl sash window. A full-width porch that is integral with the main roof provides access to the main entrance. The porch contains a concrete deck atop a brick foundation. Supporting the porch roof are four non-historic aluminum columns that rest on brick plinth blocks. Situated in the half story is a gable dormer with a pair of 1/1 double-hung vinyl sashes. This sash type is repeated in the remaining windows throughout the house.

NRHP Assessment. Architectural resource AM2526 does not exhibit a distinctive architectural style or workmanship. In addition, the house has been altered through the installation of vinyl sash windows, the application of vinyl siding, and the replacement of the original porch columns. Based on the lack of architectural merit, as well as the inability to associate the house and/or its original owner(s) with an important historical event or series of events, it is TRC's opinion that architectural resource AM2526 is not eligible for the NRHP.

Figure 6.120. Architectural resource AM2526; view is west featuring the façade.

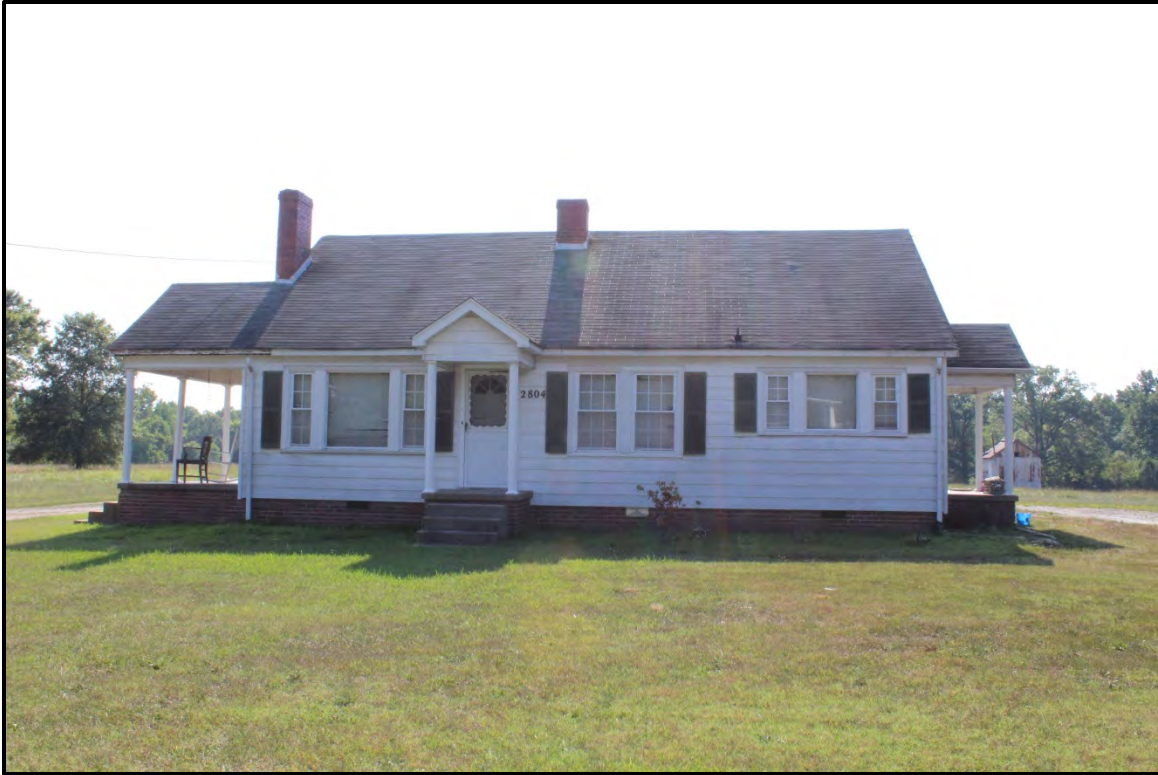
The one-story, wood-frame building features a side-gabled roof with asphalt shingles, an exterior clad with aluminum siding, two interior brick chimneys, and a brick foundation. Facing east, the façade reveals an off-center door that is flanked to the north by a pair of 6/6 double-hung vinyl sash windows. Access to the façade door is through a concrete stoop atop a brick foundation. The stoop is partly shielded by a gabled entry roof that is supported by aluminum columns. Located on either side of the central bay is a three-part picture window. The picture windows include a central, single-pane, fixed sash that is flanked by a 4/4 double-hung vinyl sash window. Attached to the south elevation is a side-gabled porch and an exterior end brick chimney. Attached to the north elevation is another porch with a side-gabled roof that is supported by aluminum columns. Associated with the house are three tobacco barns, that were not accessible at the time of the survey.

NRHP Assessment. Architectural resource AM2527 is an inactive farmstead anchored by a Minimal Traditional-style house that does not exhibit distinctive characteristics of architectural style or workmanship. In addition, the house has been altered through the application of vinyl siding, the installation of vinyl sashes, the replacement of the original porch columns. Due to these modern alterations, the farm no longer conveys its mid-twentieth century appearance, thereby rendering the property ineligible for its agricultural associations. For these reasons it is the opinion of TRC that architectural resource AM2527 is not eligible for the NRHP.

Figure 6.121. Architectural resource AM2527; view is west featuring the façade.

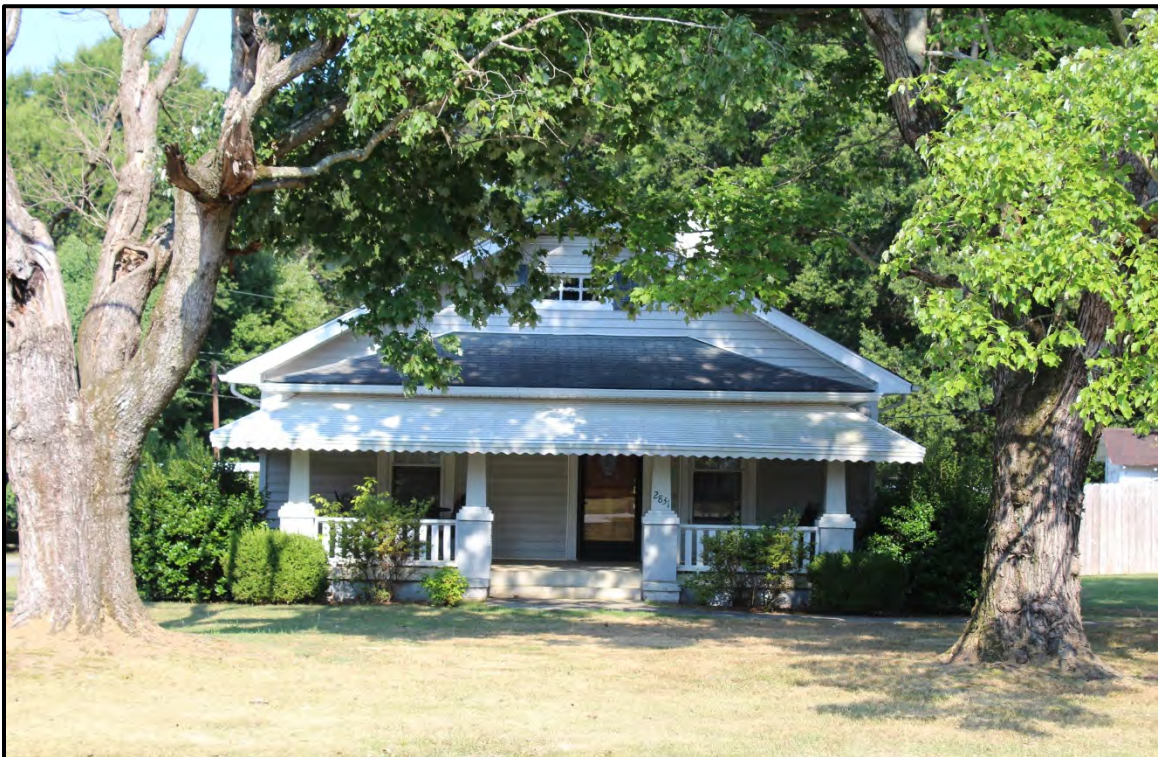
The one-story, wood-frame building features a front-gabled roof with asphalt shingles, an exterior clad with vinyl siding, an interior brick chimney, and a brick foundation. Facing west, the façade is marked by an off-centered door that is flanked on either side by a vertical 3/1 double-hung vinyl sash window. A partial-width porch containing a concrete deck atop a brick foundation provides access to the main entrance. The porch is shielded by a hipped roof that is supported by four tapered wood posts atop brick plinth blocks. Attached to the porch roof is a non-historic metal awning. Situated above the porch roof at the attic level is a 6-light wood sash window. Windows throughout the house are vertical 3/1 double-hung vinyl sashes.

NRHP Assessment. Architectural resource AM2528 does not exhibit a distinctive architectural style or workmanship. In addition, the house has been altered through the installation of vinyl sash windows and the application of vinyl siding. Based on the lack of architectural merit, as well as the inability to associate the house and/or its original owner(s) with an important historical event or series of events, it is TRC's opinion that architectural resource AM2528 is not eligible for the NRHP.

Figure 6.122. Architectural resource AM2528; view is east featuring the façade.

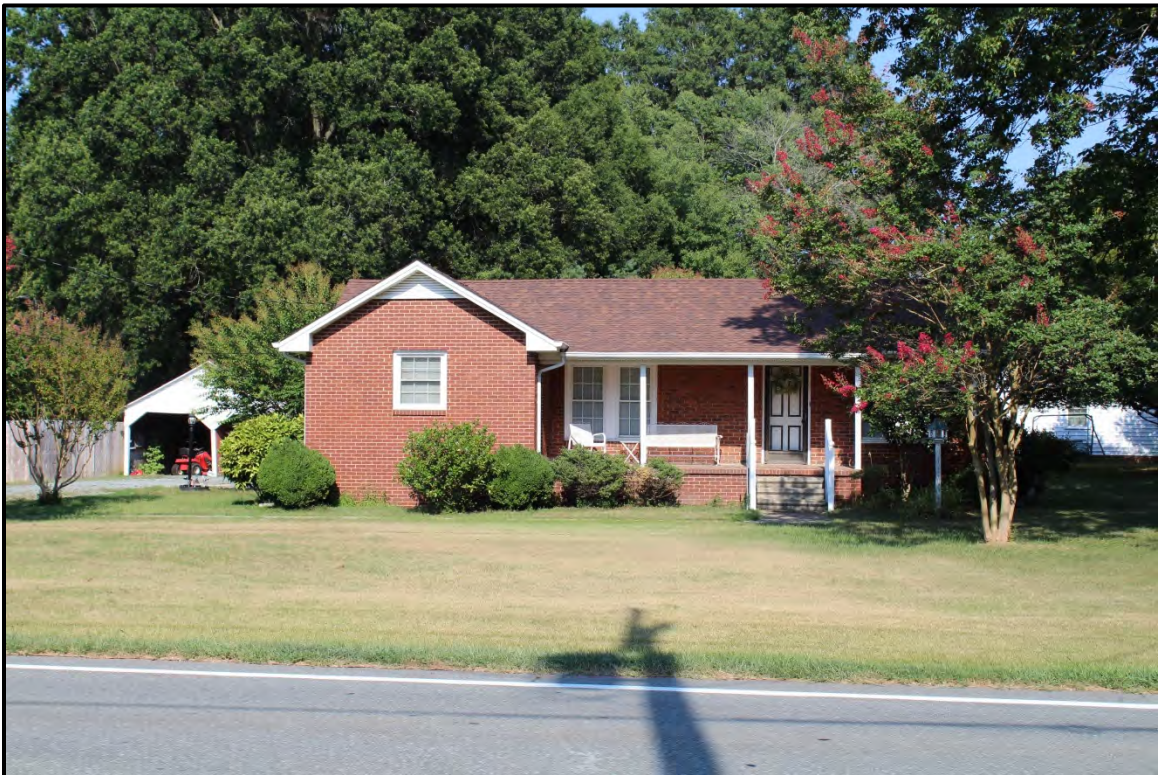
The one-story, wood-frame building features a side-gabled roof with asphalt shingles, an exterior clad with a brick veneer, and a brick foundation. Facing west, the façade reveals an off-centered door that is flanked on either side by a pair of 6/6 double-hung vinyl sash windows. A partial-width porch containing a brick deck provides access to the façade door. The porch is shielded by a shed roof that is supported by four posts composed of synthetic material. Located south of the porch is a projecting gable bay that is pierced with a 6/6 double-hung vinyl sash window. The property also contains a two-bay detached garage.

NRHP Assessment. Architectural resource AM2529 does not exhibit a distinctive architectural style or workmanship. In addition, the house has been altered through the installation of vinyl sash windows. Based on the lack of architectural merit, as well as the inability to associate the house and/or its original owner(s) with an important historical event or series of events, it is TRC's opinion that architectural resource AM2529 is not eligible for the NRHP.

Figure 6.123. Architectural resource AM2529; view is east featuring the façade.

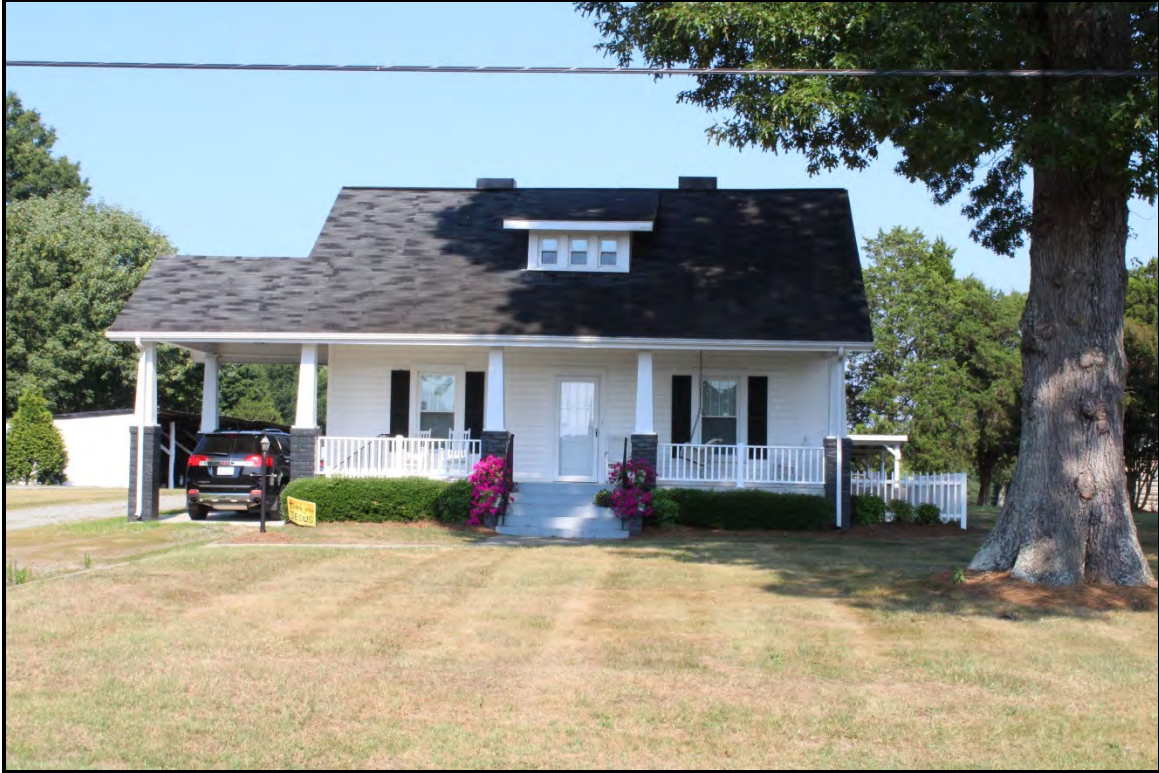
The one and one-half-story, wood-frame building features a side-gabled roof with asphalt shingles, two interior chimneys, an exterior clad with vinyl siding, and a brick foundation. Facing west, the façade reveals a central door that is flanked on either side by a vertical 4/1 double-hung vinyl sash window. A full-width porch that is integral with the main roof provides access to the façade door. The porch contains a concrete deck atop a brick foundation and four tapered wood posts atop brick plinth blocks. The porch roof extends to the south to create a porte cochere. As with the porch, the roof of the porte cochere is supported by tapered wood posts atop brick plinth blocks. A shed roof dormer is located in the second story and contains a band of three 1/1 double-hung vinyl sash windows. Additional outbuildings are located on the property but could not be documented due to limitations placed on the survey.

NRHP Assessment. Architectural resource AM2530 does not exhibit a distinctive architectural style or workmanship. In addition, the house has been altered through the installation of vinyl sash windows and the application of vinyl siding. Based on the lack of architectural merit, as well as the inability to associate the house and/or its original owner(s) with an important historical event or series of events, it is TRC's opinion that architectural resource AM2530 is not eligible for the NRHP.

Figure 6.124. Architectural resource AM2530; view is east featuring the façade.

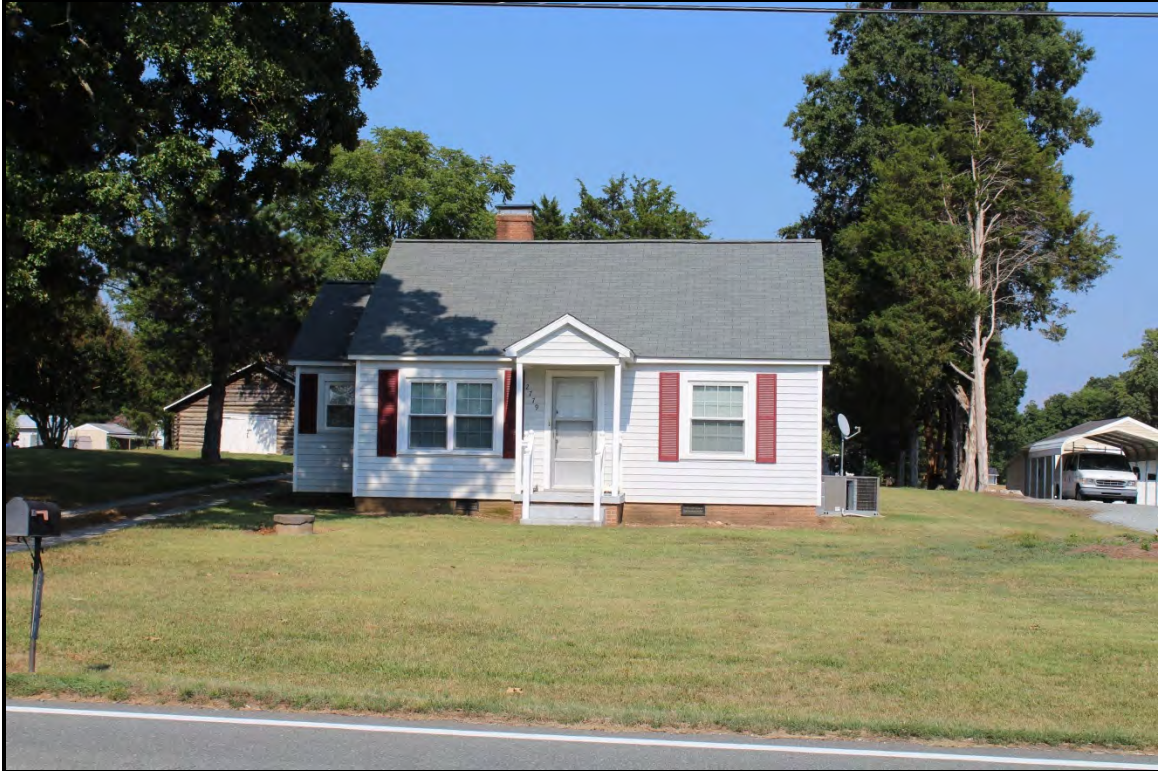
The one-story, wood-frame building features a side-gabled roof with asphalt shingles, an interior brick chimney, an exterior clad with vinyl siding, and a brick foundation. Facing west, the façade contains a central door that is flanked to the north by a pair of 6/6 double-hung. Positioned south of the door is an 8/8 double-hung vinyl sash window. Access to the façade door is through a concrete stoop atop a brick foundation. The stoop is shielded by a gable canopy that is supported by a pair of posts composed of synthetic material. Attached to the north elevation is a side-gabled wing.

NRHP Assessment. Architectural resource AM2531 does not exhibit a distinctive architectural style or workmanship. In addition, the house has been altered through the application of vinyl siding, the reconstruction of the entry porch, and the installation of vinyl sash windows. Based on the lack of architectural merit, as well as the inability to associate the house and/or its original owner(s) with an important historical event or series of events, it is TRC's opinion that architectural resource AM2531 is not eligible for the NRHP.

Figure 6.125. Architectural resource AM2531; view is east featuring the façade.

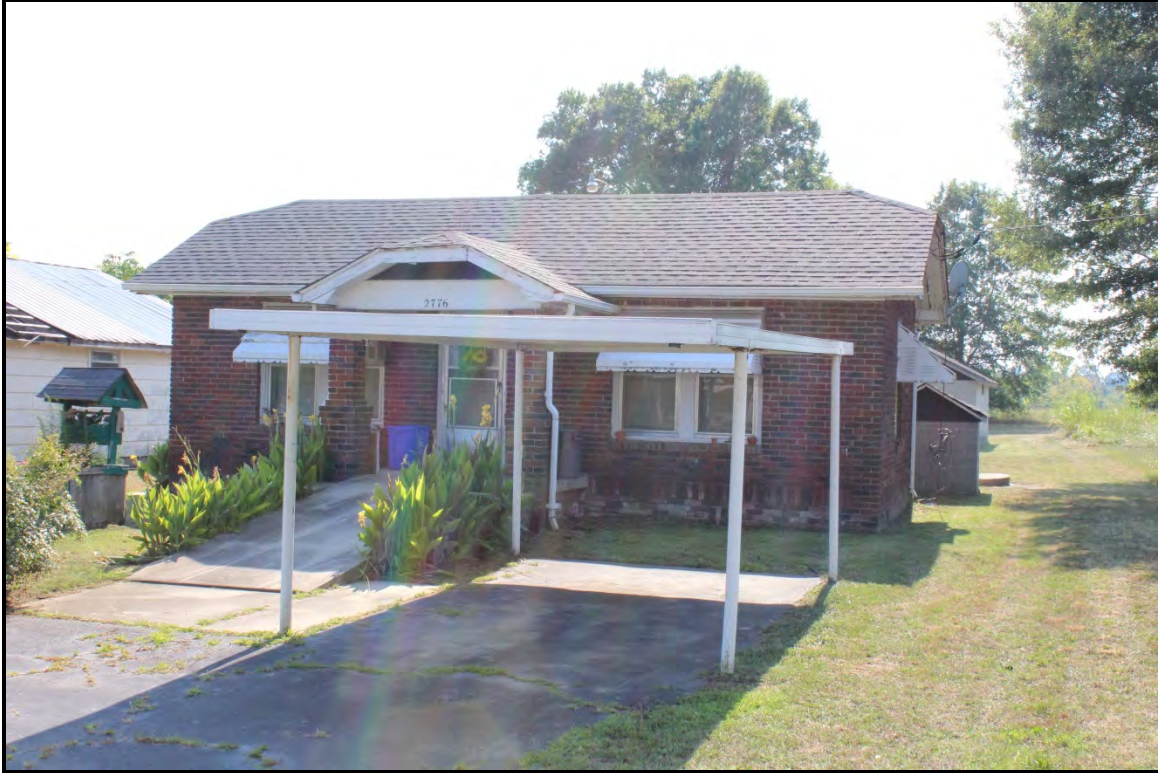
The one-story, wood-frame house features a side-gabled roof with clipped gables covered with asphalt shingles, an exterior clad with a brick veneer, and a brick foundation. Facing east, the façade contains a centrally placed door that is flanked on either side by a pair of 1/1 double-hung vinyl sash windows. Access to the façade door is through a single-bay entry porch that contains a concrete deck atop a brick foundation. The porch is shielded by a clipped-gabled roof that is supported by brick columns. Located in front of the house is a detached metal-frame carport.

NRHP Assessment. Architectural resource AM2532 does not exhibit a distinctive architectural style or workmanship. In addition, the Minimal Traditional-style house has been altered through the installation of vinyl sash windows. Based on the lack of architectural merit, as well as the inability to associate the house and/or its original owner(s) with an important historical event or series of events, it is TRC's opinion that architectural resource AM2532 is not eligible for the NRHP.

Figure 6.126. Architectural resource AM2532; view is west featuring the façade of the house.

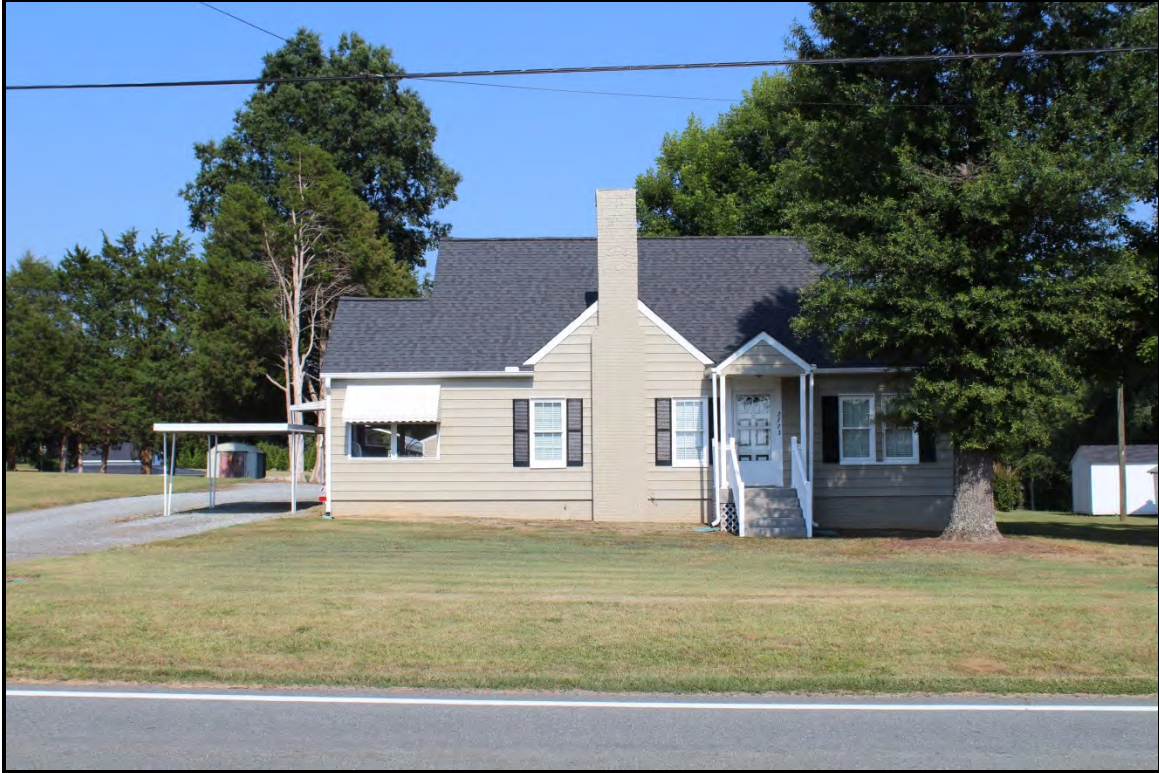
The one and one-half-story, wood-frame building features a side-gabled roof with asphalt shingles, an exterior clad with aluminum siding, and a brick foundation. The façade is marked by an off-centered projecting gable bay that contains an exterior brick chimney. Flanking either side of the chimney is a 6/6 double-hung wood sash window. Located south of the gabled bay is a door and a pair of 6/6 double-hung wood sash windows. Access to the façade door is through a single-bay entry porch topped with a gabled-roof. The porch roof is supported by a pair of posts composed of synthetic material. Situated in the half story is a gable dormer with a 6/6 wood sash window. Attached to the north elevation is a side-gabled wing that includes two pairs of windows containing 1/1 vinyl sashes.

NRHP Assessment. Architectural resource AM2533 does not exhibit a distinctive architectural style or workmanship. In addition, the house has been altered through the application of aluminum siding and the replacement of some of the original window sashes. Based on the lack of architectural merit, as well as the inability to associate the house and/or its original owner(s) with an important historical event or series of events, it is TRC's opinion that architectural resource AM2533 is not eligible for the NRHP.

Figure 6.128. Architectural resource AM2533; view is east featuring the façade.

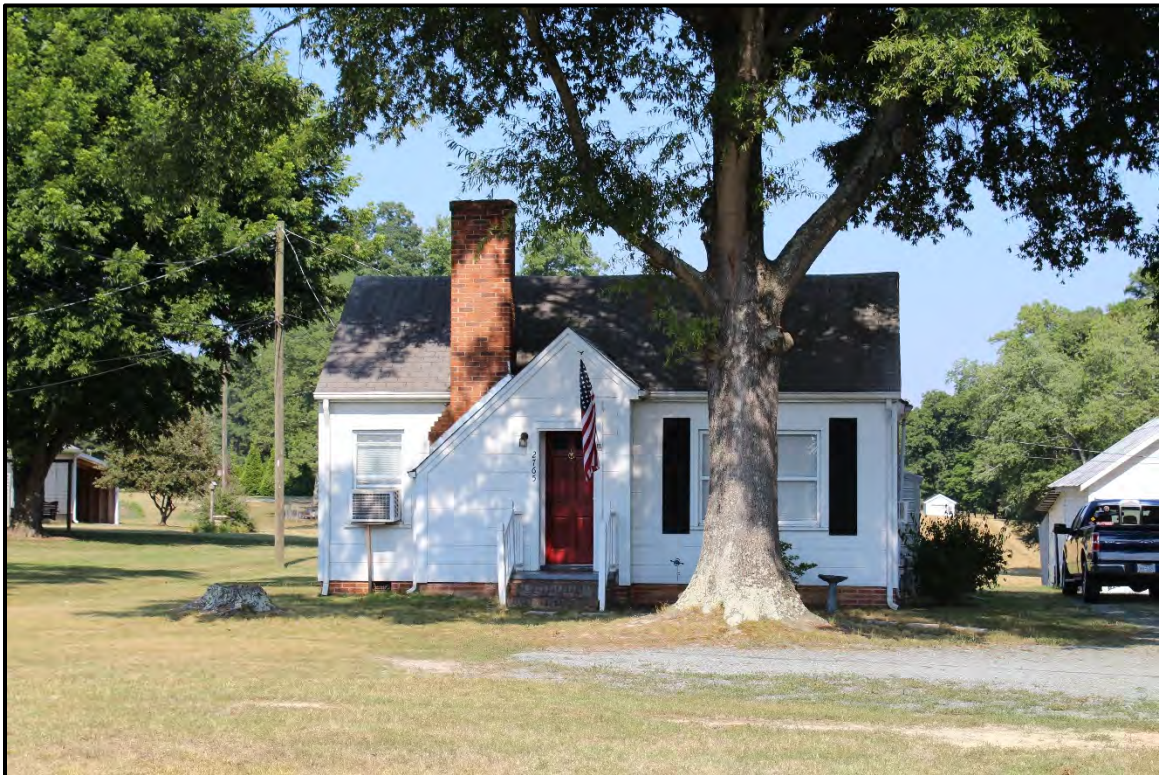
The one-story, wood-frame building features a side-gabled roof covered with asphalt shingles, an exterior clad with asbestos shingle siding, and a brick foundation. Facing west, the façade is accented with slightly projecting gable bay that contains the primary entrance. Situated within the central bay is an exterior brick chimney. Access to the façade door is through a concrete stoop atop a brick foundation. Flanking the central bay to the north is a 1/1 double-hung vinyl sash window. This sash type is repeated in a paired window located south of the central bay. Windows throughout the house are 1/1 double-hung vinyl sashes.

NRHP Assessment. Architectural resource AM2534 does not exhibit a distinctive architectural style or workmanship. In addition, the house has been altered through the installation of vinyl sash windows. Based on the lack of architectural merit, as well as the inability to associate the house and/or its original owner(s) with an important historical event or series of events, it is TRC’s opinion that architectural resource AM2534 is not eligible for the NRHP.

Figure 6.129. Architectural resource AM2534; view is east featuring the façade.
