Re: Revised Architectural Survey Report, MVP Southgate Project, Construct Interstate Pipeline, Rockingham and Alamance County, ER 18-1041

Thank you for your letter of October 11, 2019, transmitting the draft "Historic Architectural Survey for the MVP Southgate Pipeline Project". We have reviewed the report and offer the following comments.

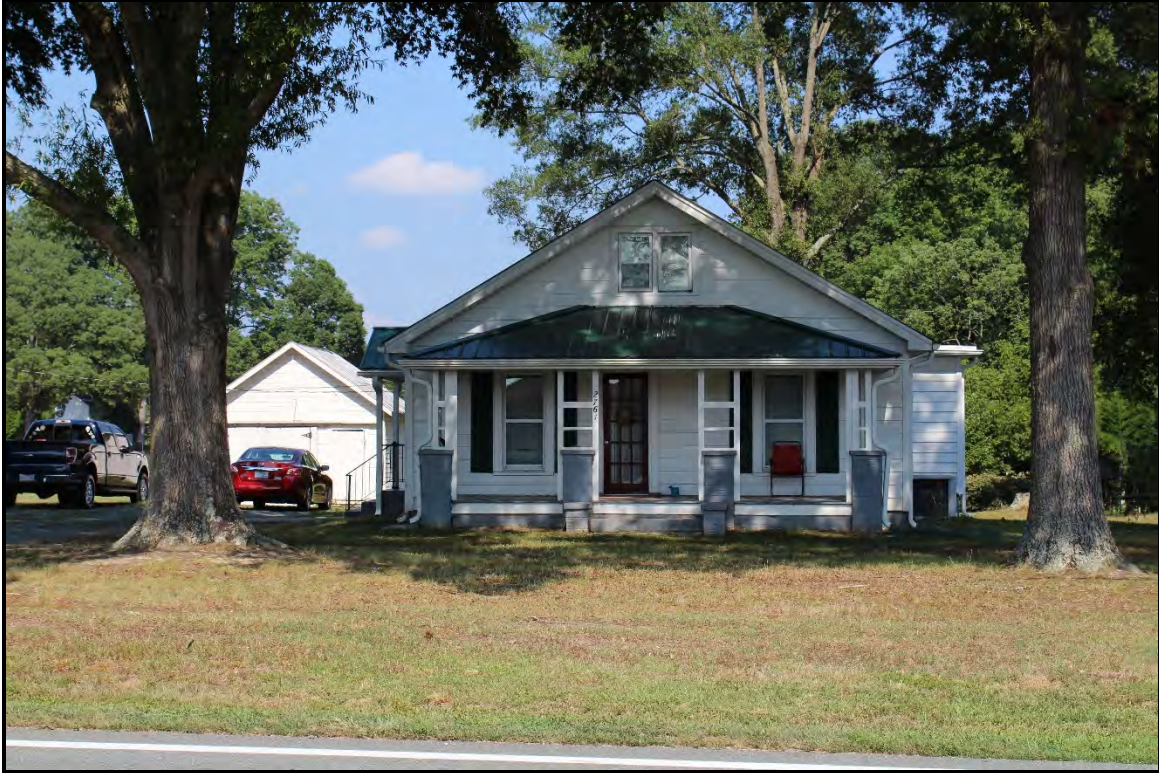
The one and one-half-story, wood-frame building features a roof covered with standing seam metal, an exterior clad with aluminum siding, and a brick foundation. Facing west, the façade contains an off-center door that is flanked on either side by a 1/1 double-hung vinyl sash window. Access to the façade door is through a partial-width porch that contains a wood deck atop a brick foundation. The porch is shielded by a hipped roof that is supported by non-historic wood posts atop brick plinth blocks. Located in the half story is a paired window with 1/1 double-hung vinyl sashes.

NRHP Assessment. Architectural resource AM2535 does not exhibit a distinctive architectural style or workmanship. In addition, the house has been altered through the installation of vinyl sash windows, the replacement of the original porch posts, and the application of aluminum siding. Based on the lack of architectural merit, as well as the inability to associate the house and/or its original owner(s) with an important historical event or series of events, it is TRC's opinion that architectural resource AM2535 is not eligible for the NRHP.

Figure 6.130. Architectural resource AM2535; view is east featuring the façade.

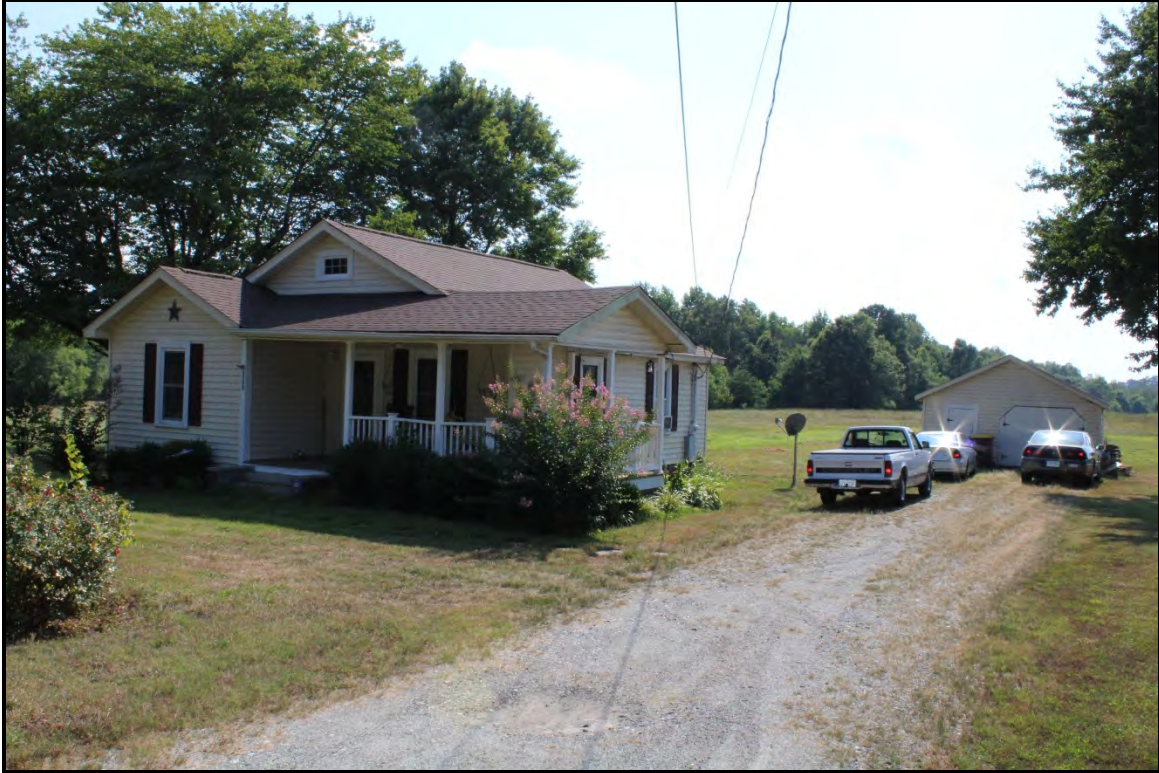
The one-story, wood-frame building features a front-gabled roof covered with asphalt shingles, and exterior clad with vinyl siding, and a brick foundation. Facing east, the façade contains a central door that is flanked to the north by a 1/1 double-hung vinyl sash window. Access to the main entrance is through a partial-width porch that is capped with a side-gabled roof. The porch includes a wood deck and a series of porch posts composed of synthetic material. Located south of the porch is a projecting gable bay with a 1/1 double-hung vinyl sash window. A window in the attic level contains a 6-light vinyl sash. Associated with the property is a detached garage. The wood-frame structure is capped with a gabled roof and features an exterior clad with vinyl siding (Figure 6.131).

NRHP Assessment. Architectural resource AM2616 does not exhibit a distinctive architectural style or workmanship. In addition, the house has been altered through the application of vinyl siding, the installation of vinyl sash windows, and the replacement of the original porch columns. Based on the lack of architectural merit, as well as the inability to associate the house and/or its original owner(s) with an important historical event or series of events, it is TRC's opinion that architectural resource AM2616 is not eligible for the NRHP.

Figure 6.131. Architectural resource AM2616; view is southwest featuring the façade and north elevation.

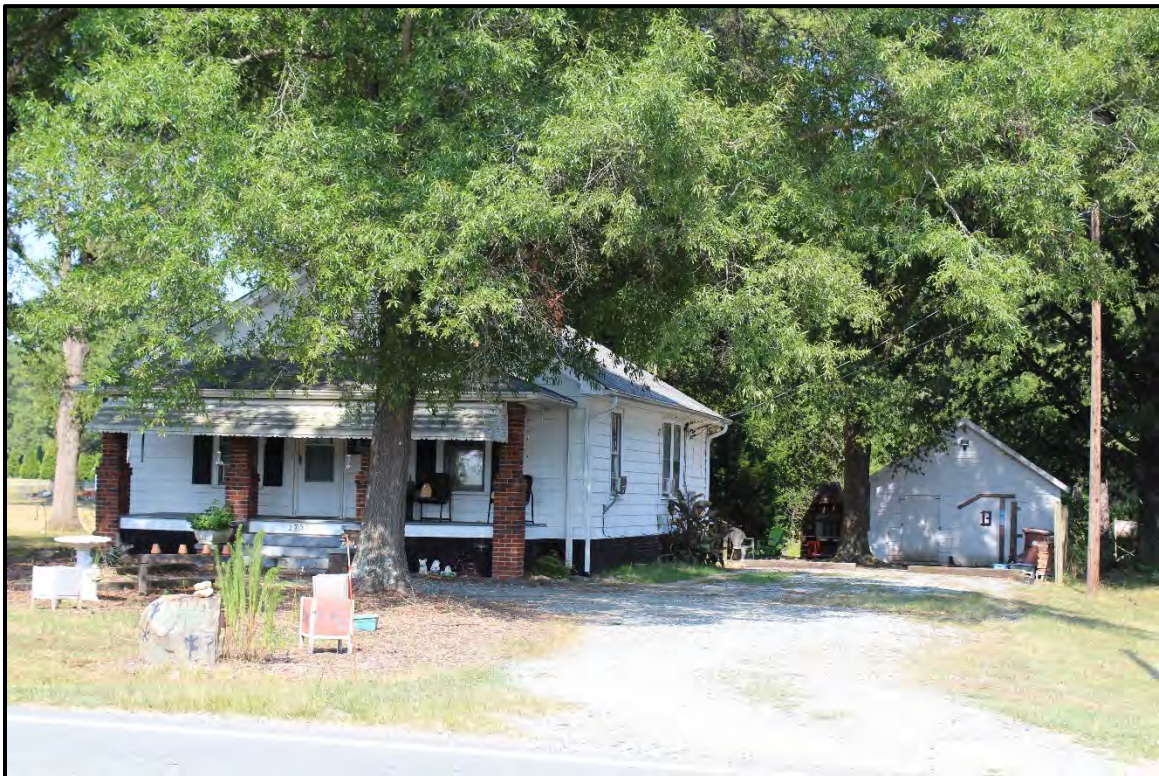
The one-story, wood-frame building features a roof covered with asphalt shingles, an exterior clad with aluminum siding, two interior brick chimneys, and a brick foundation. The façade elevation holds 4/1 vertical sash windows and includes a full width wood porch supported by decorative brick columns. Also located on the property is a rear detached garage with a front gabled roof and aluminum siding.

NRHP Assessment. Architectural resource AM2536 does not exhibit a distinctive architectural style or workmanship. In addition, the house has been altered through the application of aluminum siding. Based on the lack of architectural merit, as well as the inability to associate the house and/or its original owner(s) with an important historical event or series of events, it is TRC's opinion that architectural resource AM2536 is not eligible for the NRHP.

Figure 6.132. Architectural resource AM2536; view is northeast featuring the façade and south elevation.

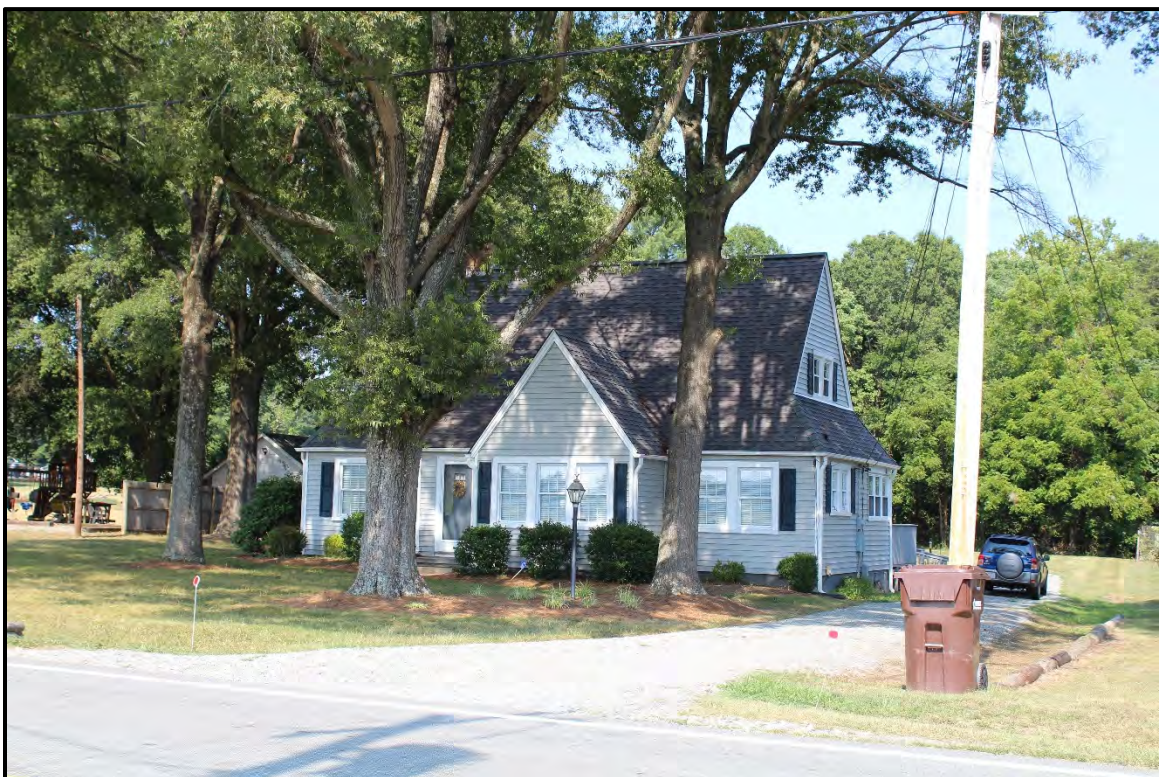
The one and one-half-story, wood-frame building features a side-gabled roof covered with asphalt shingles, an exterior clad with vinyl siding, an interior brick chimney, and a brick foundation. The façade holds 6/6 wood sash windows with vinyl shutters. A concrete stoop leads to the main entrance, which is filled with a glazed door.

NRHP Assessment. Architectural resource AM2537 does not exhibit a distinctive architectural style or workmanship. In addition, the house has been altered through the application of vinyl siding. Based on the lack of architectural merit, as well as the inability to associate the house and/or its original owner(s) with an important historical event or series of events, it is TRC’s opinion that architectural resource AM2537 is not eligible for the NRHP.

Figure 6.133. Architectural resource AM2537; view is northeast featuring the façade and south elevation.

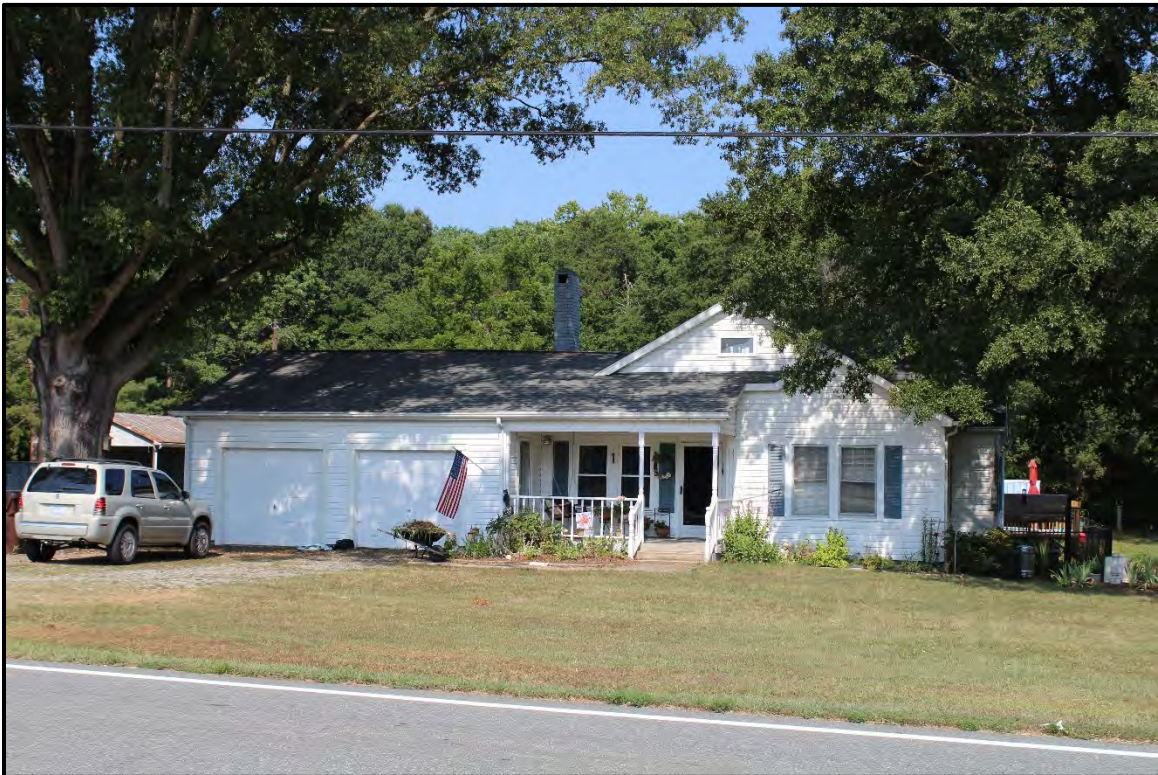
The one-story, wood-frame building features a roof with asphalt shingles, vinyl siding, an interior brick chimney, and a brick foundation. The façade elevation holds 6/6 wood sash windows with vinyl shutters. Located on the primary elevation is a recessed porch supported by vinyl posts and a vinyl railing. The house also features an attached two-car garage.

NRHP Assessment. Architectural resource AM2538 does not exhibit a distinctive architectural style or workmanship. In addition, the house has been altered through the application of vinyl siding, the construction of the garage wing, and the reconstruction of the façade porch. Based on the lack of architectural merit, as well as the inability to associate the house and/or its original owner(s) with an important historical event or series of events, it is TRC's opinion that architectural resource AM2538 is not eligible for the NRHP.

Figure 6.134. Architectural resource AM2538; view is east featuring the façade.

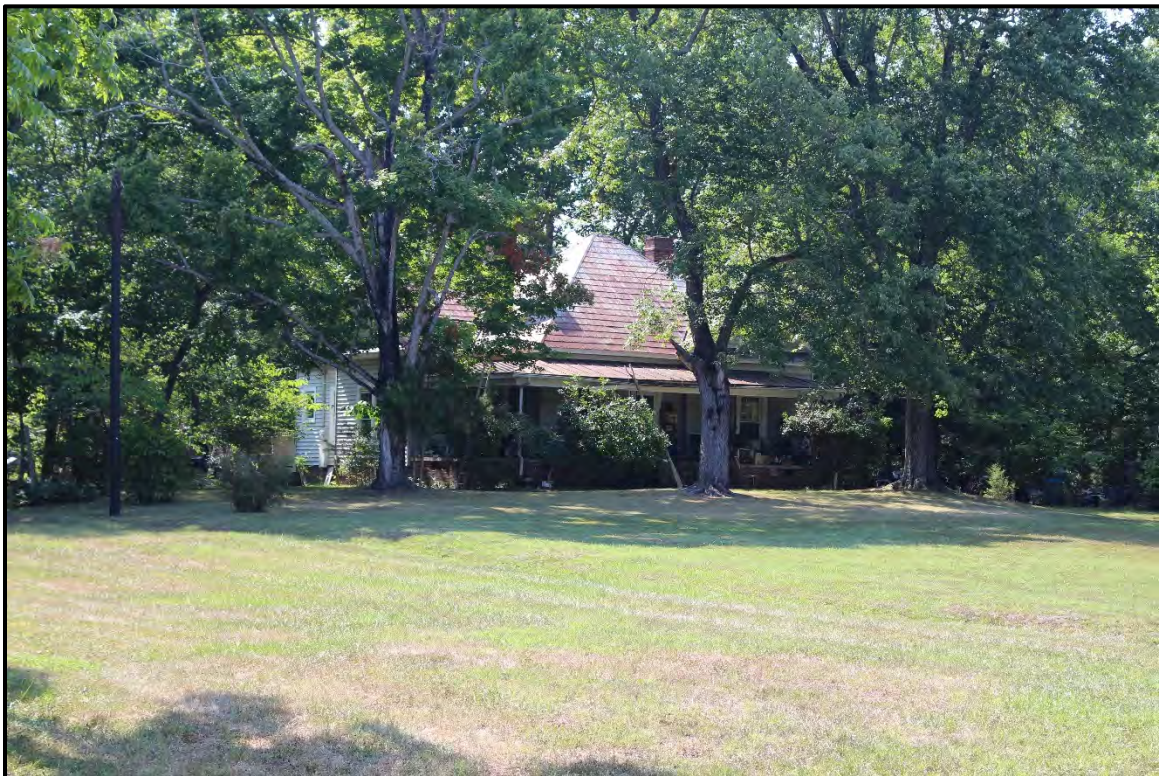
The one-story, wood-frame building features a metal shingle roof, vinyl siding, two interior brick chimneys, and a brick foundation. The façade elevation holds replaced 9/1 windows and includes a brick and concrete porch supported by vinyl posts and decorative wrought-iron style columns.

NRHP Assessment. Architectural resource AM2539 does not exhibit a distinctive architectural style or workmanship. In addition, the house has been altered through the application of vinyl siding and the replacement of the original window sashes. Based on the lack of architectural merit, as well as the inability to associate the house and/or its original owner(s) with an important historical event or series of events, it is TRC's opinion that architectural resource AM2539 is not eligible for the NRHP.

Figure 6.135. Architectural resource AM2539; view is northwest featuring the façade and south elevation.

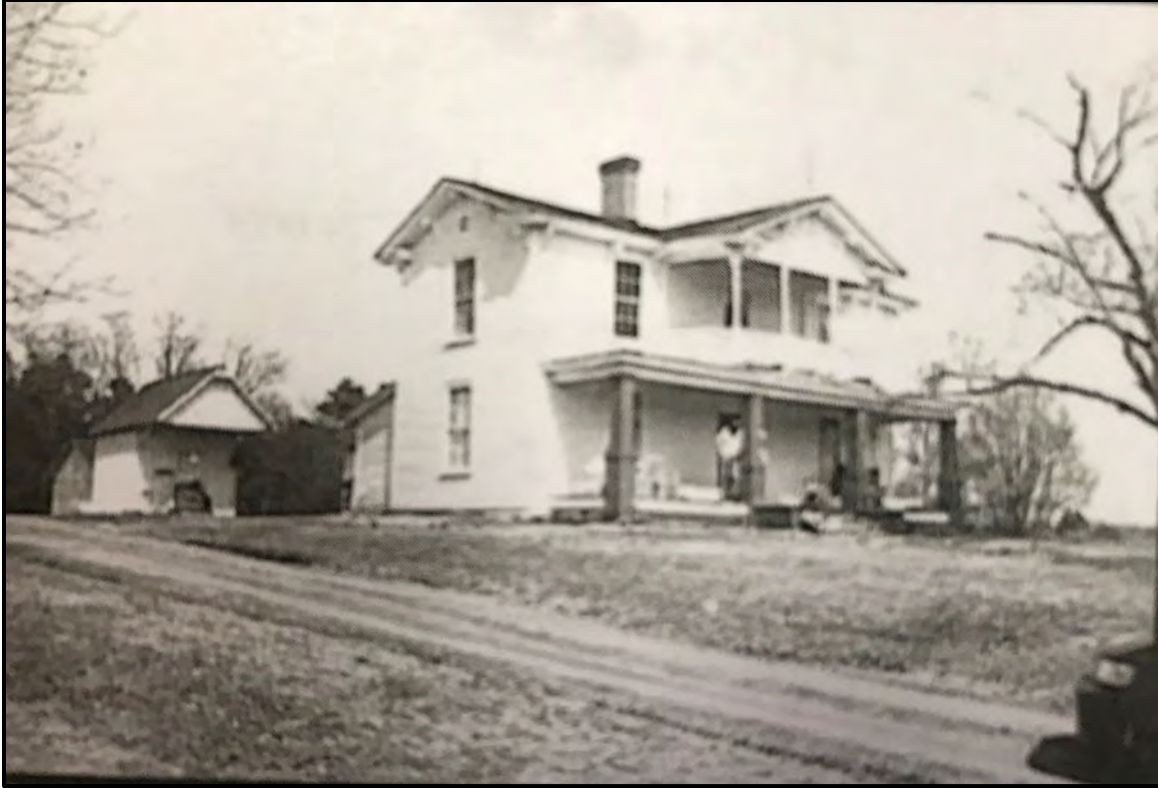
NRHP Assessment. The original ca. 1885 two-story, Folk Victorian style house associated with AM0122 has been destroyed since its recordation and replaced by a Minimal Traditional style house that appears to have been relocated to the parcel. In accordance with NRHP Criteria Consideration B, moved properties are normally not eligible for the NRHP unless they are of architectural significance, or are the surviving structure most importantly associated with a historic even or person. The current building on the parcel does not exhibit a distinctive architectural style or workmanship, nor is the property associated with important historical event(s) or person(s). Due to its lack of historic and architectural significance it is TRC’s opinion that architectural resource AM0122 is not eligible for the NRHP.

Figure 6.136. 2002 photo of AM0122 featuring the ca. 1885 Folk Victorian house (Barkhau 2002c).

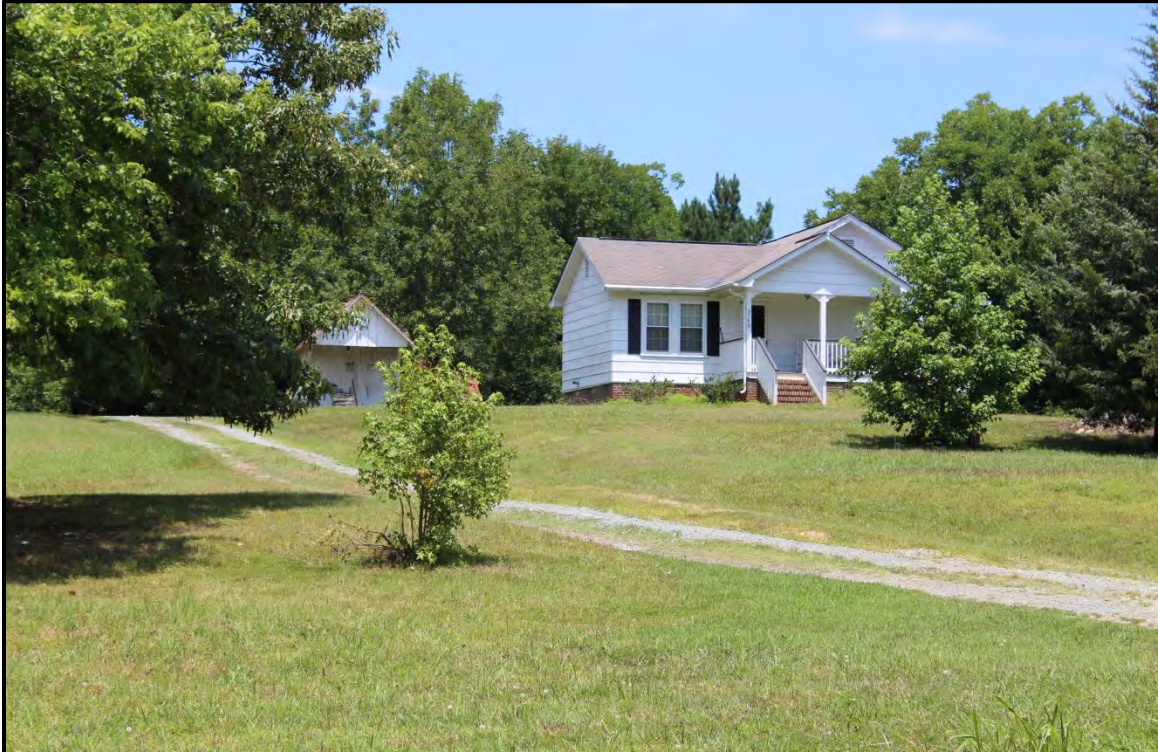
The existing residence features a side-gabled roof covered with asphalt shingles, an exterior clad with aluminum siding, a foundation composed of brick, and 6/6 double-hung vinyl sash windows. Facing south, the façade is marked with an off-centered door that is accessible via a partial-width porch. The porch contains a wood deck and is shielded by a projecting gable roof that is supported by wood posts.

- An early-twentieth century well house. The wood-frame structure features a front-gabled roof and an exterior clad with board-and-batten wood siding. A door, which is shielded by the cantilevered roof, is located on the south elevation (Figures 6.136 and 6.137);
- An early-twentieth century log tobacco barn. The structure features a gabled roof covered with standing seam metal and hand-hewn logs joined with together with square notching (Figure 6.138).

Figure 6.137. Architectural resource AM0122; view is north featuring the 1948 Minimal Traditional house and the early twentieth century well house.

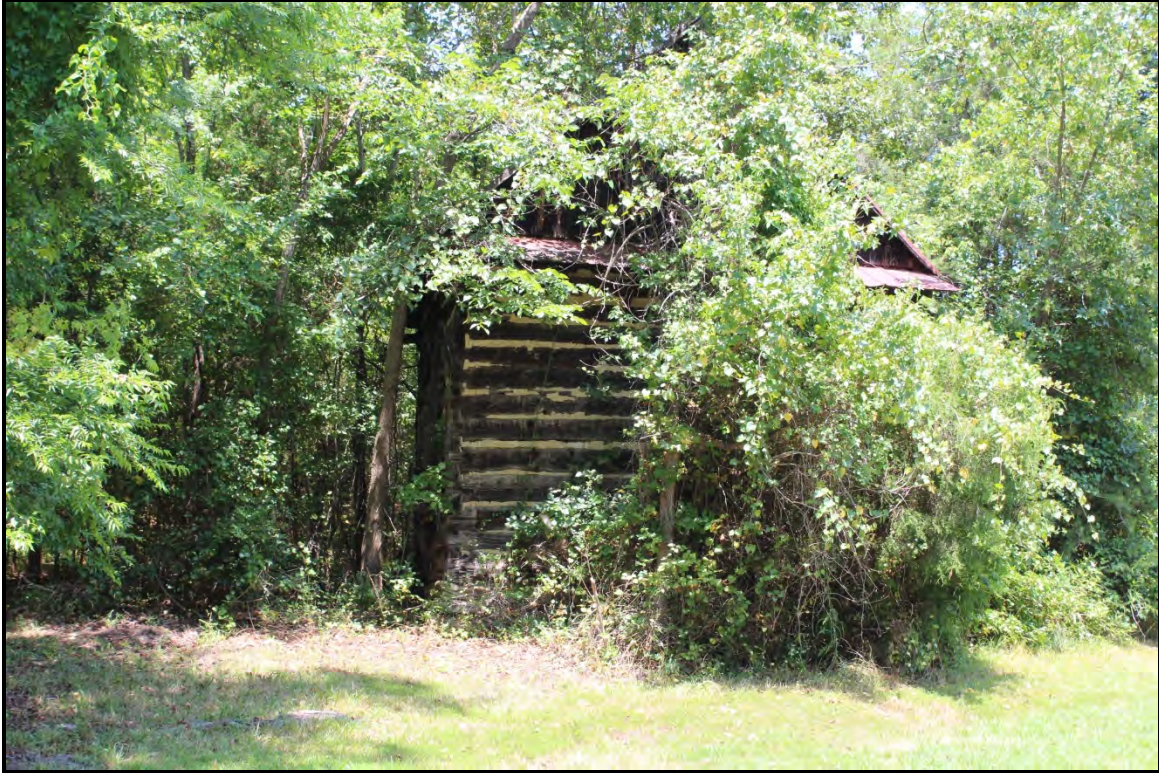
Figure 6.138. Architectural resource AM0122; view is north featuring the early-twentieth century tobacco barn.

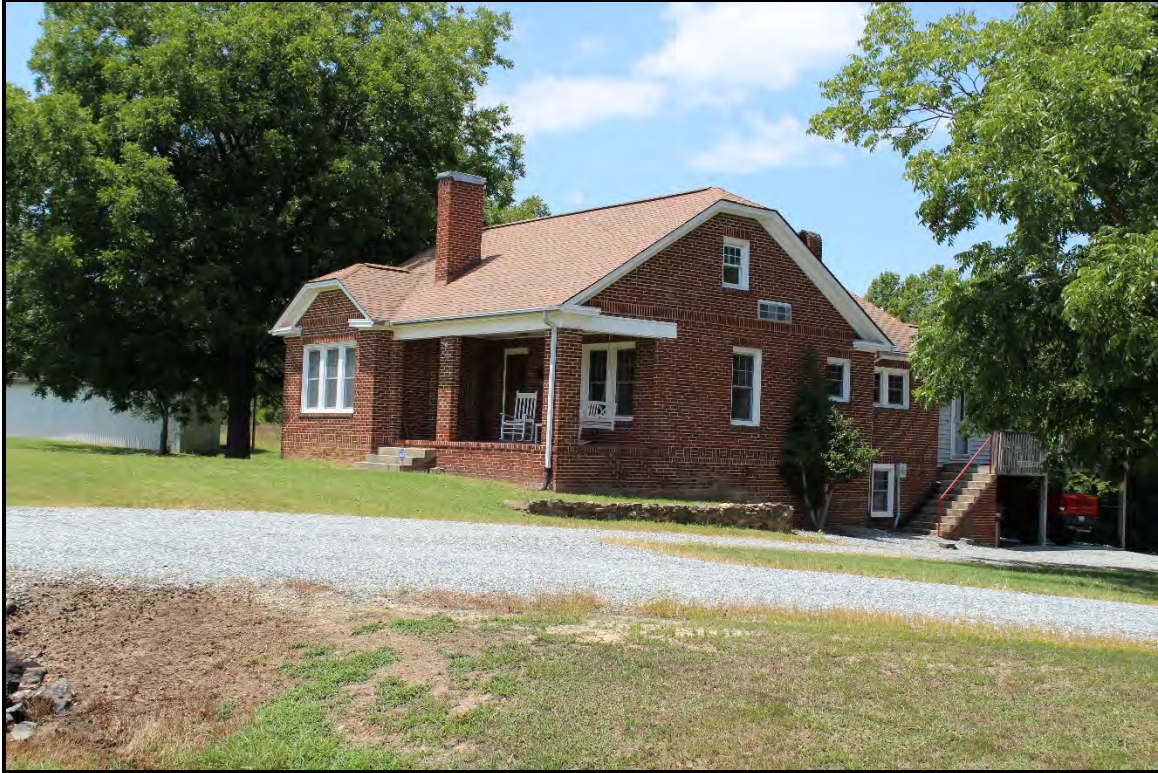
The one-story, wood-frame building features a clipped-gable roof, brick exterior, two interior brick chimneys, and a brick foundation. The façade elevation holds 6/1 vinyl windows and includes a recessed brick porch supported by brick columns. Decorative brickwork is seen on both the façade and side (east) elevation.

NRHP Assessment. Architectural resource AM2540 does not exhibit a distinctive architectural style or workmanship. In addition, the house has been altered through the installation of vinyl sash windows. Based on the lack of architectural merit, as well as the inability to associate the house and/or its original owner(s) with an important historical event or series of events, it is TRC's opinion that architectural resource AM2540 is not eligible for the NRHP.

Figure 6.139. Architectural resource AM2540; view is northwest featuring the façade and east elevation.

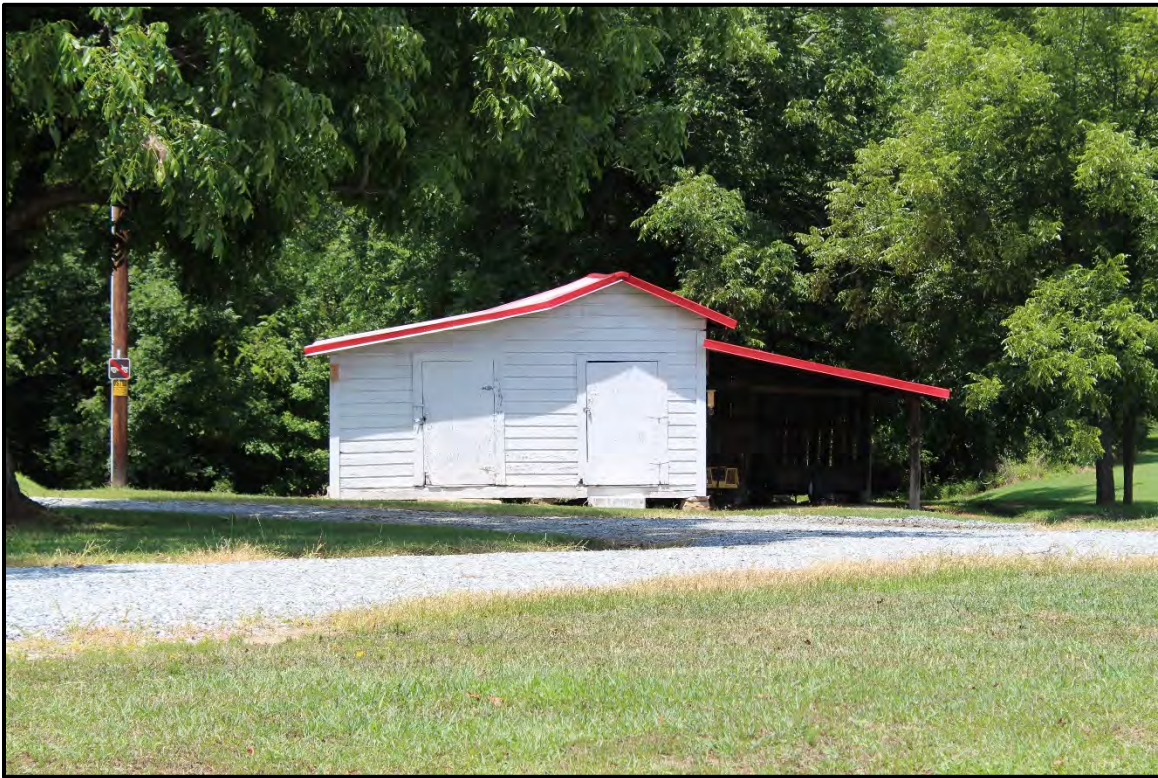
The property contains at least six agricultural outbuildings, however, photographic documentation of these support structures was precluded due to the limitations of the survey. One outbuilding photographed by TRC consists of a wood-frame storage shed, featuring a front-gabled roof covered with standing seam metal, two doors, and an exterior clad with weatherboard siding. The shed is supported by a stone pier foundation. Attached to the northeast elevation is a shed-roof extension containing an open bay (Figure 6.140).

Figure 6.140. Architectural resource AM2540; view is north featuring the shed outbuilding.

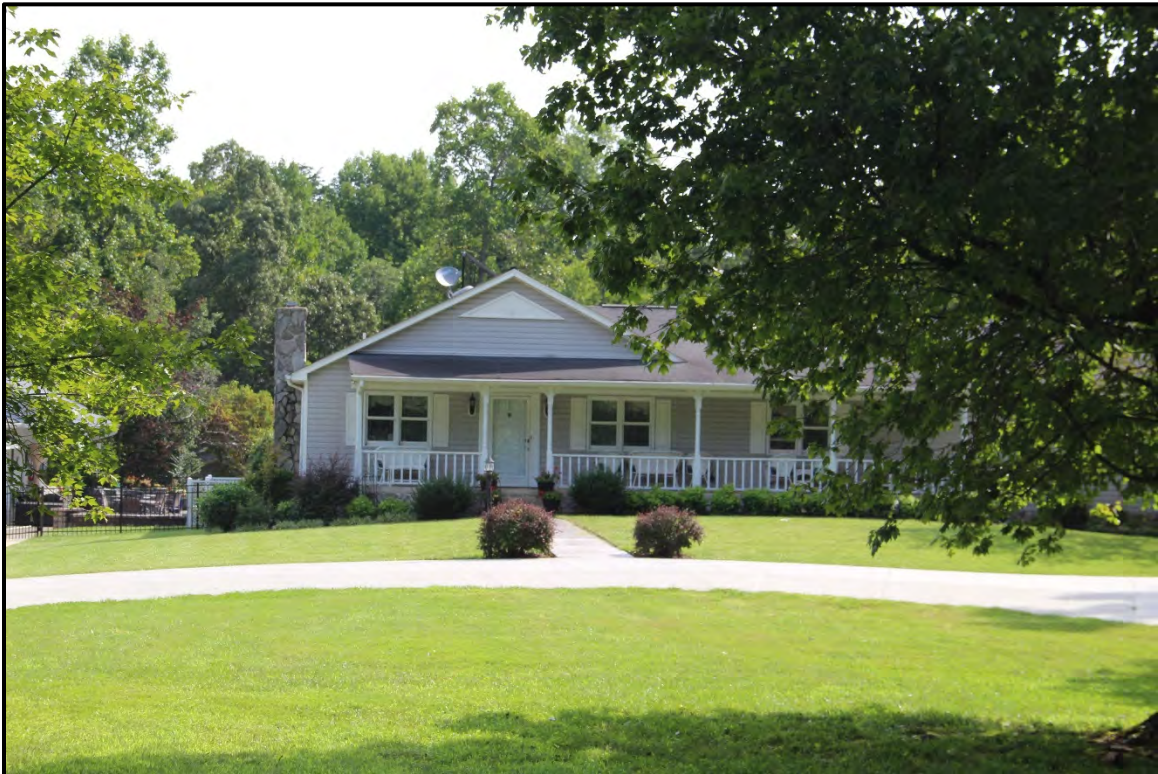
The one-story, wood-frame building features an asphalt shingle roof with a front facing gable, synthetic exterior, and a stone foundation. The façade elevation holds 1/1 vinyl sash windows and includes a concrete porch with a balustrade. The porch is supported by synthetic columns. Located on the side (northwest) elevation is an exterior stone chimney.

NRHP Assessment. Architectural resource AM2541 does not exhibit a distinctive architectural style or workmanship. In addition, the house has been altered through the application of vinyl siding, the installation of vinyl sash windows, and the reconstruction of the façade porch. Based on the lack of architectural merit, as well as the inability to associate the house and/or its original owner(s) with an important historical event or series of events, it is TRC’s opinion that architectural resource AM2541 is not eligible for the NRHP.

Figure 6.141. Architectural resource AM2541; view is northeast featuring the façade.

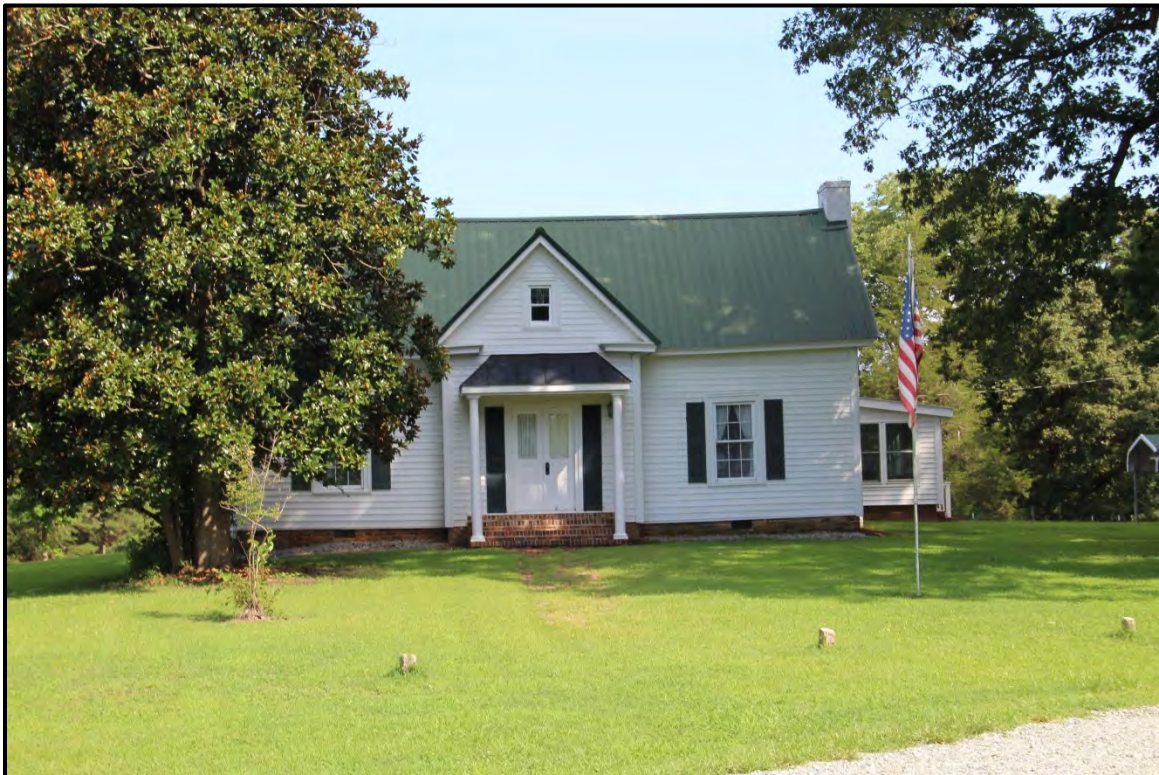
The one and one-half-story, wood-frame building features a metal roof, synthetic exterior, and a brick foundation. The façade elevation holds 6/6 vinyl sash windows and includes a gabled front entry wing. A brick stoop supported by round synthetic columns leads to the main entry. Attached to the side (southeast) elevation is a single-story addition.

NRHP Assessment. Architectural resource AM2542 does not exhibit a distinctive architectural style or workmanship. In addition, the house has been altered through the application of vinyl siding, the replacement of the original porch columns, and the installation of vinyl sash windows. Based on the lack of architectural merit, as well as the inability to associate the house and/or its original owner(s) with an important historical event or series of events, it is TRC's opinion that architectural resource AM2542 is not eligible for the NRHP.

Figure 6.142. Architectural resource AM2542; view is northwest featuring the façade.

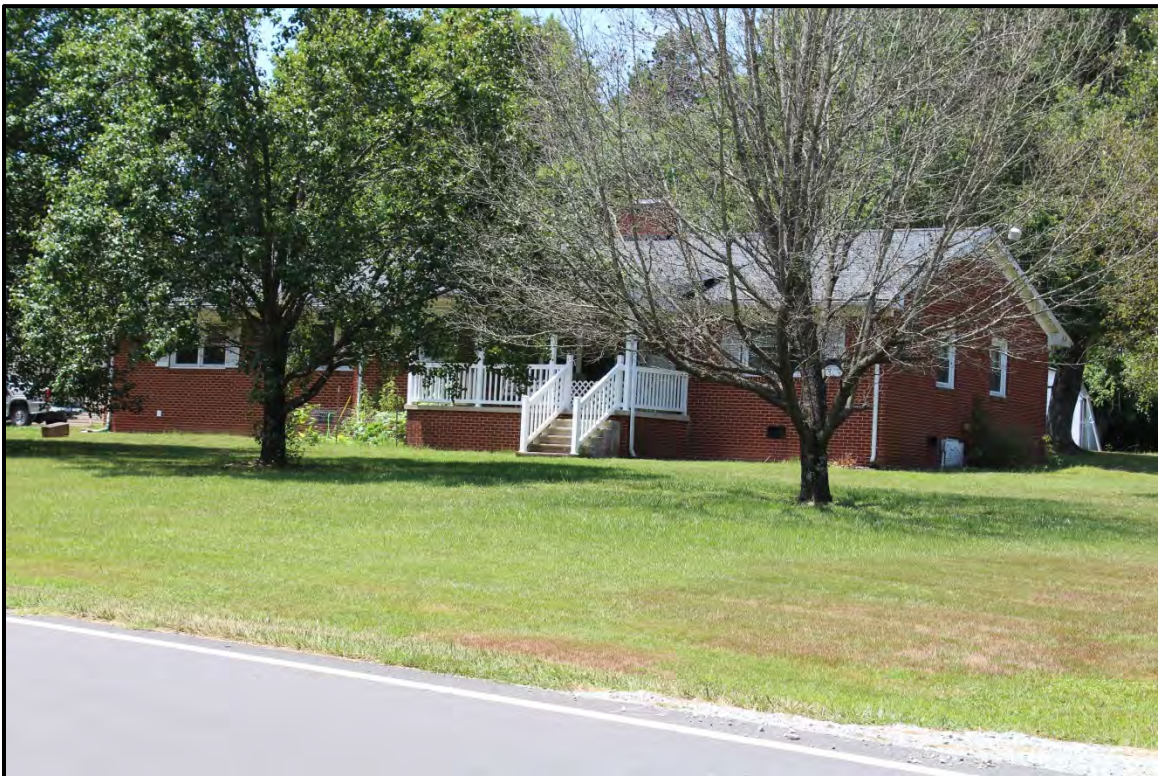
The wood-frame building features a side-gabled roof with asphalt shingles, brick exterior, an interior brick chimney, and a brick foundation. The façade elevation holds 1/1 vinyl sash windows with vinyl shutters. Located on the side (north) elevation are windows of a similar sash style. A brick and concrete stoop with a vinyl handrail and balustrade leads to the main entry.

NRHP Assessment. Architectural resource AM2543 does not exhibit a distinctive architectural style or workmanship. In addition, the house has been altered through the replacement of the original window sashes. Based on the lack of architectural merit, as well as the inability to associate the house and/or its original owner(s) with an important historical event or series of events, it is TRC's opinion that architectural resource AM2543 is not eligible for the NRHP.

Figure 6.143. Architectural resource AM2543; view is southwest featuring the façade and northeast elevation.

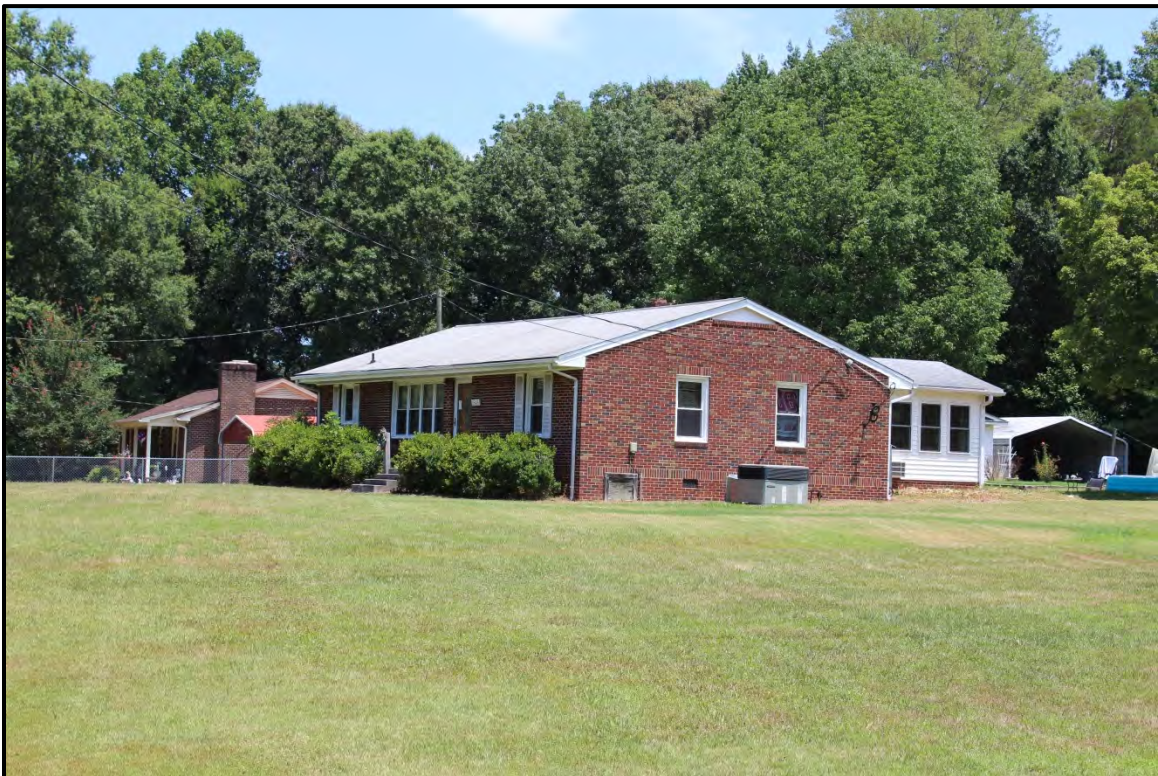
The wood-frame building features a side-gabled roof with asphalt shingles, brick exterior, an interior brick chimney, and a brick foundation. The exterior brick contains a soldier course belt on the first floor. Both the façade and the side (southwest) elevation hold 1/1 vinyl sash windows with vinyl shutters. A concrete stoop with steps leads to the main entry.

NRHP Assessment. Architectural resource AM2544 does not exhibit a distinctive architectural style or workmanship. In addition, the house has been altered through the installation of vinyl sashes. Based on the lack of architectural merit, as well as the inability to associate the house and/or its original owner(s) with an important historical event or series of events, it is TRC's opinion that architectural resource AM2544 is not eligible for the NRHP.

Figure 6.144. Architectural resource AM2544; view is northeast featuring the façade and south elevation.

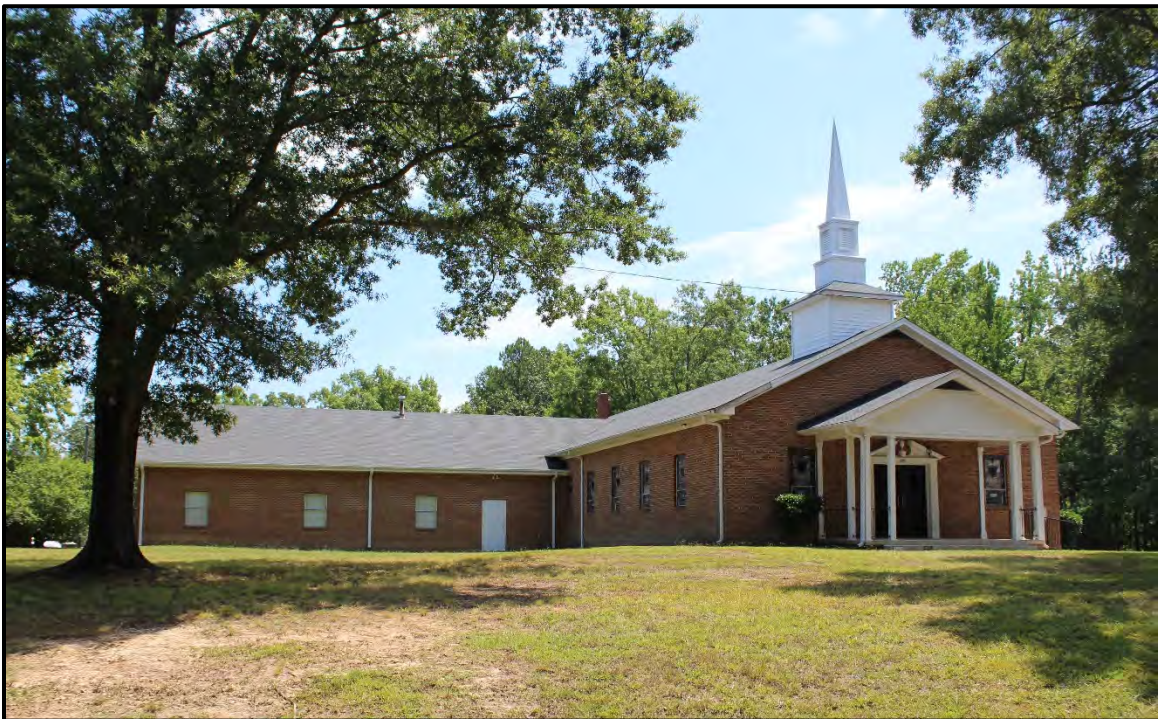
The Neoclassical-style sanctuary building has a large wing addition attached to the northwest elevation. The church has a front-gabled roof with a steeple and a brick exterior. Located on the façade elevation is a projecting gable portico with square columns. A concrete block porch leads to the main entrance, which is filled with a broken pediment door. The primary and side (northwest and southeast) elevations of the main block hold stained glass windows. The church cemetery contains multiple headstone types representing common forms.

NRHP Assessment. Architectural resource AM2545 a typical example of a mid-twentieth century Neoclassical-style church. In accordance with NRHP Criteria Consideration A, religious buildings are normally not eligible for the NRHP unless they derive their primary significance from architectural or artistic distinction or are considered to be of historical importance. The property cannot be associated with important historical event(s) or person(s). Due to lack of the historic and architectural significance it is TRC's opinion that architectural resource AM2545 is not eligible for the NRHP.

Figure 6.145. Architectural resource AM2545; view is east featuring the façade and northwest elevation of the church.

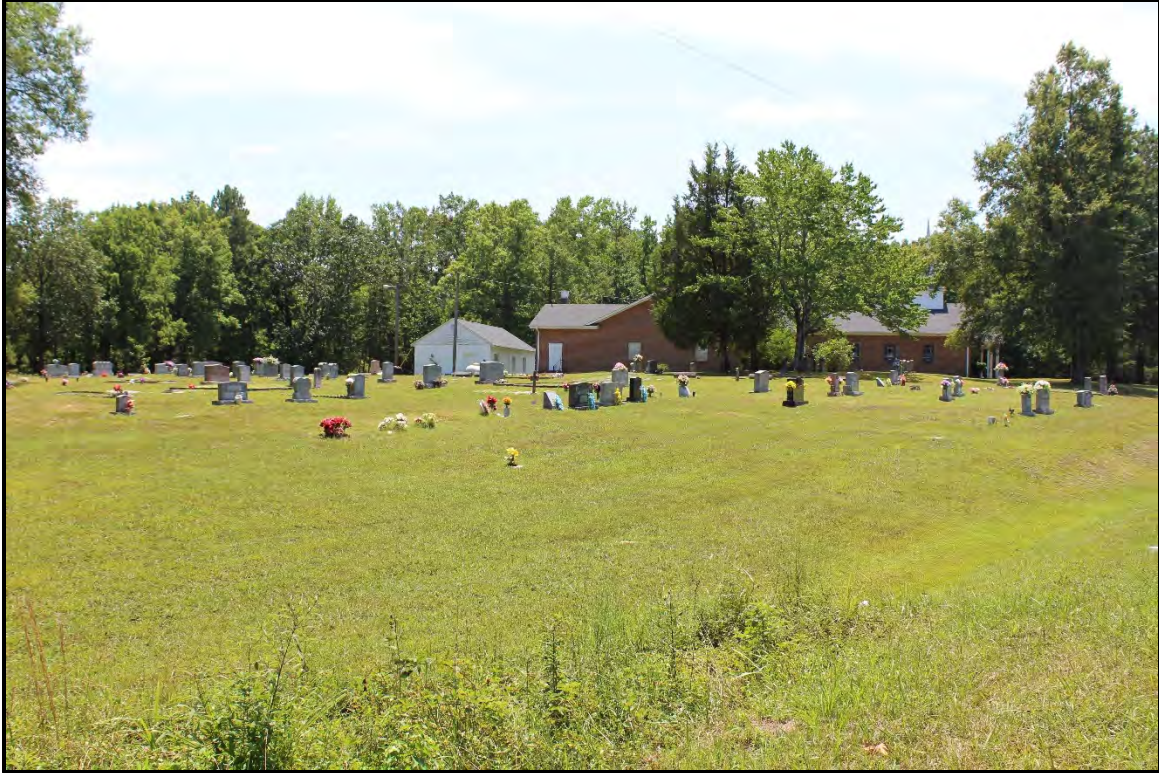
Figure 6.146. Architectural resource AM2545; view is southeast featuring the church and cemetery.

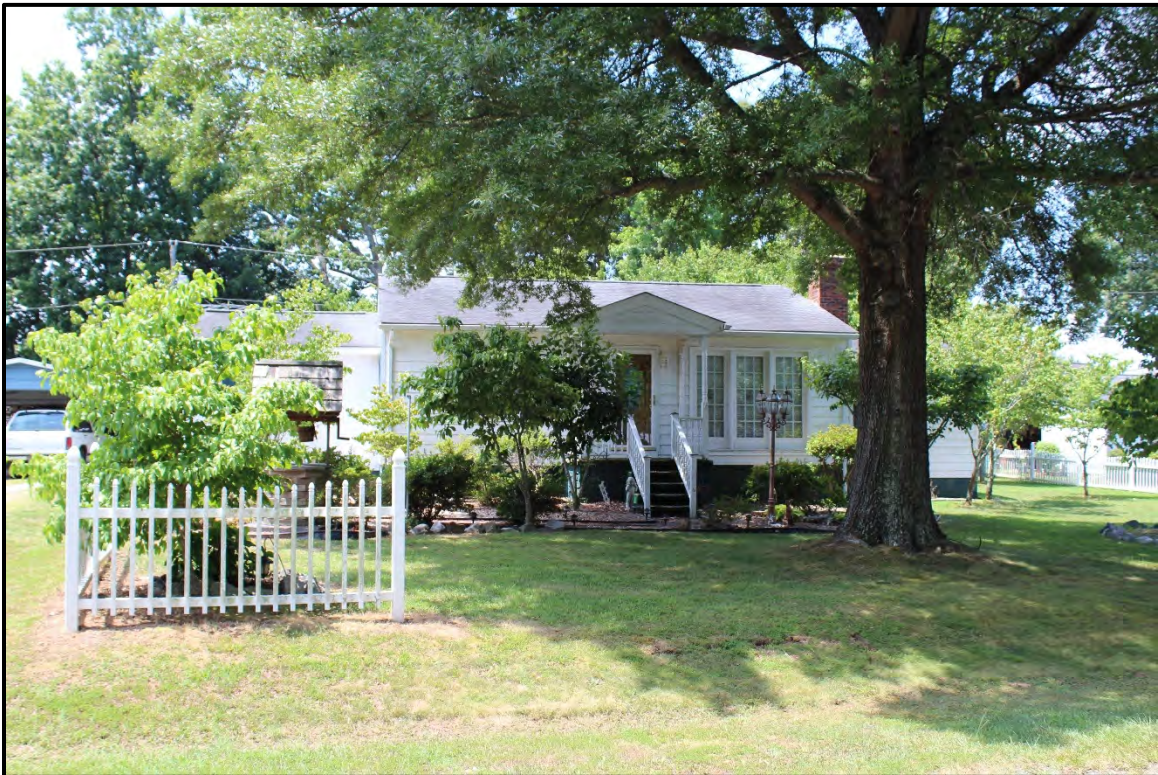
The one-story, wood-frame building features a side-gabled roof with asphalt shingles, aluminum siding, and a concrete foundation. The façade elevation holds a 1/1 vinyl sash window as well as a replacement three-part French window. Located on the side (north) elevation is an exterior brick chimney. Attached to the side (north) elevation is a side gable wing addition. A concrete stoop with a gable porch entry supported by turned posts provides access to the main entrance.

NRHP Assessment. Architectural resource AM2546 does not exhibit a distinctive architectural style or workmanship. In addition, the house has been altered through the installation of vinyl sash windows and the application of aluminum siding. Based on the lack of architectural merit, as well as the inability to associate the house and/or its original owner(s) with an important historical event or series of events, it is TRC's opinion that architectural resource AM2546 is not eligible for the NRHP.

Figure 6.147. Architectural resource AM2546; view is southwest featuring the façade.

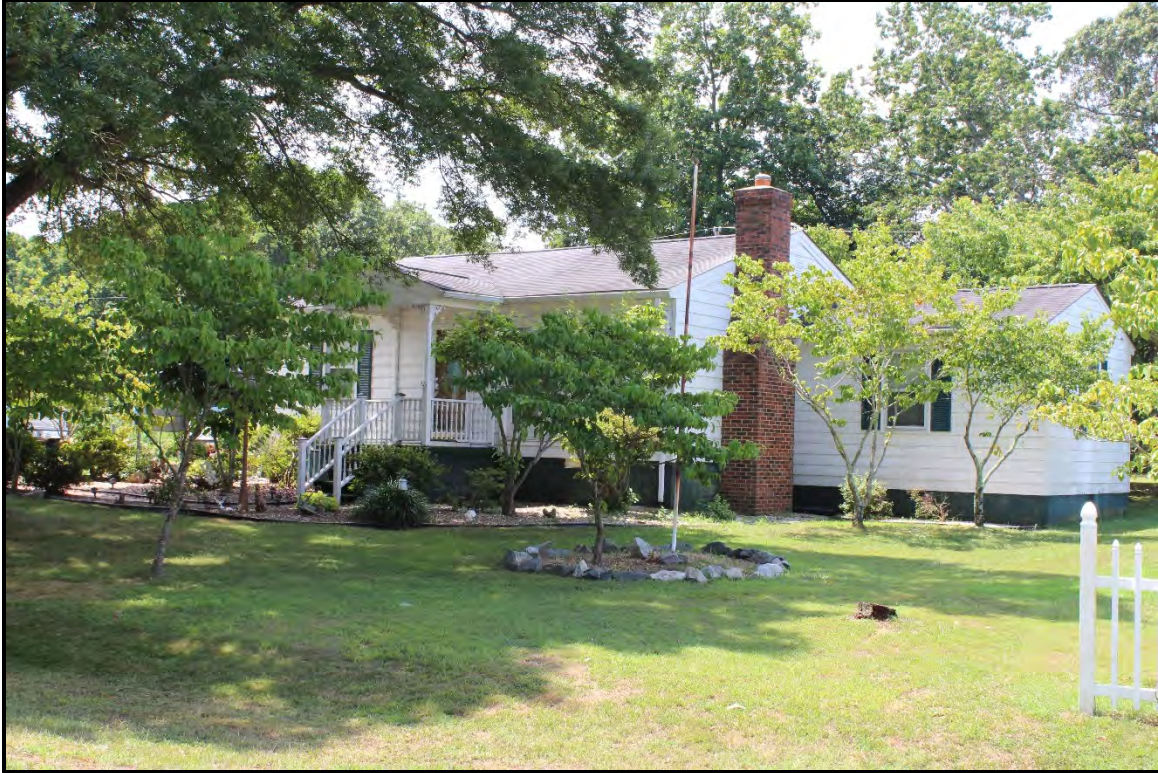
Figure 6.148. Architectural resource AM2546; view is south featuring the façade and northwest elevation.

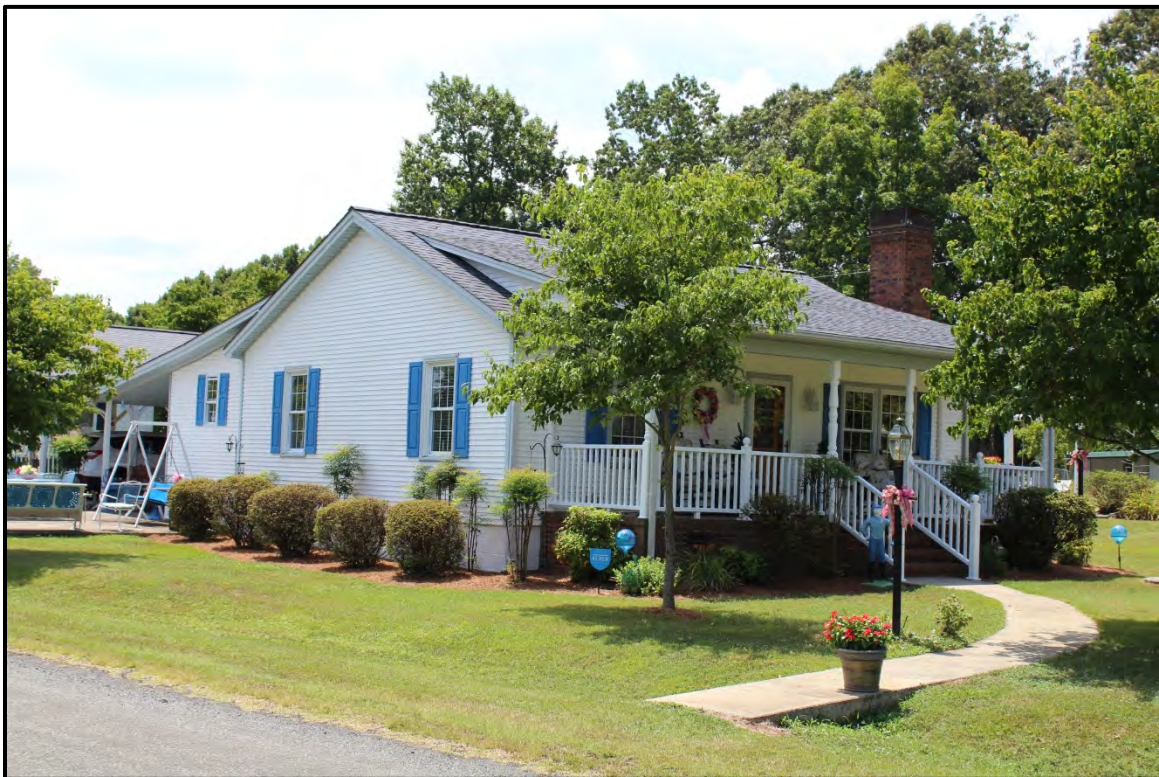
The one-story, wood-frame building features a side-gabled roof with asphalt shingles, vinyl siding, and a concrete block foundation. Both the façade and side (northeast) elevation hold 6/6 vinyl sash windows with vinyl shutters. Located on the side (southwest) elevation is an exterior brick chimney. The house also features a rear shed addition. A brick and concrete porch supported by synthetic posts provides access to the main entrance.

NRHP Assessment. Architectural resource AM2547 does not exhibit a distinctive architectural style or workmanship. In addition, the house has been altered through the application of vinyl siding and installation of vinyl sashes. Based on the lack of architectural merit, as well as the inability to associate the house and/or its original owner(s) with an important historical event or series of events, it is TRC's opinion that architectural resource AM2547 is not eligible for the NRHP.

Figure 6.149. Architectural resource AM2547; view is southwest featuring the façade and northeast elevation.
