Re: Revised Architectural Survey Report, MVP Southgate Project, Construct Interstate Pipeline, Rockingham and Alamance County, ER 18-1041

Thank you for your letter of October 11, 2019, transmitting the draft "Historic Architectural Survey for the MVP Southgate Pipeline Project". We have reviewed the report and offer the following comments.

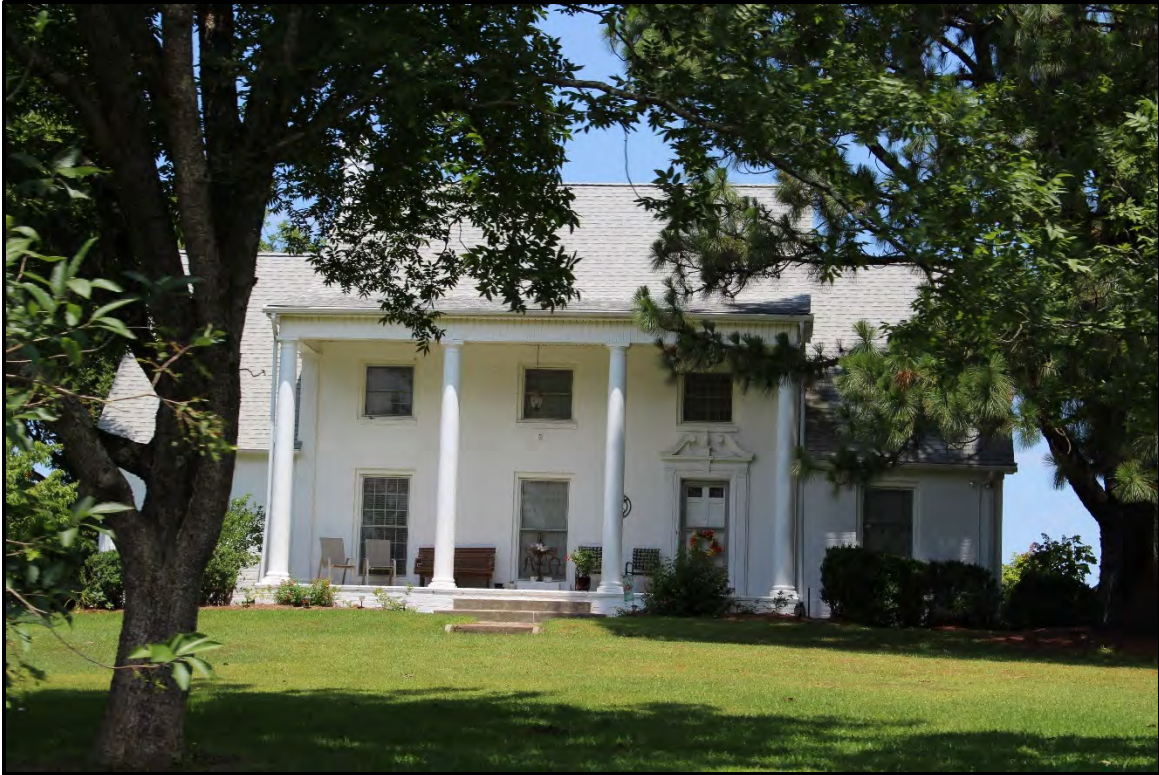
The two-story, wood-frame building features a side-gabled roof with asphalt shingles, brick exterior, and a brick foundation. The façade elevation holds 8/8 windows on the second floor as well as full-length 12/12 first floor windows. Located on both the east and west elevations are matching wings, each holding an 8/8 window on the primary and side elevations. A full façade brick porch provides access to the main entrance. The porch is covered by the main roof, which extends over the façade, and is supported by four Tuscan columns. Further accenting the façade porch is an ornamental denticulated cornice. The off-centered main entrance is filled with a broken pediment door. A porch addition is attached to the rear (northeast) elevation.

NRHP Assessment. Architectural resource AM2549 is an example of a Neoclassical influenced house in which the exterior of the building has not been significantly altered since its construction in 1940. The interior of the house was not accessible at the time of the survey; as a result, TRC's NRHP recommendation is based exclusively on the exterior condition of the house. Overall, the house retains a high degree of integrity through the retention of original character-defining details such as Tuscan columns and cornice trim woodwork. Moreover, the house has not been significantly altered, and as a result, retains its original scale and massing. Despite minor alterations, such as vinyl cladding on the entablature and the replacement of the original windows with vinyl sashes, it is TRC's opinion that architectural resource AM2549 is potentially eligible for the NRHP under Criterion C as a representative example of a mid-twentieth century Neoclassical-style house.

Figure 6.150. Architectural resource AM2549; view is north featuring the façade.

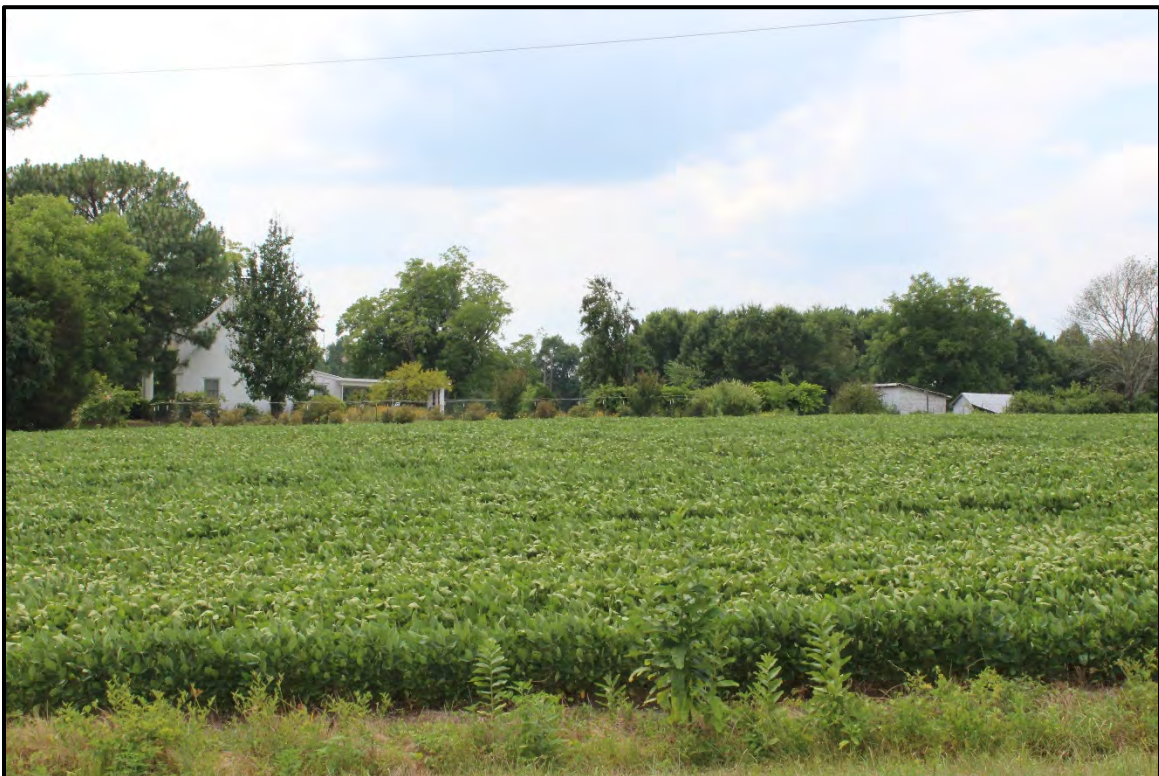
Figure 6.151. Architectural resource AM2549; view is west featuring the east elevation of the house and outbuildings.

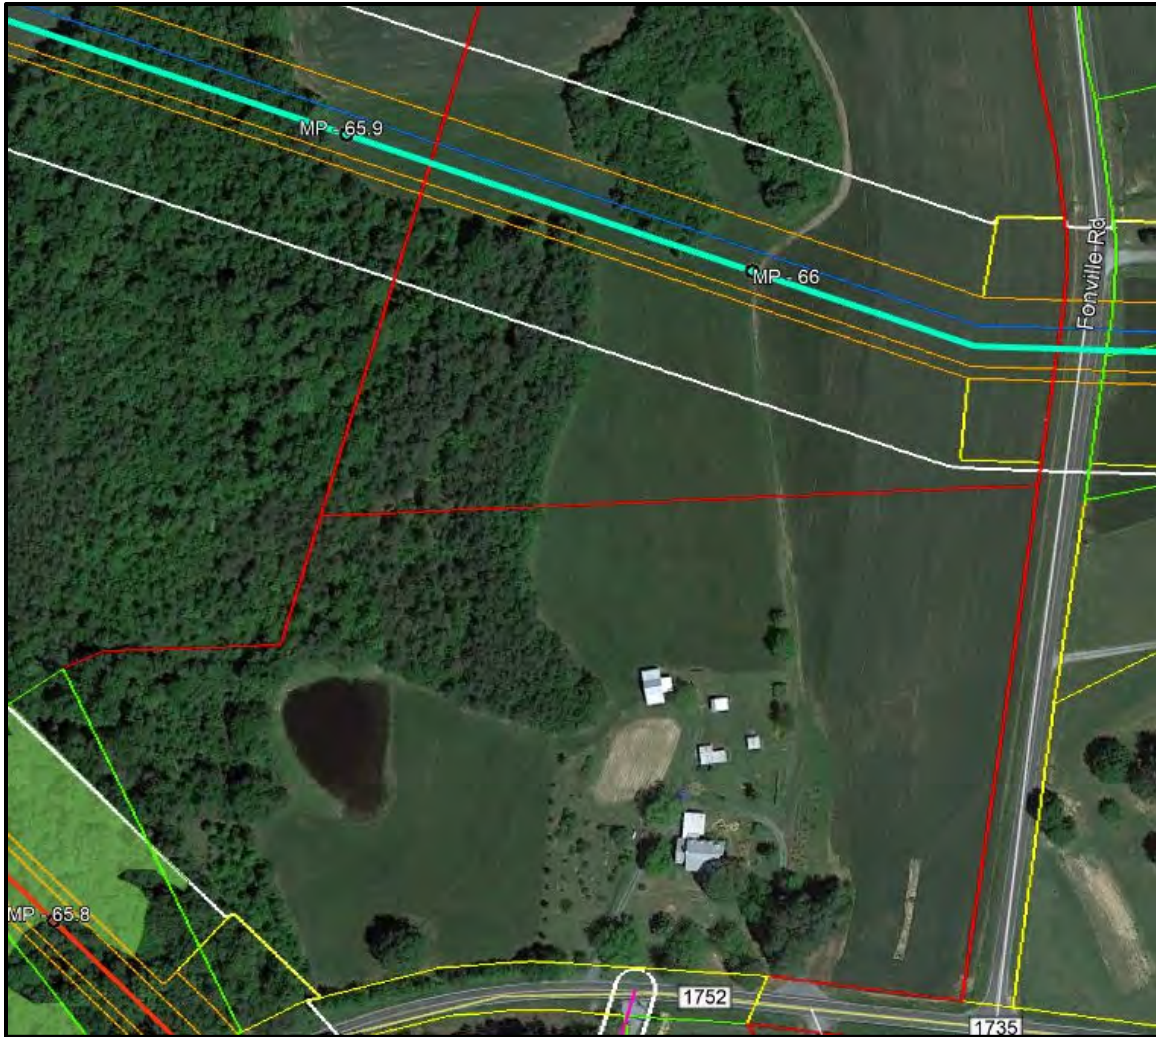
Assessment of Potential Effects. Based on current Project plans, the northern boundary of the parcel containing AM2549 is located approximately 33.50 feet south of a proposed ATWS, which is the nearest component of the Project to the architectural resource. From this area, visual lines-of-sight to the Project area will be largely unobstructed (Figure 6.152). TRC's assessment of potential effects to AM2549 finds that the proposed undertaking will not destroy, damage, or physically alter any part of the resource, nor will it remove or isolate the property from its original location. Furthermore, the proposed Project will not compromise the historical or architectural significance of the resource for which it was recommended potentially eligible for the NRHP. As a result, it is the opinion of TRC that the proposed Project would result in no effect to architectural resource AM2549.

Figure 6.152. Aerial imagery depicting the location of AM2549 relative to the Project ATWS (image courtesy of Google Earth).

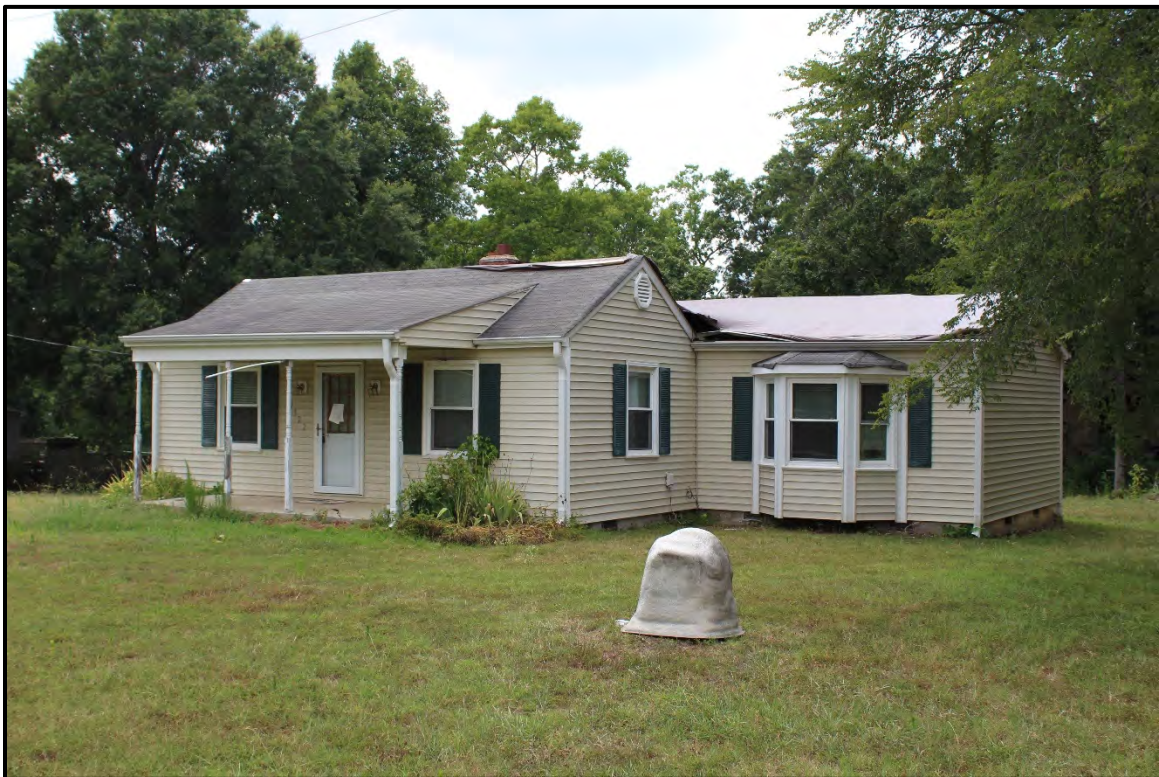
The one-story, wood-frame building features a side-gabled roof with asphalt shingles, vinyl siding, an interior brick chimney, and a concrete foundation. The façade elevation holds 1/1 vinyl sash windows with vinyl shutters. Located on the side (northeast) elevation is a single-story addition. A concrete deck supported by synthetic posts provides access to the main entrance. A wood frame shed outbuilding is located on the rear (west) elevation.

NRHP Assessment. Architectural resource AM2550 does not exhibit a distinctive architectural style or workmanship. In addition, the house has been altered through the application of vinyl siding and the installation of vinyl sash windows. Based on the lack of architectural merit, as well as the inability to associate the house and/or its original owner(s) with an important historical event or series of events, it is TRC's opinion that architectural resource AM2550 is not eligible for the NRHP.

Figure 6.153. Architectural resource AM2550; view is southwest featuring the façade and north elevation.

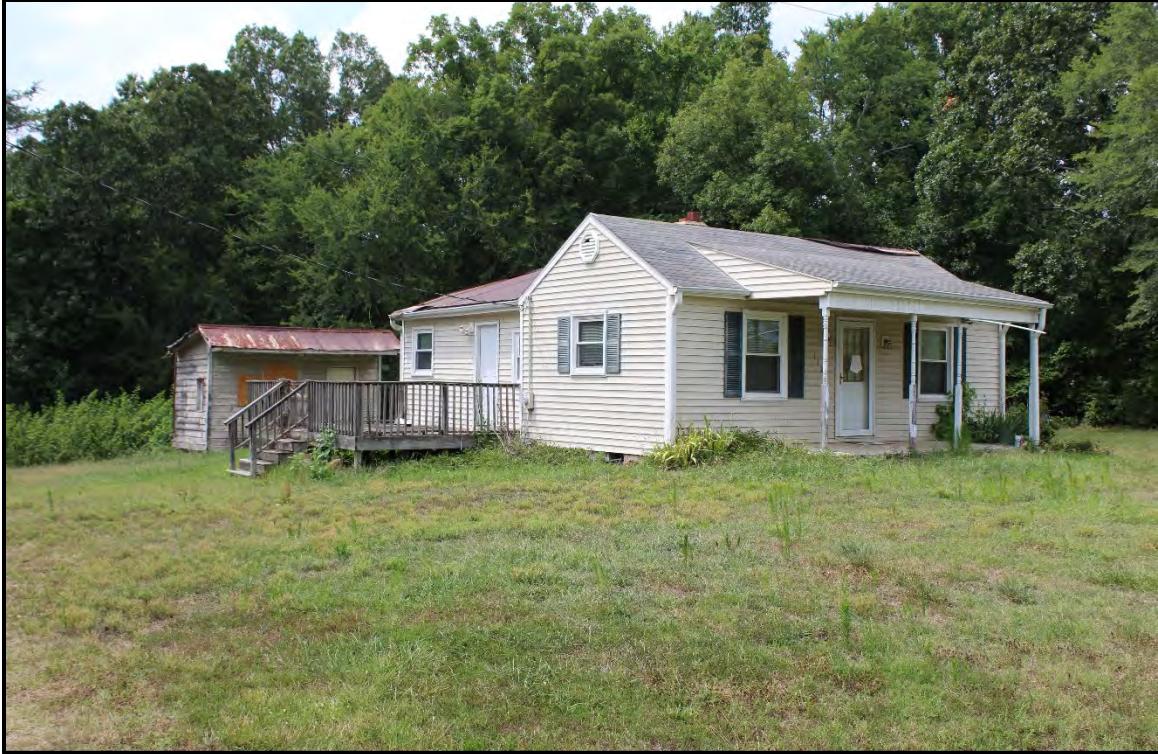
Figure 6.154. Architectural resource AM2550; view is northwest featuring the façade and south elevation. Note the shed outbuilding in the background.

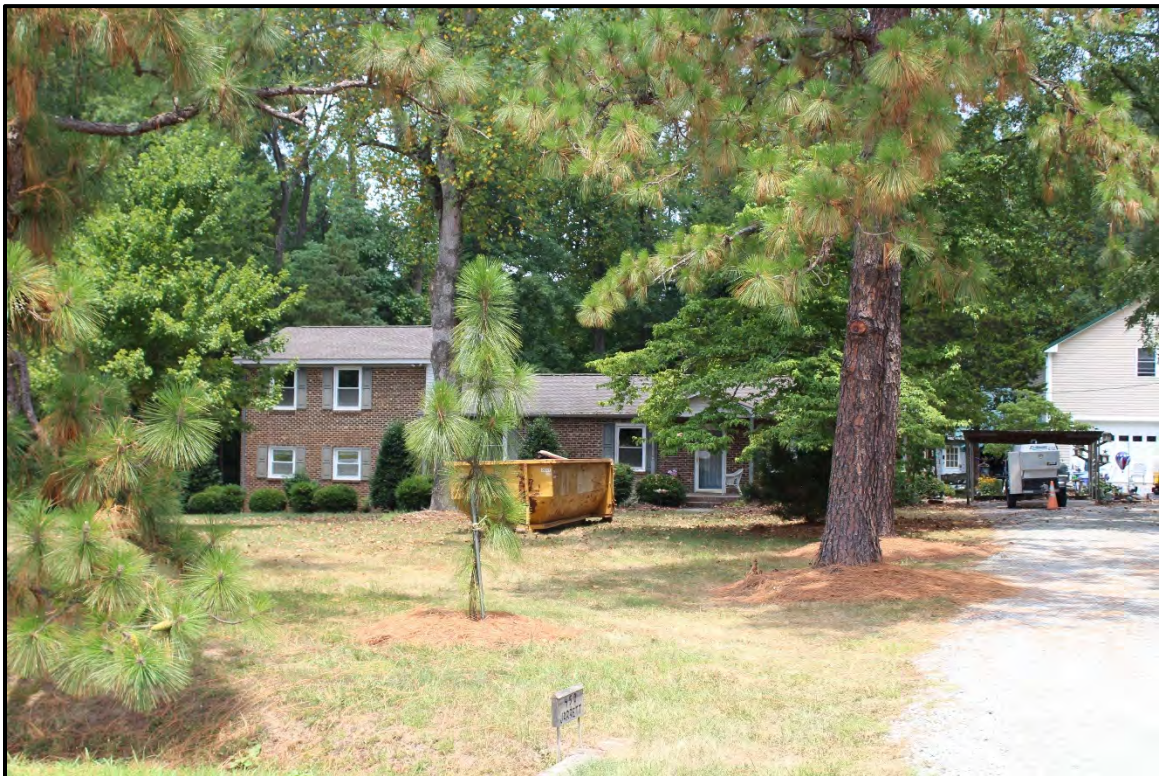
The wood-frame building features a brick veneer and a side-gable roof covered in asphalt shingles. On the front façade is a partial-width gable porch supported by wood pilasters and a brick and concrete stoop. On the north elevation is a large two-story side addition. The primary façade of the main block is marked by three modern replacement 1/1 vinyl sash windows with vinyl shutters. This sash type is repeated on both stories of the side addition.

NRHP Assessment. Architectural resource AM2551 fails to exhibit distinctive characteristics of architectural style or workmanship. In addition, the house has been altered through the installation of vinyl sash windows and the construction of the two-story addition. Based on the lack of architectural merit, as well as the inability to associate the house and/or its original owner(s) with an important historical event or series of events, it is TRC’s opinion that architectural resource AM2551 is not eligible for the NRHP.

Figure 6.155. Architectural resource AM2551; view is northeast featuring the façade.

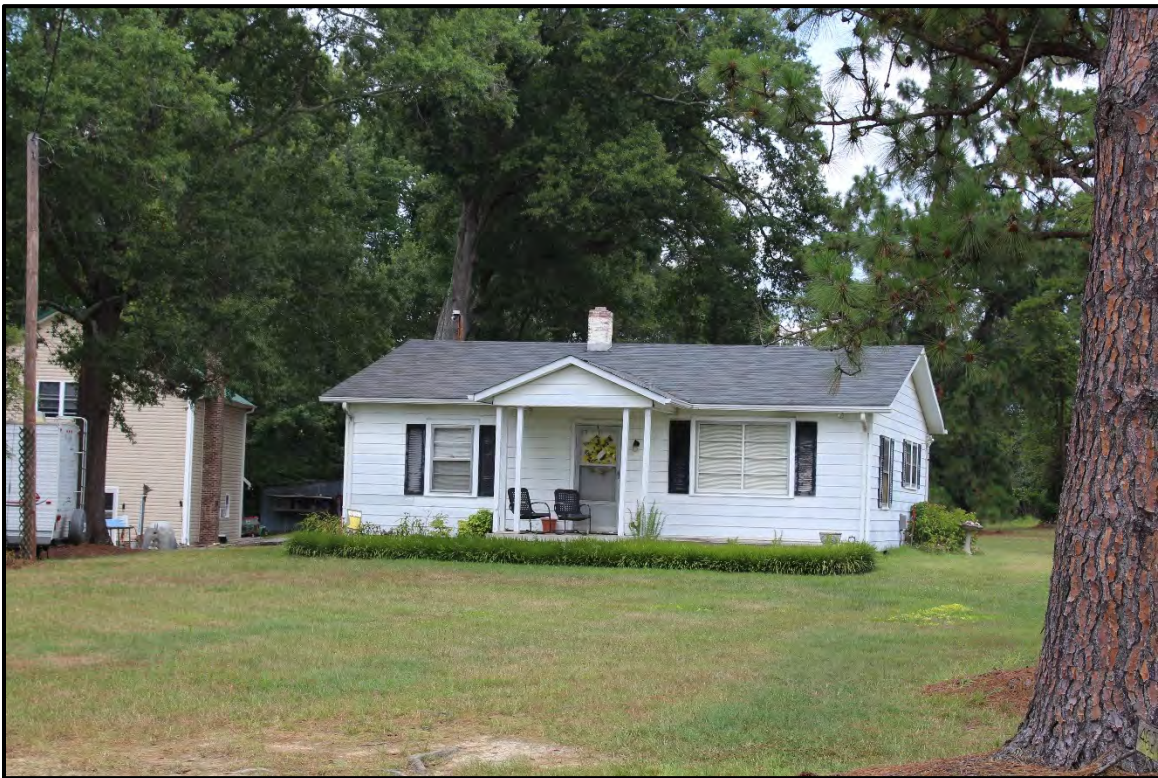
The one-story, wood-frame building features a side-gabled roof covered with asphalt shingles, exterior aluminum cladding, and a continuous concrete block foundation. The house also features a central brick chimney. The primary façade is marked with a gable porch that is supported by square wood columns on a concrete stoop. Within the porch bay, the façade entrance is slightly off center, filled with a solid core door. The house features 2/2 wood sash windows with vinyl shutters, a sash type repeated on the side elevations.

NRHP Assessment. Architectural resource AM2552 does not exhibit distinctive characteristics of architectural style or workmanship. In addition, the house has been altered through the replacement of the original porch columns and the application of aluminum siding. Based on the lack of architectural merit, as well as the inability to associate the house and/or its original owner(s) with an important historical event or series of events, it is TRC’s opinion that architectural resource AM2552 is not eligible for the NRHP.

Figure 6.156. Architectural resource AM2552; view is northeast featuring the façade.

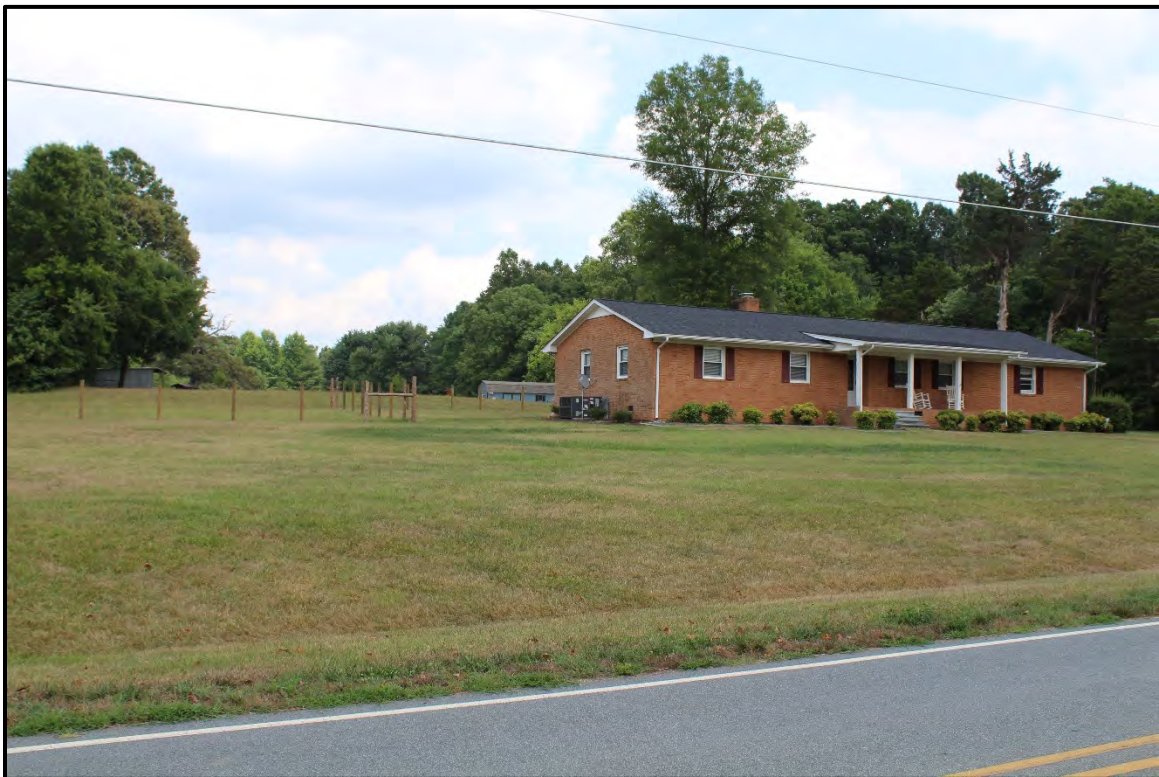
Description. Architectural resource AM2553 is a Ranch-style house located at 534 Isley Road, Burlington 27217 on parcel number 154273 (Alamance County, North Carolina GIS 2018) (see Figure 1.2n1; Figure 6.157). According to Alamance County tax records, the house was constructed in 1965 (Alamance County, North Carolina GIS 2018). Due to the limitations placed on the architectural survey, TRC’s accessibility to the property was limited to the public right-of-way along Isley Road.

The wood-frame building features a side-gabled roof covered with asphalt shingles, exterior brick veneer, and a brick foundation. The six-bay façade has a partial width shed porch that is supported by synthetic columns atop a brick stoop with concrete steps. The house features an interior brick chimney and 1/1 vinyl sash windows with vinyl shutters, a sash pattern likely repeated on the remaining elevations. A modern wood-frame shed outbuilding with a seam metal roof is situated northwest of the house within an enclosed portion of the property.

NRHP Assessment. Architectural resource AM2553 does not exhibit distinctive characteristics of architectural style or workmanship. In addition, the house has been altered through the installation of vinyl sash windows. Based on the lack of architectural merit, as well as the inability to associate the house and/or its original owner(s) with an important historical event or series of events, it is TRC’s opinion that architectural resource AM2553 is not eligible for the NRHP.

Figure 6.157. Architectural resource AM2553; view is southeast featuring the façade and northwest elevation.

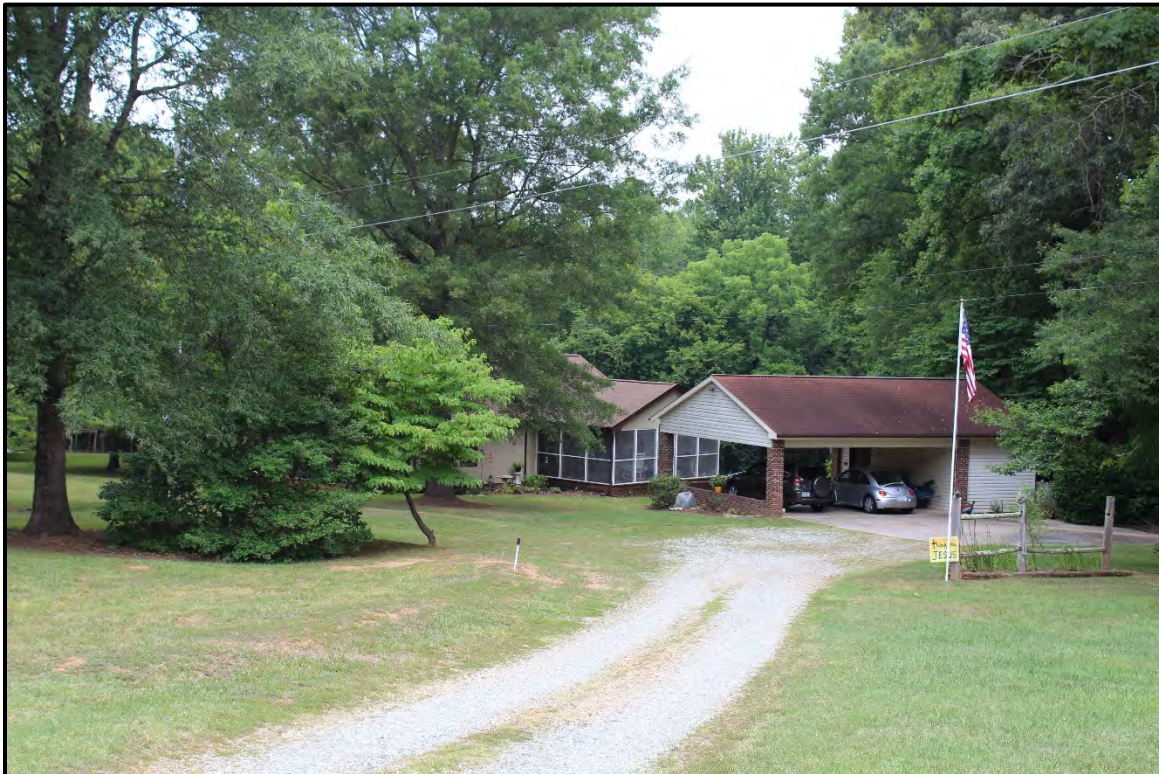
Description. Architectural resource AM2554 is a gable-front house located at 2238 Haw River Hopedale Road, Burlington 27217 on parcel number 153208 (Alamance County, NC WebGIS 2018) (see Figure 1.2n1; Figure 6.158). According to Alamance County tax records, the house was constructed in 1935 (Alamance County, NC WebGIS 2018). Due to access limitations, TRC's evaluation of the property was limited to the public right-of-way along Haw River Hopedale Road.

The wood-frame building features a roof covered with asphalt shingles, an exterior clad with wood panel siding, and a brick foundation. The house is largely obscured from the public ROW, however, TRC noted a side-gabled wing attached to the southeast elevation that functions as a screened-in porch.

Located southeast of the house is a modern carport that contains two bays and a storage shed.

NRHP Assessment. Architectural resource AM2554 does not exhibit distinctive characteristics of architectural style or workmanship. Based on the lack of architectural merit, as well as the inability to associate the house and/or its original owner(s) with an important historical event or series of events, it is TRC's opinion that architectural resource AM2554 is not eligible for the NRHP.

Figure 6.158. Architectural resource AM2554; view is northwest featuring the porch (southeast) elevation and the carport.

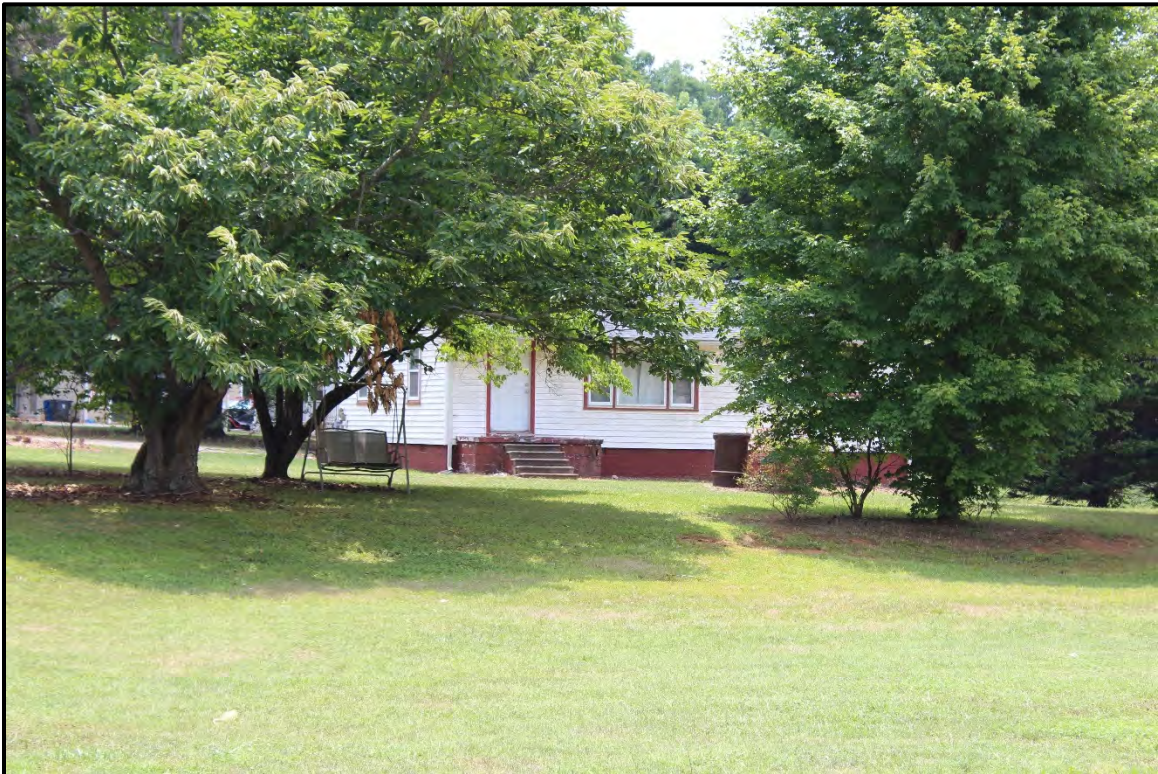
Description. Architectural resource AM2555 is a Minimal Traditional-style house located at 2349 Haw River Hopedale Road, Burlington 27217 on parcel number 153302 (Alamance County, NC WebGIS 2018) (see Figure 1.2n1; Figure 6.159). According to Alamance County tax records, the house was constructed in 1961 (Alamance County, NC WebGIS 2018). Due to access limitations, TRC’s evaluation of the property was limited to the public right-of-way along Haw River Hopedale Road.

The one-story, wood-frame building features a side-gabled roof covered with asphalt shingles, exterior vinyl siding, and a concrete block foundation covered with a brick veneer. Located on the façade elevation, the primary entry sits atop a brick and concrete stoop with stairs. The façade elevation is marked with one Chicago window as well as an additional window style indiscernible from the public right of way. On the northeast elevation are two 2/2 horizontal sash windows.

NRHP Assessment. Architectural resource AM2555 does not exhibit distinctive characteristics of architectural style or workmanship. Based on the lack of architectural merit, as well as the inability to associate the house and/or its original owner(s) with an important historical event or series of events, it is TRC’s opinion that architectural resource AM2555 is not eligible for the NRHP.

Figure 6.159. Architectural resource AM2555; view is south featuring the façade and northeast elevation.

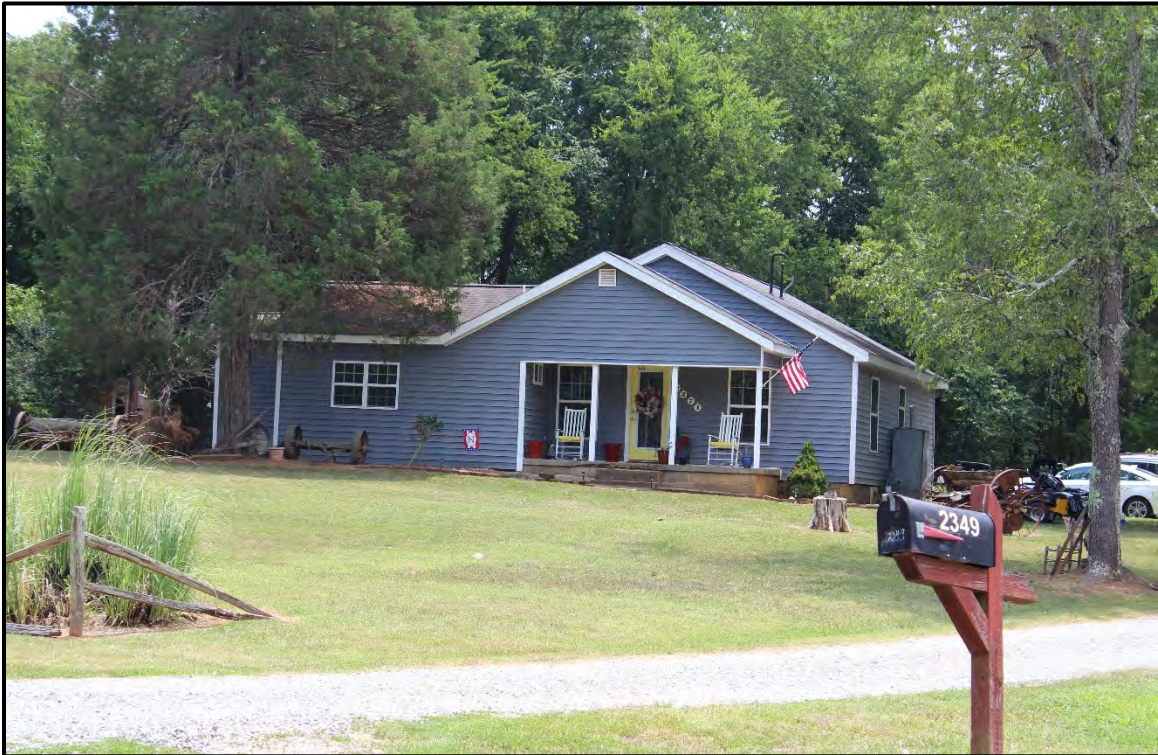
Description. Architectural resource AM2556 is a gable-front house located at 2371 Haw River Hopedale Road, Burlington 27217 on parcel number 153305 (Alamance County, NC WebGIS 2018) (see Figure 1.2n1; Figure 6.160). According to Alamance County tax records, the house was constructed in 1935 (Alamance County, NC WebGIS 2018). Due to access limitations, TRC’s evaluation of the property was limited to the public right-of-way along Haw River Hopedale Road.

The one-story, wood-frame house features a roof covered with asphalt shingles, synthetic exterior siding, and a concrete block foundation. The façade elevation is marked by an off-centered door that is flanked on either side by 6/6, double-hung vinyl sash windows (a sash style repeated on the northwest elevation), and a partial-width, projecting gable porch with a louvered vent in the gable front. The porch is supported by synthetic columns atop a concrete slab deck with a concrete block foundation. Additional paired 6/6 vinyl sash windows are located on the primary façade to the west of the main entry.

NRHP Assessment. Architectural resource AM2556 does not exhibit distinctive characteristics of architectural style or workmanship. In addition, the house has been altered through the application of vinyl siding, the replacement of the original window sashes, and the construction of the side-gabled wing. Based on the lack of architectural merit, as well as the inability to associate the house and/or its original owner(s) with an important historical event or series of events, it is TRC’s opinion that architectural resource AM2556 is not eligible for the NRHP.

Figure 6.160. Architectural resource AM2556; view is southeast featuring the façade and southwest elevation.

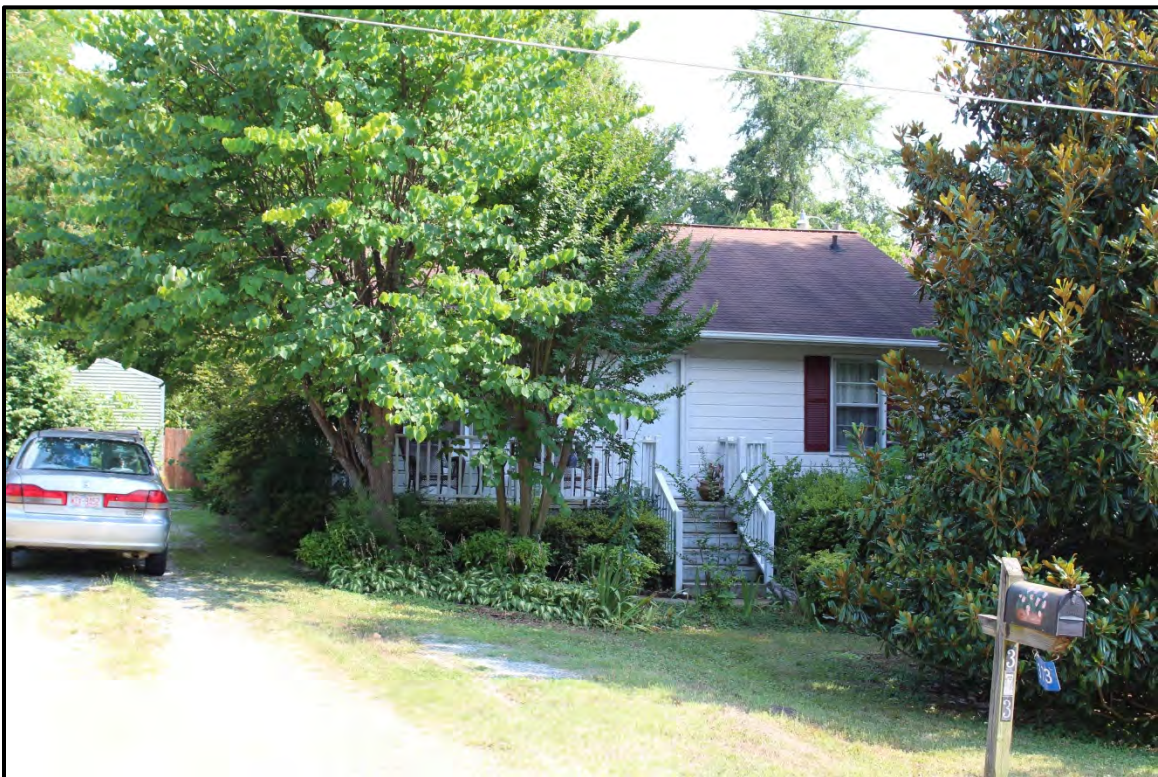
Description. Architectural resource AM2557 is a Minimal Traditional-style house located at 373 Boundary Street, Haw River 27258 on parcel number 153182 (Alamance County, NC WebGIS 2018) (see Figures 1.2n1 and 1.2n2; Figure 6.161). According to Alamance County tax records, the house was constructed in 1956 (Alamance County, NC WebGIS 2018). Due to lack of landowner permission to access properties that are not directly affected by the Project, photographic coverage of architectural resource AM2557 was limited to the public right-of-way along Boundary Street.

The one-story, wood-frame building features a side-gabled roof with asphalt shingles, wood cladding, and a brick foundation. Two 2/2 horizontal sash windows with vinyl shutters are seen on the primary façade. A partial-width porch with a wooden balustrade and a concrete stoop provides access to the main entrance.

NRHP Assessment. Architectural resource AM2557 does not exhibit a distinctive architectural style or workmanship.

Based on the lack of architectural merit, as well as the inability to associate the house and/or its original owner(s) with an important historical event or series of events, it is TRC's opinion that architectural resource AM2557 is not eligible for the NRHP.

Figure 6.161. Architectural resource AM2557; view is southwest featuring the façade.

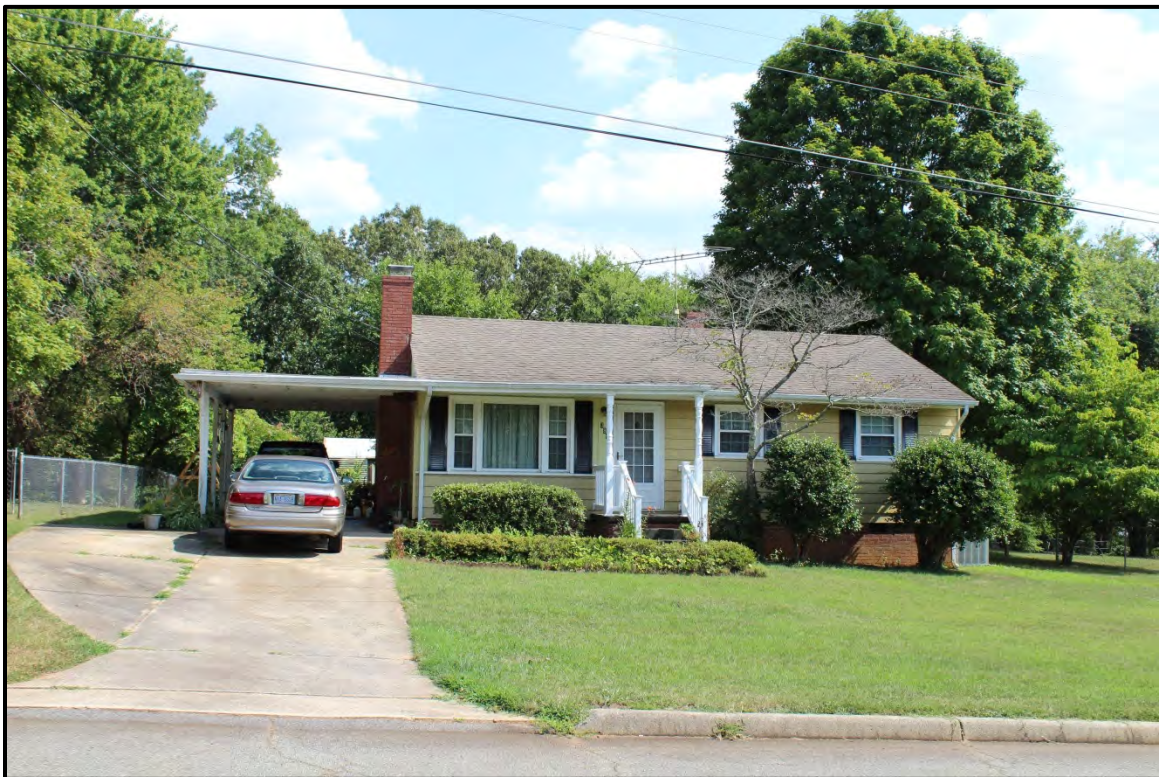
Description. Architectural resource AM2558 is a Ranch-style house located at 381 Boundary Street, Haw River 27258 on parcel number 153189 (Alamance County, NC WebGIS 2018) (see Figures 1.2n1 and 1.2n2; Figure 6.162). According to Alamance County tax records, the house was constructed in 1955. Due to lack of landowner permission to access properties that are not directly affected by the Project, photographic coverage of architectural resource AM2558 was limited to the public right-of-way along Boundary Street.

The wood-frame building features a side-gabled roof with asphalt shingles, aluminum siding, and a brick foundation. An exterior brick chimney is located on the side (northeast) elevation. The façade elevation features two 6/6 vinyl sash windows as well as one picture window. A concrete stoop with synthetic columns and a brick foundation provides access to the main entrance. Located on the northeast elevation is an attached carport supported by synthetic columns.

NRHP Assessment. Architectural resource AM2558 does not exhibit a distinctive architectural style or workmanship. In addition, the house has been altered through the replacement of the original window sashes. Based on the lack of architectural merit, as well as the inability to associate the house and/or its original owner(s) with an important historical event or series of events, it is TRC's opinion that architectural resource AM2558 is not eligible for the NRHP.

Figure 6.162. Architectural resource AM2558; view is southeast featuring the façade.

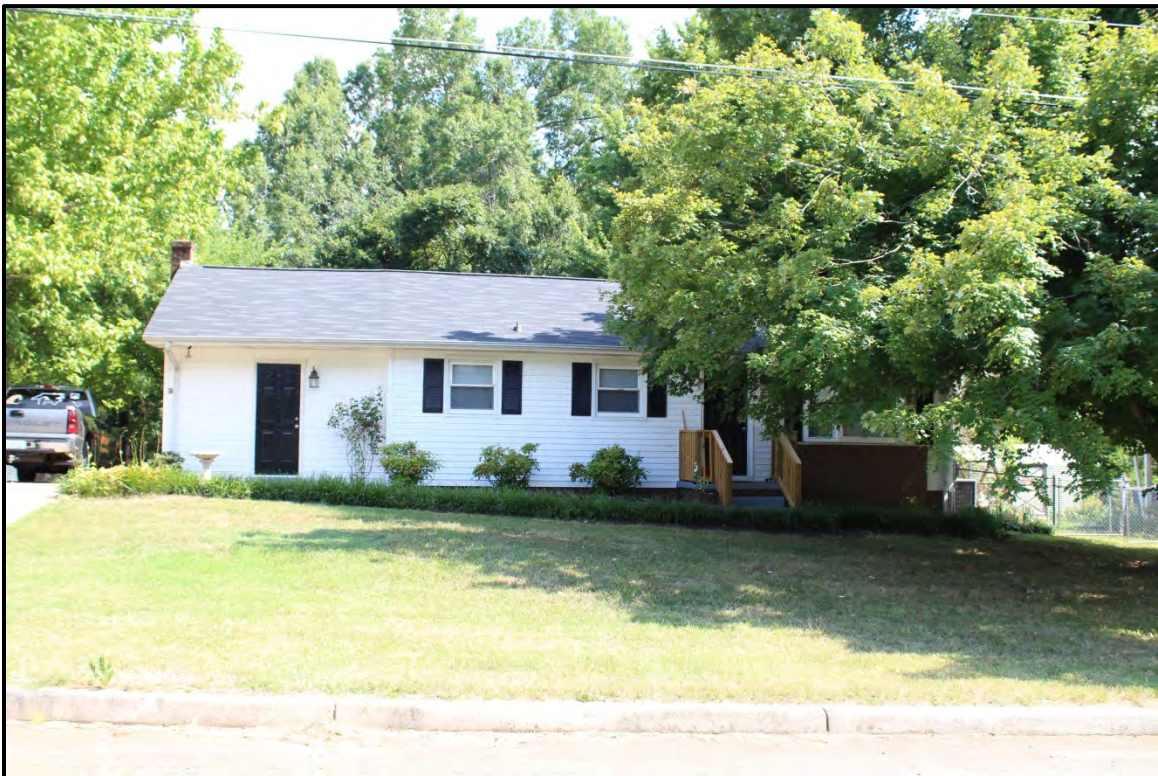
Description. Architectural resource AM2559 is a Ranch-style house located at 401 Boundary Street, Haw River 27258 on parcel number 153191 (Alamance County, NC WebGIS 2018) (see Figures 1.2n1 and 1.2n2; Figure 6.163). According to Alamance County tax records, the house was constructed in 1955 (Alamance County, NC WebGIS 2018). Due to lack of landowner permission to access properties that are not directly affected by the Project, photographic coverage of architectural resource AM2559 was limited to the public right-of-way along Boundary Street.

The wood-frame building features a side-gabled roof with asphalt shingles, vinyl siding, and a brick foundation. An exterior brick chimney is located on the side (southeast) elevation. The façade elevation features two 1/1 vinyl sash windows as well as one bay window with a false brick wall. A concrete stoop with a wood balustrade provides access to the main entrance.

NRHP Assessment. Architectural resource AM2559 does not exhibit a distinctive architectural style or workmanship. In addition, the house has been altered through the application of vinyl siding, the installation of vinyl sash windows, and the enclosure of the carport. Based on the lack of architectural merit, as well as the inability to associate the house and/or its original owner(s) with an important historical event or series of events, it is TRC's opinion that architectural resource AM2559 is not eligible for the NRHP.

Figure 6.163. Architectural resource AM2559; view is southeast featuring the façade.

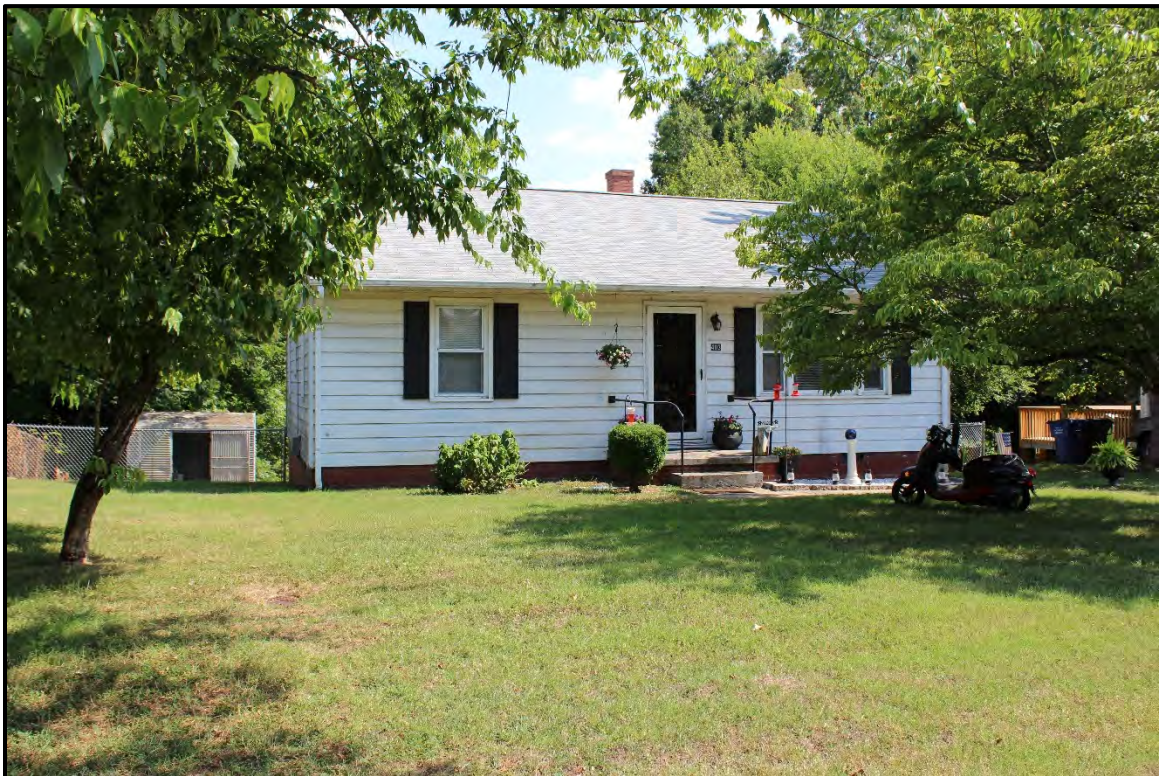
Description. Architectural resource AM2560 is a Ranch-style house located at 403 Boundary Street, Haw River 27258 on parcel number 153193 (Alamance County, NC WebGIS 2018) (see Figures 1.2n1 and 1.2n2; Figure 6.164). According to Alamance County tax records, the house was constructed in 1957 (Alamance County, NC WebGIS 2018). Due to lack of landowner permission to access properties that are not directly affected by the Project, photographic coverage of architectural resource AM2560 was limited to the public right-of-way along Boundary Street.

The wood-frame building features a side-gabled roof with asphalt shingles, aluminum cladding, and a brick foundation. A concrete stoop with a brick foundation and a pipe railing leads to the main entry. The house also features a central interior brick chimney. The façade elevation holds one 1/1 vinyl sash window as well as three-part picture window.

NRHP Assessment. Architectural resource AM2560 does not exhibit a distinctive architectural style or workmanship. In addition, the house has been altered through the application of vinyl siding and the installation of vinyl sash windows. Based on the lack of architectural merit, as well as the inability to associate the house and/or its original owner(s) with an important historical event or series of events, it is TRC's opinion that architectural resource AM2560 is not eligible for the NRHP.

Figure 6.164. Architectural resource AM2560; view is southeast featuring the façade.

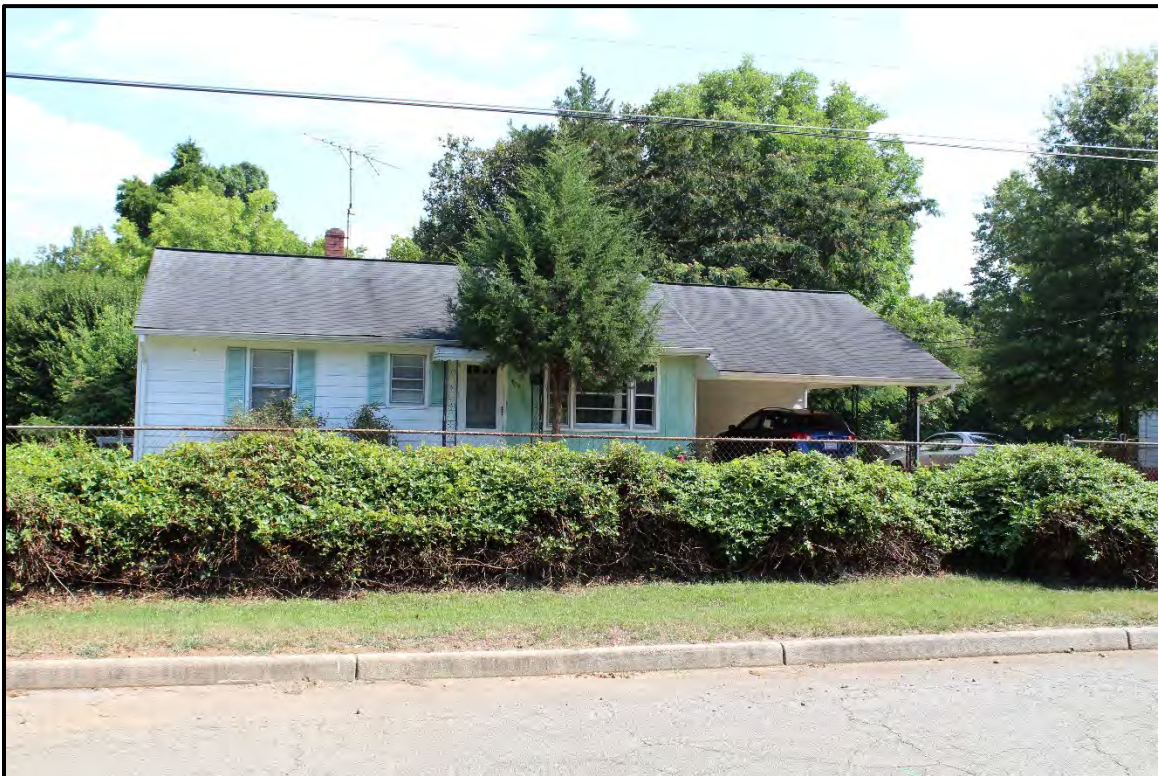
Description. Architectural resource AM2561 is a Ranch-style house located at 407 Boundary Street, Haw River 27258 on parcel number 153197 (Alamance County, NC WebGIS 2018) (see Figures 1.2n1 and 1.2n2; Figure 6.165). According to Alamance County tax records, the house was constructed in 1952. Due to lack of landowner permission to access properties that are not directly affected by the Project, photographic coverage of architectural resource AM2561 was limited to the public right-of-way along Boundary Street.

AM2561 is a single-story Ranch-style house. The building features a side-gabled roof with asphalt shingles, aluminum cladding, a central interior brick chimney, and a brick foundation. A concrete stoop leads to the main entry. The façade elevation features two 2/2 horizontal sash windows as well as three-part picture window. A partially enclosed carport is attached to the west elevation. The stoop and carport are supported by wrought iron-style columns.

NRHP Assessment. Architectural resource AM2561 does not exhibit a distinctive architectural style or workmanship. Based on the lack of architectural merit, as well as the inability to associate the house and/or its original owner(s) with an important historical event or series of events, it is TRC's opinion that architectural resource AM2561 is not eligible for the NRHP.

Figure 6.165. Architectural resource AM2561; view is southeast featuring the façade.

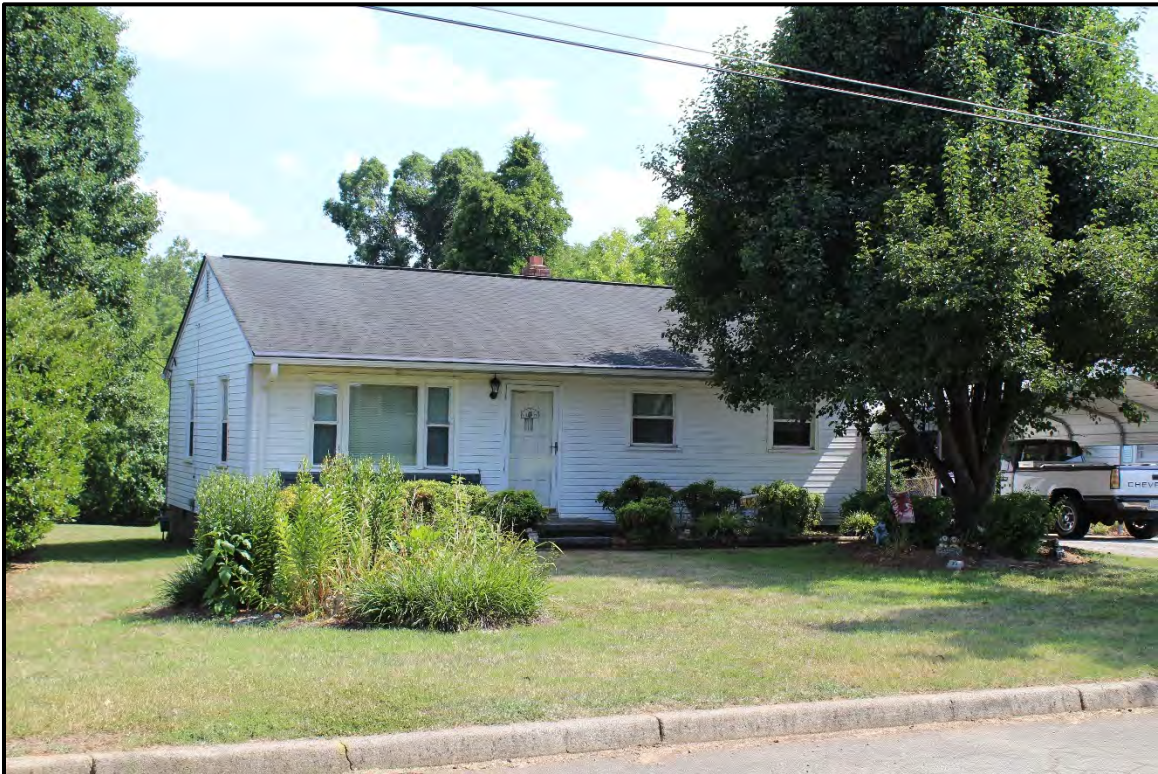
Description. Architectural resource AM2562 is a Ranch-style house located at 411 Boundary Street, Haw River 27258 on parcel number 153264 (Alamance County, NC WebGIS 2018) (see Figures 1.2n1 and 1.2n2; Figure 6.166). According to Alamance County tax records, the house was constructed in 1956 (Alamance County, NC WebGIS 2018). Due to lack of landowner permission to access properties that are not directly affected by the Project, photographic coverage of architectural resource AM2562 was limited to the public right-of-way along Boundary Street.

The wood-frame building features a side-gabled roof with asphalt shingles, vinyl siding, a central interior brick chimney, and a brick foundation. The main entry is off-center and sits atop a concrete stoop. The four-bay façade elevation features two 1/1 vinyl sash windows and a three-part picture window.

NRHP Assessment. Architectural resource AM2562 does not exhibit a distinctive architectural style or workmanship. In addition, the house has been altered through the application of vinyl siding and the replacement of the original window sashes. Based on the lack of architectural merit, as well as the inability to associate the house and/or its original owner(s) with an important historical event or series of events, it is TRC’s opinion that architectural resource AM2562 is not eligible for the NRHP.

Figure 6.166. Architectural resource AM2562; view is south featuring the façade and northeast elevation.
