Re: Revised Architectural Survey Report, MVP Southgate Project, Construct Interstate Pipeline, Rockingham and Alamance County, ER 18-1041

Thank you for your letter of October 11, 2019, transmitting the draft "Historic Architectural Survey for the MVP Southgate Pipeline Project". We have reviewed the report and offer the following comments.

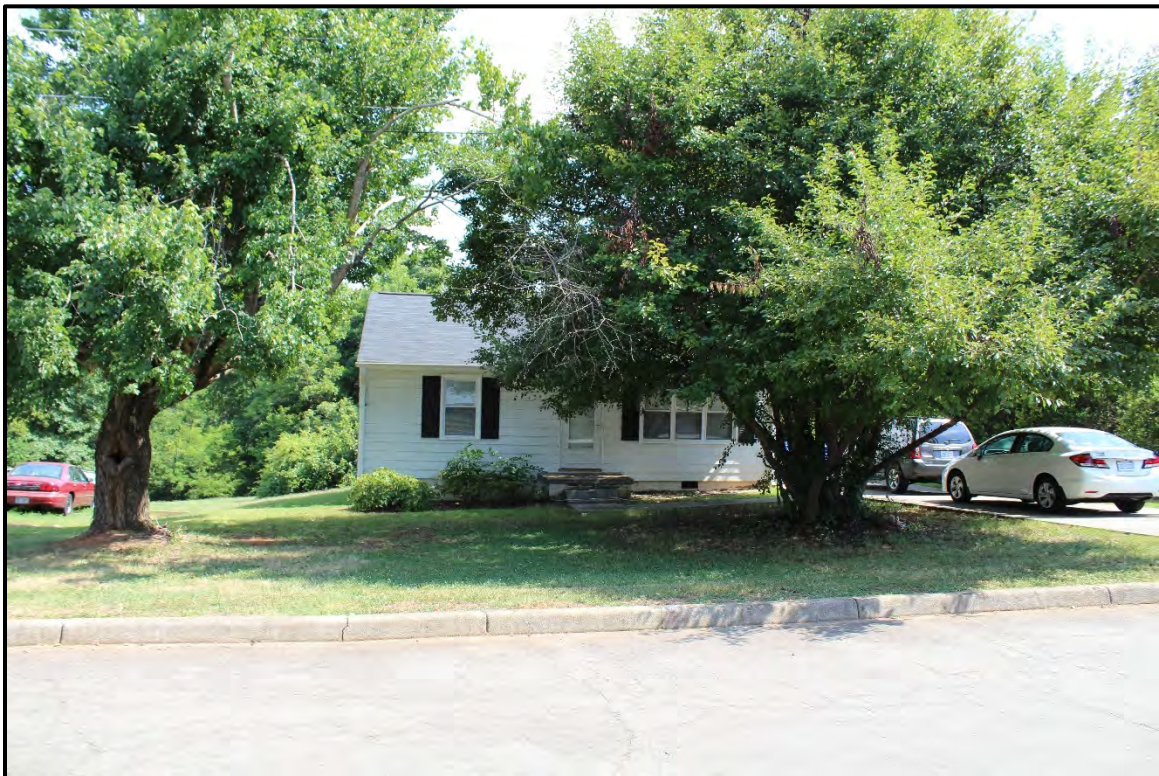
The one-story, wood-frame building features a side-gabled roof with asphalt shingles, aluminum siding, and a brick foundation. A concrete stoop atop a brick foundation provides access to the main entrance. The three-bay façade elevation features 1/1 vinyl sash windows with vinyl shutters.

NRHP Assessment. Architectural resource AM2563 does not exhibit a distinctive architectural style or workmanship). In addition, the house has been altered through the application of aluminum siding and the replacement of the original window sashes. Based on the lack of architectural merit, as well as the inability to associate the house and/or its original owner(s) with an important historical event or series of events, it is TRC's opinion that architectural resource AM2563 is not eligible for the NRHP.

Figure 6.167. Architectural resource AM2563; view is southeast featuring the façade.

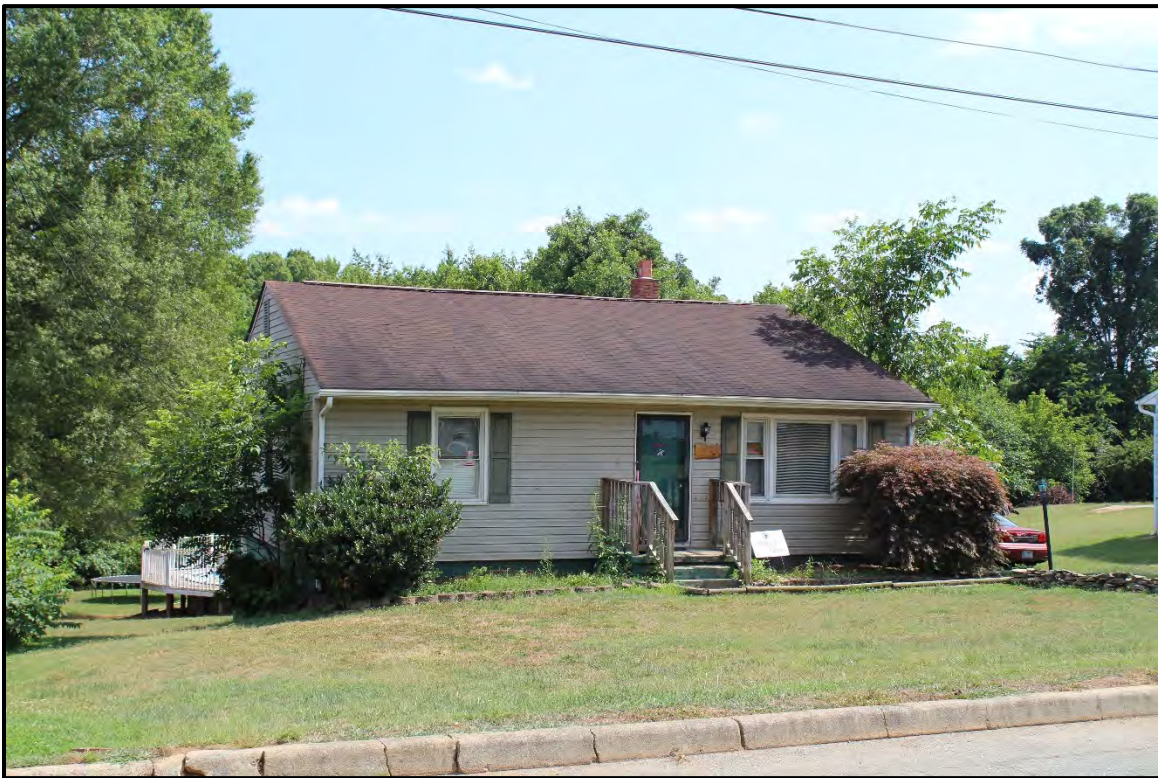
The wood-frame building features a side-gabled roof with asphalt shingles, vinyl siding, and a brick foundation. The three-bay façade elevation contains a 1/1 vinyl sash window and a three-part picture window. A concrete stoop with a wooden handrail provides access to the main entrance, which is filled with a paneled vinyl door.

NRHP Assessment. Architectural resource AM2564 does not exhibit a distinctive architectural style or workmanship. In addition, the house has been altered through the application of vinyl siding and the replacement of the original window sashes. Based on the lack of architectural merit, as well as the inability to associate the house and/or its original owner(s) with an important historical event or series of events, it is TRC's opinion that architectural resource AM2564 is not eligible for the NRHP.

Figure 6.168. Architectural resource AM2564; view is south featuring the façade.

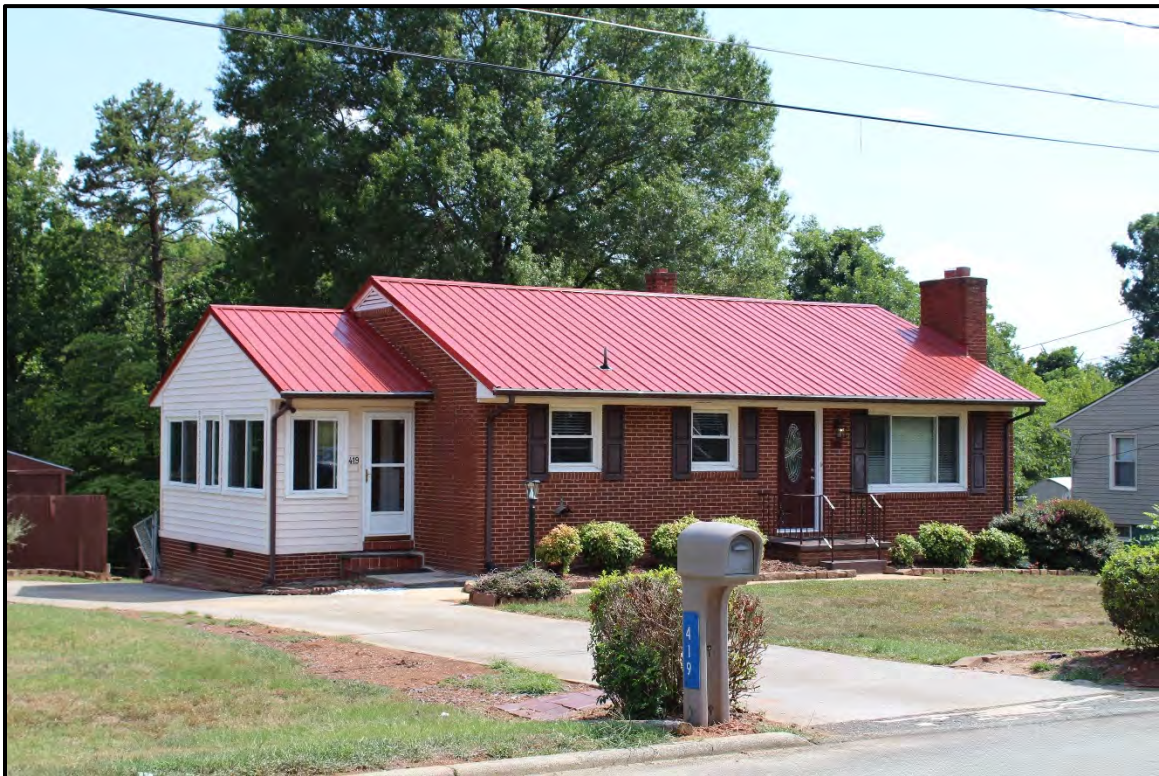
The wood-frame building features a side-gabled tin roof, brick veneer, and a brick foundation. The façade elevation contains two 1/1 vinyl sash windows and three-part picture window. The house has a central interior brick chimney as well as an exterior brick chimney located on the side (southwest) elevation. Located on the side (northeast elevation) is a one-story addition with vinyl siding. A concrete stoop with a brick foundation and a metal handrail provides access to the main entrance.

NRHP Assessment. Architectural resource AM2565 does not exhibit a distinctive architectural style or workmanship. In addition, the house has been altered through the replacement of the original window sashes and the construction of the northeast elevation wing. Due to lack of historic and architectural significance it is TRC's opinion that architectural resource AM2565 is not eligible for the NRHP.

Figure 6.169. Architectural resource AM2565; view is south featuring the façade and northeast elevation.

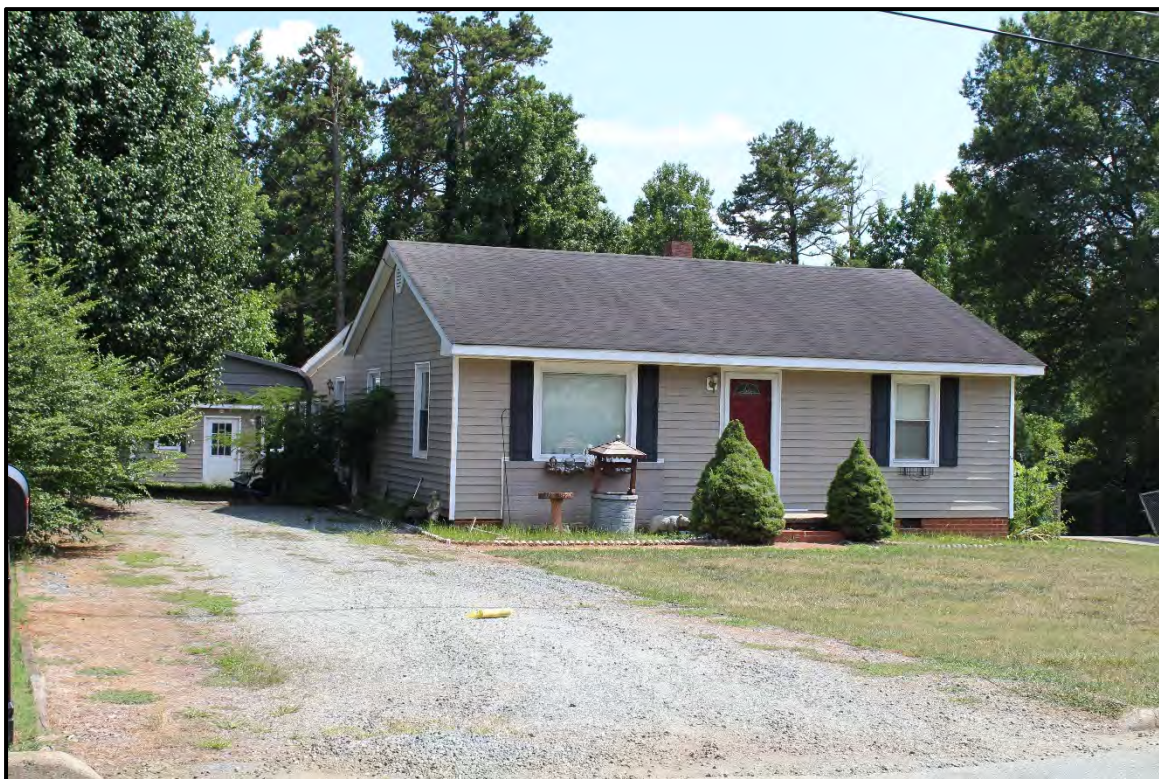
The one-story, wood-frame building features an asphalt shingle side-gabled roof, vinyl siding, and a brick foundation. The façade elevation holds replaced 1/1 vinyl sash windows with vinyl shutters. The house has a central interior brick chimney and features a rear shed addition. A modern shed outbuilding is located northwest of the house.

NRHP Assessment. Architectural resource AM2566 does not exhibit a distinctive architectural style or workmanship. In addition, the house has been altered through the application of vinyl siding and the replacement of the original window sashes. Based on the lack of architectural merit, as well as the inability to associate the house and/or its original owner(s) with an important historical event or series of events, it is TRC’s opinion that architectural resource AM2566 is not eligible for the NRHP.

Figure 6.170. Architectural resource AM2566; view is south featuring the façade and northeast elevation.

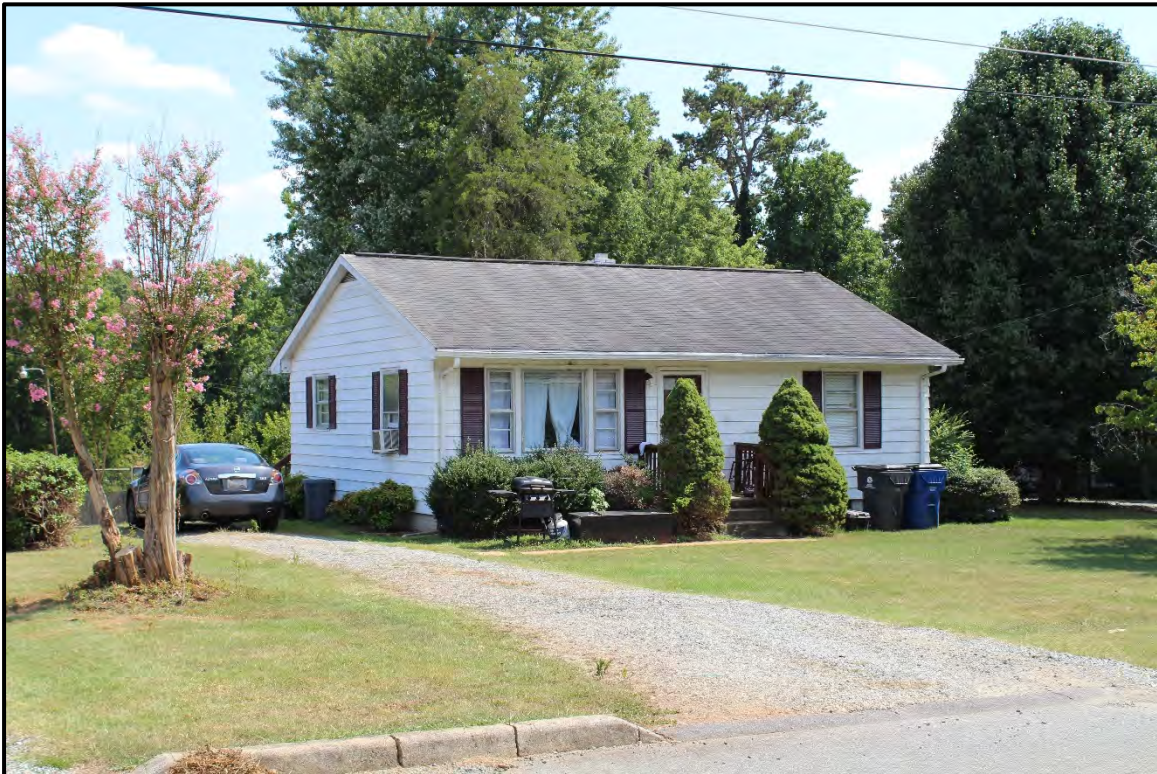
The one-story, wood-frame building features a side-gable asphalt shingle roof, aluminum siding, a brick foundation, and a central interior brick chimney. The façade elevation holds one 2/2 horizontal sash window and a three-part picture window, both with vinyl shutters. A concrete stoop with a brick foundation and handrail provides access to the main entrance.

NRHP Assessment. Architectural resource AM2567 does not exhibit a distinctive architectural style or workmanship. Based on the lack of architectural merit, as well as the inability to associate the house and/or its original owner(s) with an important historical event or series of events, it is TRC's opinion that architectural resource AM2567 is not eligible for the NRHP.

Figure 6.171. Architectural resource AM2567; view is south featuring the façade and northeast elevation.

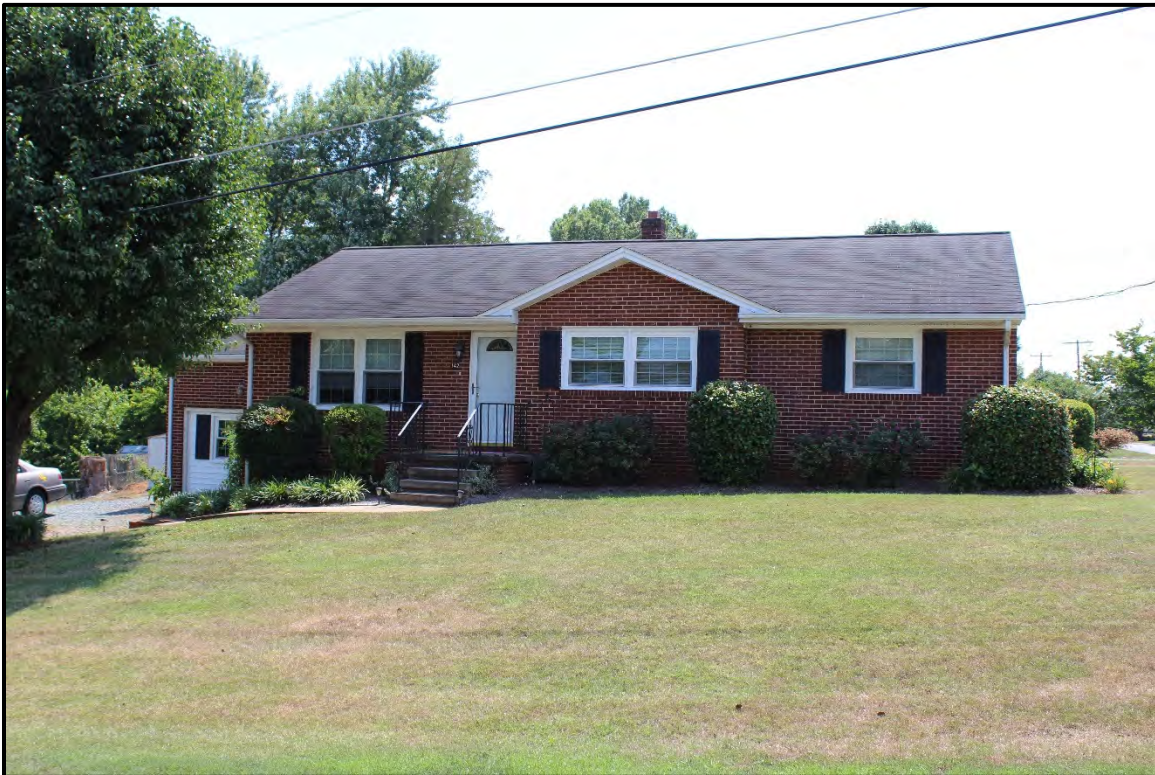
The wood-frame building features a side-gabled roof, brick exterior, and a brick foundation. The façade elevation contains both 8/8 and 6/6 vinyl sash windows and a projecting gable with 8/8 vinyl sash windows. The house has a central interior brick chimney. A concrete stoop with a brick foundation and metal handrail provides access to the main entrance. An enclosed brick garage is attached at the southwest elevation.

NRHP Assessment. Architectural resource AM2568 does not exhibit a distinctive architectural style or workmanship. In addition, the house has been altered through the installation of vinyl sash windows. Based on the lack of architectural merit, as well as the inability to associate the house and/or its original owner(s) with an important historical event or series of events, it is TRC's opinion that architectural resource AM2568 is not eligible for the NRHP.

Figure 6.172. Architectural resource AM2568; view is southwest featuring the façade.

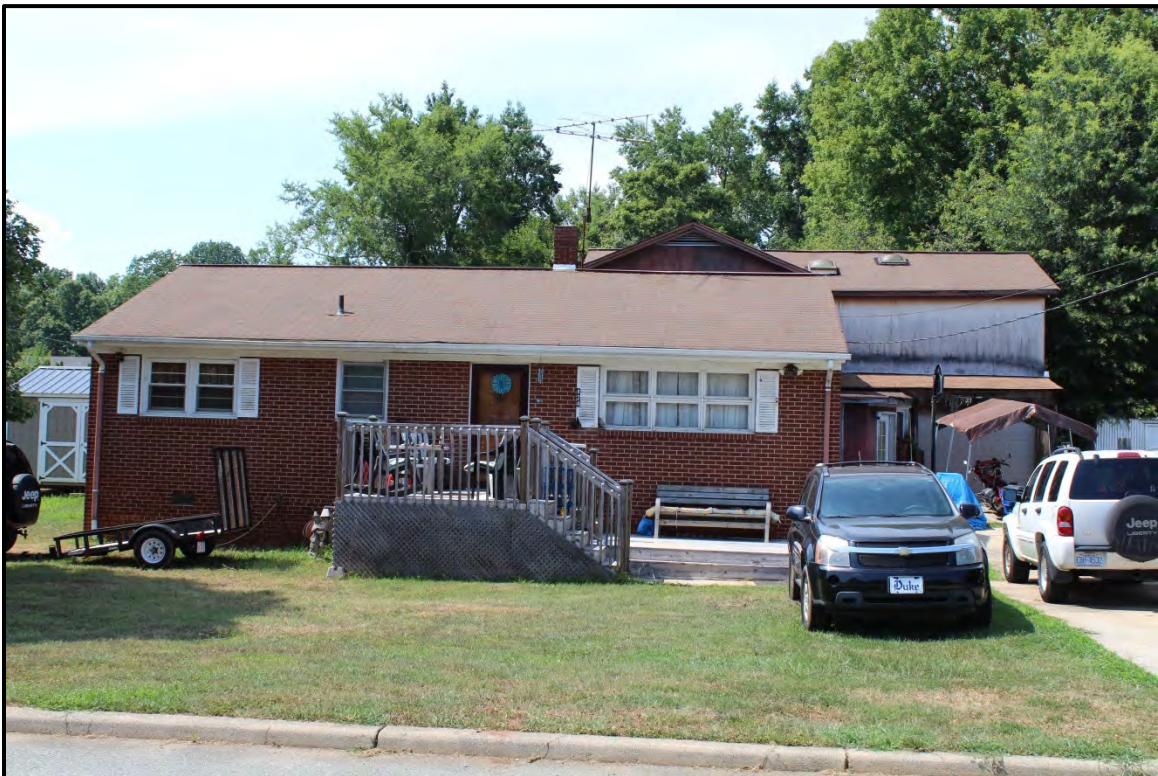
The wood-frame building features a side-gabled roof, brick exterior, a brick foundation, and a central interior brick chimney. The façade elevation contains both 2/2 and 1/1 horizontal sash windows with vinyl shutters. A large, two-story garage addition with a projecting gable front is attached at the rear (northwest) elevation.

NRHP Assessment. Architectural resource AM2569 does not exhibit a distinctive architectural style or workmanship. In addition, the house has been altered through the reconstruction of the façade entry porch and rear addition. Based on the lack of architectural merit, as well as the inability to associate the house and/or its original owner(s) with an important historical event or series of events, it is TRC’s opinion that architectural resource AM2569 is not eligible for the NRHP.

Figure 6.173. Architectural resource AM2569; view is northwest featuring the façade.

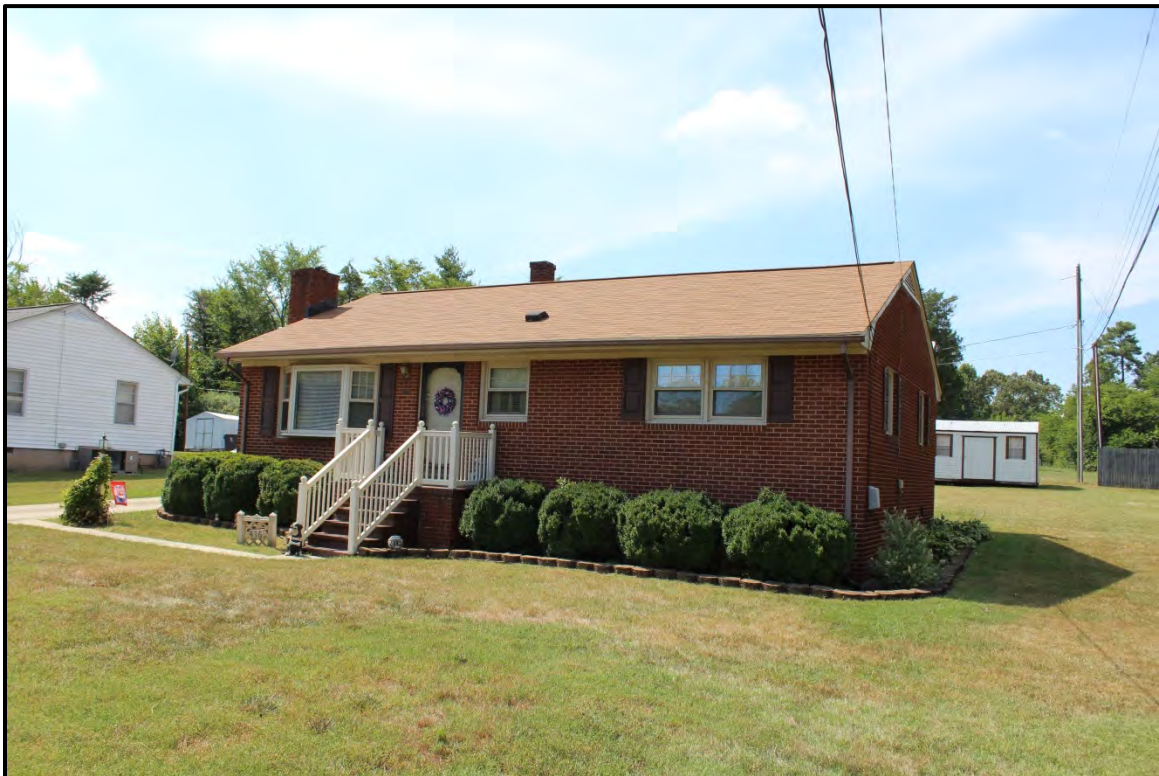
The wood-frame building features a side-gabled roof, brick exterior, and a brick foundation. The façade elevation contains a replacement bay window as well as 6/1 vinyl sash windows. A concrete stoop with a brick foundation and vinyl railing leads to the main entrance. The house features a central interior brick chimney as well as an exterior brick chimney located on the side (southwest) elevation.

NRHP Assessment. Architectural resource AM2570 does not exhibit a distinctive architectural style or workmanship. In addition, the house has been altered through the replacement of the original window sashes. Based on the lack of architectural merit, as well as the inability to associate the house and/or its original owner(s) with an important historical event or series of events, it is TRC’s opinion that architectural resource AM2570 is not eligible for the NRHP.

Figure 6.174. Architectural resource AM2570; view is northwest featuring the façade and northeast elevation.

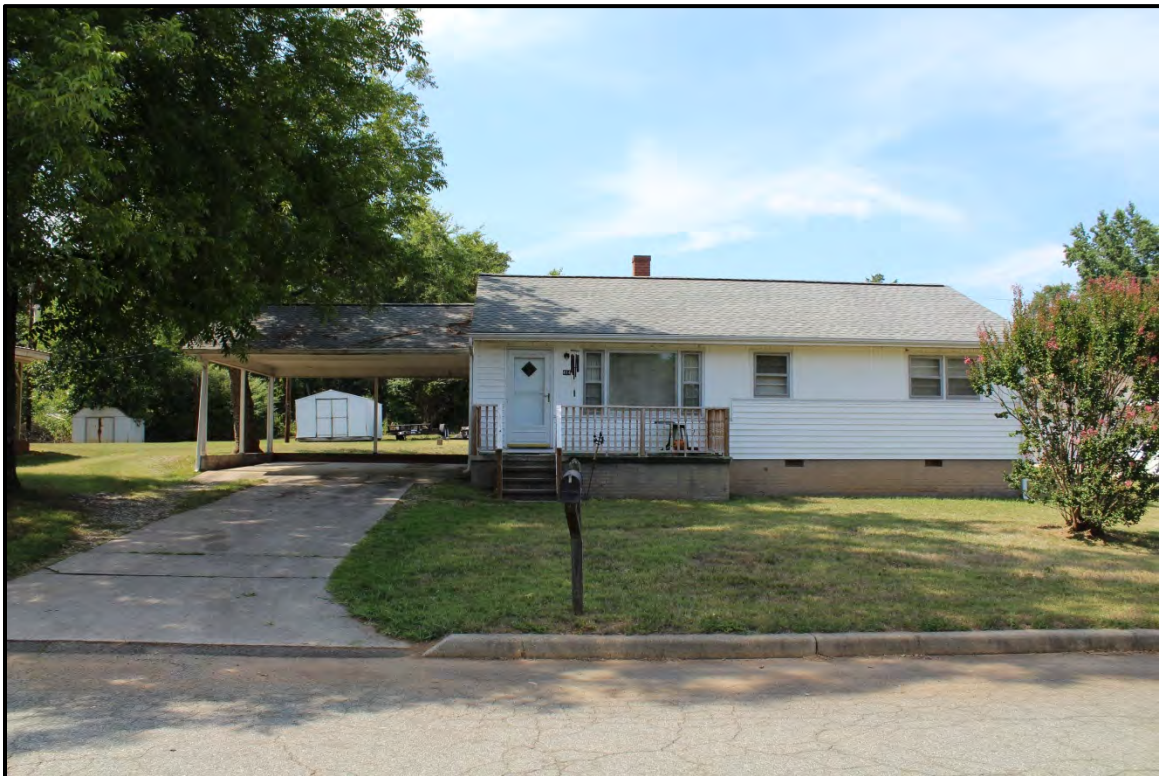
The wood-frame building features a side-gabled roof, vinyl siding, and a yellow brick foundation. The façade elevation contains a three-part picture window as well as 2/2 horizontal sashes. A brick stoop with concrete steps leads to the main entrance, which contains a diamond door. The house also features a central interior brick chimney. Attached to the side (west) elevation is a carport supported by synthetic columns.

NRHP Assessment. Architectural resource AM2571 does not exhibit a distinctive architectural style or workmanship. In addition, the house has been altered through the application of vinyl siding and the modifications to the façade porch. Based on the lack of architectural merit, as well as the inability to associate the house and/or its original owner(s) with an important historical event or series of events, it is TRC's opinion that architectural resource AM2571 is not eligible for the NRHP.

Figure 6.175. Architectural resource AM2571; view is northwest featuring the façade.

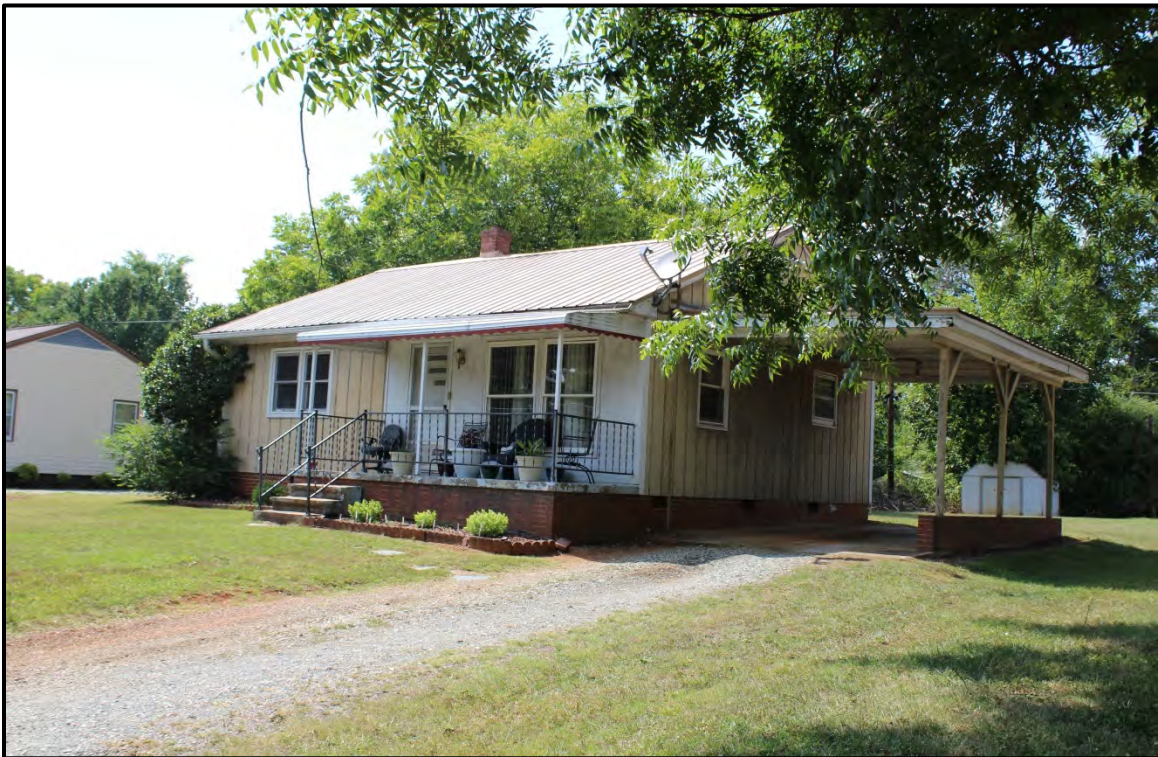
The one-story, wood-frame building features a side-gabled metal roof, vertical wood siding, and a brick foundation. The façade elevation contains 1/1 vinyl sash windows. A partial-width concrete porch supported by synthetic columns leads to the main entrance, which contains a three-light horizontal door. The house also features a central interior brick chimney. Attached to the side (southeast) elevation is a carport supported by wood columns.

NRHP Assessment. Architectural resource AM2572 does not exhibit a distinctive architectural style or workmanship. In addition, the house has been altered through the replacement of the original window sashes, the construction of the carport to the southeast elevation, and the modifications to the façade porch. Based on the lack of architectural merit, as well as the inability to associate the house and/or its original owner(s) with an important historical event or series of events, it is TRC's opinion that architectural resource AM2572 is not eligible for the NRHP.

Figure 6.176. Architectural resource AM2572; view is northwest featuring the façade and northeast elevation.

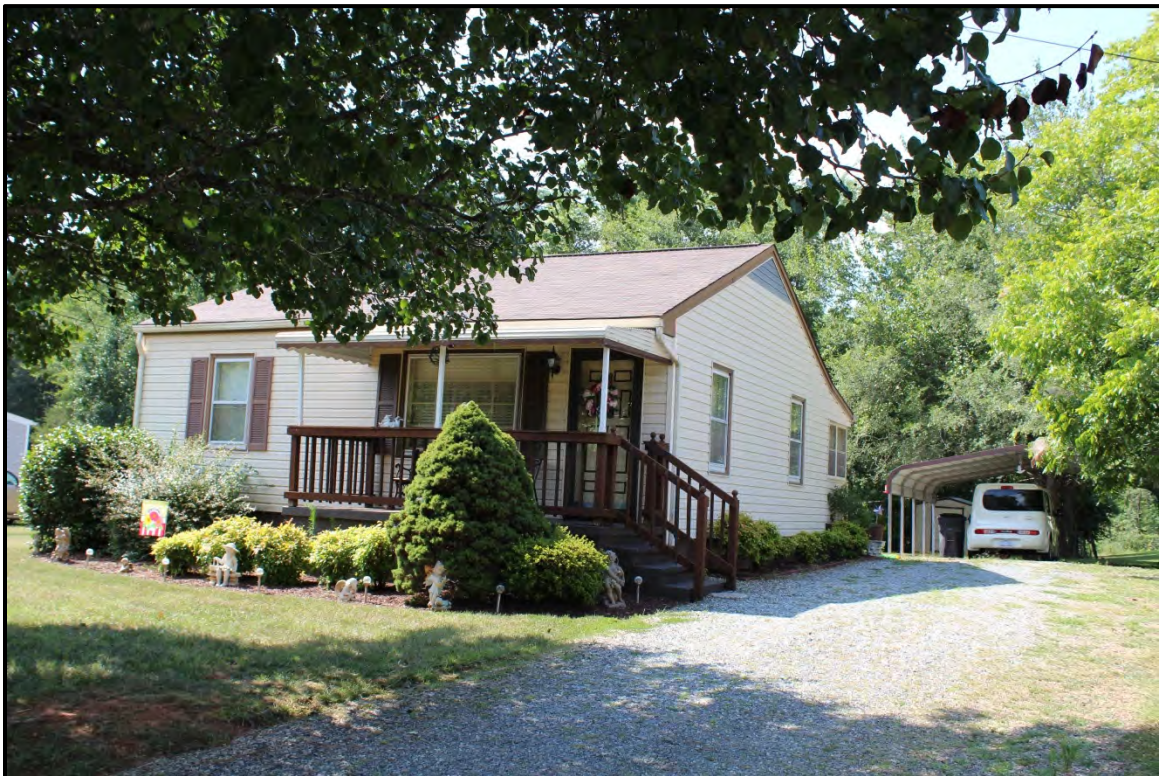
The one-story, wood-frame building features a side-gabled roof, vinyl siding, and a brick foundation. The façade elevation contains a 1/1 vinyl sash window and a 16-light picture window, both with vinyl shutters. A concrete stoop with an aluminum awning roof, synthetic columns, and a wood balustrade leads to the main entrance.

NRHP Assessment. Architectural resource AM2573 does not exhibit a distinctive architectural style or workmanship. In addition, the house has been altered through the application of vinyl siding and the replacement of the original window sashes. Based on the lack of architectural merit, as well as the inability to associate the house and/or its original owner(s) with an important historical event or series of events, it is TRC’s opinion that architectural resource AM2573 is not eligible for the NRHP.

Figure 6.177. Architectural resource AM2573; view is northwest featuring the façade and northeast elevation.

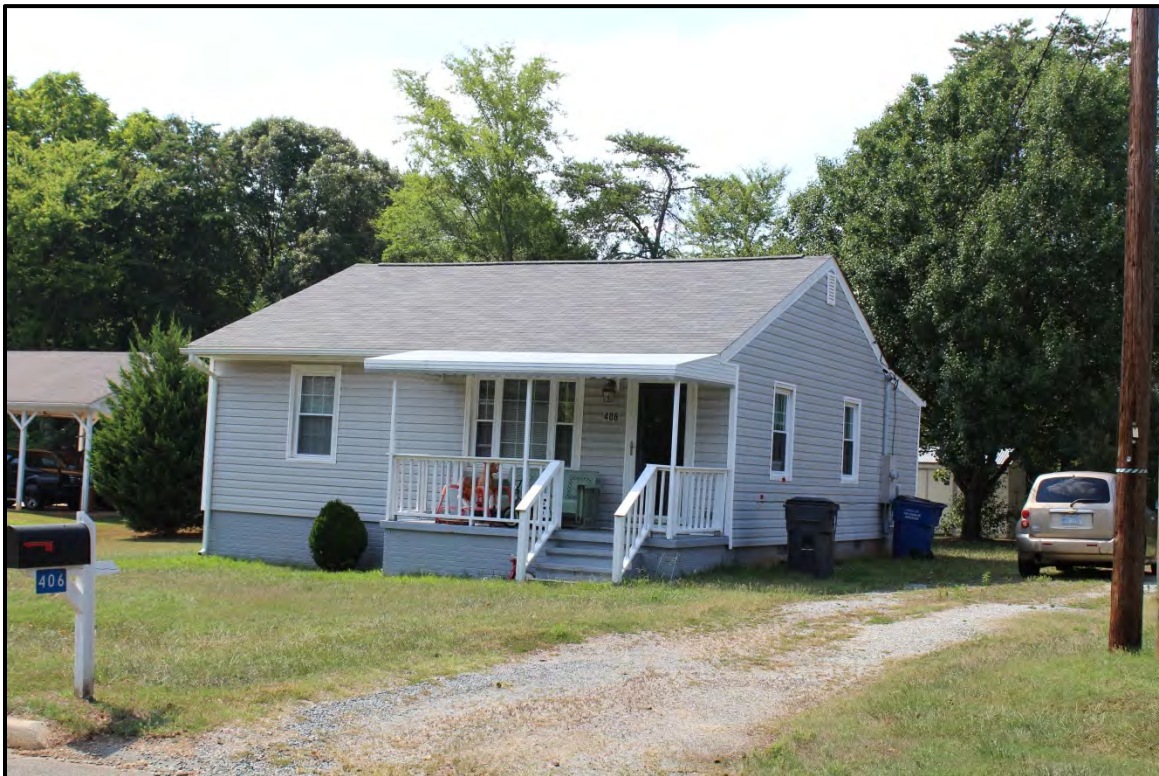
The one-story, wood-frame building features a side-gabled roof, vinyl siding, and a brick foundation. The façade elevation contains a bay window as well as a 6/6 vinyl sash window. A concrete and brick stoop with an aluminum awning roof, synthetic columns, and a synthetic balustrade leads to the main entrance. The side (southeast) elevation holds 6/6 windows and features a gable vent.

NRHP Assessment. Architectural resource AM2574 does not exhibit a distinctive architectural style or workmanship. In addition, the house has been altered through the application of vinyl siding and the replacement of the original window sashes. Based on the lack of architectural merit, as well as the inability to associate the house and/or its original owner(s) with an important historical event or series of events, it is TRC’s opinion that architectural resource AM2574 is not eligible for the NRHP.

Figure 6.178. Architectural resource AM2574; view is northwest featuring the façade and northeast elevation.

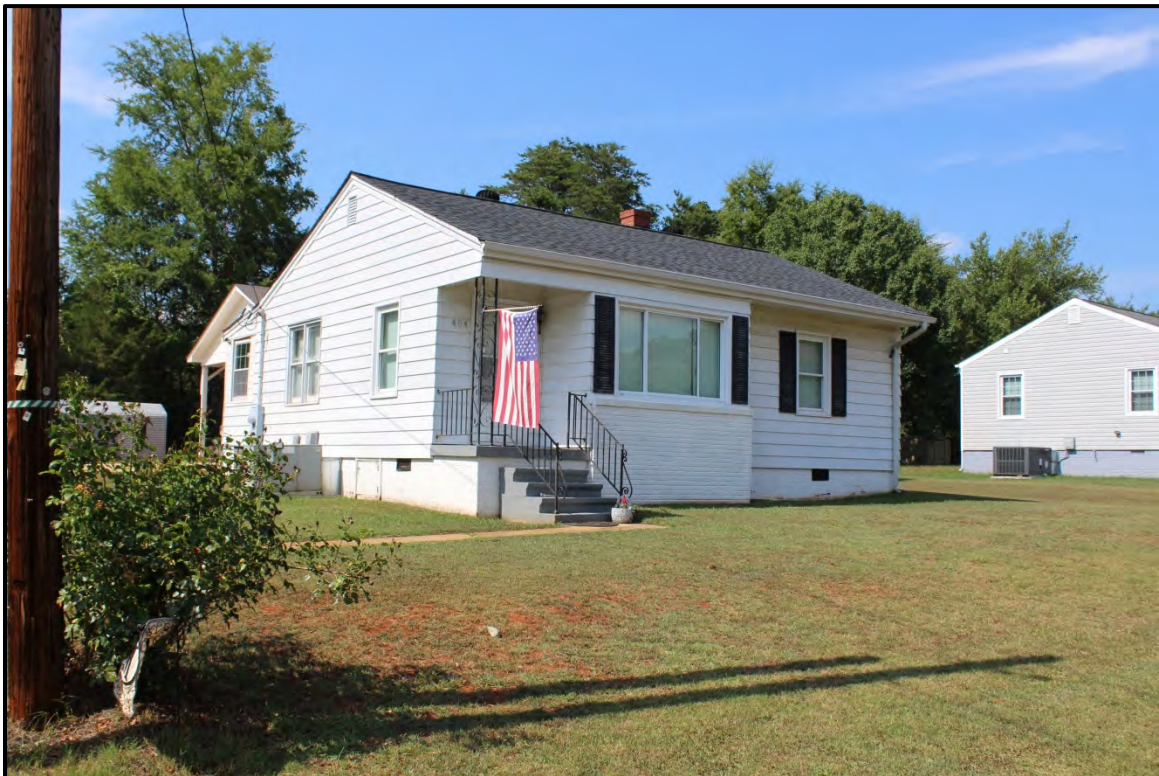
The one-story, wood-frame building features a side-gabled roof, aluminum siding, a central interior brick chimney, and a brick foundation. The façade elevation has a projecting bay and 1/1 vinyl sash windows with vinyl shutters. A concrete and brick stoop with wrought iron columns and balustrade leads to the main entrance. The side (southwest) elevation holds 1/1 windows and features a gable vent.

NRHP Assessment. Architectural resource AM2575 does not exhibit a distinctive architectural style or workmanship. In addition, the house has been altered through the application of aluminum siding and the replacement of the original window sashes. Based on the lack of architectural merit, as well as the inability to associate the house and/or its original owner(s) with an important historical event or series of events, it is TRC’s opinion that architectural resource AM2575 is not eligible for the NRHP.

Figure 6.179. Architectural resource AM2575; view is north featuring the façade and southwest elevation.

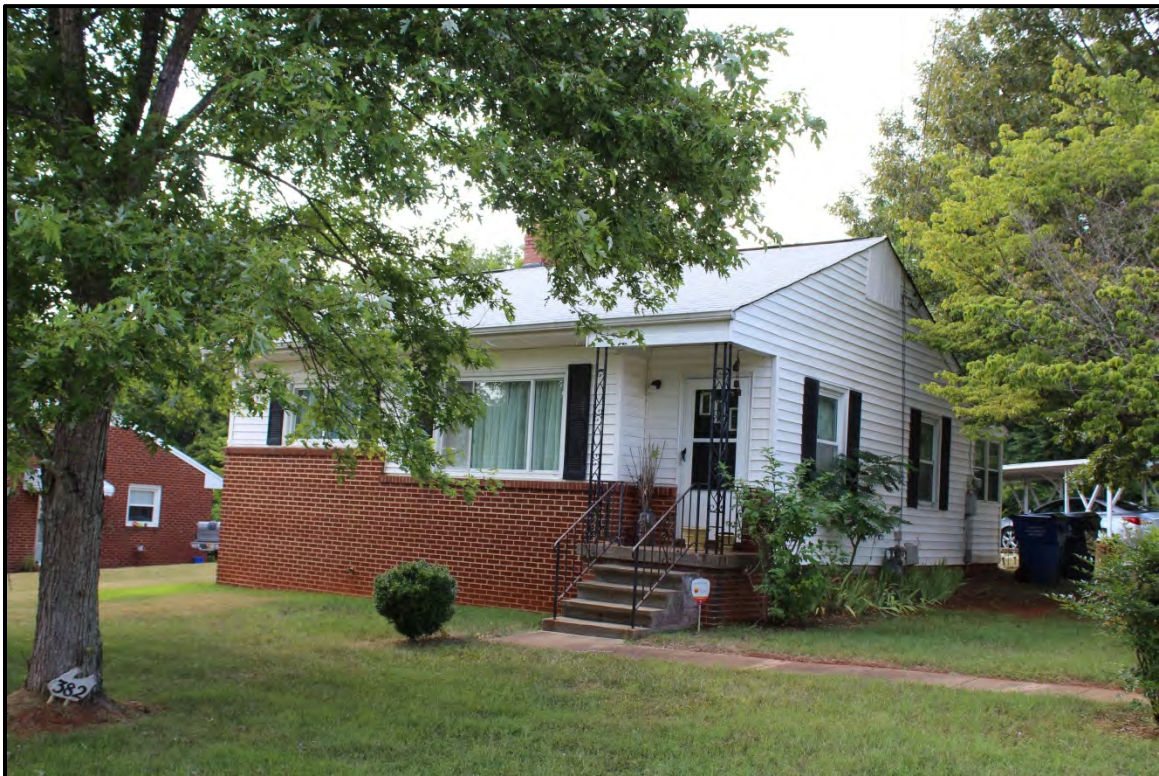
The one-story, wood-frame building features a side-gabled roof, vinyl siding, a brick water table, and a brick foundation. The façade holds a 1/1 sliding window as well as a modern three-part window containing casement sashes. A recessed porch with a concrete stoop supported by wrought iron style columns leads to the main entrance. The side (southeast) elevation holds 1/1 vinyl sash windows.

NRHP Assessment. Architectural resource AM2576 does not exhibit a distinctive architectural style or workmanship. In addition, the house has been altered through the application of vinyl siding and the replacement of the original window sashes. Based on the lack of architectural merit, as well as the inability to associate the house and/or its original owner(s) with an important historical event or series of events, it is TRC's opinion that architectural resource AM2576 is not eligible for the NRHP.

Figure 6.180. Architectural resource AM2576; view is northwest featuring the façade and northeast elevation.

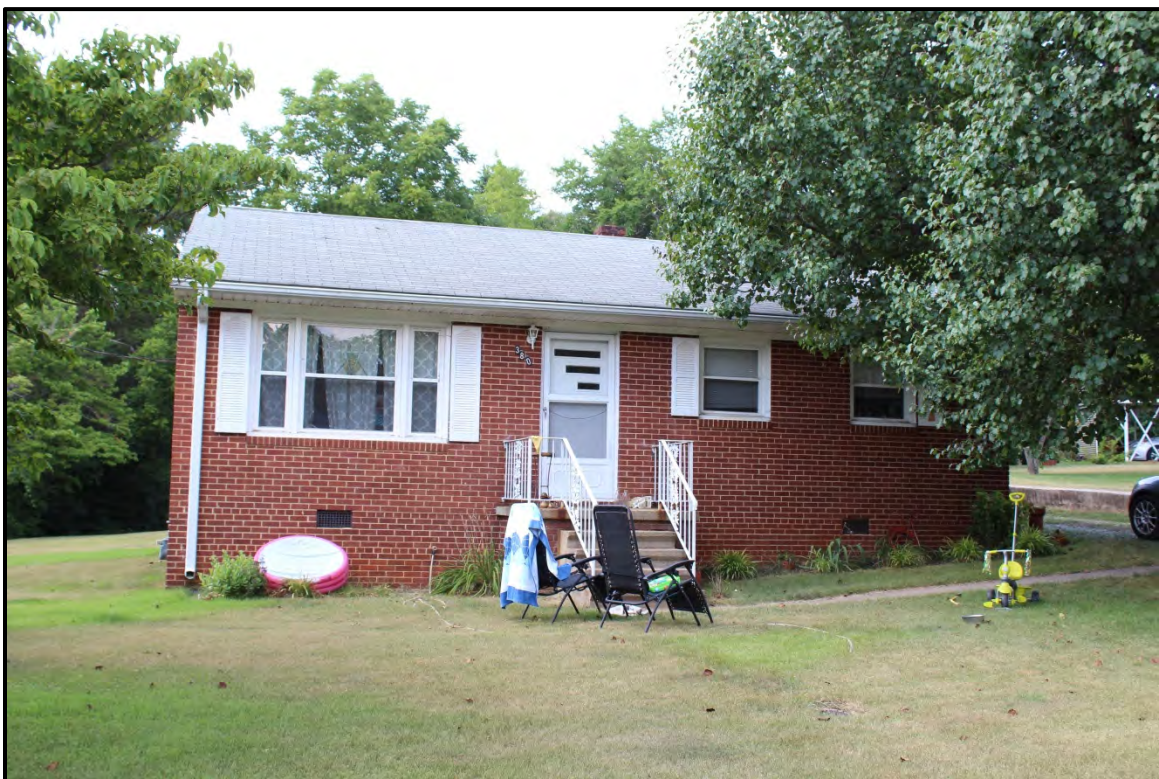
The one-story, wood-frame building features a side-gabled roof covered with asphalt shingles, brick veneer, a brick foundation, and a central interior brick chimney. The façade holds 1/1 vinyl sash windows. A concrete stoop with synthetic handrails leads to the main entrance, which is filled with a three-light horizontal door.

NRHP Assessment. Architectural resource AM2577 does not exhibit a distinctive architectural style or workmanship. In addition, the house has been altered through the replacement of the original window sashes. Based on the lack of architectural merit, as well as the inability to associate the house and/or its original owner(s) with an important historical event or series of events, it is TRC's opinion that architectural resource AM2577 is not eligible for the NRHP.

Figure 6.181. Architectural resource AM2577; view is northwest featuring the façade.

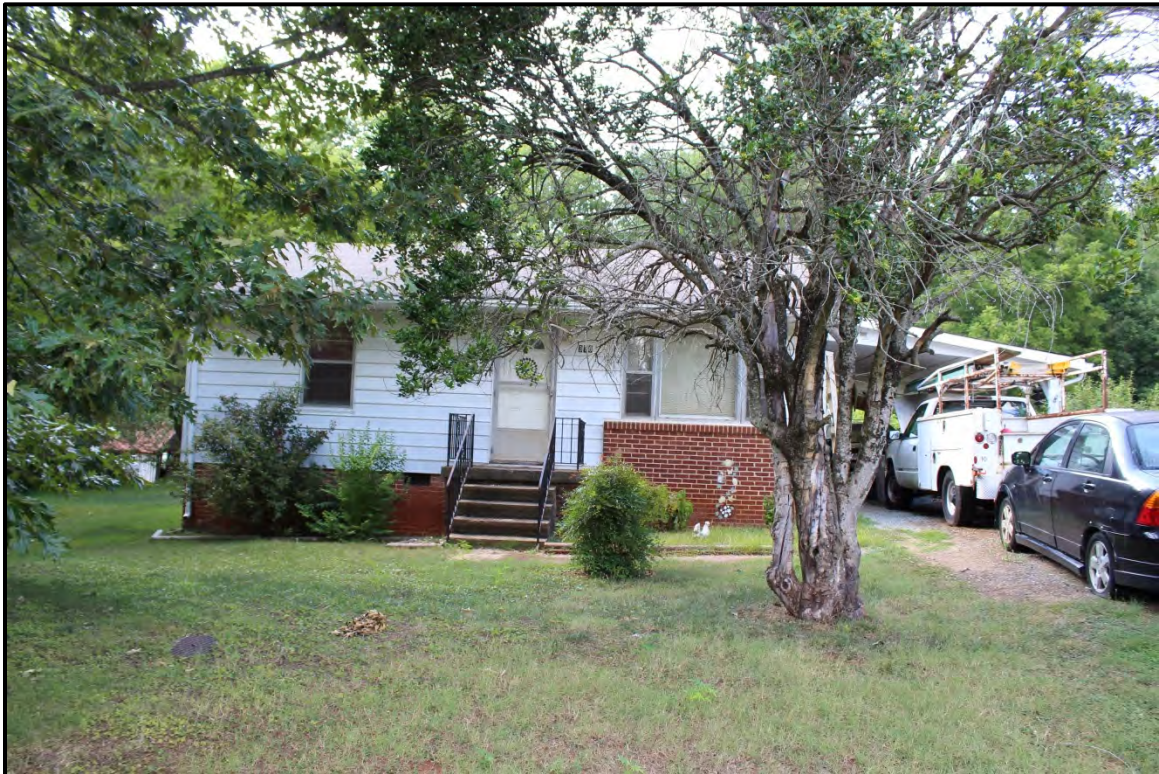
The one-story, wood-frame building features a side-gabled roof, aluminum siding, a brick water table, and a brick foundation. The façade elevation holds one 2/2 horizontal wood sash window as well as three-part picture window. A concrete stoop with an iron handrail leads to the main entrance, which is filled with a replacement vinyl door. Attached to the southeast elevation is a carport supported by synthetic columns.

NRHP Assessment. Architectural resource AM2578 does not exhibit a distinctive architectural style or workmanship. Based on the lack of architectural merit, as well as the inability to associate the house and/or its original owner(s) with an important historical event or series of events, it is TRC's opinion that architectural resource AM2578 is not eligible for the NRHP.

Figure 6.182. Architectural resource AM2578; view is northwest featuring the façade.

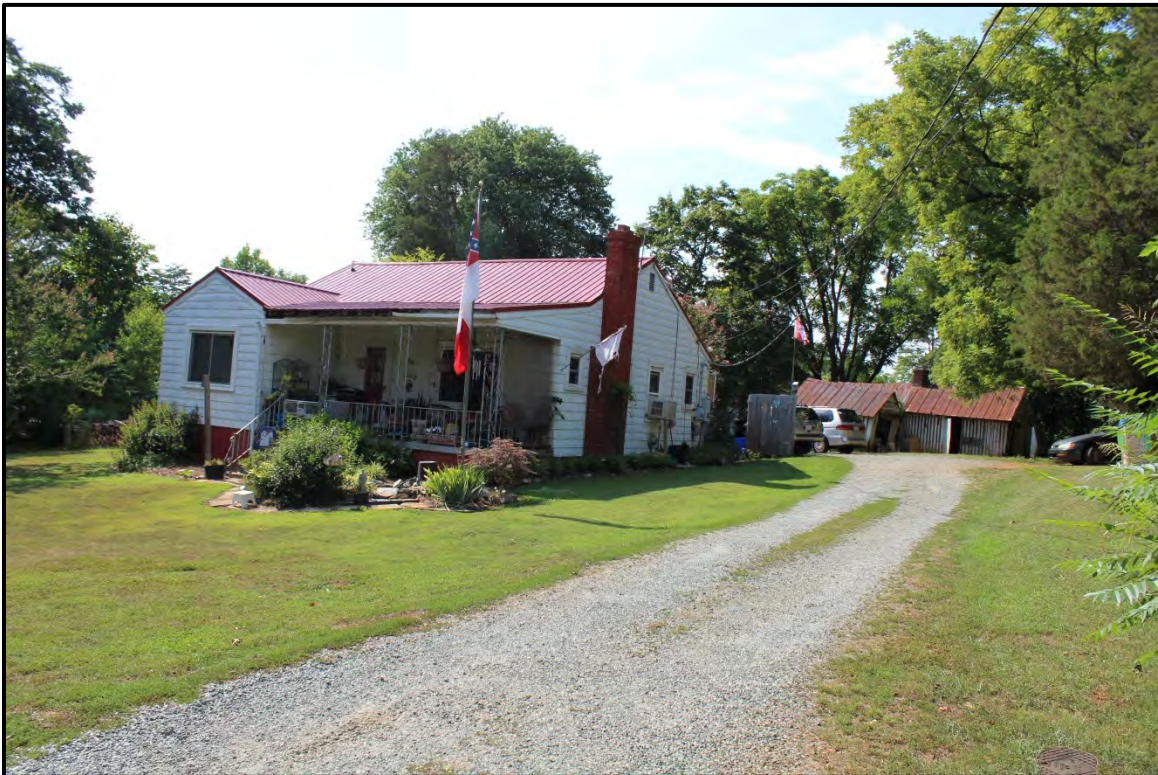
The one-story, wood-frame building features a side-gabled metal roof, aluminum siding, and a brick foundation. The façade elevation holds 1/1 vinyl sash windows. An exterior brick chimney is located at the side (east) elevation. A concrete porch with a wrought iron style balustrade leads to the main entrance. The porch is supported by wrought iron style columns. Northeast of the house are two outbuildings, both with metal siding and side gabled roofs covered with seamed metal.

NRHP Assessment. Architectural resource AM2579 does not exhibit a distinctive architectural style or workmanship. In addition, the house has been altered through the application of aluminum siding and the replacement of the original window sashes. Based on the lack of architectural merit, as well as the inability to associate the house and/or its original owner(s) with an important historical event or series of events, it is TRC's opinion that architectural resource AM2579 is not eligible for the NRHP.

Figure 6.183. Architectural resource AM2579; view is northwest featuring the façade and northeast elevation.

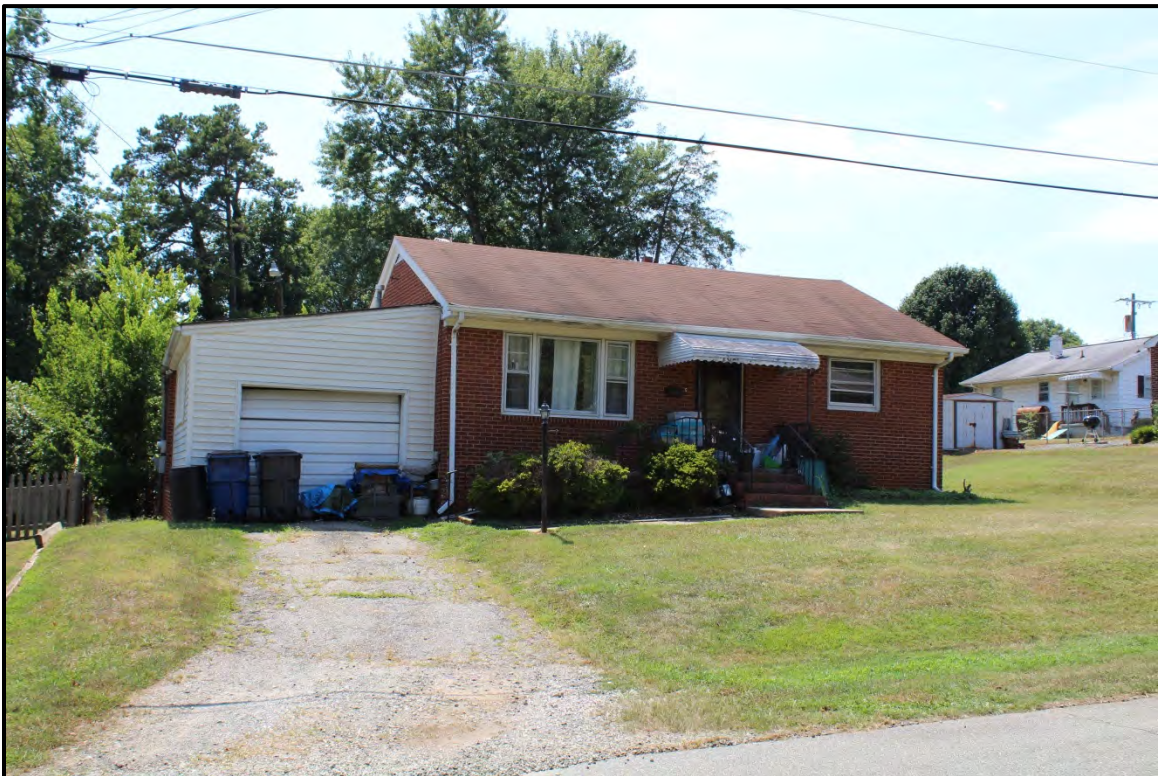
The one-story, wood-frame building features a side-gabled roof, brick veneer, and a brick foundation. The façade elevation holds a 2/2 horizontal sash window as well as one Chicago window. A concrete and brick stoop with an aluminum awning, iron handrail, and balustrade leads to the main entry. Attached to the southeast elevation is an enclosed carport.

NRHP Assessment. Architectural resource AM2580 does not exhibit a distinctive architectural style or workmanship. In addition, the house has been altered through the construction of the garage addition to the southeast elevation. Based on the lack of architectural merit, as well as the inability to associate the house and/or its original owner(s) with an important historical event or series of events, it is TRC's opinion that architectural resource AM2580 is not eligible for the NRHP.

Figure 6.184. Architectural resource AM2580; view is northwest featuring the façade.

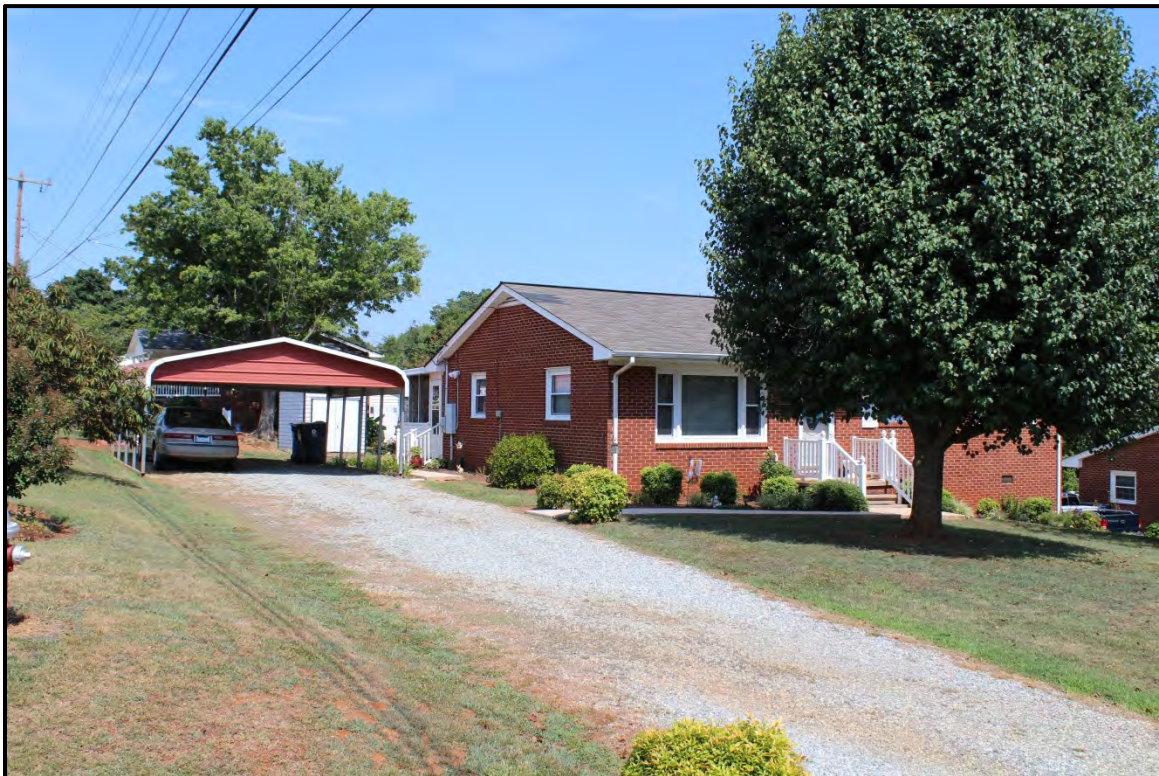
The one-story, wood-frame building features a side-gabled roof, brick exterior, and a brick foundation. The façade elevation holds both a three-part picture window and 1/1 vinyl sash windows. The side (northwest) elevation also contains 1/1 vinyl sash windows. A concrete and brick stoop with a vinyl handrail leads to the main entry, which is filled with a vinyl door.

NRHP Assessment. Architectural resource AM2581 does not exhibit a distinctive architectural style or workmanship. In addition, the house has been altered through the replacement of the original window sashes. Based on the lack of architectural merit, as well as the inability to associate the house and/or its original owner(s) with an important historical event or series of events, it is TRC’s opinion that architectural resource AM2581 is not eligible for the NRHP.

Figure 6.185. Architectural resource AM2581; view is east featuring the façade and northwest elevation.
