Re: Revised Architectural Survey Report, MVP Southgate Project, Construct Interstate Pipeline, Rockingham and Alamance County, ER 18-1041

Thank you for your letter of October 11, 2019, transmitting the draft "Historic Architectural Survey for the MVP Southgate Pipeline Project". We have reviewed the report and offer the following comments.

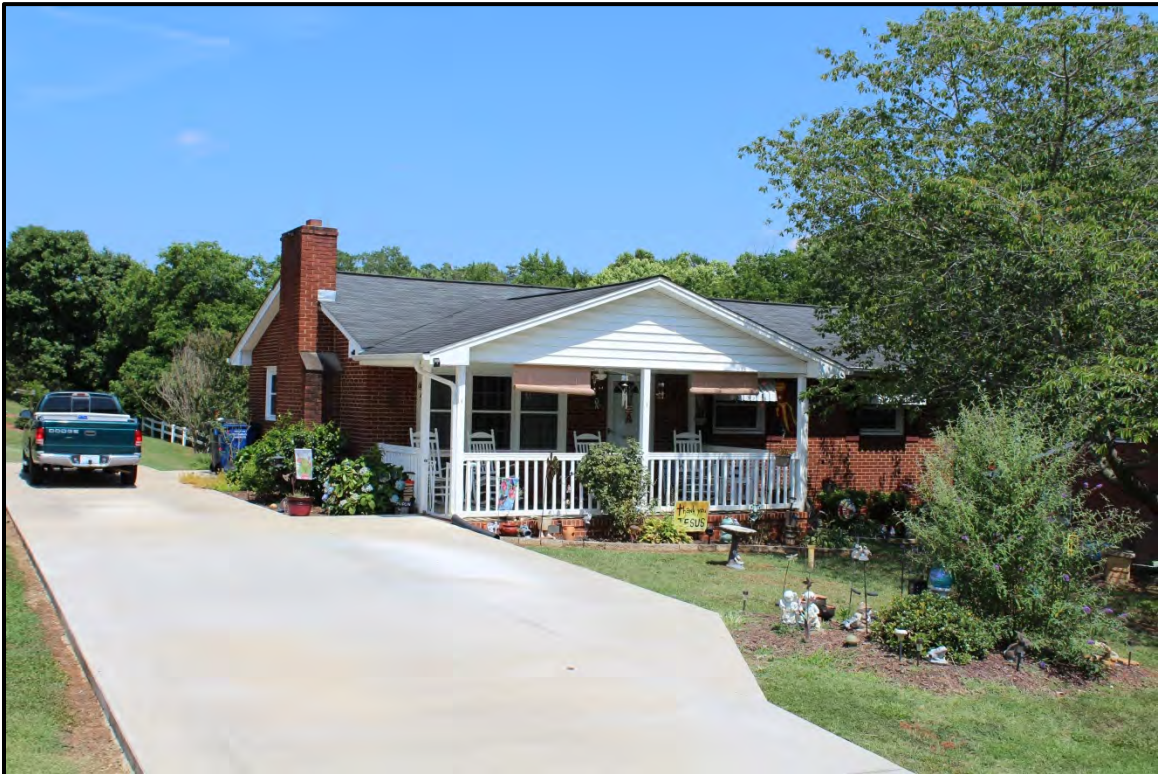
The wood-frame building features a side-gabled roof, brick exterior, and a brick foundation. The façade elevation holds 6/6 vinyl sash windows and the main entry is filled with a replacement door. Also located on the primary elevation is a gable porch addition supported by vinyl columns. The side (northwest) elevation contains an exterior brick chimney.

NRHP Assessment. Architectural resource AM2582 does not exhibit a distinctive architectural style or workmanship. In addition, the house has been altered through the construction of the modern porch on the façade and the replacement of the original window sashes. Based on the lack of architectural merit, as well as the inability to associate the house and/or its original owner(s) with an important historical event or series of events, it is TRC's opinion that architectural resource AM2582 is not eligible for the NRHP.

Figure 6.186. Architectural resource AM2582; view is east featuring the façade and northwest elevation.

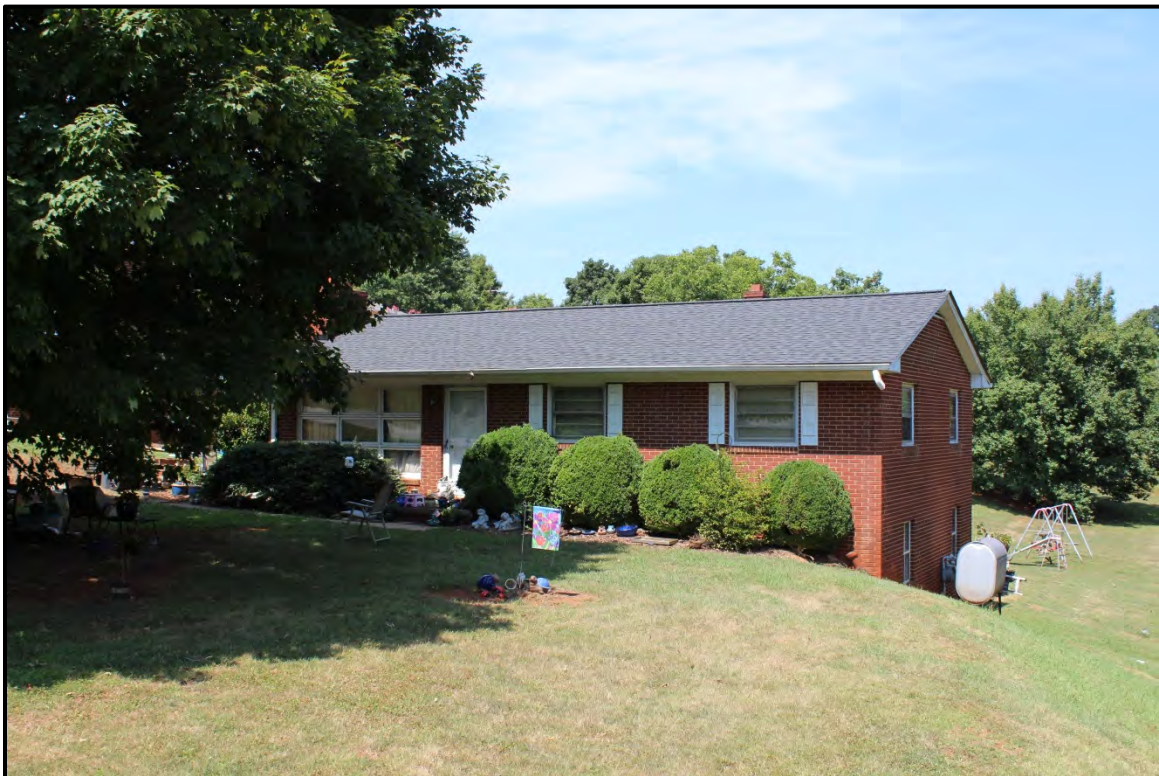
The wood-frame building features a side-gabled roof, brick exterior, and a brick foundation. The façade elevation holds horizontal 2/2 windows. Located on the side (southeast) elevation are 1/1-windows. The house also contains two interior brick chimneys.

NRHP Assessment. Architectural resource AM2583 does not exhibit a distinctive architectural style or workmanship. Based on the lack of architectural merit, as well as the inability to associate the house and/or its original owner(s) with an important historical event or series of events, it is TRC's opinion that architectural resource AM2583 is not eligible for the NRHP.

Figure 6.187. Architectural resource AM2583; view is northeast featuring the façade and southeast elevation.

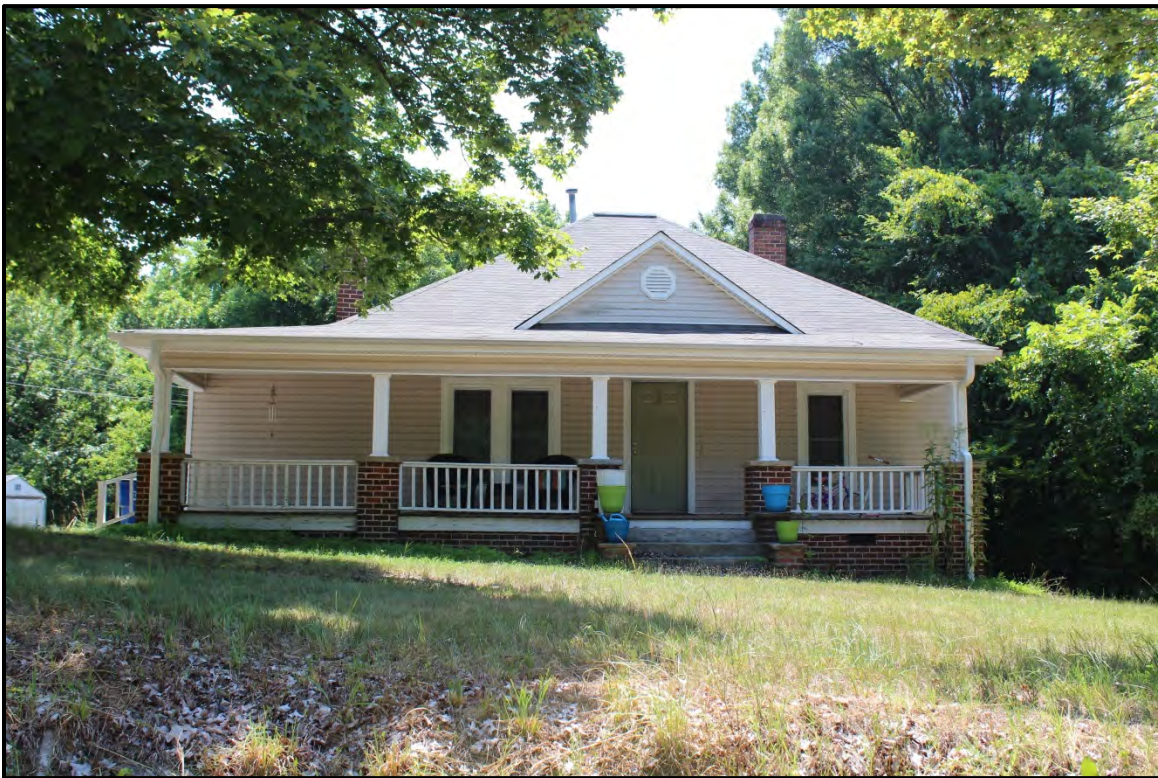
The one-story, wood-frame building features a roof covered with asphalt shingles, vinyl siding, and a brick foundation. The façade elevation holds 1/1 vinyl sash windows and contains a wraparound porch with a wood deck and concrete steps. Supporting the porch are vinyl-clad columns with a brick base. The house also contains two interior brick chimneys.

NRHP Assessment. Architectural resource AM2584 does not exhibit a distinctive architectural style or workmanship. In addition, the house has been altered through the application of vinyl siding and the replacement of the original window sashes. Based on the lack of architectural merit, as well as the inability to associate the house and/or its original owner(s) with an important historical event or series of events, it is TRC's opinion that architectural resource AM2584 is not eligible for the NRHP.

Figure 6.188. Architectural resource AM2584; view is southwest featuring the façade.

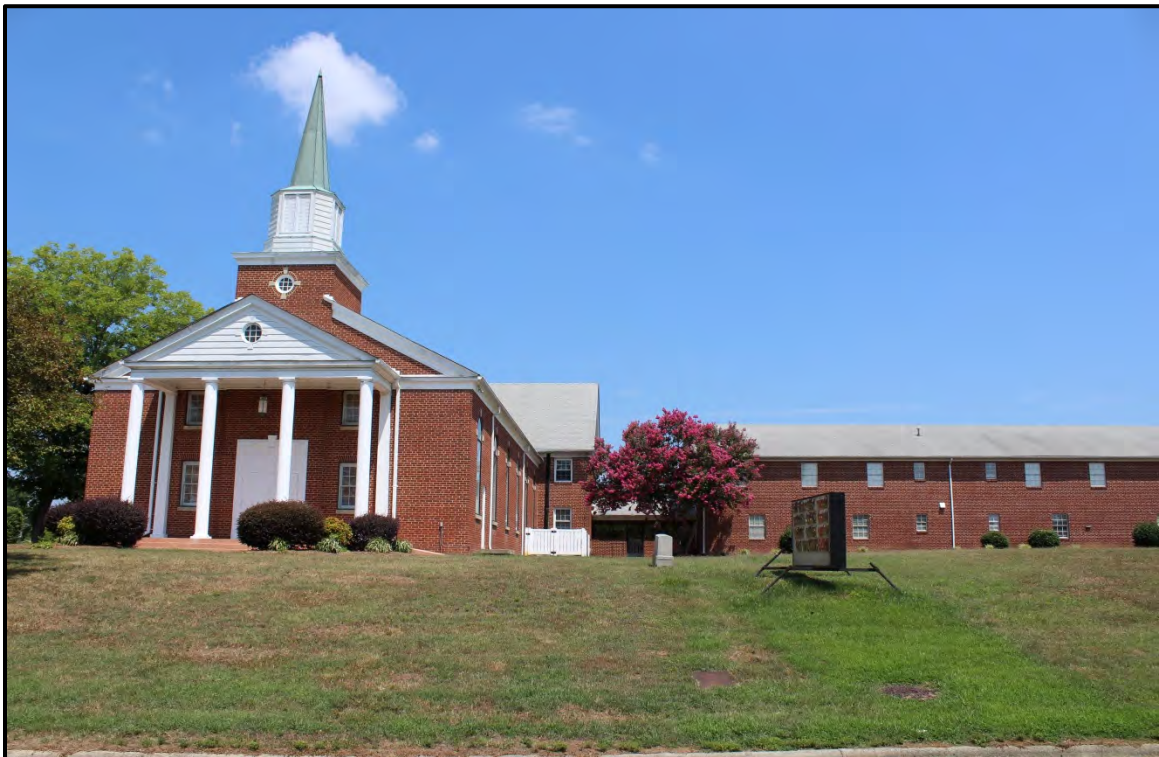
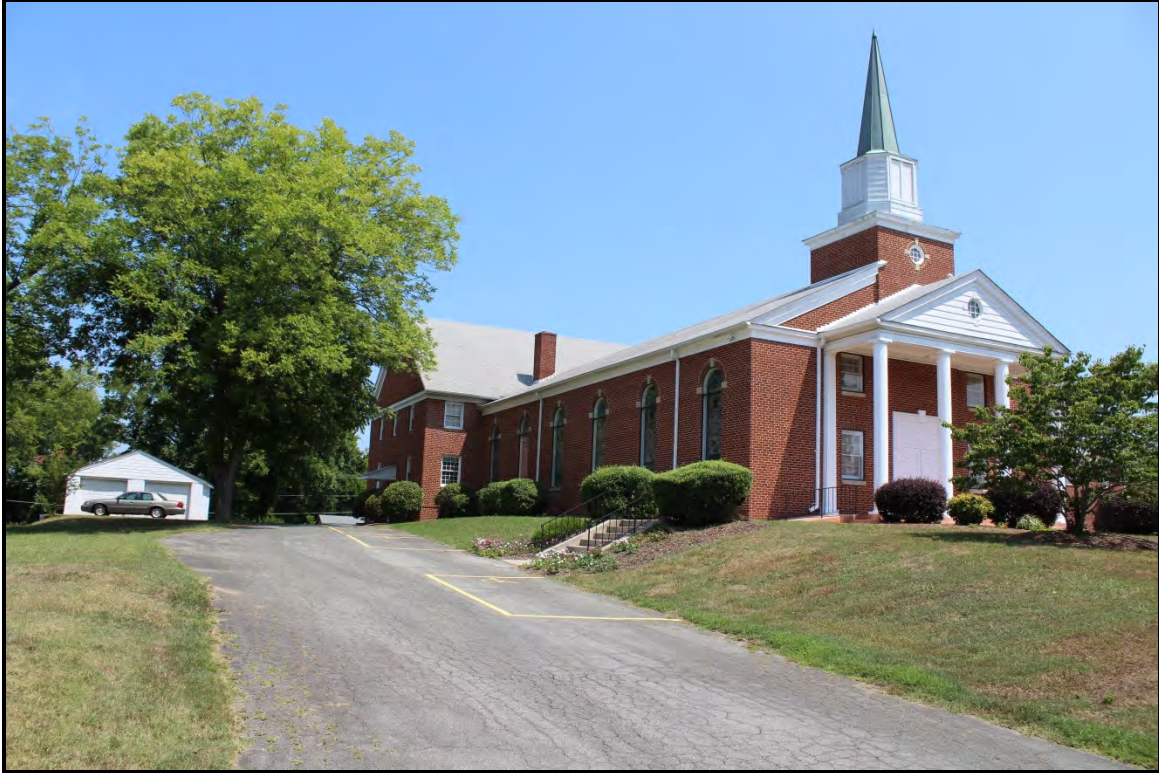
The Neoclassical-style building features a gabled roof with asphalt shingles and a brick foundation. The church building includes a main sanctuary in the front and a ca. 1970 wing added to the side (northeast) elevation. The façade elevation includes a pediment with an oculus and a porch supported by round columns. The building contains a mixture of original and replaced 6/6 windows as well as stained glass windows on the east and west elevations of the main sanctuary block. The property also includes a modern concrete block garage.

NRHP Assessment. In accordance with NRHP Criteria Consideration A, religious buildings are normally not eligible for the NRHP unless they derive their primary significance from architectural or artistic distinction or are considered to be of historical importance. The property cannot be associated with important historical event(s) or person(s). Due to lack of the historic and architectural significance it is TRC's opinion that architectural resource AM2585 is not eligible for the NRHP.

Figure 6.189. Architectural resource AM2585; view is northwest featuring the façade.

Figure 6.190. Architectural resource AM2585; view is northeast featuring the southwest elevation.

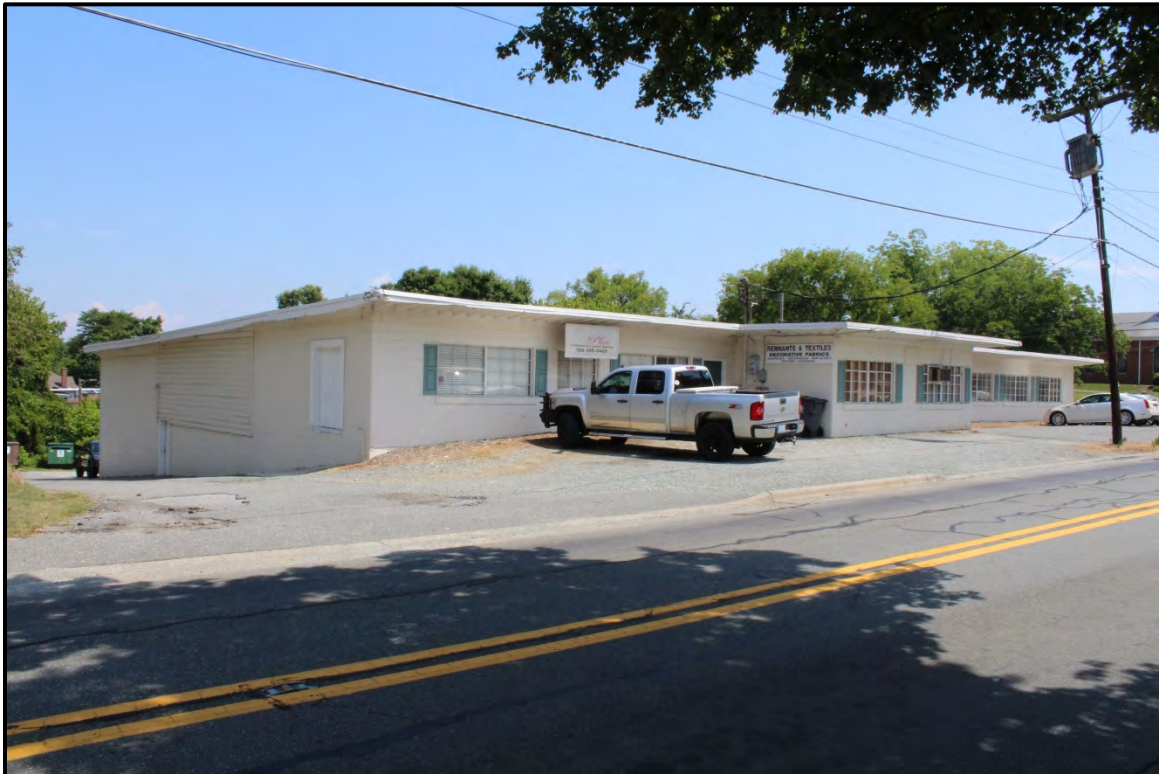
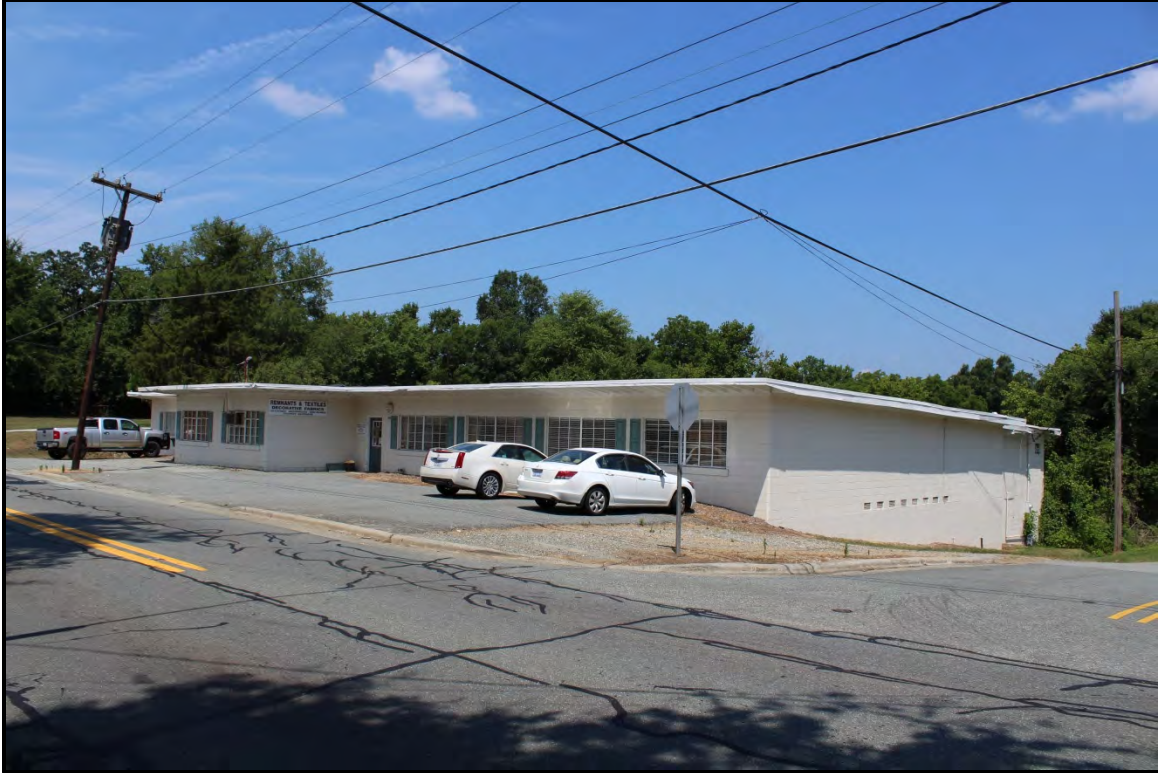
The one-story, concrete block building features a flat roof with exposed rafter tails, aluminum trim, rounded corners, and a concrete block foundation. The façade elevation holds 12-light single and paired metal sash windows with vinyl shutters. A paved parking lot in front of the building on the primary elevation.

NRHP Assessment. Architectural resource AM2586 does not exhibit a distinctive architectural style or workmanship. Based on the lack of architectural merit, as well as the inability to associate the house and/or its original owner(s) with an important historical event or series of events, it is TRC's opinion that architectural resource AM2586 is not eligible for the NRHP.

Figure 6.191. Architectural resource AM2586; view is northeast featuring the façade and southwest elevation.

Figure 6.192. Architectural resource AM2586; view is west featuring the northeast elevation.

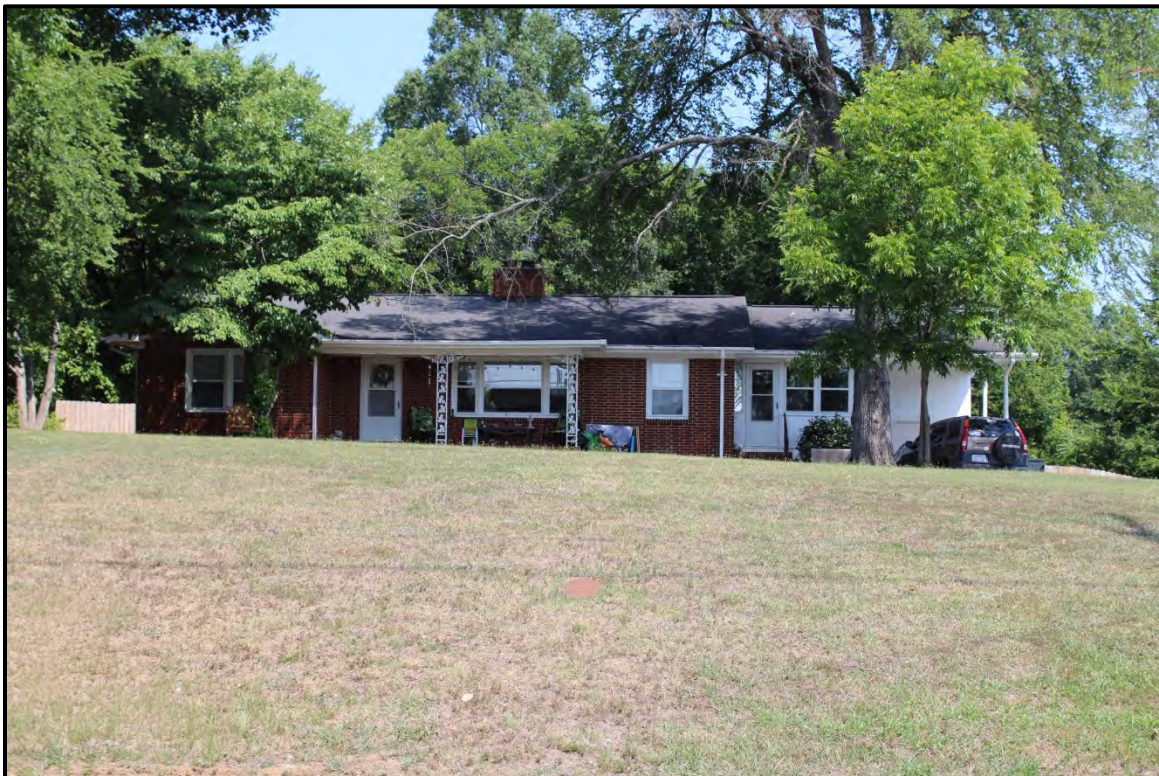
The wood-frame building features a side-gabled roof with asphalt shingles, brick exterior, and a brick foundation. The façade elevation holds a three-part picture window as well as 1/1 vinyl sash windows. The primary elevation contains a partial width porch supported by decorative columns and a central interior brick chimney. Attached to the southeast elevation is a carport supported by synthetic columns.

NRHP Assessment. Architectural resource AM2587 does not exhibit a distinctive architectural style or workmanship. In addition, the house has been altered through the installation of vinyl sashes and the enclosure of the carport. Based on the lack of architectural merit, as well as the inability to associate the house and/or its original owner(s) with an important historical event or series of events, it is TRC's opinion that architectural resource AM2587 is not eligible for the NRHP.

Figure 6.193. Architectural resource AM2587; view is northwest featuring the façade.

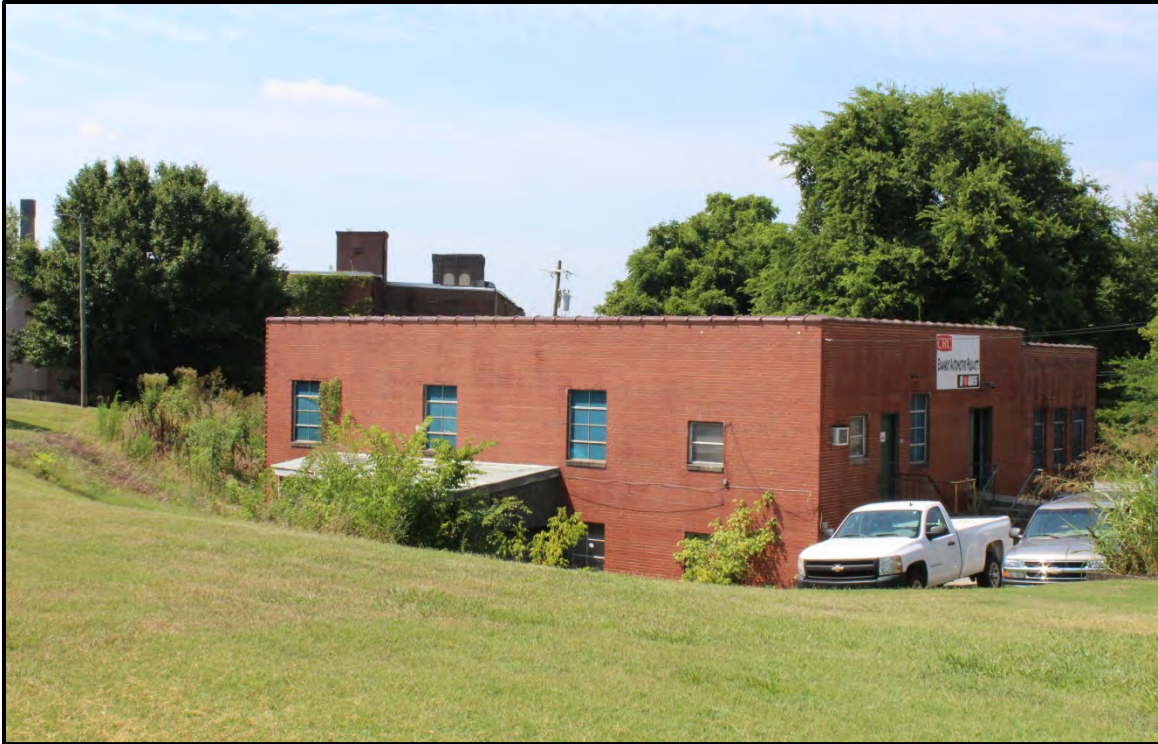
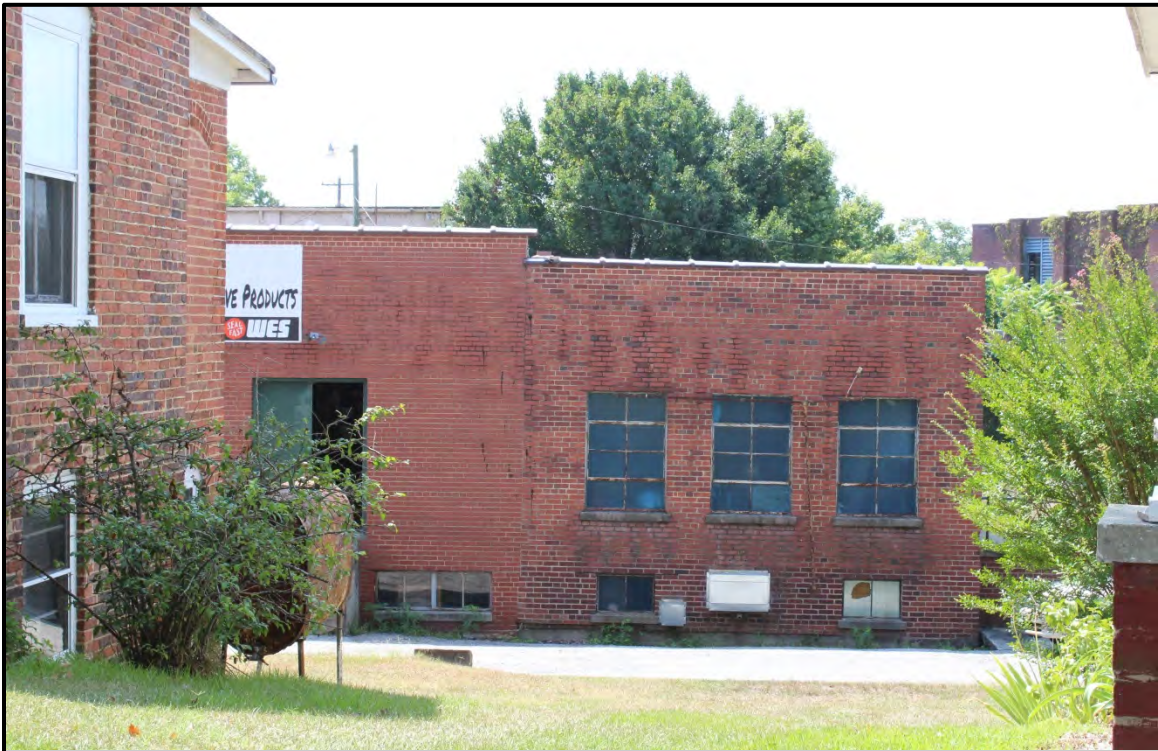
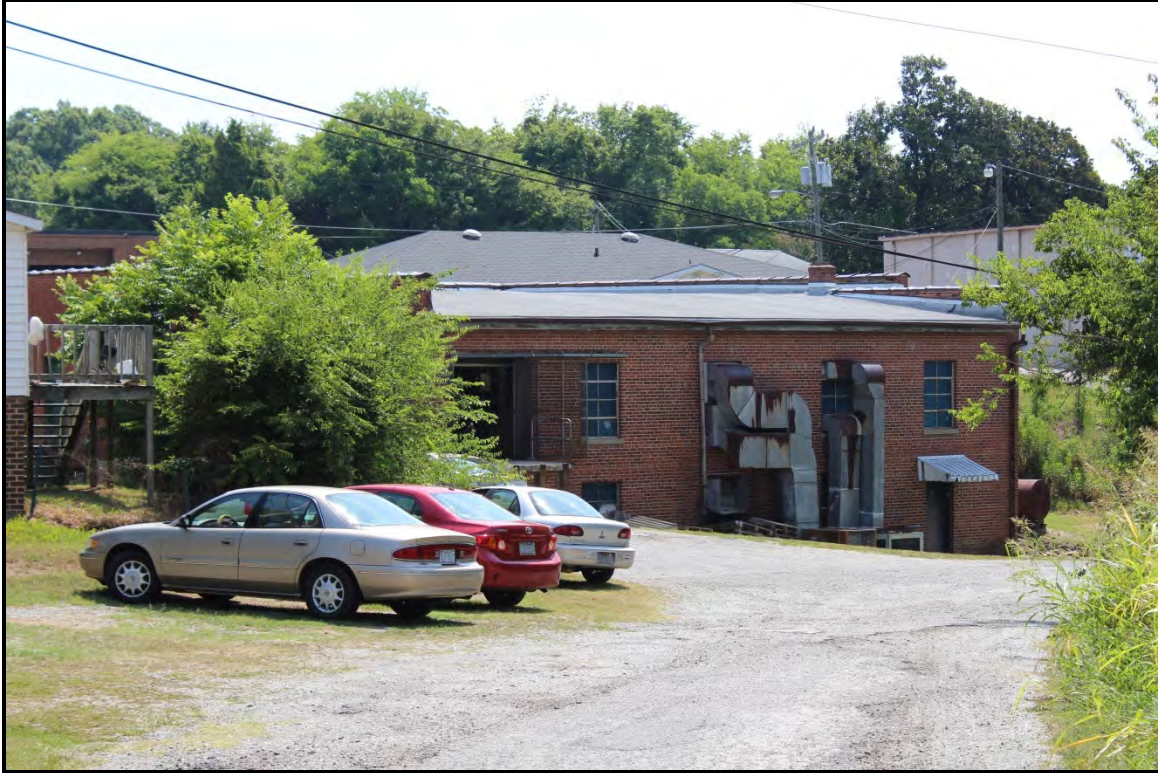
The one-story, brick commercial building features terra cotta coping and eight-light metal awning sash windows on the façade elevation. This sash style is repeated on the remaining elevations. The primary entry has a metal door and includes a concrete loading dock (Figures 6.194 and 6.196).

Figure 6.194. Architectural resource AM2588; view is south featuring the northeast corner of the commercial building.

Figure 6.195. Architectural resource AM2588; view is southeast featuring a portion of the northwest elevation of the commercial building.

Figure 6.196. Architectural resource AM2588; view is east featuring the southwest (rear) elevation of the commercial building.

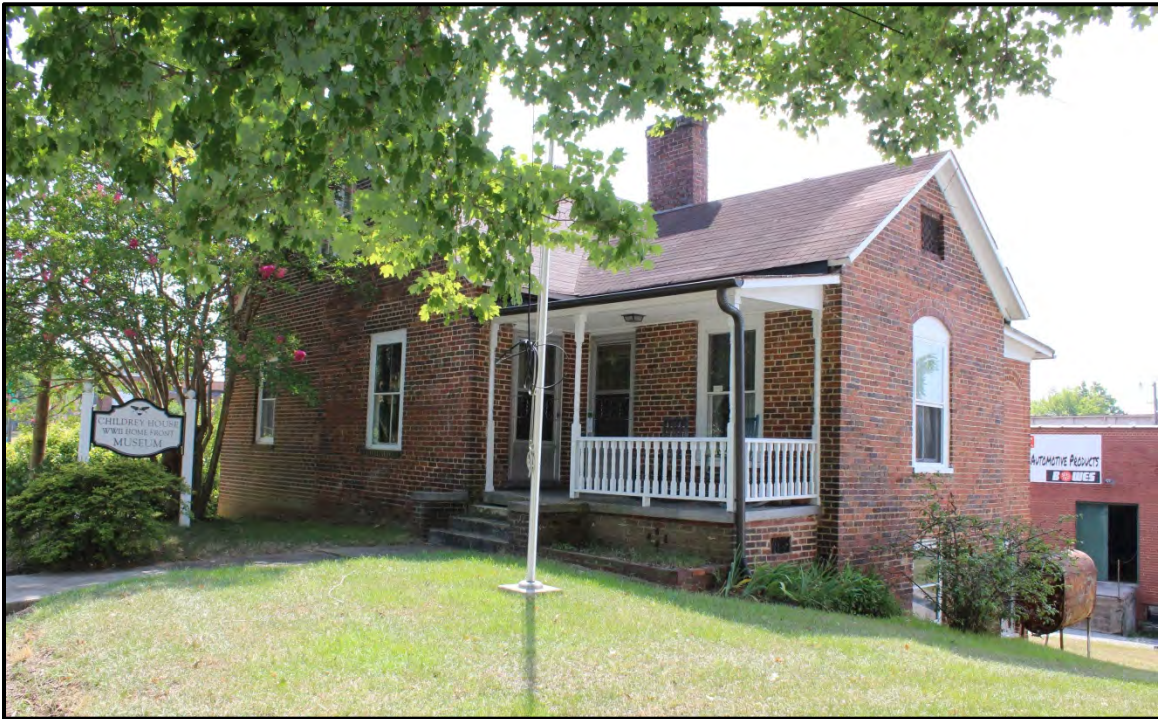
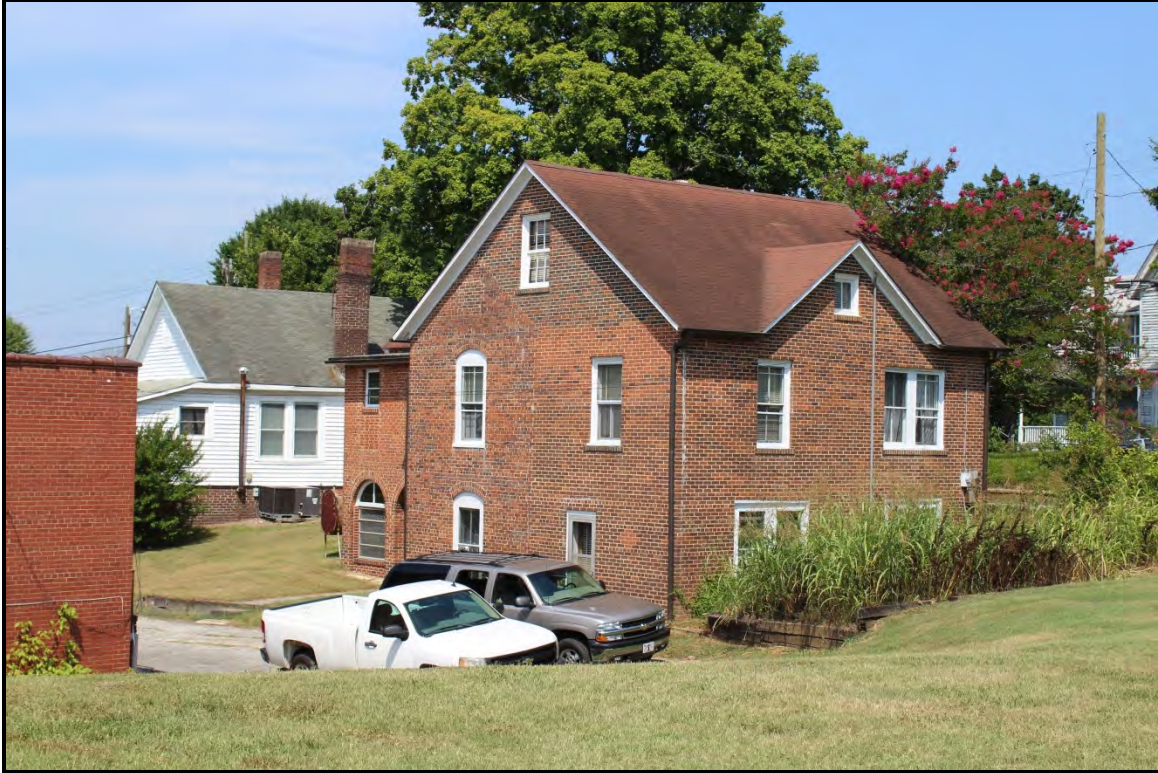
The Folk Victorian-style house is currently used as the Childrey House World War Two Home Front Museum (Figures 6.197 and 6.198). The two-story brick house features mixed common and American bond masonry. The house has a front gable and ell roof with asphalt shingles, brick exterior, and a brick foundation. The front gable is enlarged to two bays and the façade elevation holds 2/2 wood sash windows. The primary elevation contains a partial width porch supported by synthetic columns and a central interior brick chimney.

NRHP Assessment. Architectural resource AM2588 does not exhibit a distinctive architectural style or workmanship. In addition, the Folk Victorian-style house has been altered through the reconstruction of the façade porch. Based on the lack of architectural merit, as well as the inability to associate the buildings and/or its original owner(s) with an important historical event or series of events, it is TRC’s opinion that architectural resource AM2588 is not eligible for the NRHP.

Figure 6.197. Architectural resource AM2588; view is southeast featuring the façade and southwest elevation of the Folk Victorian-style house.

Figure 6.198. Architectural resource AM2588; view is northwest featuring the east and south (rear) elevations of the Folk Victorian-style house.

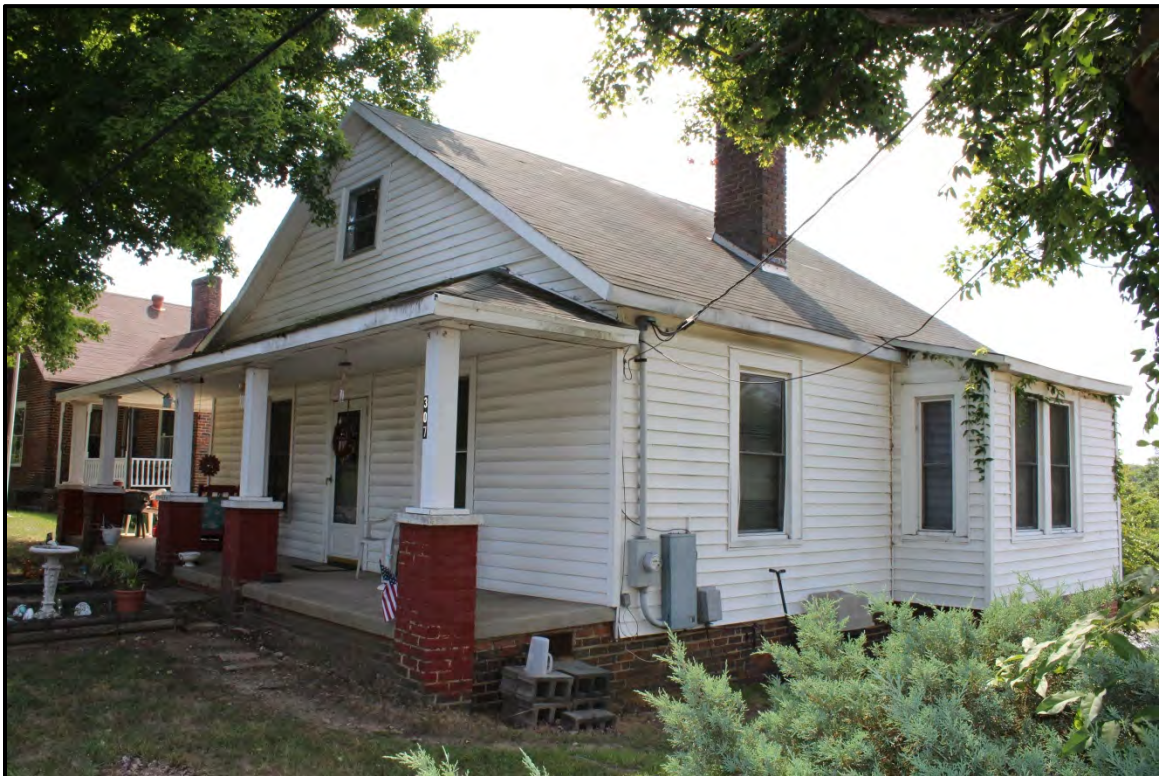
The one and one-half--story, wood-frame building features an asphalt shingle roof, vinyl siding, and a brick foundation. The façade and side (west) elevation hold 1/1 vinyl sash windows and the house features an interior brick chimney. On the primary elevation is a concrete slab wrap porch supported by synthetic square columns on brick piers.

NRHP Assessment. Architectural resource AM2589 does not exhibit a distinctive architectural style or workmanship. In addition, the house has been altered through the application of vinyl siding and the replacement of the original window sashes. Based on the lack of architectural merit, as well as the inability to associate the house and/or its original owner(s) with an important historical event or series of events, it is TRC's opinion that architectural resource

Figure 6.199. Architectural resource AM2589; view is southeast featuring the façade and southwest elevation.

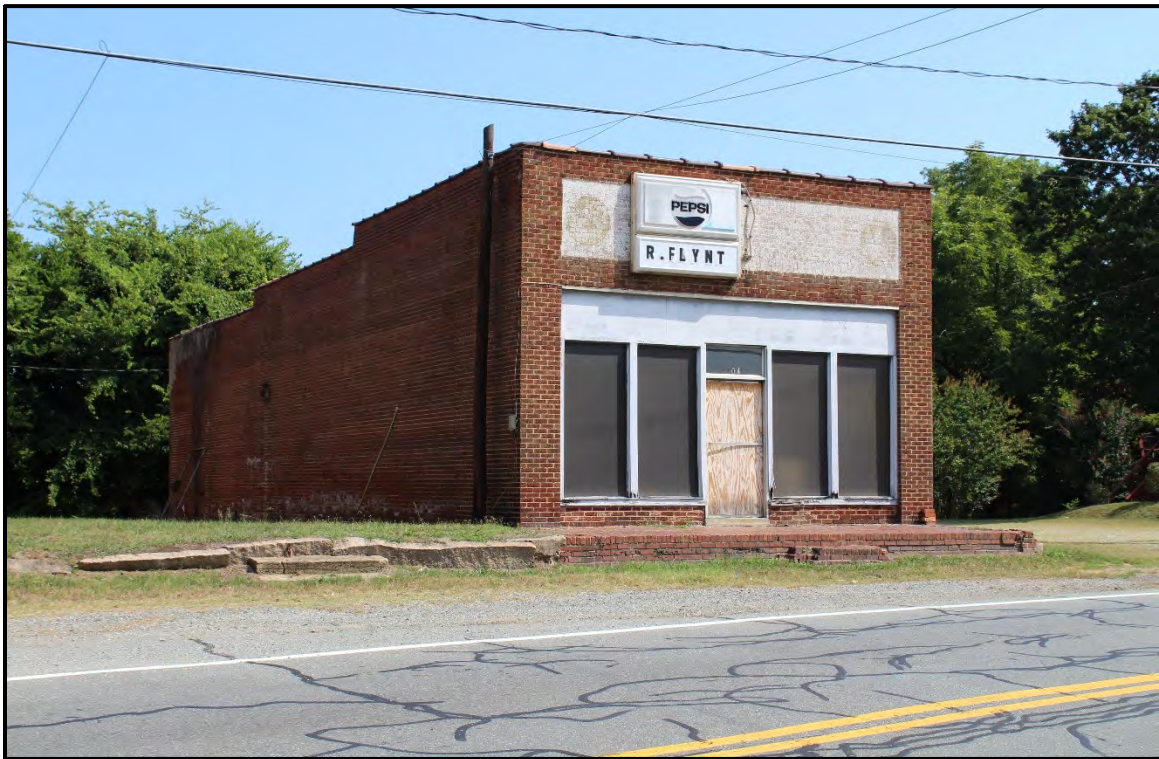
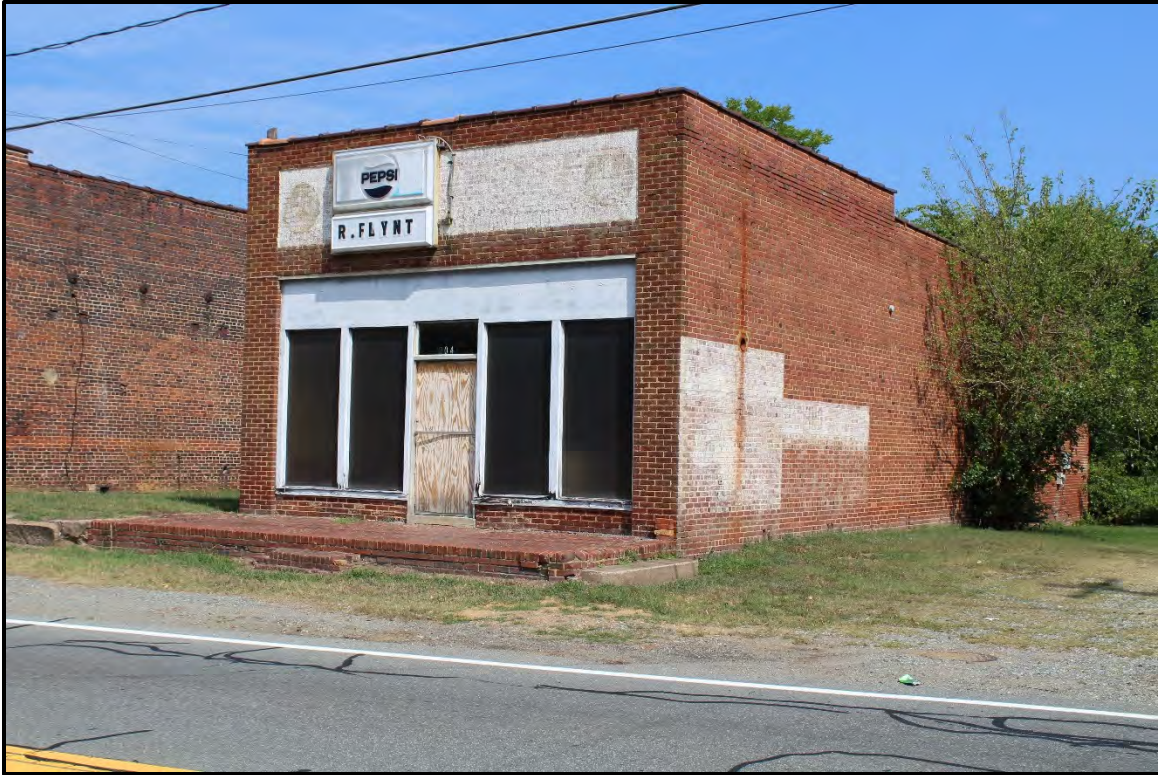
The single-story brick building features a flat roof, terra cotta coping, and a brick foundation. The façade elevation contains a replaced storefront and a brick sidewalk. Located on the primary elevation is a modern Pepsi sign that reads “R. Flynt.”

NRHP Assessment. Architectural resource AM2590 does not exhibit a distinctive architectural style or workmanship. In addition, the building has been altered through the replacement of the original storefront windows. Based on the lack of architectural merit, as well as the inability to associate the building and/or its original owner(s) with an important historical event or series of events, it is TRC’s opinion that architectural resource AM2590 is not eligible for the NRHP.

Figure 6.200. Architectural resource AM2590; view is northeast featuring the façade and southwest elevation.

Figure 6.201. Architectural resource AM2590; view is northwest featuring the façade and southeast elevation.

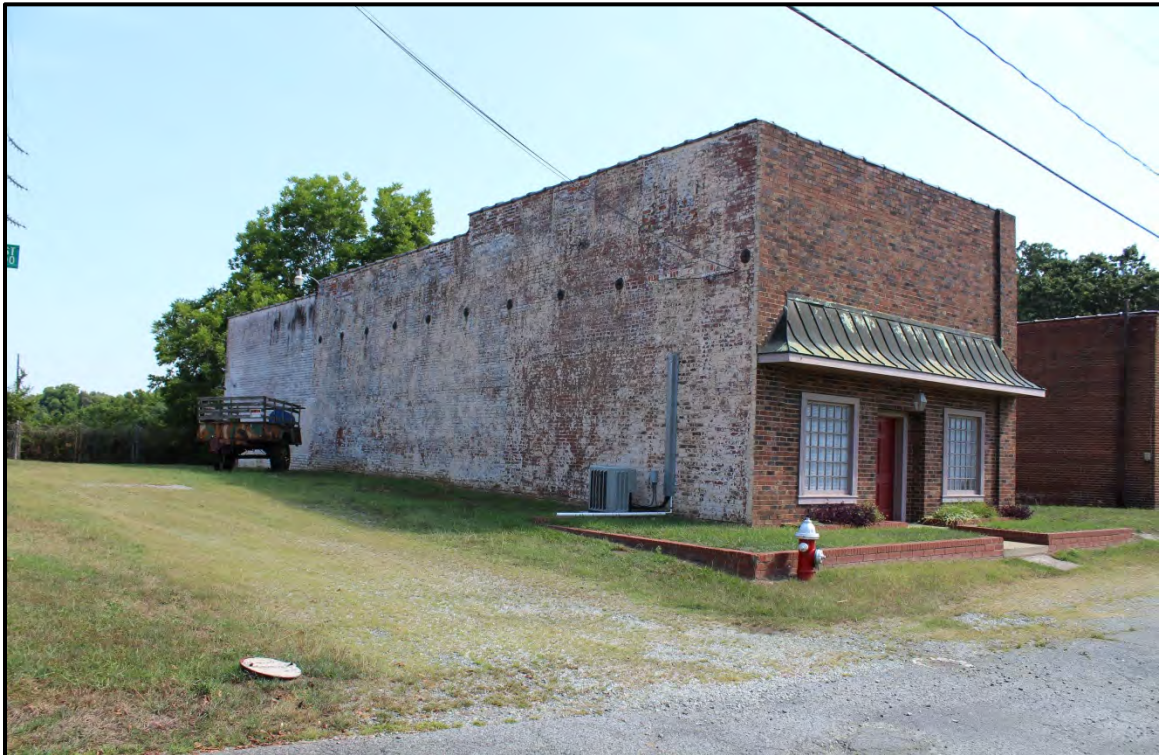
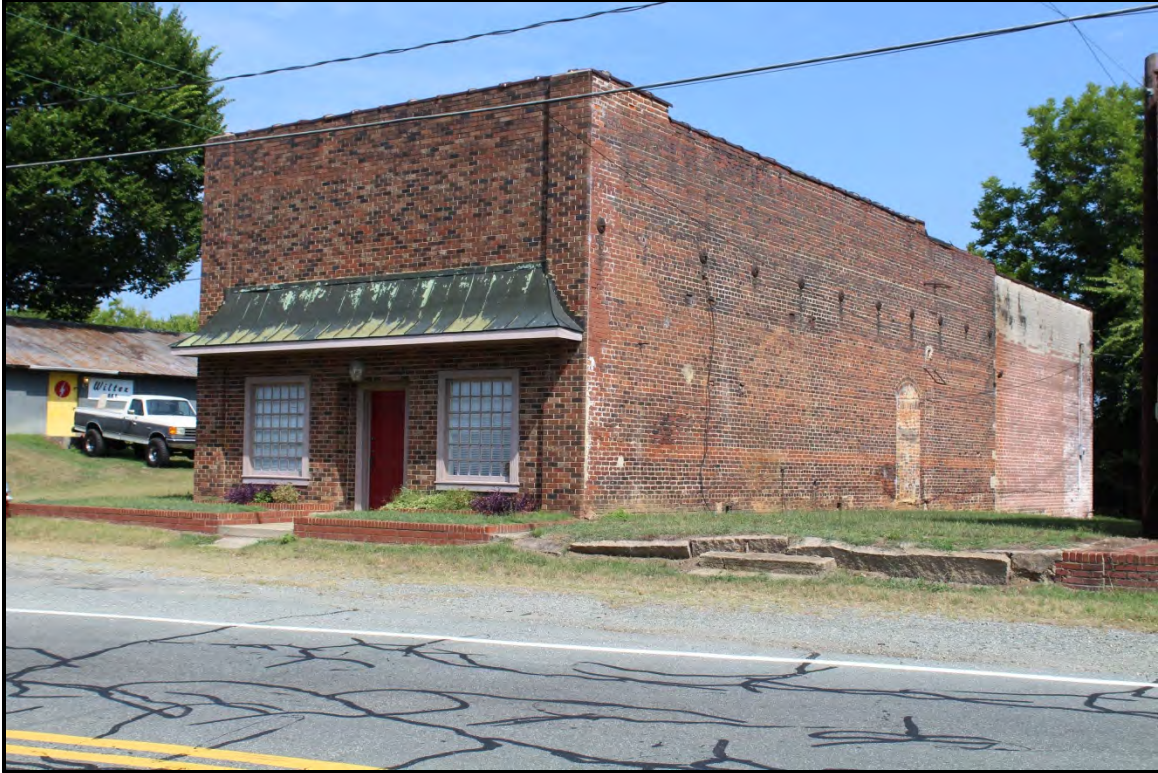
The one-story, brick building features a flat roof, terra cotta coping, and a brick foundation. The primary elevation contains replaced wood sash store windows and the main entry is filled with a replaced door. Located on the façade elevation is a pent roof attached above the first-floor windows.

NRHP Assessment. Architectural resource AM2592 does not exhibit a distinctive architectural style or workmanship. In addition, the building has been altered through the remodeling of the original storefront to include modern windows, entrance, and entrance canopy. Based on the lack of architectural merit, as well as the inability to associate the house and/or its original owner(s) with an important historical event or series of events, it is TRC’s opinion that architectural resource AM2592 is not eligible for the NRHP.

Figure 6.202. Architectural resource AM2592; oblique view featuring the façade and southwest elevation.

Figure 6.203. Architectural resource AM2592; oblique view featuring the façade and southeast elevation.

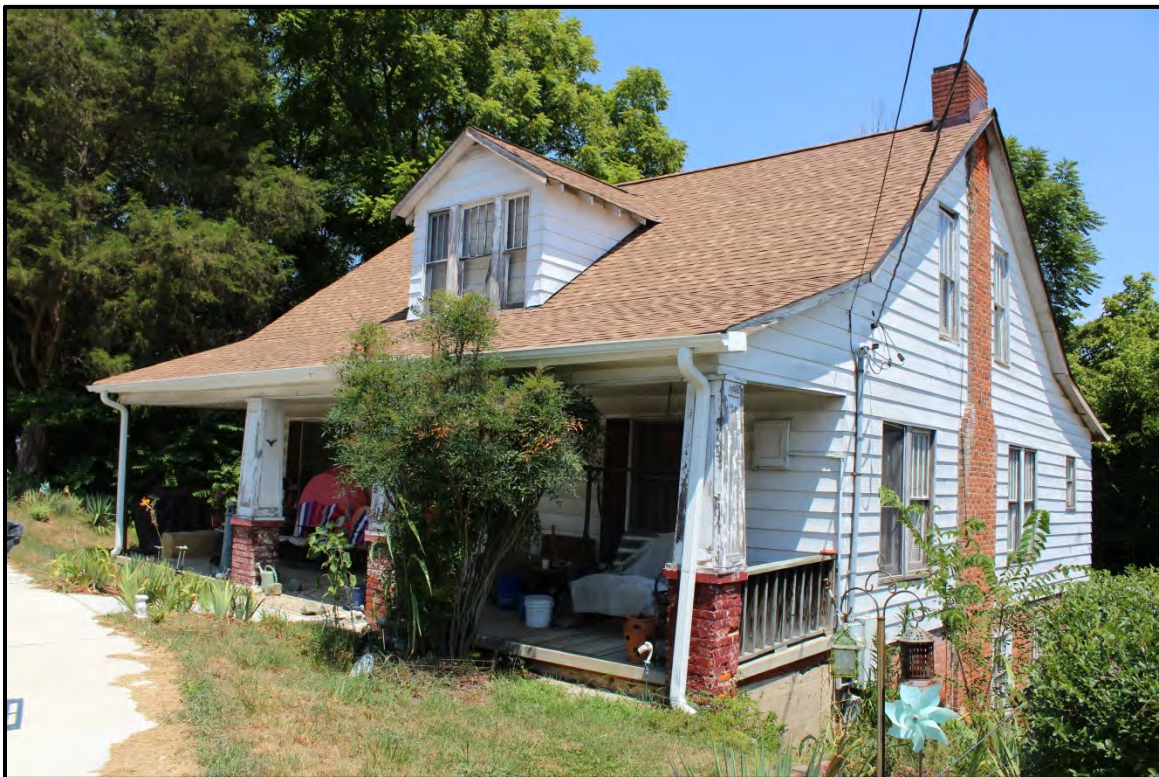
The one and one-half story, wood-frame house features a side-gabled roof covered with asphalt shingles, an exterior end brick chimney, and an aluminum siding-clad exterior. Fenestration includes 4/1 double-hung wood sash windows. A full-width porch provides access to the main entrance and is integral with the main roof, which is partially supported by tapered wood columns set atop brick plinth blocks. The porch features a modern concrete block deck.

NRHP Assessment. Architectural resource AM2593 does not exhibit a distinctive architectural style or workmanship. In addition, the house has been altered through the application of aluminum siding. Based on the lack of architectural merit, as well as the inability to associate the house and/or its original owner(s) with an important historical event or series of events, it is TRC's opinion that architectural resource AM2593 is not eligible for the NRHP.

Figure 6.204. Architectural resource AM2593; view is northeast featuring the façade and southwest elevation.

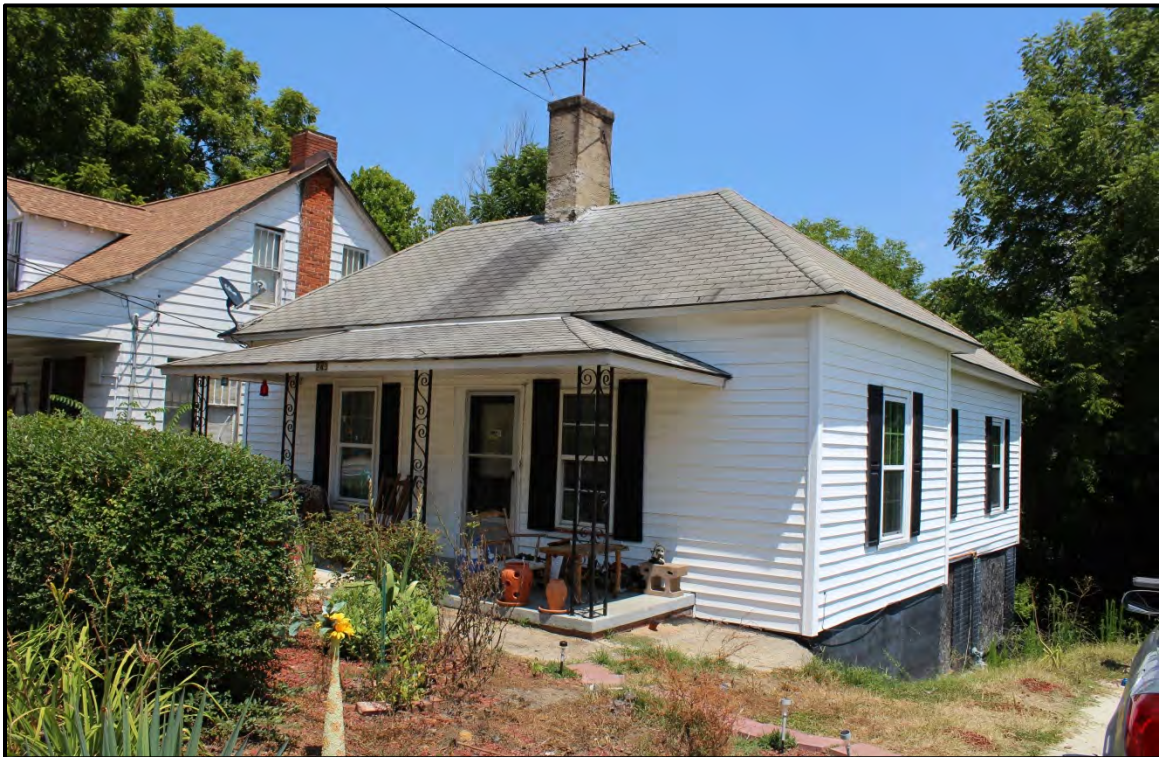
that the one-story, wood-frame house features a roof covered with asphalt shingles, an interior central concrete chimney, a vinyl siding-clad exterior, and a brick pier foundation with concrete block infill. Fenestration includes 6/6 double-hung vinyl sash windows. A reconstructed partial-width porch provides access to the main entrance and features a hipped roof that is supported by ornamental metal columns and a concrete slab deck.

NRHP Assessment. Architectural resource AM2594 does not exhibit a distinctive architectural style or workmanship. In addition, the house has been altered through the application of vinyl siding, the replacement of the original porch, and the installation of vinyl sashes. Based on the lack of architectural merit, as well as the inability to associate the house and/or its original owner(s) with an important historical event or series of events, it is TRC's opinion that architectural resource AM2594 is not eligible for the NRHP.

Figure 6.205. Architectural resource AM2594; view is northeast and features the façade and south elevation.

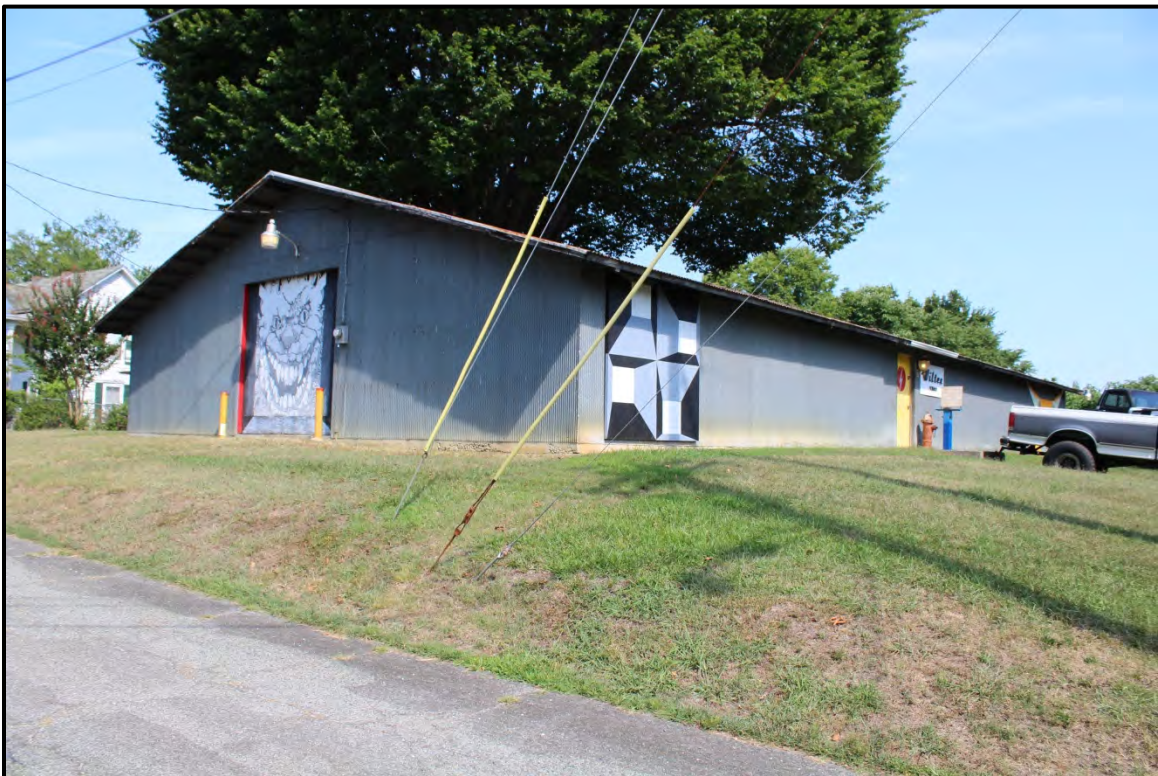
that the one-story, wood-frame building features a side-gabled roof covered with metal sheeting, an exterior clad with metal sheeting, and a continuous concrete foundation. Fenestration includes an overhead bay door on the south elevation and a pedestrian door on the east elevation.

NRHP Assessment. Architectural resource AM2595 does not exhibit a distinctive architectural style or workmanship. Based on the lack of architectural merit, as well as the inability to associate the building and/or its original owner(s) with an important historical event or series of events, it is TRC's opinion that architectural resource AM2595 is not eligible for the NRHP.

Figure 6.206. Architectural resource AM2595; view is northwest and features the south and east elevations.
